UK Highways Bridge Management

Principal Inspection Report Menai Bridge (Structure Ref. A5 Menai Bridge)

December 2019

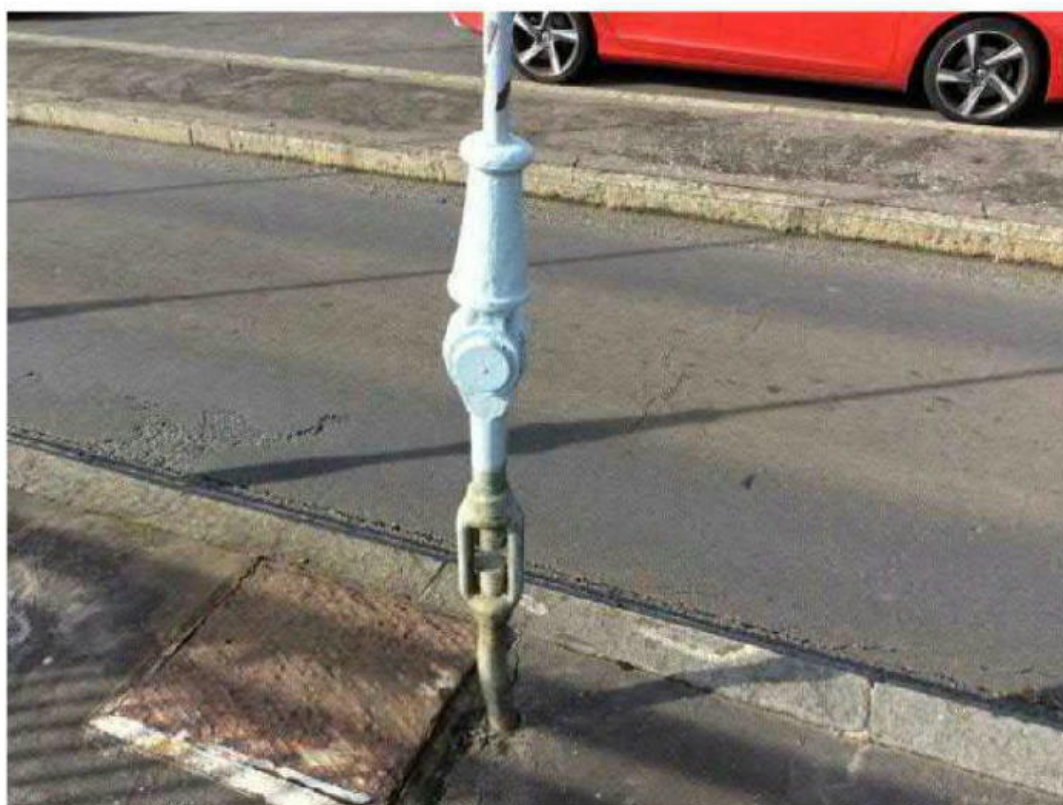
Figure 26: Tie bar - monitor the possible vehicle impact damage to the east 4th hanger south of the south tower. Bent lower section and paint loss to cable

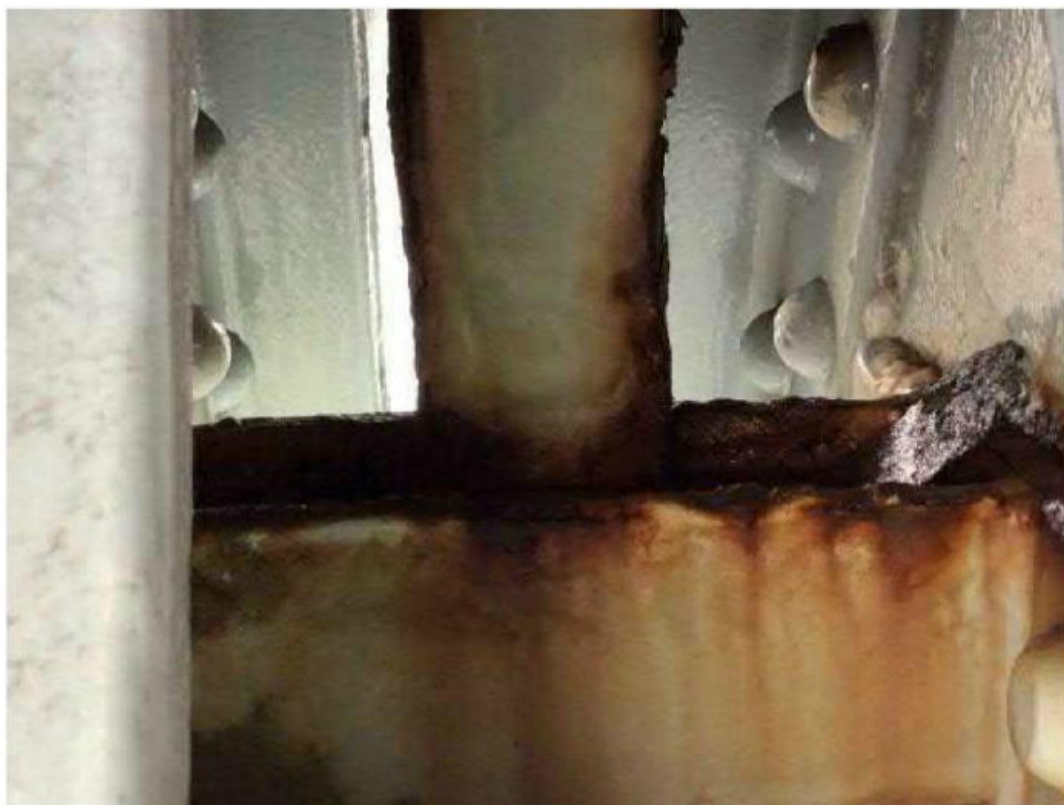
Figure 29: Tie bars - localised paint loss, corrosion and minor section loss to the 34no (17no each side) square drop link bar lower portion. east

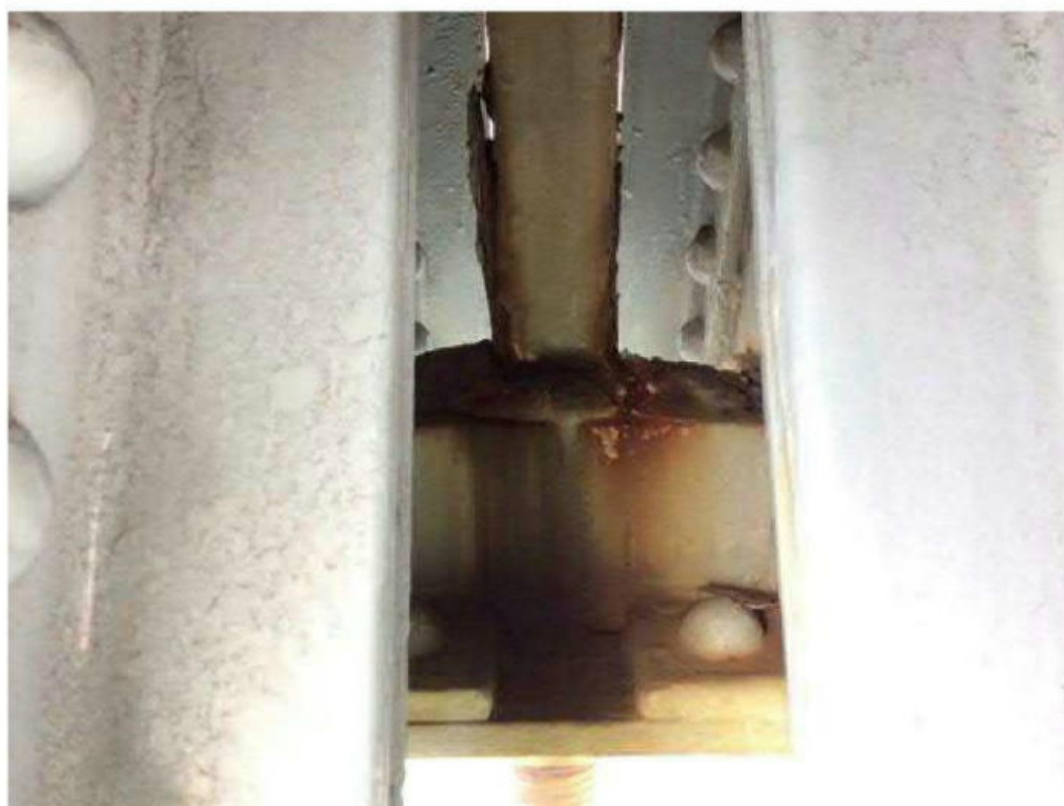
Figure 30: Tie bars - localised paint loss, corrosion and minor section loss to the 34no (17no each side) square drop link bar lower portion. east

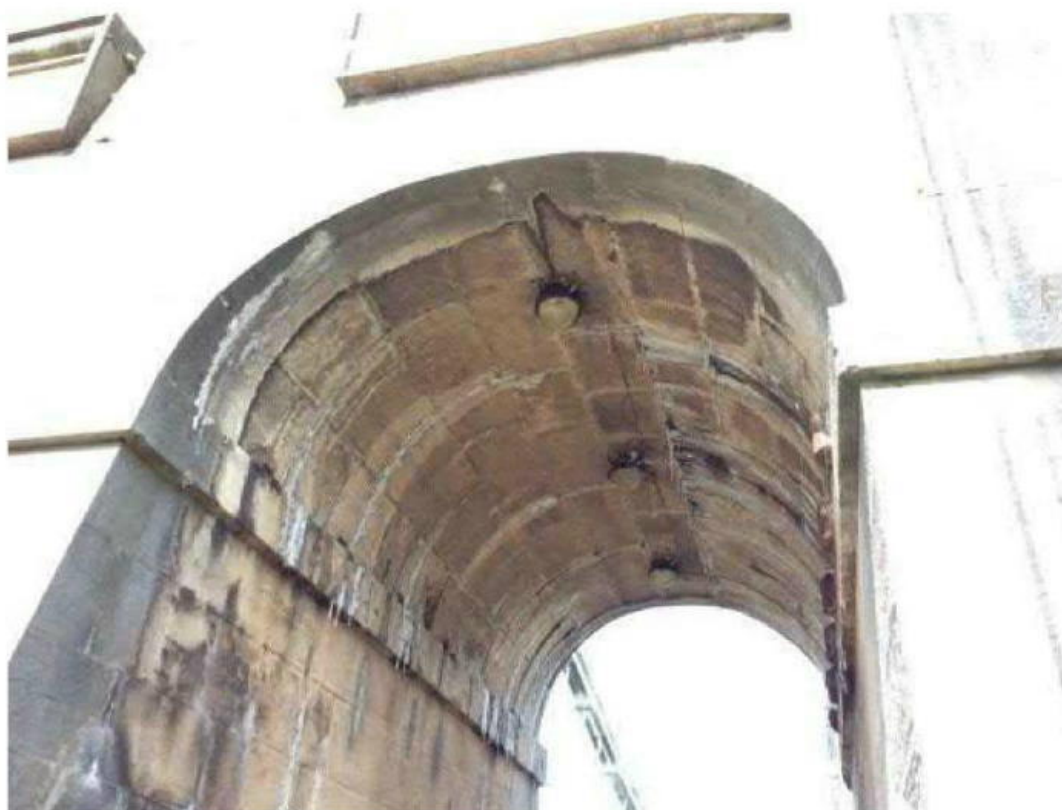
Figure 32: Secondary deck element/s - Transverse beams - monitor several small areas of efflorescence, stalactites and damp staining to the lower transverse arches. typical to south east arch intrados

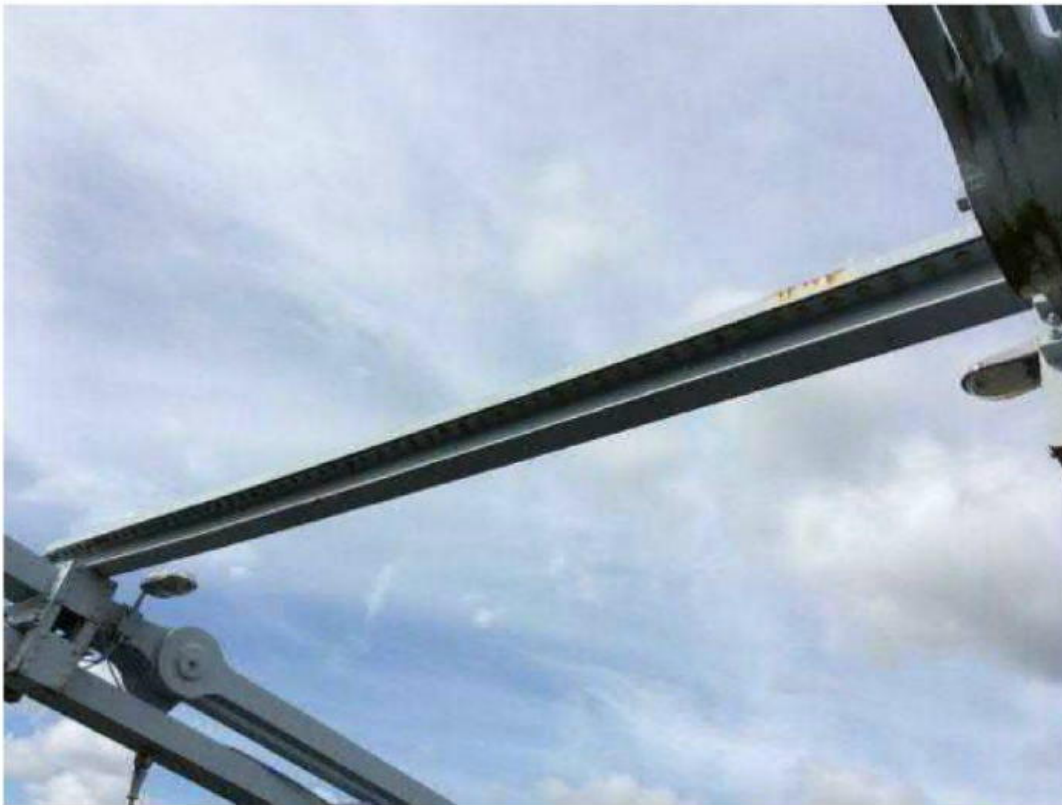
Figure 33: Bracing - Transverse beams - monitor minor paint loss and corrosion to north transverse chain brace mainly to bolt heads

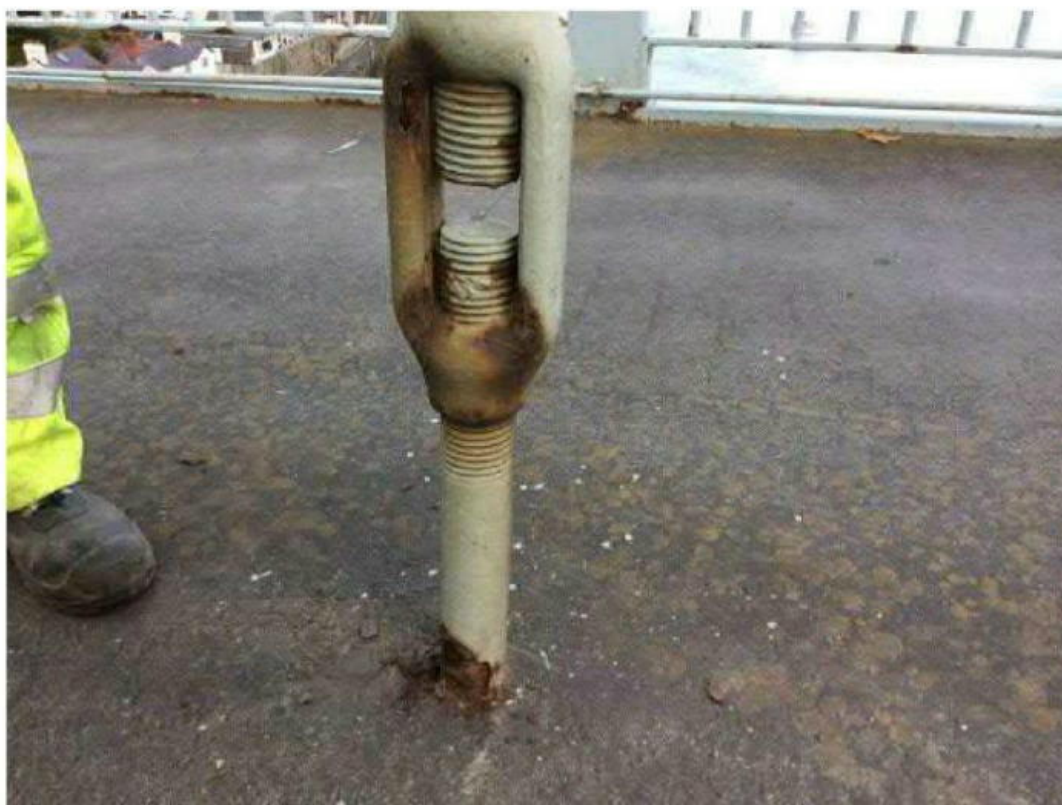
Figure 35: Tie beam/rod - monitor the small areas of paint loss and surface corrosion to lower tie bars particularly to the east at 21m north of north tower

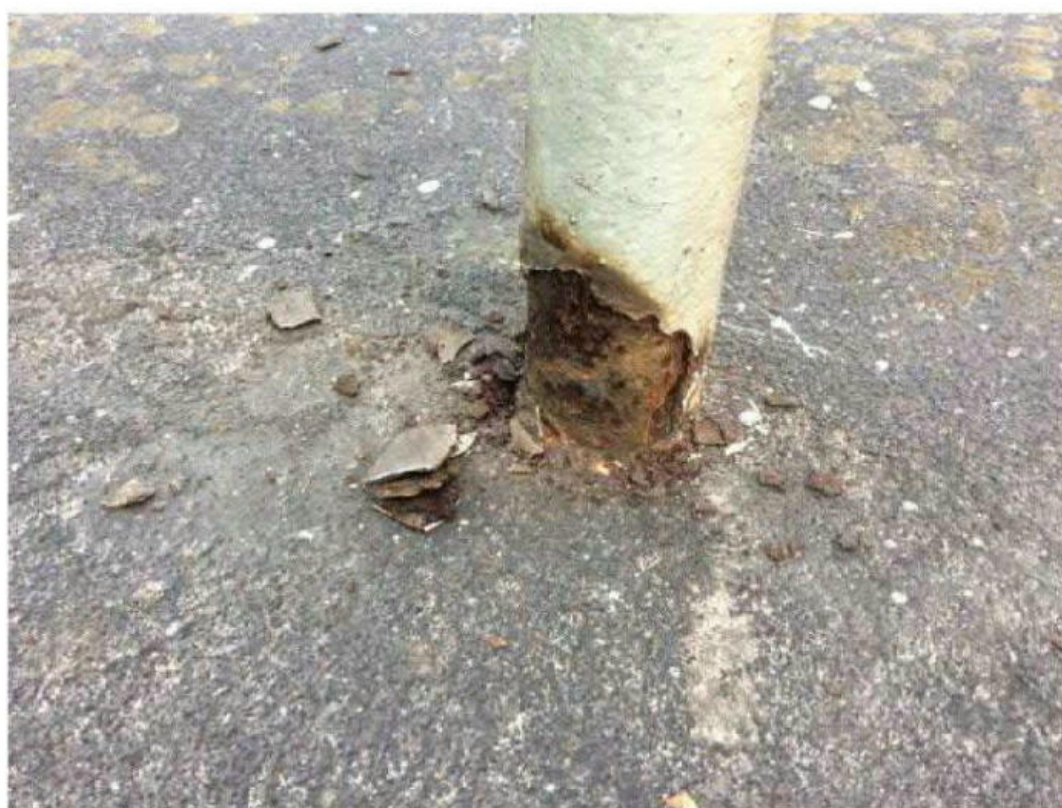
Figure 36: Tie beam/rod – close up of the small areas of paint loss and surface corrosion to lower tie bars particularly to the east at 21m north of north tower

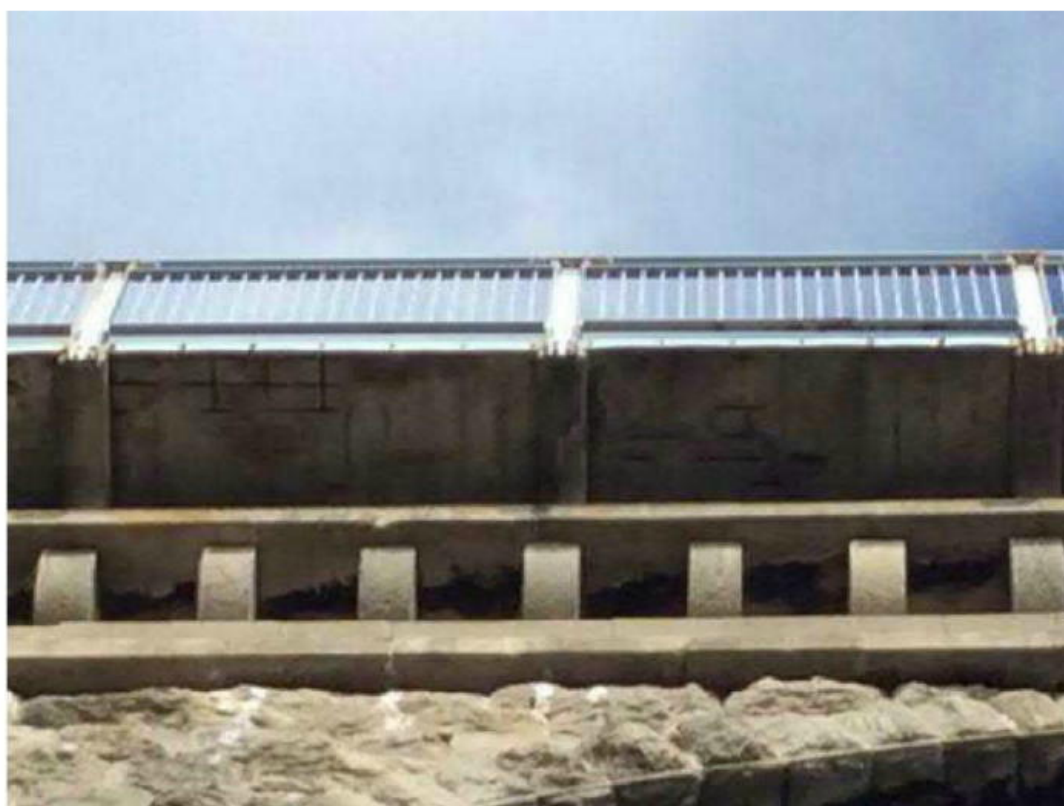
Figure 38: Parapet beam or cantilever - wide areas of spalling and exposed rebar to soffit of cantilevered footway to the west of spans 1-4

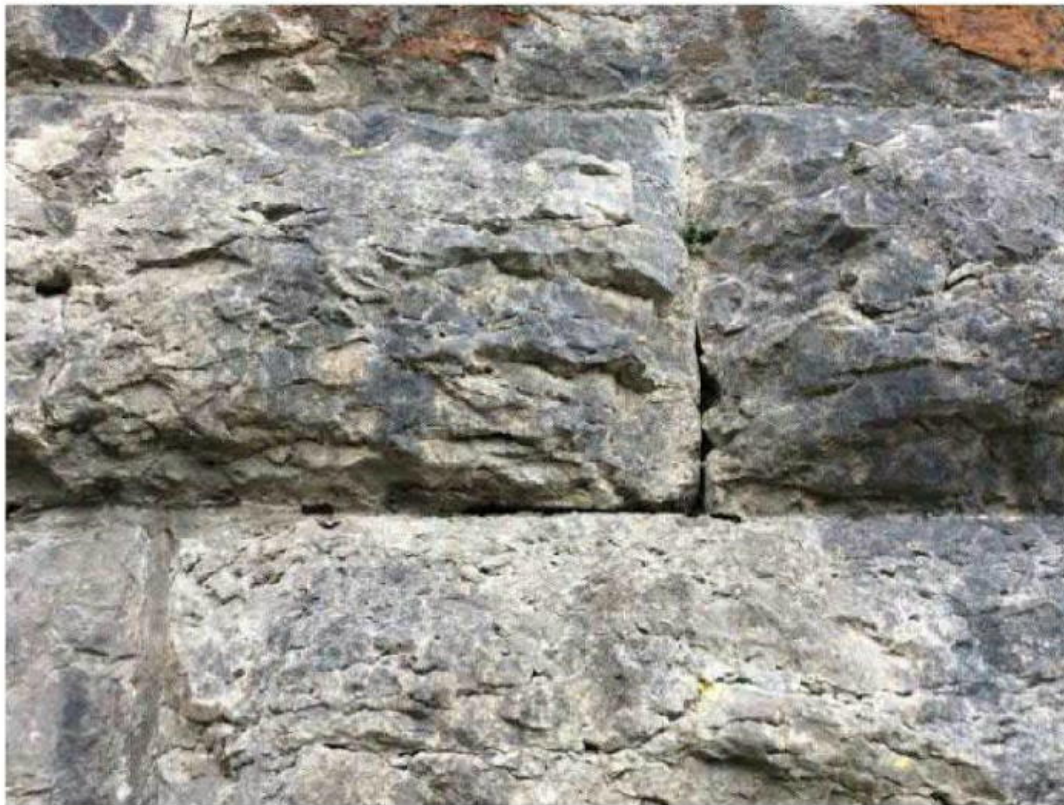
Figure 39: Abutments (incl arch springing) - several small areas of deep mortar loss to the north abutment particularly to west face

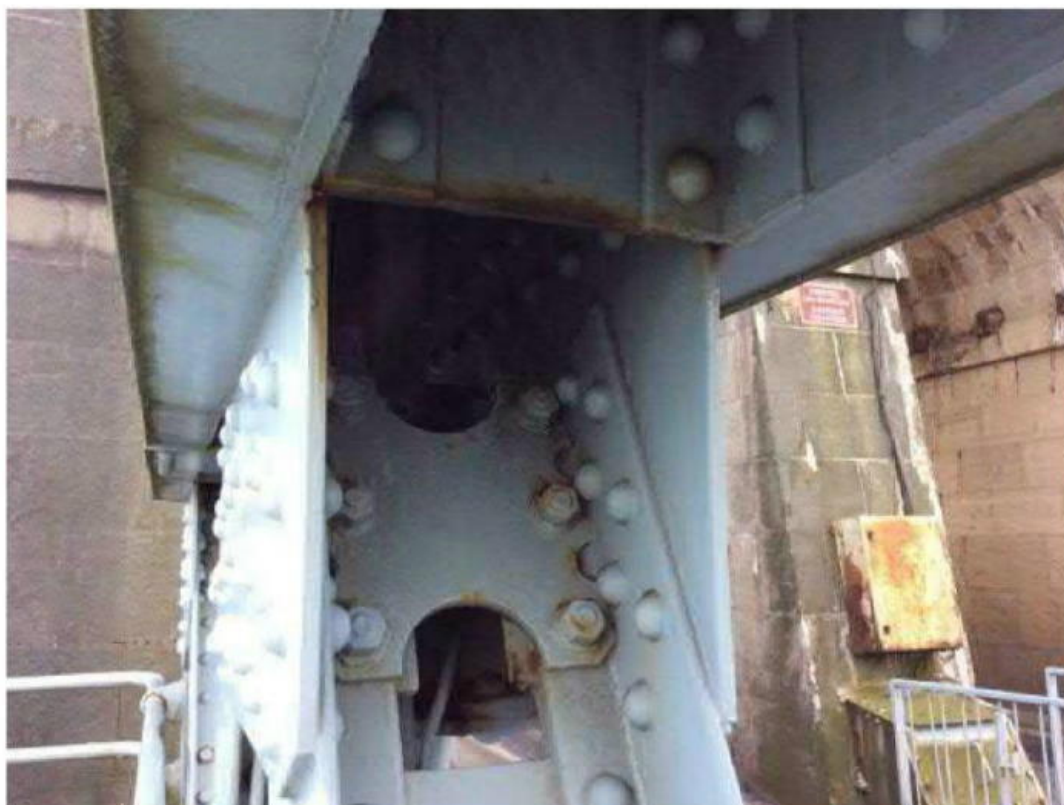
Figure 43: Finishes: deck elements - monitor to small areas of paint loss, minor corrosion and rust staining throughout the centre span truss members, particularly the bolts, rivets and plate ends. east side 4m north of south tower

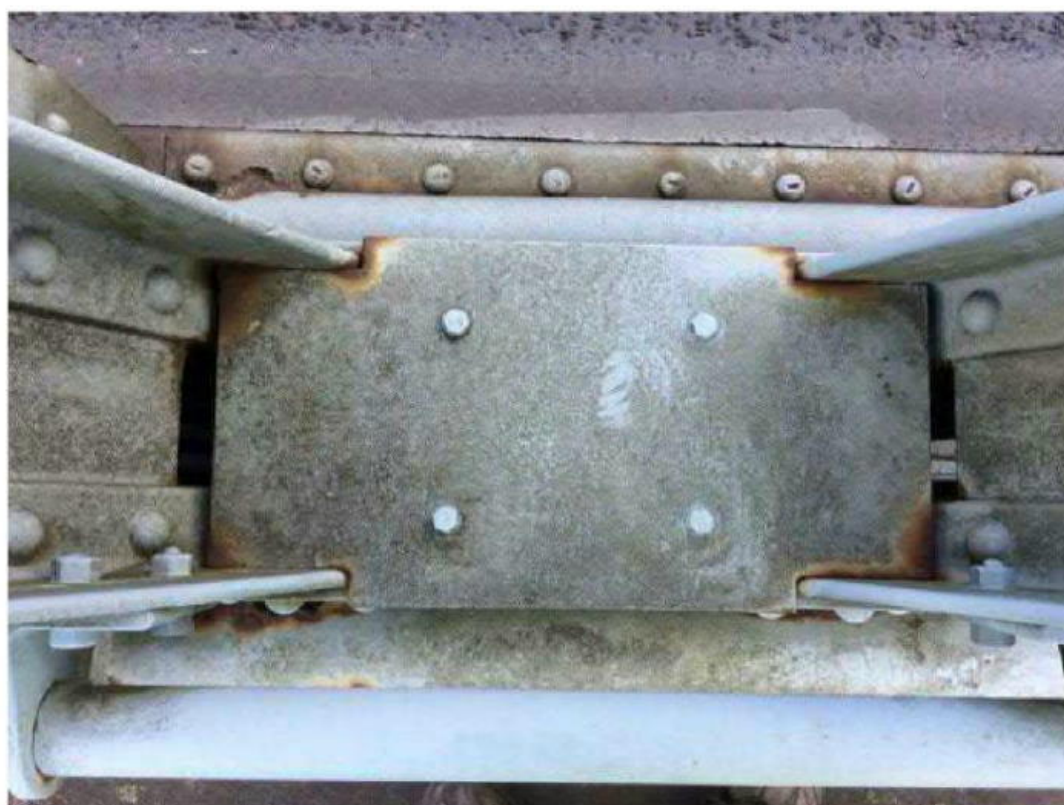
Figure 44: Finishes: deck elements - monitor to small areas of paint loss, minor corrosion and rust staining throughout the centre span truss members, particularly the bolts, rivets and plate ends. east side 4m north of south tower

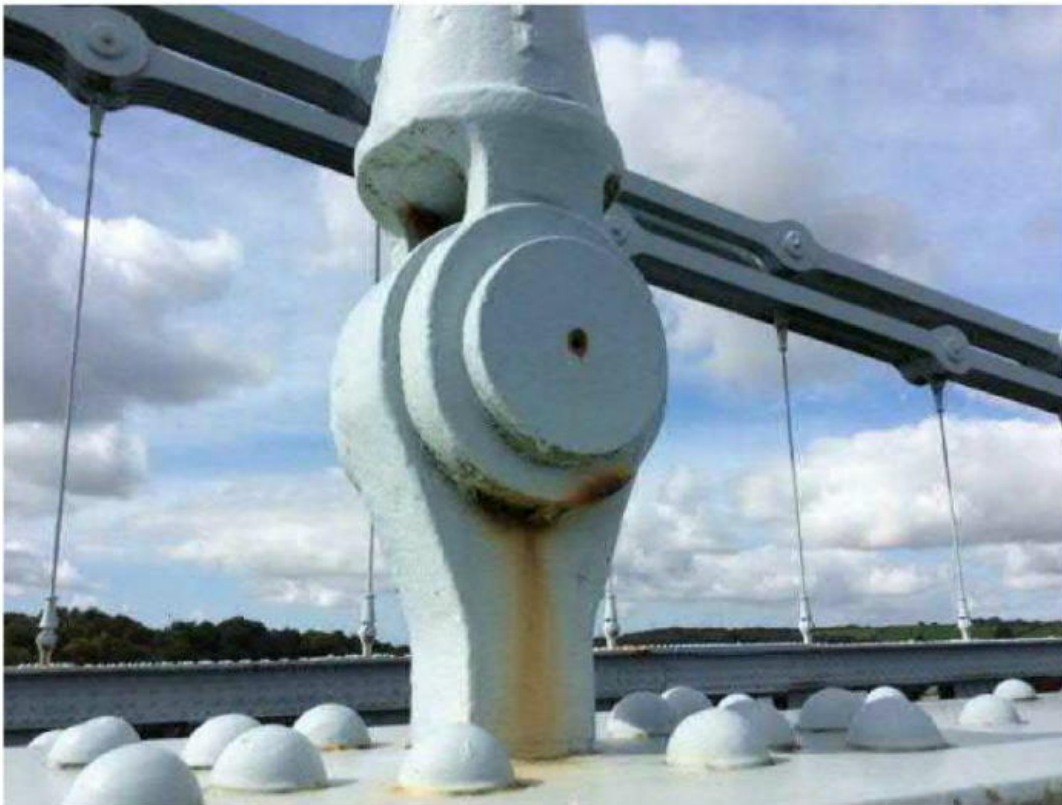
Figure 45: Finishes: deck elements - monitor the small areas of failed paint and resulting rust staining to the lower hanger lugs. typical to east side 28m north of south tower

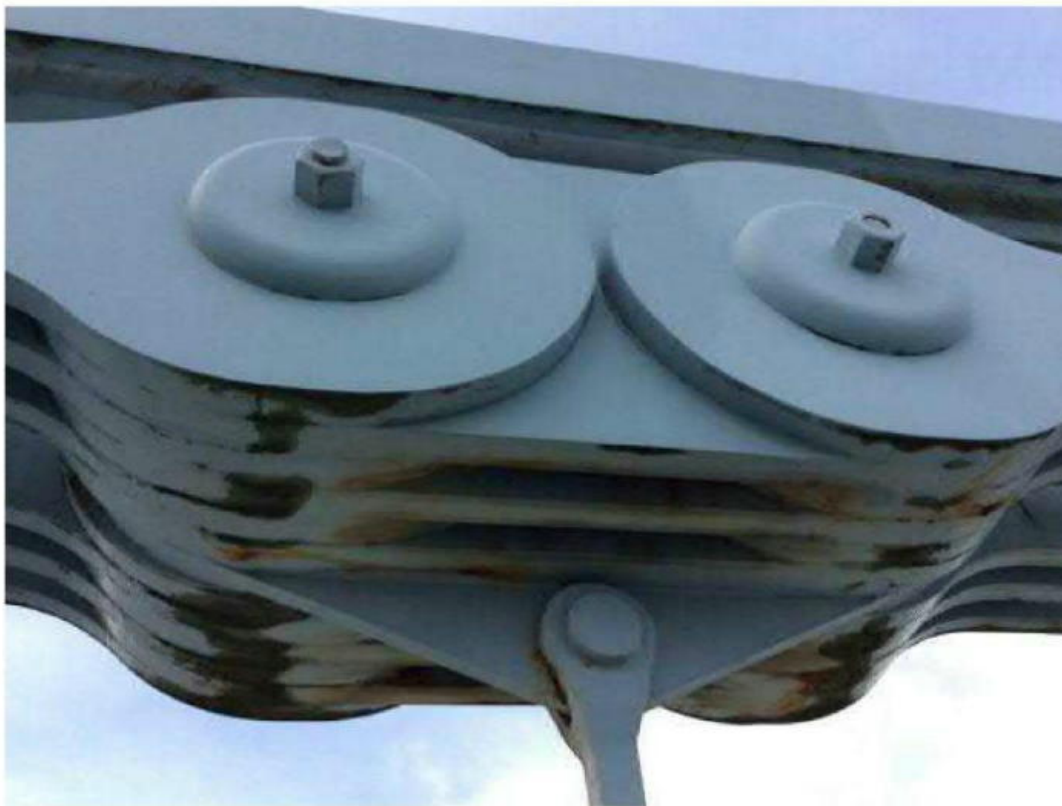
Figure 48: Finishes: deck elements - rust staining to the chain link underside at east mid span

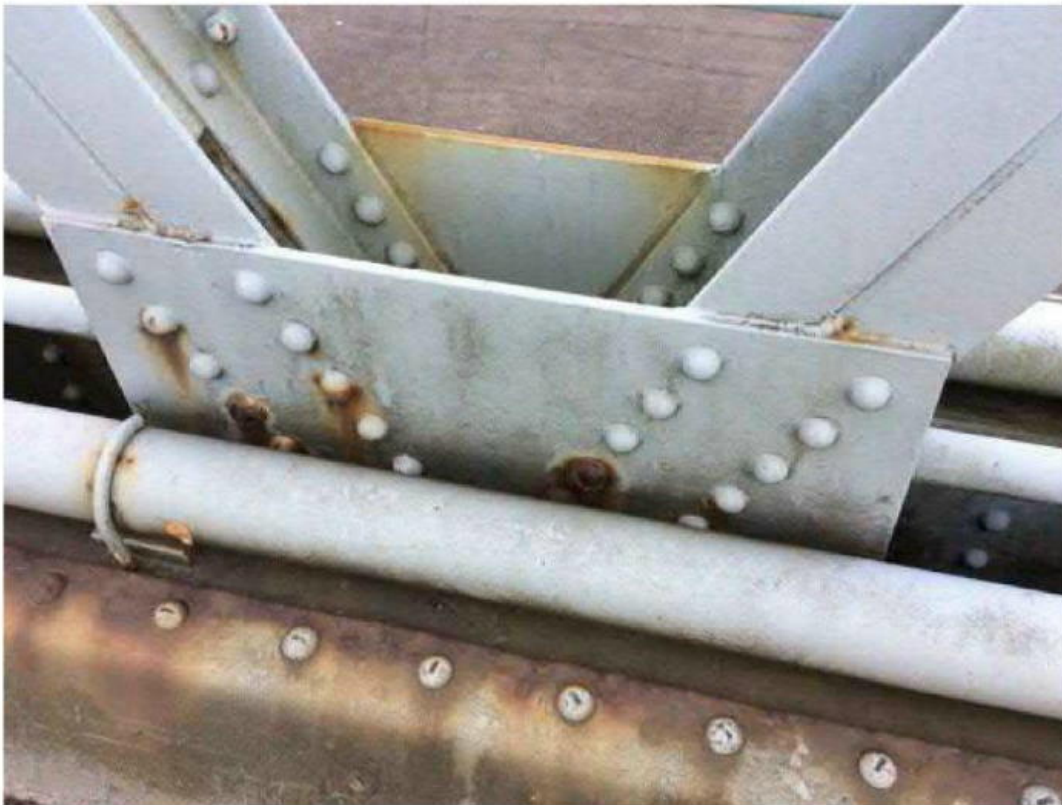
Figure 49: Finishes: deck elements - several areas of full depth paint loss, minor corrosion and rust staining to the truss rivets throughout

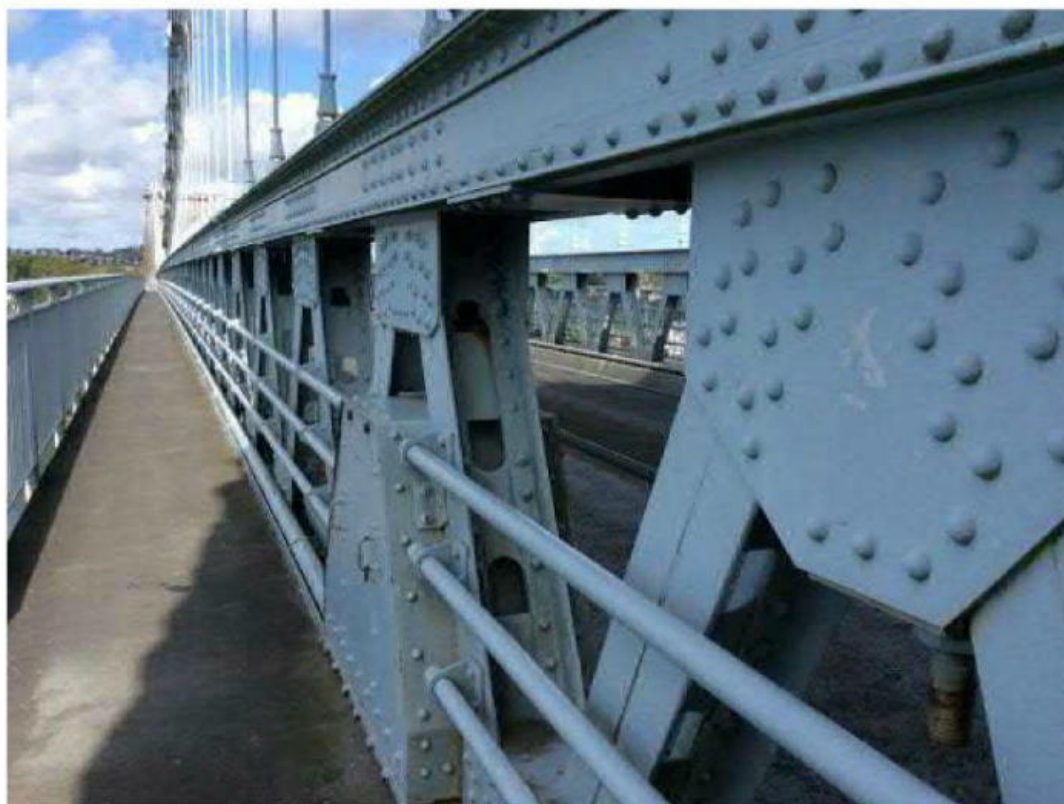
Figure 54: Finishes: deck elements - monitor the small areas of chipped paint and rust staining throughout the west truss

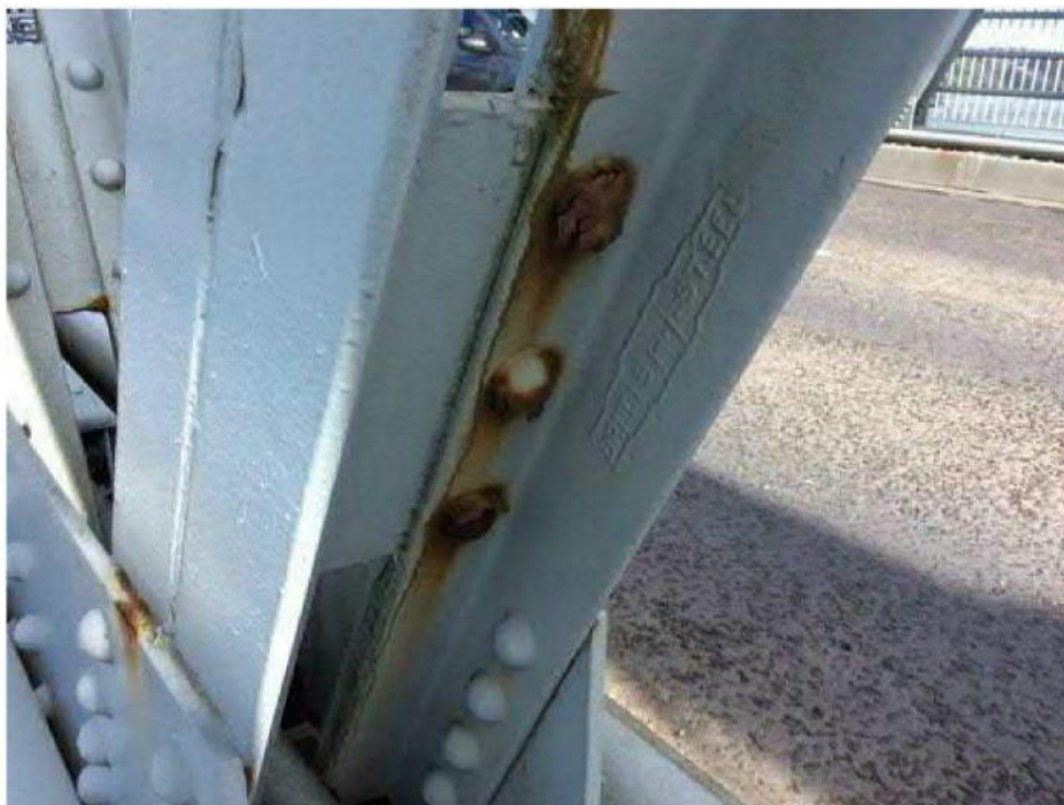
Figure 55: Finishes: deck elements - chipped paint and rust staining to rivets on the west truss. 35m north of south tower

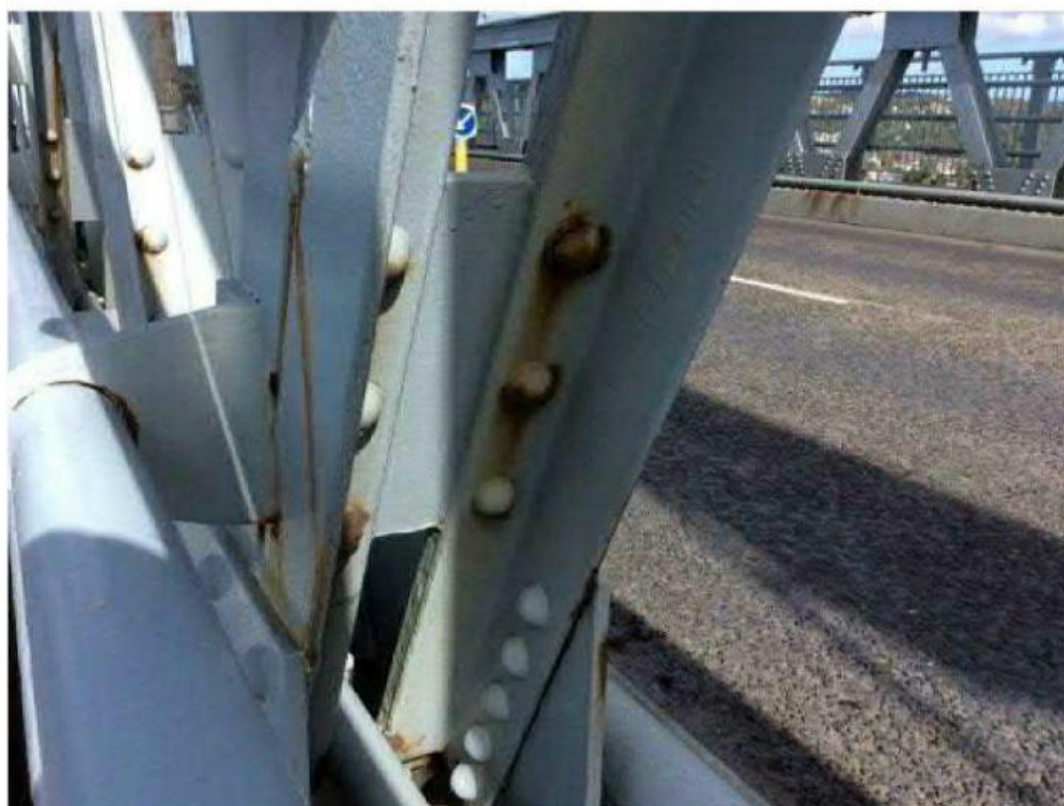
Figure 56: Finishes: deck elements - chipped paint and rust staining to rivets on the west truss. 20m south of north tower

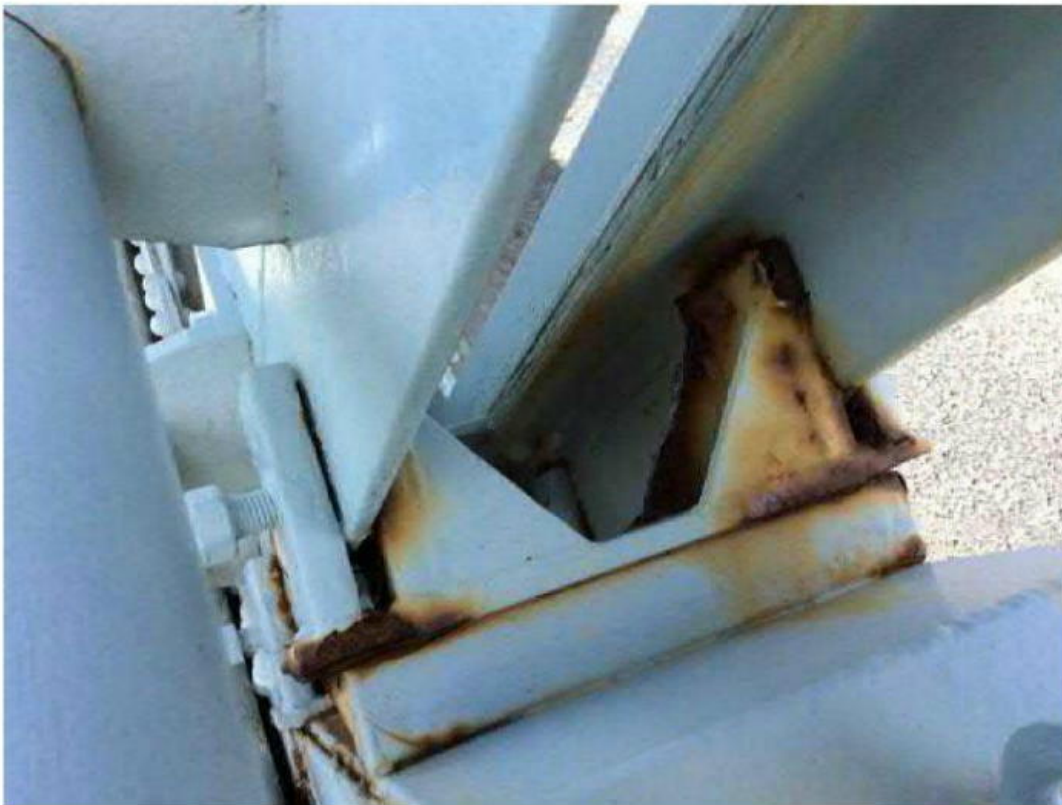
Figure 57: Finishes: deck elements - full depth paint loss and moderate corrosion to electrical box to west side at mid span

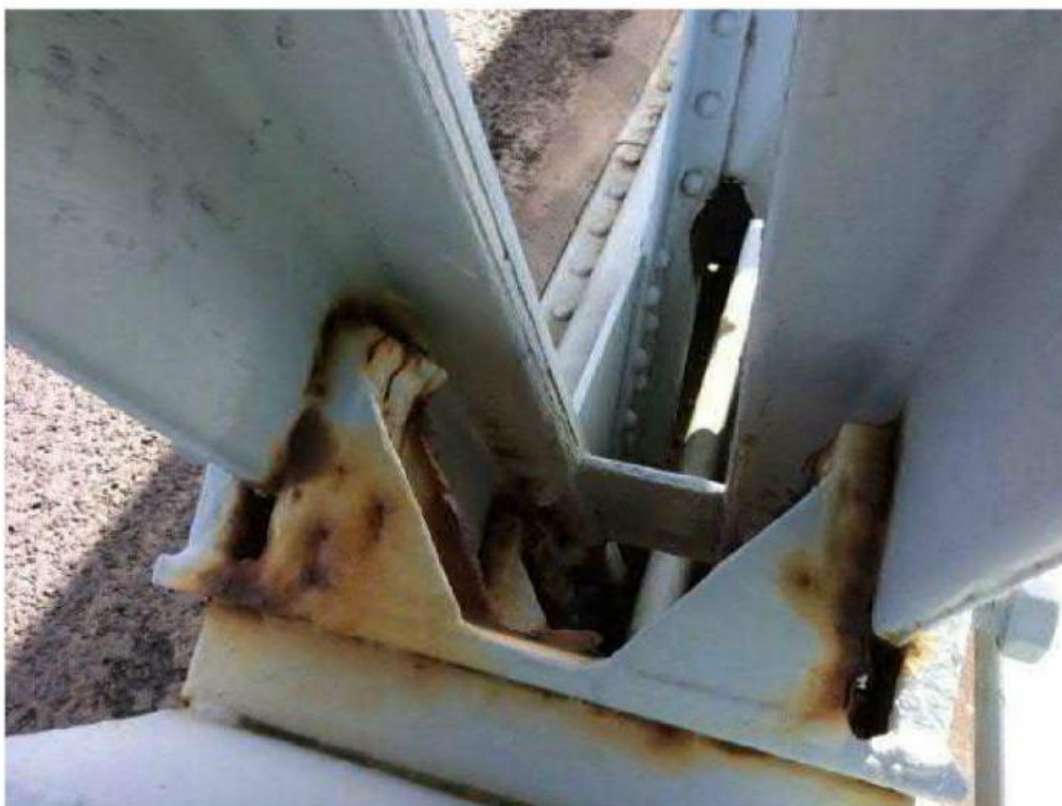
Figure 58: Finishes: deck elements - full depth paint loss and moderate corrosion to electrical box to west side at mid span

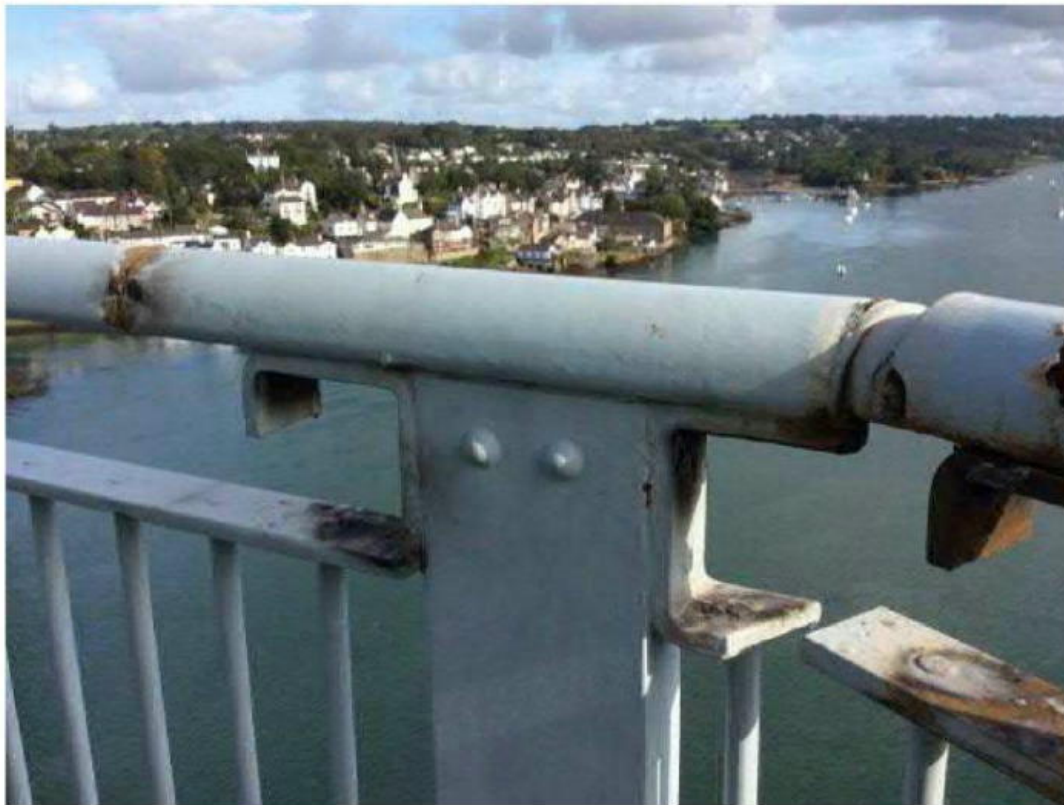
Figure 63: Finishes: parapets/safety fences - paint loss and corrosion with evidence of recent repair weld to east parapet adjacent the south tower

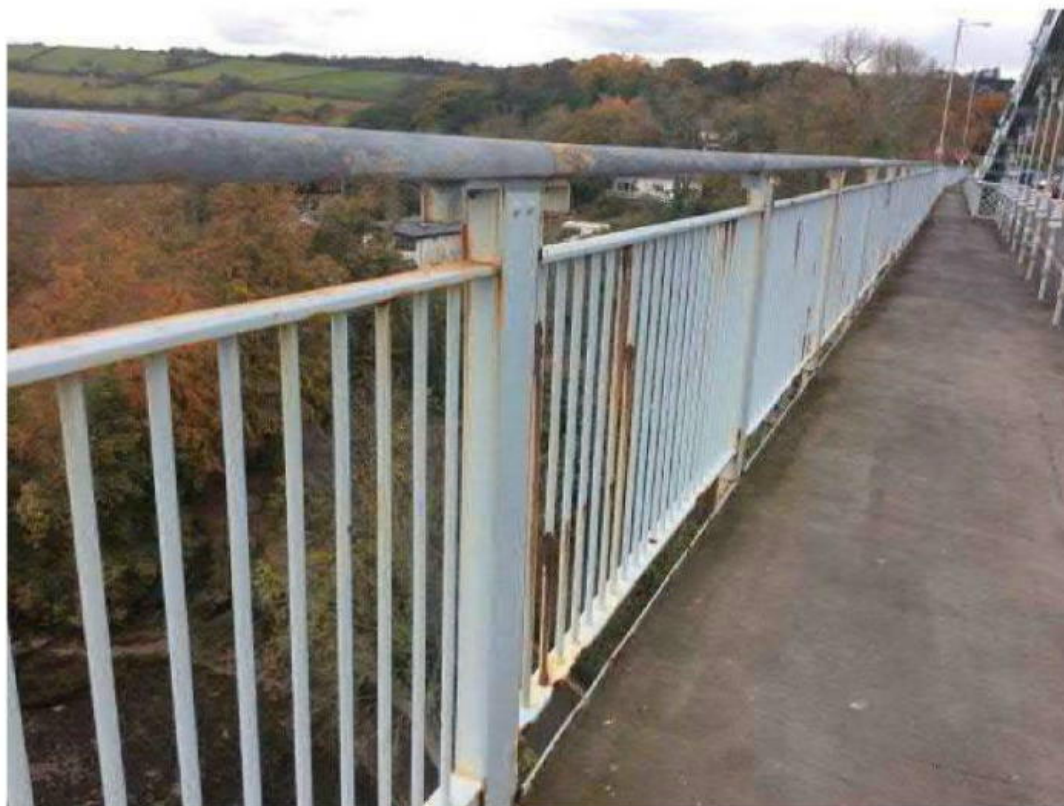
Figure 64: Finishes: parapets/safety fences - paint loss and corrosion to west parapet at north end

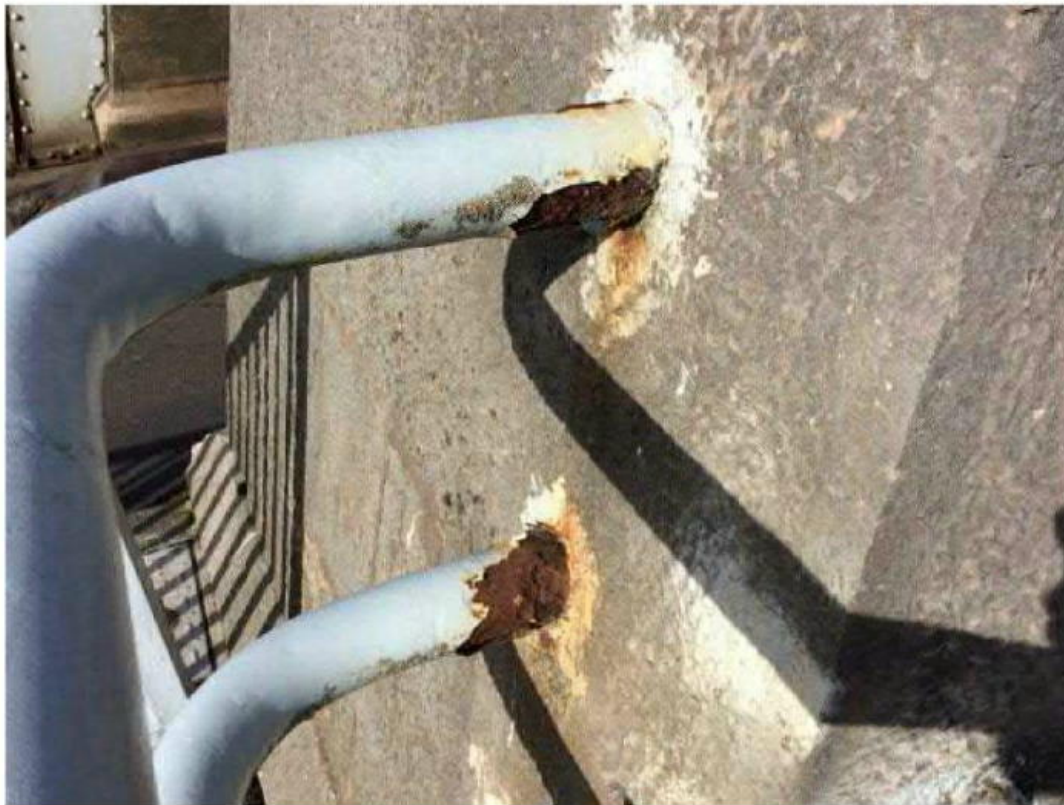
Figure 69: Handrail / parapets / safety fences - paint loss and corrosion to inner parapet to east side of south tower

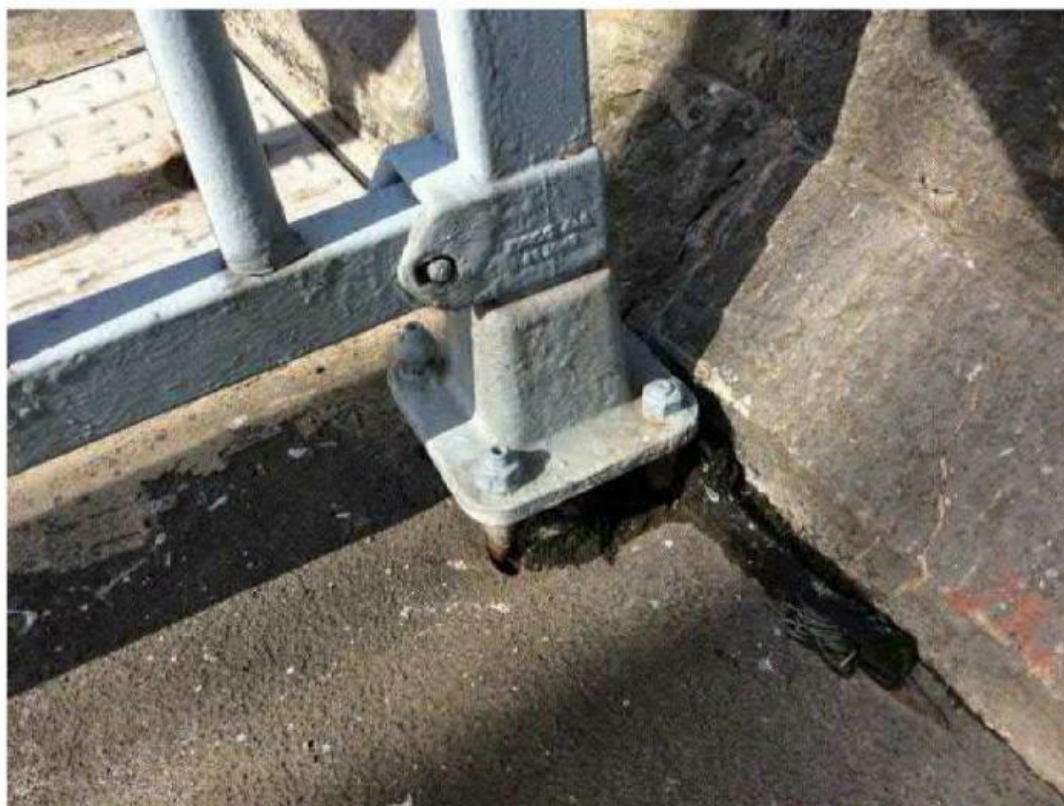
Figure 70: Handrail / parapets / safety fences - failure of holding down bolt arrangement to south west inner pedestrian guardrail

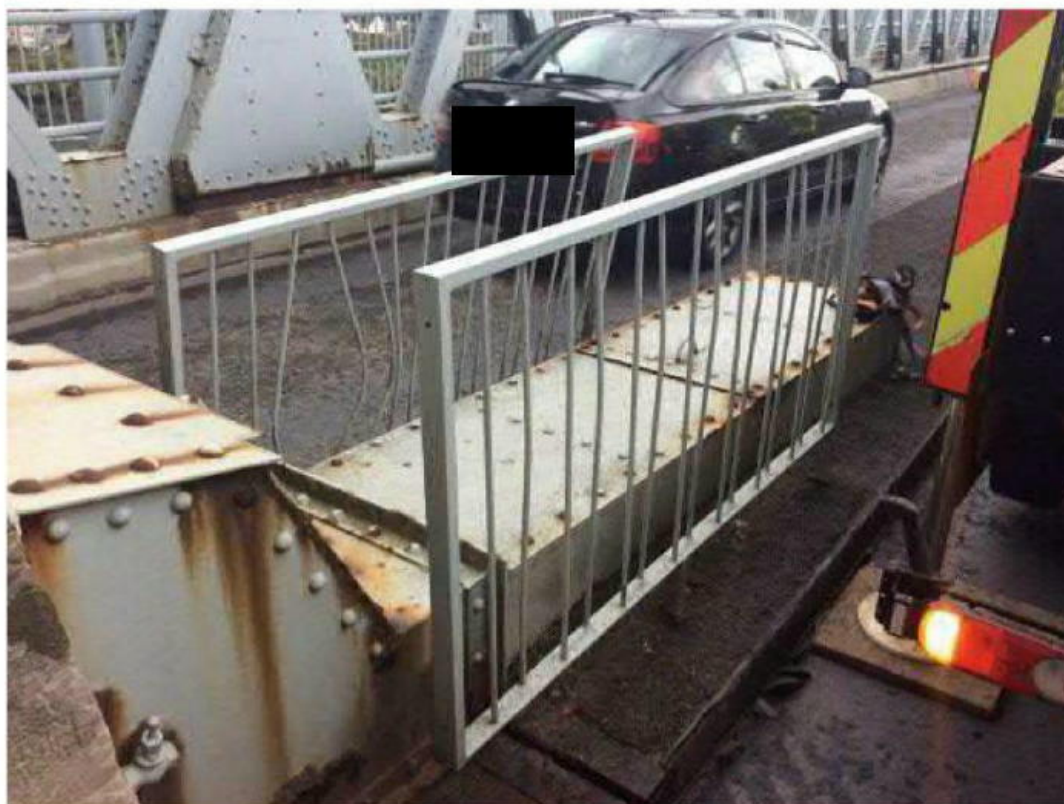
Figure 72: Handrail / parapets / safety fences - severe impact damage to the central reservation guardrail to the south of north tower

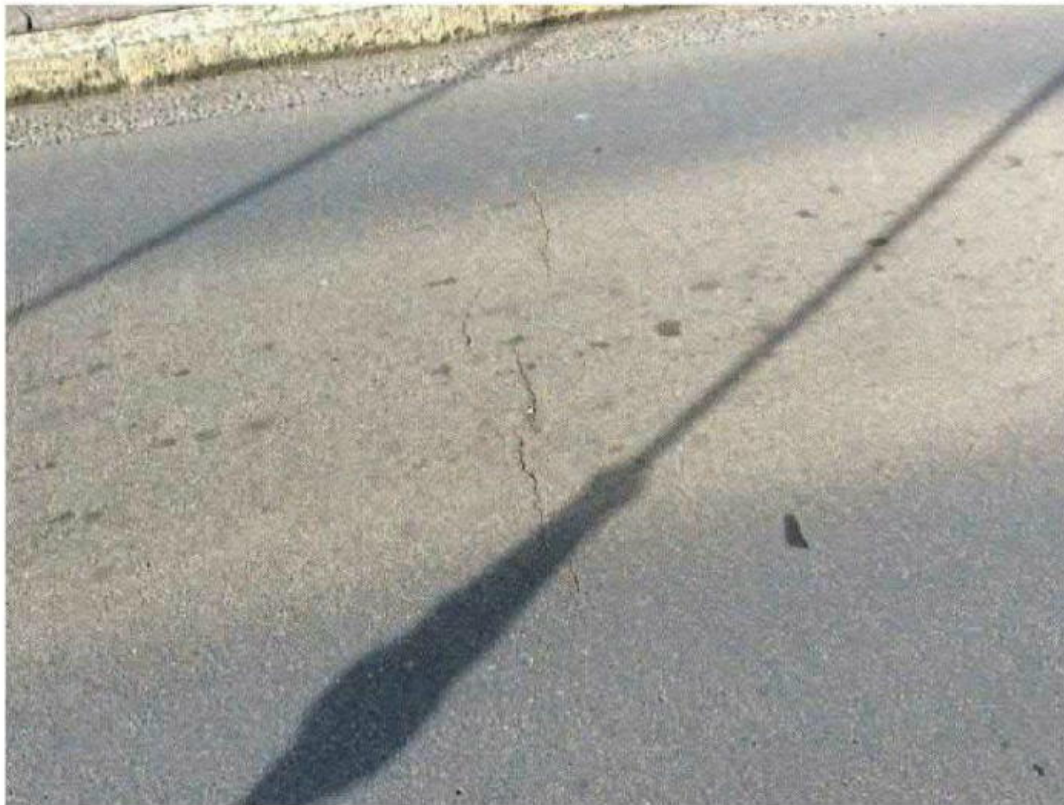
Figure 77: Carriageway surfacing - monitor the minor wear and regular narrow transverse cracking along the carriageway. typical to south of south tower

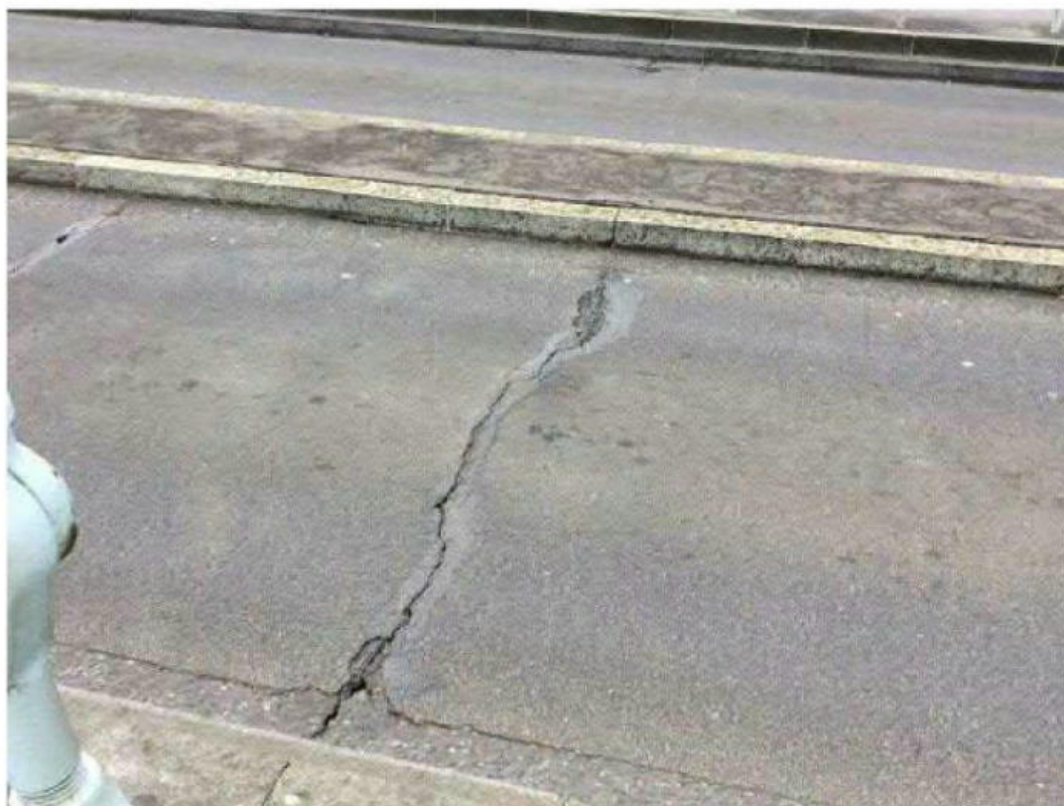
Figure 78: Carriageway surfacing - 3mm wide transverse crack to surfacing above north abutment
