UK Highways Bridge Management

Principal Inspection Report Menai Bridge (Structure Ref. A5 Menai Bridge)

December 2019

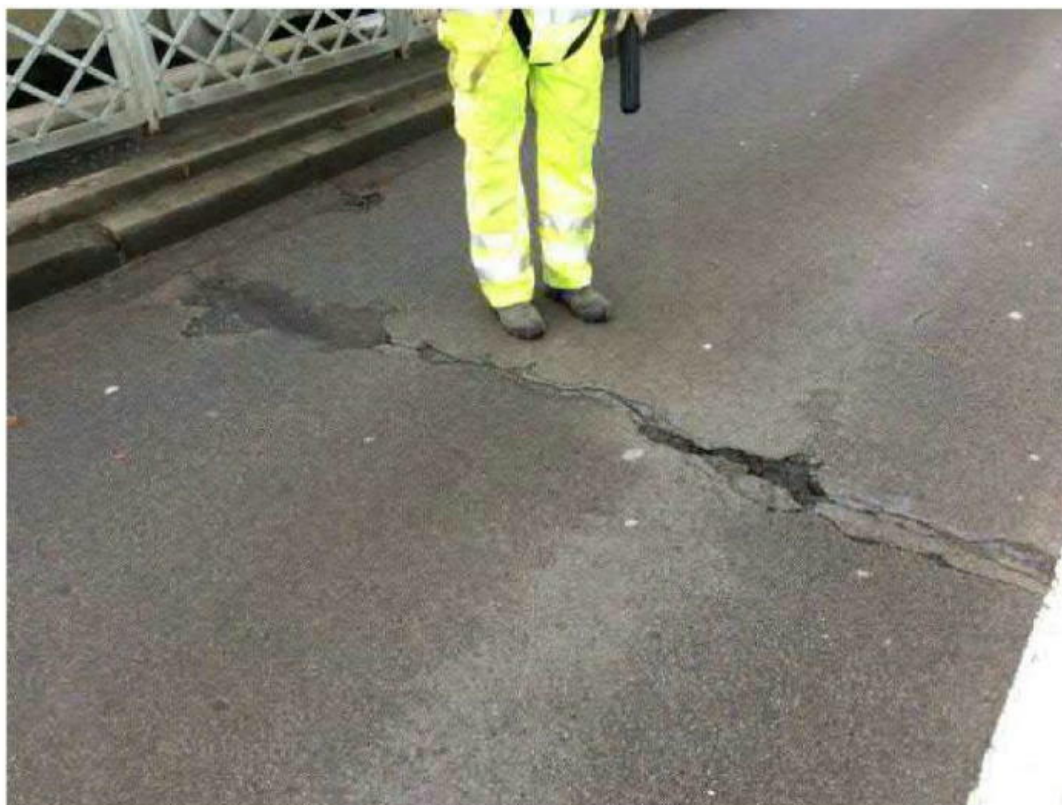
Figure 79: Carriageway surfacing - 3mm wide transverse crack to surfacing above north abutment

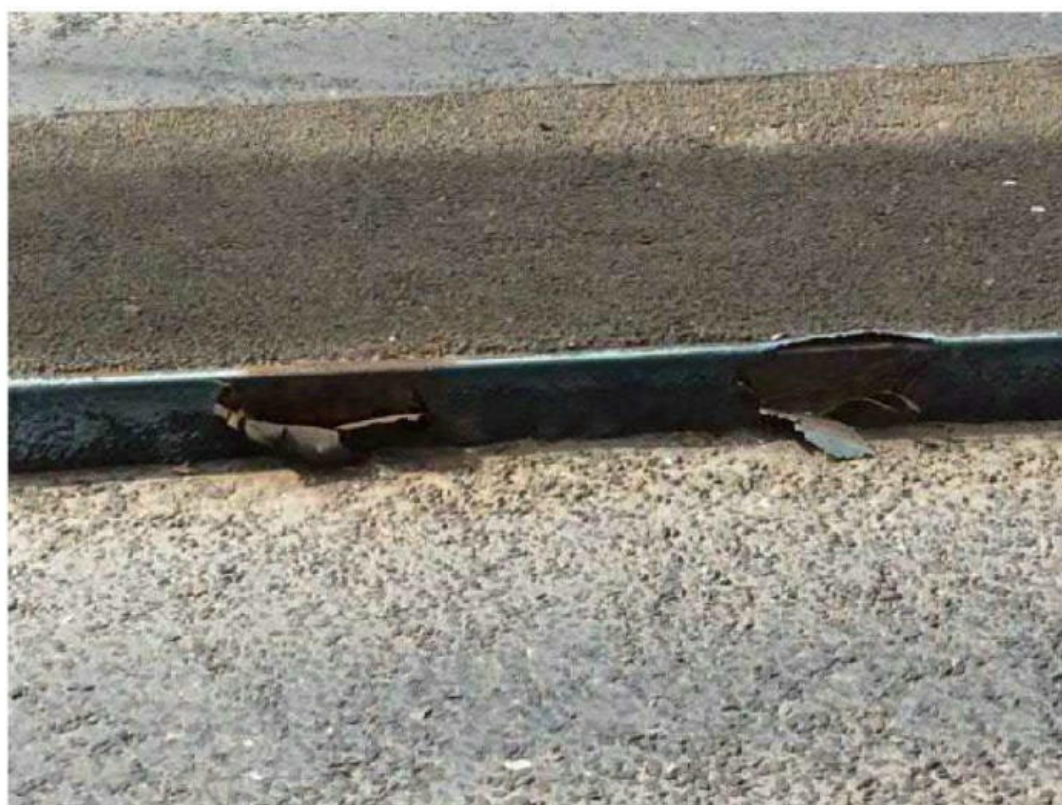
Figure 80: Footway / verge / footbridge surfacing - sections of full depth paint loss and moderate corrosion to the verge steel kerbs on the approaches to the towers. typical at 6m south of north tower

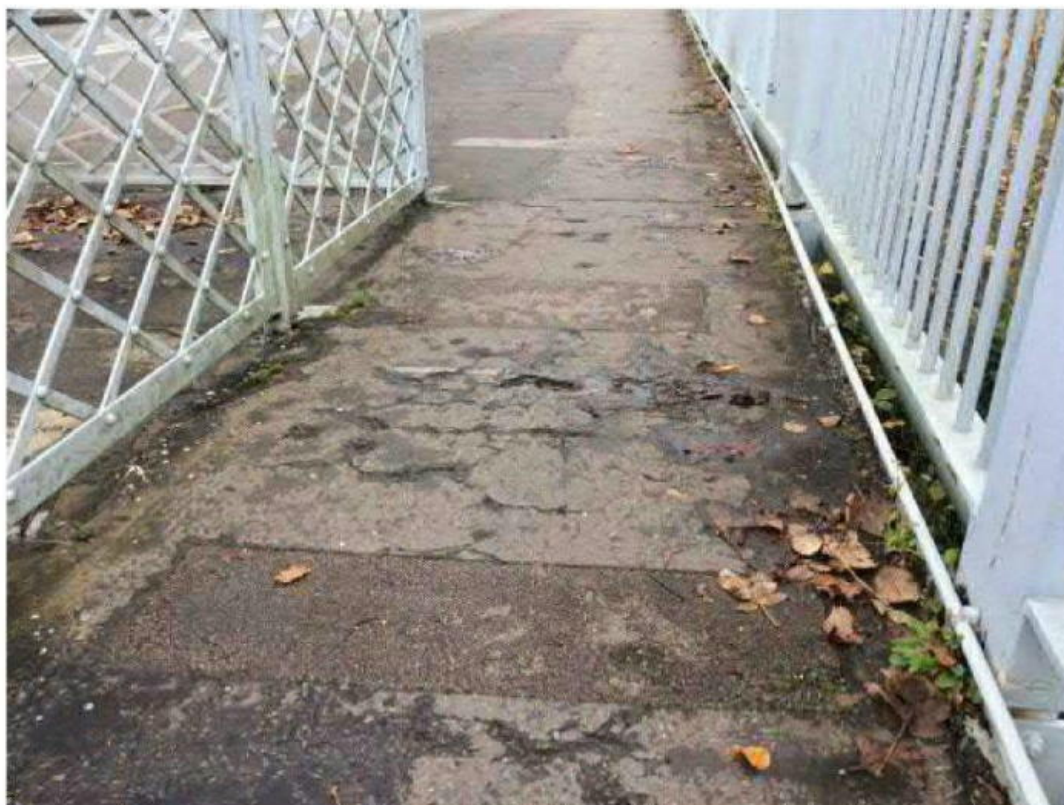
Figure 81: Footway / verge / footbridge surfacing - several wide cracks and 100mm diameter x 40mm deep pothole in east footway 35m north of the north abutment

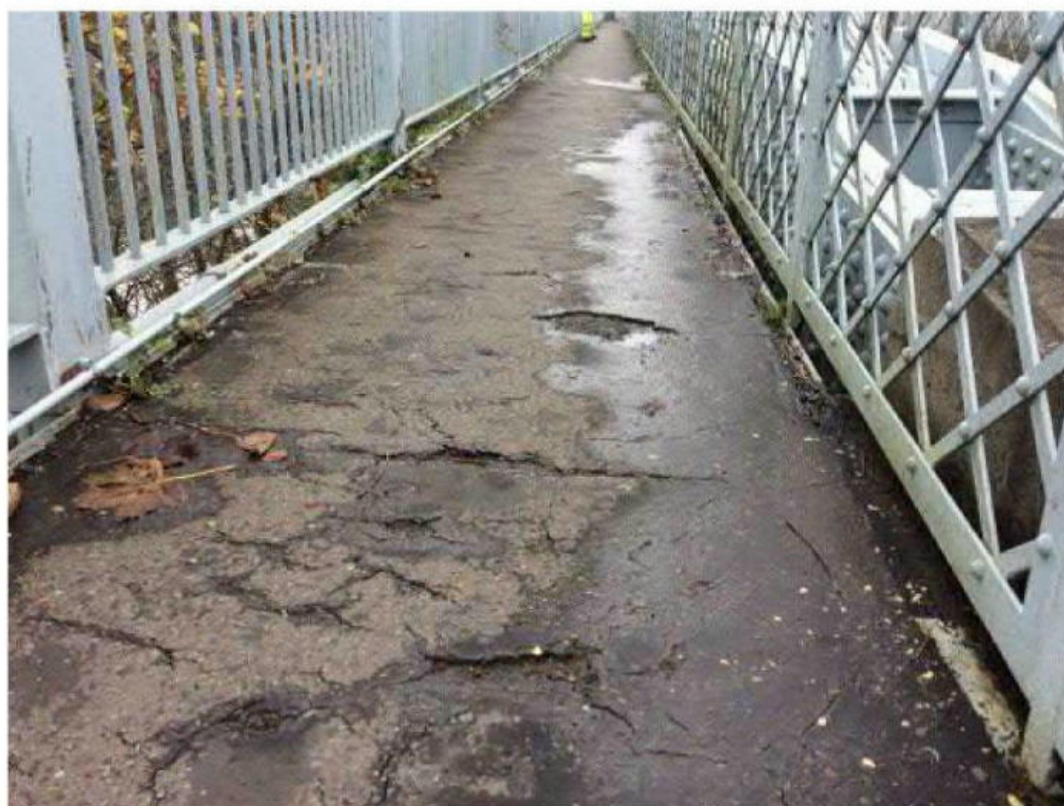
Figure 82: Footway / verge / footbridge surfacing - several wide cracks and 100mm diameter x 40mm deep pothole in east footway 35m north of the north abutment

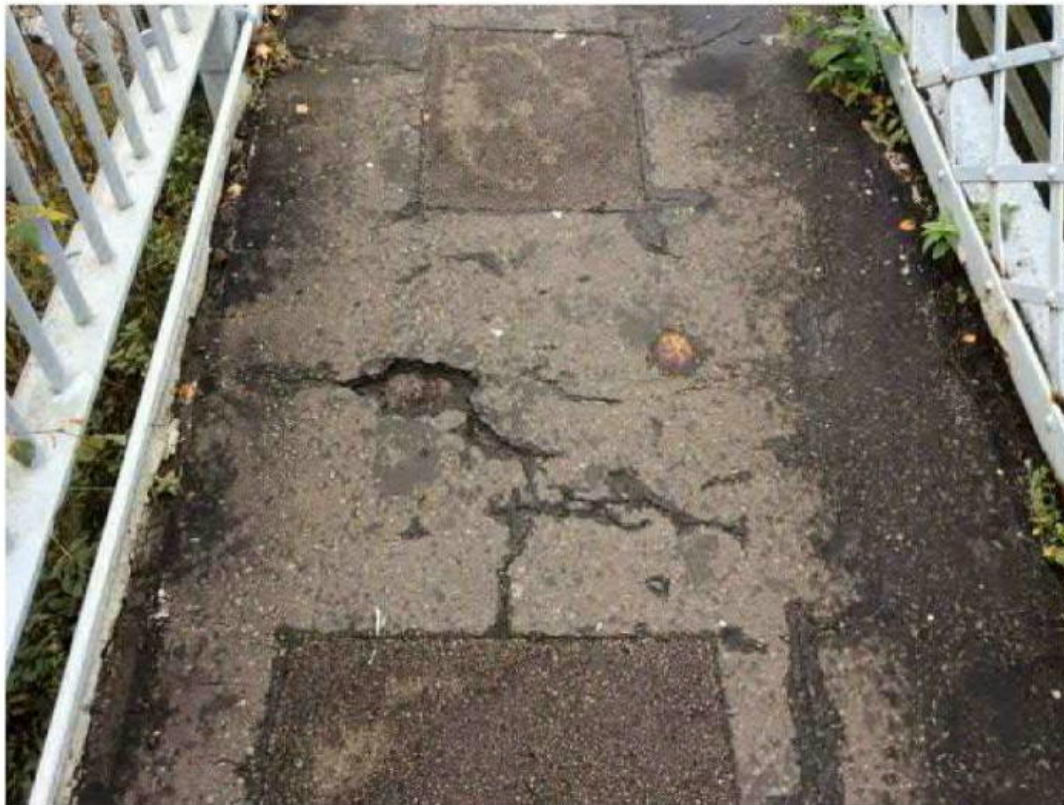
Figure 83: Footway / verge / footbridge surfacing - several wide cracks and 100mm diameter x 40mm deep pothole in east footway 35m north of the north abutment

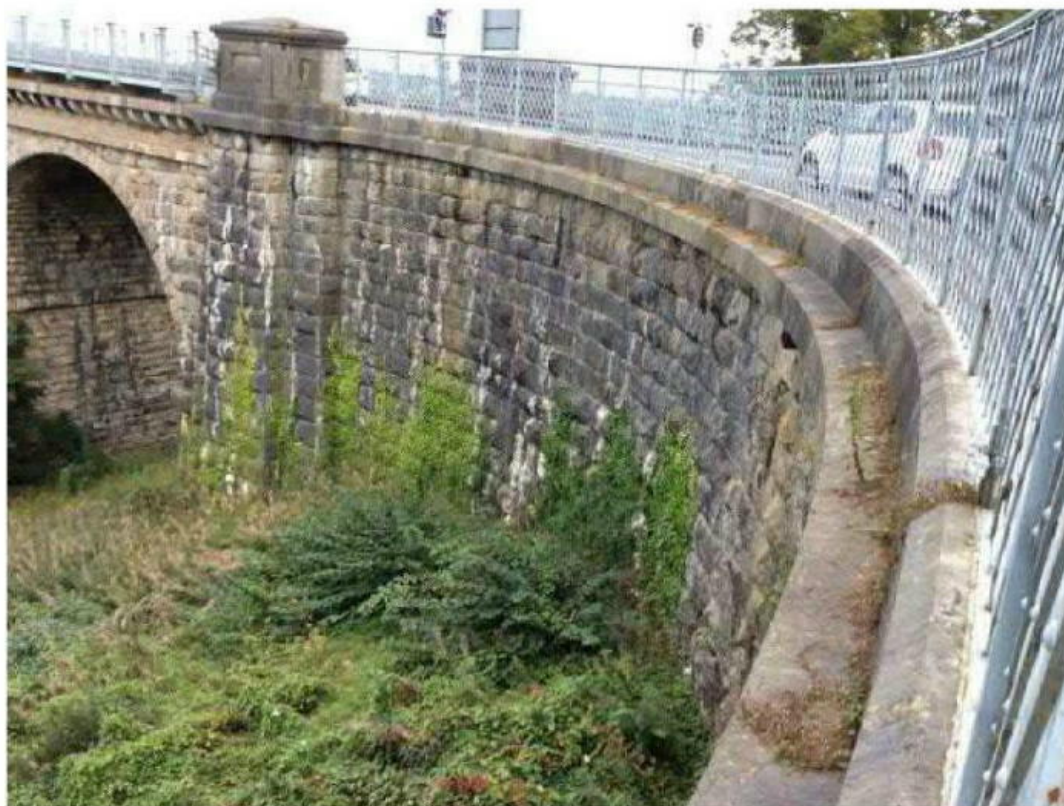
Figure 84: Wing walls - ivy to lower parts of south west wing wall

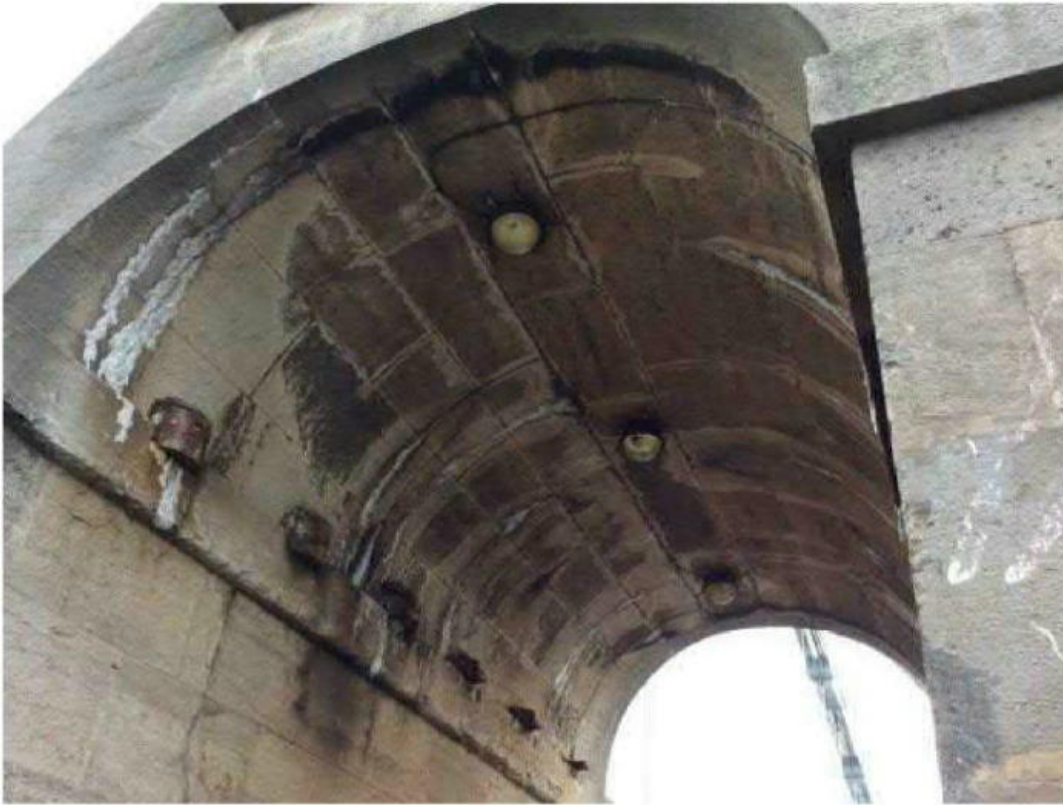
Figure 89: Lighting - broken lighting unit to east transverse arch of north tower

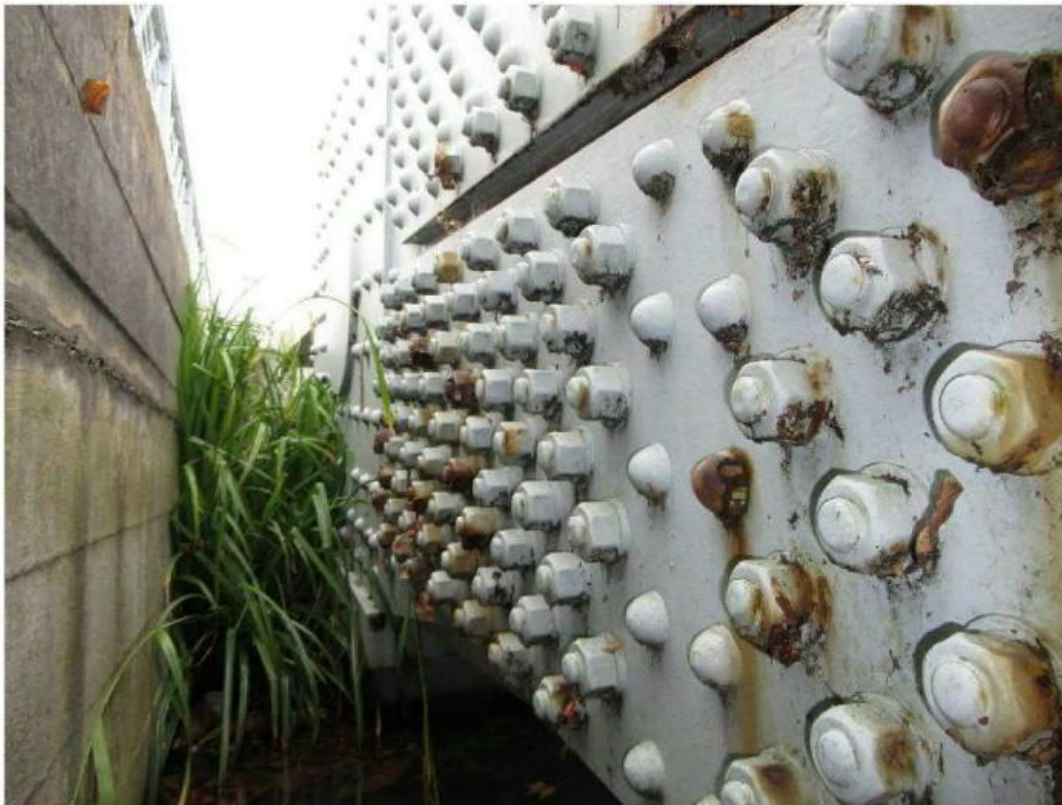
- The west face of the west back-stay anchor arrangement was generally in good condition with minor algae staining (Figure 92) but general light surface corrosion was noted to the inside, east face bolt group of the west back-stay anchor arrangement. Several small areas of minor to moderate paint loss and corrosion was found to bolt heads. Also, vegetation was growing from silting/ponding to the base (Figure 93).

Figure 93: North anchor block – looking south along the inside, east face of the west back-stay anchor arrangement bolt group. Several small areas of minor to moderate paint loss and corrosion to bolt heads. Also, vegetation growing from silting/ponding to the base.

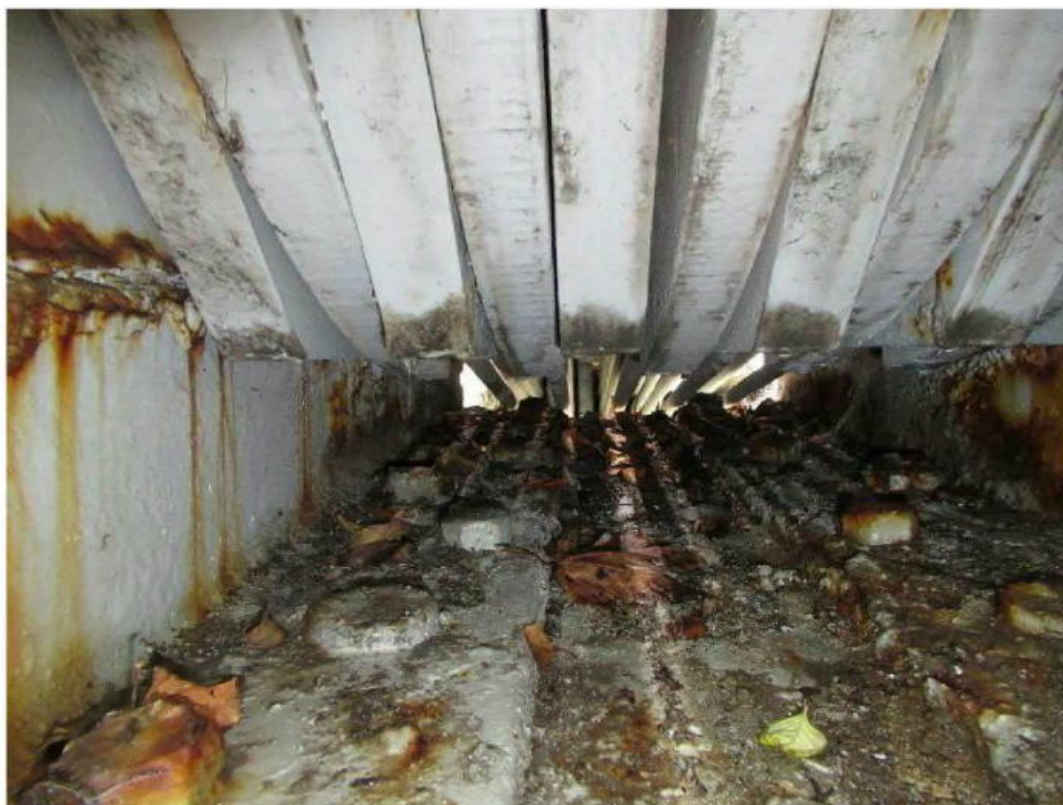
Figure 97: North anchor block – minor rust staining and debris surrounding last chain links near the east anchor block

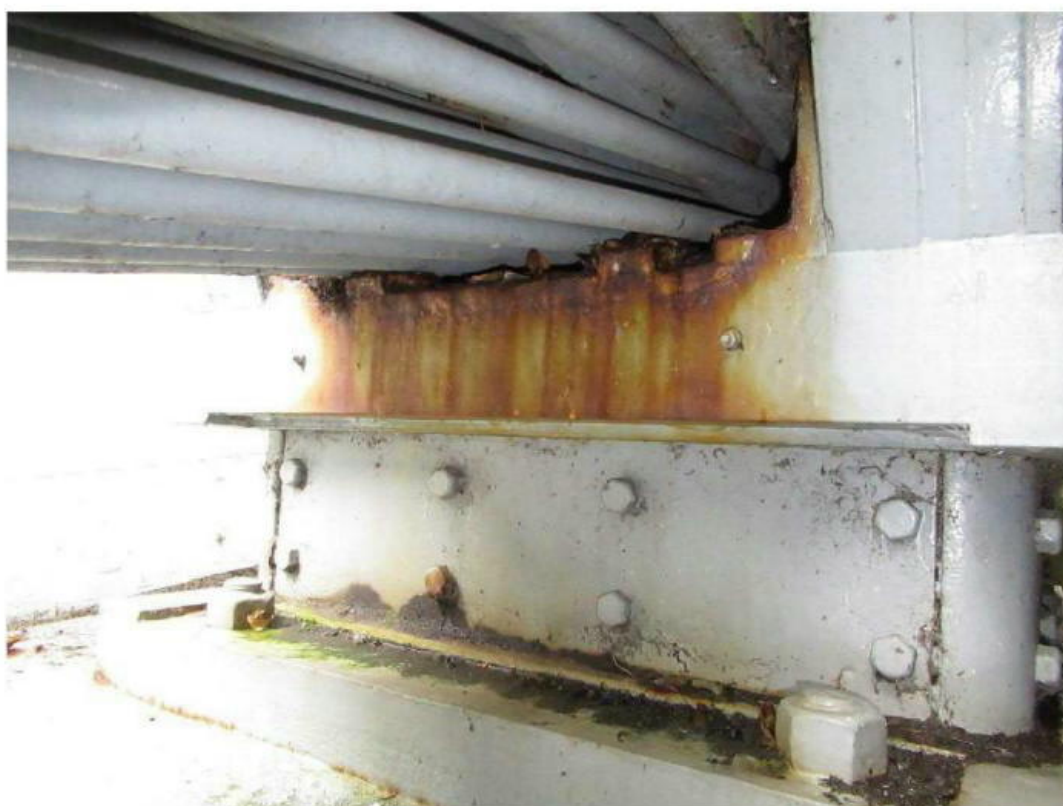
- The north anchor block showed corrosion and rust staining beneath the south end of the east anchor block strands (Figure 98). There were also algae to, and debris beneath the west face of the east anchor block strands (Figure 99) and algae to the concrete plinth near the east anchor block (Figure 100).

Figure 98: North anchor block – corrosion and rust staining beneath the south end of the east anchor block strands

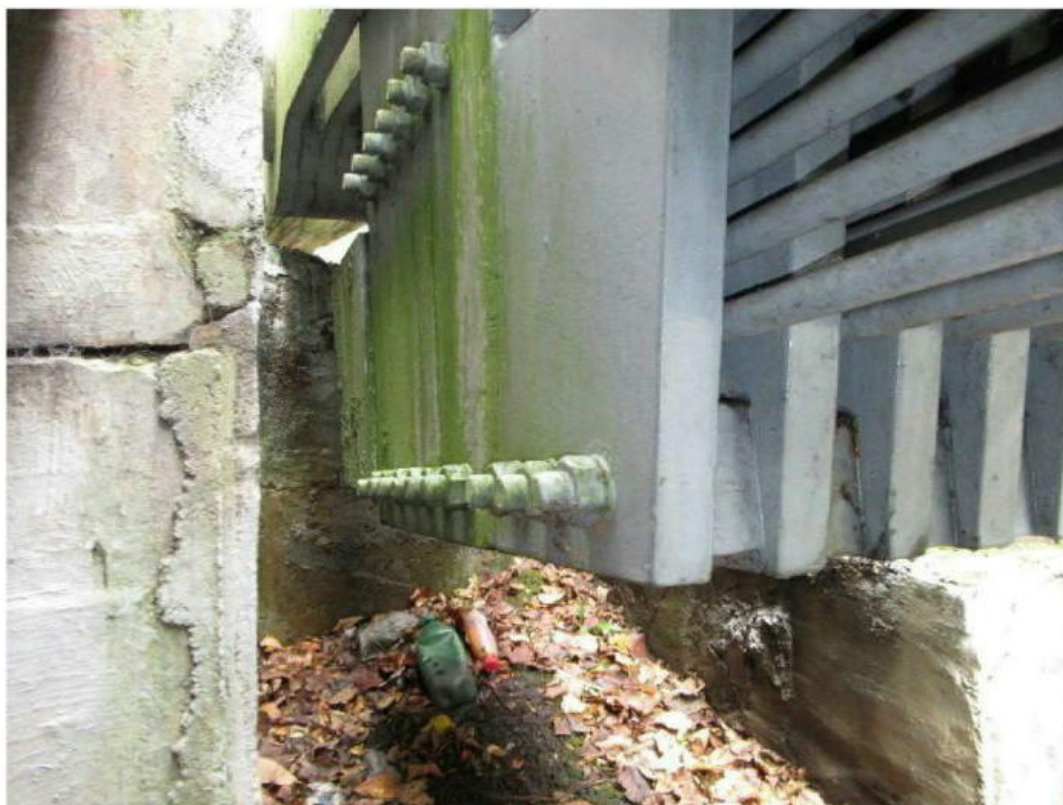
Figure 99: North anchor block – algae to and debris beneath the west face of the east anchor block strands

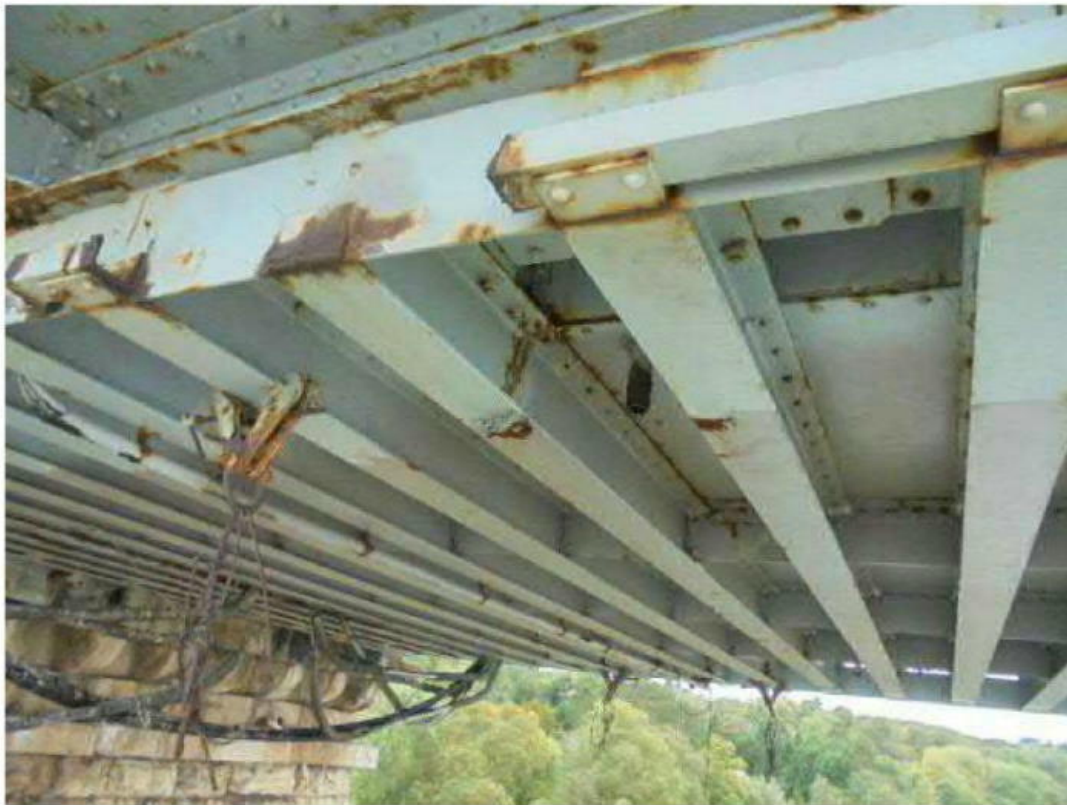
- Several areas of minor to moderate paint loss and corrosion was noted to the south end of the main span (typical examples of this, along with areas of previous painting visible to beam ends, defects are shown within Figure 103).

Figure 103: secondary deck – typical paint loss and corrosion to south east end of main span (areas of previous painting visible to beam ends)

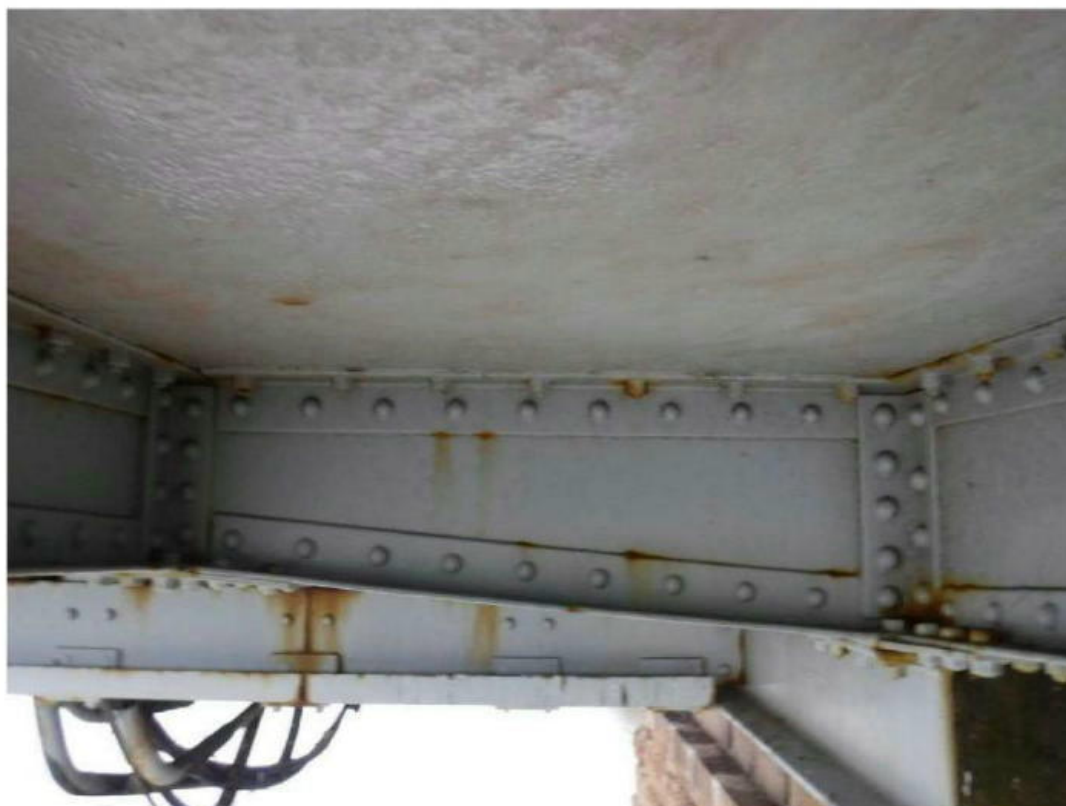
Figure 104: secondary deck – typical paint loss and corrosion to south west end of main span transverse beams and longitudinal stiffeners

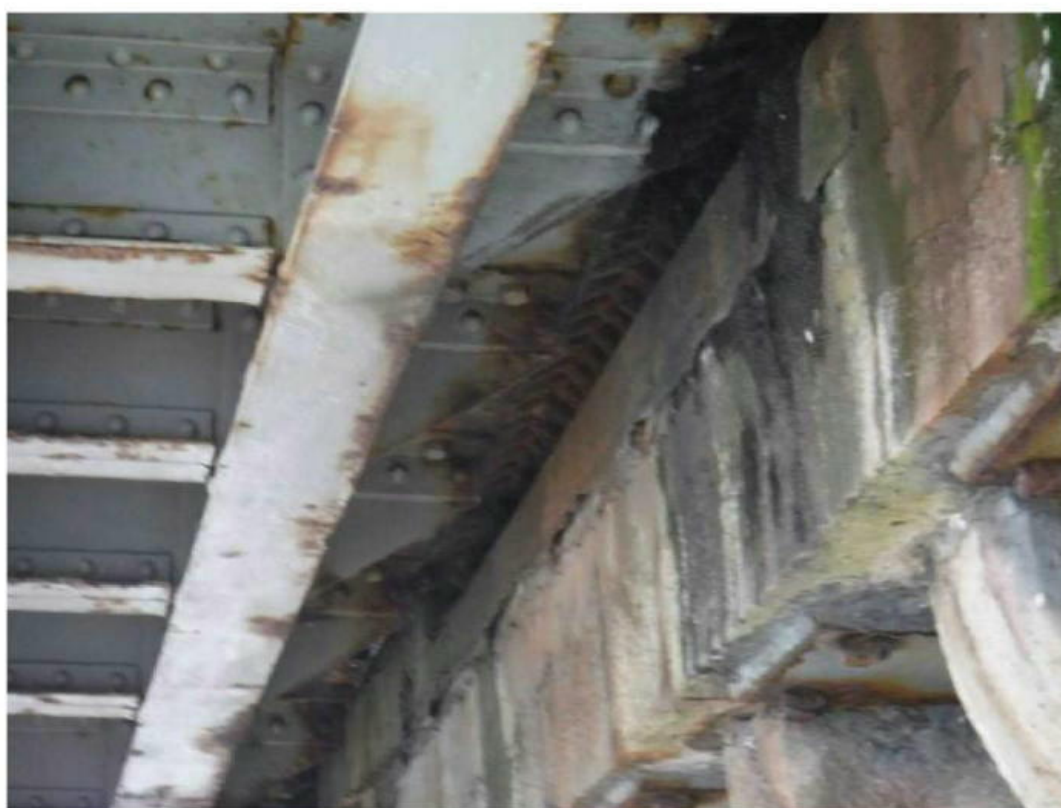
Figure 107: Bearings – typical paint loss and corrosion to south pin/comb bearing, south end

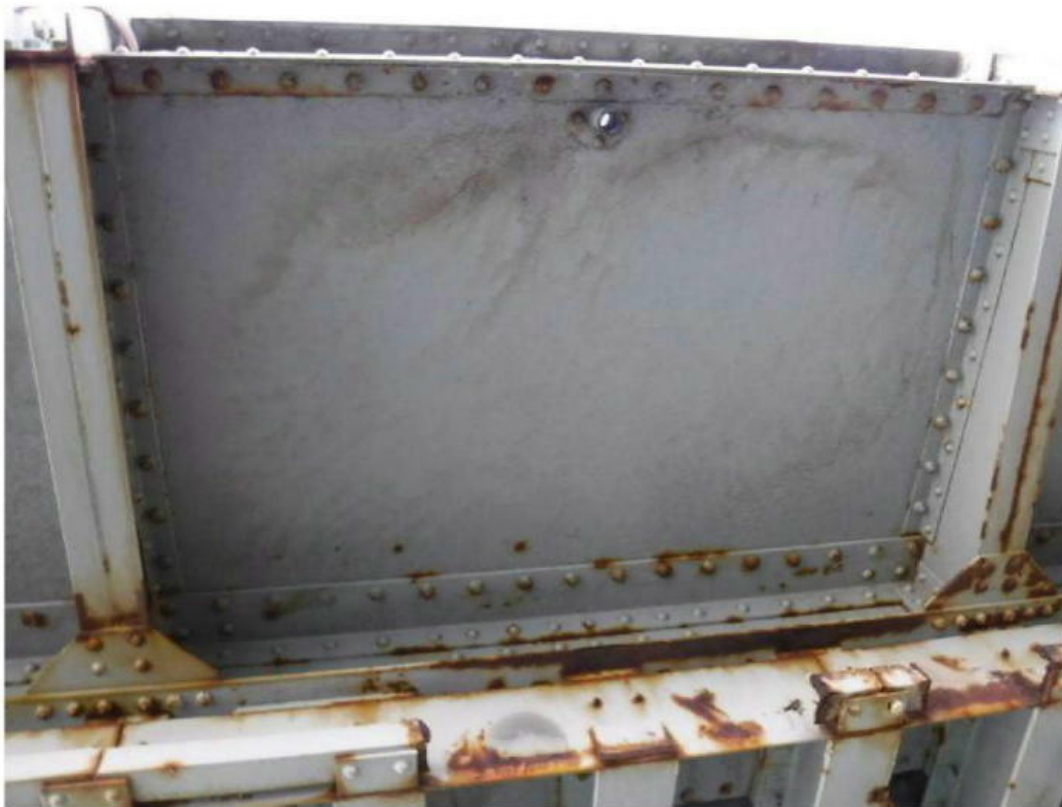
Figure 108: cantilever – typical paint loss and corrosion to south end of main span west walkway soffit, 8m from south

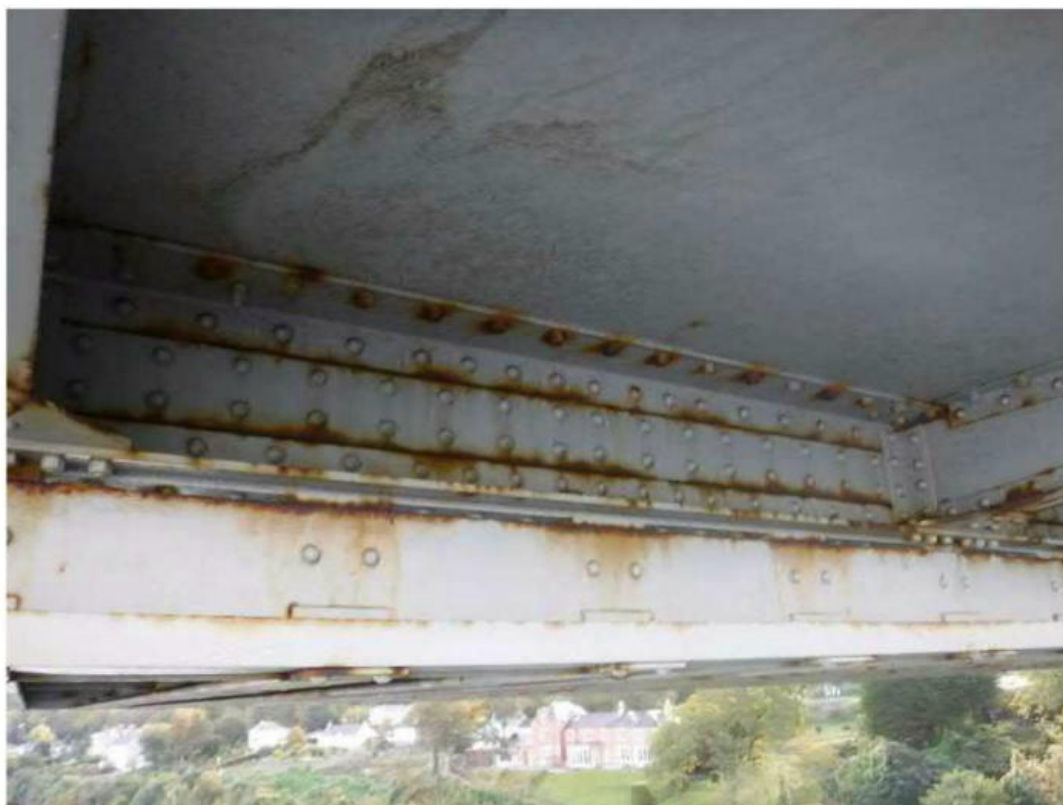
- The walkway edge girders exhibited signs of light corrosion throughout.
- Several small areas of paint loss and corrosion were noted throughout lower truss typically to the main span lower west elevation, 27m from south (Figure 110).

Figure 110: secondary deck – typical paint loss and corrosion to main span lower west elevation, 27m from south

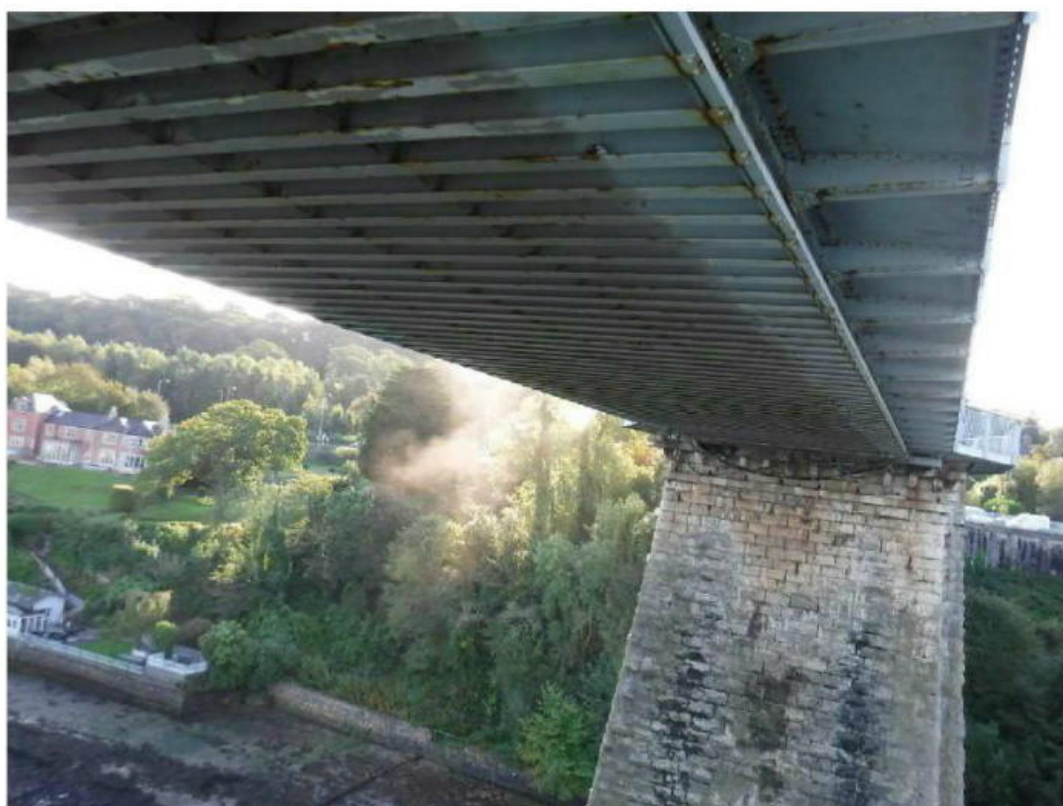
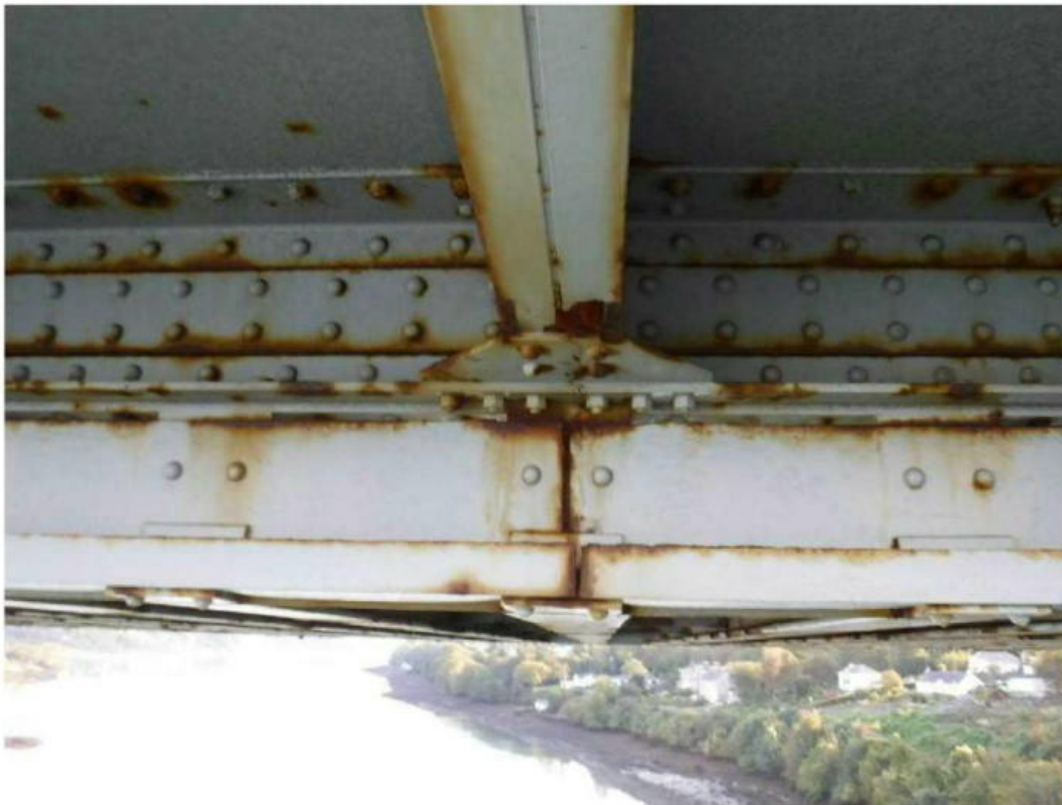
- Paint loss and corrosion was prevalent throughout the main span soffit and lower face of truss, typical to 37m from the south (Figure 111, Figure 112). Further paint loss and corrosion was noted to the main deck soffit, typical at 46.5m from the south (Figure 113).

Figure 111: secondary deck – general photo looking south at typical paint loss and corrosion throughout main span soffit, 37m from south

Figure 112: secondary deck – typical paint loss and corrosion to lower west face of truss, 37m from south

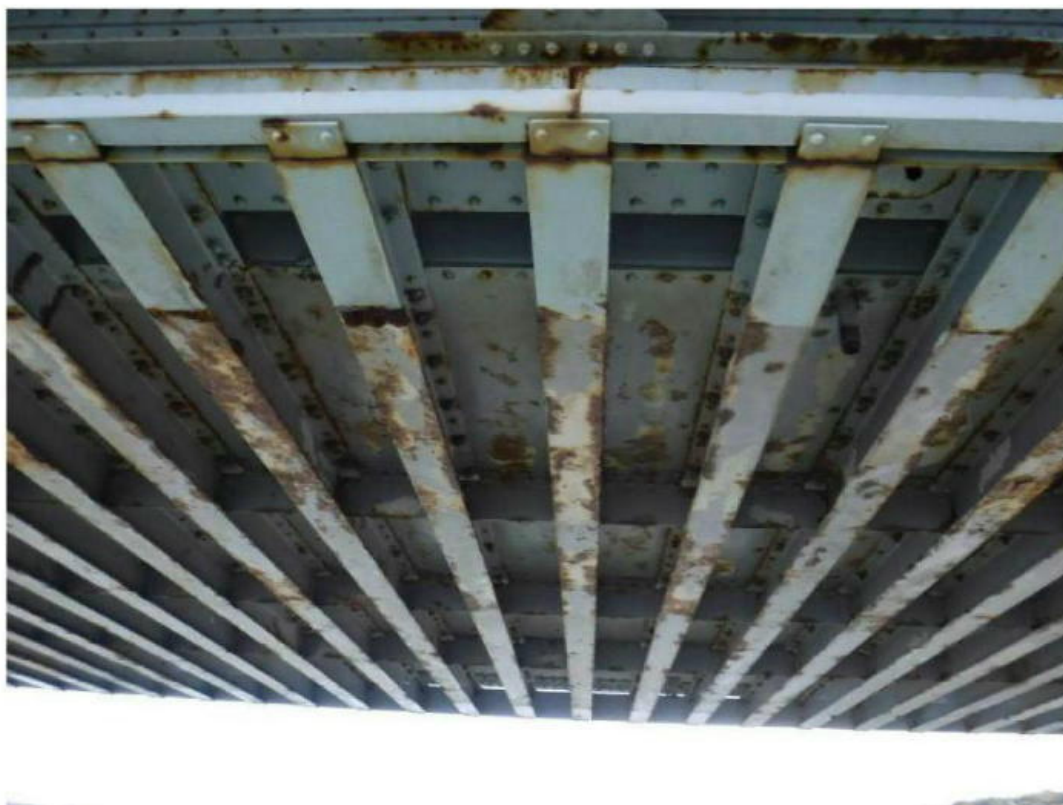
Figure 116: secondary deck – looking east at typical paint loss and corrosion to deck soffit, 66m from south

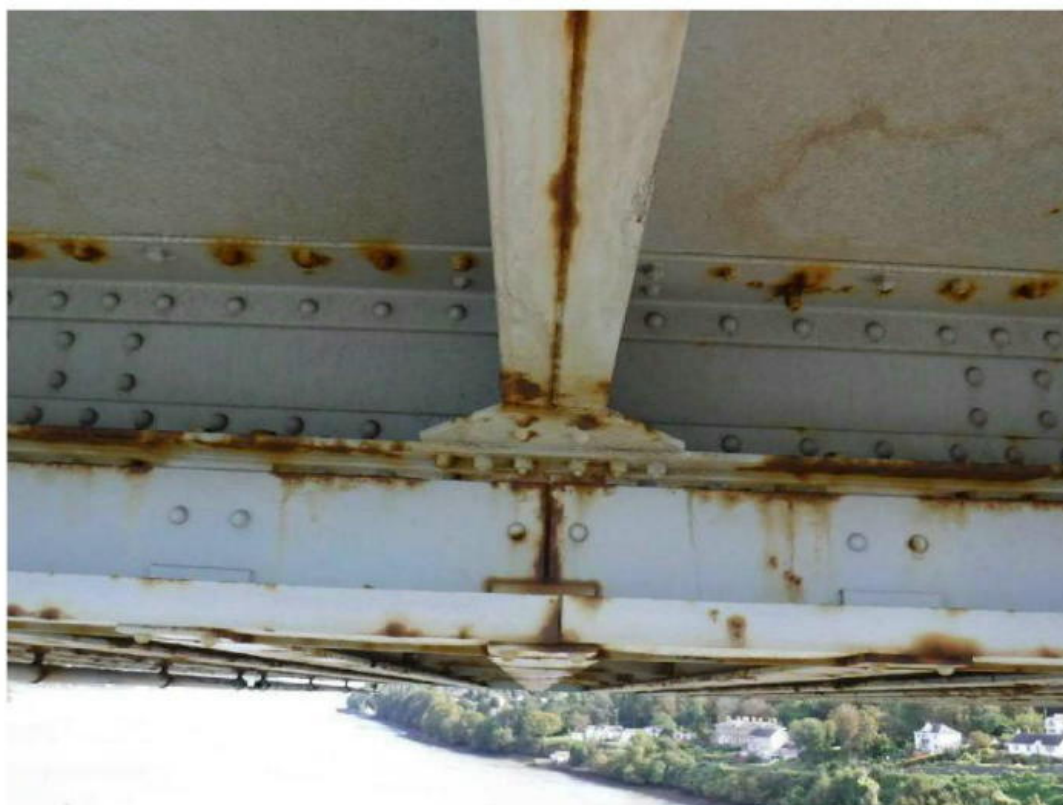
- Several small areas of paint loss and surface corrosion were noted throughout the east and west longitudinal trusses located between the footways and carriageway. Most of the paint loss/corrosion areas were to truss element nodes and discrete pockets where water collects due to the intricate detail around rivet heads and in areas where several plates meet and intersect (Figure 35). Typical paint loss and corrosion was noted to the lower west face of the main truss and walkway cantilever, 80.5m from south (Figure 117).

Figure 117: secondary deck – looking east at typical paint loss and corrosion to lower west face of main truss and walkway cantilever, 80.5m from south

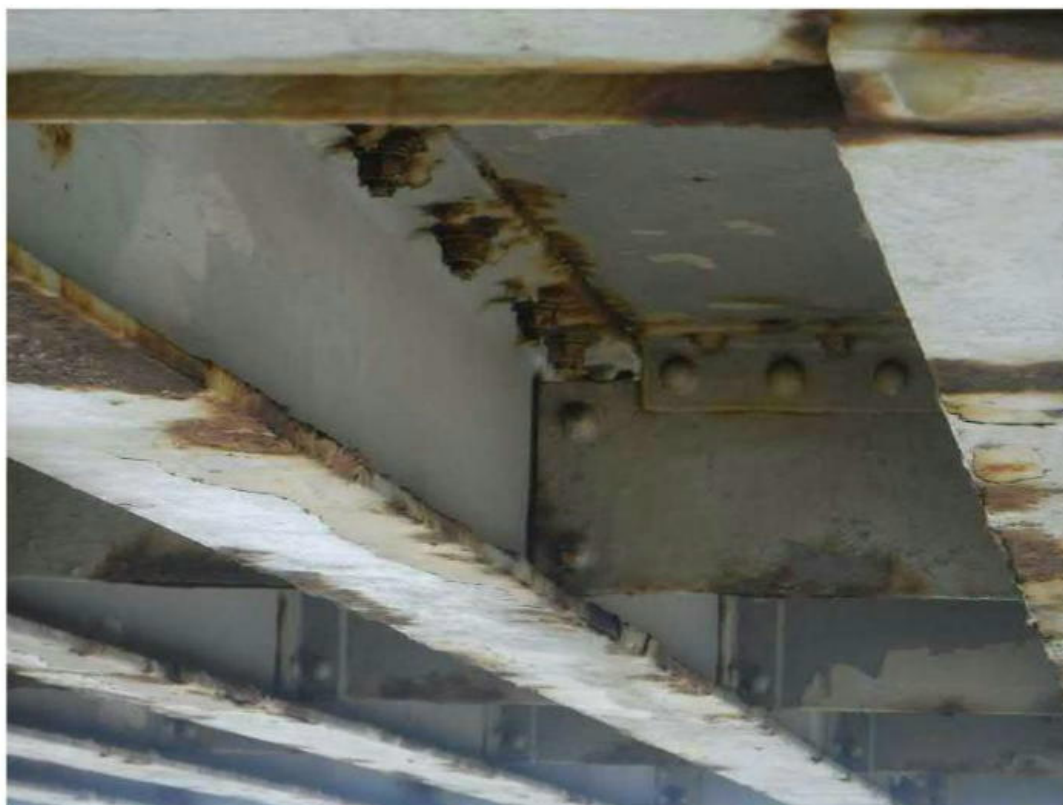
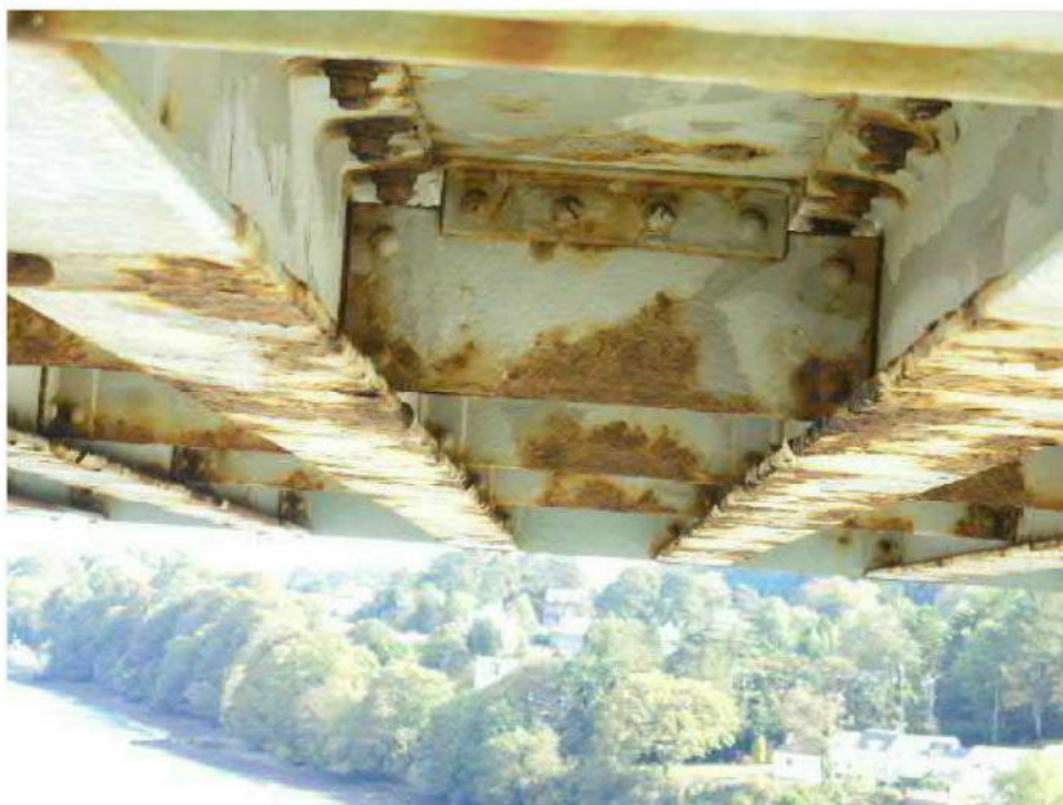
- Deep pitting corrosion and full depth section loss was noted to the lower edge beam flange, 52m from the south (Figure 114).
- Paint loss and corrosion was noted to transverse beam edges, longitudinal stiffeners and bolts, 85.5m and 90.5m from the south end (around mid-span) (Typically within Figure 118, Figure 119 respectively).

Figure 118: secondary deck – looking east at typical paint loss and corrosion to transverse beam edges, longitudinal stiffeners and bolts, 85.5m from south (around mid-span)

Figure 119: secondary deck – looking east at typical paint loss and corrosion to transverse beam edges, longitudinal stiffeners and bolts, 90.5m from south (around mid-span)

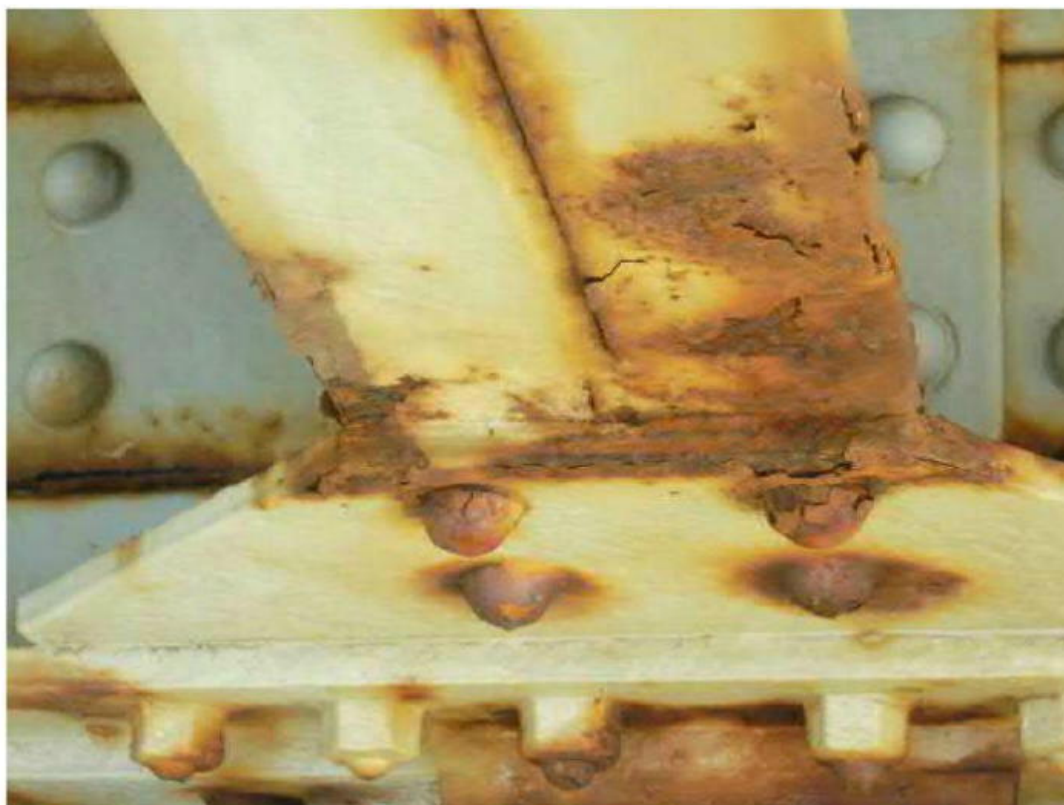
Figure 120: secondary deck – close-up of paint loss and corrosion to west walkway cantilever, gusset plate and rivet heads, 117.5m from south

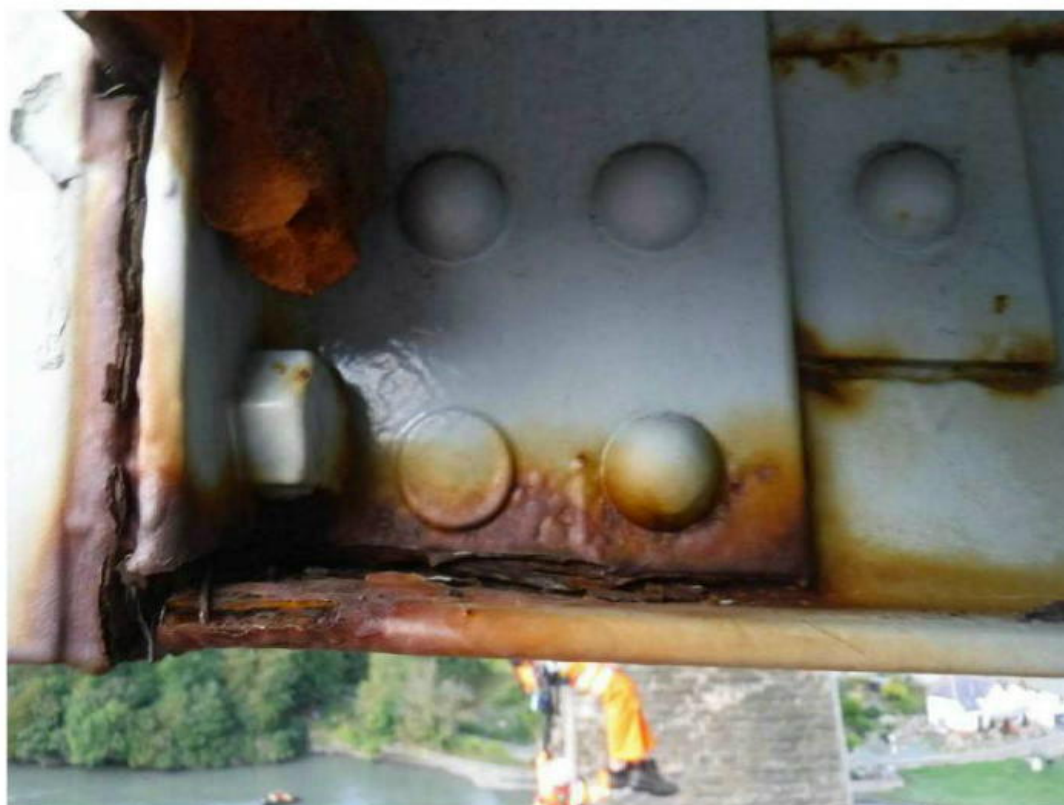
Figure 121: secondary deck – close-up of paint loss and corrosion to west walkway cantilever flange end and rivet heads, 121.5m from south

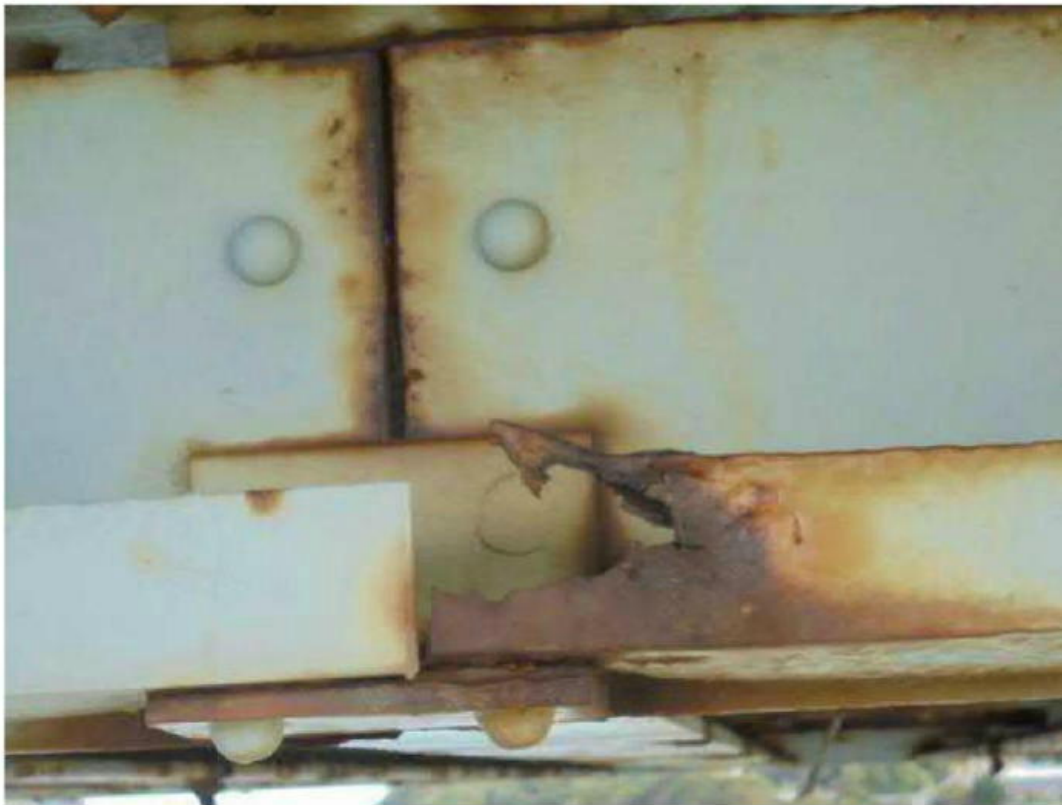
Figure 122: secondary deck – close-up of paint loss and total section loss from corrosion to angle sections beyond lower west face of truss, 144m from south
