UK Highways Bridge Management

Principal Inspection Report Menai Bridge (Structure Ref. A5 Menai Bridge)

December 2019

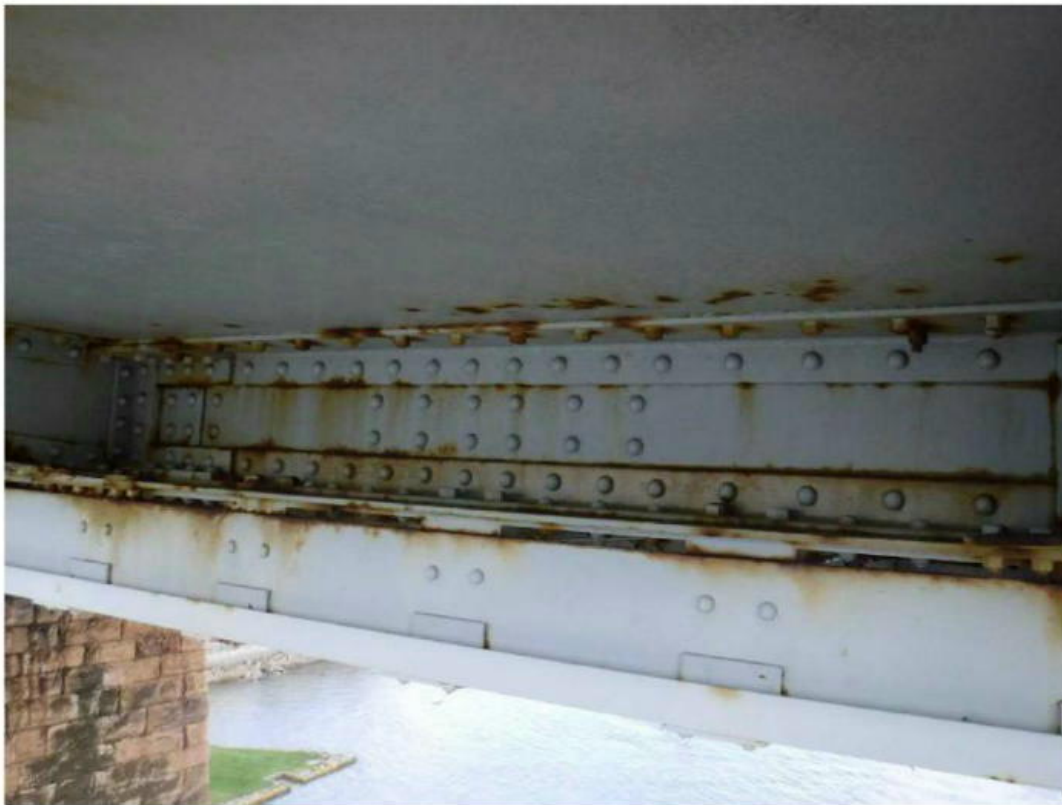
- The upper part of the main longitudinal truss, separating the carriageway and the footways, showed several small areas of light corrosion up to 1mm deep throughout, to less than 1% surface area. Typical at 149m from the south (Figure 124). The typical condition of the outer lower truss and cantilevers looking south from the east side at 12.5m and 17.5m from the south end (Figure 130, Figure 131 respectively).

Figure 124: secondary deck – paint loss and corrosion to west face of lower truss, upper flanges of transverse beams and walkway soffit, 149m from south

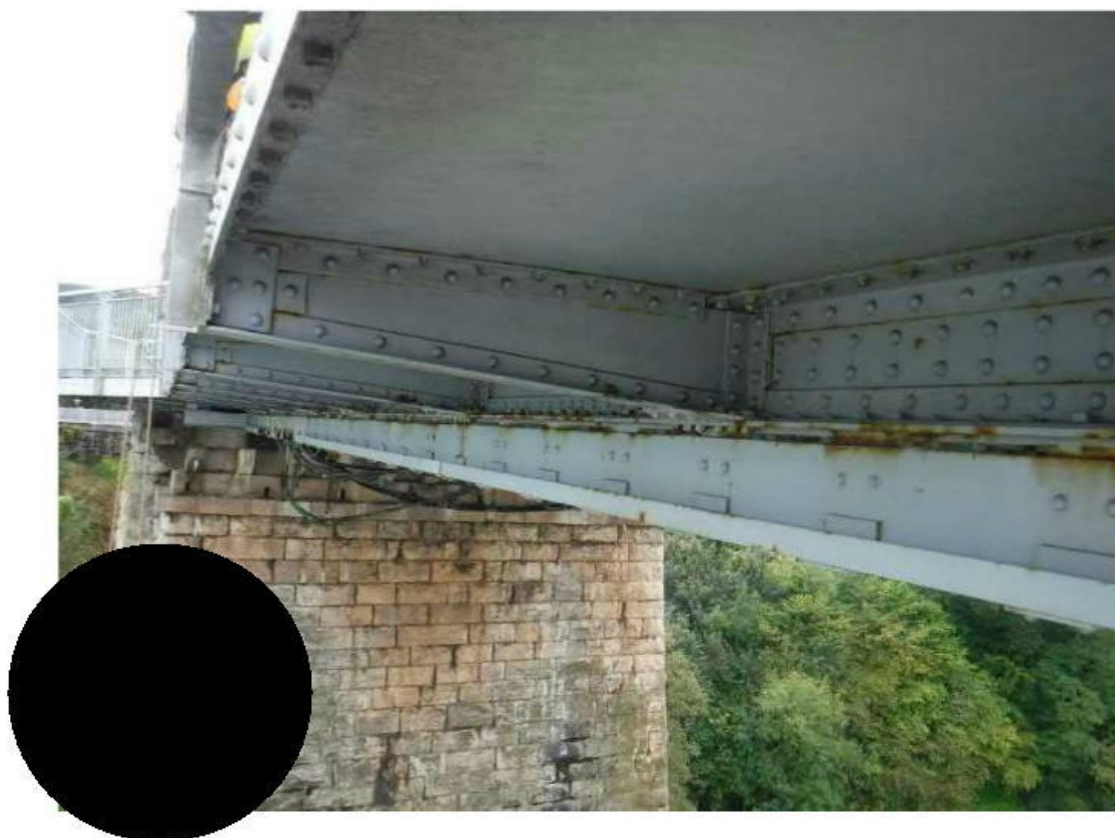
Figure 130: secondary deck – typical condition of outer lower truss and cantilevers looking south from east side, 12.5m from south end

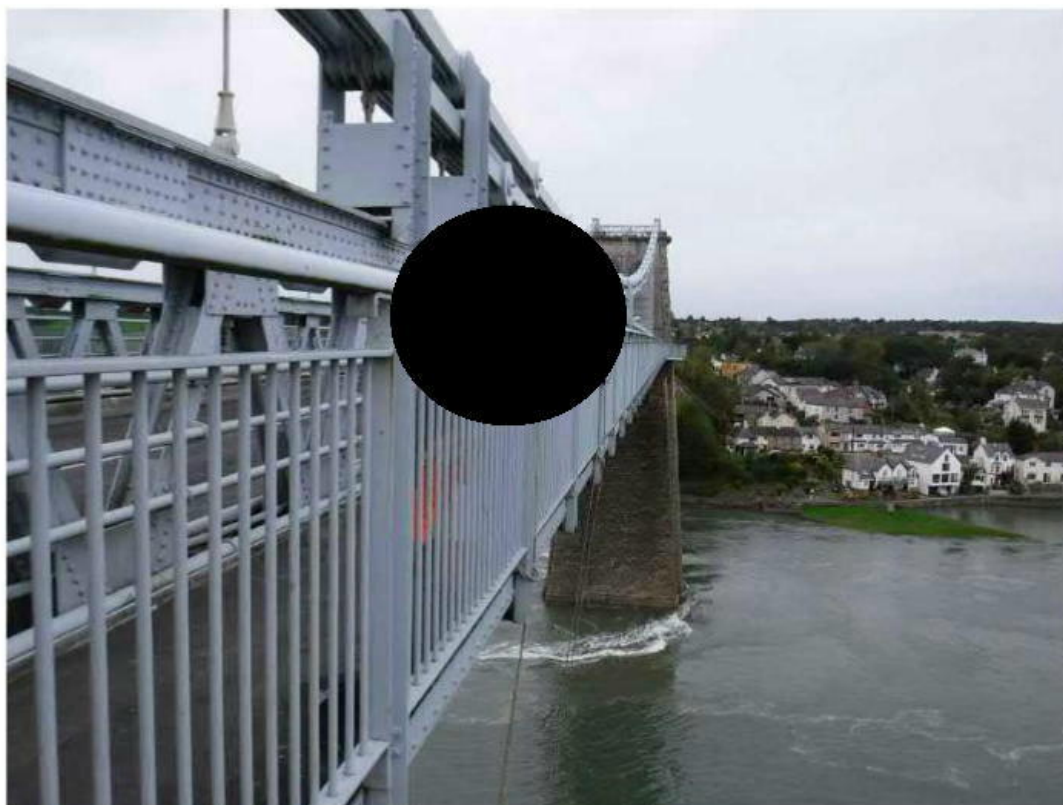
Figure 134: parapet – looking north at typical paint loss, corrosion and rust staining to the outer face ends of the east parapet posts, 58.5m from south end

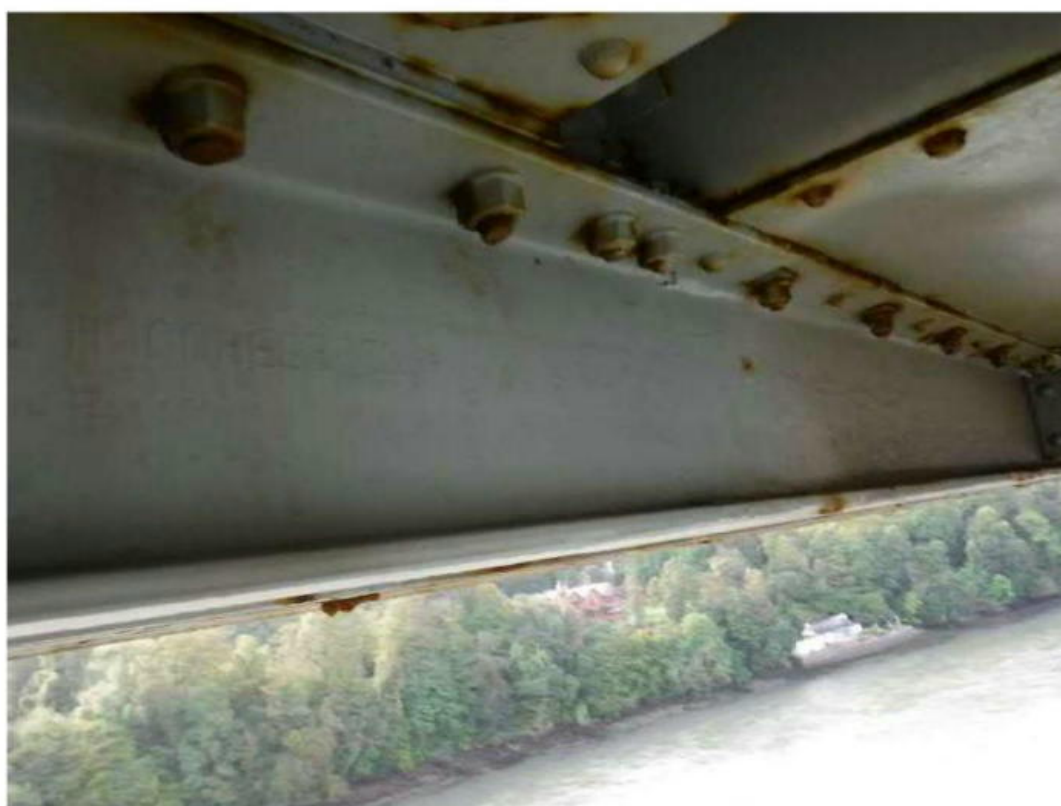
Figure 137: secondary deck – paint loss and corrosion to bolt heads to inside face of east edge beam, 112.5m from south

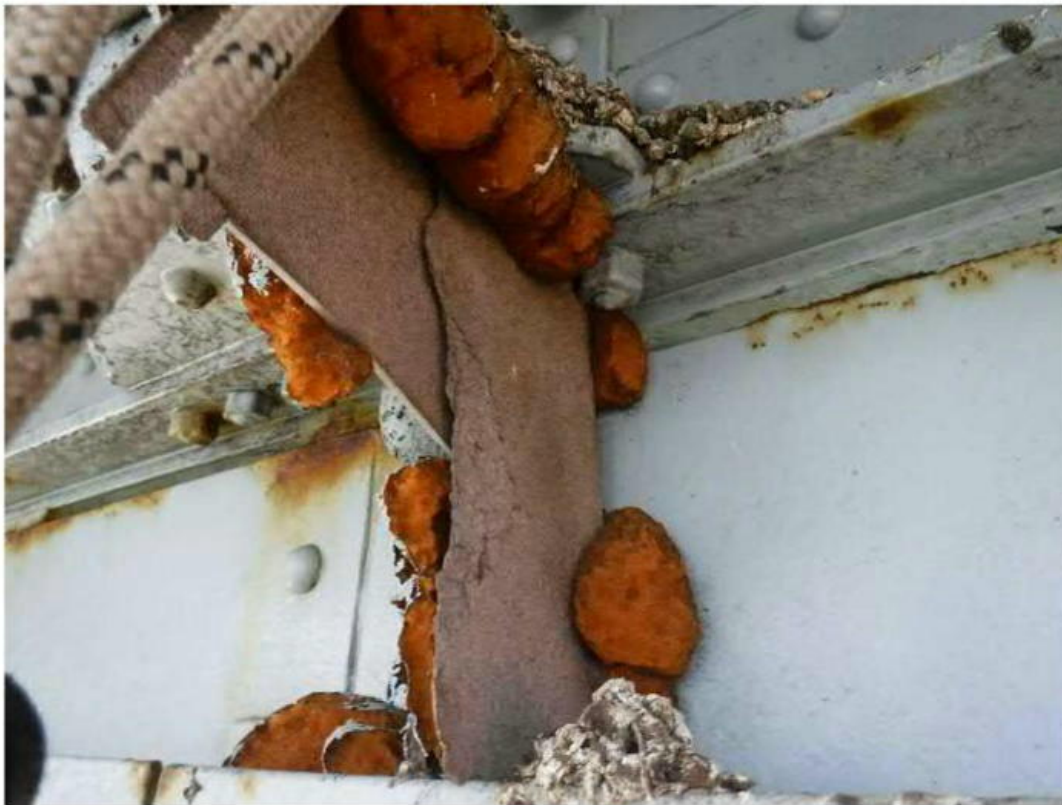
Figure 138: secondary deck – expanding foam and compressible fibre board to lower outer east face of east edge beam, 126m from south

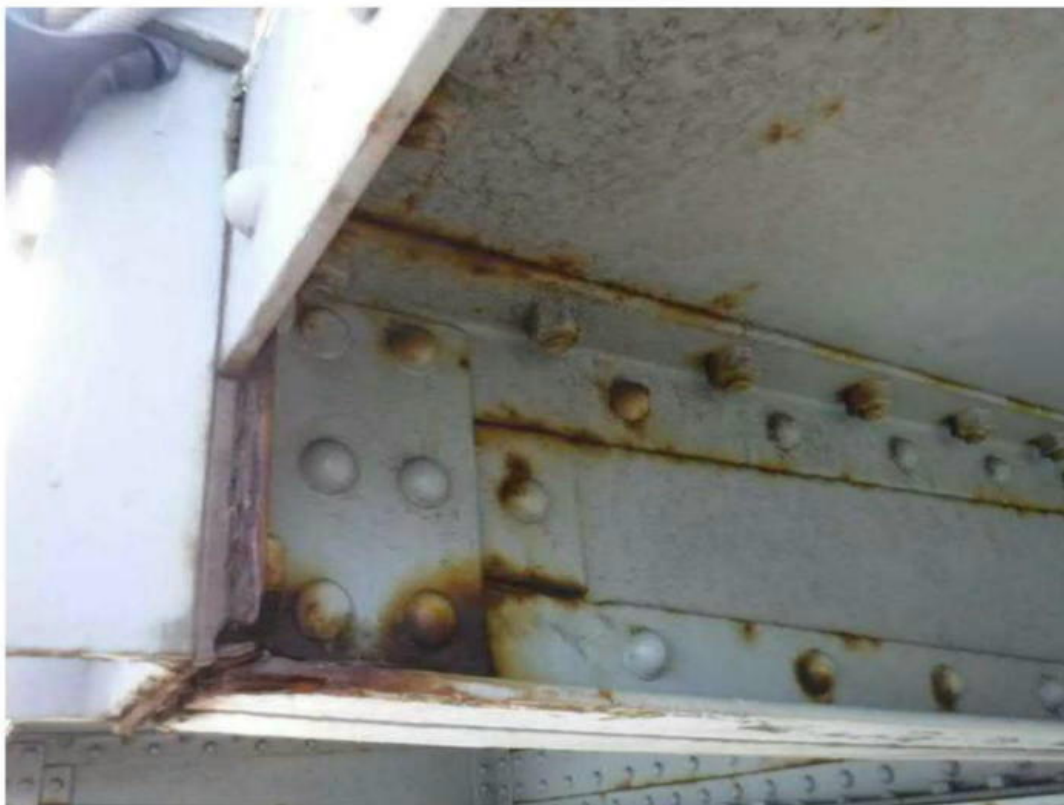
Figure 139: secondary deck – paint loss and corrosion to outer east end of cantilever, 139.5m from south

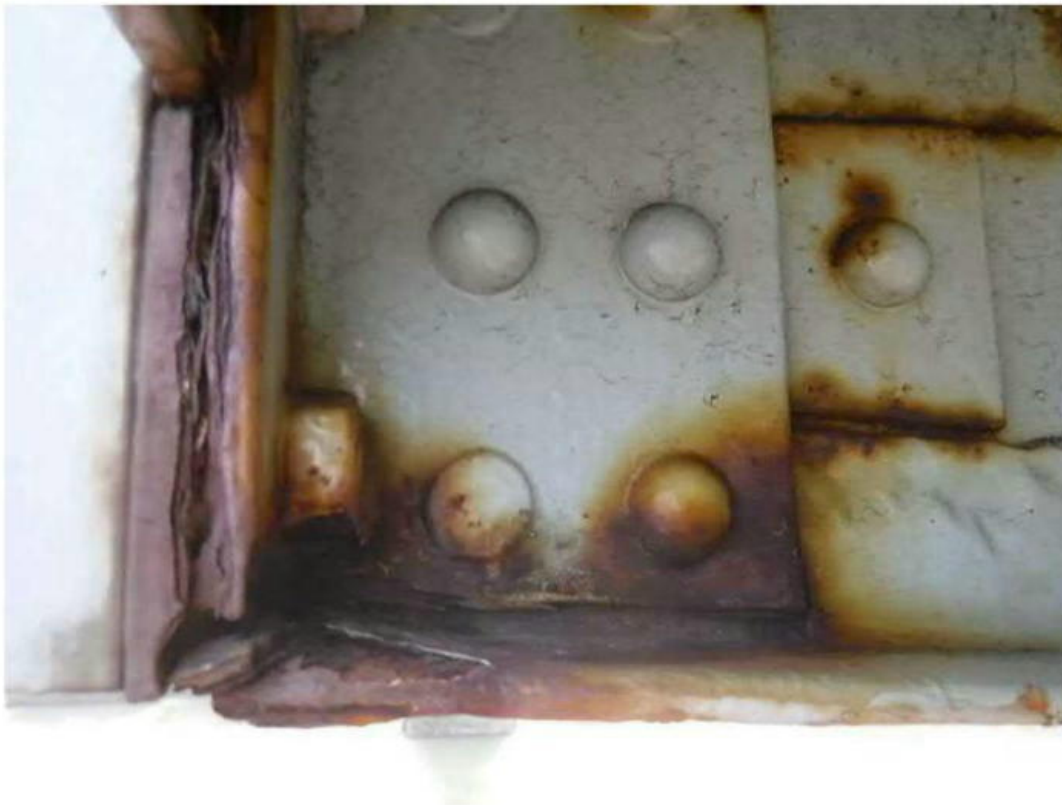
Figure 140: secondary deck – close-up of paint loss and corrosion to outer east end of cantilever, 139.5m from south

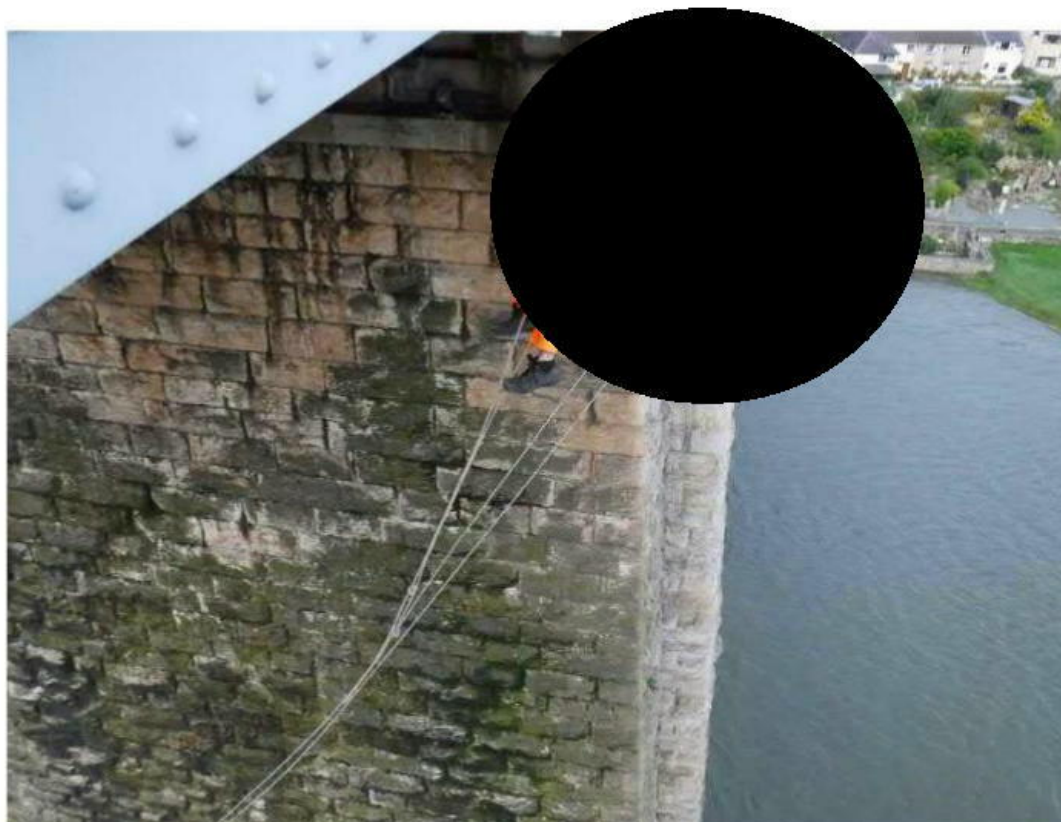
Figure 145: secondary deck – minor water staining to upper south face of pier 5

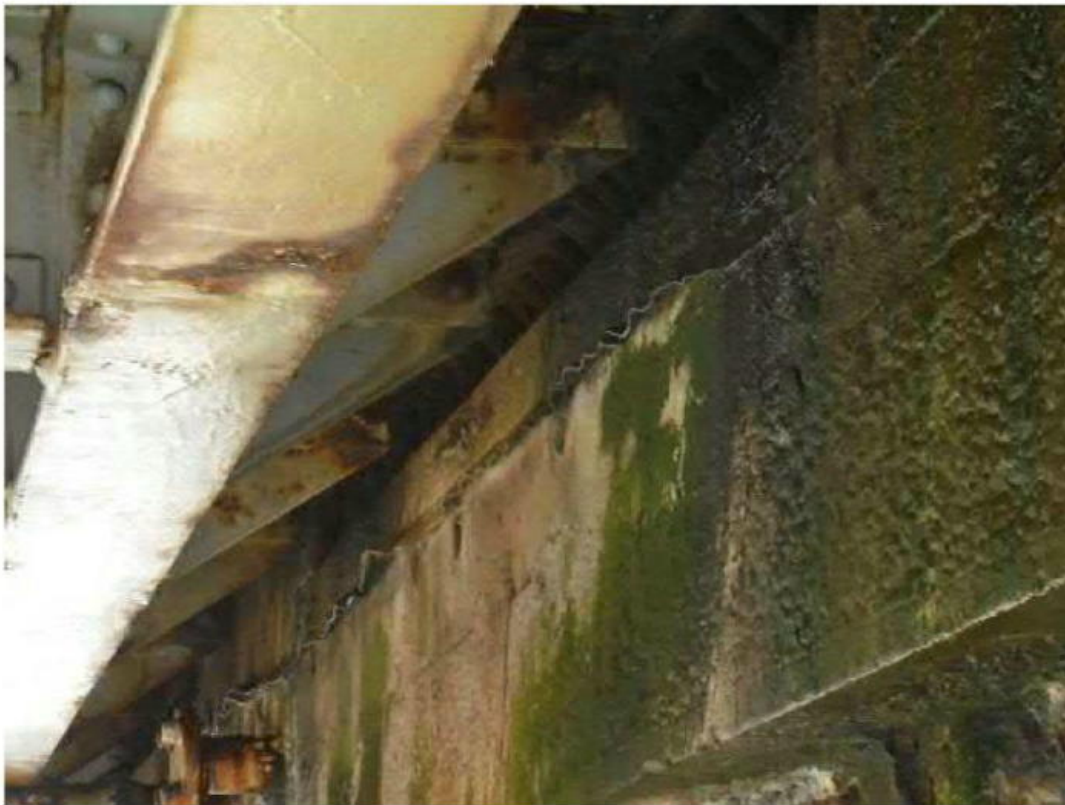
Figure 146: secondary deck – extensive surface corrosion to north main span bearings on pier 5

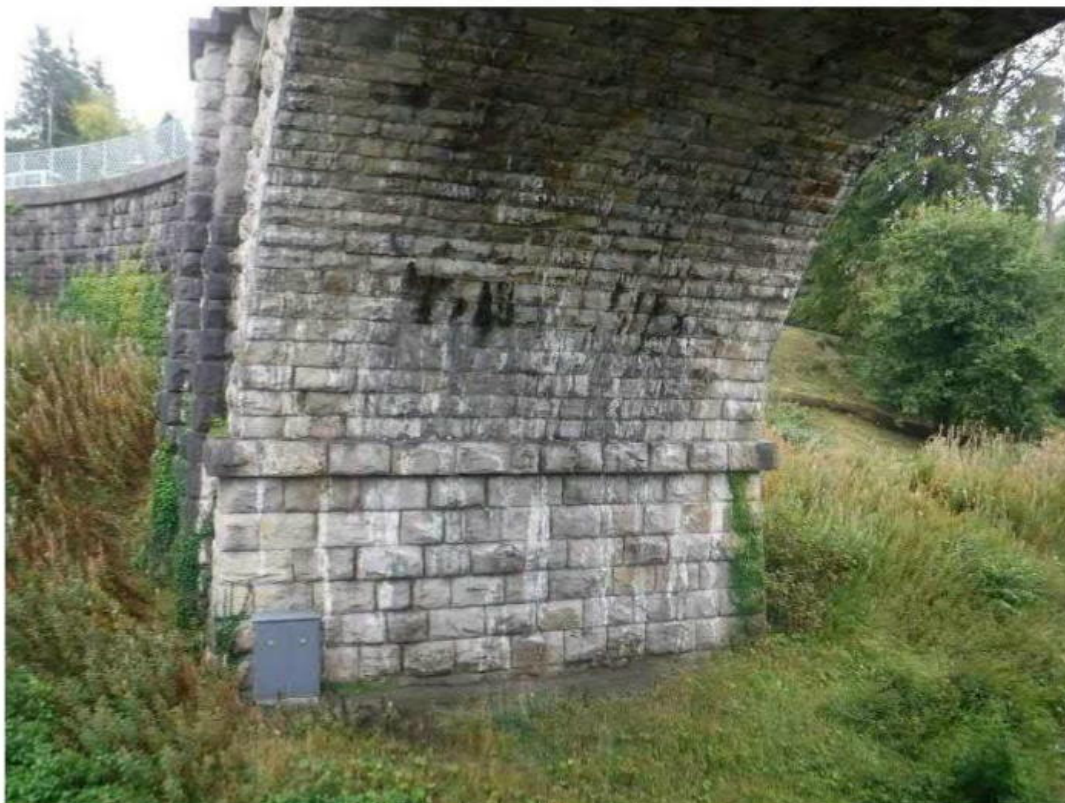
Figure 147: Waterproofing – minor damp staining and efflorescence to south abutment

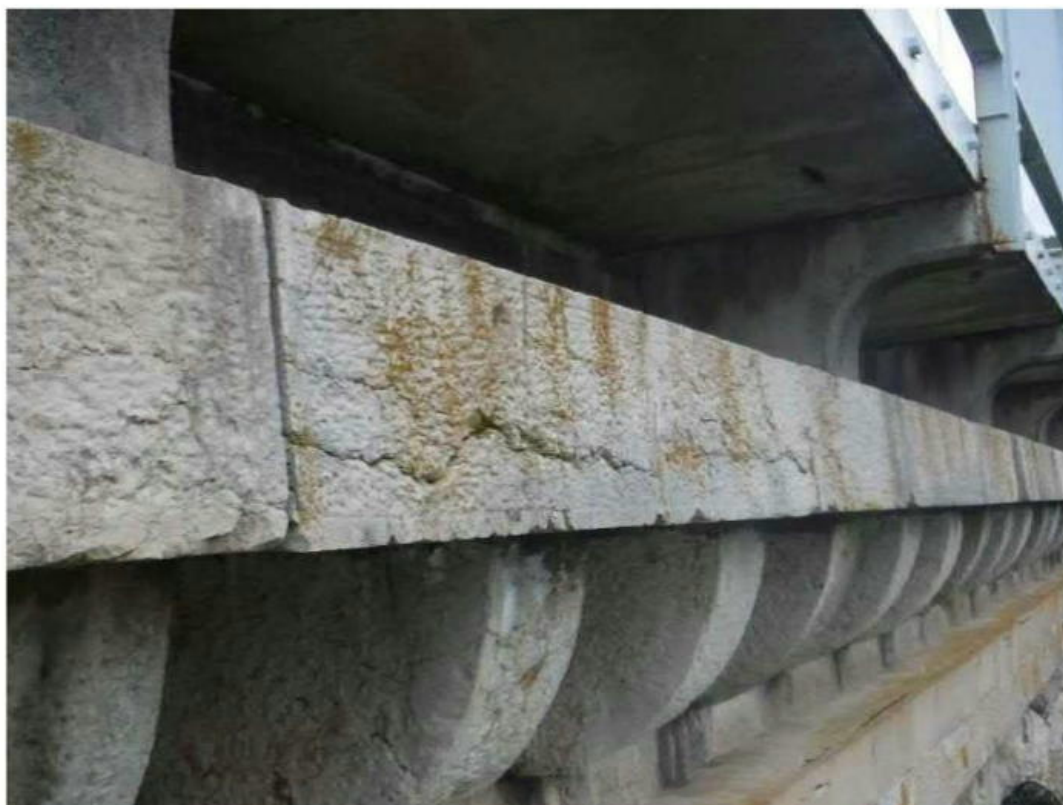
Figure 152: Edge beam/cantilever – several small areas of spalling and exposed rebar to the west walkway soffit above arch 7 (span 7).

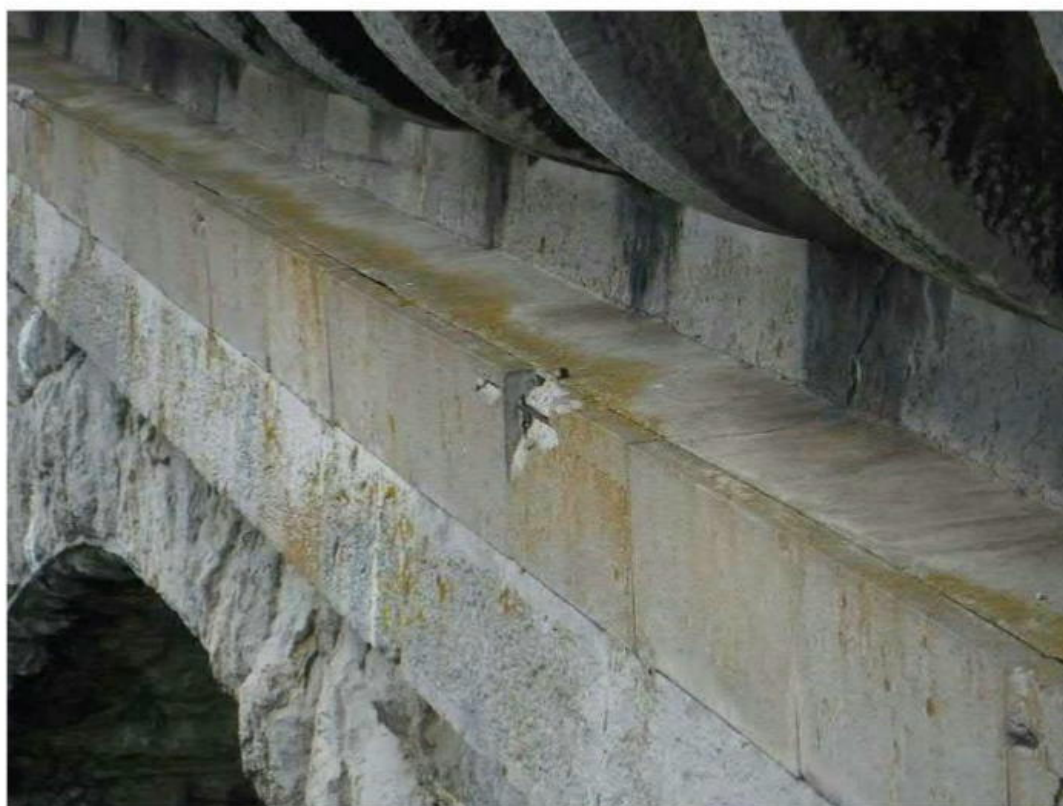
Figure 153: Spandrels – several areas of up to 350mm x 350mm of delamination and spalling with exposed rebar to the west spandrel panels above arch 7 (span 7).

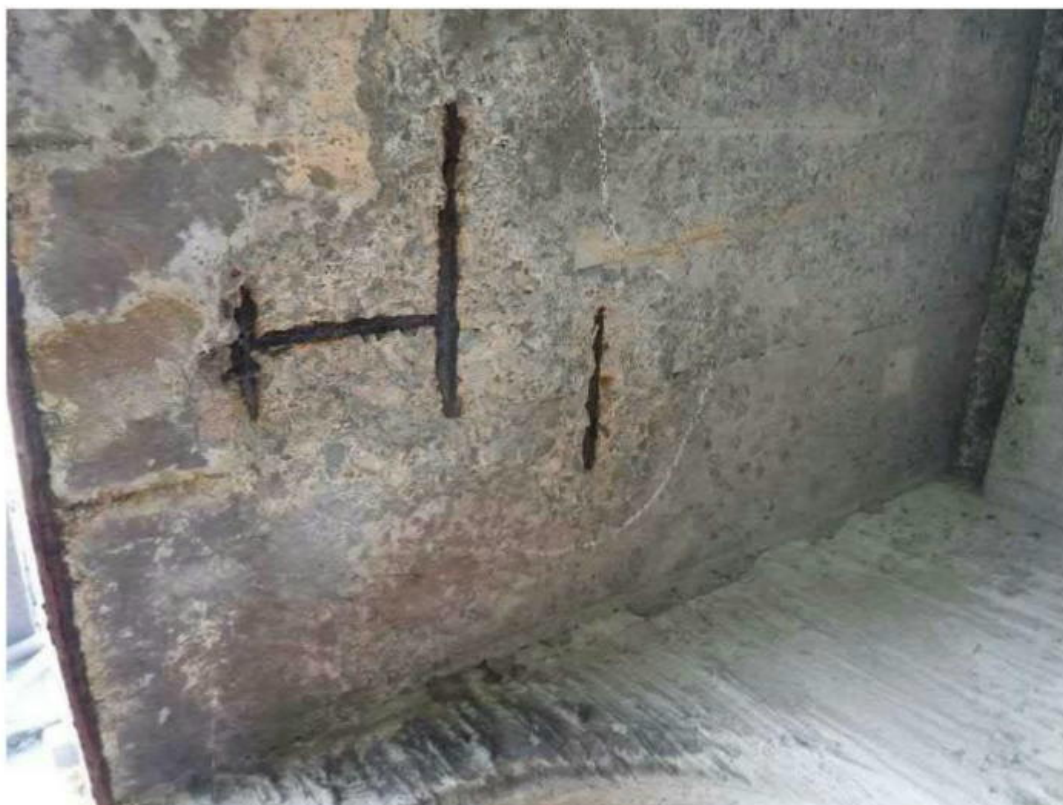
Figure 154: Parapet cantilever – approximately 800mm diameter x 40mm deep spalling with exposed rebar to the west walkway soffit above the cantilever off span 7.

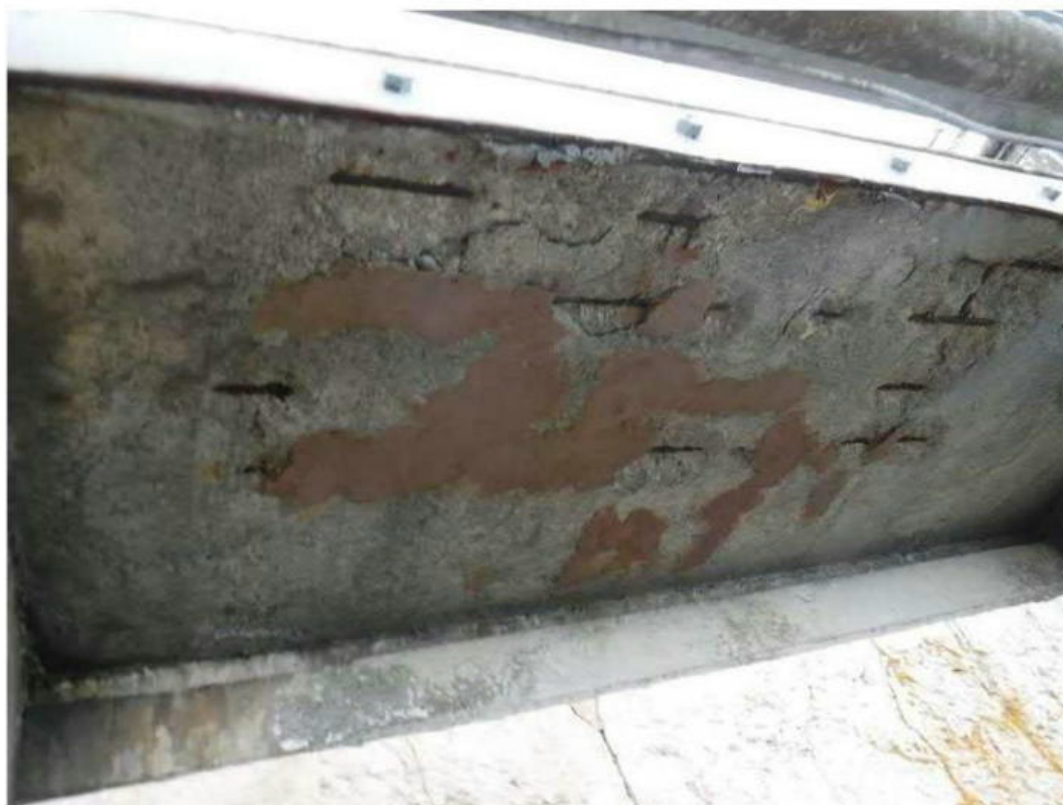
Figure 155: Parapet cantilever – several areas of typically 100mm x 50mm x 20mm deep delamination and spalling with exposed rebar to the east walkway soffit of span 8 (south span). Previously repaired areas also visible.

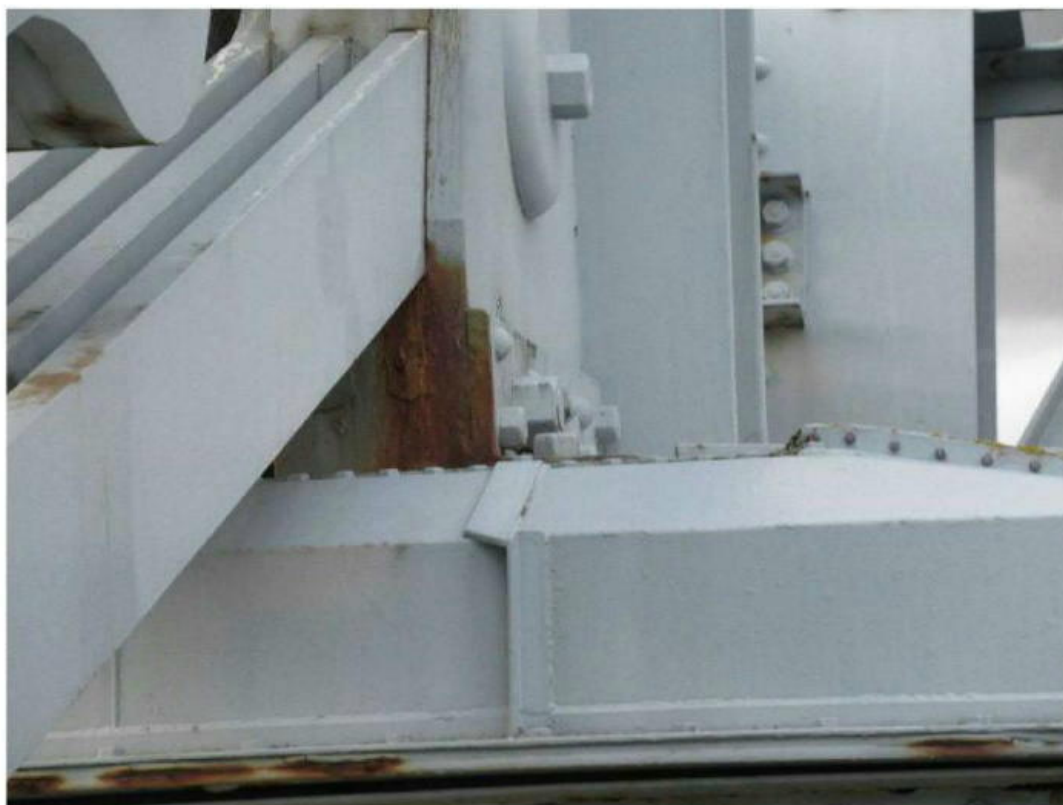
Figure 170: Primary deck element – close-up of small areas of surface corrosion to west chain saddle on the south tower, south face.

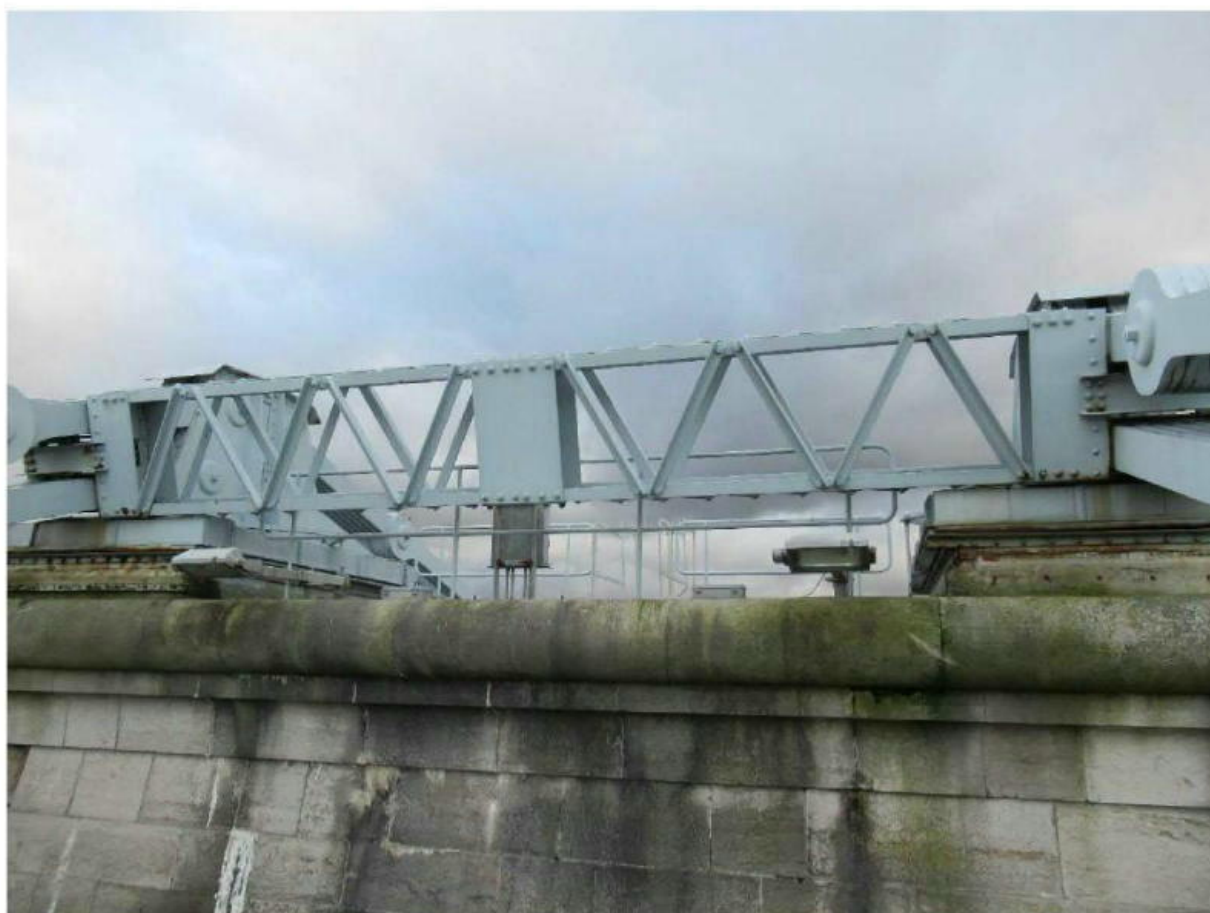
Figure 171: Bracing – small areas of surface corrosion to chain bracing on the south tower saddles, north face.

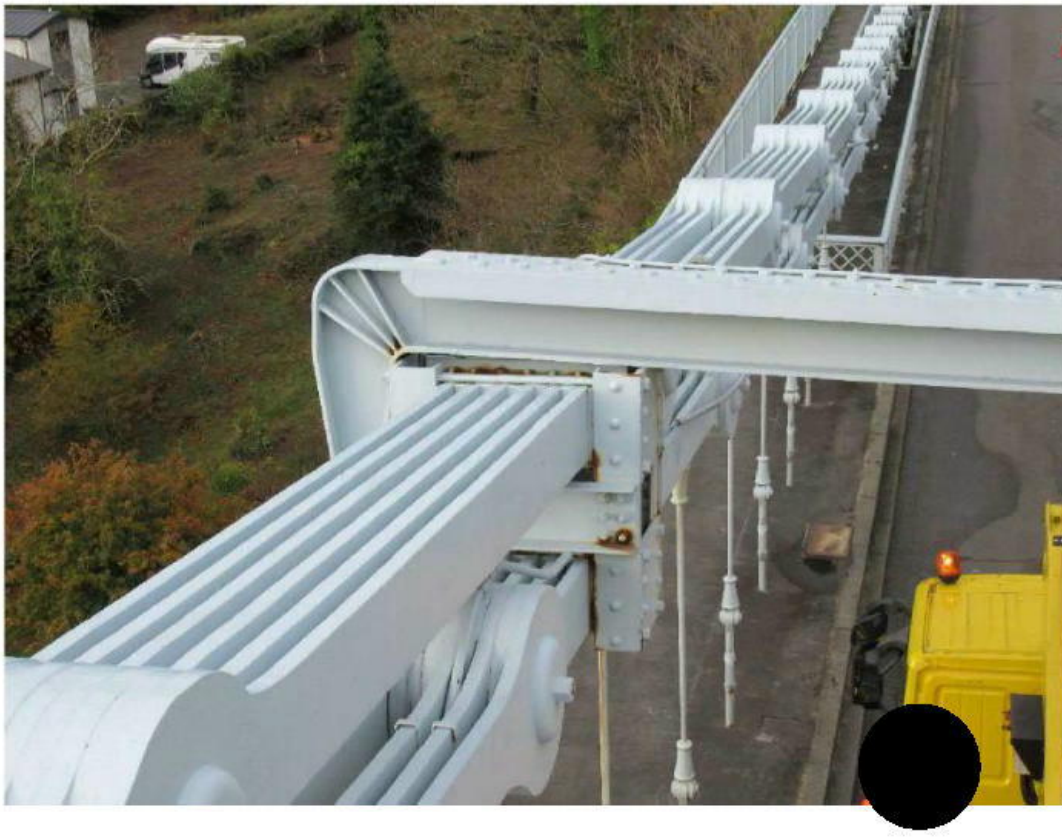
Figure 178: Deck bracing – west side of north back-stay transverse brace connection. Generally, in good condition with some minor surface corrosion.
