<b>Coal Tip Name</b>		Bryngwyn		<b>UID</b>		T23077	
<b>Located in</b>		Gellideg		<b>Tip Category</b>		C	
<b>Inspection Led by</b>		[REDACTED]		<b>Date of Inspection</b>		17-12-2024	
				<b>Date of last Inspection</b>		24-10-2023	
<b>Weather</b>		Overcast		<b>Wet Ground Conditions</b>		Calm	
<b>Comments on access and any limitations</b>		Access to the upper flatter area is restricted as it is occupied by residential properties, the north west was inaccessible due to a small holding. Access to the main north face slopes was via a footpath off Swansea Road, no detailed survey/engineering plans or geotechnical/geological reports relating to the tip site were made available.					
		<b>Description</b>				<b>Status</b>	
<b>RAG Status: Capital &amp; Maintenance Works</b>		None required at present.					
<b>General Remarks</b>		The small tip was formed from levels extracting ironstone, the structure has been emplaced on relatively flat terrain, and is comprised from loosely consolidated coal measure mudstone, siltstone, sandstone and small traces of ironstone/coal. A channel exits at the toe with flow into a concrete pipe which discharges flows into an unlined steeply incised gully. There is

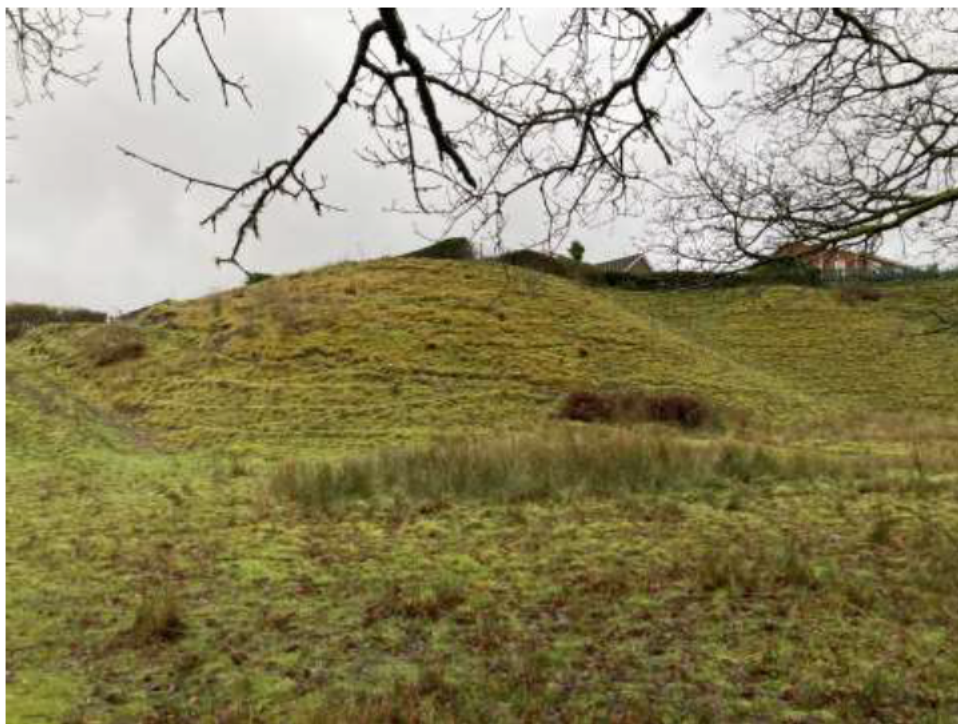
Photo No.	1	Comment	Minor creep on main north facing slopes.
Feature ID	24/G/01

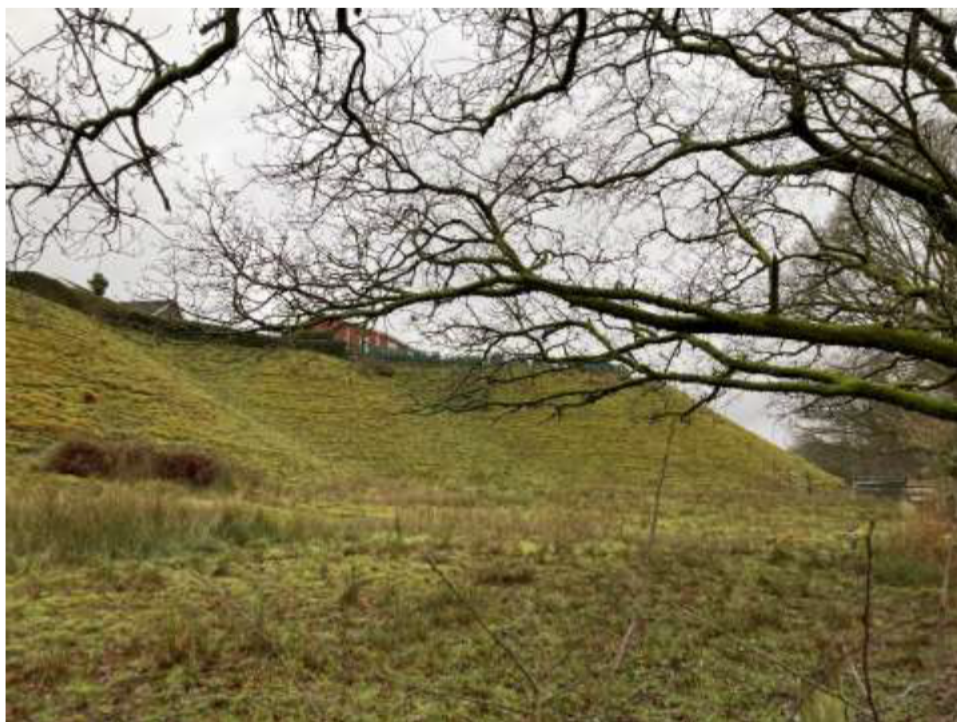
Photo No.	2	Comment	Saturated ground below toe of north face.
Feature ID	24/G/02

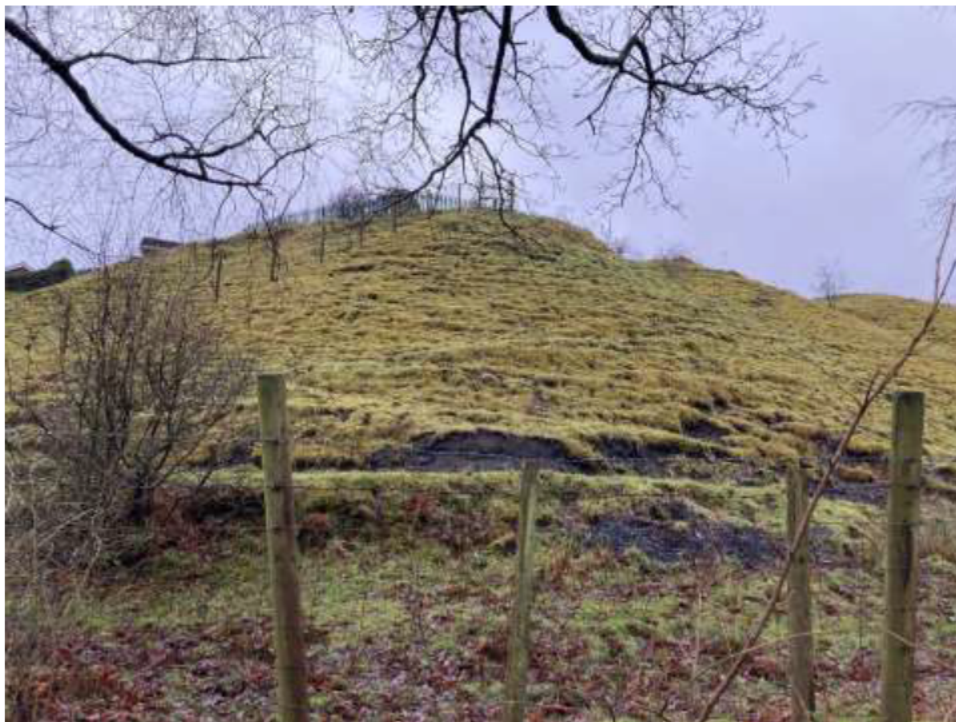
Photo No.	3	Comment	Erosion on north face.
Feature ID	24/G/03

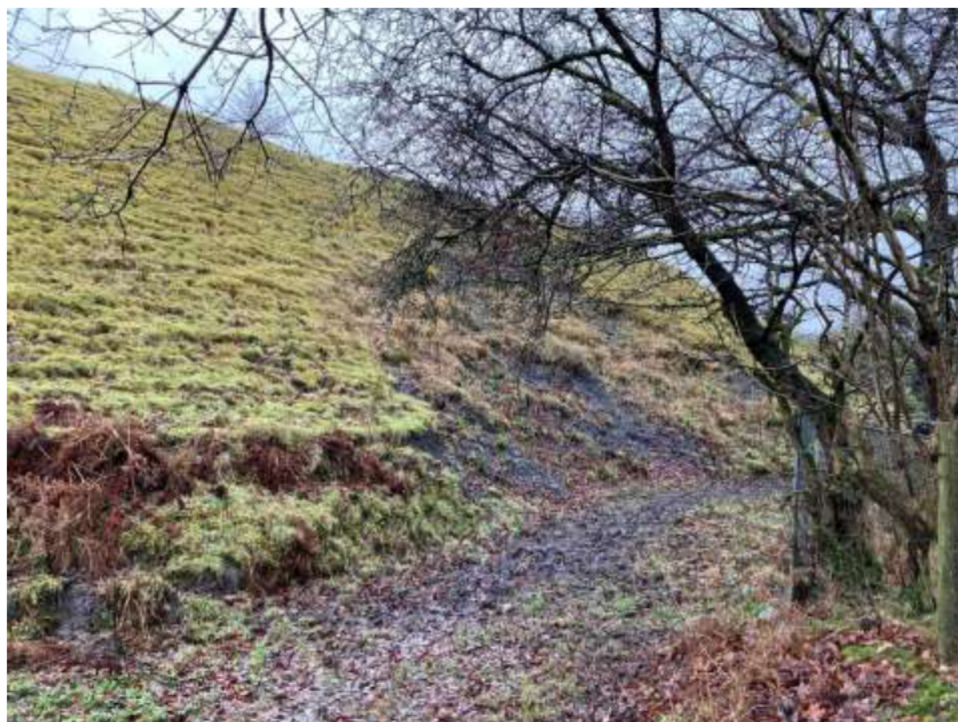
Photo No.	4	Comment	Slip near toe of north face.
Feature ID	24/G/04

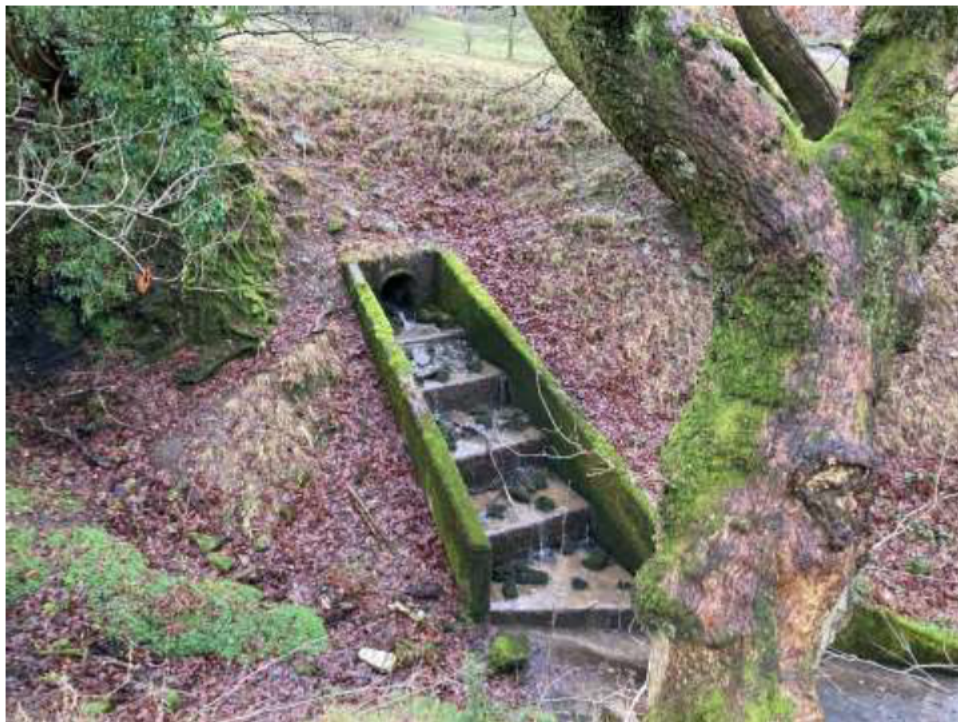
Photo No.	5	Comment	Pipe with discharge of water in steep side gully.
Feature ID	24/D/01

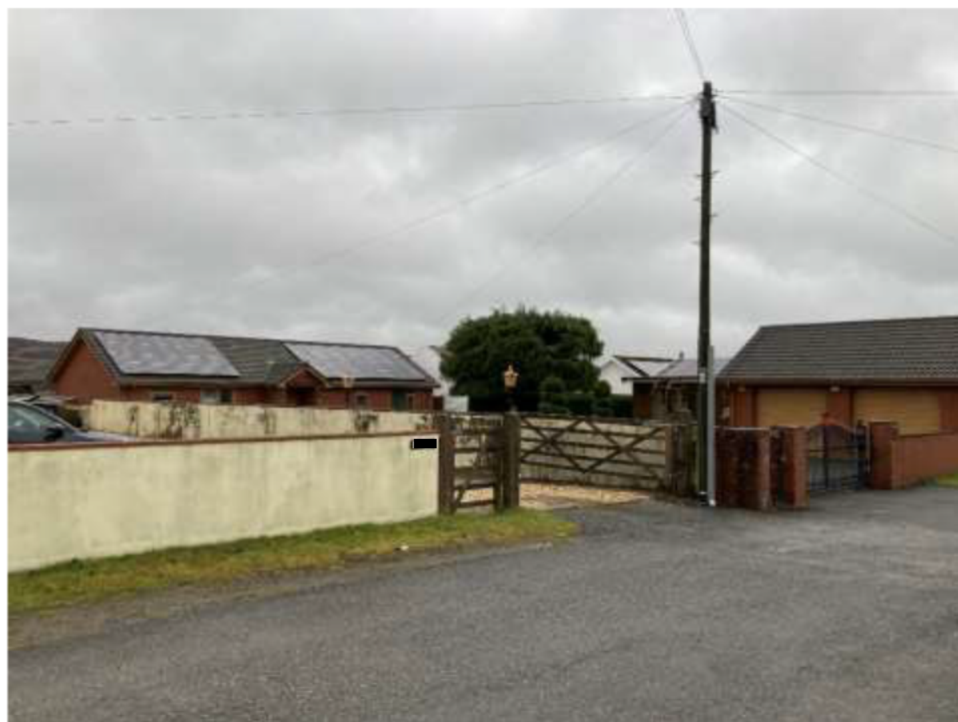
LAND USE				
ID	Feature	Location	Comment	Change to Condition (New, Worse, None or N/A)
24/L/01	Residential development	E 302417      N 207185	A number of houses exist on the upper flatter section.	No Change
Recommendations				
CONTAMINATION / GEO-ENVIRONMENTAL				
ID	Feature	Location	Comment	Change to Condition (New, Worse, None or N/A)
N/A				
Recommendations				
OTHER				
ID	Feature	Location	Comment	Change to Condition (New, Worse, None or N/A)
N/A				
Recommendations				
Any other remarks

Photo No.	6	Comment	Residential dwelling on upper flatter section.
Feature ID	24/L/01
