Coal Tip Name	Godre'r-graig Quarry / Cilmaengwyn		Tip Ref Number	L044A	
			Ownership Status	Private	
Located In	Godre'r-graig, Neath-Port Talbot		Tip Category	D	
Inspection Led By		Date of Inspection	24/07/2023	Date of last Inspection	13/06/2019 (TCA)
Weather	Overcast		Damp		Calm
General Remarks (e.g. access, limitations)	<p>Access to the site was gained via an access path situated just off the [REDACTED] access track. The access path extends up the hillside in a north-easterly direction, passing through Cwar Pentwyn Quarry before reaching a narrow, overgrown path which extends up-slope towards the site. It should be noted that this inspection was conducted without the benefit of a detailed site plan; whilst dense vegetation significantly limited accessibility and visual inspection. Therefore, instability within these areas could exist, but was not detectable at the time of the inspection. The densely overgrown nature of the site prevented inspection of the spoil material; it is presumed that the site is comprised of sandstone quarry waste material, however some exposures of colliery spoil material were evident downslope (off-site), adjacent to the access path.</p>

Coal Tip Name	G

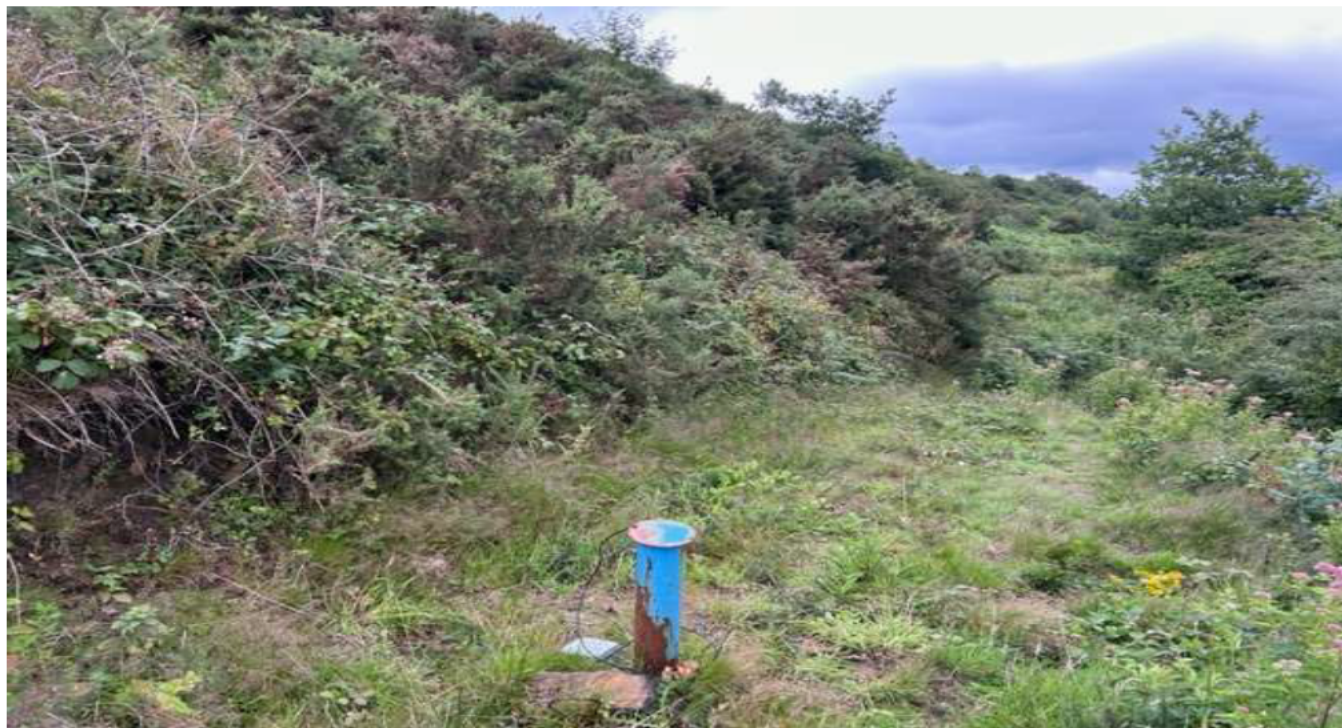
Photo No.	1	Comment	Piezometer borehole located on the site access track, downslope of the tip.

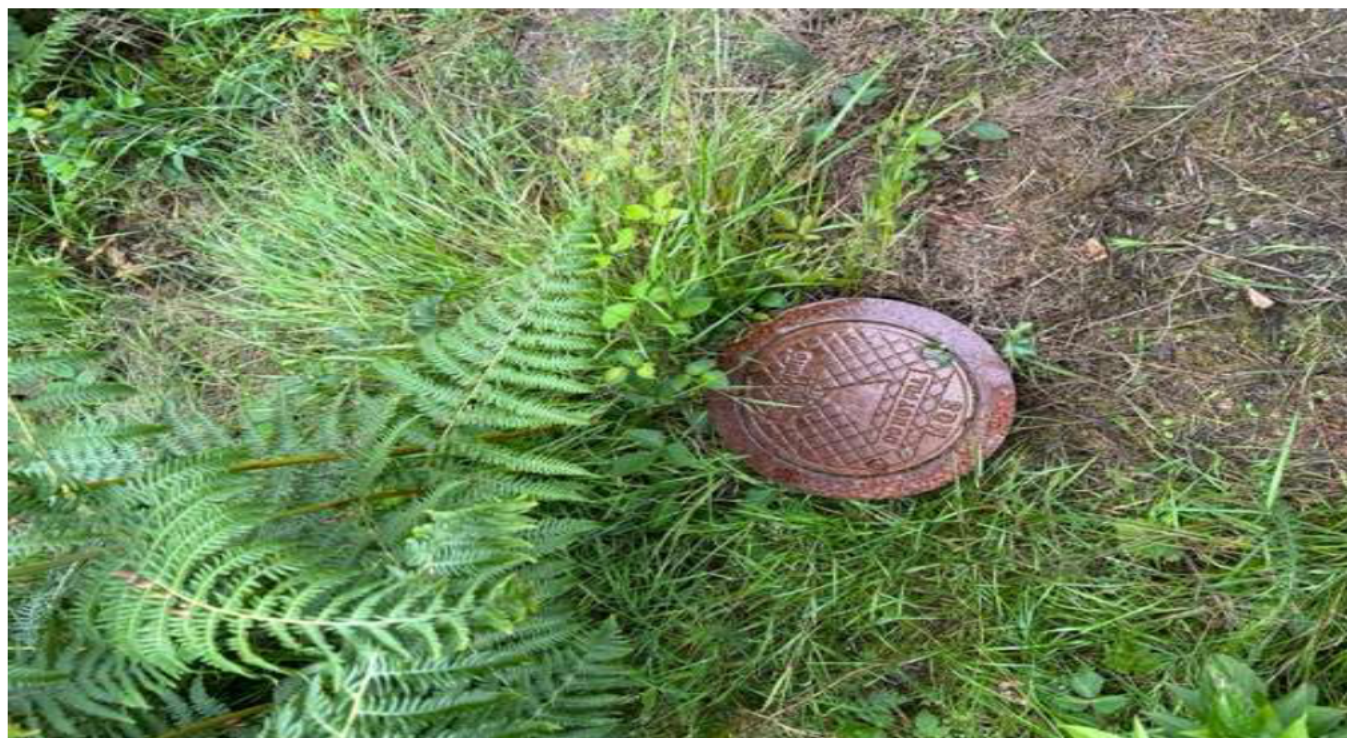
Photo No.	2	Comment	Monitoring well located on the site access track, downslope of the tip.

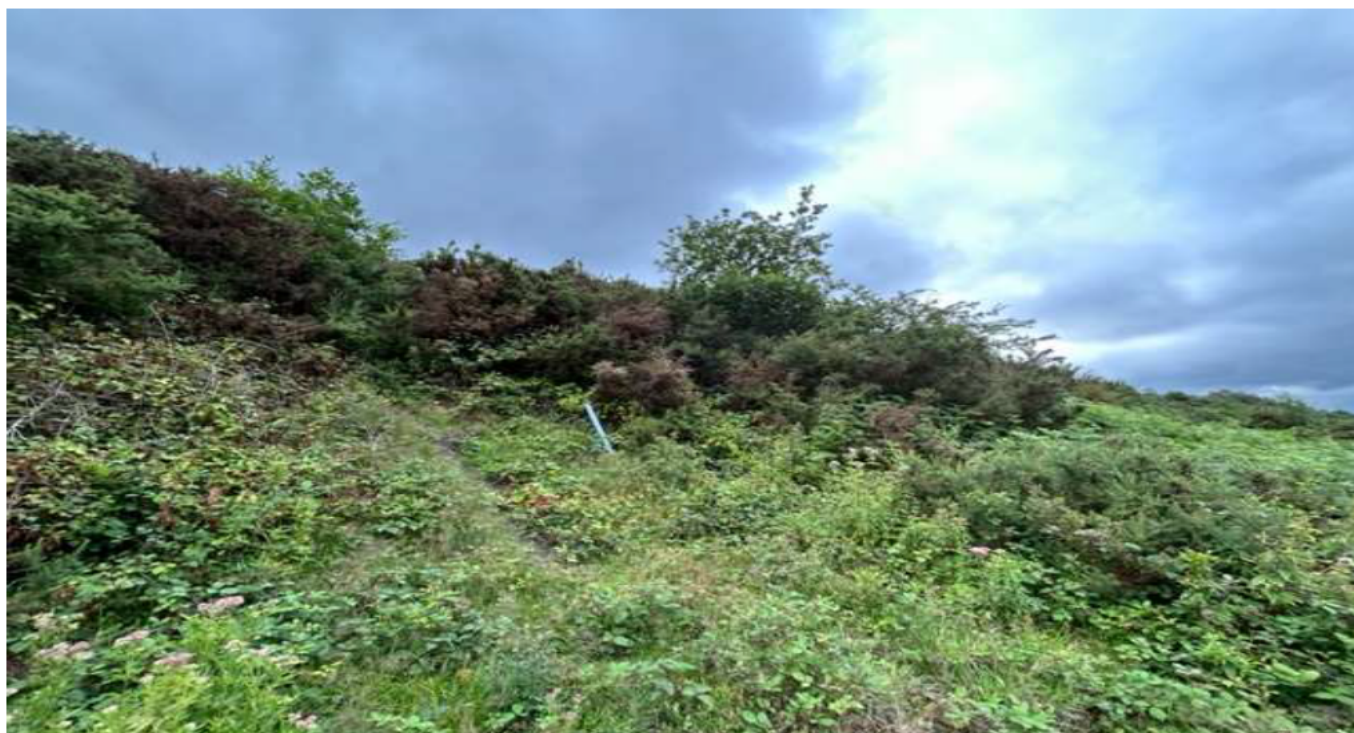
Photo No.	3	Comment	Minor surface erosion exposing bare spoil material along a narrow, overgrown access path; of which extends up-slope off the main site access path, towards the site.

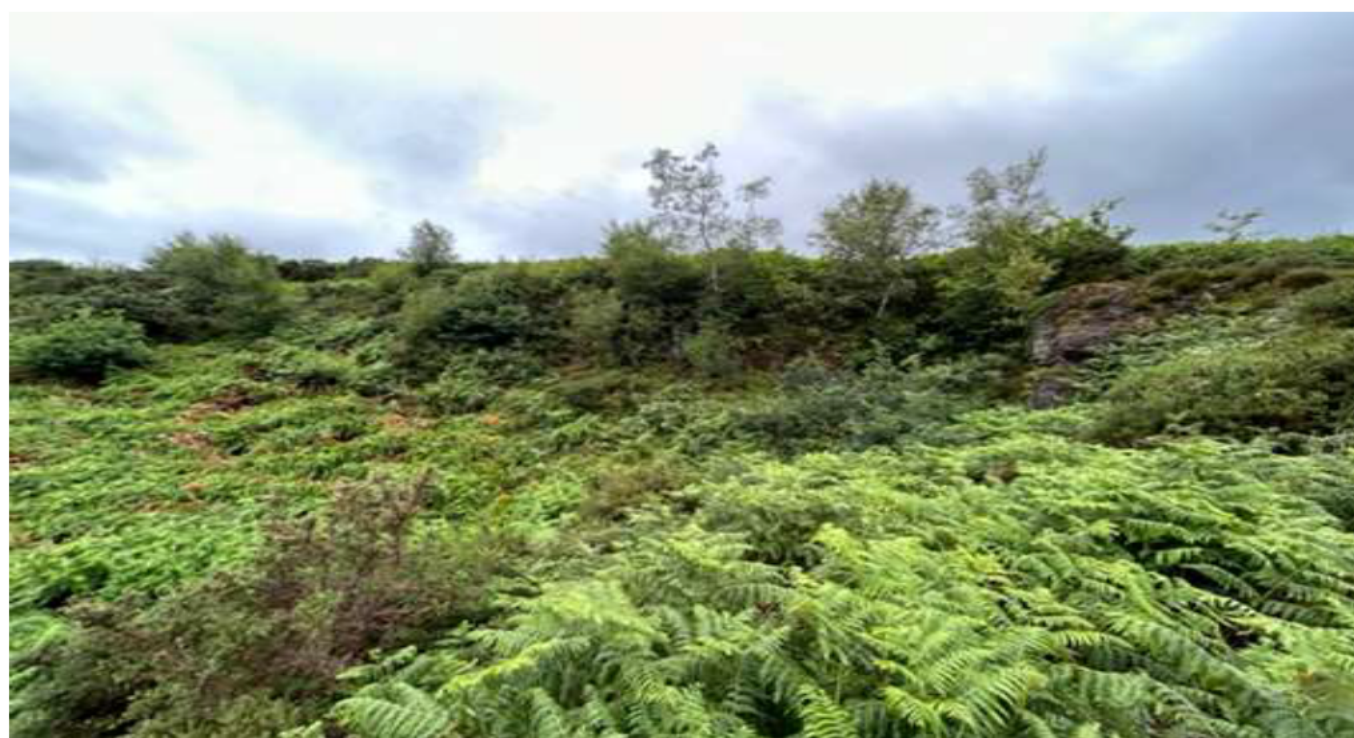
Photo No.	4	Comment	View looking towards an outcrop of bedrock at the rear of the tip; likely the quarry high wall.

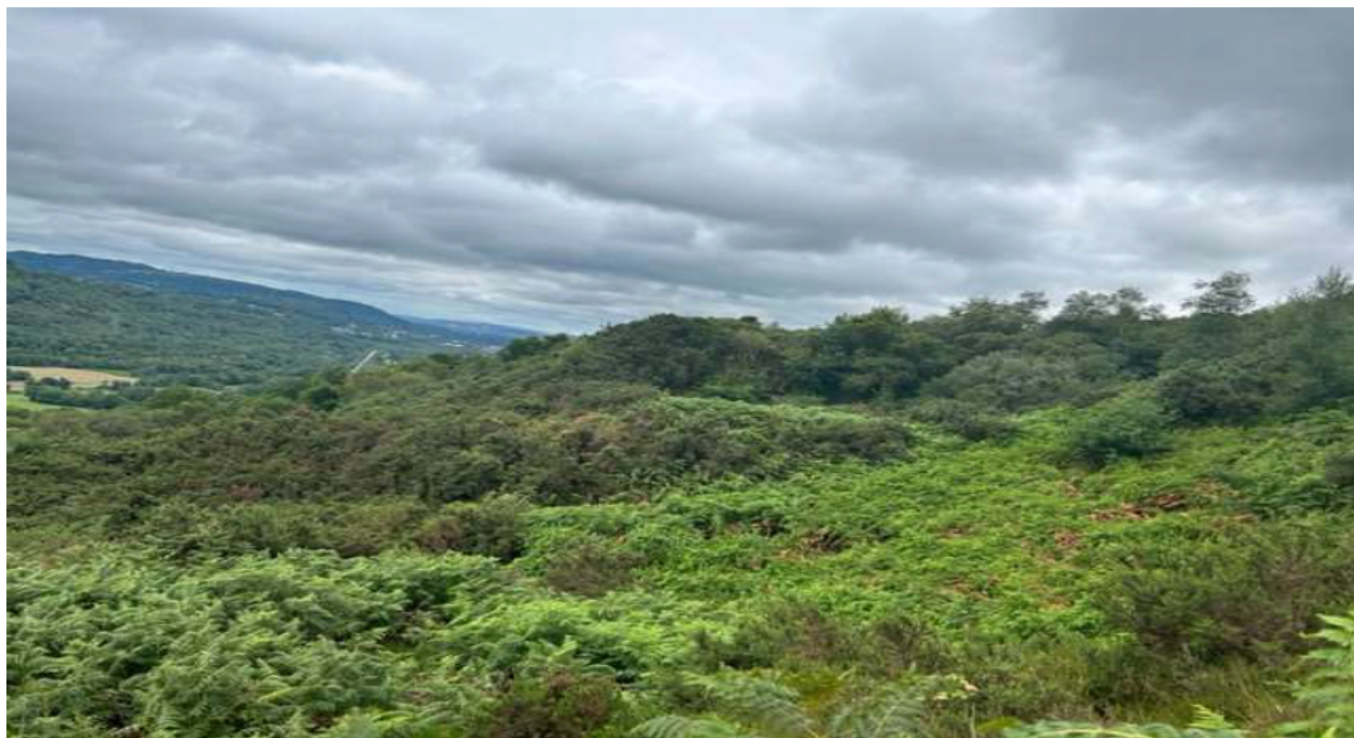
Photo No.	5	Comment	View looking south-west across the very densely vegetated lobes of tip material. Image conveys associated accessibility issues.
