| <b>Coal Tip Name</b> | Godre'r-graig Quarry / Cilmaengwyn | <b>Tip Ref Number</b> | L044A |
| <b>Located in</b> | Godre'r-graig, Neath-Port Talbot | <b>Tip Category</b> | D |
| <b>Date</b> | 08/11/2023 | <b>Date of last Detailed Inspection</b> | 24/07/2023 |

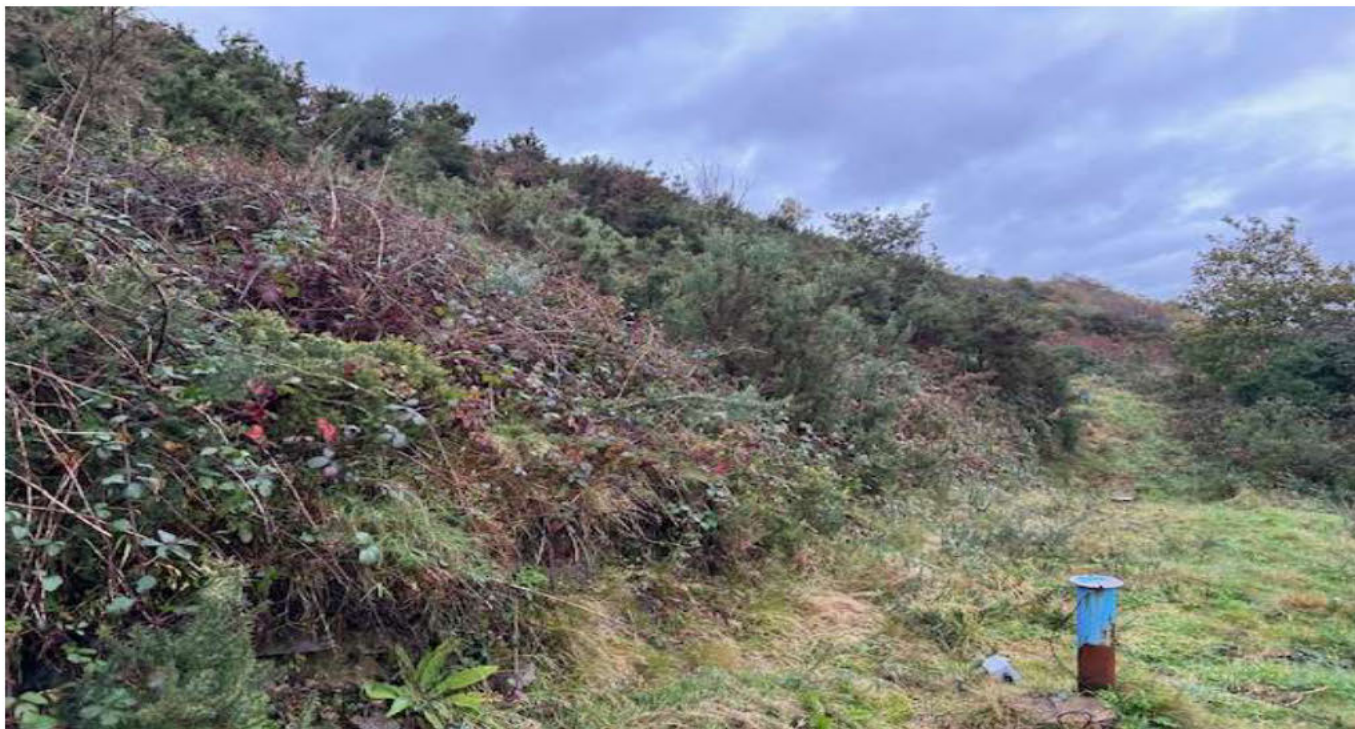
| <b>Feature ID</b> | 23/IM/01 | | |

| OBSERVATIONS | | | |
|---|---|---|---|
| 23/IM/01 | Piezometers & Inclinometers | E – 275048<br>N - 206996 | Series of piezometer boreholes and monitoring wells, situated on the site access track (outside the provided site boundary). Plastic casing associated with a piezometer appears to have been discarded next to a path which ascends towards the tip. Inclinometers are recorded as being installed within some of the boreholes. |

| <b>Photo No.</b> | 1 | <b>Comment</b> | Piezometer borehole located on the site access track, downslope (outside the provided site boundary). |

| OBSERVATIONS | | | |
|---|---|---|---|
| Recommendations | | | Continue to utilise the monitoring equipment across the site. |

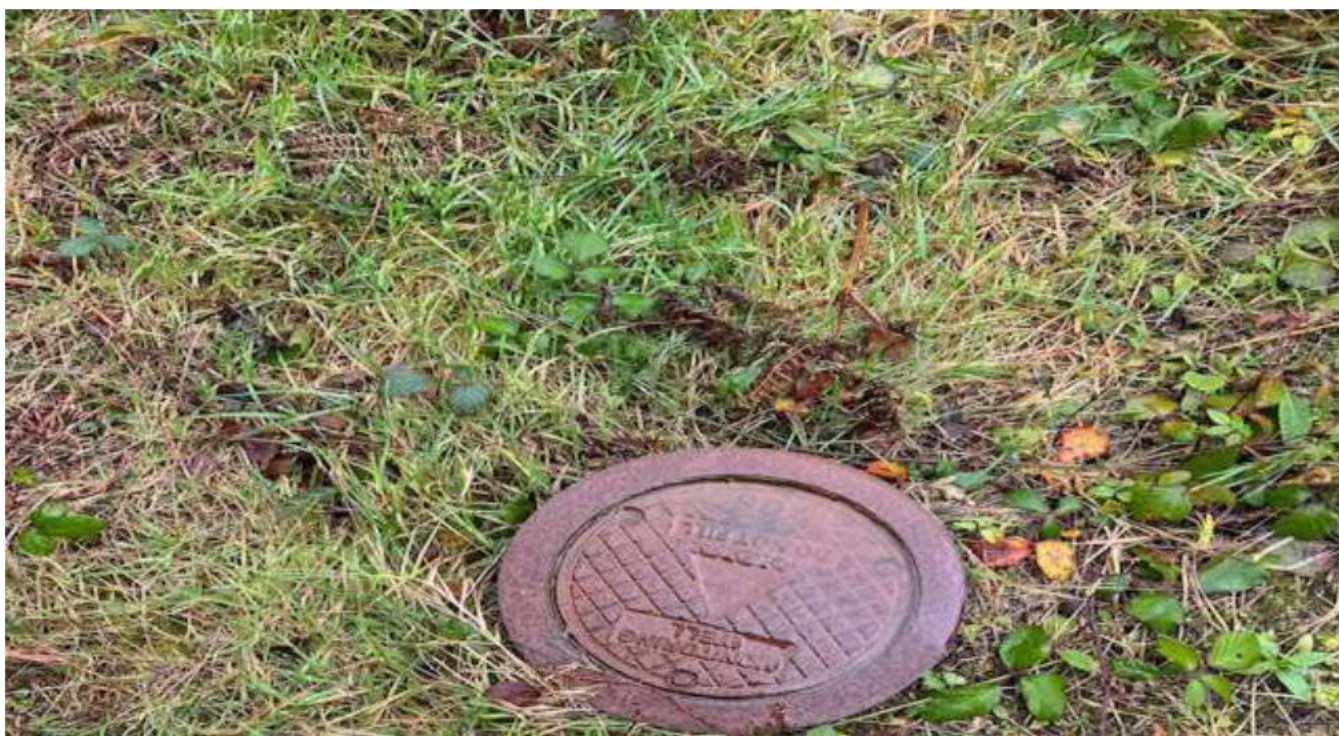
| <b>Feature ID</b> | 23/IM/01 | | |

| <b>Photo No.</b> | 2 | <b>Comment</b> | Monitoring well located on the site access track, downslope (outside the provided site boundary). |

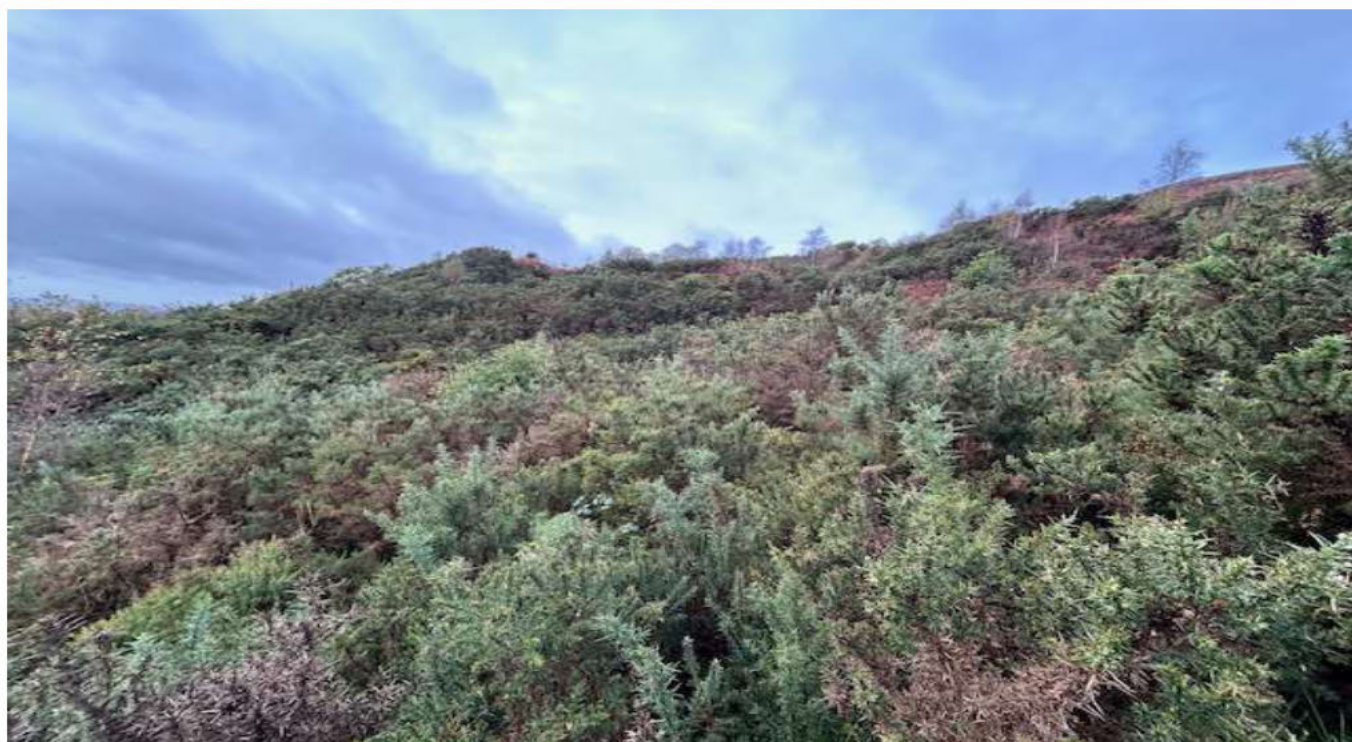
| <b>Feature ID</b> | 23/L/01 | | |

| OBSERVATIONS | | | |
|---|---|---|---|
| 23/L/01 | Vegetation Cover | E – 275025<br>N - 207030 | The surfaces of the tip are densely vegetated with grass, bracken and gorse. |

| <b>Photo No.</b> | 5 | <b>Comment</b> | View looking south-west across the very densely vegetated lobes of tip material. Image conveys associated accessibility issues. |

| OBSERVATIONS | | | |
|---|---|---|---|
| Recommendations | | | Consider conducting vegetation clearance (clear pathways) to enable a more detailed inspection to be undertaken. |

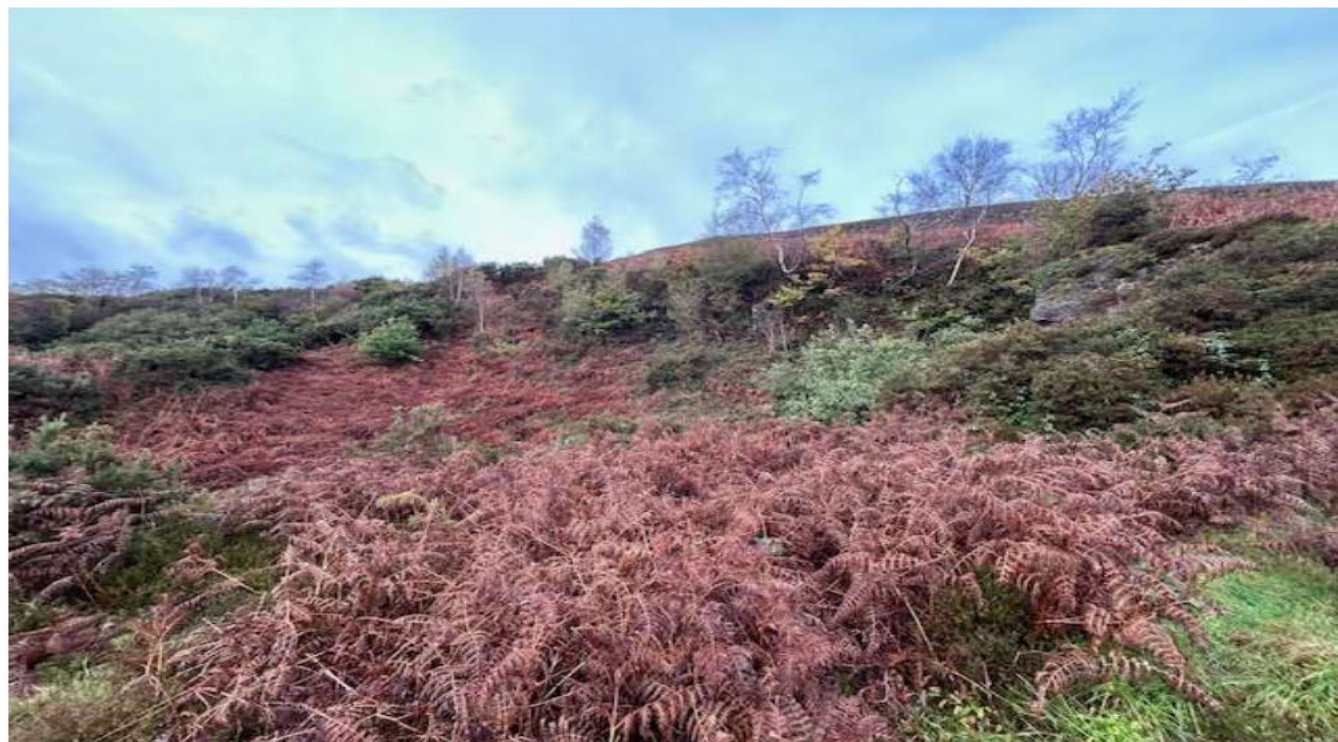
| <b>Feature ID</b> | 23/L/01 | | |

| <b>Photo No.</b> | 6 | <b>Comment</b> | View looking towards an outcrop of bedrock at the rear of the tip; likely the quarry high wall. |
