| <b>Coal Tip Name</b> | <b>Godre'r-graig Quarry / Cilmaengwyn</b> | | <b>Tip Ref Number</b> | <b>T37552</b> | |
| <b>Located In</b> | <b>Godre'r Graig, Neath-Port Talbot</b> | | <b>Tip Category</b> | <b>D</b> | |
| <b>Inspection Led By</b> | | <b>Date of Inspection</b> | <b>09/09/2024</b> | <b>Date of last Inspection</b> | <b>08/11/2023</b> |

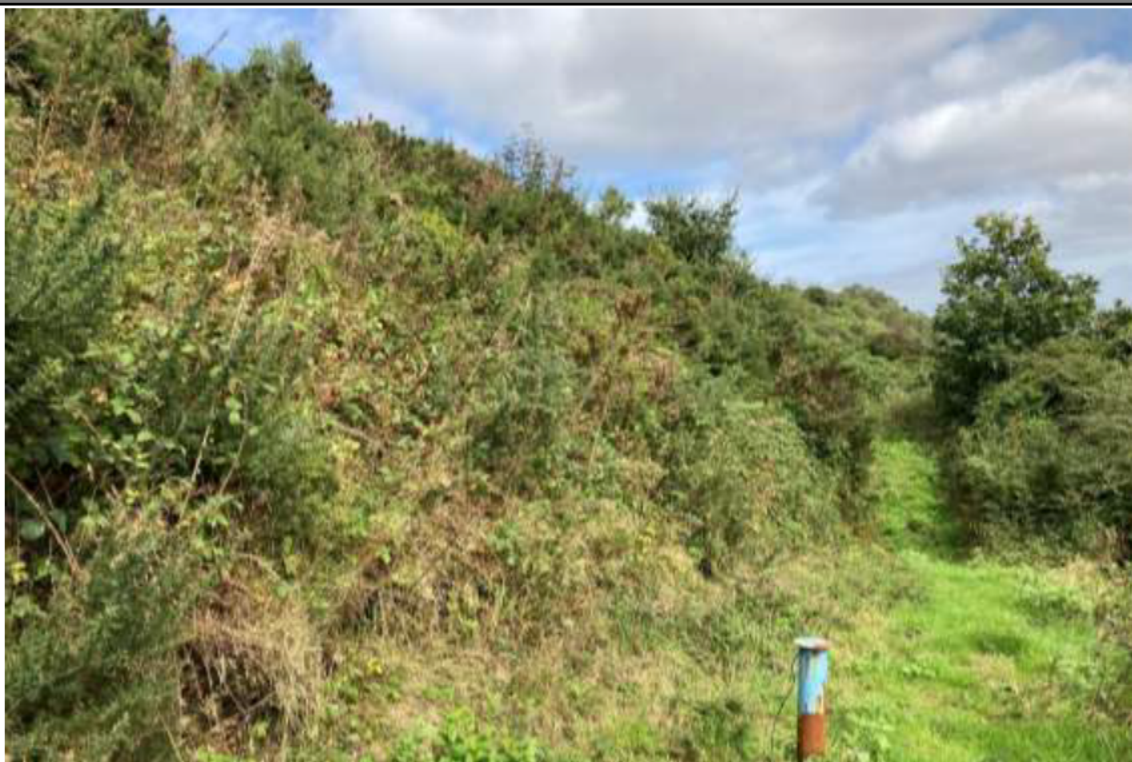
| <b>Photo No.</b> | 1 | <b>Comment</b> | Piezometer borehole located on the site access track, downslope (outside the provided site boundary). |

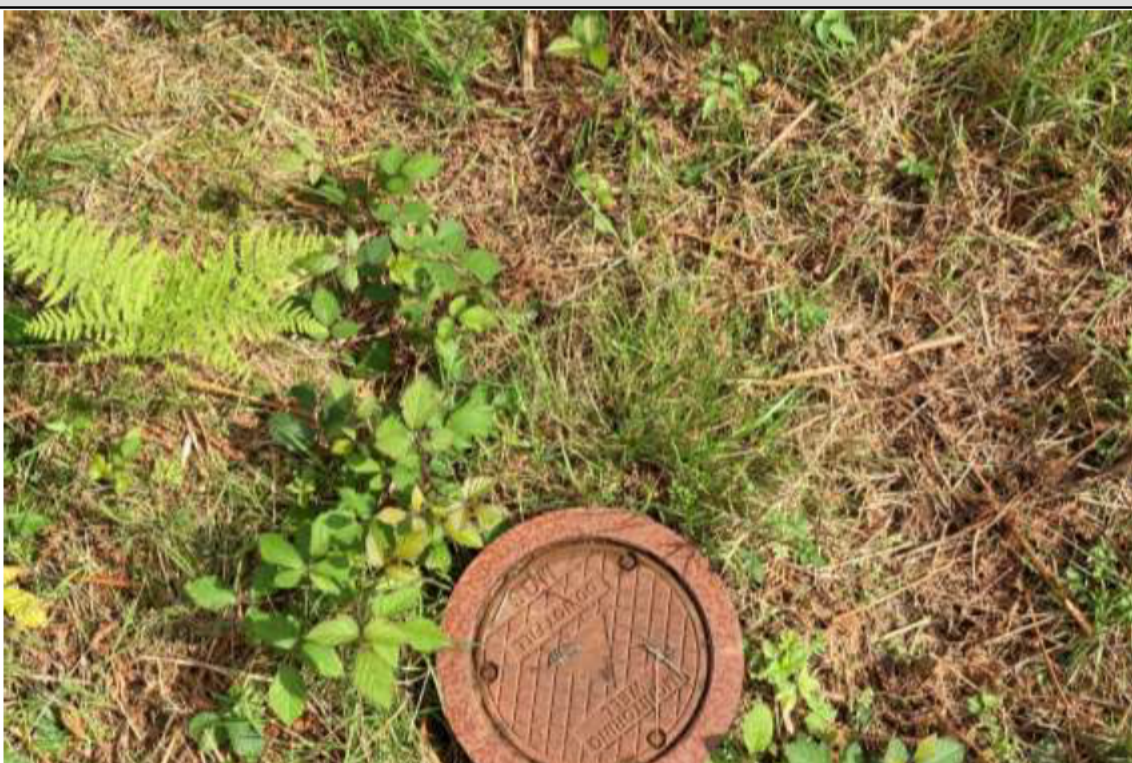
| <b>Photo No.</b> | 2 | <b>Comment</b> | Monitoring well located on the site access track, downslope (outside the provided site boundary). |

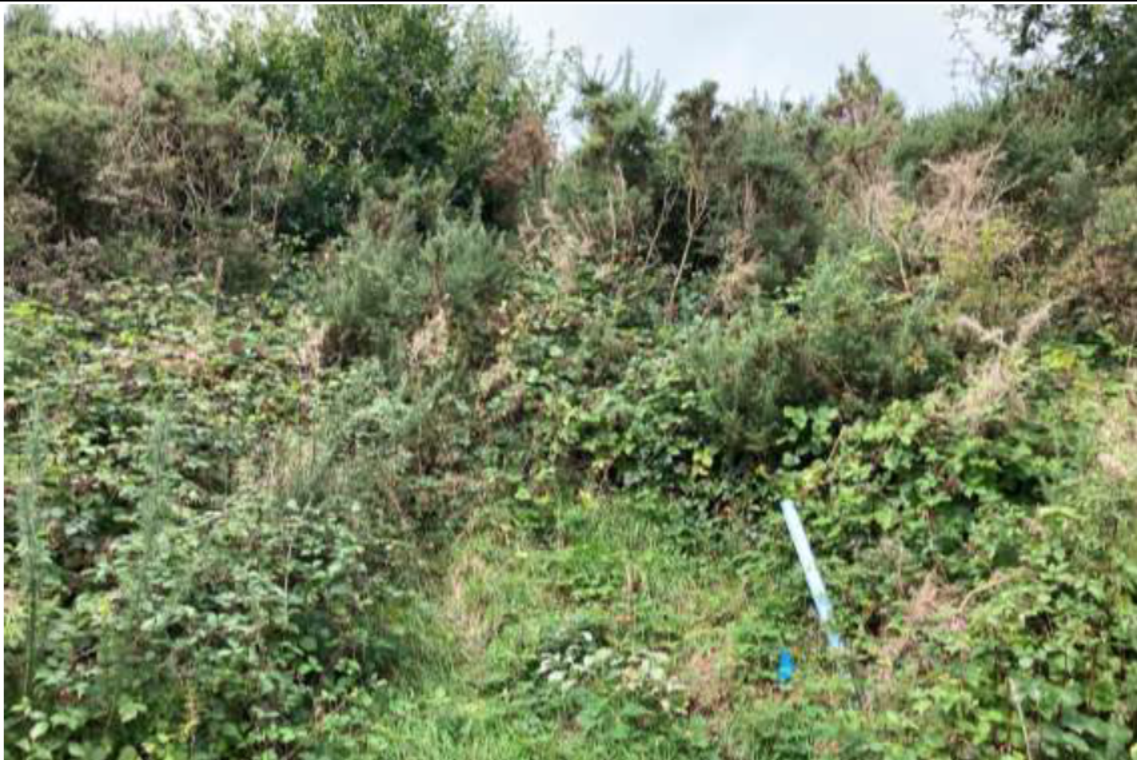
| <b>Photo No.</b> | 3 | <b>Comment</b> | View looking towards the narrow, overgrown access path; of which extends up-slope off the main site access path, towards the site. Plastic casing associated with a piezometer appears to have been discarded next to the path. |
