Coal Tip Name		Godre'r-graig Quarry / Cilmaengwyn		UID		T37552	
Located in		Godre'r Graig, Neath-Port Talbot		Tip Category		D	
Inspection Led by		[REDACTED]		Date of Inspection		12/02/2025	
				Date of last Inspection		09/09/2024	
Weather		Overcast		Damp		Breeze	
Comments on access and any limitations		Access to the site was gained via an access path situated just off the [REDACTED] access track. The access path extends up the hillside in a north-easterly direction, passing through Cwar Pentwyn Quarry before reaching a narrow, overgrown path which extends up-slope towards the site. It should be noted that this inspection was conducted without the benefit of a detailed site plan; whilst dense vegetation significantly limited accessibility and visual inspection. Therefore, instability within these areas could exist, but was not detectable at the time of the inspection. The densely overgrown nature of the site largely prevented/limited inspection of the spoil material; it is presumed that the site is comprised of sandstone quarry waste material, however some exposures of colliery spoil material were present downslope (outside the provided site boundary), adjacent to the access path.

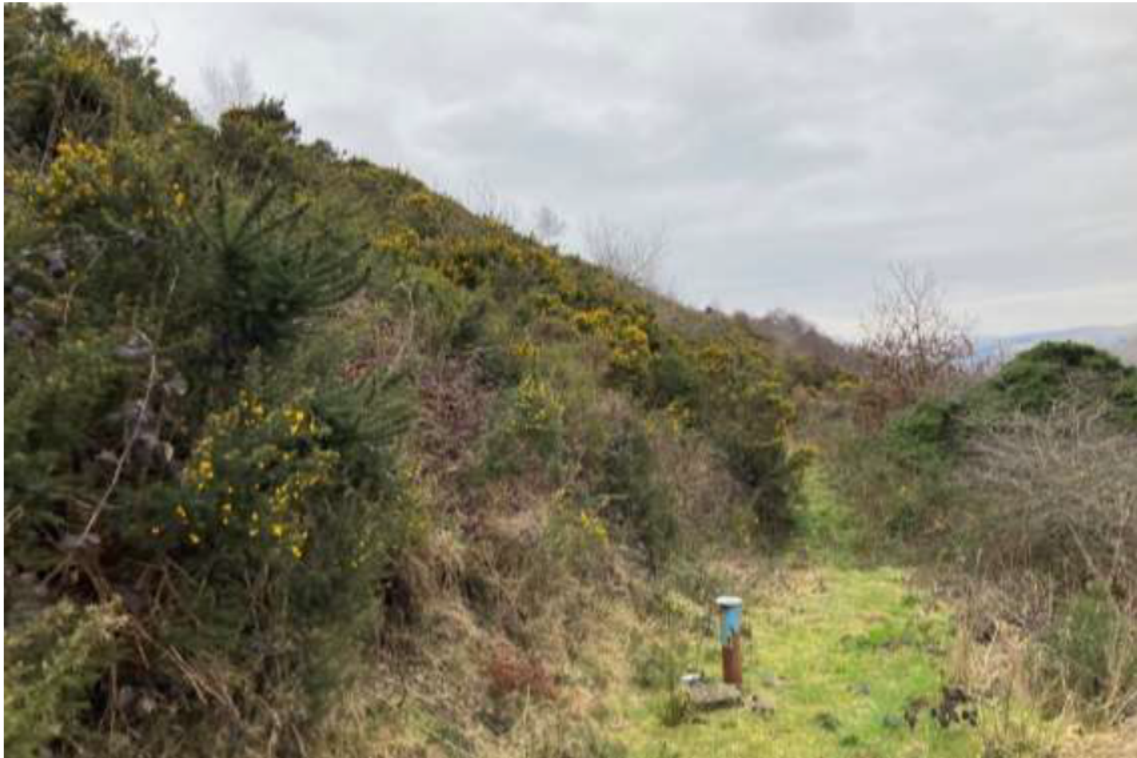
Photo No.	1	Comment	Piezometer borehole located on the site access track, downslope (outside the provided site boundary).
Feature ID	25/IM/01

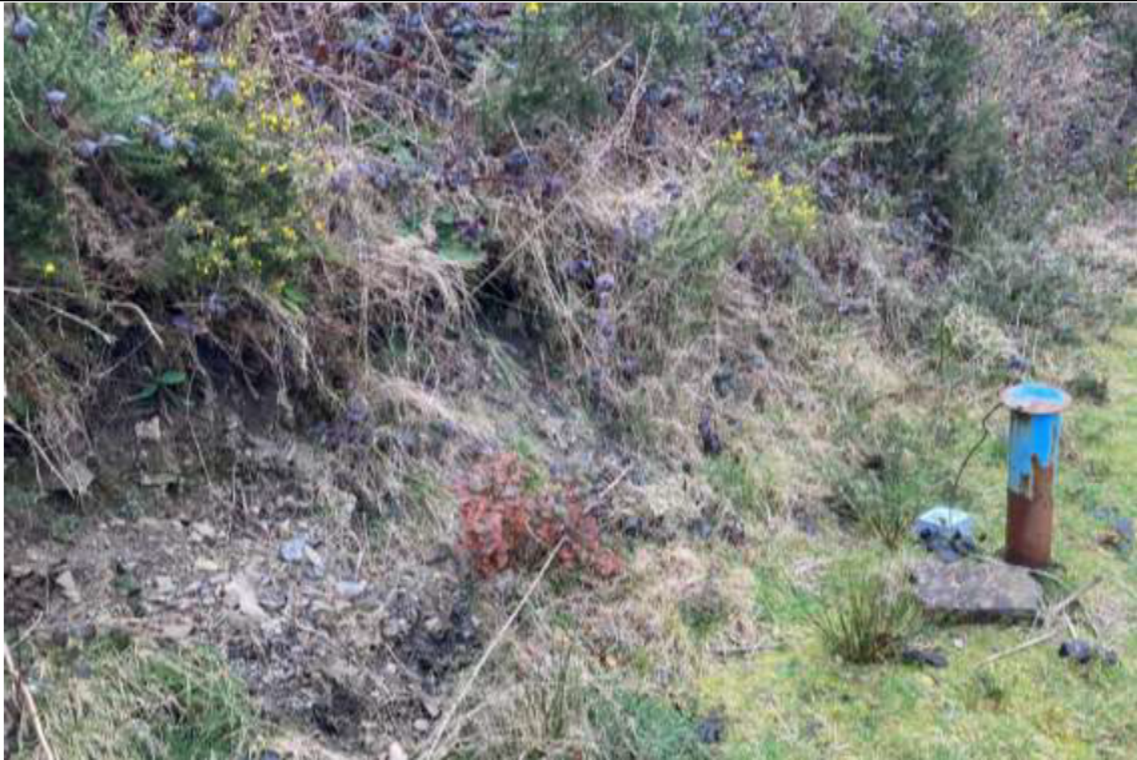
Photo No.	2	Comment	A small exposure of overburden and sandstone spoil material, adjacent to the site access track.
Feature ID	N/A

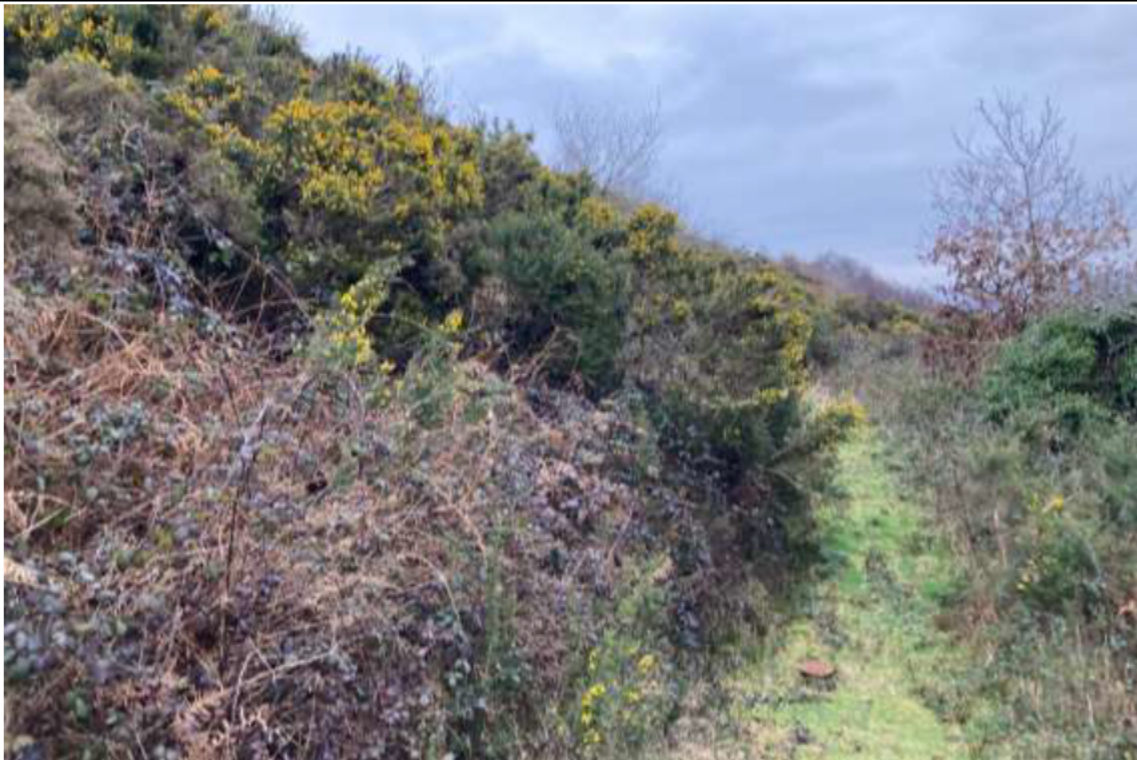
Photo No.	3	Comment	Monitoring well located on the site access track, downslope (outside the provided site boundary).
Feature ID	25/IM/01

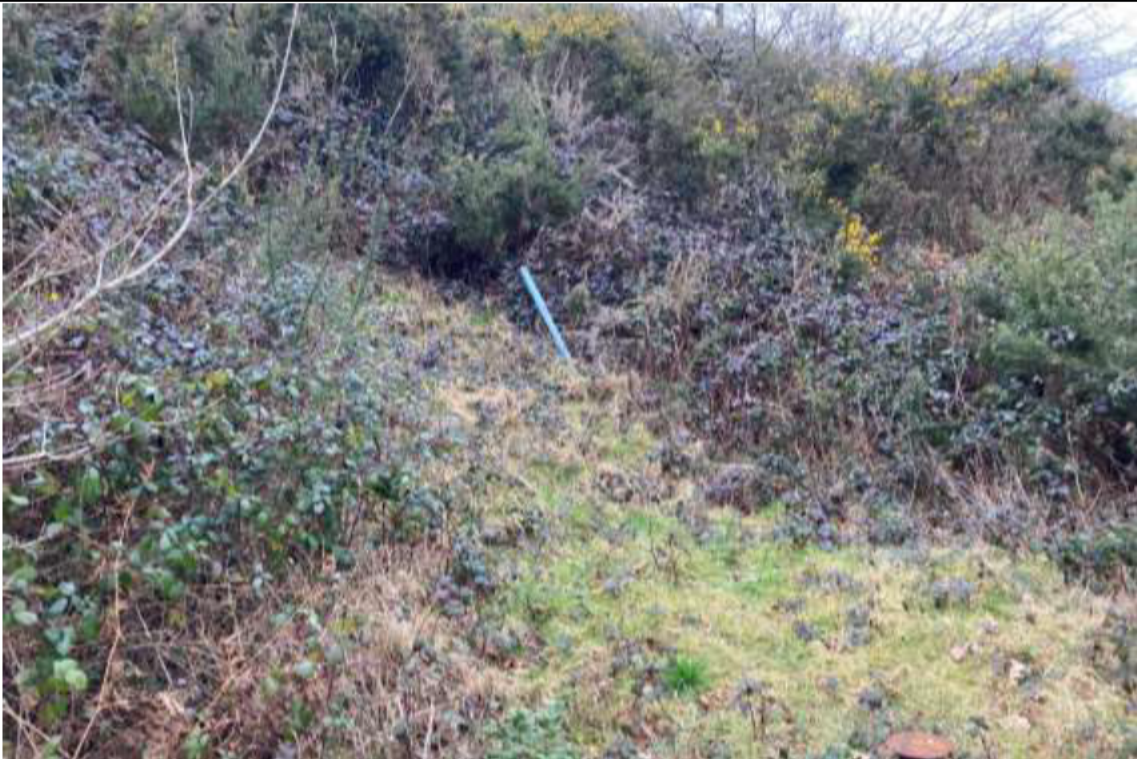
25/IM/01	Piezometers & Inclinometers	E – 275048 N - 206996	Series of piezometer boreholes and monitoring wells, situated on the site access track (outside the provided site boundary). Plastic casing associated with a piezometer appears to have been discarded next to a path which ascends towards the tip. Inclinometers are recorded as being installed within some of the boreholes.	None
Recommendations			- Continue to utilise the monitoring equipment across the site.

Photo No.	4	Comment	View looking towards the narrow, overgrown access path; of which extends up-slope off the main site access path, towards the site. Plastic casing associated with a piezometer appears to have been discarded next to the path.
Feature ID	25/IM/01
