Ruperra Castle

Structural Condition Survey and Strategic Appraisal Report

Project Number: 10247

Date: August 2024

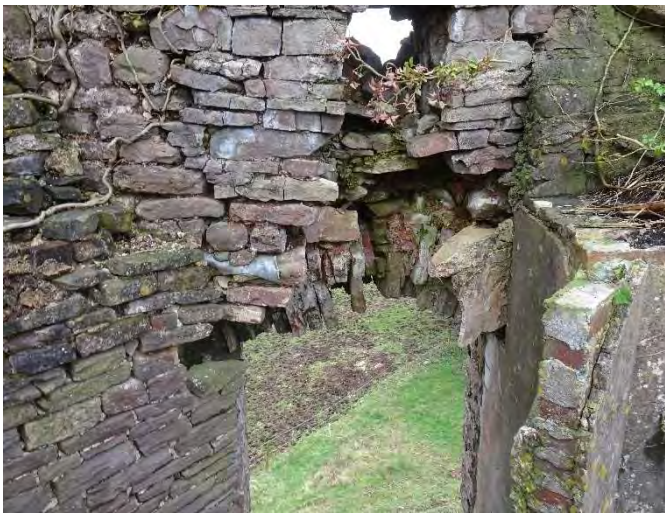
Cell A – Door into SE tower

4.5.2.2. The arches over the doorways to the SE and SW towers at second floor level have generally lost their faces therefore leaving the significantly vulnerable panels of masonry over poorly supported and at risk of collapse. The entrance into the NE and NW towers appears to have lost lintels which replaced original facing arches leaving the facework over vulnerable and poorly supported.

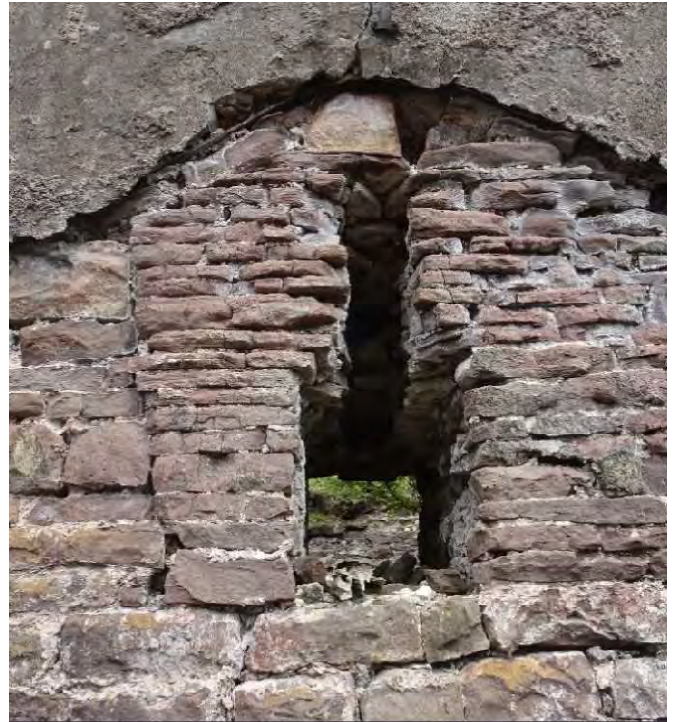
- 4.5.2.3. The interior of the NE tower has an example of an intact valley beam pocket with the surround masonry in better condition.

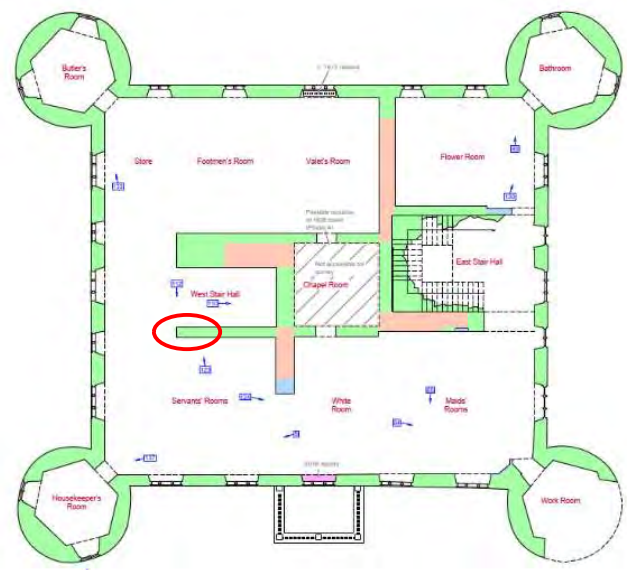
- 4.5.3.1. At second floor level in Cell G (north elevation), there is a significant patch of masonry (cross hatched in blue below) which is showing varying signs of degradation and is of significant structural concern.

- 4.5.3.2. As denoted with red lines, there is a significant crack visible on both sides of the wall which appears to suggest that this panel of masonry is separating from the rest of the wall. There is also a hole in the wall with a small badly eroded stack of masonry to the underside of the dressed stone which appears very vulnerable and is at risk of falling out.

- 4.5.3.3. Generally, the condition of this panel is very poor and there is a very significant risk of this section collapsing which has the potential to disturb and destabilise the dressed stone wall over and potentially lead to the total collapse of the wall panel.

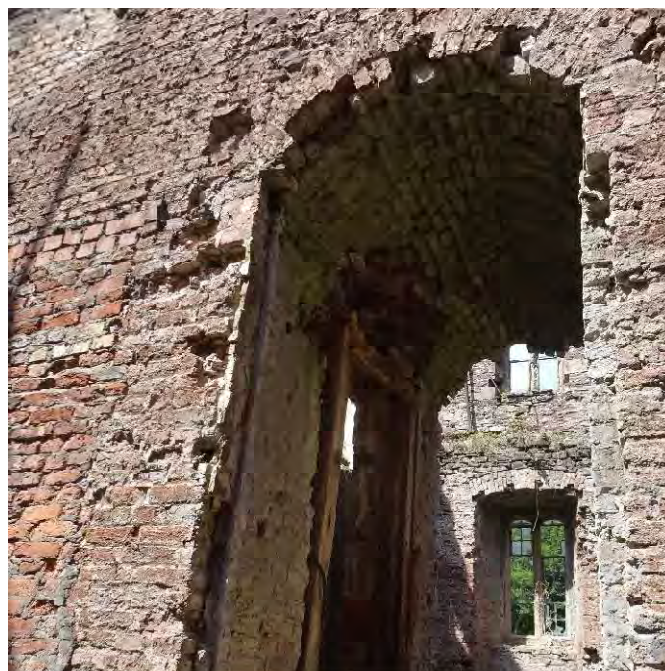
4.5.5.2. At second floor level, the vaulted arch over doorway D15 has a large patch of collapsed masonry with the remaining masonry loose and vulnerable to further collapses. The remainder of the vaults have localised loose and degraded bricks and some further loss has occurred on both faces of the arches.

4.5.5.3. Progression is likely to comprise further loss of the masonry with the potential to fail the full arch and compromise the floor over. Collapse is likely to cause significant damage to the surrounding structures and would represent a significant loss of historic fabric.

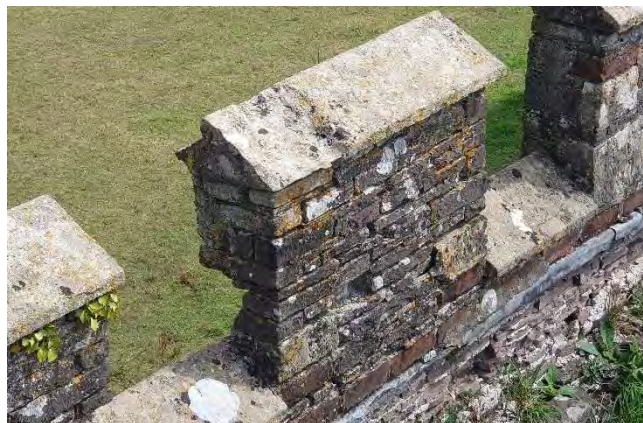
Cell B – East elevation merlon over W9

- 4.5.6.1. Generally where inspected on site, remains of the original parapets are in reasonable condition with some very localised merlons / crenels showing signs of deterioration by means of lost pointing and masonry units.
- 4.5.6.2. The remains of the parapet to the south of the west elevation is in poorer condition with more widespread areas of lost masonry and degrading bedjoints, in addition to localised areas of vegetation. There are 2No. significant defects which have been identified which are described further below.
- 4.5.6.3. At third floor / roof level on the east elevation, the Merlon over window W9 has lost a large area of stonework on the external side and is currently leaning into the building. It is unclear whether movement of the merlon is ongoing however further loss of fabric has the potential to destabilise the merlon with the risk of it falling into the building.

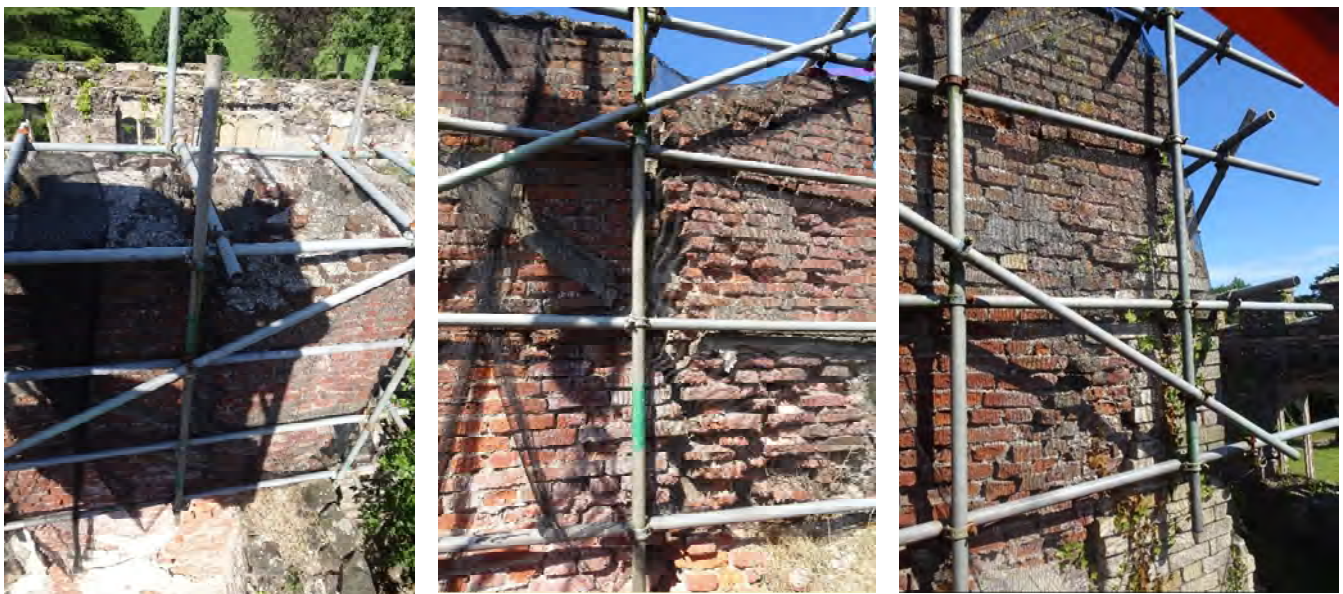
4.6.3.1. The upper stack of chimney C1 is in very poor condition with significant structural defects putting the historic fabric at risk of collapse. There are several localised patches of masonry missing on the elevations and a significant full height crack on the east elevation of the stack which prompted a more recent phase of temporary stabilisation works. The temporary works comprised wrapping the stack in scaffolding to mitigate movement and potential collapse which would represent a significant loss of historic fabric and significant risk to building users.

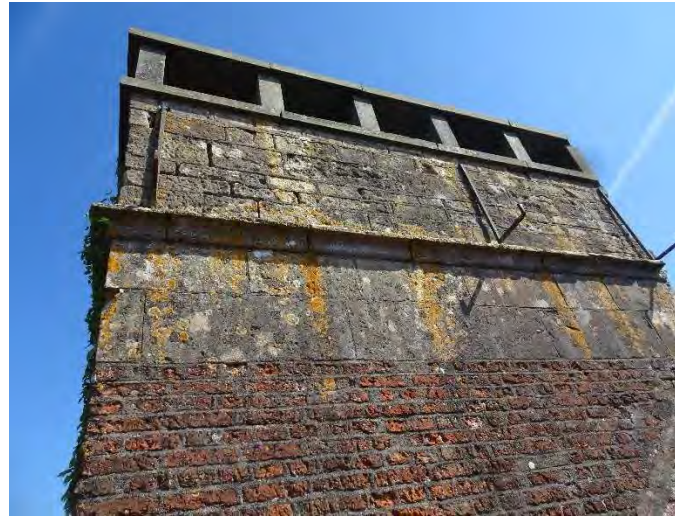
4.6.4.1. Compared to the other chimney stacks, chimney C2 is in reasonable condition with very localised patches of masonry in poor condition. Where in poor condition the masonry is generally missing pointing with localised open joints between masonry units. Chimney caps are generally intact and in reasonable condition.

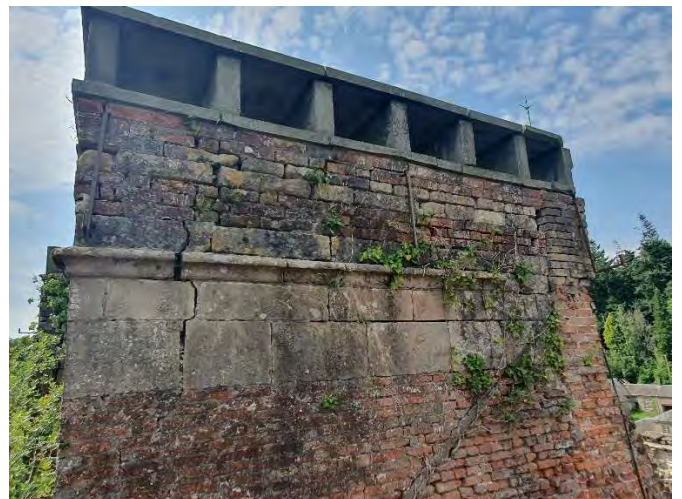
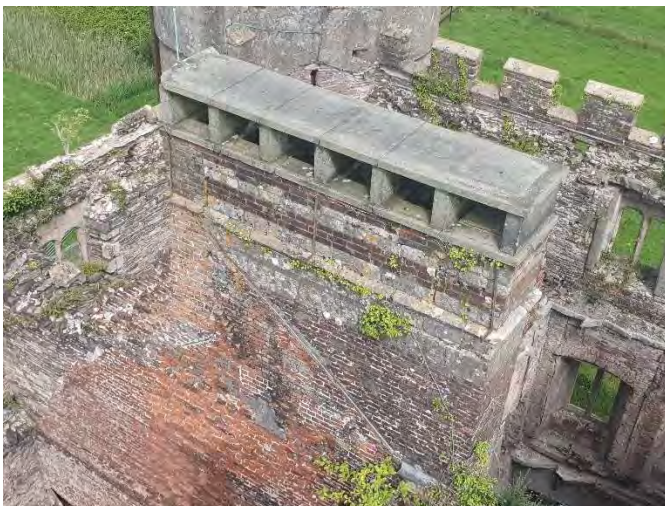
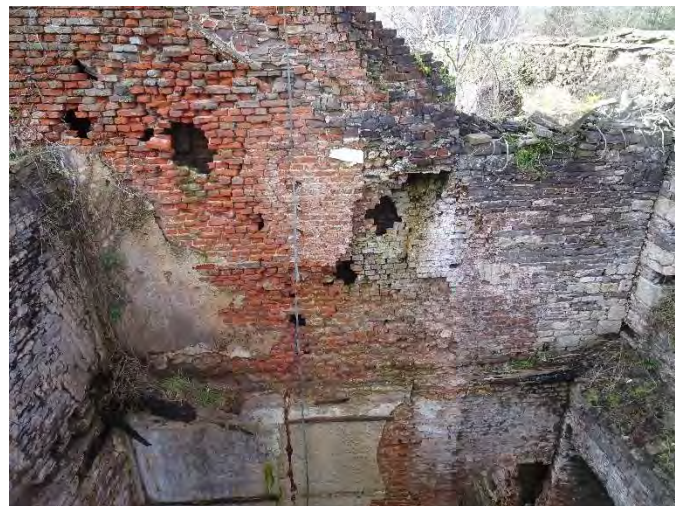
4.6.5.1. The stack of chimney 3 is in poor condition with some localised areas in very poor condition. On the east elevation there are large patches of brickwork missing exposing the flues, with remaining masonry in a significantly deteriorated state. The upper stack has a crack on the south end of the chimney which suggests movement within the masonry. The stonework is generally missing pointing. The stone capping to the chimney appears to be generally in reasonable condition.

4.6.5.2. Inspection within the holes into the flues on the east elevation of the stack identified that the masonry cross walls appear to be in reasonable condition generally.

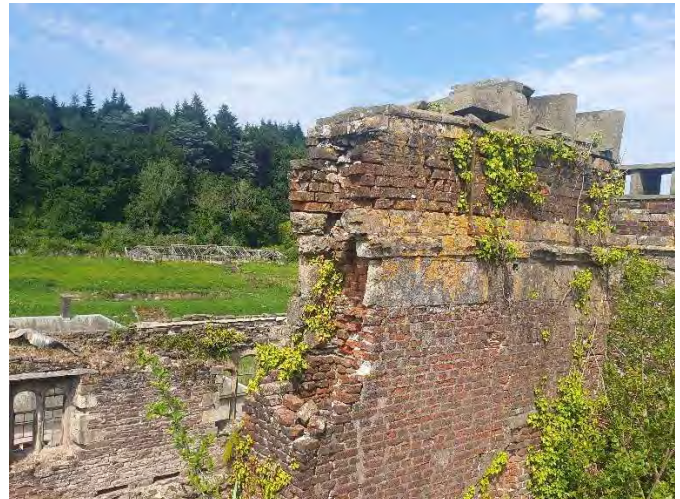
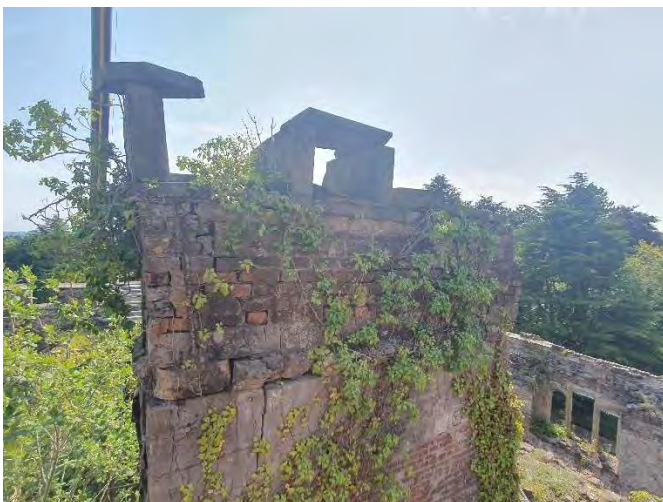
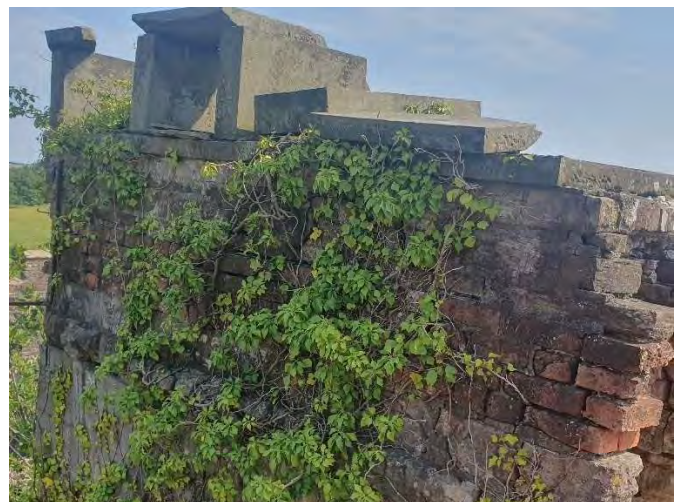
4.6.6.1. Chimney 4 is in very poor condition with defects of significant structural concern or of concern when considering safety to building users. Capping slabs are generally shattered and surrounded by significant amounts of loose debris. There are several cracks in the facework on all elevations with various areas of severely degraded / cracked masonry up the full height of the stack.

- Risk to site users – Continued degradation of the brickwork particularly about the areas of significant loss on the north end of the stack which is likely to loosen localised patches of brickwork with the potential of striking building users. There is also a risk of the very loose capping slabs falling from height and inflicting the same. Likelihood (7) / Consequence (10) / Total (7.0)
- Risk to historic fabric – Continued loss of historic brickwork which reduces the overall robustness of chimney stack with the potential to cause further localised collapses. Potential for large corbelling section of chimney stack to break off and fall to ground which could cause significant damage to structures below. Likelihood (7) / Consequence (8) / Total (5.6)

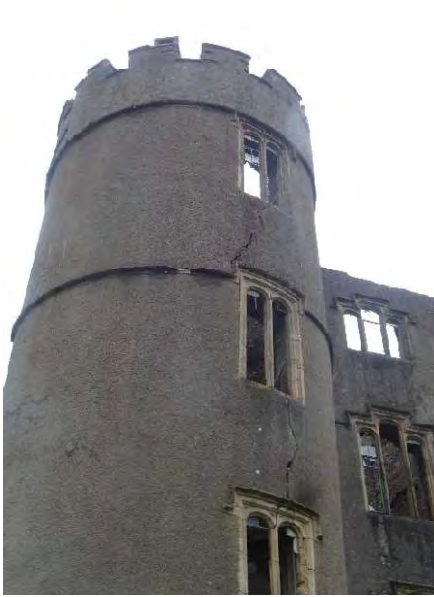
NE Tower (west facing windows)

4.7.4.3. It is unclear whether the cracks are continuing to open however propagation is likely to comprise continued degradation of the masonry and increased deterioration as a result of water ingress and potential for deep vegetation growth within the cracks.

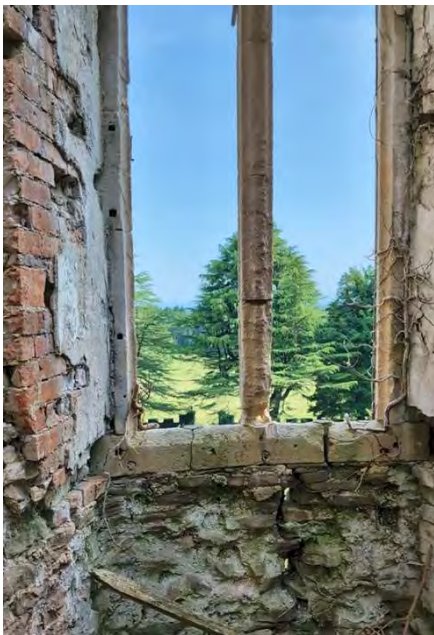
SW tower (2nd floor window)

4.7.4.4. Cracks appear to be more significant where the spandrel panels between windows have been historically narrowed, reducing the panel thickness from approx. 400-500mm to a single stone skin (150-200mm) with limited structural capacity. Daylight is visible through the crack in the spandrel panels in the SW tower where closer inspection was possible from the man basket. Some of the cracks (in particular on the NW Tower) are showing signs of out of plane movement in addition to lateral movement.

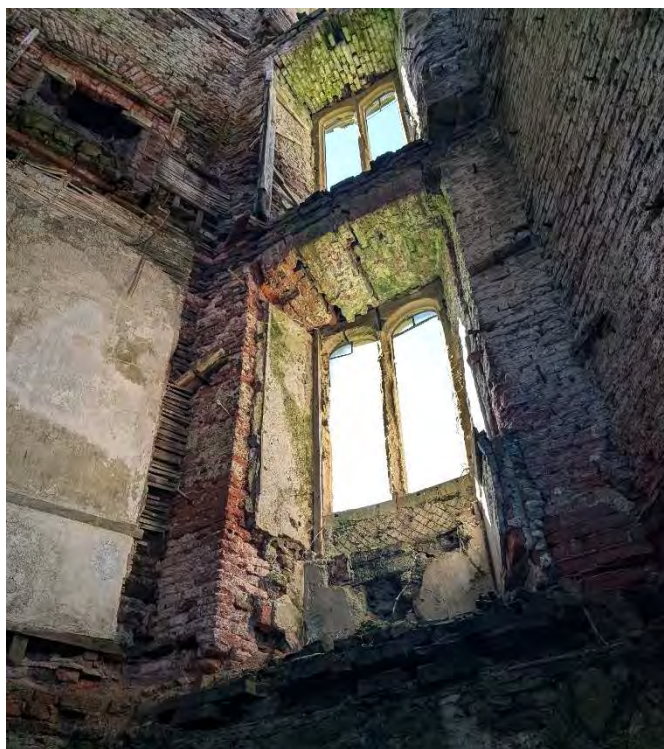
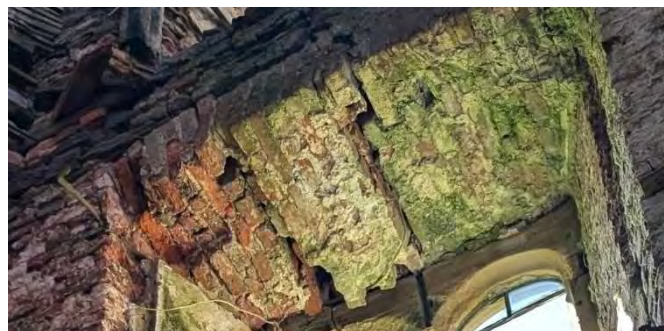
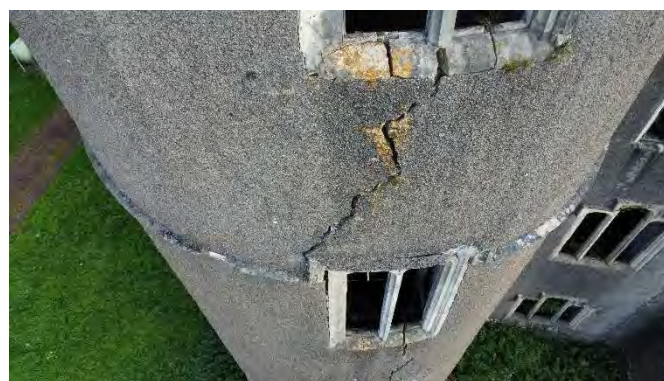
4.7.5.4. The cracks on the west elevation of the NW tower are the most significant of all of the cracking observed on site. The cracks through the spandrel panels are generally 40mm wide from the top of the parapet to second floor level. The wall to the south of the crack is out of plane by approximately 25mm (outwards) at third floor and reduces to approximately 5mm at first floor level. This implies that the masonry panel has moved in both directions.

- NW Tower – Install ratchet strapping to restrain the cracked face of the tower.
 - NW Tower – Install temporary roof to mitigate further vegetation growth and water ingress.

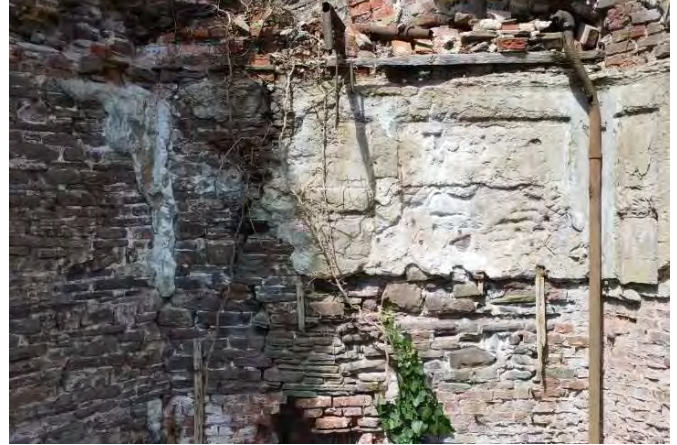
Above D9 at first floor

4.7.6.3. It is likely that these panels will continue to deteriorate with the potential for significant collapse to the masonry spandrel panels between the openings.

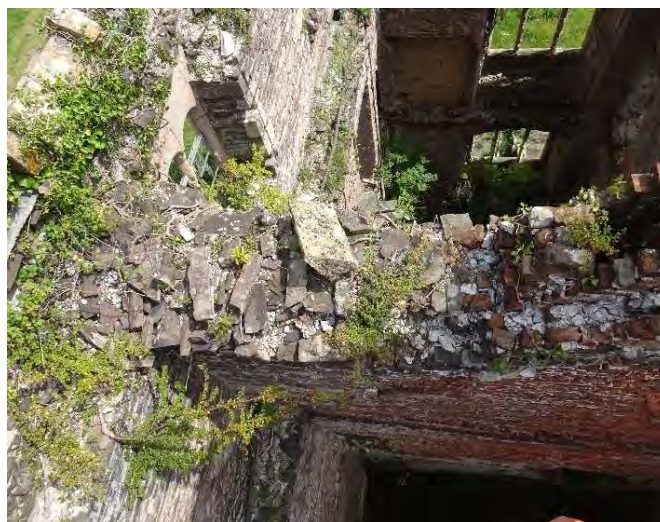
Cell D (head of east wall)

4.8.2.3. In some localised areas, bricks / stones are very loose and on the edge of the wall head and at significant risk of falling to ground.

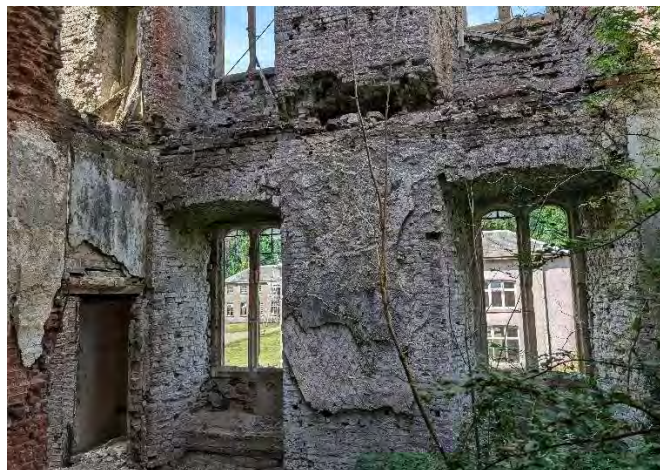
Cell C (North Wall)

4.8.3.2. Where inspected, the remaining masonry about the slots were found to be in poor to very poor condition generally with the remaining brickwork poorly bonded or loose and the core work fully exposed to further degradation, in particular where loss has formed a shelf for water to collect. Slots are typically between 300 & 500mm high and approximately 200-400mm deep into the wall thickness, resulting in the masonry over being poorly supported longer term.

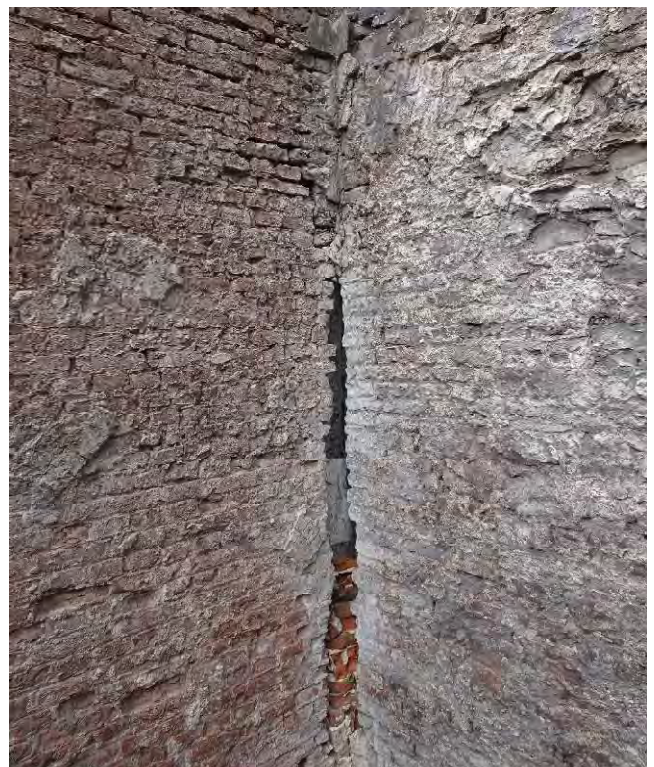
Cell E – Connection to west elevation

4.8.6.4. This defect is explored further in the discussions to describe our interpretation of the global impact of the lack of tie between the cross walls and the external walls.

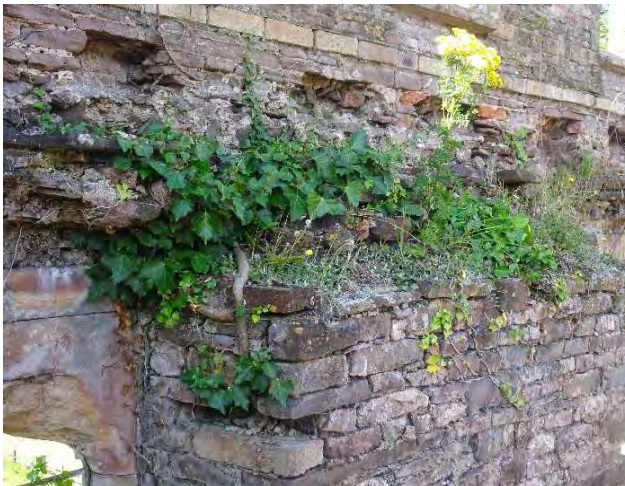
Cell A - South Elevation

4.9.2.2. Vegetation is causing degradation of the masonry fabric in several areas around the building. Where present, Ivy and other plant species including buddleia have rooted between and behind masonry units degrading the joints and thereby loosening localised or clusters of bricks / stonework.
