Godre'r Graig Primary School, Godre'r Graig Preliminary Investigation and Additional Assessment

Report Reference: ESP.7234e.02.3302

Godre'r Graig Primary School Preliminary Investigation and Additional Assessment

Prepared for:
Neath Port Talbot County Borough Council
 The Quays, Baglan Energy Park,
 Brunel Way, Briton Ferry,
 SA11 2GG

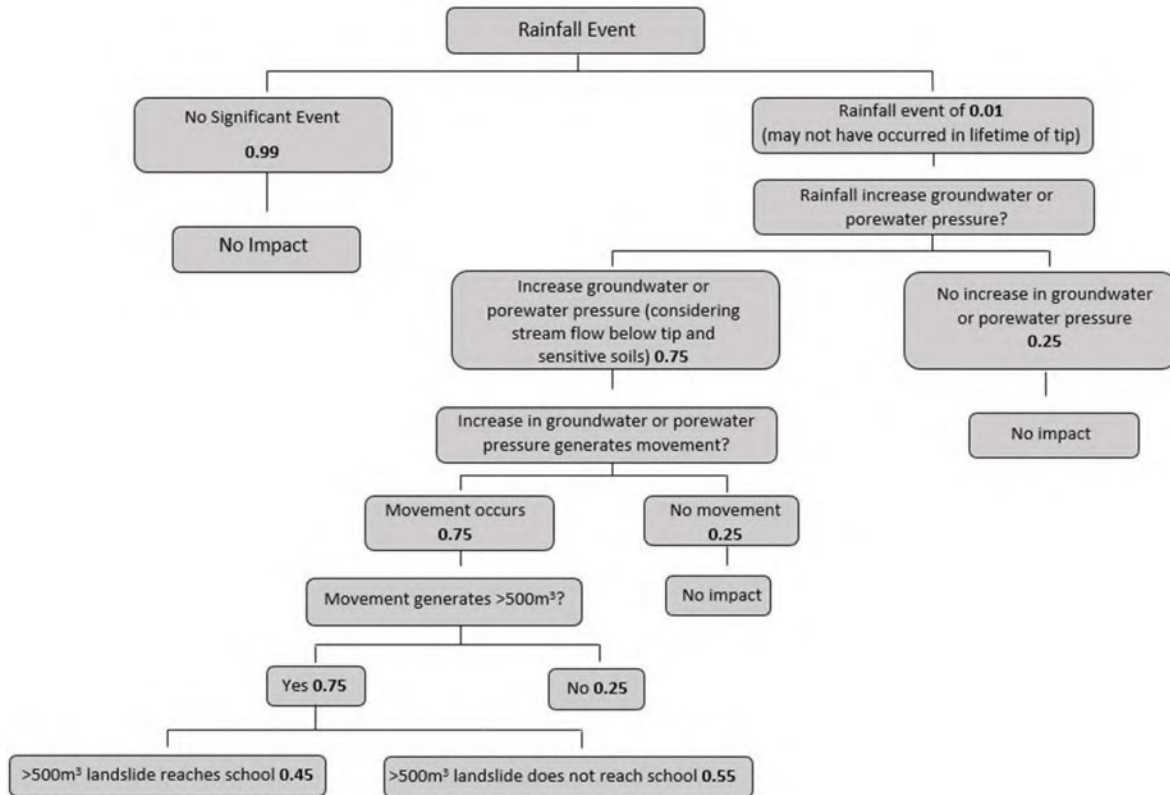
In order to assess the risk from Hazard 2, "impact from debris avalanche initiating from quarry spoil", an event tree was produced to provide a qualitative, indicative value of approximate annual probability for such an event occurring. Based on the event tree and the qualitative risk analysis matrix detailed in the previous report (ESP, 2019 -Section 7), a medium risk was identified.

Using the probabilities assigned in the event tree, for a 1 in 100 year rainfall event (which is equivalent to 0.01), it suggests that the estimated annual probability of a landslide hitting the school is 0.0019, or 1.9×10^{-3} .

This annual probability correlates to a 'possible' likelihood i.e. the event could occur under adverse conditions over the design life. Using a consequence of 'moderate', for a >500m³ landslide hitting the school, the qualitative risk assessment is of medium risk.

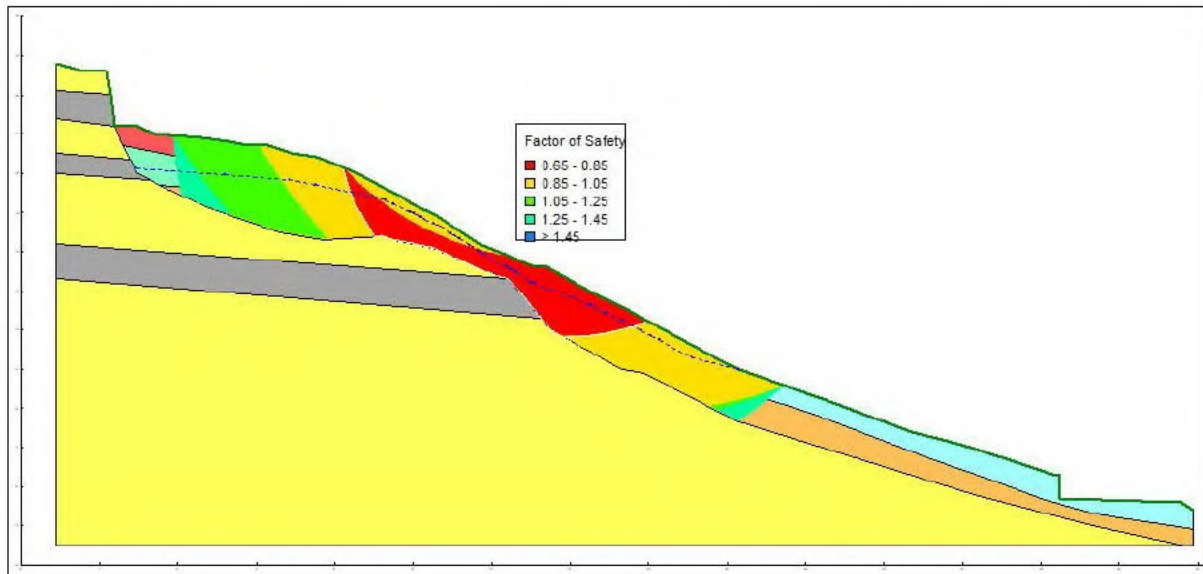
Insert 11: Contoured failure planes in Quarry Spoil Tip using Reasonable Case Parameters.

Analyses of the section has shown that for the strength parameters outlined in Table 9 and on the assumed piezometric surfaces shown, a minimum factor of safety of around 0.6 can be assumed when considering the current slope geometries. The model shows numerous potential failures below a Factor of Safety of 1, suggesting that the Quarry Spoil Tip is unstable.

The site walkover, historical mapping and aerial photographic review show no sign of instability predicted by the modelling. It is therefore likely that the Reasonable Case Material Parameters adopted are too low as signs of movement would likely be visible at the Quarry Spoil Tip.

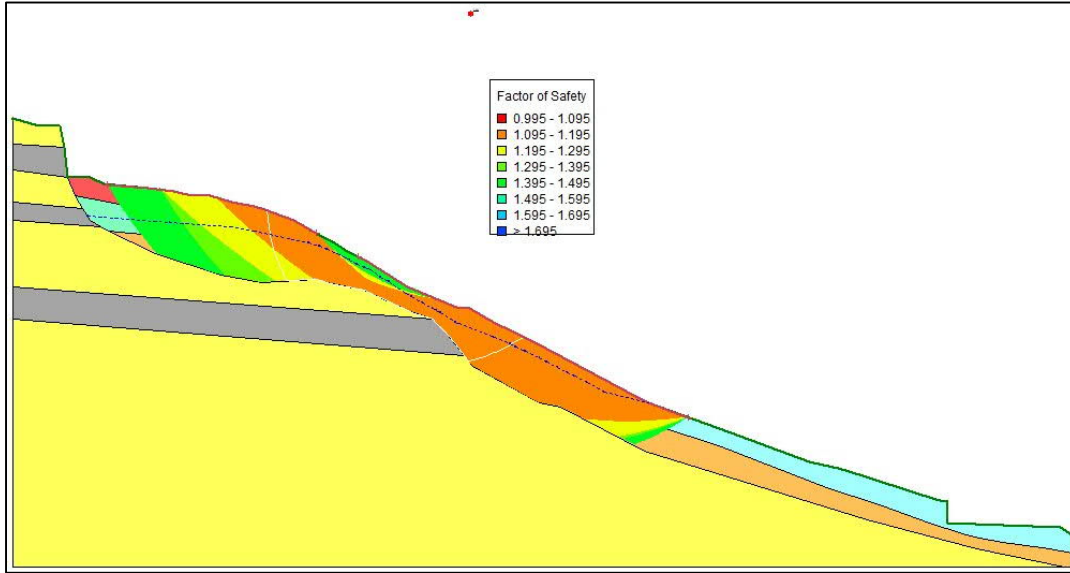
Insert 12: Contoured failure planes in Quarry Spoil Tip using Upper Range Parameters.

Analyses of the section has shown that for the Upper Range Parameters outlined in Table 10 and on the assumed piezometric surfaces shown, a minimum factor of safety of around 0.95 can be assumed when considering the current slope geometries. Much of the possible failure planes are however above unity, i.e. have a factor of safety of 1 or above, as can be seen on Insert 12 below.

The modelling shows that the Quarry Spoil Tip could be considered marginally stable, which is likely to represent the current condition, as the material would have been ‘end tipped’ and reached a state of stability on the hillside. Based upon the above, it is likely that the Upper Range Parameters are reasonable for modelling of the slope.

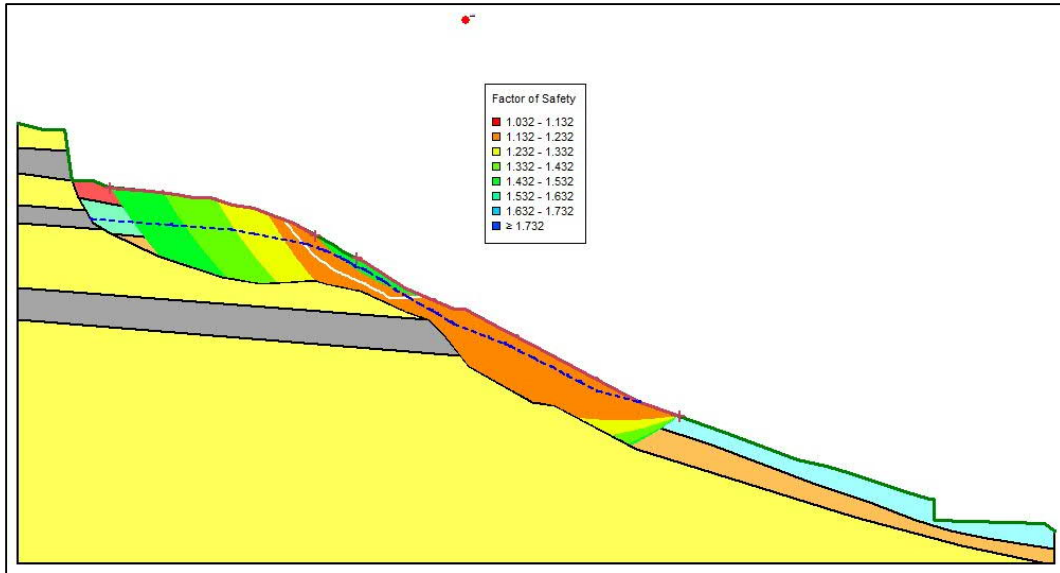
Insert 13: Contoured failure planes in Quarry Spoil Tip using Upper Range Parameters – DA1 C1.

The above inserts show that the worst-case design situation would be DA1, C2, with significantly lower FoS, or AFs being realised.

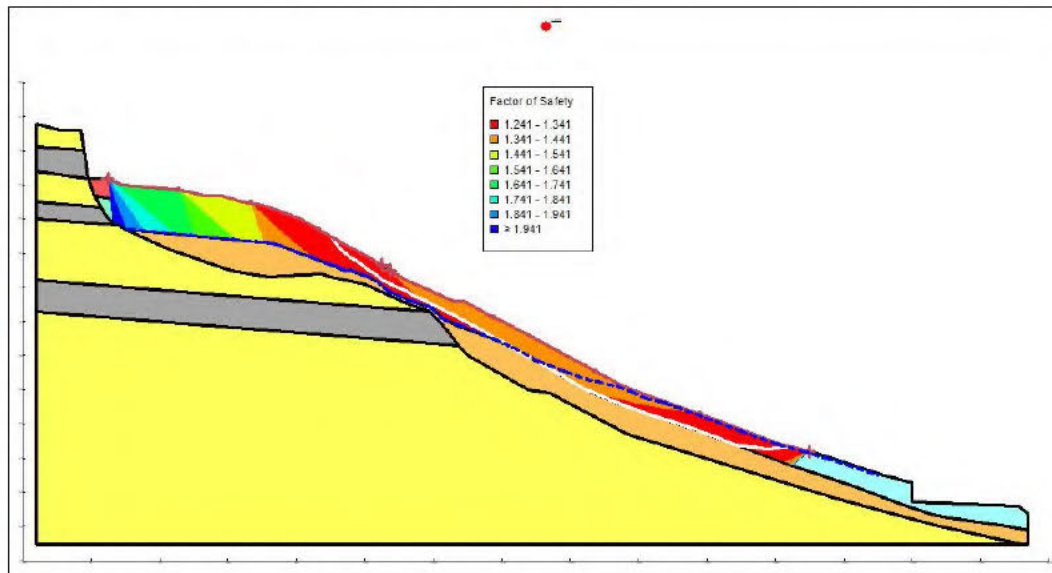
Insert 15: Contoured failure planes in Quarry Spoil Tip using Upper Range Parameters and groundwater at the tip base – global stability.

The above shows that an increase in groundwater height decreased the quarry Spoil Tip stability and reducing the groundwater level to 2m below the expected base of the tip increased stability.
