Bro Tathan East Building 354 External & Internal Visual Condition Survey

| Report Ref: | PR01 | Created | 19/06/24 |

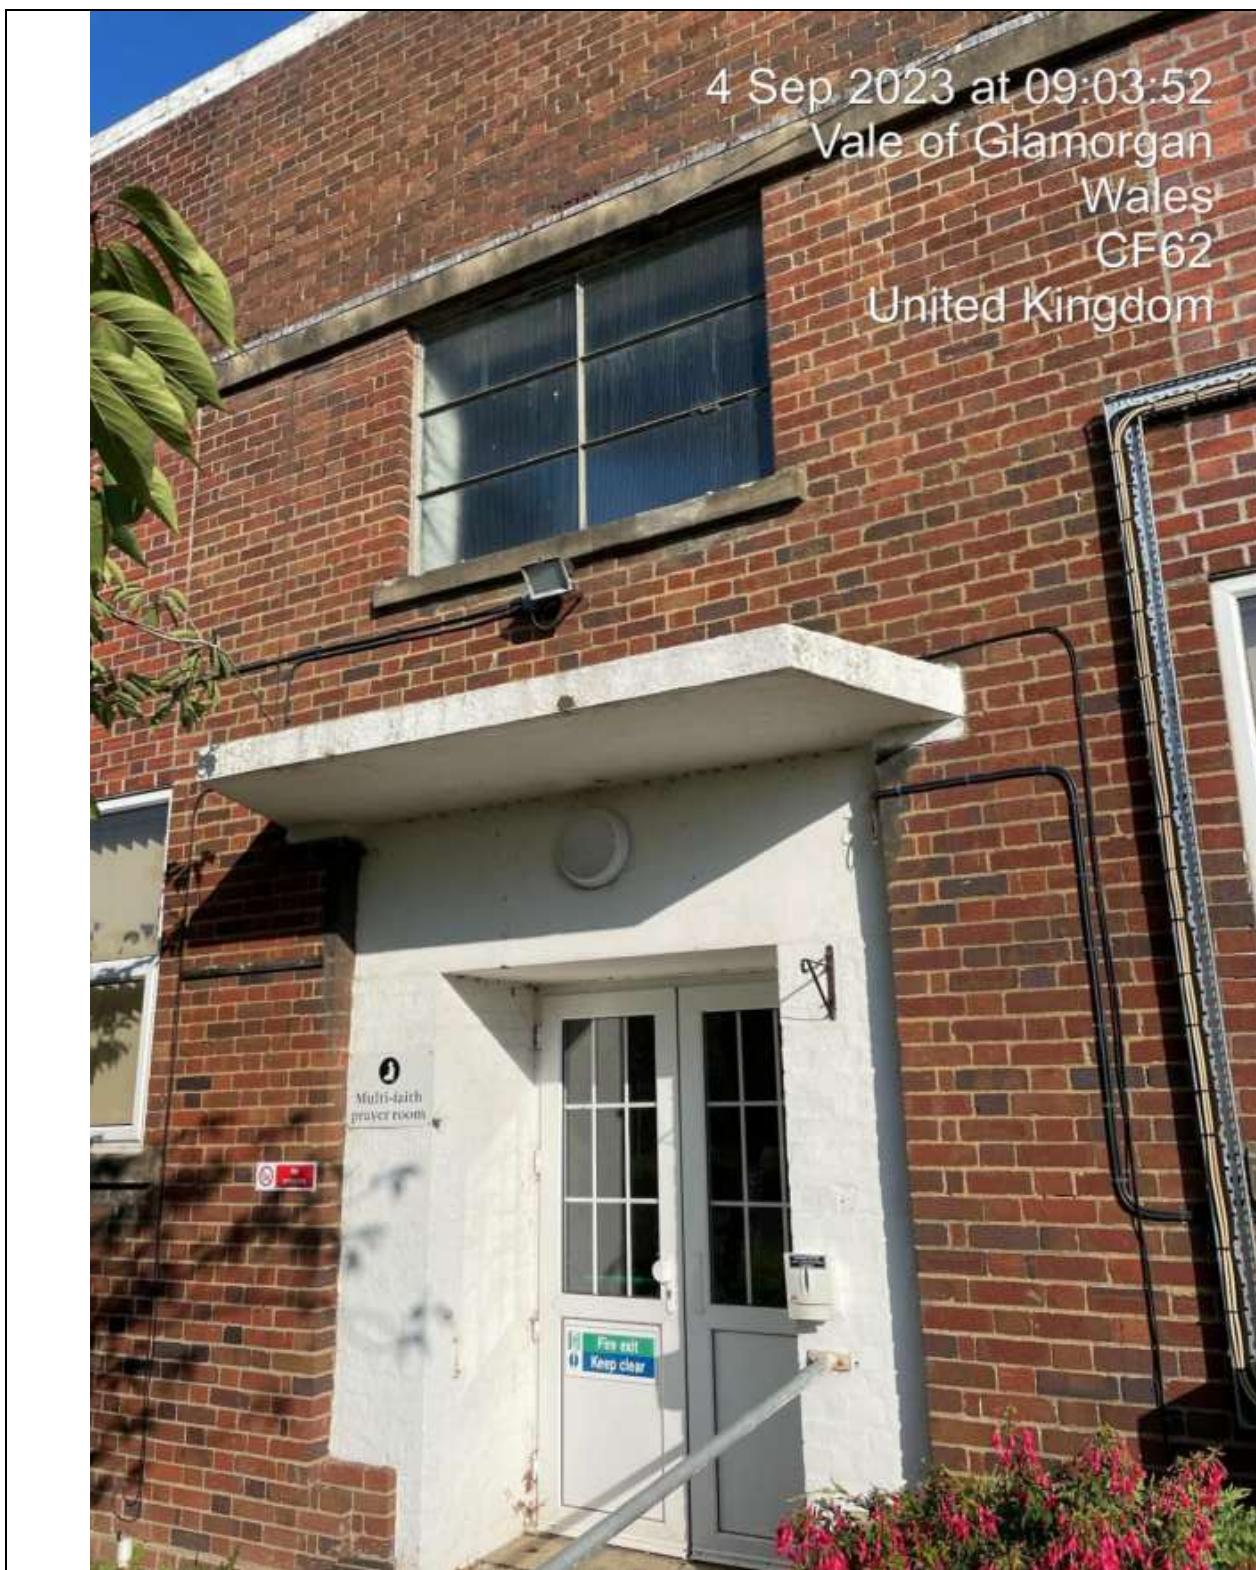
**Southern Elevation. Mixture of Original & Replacement Fenestration.**

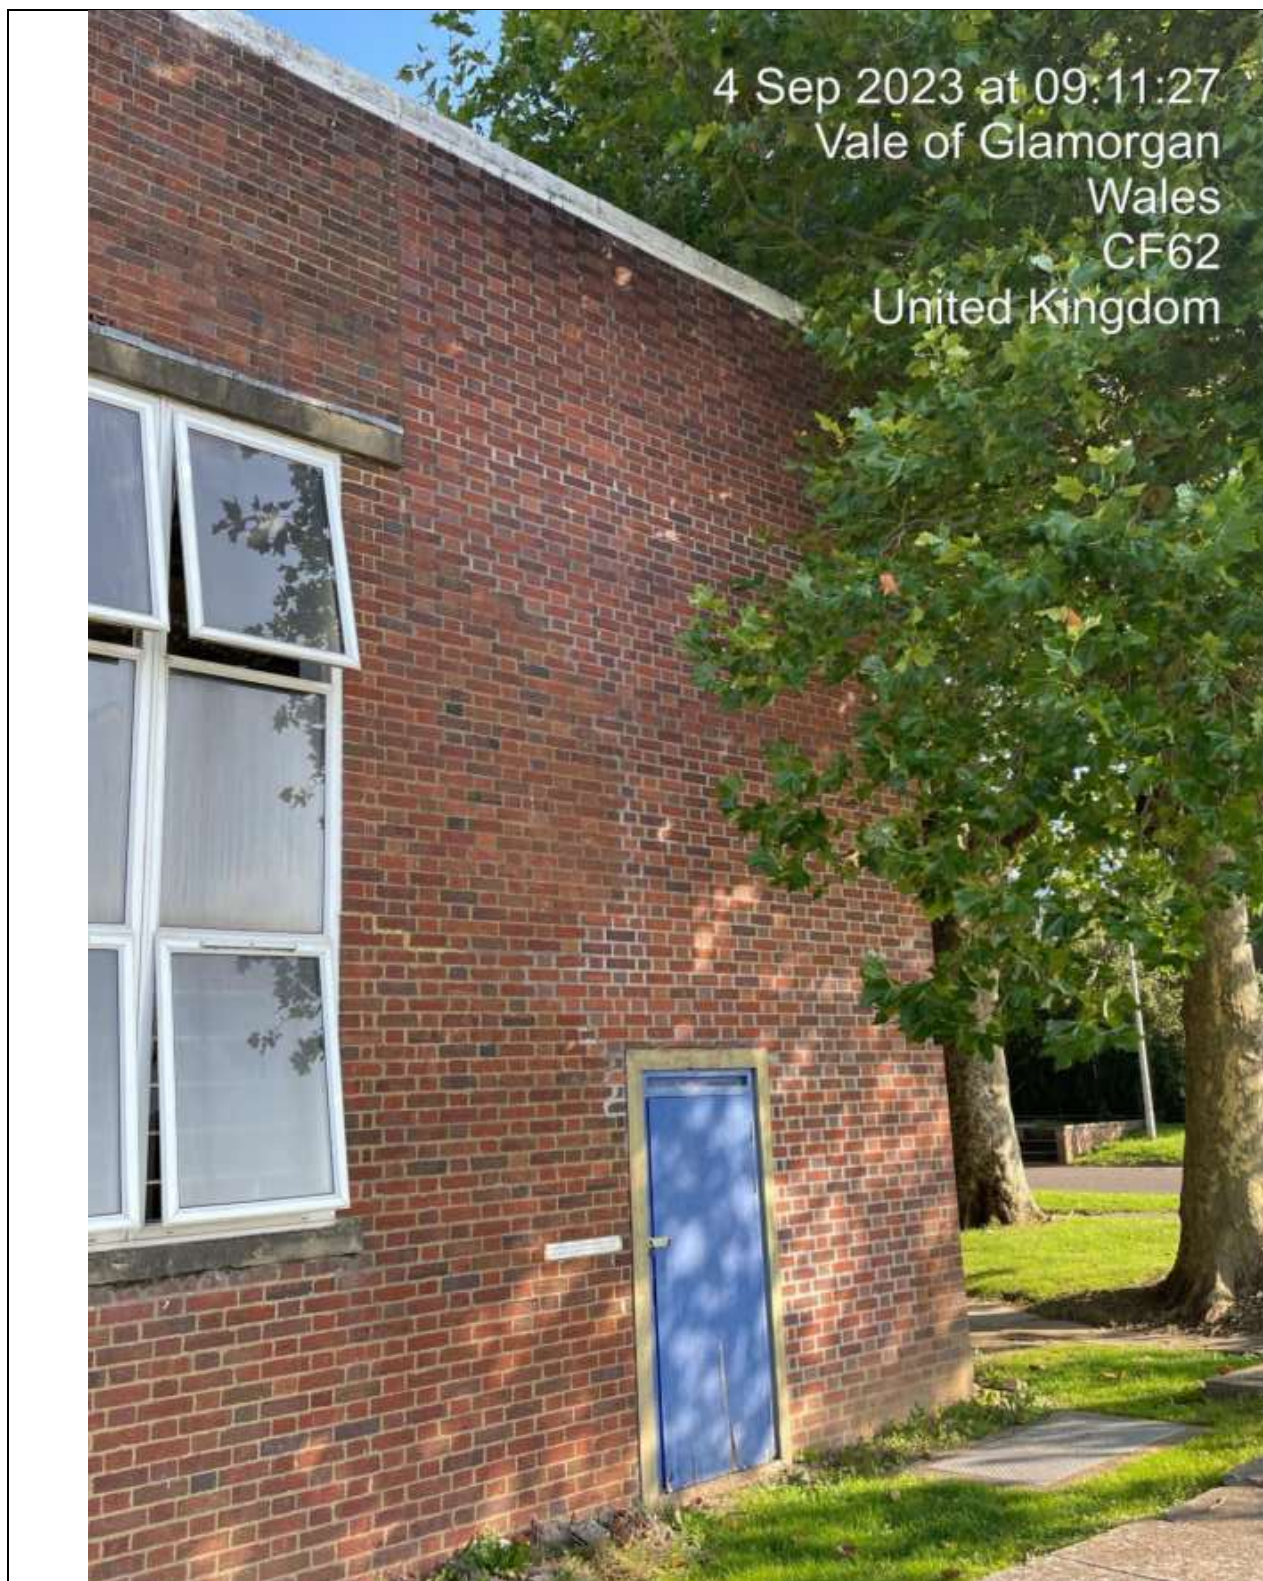
**Southern Elevation. Note the Replacement Brickwork & Deterioration of Plant Room Door.**

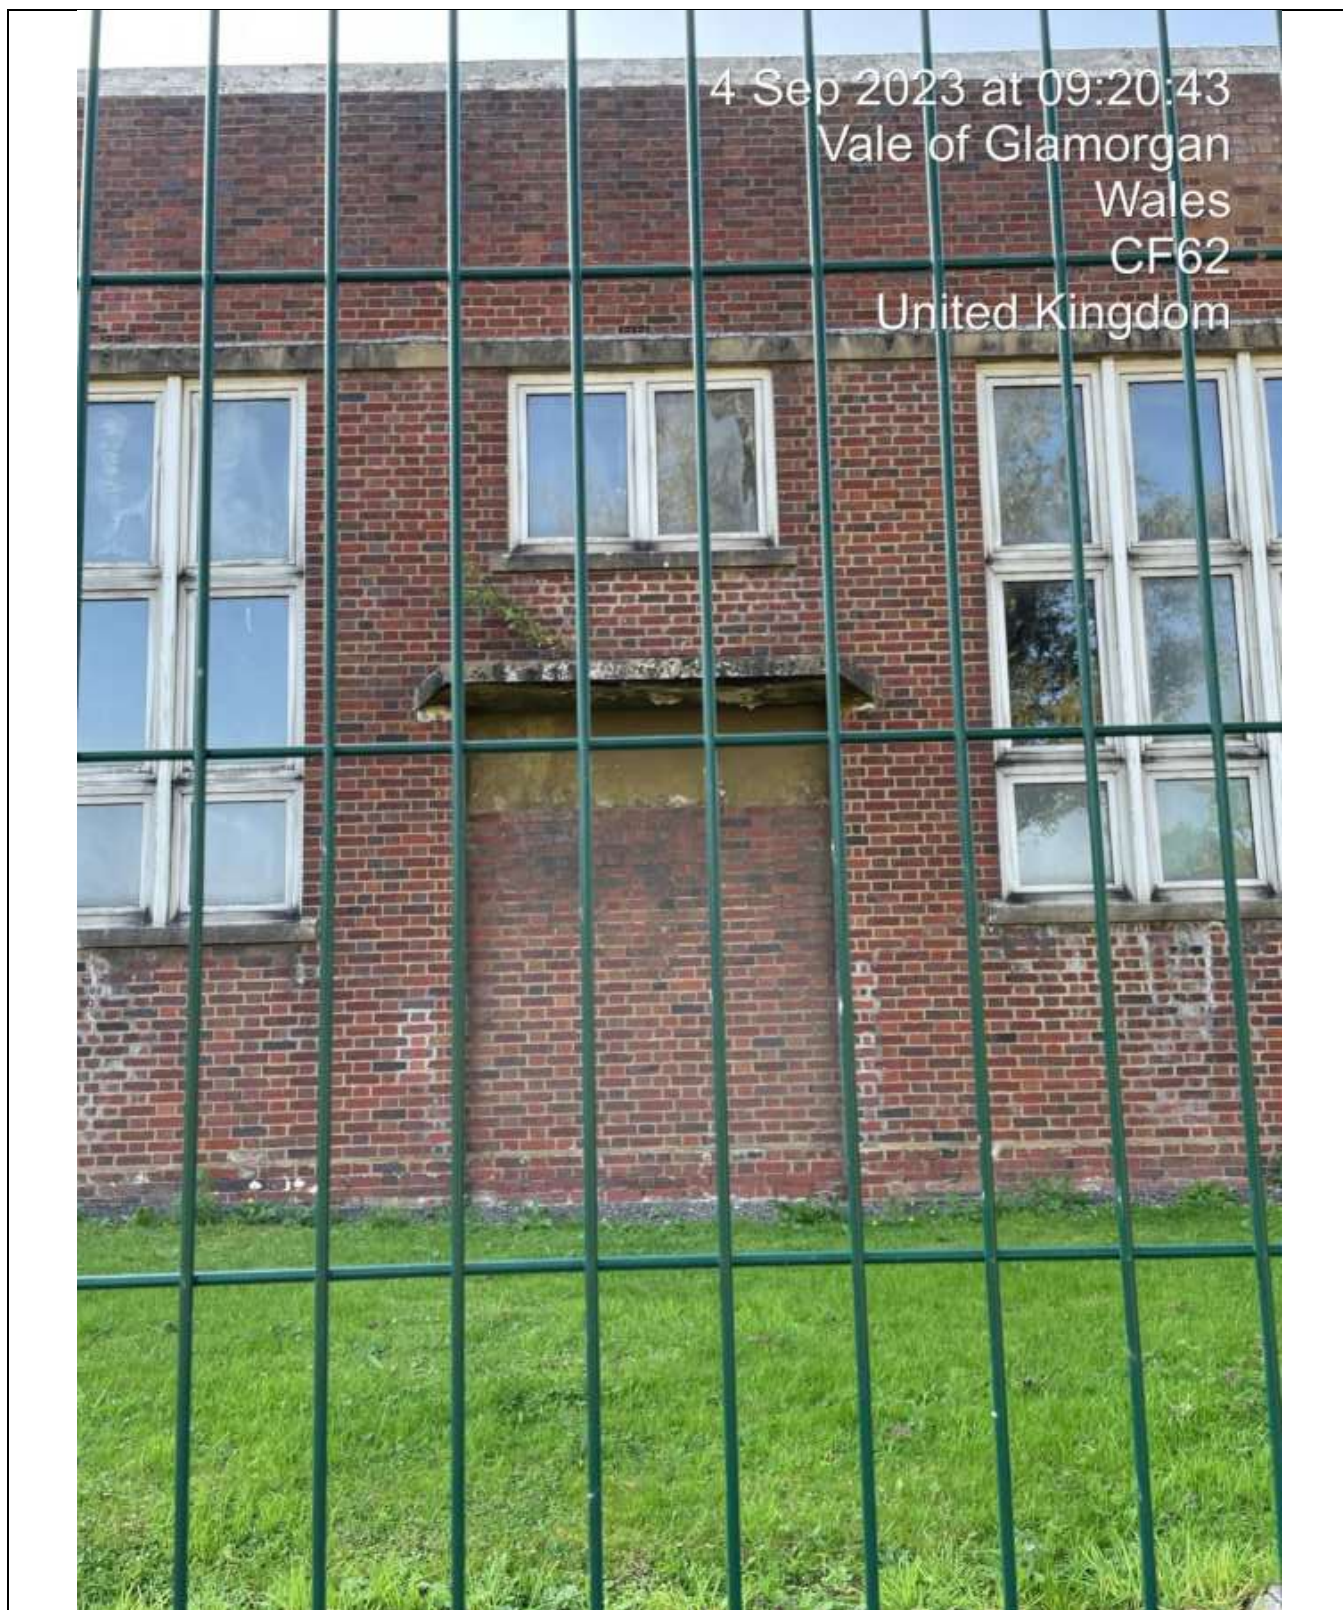
**Northern Elevation. Replacement Fenestration & Bricked Up Former Entrance Doorway.**

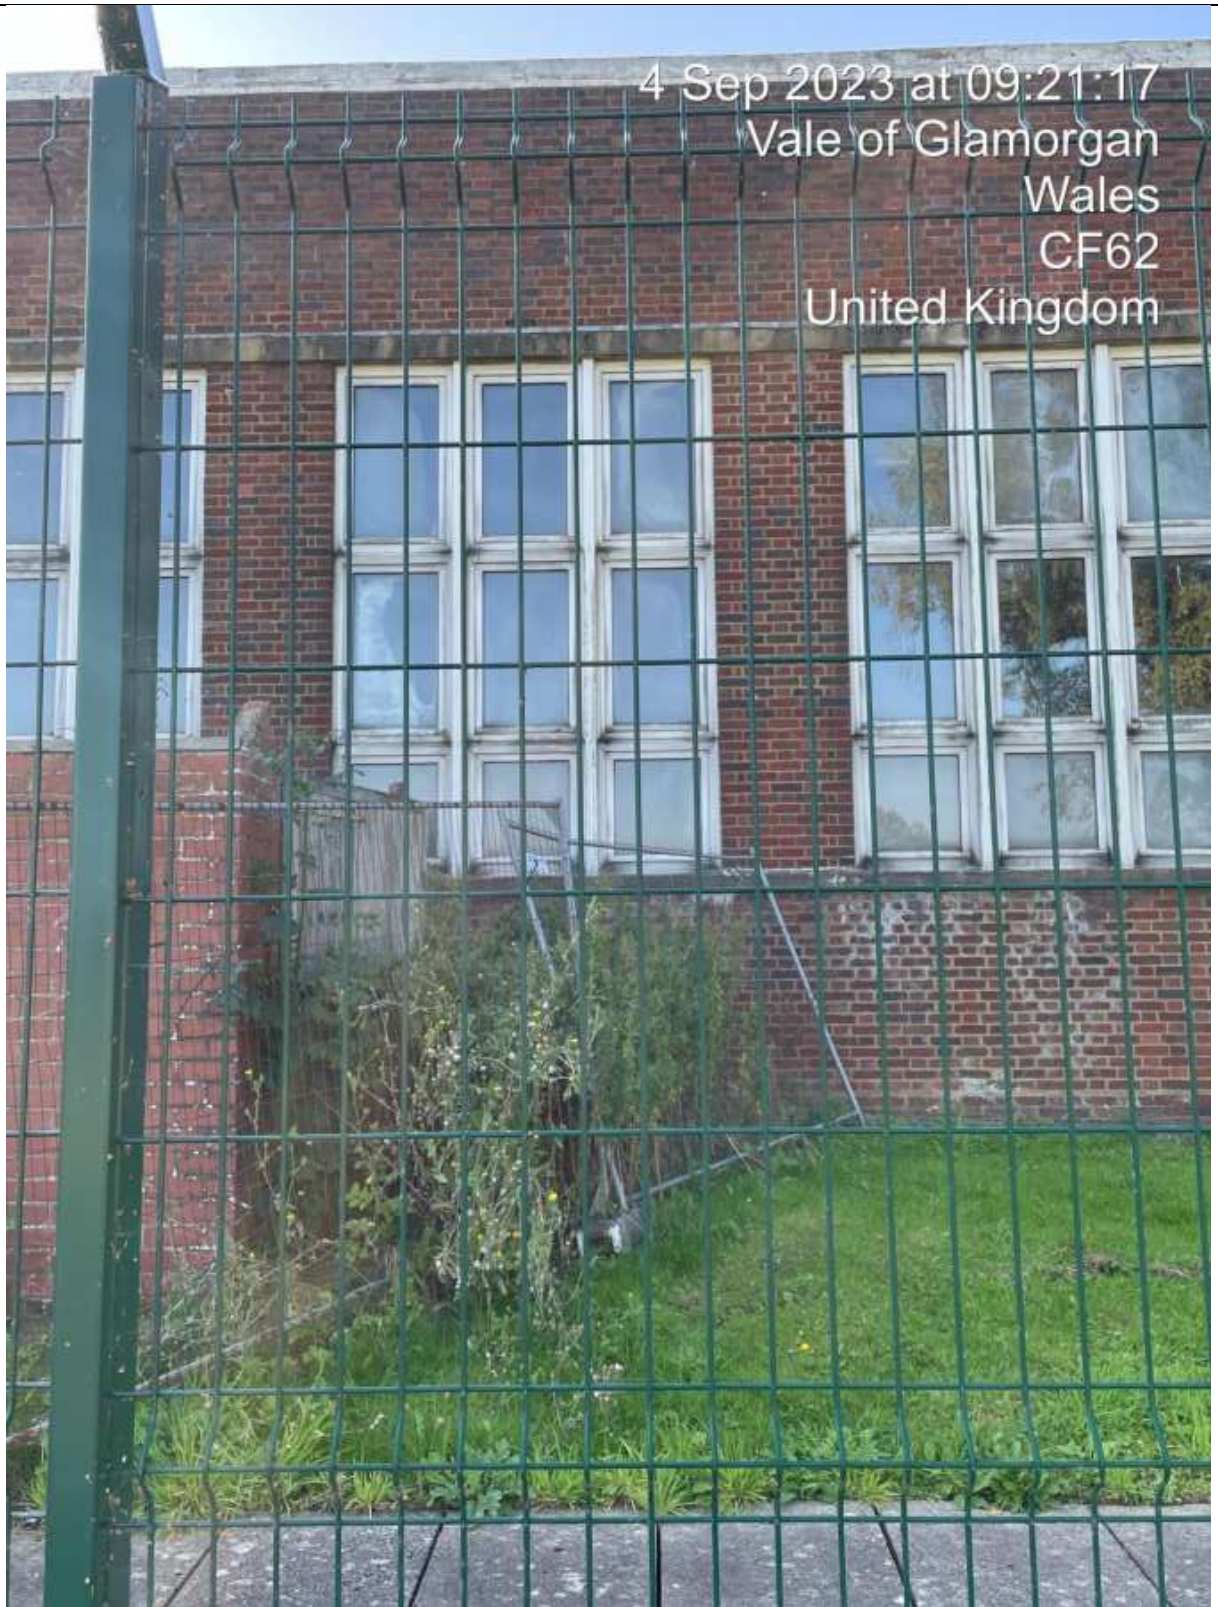
**Northern Elevation. Structural Collapse.**

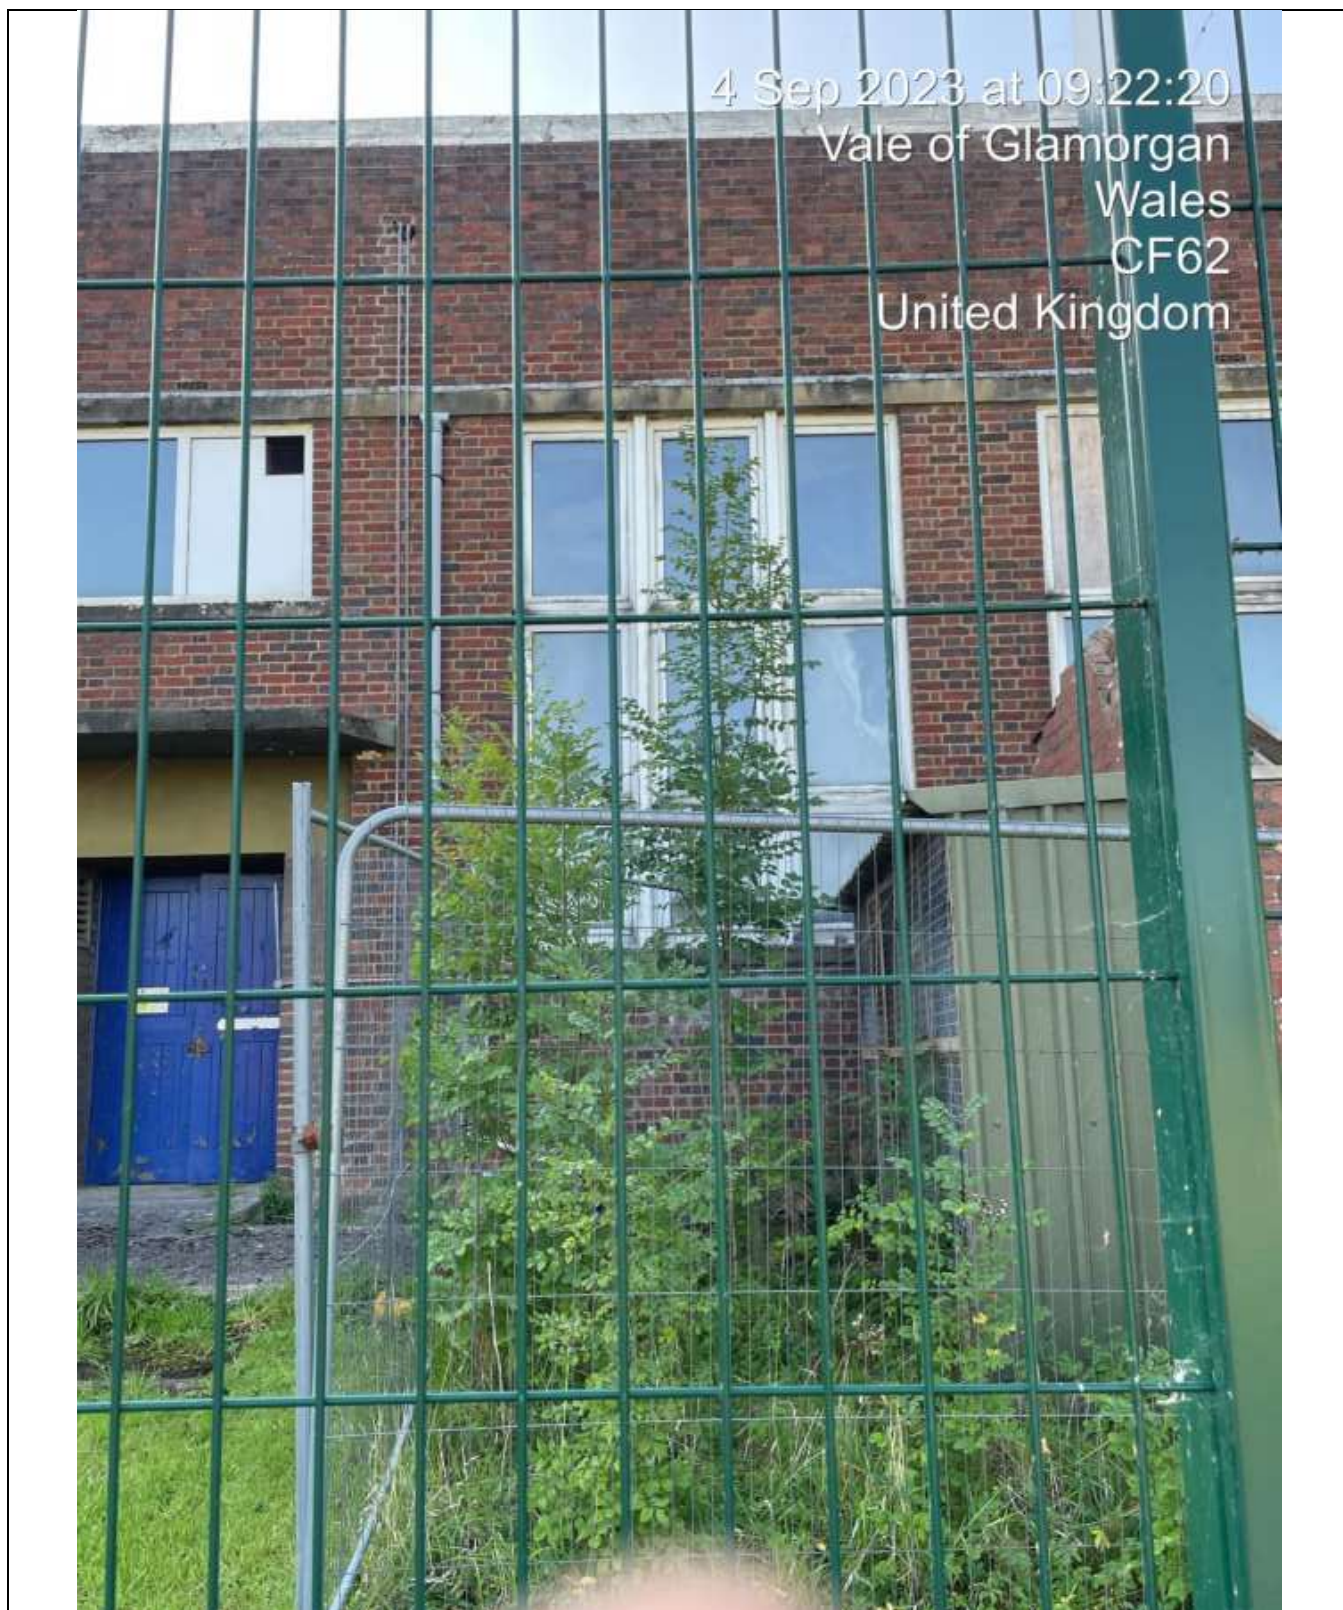
**Northern Elevation. Structural Collapse.**

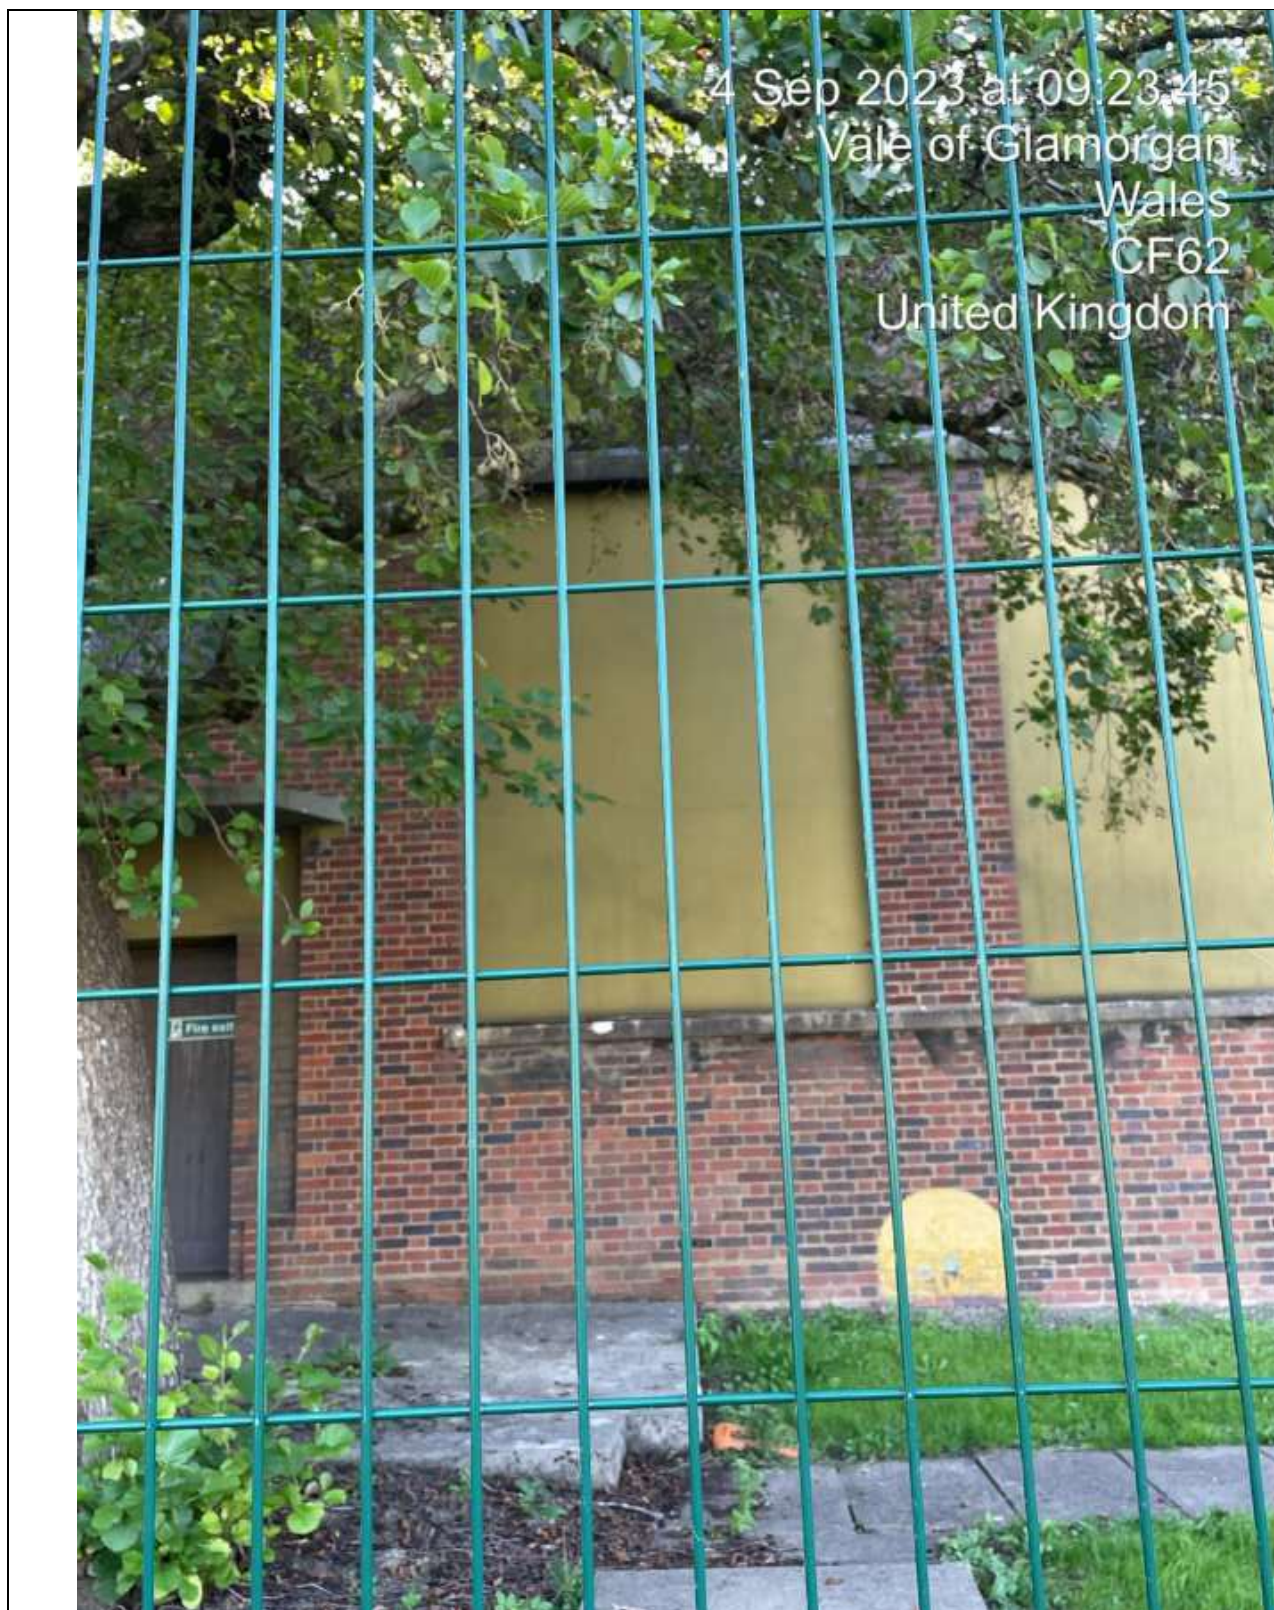
**Northern Elevation. Blanked Off Fenestration and Trip Hazards to Path.**

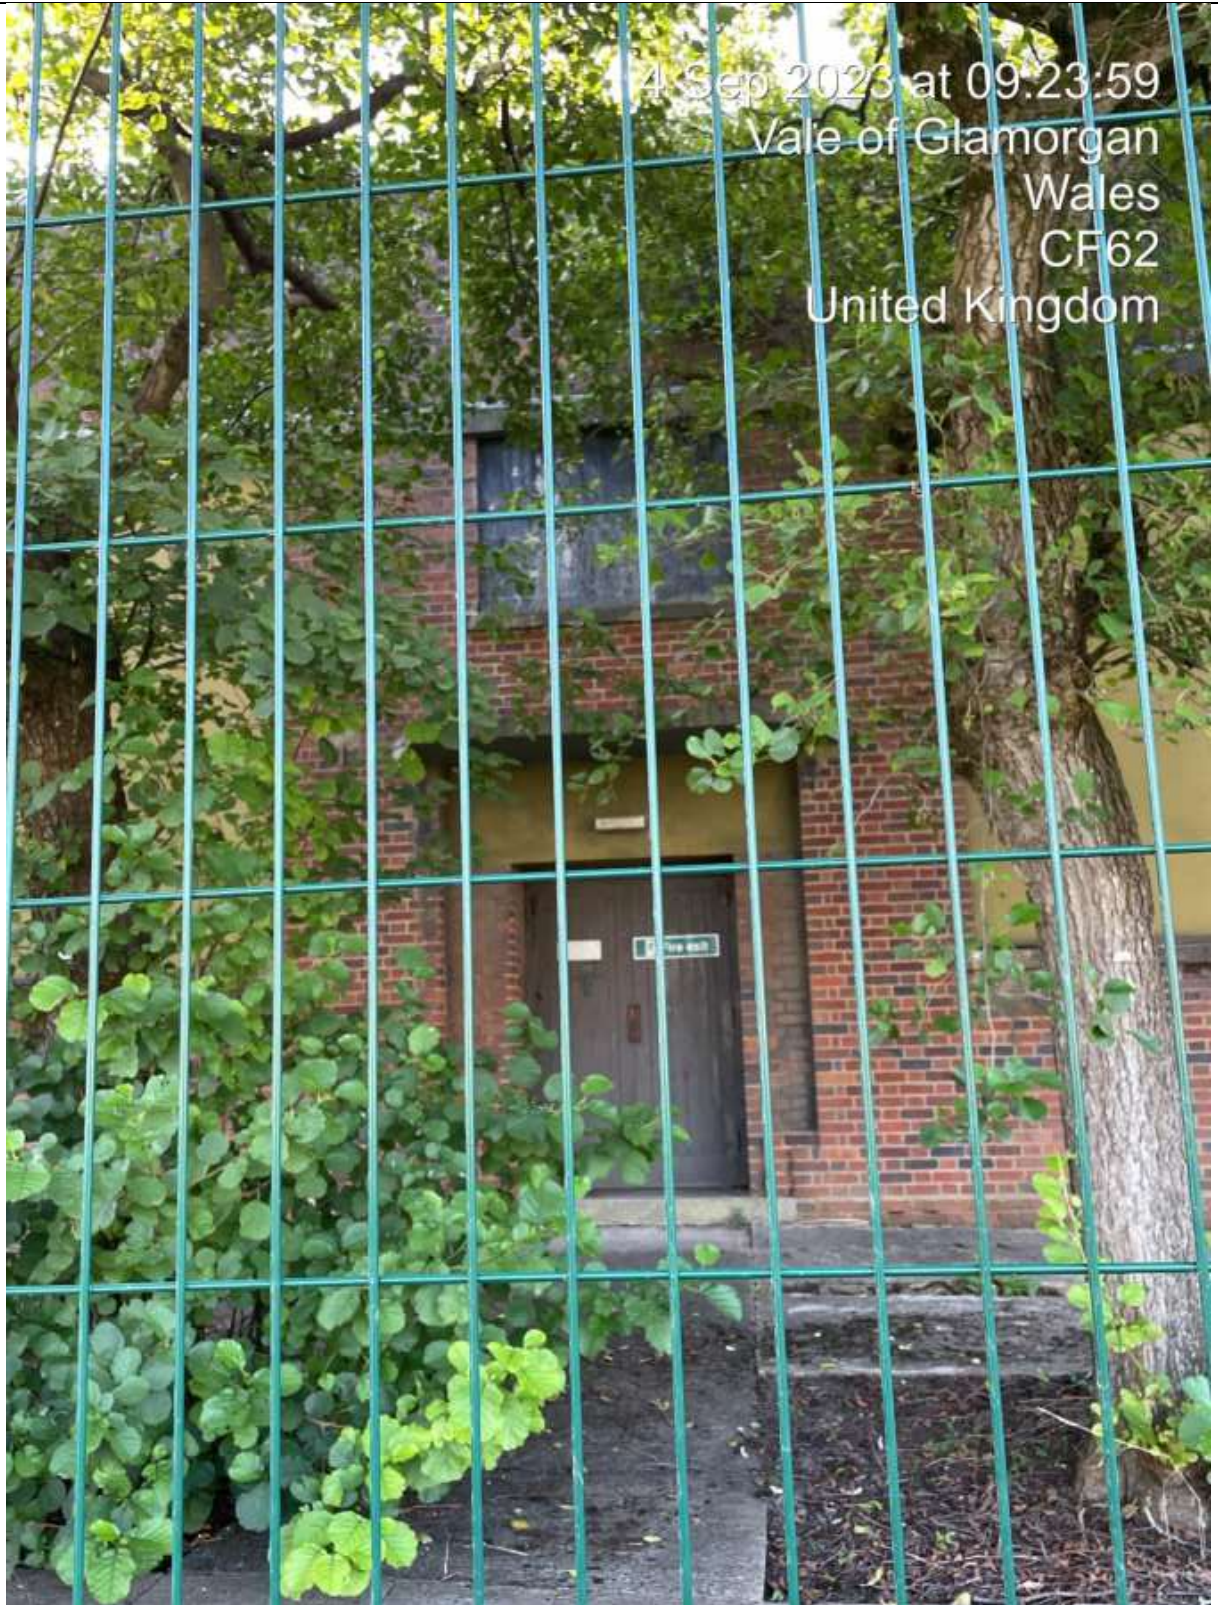
**Noethen Elevation. Non-Complaint Fire Exit.**

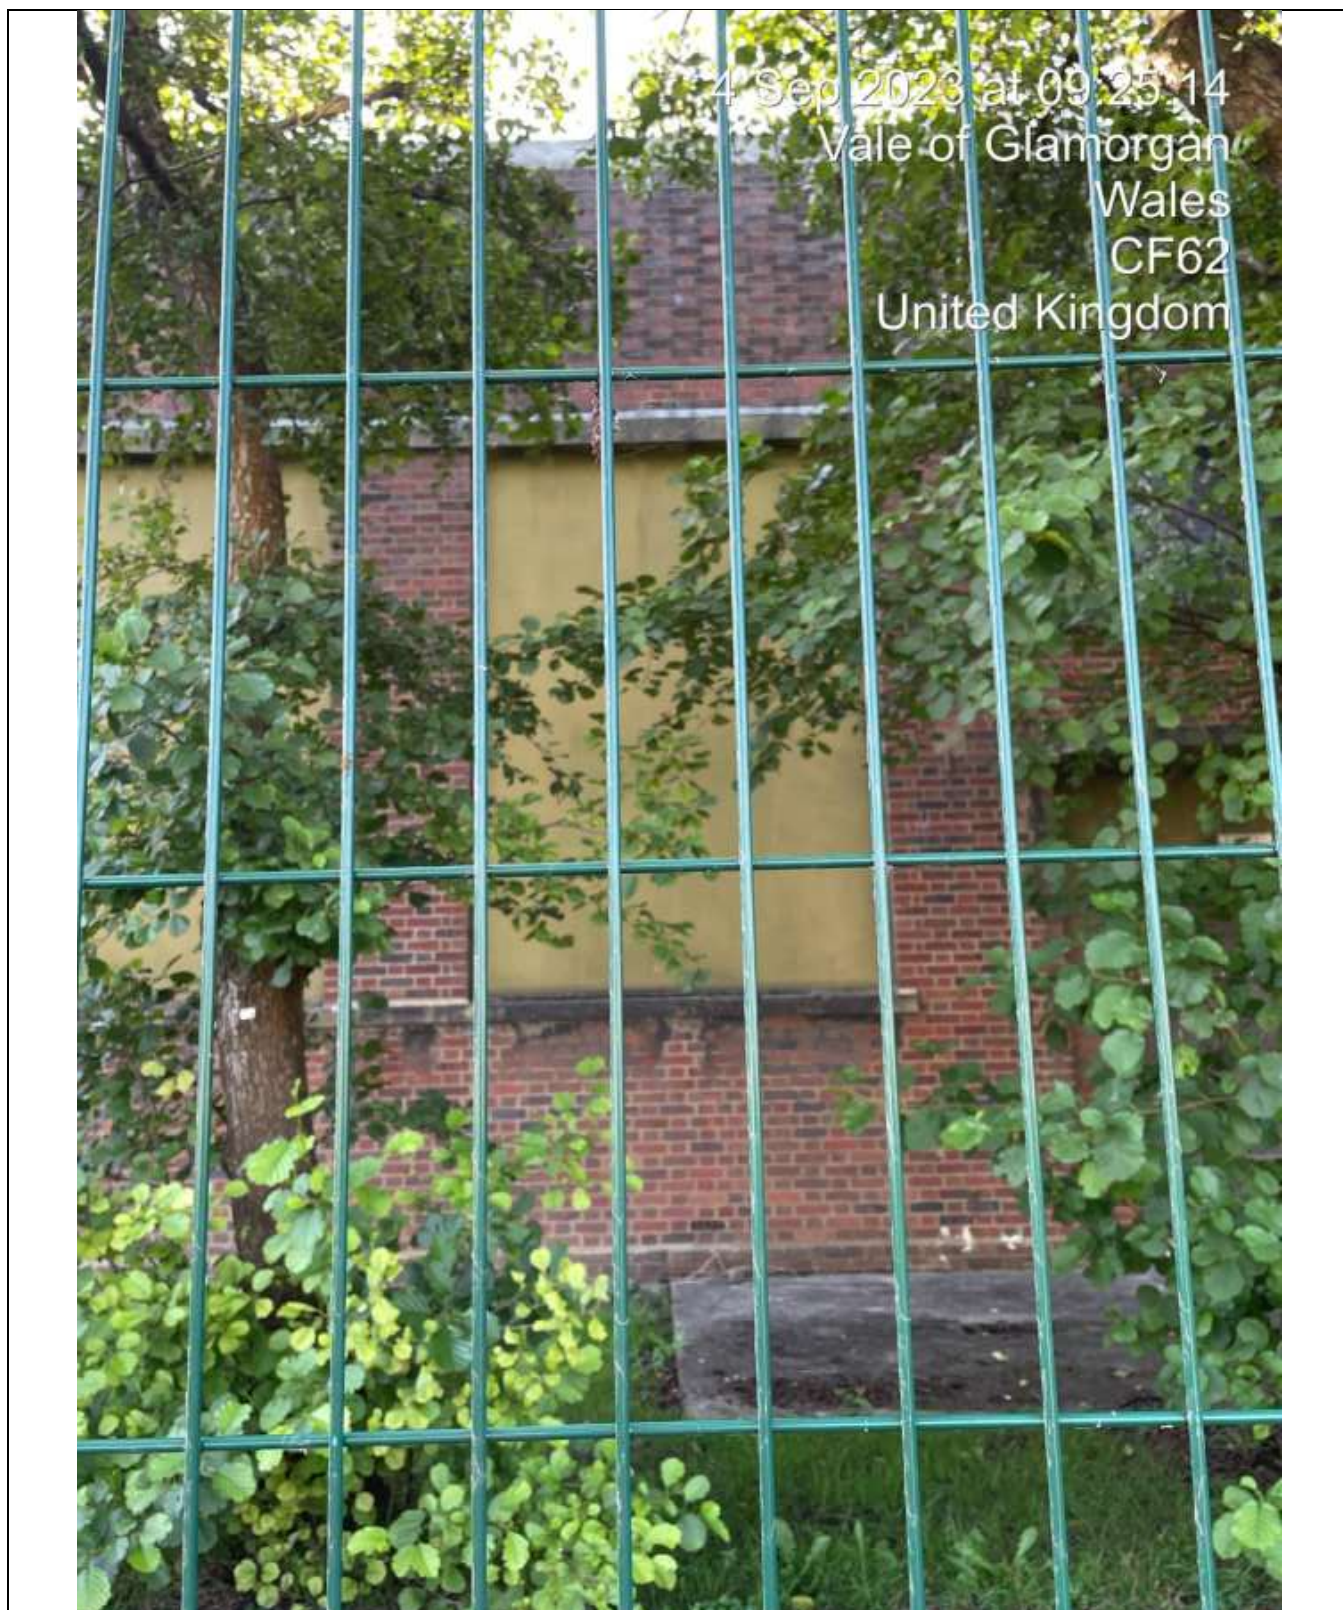
**Northern Elevation. Blanked Off Fenestration.**

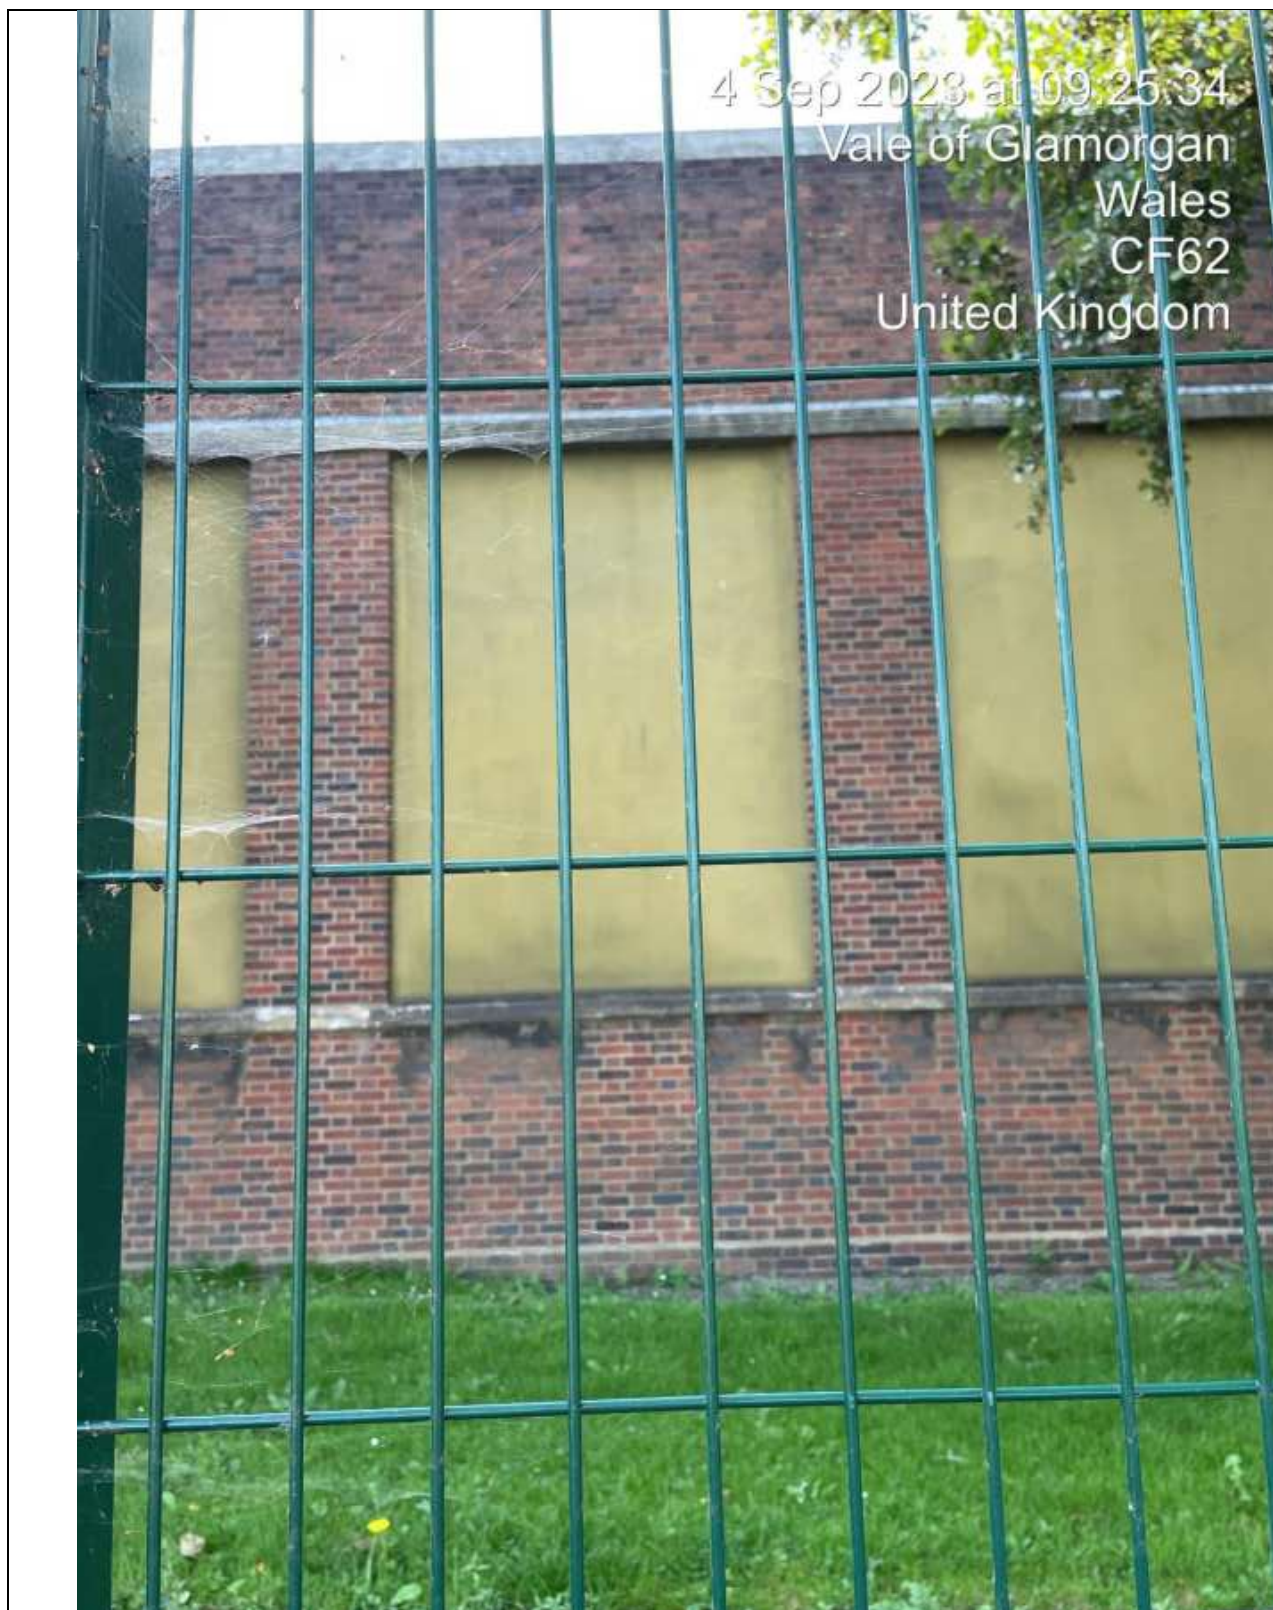
**Northern Elevation. Blanked Off Fenestration.**

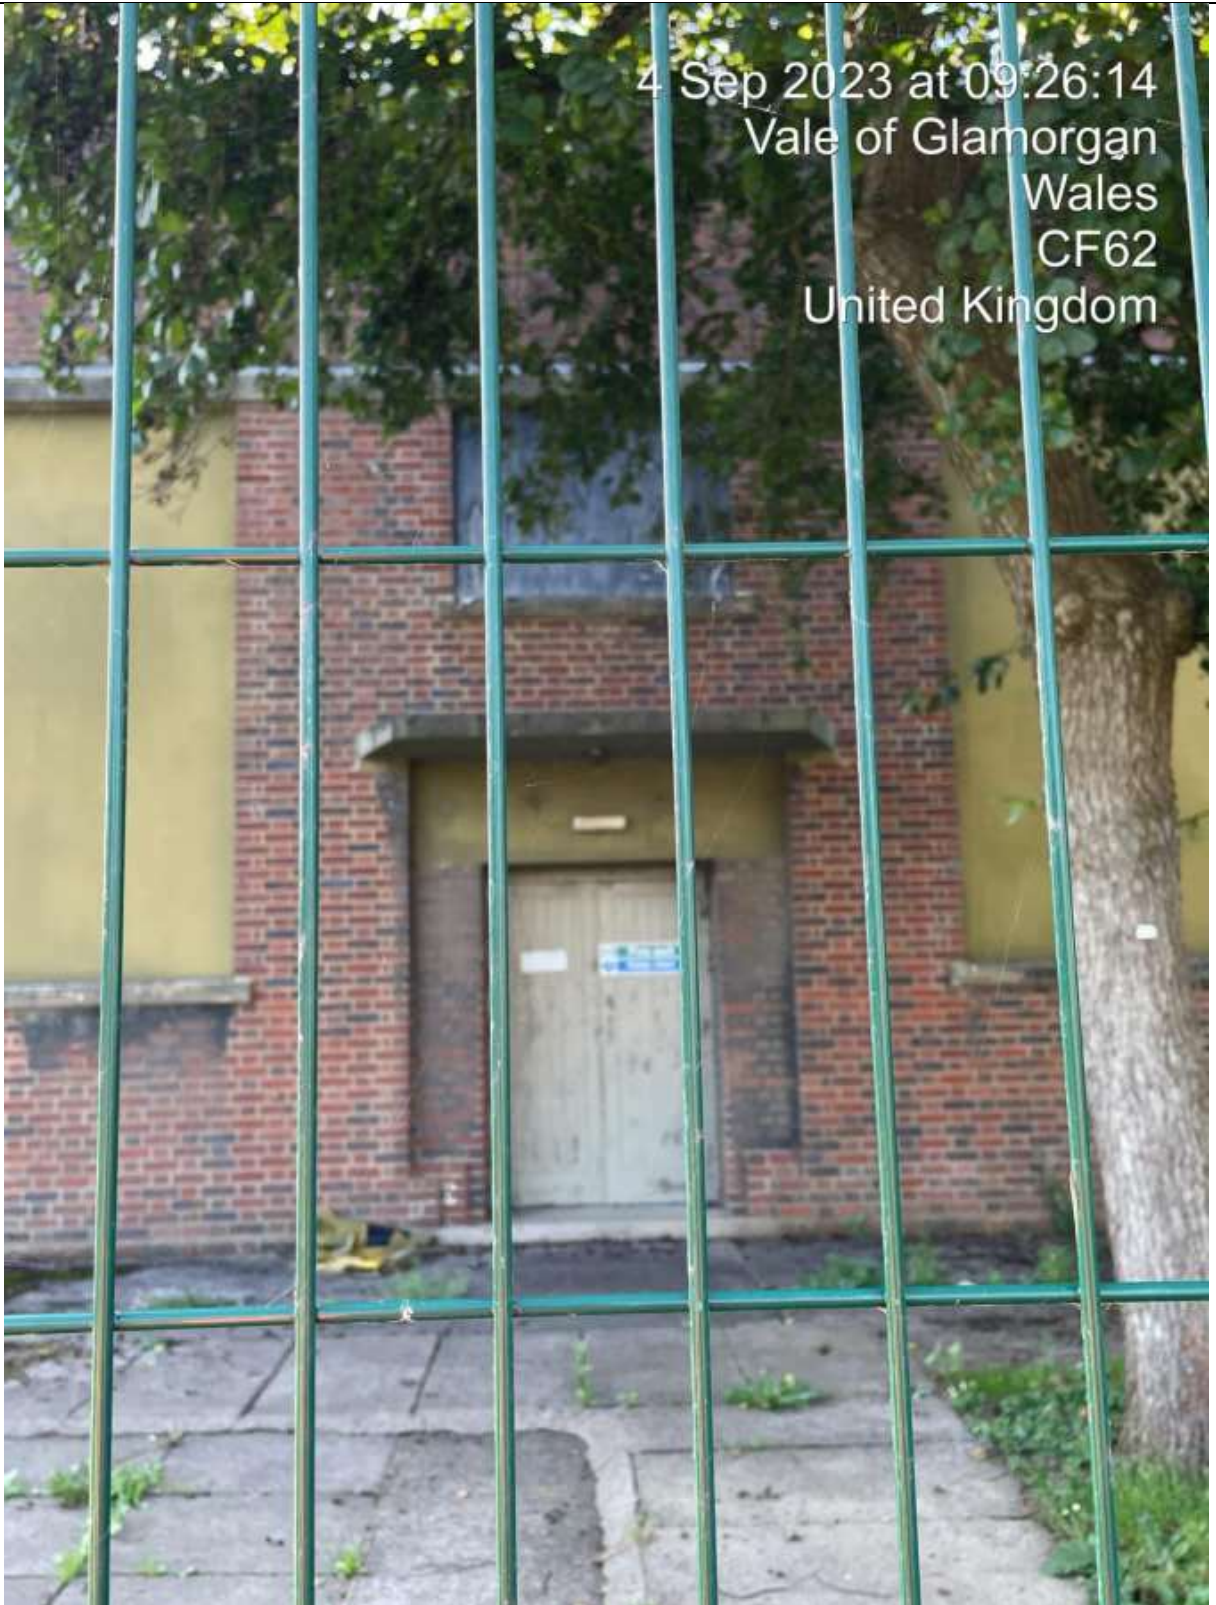
**Northern Elevation. Un-treated Doors.**

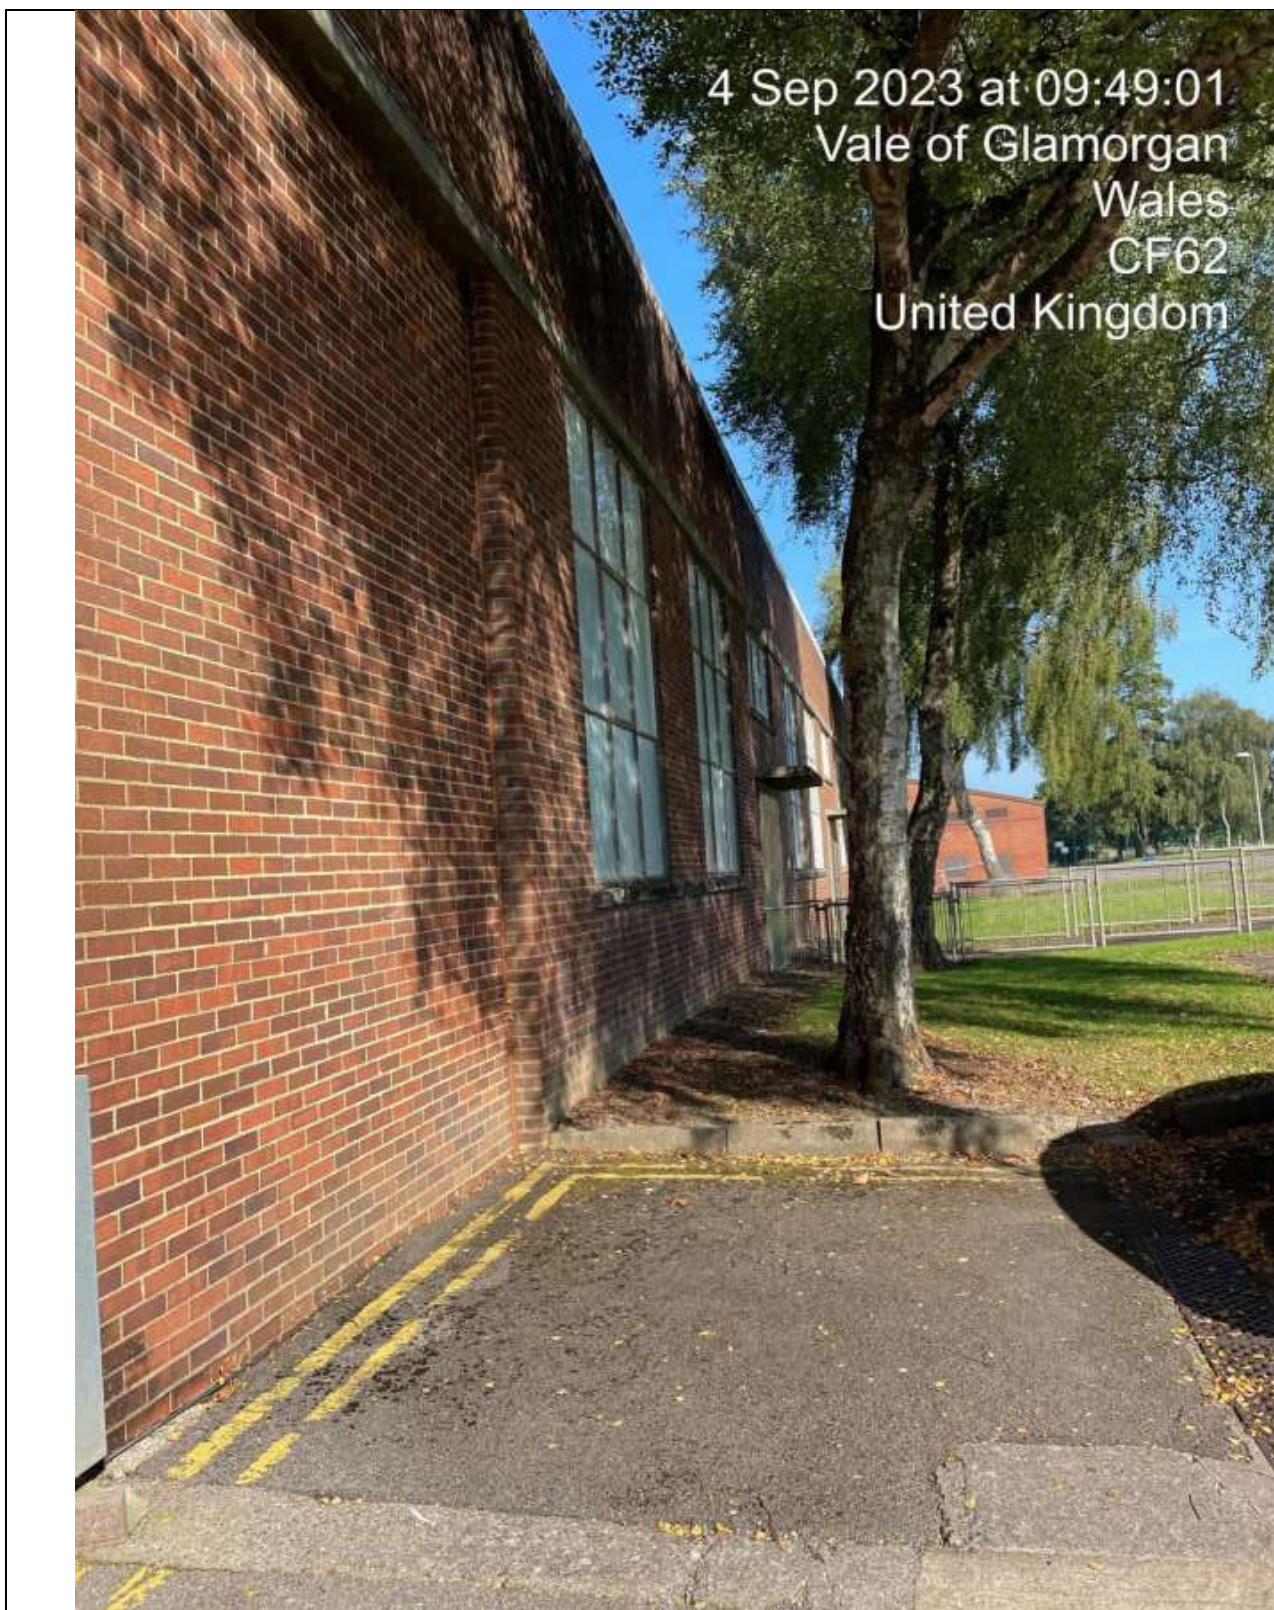
**Eastern Elevation. Proximity of Trees to Building cause suspect of Damage to Foundations.**
