Bro Tathan East Building 354 External & Internal Visual Condition Survey

| Report Ref: | PR01 | Created | 19/06/24 |

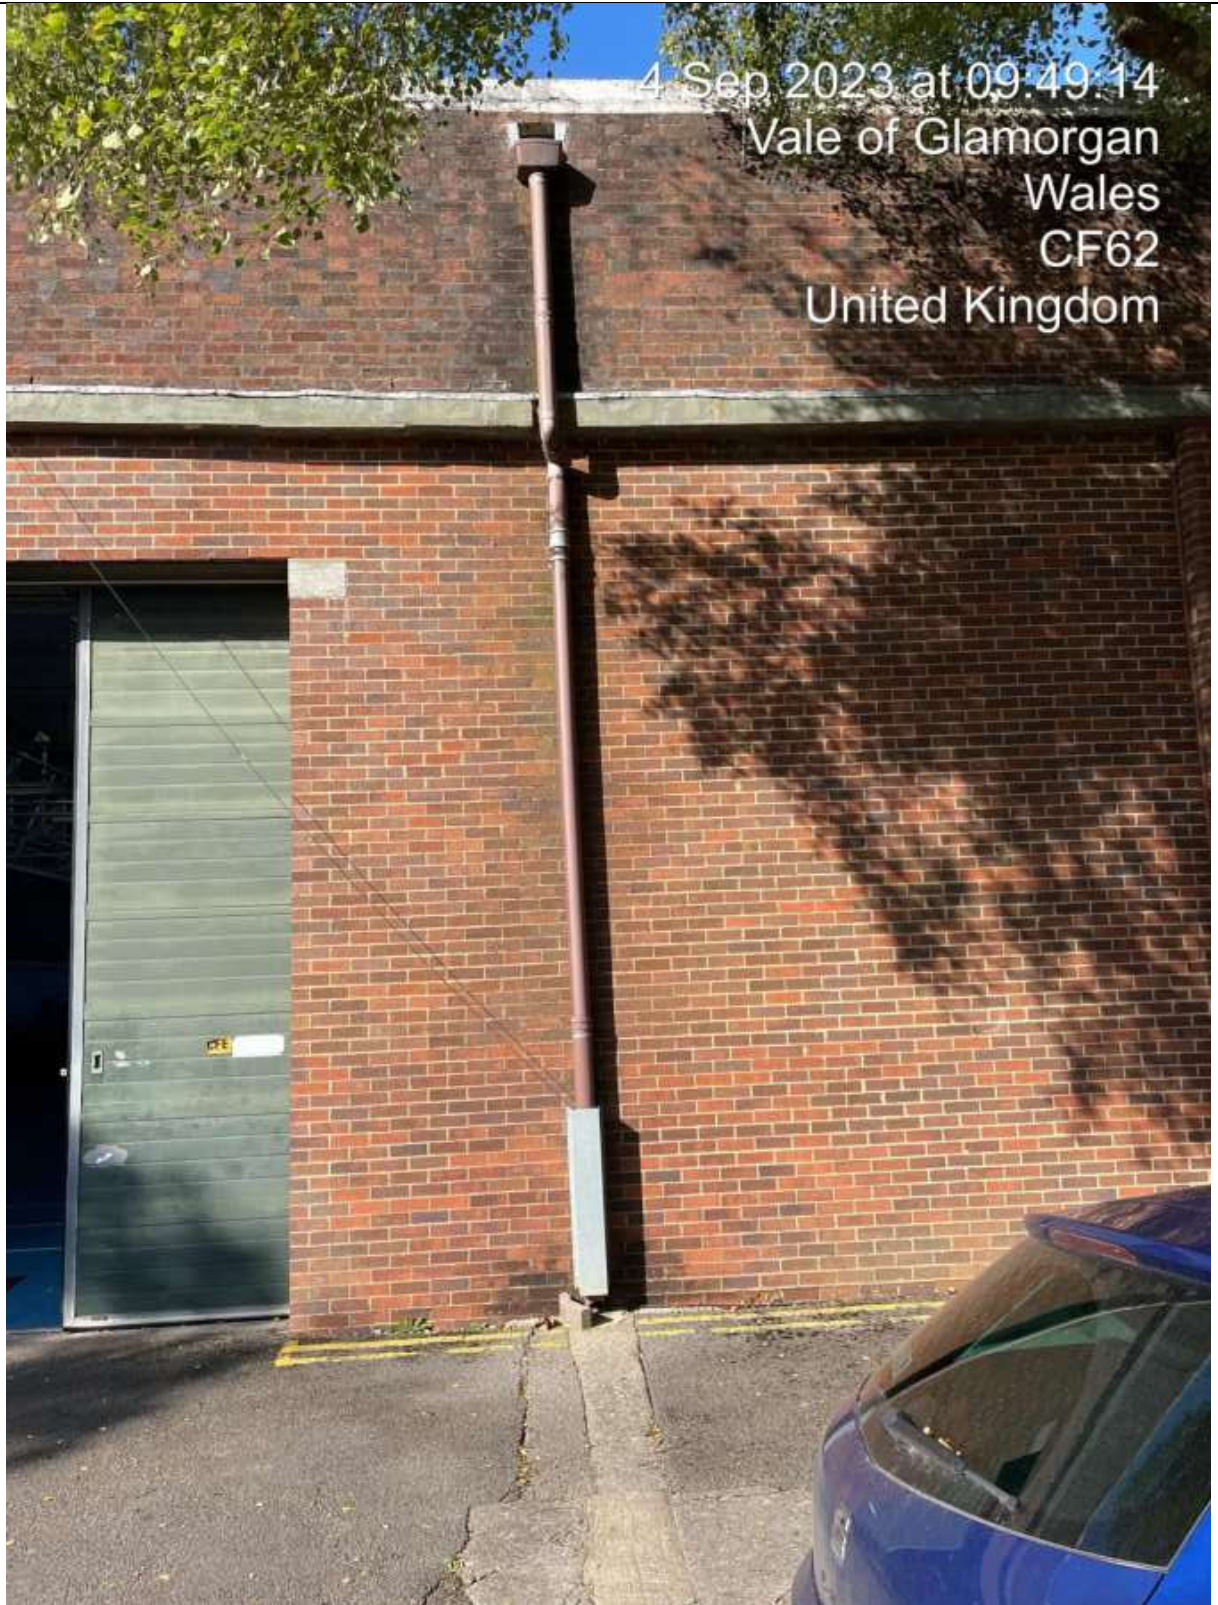
**Eastern Elevation. Downpipe from Hidden Gutter.**

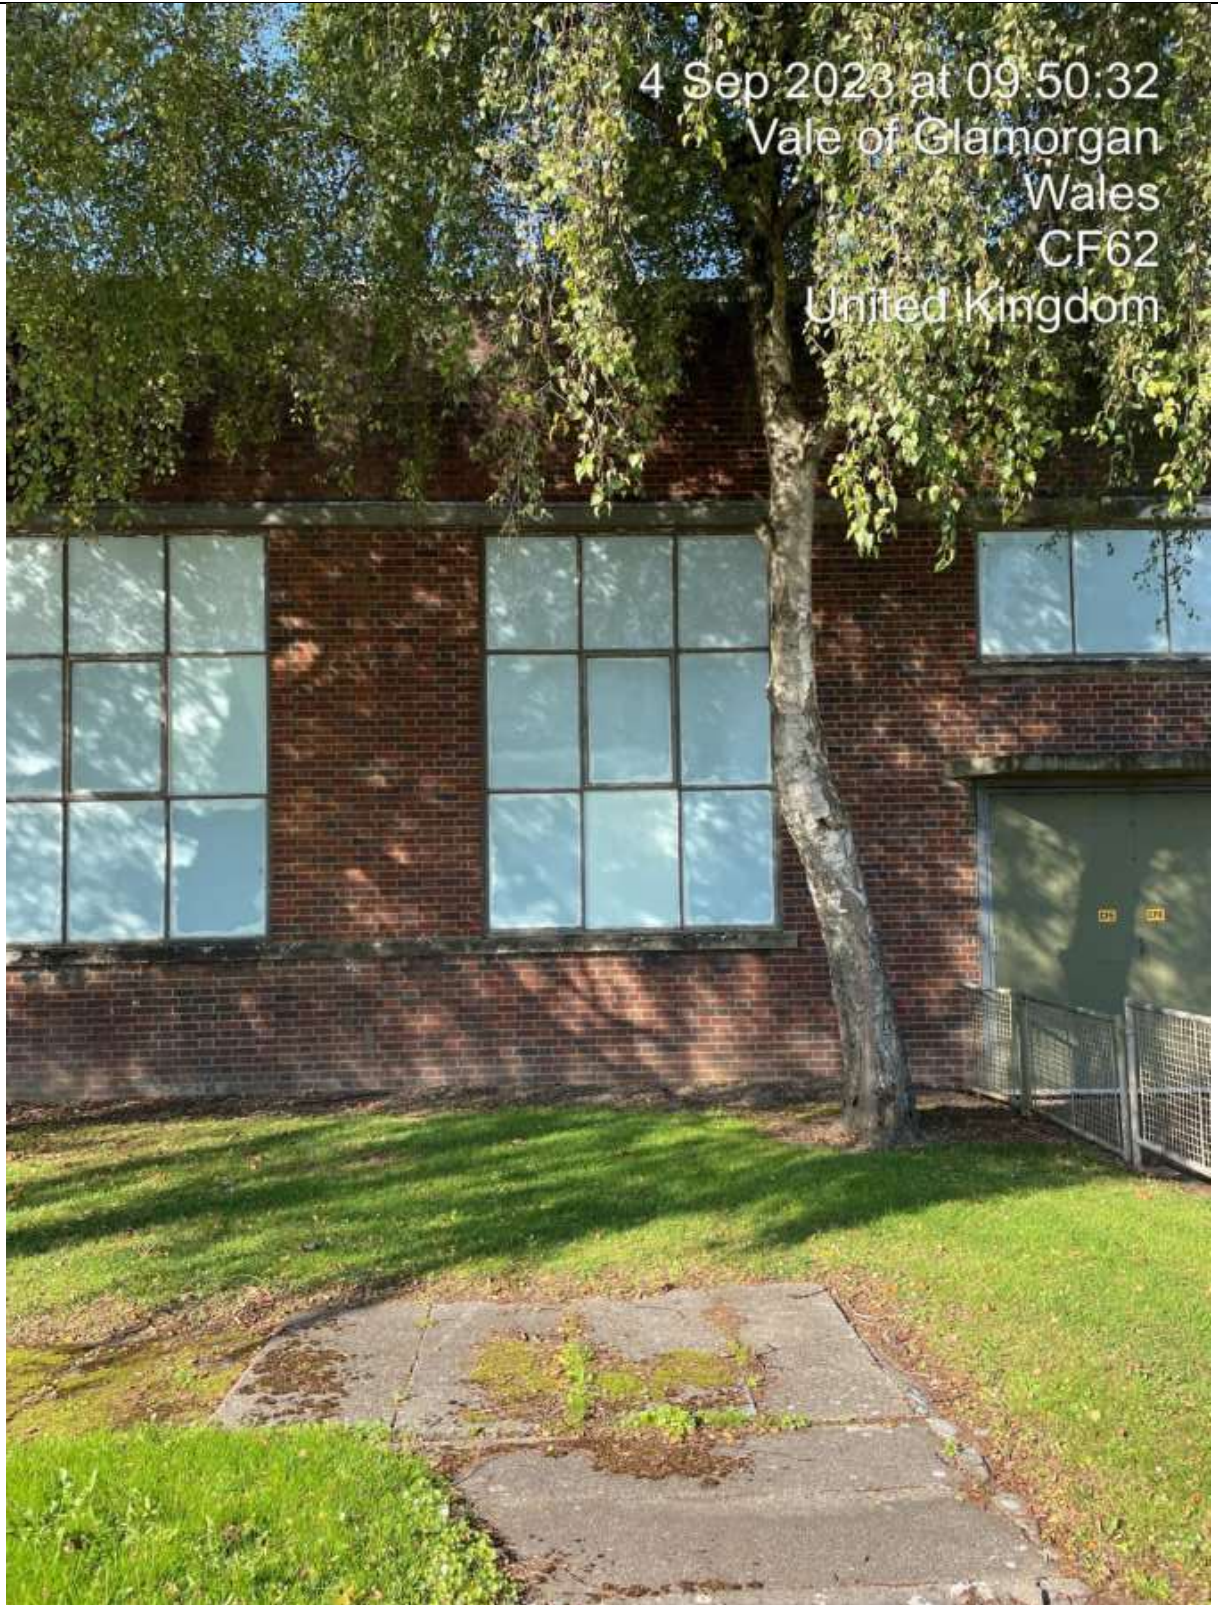
**Eastern Elevation. Original Fenestration.**

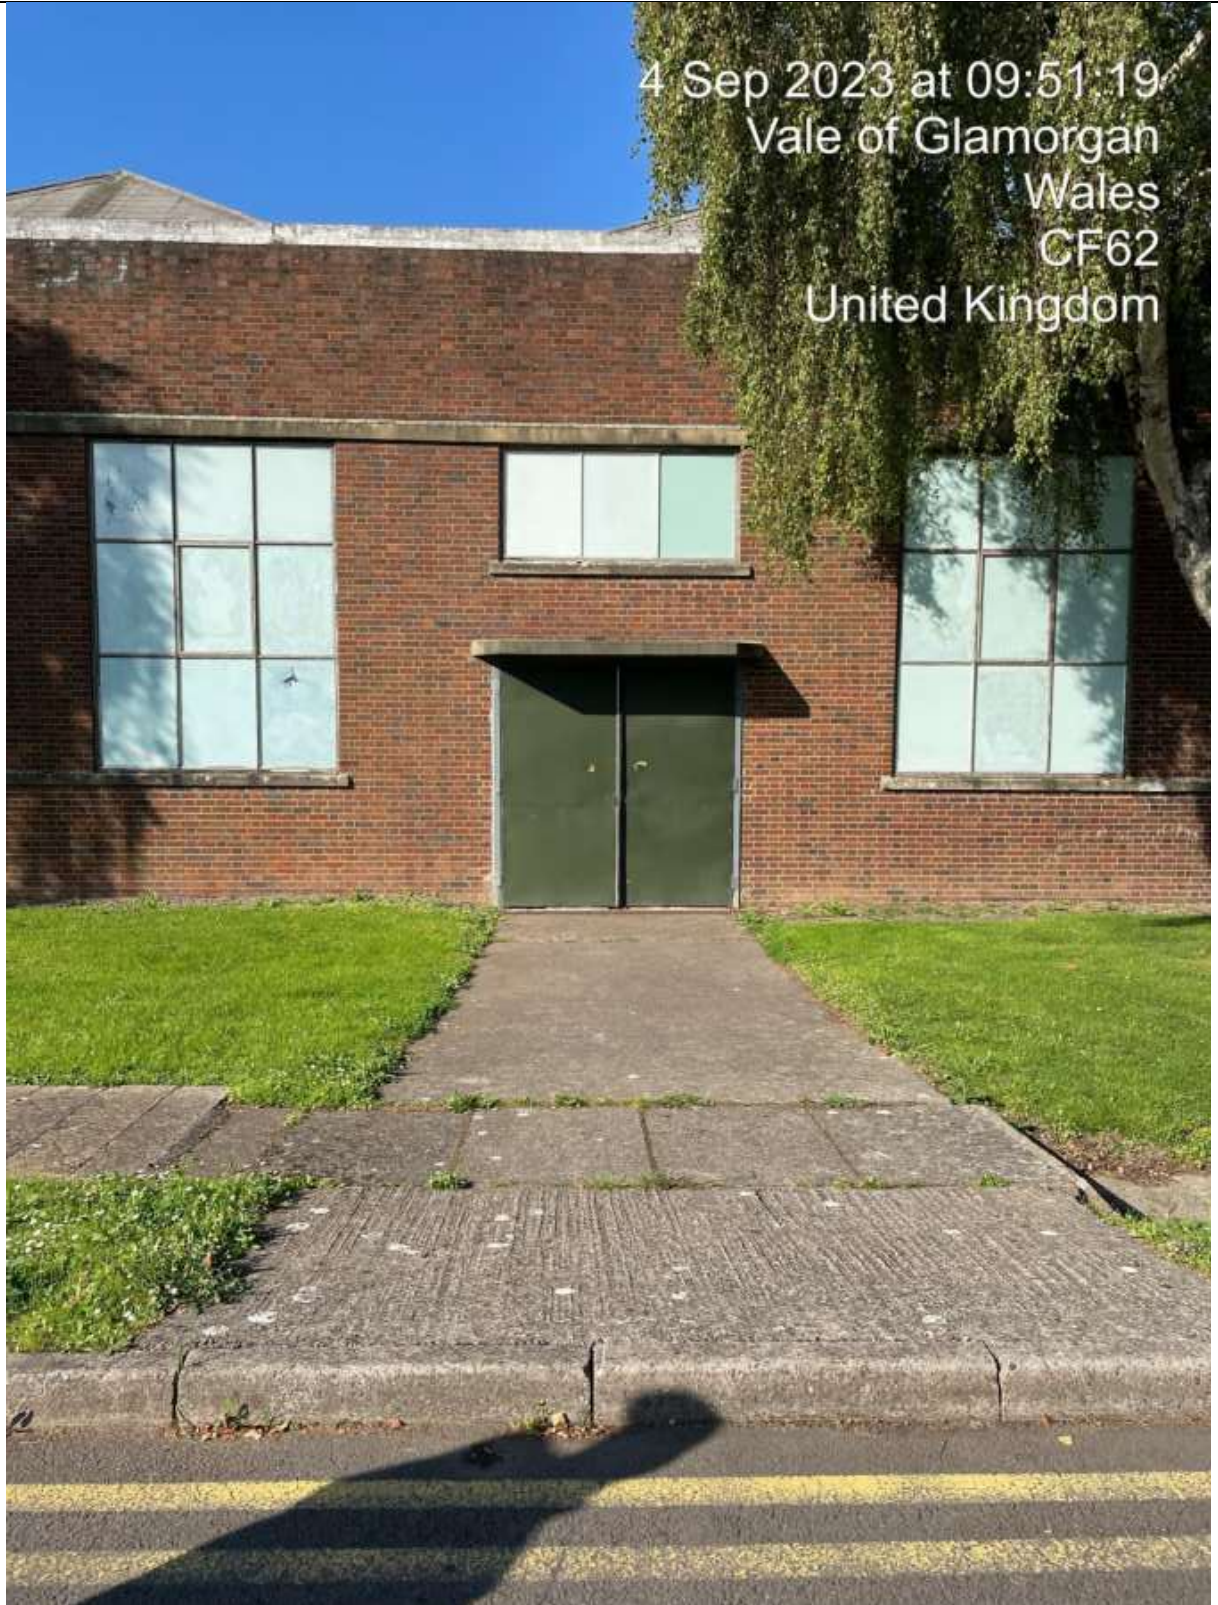
**Eastern Elevation. Non-Compliant Access & Egress.**

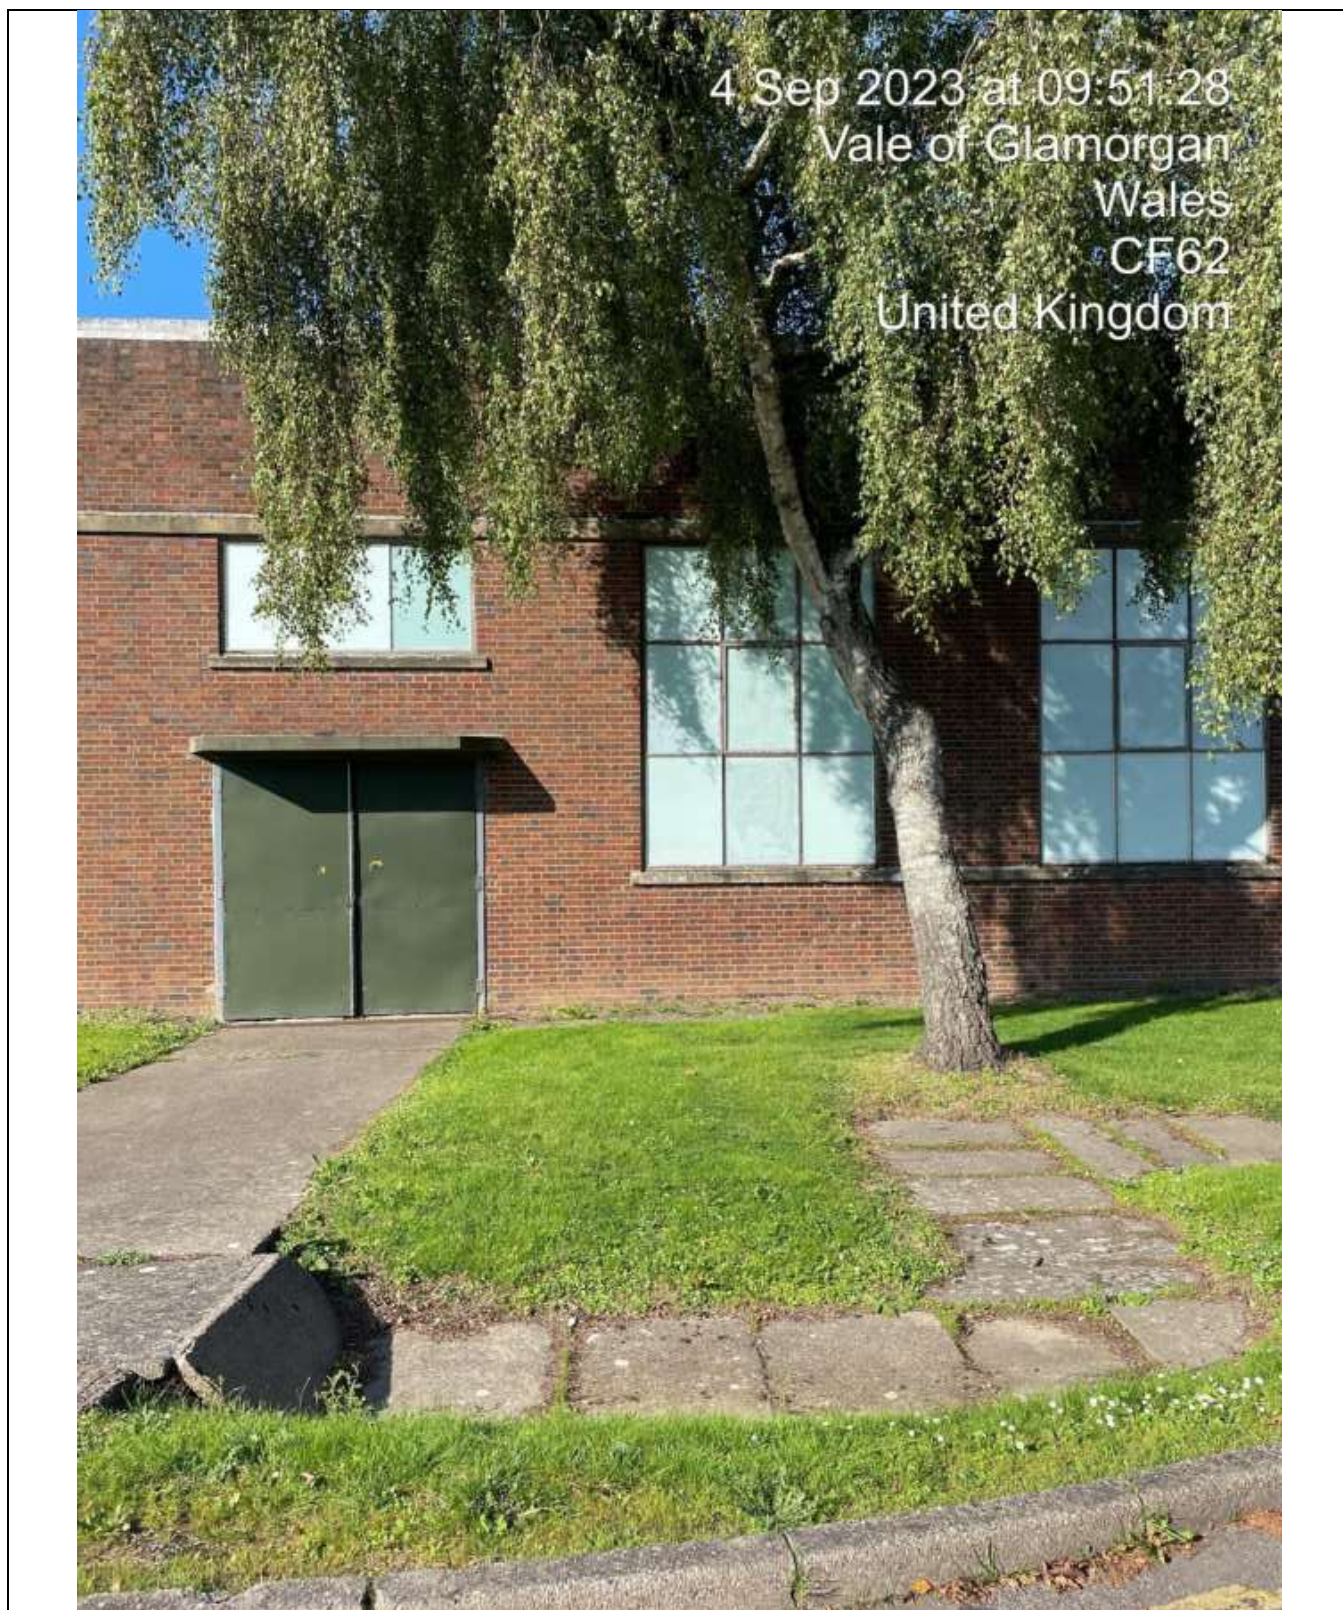
**Eastern Elevation. SIGNIFICANT Trip Hazards to Path.**

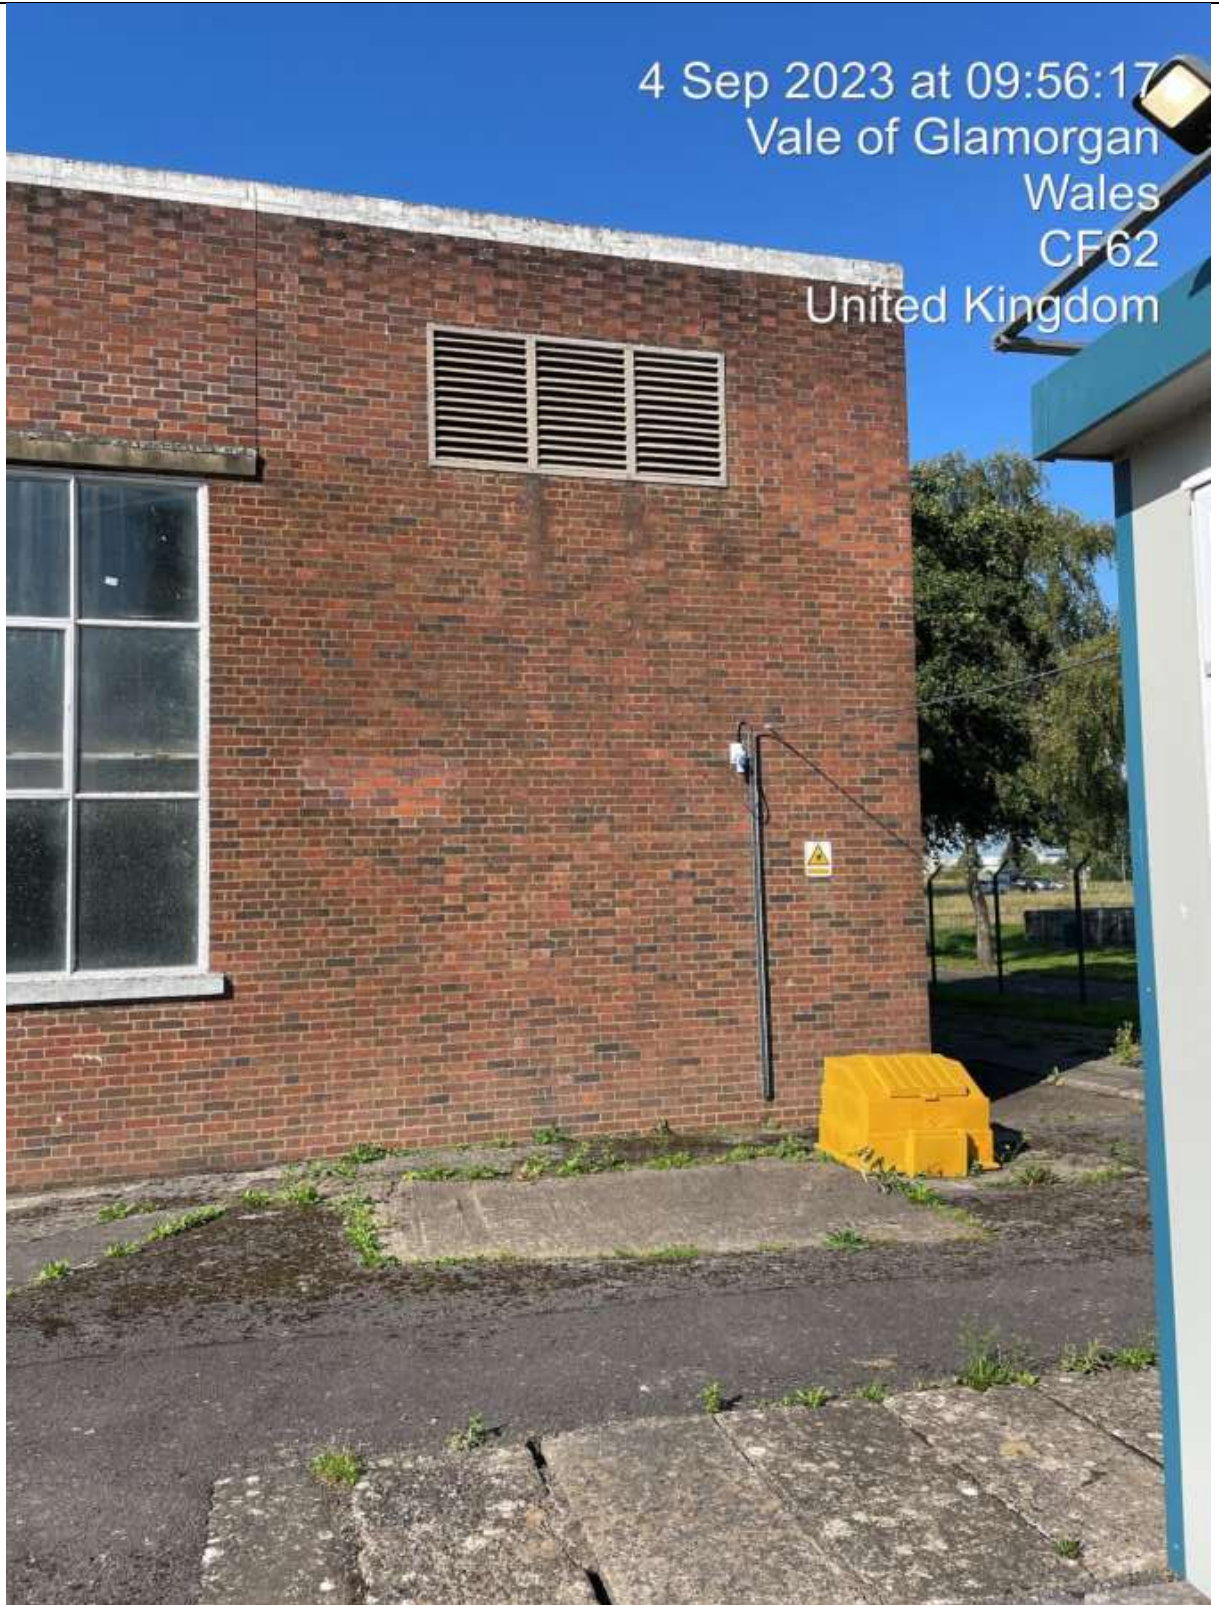
**Eastern Elevation. Replacement Brick Work at High Level.**

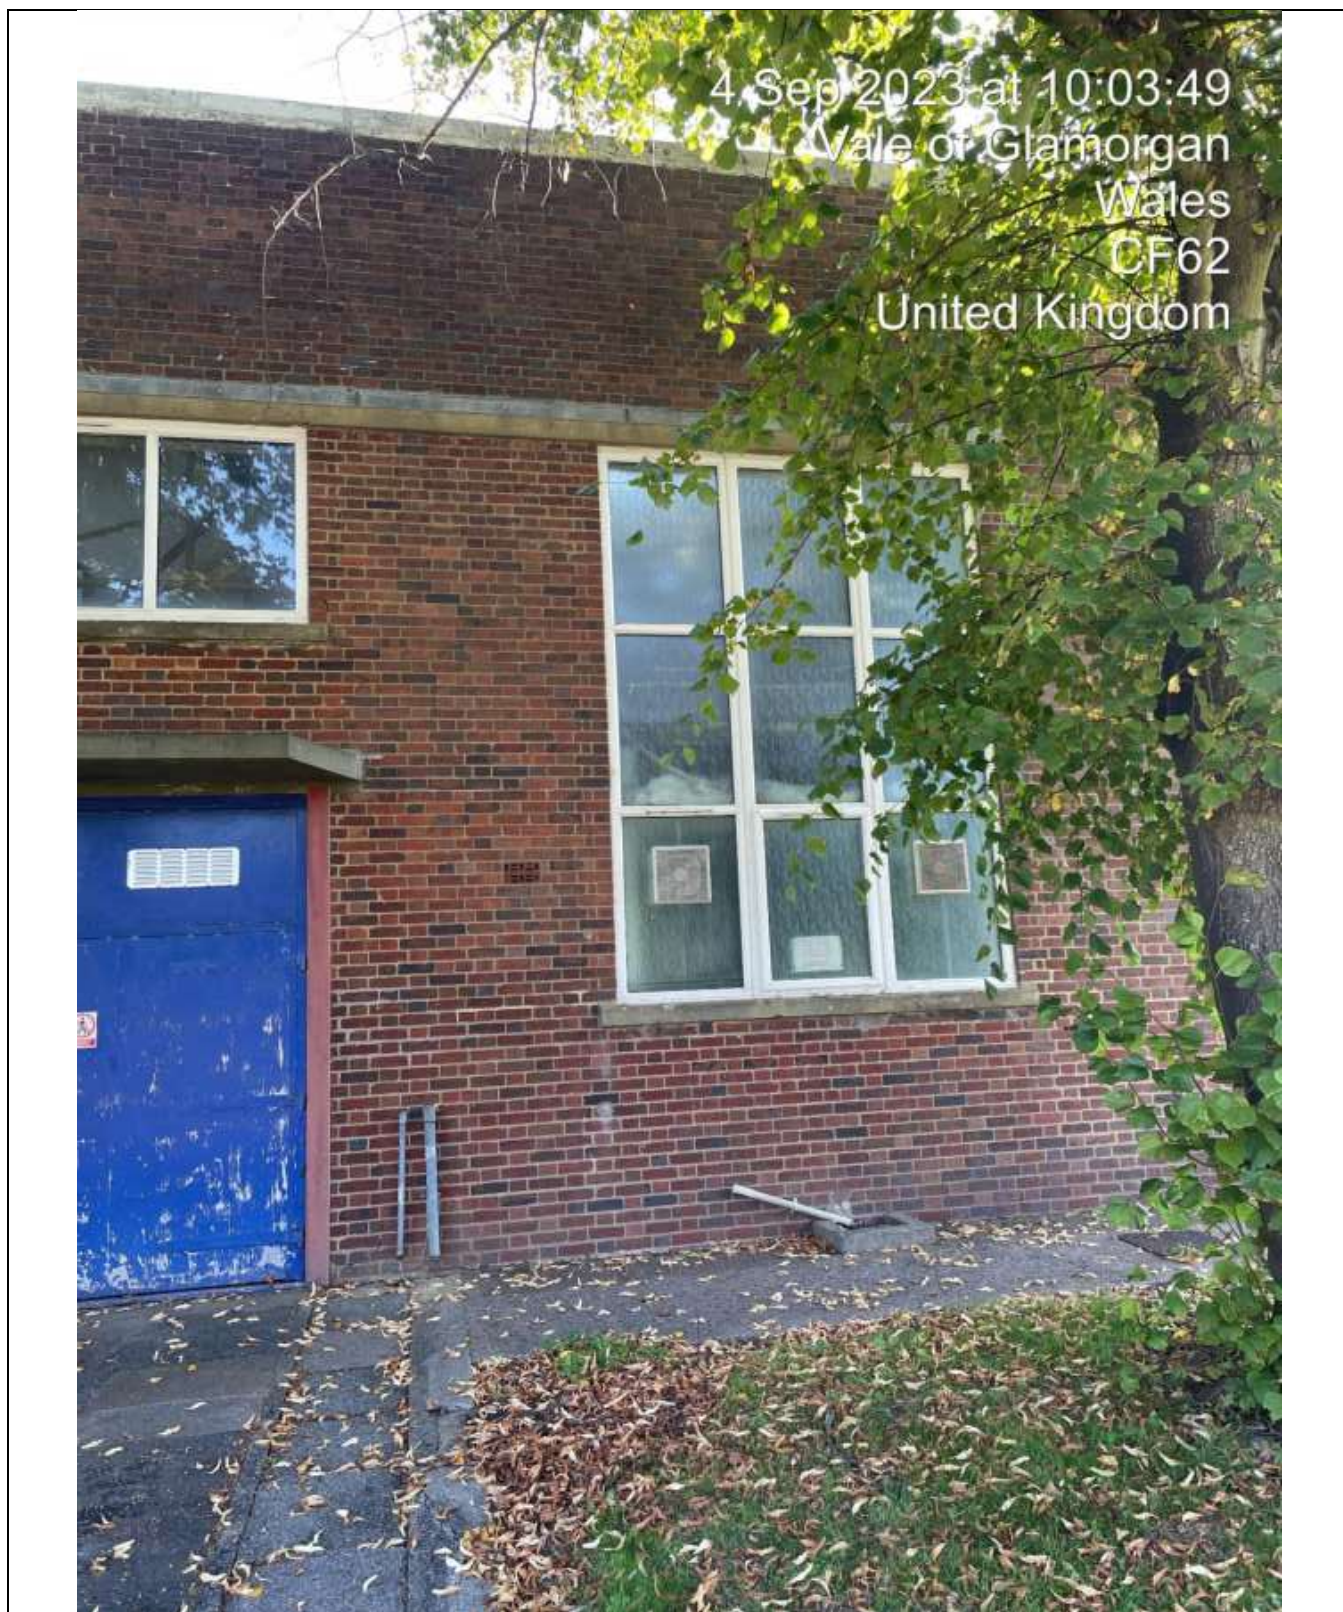
**Western Elevation. Replacement Fenestration.**

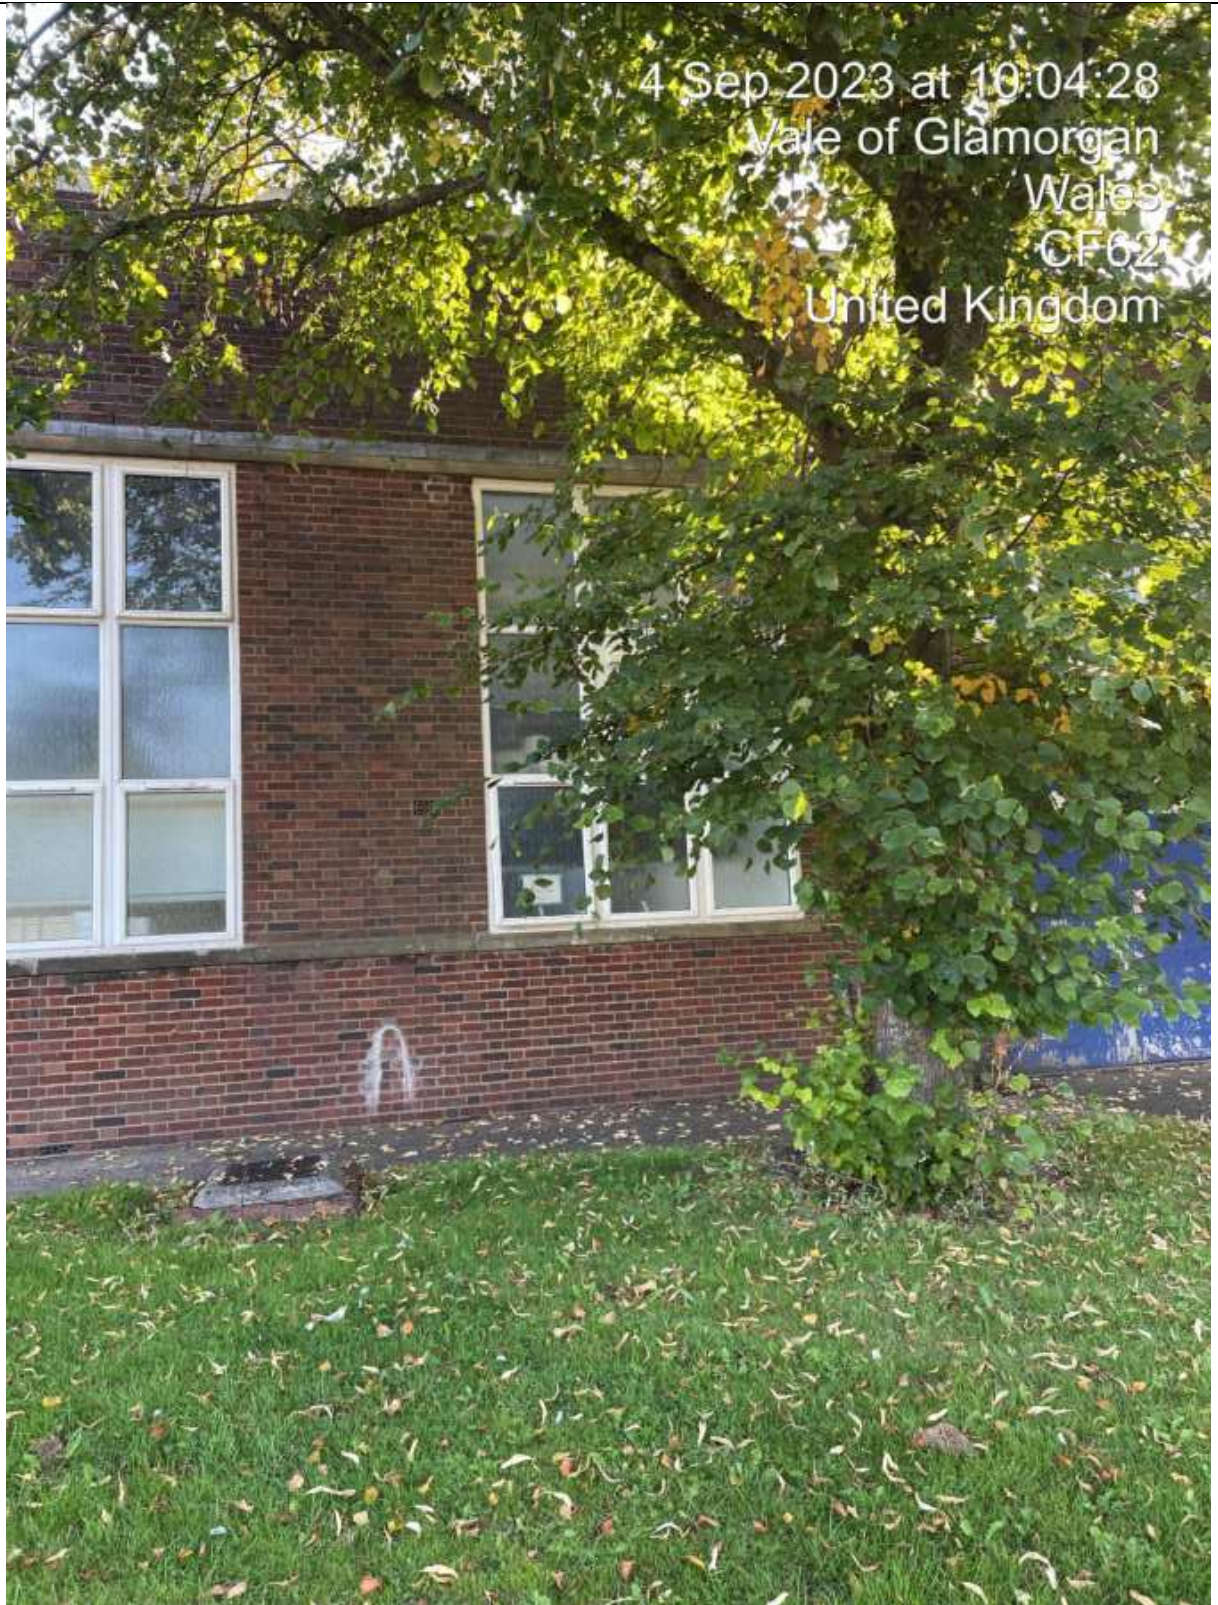
**Western Elevation. Proximity of Trees to Building cause suspect of Damage to Foundations.**

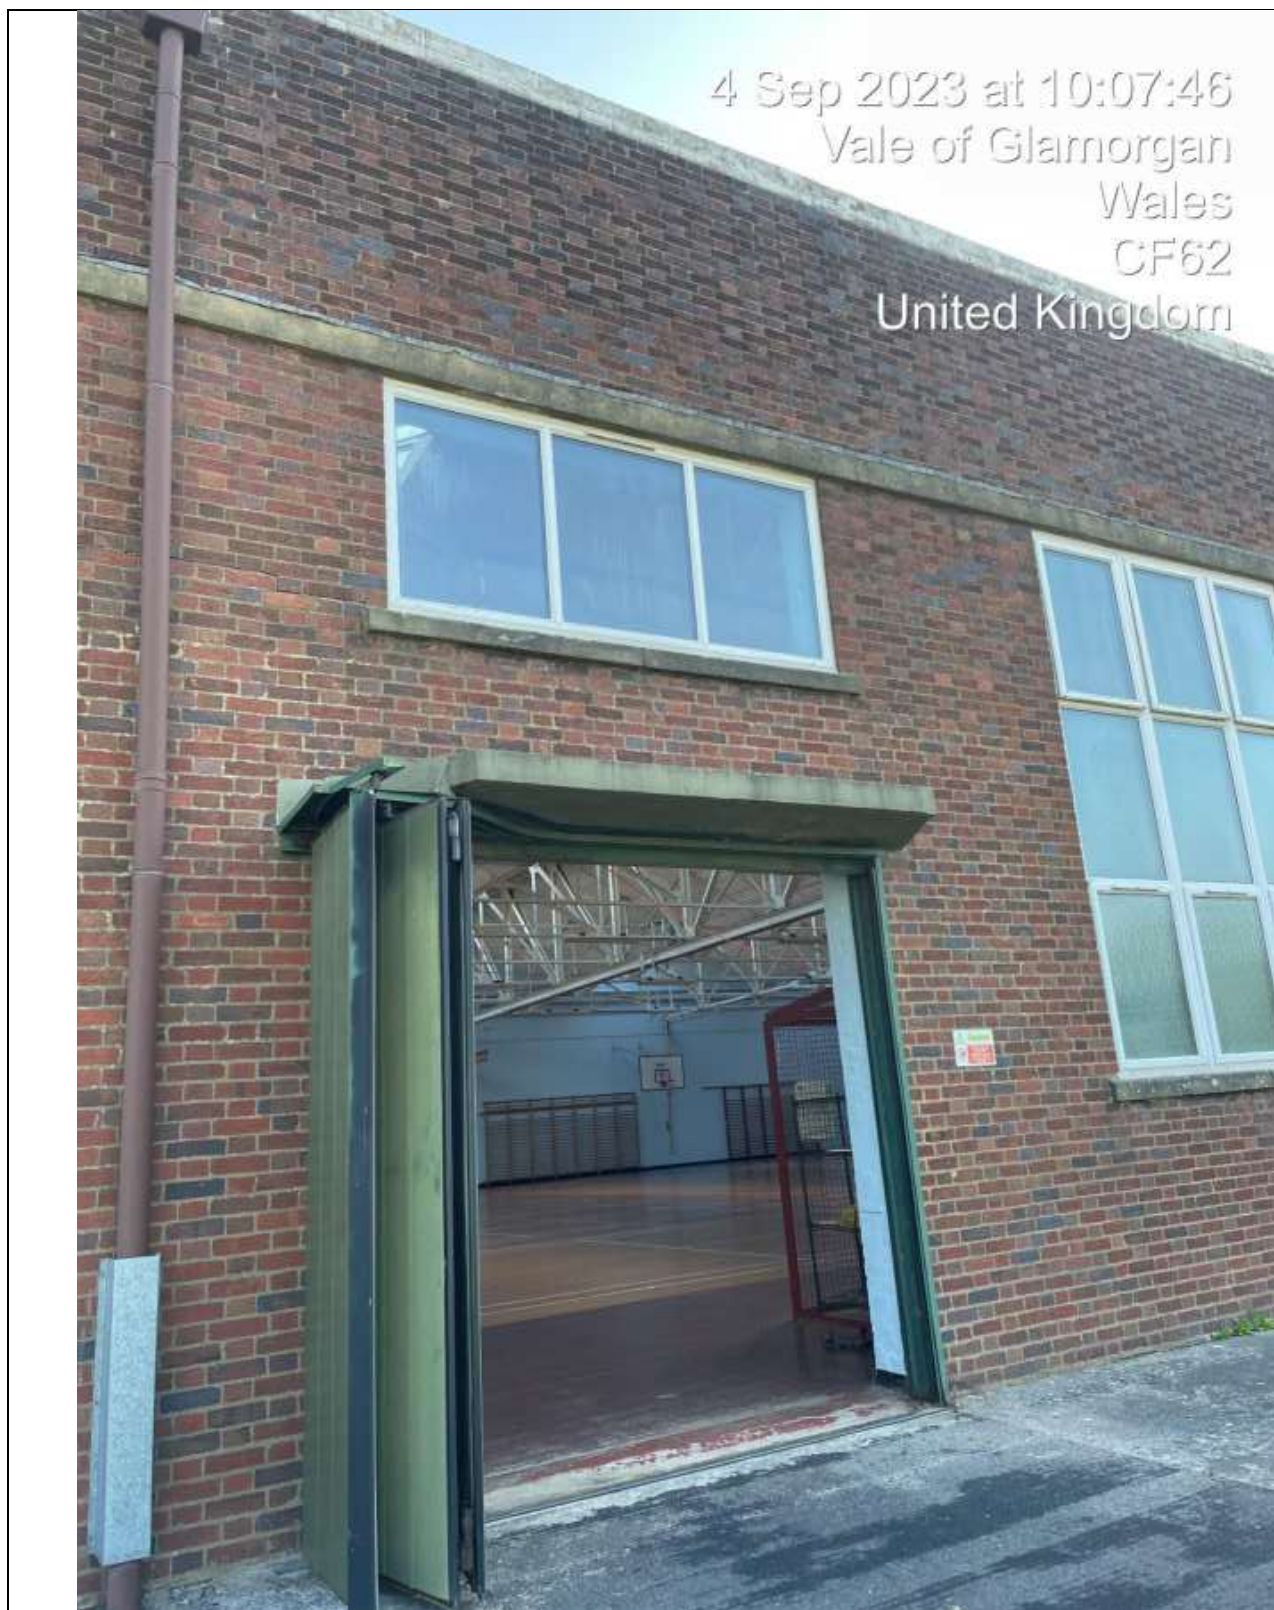
**Western Elevation. Access & Egress Point.**

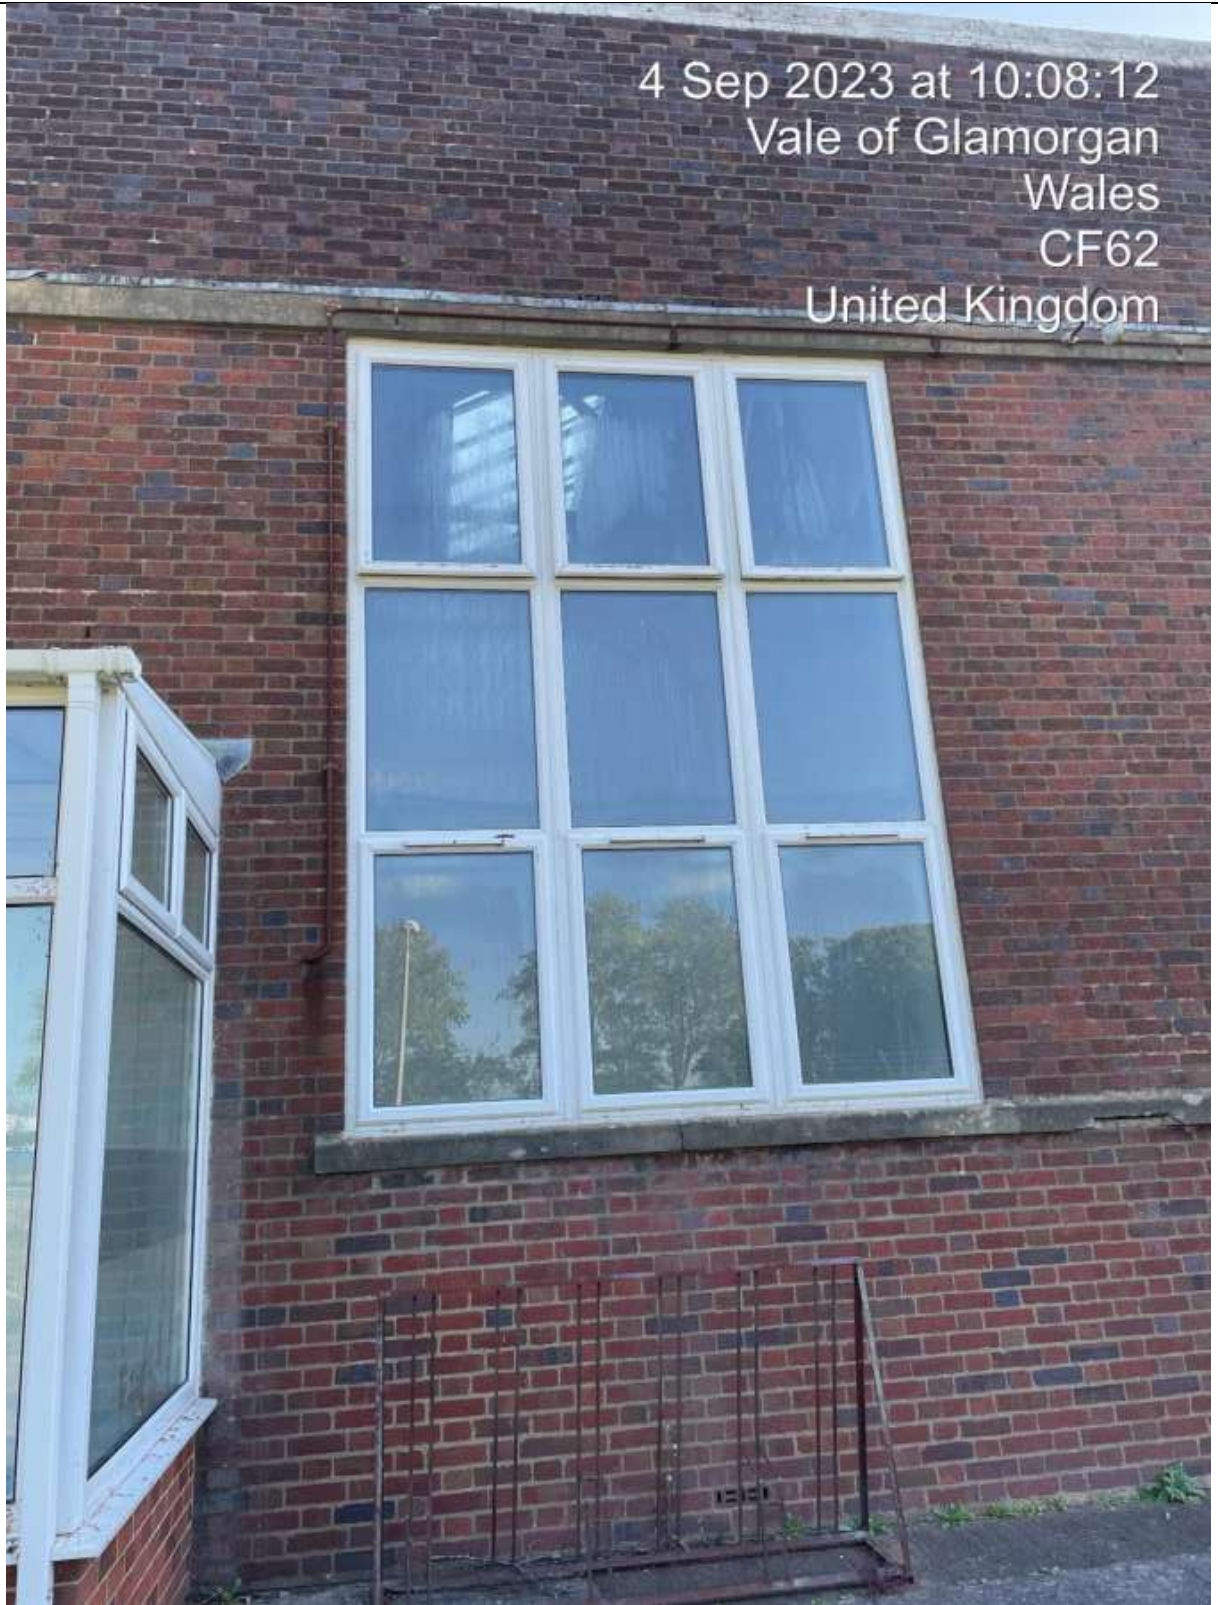
**Western Elevation. Replacement Fenestration.**

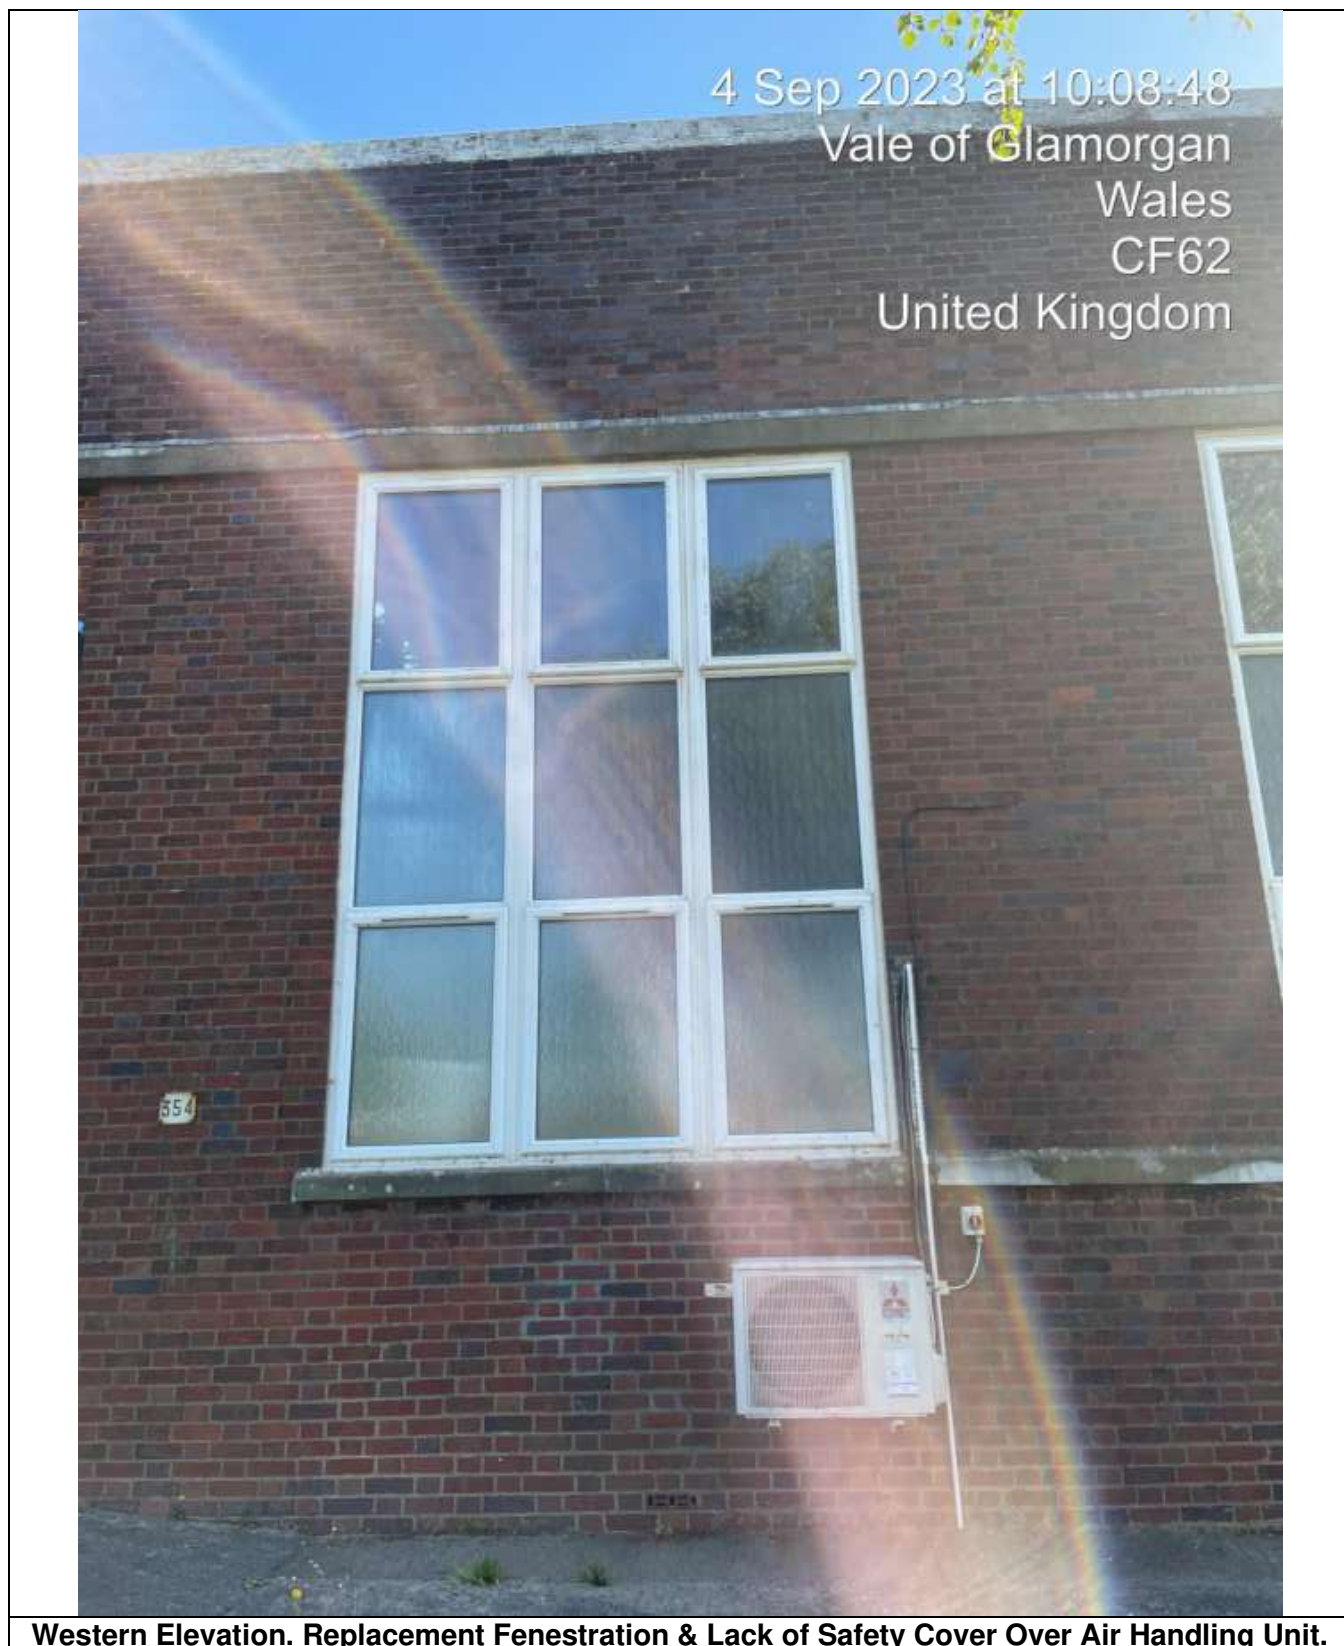
Western Elevation. Replacement Fenestration & Lack of Safety Cover Over Air Handling Unit.

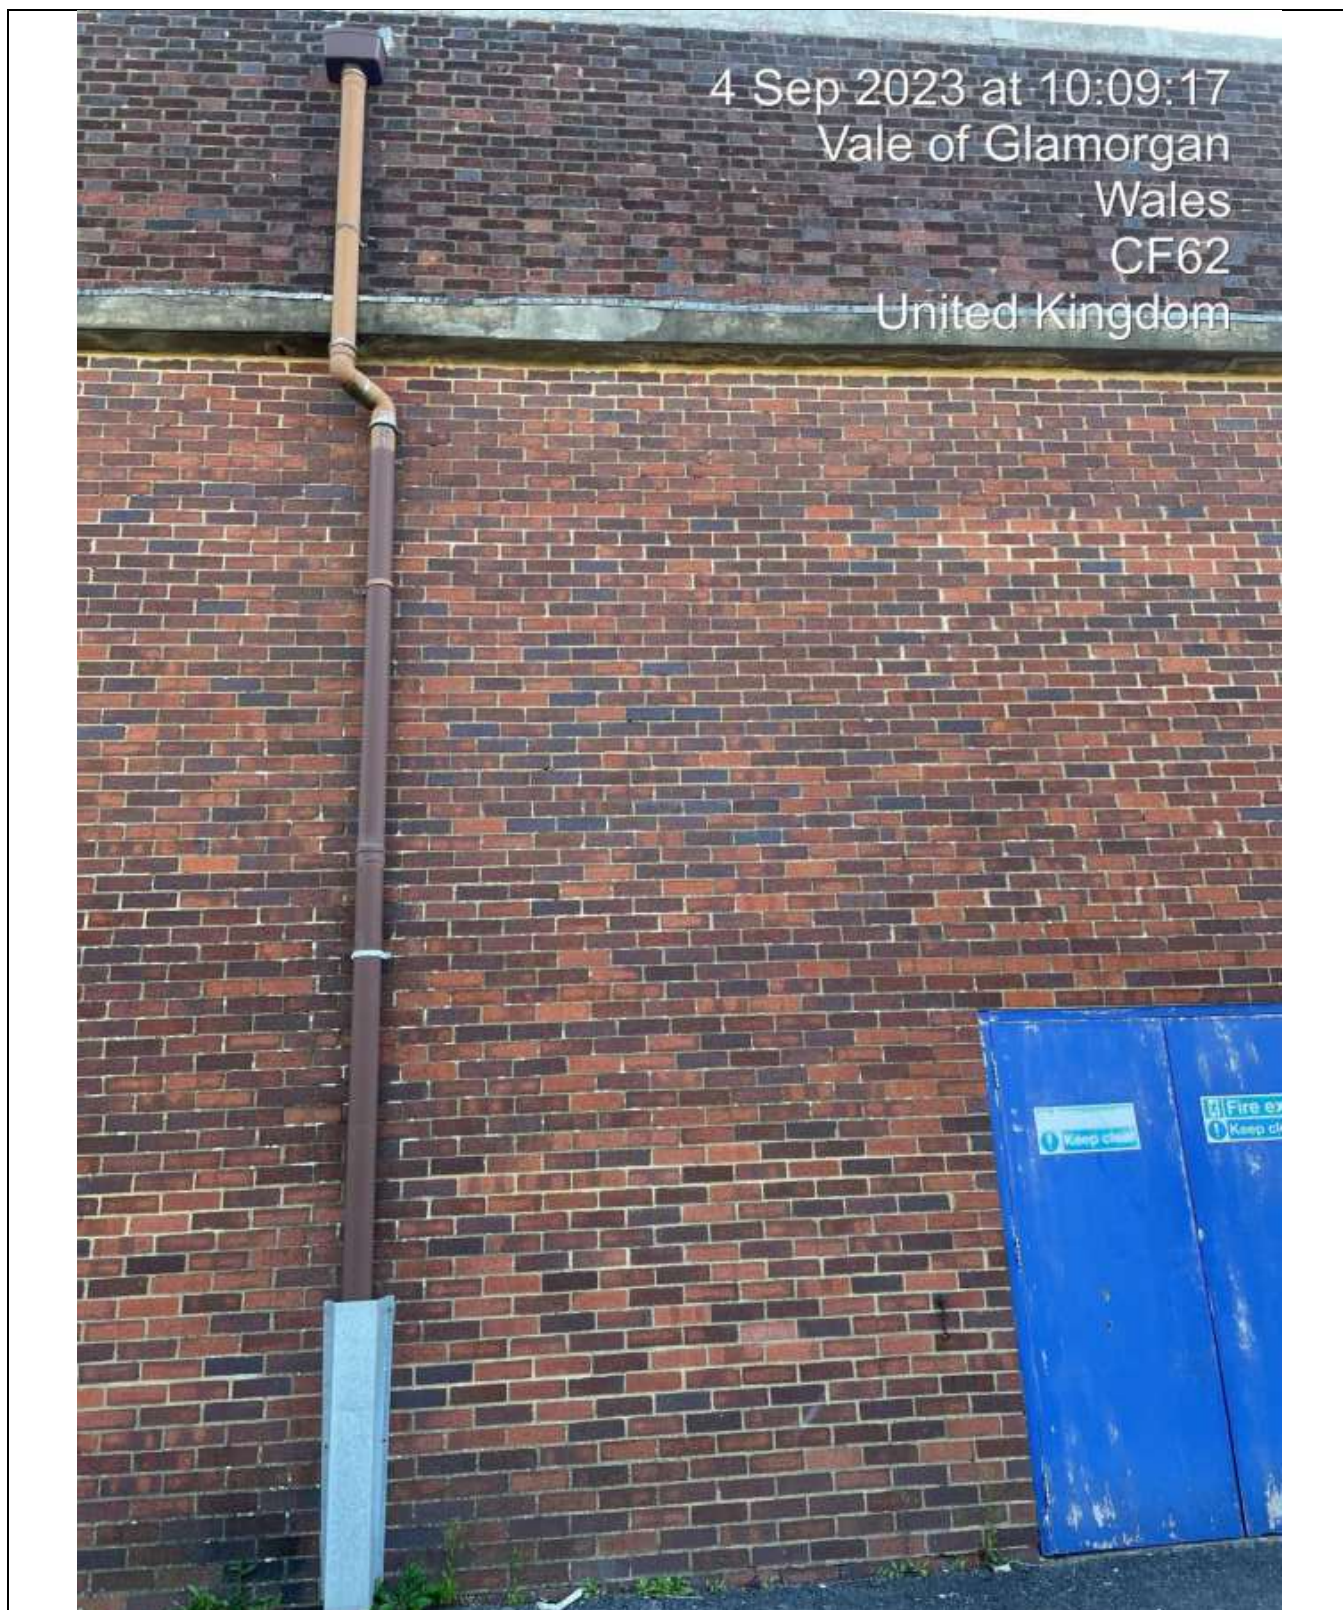
Western Elevation. Downpipe from Hidden Gutter. Deterioration to Doors.
