Bro Tathan East Building 354 External & Internal Visual Condition Survey

| Report Ref: | PR01 | Created | 19/06/24 |

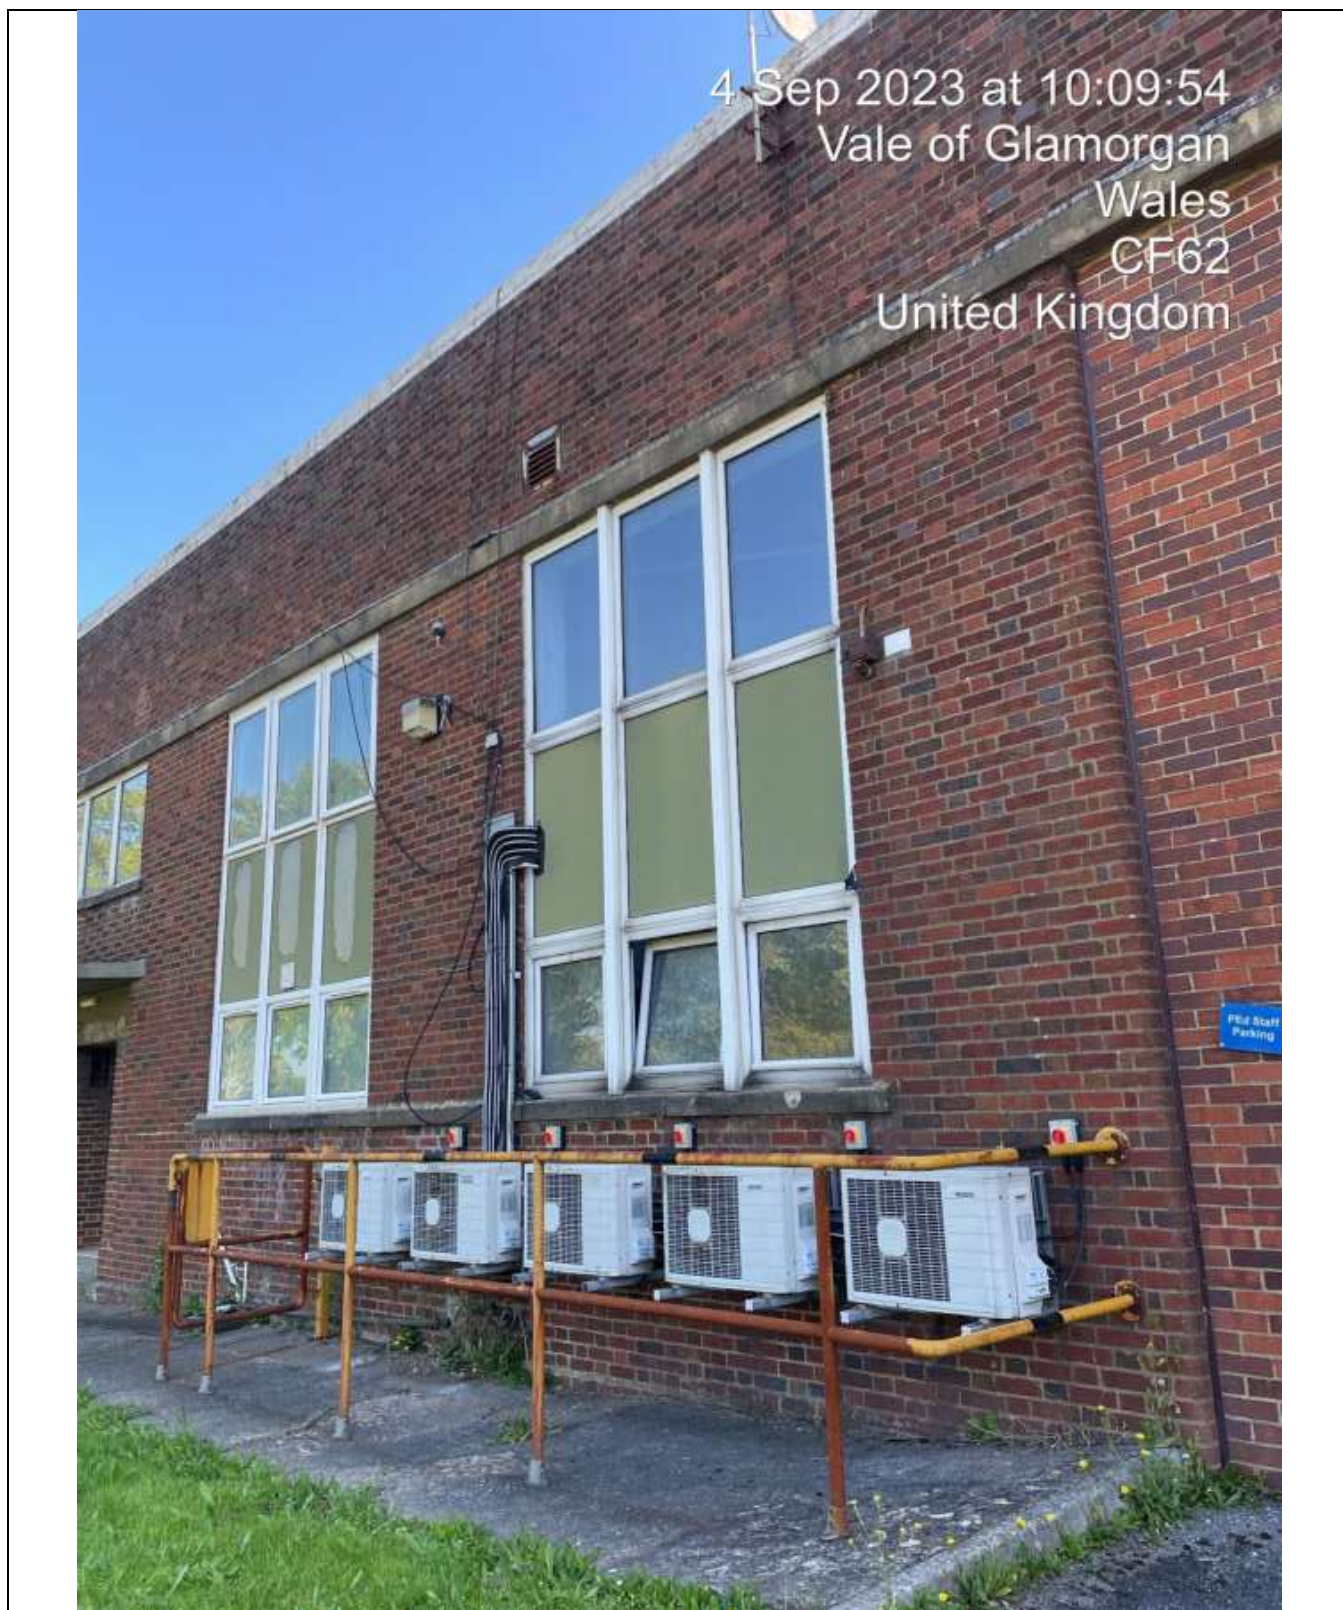
**Western Elevation. Lack of Safety Covers Over Air Handling Units. Unprotected Switch Gear.**

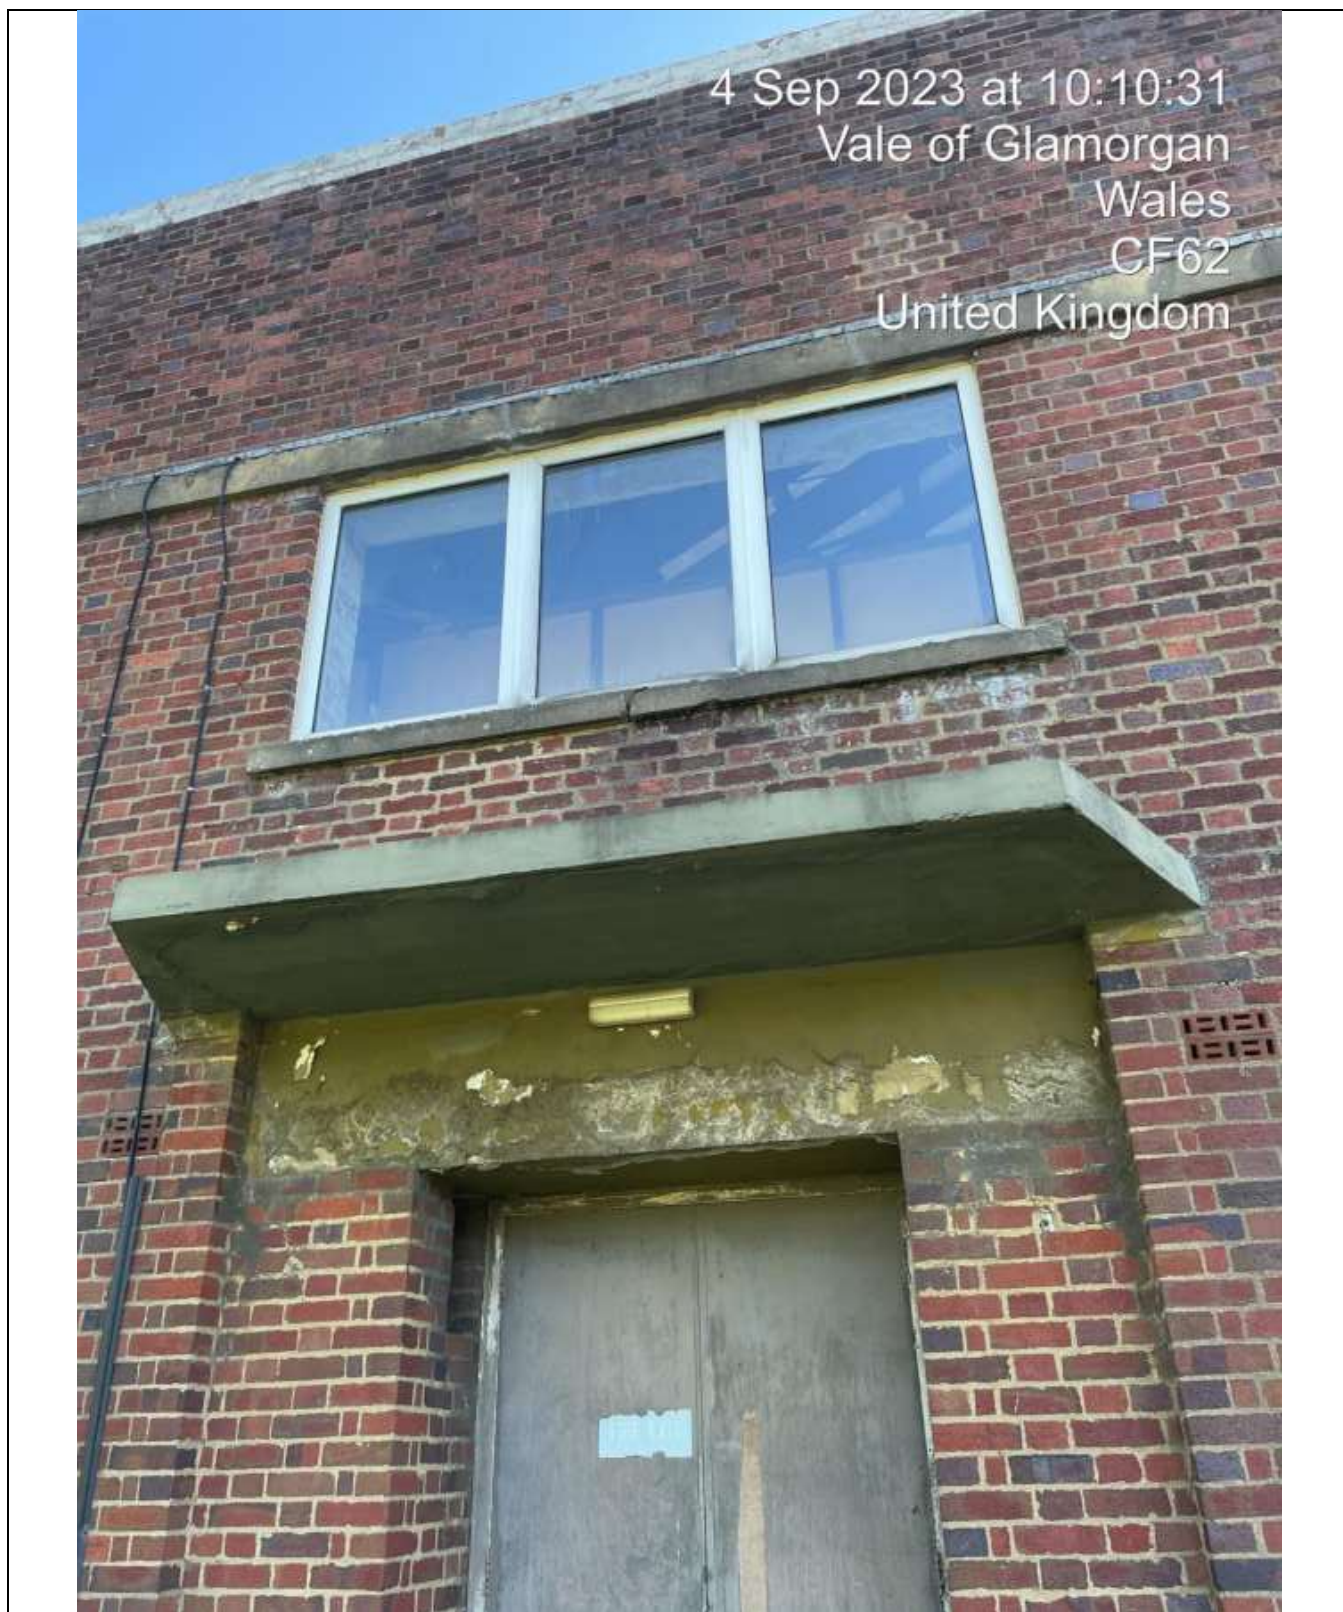
**Western Elevation. Deterioration to Doors. Poor Patching Repair to Concrete Lintel Over.**

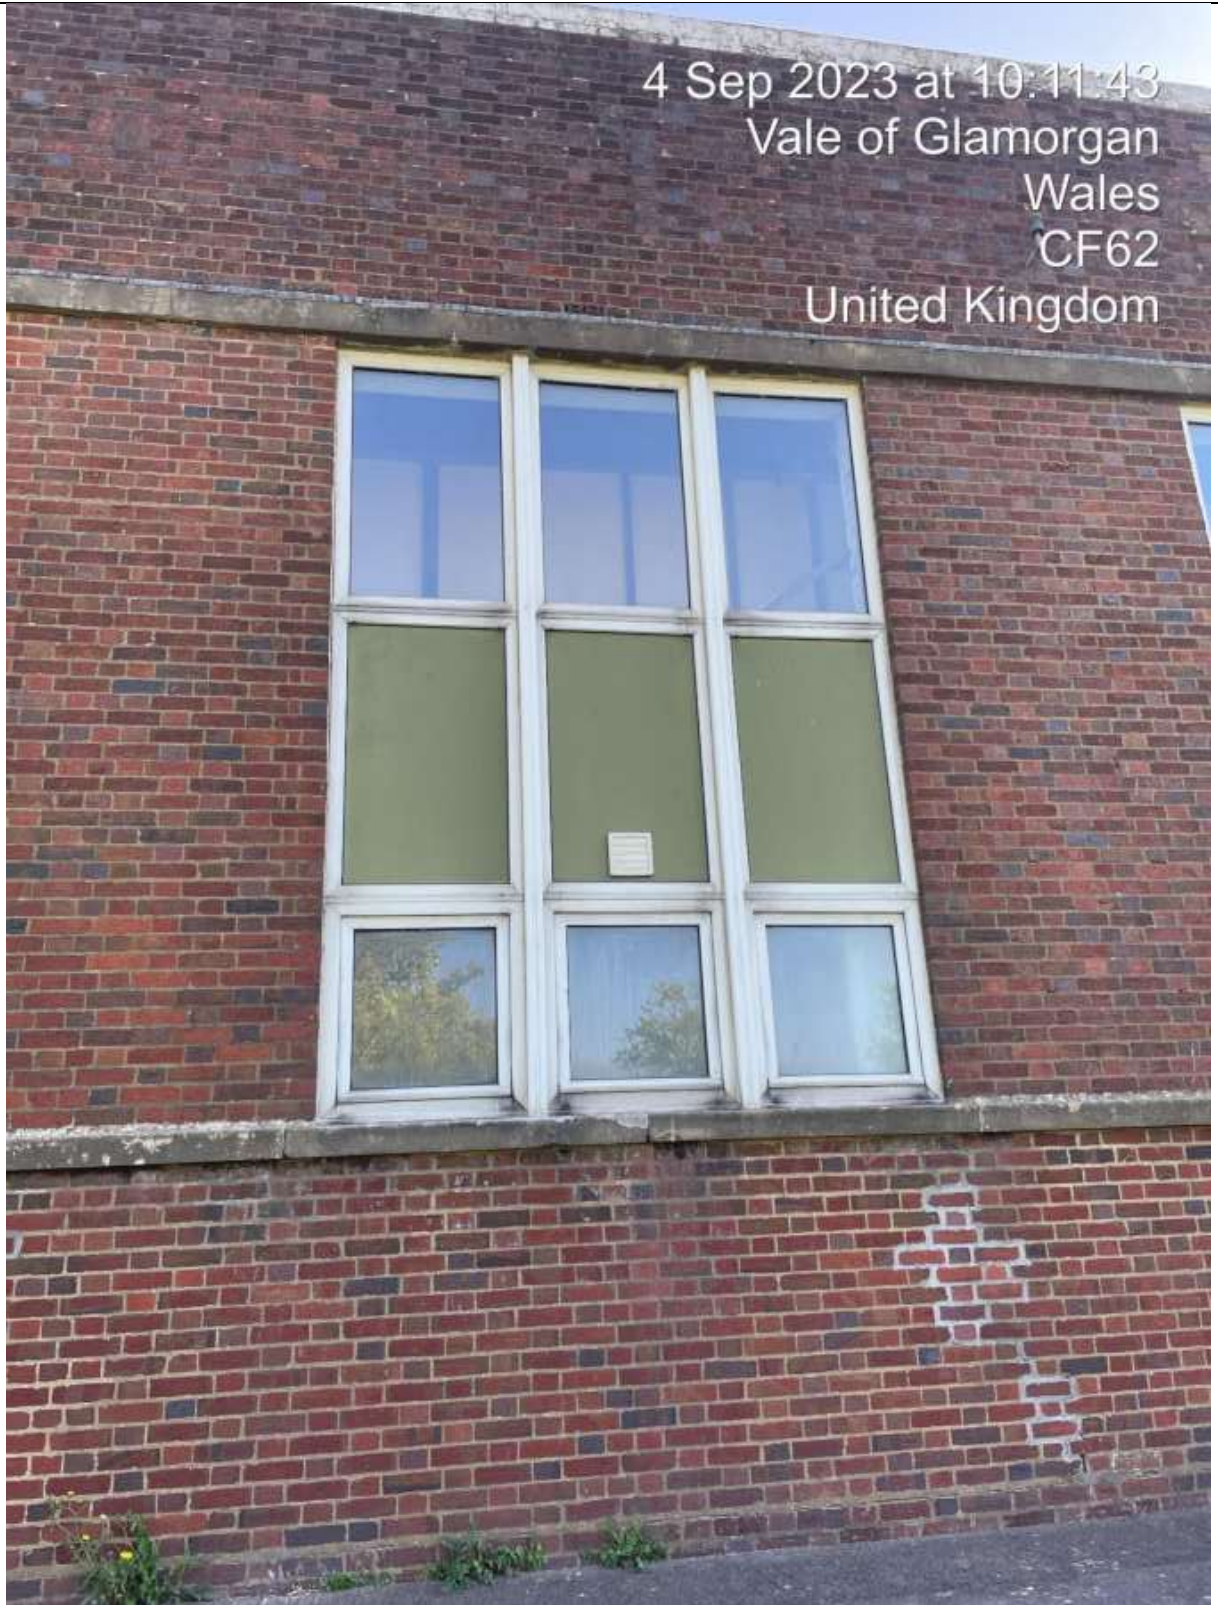
**Western Elevation. Replacement Fenestration.**

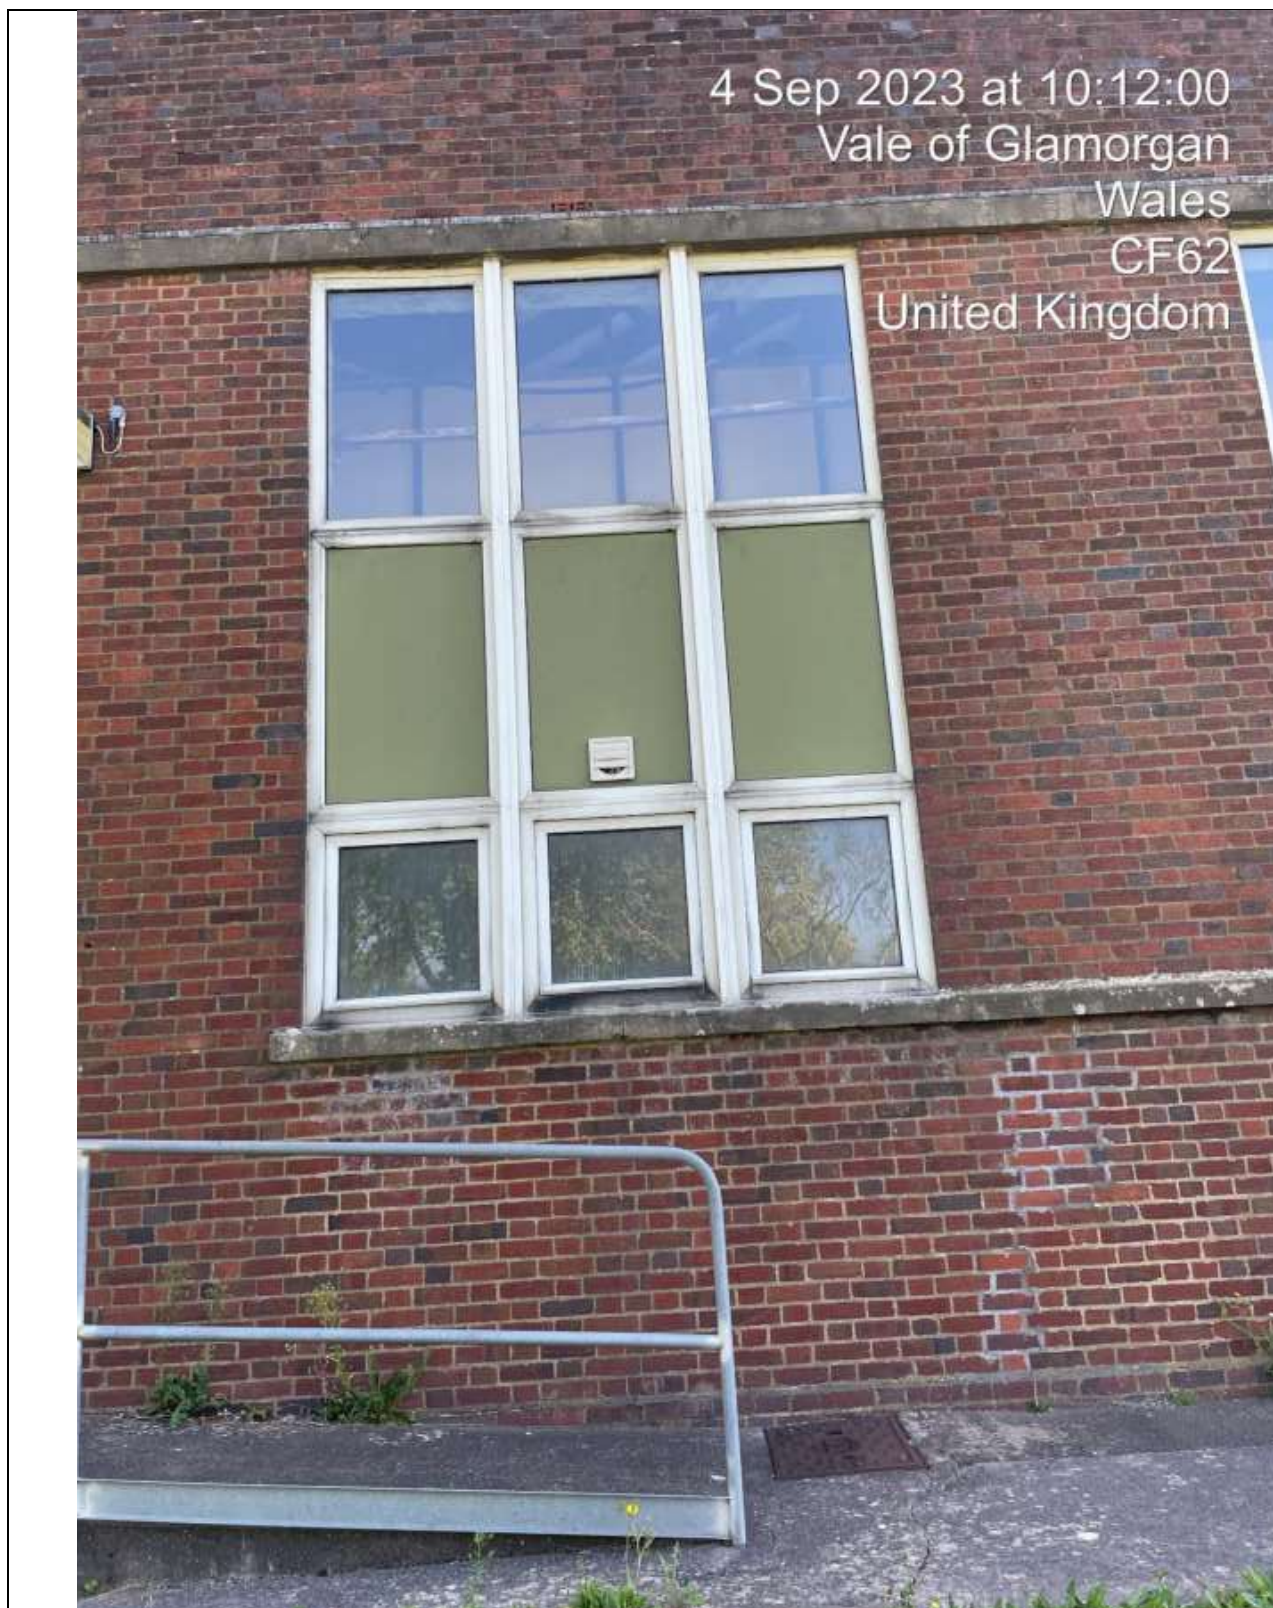
**Western Elevation. Replacement Fenestration.**

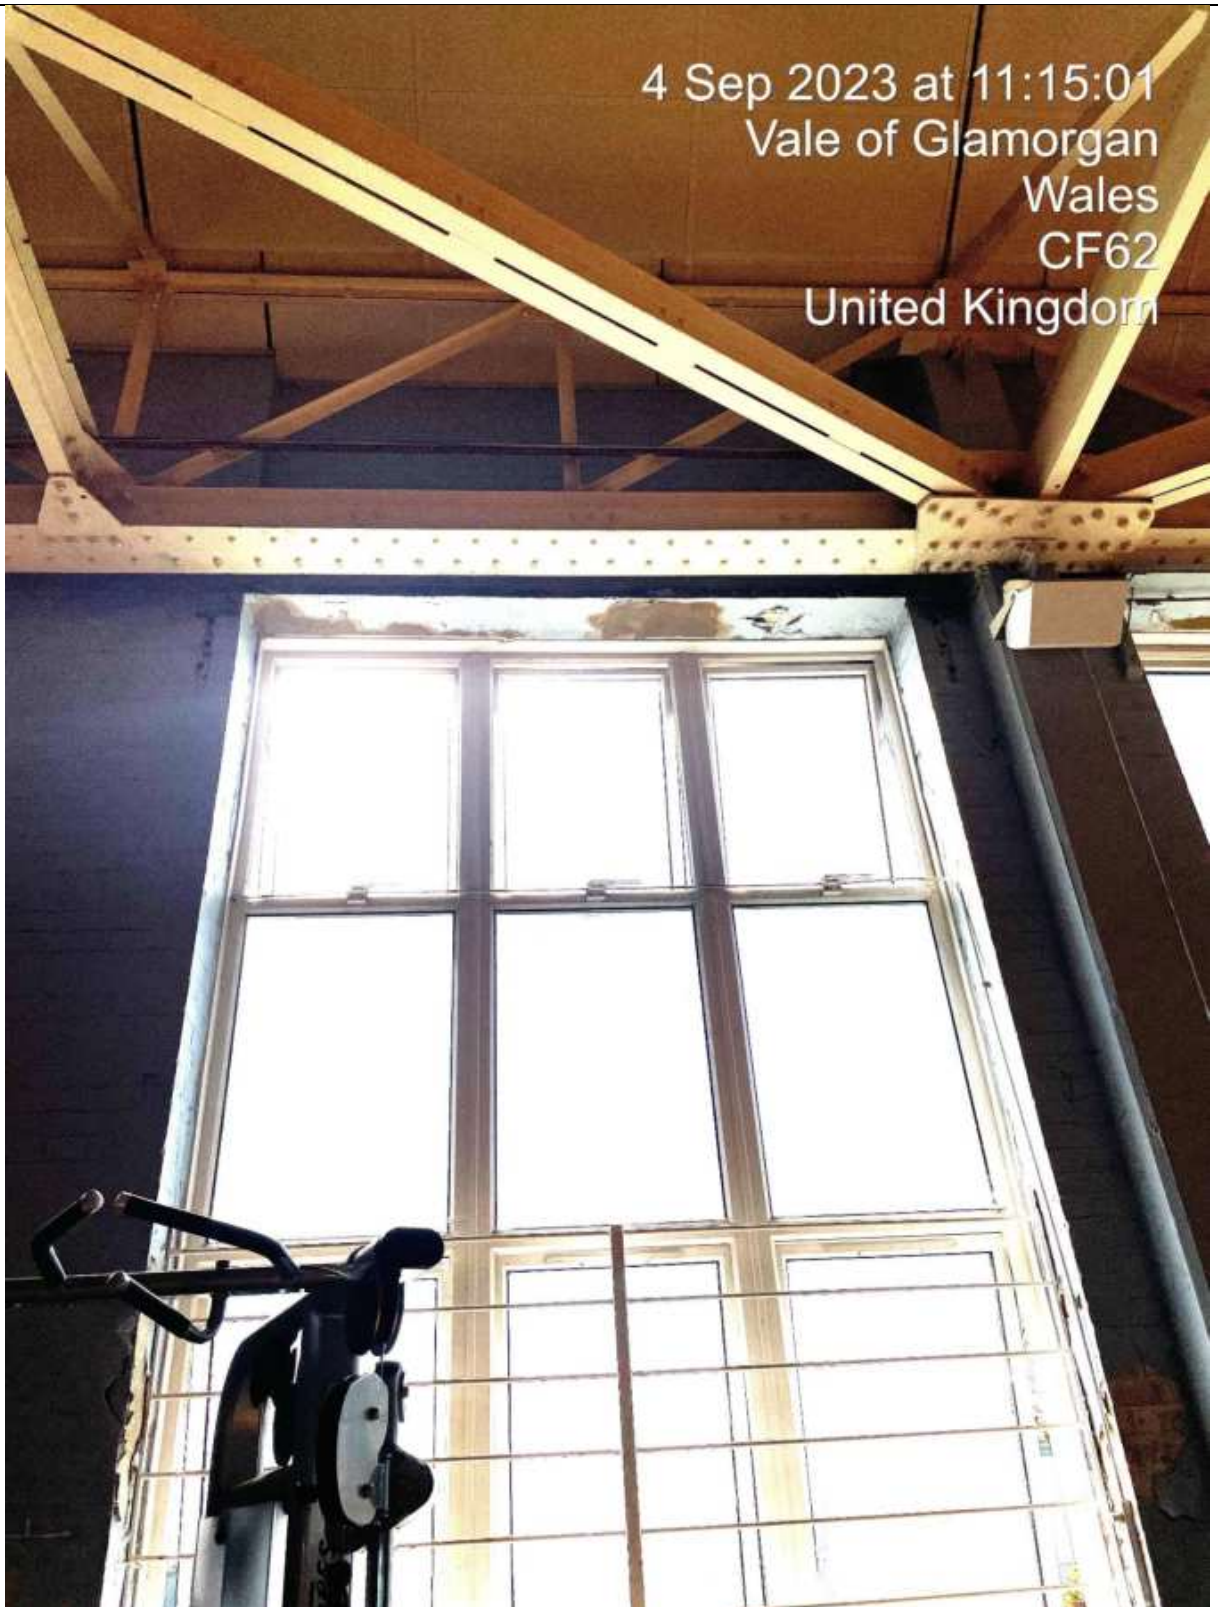
**Penetrating Damp.**

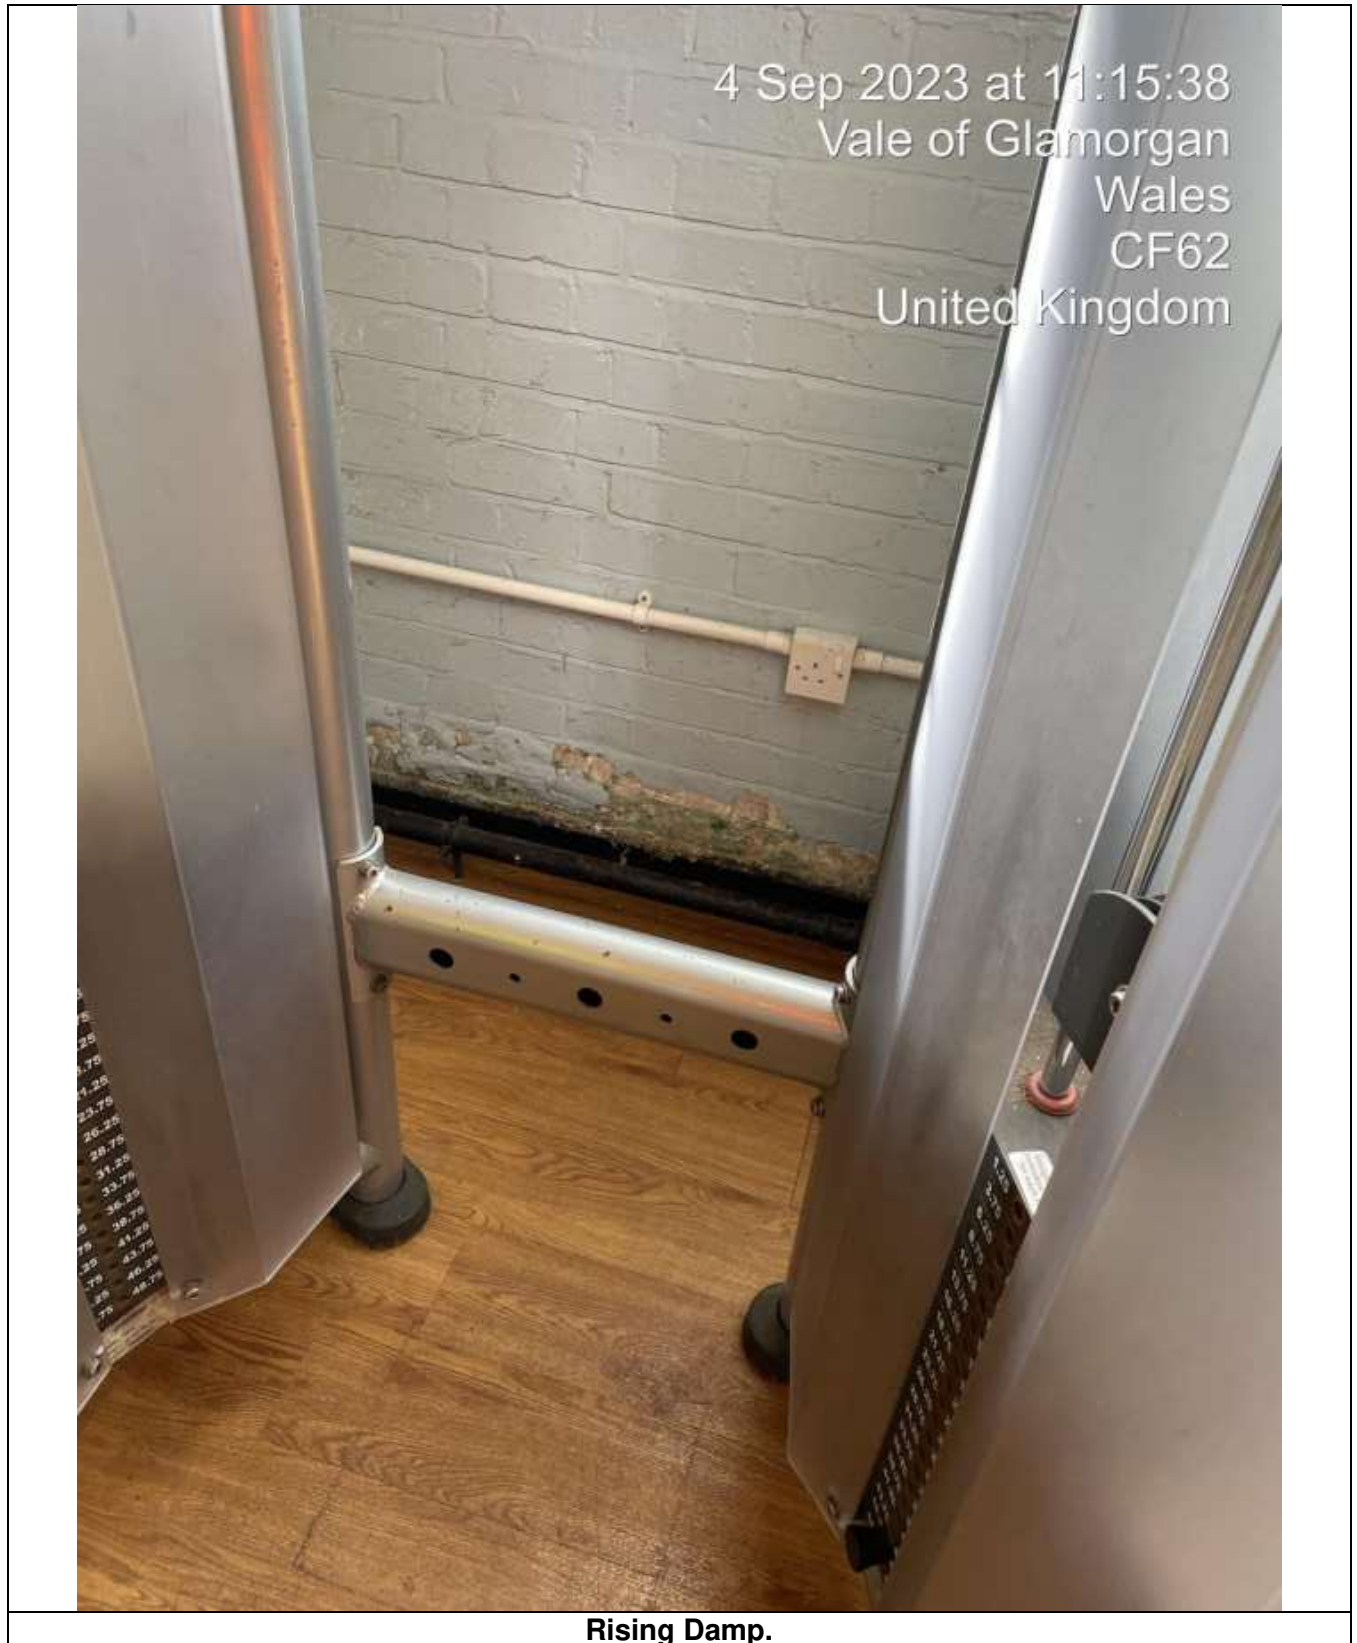
**Rising Damp.**

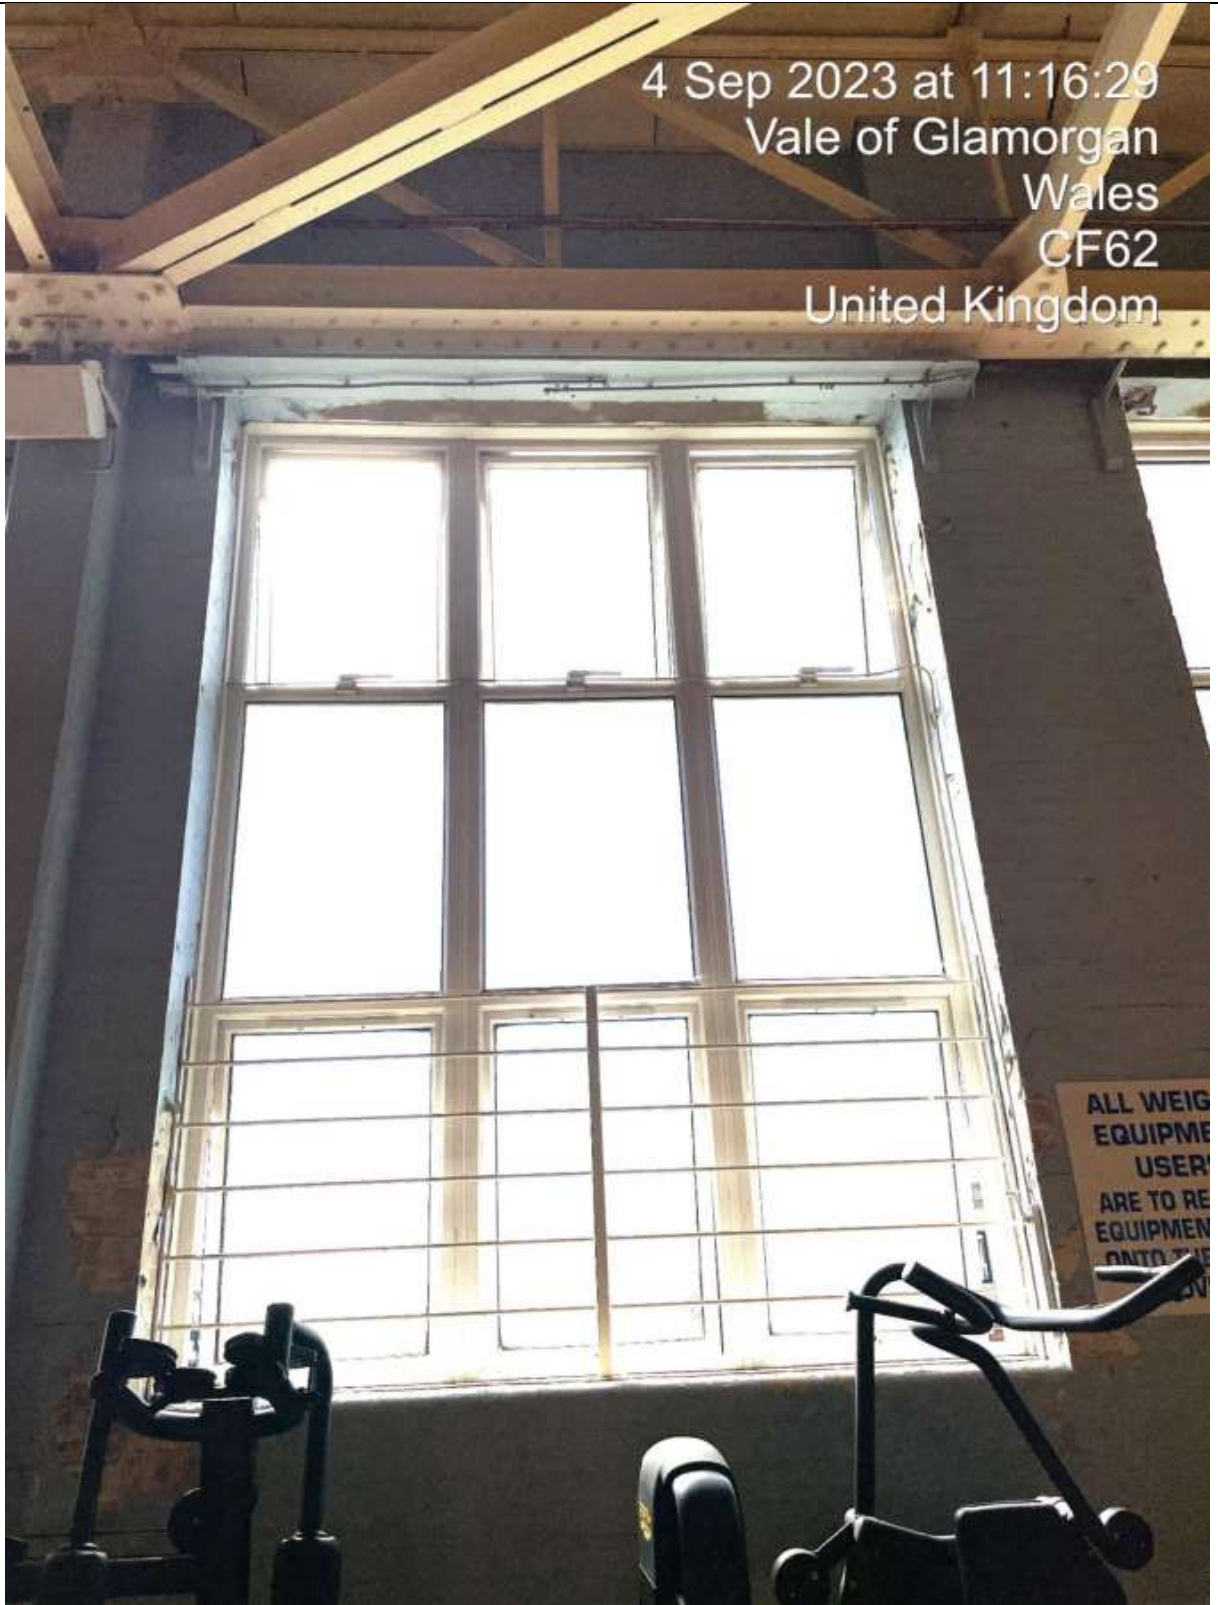
**Penetrating Damp.**

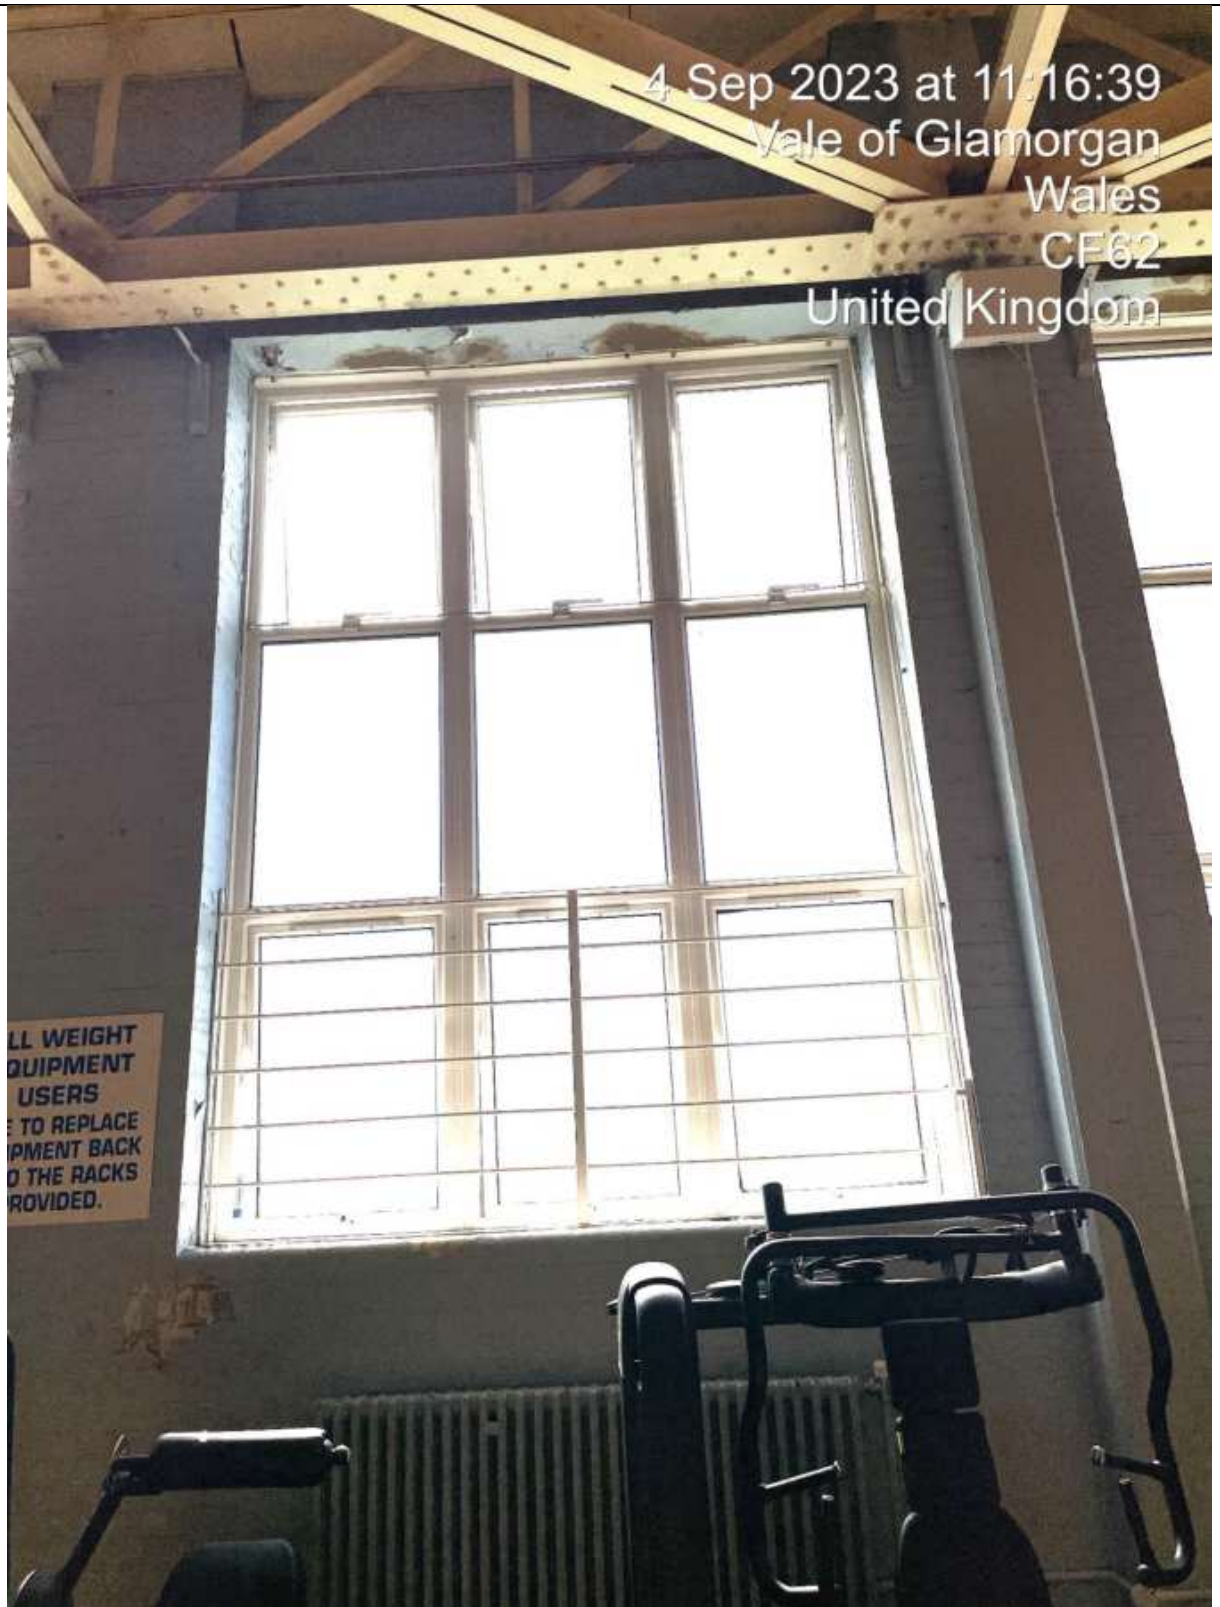
**Penetrating Damp.**

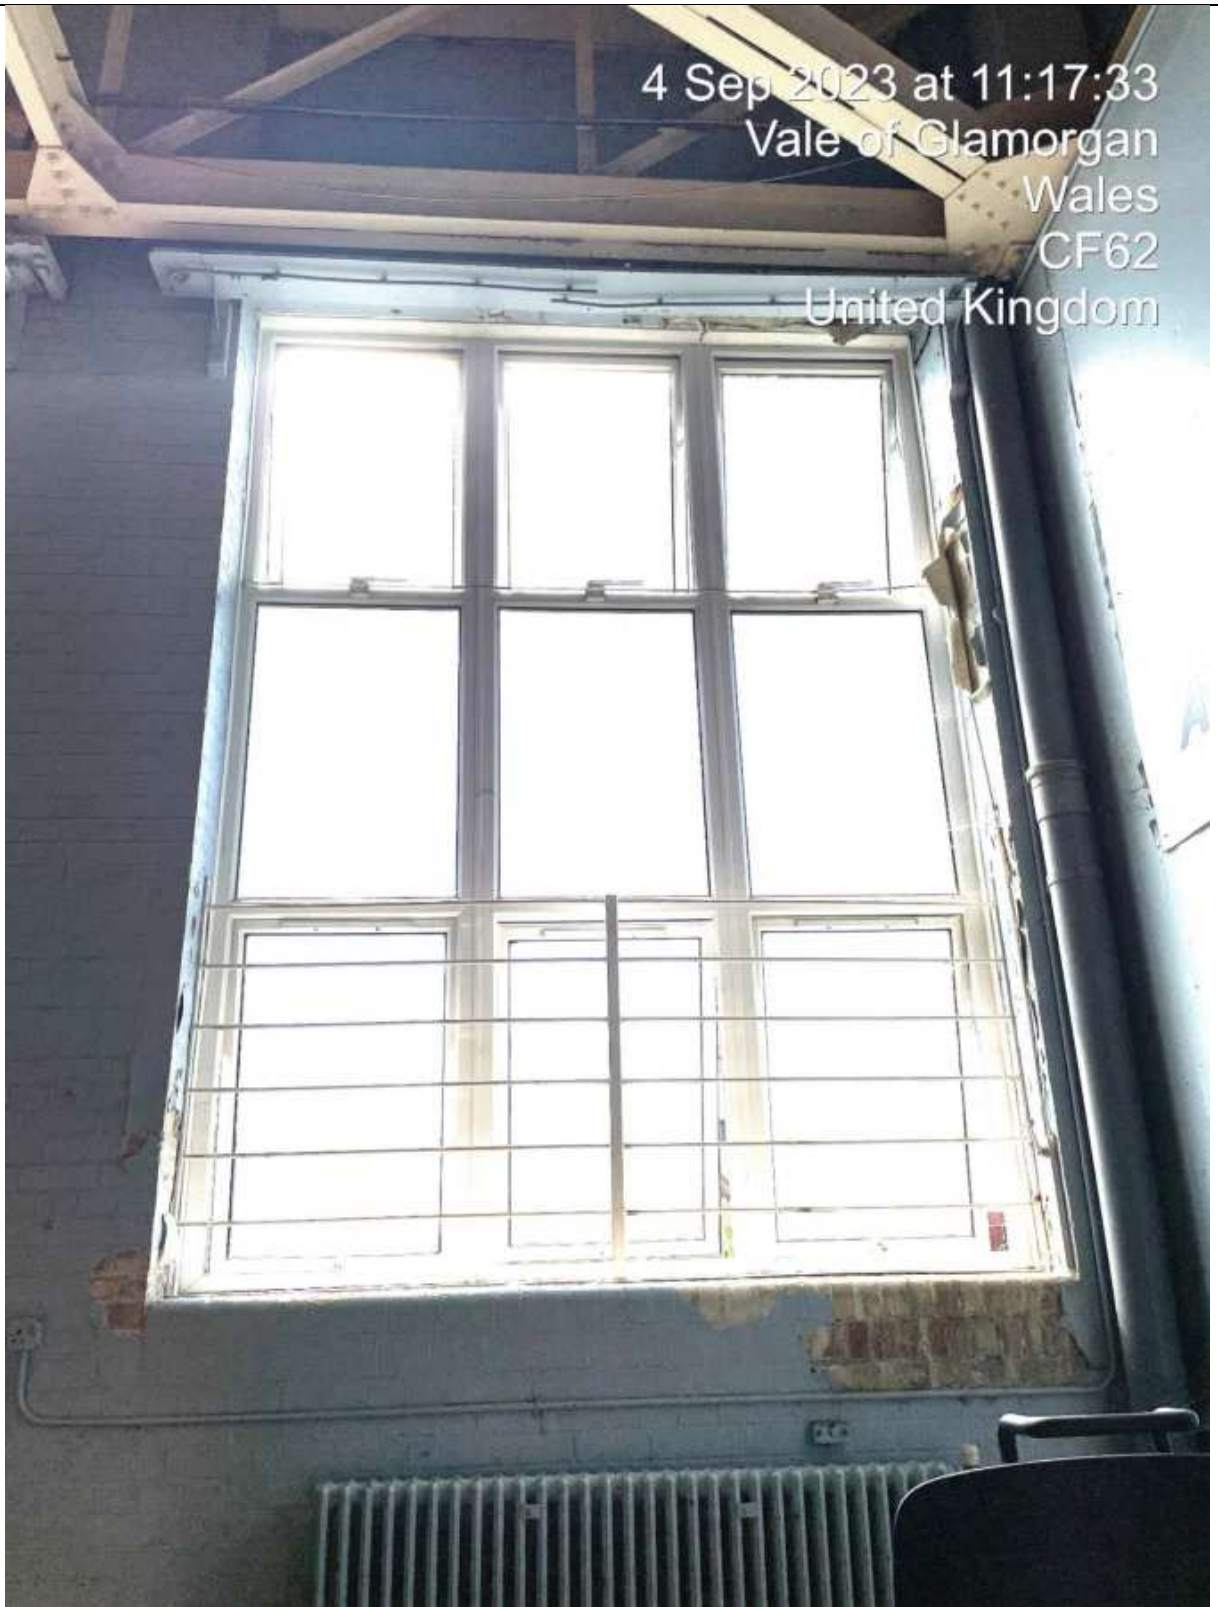
**Penetrating Damp.**

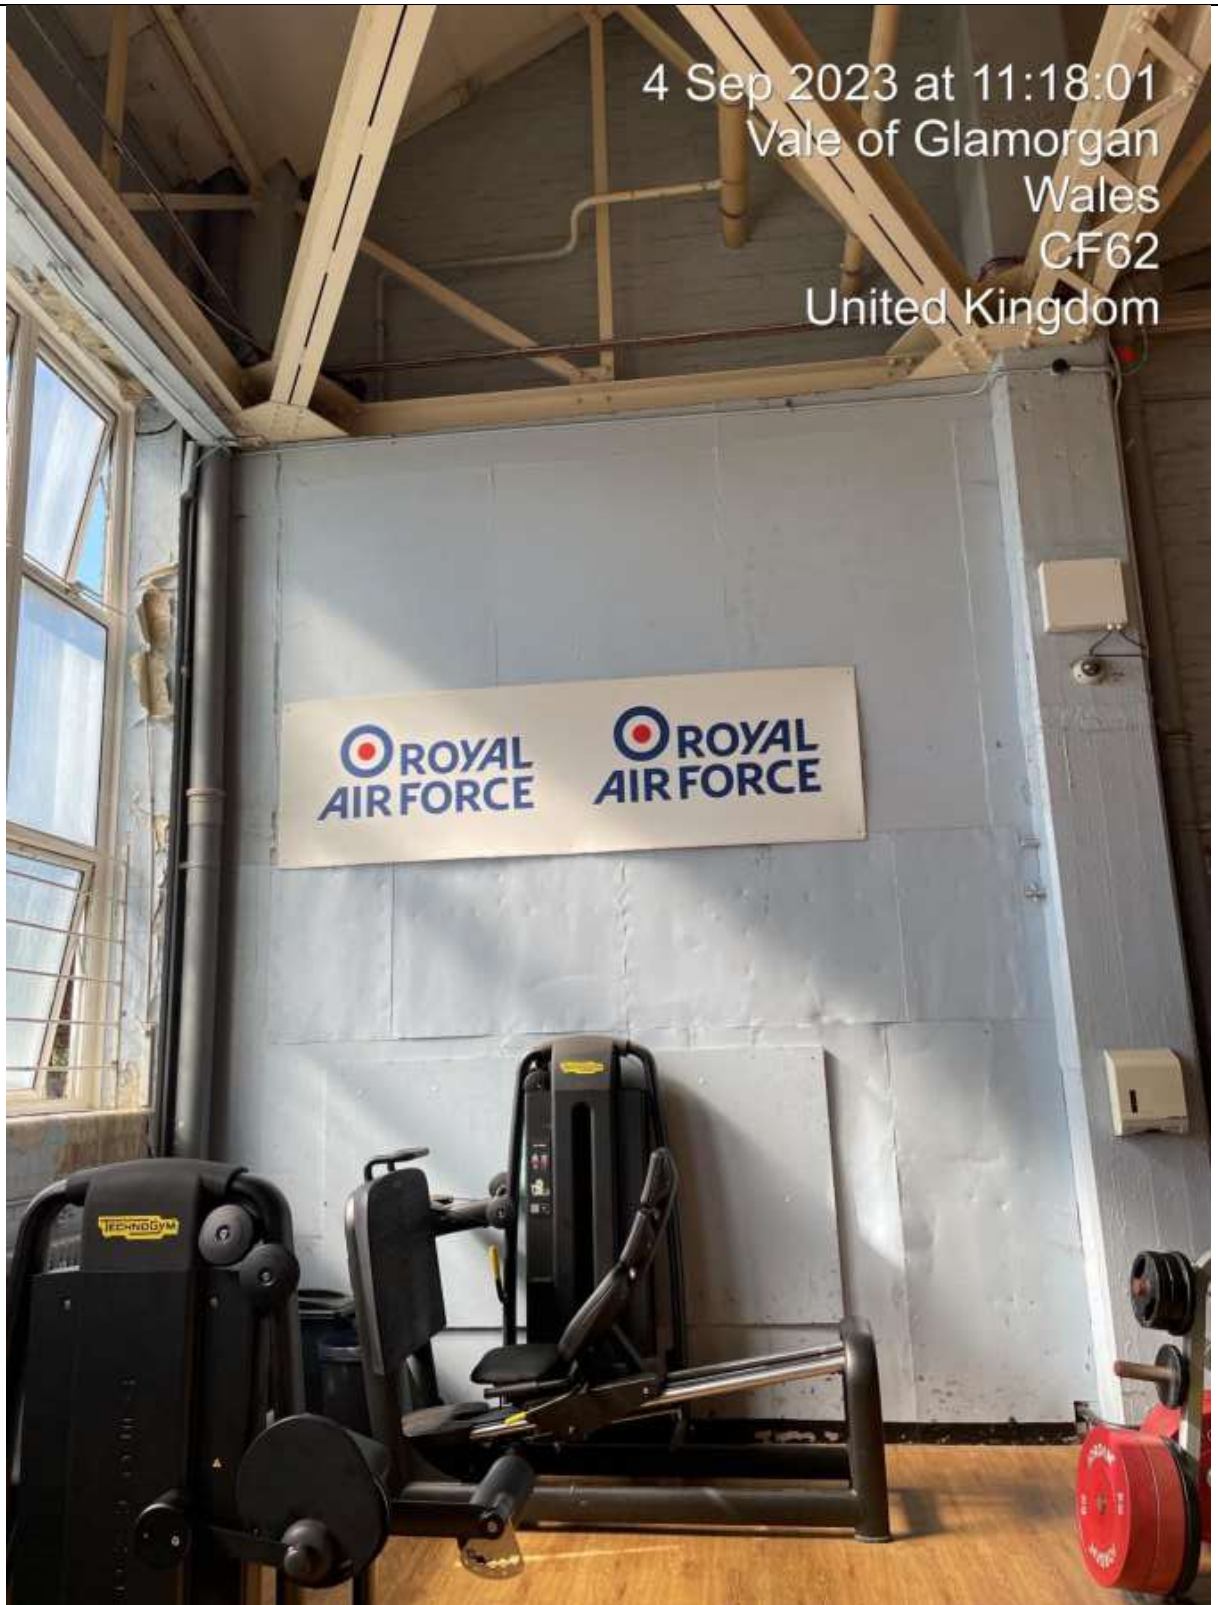
**Penetrating Damp & Wall Panelling that is suspected of having Asbestos Content of which the Condition is Considered Poor.**

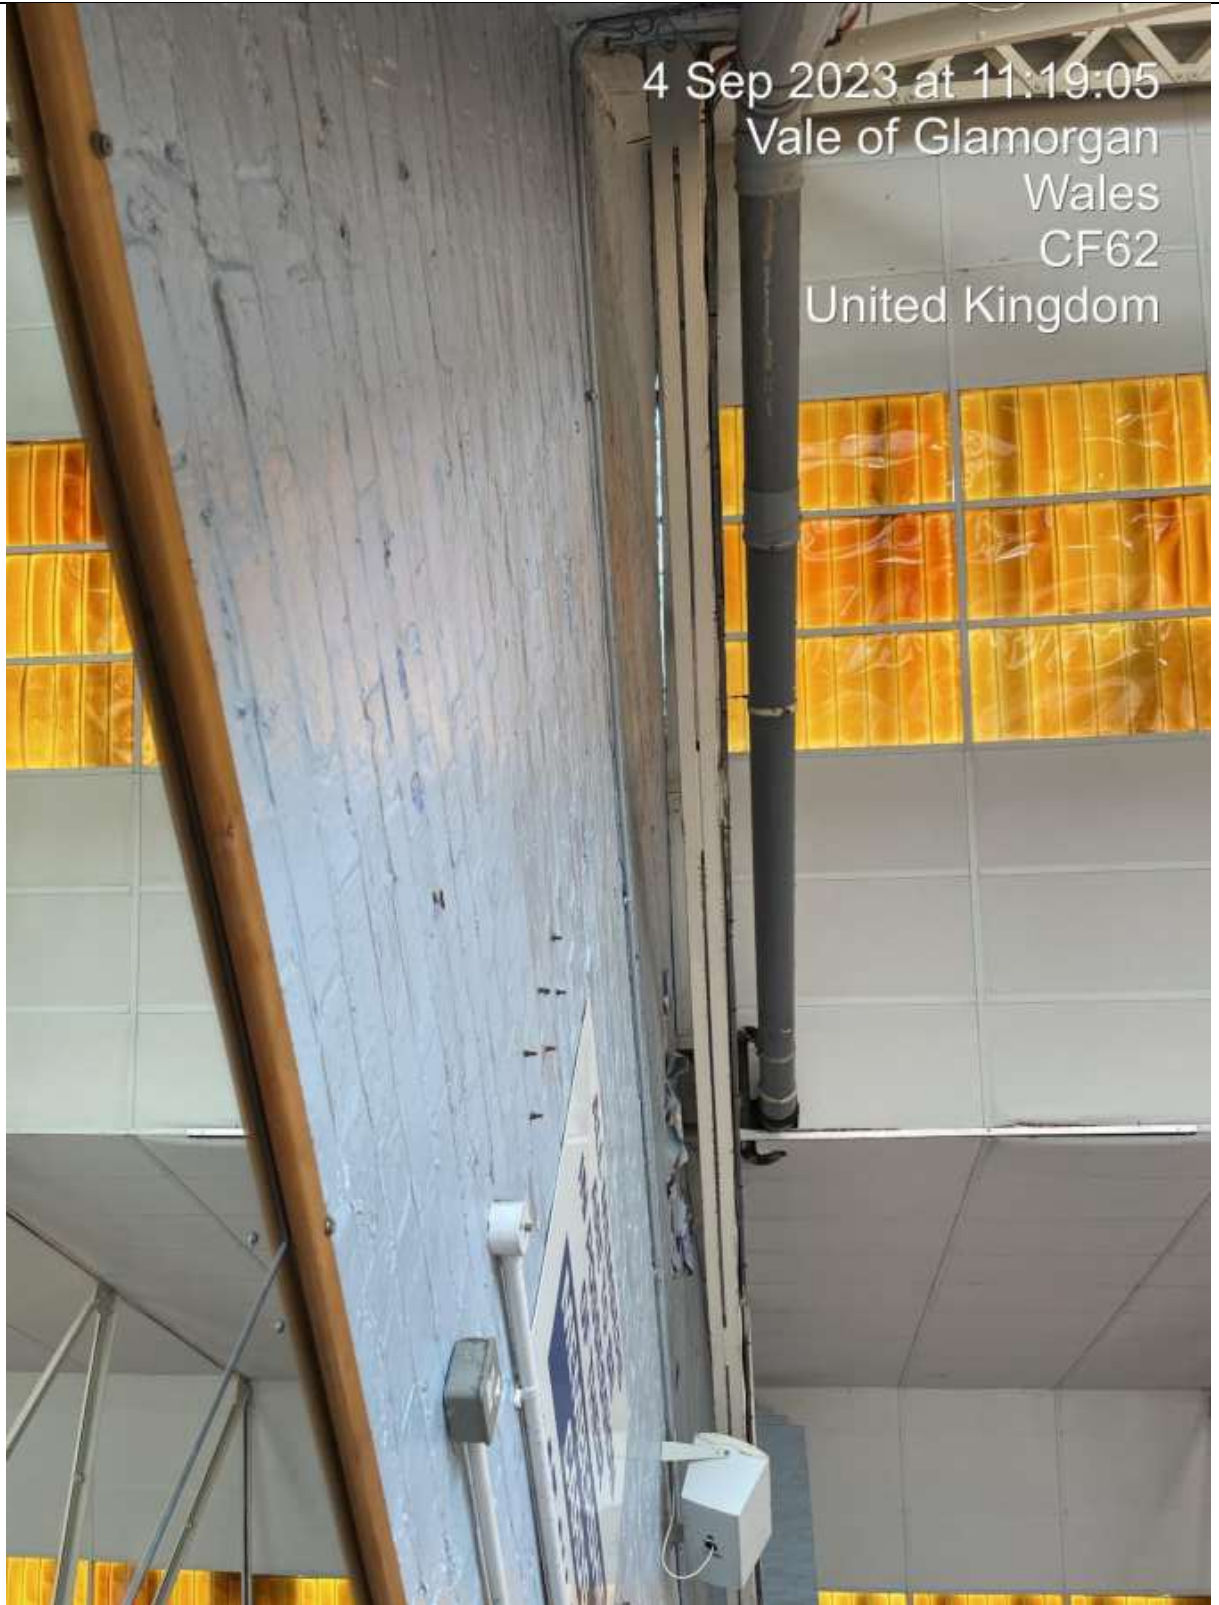
**Discoloration to Roof Lights.**
