Bro Tathan East Building 354 External & Internal Visual Condition Survey

| Report Ref: | PR01 | Created | 19/06/24 |

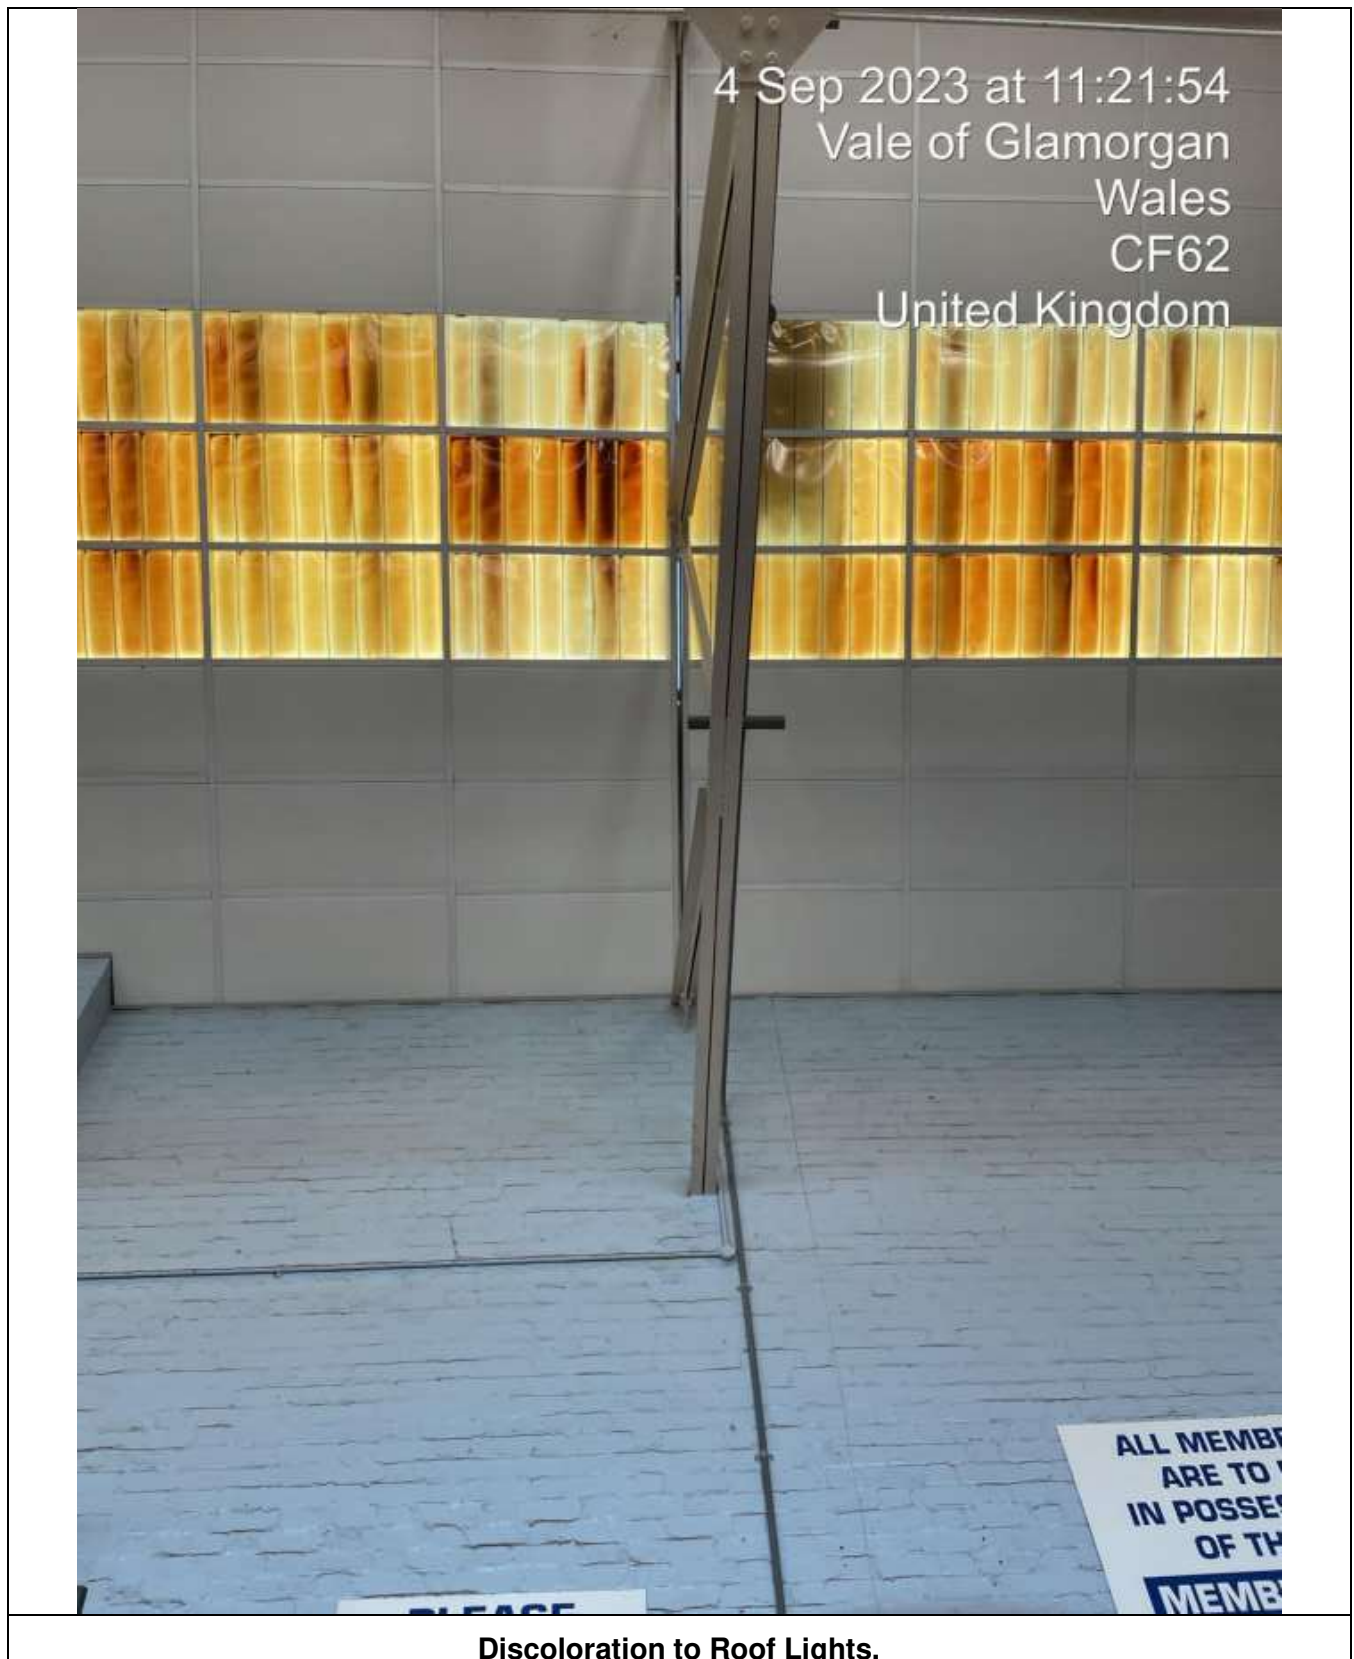
Discoloration to Roof Lights.

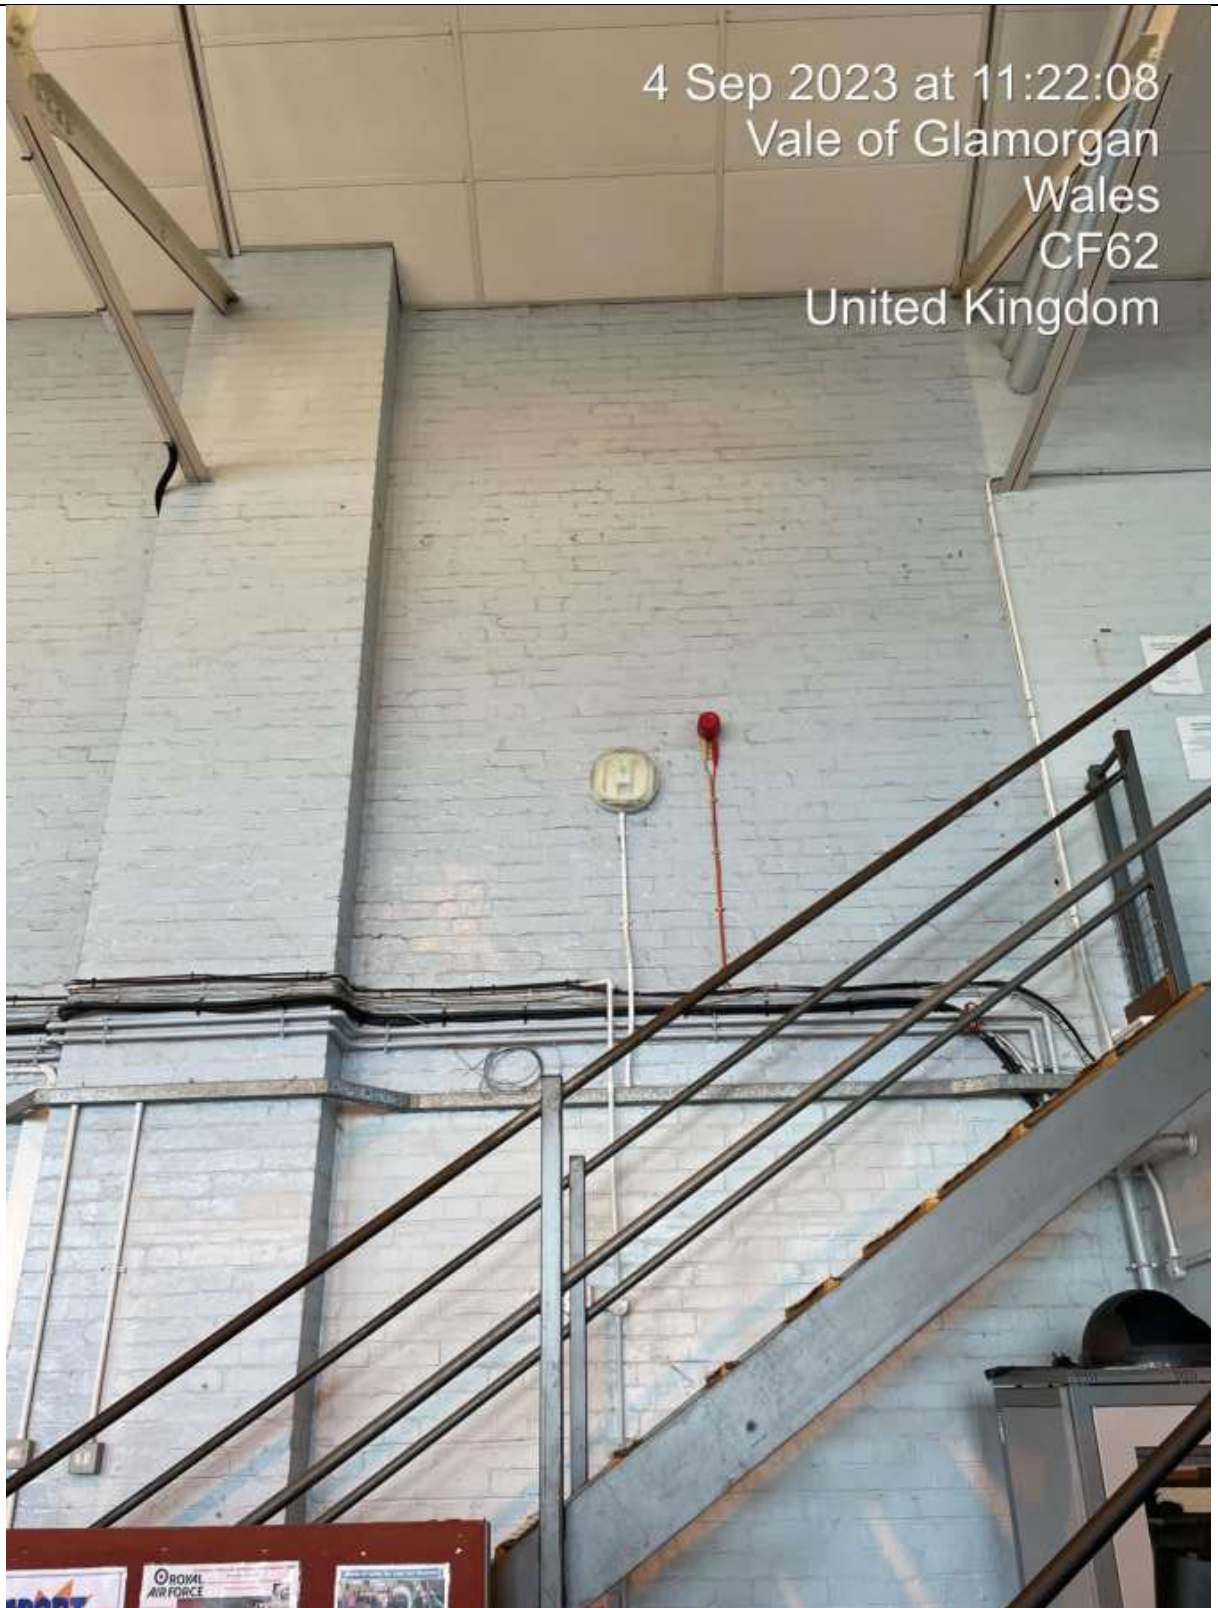
**Penetrating Damp & Unprotected Cable Installations.**

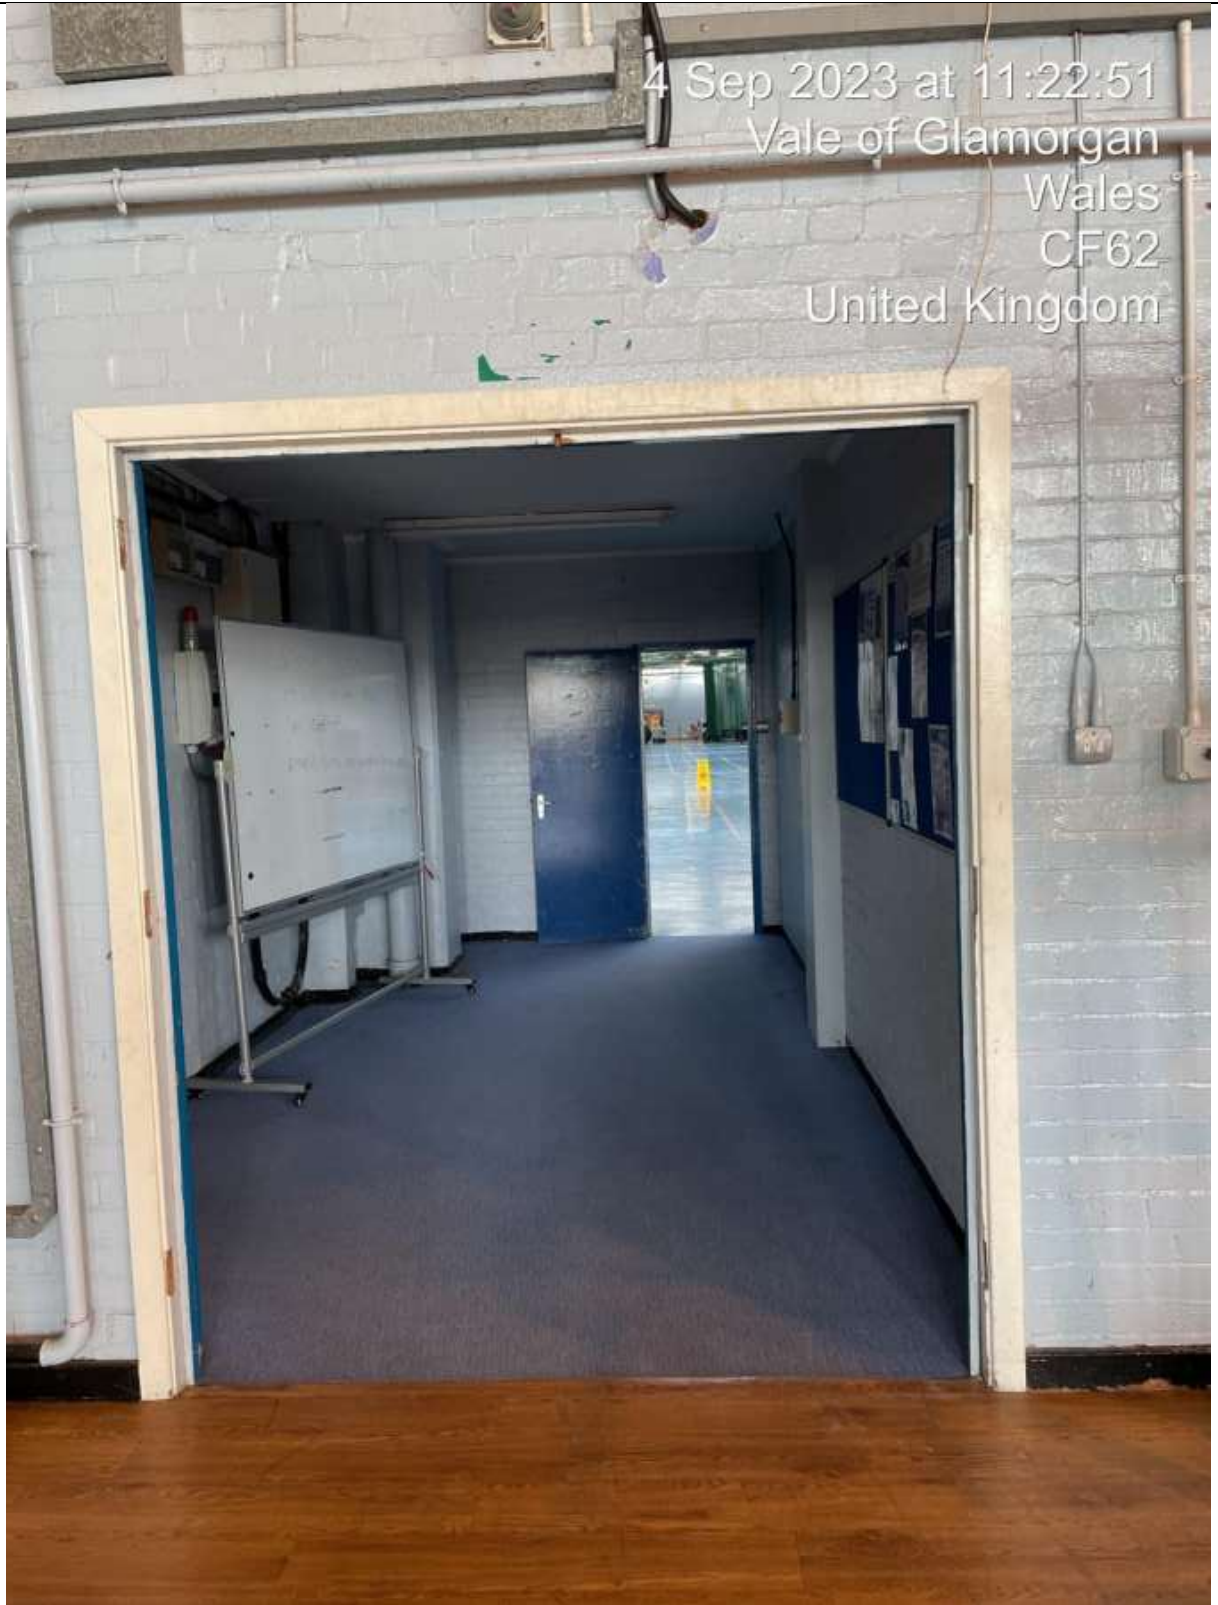
**Non-Compliant Fire Compartmentation.**

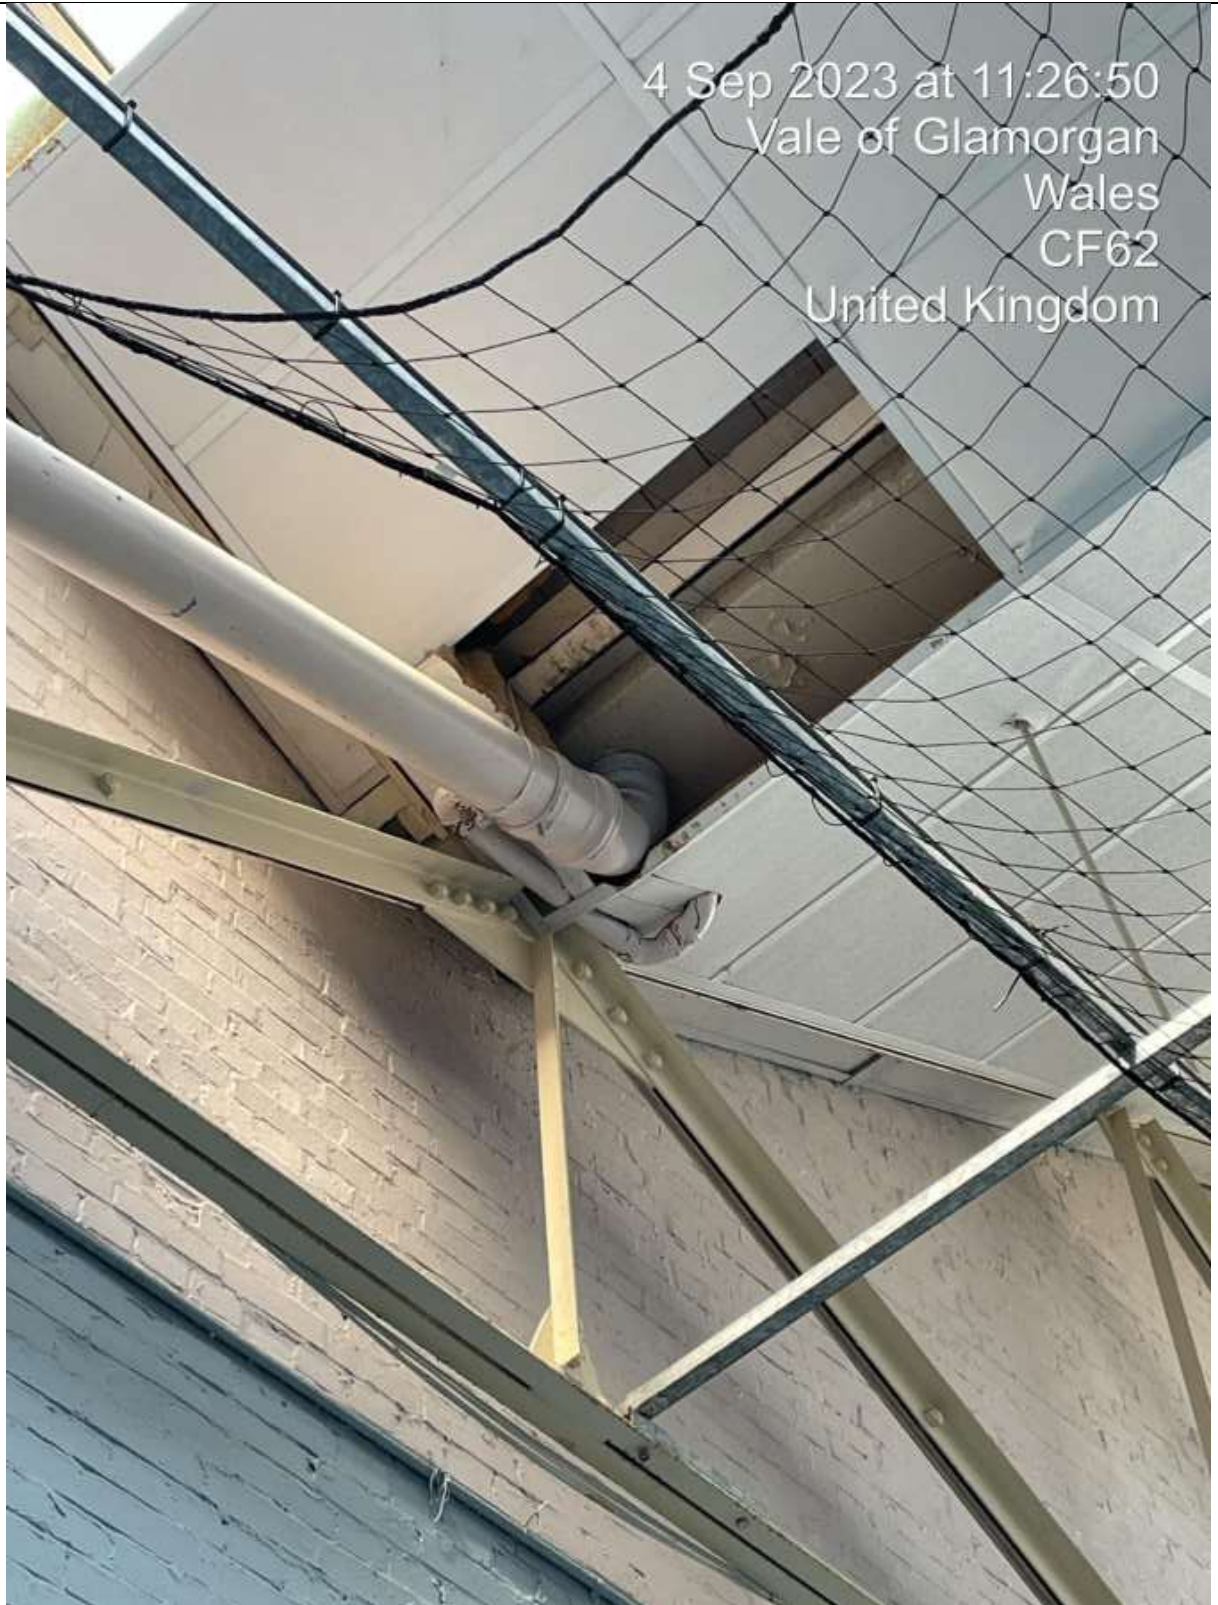
**Damaged CONSIDERED LOOSE & Missing Suspended Ceiling Tile.**

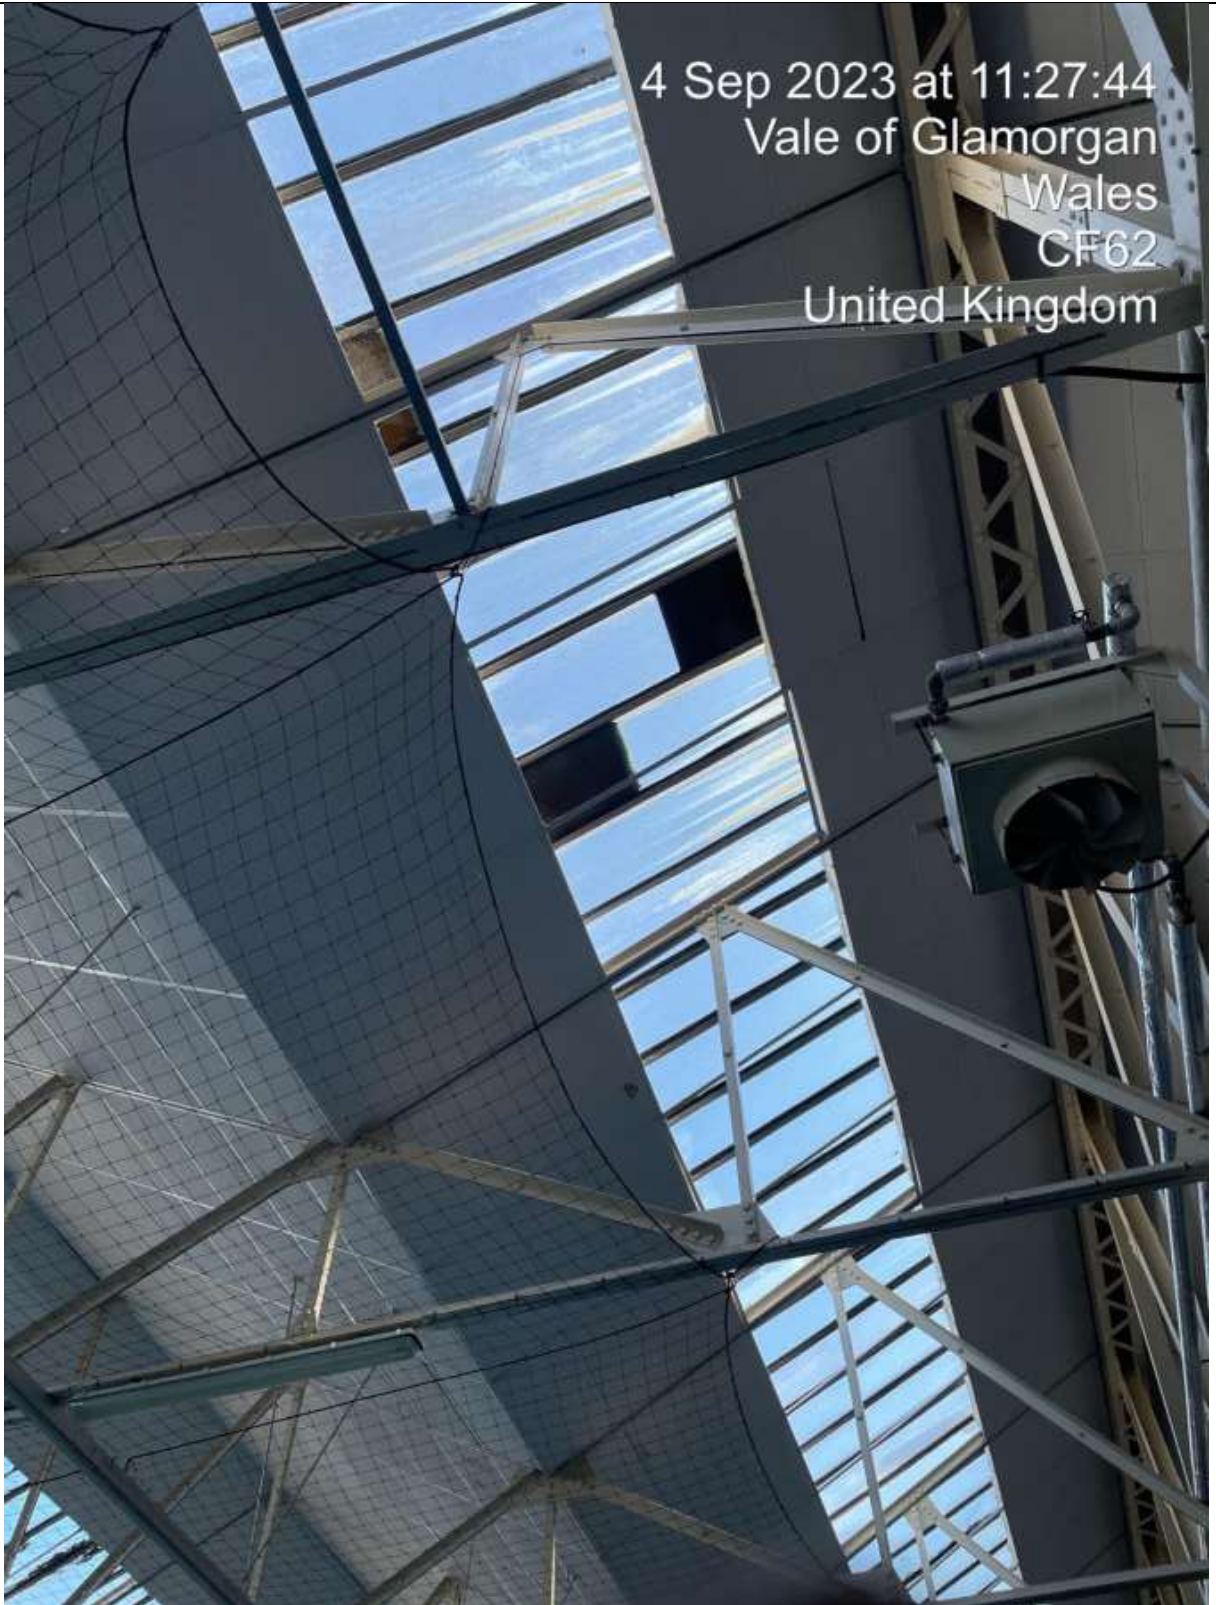
**Damaged & Slipped Roof Lights.**

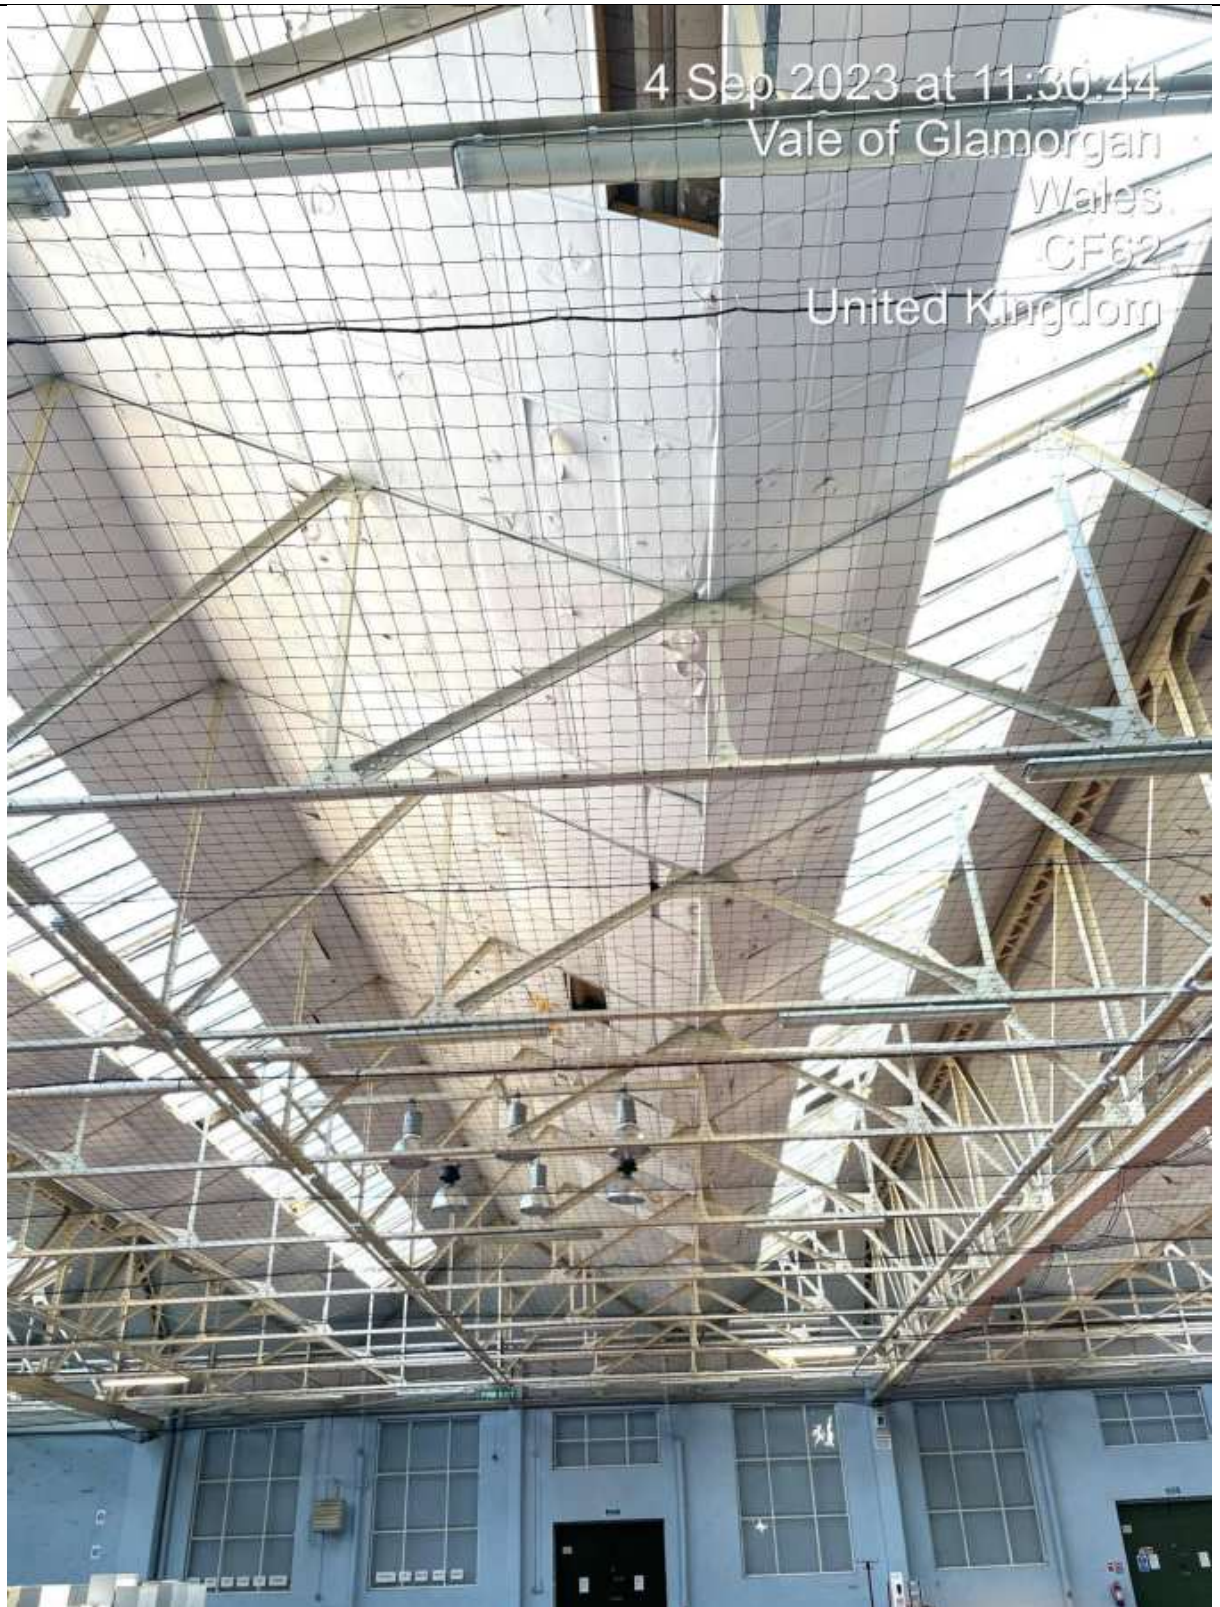
**Deterioration & Missing Suspended Ceiling Tiles.**

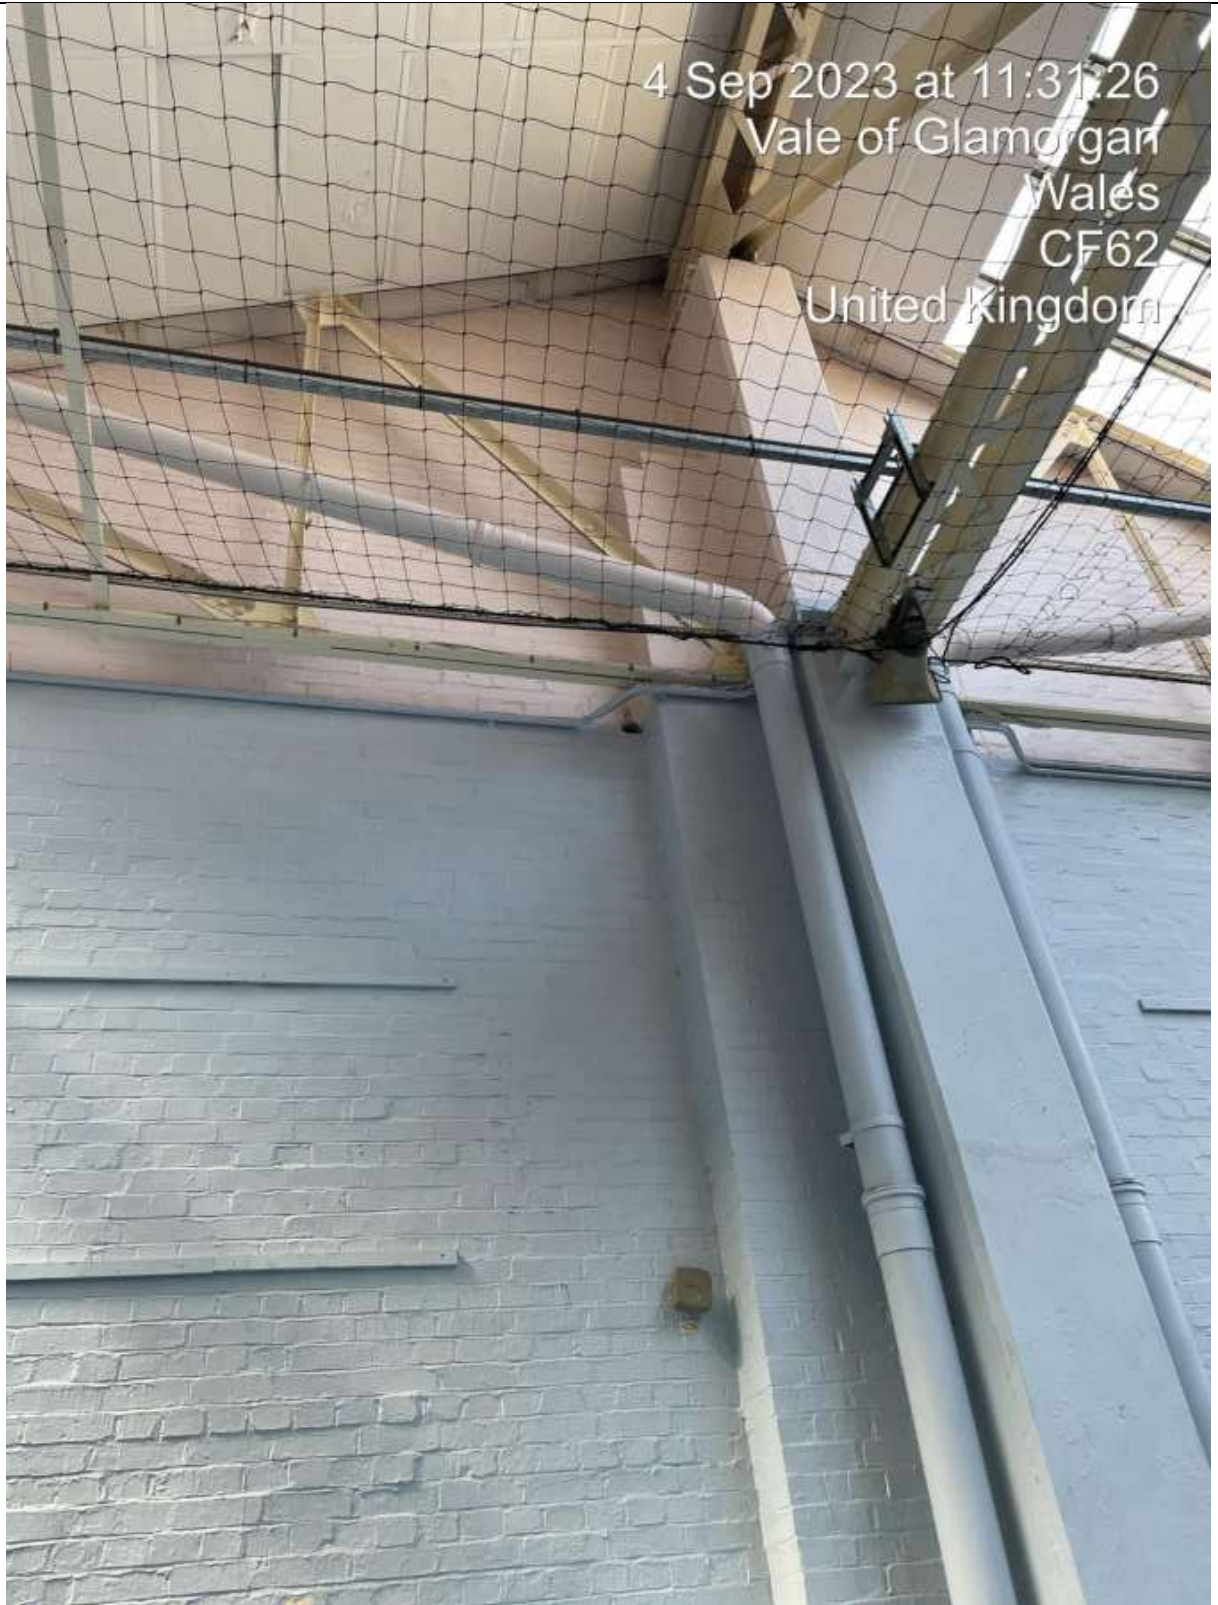
**Internal & Exposed Rainwater Downpipes.**

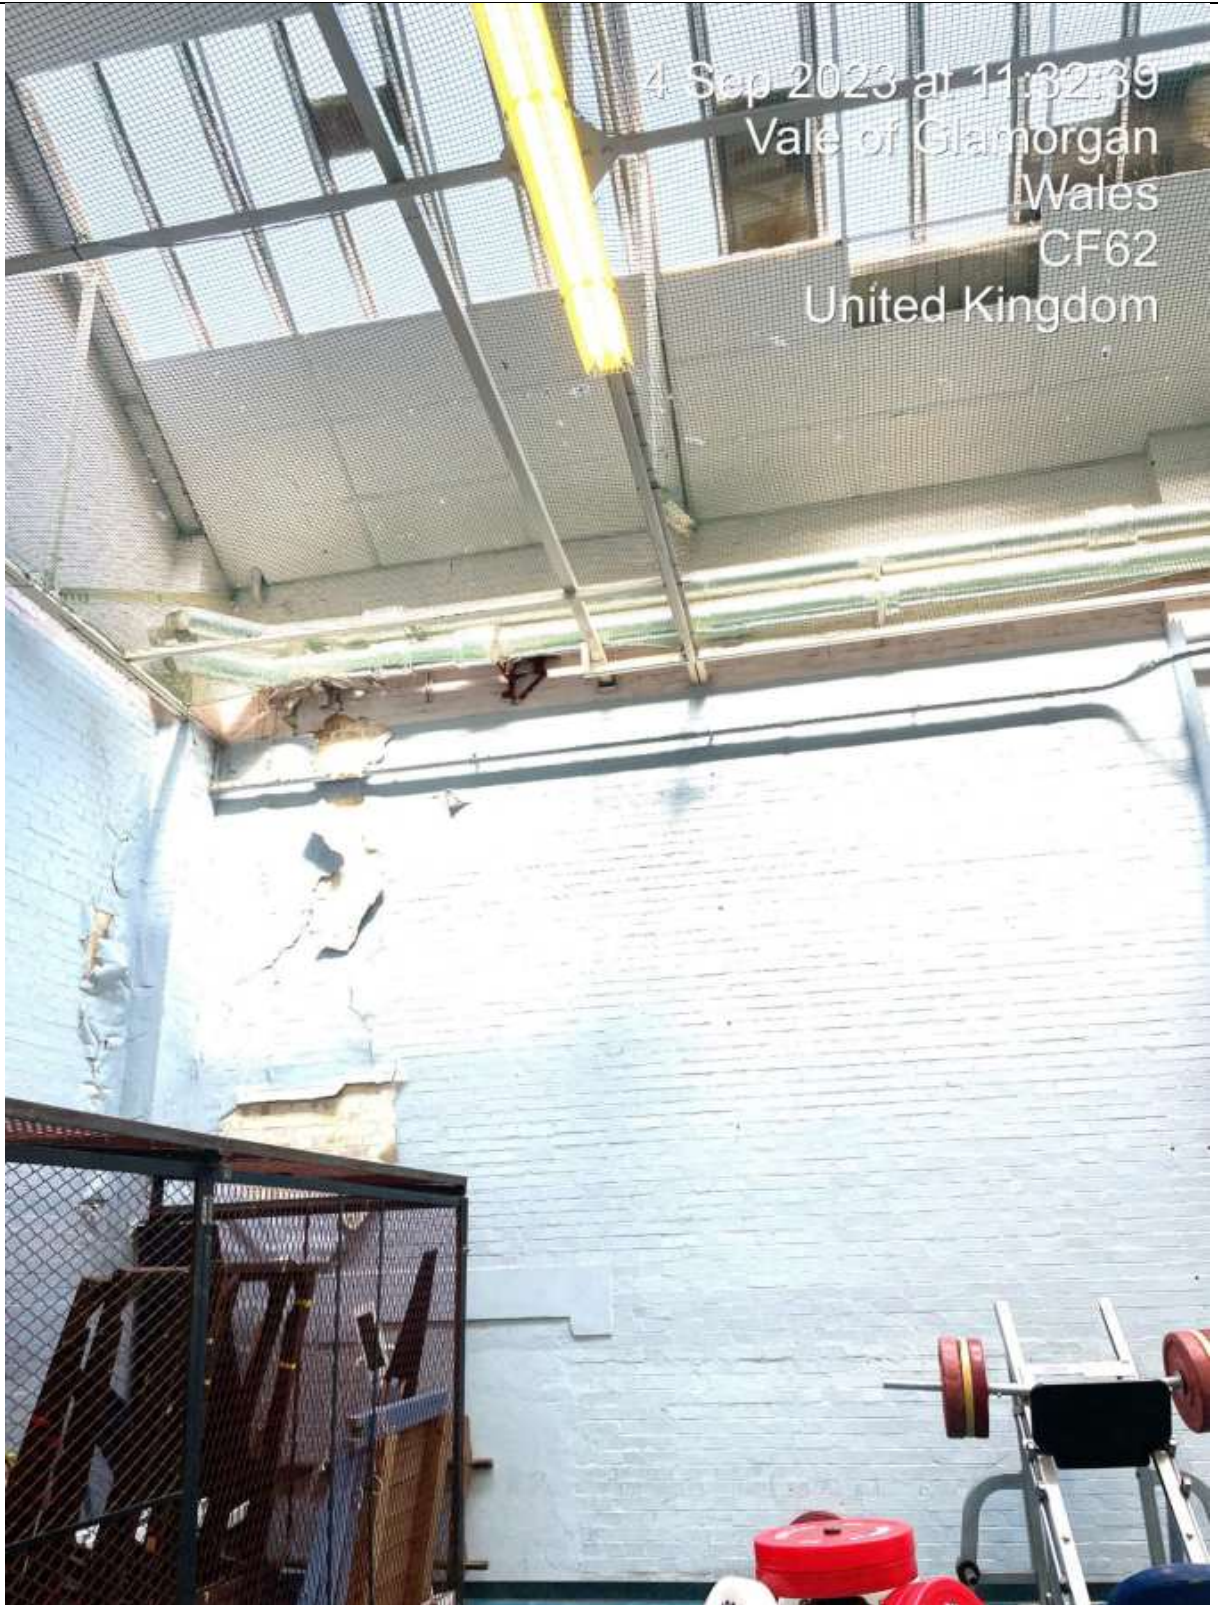
**SIGNIFICANT Penetrating Damp.**

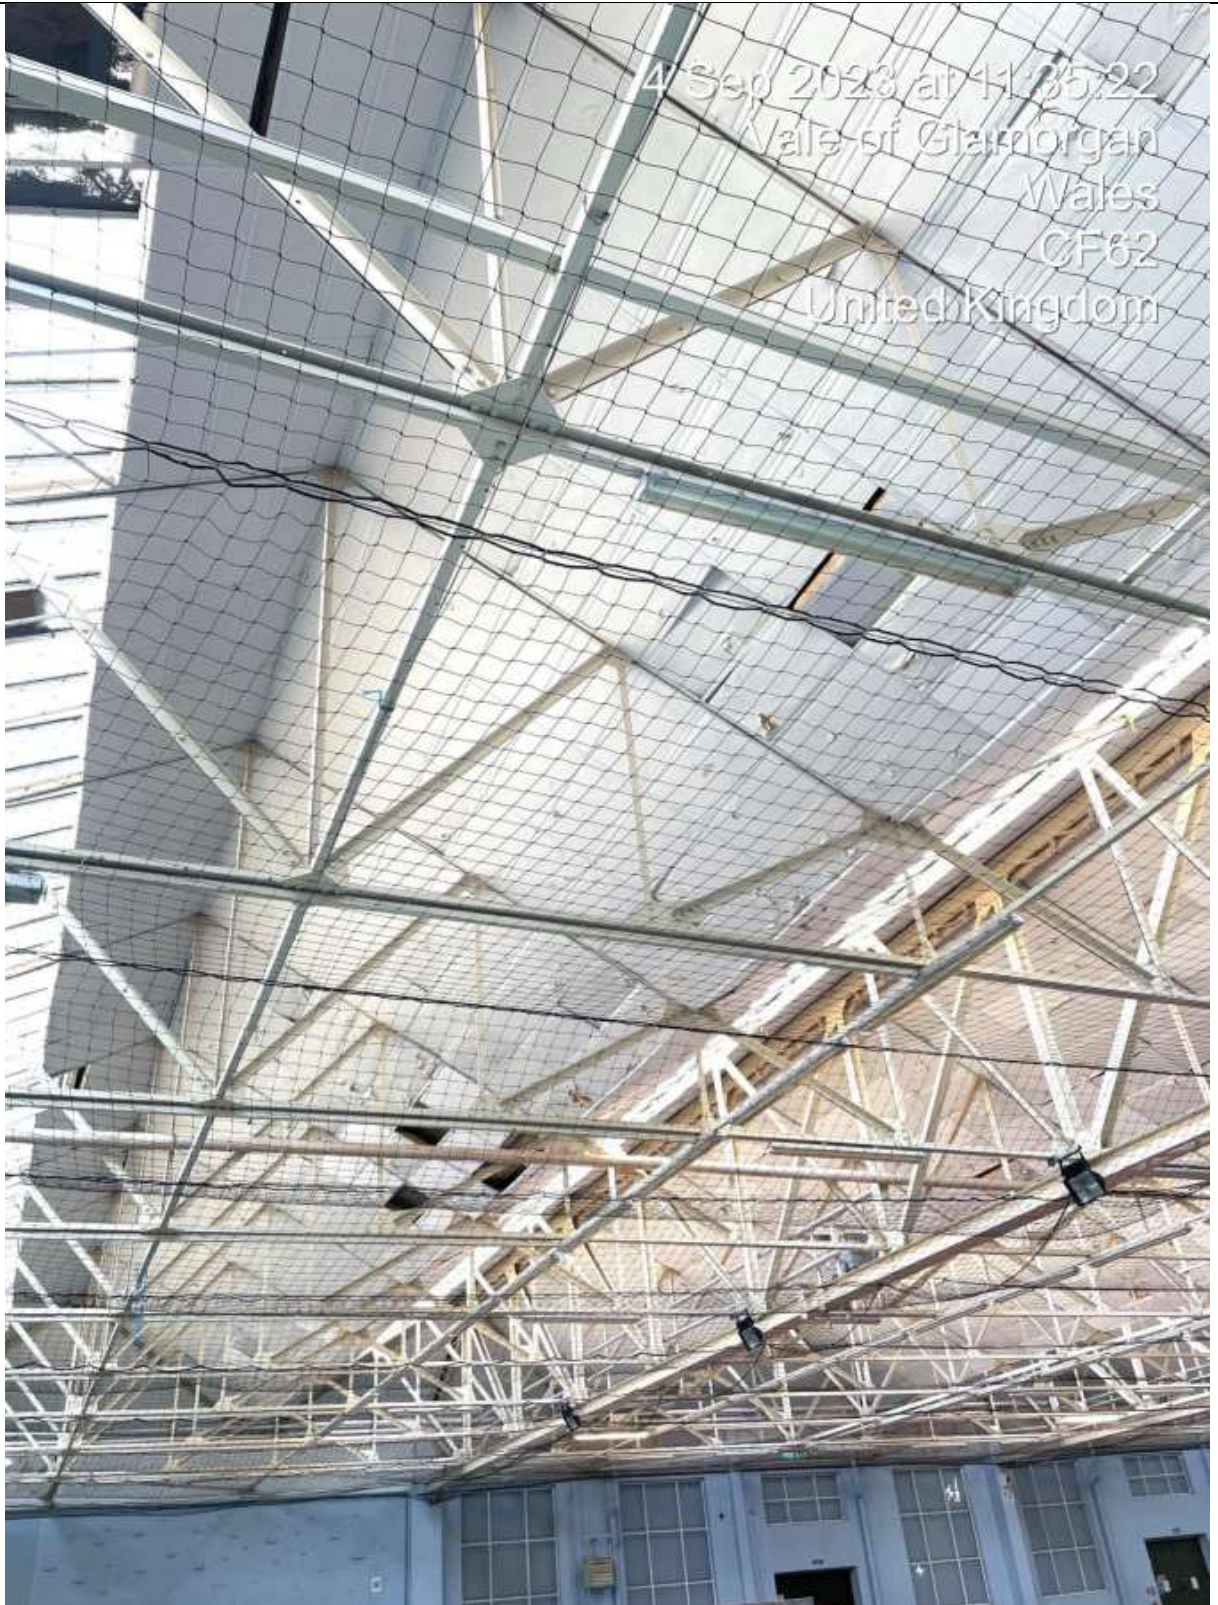
**Deterioration & Missing Suspended Ceiling Tiles.**

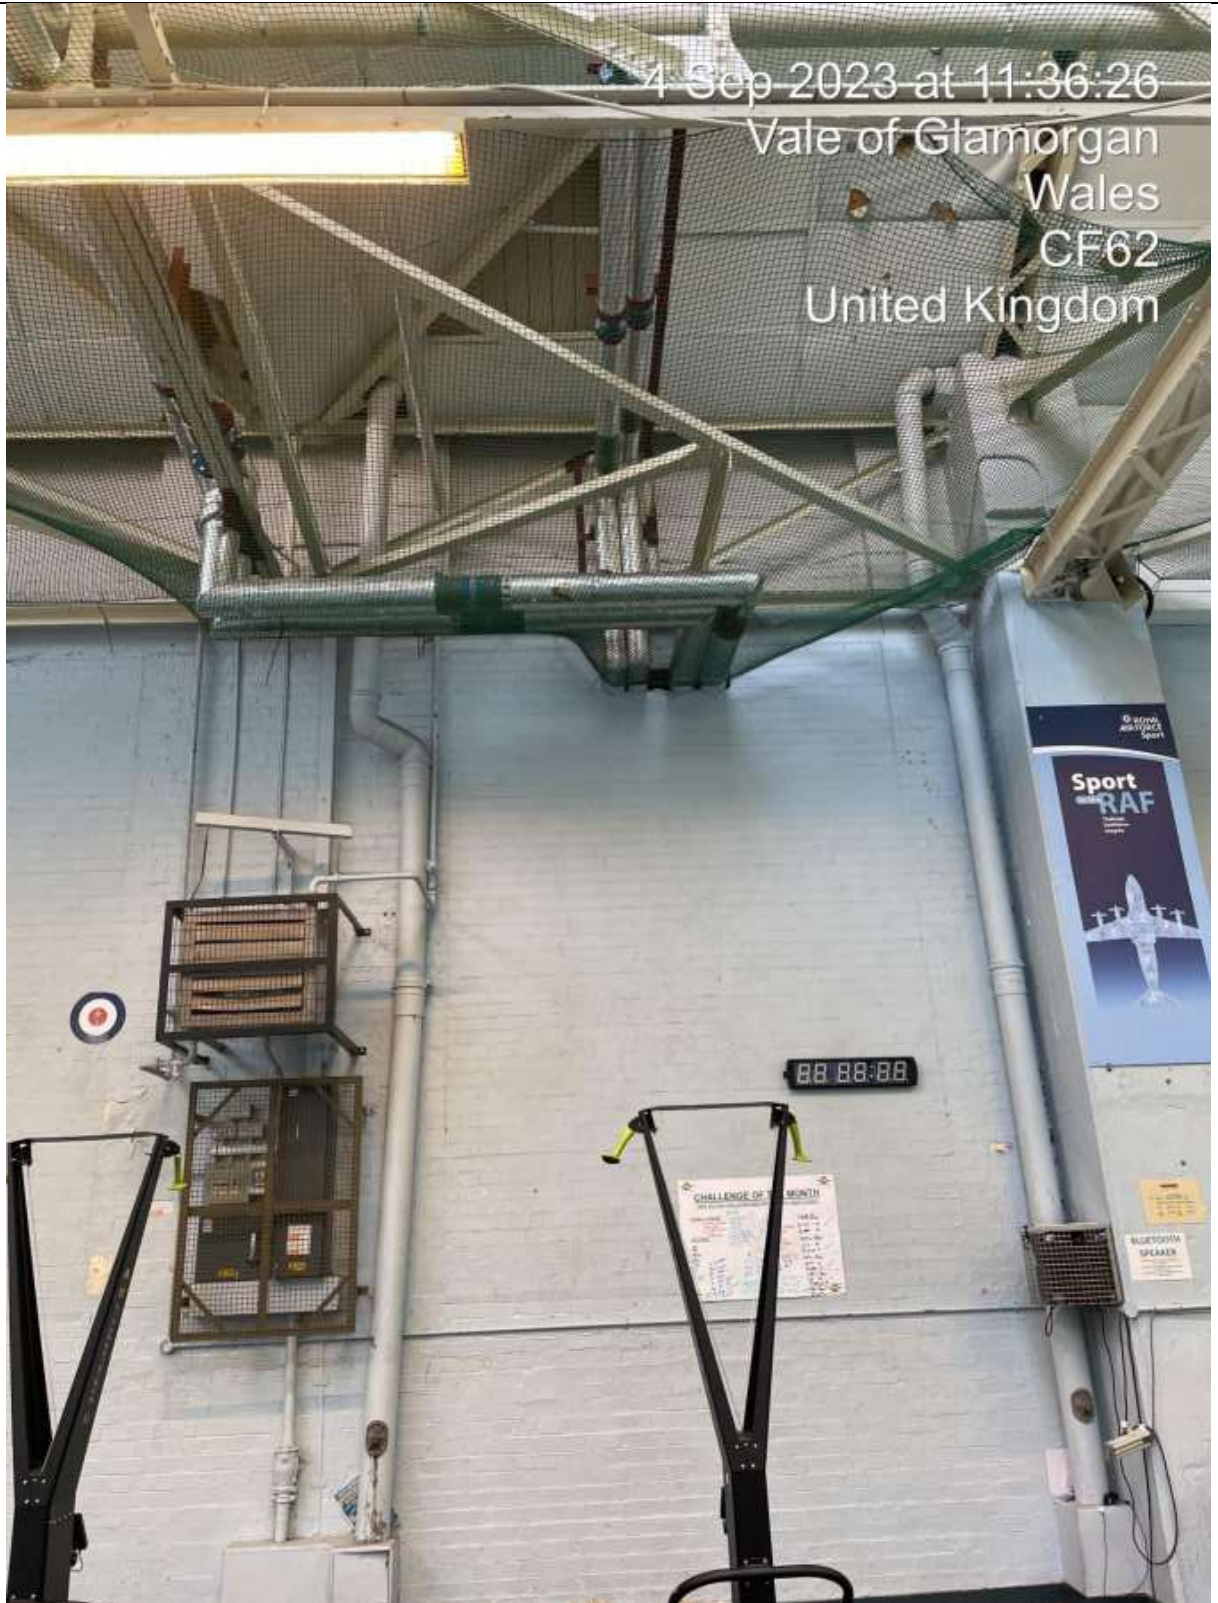
Un-Protected Service Pipe Penetrations.

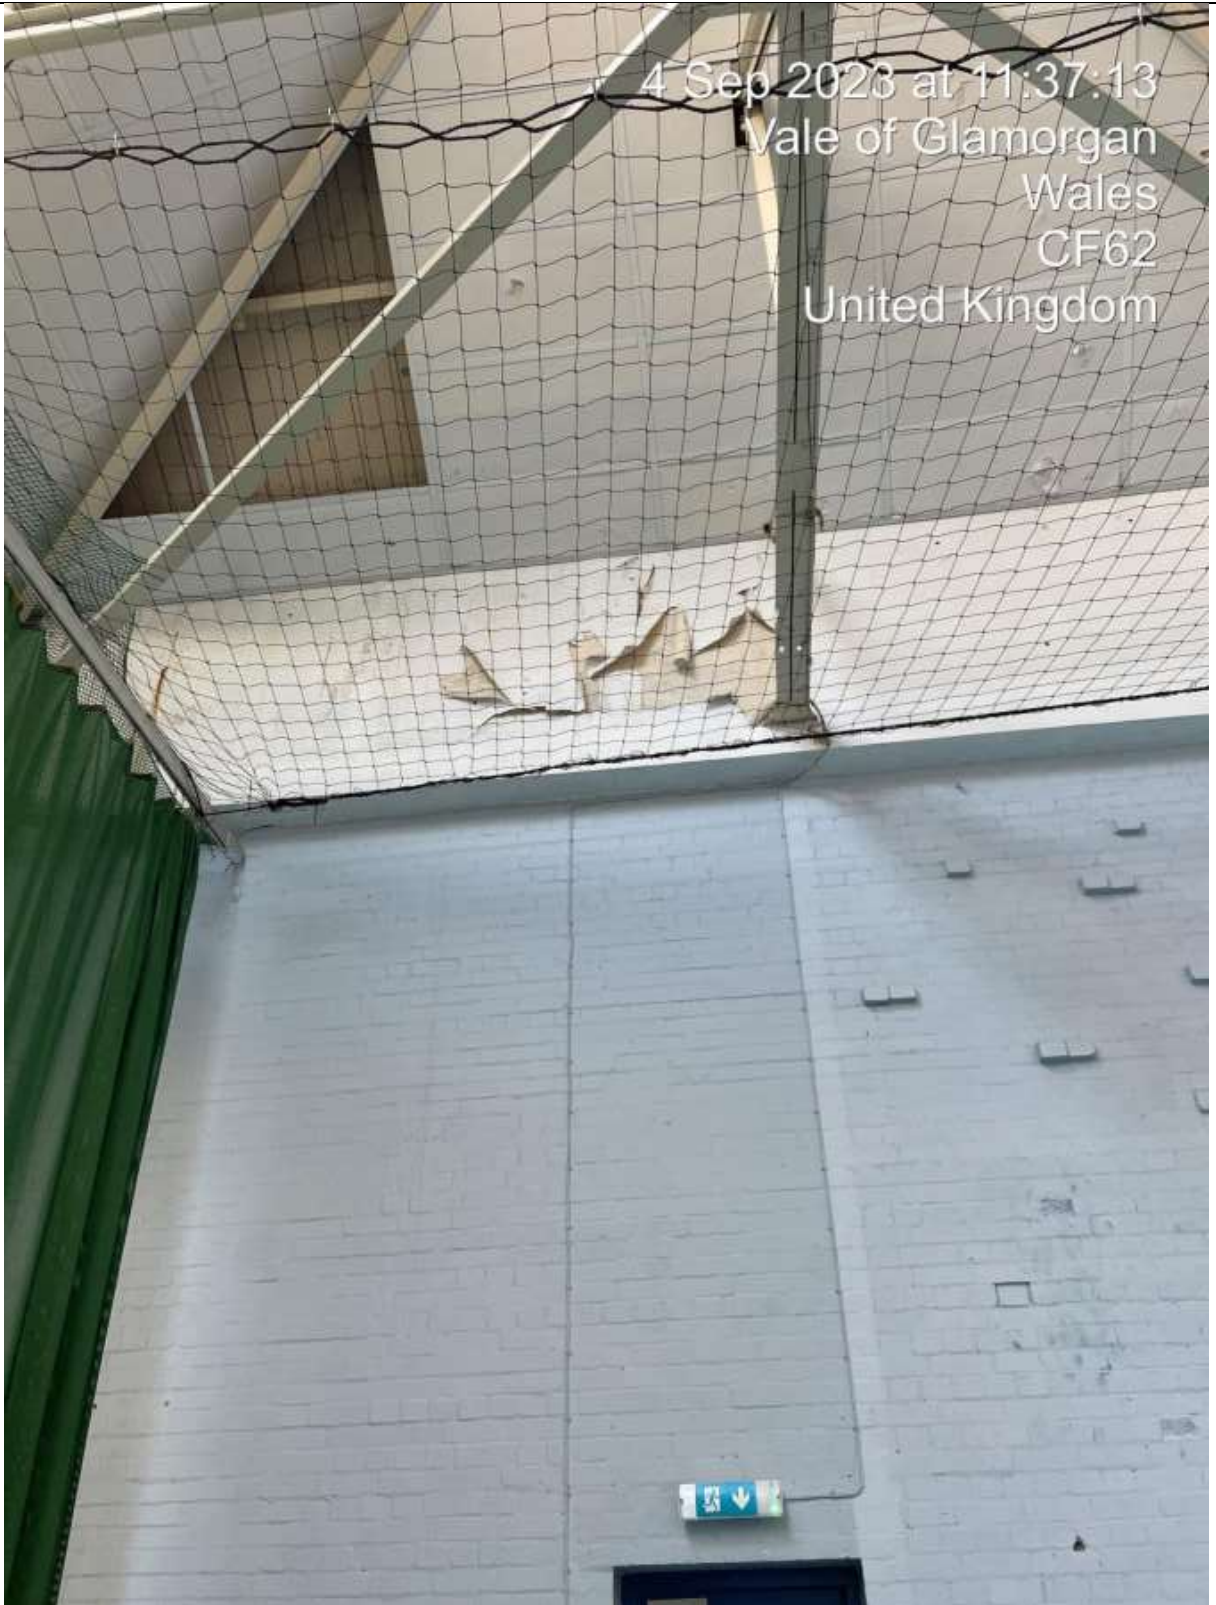
**Penetrating Damp.**
