Bro Tathan East Building 354 External & Internal Visual Condition Survey

| Report Ref: | PR01 | Created | 19/06/24 |

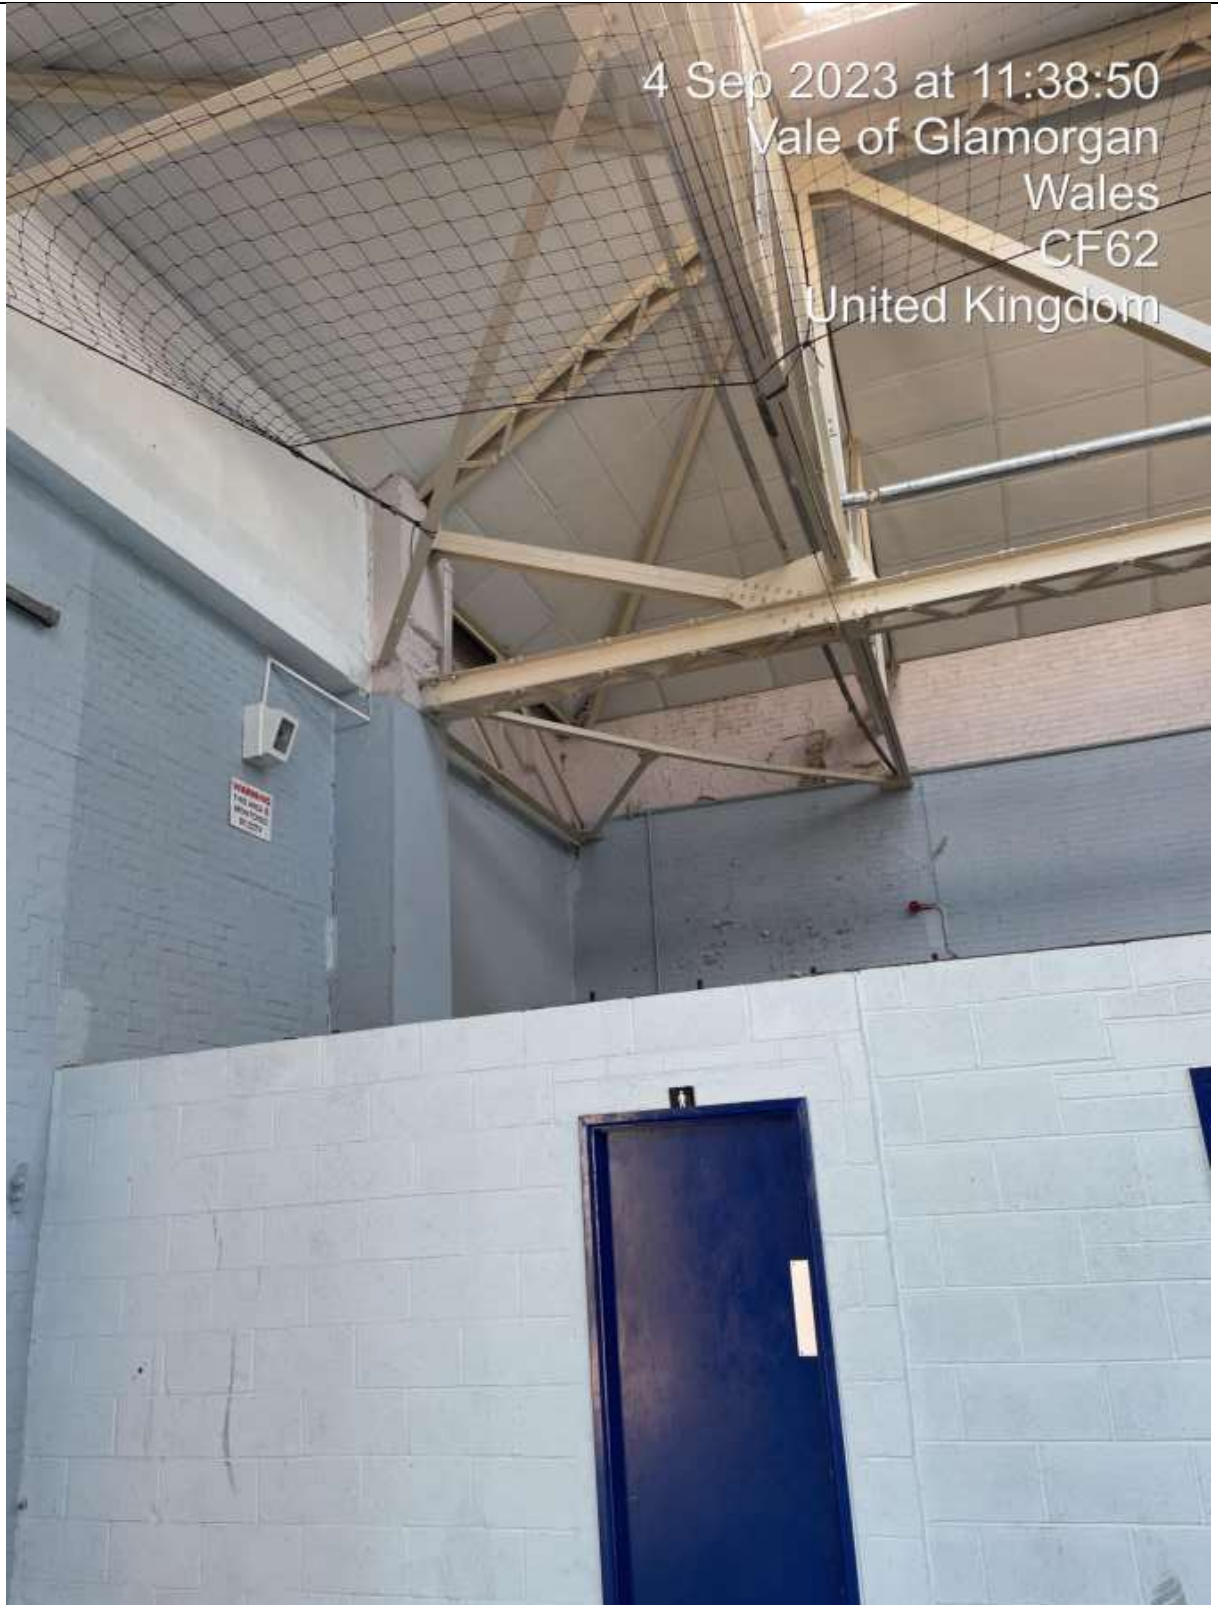
**Penetrating Damp.**

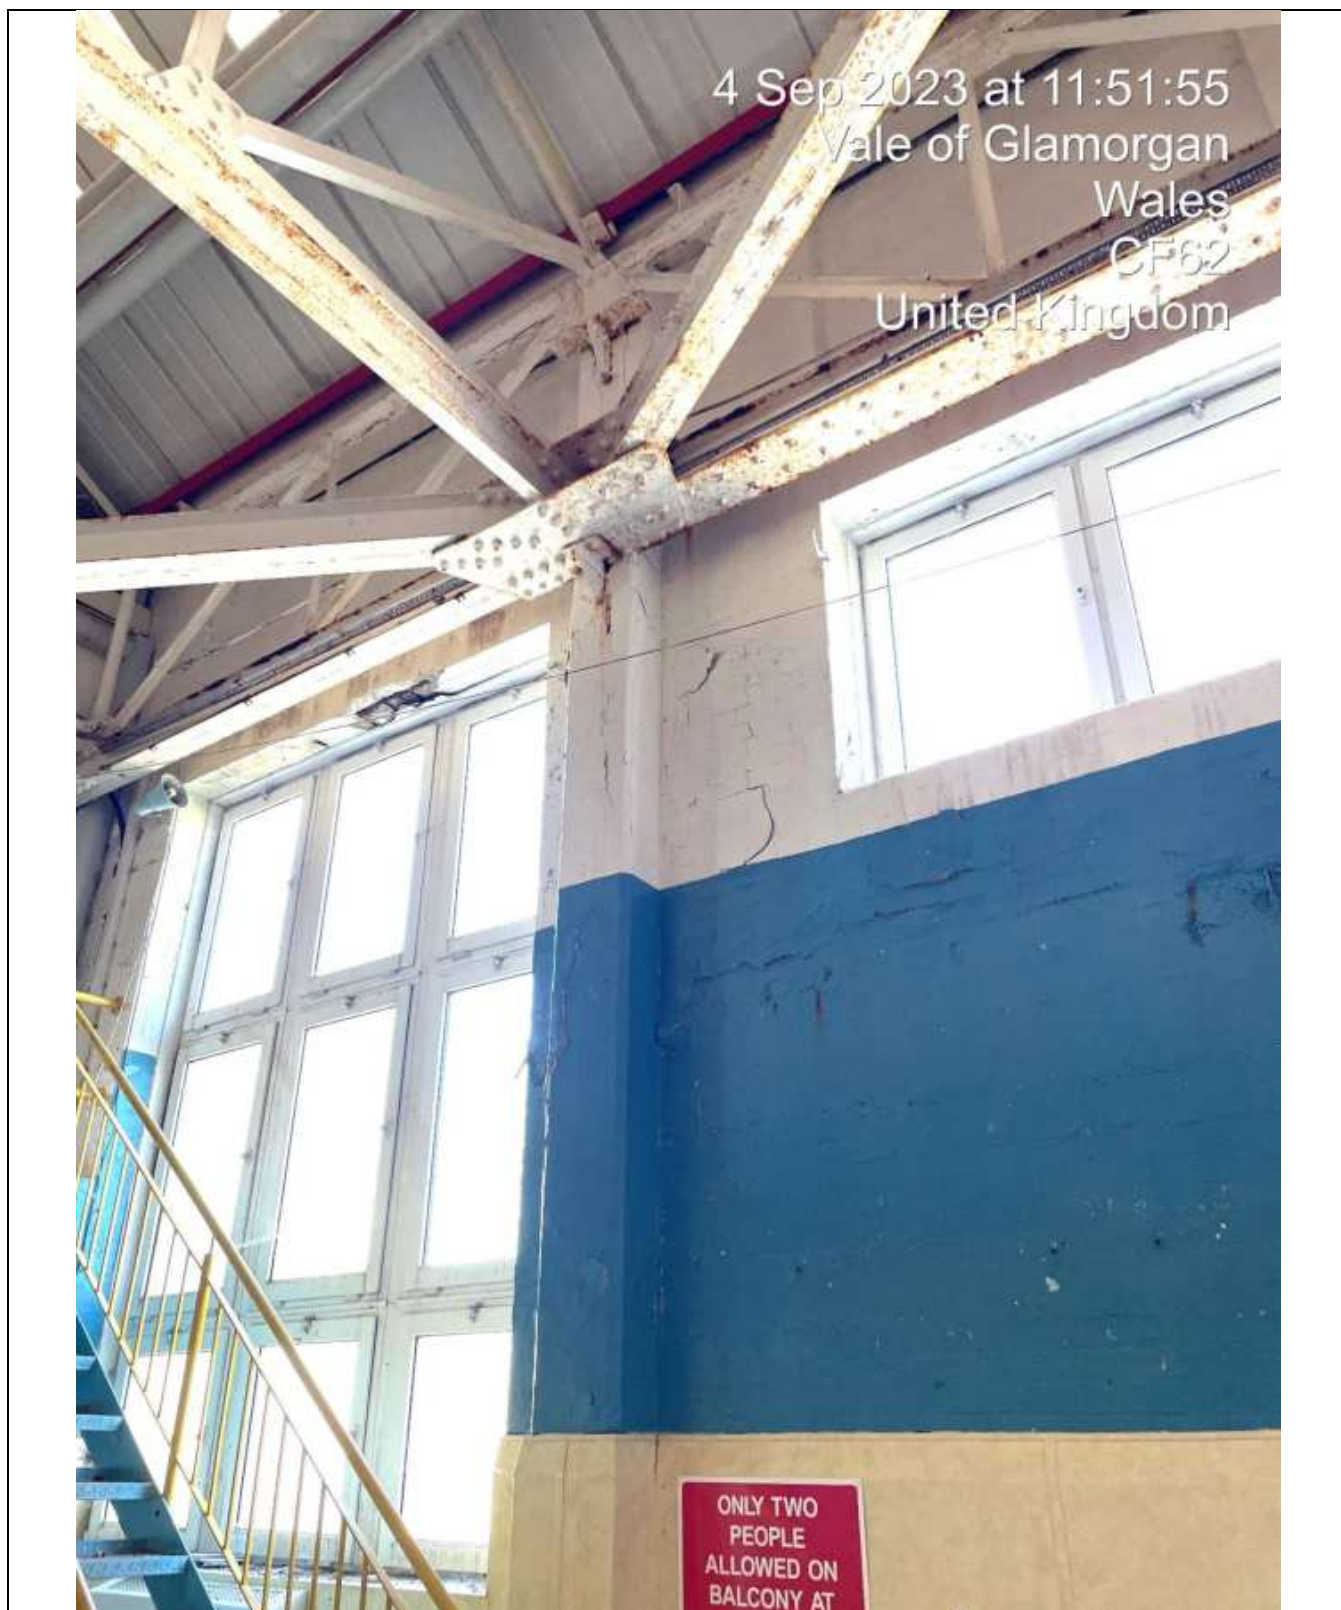
**Corrosion to Steel Roof Frame. Penetrating Damp. Partial COLLAPSE of Lintel over Window.**

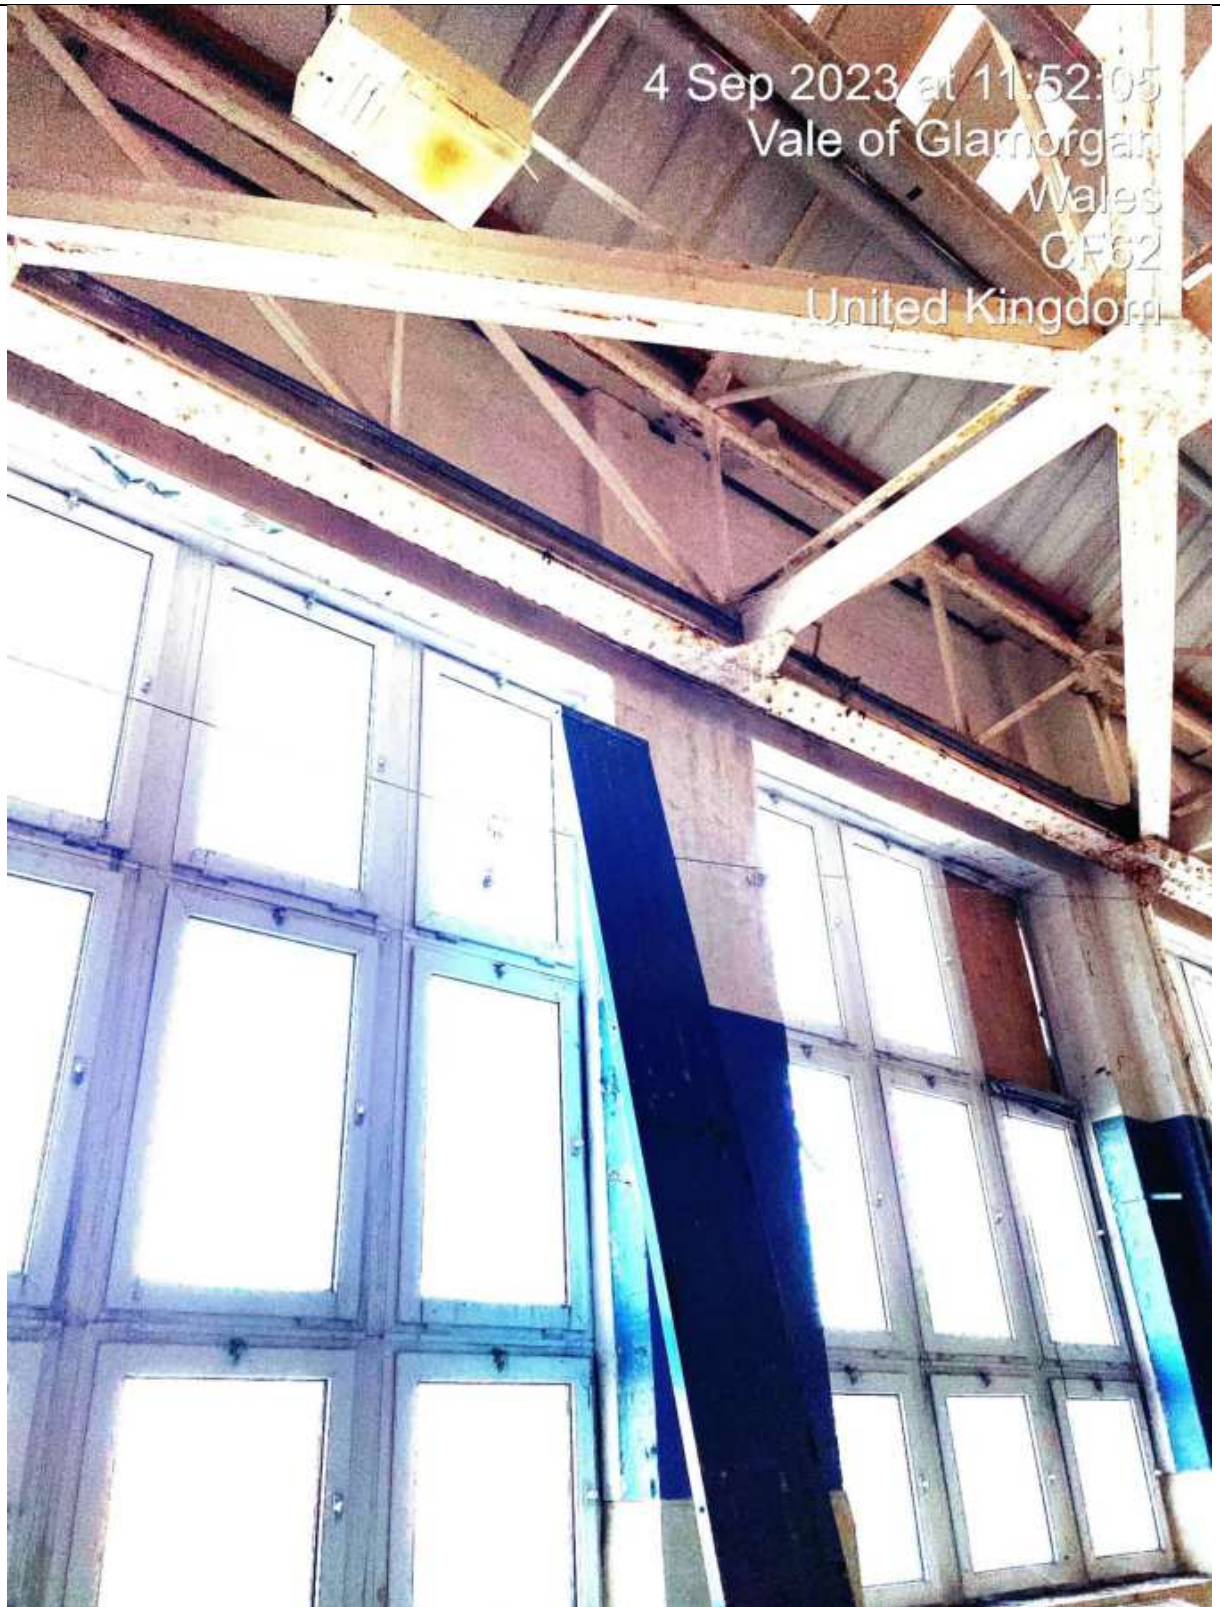
**Corrosion to Steel Roof Frame & MISSING Glazing to Fenestration.**

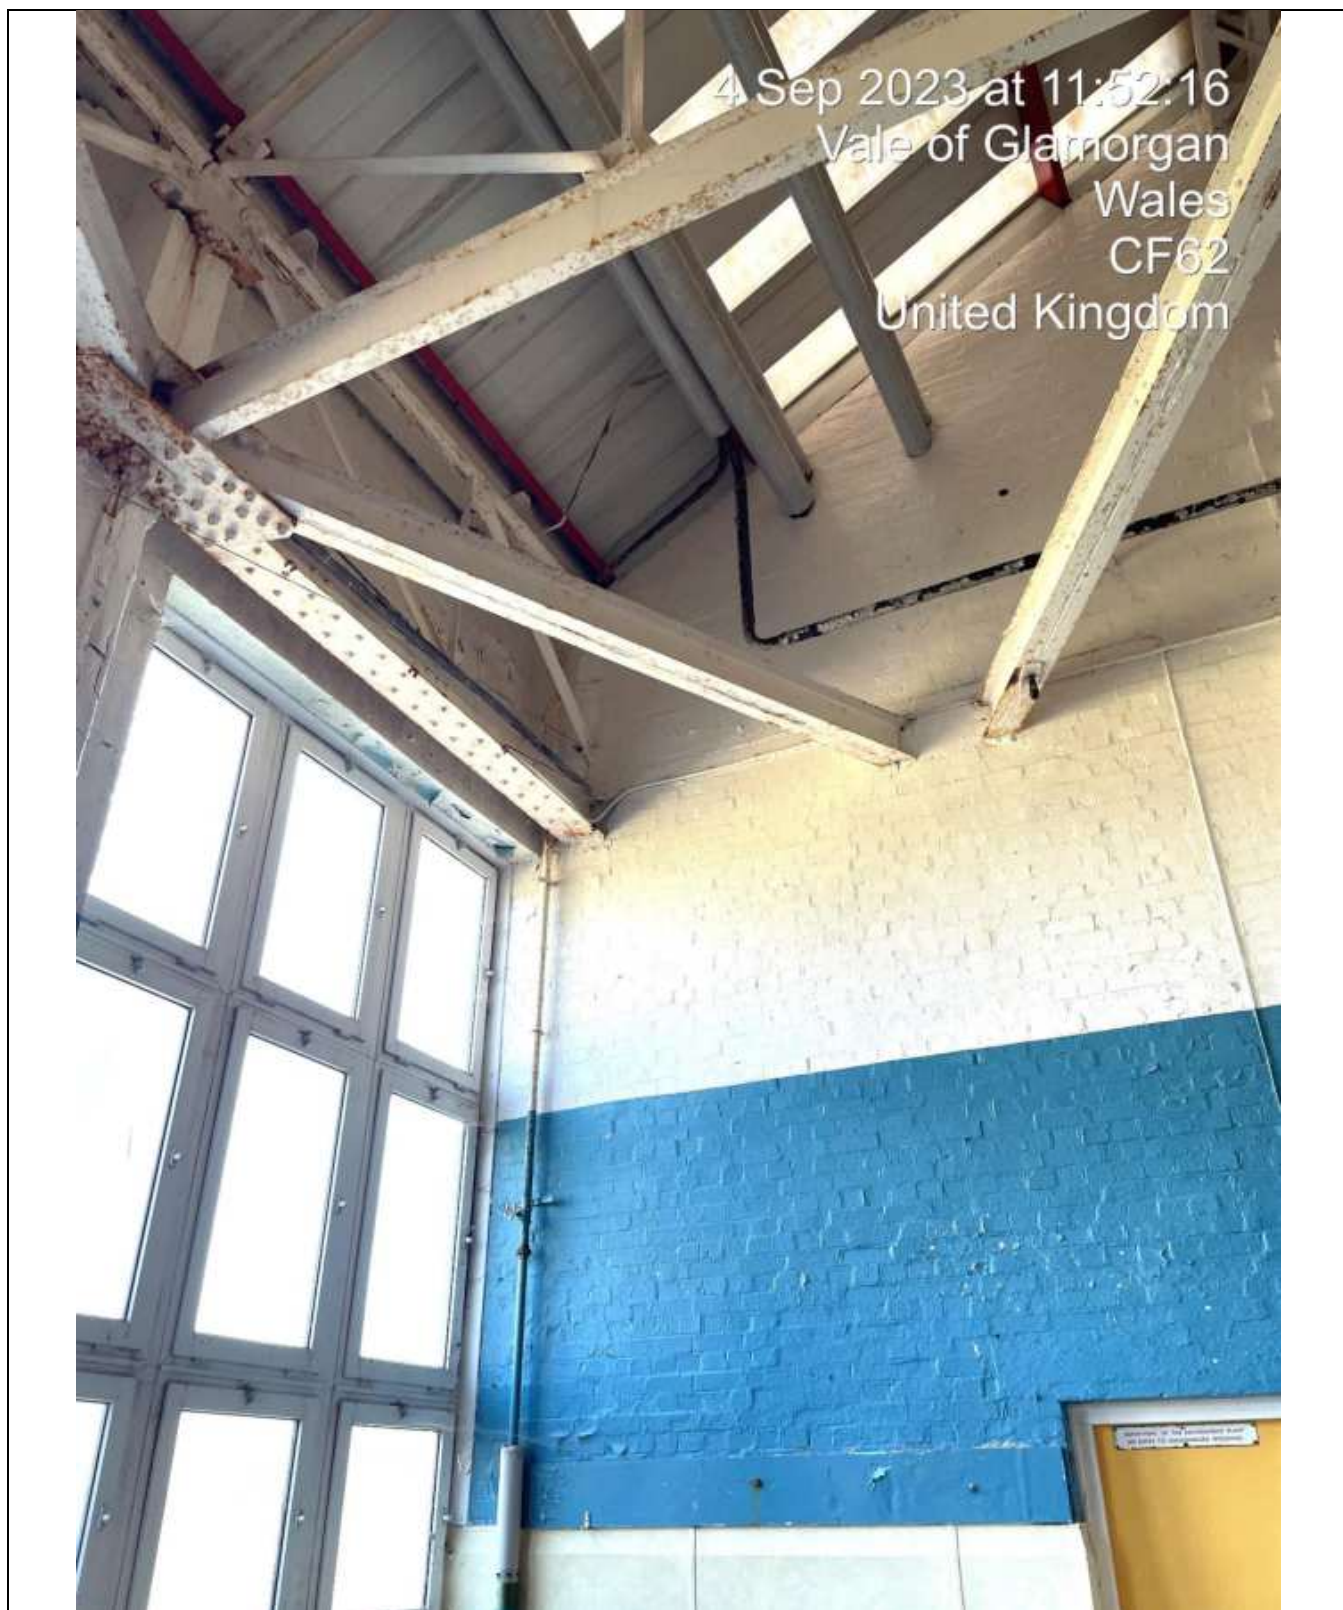
**Corrosion to Steel Roof Frame. Penetrating Damp.**

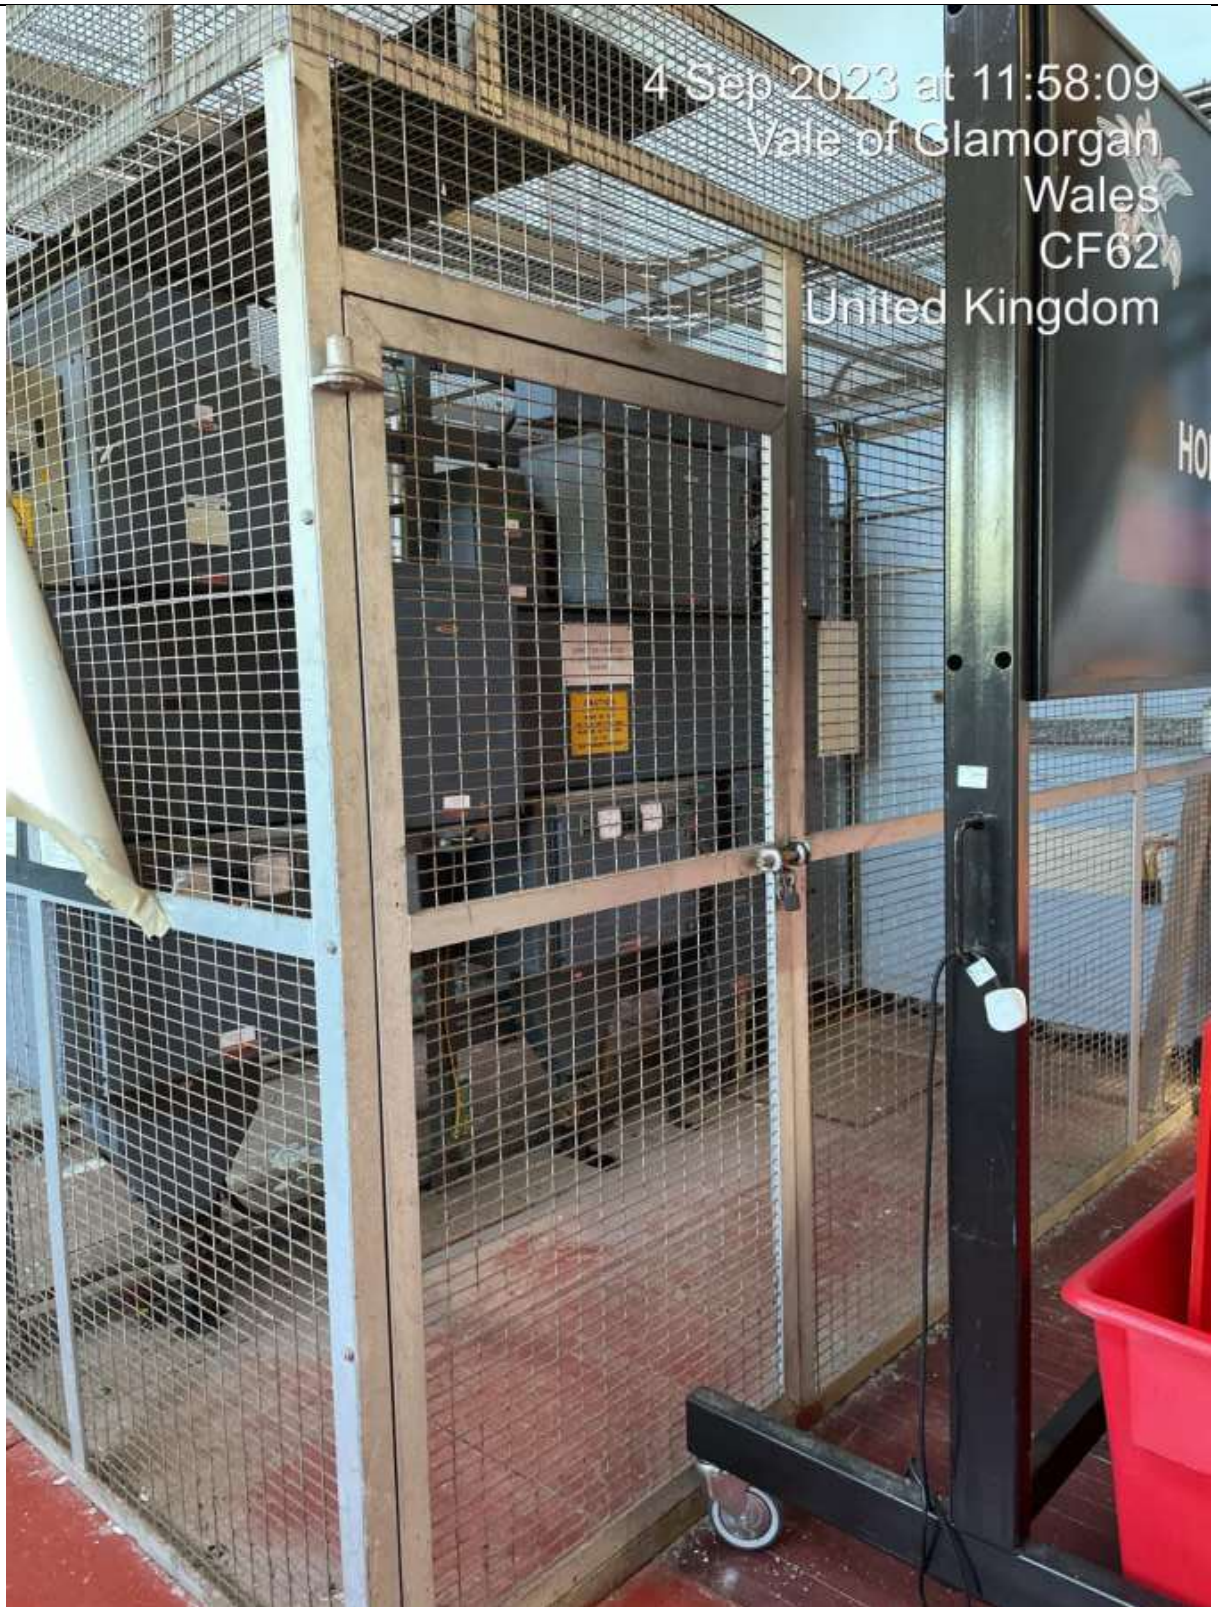
**SIGNIFICANT Electrical Infrastructure.**
