## A487 New Dyfi Bridge

Environmental Statement -  
Volume 3: Appendix 15.5

Site Walkover Photo Plates

Final Issue | March 2016

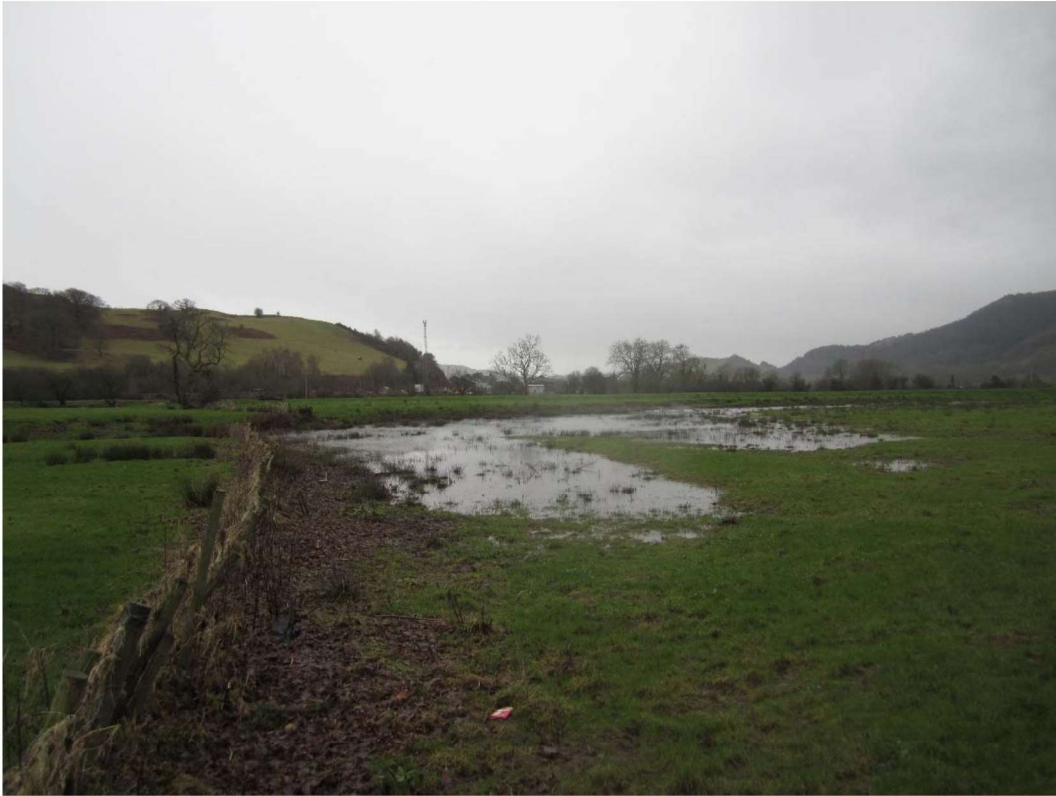
**Photo 1: Rain and floodwaters standing in a meander scar on the floodplain south of the river and the proposed viaduct**

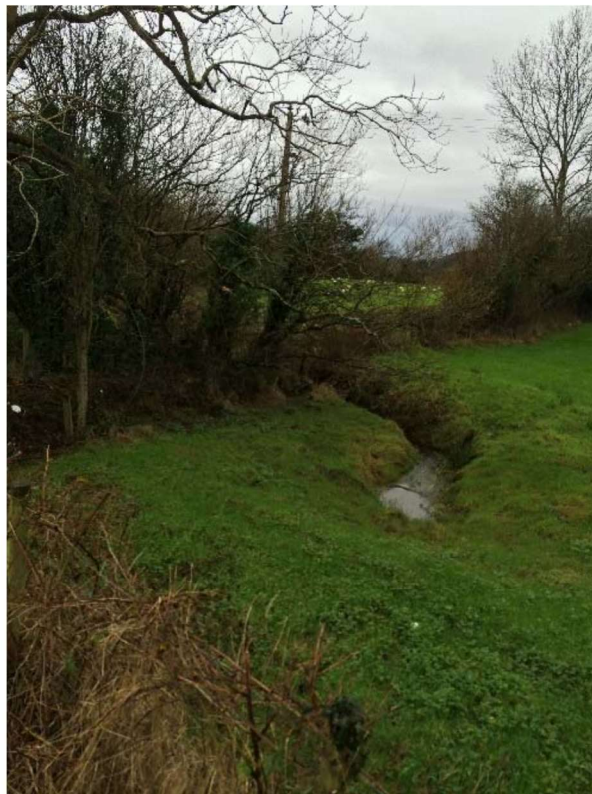
**Photo 2 a – Southern drainage ditch looking south west**

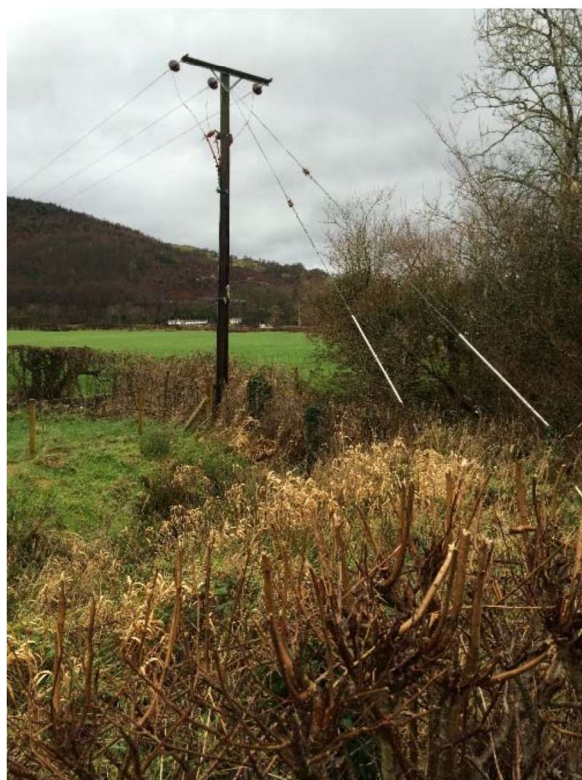
**Photo 2 b – Southern drainage ditch looking north east**

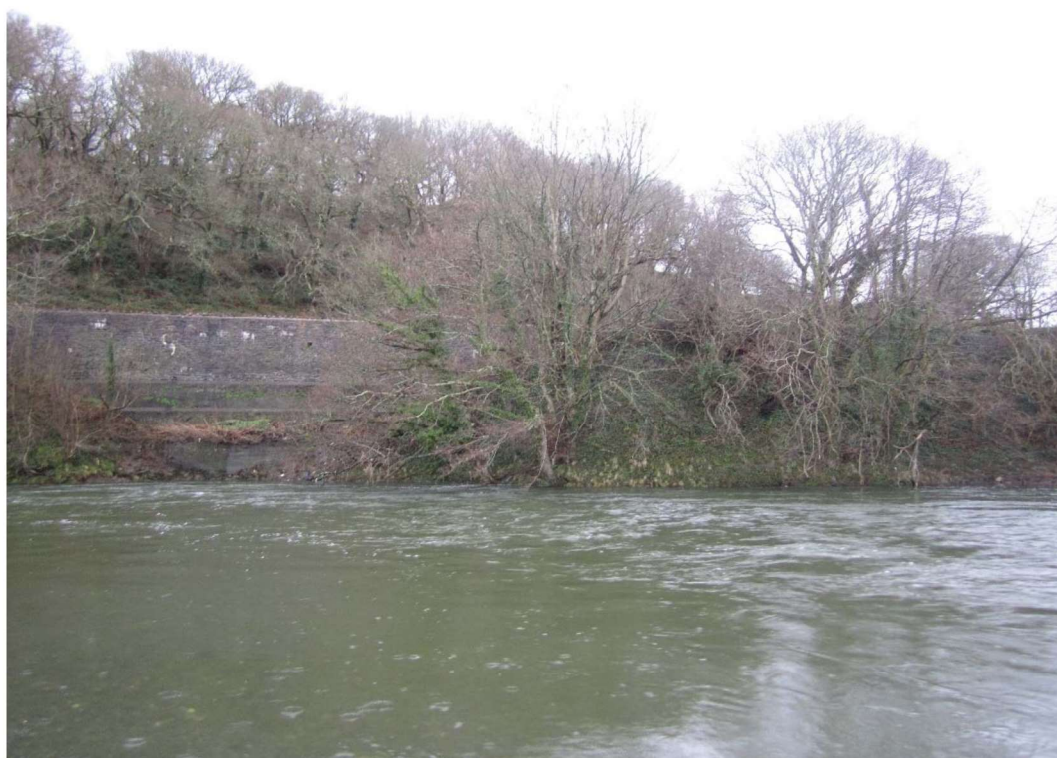
**Photo 3: Outside of meander bend (right bank) showing retaining wall and steep bank with mature trees**

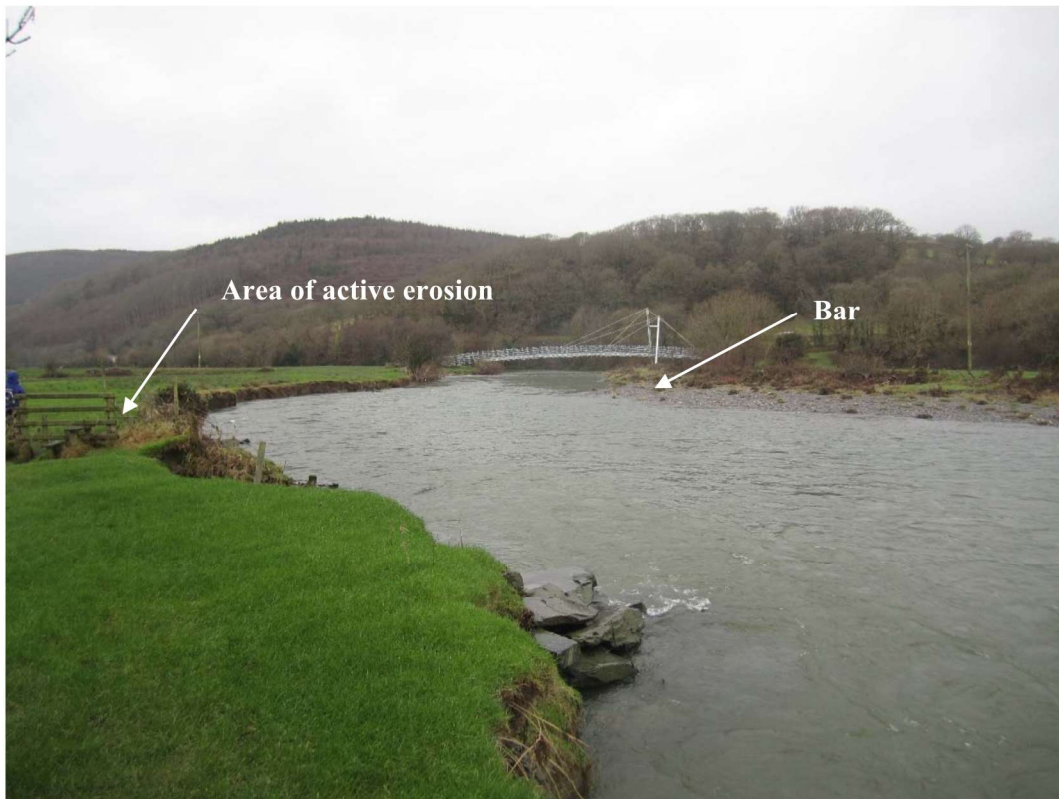
**Photo 4: Looking downstream at coupled bar deposition and bank erosion resulting in lateral migration and the formation of a meander bend upstream of the Millennium Bridge**

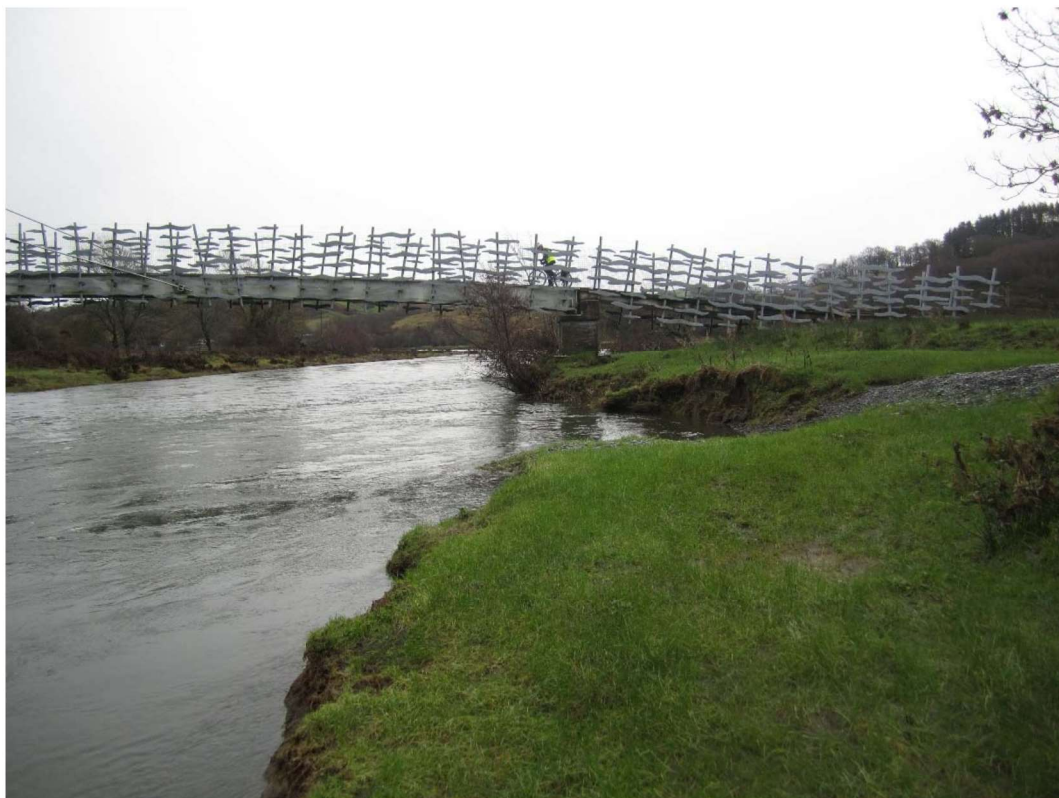
**Photo 5: Looking upstream at eroded area of left bank immediately downstream of the Millennium bridge**

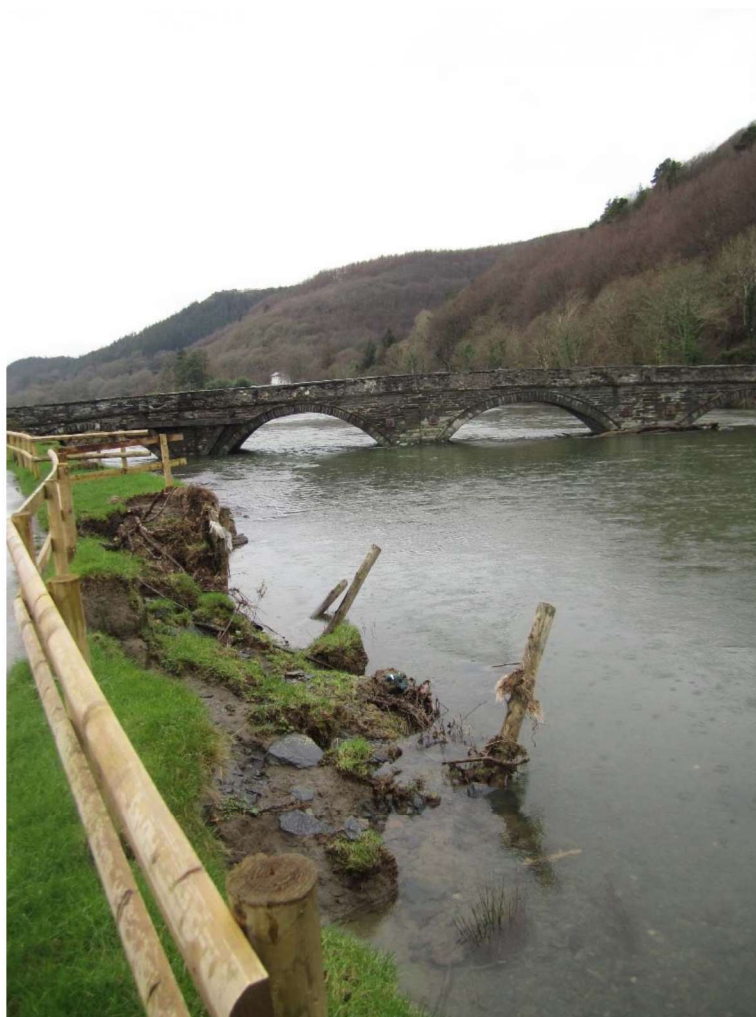
**Photo 6: Looking downstream at bank erosion occurring on the left bank near the Pont-ar-Ddyfi**
