# Not All Insulation is the Same...

Fire Test Certification  
& Real Fire Case Studies

# Introducing QuadCore™ Technology

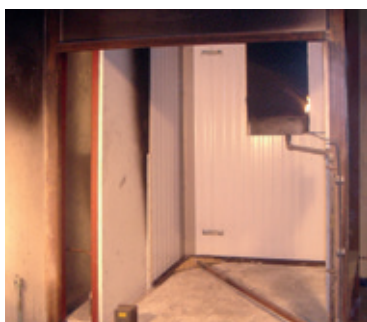
**EN 13823 SBI (Single Burning Item) Fire Test.** B-s1,d0 can be achieved to EN 13501-1.

Test set up

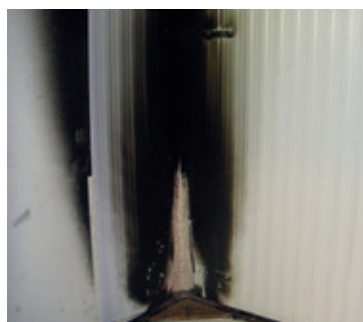
End of test showing minimal panel damage

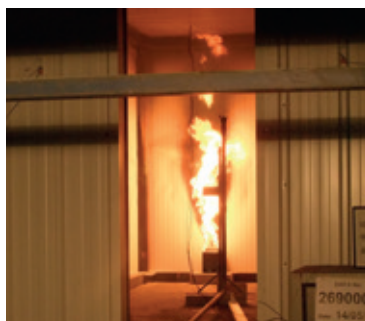
Test in progress - note burner adjacent to vertical panel joints

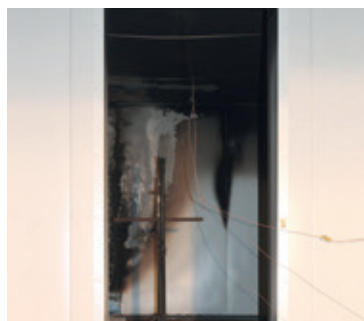
End of test showing limited internal damage and no evidence of flash-over conditions

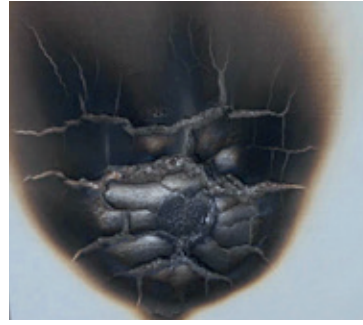
End of test showing localised char formation with no evidence of fire spread

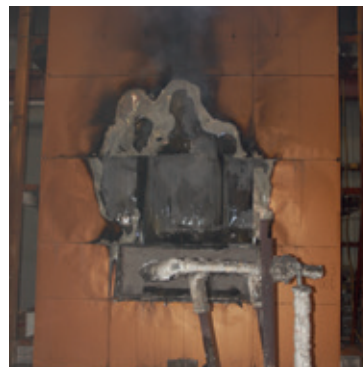
End of test demonstrating damage to ACM rainscreen with Kingspan insulated metal panels remaining intact

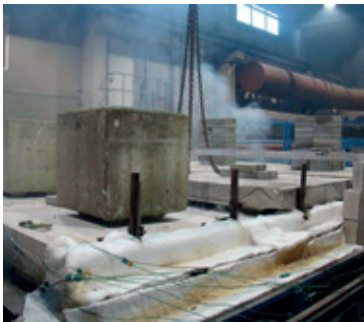
**EN 1365 Part 2.** Fire resistance tests for loadbearing elements. Floors and roofs.

Op-Deck after 1 hour demonstrating no failure of insulation, integrity and load bearing capacity.

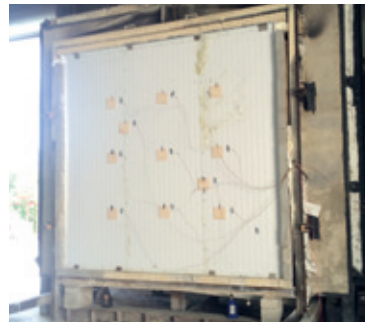
**ASTM E119 Standard Test Methods for Fire Tests of Building Construction and Materials.** Fire resistance test.

External face of QuadCore™ panel assembly after completion of 60 minute exposure.

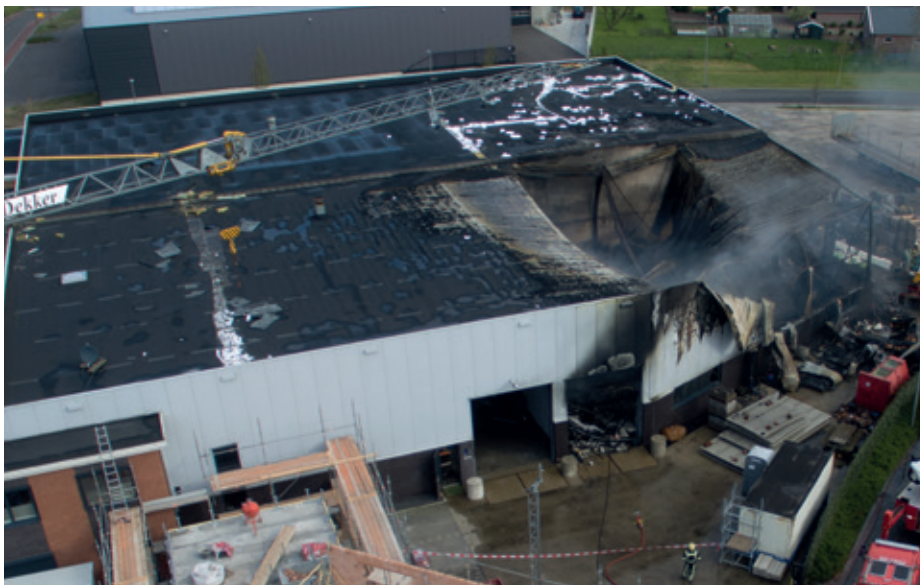
The fire in the army surplus store was extremely intense and lasted for over 4 hours. This was due, in part, to the storage of significant amounts of combustible materials in the building and the reported presence in appreciable quantities of accelerants such as cigarette lighter fluid and aerosol paint spray cans.

Aerial view of the damage showing structural collapse of the army surplus warehouse.

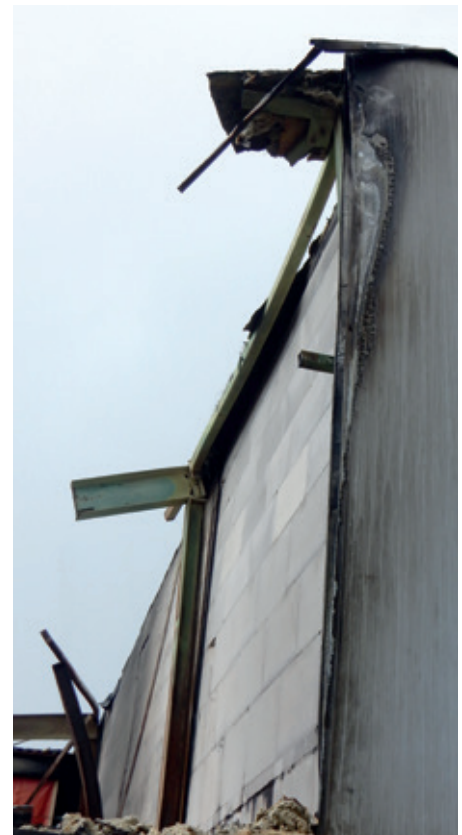
- The findings provide evidence that the PIR core of Kingspan LPCB and FM approved KS1000 AWP panels can provide sufficient resistance to fire propagation and erosion such that they meet the intent of reported local regulations where KS1000 AWP panels bridge across fire compartment walls.

Panel at junction with internal compartment wall.

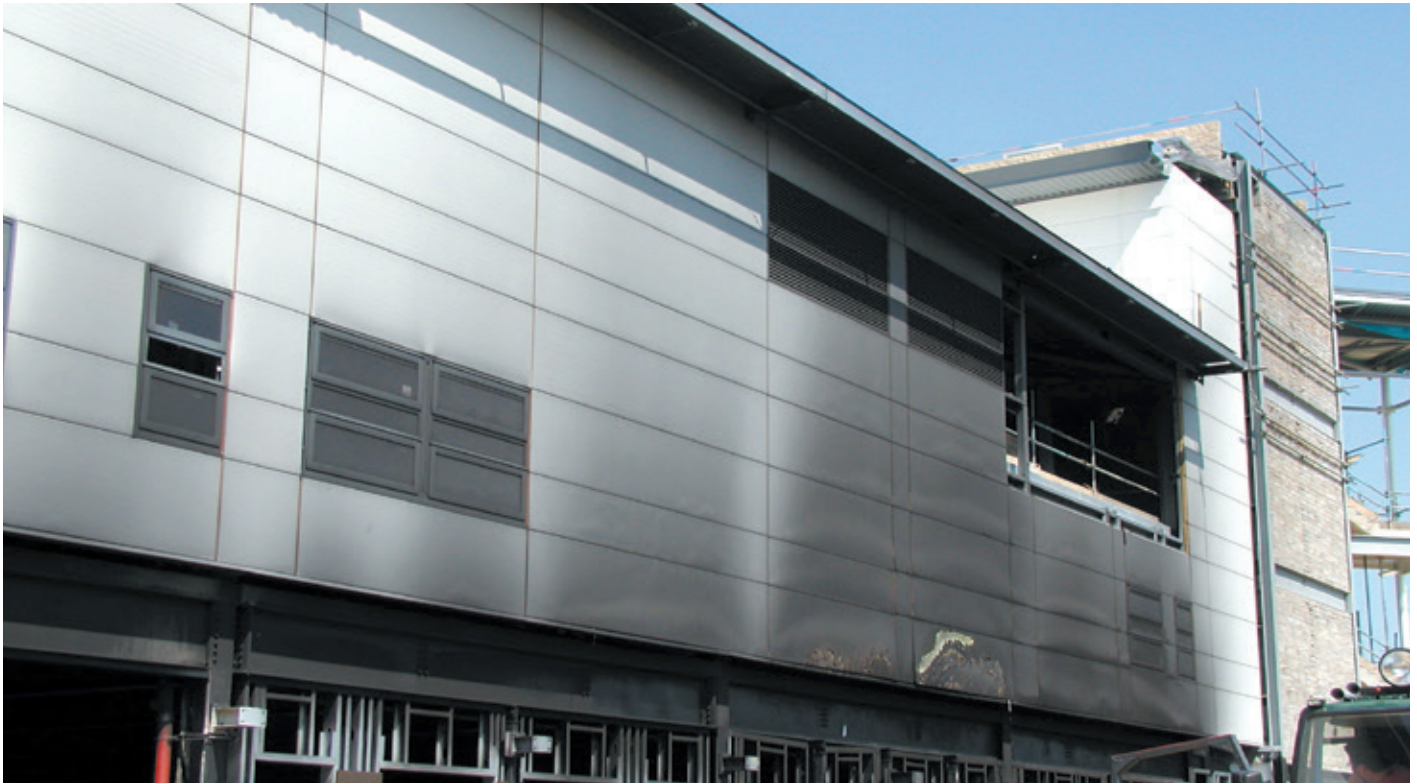
A fire occurred at a hospital under construction during the summer of 2003. The building was steel framed with concrete floors. The first and second floors were clad with Kingspan PIR insulated panels approved by LPCB to EXT-B of LPS 1181 Part 1.

The heat generated by the fire was significant, as evidenced by cracking of the concrete floor above the fire and the distortion of steel beams that had been protected by a fire resisting intumescent coating.

The fire service found light smoke but no fire spread on the upper floors of the building. They also reported that although the joint between the floor and first floor walls had not been fire stopped there was no fire spread within the PIR core material. *Photograph 2* shows where the flame damaged outer skin of the bottom panel has been lifted to inspect the slight charring of PIR core beneath.

The main image above shows where the insulated cladding panels on the external face of the building had been attacked by flames.

In spite of a very severe fire at ground level (sufficient to damage the concrete floors and distort fire protected steel beams) the cores of the insulated panels:

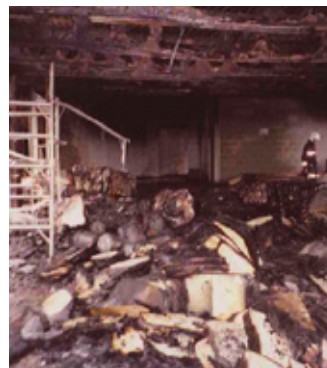
Photograph 1

The fire, which was caught on CCTV, was started maliciously by two people pouring a flammable liquid over the interior of a vehicle parked across the front of the building. Flames impinged on the building and there was an 'explosion' of debris from the sides and top of the vehicle causing a fireball and burning debris to be projected onto the cladding, as captured by the CCTV image (*photograph 1*).

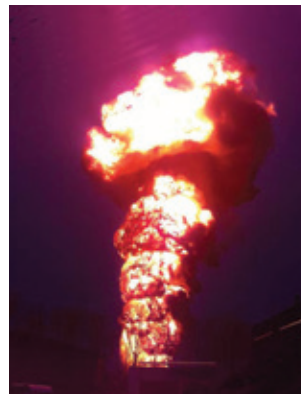
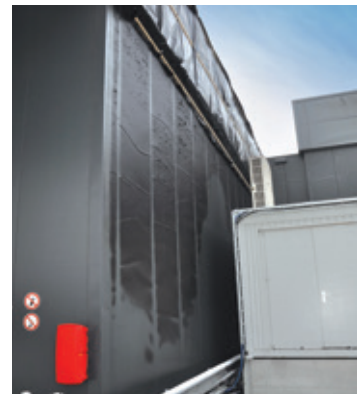
There appears to have been little or no direct flame impingement on the external cladding of the building. However, the building would have been subject to high levels of radiant heat flux from the fire plume and this has been estimated to be of the order of  $24\text{kW/m}^2$ .

The intensity of radiation received by the panels caused some surface flaming but this ceased after approximately 30s (presumably after the surface coating had burned away). There was otherwise no evidence of self-sustaining flaming from the panel surface or at joints between panels.

As a result of the intensity of heat radiation the steel facing to the panels became rippled and delaminated from the foam core but there was only limited foam degradation at the core surface.

Despite the intensity of heat radiation being sufficient to cause ignition of the roofing system and being approximately double normal design values there was no evidence of any significant charring of the PIR panel cores or the promotion of fire spread via the panels.

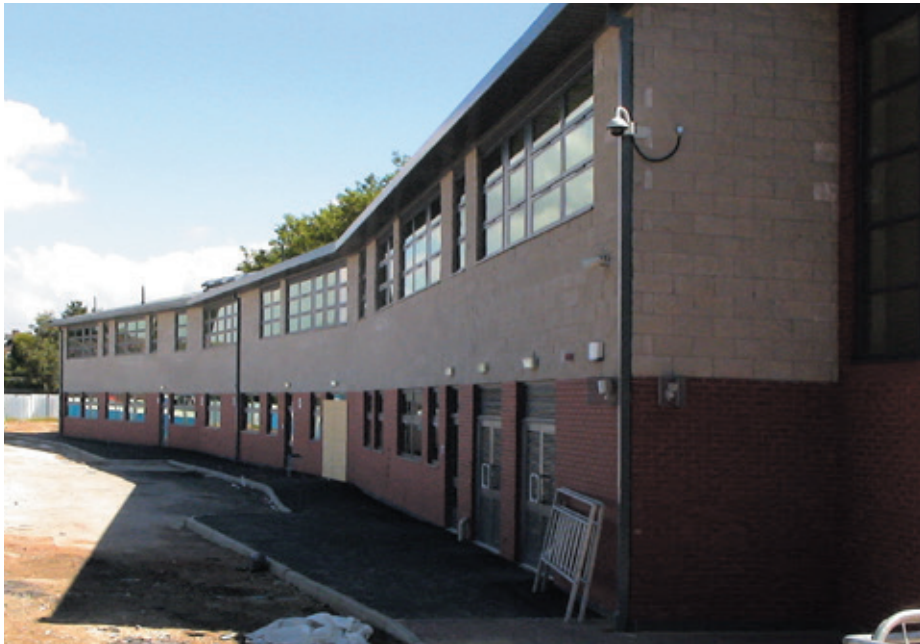
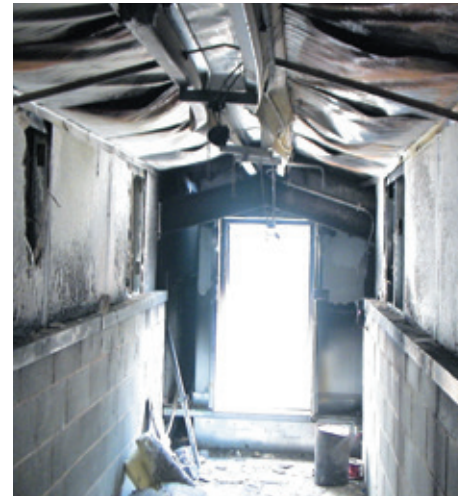
Photograph 1

*Photograph 1* shows the area where the fire started, in an enclosed passageway linking two open air plant areas on the roof. There was scaffolding at the rear of the premises which gave access to the roof and the fire was thought to have been caused by the accidental or malicious ignition of roof sealant.

- The Kingspan insulated roof panels did not contribute to the cause of the fire.
- The Kingspan insulated roof panels did not contribute to fire spread to any other area of the building and assisted in containing the fire.
- Had the roof been of a more traditional construction (e.g. tiles on timber battens with a felt membrane), the fire may have been severe enough to ignite the roof construction and cause the fire to spread over the compartment walls.

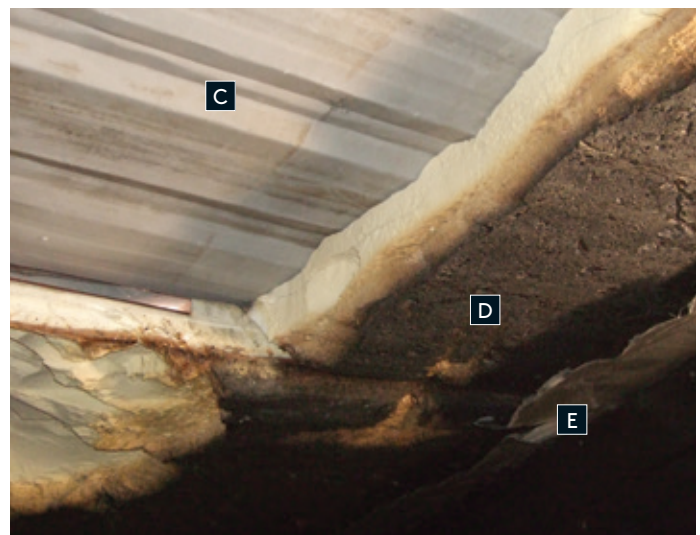
C: Temporary roof covering over hole in roof. D: PIR core showing delaminated lower surface and extent of through-thickness charring. E: Cut edge of lower steel skin of sandwich panel.

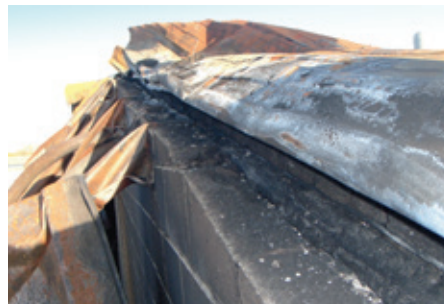
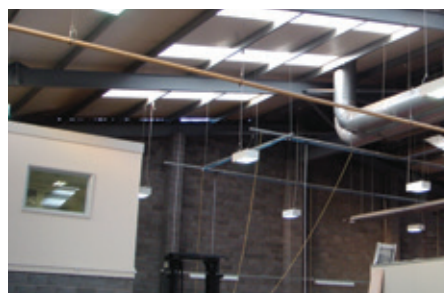
An examination, carried out on the panel interface at the head of the wall, showed that the PIR core had charred to form a stable and effective seal between the steel skins of the sandwich panel to prevent fire transmission to the protected side of the wall. It should be noted that UK design guidance now recognises that an alternative approach might be to use a panel system which has been shown in a large scale test to resist internal and external surface flaming and concealed burning.

The charring exhibited by the Kingspan Insurer Certified PIR core material indicated the formation of a sufficiently stable char within the panel to provide an effective fire stop between the steel skins of the cladding panels at the head of the compartment party wall.

The findings of the site inspection provide evidence that the Insurer Certified PIR core of the Kingspan Trapezoidal KS1000 RW panel can provide sufficient resistance to fire propagation and erosion to such an extent that the functional requirement of the UK Building Regulations (Regulation B3) can be satisfied without providing a 300mm wide band of limited combustibility material to replace the PIR core where the panel passes over a compartment wall.

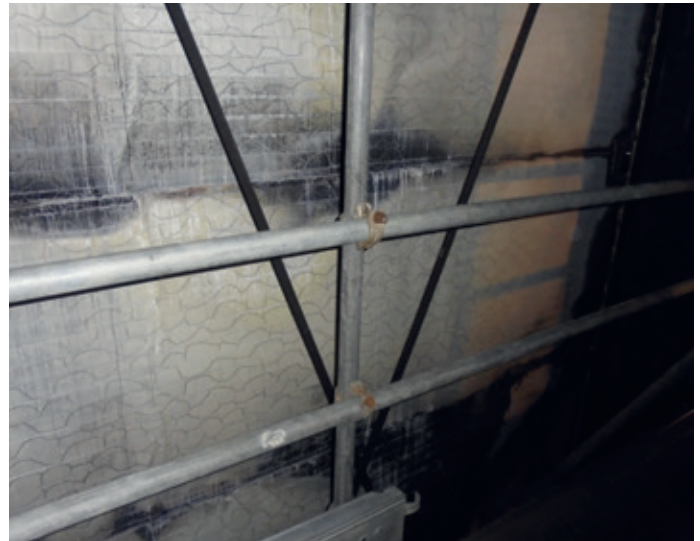
Panels exposed to fire internally.

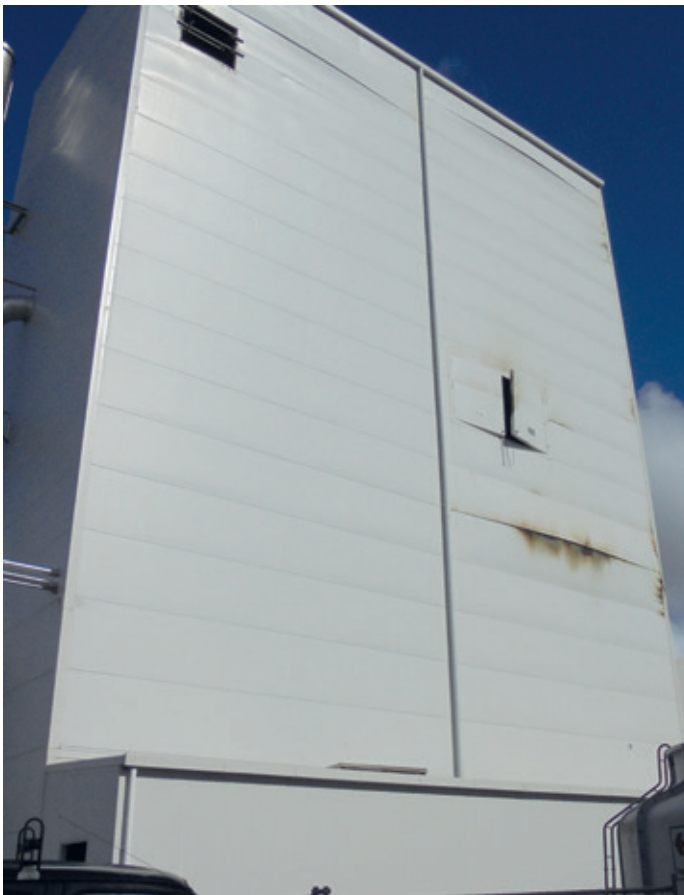
Milk powder drying tower showing external fire damage to panels explosion doors opened manually after fire).

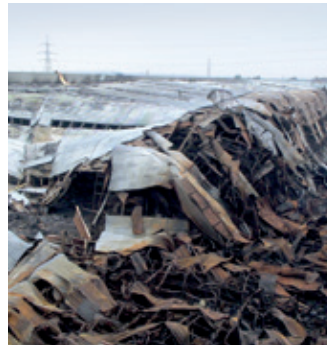
Collapsed south end of building.

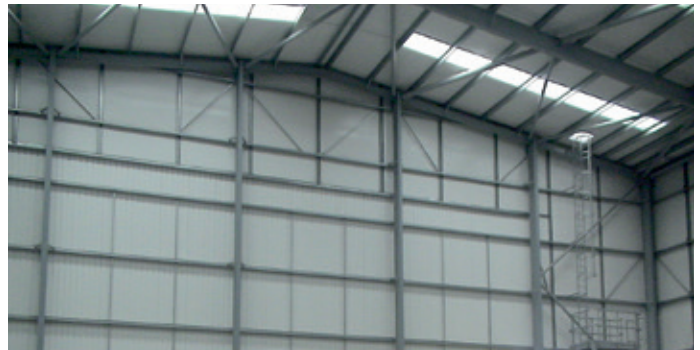
No heat transfer damage to interior of adjacent property.

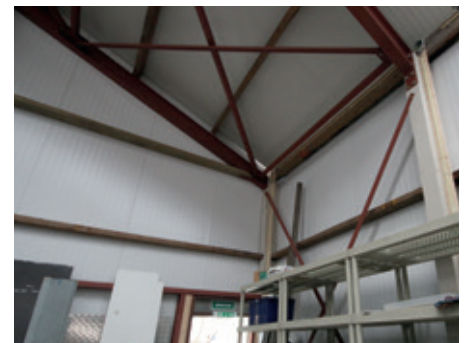
No heat transfer damage to interior of adjacent property (building A).

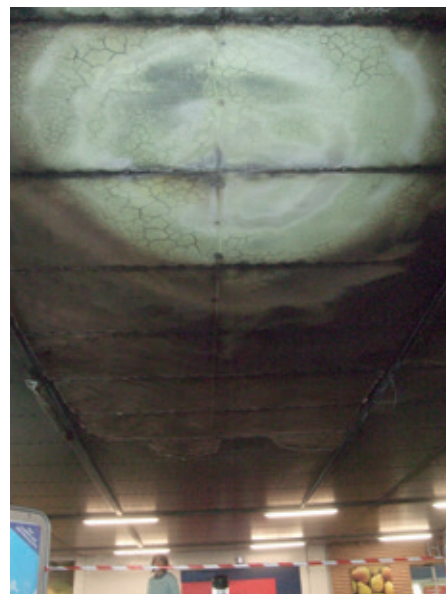
Evidence of direct flame impingement on soffit lining directly above the car.
