M4 Corridor around Newport

Environmental Statement Volume 3: Appendix 10.14 Aquatic Macrophyte Survey 2014

M4 CORRIDOR AROUND NEWPORT, SOUTH WALES

BASELINE AQUATIC MACROPHYTE SURVEY 2014

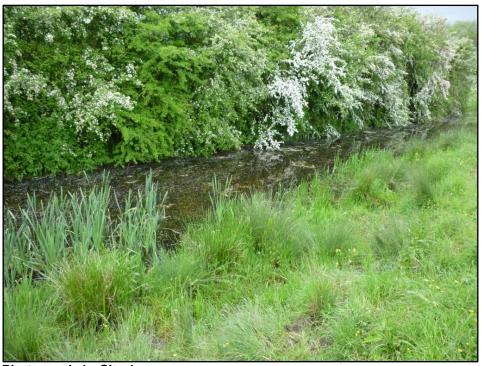
Photograph 1 - Site 1

3.4 Site 1 is Neways Reen, located on the eastern border of the Tata Steel land (see Photograph 1), within the Gwent Levels - Whitson SSSI. Table 1 details the parameters recorded at the site.

3.5 A total of 23 species of aquatic macrophyte were recorded here (see Appendix 1), including emergent vegetation such as Lesser Water-parsnip Berula erecta, Common Spike-rush Eleocharis palustris, Pink Water-speedwell Veronica catenata, Arrowhead Sagittaria sagittifolia and Brooklime Veronica beccabunga. A number of floating species occur here including Greater Duckweed Spirodella polyrhiza, Frogbit Hydrocharis morsus-ranae and Ivy-leaved Duckweed Lemna trisulca. Submerged vegetation includes Rigid Hornwort Ceratophyllum demersum and Curly Pondweed Potamogeton crispus. The Red Data Book species Tubular Water-dropwort Oenanthe fistulosa occurs here.

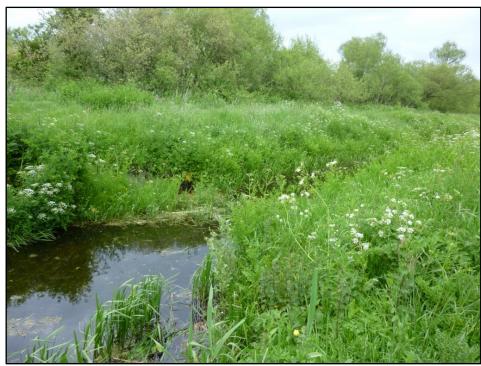
Photograph 2 - Site 3

3.8 Middle Road Reen is a wide, deep reen with steep banks (see Photograph 2). The banks are well vegetated, making access to the reen difficult in places. Middle Road Reen is located within the Tata Steel site and lies within the Gwent Levels - Whitson SSSI. Table 3 details the reen.

3.9 A total of 12 species of aquatic macrophyte were recorded from Site 3. This includes the emergent species Great Willowherb *Epilobium hirsutum*, Reed Sweet-grass *Glyceria maxima*, Amphibious Bistort *Persicaria amphibia* and Hemlock Water-dropwort *Oenanthe crocata*. Floating vegetation includes Frogbit *Hydrocharis morsus-ranae*, Common Duckweed *Lemna minor* and Greater Duckweed *Spirodella polyrhiza*. Submerged vegetation includes Spiked Water-milfoil *Myriophyllum spicatum* and Small Pondweed *Potamogeton berchtoldii*. Small pockets of filamentous algae occur at this reen.

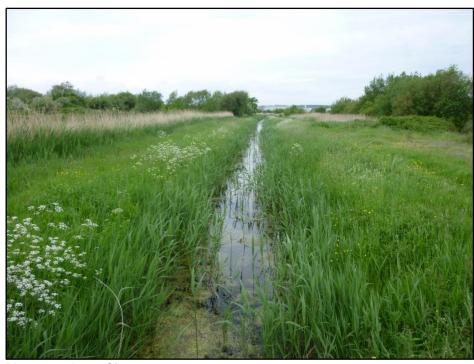
Photograph 3 - Site 4

3.10 Elver Pill Reen is a narrow, deep reen, located within the Tata Steel site (see Photograph 3), within the Gwent Levels - Whitson SSSI. Table 4 details the reen.

3.11 A total of 7 species of aquatic macrophyte were recorded from Site 4. The ditch is dominated by Common Reed *Phragmites australis*. Other vegetation includes floating Ivy-leaved Duckweed *Lemna trisulca* and Common Duckweed *Lemna minor*. Submerged vegetation is limited to Spiked Water-milfoil *Myriophyllum spicatum*. Filamentous algae occurs at this reen.

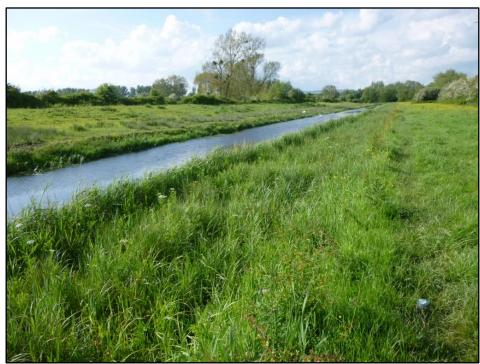
Photograph 4 - Site 5

3.12 Site 5 is a wide reen which runs parallel to North Row (road) off the A4810 (see Photograph 4) and lies within the Gwent Levels - Redwick and Llandevenny SSSI. It is connected to Sites 3 and 4. Table 5 details this site.

3.13 A total of 32 species of aquatic macrophyte were recorded from Site 5. This is the greatest number of species found at any site across the study area. Emergent vegetation includes Greater Pond-sedge Carex riparia, Water Mint Mentha aquatica, Water Dock Rumex hydrolapathum, Wild Angelica Angelica sylvestris, Cyperus Sedge Carex pseduocyperus, Marsh Thistle Cirsium palustre, Marsh Bedstraw Galium palustre and Arrowhead Sagittaria sagittifolia. The Red Data Book species Tubular Water-dropwort Oenanthe fistulosa occurs here. Floating vegetation includes Greater Duckweed Spirodela polyrhiza and Common Duckweed Lemna minor. Submerged

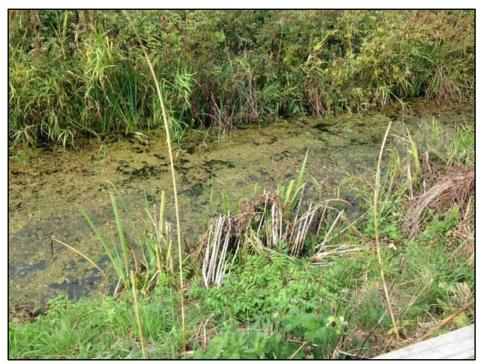
Photograph 5 - Site 6

3.14 Site 6 is a narrow, deep reen which runs adjacent to the A4810, close to Meadow Farm, within the Gwent Levels - Redwick and Llandevenny SSSI. The banks are steep and well vegetated (see Photograph 5). An algal scum lay on the surface of the water on every survey visit. Table 6 details this reen.

3.15 A total of 11 species of aquatic macrophyte were recorded from Site 6. This includes emergent vegetation such as Water Dock *Rumex hydrolapathum*, Yellow Flag *Iris pseudacorus* and Lesser Pond-sedge *Carex acutiformis*. Floating vegetation includes Frogbit *Hydrocharis morsus-ranae*, Common Duckweed *Lemna minor* and Greater Duckweed *Spirodella polyrhiza*.

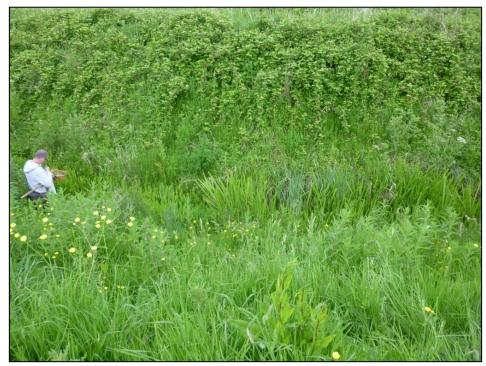
Photograph 6 - Site 8

3.17 Site 8 is a narrow ditch situated adjacent to Monk's Drain (see Photograph 6). The ditch is well vegetated. Table 7 details this site.

3.18 A total of 7 species of aquatic macrophyte were recorded from Site 8. This includes emergent vegetation such as Water Horsetail *Equisetum fluviatile*, Lesser Water-parsnip *Berula erecta*, Branched Bur-reed *Sparganium erectum* and Hard Rush *Juncus inflexus*.

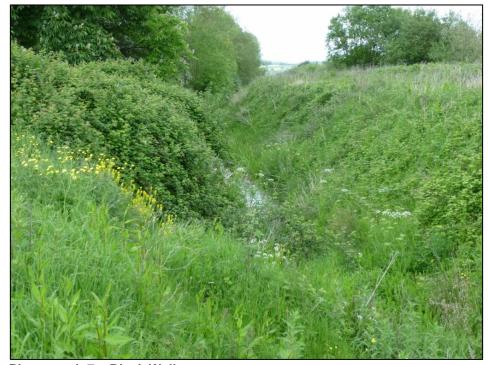
Photograph 7 - Black Wall reen

3.19 Site 9 is Black Wall reen, which is situated on the western side of Monk's Drain (see Photograph 7), within the Gwent Levels Nash and Goldcliff SSSI. It is botanically species-poor and similar to Site 8. Table 8 details this site.

3.20 A total of 7 species of aquatic macrophyte were recorded from Site 9. Submerged vegetation comprises of Rigid Hornwort Ceratophyllum demersum. Emergent vegetation includes Branched Bur-reed Sparganium erectum, Yellow Flag Iris pseudacorus, Reed Canary-grass Phalaris arundinacea and Hemlock Water-dropwort Oenanthe crocata.

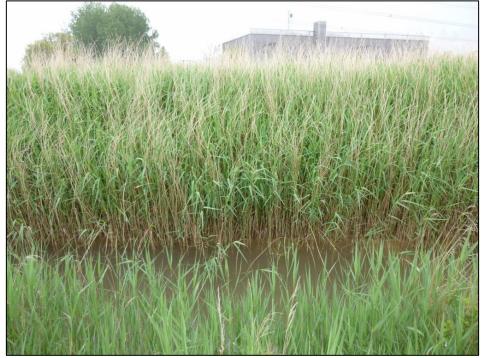
Photograph 8 - Site 10

3.21 Site 10 is a reen within the land behind the 'Air Products' factory. The whole of this land is criss-crossed with species-poor polluted reens. Table 9 details this reen.

3.22 A total of 2 species of aquatic macrophyte were recorded from Site 10. This includes Common Reed *Phragmites australis* (see Photograph 8) with Greater Willowherb *Epilobium hirsutum*.

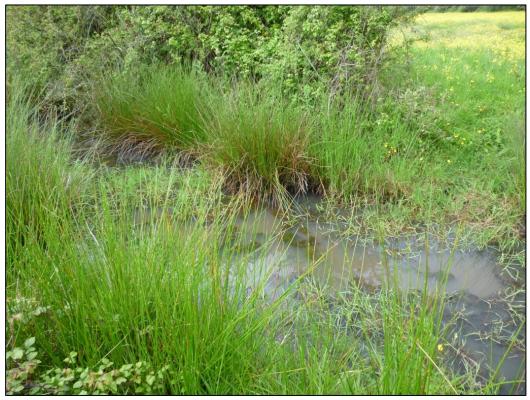
Photograph 9 - Site 11

3.23 Site 11 is a ditch which lies just north of the disused laboratory site (see Photograph 9). Table 10 details the site.

3.24 A total of 10 species of aquatic macrophyte were recorded at Site 11. This includes emergent vegetation such as Common Spike-rush *Eleocharis palustris*, Water-plantain *Alisma plantago-aquatica* and Floating Sweet-grass *Glyceria fluitans*. Floating vegetation includes Common Duckweed *Lemna minor*. Parsley Water-dropwort *Oenanthe lachenalii* occurs here.

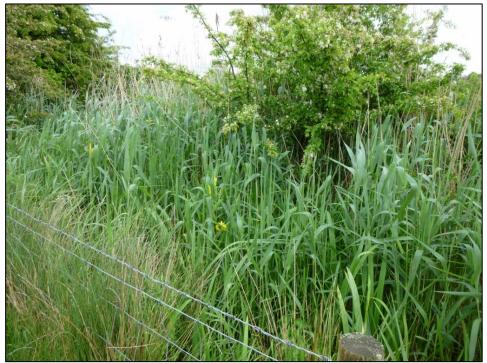
Photograph 10 - Site 12

3.25 Site 12 is a mainly shaded, narrow ditch, covered in tall vegetation (see Photograph 10), within the Gwent Levels - Nash and Goldcliff SSSI. Small stretches of the ditch are unshaded. Table 11 details this site.

3.26 A total of 14 species of aquatic macrophyte were recorded from Site 12. This includes emergent vegetation such as Common Reed *Phragmites australis*, Hairy Sedge *Carex hirta*, Yellow Flag *Iris pseudacorus*, Greater Pond-sedge *Carex riparia*, Gipsywort *Lycopus europaeus* and Marsh Bedstraw *Galium palustre*. Floating vegetation includes Common Duckweed *Lemna minor* and Least Duckweed *Lemna minuta*.

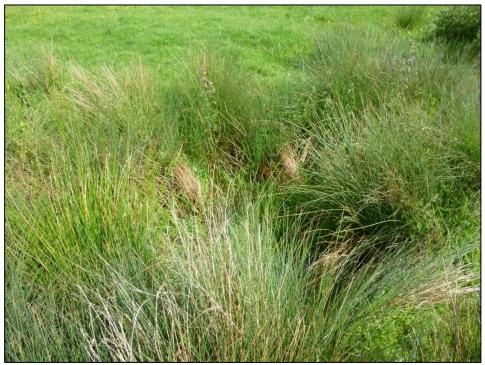
Photograph 11 - Site 13

3.27 Site 13 is a shallow ditch (see Photograph 11), within the Gwent Levels - Nash and Goldcliff SSSI. The ditch is covered in vegetation, with the odd pocket of open water. Table 12 details Site 13.

3.28 A total of 13 species of aquatic macrophyte were recorded from Site 13. This includes emergent vegetation such as Greater Pond-sedge *Carex riparia*, Fool's-water-cress *Apium nodiflorum*, Celery-leaved Buttercup *Ranunculus sceleratus* and Soft Rush *Juncus effusus*. Floating vegetation includes Common Duckweed *Lemna minor* and Least Duckweed *Lemna minuta*.

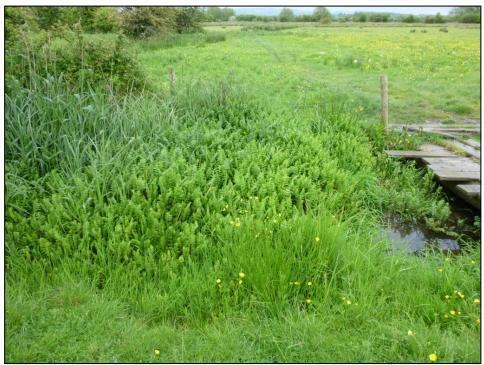
Photograph 12 - Site 14

3.29 Site 14 is a shallow ditch (see Photograph 12), within the Gwent Levels - Nash and Goldcliff SSSI. The majority of the ditch is shaded apart from at a land bridge, which is where the survey took place. Table 13 details the site.

3.30 A total of 6 species of aquatic macrophyte were recorded at Site 14. Vegetation includes Water Forget-me-not *Myosotis scorpioides*, Hard Rush *Juncus inflexus*, Lesser Water-parsnip *Berula erecta*, Cuckooflower *Cardamine pratensis* and Reed Sweet-grass *Glyceria fluitans*.

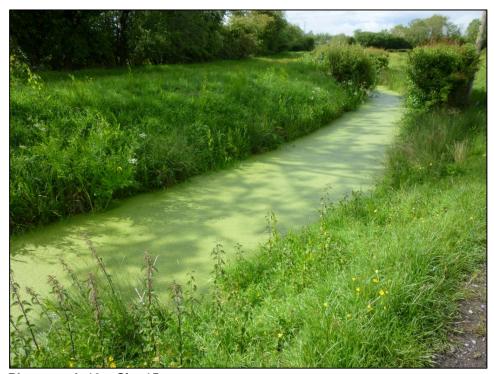
Photograph 13 - Site 15

3.31 Julian's Reen is a wide reen, situated next to a farm track (see Photograph 13), within the Gwent Levels - Nash and Goldcliff SSSI. Table 14 details Site 15.

3.32 A total of 10 species of aquatic macrophyte were recorded from Site 15. The water is completely covered in Common Duckweed *Lemna minor* and Greater Duckweed *Spirodela polyrhiza*. Emergent vegetation includes Lesser Pondsedge *Carex acutiformis*, Water Figwort *Scrophularia auriculata* and Yellow Flag *Iris pseudacorus*.

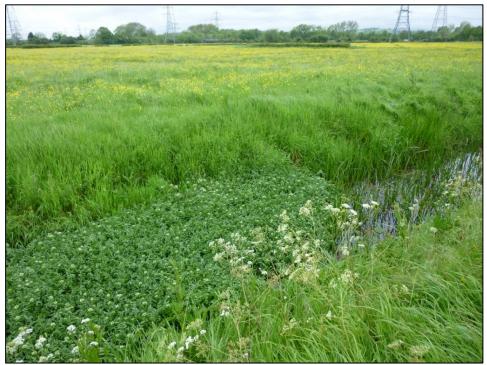
Photograph 14 - Site 16

3.33 Site 16 is a wide reen running by the side of a track leading to New Dairy Farm (see Photograph 14), within the Gwent Levels - St. Brides SSSI. Table 15 details this site.

3.34 A total of 15 species of aquatic macrophyte were recorded from Site 16. The vegetation exists in dense clusters, fragmented by stretches of open water. Emergent species include Water-cress *Nasturtium officinale*, Lesser Water-parsnip *Berula erecta*, Reed Canary-grass *Phalaris arundinacea* and Marsh Woundwort *Stachys palustris*. Floating species include Frogbit *Hydrocharis morsus-ranae* and Broad-leaved Pondweed *Potamogeton natans*.

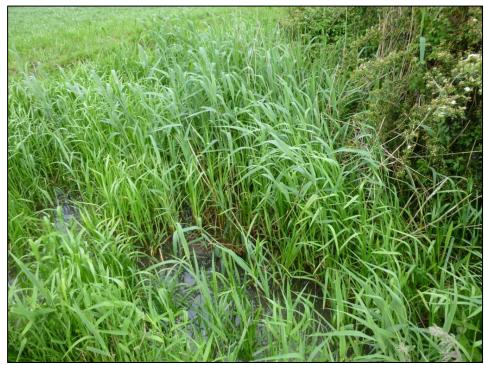
Photograph 15 - Site 17

3.35 Site 17 is a where two ditches meet, within the Gwent Levels - St. Brides SSSI. This corner ditch is narrow and shallow (see Photograph 15). Table 16 details the site.

3.36 A total of 4 species of aquatic macrophyte were recorded within Site 17. The ditch is covered in Reed Sweet-grass *Glyceria maxima* with patches of Common Reed *Phragmites australis*. Floating species comprise of Least Duckweed *Lemna minuta*.

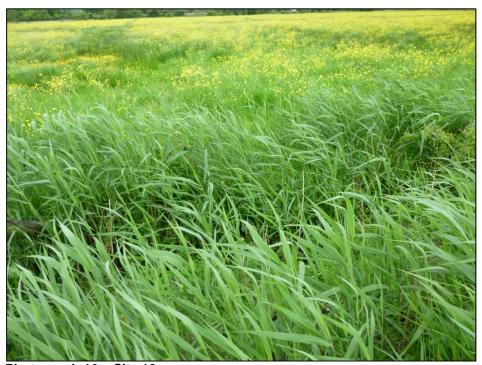
Photograph 16 - Site 18

3.37 Site 18 is a narrow ditch which is connected to Site 16 (see Photograph 16), within the Gwent Levels - St. Brides SSSI. The ditch has emergent vegetation on the edges and a small amount of open water in the centre. Table 17 details the site.

3.38 A total of 13 species of aquatic macrophyte were recorded from Site 18. Emergent vegetation includes Hairy Sedge *Carex hirta*, Marsh Woundwort *Stachys palustris*, Common Reed *Phragmites australis*, Lesser Water-parsnip *Berula erecta* and Water Horse-tail *Equisetum fluviatile*. Floating vegetation comprises of Frogbit *Hydrocharis morsus-ranae*.

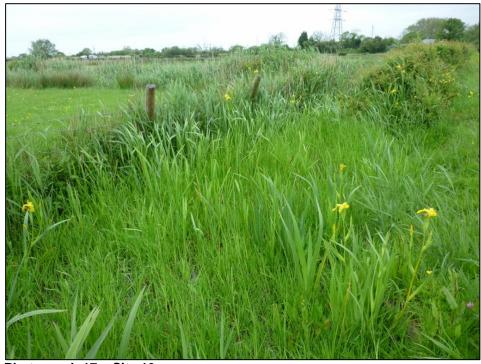
Photograph 17 - Site 19

3.39 Site 19 lies opposite Old Dairy Reen (Site 20) and runs parallel with it, within the Gwent Levels - St. Brides SSSI (see Photograph 17). The ditch is partially cattle poached. No open water exists. Table 18 details the site.

3.40 A total of 11 species of aquatic macrophyte were recorded from Site 19. Emergent vegetation covers the reen and includes Yellow Flag *Iris pseudacorus*, Marsh Bedstraw *Galium palustre*, Branched Bur-reed *Sparganium erectum*, Lesser Pond-sedge *Carex acutiformis*, Water Forgetme-not *Myosotis scorpioides* and Water-pepper *Persicaria hydropiper*. The Red Data Book species Tubular Water-dropwort *Oenanthe fistulosa* occurs here.

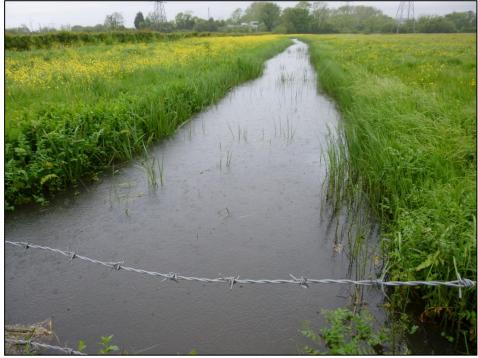
Photograph 18 - Site 20

3.41 Site 20 is Old Dairy Reen, a wide reen (see Photograph 18), within the Gwent Levels - St. Brides SSSI. Table 19 details the site.

3.42 A total of 13 species of aquatic macrophyte were recorded from Site 20. Emergent vegetation includes Lesser Water-parsnip Berula erecta, Water Horse-tail Equisetum fluviatile, Flowering-rush Butomus umbellatus, Jointed Rush Juncus articulatus and Branched Bur-reed Sparganium erectum. Floating vegetation includes Common Duckweed Lemna minor. Submerged vegetation comprises of Nuttall's Waterweed Elodea nuttallii. The Red Data Book species Tubular Water-dropwort Oenanthe fistulosa occurs here.

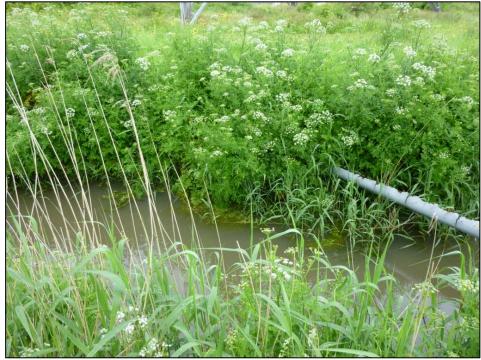
Photograph 19 - Site 21

3.43 Site 21 runs alongside Green Lane, on the northern boundary of the Gwent Levels - St. Brides SSSI. It is a wide reen with emergent vegetation at the edges and open water in the centre (see Photograph 19). Table 20 details Site 21.

3.44 A total of 4 species of aquatic macrophyte were recorded from Site 21. Emergent vegetation includes Common Reed *Phragmites australis* and Hemlock Water-dropwort *Oenanthe crocata*. Floating vegetation includes Common Duckweed *Lemna minor* and Greater Duckweed *Spirodela polyrhiza*.

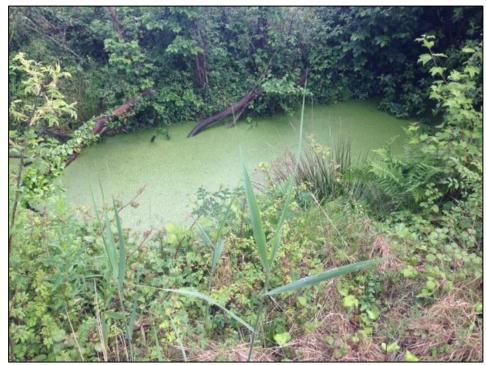
Photograph 20 - Site 22

3.45 Site 22 is a shaded ditch of poor quality (see Photograph 20), within the Gwent Levels - St. Brides SSSI. A small part could be sampled. Table 21 details this site.

3.46 A total of 4 species of aquatic macrophyte were recorded from Site 22. The water surface is completely covered in Common Duckweed *Lemna minor* and Greater Duckweed *Spirodela polyrhiza*. Emergent vegetation includes Soft Rush *Juncus effusus* and Lesser Water-parsnip *Berula erecta*.

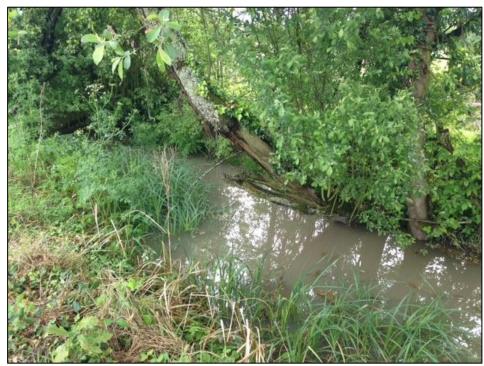
Photograph 21 - Site 23

3.47 Site 23 is a shaded ditch of poor quality (see Photograph 21), within the Gwent Levels - St. Brides SSSI. Table 22 details the site.

3.48 A total of 6 species of aquatic macrophyte were recorded from Site 22. Emergent vegetation includes Floating Sweet-grass *Glyceria fluitans*, Reed Canary-grass *Phalaris arundinacea* and Hemlock Water-dropwort *Oenanthe crocata*.

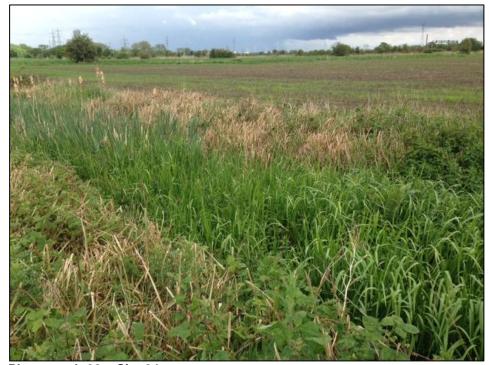
Photograph 22 - Site 24

3.49 Site 24 is an unshaded ditch, covered in vegetation (see Photograph 22), within the Gwent Levels - St. Brides SSSI. Table 23 details this site.

3.50 A total of 4 species of aquatic macrophyte were recorded from Site 24. Floating vegetation includes New Zealand Pigmyweed *Crassula helmsii* and Common Duckweed *Lemna minor*. Emergent vegetation includes Reed Sweet-grass *Glyceria maxima* and Bulrush *Typha latifolia*. *Crassula helmsii* is an invasive species, listed on Schedule 9 of The Wildlife & Countryside Act 1981 (as amended).

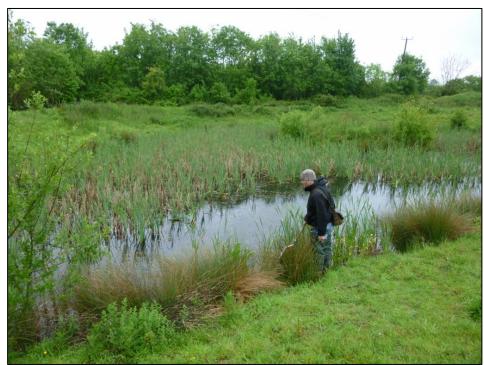
Photograph 23 - Site 25

3.51 Site 25 is a large, open pond (see Photograph 23), situated just north of a disused road on the western edge of Newport. Table 24 details Site 25.

3.52 A total of 14 species of aquatic macrophyte were recorded within Site 25. The pond supports a mixture of open water and emergent and marginal vegetation, including Lesser Spearwort Ranunculus flammula, Water Dock Rumex hydrolapathum, Gipsywort Lycopus europaeus, Bulrush Typha latifolia and Broad-leaved Pondweed Potamogeton natans. Submerged vegetation includes New Zealand Pigmyweed Crassula helmsii and Nuttall's Waterweed Elodea nuttallii.

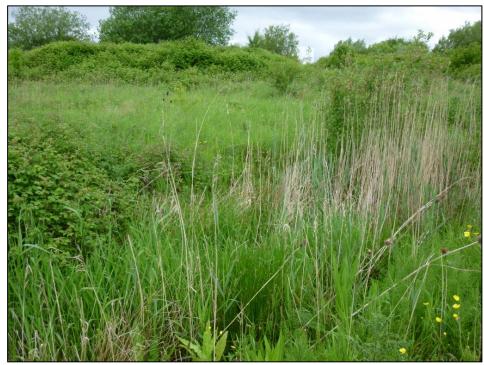
Photograph 24 - Site 26

3.53 Site 26 is a small stream (see Photograph 24), which flows into a small pond, close to the disused site of Great Pen-carn. Table 25 details this site.

3.54 A total of 5 species of aquatic macrophyte were recorded within the stream at Site 26. Emergent vegetation includes Floating Sweet-grass *Glyceria fluitans*, Reed Canary-grass *Phalaris arundinacea*, Greater Bird's-foot Trefoil *Lotus pedunculatus* and Hard Rush *Juncus inflexus*.

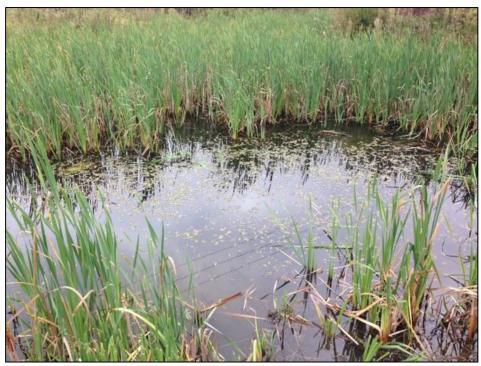
Photograph 25 - Site 28

3.57 Site 28 is a large, recently created pond (see Photograph 25). The pond is part of a County Wildlife Site. Table 27 details the site.

3.58 A total of 13 species of aquatic macrophyte were recorded from within the pond at Site 28. Emergent vegetation includes Common Spike-rush Eleocharis palustris, Bulrush Typha latifolia, Water-plantain Alisma plantago-aquatica, Hard Rush Juncus inflexus and Bittersweet Solanum dulcamara. Floating vegetation includes Ivy-leaved Duckweed Lemna trisulca and Broadleaved Pondweed Potamogeton natans. Submerged vegetation comprises of Spiked Water-milfoil Myriophyllum spicatum.

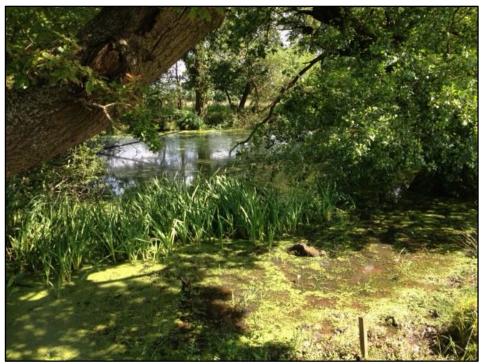
Photograph 26 - Site 29

3.59 Site 29 is a large pond (see Photograph 26). It is 80% shaded along its edge by mature trees and scrub. The edges of the pond are deep silt. Table 28 details the site.

3.60 A total of 17 species of aquatic macrophyte were recorded from Site 29. Emergent vegetation includes Brooklime *Veronica beccabunga*, Waterplantain *Alisma plantago-aquatica*, Small Sweet-grass *Glyceria declinata*, Remote Sedge *Carex remota* and Tufted Forget-me-not *Myosotis laxa*. Submerged vegetation includes Water Star-wort *Callitriche stagnalis*. Floating vegetation includes Greater Duckweed *Spirodella polyrhiza* and Common Duckweed *Lemna minor*.

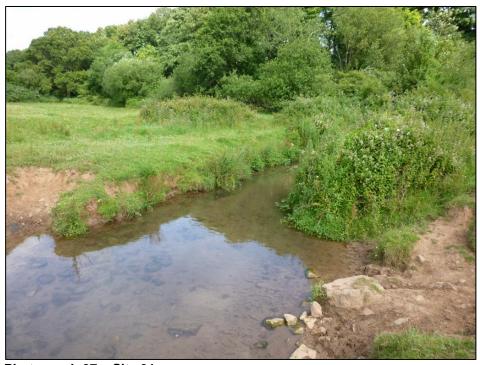
Photograph 27 – Site 31

3.63 Site 31 is St. Bride's Brook, a stream which flows through the village of Magor (see Photograph 27). The substrate comprises of stones and silt. Table 30 details the site.

3.64 A total of 18 species of aquatic macrophyte were recorded from Site 31. Submerged vegetation comprises of Canadian Pondweed *Elodea canadensis*. Emergent vegetation is varied and includes Water-cress *Nasturtium officinale*, Wild Angelica *Angelica sylvestris*, Water Mint *Mentha aquatica*, Brooklime *Veronica beccabunga* and Water Figwort *Scrophularia auriculata*.

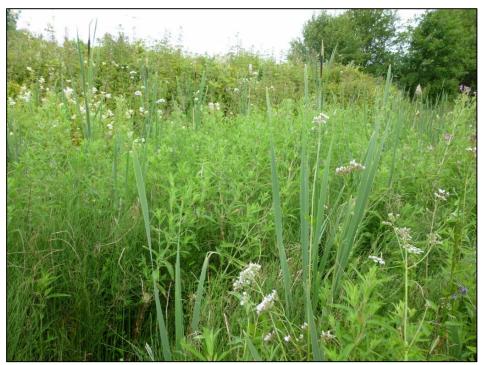
Photograph 28 - Site 32

3.65 Site 32 is a ditch which runs on the southern side of the A4810, close to the Tesco distribution centre, within the Gwent Levels - Redwick and Llandevenny SSSI. It lies at the bottom a steep embankment which supports the road (see Photograph 28). Table 31 details this site.

3.66 A total of 18 species of aquatic macrophyte were recorded from Site 32. Emergent vegetation includes Hemp-agrimony *Eupatorium cannabinum*, Skullcap *Scutellaria galericulata*, Tufted Forget-me-not *Myosotis laxa*, Fool's Watercress *Apium nodiflorum*, Marsh Bedstraw *Galium palustre*, Skullcap *Scutellaria galericulata* and Common Valerian *Valeriana officinalis*. No floating or submerged vegetation exists at Site 32.

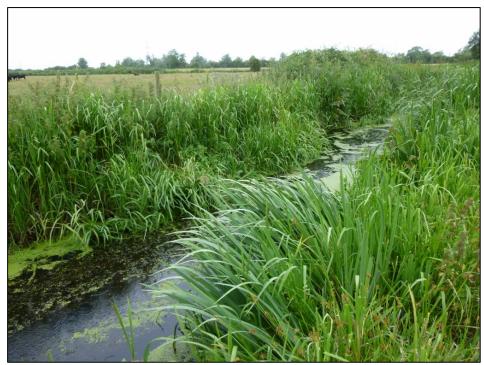
Photograph 29 - Site 33

3.67 Site 33 lies across a field from Site 32, within the Gwent Levels - Redwick and Llandevenny SSSI. It is a well vegetated ditch and supports areas of open water (see Photograph 29). Table 32 details the site.

3.68 A total of 30 species of aquatic macrophyte were recorded from Site 33. Emergent vegetation includes Reed Sweet-grass *Glyceria maxima*, Water Mint *Mentha aquatica*, Marsh Woundwort *Stachys palustris*, Water-plantain *Alisma plantago-aquatica*, Yellow Flag *Iris pseudacorus* and Celery-leaved Buttercup *Ranunculus sceleratus*. Submerged vegetation comprises of Rigid Hornwort *Ceratophyllum demersum*.and Nuttall's Waterweed *Elodea nuttallii*. Floating vegetation includes Frogbit *Hydrocharis morsus-ranae* and Ivyleaved Duckweed *Lemna trisulca*.

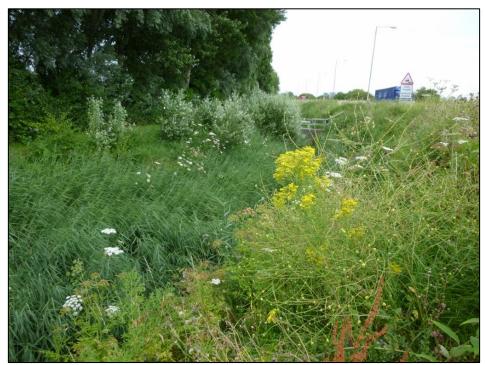
Photograph 30 - Site 34

3.69 Site 34 lies close to the A4810 roundabout which leads to the Tesco distribution centre, within the Gwent Levels - Redwick and Llandevenny SSSI (see Photograph 30). Access to the water was difficult. Table 33 details the site.

3.70 A total of 9 species of aquatic macrophyte were recorded from Site 34. Emergent vegetation includes Common Reed *Phragmites australis*, Hemlock Water-dropwort *Oenanthe crocata*, Tufted Forget-me-not *Myosotis laxa* and Reed Sweet-grass *Glyceria maxima*. Submerged vegetation includes Small Pondweed *Potamogeton berchtoldii*.

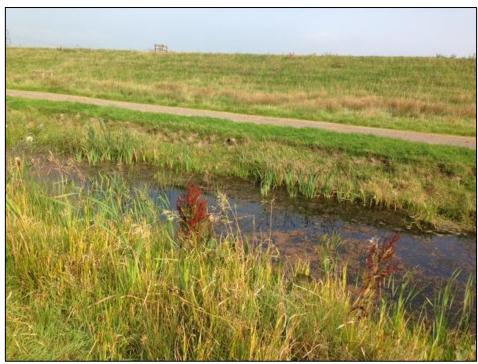
Photograph 31 - Site 37

3.73 Site 37 is a deep, wide reen, close to the River Ebbw (see Photograph 31), within the Gwent Levels - St. Brides SSSI. It was dredged earlier in the year. Table 34 details the site.

3.74 A total of 22 species of aquatic macrophyte were recorded from Site 37. Emergent vegetation includes Arrowhead Sagittaria sagittitifolia, Reed Canary-grass Phalaris arundinacea, Flowering-rush Butomus umbellatus, Soft Rush Juncus effusus and Tufted Forget-me-not Myosotis laxa. Floating vegetation includes Frogbit Hydrocharis morsus-ranae, Water Fern Azolla filiculoides and Ivy-leaved Duckweed Lemna trisulca. Submerged vegetation includes Curly Pondweed Potamogeton crispus, Rigid Hornwort Ceratophyllum demersum and Nuttall's Waterweed Elodea nuttallii. The Red Data Book species Tubular Water-dropwort Oenanthe fistulosa occurs here.

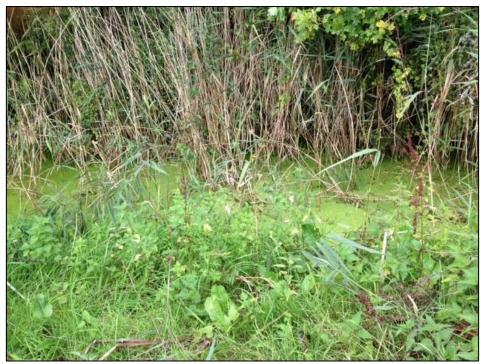
Photograph 32 - Site 38

3.75 Site 38 is a narrow ditch of poor quality, within the Gwent Levels - St. Brides SSSI. It is situated on the edge of improved grassland fields. The ditch is heavily shaded on one side by a mature hedgerow (see Photograph 32). Table 35 details the site.

3.76 A total of 6 species of aquatic macrophyte were recorded from Site 38. Floating vegetation dominates the ditch and includes Common Duckweed Lemna minor and Least Duckweed Lemna minuta. Emergent vegetation includes Common Reed *Phragmites australis*, Yellow Flag *Iris pseudacorus* and Gipsywort *Lycopus europaeus*.

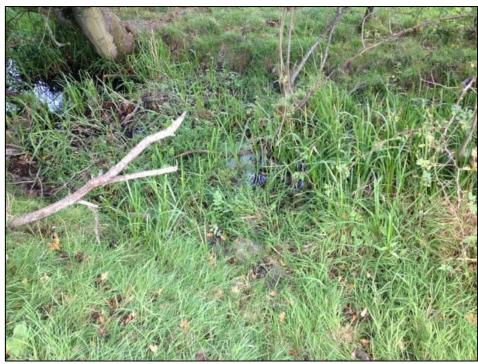
Photograph 33 - Site 39

3.77 Site 39 is a narrow, shallow ditch (see Photograph 33), within the Gwent Levels - St. Brides SSSI. Table 36 details this site.

3.78 A total of 11 species of aquatic macrophyte were recorded from Site 39. This includes emergent vegetation such as Lesser Water-parsnip *Berula erecta*, Water-pepper *Persicaria hydropiper* and Lesser Pond-sedge *Carex acutiformis*. Submerged vegetation includes Common Water-starwort *Callitriche stagnalis*. Floating vegetation includes Common Duckweed *Lemna minor*.

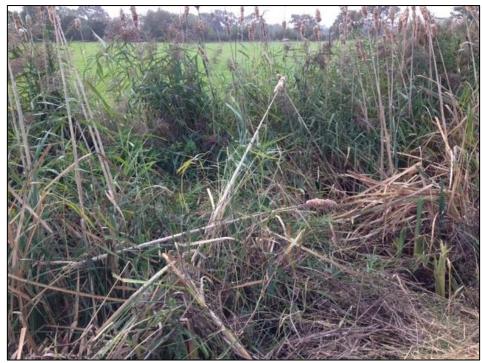
Photograph 34 - Site 40

3.79 Site 40 is a wide ditch which is completely covered in tall vegetation (see Photograph 34), within the Gwent Levels - St. Brides SSSI. Table 37 details this site.

3.80 A total of 4 species of aquatic macrophyte were recorded from Site 40. Emergent vegetation covers the ditch and includes Bulrush *Typha latifolia* with some Reed Canary-grass *Phalaris arundinacea* and Greater Willowherb *Epilobium hirsutum*.

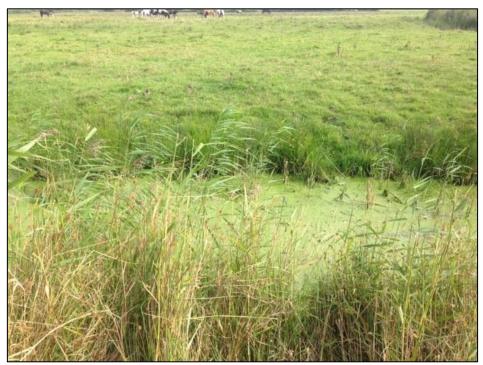
Photograph 35 - Control Site 1

3.83 Control Site 1 is an open ditch (see Photograph 35), within the Gwent Levels - St. Brides SSSI. Table

3.84 A total of 10 species of aquatic macrophyte were recorded from Control Site 1. Floating vegetation dominates the ditch and includes Common Duckweed Lemna minor and Greater Duckweed Spirodela polyrhiza. Emergent vegetation includes Reed Canary-grass Phalaris arundinacea, Lesser Waterparsnip Berula erecta, Water Dock Rumex hydrolapathum and Soft Rush Juncus effusus. Submerged vegetation comprises of Nuttall's Waterweed Elodea nuttallii.

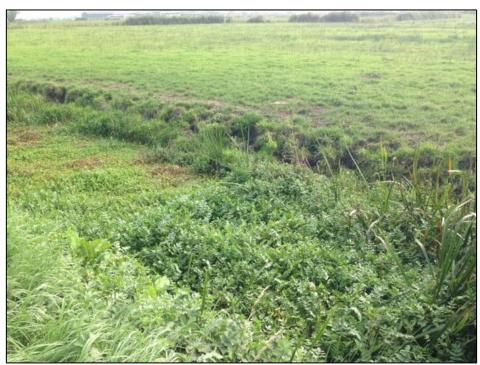
Photograph 36 - Control Site 2

3.85 Control Site 2 is a wide, open reen, covered in vegetation (see Photograph 36). Table 39 details the site.

3.86 A total of 12 species of aquatic macrophyte were recorded from Control Site 2. Emergent vegetation includes Lesser Water-parsnip *Berula erecta*, Marsh Woundwort *Stachys palustris*, Clustered Rush *Juncus conglomeratus* and Branched Bur-reed *Sparganium erectum*. Submerged vegetation includes Nuttall's Waterweed *Elodea nuttallii*. Floating vegetation includes Common Duckweed *Lemna minor* and Least Duckweed *Lemna minuta*.

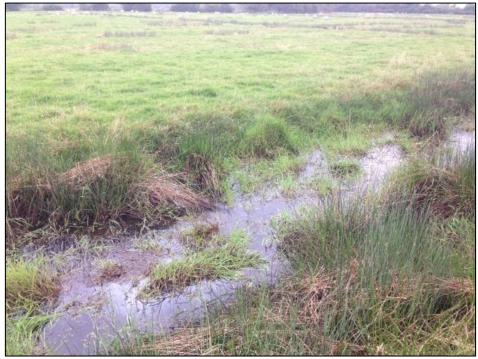
Photograph 37 - Control Site 3

3.87 Control Site 3 is a shallow ditch which is unshaded (see Photograph 37), within the Gwent Levels - Nash and Goldcliff SSSI. Table 40 details the site.

3.88 A total of 5 species of aquatic macrophyte were recorded from Control Site 3. Emergent vegetation includes Small Sweet-grass *Glyceria declinata*, Hard Rush *Juncus inflexus* and Soft Rush *Juncus effusus*. Floating vegetation comprises of Common Duckweed *Lemna minor*.

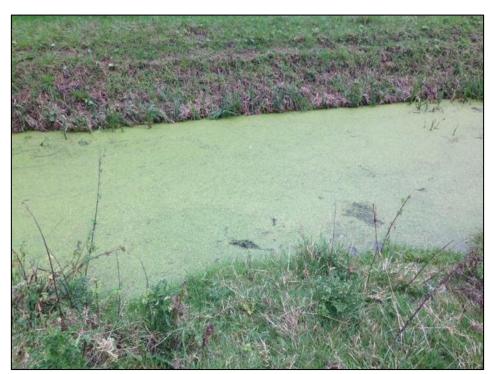
Photograph 38 - Control Site 4

3.89 Control Site 4 is a wide, deep reen (see Photograph 38), within the Gwent Levels - Nash and Goldcliff SSSI. Table 41 details the site.

3.90 A total of 5 species of aquatic macrophyte were recorded from Control Site 4. Floating vegetation includes Common Duckweed *Lemna minor* and Greater Duckweed *Spirodela polyrhiza*. Emergent vegetation includes Reed Sweetgrass *Glyceria maxima*. Submerged vegetation includes Rigid Hornwort *Ceratophyllum demersum*.
