**M4 Corridor around Newport**

December 2016 Environmental  
Statement Supplement

Appendix SS10.3

Bat Roost Surveys of Buildings and  
Structures 2016

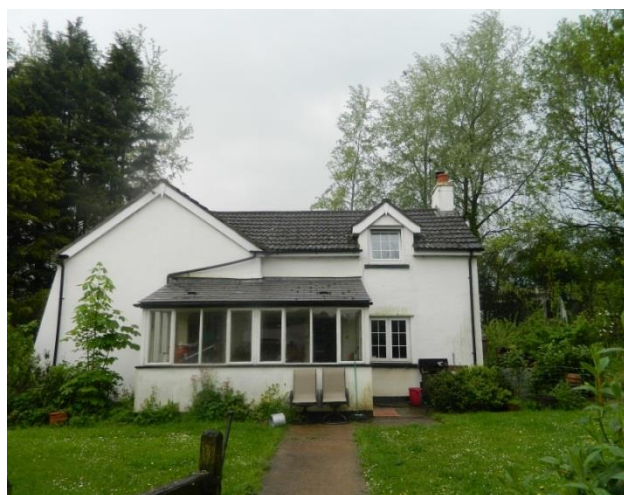
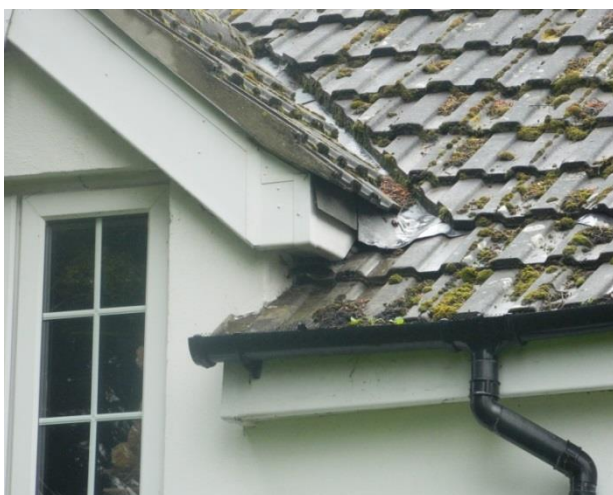
| Building Name | Roost assessment | Notes | Photographs | |
|---|---|---|---|---|
| Barecroft House | Confirmed roost<br><br>Common pipistrelle summer day roost (up to two bats) | Residential house ( <i>Plate1</i> ). Generally tight fitting roof tiles and modern plastic soffit boxes affording a limited number of potential roost locations for bats. Potential roost locations were noted under lead flashing adjacent to south facing dormer windows ( <i>Plate 2</i> ) and gaps between roof tiles along the east facing roof edge ( <i>Plate 1</i> ). | <i>Plate 1 – eastern elevation</i><br> | <i>Plate 2 at south facing elevation</i><br> |

- 4.1.1** Barecroft House is considered to be a summer day roost for a small number of common pipistrelle bats (up to two bats observed during surveys) and is of Local value in accordance with Table 2.3.
- 4.1.2** Barecroft House is connected to good quality foraging habitat along the railway line to the north and along a network of tall hedgerows and tree lines running into Gwent Levels reën, field ditch and wet grassland.

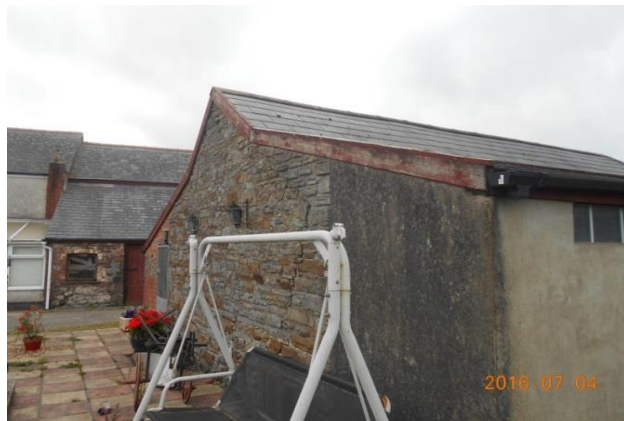
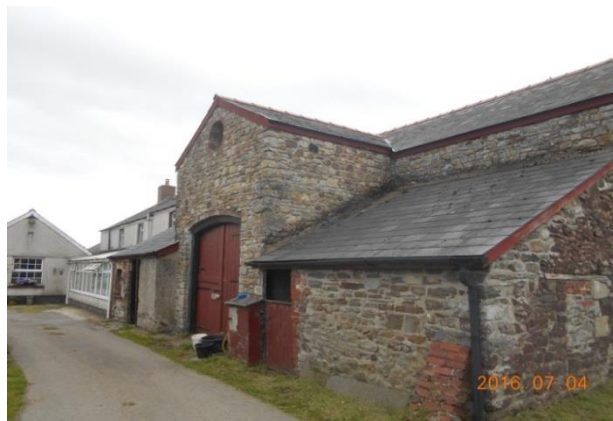
| Building Name | Roost assessment | Notes | Photographs | |
|---|---|---|---|---|
| Fair Orchard Farm | Confirmed roost<br><br>The main building at Fair Orchard Farm (including B2, B3, B4, B5 and B7) is a common pipistrelle summer day roost (up to eight bats). | <u><i>Building 1a and 1b</i></u><br>Two farm sheds with no loft space. Gaps under barge boards suitable for bats to access ( <i>Plate 3</i> ).<br><br><u><i>Building 2 - confirmed roost</i></u><br>This is the northern section of the main building complex. An open circular window on the east-facing gable end provides access into the building ( <i>Plate 4</i> ). An open door used by nesting birds (swallow) also allows access for bats into a small side room of the building. There is no apparent access into the main building from the small side room. Gaps under barge boards and lead flashing provide potential roosts. Deteriorating brick work at the top of wall to west side of building ( <i>Plate 5</i> ) provides cracks and potential access under soffit box. Gaps above a large door also provide potential access for bats into the main building ( <i>Plate 6</i> ). Occasional raised tiles provide potential bat roosts/access.<br><br><u><i>Building 3 – confirmed roost</i></u><br>This is the residential section of the main building complex ( <i>Plate 7</i> ) and forms the middle part of the main farm building complex. Relatively recent renovations, including new brick work, roof, windows and soffit box provide few potential roost locations.<br><br><u><i>Building 4 – confirmed roost</i></u><br>To the south of the residential section there is a series of apparently interconnected stables and sheds ( <i>Plate 8</i> ). Potential access for bats is available over a door, through open windows and broken and damaged | <i>Plate 3 – south facing elevation</i><br> | <i>Plate 4 – east facing elevation of B2</i><br> |

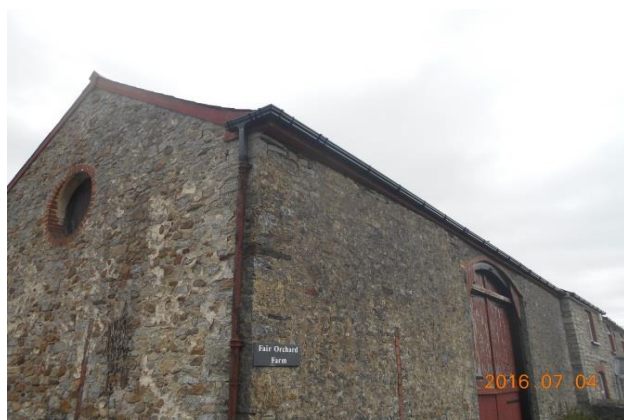
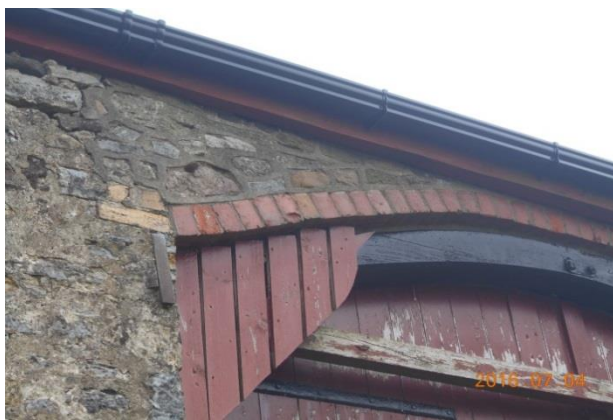
| Building Name | Roost assessment | Notes | Photographs | |
|---|---|---|---|---|
| | | | <i>Plate 5 north facing gable end and west facing wall of B2</i><br> | <i>Plate 6 top of door and gaps within fascia boards of B2</i><br> |

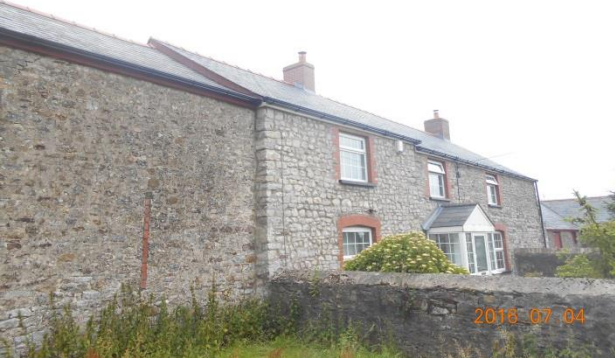
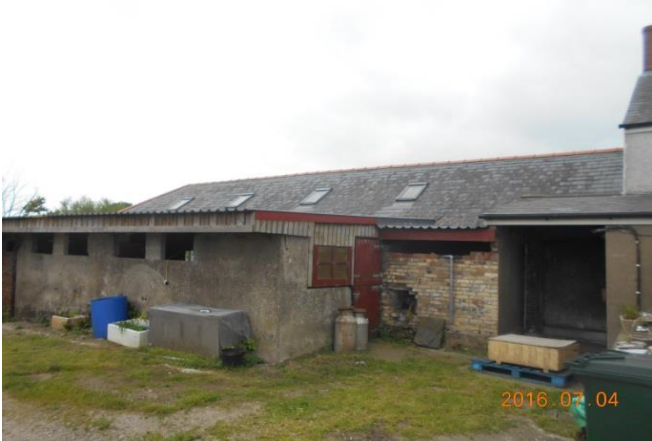
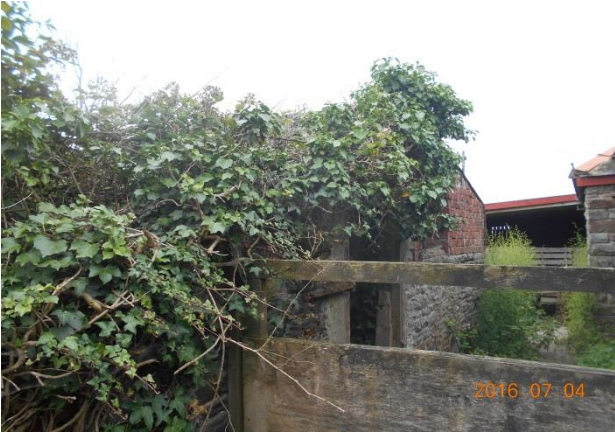
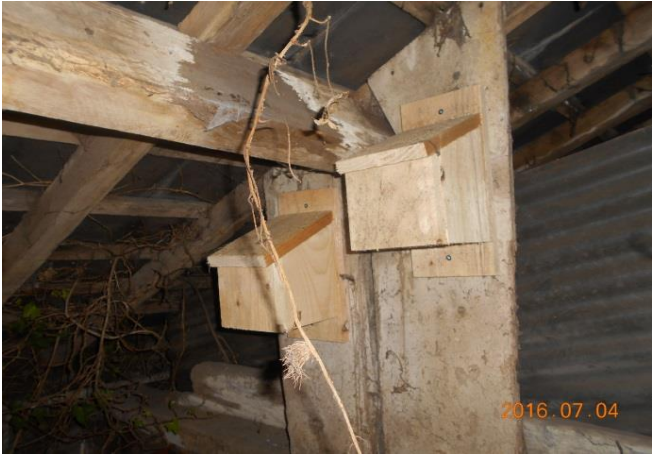
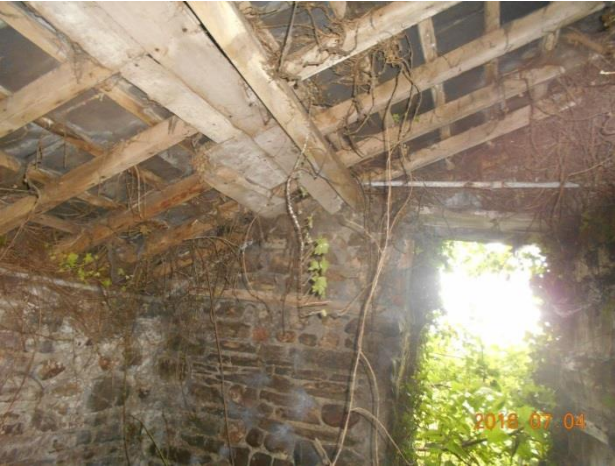
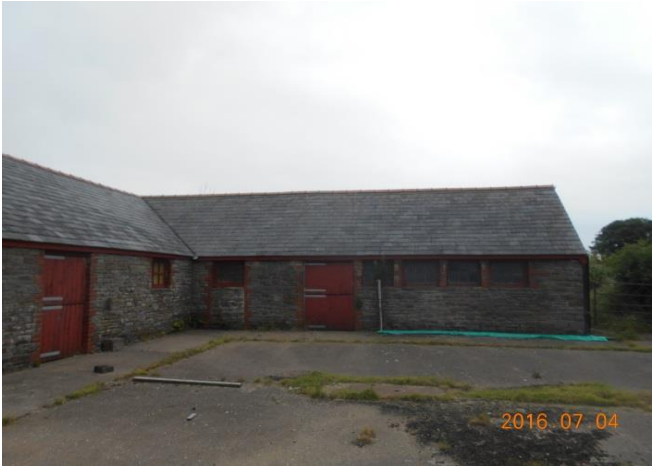
| Building Name | Roost assessment | Notes | Photographs |
|---|---|---|---|
| | | <p>brickwork.</p> <p><u>Building 5</u><br/>These are roofed storage sheds with no surrounding walls. Negligible potential for roosting bats within these structures.</p> <p><u>Building 6</u><br/>Dilapidated stone shed covered in climbing vegetation with open doors and windows to north and south (<i>Plate 9</i>). Two wooden bat boxes were present in the building (<i>Plate 10</i>), both boxes were examined and no signs of use (i.e. presence of bats, dropping or urine staining) was noted. Potential roosts are present in gaps between purlins and supporting beams (<i>Plate 11</i>).</p> <p><u>Building 7 – confirmed roost</u><br/>Interconnected sheds to south of main building complex (<i>Plate 12</i>). 3 no. common pipistrelle (DNA analysis confirmed) droppings (<i>Plate 13</i>) were found on stable door with 100mm gaps above. Barge boards over west facing gable end provide gaps to top of brick work (<i>Plate 14</i>) that contained a house sparrow colony including up to six nests.</p> <p><u>Building 8</u><br/>Large, modern industrial shed open to roof. Very few external features were noted suitable for roosting bats, however internal structures may provide roost potential..</p> <p>The owner did not allow access to buildings to the south and east of the main complex therefore no assessment was made.</p> | <p><i>Plate 7 west facing elevation of B3</i></p> <p><i>Plate 8 east facing elevation of B4</i></p> <p><i>Plate 9 open door to north of B6</i></p> <p><i>Plate 10 bat boxes inside B6</i></p> <p><i>Plate 11 showing roof of B6</i></p> <p><i>Plate 11 western elevation of B4 and northern elevation of B7</i></p> |

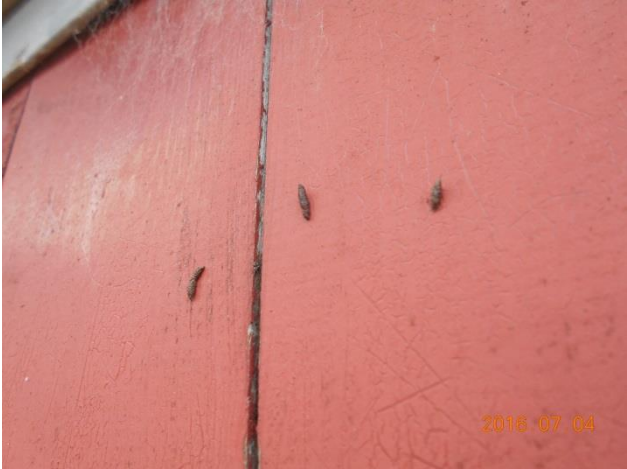
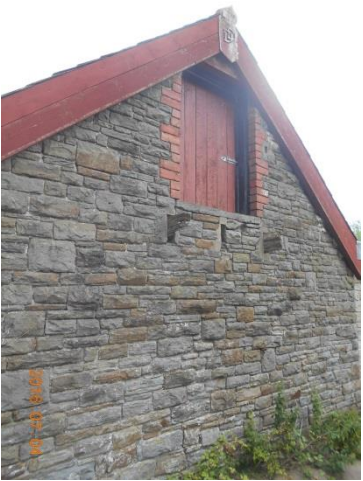
| Building Name | Roost assessment | Notes | Photographs |
|---|---|---|---|
| | | | <div><div><p><i>Plate 13 droppings on north facing barn door of B7</i></p></div><div><p>Plate 14 west facing elevation of B7</p></div></div> |

**3.2.9** A dropping found on the north facing barn door of building 4 (Figure 2) and a dropping found on the barn door were sent for DNA analysis and were confirmed as from common pipistrelle.

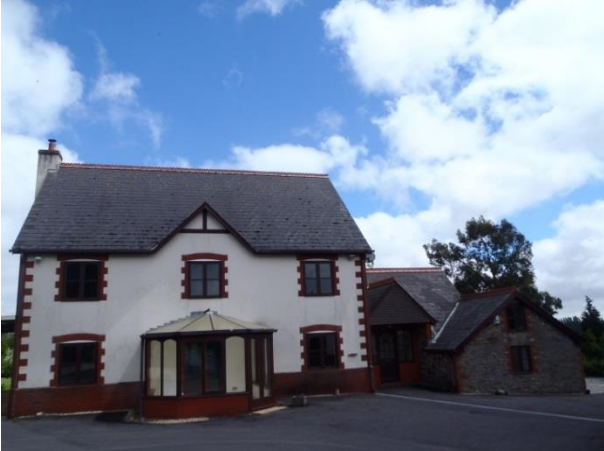
| Building Name | Roost assessment | Notes | Photographs | |
|---|---|---|---|---|
| The Conifers | Confirmed roost<br><br>Common pipistrelle maternity roost (up to 55 bats observed);<br><br>Brown long-eared summer day roost (up to three bats observed)<br><br>Soprano pipistrelle summer day roost (for a single bat observed). | <p><u>Building 1 – confirmed roost</u><br/>This two storey house has a high pitched roof and associated more recent stone clad extension to the south side (<i>Plate 21</i>). The main building is fairly tight with potential access provided under the eaves on the south west corner of the building and a large potential access into the south facing gable end soffit box where the underside of the soffit has come away from the main structure (<i>Plate 22</i>).<br/>The southern extension provides a wide range of potential roost features including</p> <ul style="list-style-type: none"><li>- gaps at the top of the wall above the stone wall and window on the west facing gable end (<i>Plate 23</i>);</li><li>- gaps between barge boards and hanging tiles to the doorway porch (<i>Plate 23</i>);</li><li>- gaps within the south facing gable end (<i>Plate 24</i>).</li></ul> <p>Other potential bat roost features include raised tiles; lifted lead flashing; and an opening into the soffit box above the east facing ground floor door.</p> <p><u>Building 2</u><br/>Garage with open garage door. This building is very tight throughout and affords little potential for roosting bats (<i>Plate 25</i>).</p> <p><u>Building 3</u><br/>Framed glass structure with swimming pool. This building offers no potential for roosting bats (<i>Plate 26</i>).</p> | <p><i>Plate 21 west facing elevation of main building and southern extension</i></p> | <p><i>Plate 22 open soffit box on south facing elevation of main building</i></p> |

- 4.1.7** Three bat species have been confirmed roosting at The Conifers, as follows:
- Common pipistrelle maternity roost (up to 55 bats observed).
  - Long-eared summer day roost (up to three bats observed).
  - Soprano pipistrelle summer day roost (one bat observed).
- 4.1.8** The Conifers is only 250m from the common pipistrelle maternity roost at Berryhill Farm and the bats using both buildings are extremely likely to be part of the same colony, which moves between the two roosts. This is a common habit of common pipistrelle bats (Altringham 2003).
- 4.1.9** As with Berryhill Farm the Conifers are connected to the same contiguous mosaic of old orchards, tall dense hedgerows, semi-natural broadleaved woodland, mature trees and semi-improved pasture.

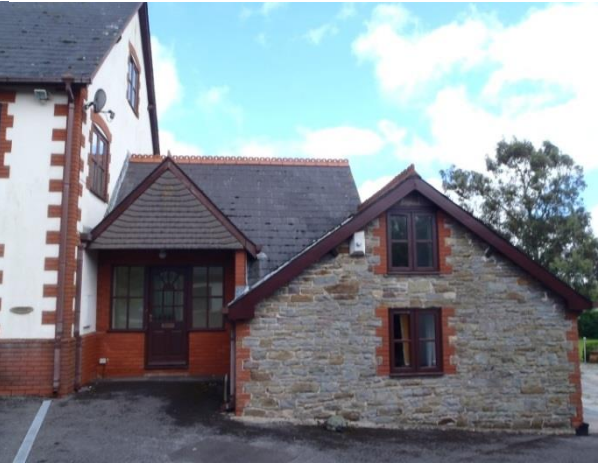
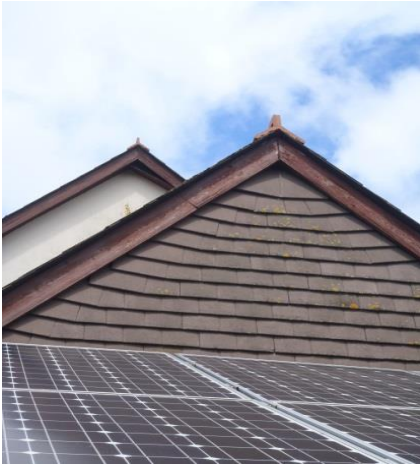
| Building Name | Roost assessment | Notes | Photographs | |
|---|---|---|---|---|
| | | | <p><i>Plate 23 west facing elevation of southern extension</i></p> | <p><i>Plate 24 hanging tiles and gaps into fascia on south facing gable end of southern extension</i></p> |

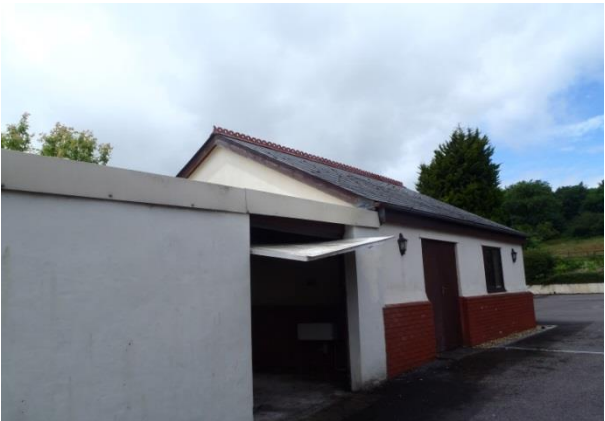
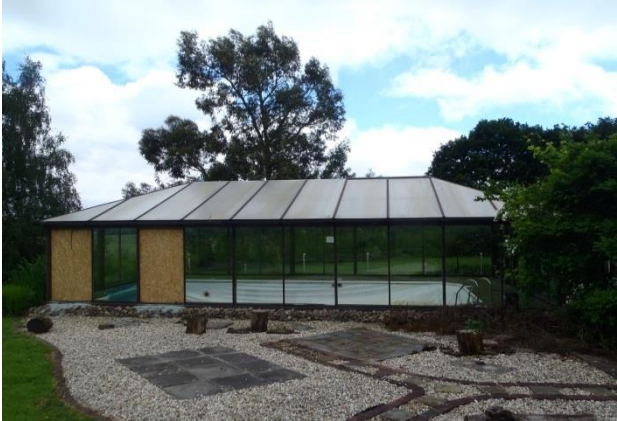
| Building Name | Roost assessment | Notes | Photographs | |
|---|---|---|---|---|
| | | | <p><i>Plate 25 garage to west of main building</i></p> | <p><i>Plate 26 glass clad swimming pool</i></p> |

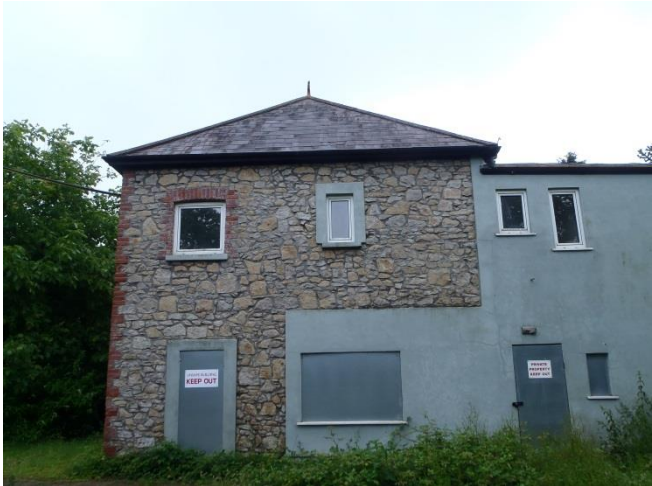
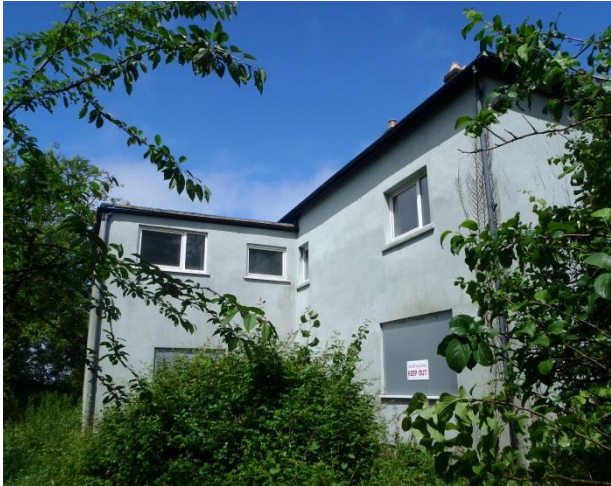
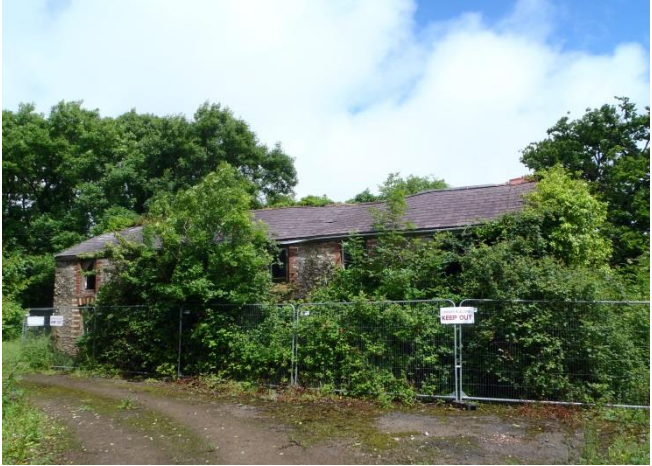
| Building Name | Roost assessment | Notes | Photographs | |
|---|---|---|---|--|
| Undy House | <p>Confirmed roost</p> <p>Common pipistrelle summer day roosts (single bats observed from each building).</p> | <p><u><i>Building 1 - confirmed roost</i></u><br/>Building boarded up with metal window covers to prevent access (<i>Plate 27</i>). Generally all features around building were noted as tight with the only potential roost features noted being broken tiles on west side of roof. Southern extension to building was noted as having no roof and protected with plastic sheets therefore potential features may have been present between this section and the main building (<i>Plate 28</i>).</p> <p><u><i>Building 2 – confirmed roost</i></u><br/>Old derelict building surrounded by shrubs and collapsed to the north side (<i>Plate 29</i>) (showing southern elevation). Significant sagging of the roof provides potential roost features. The windows are missing allowing access into the main building, which is likely to contain a variety of features suitable for both crevice dwelling and hanging bats.</p> | <p><i>Plate 27 west facing elevation of B1</i></p> <p><i>Plate 28 south eastern elevation of B1</i></p> <p><i>Plate 29 southern elevation of B2</i></p> | |

**4.1.11** Both the main building and the derelict building to the north (buildings 1 and 2 respectively) are considered to be common pipistrelle summer day roosts (single bats observed from each building) and are of Local value in accordance with Table 2.3. Undy house is located within an old orchard and is surrounded by good foraging habitats in the north, east and west and bordered on the south by good foraging habitats in plantation woodland along the M4.

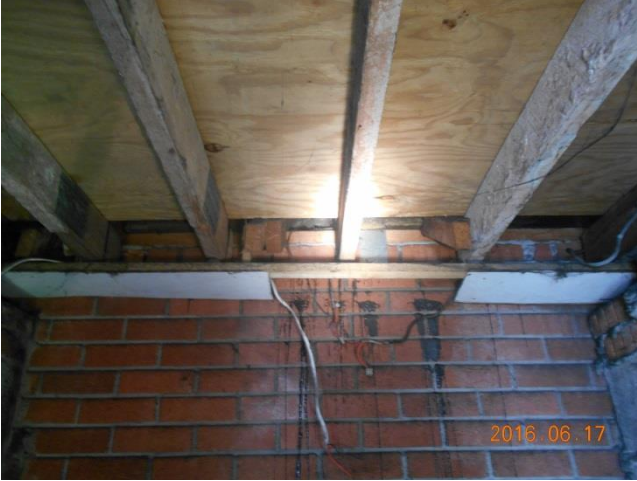
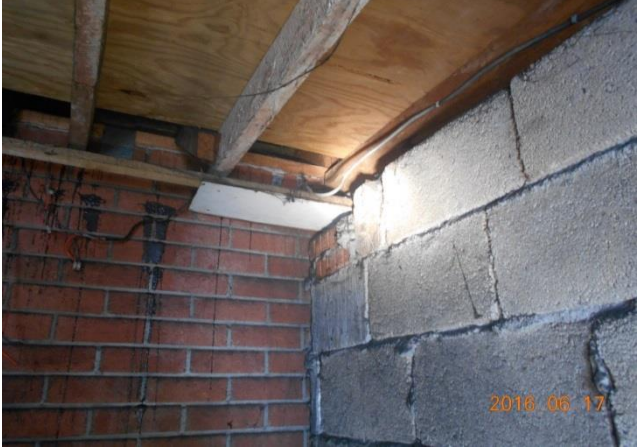
| Building Name | Roost assessment | Notes | Photographs |
|---|---|---|---|
| San Remo | Confirmed roost<br><br>Common pipistrelle summer day roost (up to eight bats observed during surveys) | Residential property disused at time of survey ( <i>Plate 30</i> ). Roof tiles are generally tight with little access potential, however missing hanging tiles and lead flashing around both the east and west dormers are features that provide potential for roosting bats. Other features on this building included openings (through wood rot) into soffit box on both north and south sides; under plastic fascia; and into open door on west side that allow access into space between roof tiles and lining ( <i>Plate 31 / Plate 32</i> ). | <div><i>Plate 30 southern elevation</i><br/></div> <div><i>Plate 31 in lean to at western side of building</i><br/></div> <div><i>Plate 32 in lean to at western side of building</i><br/></div> |

**4.1.12** San Remo is considered to be a common pipistrelle summer day roost (up to eight bats observed during surveys) and is of Local value in accordance with Table 2.3.

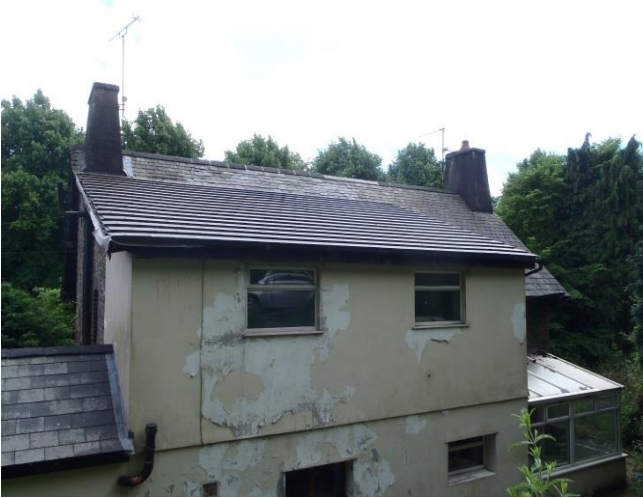
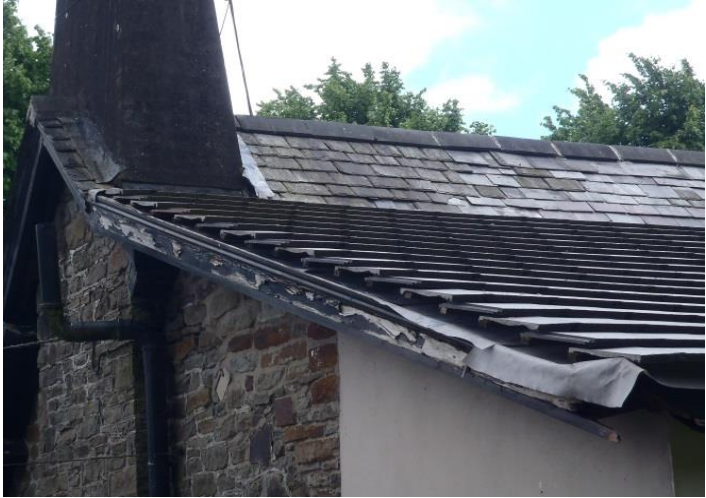
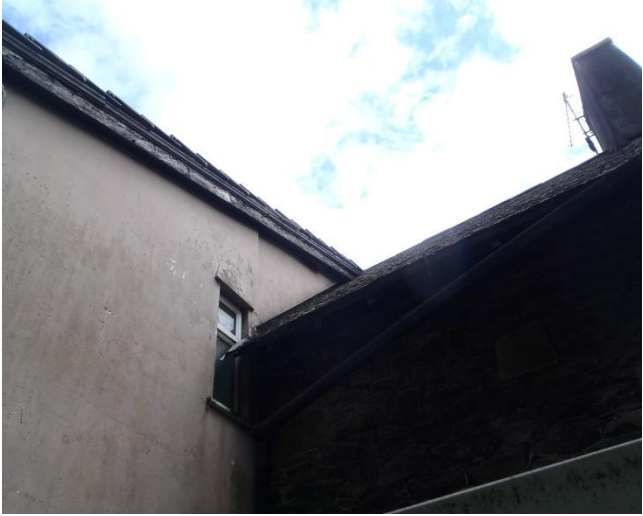
| Building Name | Roost assessment | Notes | Photographs |
|---|---|---|---|
| Berryhill Cottage | <p>Confirmed roost</p> <p>Common pipistrelle summer day roost (up to four bats observed);</p> <p>Soprano pipistrelle summer day roost (one bat observed)</p> | <p>Building under renovation following long term neglect (<i>Plate 33</i>). During 2015 roof tiles were reportedly stolen causing significant rain damage within the building that has subsequently been fully gutted by the owner. During early 2016 the tiles were recently replaced however soffit and barge boards have not been fitted allowing access throughout building (<i>Plate 34</i>). Soffit box on north west side of building has partially collapsed provide access into roof lining and tiles through eaves. Other potential bat roost features were numerous including openings into soffit box on northwest side (<i>Plate 35</i>); broken and raised tiles; and gaps between eaves and supporting walls.</p> | <div><p><i>Plate 33 northern elevation</i></p></div> <div><p><i>Plate 34 eastern elevation</i></p></div> <div><p><i>Plate 35 open soffit box and gaps into barge boards at northern and eastern elevations</i></p></div> |

- Common pipistrelle summer day roost (up to four bats observed).
- Soprano pipistrelle summer day roost (one bat observed).

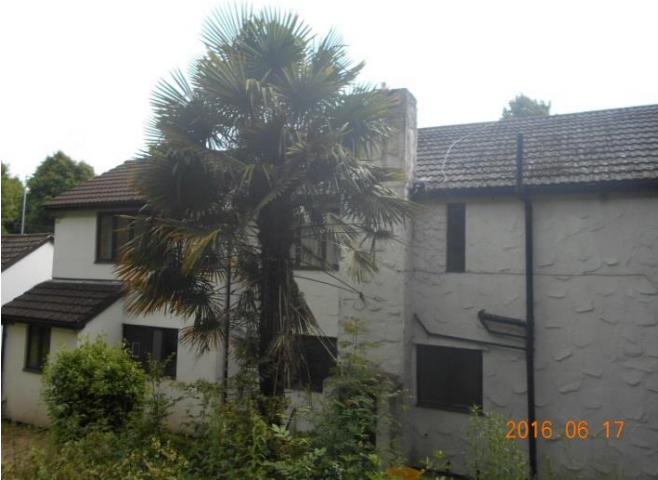
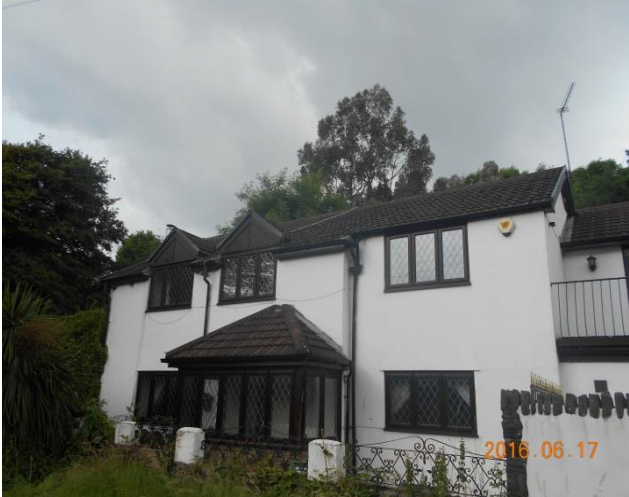
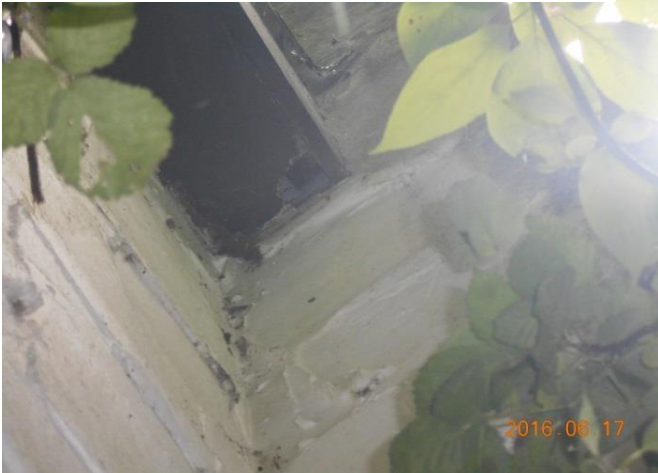
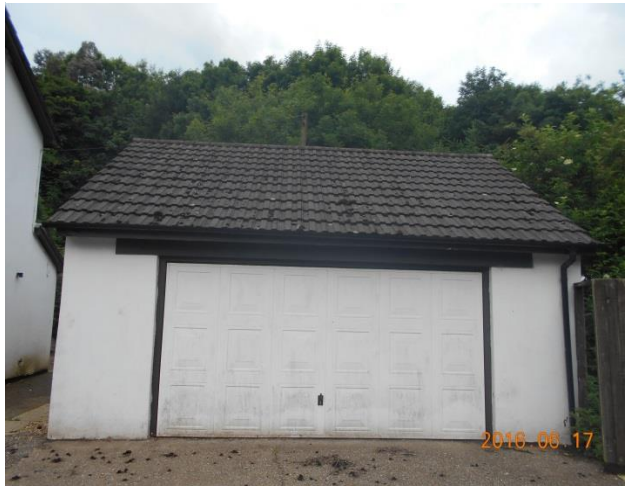
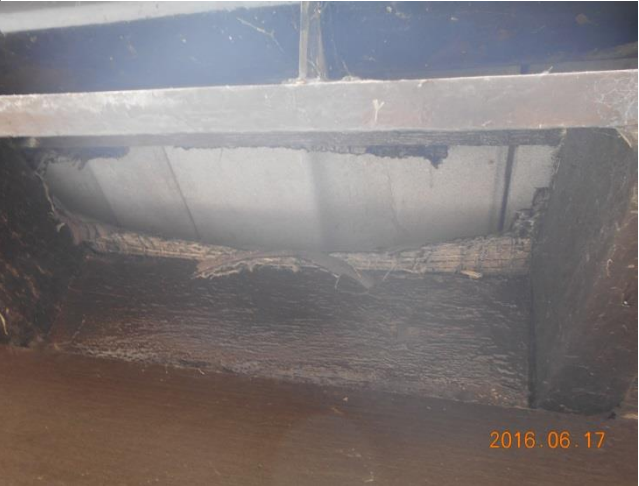
| Building Name | Roost assessment | Notes | Photographs | |
|---|---|---|---|--|
| White Cottage | High suitability | <p><u>Main residential building</u></p> <p>The empty building had tightly fitting roof tiles on both north (<i>Plate 36</i>) and south elevations (<i>Plate 37</i>). Openings into soffit box on the north side are features with high potential for roosting bats (<i>Plate 38</i>) with good connectivity to mosaic of woodland and grassland habitats within the gardens to the north.</p> <p><u>Garage</u></p> <p>This garage (<i>Plate 39</i>) adjacent to the east side of the main building has tears within the roof lining along both the north and south elevations that provide suitable roost features for bats (<i>Plate 40</i>).</p> | <p><i>Plate 36 northern aspect of main building</i></p> <p><i>Plate 37 southern aspect of main building</i></p> <p><i>Plate 38 opening into soffit box at western elevation</i></p> <p><i>Plate 39 southern elevation of garage</i></p> <p><i>Plate 40 opening into roofing felt under eaves of garage</i></p> | |

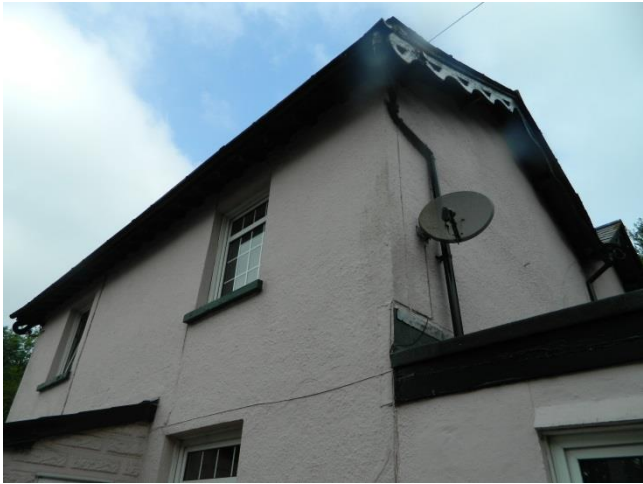
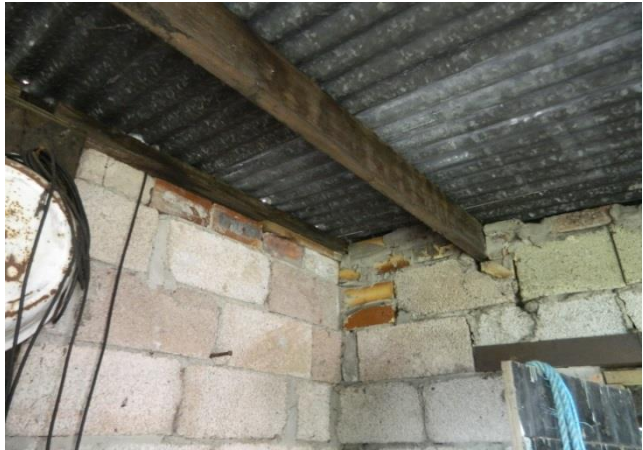
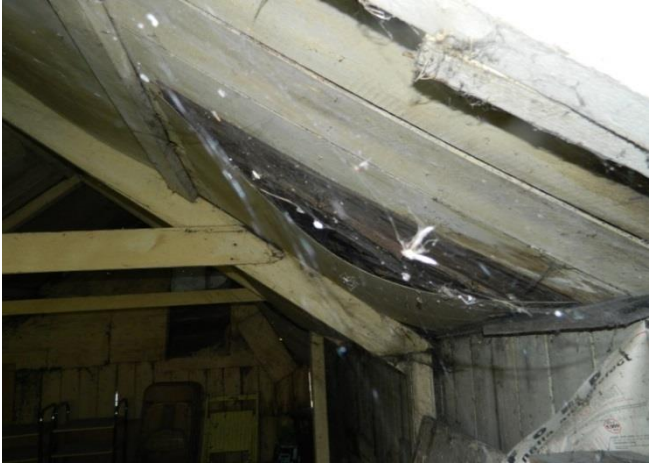
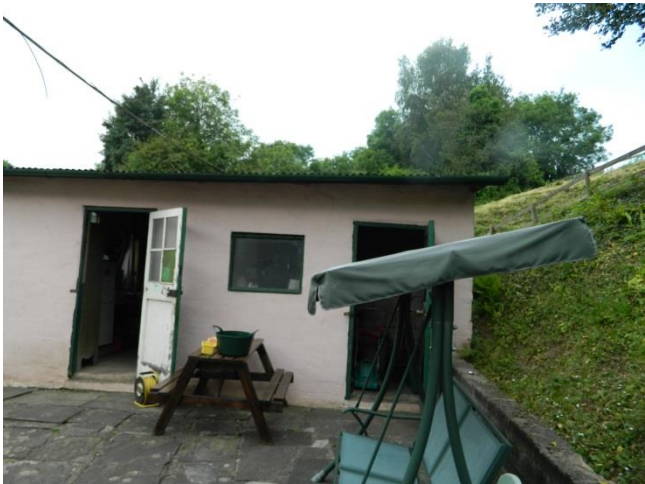
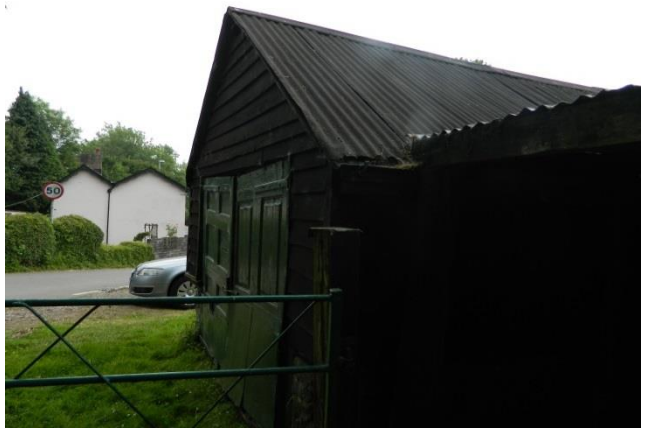
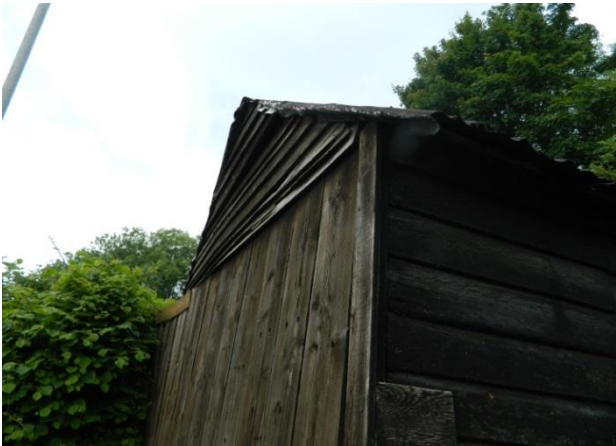
| Building Name | Roost assessment | Notes | Photographs | |
|---|---|---|---|---|
| Myrtle House | Low suitability | <p><u>Building 1</u><br/>Main residential property (<i>Plate 41</i>) was generally tight all around with few discernible potential bat roost features. Some raised lead flashing was noted that provides potential for individual crevice dwelling bats to roost.</p> <p><u>Building 2</u><br/>Shed with series of interconnected rooms (<i>Plate 42</i>). Generally limited potential however cracks in brickwork and at top of walls provide some possible roosting locations (<i>Plate 43</i>).</p> <p><u>Building 3</u><br/>Series of small sheds with negligible potential for roosting bats.</p> <p><u>Building 4</u><br/>Disused garage with corrugated sheet roof and wood cladding (<i>Plate 44</i>). Owner opened garage door revealing internal space full of dense cobwebs suggesting no use by bats (<i>Plate 45</i>). Gaps within wood cladding offer numerous potential roosting features and access into wooden walls of the structure (<i>Plate 46</i>).</p> | <p><i>Plate 41 north and eastern elevation of B1</i></p> <p><i>Plate 43 internal of B2</i></p> <p><i>Plate 45 dense cobwebs with B4</i></p> | <p><i>Plate 42 western elevation of B2</i></p> <p><i>Plate 44 northern aspect of B4</i></p> <p><i>Plate 46 southern aspect of B4</i></p> |

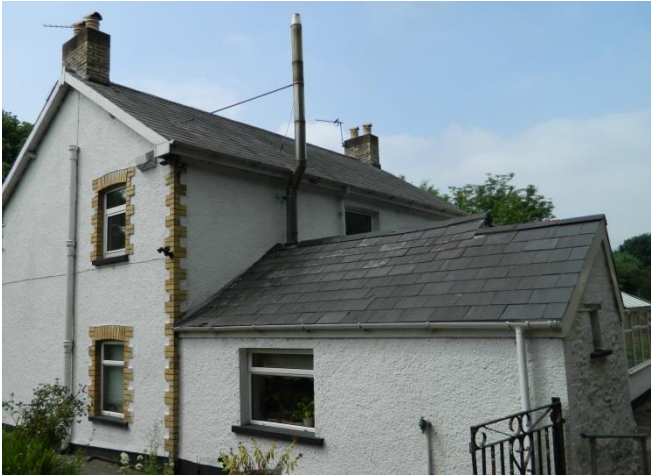
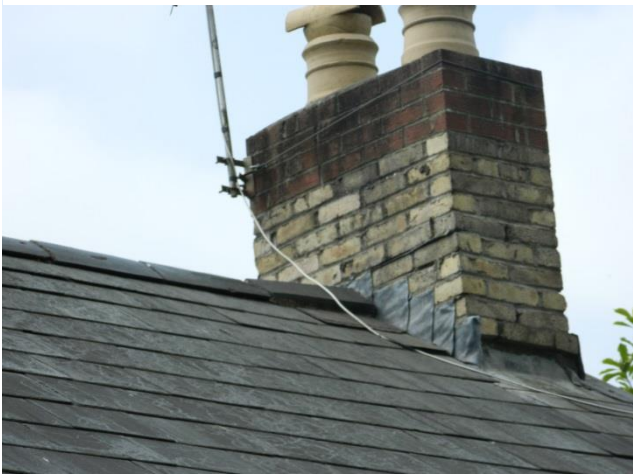
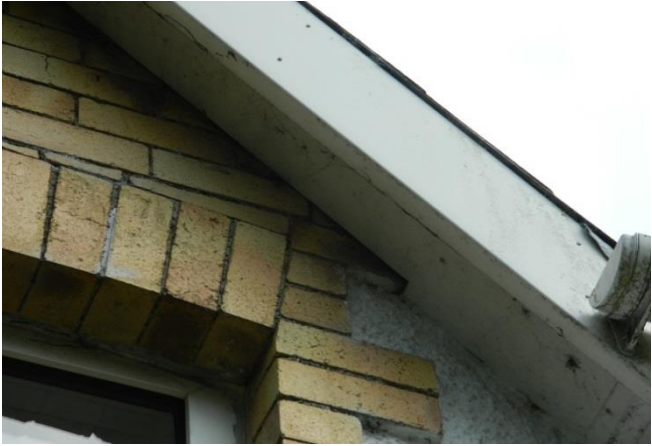
| Building Name | Roost assessment | Notes | Photographs | |
|---|---|---|---|---|
| Quarry Cottage | Low suitability | <p><u>Building 1</u></p> <p>Main residential building generally tight (<i>Plate 47</i>). Potential roost features were noted under raised ridge tile (<i>Plate 48</i>) and within small gaps under soffit box along western elevation (<i>Plate 49</i>).</p> | <p><i>Plate 47 northern and eastern elevation</i></p> | <p><i>Plate 48 raised ridge tile</i></p> <p><i>Plate 49 gap into soffit box on eastern elevation</i></p> |

| Building name | Roost Assessment Summary | Notes |
|---|---|---|
| Quarry Cottage | Low suitability | Potential for individual bats to roost opportunistically were noted in small gap within ridge tile and within small gap under soffit box along western |

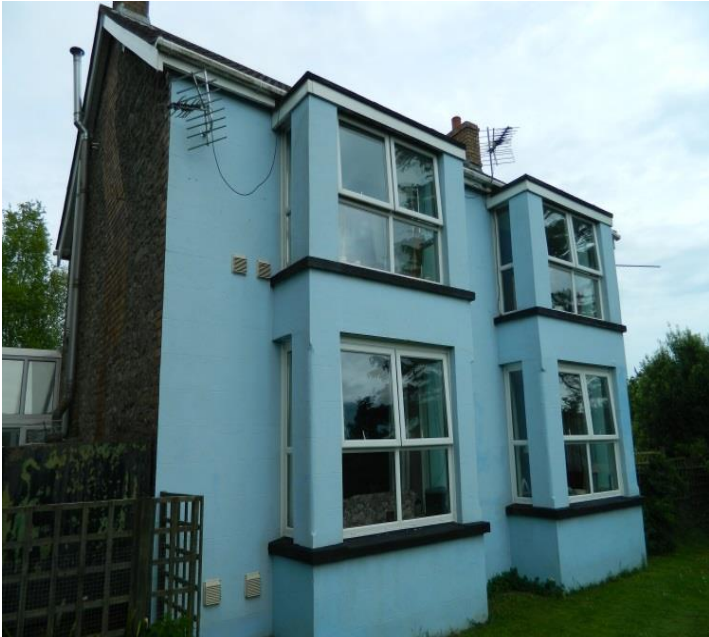
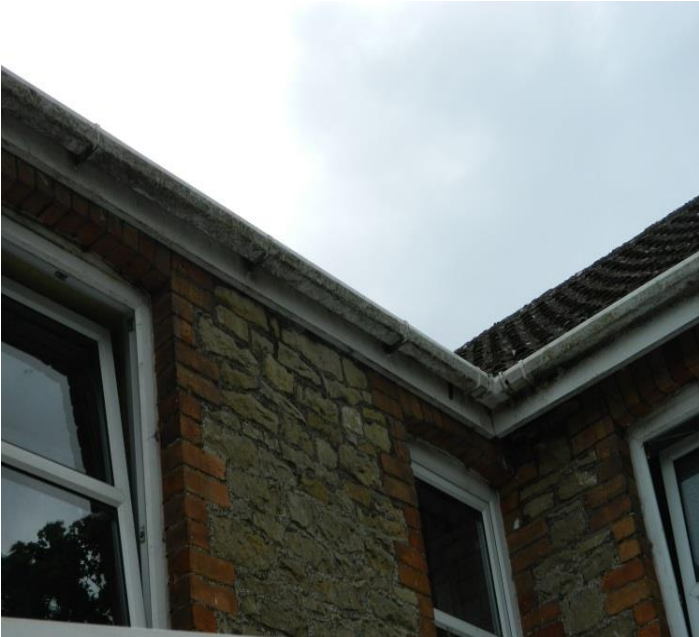
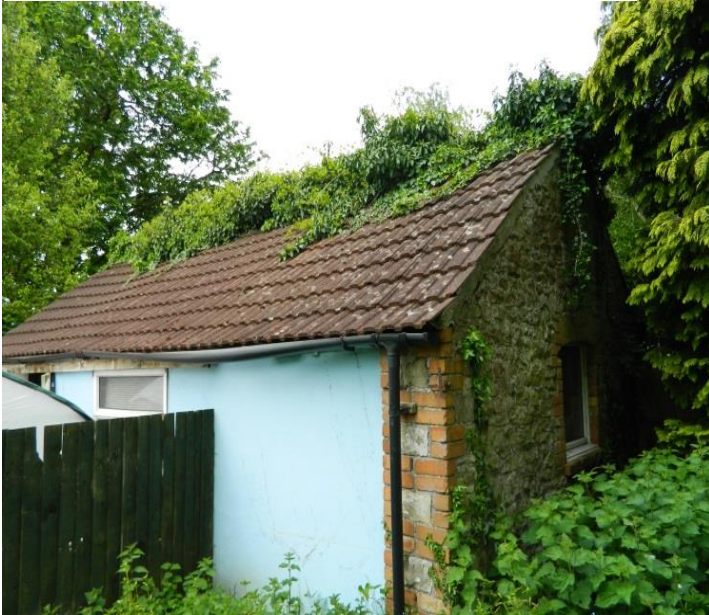
| Building Name | Roost assessment | Notes | Photographs |
|---|---|---|---|
| Dunline<br>Knollbury | Low suitability | <p><u>Building 1</u><br/>Main building was found to be tight on all sides with recently renovated soffit and eaves (<i>Plate 50</i>). Roof tiles were generally very tight with the exception of small gaps under fascia boards above windows on the western elevation (<i>Plate 51</i>).</p> <p><u>Building 2</u><br/>Shed adjacent to the main building (<i>Plate 52</i>). Potential roost features under gaps between hanging tiles along eaves and small cracks in brickwork to the south.</p> | <div><p><i>Plate 50 southern elevation of B1</i></p></div> <div><p><i>Plate 41 fascia boards above windows on the western elevation</i></p></div> <div><p><i>Plate 52 Shed adjacent to the main building</i></p></div> |

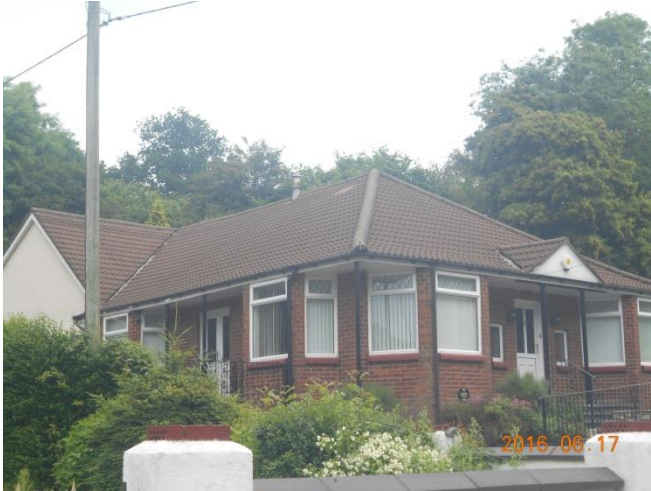
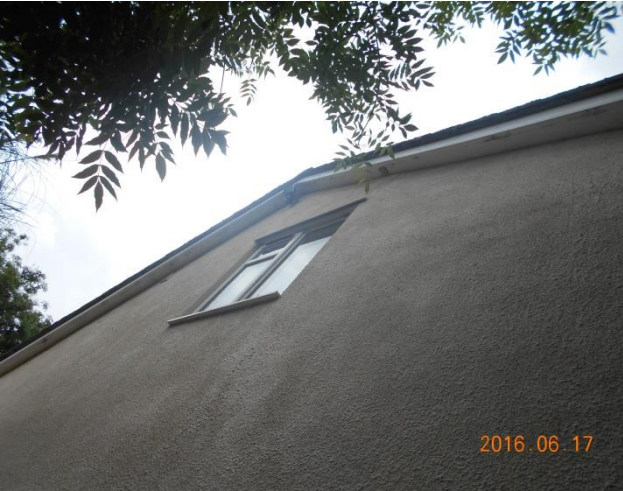
| Building Name | Roost assessment | Notes | Photographs | |
|---|---|---|---|---|
| The Glen | Low suitability | Modern bungalow ( <i>Plate 53</i> ). Very tight with modern eaves and fascia providing no internal access ( <i>Plate 54</i> ). Features with potential for roosting bats were noted on the north side at the intersection between tiles and lead flashing within the valley between two pitched roofs. | <p><i>Plate 53 southern and eastern elevation</i></p> | <p><i>Plate 54 tight barge boards and fascia around south facing</i></p> |

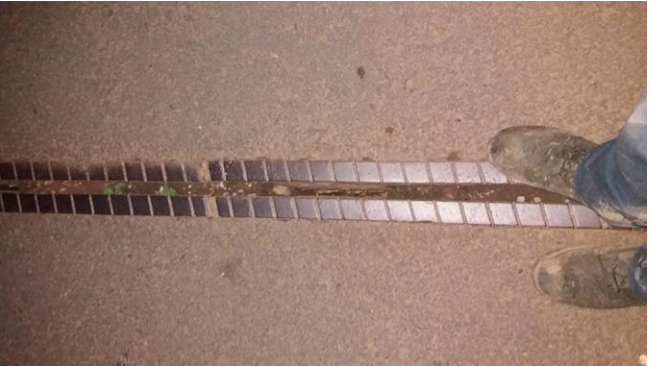
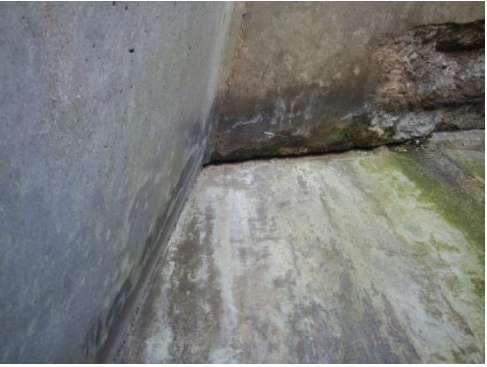
| Building Name | Roost assessment | Notes | Photographs | |
|---|---|---|---|---|
| Pound Hill M4 Overbridge | Low suitability | Concrete motorway bridge. Potential roost features noted within expansion joints ( <i>Plate 55</i> ) (showing gaps from above) that although were open to the road section were filled with debris providing gaps with shelter either side. Very noisy and subject to constant vibration. | <p><i>Plate 55 gaps into expansion crack from surface of Pound Lane</i></p> | <p><i>Plate 56 expansion crack</i></p> |

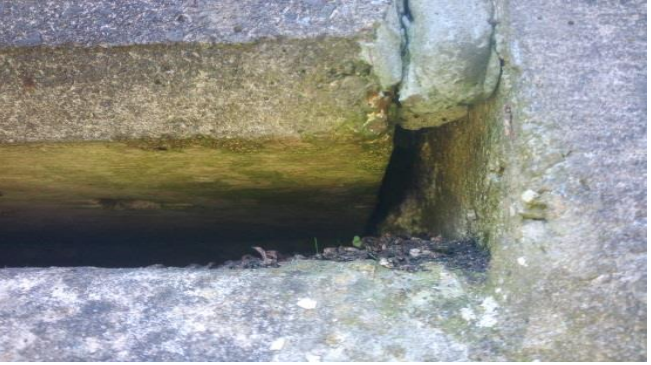
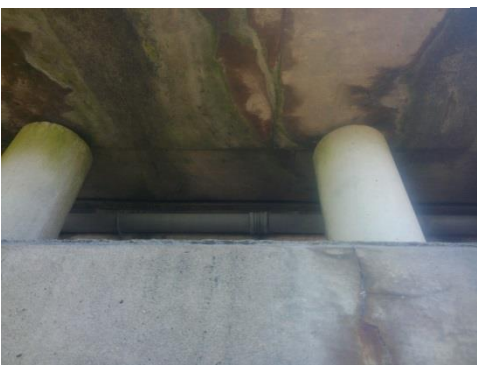
| Building Name | Roost assessment | Notes | Photographs | |
|---|---|---|---|---|
| A48 (M)bridge over M4 | Low suitability | Concrete motorway bridge. Potential roost features noted within expansion joints ( <i>Plate 57</i> ) that although were open to the road section were filled with debris providing gaps with shelter either side. Very noisy and subject to constant vibration. | <p><i>Plate 57expansion joints</i></p> | <p><i>Plate 58 expansion joints</i></p> |

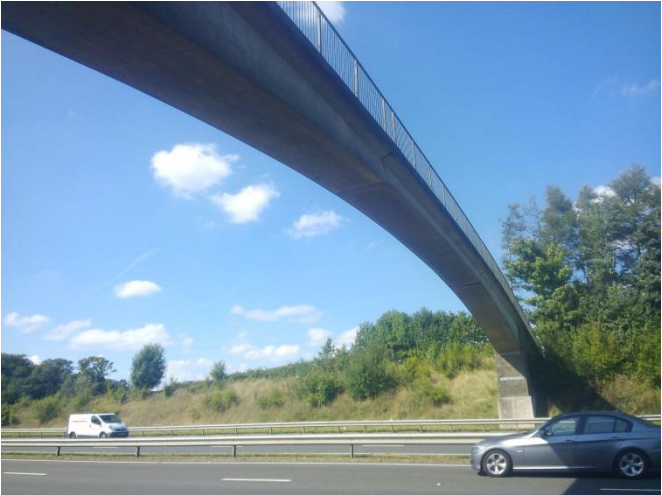
| Building Name | Roost assessment | Notes | Photographs |
|---|---|---|---|
| New Farm Footbridge | Negligible suitability | Concrete footbridge with no opening noted suitable for roosting bats. | <p><i>Plate 59 New Farm Footbridge</i></p> |

| Building name | Roost Assessment Summary | Notes |
|---|---|---|
| New Park Farm Footbridge | Negligible suitability | No potential noted. |
