6 CULTURAL HERITAGE

REV	DATE	DESCRIPTION	BY	CHKD	APPD	<div><div><div>• TITLE</div><div>A487 CAERNARFON AND BONTNEWYDD BYPASS</div><div>Cultural Heritage Assets In Relation To Scheme ZVI (a-b) Sheet 2 of 2</div></div><div><div>THIS DRAWING WAS PRODUCED USING AUTOCAD AND SHOULD ON NO ACCOUNT BE AMENDED BY HAND</div></div></div>	<div><div><div><div>  Llywodraeth Cymru Welsh Government</div><div><div><div><div>  Balfour Beatty JONES BROS CIVIL ENGINEERING UK</div><div><div><div><div>     </div><div><div>Ty Glyn, Canol Y Dre, Ruthin Denbighshire Tel: 01824 703661</div></div></div></div><div>FINAL</div></div></div></div><div><div><div><div>• DATE</div><div>29/06/16</div></div><div><div>• SCALE</div><div>Not To Scale</div></div></div><div><div><div>DRAWN BY</div><div>MS</div></div><div><div>DESIGNED</div><div></div></div><div><div>CHECKED</div><div>LJ</div></div><div><div>APPROVED</div><div>PM</div></div></div></div><div><div><div>• FIGURE NUMBER</div><div>6.1b</div></div></div></div></div></div></div>

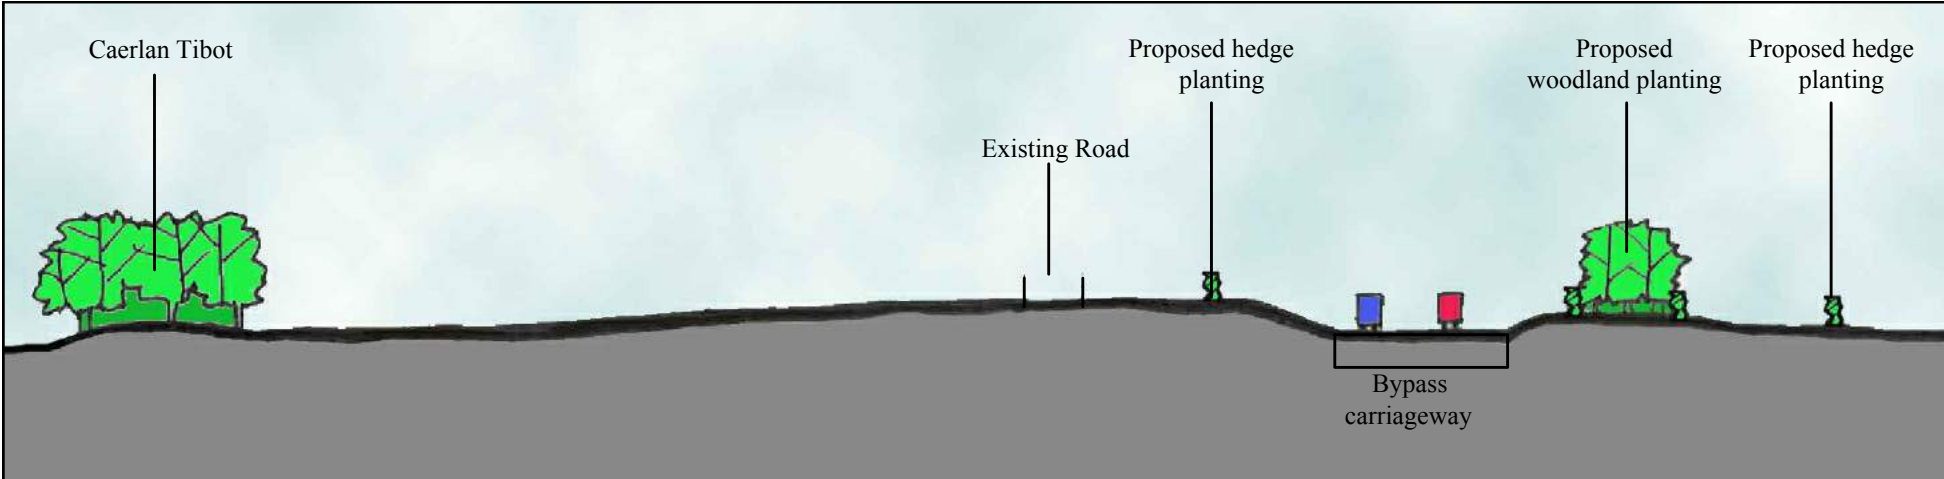
Section A-AA

REV	DATE	DESCRIPTION	BY	CHKD	APPD	TITLE
						A487 CAERNARFON AND BONTNEWYDD BYPASS
						Cultural Heritage Indicative Cross Sections through Caerlan Tibot

The Scheme would replace the existing minor road at this location, running at almost exactly the same distance from the monument (60m, as opposed to the present 50m) and on the same north-south alignment. It would be substantially larger than the existing 10m-wide road - its main carriageway, roundabout slip road and the associated cuttings making for a total width of 75m.

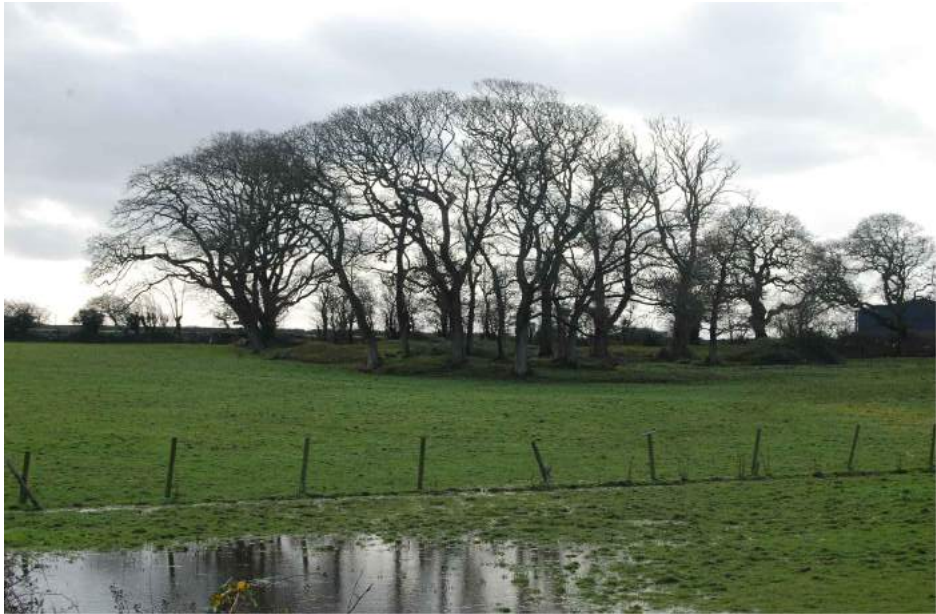
Plan showing section lines from Caerlan Tibot

Caerlan Tibot view South from NGR 250766,364959

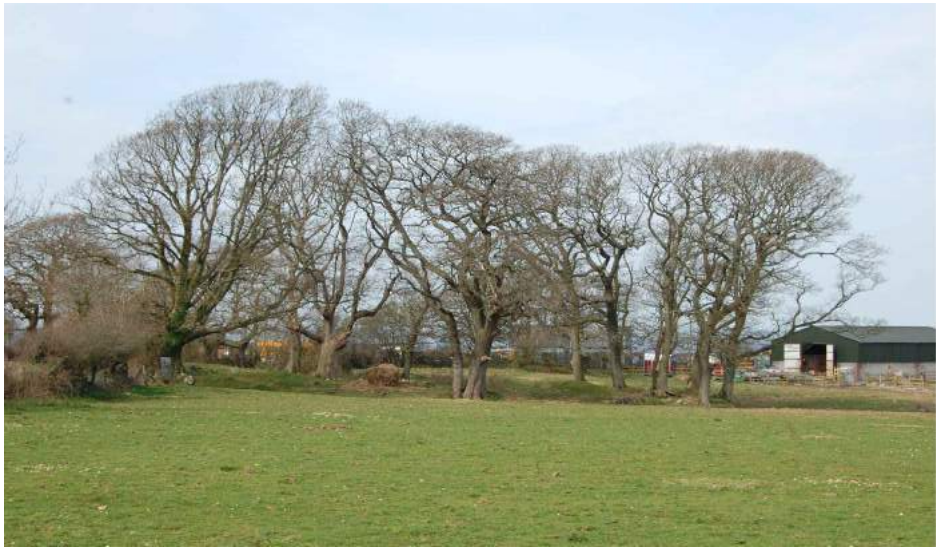
Caerlan Tibot view West from NGR 250811, 364780
