## Appendix E.1

Section 42 NERC Act 2006

Habitats and Species List

# A483-A489 Newtown Bypass - Otter Method Statement

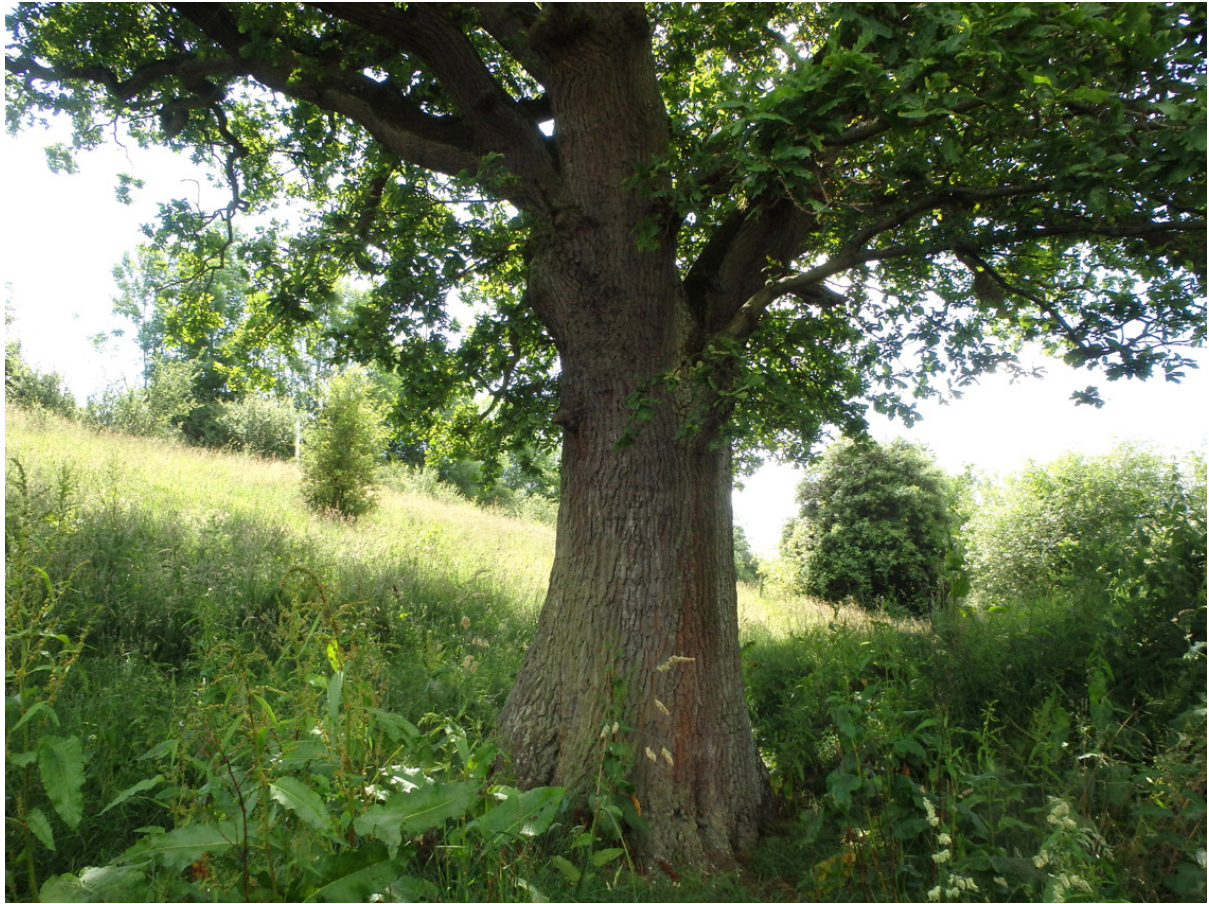
Fig. 3. Large oak (379 cm circumference at breast height) in pasture (target note 4/3) with *Calicium viride*, *Chaenotheca trichialis* and *Schismatomma decolorans* on the dry side on the right, and *Pertusaria coccodes* and *P. flavida* on the other side.

(Fig. 3). Ash carried a flora indicative of slightly higher pH. Nearly all the lichen communities were seen strongly influenced by nutrient-enrichment from agriculture, with nutrients probably delivered to the bark by such processes as dust deposition, fertiliser spreading, and release of gaseous ammonia. Species indicating nutrient-enrichment were found on most trees, except those in woodland, and included *Amandinea punctata*, *Arthonia impolita*, *Candelariella* spp., *Physcia* spp., *Physconia* spp. and *Xanthoria* spp. On mature trunks these were only rarely dominant, for instance beside sheep lying-up places (Fig. 4), and were more typically mixed with species including *Parmelia ernstiae*, *P. sulcata*, *Pertusaria* spp. and *Pyrrospora quernea*. Branches and twigs, however, usually bore a community dominated by species of nutrient-rich conditions, including abundant *Physcia tenella* and *Xanthoria parietina*. Naturally acid-barked trees, such as larch, had a very poor flora, and may still be influenced by acid deposition. However, *Chaenotheca stemonea* occurred on the rain-sheltered bases of old larch in a woodland. Most areas of woodland were very shady and lichen-poor. Rock was a rare substrate at the site, represented only by a small mudstone exposure and a few stones at field margins.

| Number | GPS reference | GPS stated accuracy (m) | Notes | Number in tree survey report (when identified) |
|---|---|---|---|---|
| 4/3 | 10404.90303 | 9 | Large oak in meadow, with <i>Chaenotheca trichialis</i> (Fig. 3). | 22 |

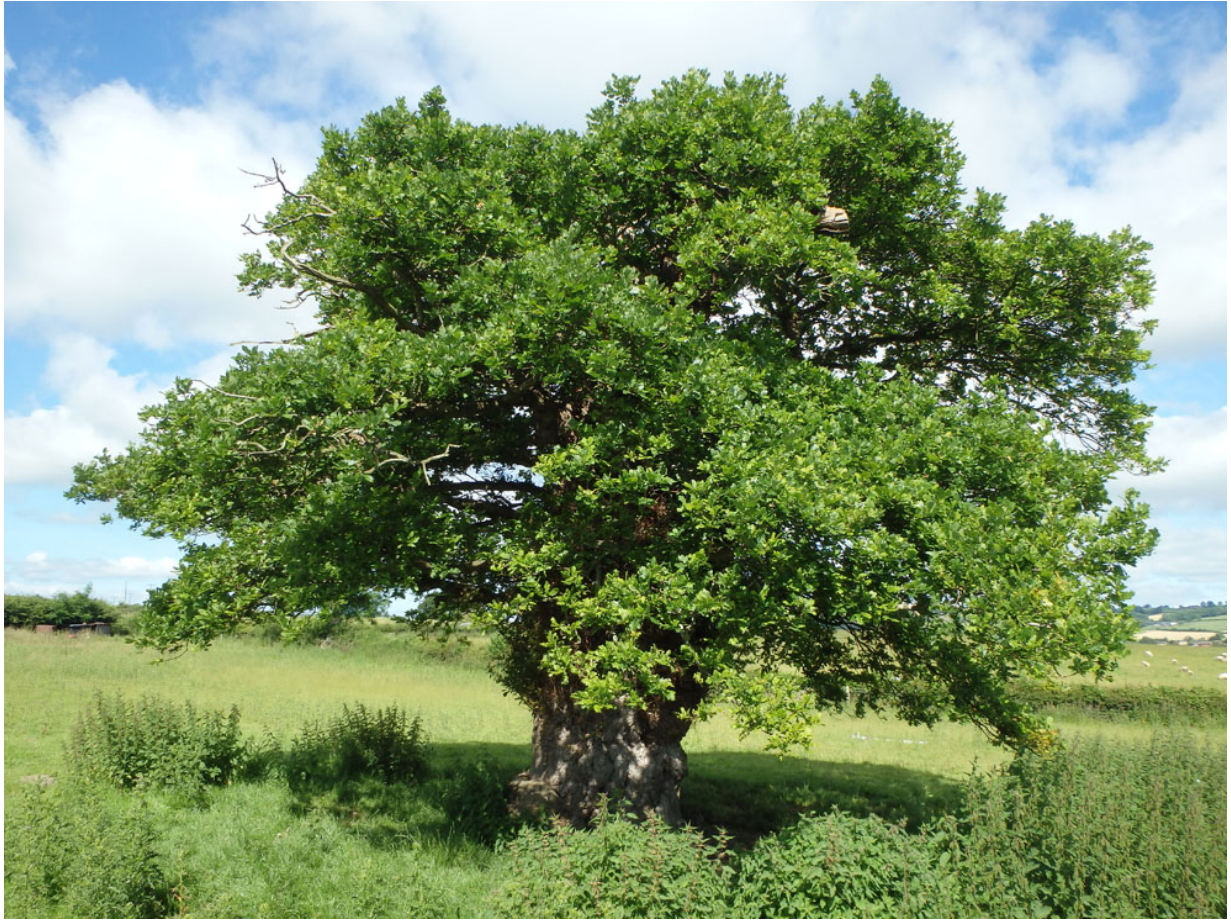
Fig. 4. A mature oak with nutrient-enriched bark, in pasture (target note 6/5), this side with *Parmelia sulcata*, *Physcia tenella* and *Ramalina farinacea* and the other side, beside a sheep lying-up area, with much *Physconia distorta*. The root buttresses have the normally saxicolous *Lecidella scabra*, and an unidentified *Caloplaca* sp., also found on stones nearby.

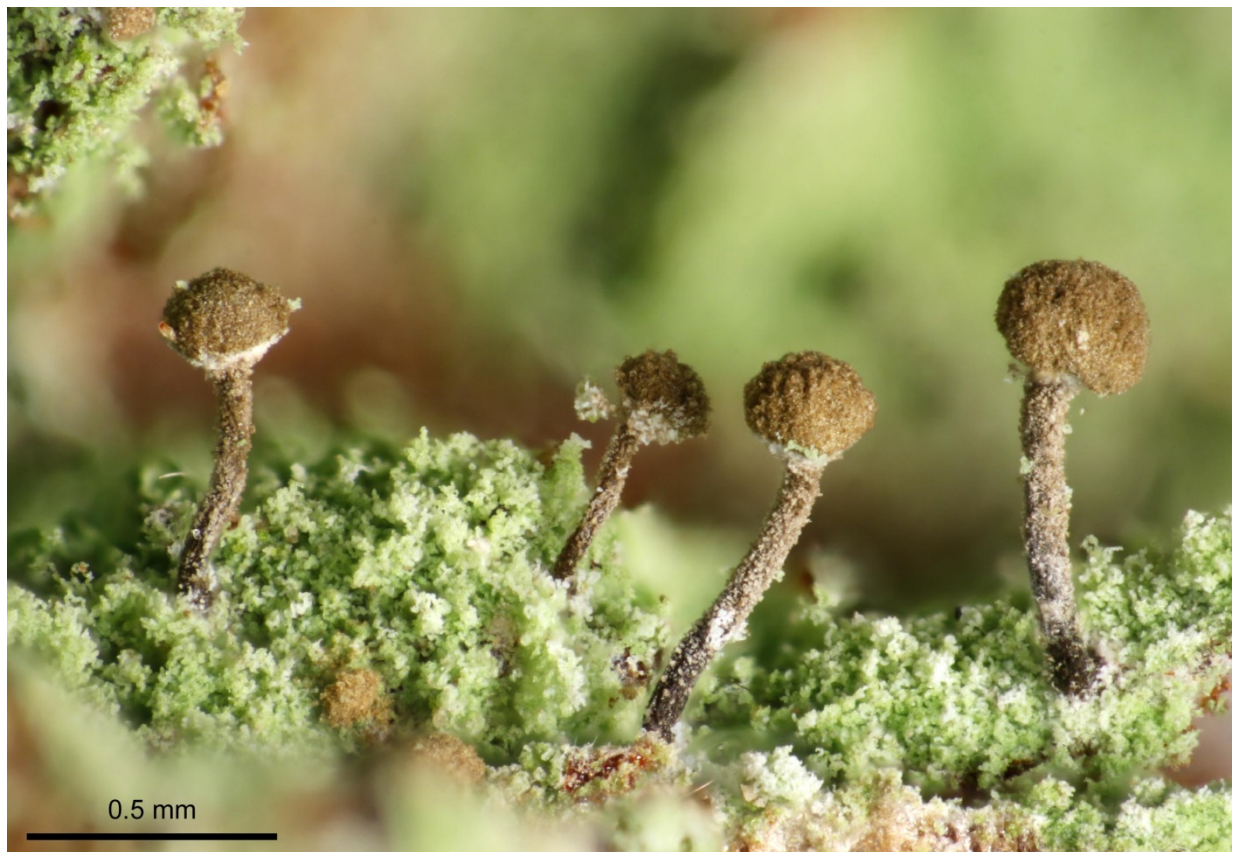
Fig. 6. *Chaenotheca stemonea*, graded Vulnerable in Wales, from the dry, rain-sheltered base of a mature larch (target note 13/3). The thallus is pale green and very finely powdery; the fruiting bodies are stalked and bear a mass of dry brown spores at the apex. This group of 'pin lichens' with stalked fruiting bodies are more frequent in the drier eastern parts of Wales than in the west.

| Species | Notes |
|---|---|
| <i>Chaenotheca stemonea</i> | Rare, in fissures of rain-sheltered mature larch, 13/3 Ld, and sterile on two more nearby. Fig. 6. |

| 13/3 | 08266.90119 | 7 | Mature larch with <i>Chaenotheca stemonea</i><br>(Fig. 6). | 41 |

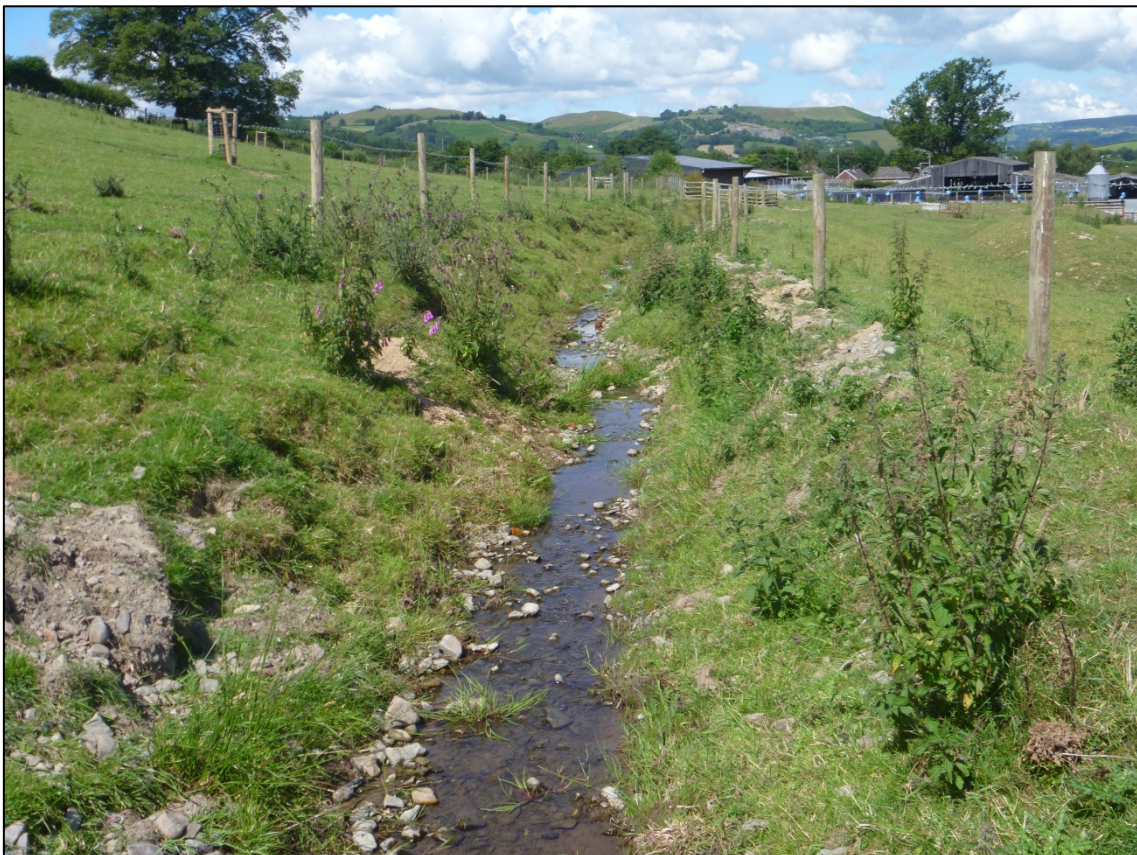
The unnamed watercourse at site C3a is a tributary of Mochdre Brook. Flow was relatively low during the time of the survey, with a maximum water depth of 14 cm and an average depth of ~4 cm (Figure 2). A total river length of 133 m was surveyed.

Figure 2 Typical stretch at site C3a.

The mixed substrate of cobble (40%), pebble (40%), gravel (10%) and sand/silt (10%) appears potentially suitable for both brown trout and bullhead, although shallow water depths and minimal low flow refuge areas (e.g. deep pools) would likely compromise survival of fish during low flows. In addition, an existing lack of connectivity to the downstream Mochdre Brook is likely limiting fish populations in this watercourse. The extent of existing culverts is unclear; however, there appears to be substantial culverting associated with the industrial premises at the south-western edge of Mochdre which would likely inhibit upstream migration.

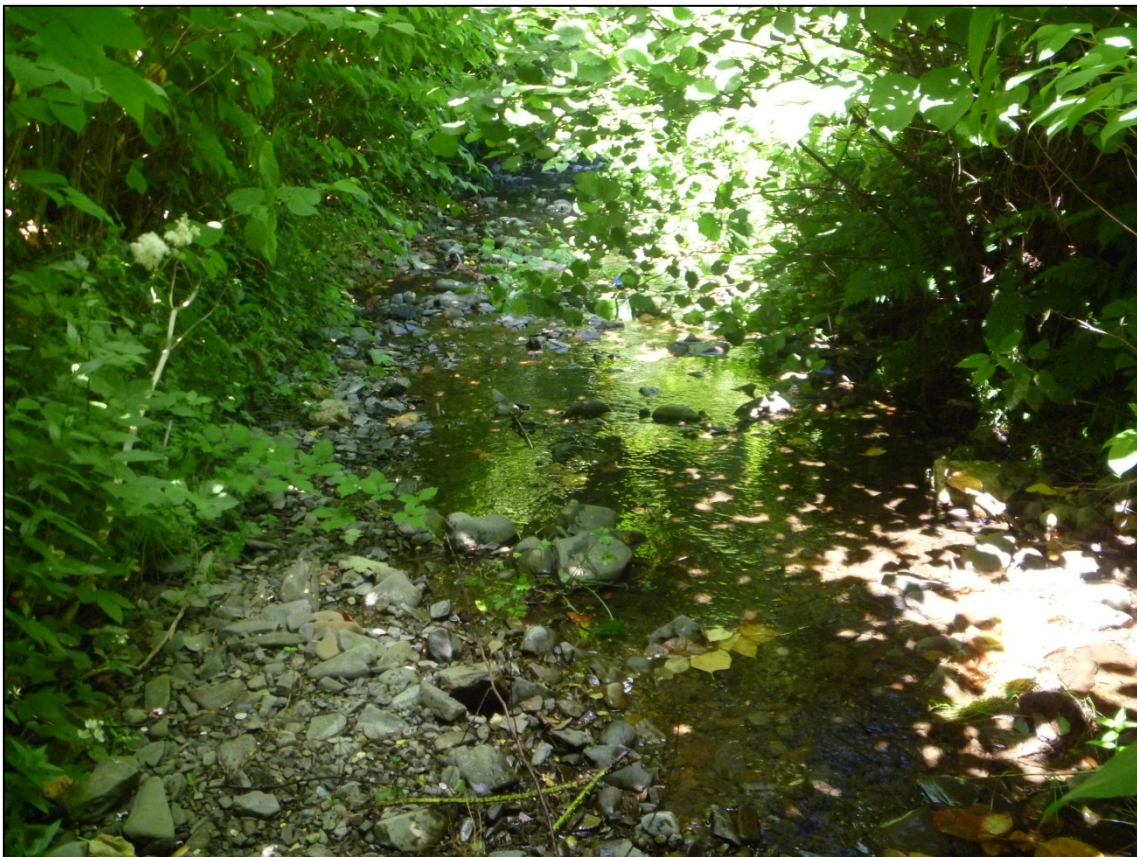
Site S5 is located on the Dolfor Brook. Flow was relatively low during the time of the survey, with a maximum water depth of 19 cm and an average depth of ~7 cm (Figure 3). The average width of the brook was 1.0 m and a total length of 50 m was surveyed.

**Figure 3** Heavily shaded stretch at site S5.

The mixed substrate of gravel (40%), pebble (35%), cobble (15%) and sand/silt (5%), and heterogeneity of habitat and depths, appears potentially suitable for both brown trout and

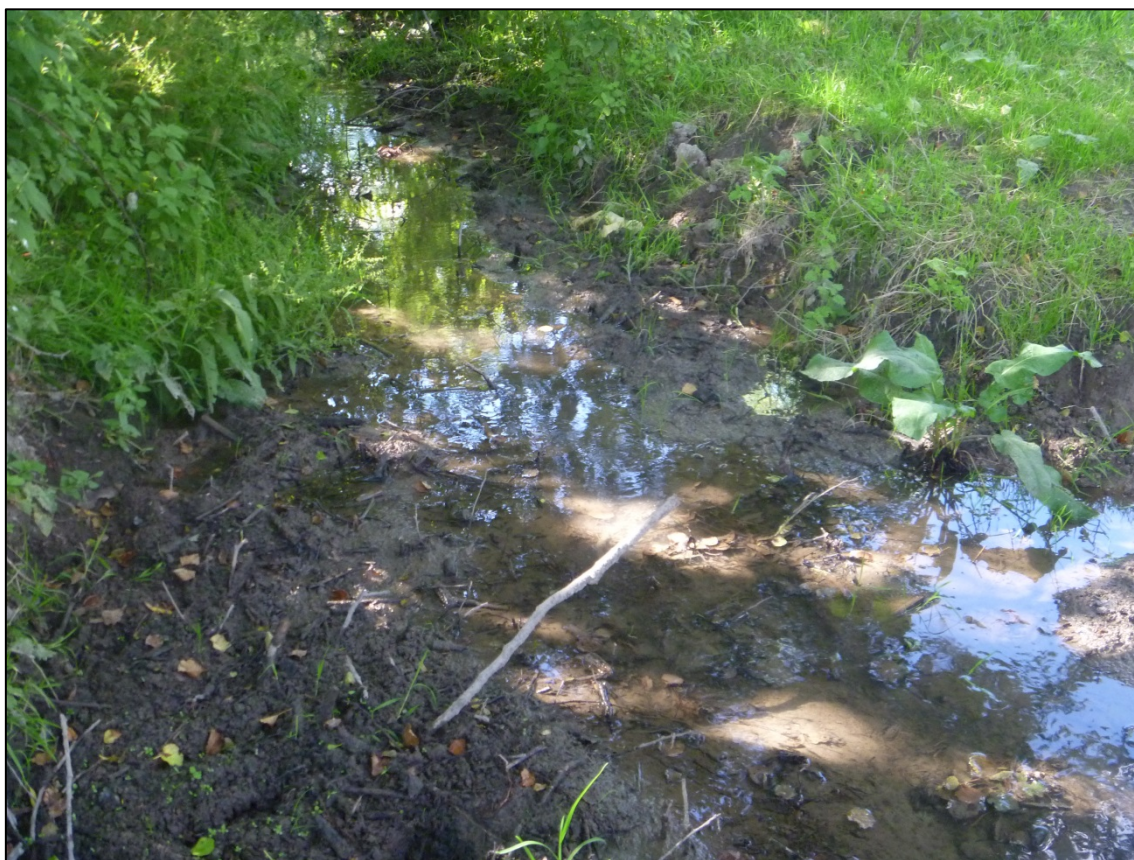
**Figure 4** Heavily poached, silted and shallow habitat at site C11.

The substrate at this site was heavily silted, with evidence of extensive cattle poaching and bank erosion, and the shallow nature of the watercourse would likely make it susceptible to complete de-watering under very dry conditions (Figure 4).

Habitat both upstream and downstream of the existing culvert/pipe at the survey site does not appear suitable for brown trout or bullhead; furthermore, the existing culvert/pipe is likely to act as a total barrier to fish migration. In addition, although the full extent of culverting is

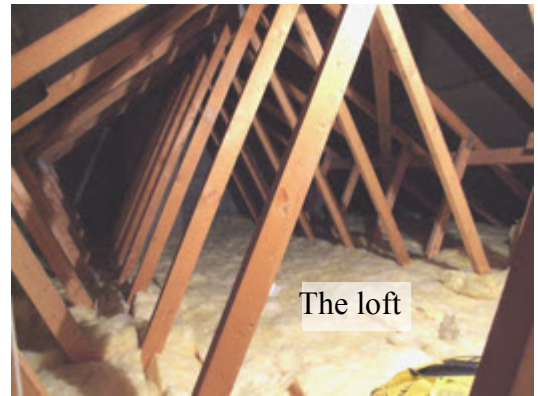
The loft

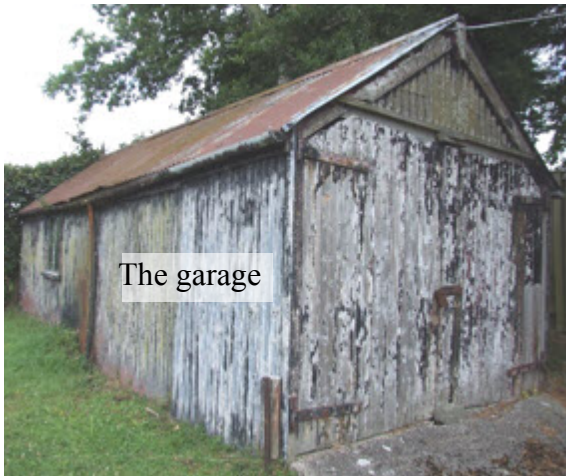
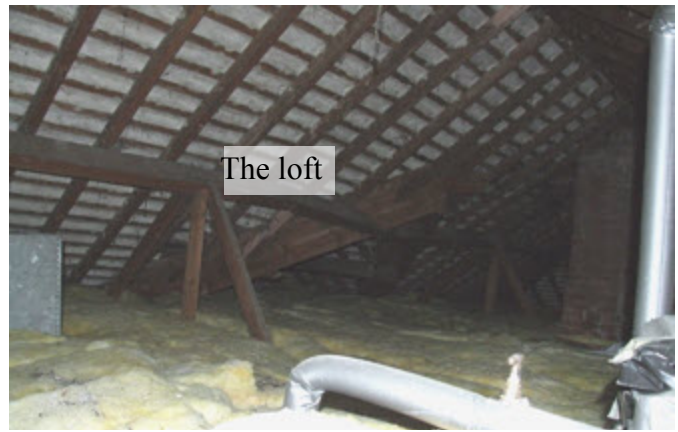
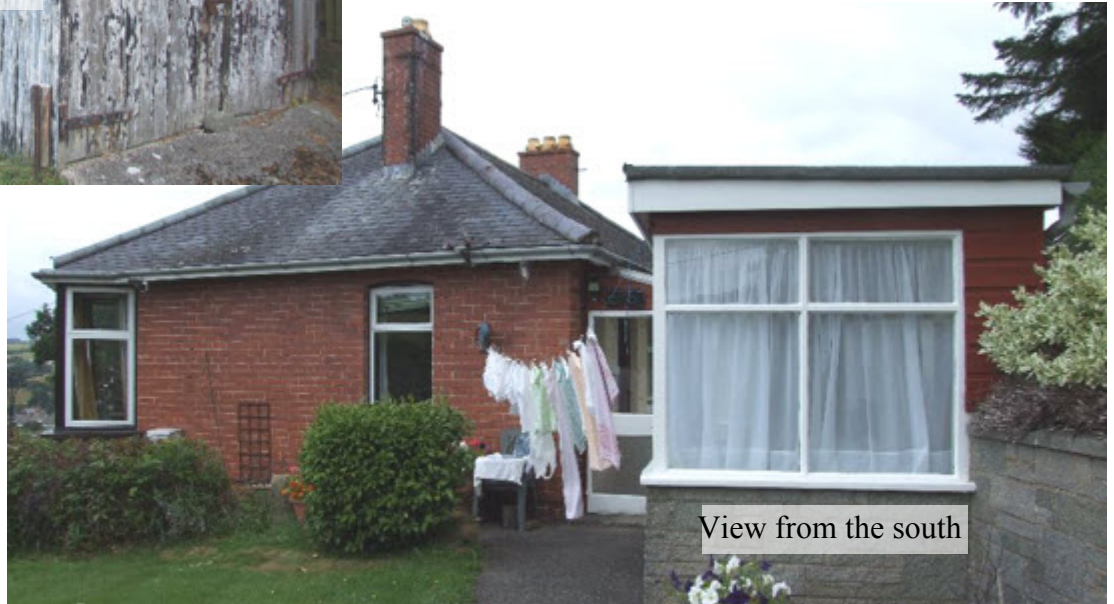
## Hillcrest - 12.8.13

Brick built house with slate roof with torching. A small number of slates slightly damaged with small gaps under some slates including ridge tiles. Windows glazed and intact. Barge boards at gable ends. The loft was not accessible without risk of damage to the kitchen units, due to the position of the hatch, therefore not all areas of the loft could be examined. Photographs were taken through the hatch. There was also a brick built outbuilding with a flat felt roof and a wood garage with corrugated steel roof.

One emergence/re-entry survey to eliminate the possibility of bats using the loft as a roost via access points not visible during the inspection.

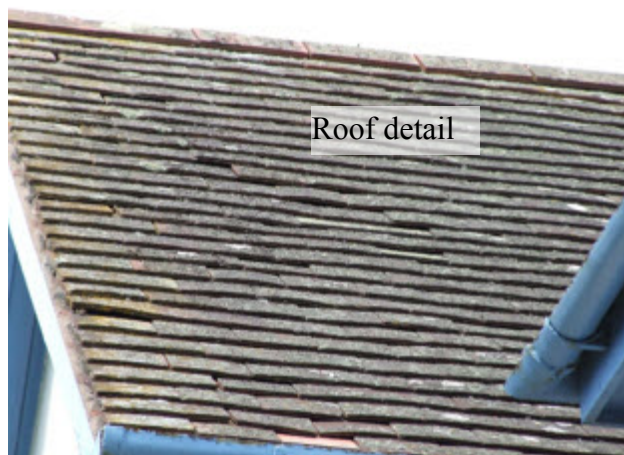
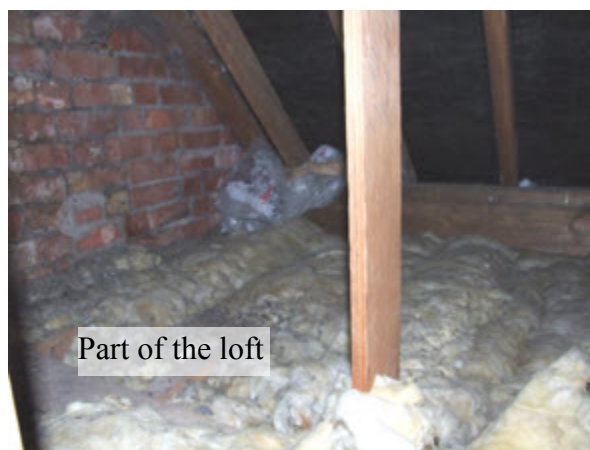
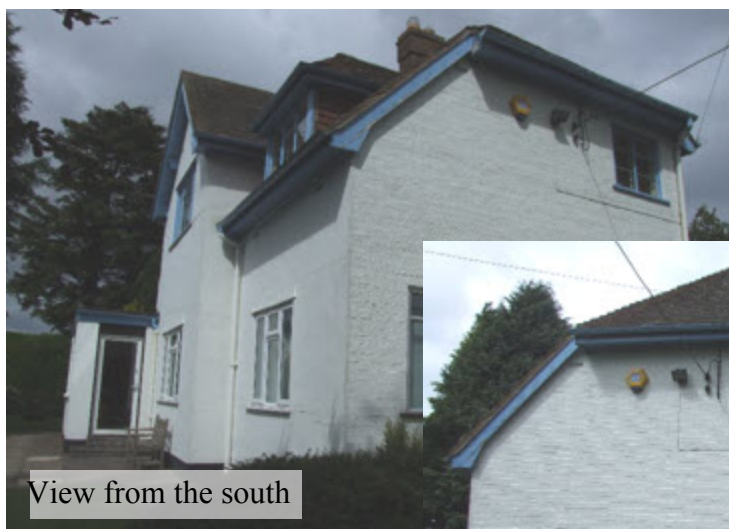
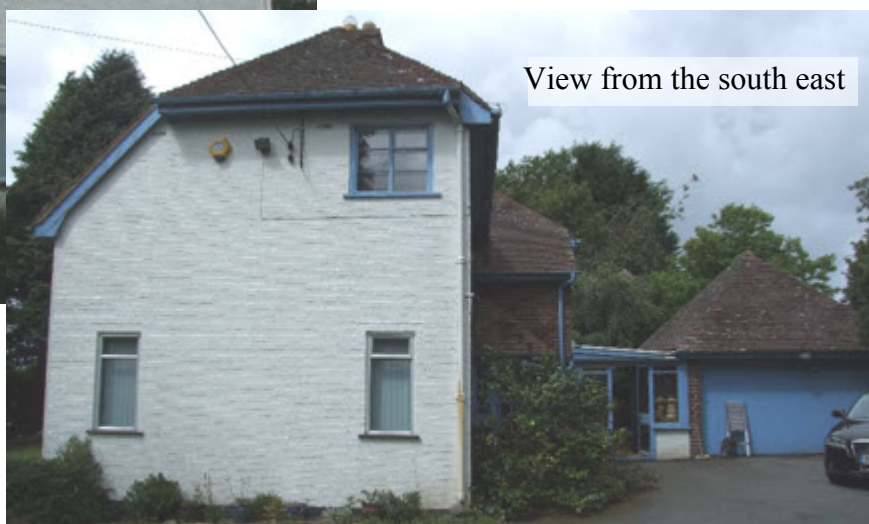
## Cwn-y-Gwynt - 12.8.13

Brick built building with tile roof, some of which were loose or damaged. Roof lined with plastic woven membrane. Garage also brick with tile roof. One section of loft was not accessible.

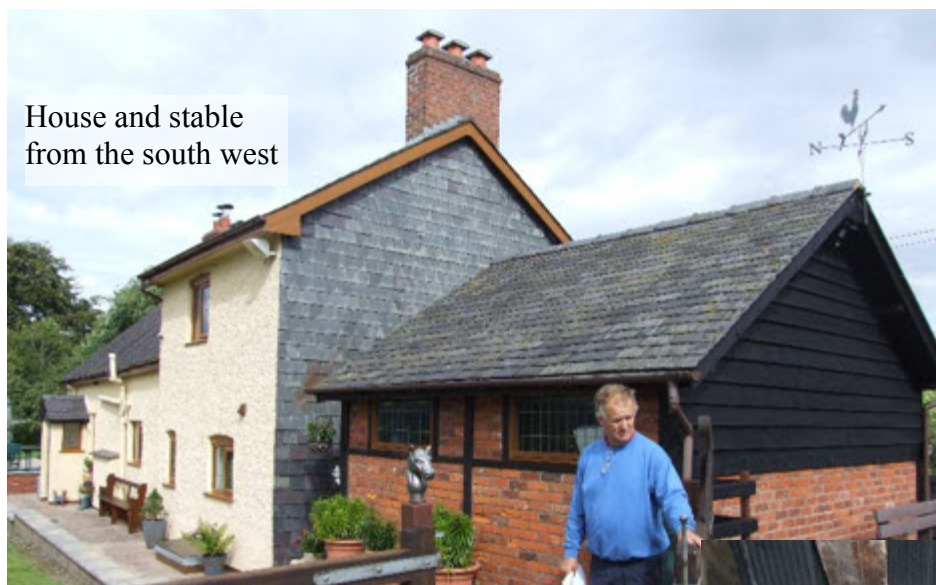
House and stable  
from the south west

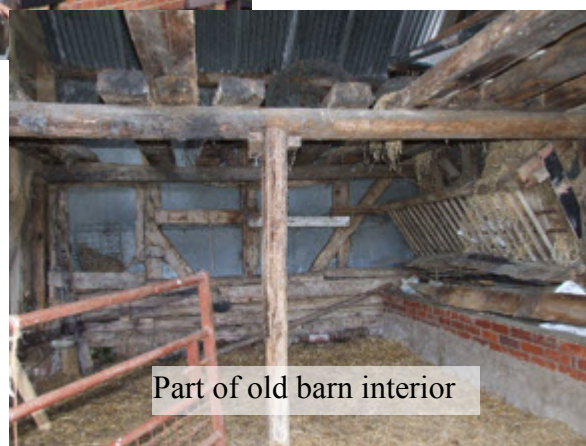
Part of old barn interior

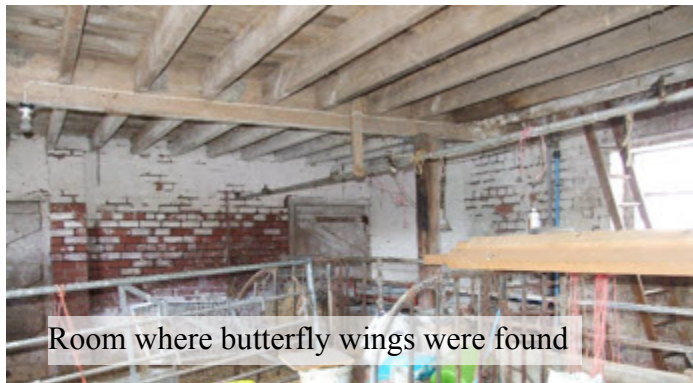
Room where butterfly wings were found

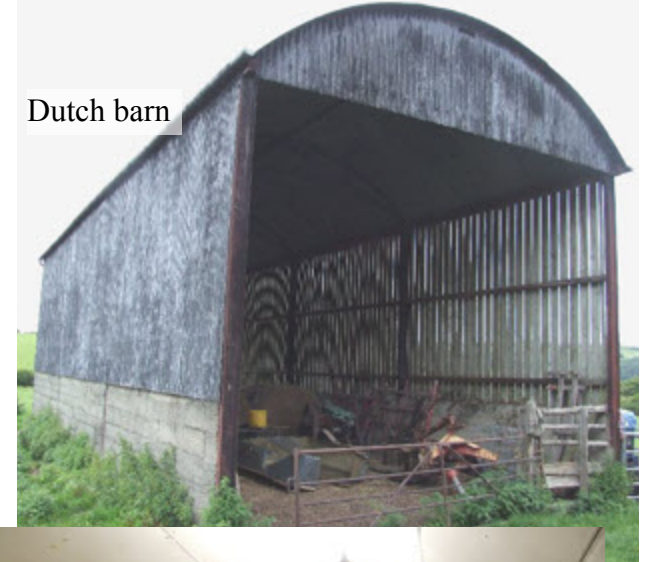
Dutch barn

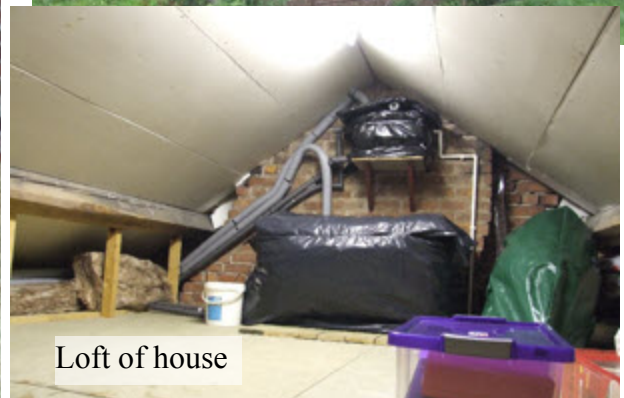
Loft of house

Two or three emergence/re-entry survey surveys to establish nature of use by bats, to include the main house, barn and old barn.

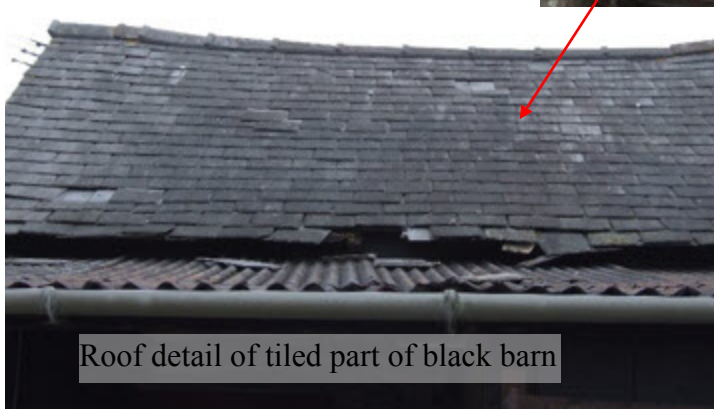
Roof detail of tiled part of black barn

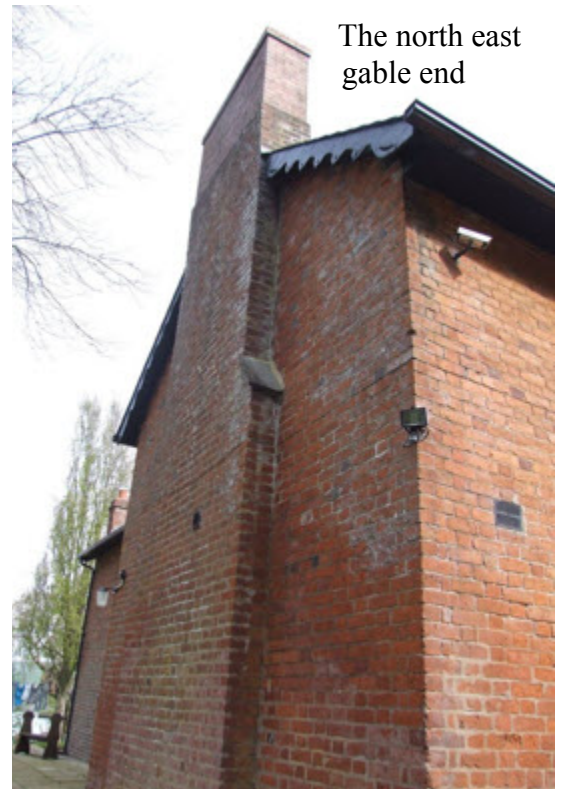
## Castell y Dail House - 20.4.14

Well maintained brick built house with tile roof, lined with plastic membrane. Tiles intact and none damaged or missing. Windows glazed and intact. Barge boards at gable ends. We were informed that the roof had been replaced approximately two years ago and a bat survey done at that time which had not identified a roost.

No further surveys considered necessary.

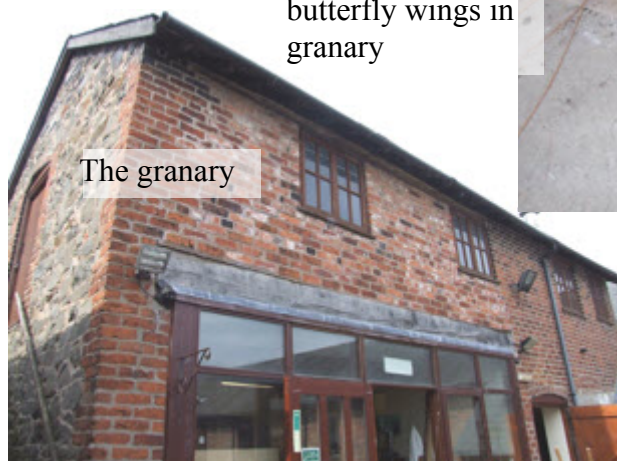
The granary

Bat droppings and butterfly wings in granary

Two small accumulations of 20-30 bat droppings were found inside (upper storey) with feeding remains (butterfly wings) found in the same area, suggesting a regular feeding perch by bats, possibly brown long-eared bats (*Plecotus auritus*).

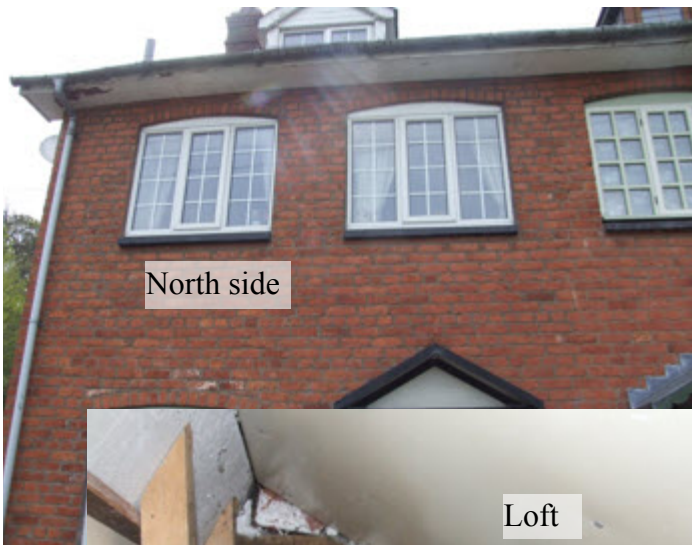
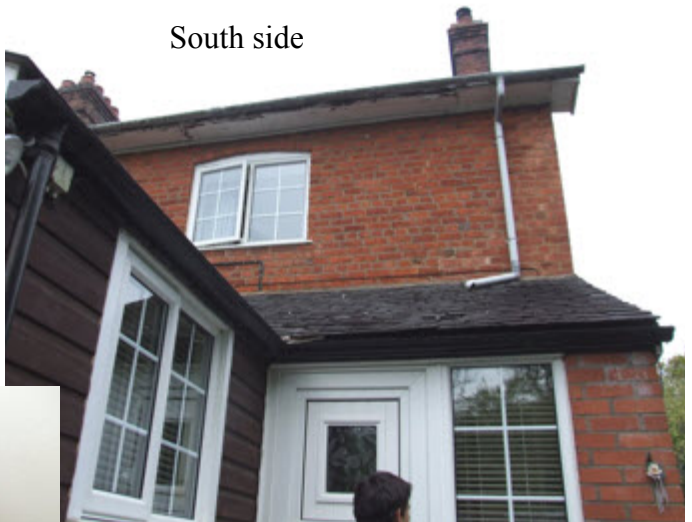
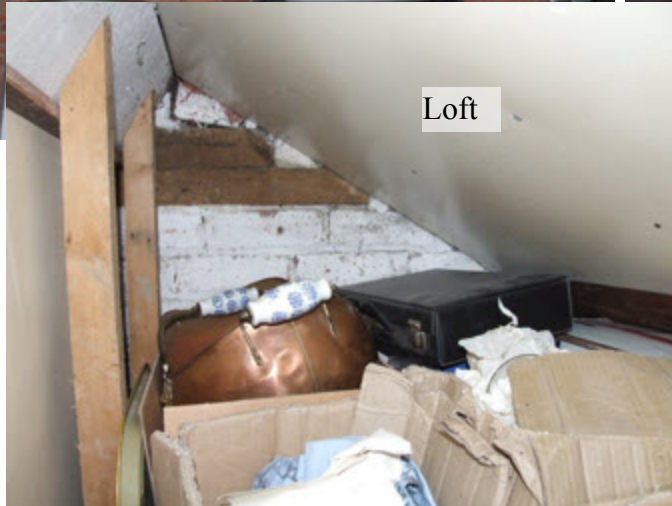
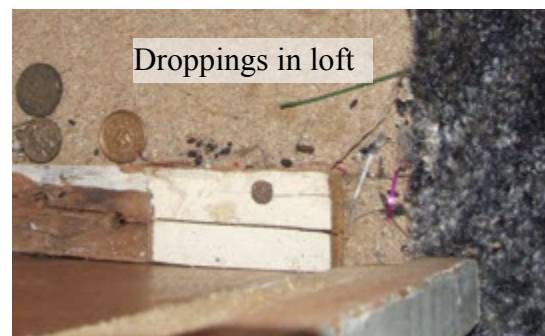
#### 4, Bontdulas - 20.4.14

Brick built house with tile roof. Tiles intact and none damaged or missing. Windows glazed and intact. Some damage to soffits allowing possible access.

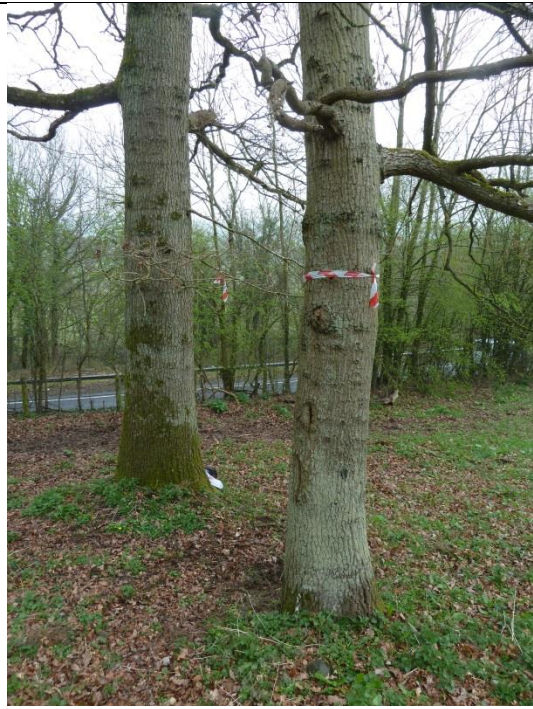
Tree Reference B5

| Ref. No | Species | Notes | Category <sup>1</sup> |
|---|---|---|---|
| B5 | Oak | Small splits in bark at chest height, has some limited potential. Small hole left from broken branch above head height also has limited potential. | 2 |

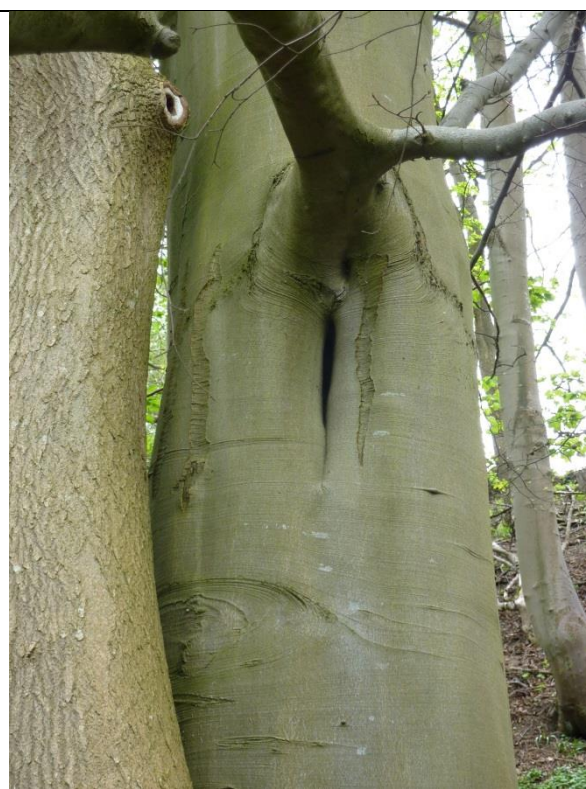
Tree Reference B11 Feature

| Ref. No | Species | Notes | Category <sup>1</sup> |
|---|---|---|---|
| B11 | Beech | Large tree with a number of natural cavities in the trunk underneath branches. These are on all sides of the tree. Note that these cavities that can be observed at ground level do not appear to extend to any great depth. | 1 |

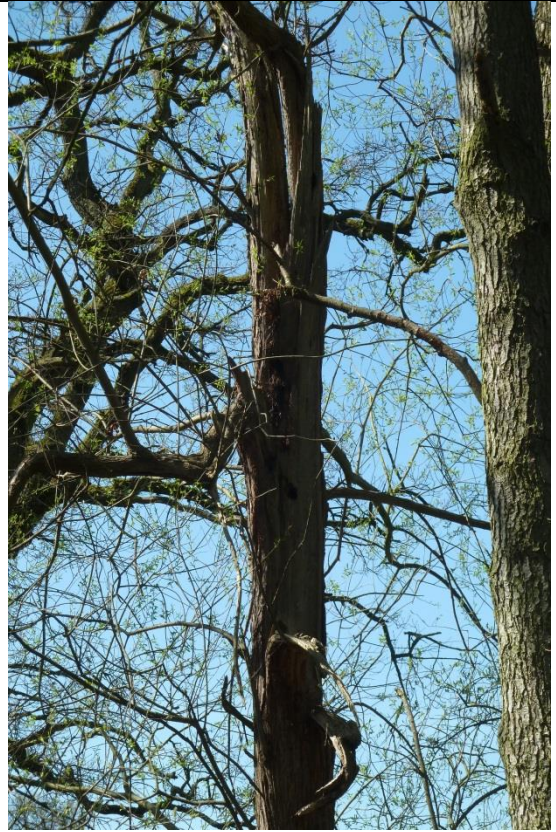
Tree Reference B122

| Ref. No | Species | Notes | Category <sup>1</sup> |
|---|---|---|---|
| B122 | Unknown | Three woodpecker holes in damaged trunk. Small hole with possible staining on adjacent larger trunk. | 1* |

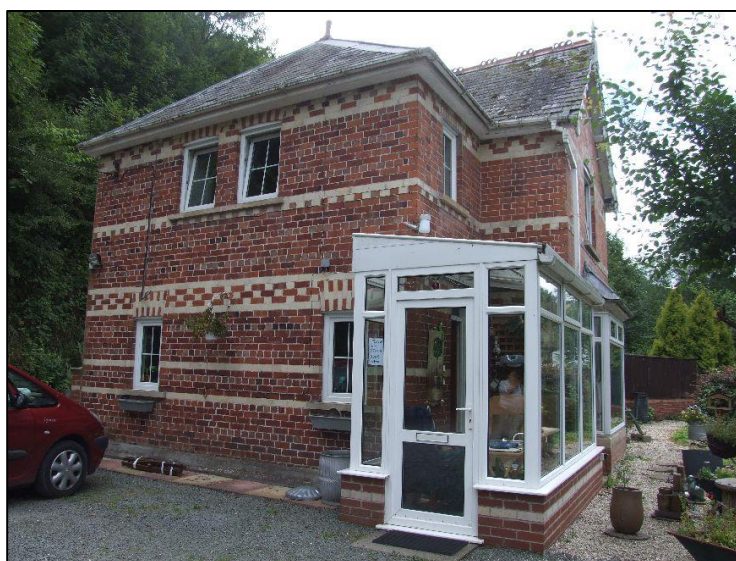
**Photo 1 – exterior of the property, view from the north-west**

A small accumulation of bat droppings was found within the loft during the survey (approximately 20 – 30). The DNA test results show that the droppings analysed were that of a Whiskered bat (*Myotis mystacinus*) (refer to test results at Appendix A). Photographs of the house and loft are shown below.

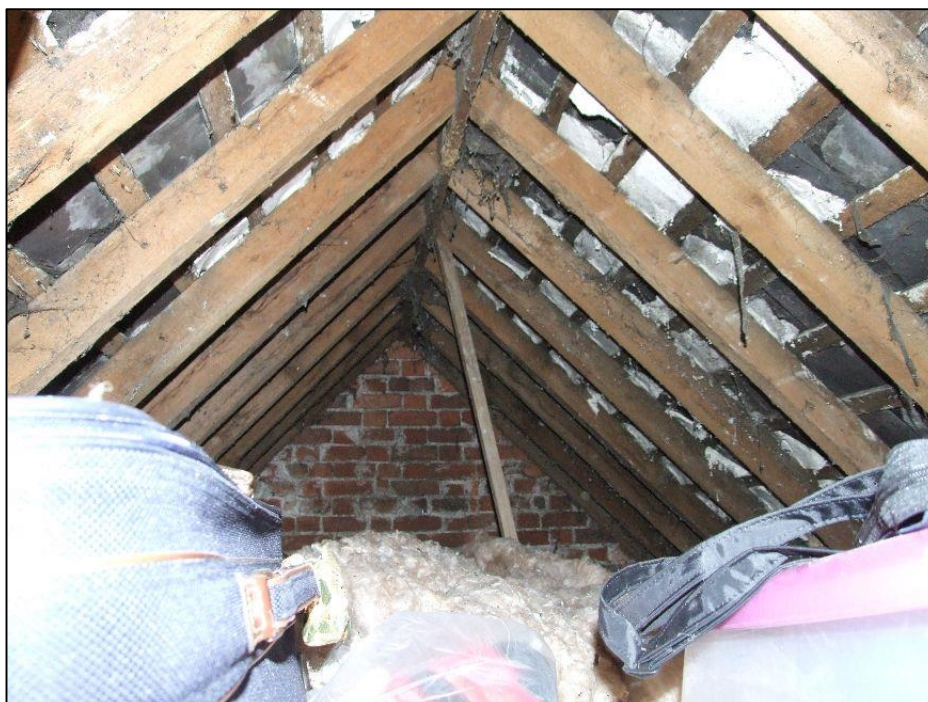
**Photo 3 – View of inside the loft**

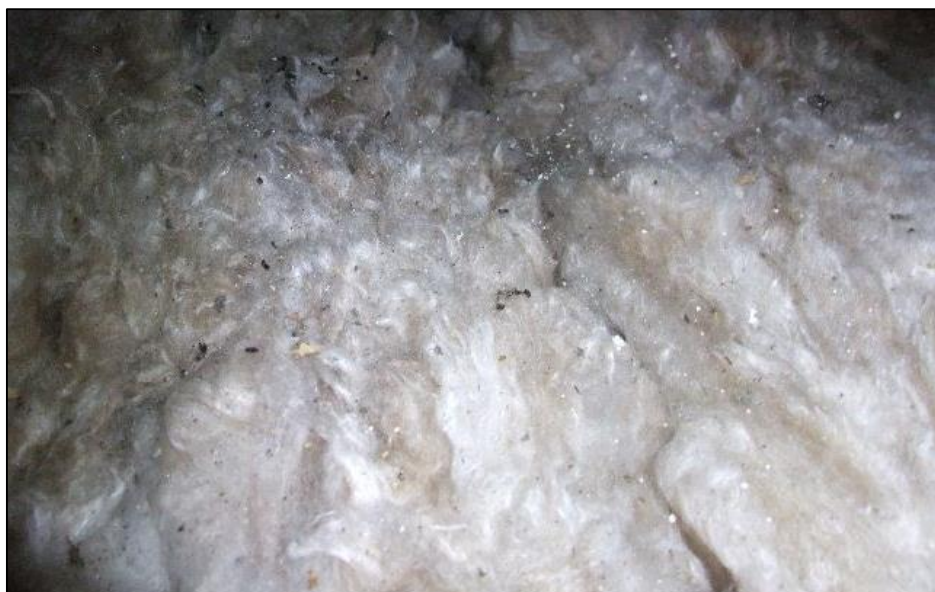
**Photo 4 – Droppings found within the loft of Kinsale**

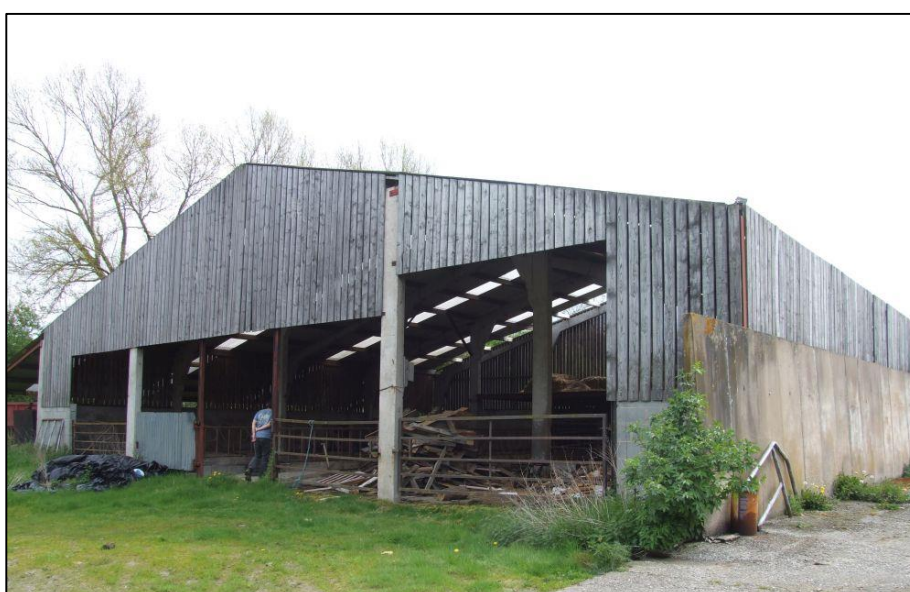
The Barn along Pool Road has slatted wood walls and a corrugated steel roof with plastic windows, concrete pillars and wood beams. There is an open steel lean-to at the east side.

**Photo 5 – Barn exterior**

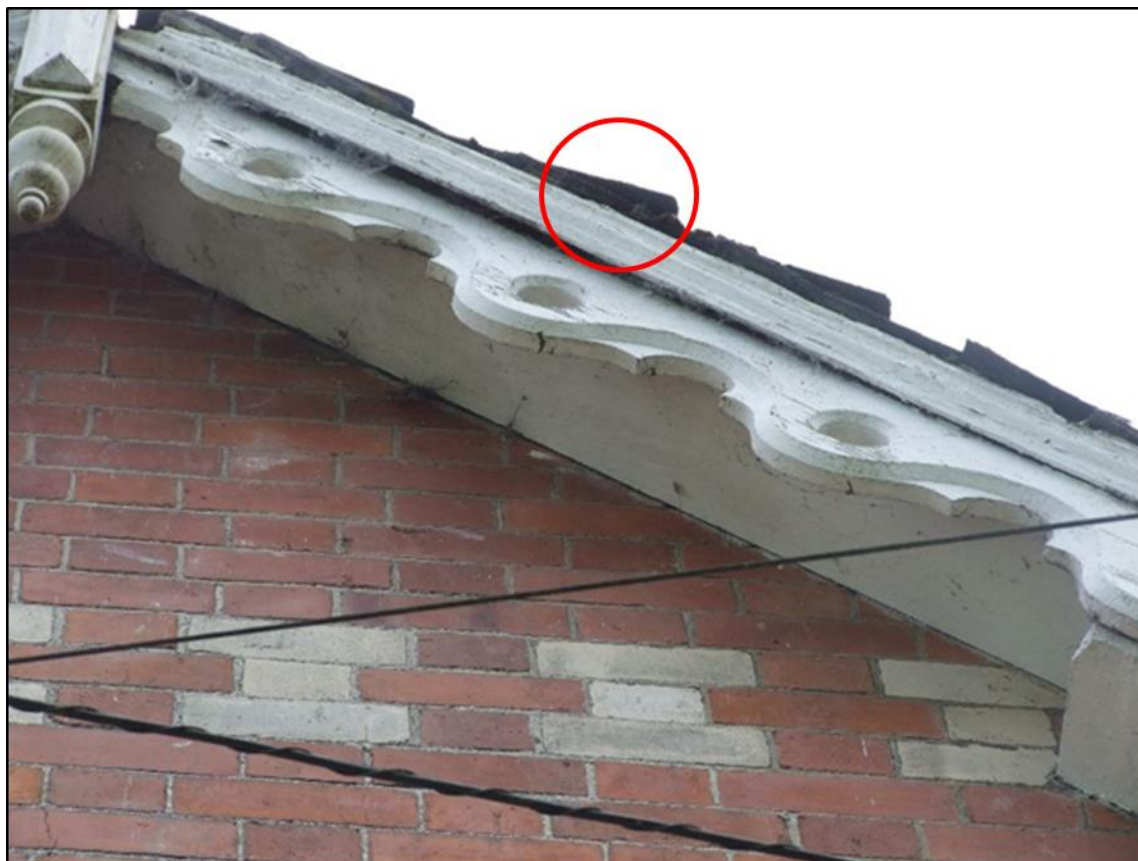
**Photograph 8 – Emergence /re-entry location of the Soprano pipistrelle (*Pipistrellus pygmaeus*) at the west facing gable end of Kinsale**

| Time | Species | Notes |
|---|---|---|
| 04.41 | Soprano pipistrelle<br>( <i>Pipistrellus pygmaeus</i> ) | Bat returned to the same place it was recorded emerging on 08/07/2014. Presumed to be the same animal. Entry point underneath the second tile down on the southern aspect of the roof near the west facing gable end (refer to Photograph 8 below). |

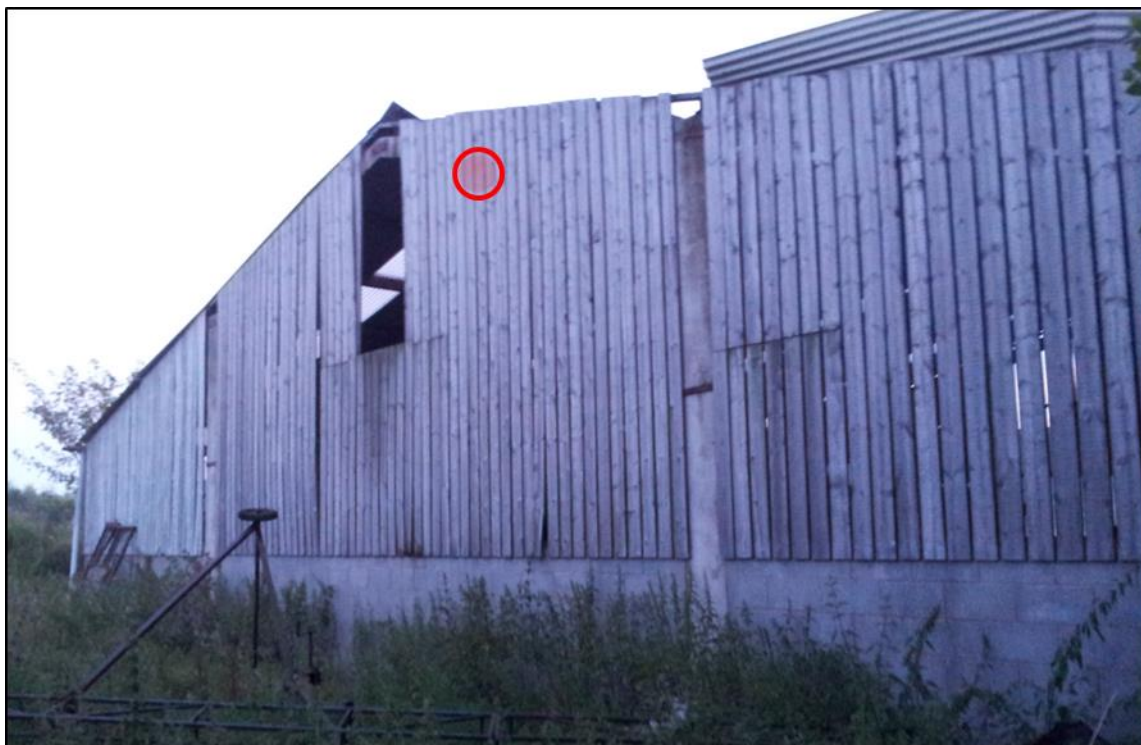
**Photograph 9 – Re-entry location of the Soprano pipistrelle (*Pipistrellus pygmaeus*) at the south facing side of the Barn along Pool Road**

| Time | Species | Notes |
|---|---|---|
| 05:01 | Soprano pipistrelle<br>( <i>Pipistrellus pygmaeus</i> ) | Returned to southern side of barn and entered under one of the vertical wooden slats. Roost location presumed to be under one of the slats (refer to Photograph 9). |

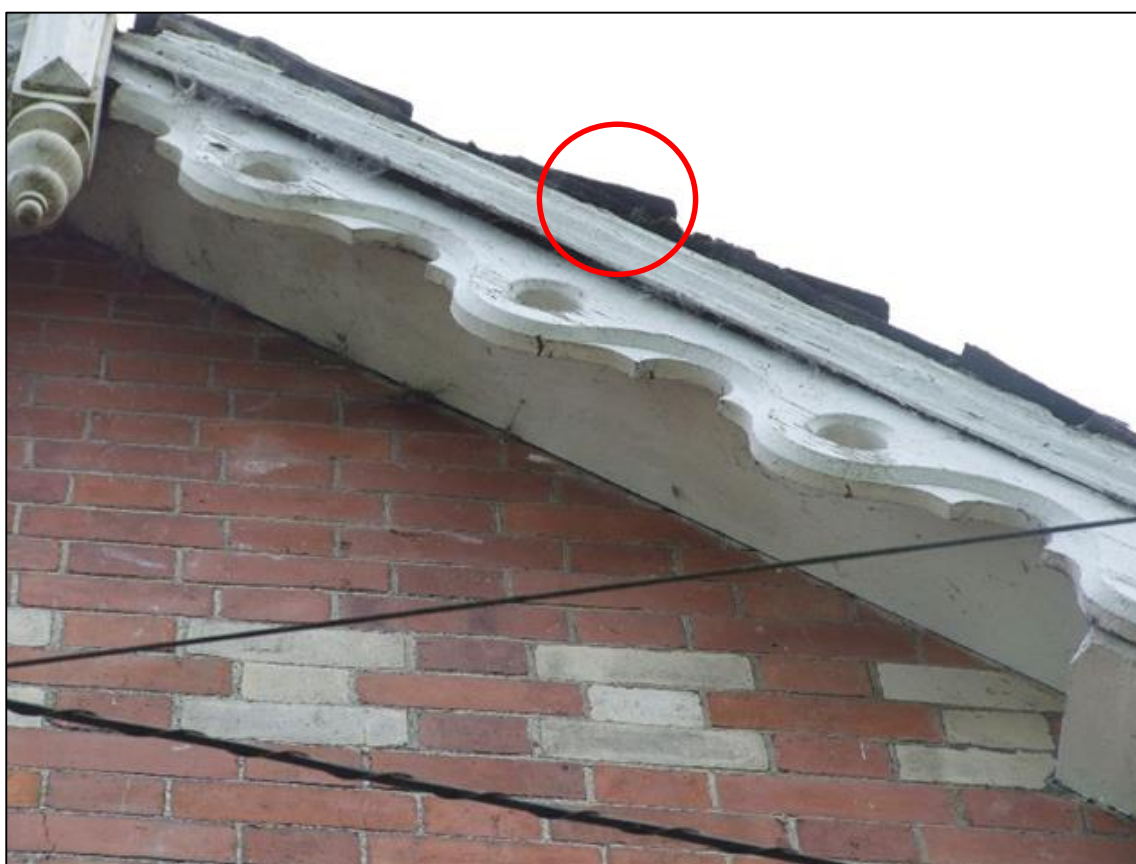
**Photograph 1 – Emergence /re-entry location of the Soprano pipistrelle (*Pipistrellus pygmaeus*) at the west facing gable end of Kinsale**

| Other notes: The following species were also recorded foraging or commuting within the vicinity of the surveyors: Common pipistrelle ( <i>Pipistrellus pipistrellus</i> ), Soprano pipistrelle ( <i>Pipistrellus pygmaeus</i> ), Noctule ( <i>Nyctalus noctula</i> ) and Brown long-eared ( <i>Plecotus auritus</i> ). | | |

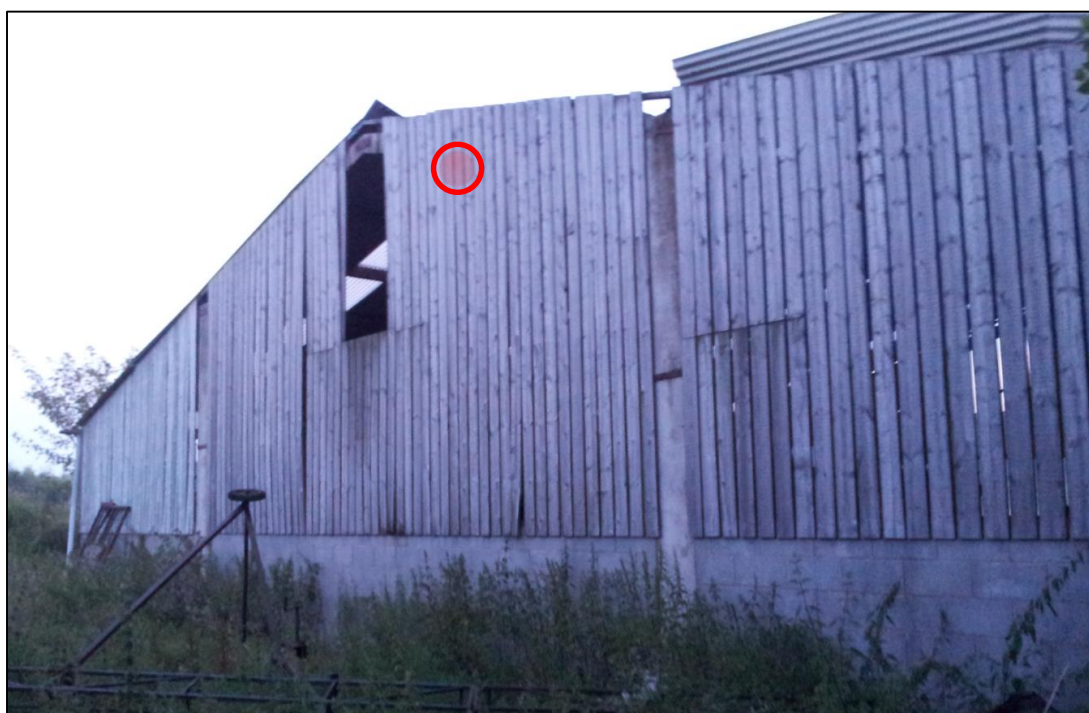
Photograph 2 – Re-entry location of the Soprano pipistrelle (*Pipistrellus pygmaeus*) at the south facing side of the Barn along Pool Road

| Time | Species | Notes |
|---|---|---|
| 05:01 | Soprano pipistrelle ( <i>Pipistrellus pygmaeus</i> ) | Returned to southern side of barn and entered under one of the vertical wooden slats. Roost location presumed to be under one of the slats (refer to Photograph 2). |

The results of the activity survey suggest that the Barn along Pool Road is used by one Soprano pipistrelle bat with the entrance to the roost site located under one of the vertical wooden slats on the south facing side of the building (refer to Photograph 2 above and Figure 4.0).
