## Appendix E.1

Section 42 NERC Act 2006

Habitats and Species List

# A483-A489 Newtown Bypass - Otter Method Statement

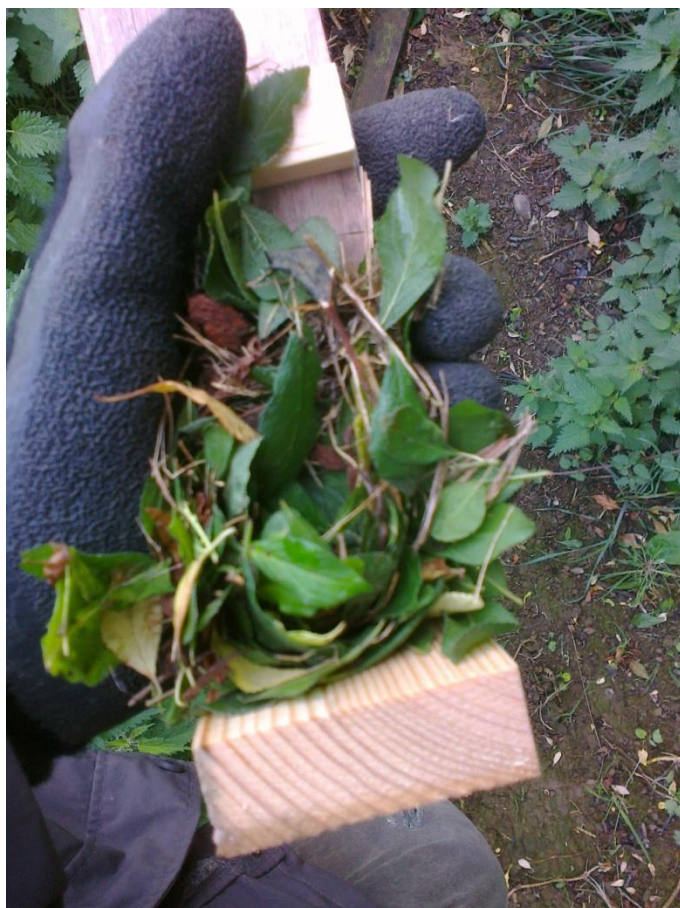
Glandulais Caravan Park:

### Photographs of dormouse nests found:
