A55(T) Chester to Bangor Trunk Road: Abergwyngregyn to Tai'r Meibion Improvement

ENVIRONMENTAL STATEMENT VOLUME 2: TECHNICAL APPENDIX A CULTURAL HERITAGE

DESK BASED ASSESSMENT REPORT

Report No. 1258

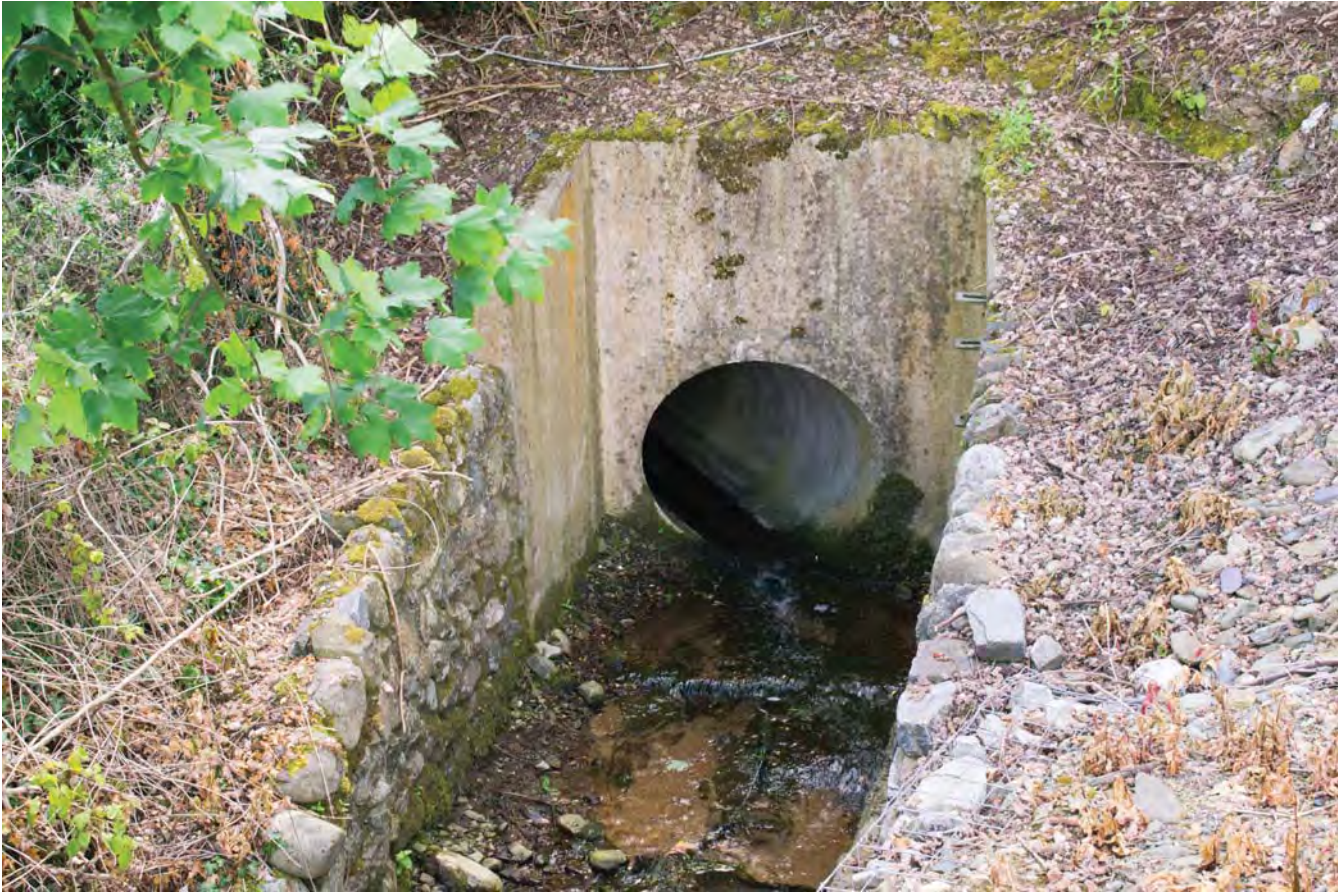
Plate 11: Photo of Asset No 17, Culverts, north of Tan-yr-Allt cottages. View from the northwest.

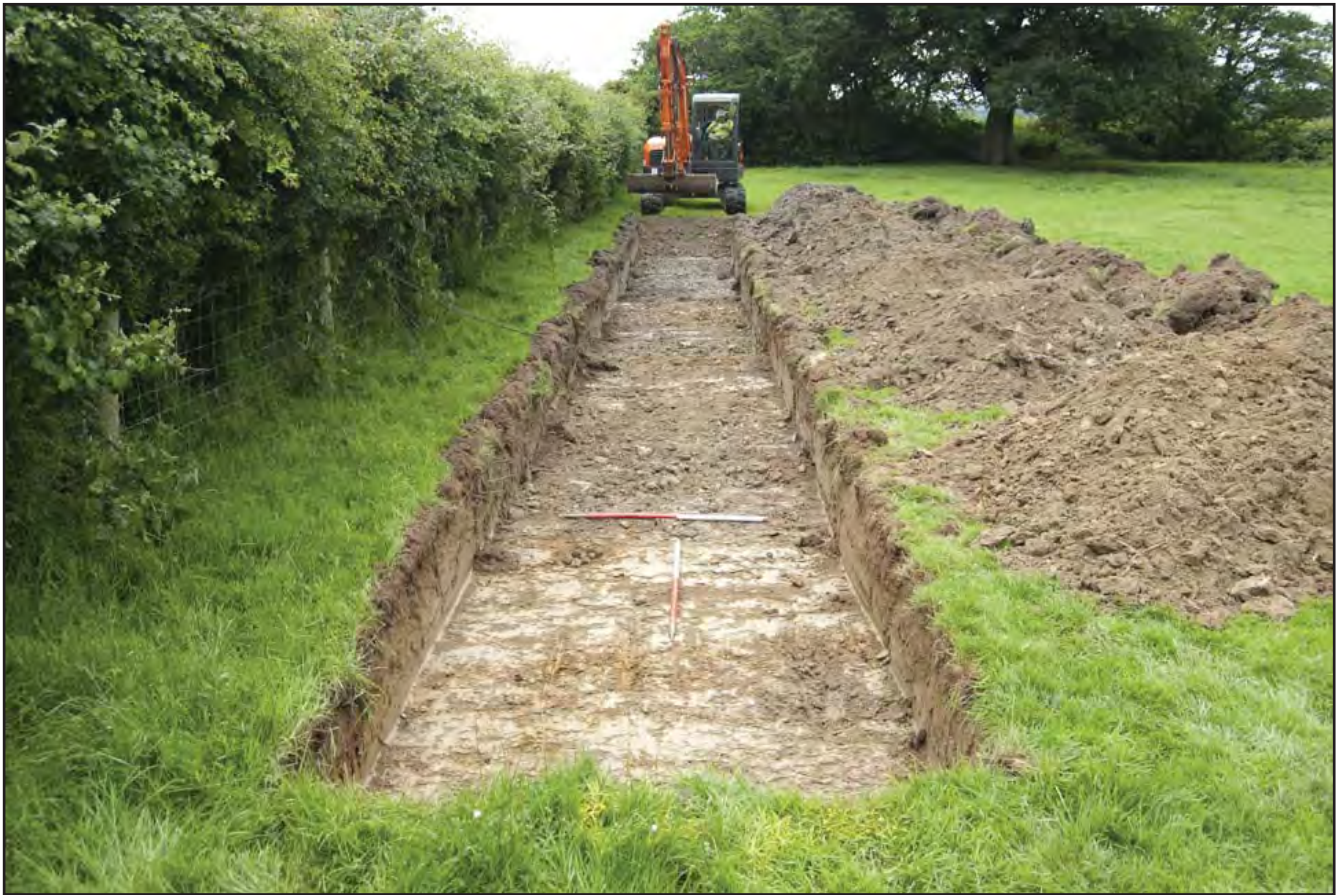
Plate 01: Post-ex shot of Trench 01, viewed from the NE (scale: 2x1m; archive image: G2424_PCTT_2016_011).

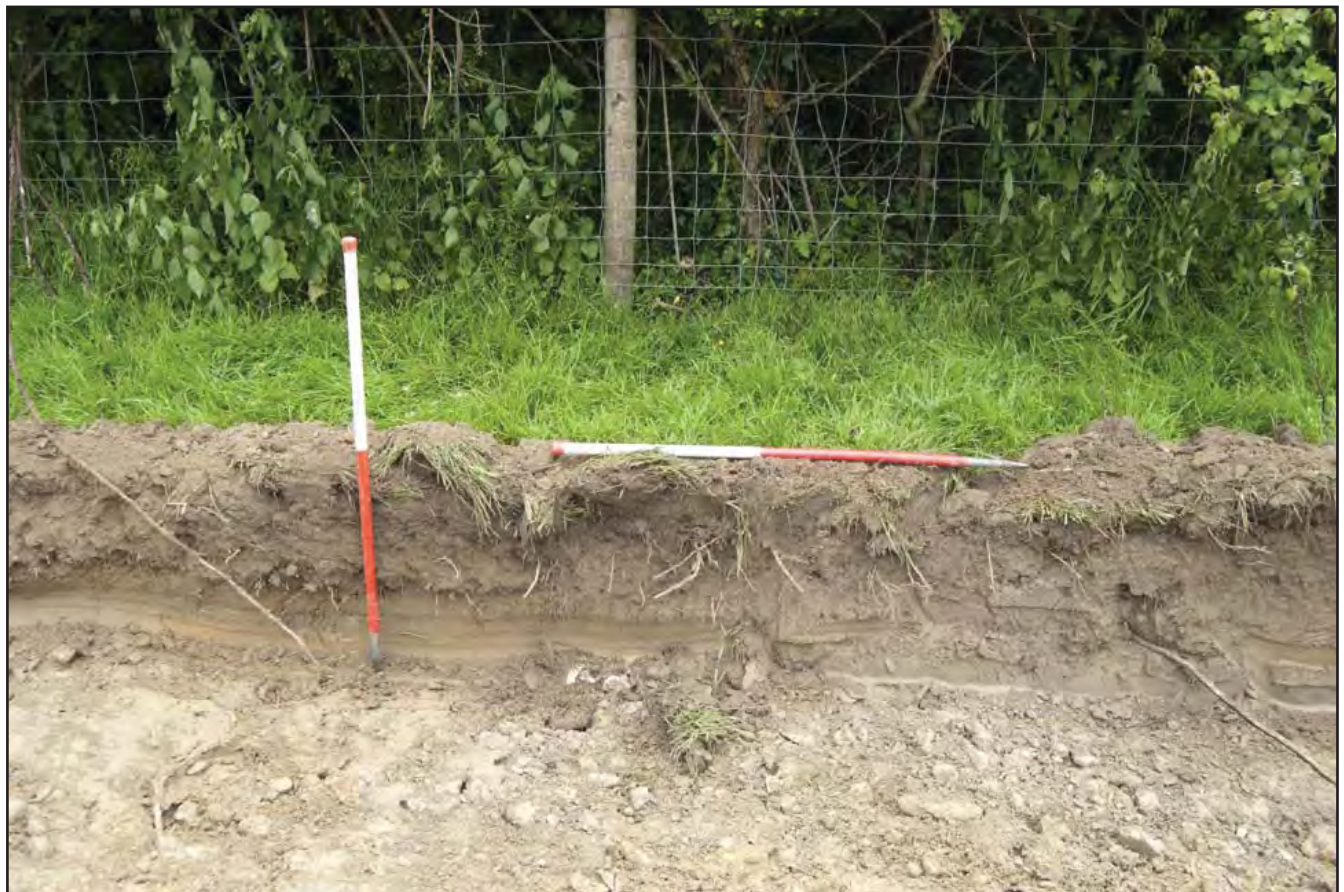
Plate 02: NW facing baulk section of Trench 01, viewed from the NW (scale: 2x1m; archive image: G2424_PCTT_2016_012).

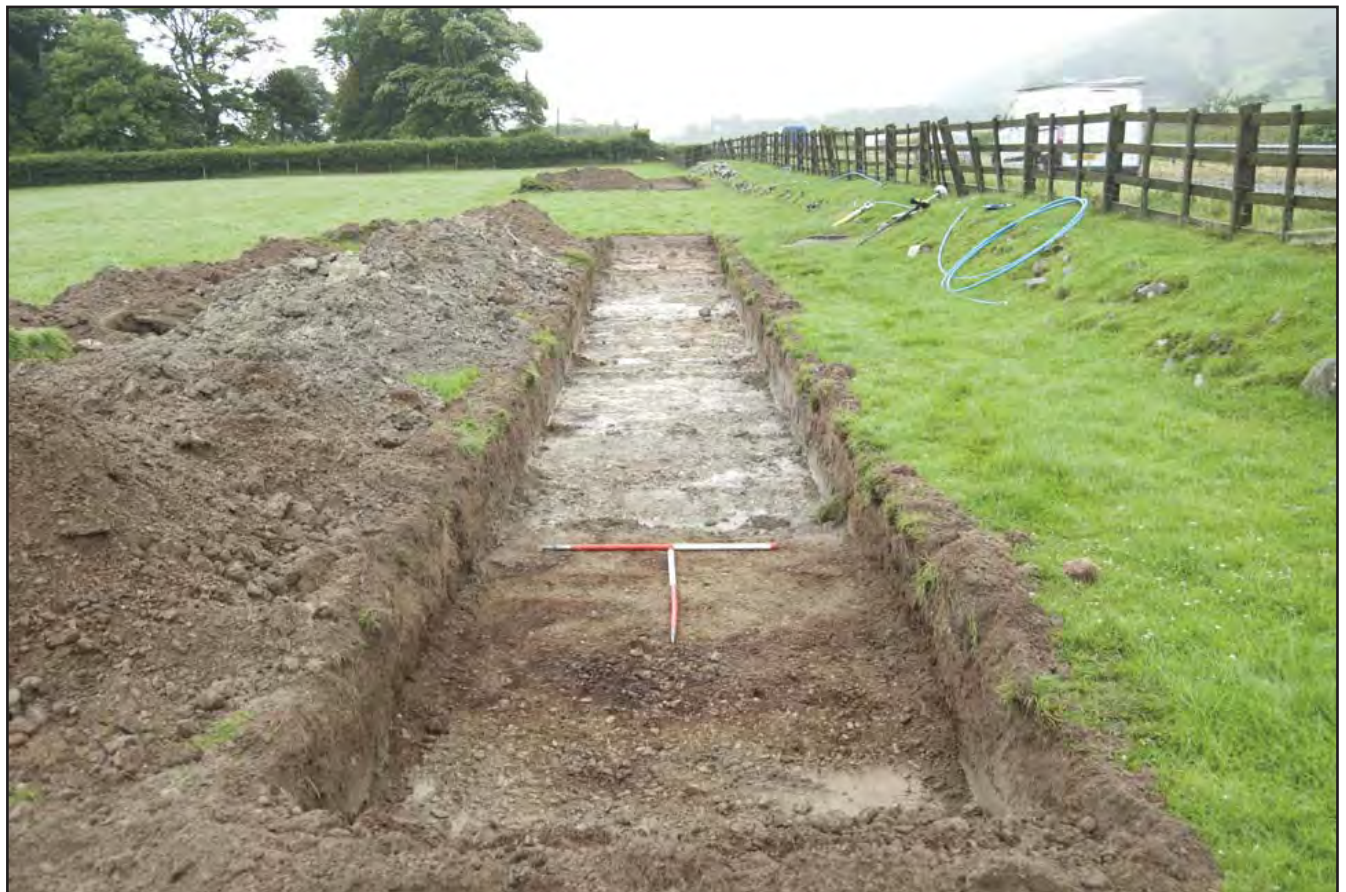
Plate 04: Post-machining shot of Trench 02, viewed from the SW (scale: 2x1m; archive image: G2424_PCTT_2016_006).

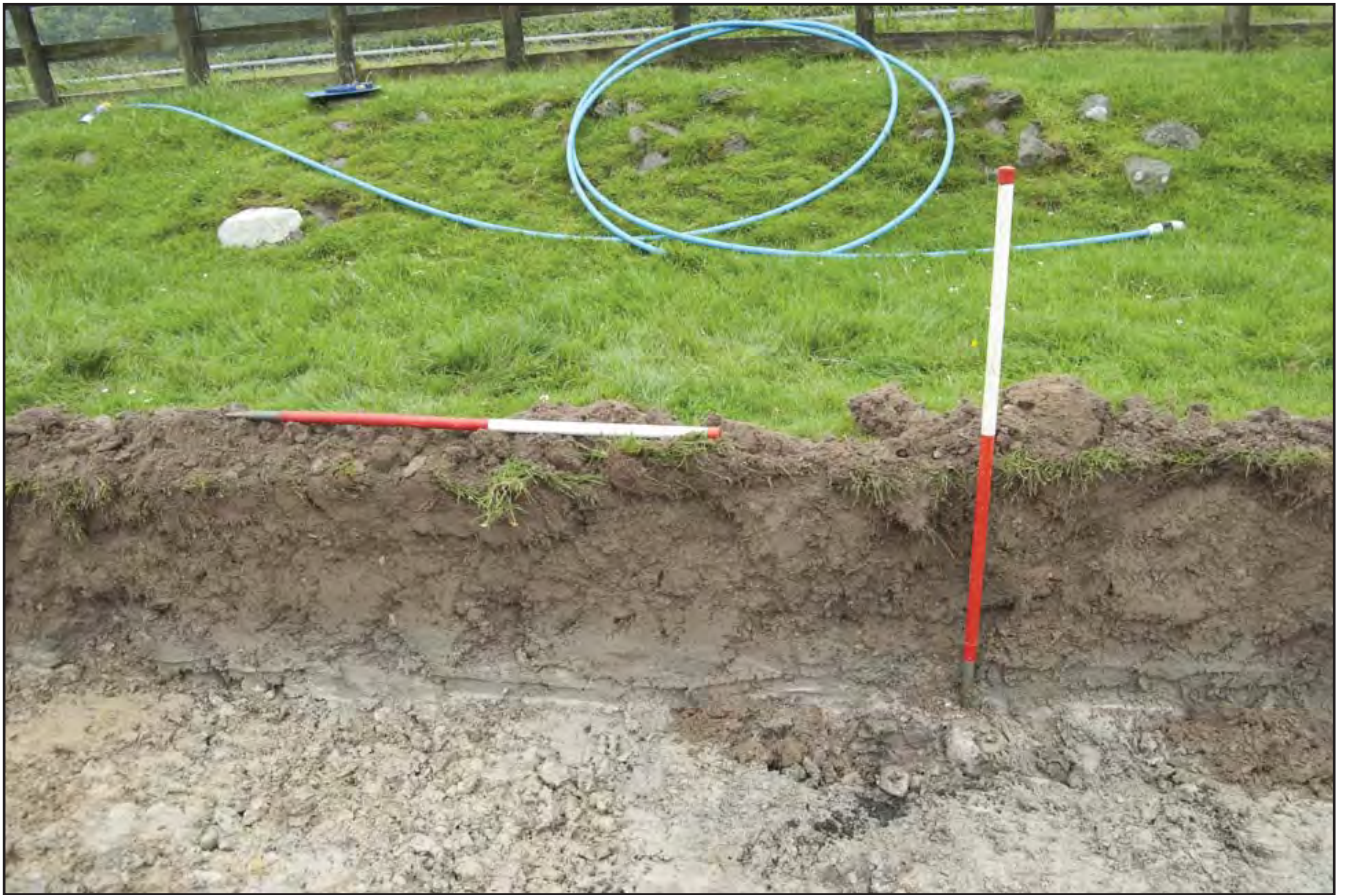
Plate 05: NW facing baulk section of Trench 02, viewed from the NW (scale: 2x1m; archive image: G2424_PCTT_2016_007).

Another, presumably modern, 0.30m wide straight linear land drain cut **[0207]** was observed approximately 6.00m from the SW end of Trench 02. It was cut through the subsoil **(0202)** and ran NW-SE, perpendicular to the orientation of the trench. It was filled with **(0208)**, a light greyish brown clean clay.

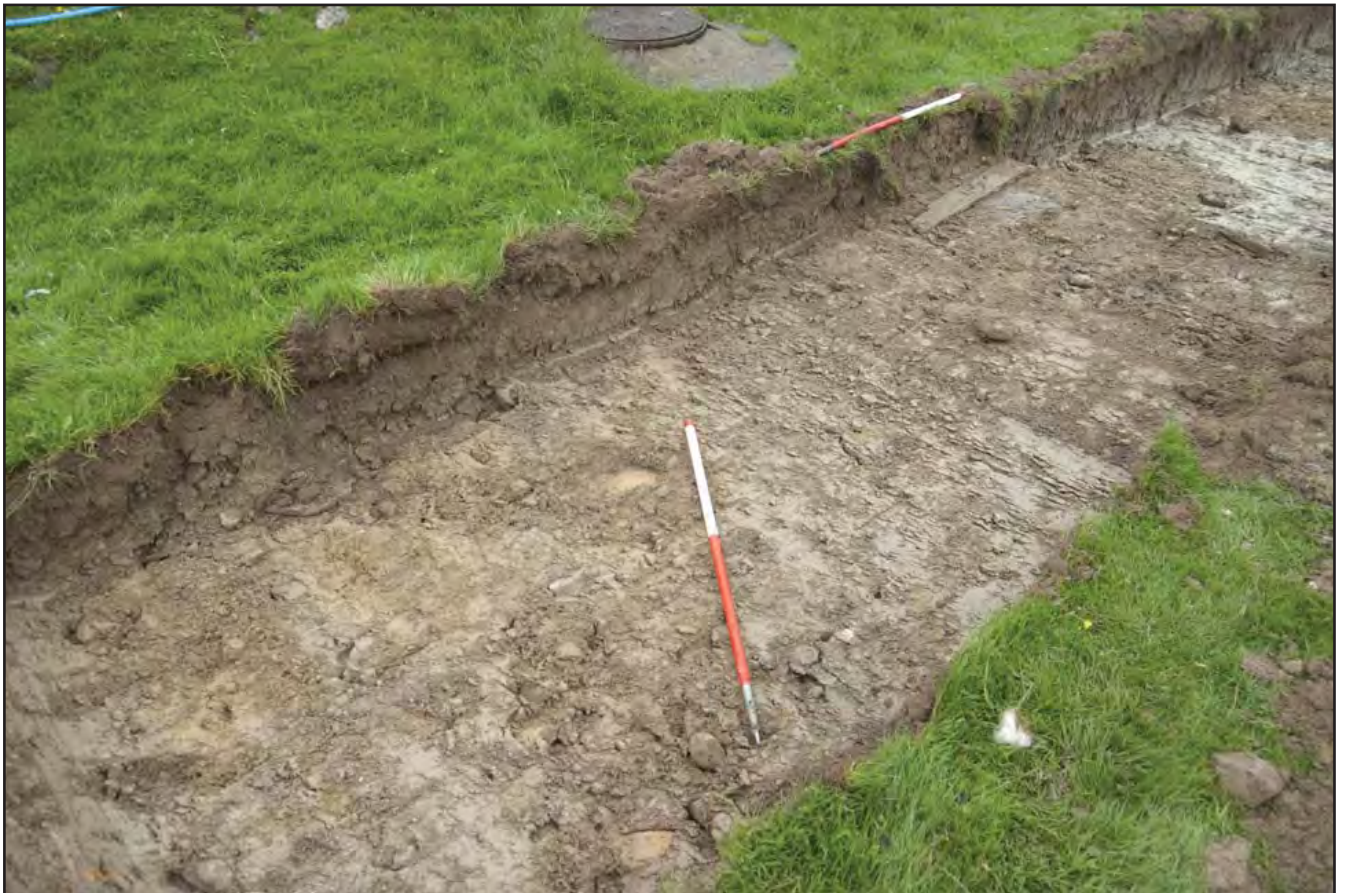
Plate 06: View of ceramic drain pipe (0206) in Trench 02, viewed from the NNE (scale: 2x1m; archive image: G2424_PCTT_2016_009).

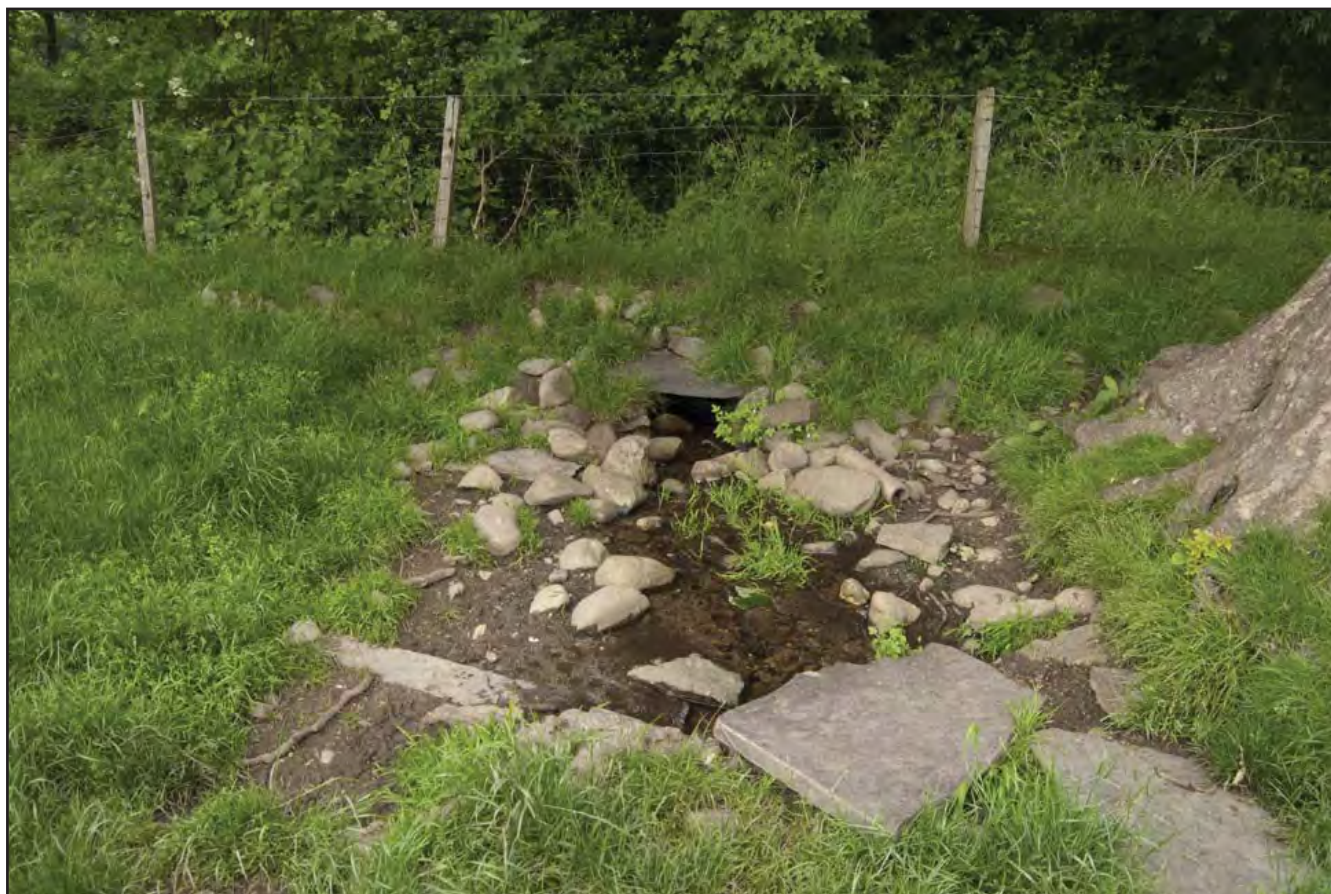
Plate 08: Probable continuation of slate culvert (recorded as 0205) at NW side of field, viewed from the SSE (archive image: G2424_PCTT_2016_027).

The slate culvert (**0205**) appears to be part of a Post-medieval water management system. The collapsed remains of most likely the same culvert were identified 50m to the NW at the edge of the field, the water emerging from it and feeding into a disused mill pond (Plate 08). A leat from the mill pond still carries water NW to the location of the disused water wheel. The observation that the culvert is still actively carrying water means that, unless replaced there by a more recent pipe, it may also survive underneath the present carriageway of the A55 to the SE.

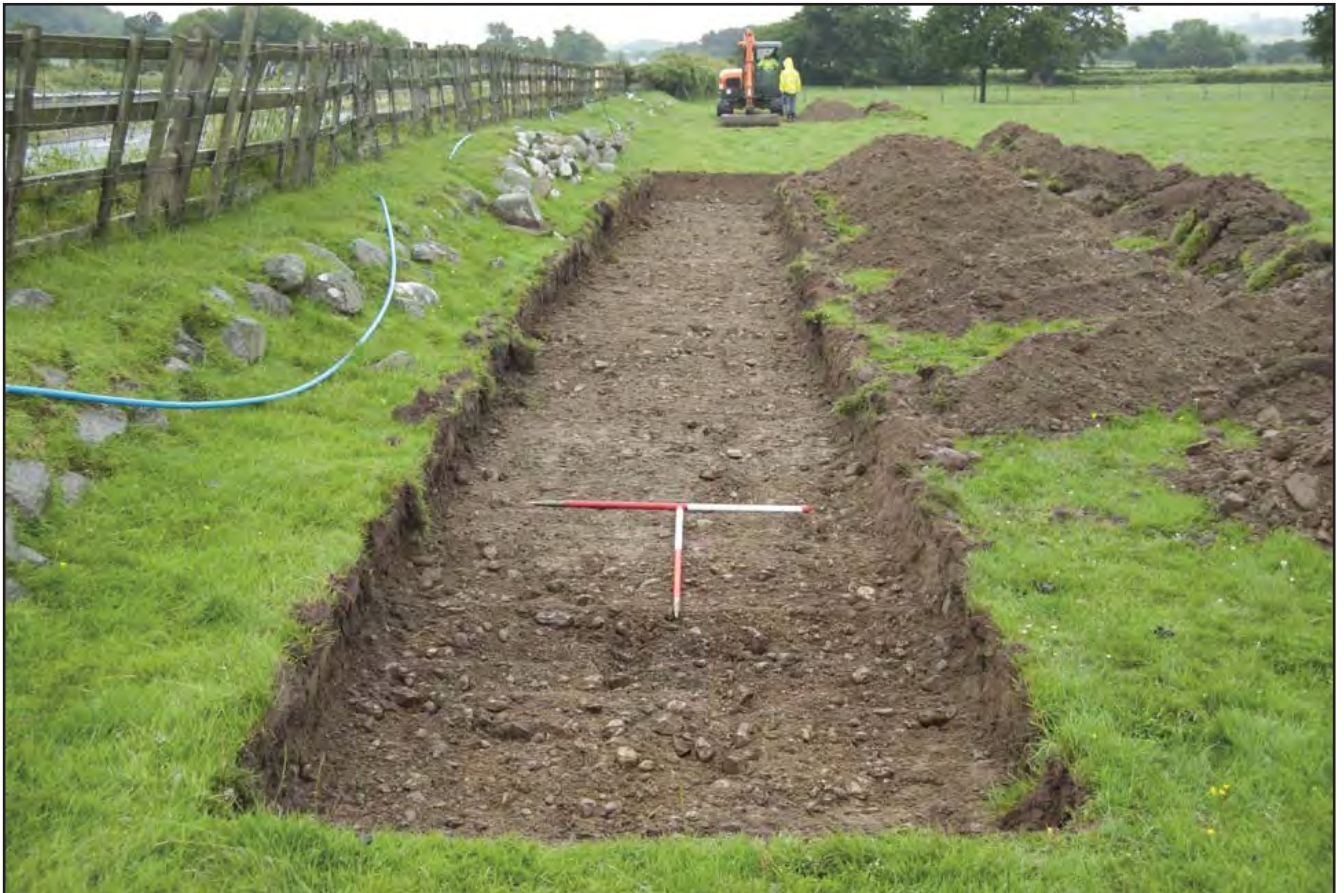
Plate 11: Post-machining shot of Trench 03, viewed from the NE (scale: 2x1m; archive image: G2424_PCTT_2016_005).

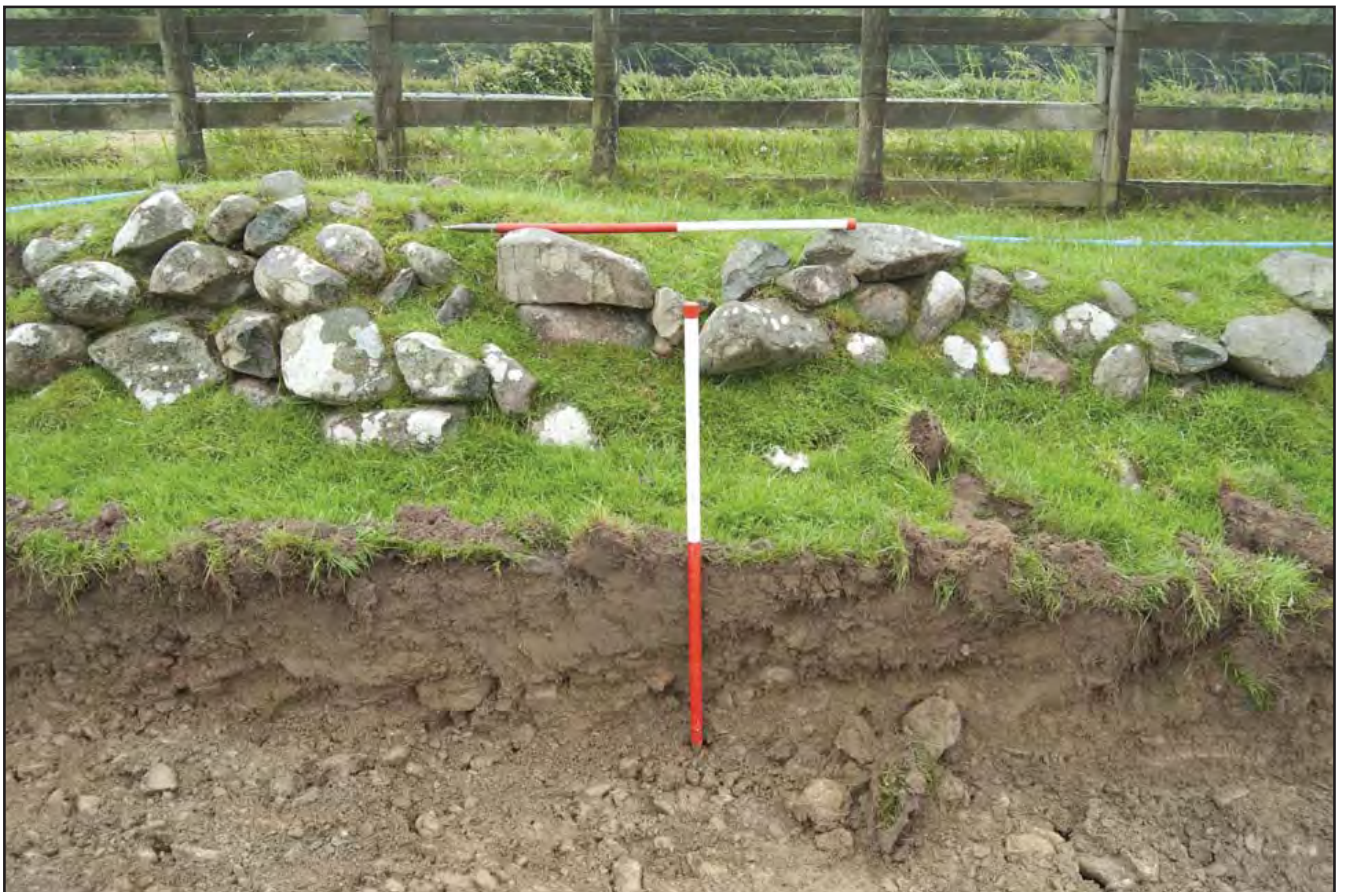
Plate 12: NW facing baulk section of Trench 03 with field boundary in background, viewed from the NW (scale: 2x1m; archive image: G2424_PCTT_2016_004).

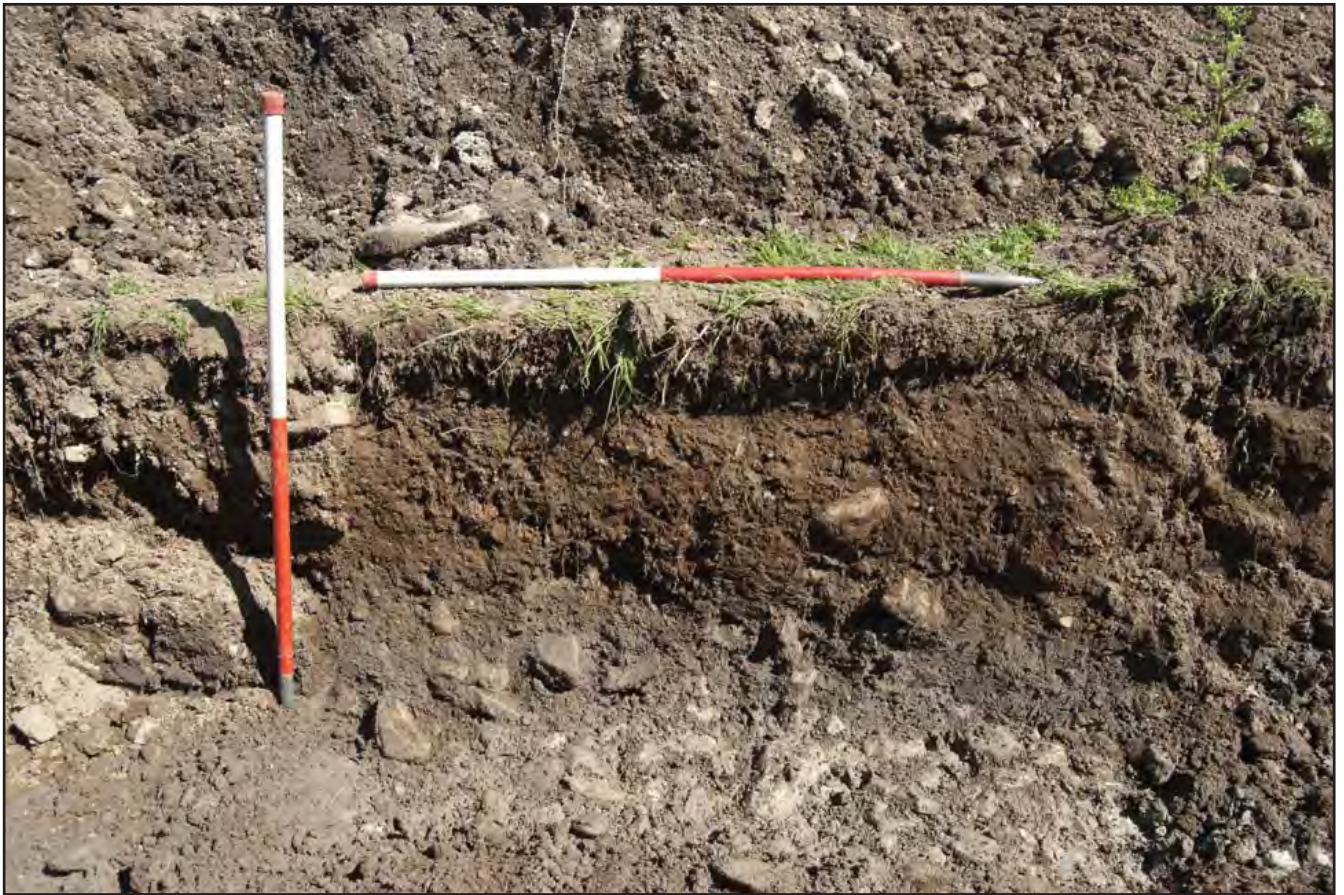
Plate 15: SSW facing baulk section Trench 04, viewed from the SSW (scale: 2x1m; archive image: G2424_PCTT_2016_036).
