RWE Clocaenog Wind Farm, 11th of June 2024.

Images taken by Welsh Government Official during 5yr Habitat Management Plan Review visit.

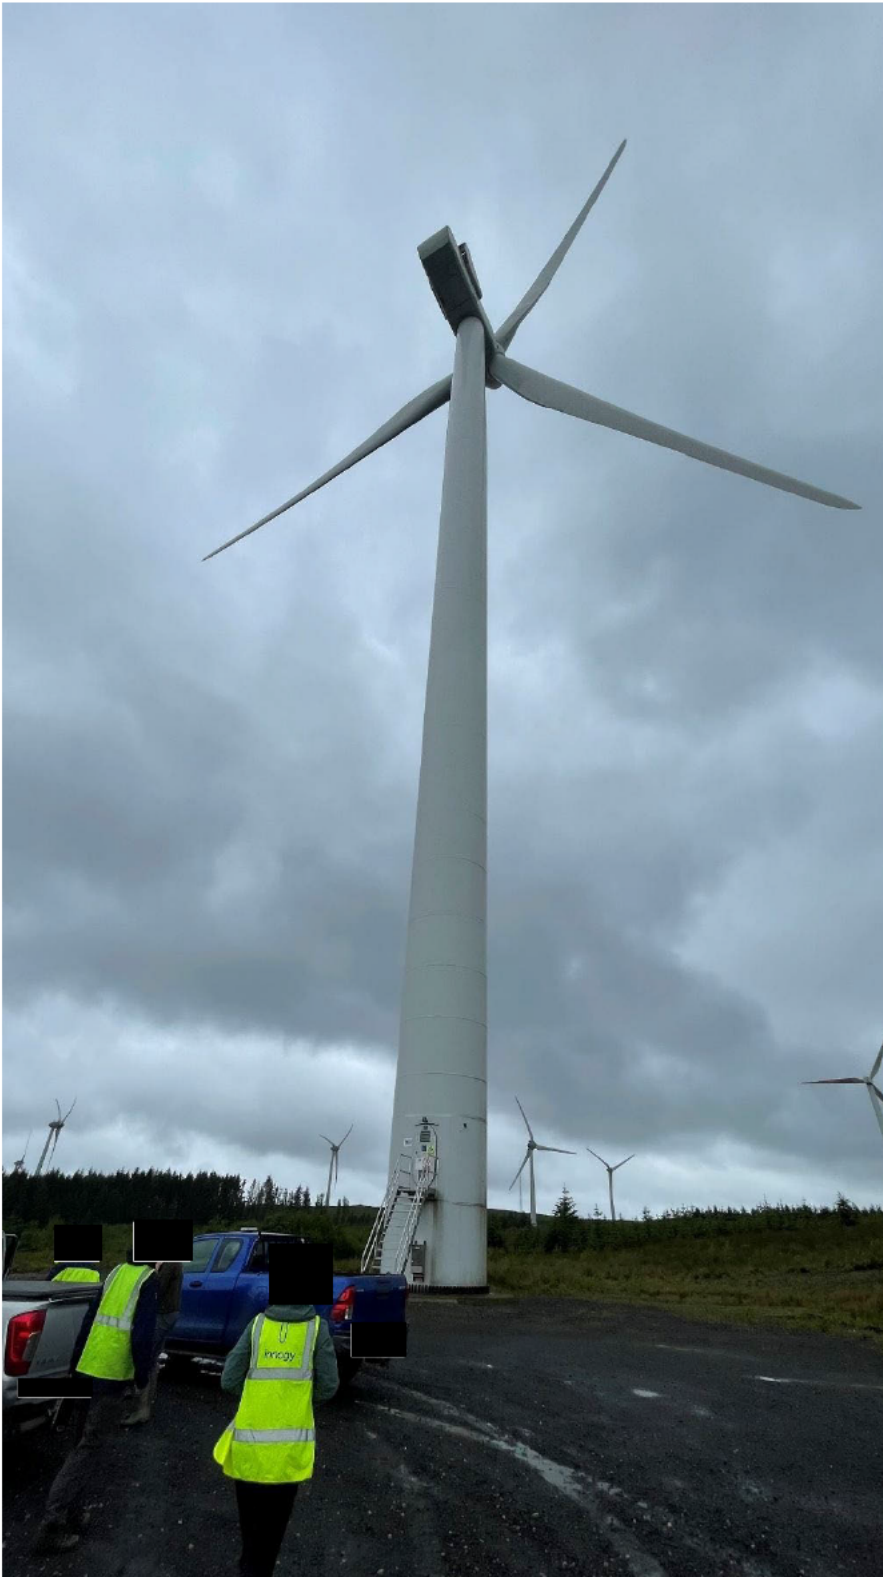
Image of turbine at <https://what3words.com/unearthly.saints.balanced>

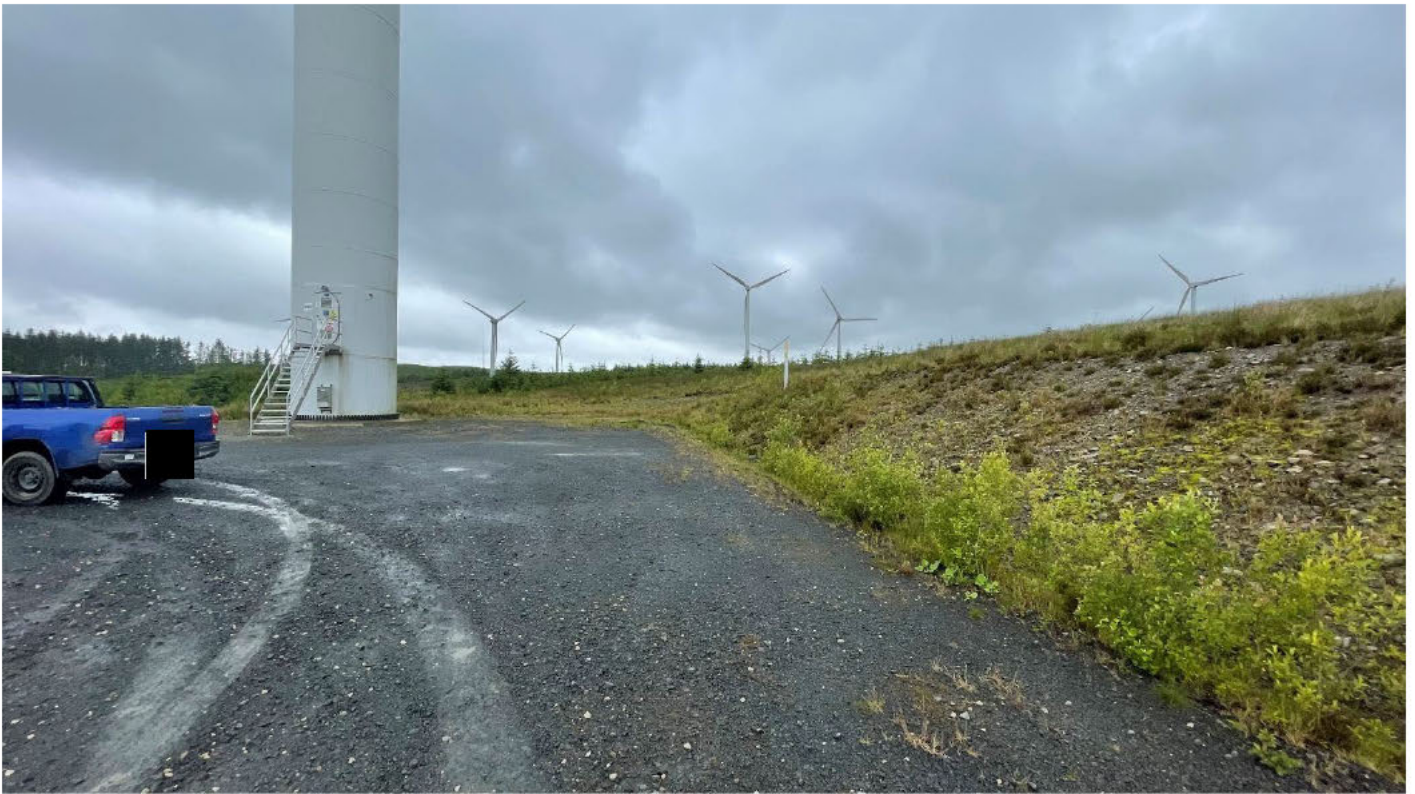
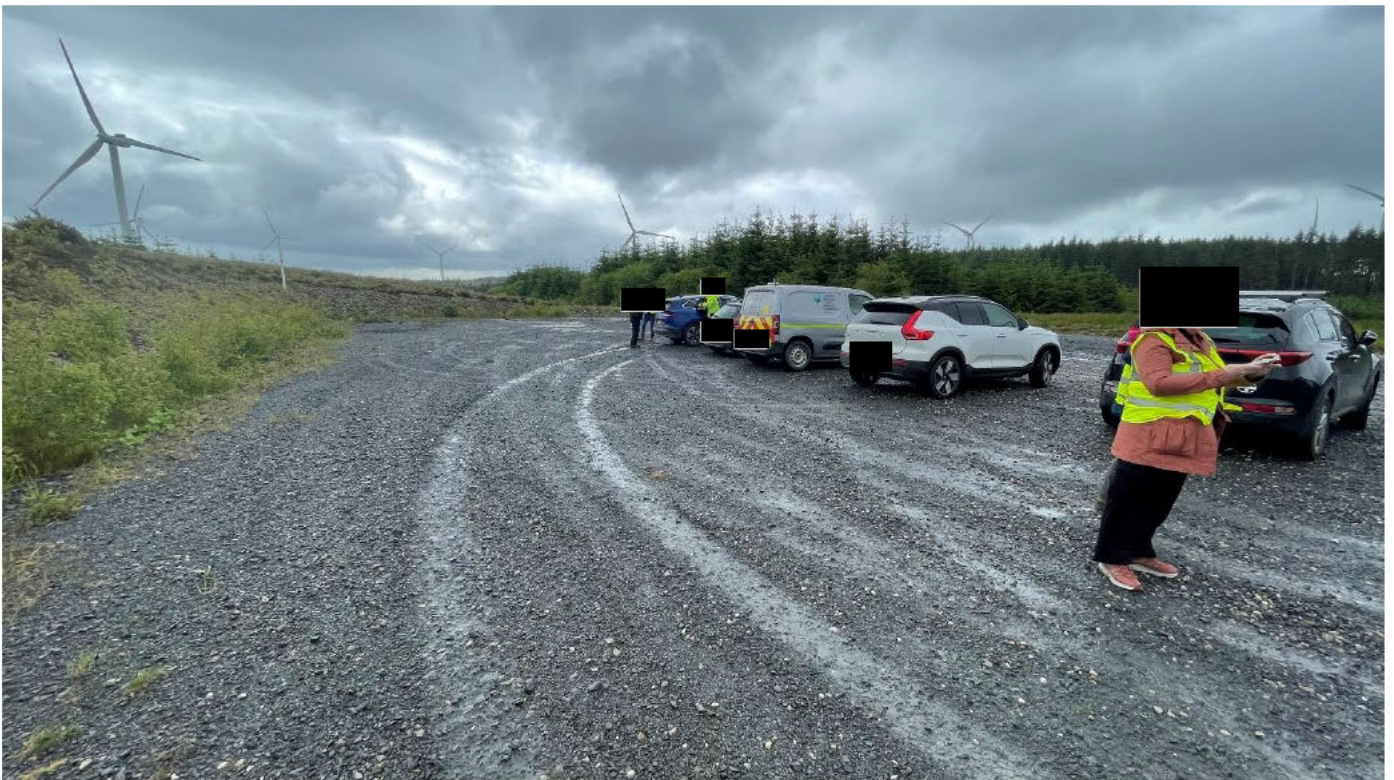
Above (looking north west) and below (looking south east), images of excavated turbine blade laydown pad and crane pad at <https://what3words.com/bleaker.should.tributes>

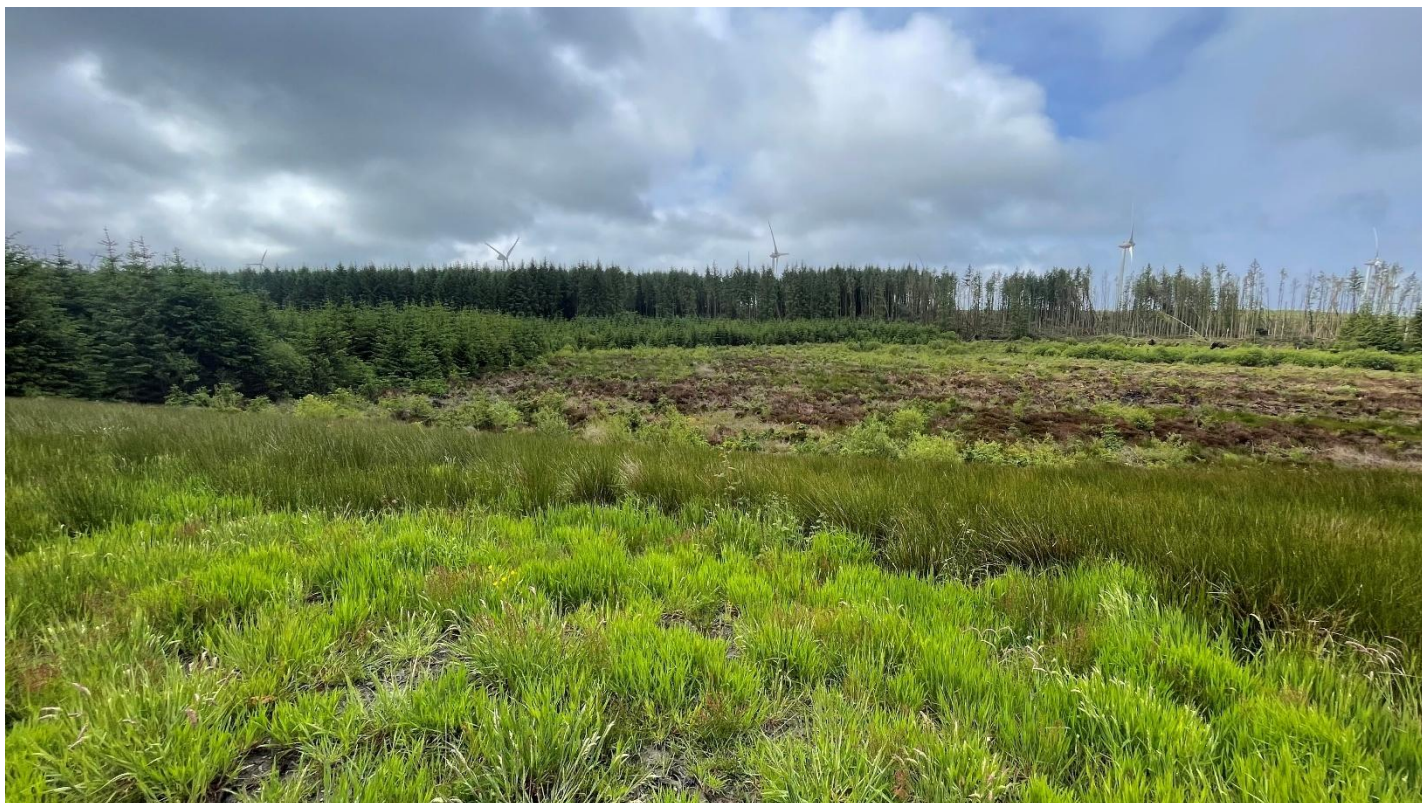
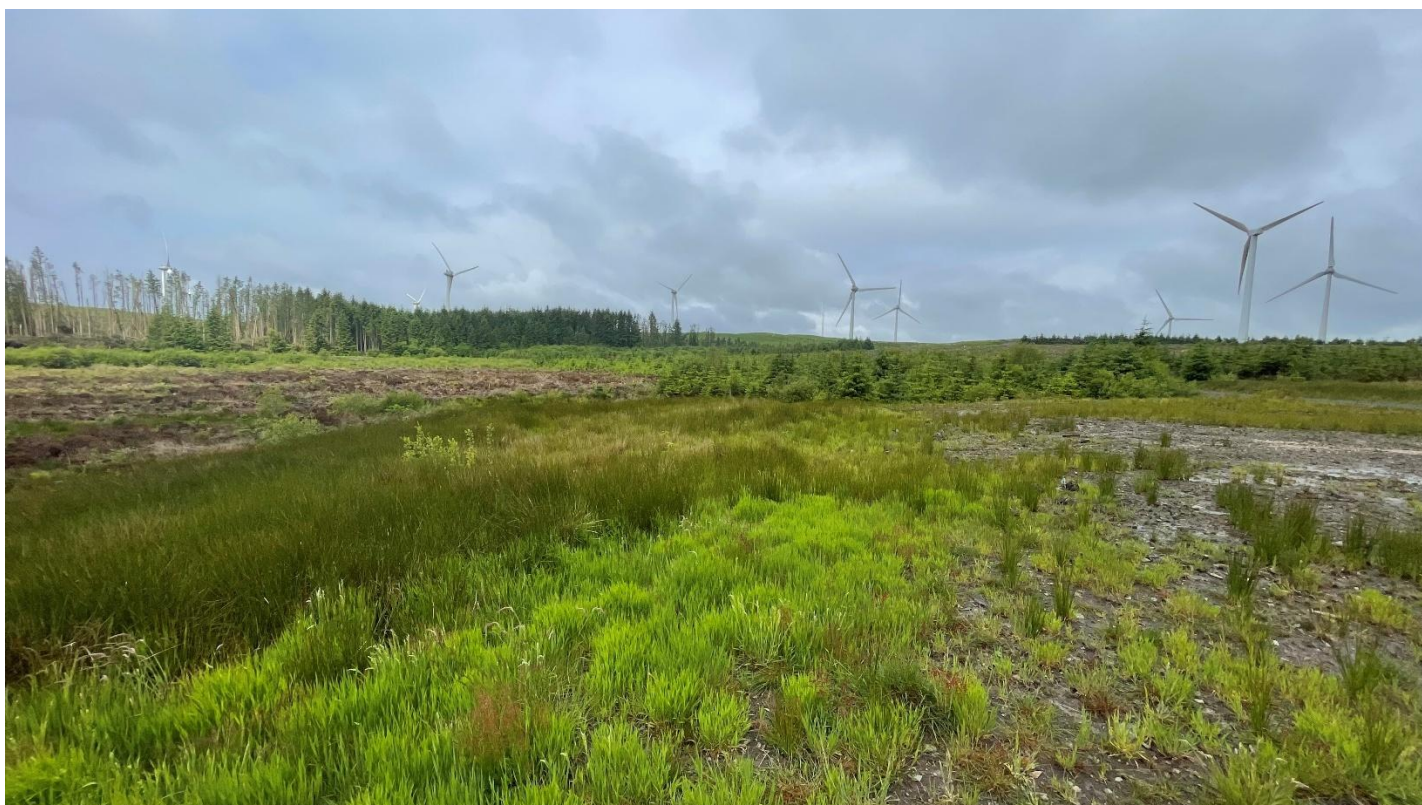
Images above (looking south west) and below (looking west) from
<https://what3words.com/bleat.supposes.ruins>

Image Background = peatland restoration area as part of Habitat Management Plan

Image foreground = extent of disturbance from turbine base spoil, illustrated by bare soil and different vegetation (Soft Rush and Yorkshire Fog). Placement of soil from base onto peatland confirmed by RWE representative during discussion on site.

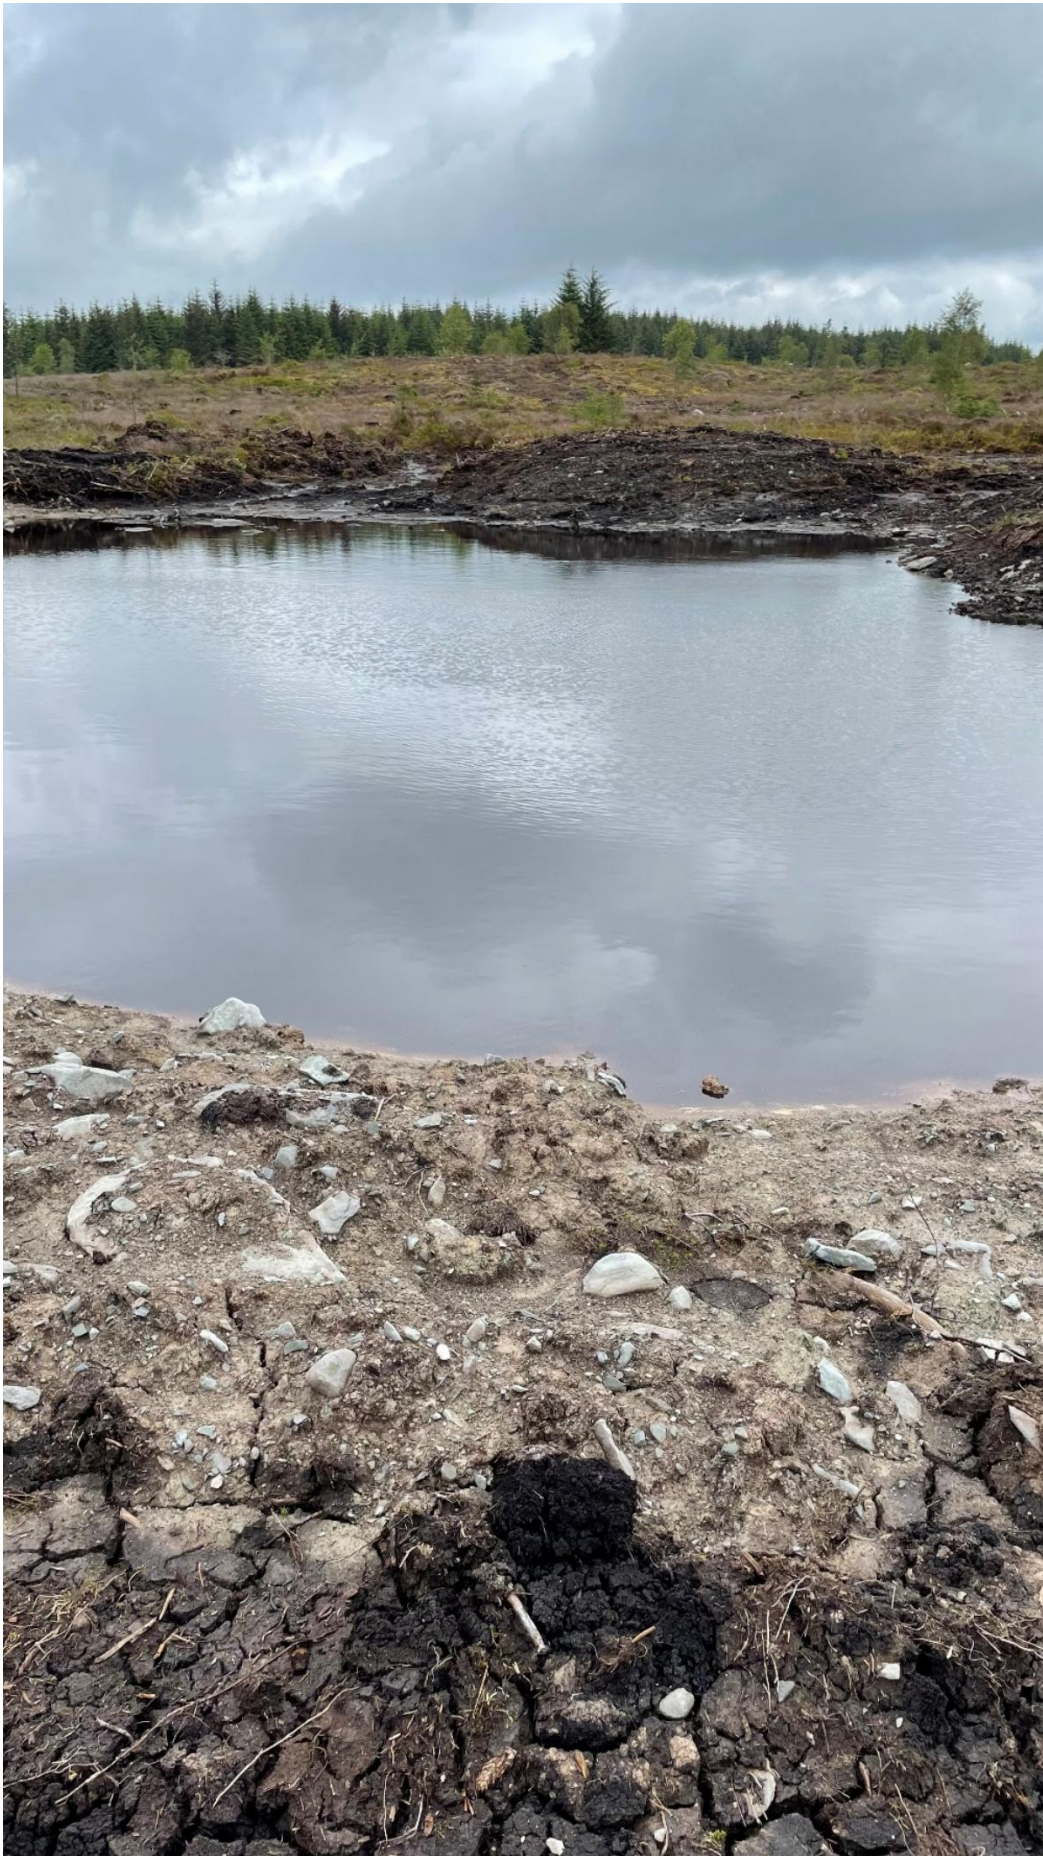
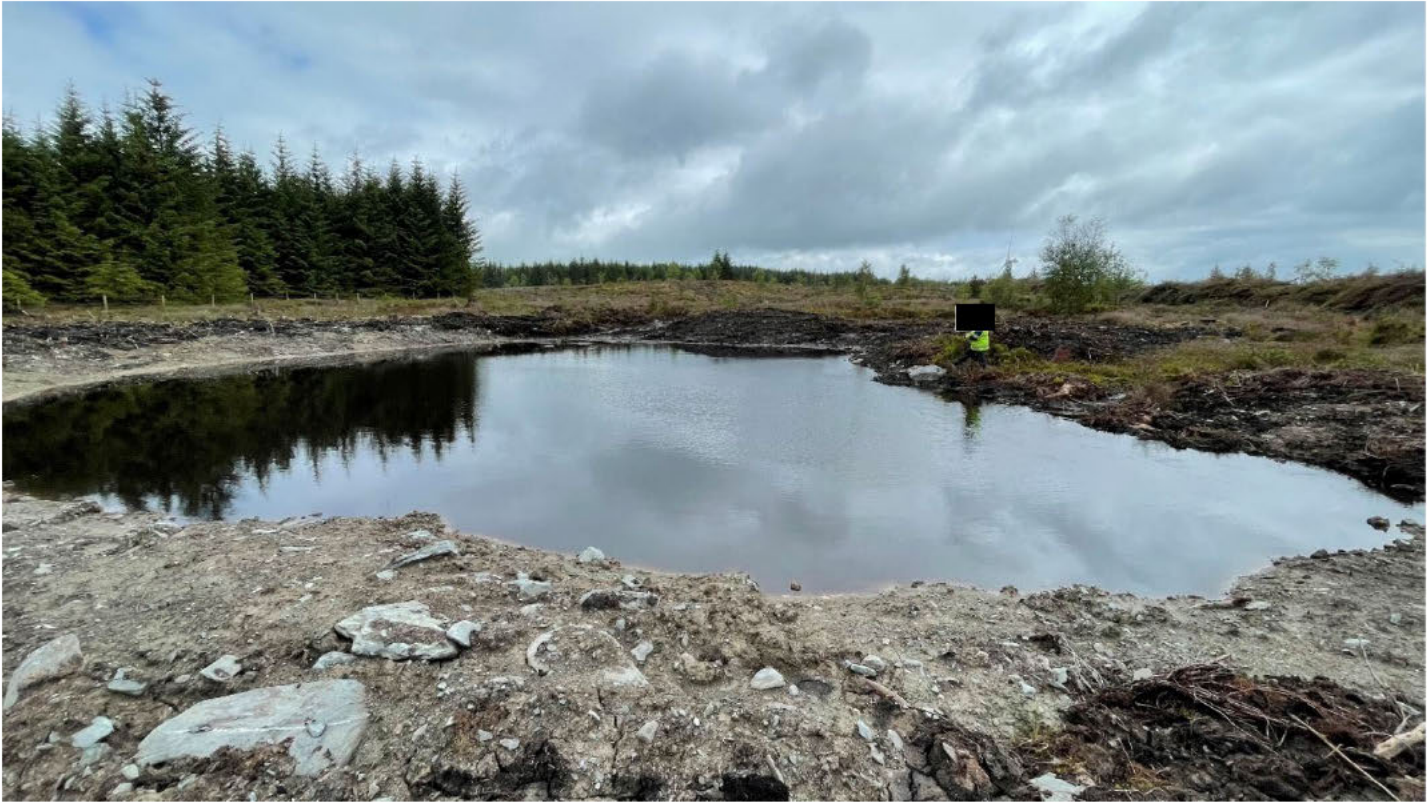
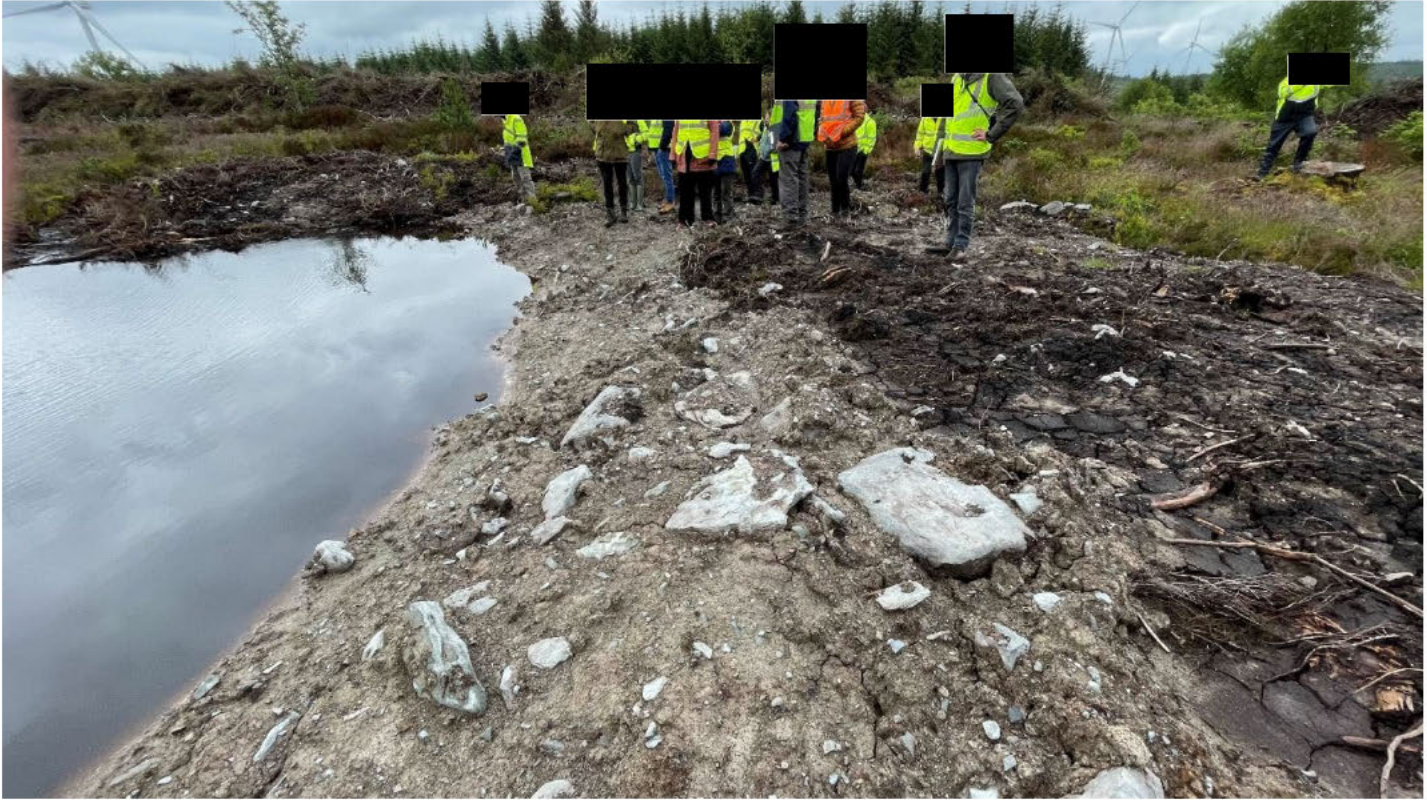
Looking north from <https://what3words.com/excusing.campsites.edits>

3x Images of excavated new water feature created as part of Clocaenog Wind Farm Habitat Management Plan (confirmed by RWE representative). Peat soils excavated.

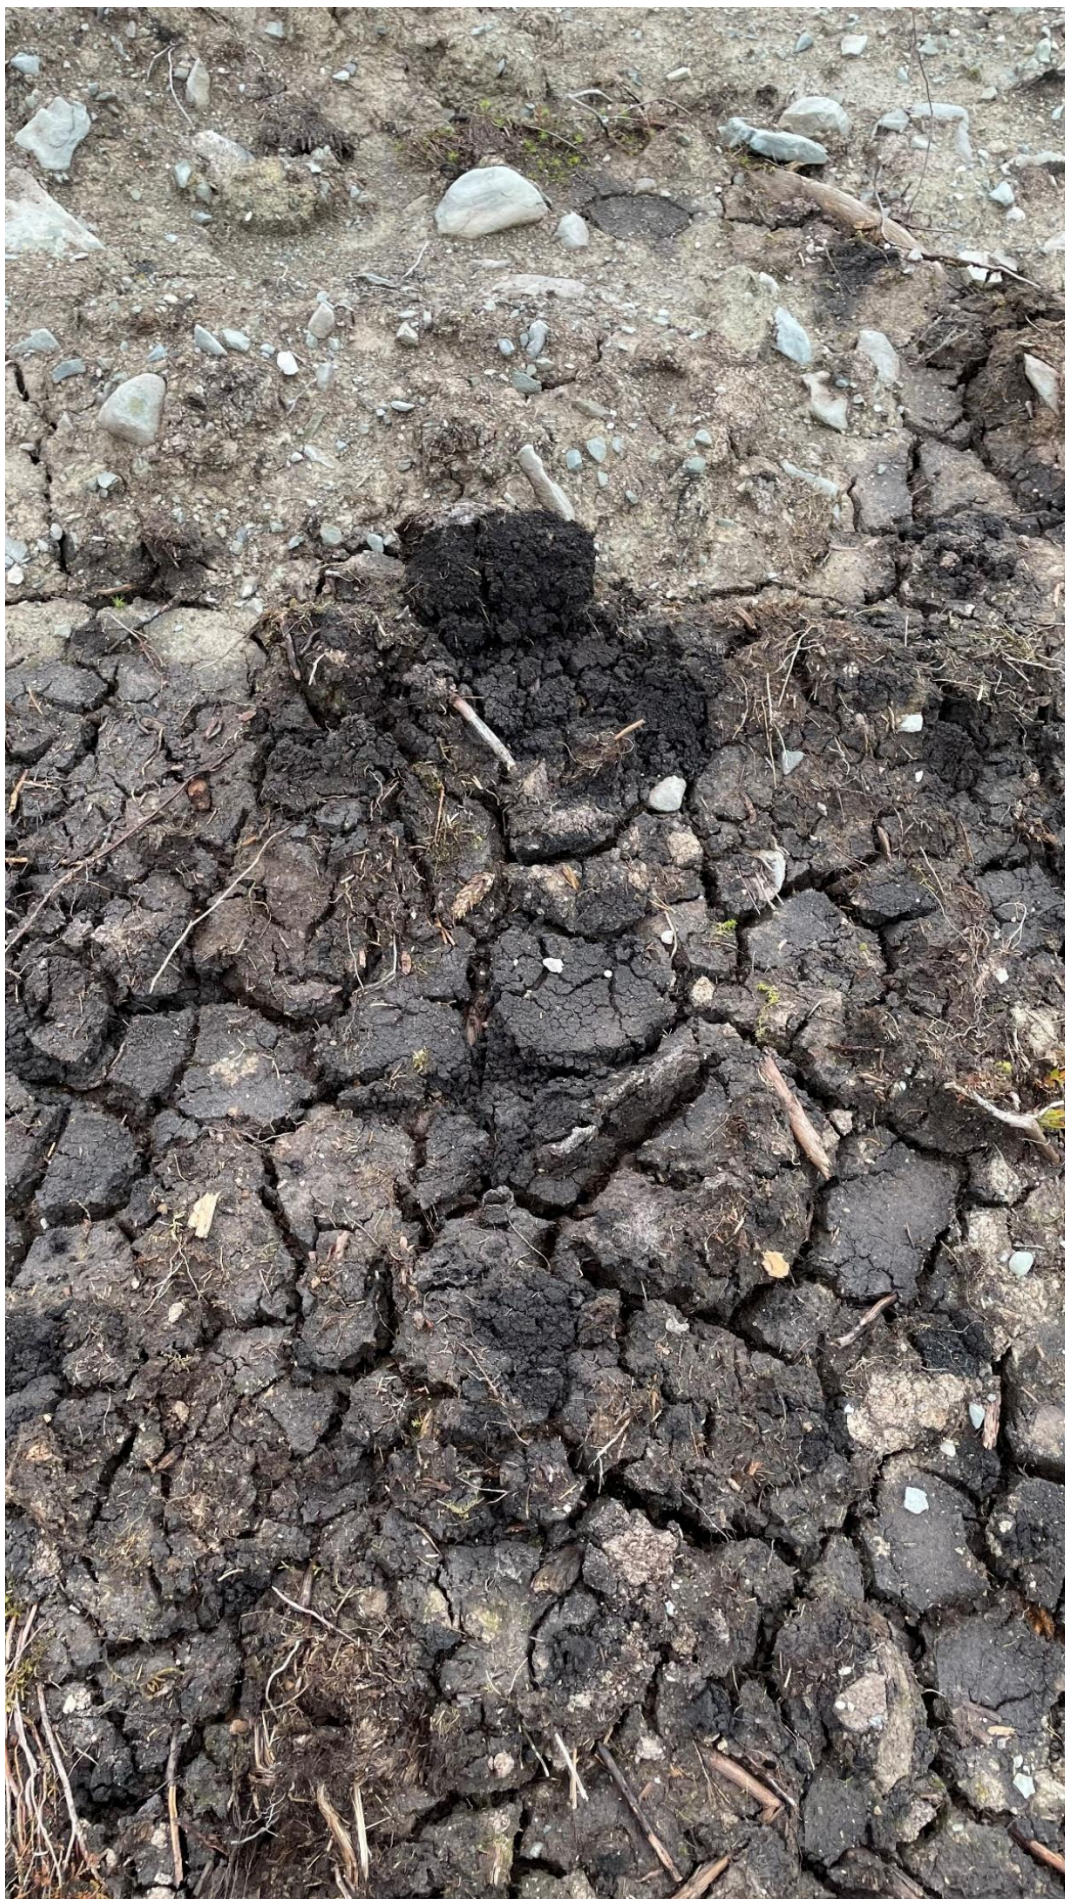
Cloes-up image of dry peat soil excavated.

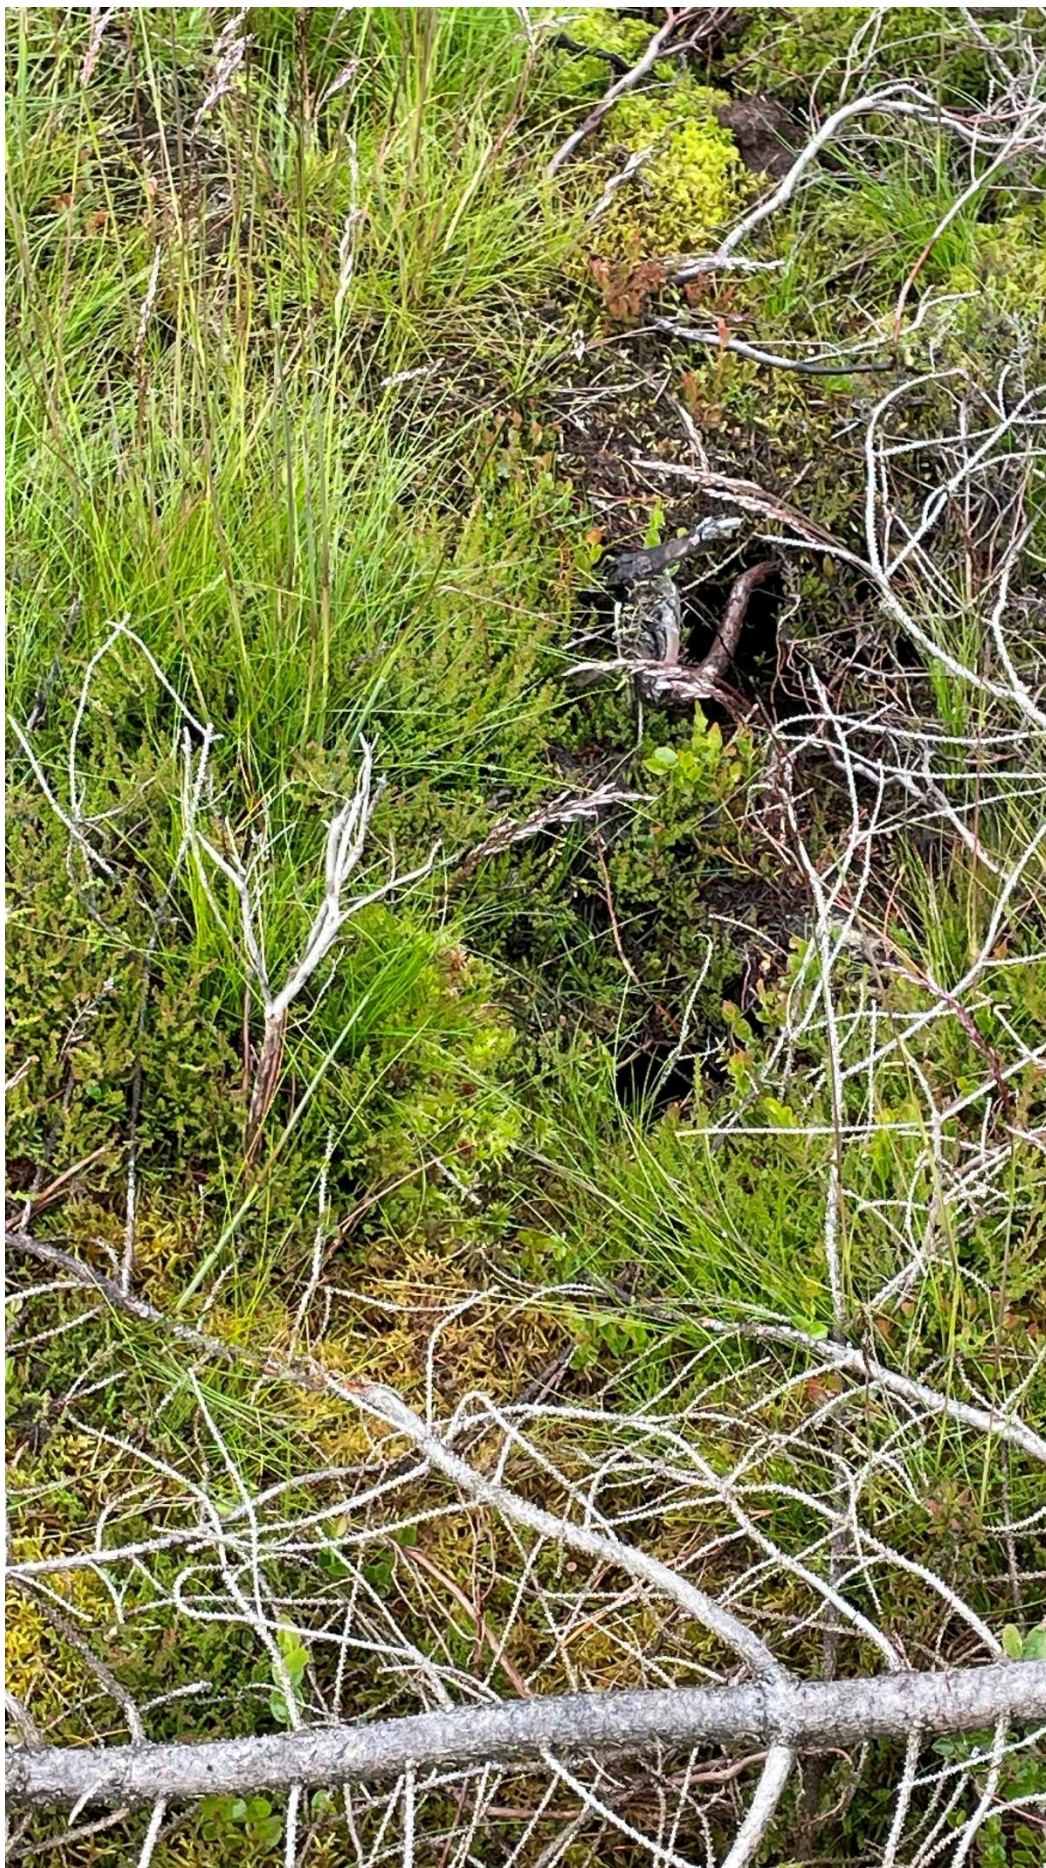
Image of vegetation next to excavated area. Evidence of *Sphagnum* sp. observed.
