UK Highways Bridge Management

Principal Inspection Report Menai Bridge (Structure Ref. A5 Menai Bridge)

December 2019

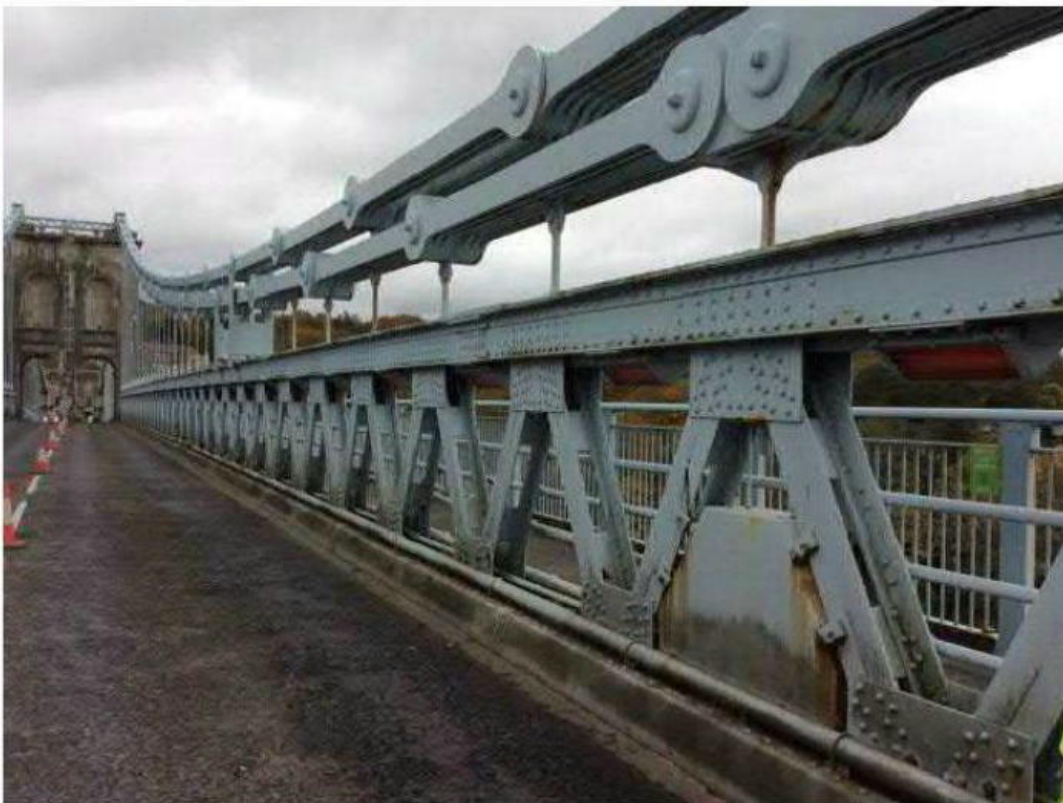
Figure 22: GA Photo - looking south along west truss

Street lighting mounted on columns were in good condition but during night time inspections it was noted that several of the carriageway lighting units, located along the inner faces of the truss, were not illuminated and appeared to be broken (Figure 22). Other defects were as follows:

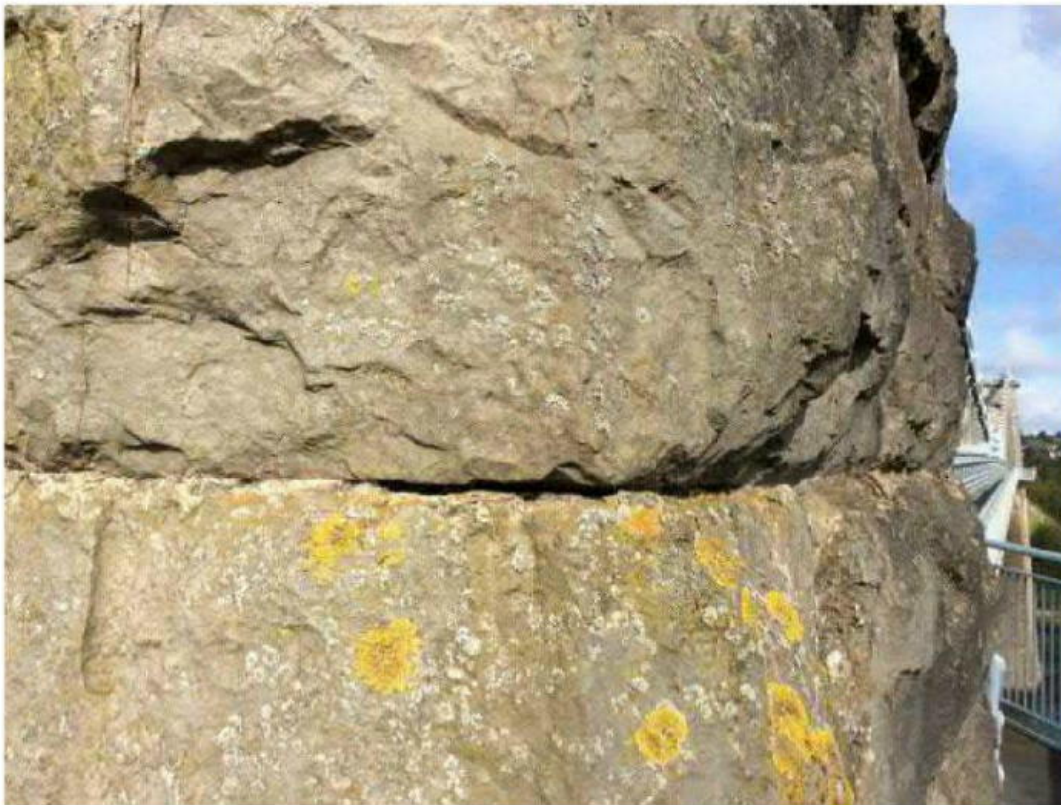
- Several small areas of deep mortar loss were noted to joints throughout both towers particularly to the lower third of the upper towers above the road deck. A typical example of this was to the lower east face of the south tower above the road deck level (Figure 27).

Figure 27: Primary deck element - several small areas of deep mortar loss to joints throughout both towers. typical to lower east face of south tower

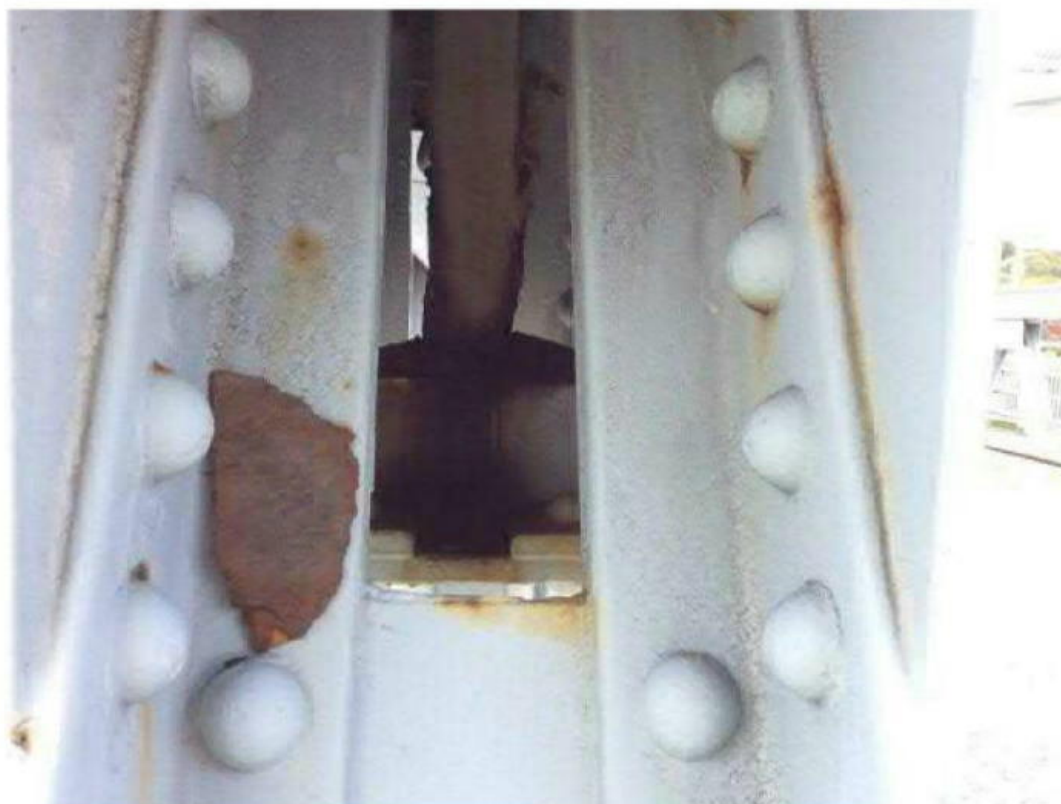
Figure 28: Tie bars - localised paint loss, corrosion and minor section loss to the 34no (17no each side) square drop link bar lower portion. paint and steel flake to left. east

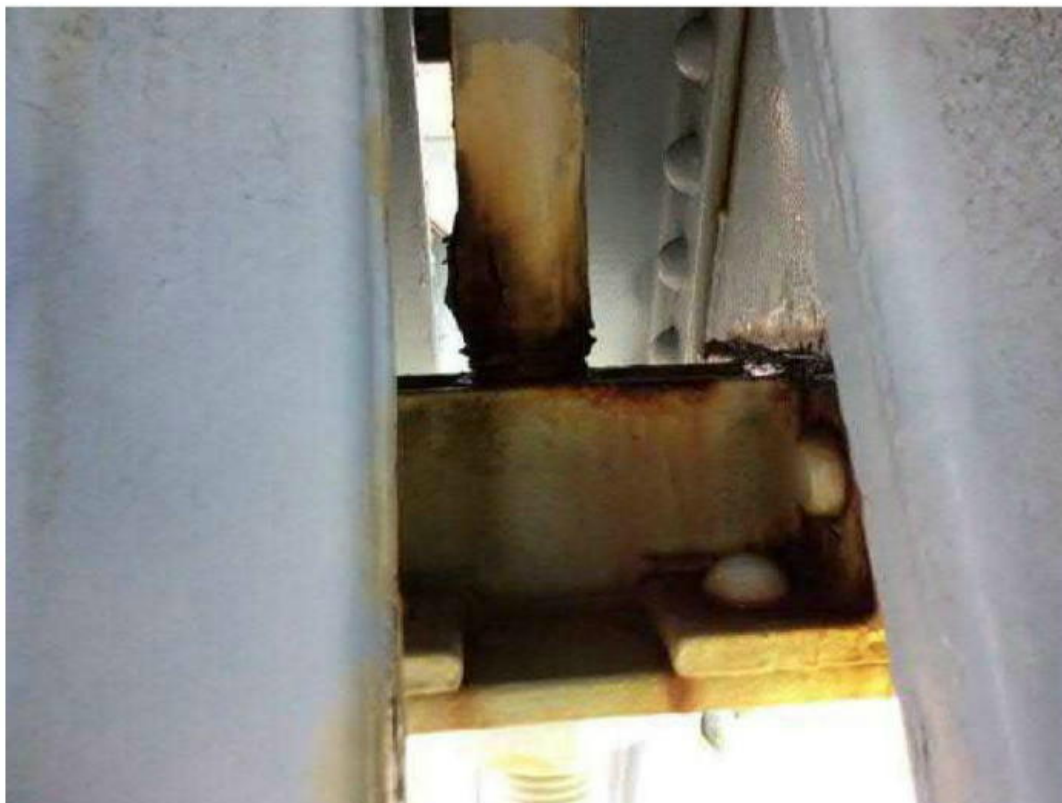
Figure 31: Tie bars - localised paint loss, corrosion and minor section loss to the 34no (17no each side) square drop link bar lower portion. west

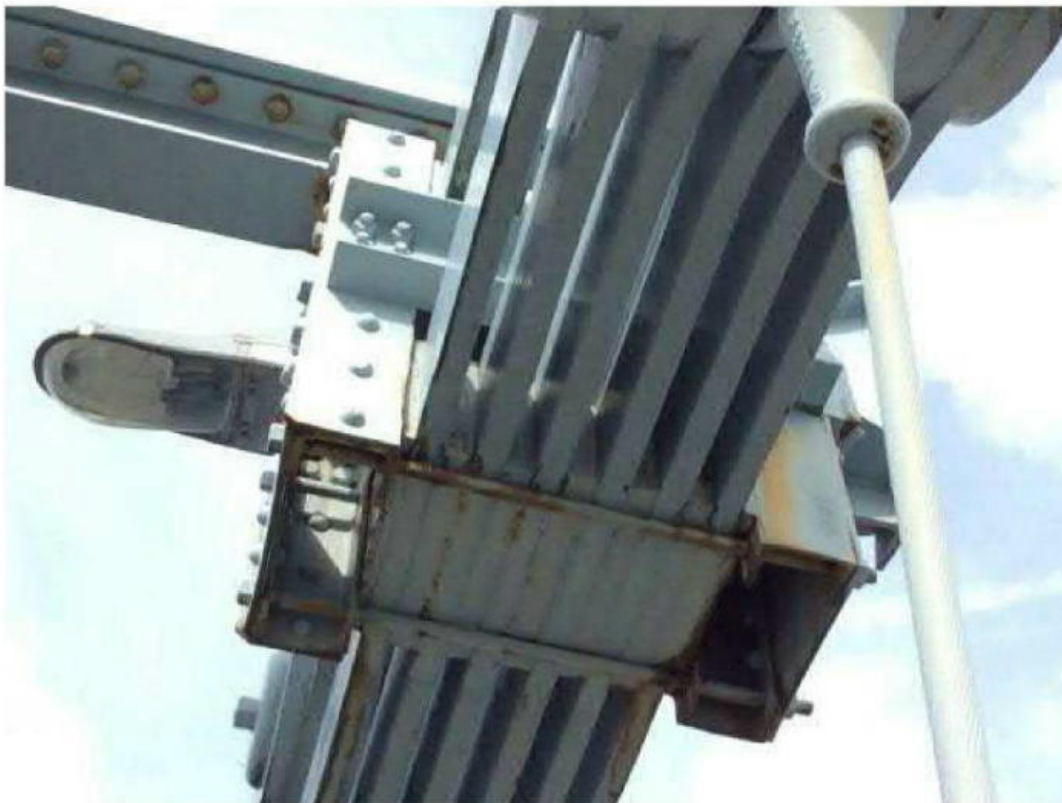
- Minor paint loss and corrosion was noted to the north transverse chain brace mainly to bolt heads (Figure 33, Figure 34).

Figure 34: Bracing - Transverse beams - minor paint loss and corrosion to north transverse chain brace mainly to bolt heads

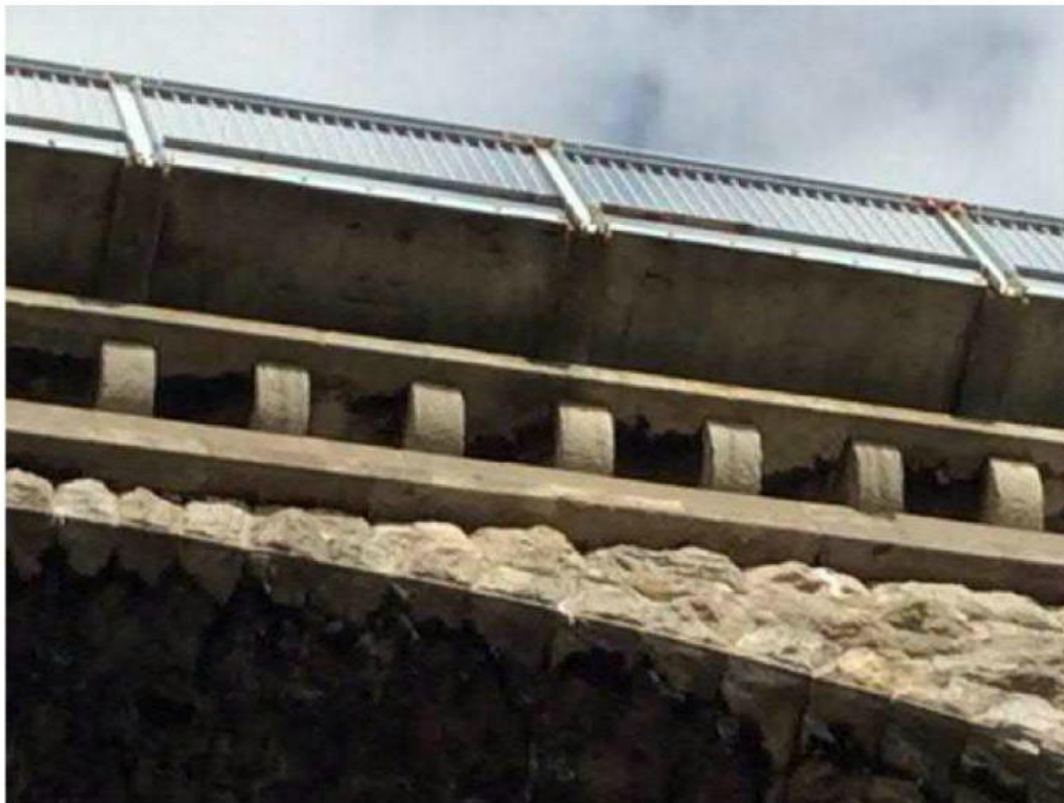
- Wide areas of spalling and exposed rebar was noted to the soffit of the cantilevered footway to the west of spans 1-4 and, to a lesser extent, throughout all the walkway slab soffits (Figure 37, Figure 38). Due to some repairs cracking and ongoing spalling, there was a risk of falling masonry to boaters below.

Figure 37: Parapet beam or cantilever - wide areas of spalling and exposed rebar to soffit of cantilevered footway to the west of spans 1-4

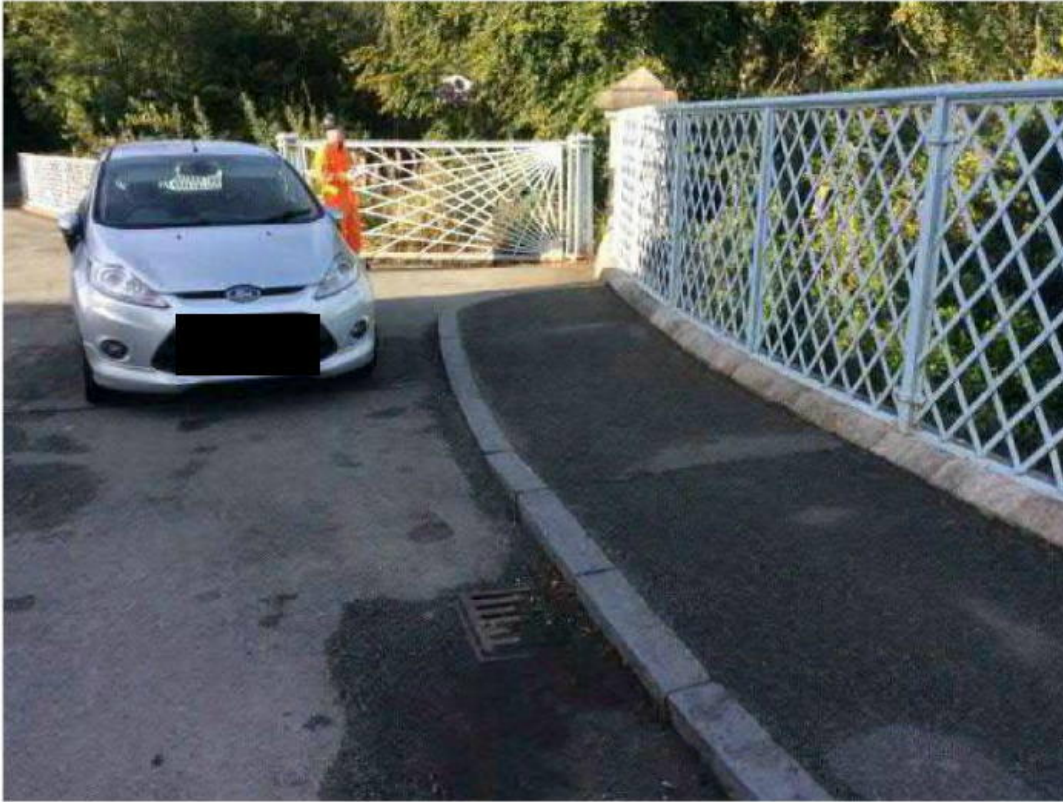
- A rectangular highway edge gully was blocked to the south west access road where it adjoins the A5 immediately beyond the south end of the bridge (Figure 41).

Figure 41: Superstructure drainage - gully blocked to south west access road

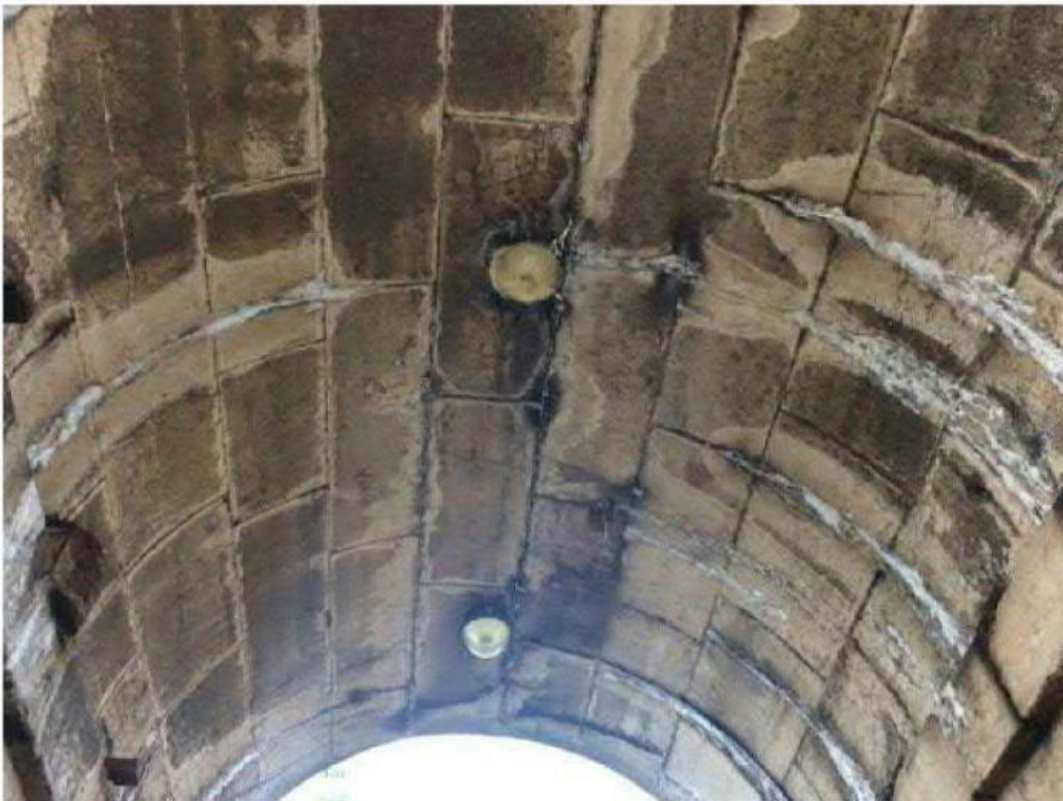
- General areas of efflorescence and damp-staining were noted through the arch intradoses particularly the slight dripping noted through the west side of the north arch (Figure 42).
- Minor damp staining and efflorescence was noted throughout but typically to the south abutment (Figure 147) and arch 7 (Figure 148).

Figure 42: Waterproofing - monitor slight dripping through north west arch

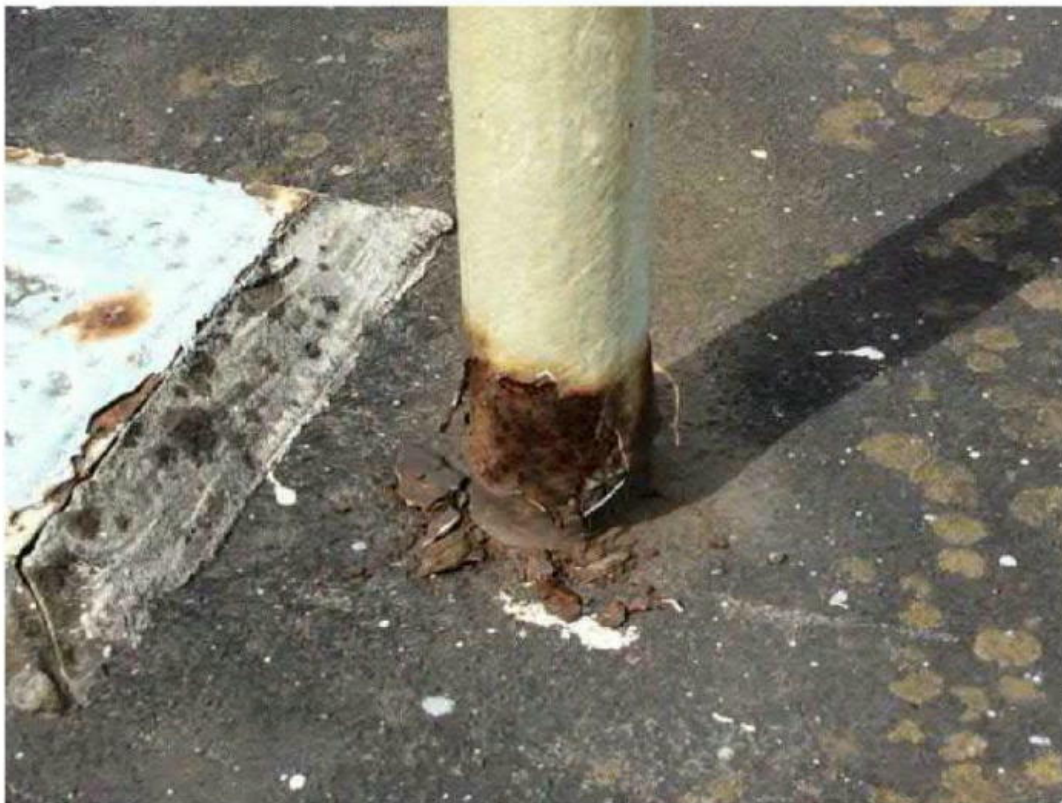
- Several discrete areas of failed paint, minor corrosion and resulting rust staining to the lower hanger lugs (Figure 45, Figure 46).
- Several areas of full depth paint loss, minor corrosion and rust staining were noted to the truss rivets throughout the entire main span (Figure 47, Figure 48, Figure 49).

Figure 46: Finishes: deck elements - monitor the small areas of failed paint and resulting rust staining to the lower hanger lugs. typical to east side 22m north of north tower

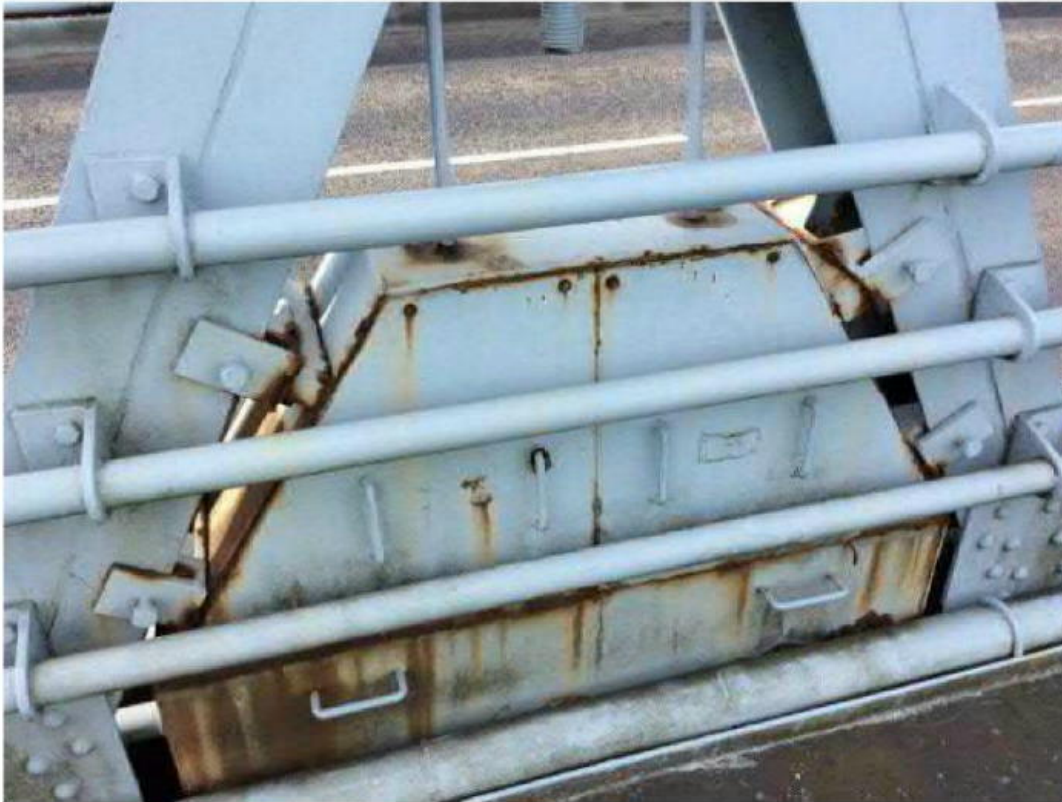
- Small areas of chipped paint and rust staining were noted throughout the west truss (Figure 54, Figure 55, Figure 56).
- Full depth paint loss and moderate corrosion were noted to the electrical box, just off the carriageway within the truss, to the west side at mid-span (Figure 47, Figure 58).

Figure 47: Finishes: deck elements - several areas of full depth paint loss, minor to moderate corrosion and rust staining to the lighting electrical box at mid span

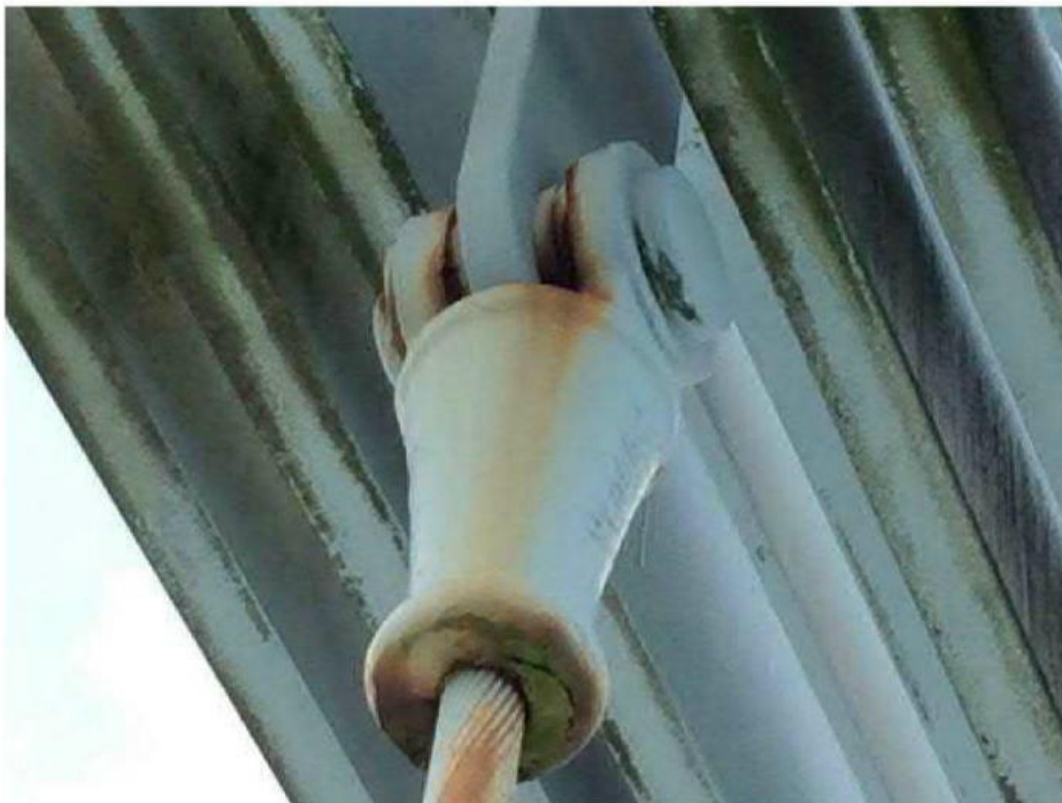
- Small areas of failed paint, corrosion and resulting rust staining was noted to the upper hanger lugs (Figure 50, Figure 51).
- Moderate areas of paint loss and minor corrosion were noted to the inside faces of the upper truss members, typically to the east side at 15m south of the north tower (Figure 52, Figure 53).

Figure 50: Finishes: deck elements - monitor the small areas of failed paint and resulting rust staining to the upper hanger lugs. typical at east side just north of mid span

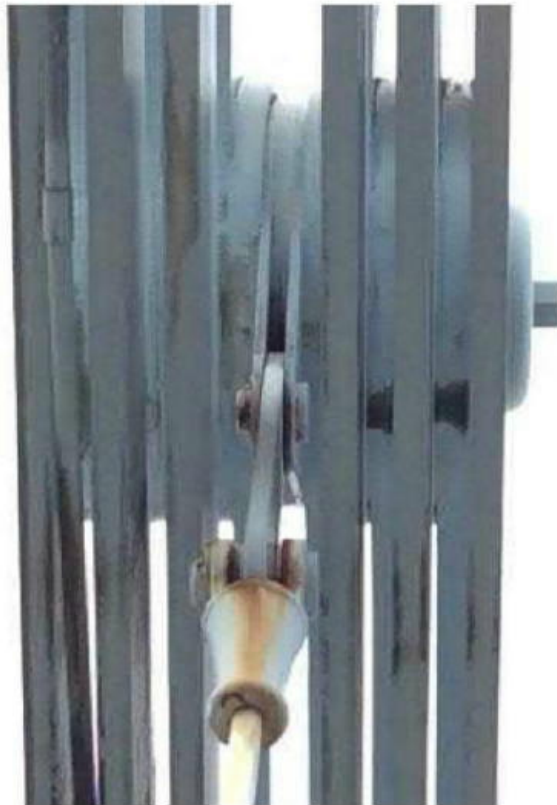
Figure 51: Finishes: deck elements - monitor the small areas of failed paint and resulting rust staining to the upper hanger lugs. typical at east side 30m north of north tower

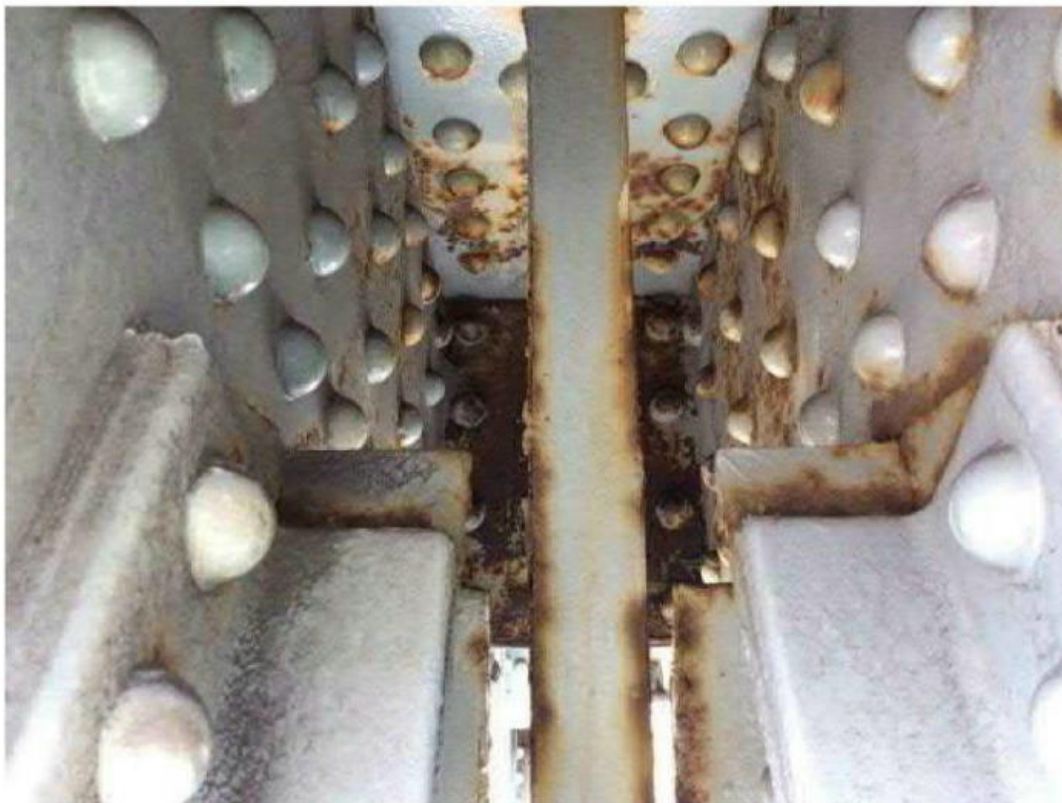
Figure 52: Finishes: deck elements - moderate areas of paint loss and minor corrosion to the inside faces of the upper truss members. typical to east side 15m south of north tower

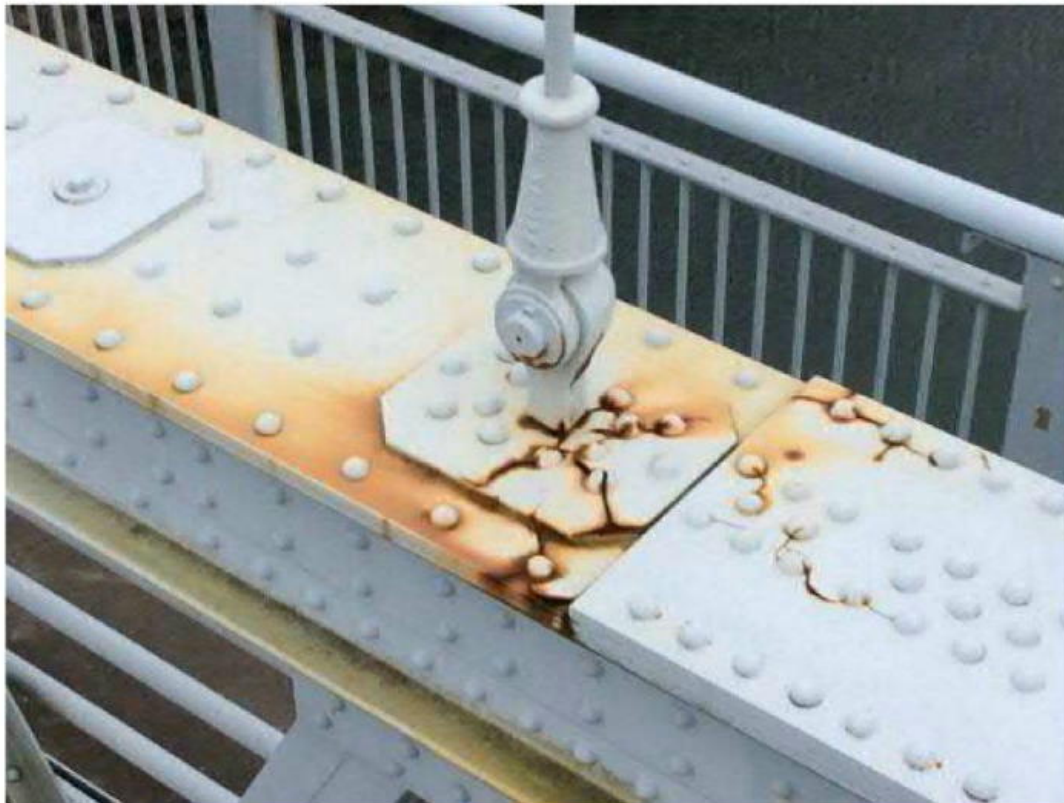
Figure 53: Finishes: deck elements - moderate areas of paint loss and minor corrosion to the inside faces of the upper truss members. typical to west at 35m north of south tower

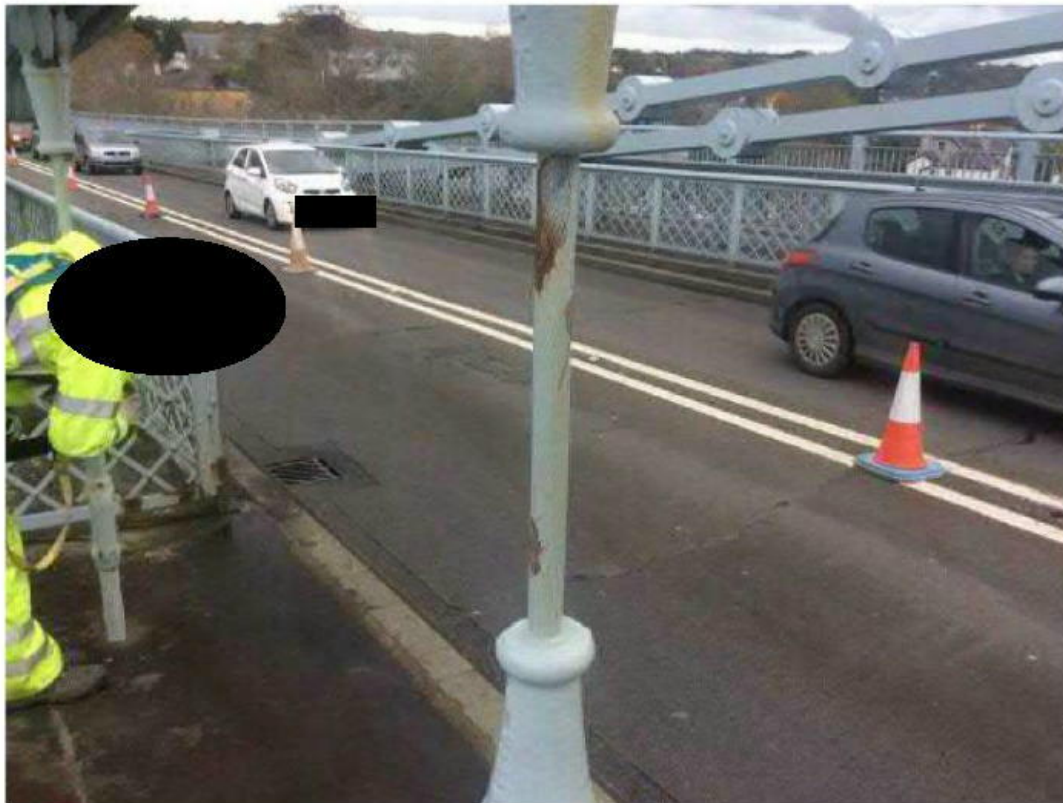
- Several small areas of paint loss were noted to the hangers, typically to the 2nd north west hanger (Figure 59, and typical to first north west in Figure 60).

Figure 59: Finishes: deck elements - several small areas of paint loss to hangers, typical to 2nd north west hanger

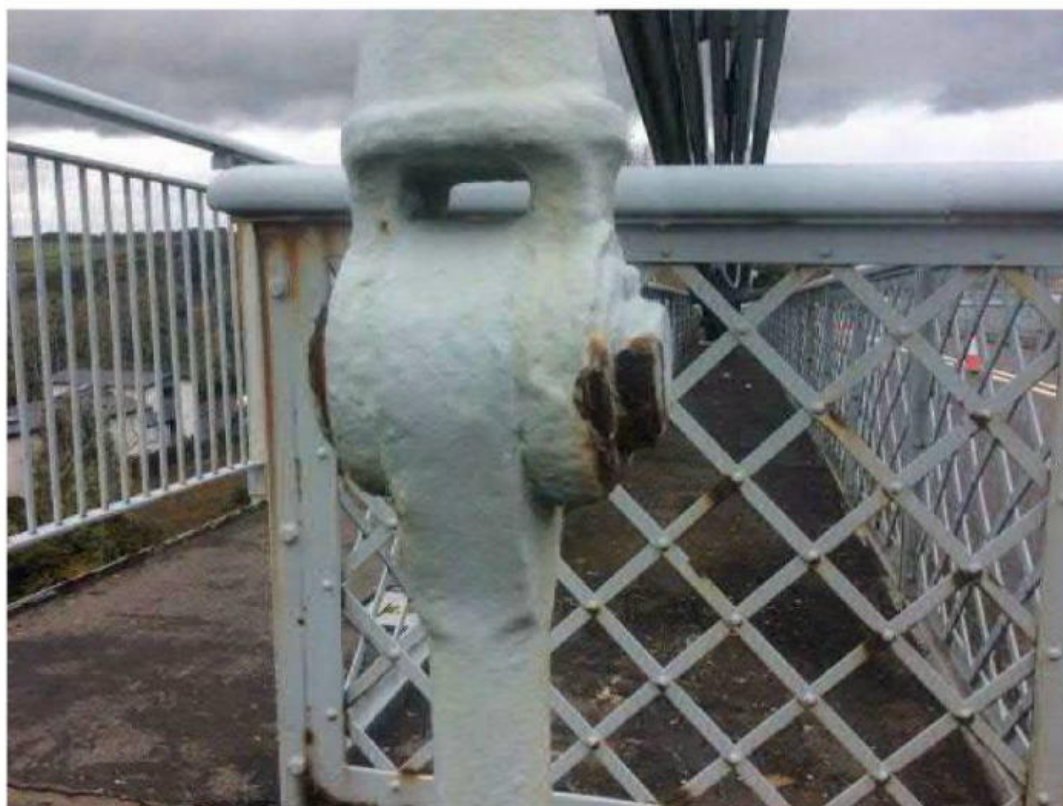
Figure 60: Finishes: deck elements - several small areas of paint loss to hangers, typical to 1st north west hanger

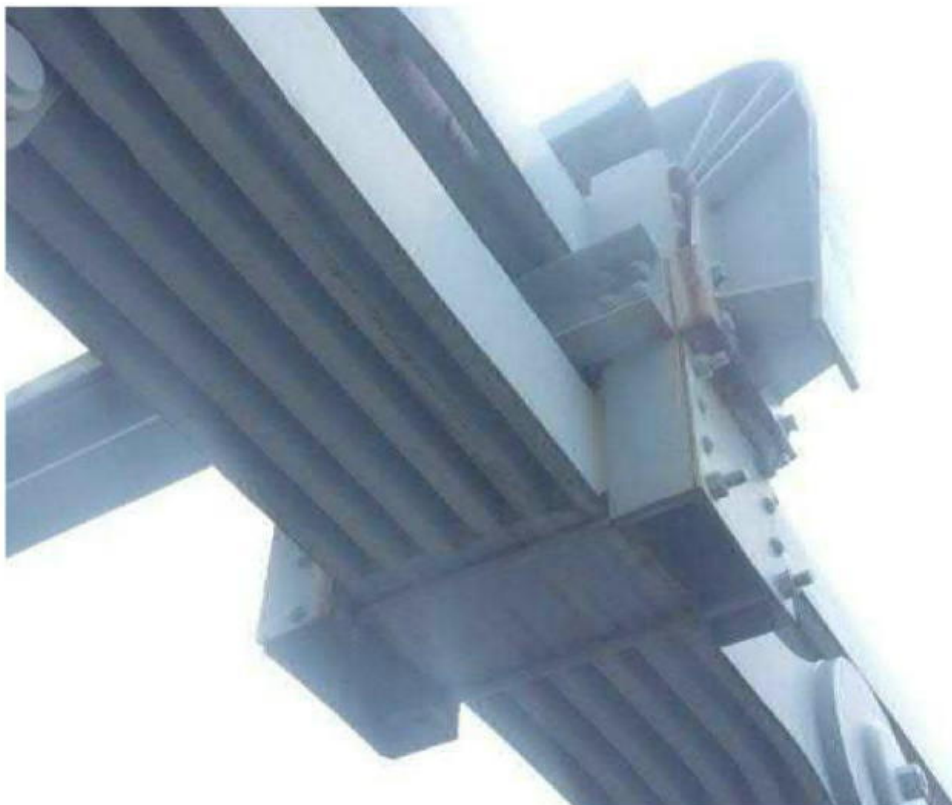
- Several small areas of paint loss were located to the north chain brace (Figure 61).
- Paint loss and minor corrosion with rust-staining was noted to the lower hanger connection area to a hanger on the central west catenary chains (Figure 165).

Figure 61: Finishes: deck elements - several small areas of paint loss to north chain brace

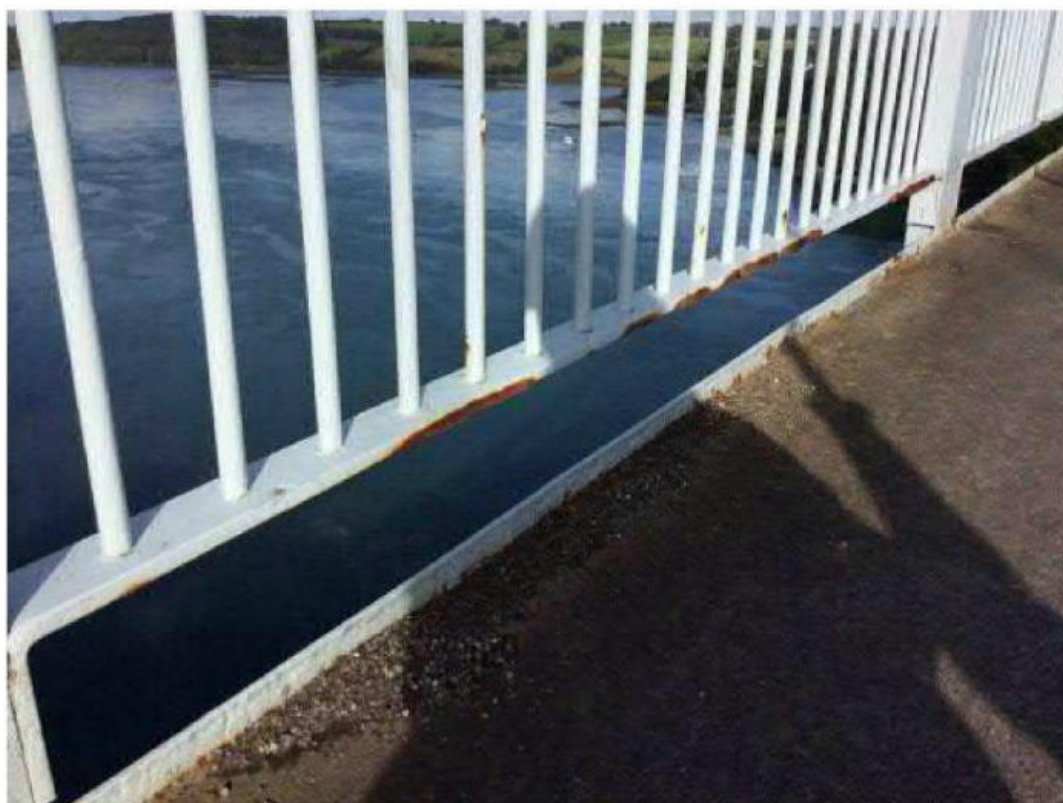
- Numerous small areas of full depth paint loss was noted throughout the handrail parapet paint system, particularly to rails and lower ends of the vertical infill bars (Figure 62, Figure 63, Figure 64, Figure 65).

Figure 62: Finishes: parapets/safety fences - numerous small areas of full depth paint loss to parapet paint system, particularly to rails and lower ends of vertical infill bars. typical to west parapet 10m south of south tower

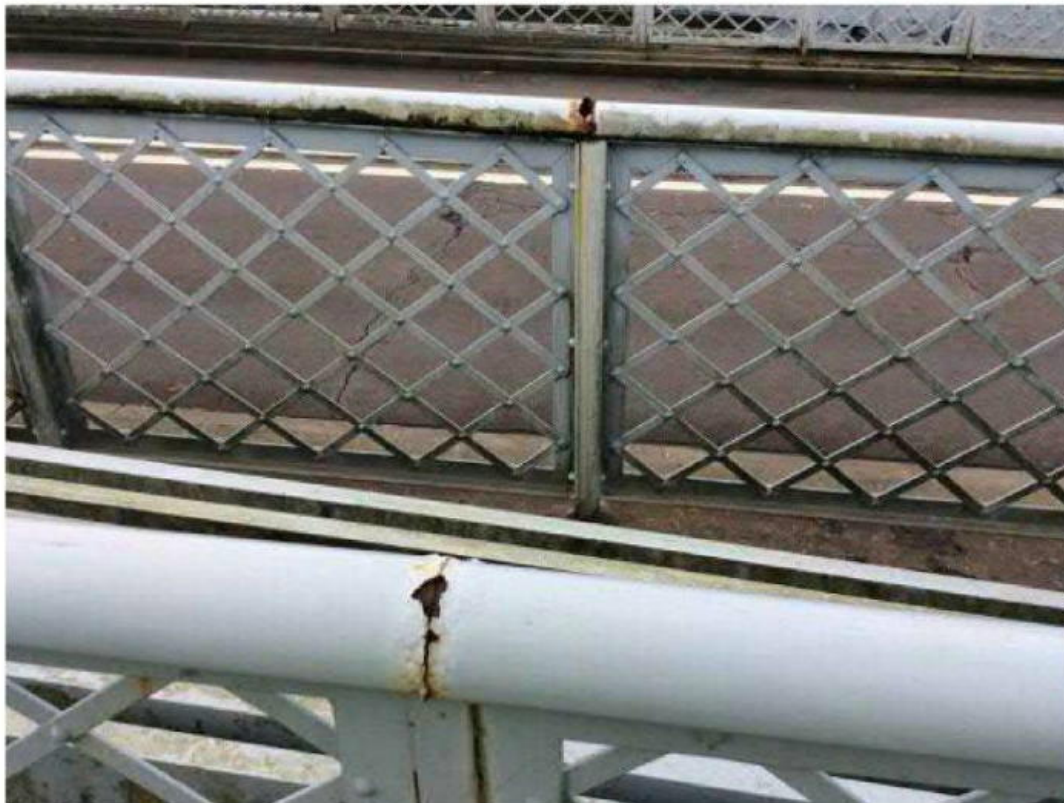
Figure 85: Finishes: parapets/safety fences - numerous small areas of full depth paint loss to parapet paint system, particularly to north back stay guardrails where there is also full depth section loss

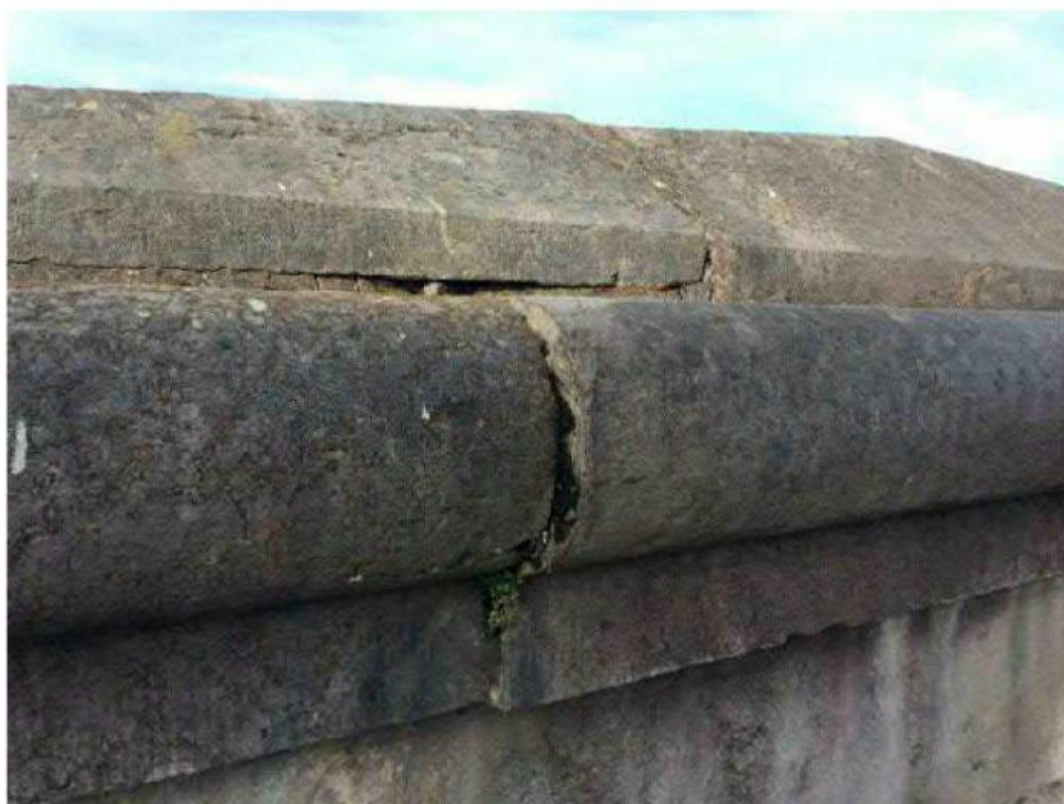
- 30mm outward displacement was noted to the south west pilaster coping (Figure 66).
- Several small and discrete areas of corrosion and minor section loss was noted to the east and west parapets, mainly to connections and rail joints (Figure 67, Figure 68, Figure 69).

Figure 66: Handrail / parapets / safety fences - 30mm displacement to south west plaster coping

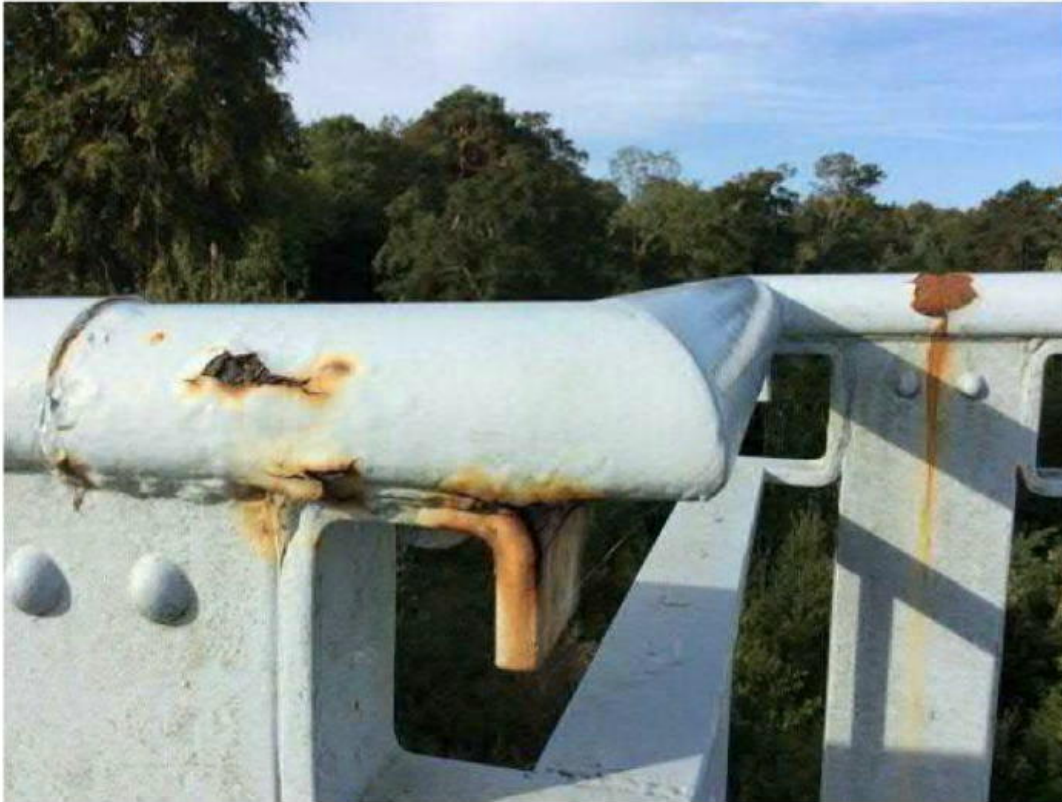
Figure 87: Handrail / parapets / safety fences - several small and discrete areas of corrosion and minor section loss to east and west parapets. west side, south pillar

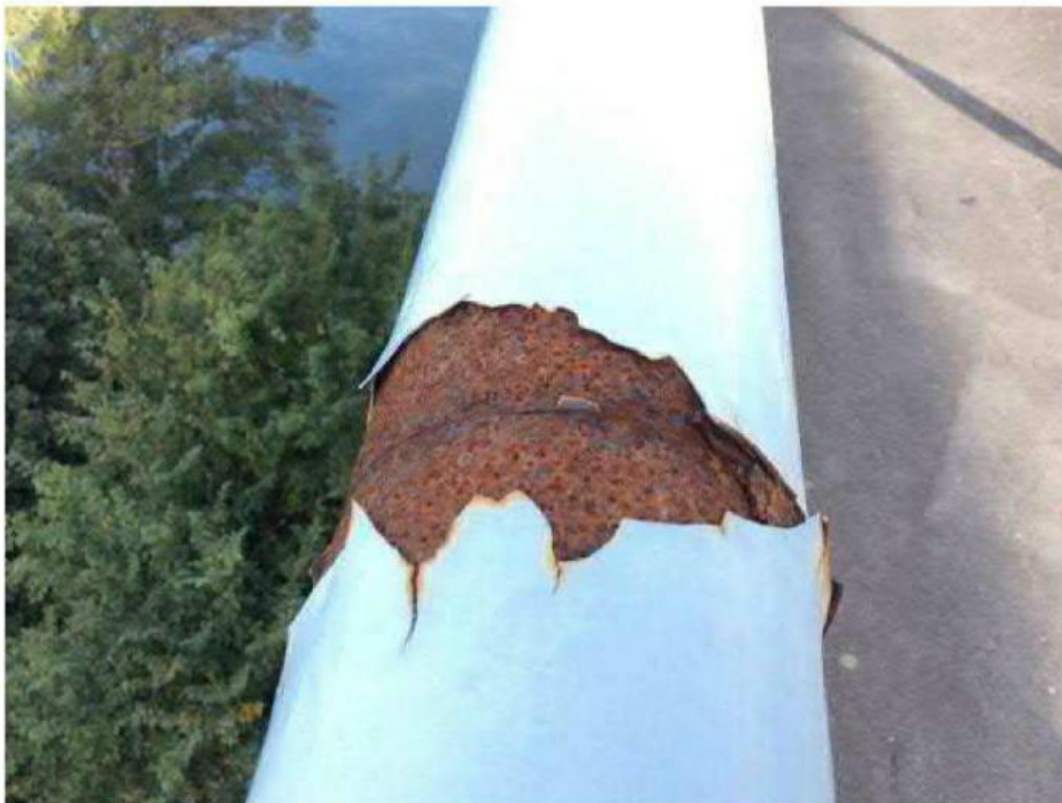
Figure 88: Handrail / parapets / safety fences - example of paint loss and surface corrosion to parapet top rail joints at south end of west parapet

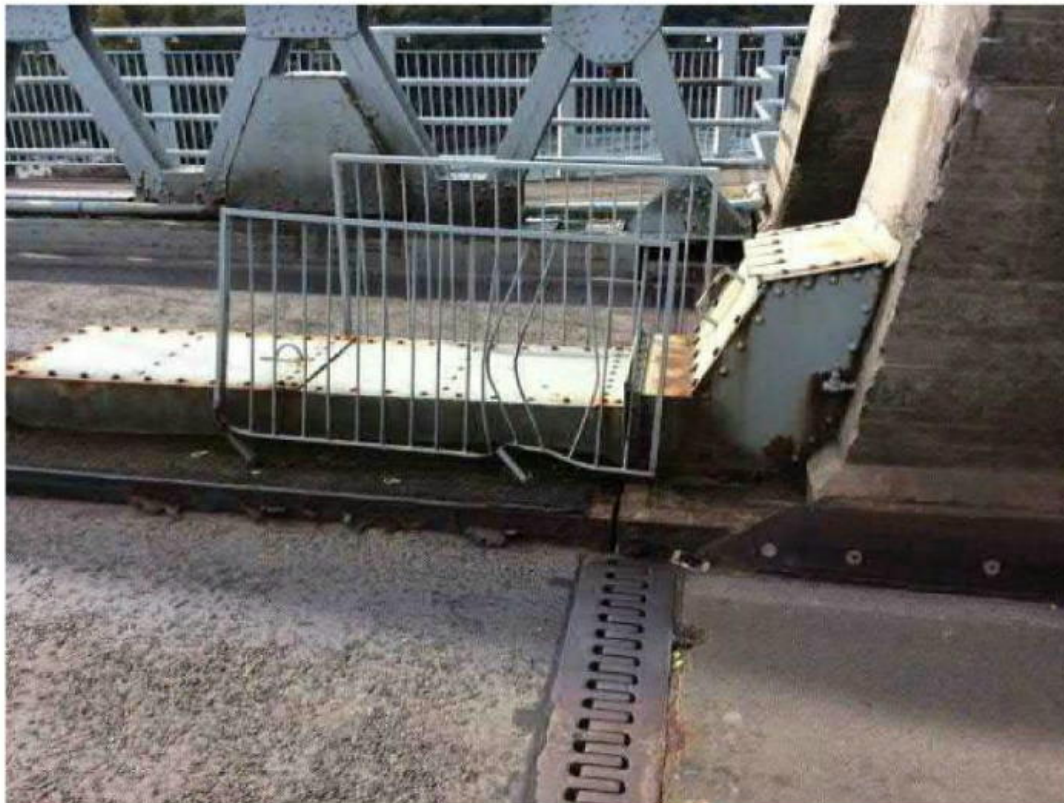
- Failure of the holding down bolt arrangement was located to the south west inner pedestrian guardrail (Figure 70).
- Severe impact damage was noted to the central reservation guardrail to the south of the north tower and south of north tower (Figure 71, Figure 72).

Figure 71: Handrail / parapets / safety fences - severe impact damage to the central reservation guardrail to the south of the north tower

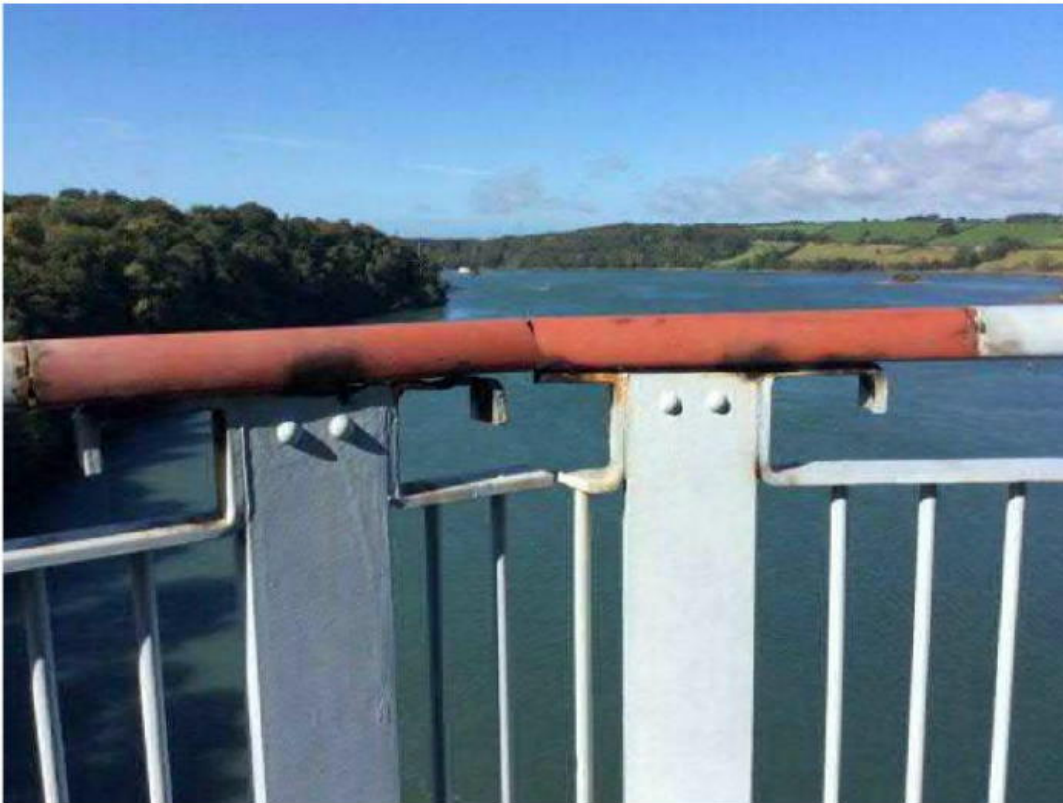
- Section loss from corrosion was noted to the west handrail at the south tower (Figure 73).
- Small areas of full depth section loss from corrosion was noted to the inner west guardrail at 23m north of the south tower (Figure 74, Figure 75, Figure 76).

Figure 73: Handrail / parapets / safety fences - section loss to west handrail at south tower

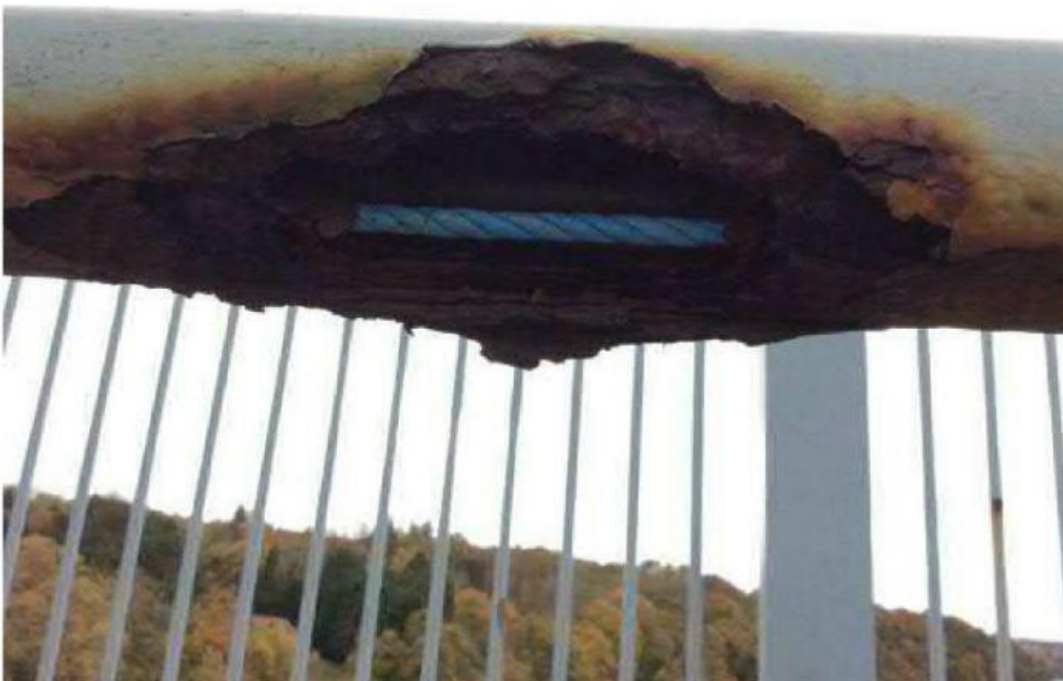
Figure 74: Handrail / parapets / safety fences - small areas of full depth section loss to inner west guardrail at 23m north of south tower
