UK Highways Bridge Management

Principal Inspection Report Menai Bridge (Structure Ref. A5 Menai Bridge)

December 2019

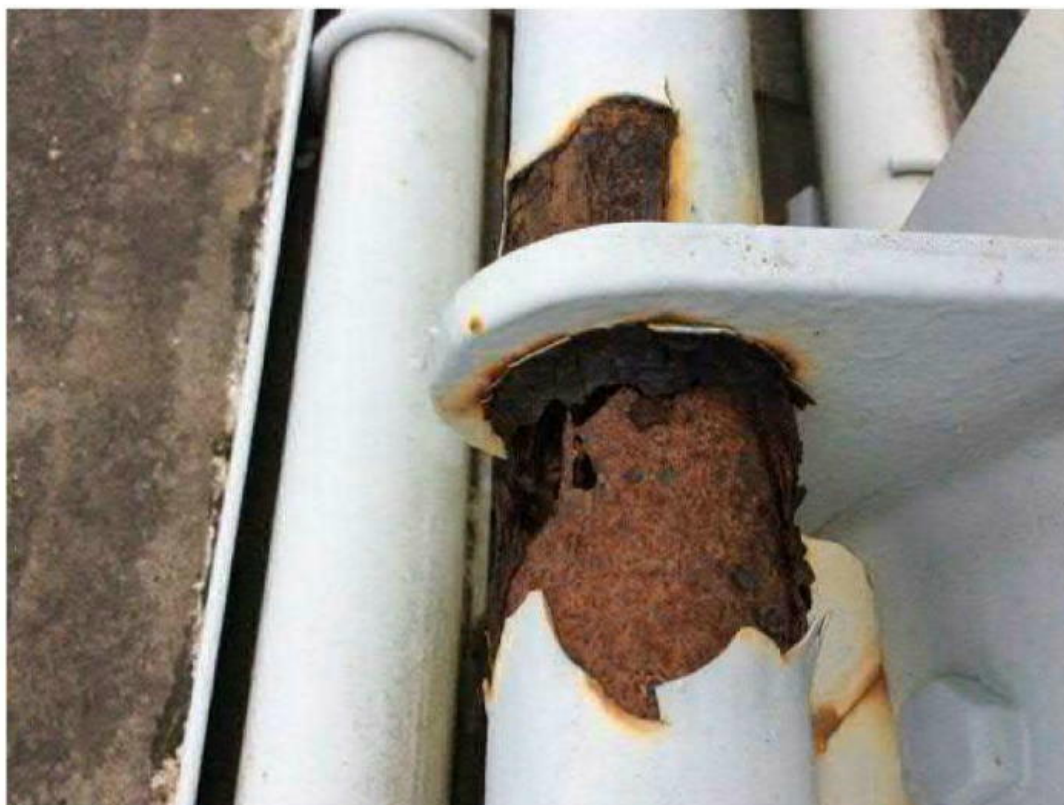
- Section loss from corrosion was noted to the west handrail at the south tower (Figure 73).
- Small areas of full depth section loss from corrosion was noted to the inner west guardrail at 23m north of the south tower (Figure 74, Figure 75, Figure 76).

Figure 75: Handrail / parapets / safety fences - small areas of full depth section loss to inner west guardrail at 23m north of south tower

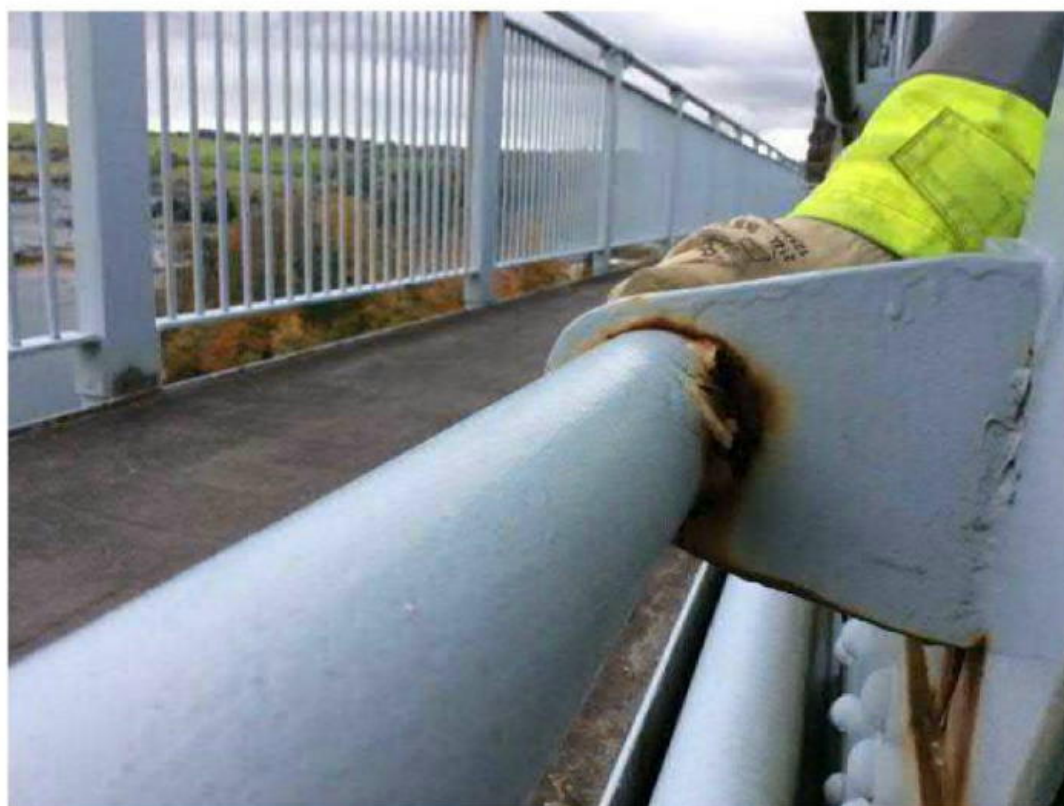
Figure 76: Handrail / parapets / safety fences - small areas of full depth section loss to inner west guardrail at 34m south of north tower

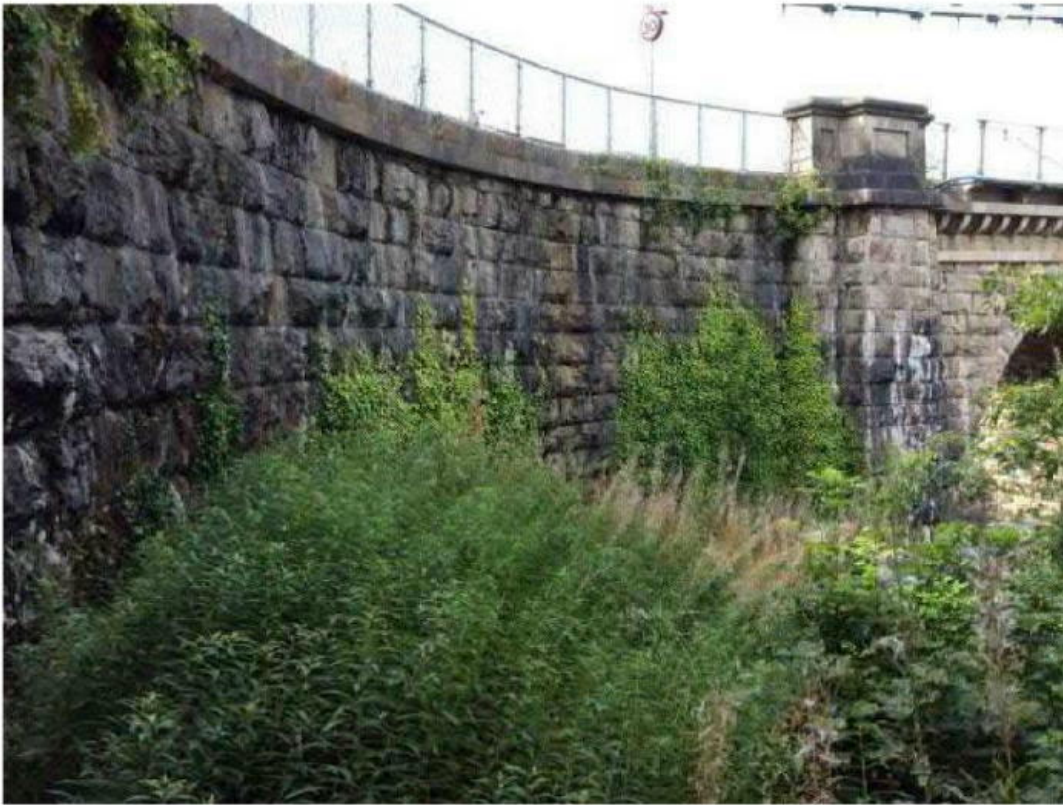
- Ivy was located to lower parts of all the four corner wing walls (Figure 84, Figure 85, Figure 86, Figure 87, Figure 88).

Figure 85: Wing walls - Ivy to lower parts of north end of south east wing wall

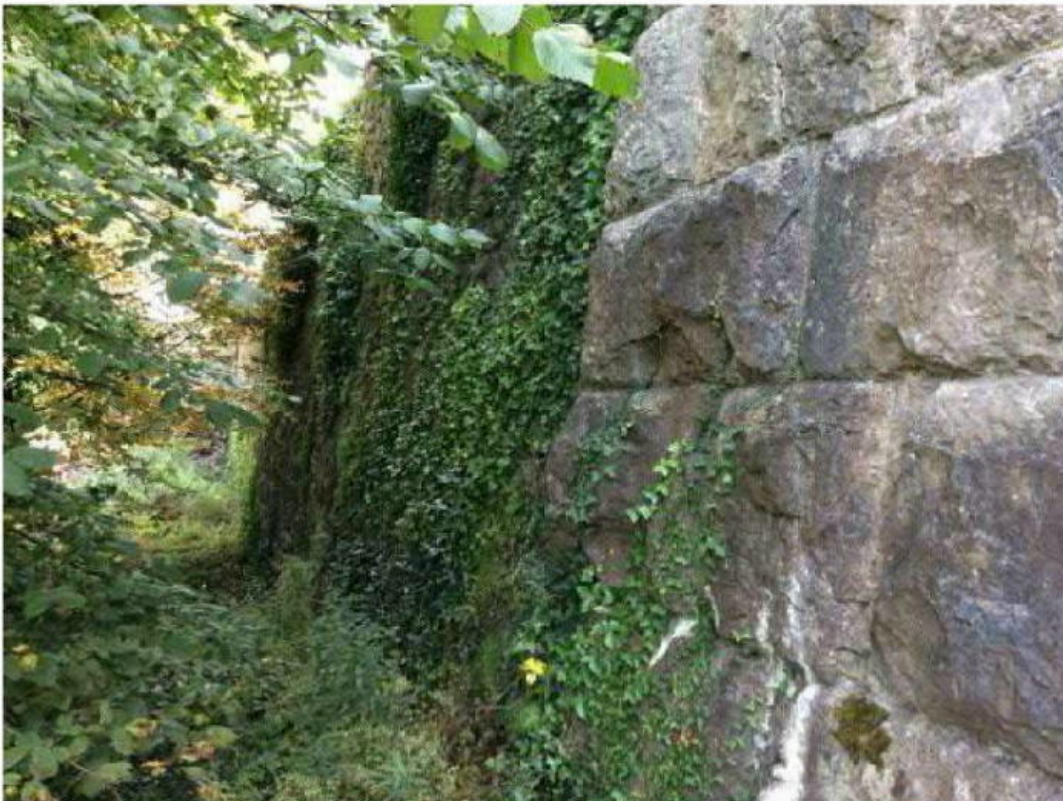
Figure 86: Wing walls - Ivy to lower parts of south end of south east wing wall

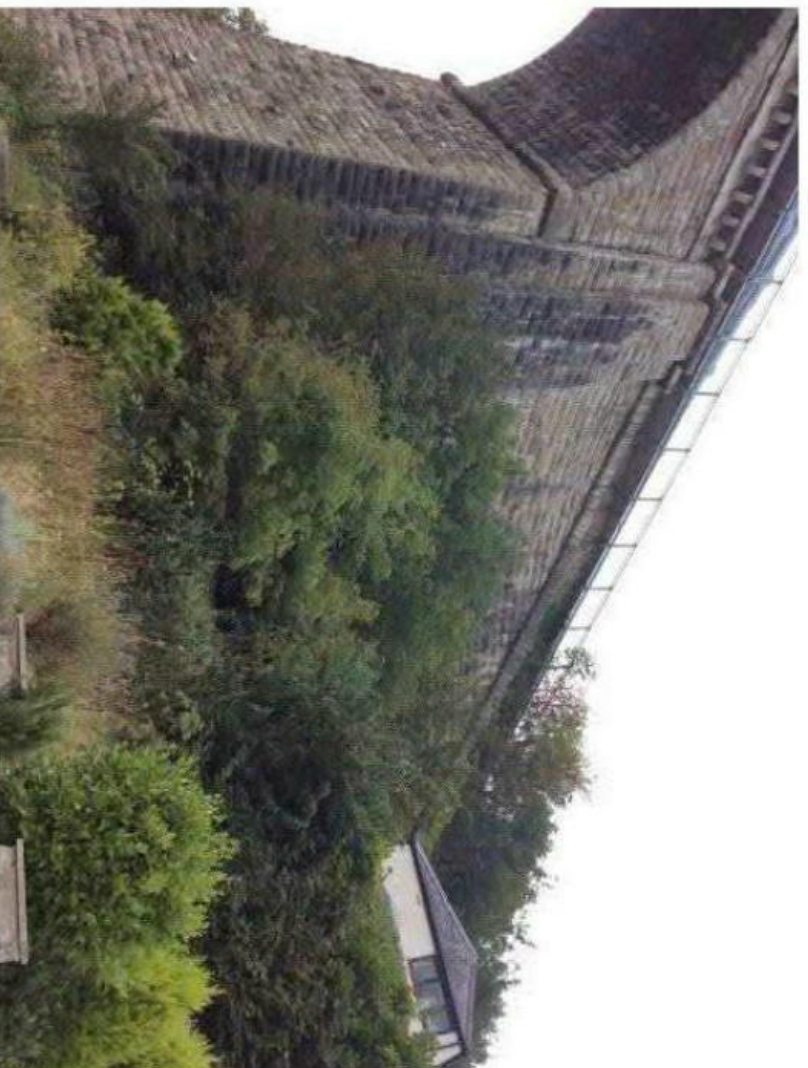
- Several small areas of deep mortar loss were noted to the north abutment particularly to the lower west face (Figure 39, Figure 40, Figure 88). The abutment faces had some light-coloured efflorescence and dark-coloured minor damp-staining evident, but these were generally aesthetical defects owing to the age of the structure.

Figure 88: Wing walls - try to lower parts of north east wing wall

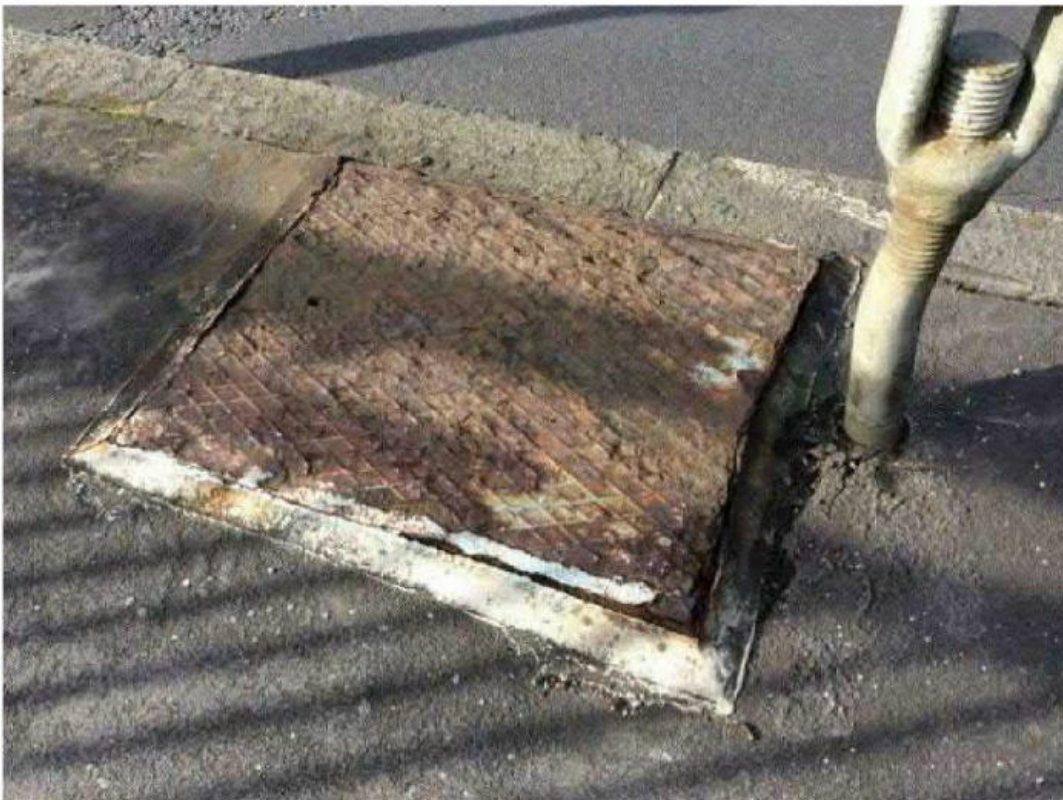
- Corrosion and section loss were noted to the edges of a west manhole cover 6m south of the south tower (Figure 90).
- Corrosion and section loss was noted to the edges of an unknown services box to the south of the north tower (Figure 91).
- Corrosion and full-depth section loss was noted to angle sections which project laterally beyond the lower west face of the main truss at 144m from the south end of the main span (Figure 122).

Figure 90: Services - corrosion and section loss to the edges of a west manhole cover 6m south of the south tower

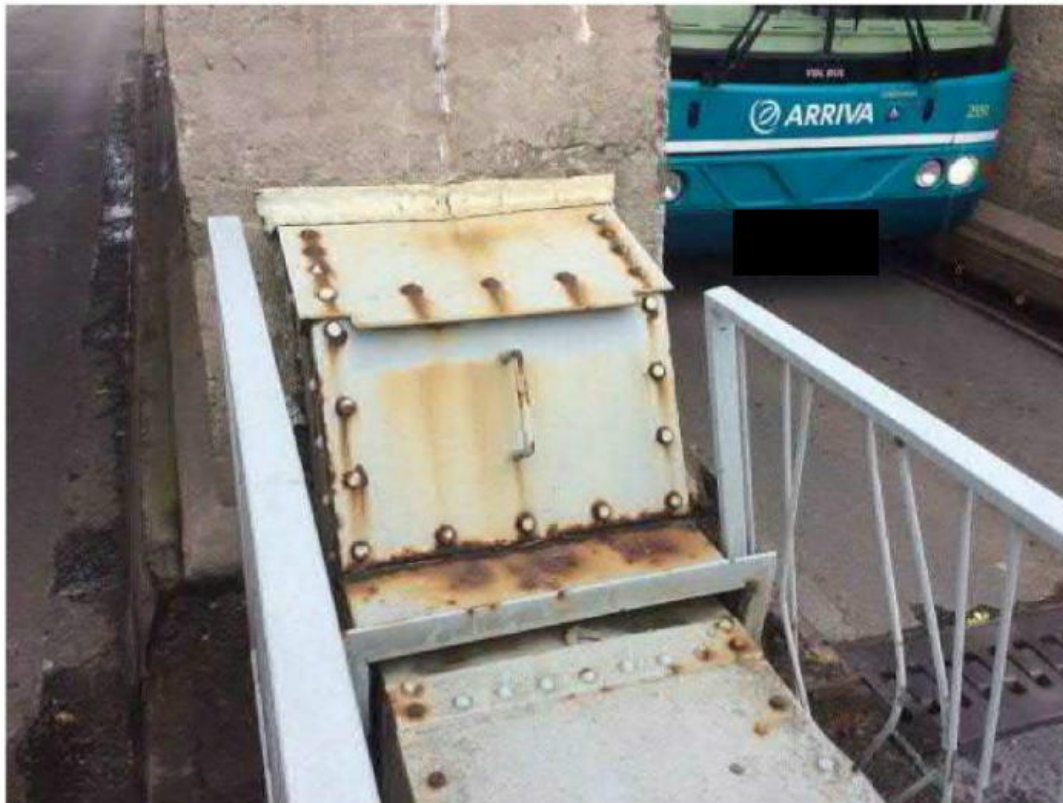
Figure 91: Services - corrosion and section loss to the edges of services box to the south of the north tower

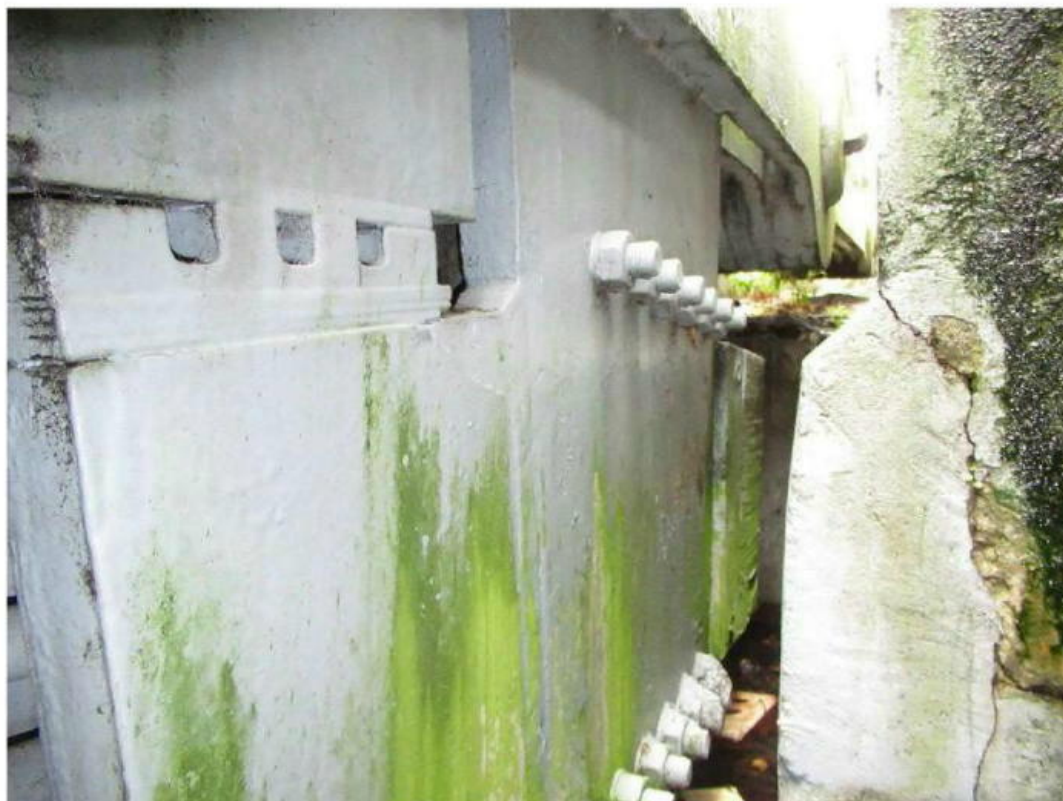
Figure 92: North anchor block – west face of the west back-stay anchor arrangement generally in good condition with minor algae

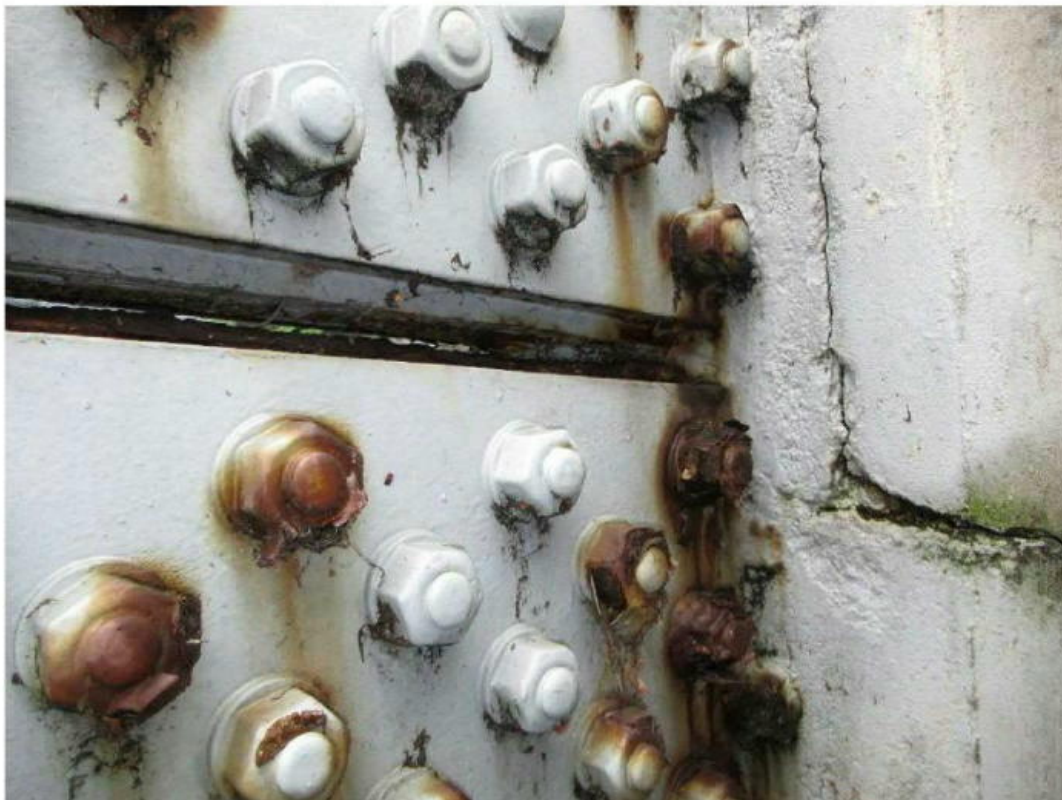
Figure 94: North anchor block – looking north along the inside, east face of the west back-stay anchor arrangement bolt group where it meets the buried concrete anchor block. Several small areas of minor to moderate paint loss and corrosion to bolt heads

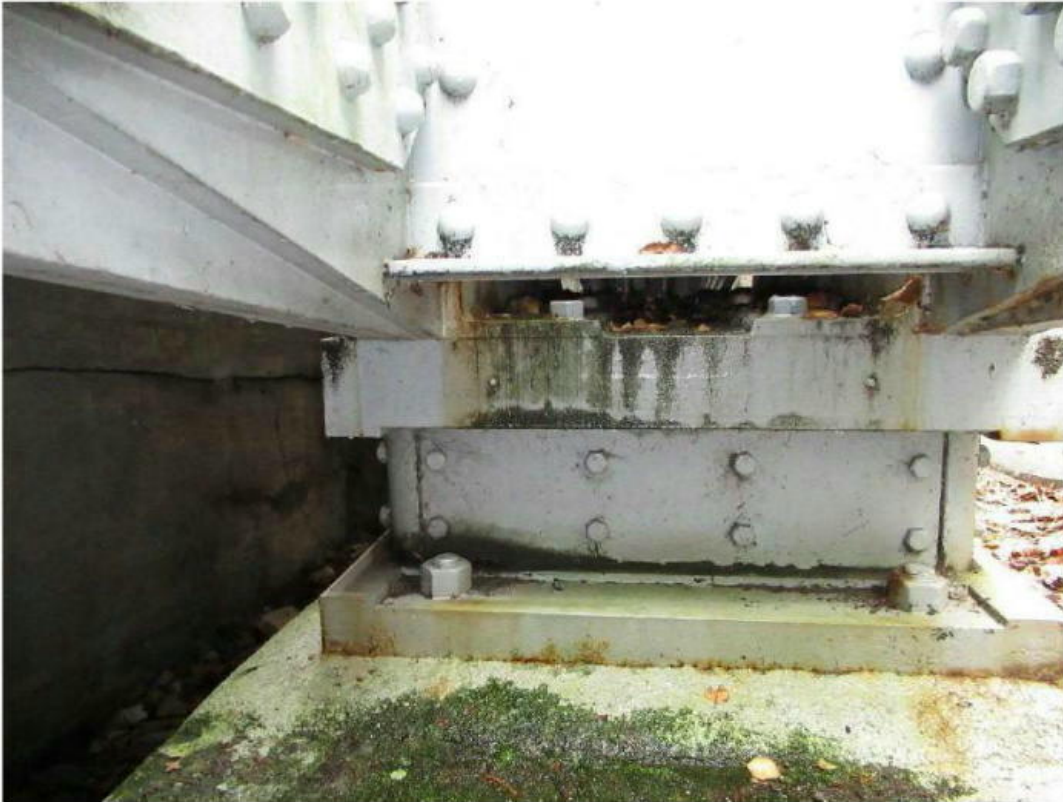
Figure 95: North anchor block – north face of the east back-stay anchor arrangement generally in good condition but with minor cracking to the short retaining wall supporting the east footpath

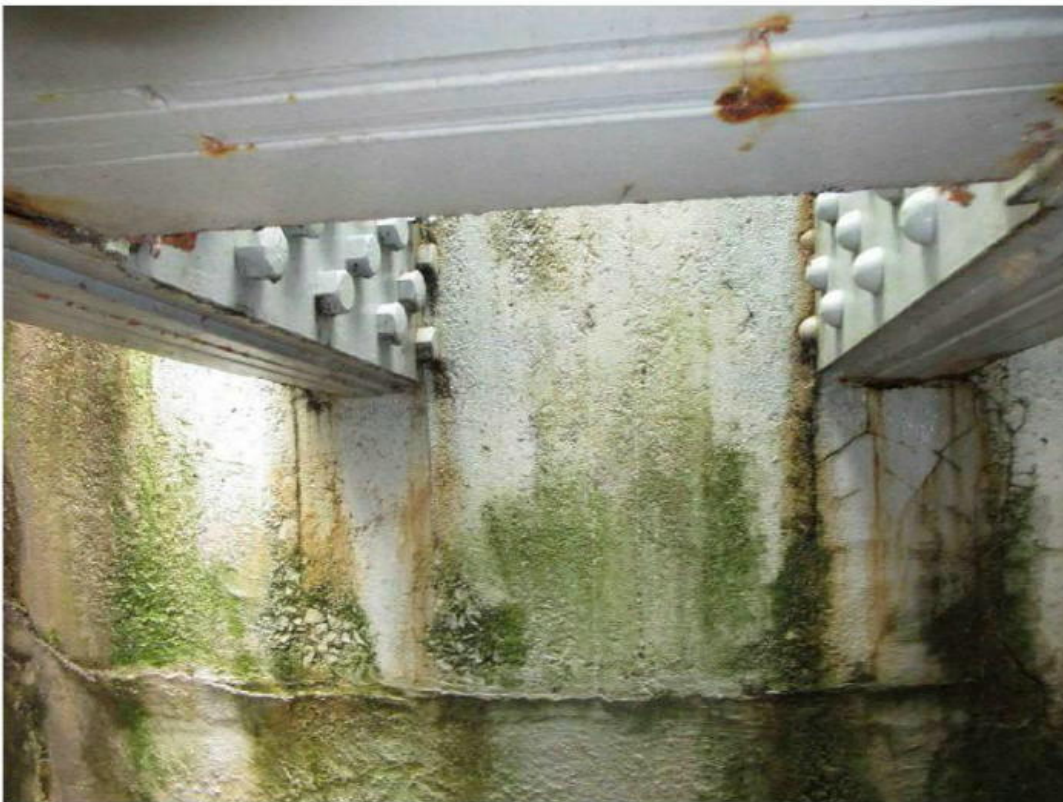
Figure 96: North anchor block – very minor cracking and algae to the south face of the east anchor block

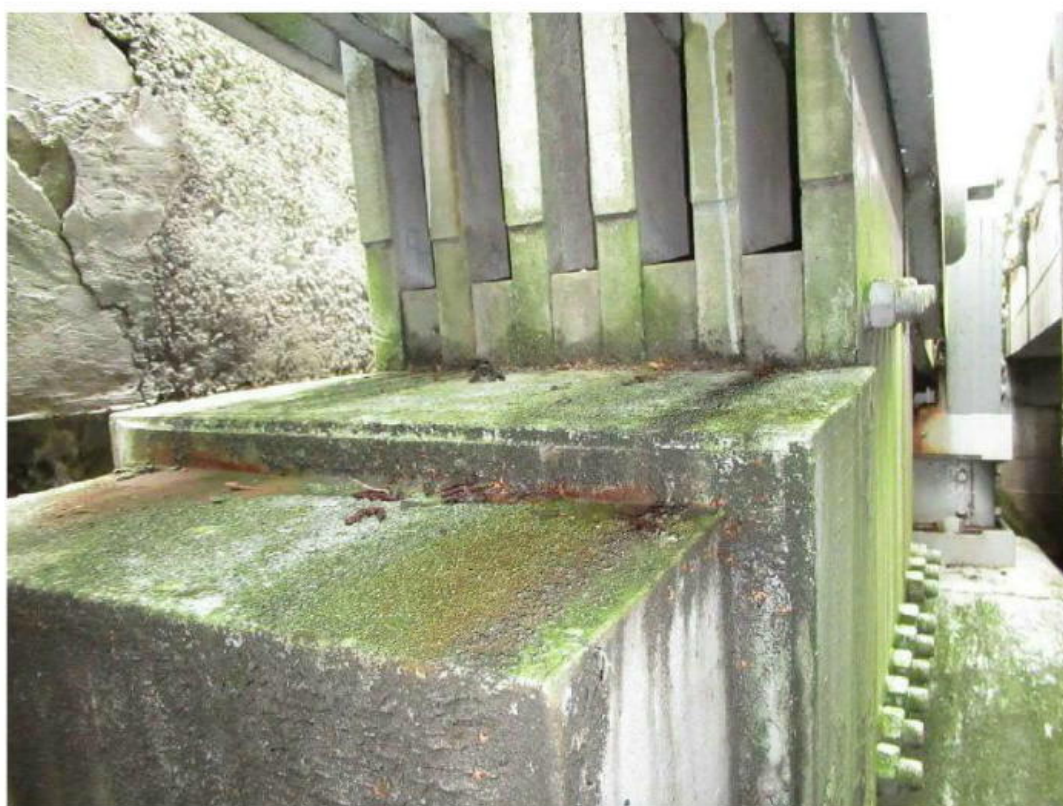
Figure 100: North anchor block – algae to the concrete plinth near the east anchor block

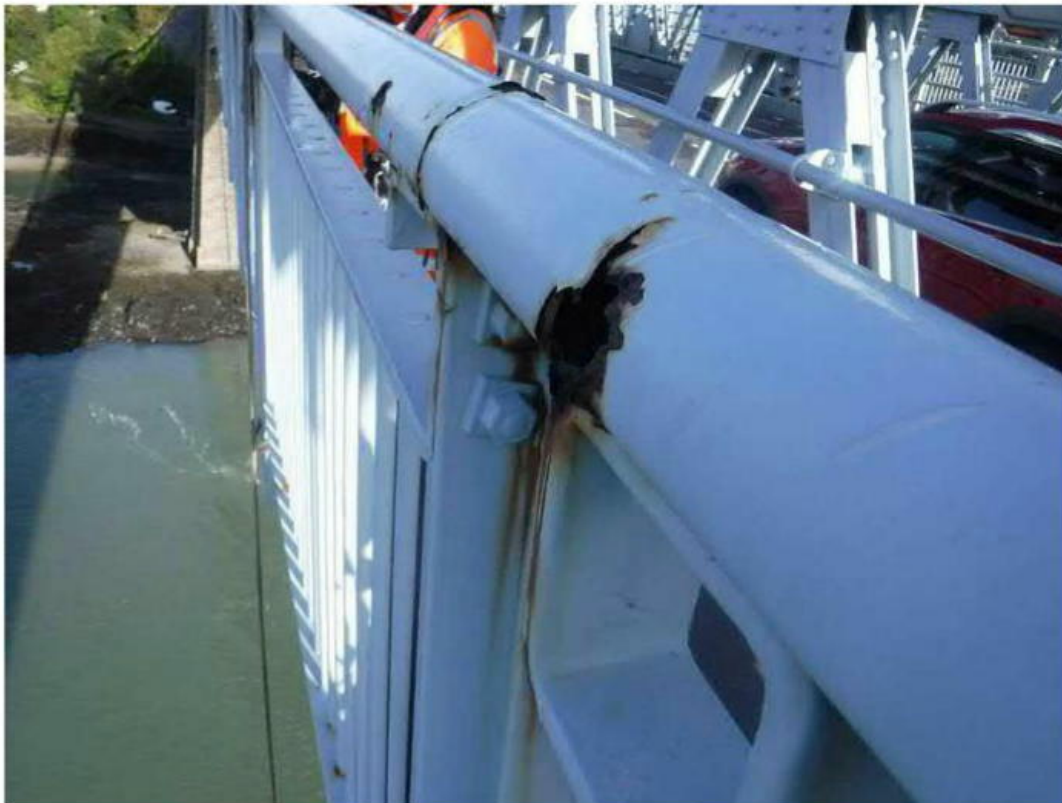
- Corrosion, which was severe in places, and full depth section loss was noted throughout typically to the west handrail at 64m north of the south tower. It is thought that corroded areas are more prevalent where rails meet and have been site butt welded prior to painting (Figure 101).

Figure 101: Parapet – corrosion and full depth section loss to west handrail at 64m north of south tower

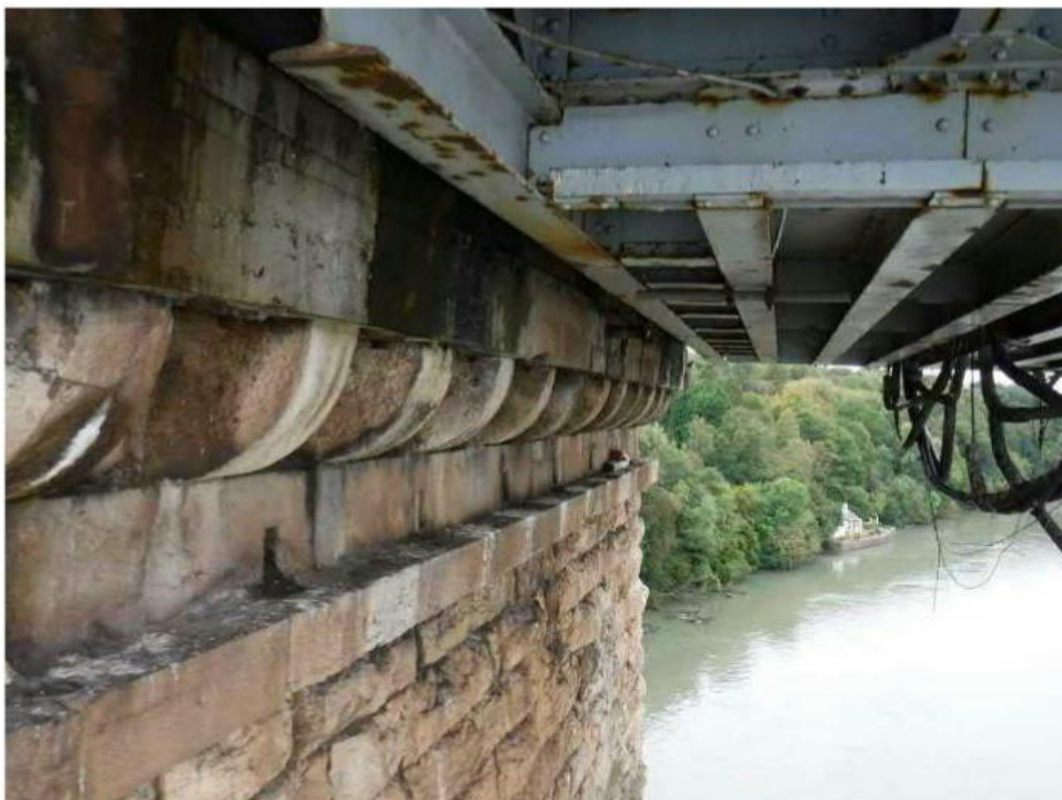
Figure 102: secondary deck – typical paint loss and corrosion to south end of main span (bearings obscured behind southernmost transverse beam)

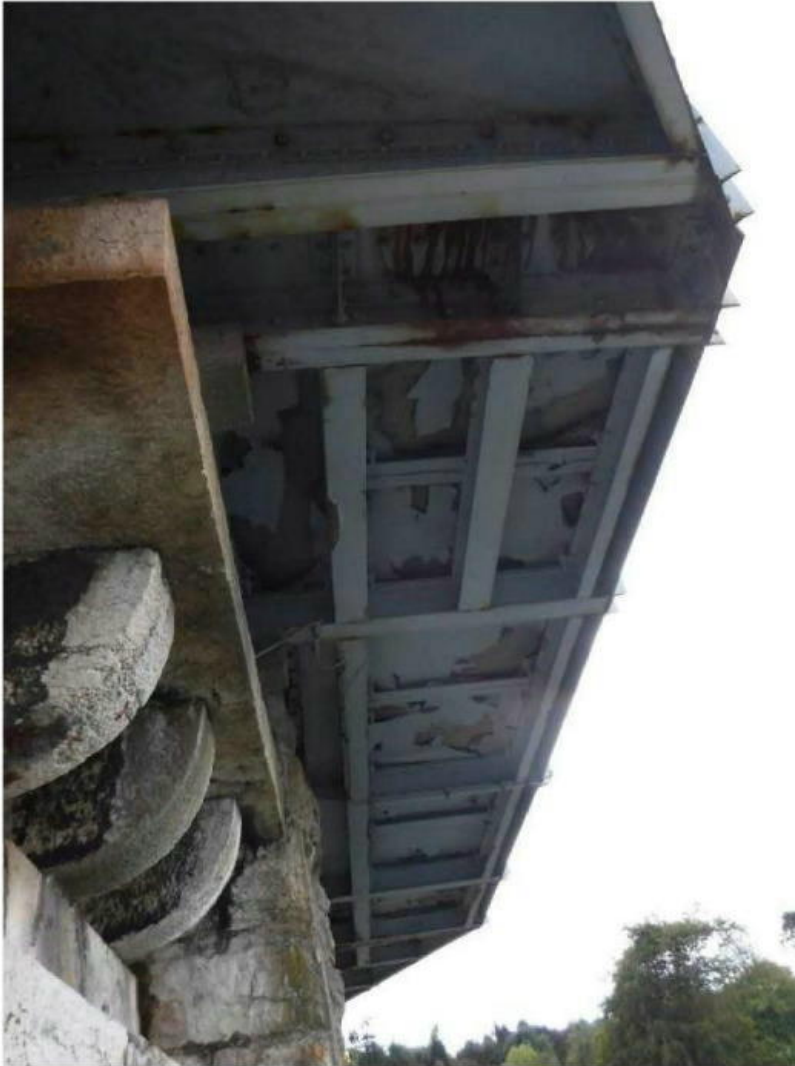
- Paint loss and corrosion was noted to the soffit of the west footpath cantilever to the south tower. Note flaking paint where the concrete soffit had been incorrectly painted (Figure 105).

Figure 105: secondary deck – typical paint loss and corrosion to soffit of west footpath cantilever to south tower. Note flaking paint where the concrete soffit has been incorrectly painted

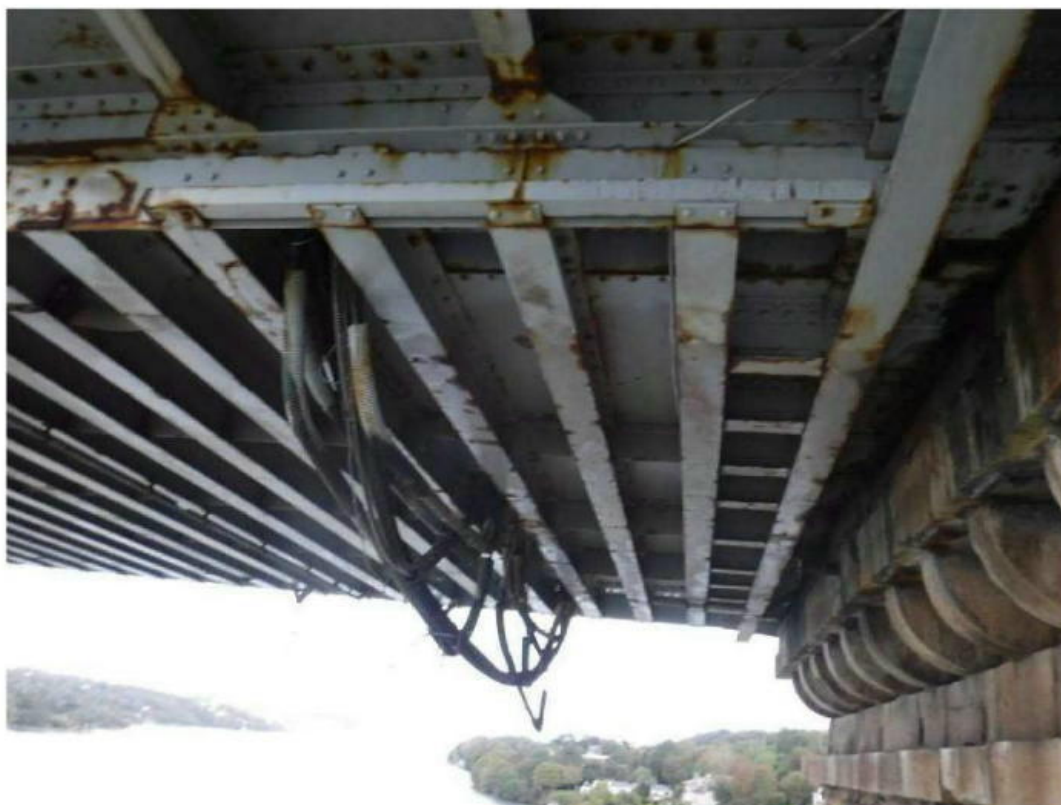
Figure 106: secondary deck – typical paint loss and corrosion to south west end of main span, 1m from south end

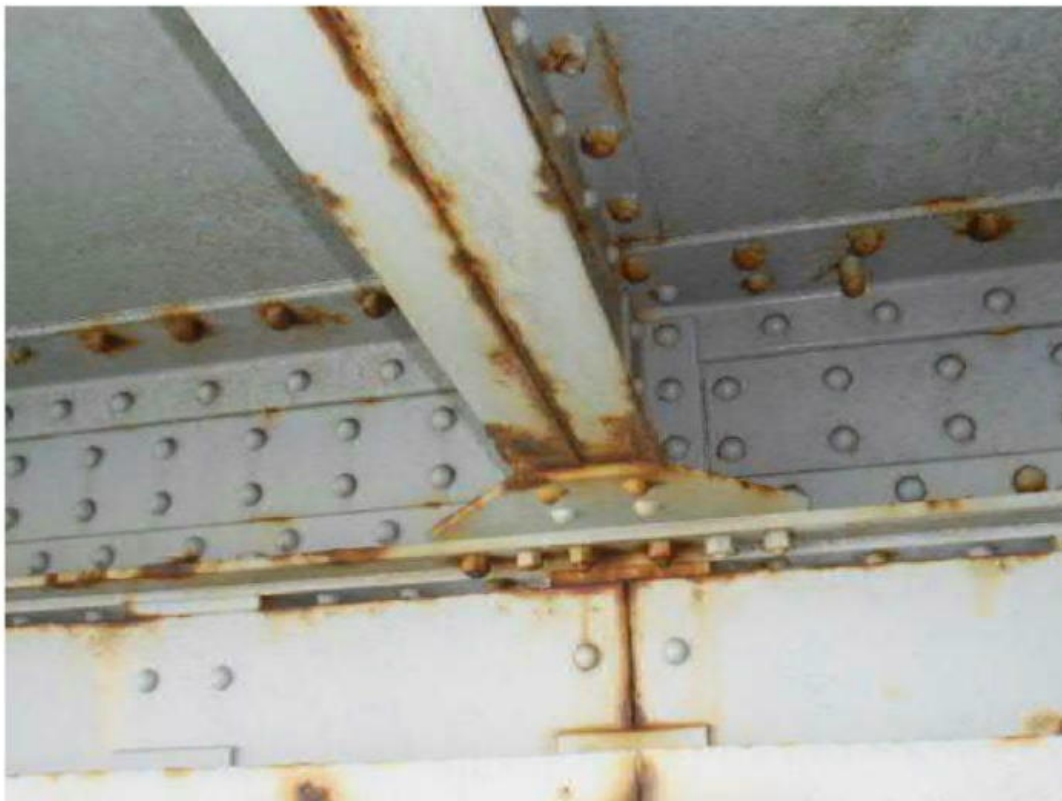
- Moderate paint loss and minor corrosion was noted to the walkway soffit particularly to the south end of the main span west walkway soffit, 8m from south (Figure 108), south end of main span west walkway soffit, 17.5m from south (Figure 109).

Figure 109: secondary deck – typical paint loss and corrosion to south end of main span west walkway soffit, 17.5m from south

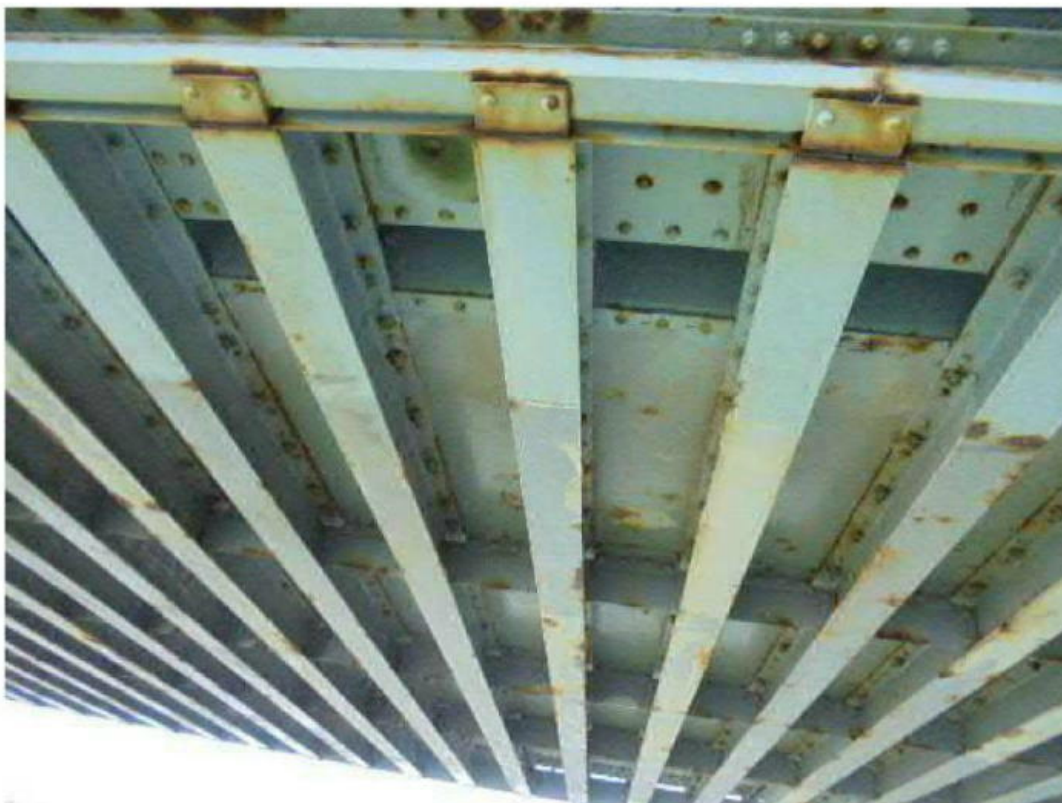
Figure 113: secondary deck –looking east at typical paint loss and corrosion to deck soffit, 46.5m from south

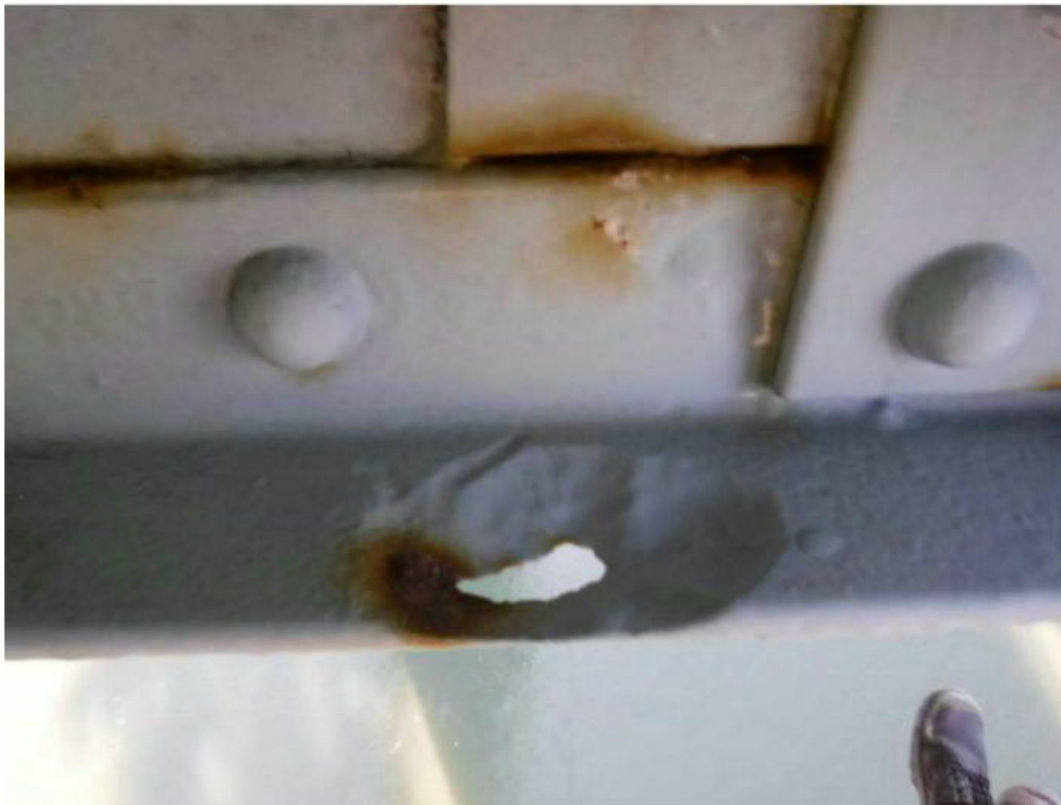
Figure 114: secondary deck – deep pitting corrosion and full depth section loss to lower edge beam flange, 52m from south

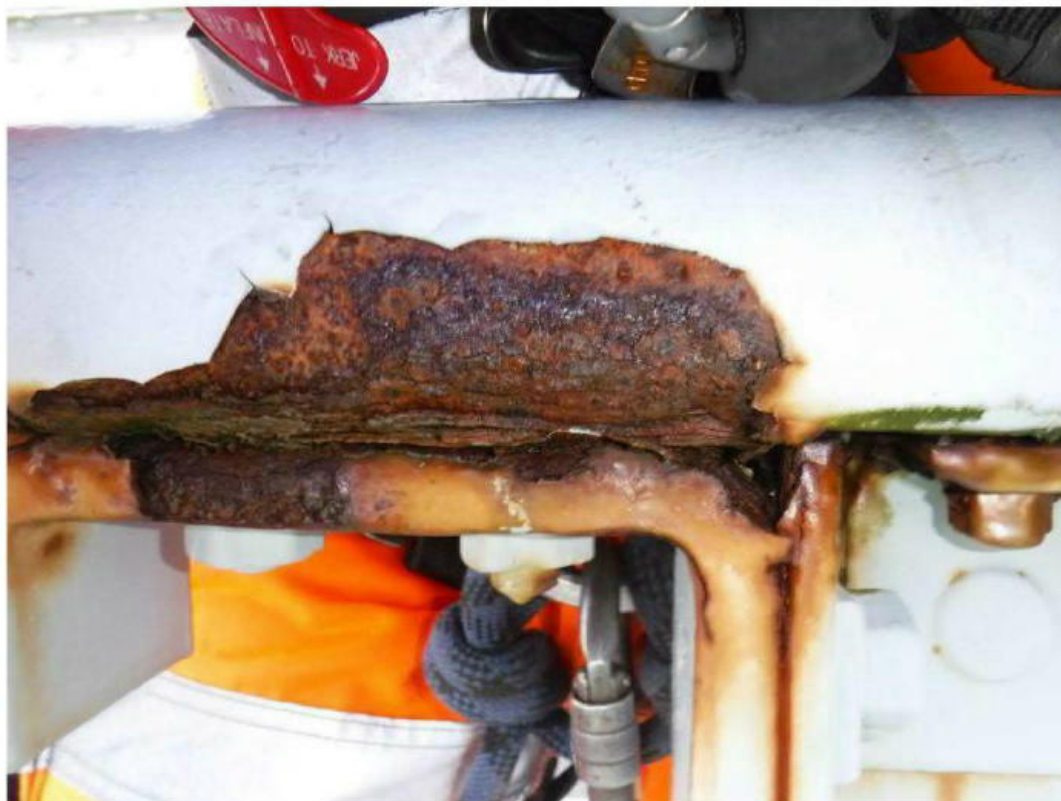
- Deep pitting corrosion was noted to the upper west parapet rail, 52m from the south end of the main span (Figure 115).

Figure 115: parapet – deep pitting corrosion to upper west parapet rail, 52m from south

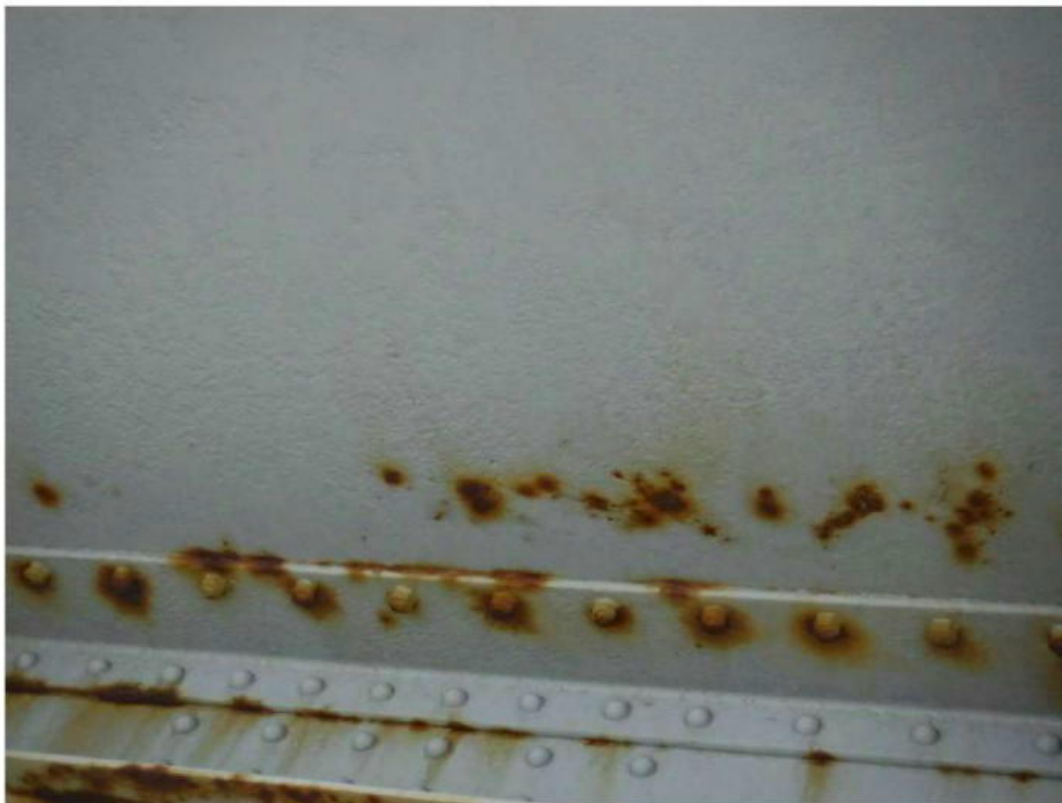
- Moderate paint loss and corrosion was noted to the west walkway cantilever flange end and rivet heads, 121.5m from the south end of the deck (Figure 121) and at 149m (Figure 123). Paint loss and moderate corrosion was noted to the base of the east parapet infill bars, 27m from the south end (Figure 132) with corrosion and rust staining to the base of the east parapet post, 41m from the south end (Figure 133), at 56.5m from the south end (Figure 134) and 139.5m from the south (Figure 139, Figure 140).

Figure 123: secondary deck – close-up of paint loss and corrosion to walkway soffit, 149m from south

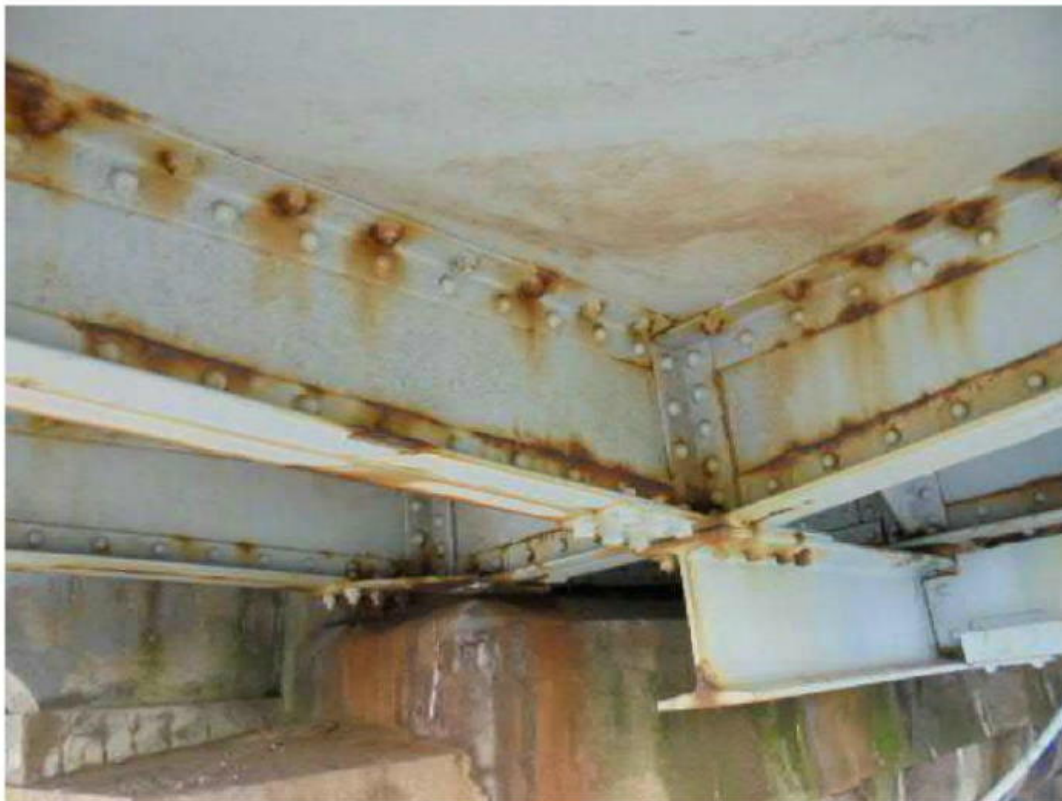
Figure 125: secondary deck – paint loss and corrosion to west face of lower truss, upper flanges of walkway cantilever and rust-staining to bearing shelf, north end

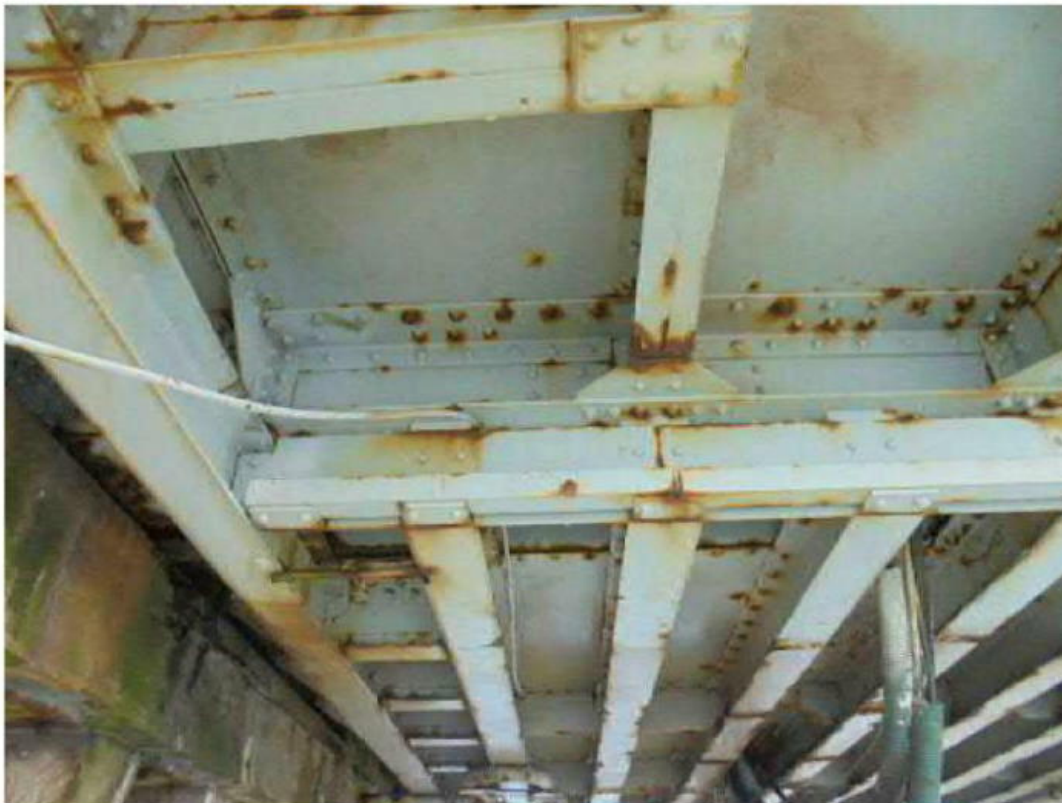
Figure 126: secondary deck – paint loss and corrosion to west face of lower truss, transverse beams and deck soffit plates, north end

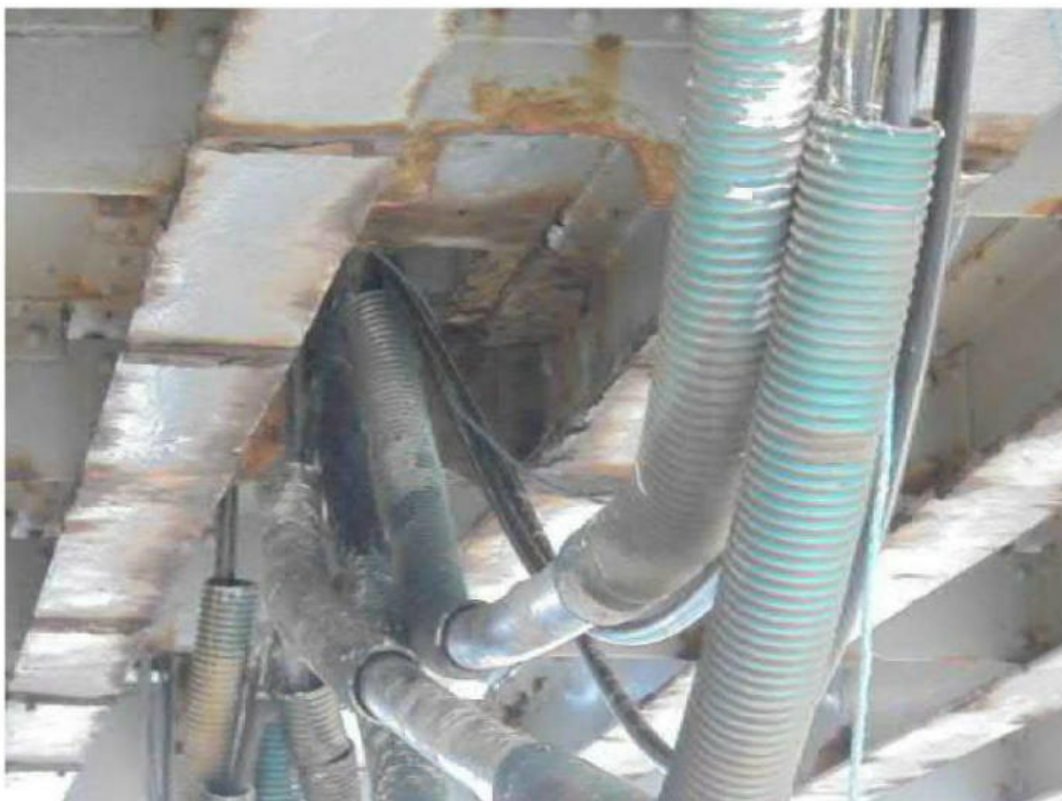
Figure 127: secondary deck – paint loss and corrosion to deck soffit plates where service ducts penetrate, north end

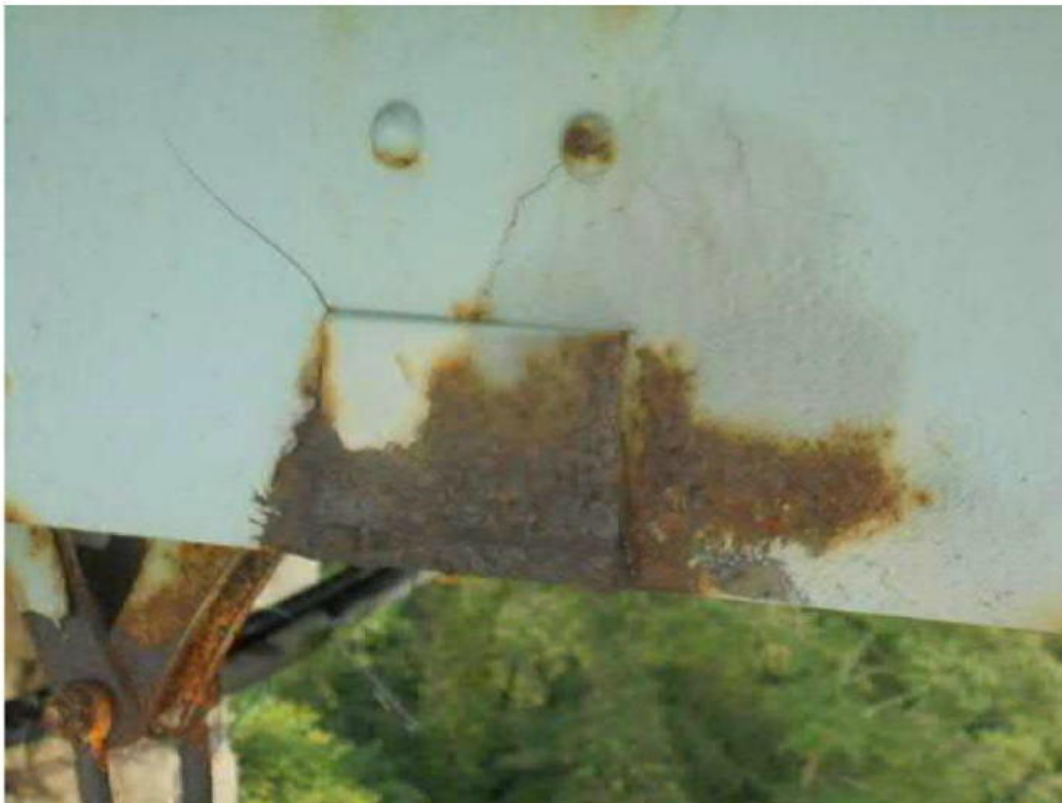
- Paint loss, flaking paint, paint loss and corrosion was noted to a small steelwork repair panel to the lower east face of the parapet, 8m from the south end (Figure 128).
- Paint loss and minor corrosion was noted to the transverse beam east end, 12.5m from south end (Figure 129). Further paint loss and corrosion was noted throughout the transverse beams and longitudinal stiffeners, 71m from the south (Figure 135).

Figure 128: secondary deck – flaking paint, paint loss and corrosion to steelwork repair panel to the lower east face of the parapet, 8m from south end
