UK Highways Bridge Management

Principal Inspection Report Menai Bridge (Structure Ref. A5 Menai Bridge)

December 2019

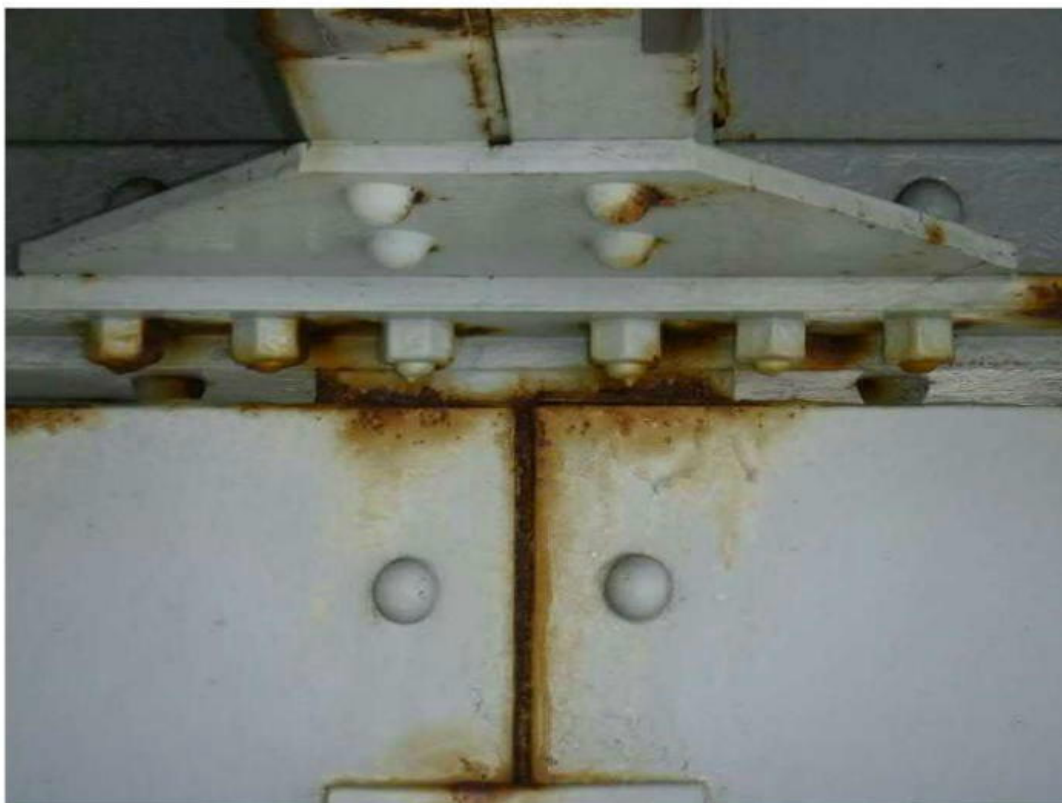
- Paint loss, flaking paint, paint loss and corrosion was noted to a small steelwork repair panel to the lower east face of the parapet, 8m from the south end (Figure 128).
- Paint loss and minor corrosion was noted to the transverse beam east end, 12.5m from south end (Figure 129). Further paint loss and corrosion was noted throughout the transverse beams and longitudinal stiffeners, 71m from the south (Figure 135).

Figure 129: secondary deck – minor corrosion to transverse beam east end, 12.5m from south end

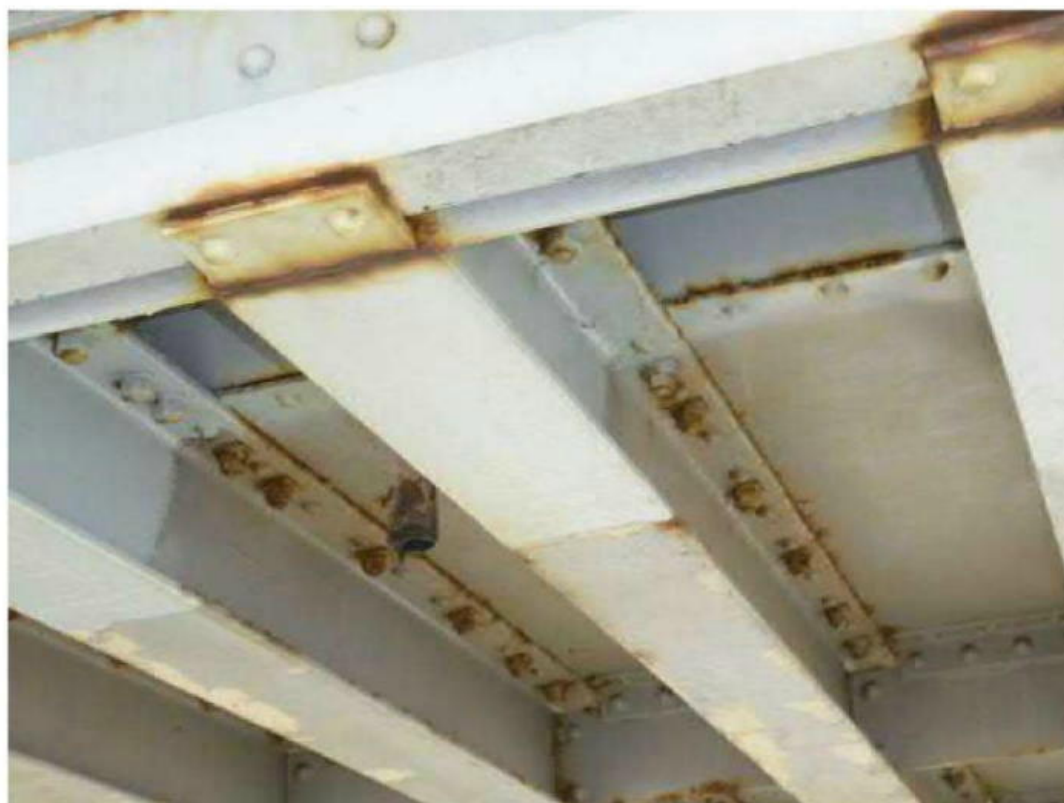
Figure 131: secondary deck – paint loss and corrosion to east end of transverse beam and riveted plates, 17.5m from south end

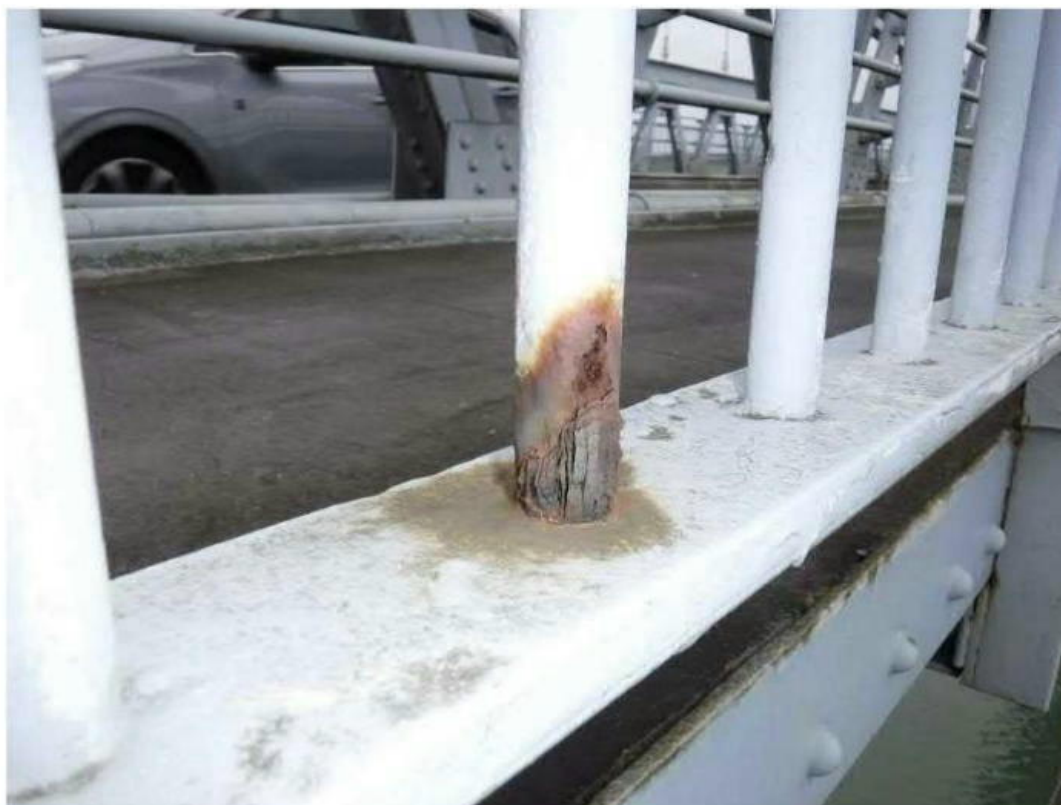
- Moderate paint loss and corrosion was noted to the west walkway cantilever flange end and rivet heads, 121.5m from the south end of the deck (Figure 121) and at 149m (Figure 123). Paint loss and moderate corrosion was noted to the base of the east parapet infill bars, 27m from the south end (Figure 132) with corrosion and rust staining to the base of the east parapet post, 41m from the south end (Figure 133), at 56.5m from the south end (Figure 134) and 139.5m from the south (Figure 139, Figure 140).

Figure 132: parapet – typical paint loss and corrosion to the base of the east parapet infill bars, 27m from south end

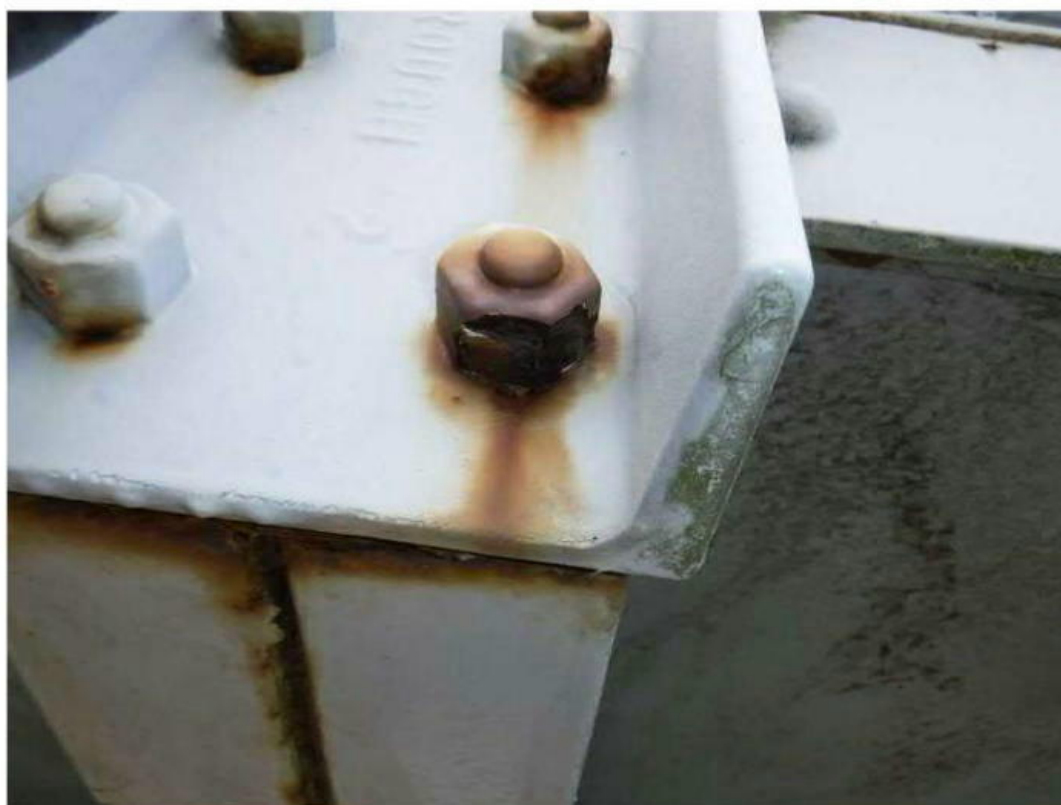
Figure 133: parapet – typical paint loss, corrosion and rust staining to the base of the east parapet post, 41m from south end

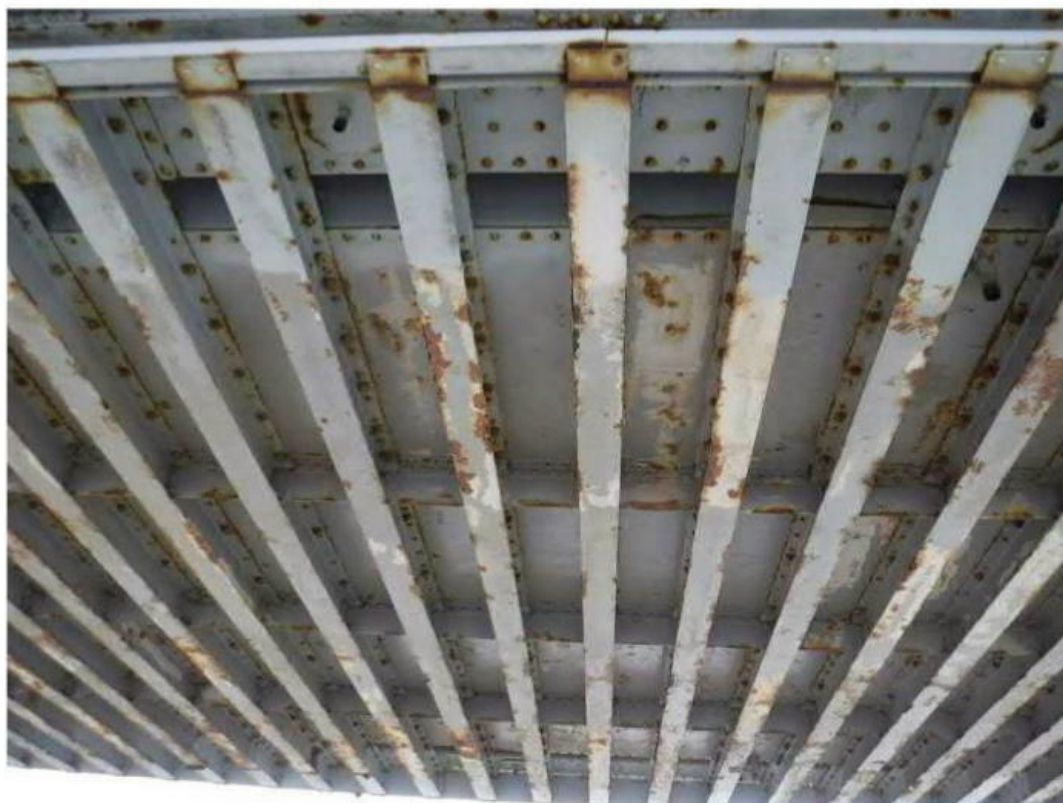
Figure 135: secondary deck – typical paint loss and corrosion throughout transverse beams and longitudinal stiffeners, 71m from south

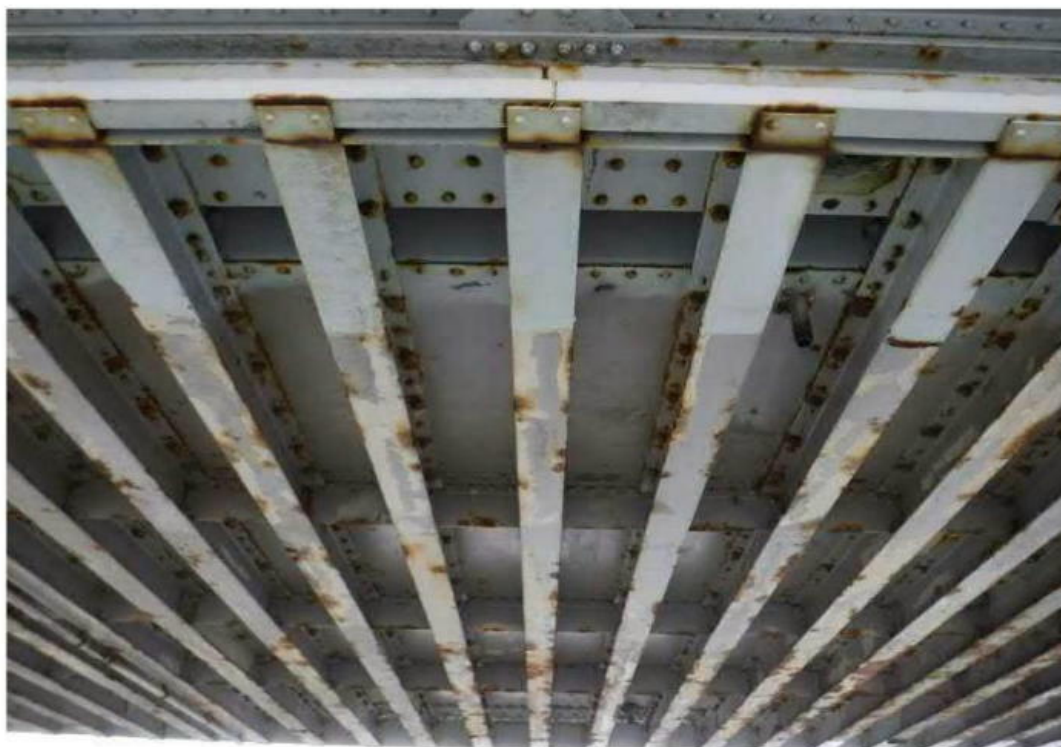
Figure 136: secondary deck – typical paint loss and corrosion to throughout transverse beams and longitudinal stiffeners, 85.5m from south (around mid-span)

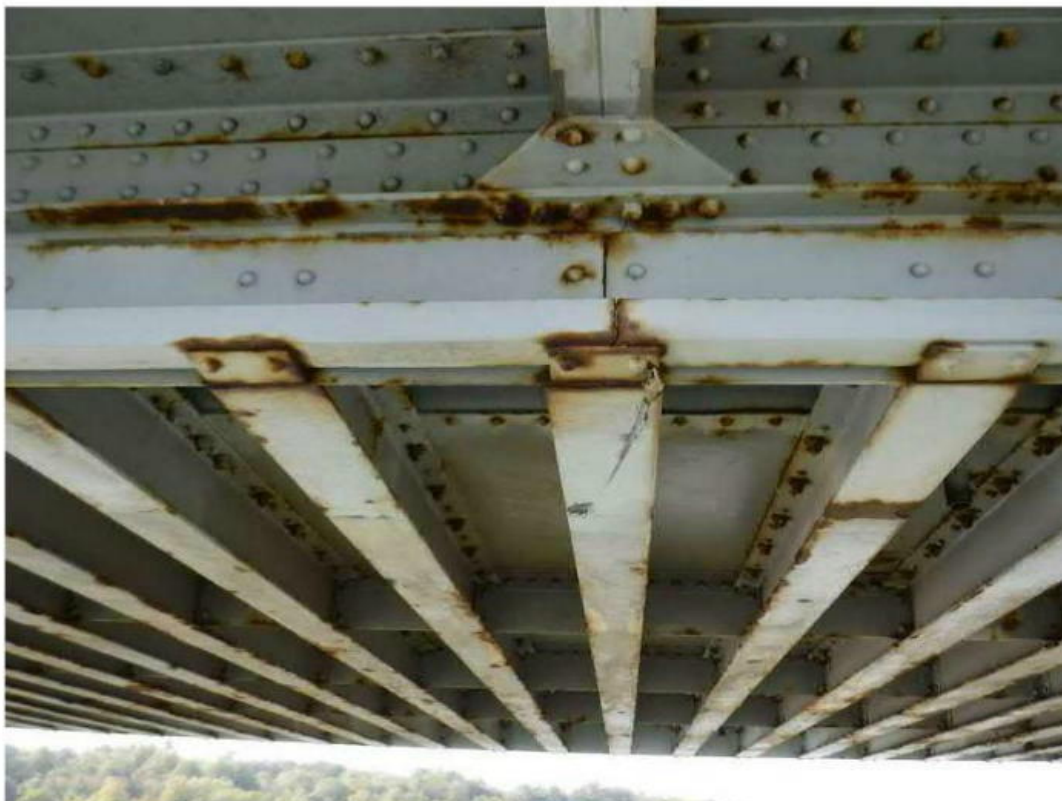
Figure 141: secondary deck –paint loss and corrosion to several areas throughout lower truss and transverse beams, 139.5m from south

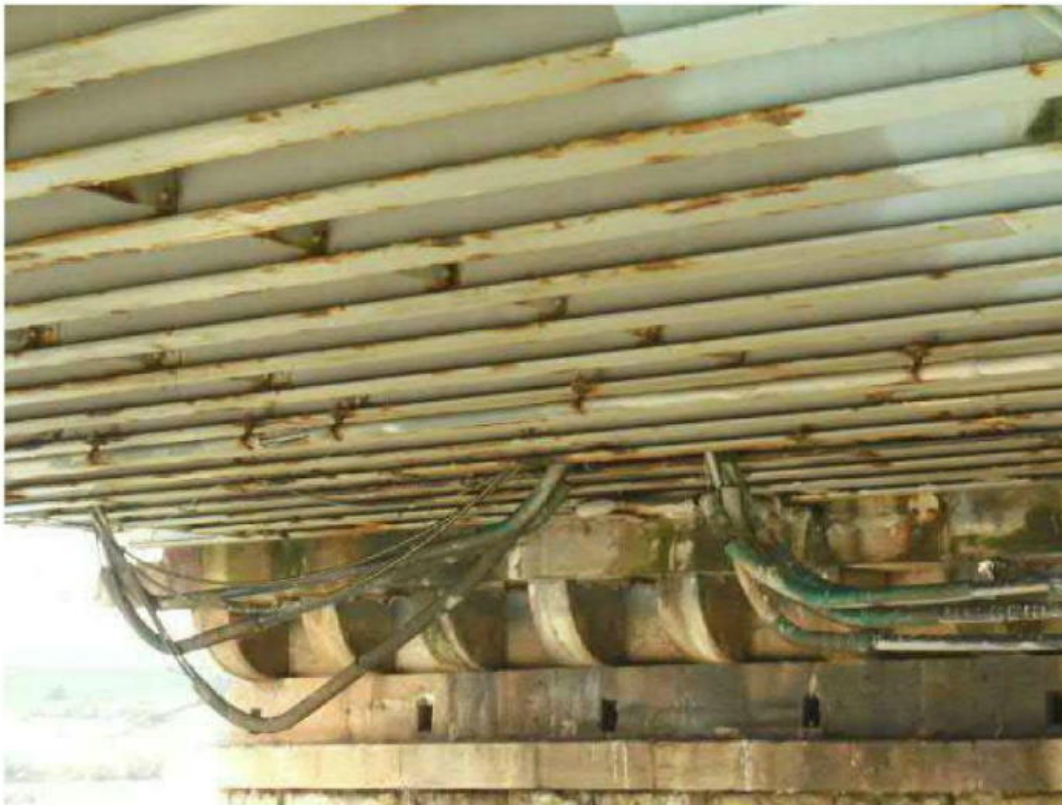
Figure 142: secondary deck –suspended service ducts to north end with paint loss and corrosion to several areas throughout transverse beams, 149m from south

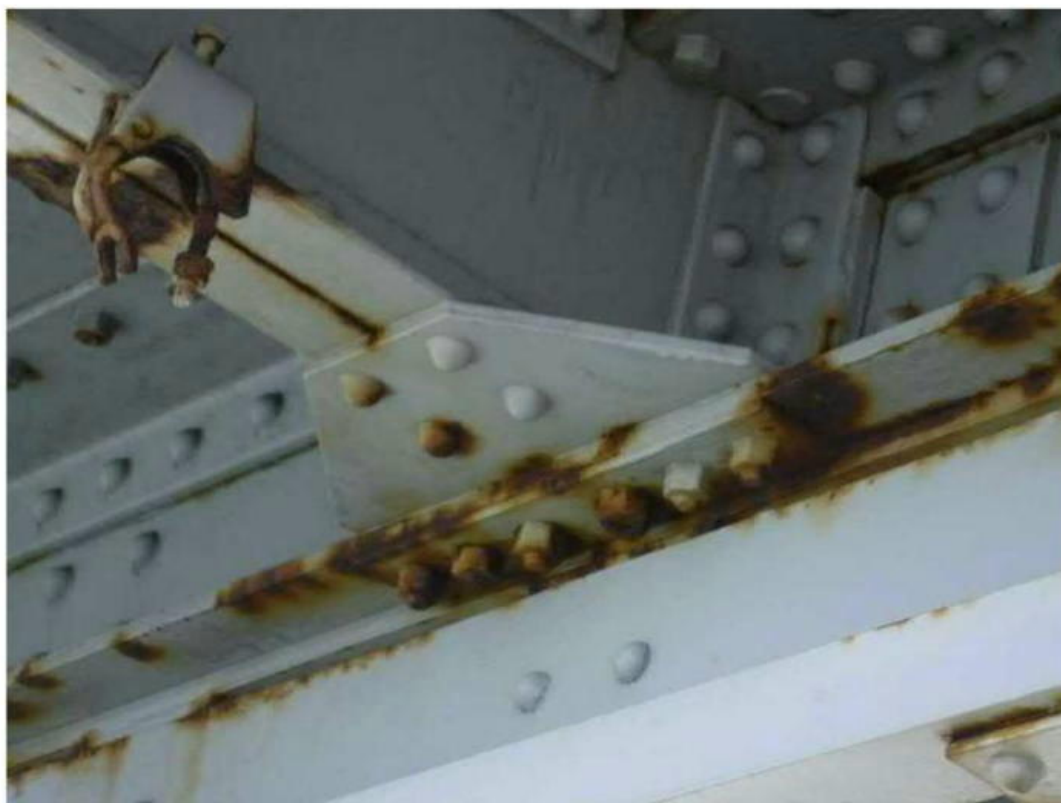
- Several small areas of moderate paint loss and corrosion were noted to bolt heads to the inside face of the east edge beam, 112.5m from the south (Figure 137) and at 153.5m from the south (Figure 144).

Figure 144: secondary deck – paint loss and corrosion to lower outer truss face, cantilever, gusset and bolt heads, 153.5m from south

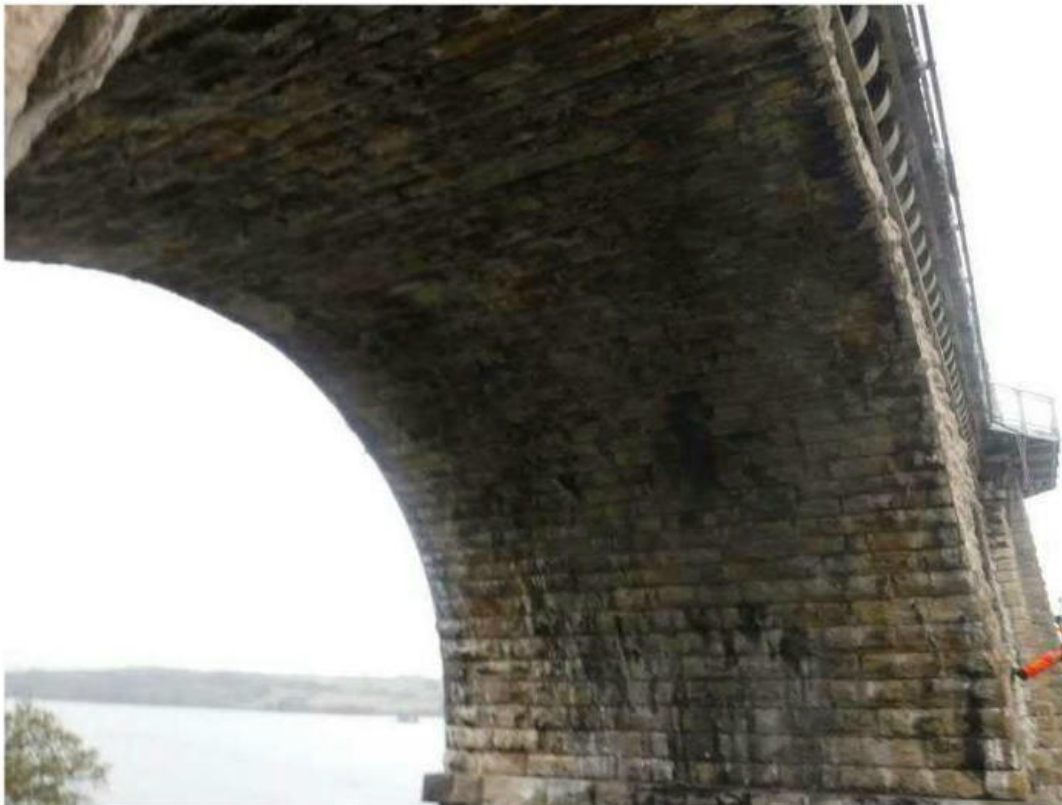
- General areas of efflorescence and damp-staining were noted through the arch intradoses particularly the slight dripping noted through the west side of the north arch (Figure 42).
- Minor damp staining and efflorescence was noted throughout but typically to the south abutment (Figure 147) and arch 7 (Figure 148).

Figure 148: Waterproofing – minor damp staining and efflorescence throughout south end of arch span 7.

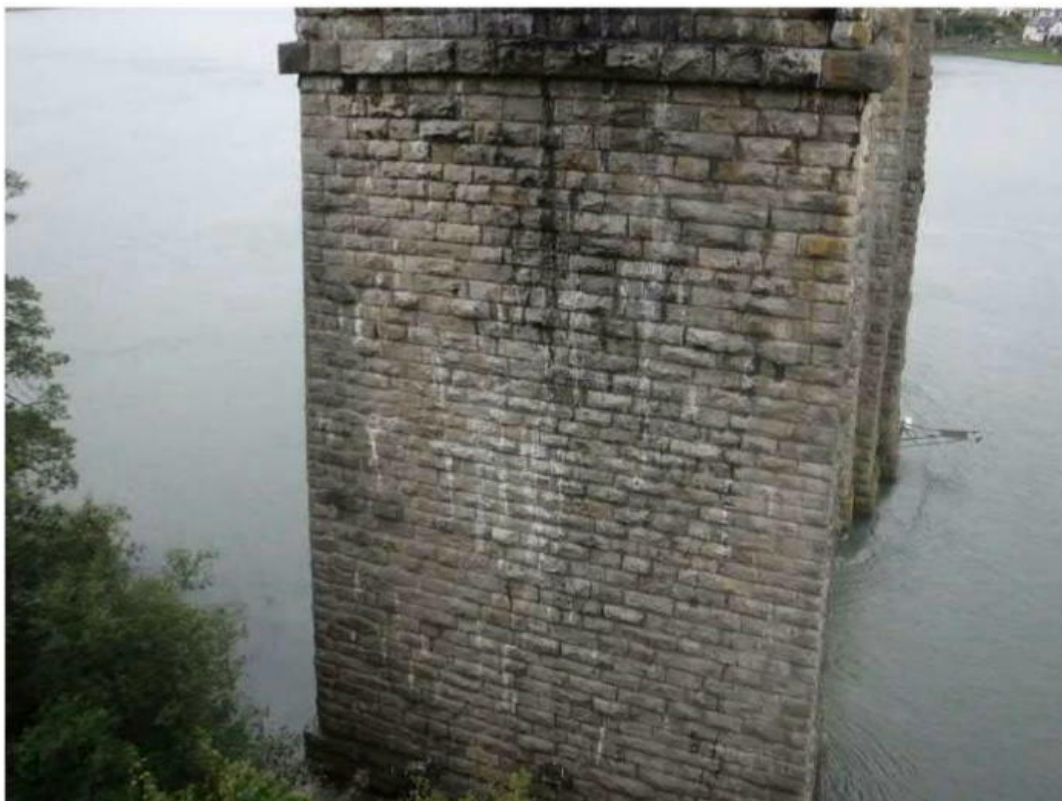
- Areas of minor damp staining and efflorescence were noted throughout all pier north and south faces, typically to the south face of pier 7 (Typically shown on Figure 149) and the south face of pier 5 (Figure 145). Very minor damp staining and efflorescence was also noted throughout the south face of pier 7 (Figure 149).

Figure 149: Piers – very minor damp staining and efflorescence throughout south face of pier 7 (span 7).

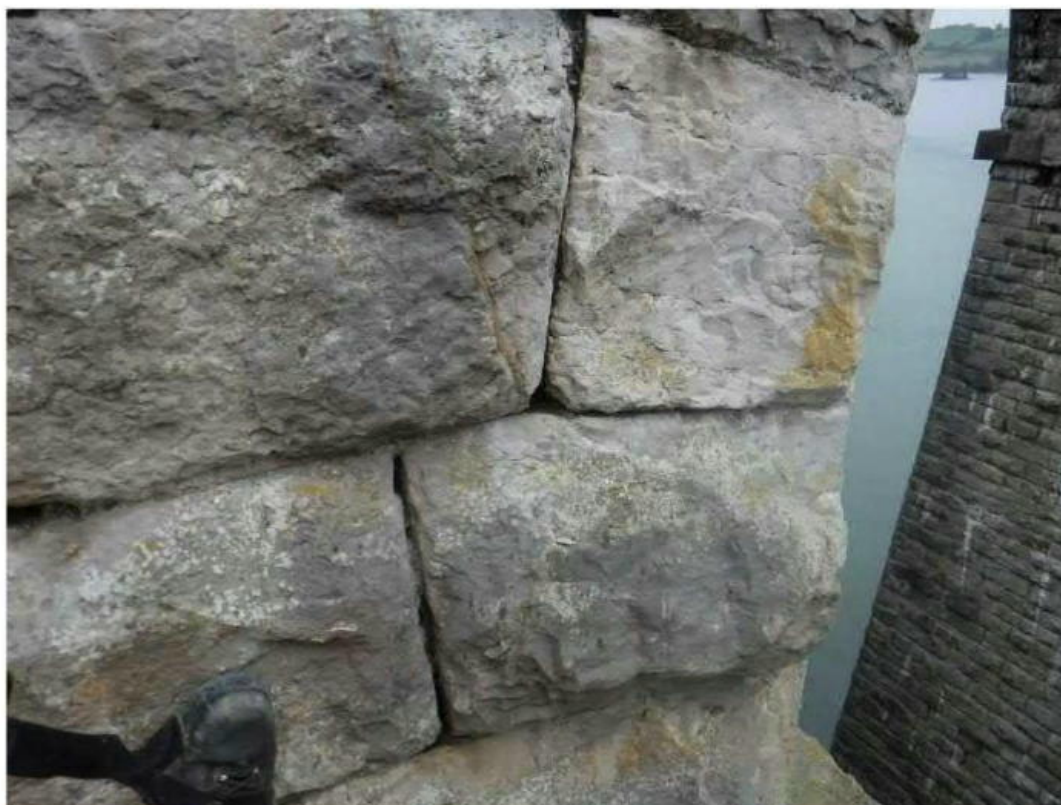
Figure 150: primary deck element – several small areas of deep mortar loss to joints throughout the arches. Typical area around the east side, above south springer of arch 7 (span 7).

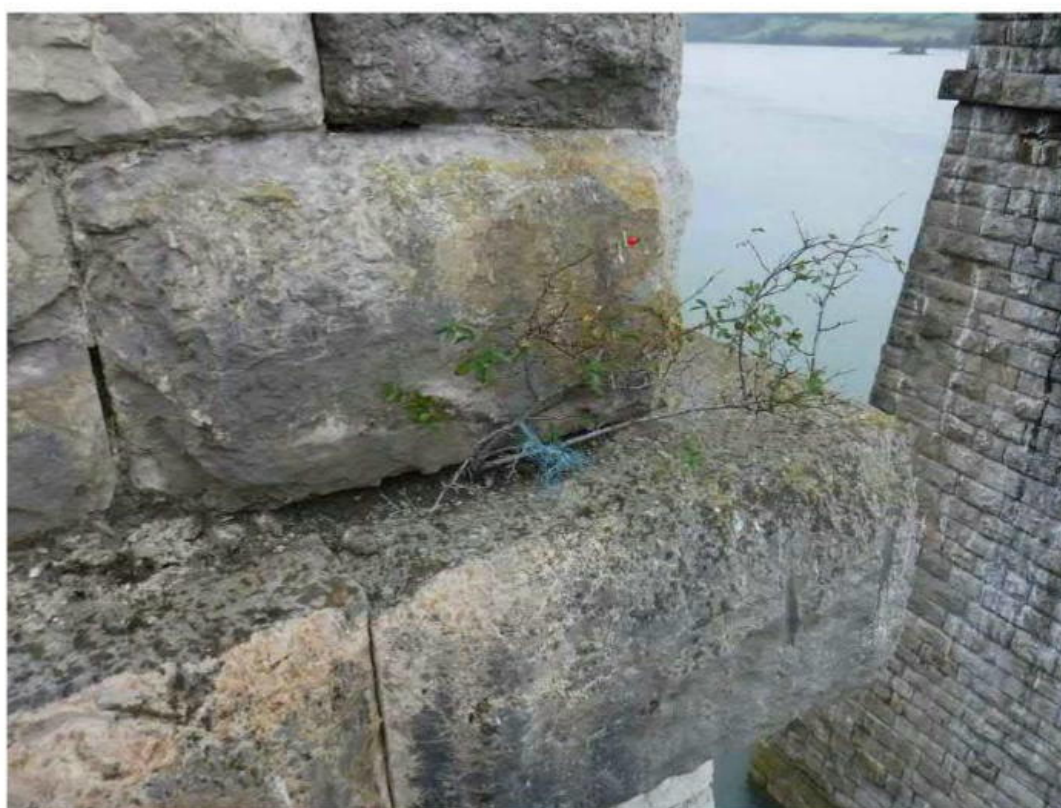
Figure 151: primary deck element – several small areas of deep mortar loss to joints throughout the arches. Typical area around the east side, at south springer of arch 7 (span 7) where vegetation is starting to take hold.

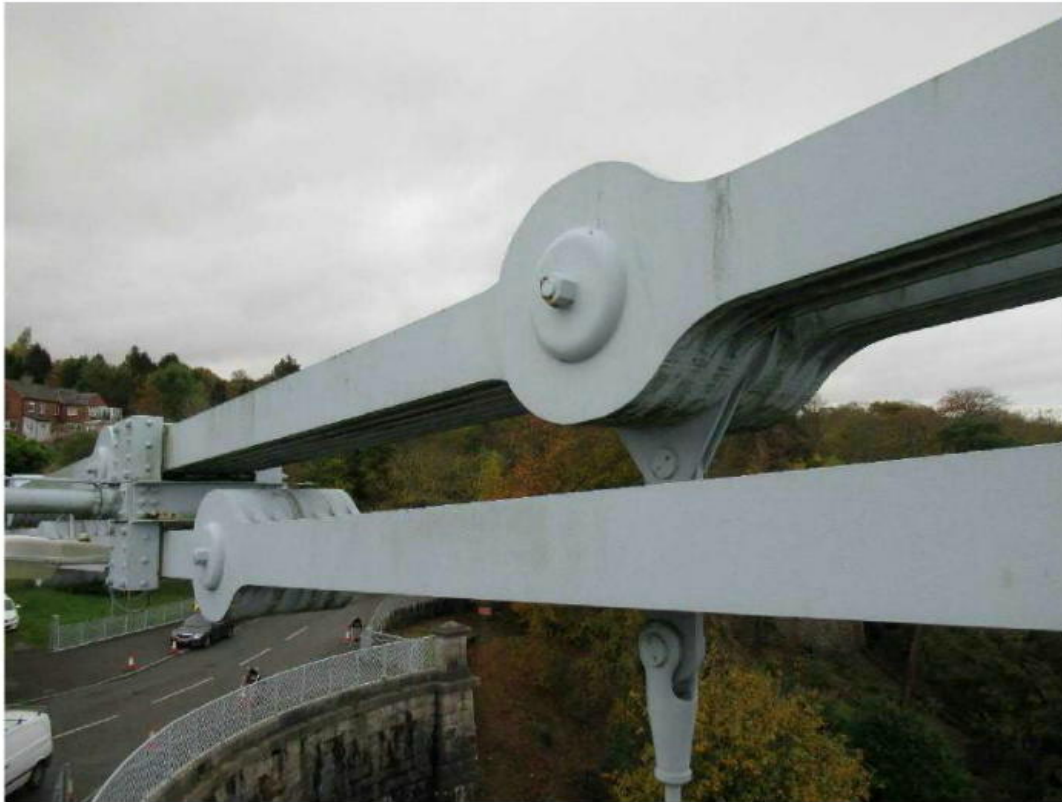
Figure 156: Primary deck element – looking south along south west back-stay chains and transverse brace connection. Generally, In good condition.

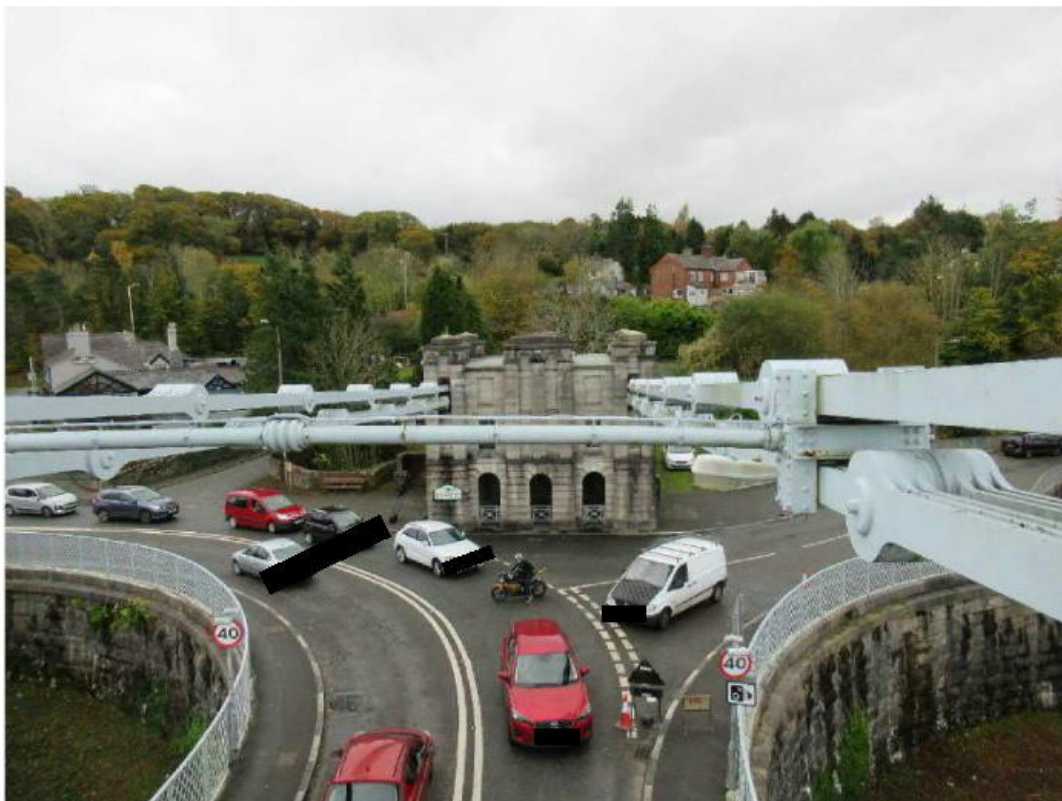
Figure 157: Primary deck element – looking south along south west back-stay chains and transverse brace connection. Generally, In good condition.

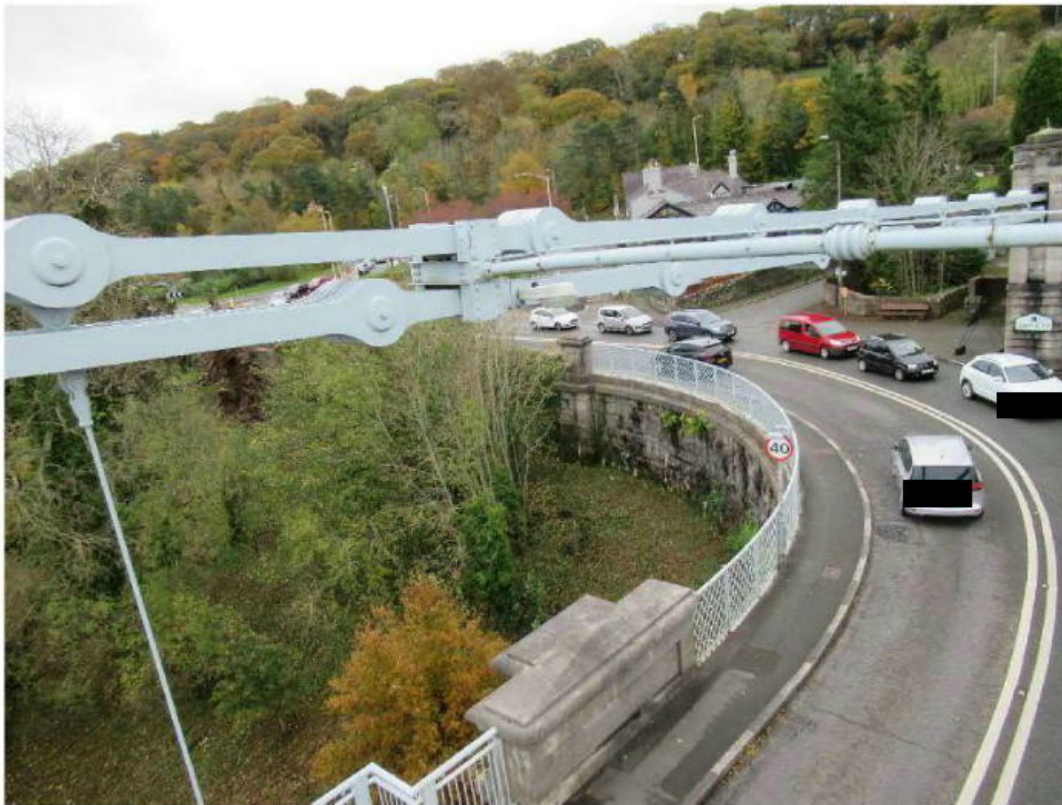
Figure 158: Primary deck element – looking south along south east back-stay chains and transverse brace connection. Generally, in good condition.

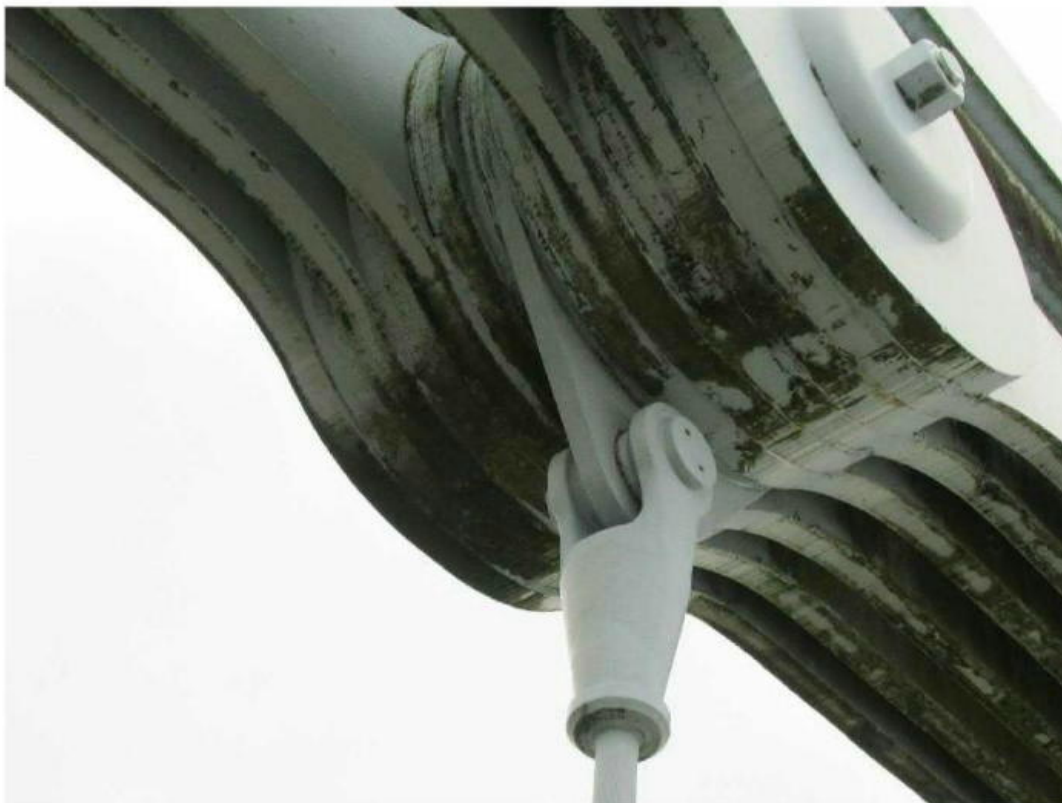
Figure 159: Primary deck element – upper hanger connection to south hanger to lower south west back-stay chains. Structurally, in good condition with minor water-staining.

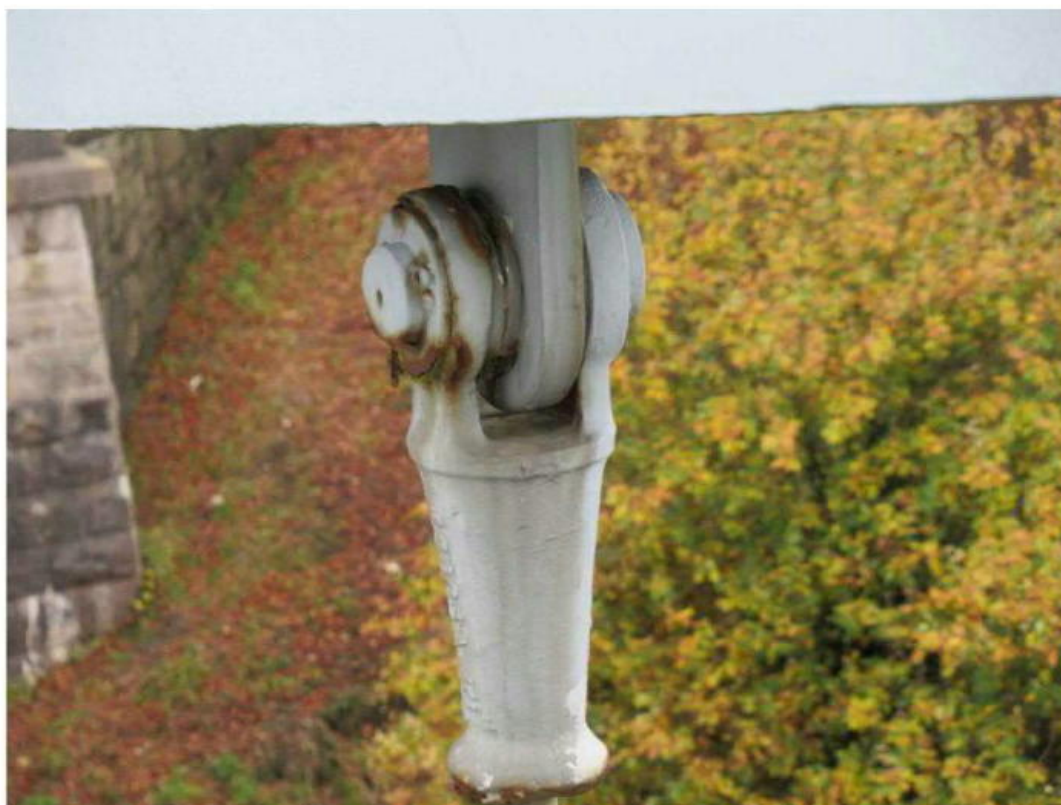
Figure 160: Tie bar – paint loss and minor corrosion to upper hanger connection to 19th hanger on the south west back-stay chains. Structurally, in good condition.

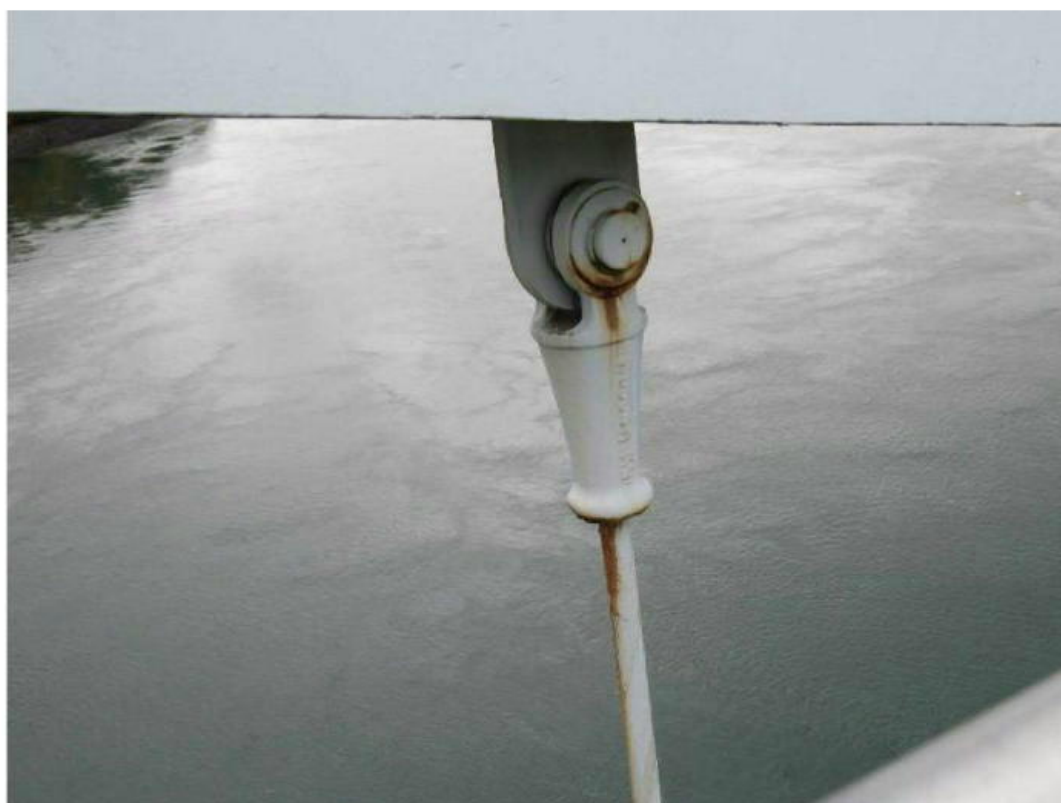
Figure 161: Tie bar – paint loss and minor corrosion with rust-staining to upper hanger connection to a southern hanger on the central west catenary chains.

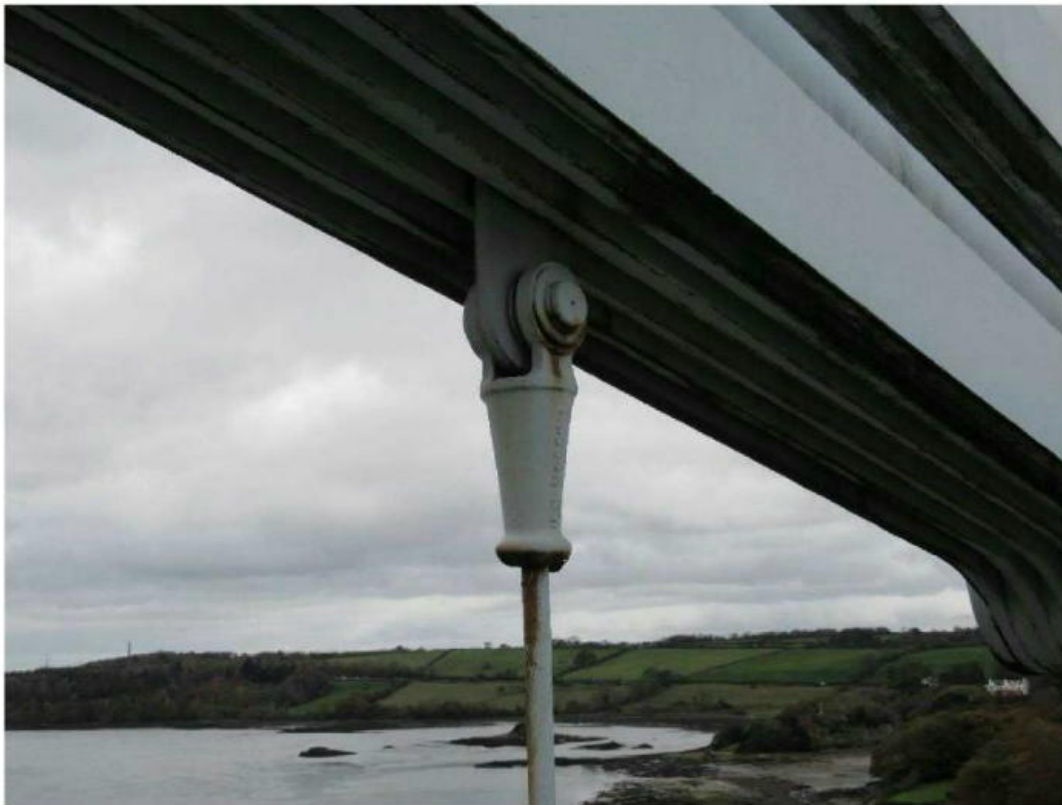
Figure 162: Tie bar – paint loss and minor corrosion with rust-staining to upper hanger connection to a southern hanger on the central west catenary chains.

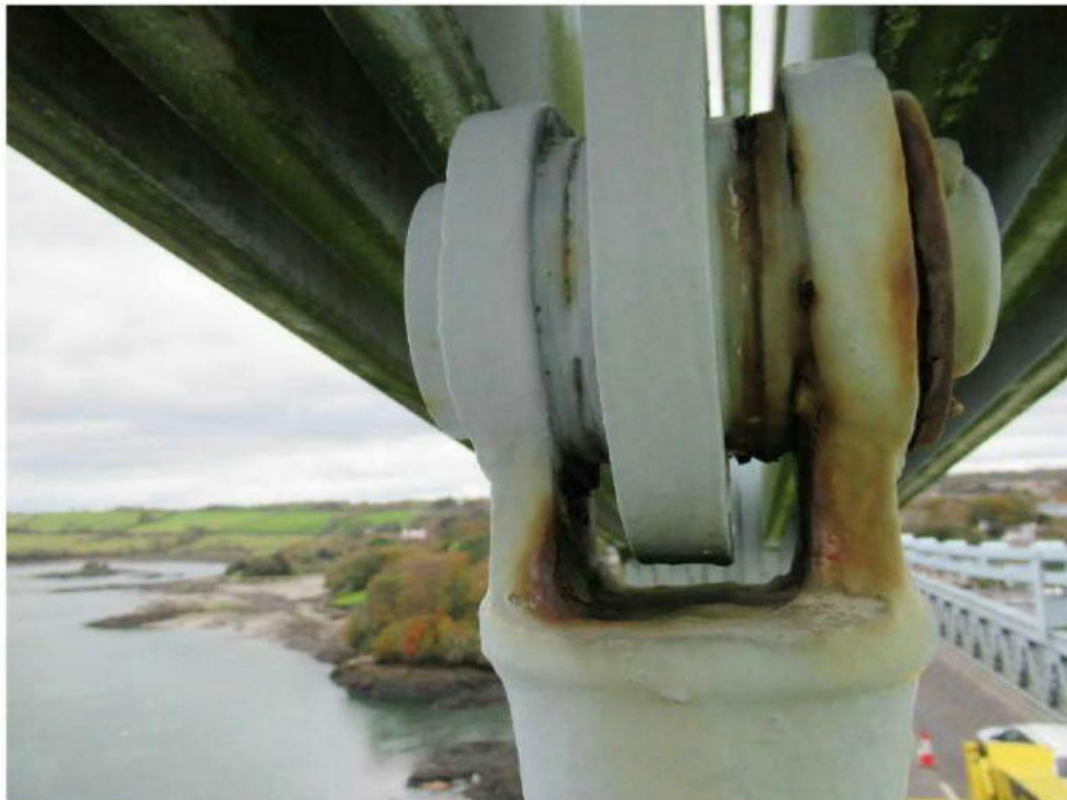
Figure 163: Tie bar – paint loss and minor corrosion with rust-staining to upper hanger connection to a southern hanger on the central west catenary chains.

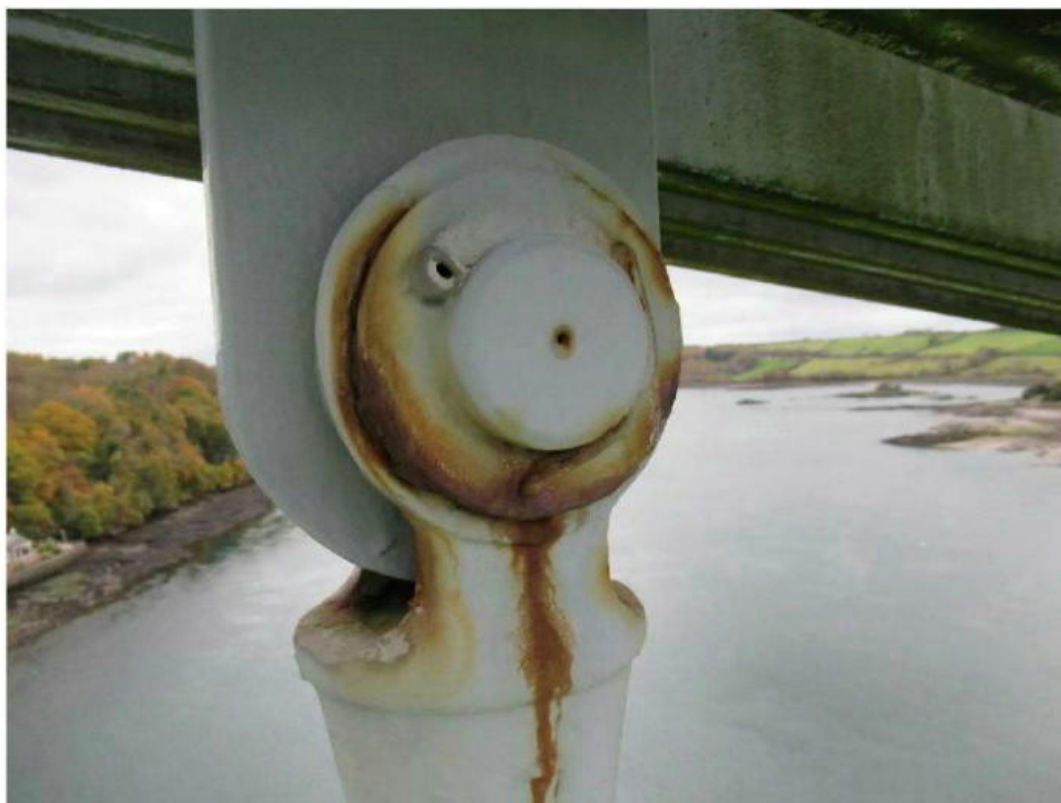
Figure 164: Tie bar – paint loss and minor corrosion with rust-staining to upper hanger connection to a southern hanger on the central west catenary chains.

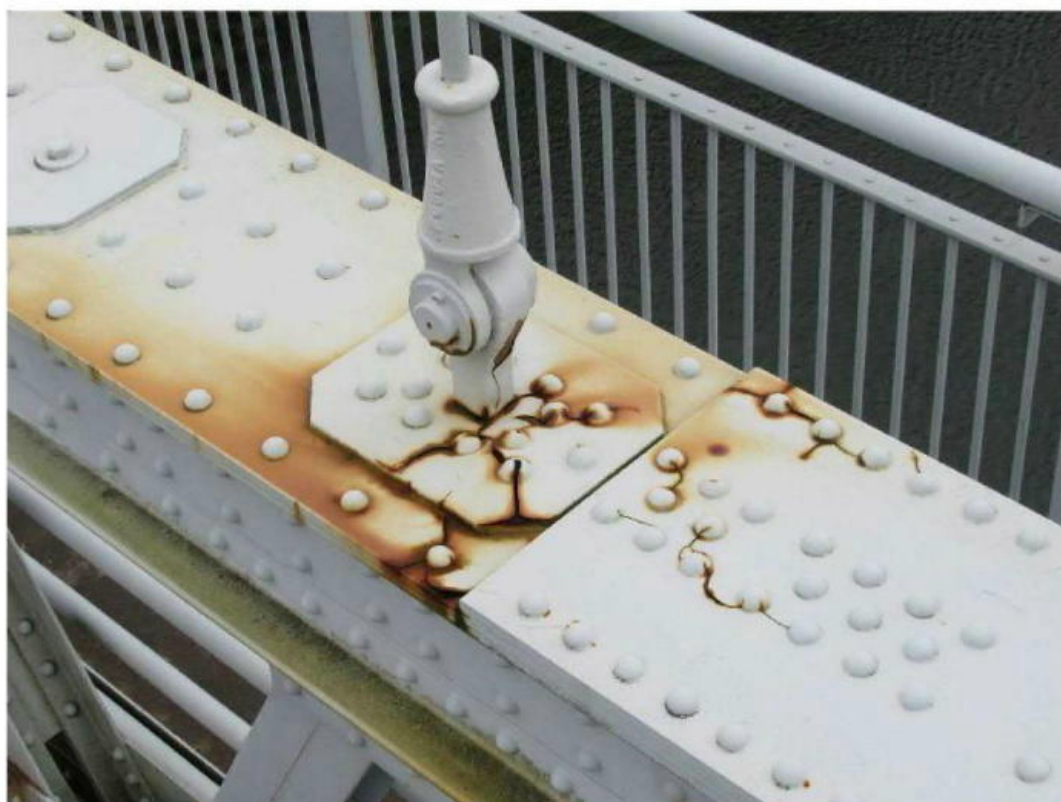
- Several small areas of paint loss were located to the north chain brace (Figure 61).
- Paint loss and minor corrosion with rust-staining was noted to the lower hanger connection area to a hanger on the central west catenary chains (Figure 165).

Figure 165: Finishes – paint loss and minor corrosion with rust-staining to lower hanger connection to a hanger on the central west catenary chains.

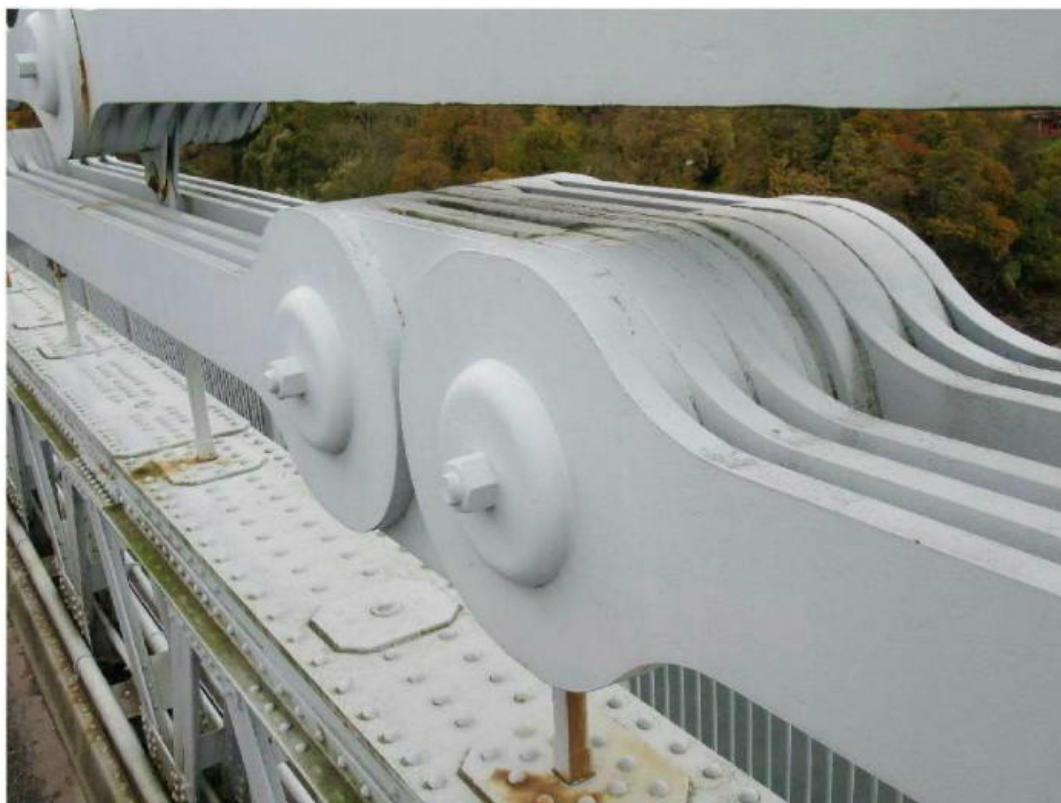
Figure 166: Primary deck element – paint loss and minor corrosion with rust-staining to mid-span drop link on the central west catenary chains.

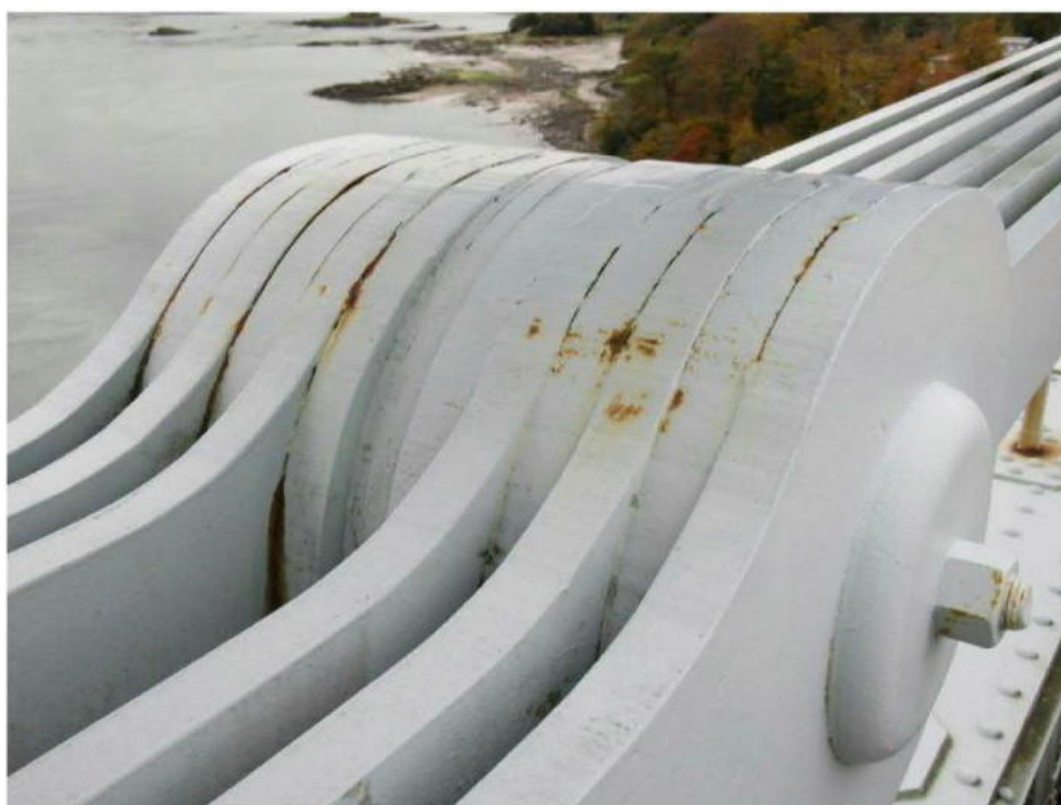
Figure 167: Primary deck element – minor paint loss and minor corrosion to lower chain near mid-span on the central west catenary chains.
