UK Highways Bridge Management

Principal Inspection Report Menai Bridge (Structure Ref. A5 Menai Bridge)

December 2019

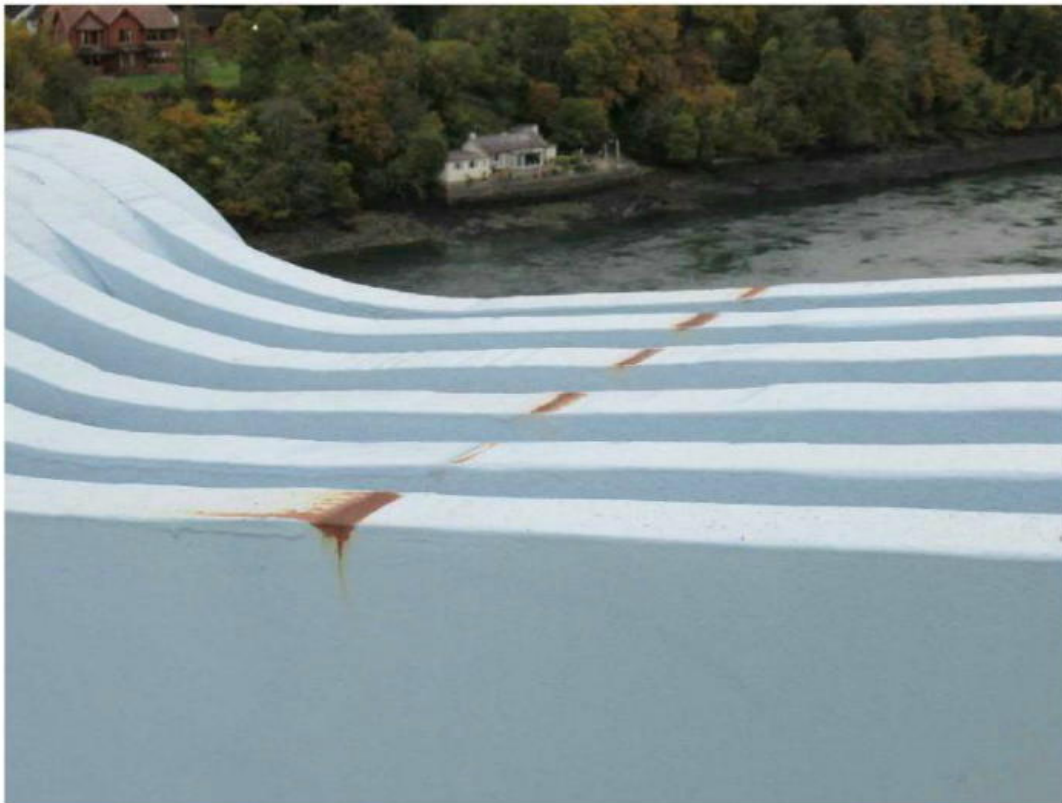
Figure 168: Primary deck element – band of minor paint loss and minor corrosion to upper chain near mid-span on the central west catenary chains.

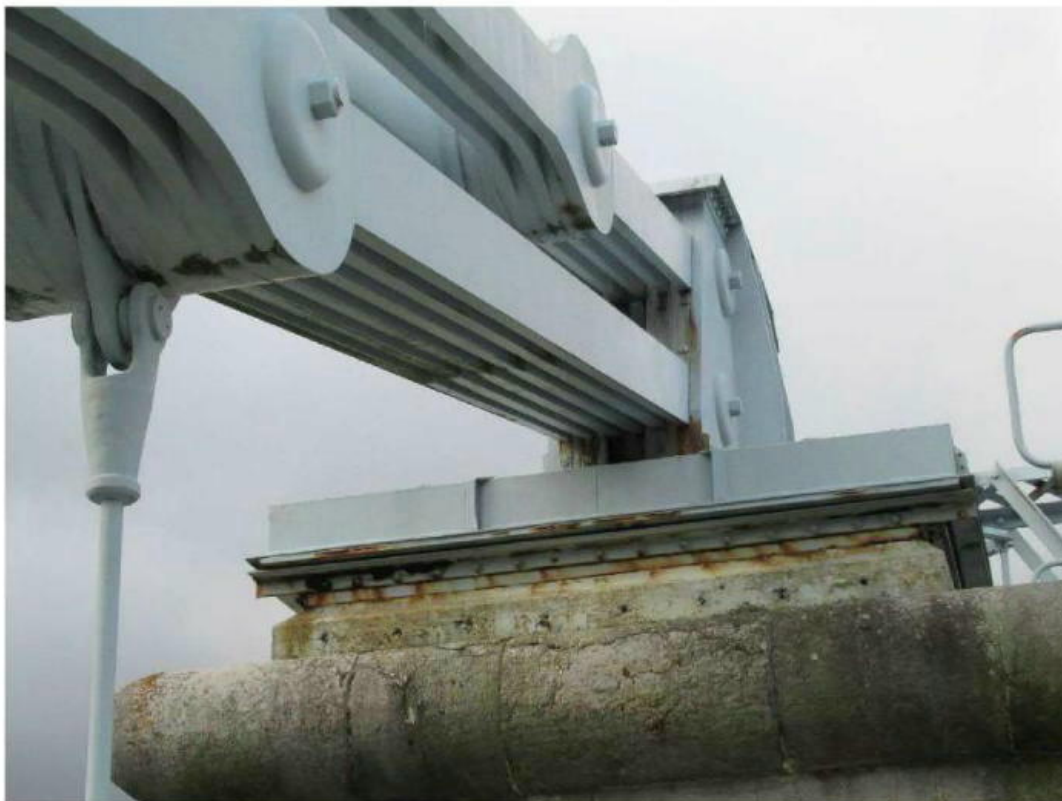
Figure 169: Primary deck element – small areas of surface corrosion to west chain saddle on the south tower.

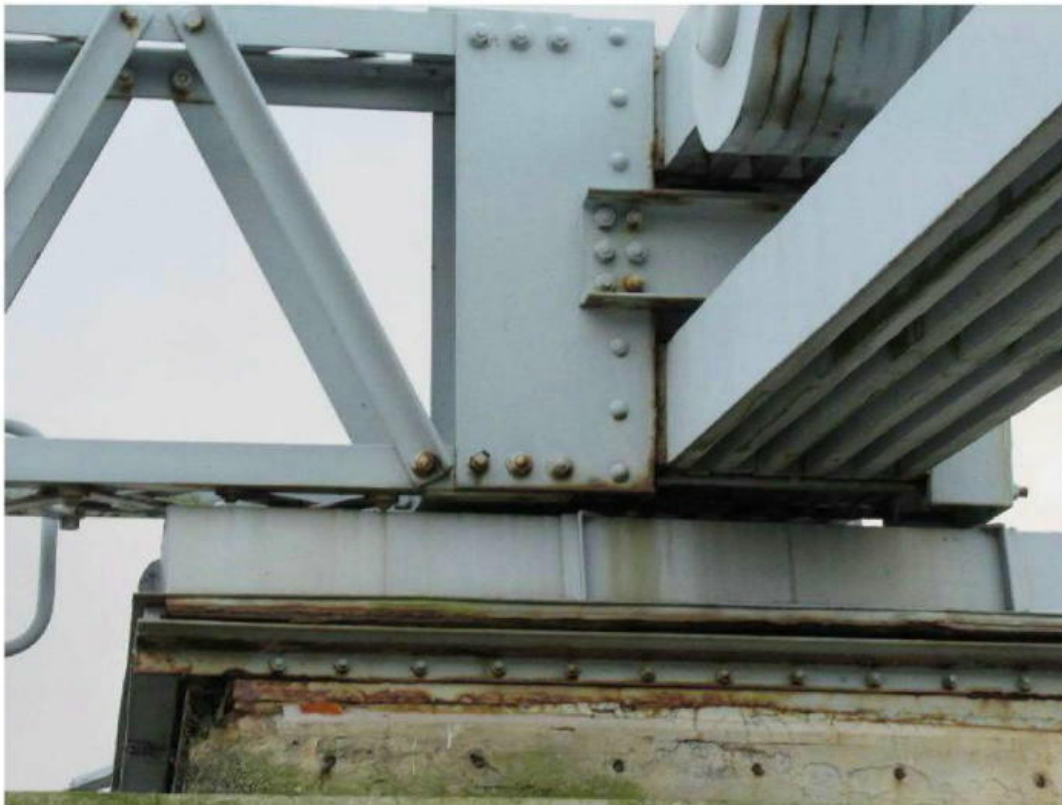
- Small areas of surface corrosion were noted throughout the ends of the chain bracing on the south tower saddles, north face (Figure 171). A close-up of this defect is in Figure 172.

Figure 172: Primary deck element – close-up of small areas of surface corrosion to west chain saddle on the south tower, north face.

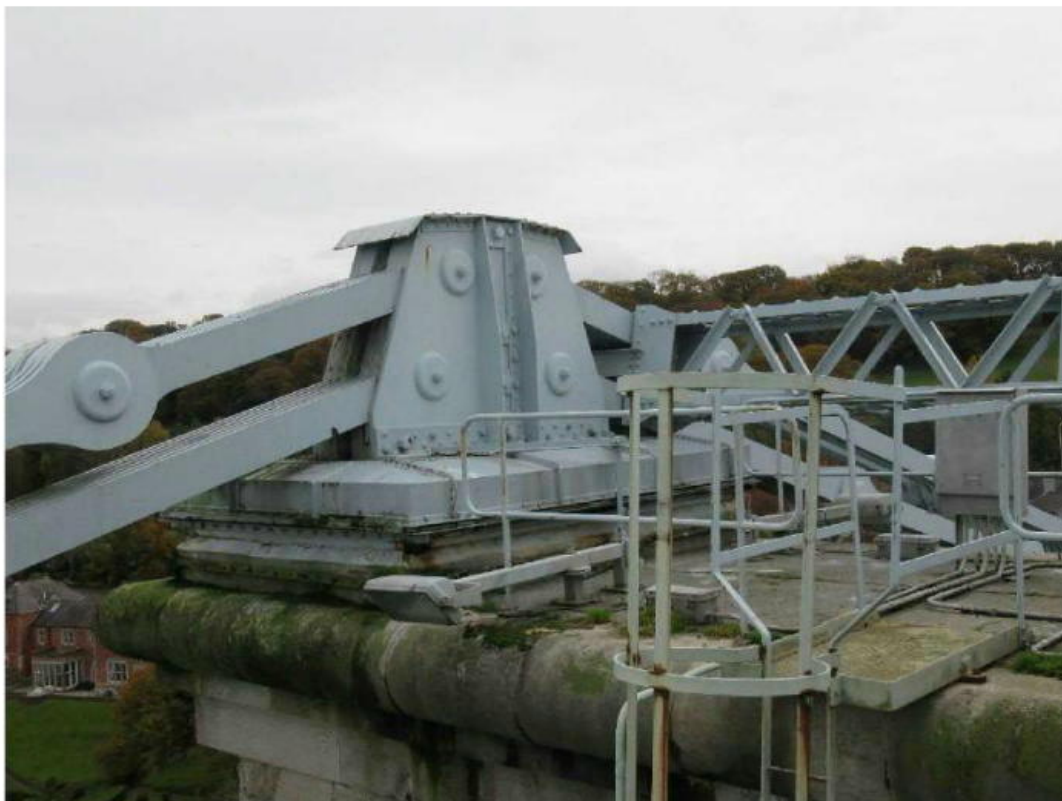
- Small areas of surface corrosion were noted to the east chain saddle and to the roller bearing bath on the south tower (Figure 173).

Figure 173: Primary deck element – small areas of surface corrosion to east chain saddle and to the roller bearing bath on the south tower.

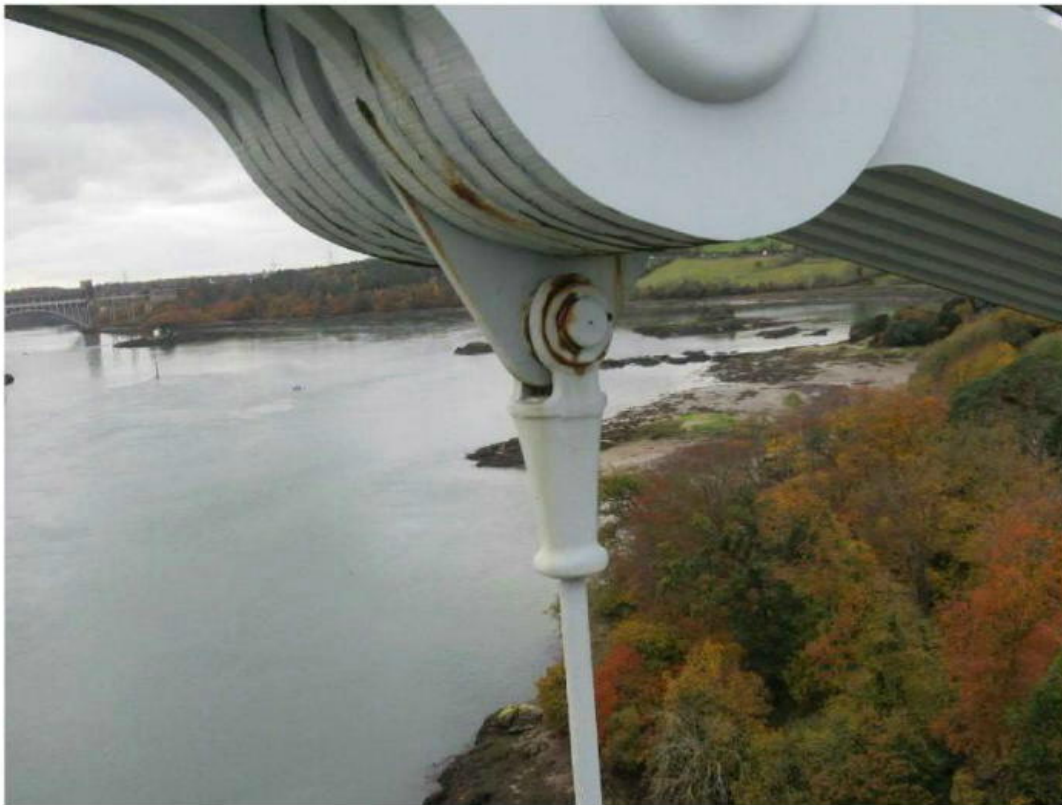
- Paint loss and minor corrosion was noted to the upper hanger connection and split pin to a hanger on the west side north back-stay chains (Figure 174). A close-up of this defect is in Figure 175.

Figure 174: Primary deck element – paint loss and minor corrosion to upper hanger connection and split pin to a hanger on the west side north back-stay chains.

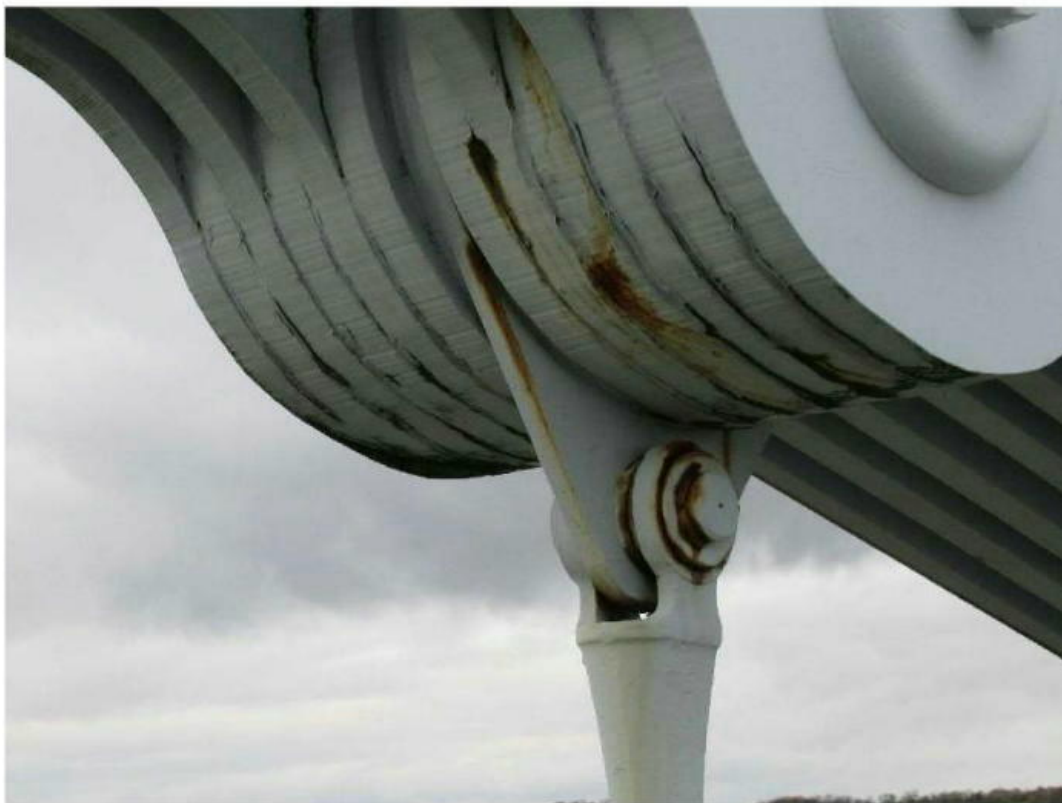
Figure 175: Primary deck element – close-up of the paint loss and minor corrosion to upper hanger connection and split pin to a hanger on the west side north back-stay chains.

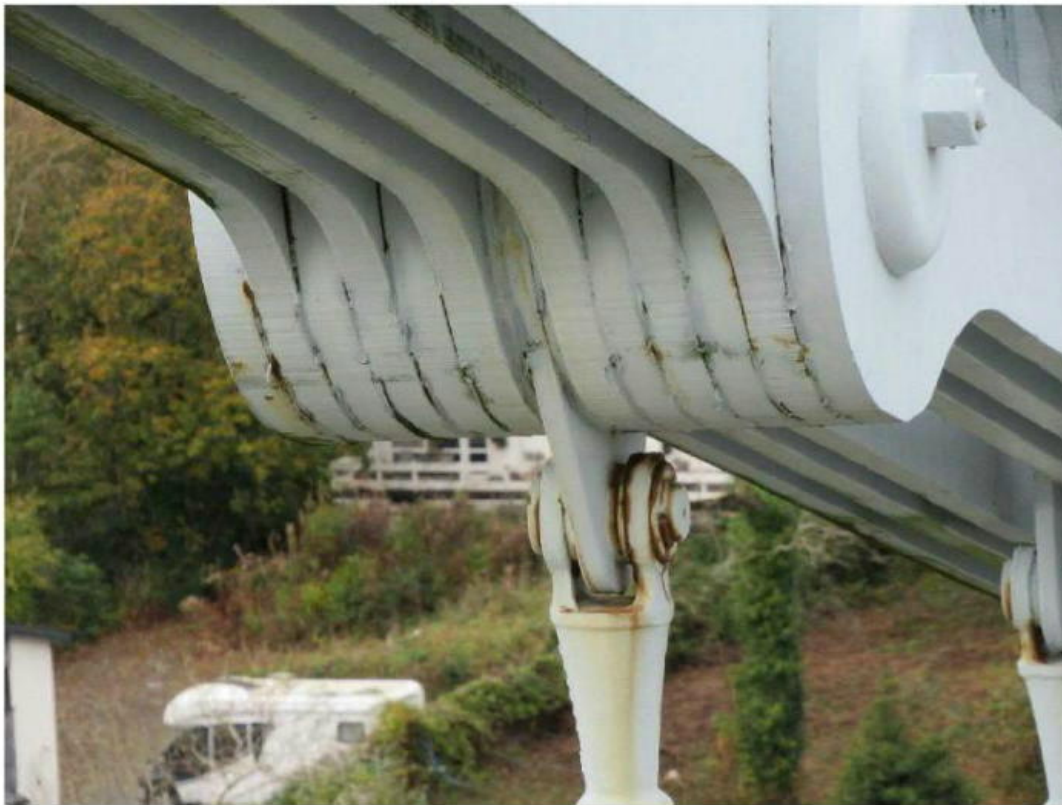
- Paint loss and minor corrosion was noted to the upper hanger connection and split pin to a hanger on the west side north back-stay chains (Figure 176).

Figure 176: Primary deck element – paint loss and minor corrosion to upper hanger connection and split pin to a hanger on the west side north back-stay chains.

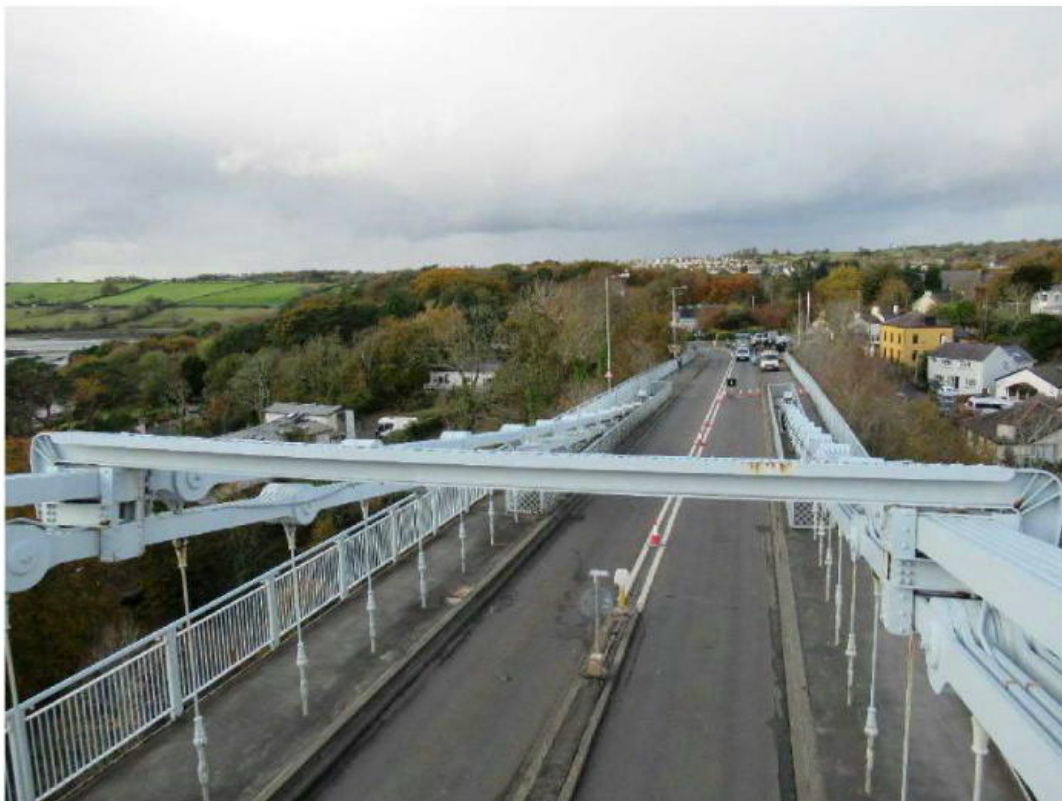
When looking north along the north back-stay chains and transverse brace connection, there were small areas of corrosion along the top edge, west connection and east corner stiffeners. This brace was generally, in good condition with some minor surface corrosion (Figure 177). A close-up of these defects is shown within Figure 178 and Figure 179 respectively. The outer face of the south east back-stay chains and transverse brace connection were generally in good condition with small areas of minor corrosion (Figure 199).

Figure 177: Deck bracing – looking north along north back-stay chains and transverse brace connection. Generally, in good condition with some minor surface corrosion.

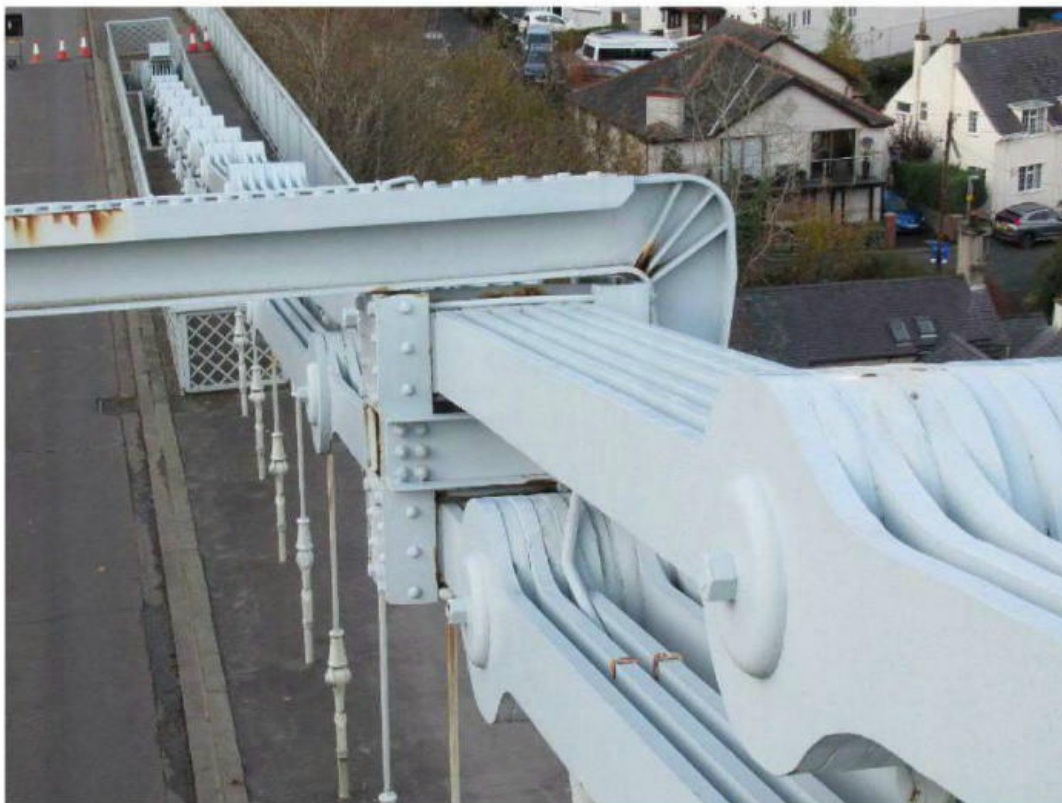
Figure 179: Deck bracing – east side of north back-stay transverse brace connection. Generally, in good condition with some minor surface corrosion.

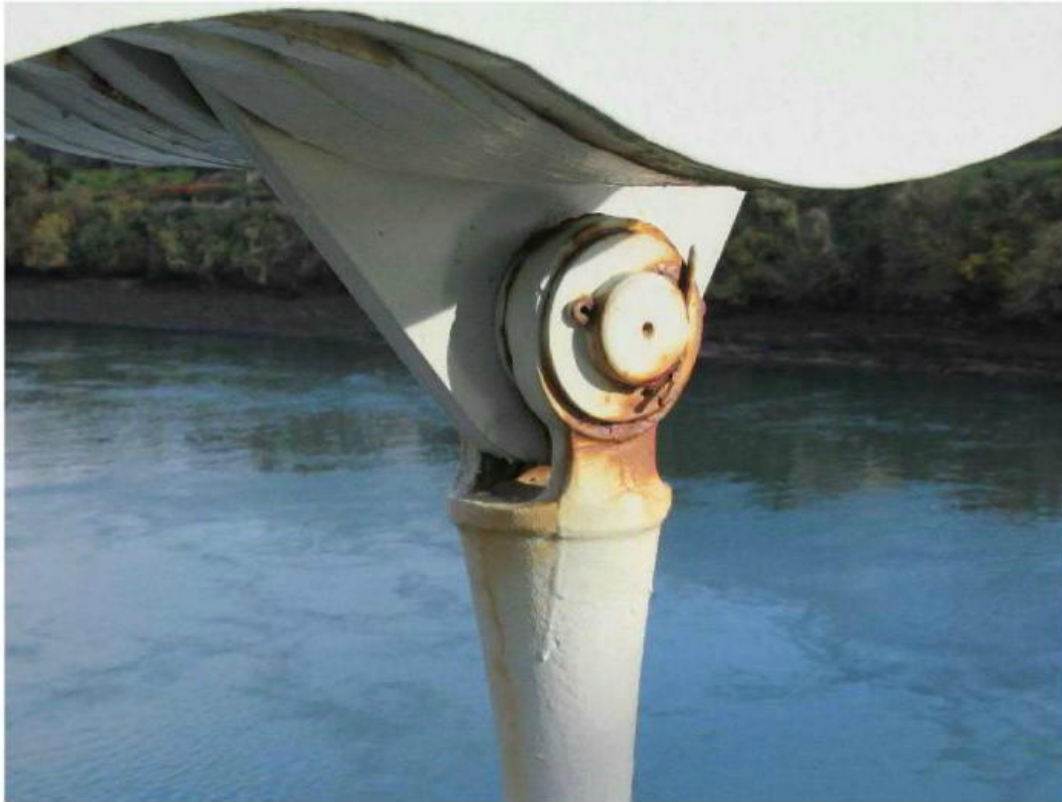
Figure 180: Tie bars – paint loss and minor corrosion to upper hanger connection and split pin to a hanger on the east side north back-stay chains.

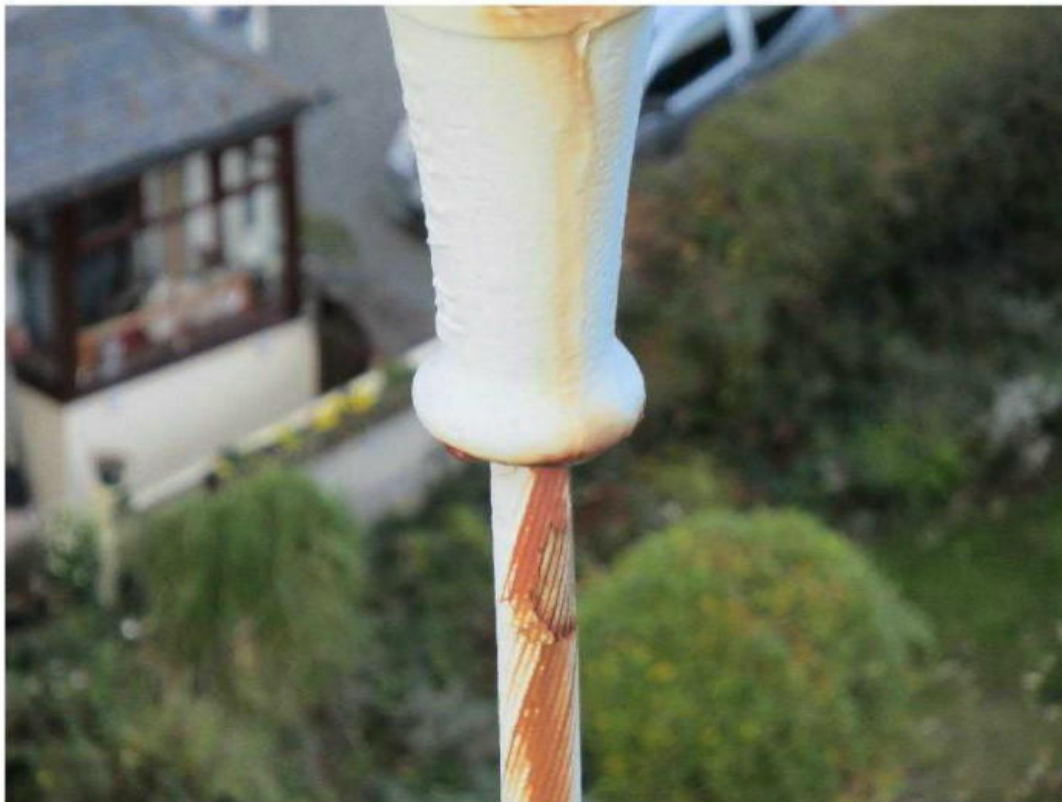
- Flaking paint loss and minor corrosion with rust-staining was noted to the upper tie cable on the east side north back-stay chains (Figure 181).

Figure 181: Tie bars – flaking paint loss and minor corrosion with rust-staining to upper tie cable on the east side north back-stay chains.

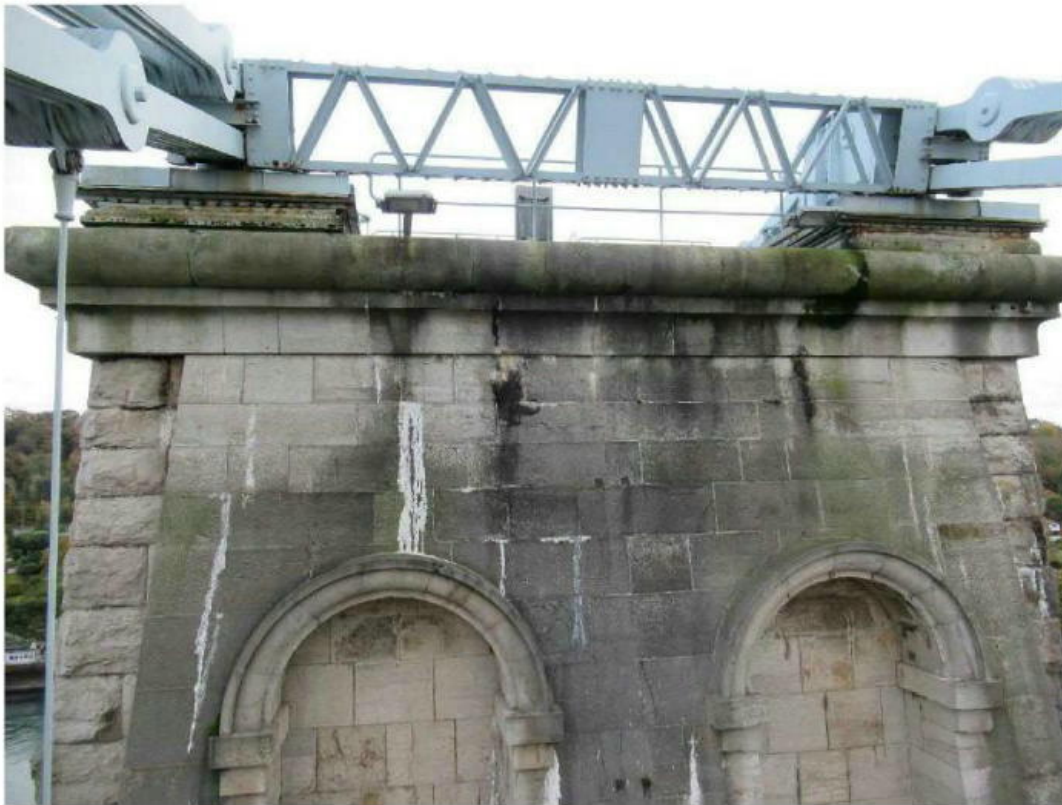
- Several areas of water-staining and efflorescence were noted to the north face of the north pier (Figure 182).
- Monitor several small areas of efflorescence, small stalactites and minor damp staining was noted to the north and south towers' transverse arches (Figure 32).

- Small areas of surface corrosion were noted to the chain saddles, roller bearing baths and bracing on the north tower. Figure 182 shows this defect on the north face of the north tower. Figure 183 shows the north side of the east saddle and Figure 184 shows the south side of the east saddle.

Figure 182: Primary deck element – small areas of surface corrosion to chain saddles, roller bearing baths and bracing on the north tower. Several areas of water-staining and efflorescence to the north face of the north pier.

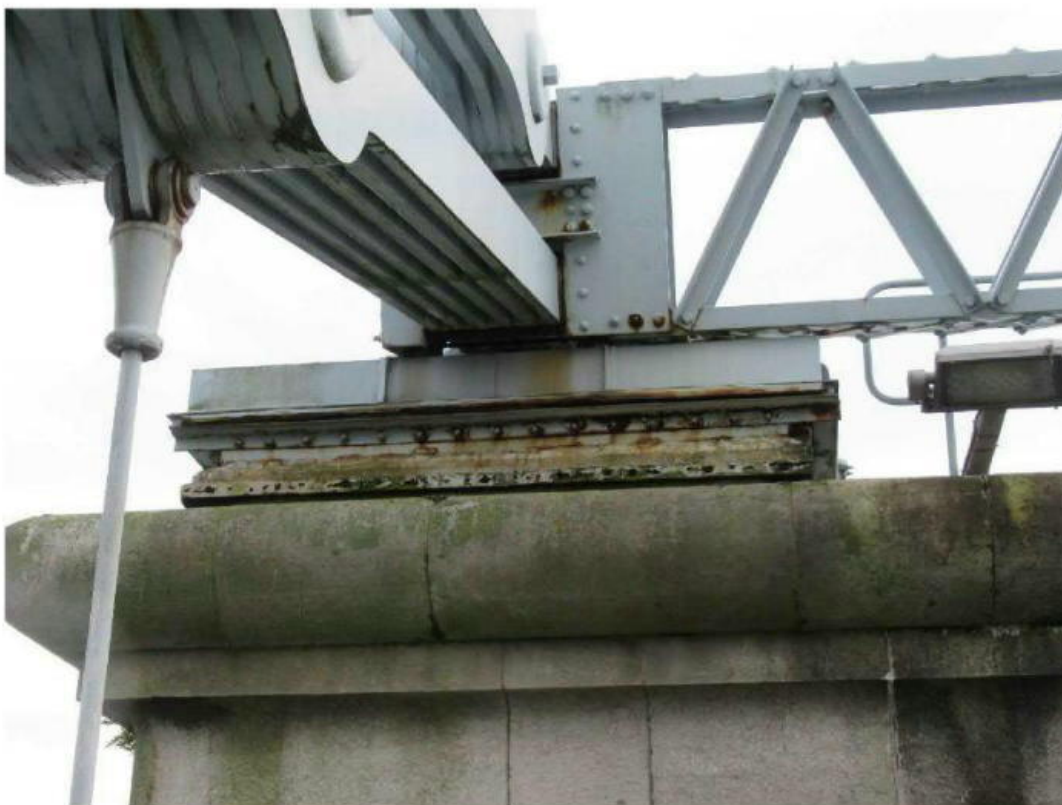
Figure 183: Primary deck element – small areas of surface corrosion to north side of the east chain saddle and to the roller bearing bath on the north tower.

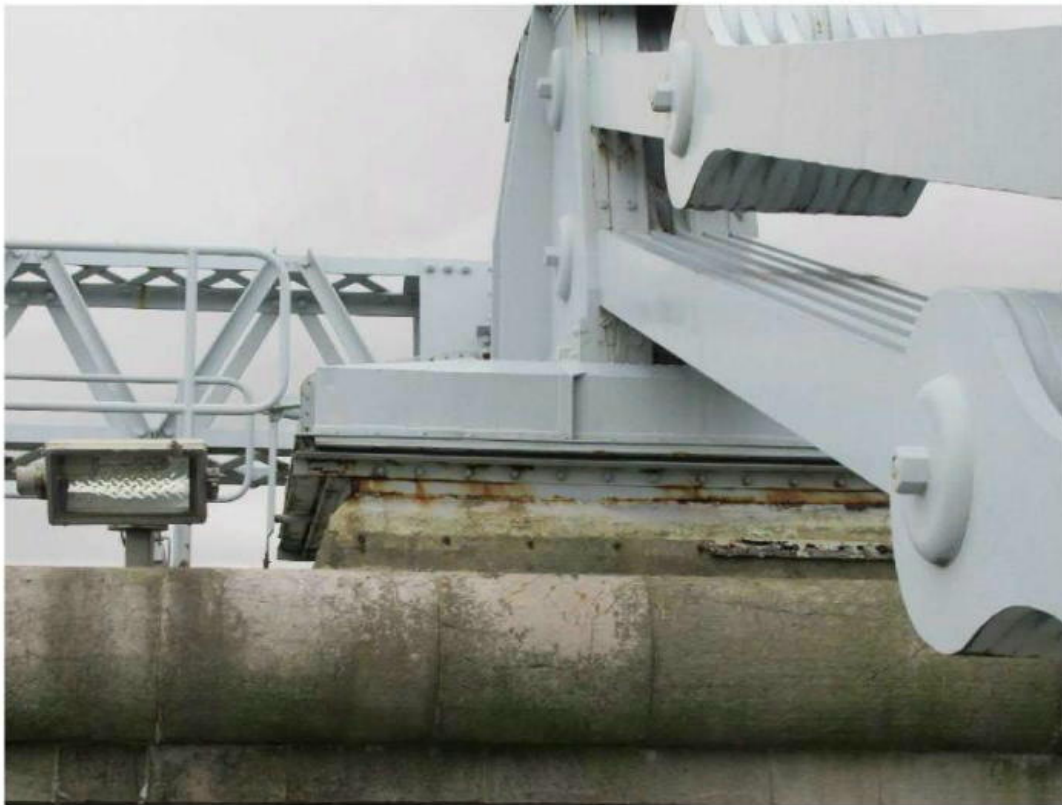
Figure 184: Primary deck element – small areas of surface corrosion to south side of the east chain saddle and to the roller bearing bath on the north tower.

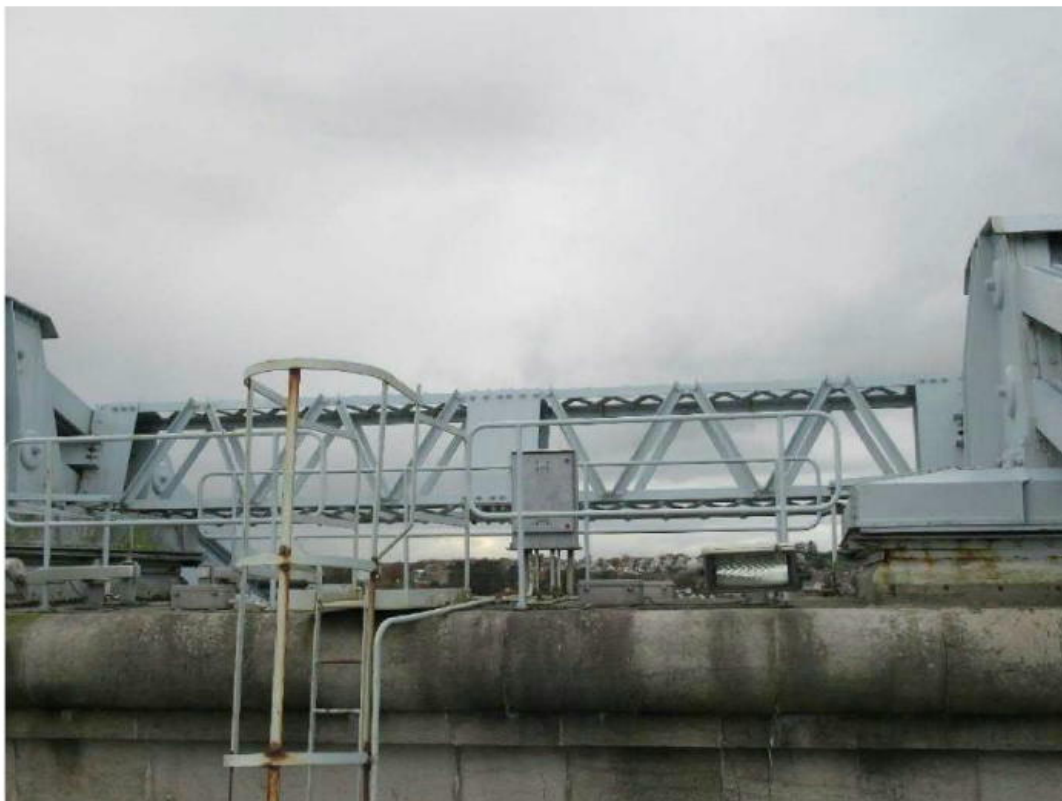
- Small areas of surface corrosion were noted to the chain saddles, roller bearing baths and bracing on the north tower. Several areas of corrosion to access ladder which is no longer in use (Figure 185).

Figure 185: Bracing – small areas of surface corrosion to chain saddles, roller bearing baths and bracing on the north tower. Several areas of corrosion to access ladder which is no longer in use.

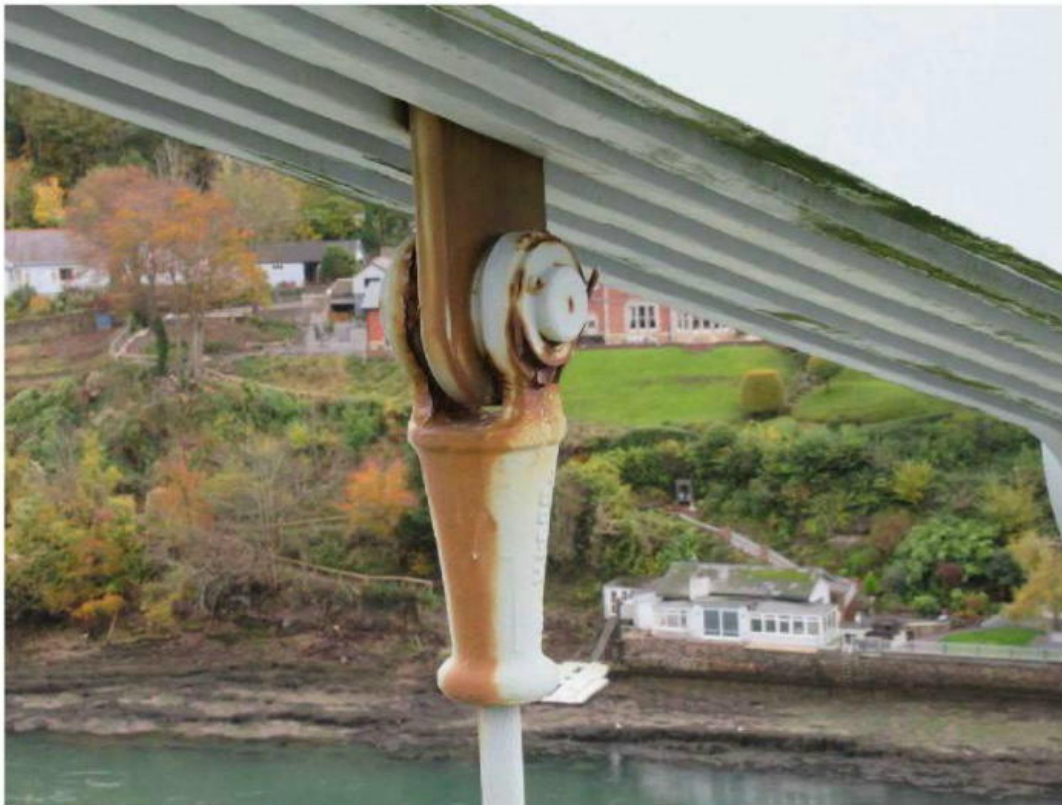
- Paint loss, minor corrosion and rust-staining was noted to the upper hanger connection and split pin to a northern hanger on the central east catenary chains (Figure 186) and another typical example on Figure 187.

Figure 186: Primary deck element – paint loss, minor corrosion and rust-staining to upper hanger connection and split pin to a hanger on the central east catenary chains.

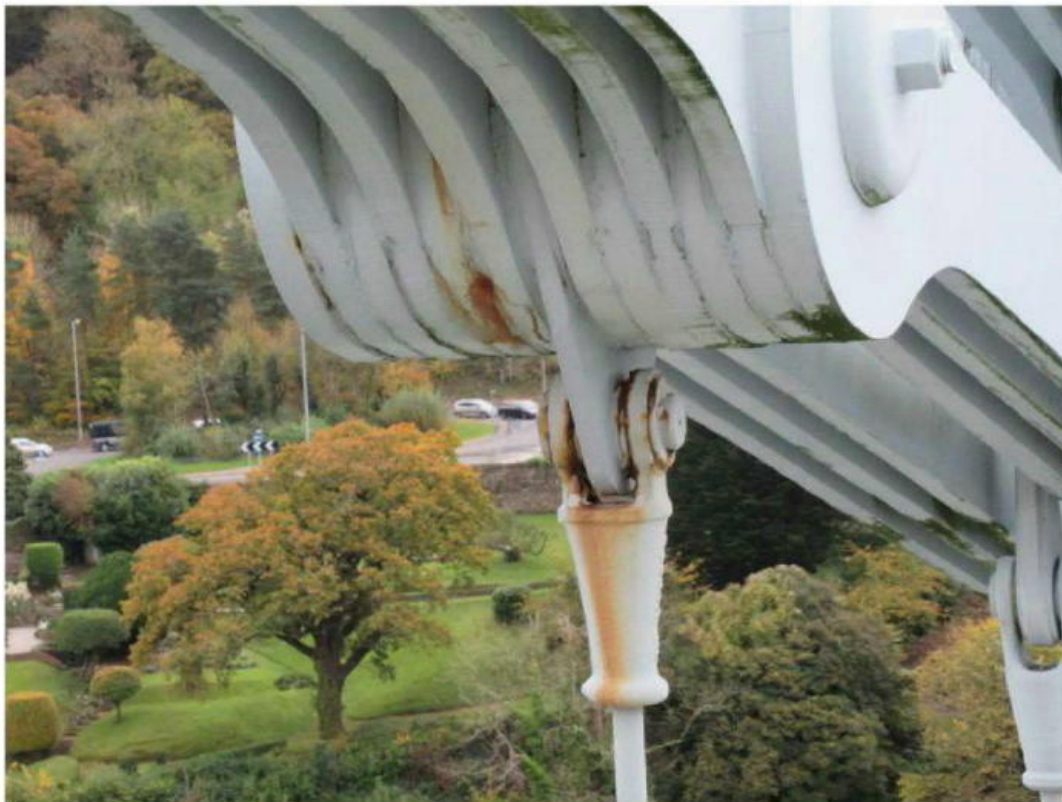
Figure 187: Primary deck element – paint loss, minor corrosion and rust-staining to moving parts of the upper pin to a hanger on the central east catenary chains.

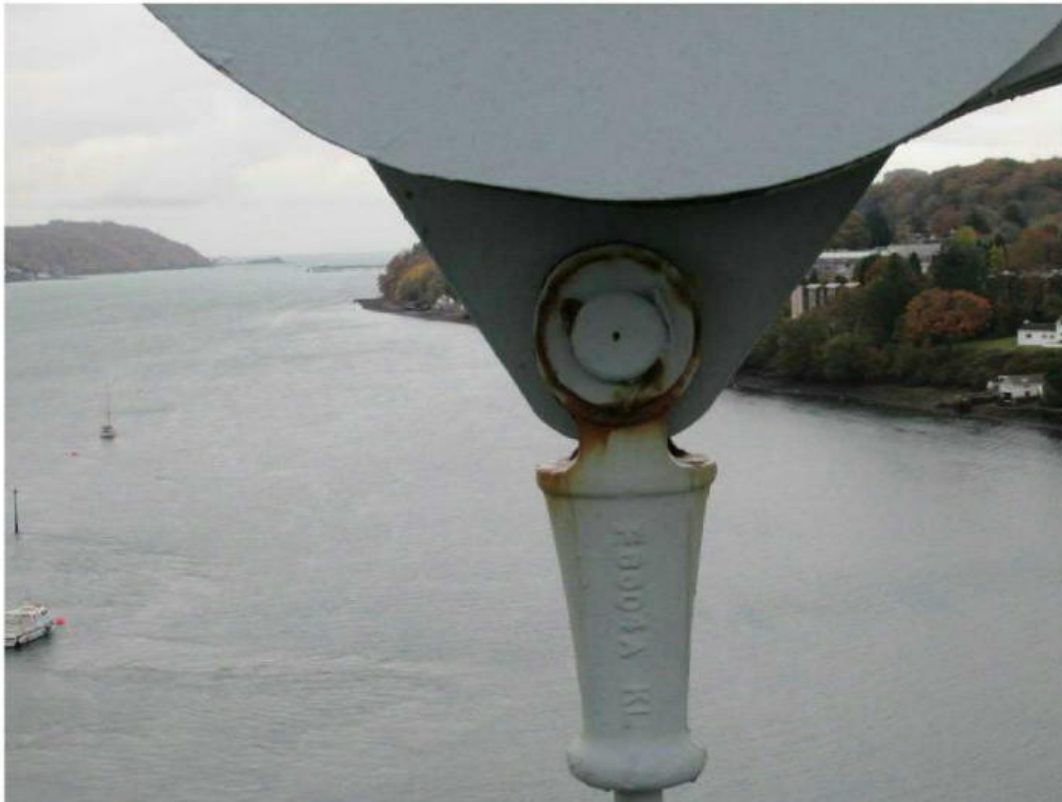
- Paint loss, minor corrosion and some rust-staining was noted to the upper hanger connection and split pin to a hanger on the central east catenary chains (Figure 188). A general view looking north from the south tower is shown in Figure 189 and a general view looking south from the north tower is within Figure 190.

Figure 188: Primary deck element – paint loss, minor corrosion and some rust-staining to upper hanger connection and split pin to a hanger on the central east catenary chains.

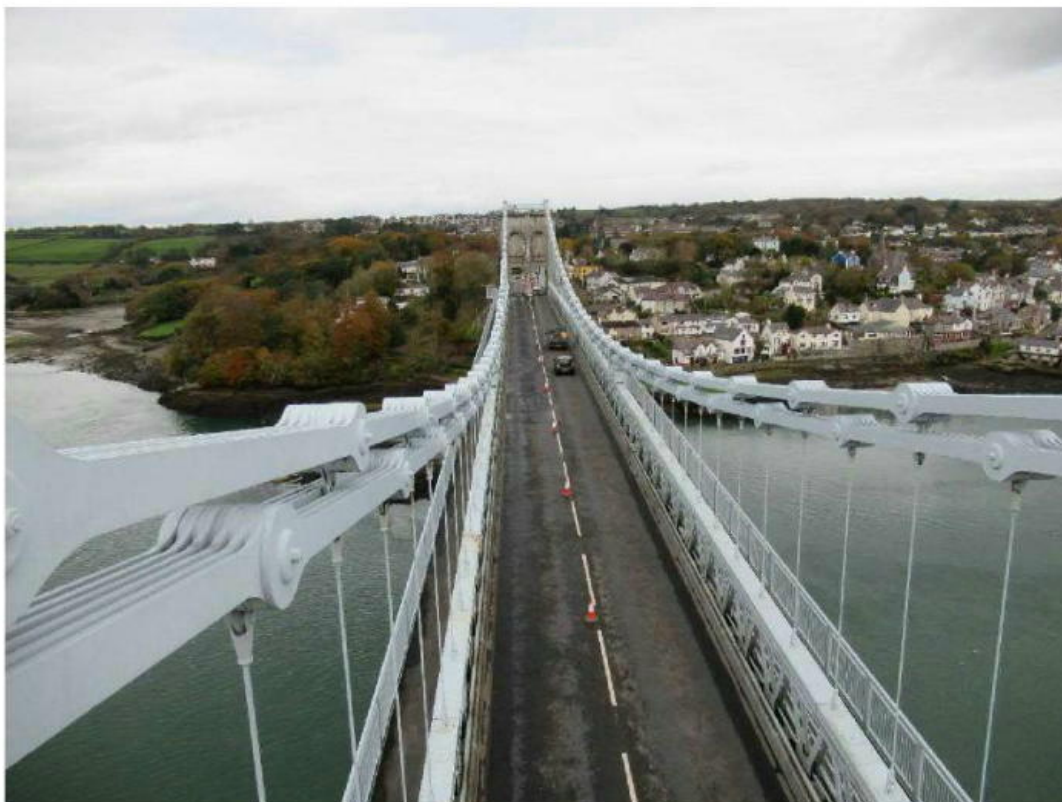
Figure 189: Primary deck element – general view looking north from the south tower.

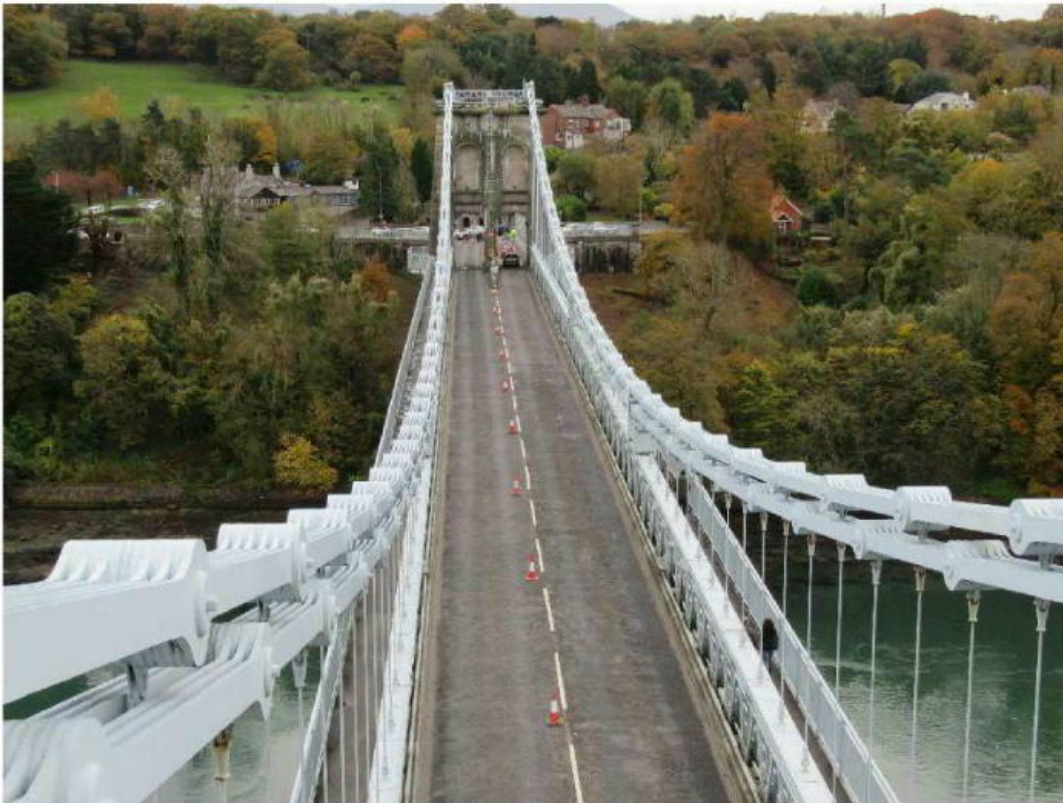
Figure 190: Primary deck element – general view looking south from the north tower.

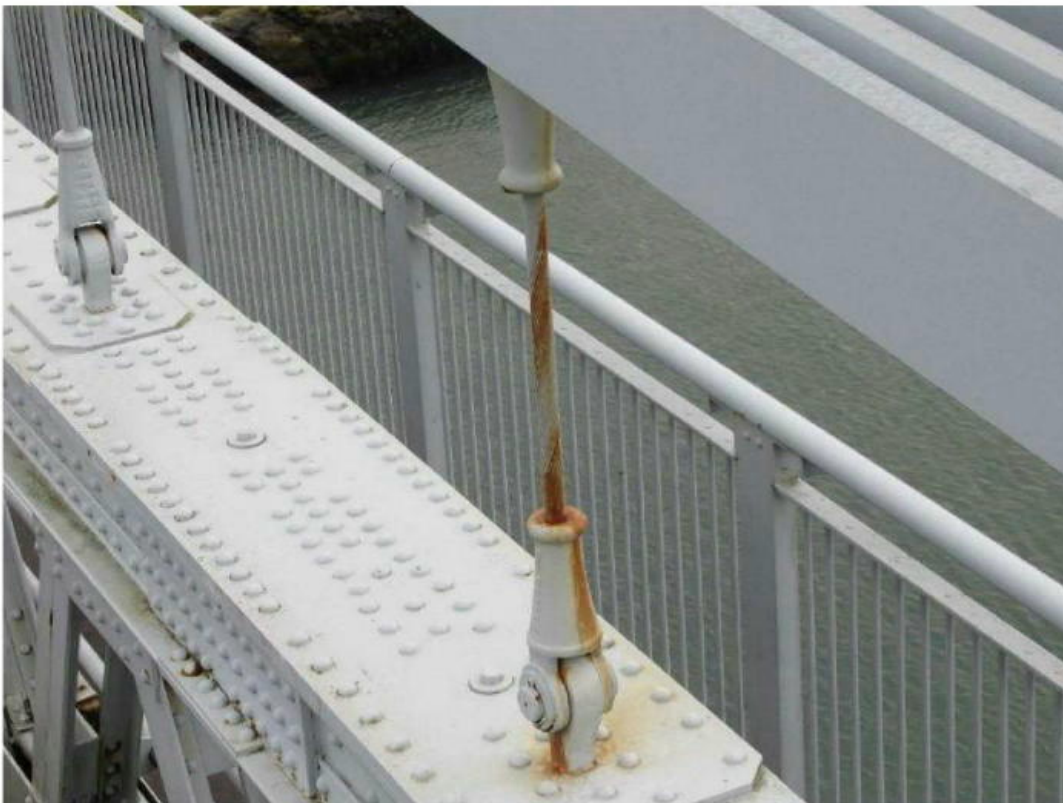
- Paint loss, minor corrosion and rust-staining was noted to the strands on the central east catenary chains, just north of mid-span drop links (Figure 191) and mid-span drop links (Figure 192).

Figure 191: Tie bar – paint loss, minor corrosion and rust-staining to tie strands on the central east catenary chains, just north of mid-span drop links.

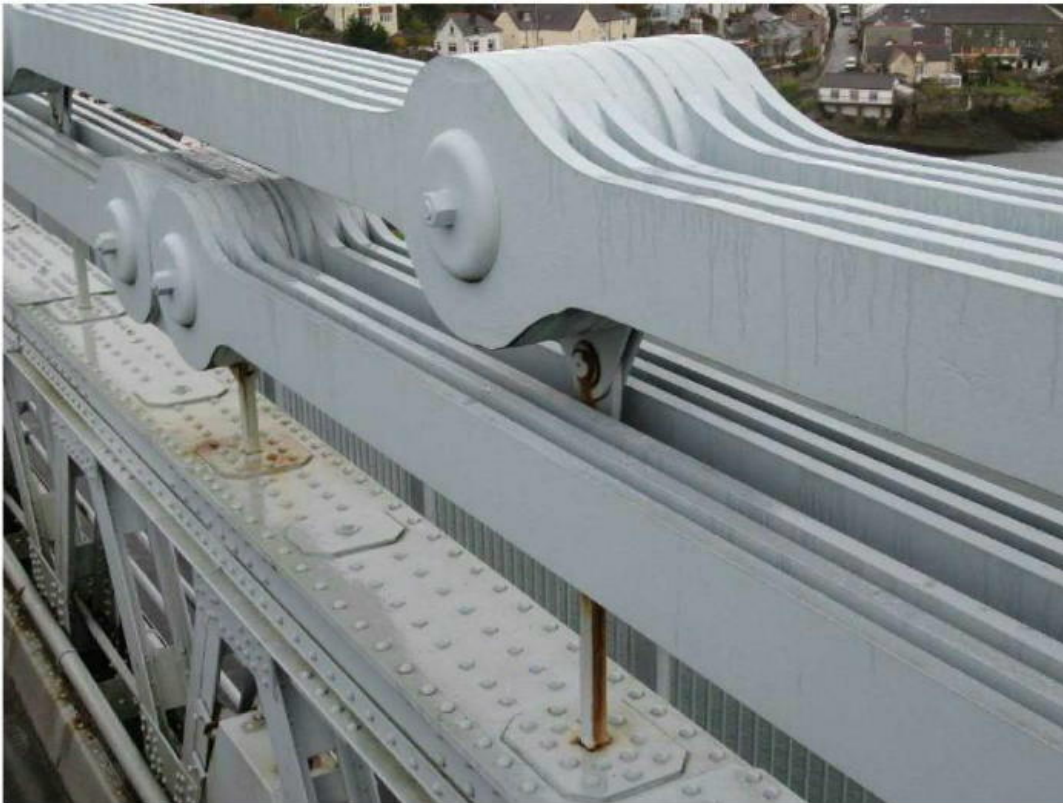
Figure 192: Tie bar – paint loss, corrosion and rust-staining to mid-span drop links.

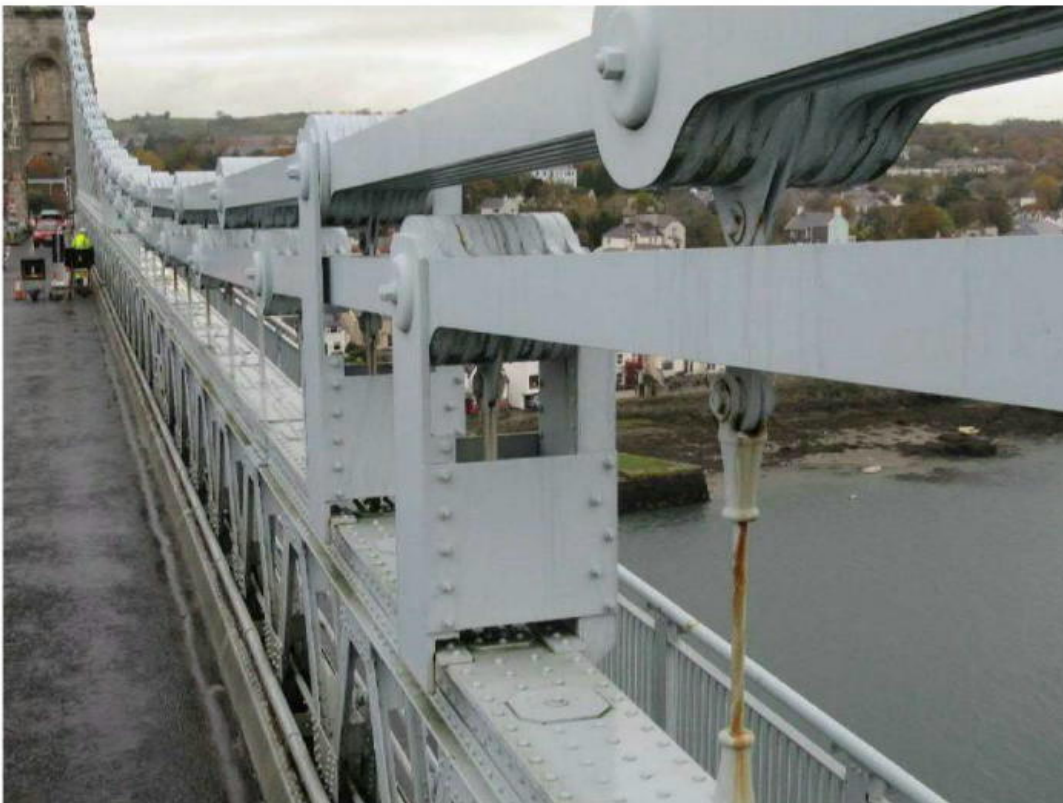
- Paint loss, minor corrosion and rust-staining was noted to tie strands on the central east catenary chains, just south of the mid-span drop links (Figure 193).

Figure 193: Tie bar – paint loss, minor corrosion and rust-staining to tie strands on the central east catenary chains, just south of mid-span drop links.

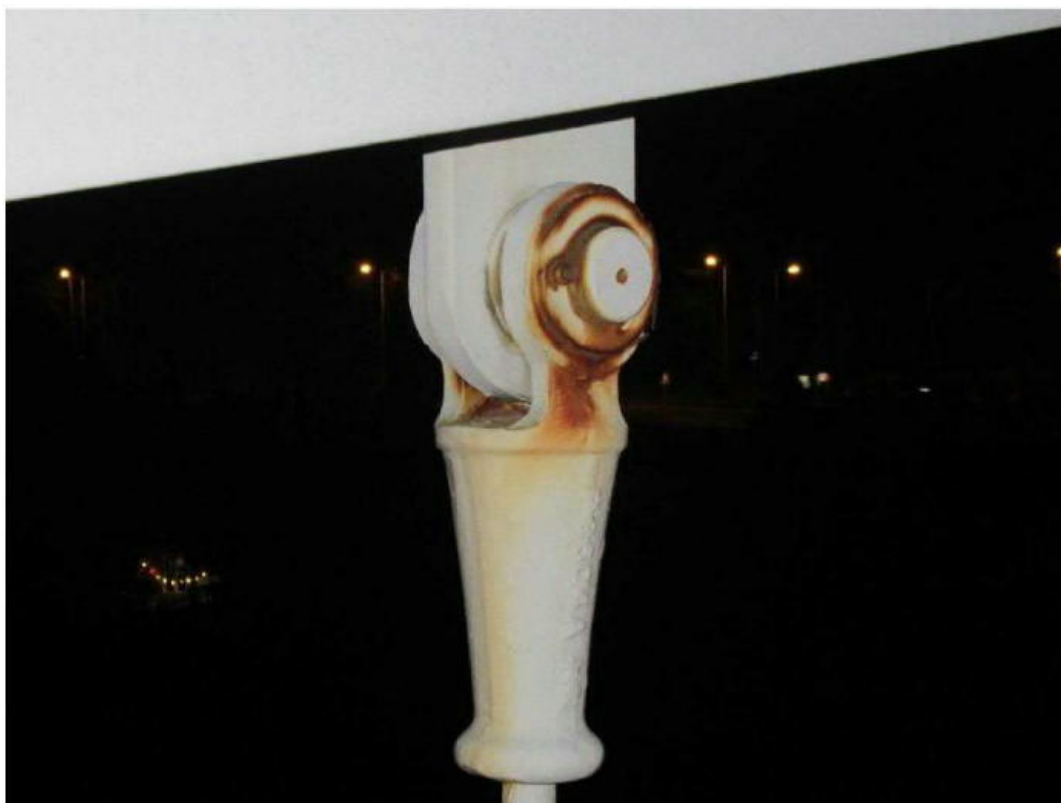
- Paint loss, corrosion and rust-staining was noted to articulating parts of the upper hanger connection the 18th hanger north of the south tower on the central east catenary chains (Figure 194) and the 6th hanger in this section (Figure 195) with a close-up within Figure 196.

Figure 194: Primary deck element – paint loss, corrosion and rust-staining to articulating parts of the upper hanger connection the 18th hanger north of south tower on the central east catenary chains.
