UK Highways Bridge Management

Principal Inspection Report Menai Bridge (Structure Ref. A5 Menai Bridge)

December 2019

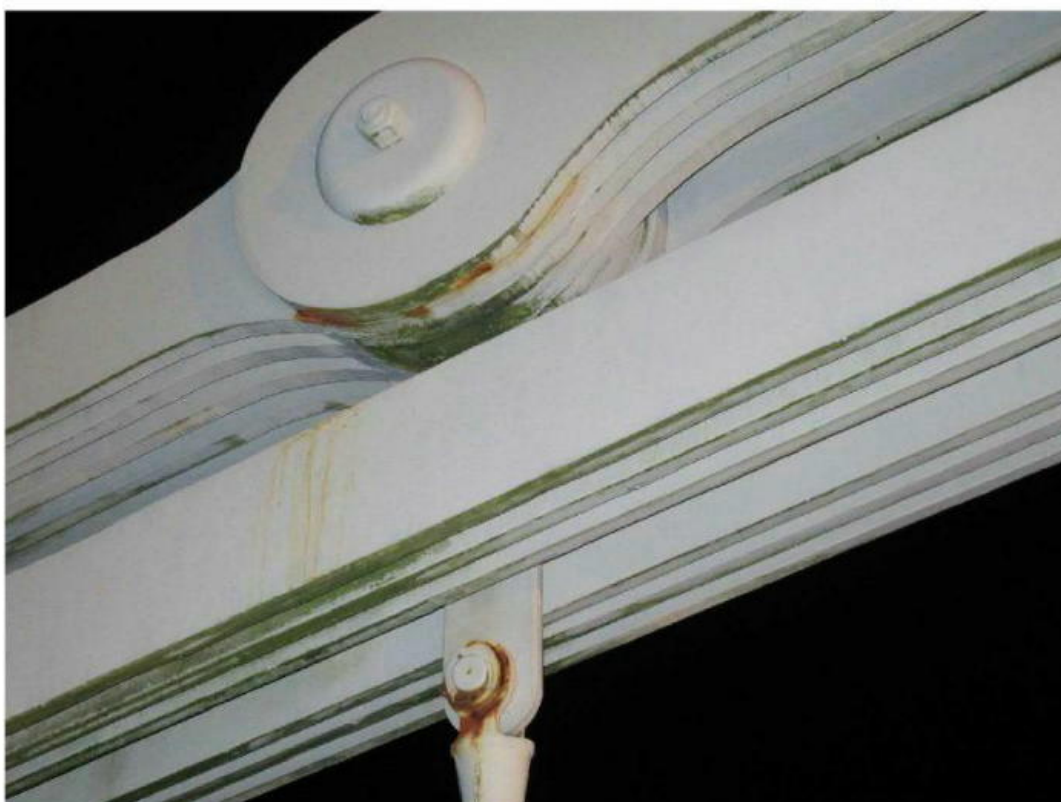
Figure 195: Primary deck element – paint loss, corrosion and rust-staining to articulating parts of the upper hanger connection the 6th hanger north of south tower on the central east catenary chains.

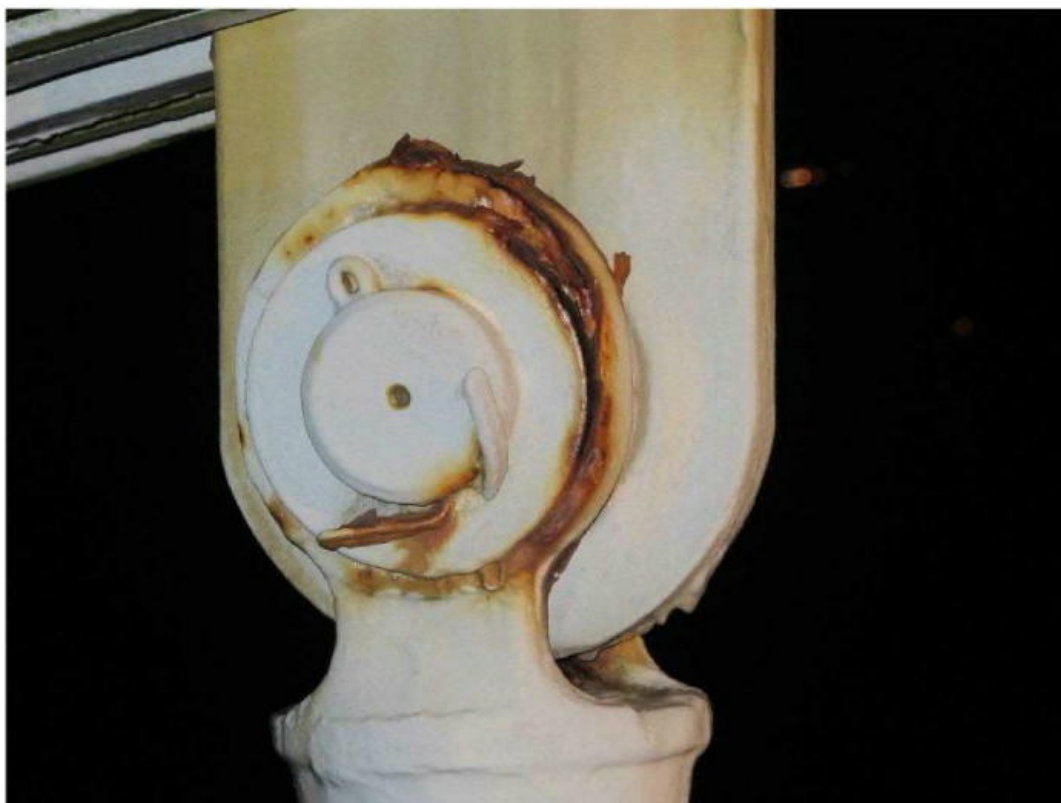
Figure 196: Primary deck element – close-up of paint loss, corrosion and rust-staining to articulating parts of the upper hanger connection the 6th hanger north of south tower on the central east catenary chains.

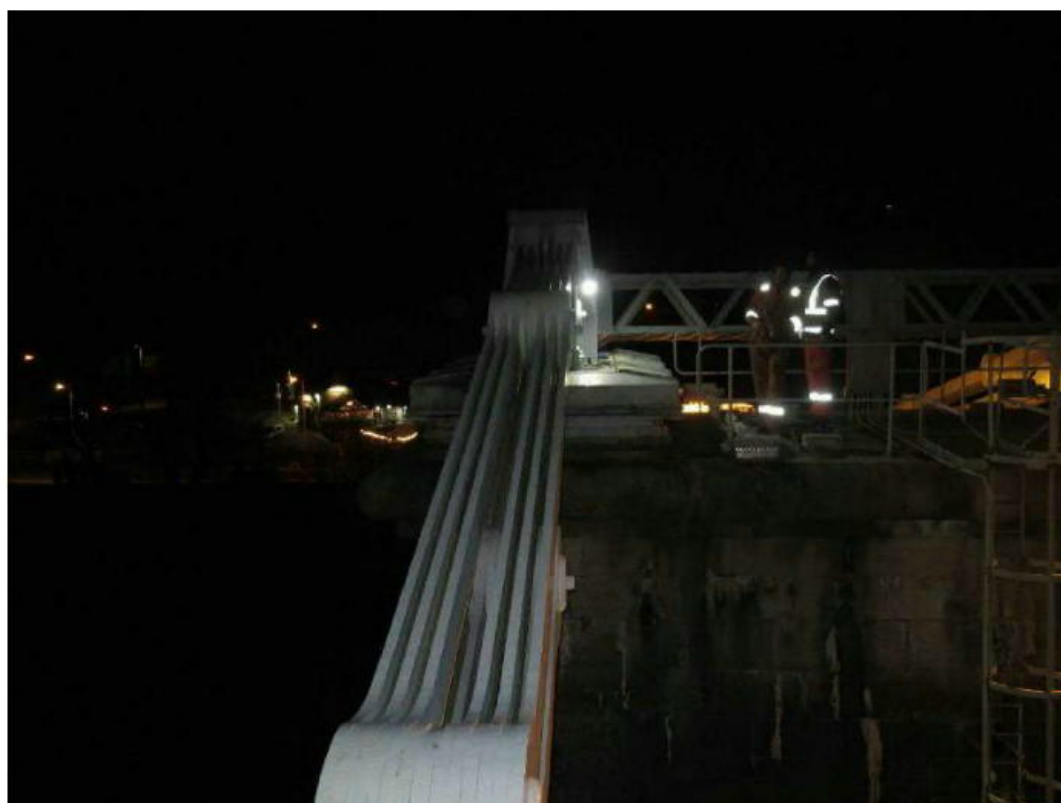
Figure 197: Primary deck element – looking south at upper chain to central east section of catenary chains and upper north face of south tower.

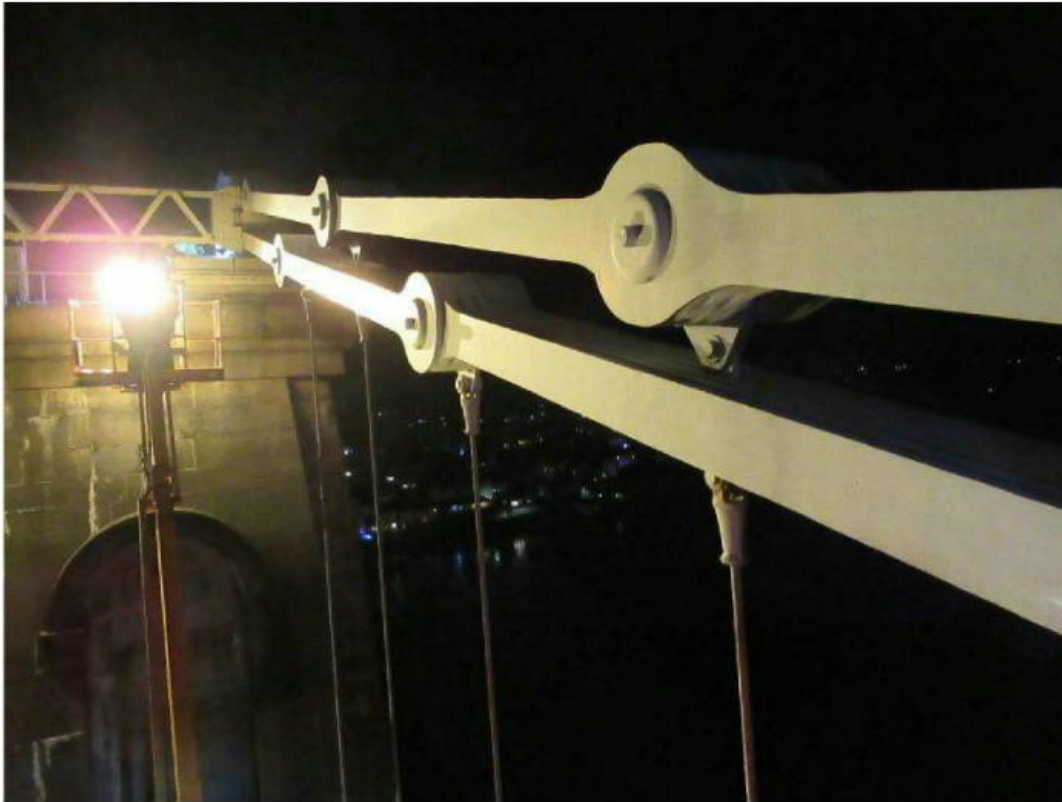
Figure 198: Primary deck element – upper south face of south tower and south east back-stay chains.

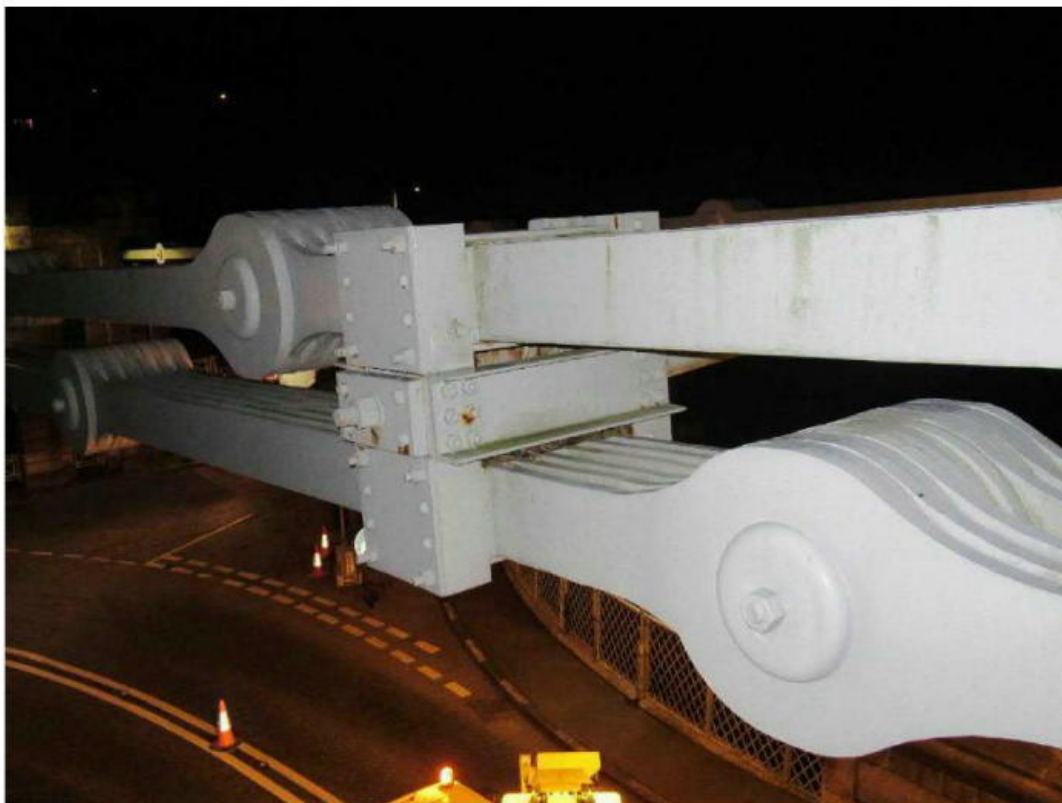
Figure 199: Bracing – looking south along outer face of south east back-stay chains and transverse brace connection. Generally, in good condition with small areas of minor corrosion.

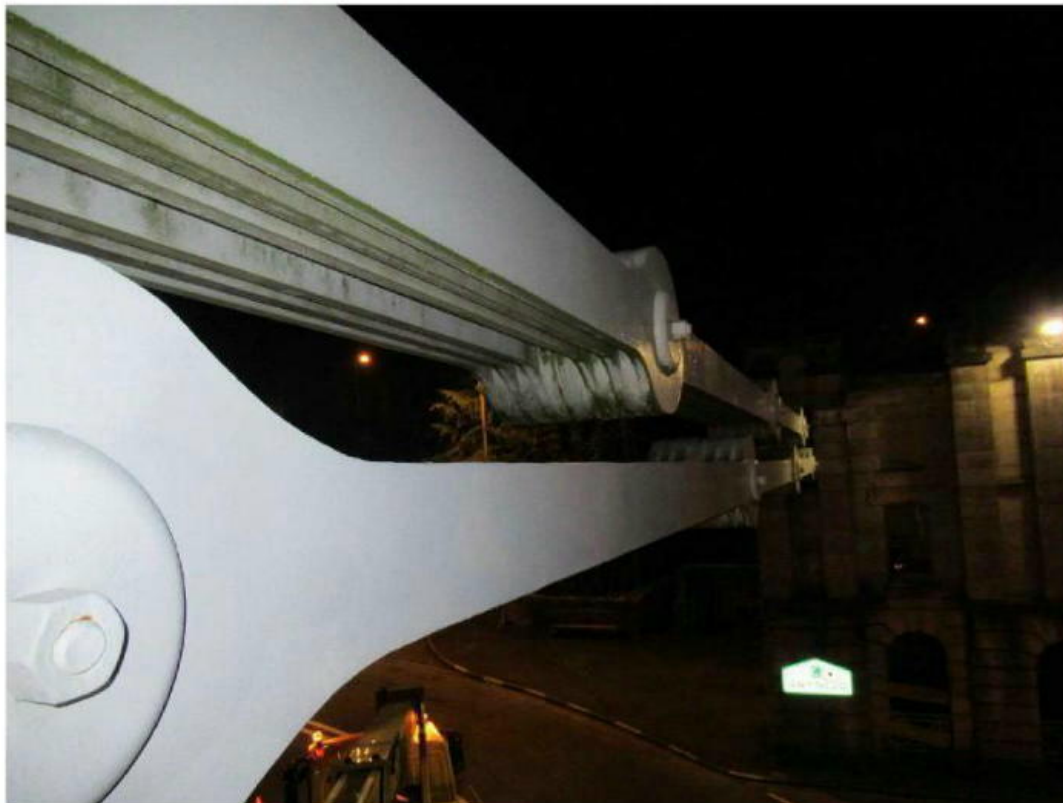
Figure 200: Primary deck element – looking south along inner face of south east back-stay chains and south bridge building.

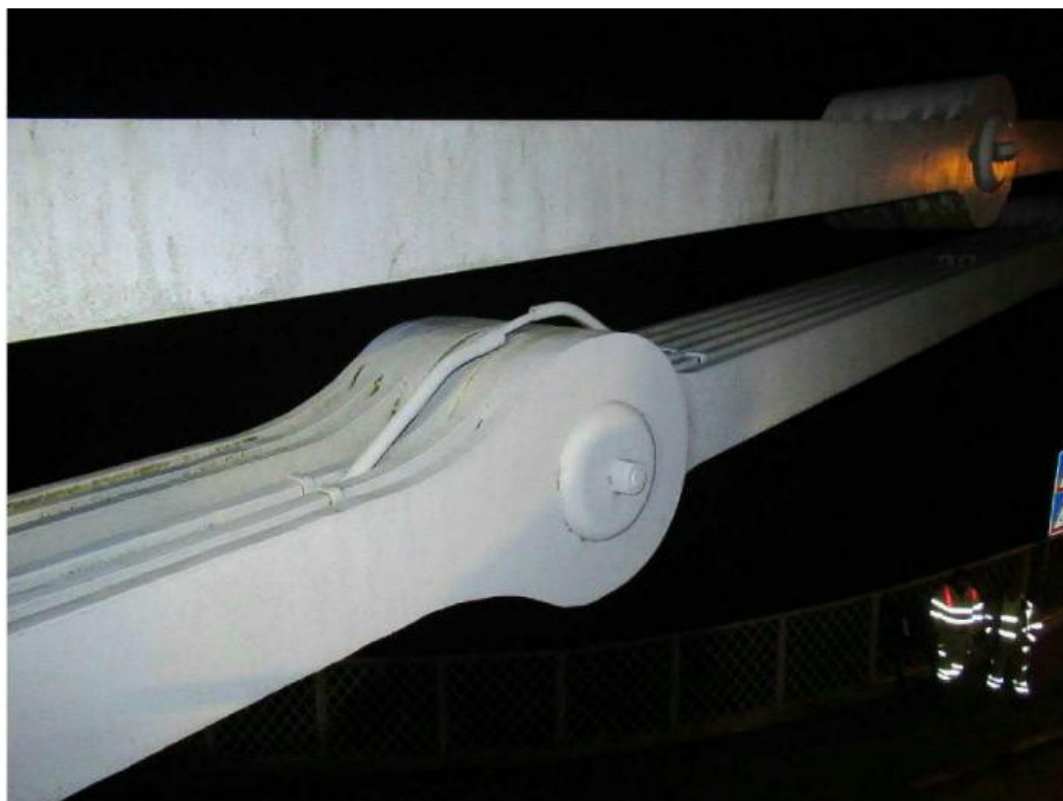
Figure 201: Primary deck element – minor algae and water staining to inner face of south west back-stay chains.

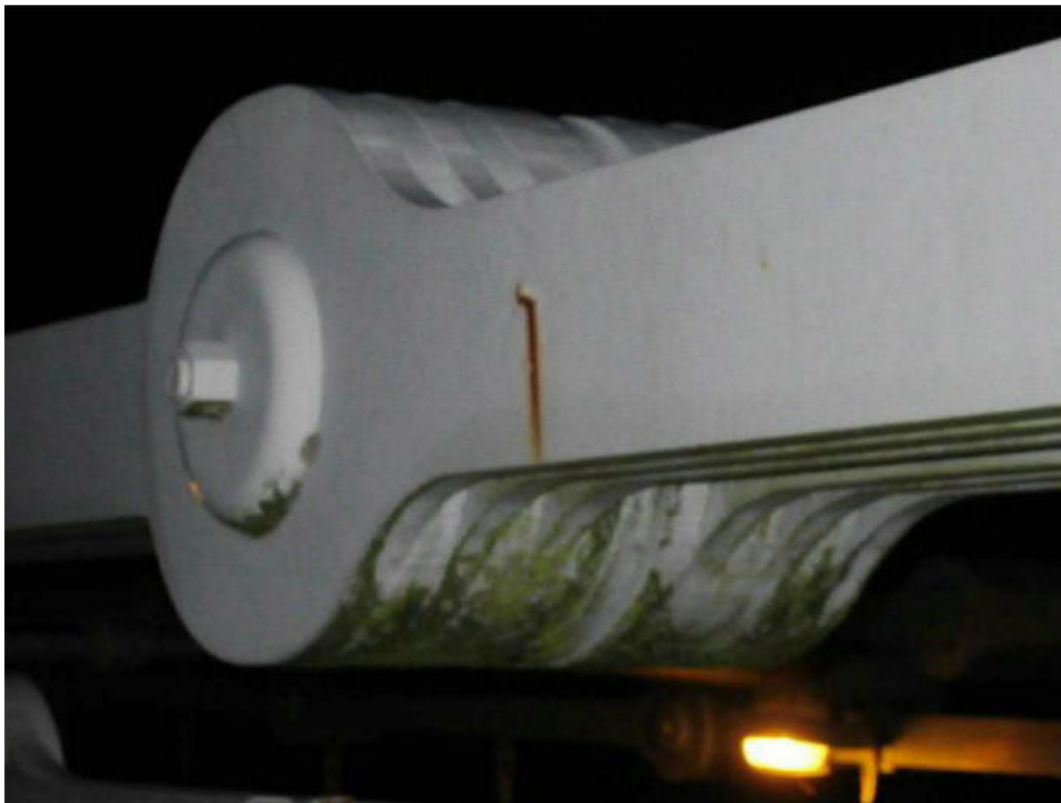
- Rust staining from metallic debris was trapped beneath paintwork to the outer face of the south west back-stay chain just before the 1st hanger (Figure 202). A general view looking along the north outside face of the south west back-stay chains is shown within Figure 203.

Figure 202: Primary deck element – rust staining from metallic debris trapped beneath paintwork to outer face of south west back-stay chain just before 1st hanger.

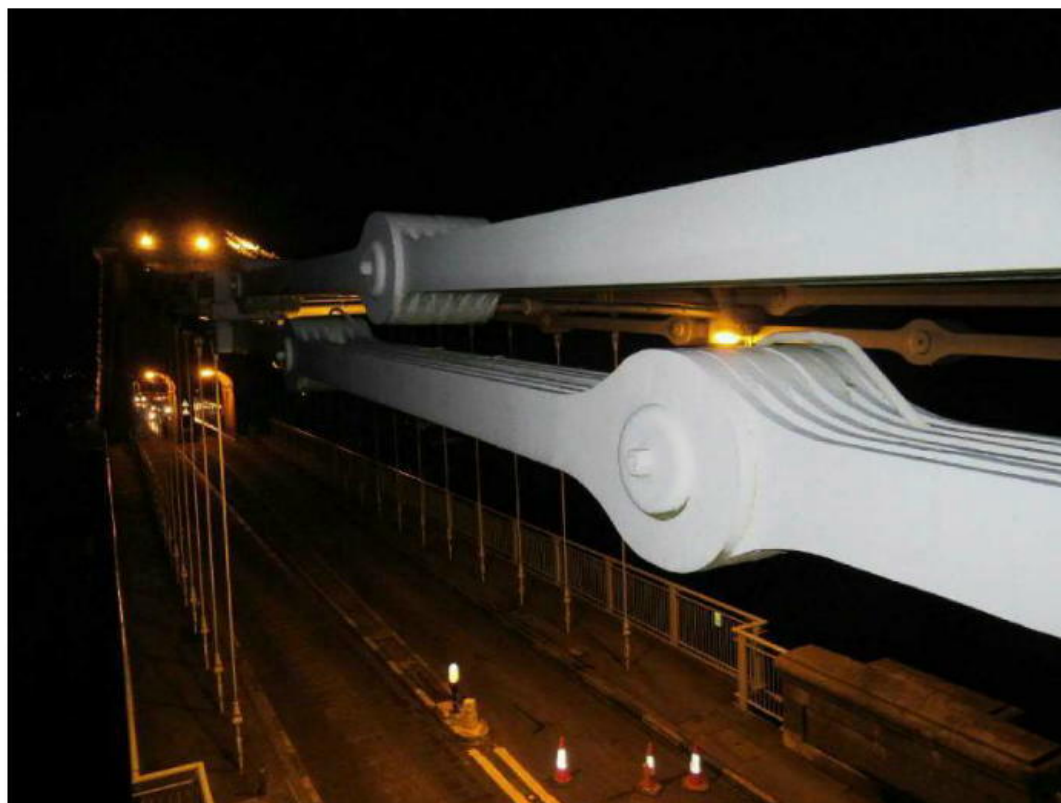
Figure 203: Primary deck element – looking north along outside face of south west back-stay chains.

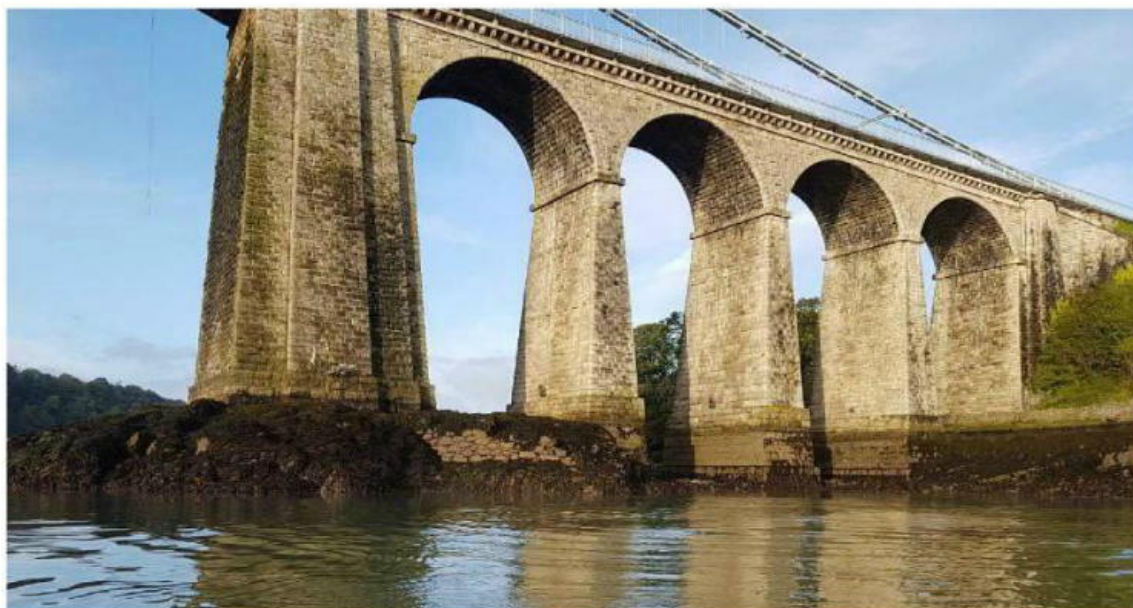
Fig 01: General view of piers 4-1 on the east side looking west – All piers are in good condition – some small scour pools approx. 300mm deep on average – Retaining wall between piers 3 & 4 has some loose stone work - No undermining to piers

1. Consider repairs to retaining wall between piers 3 & 4
2. Investigate further the loose stonework adjacent pier 5 on the north side

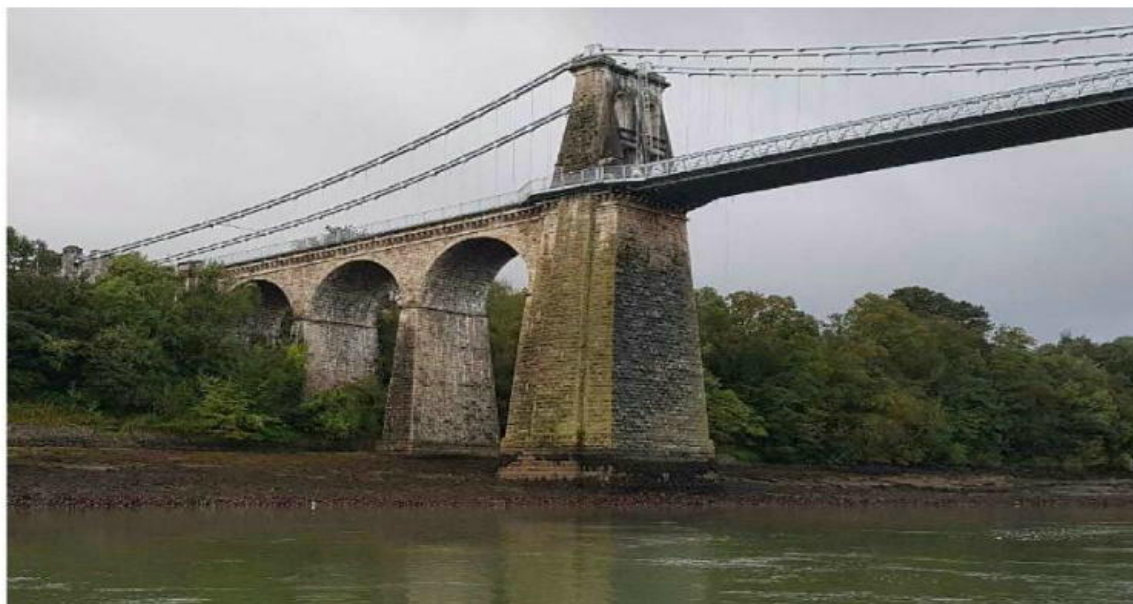
Fig 02: General view of piers 5 & 6 on the east side looking west – Both piers are in good condition – Some loose stone work laying on the sea bed immediately in front of pier 5 on the north side - Possibly part of a small plinth/wall which acted as an anti scour measure to protect the pier – No undermining

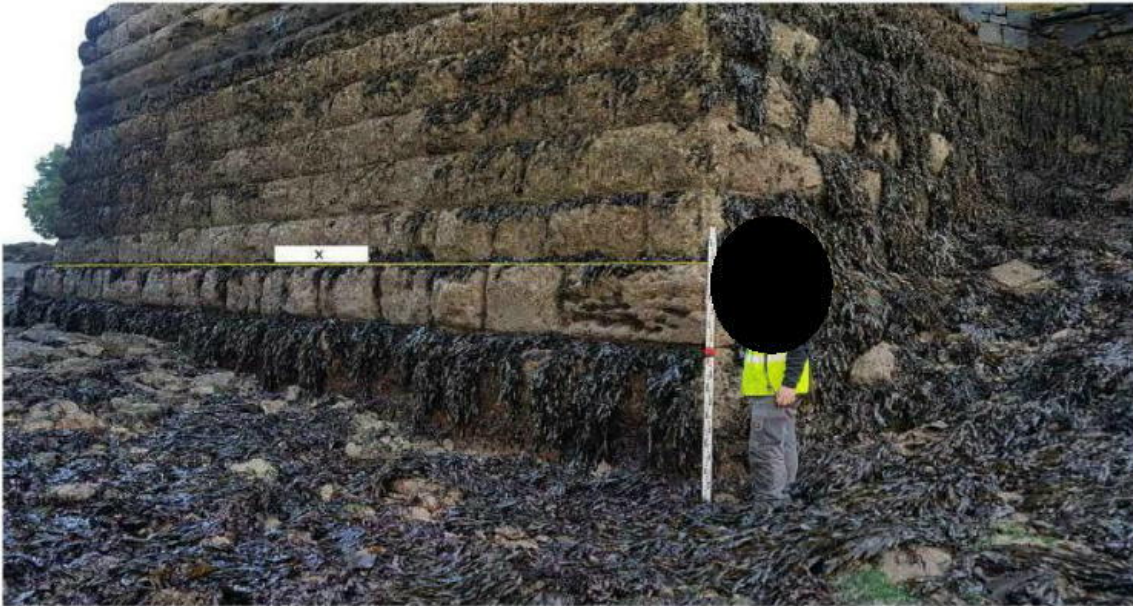
Fig 03: Bed levels at the eastern corner are approx. 800mm lower than the west side. Yellow line is location of measured distance X on pier 1 south face (refer appendix A for measurements) -- No undermining - Good condition

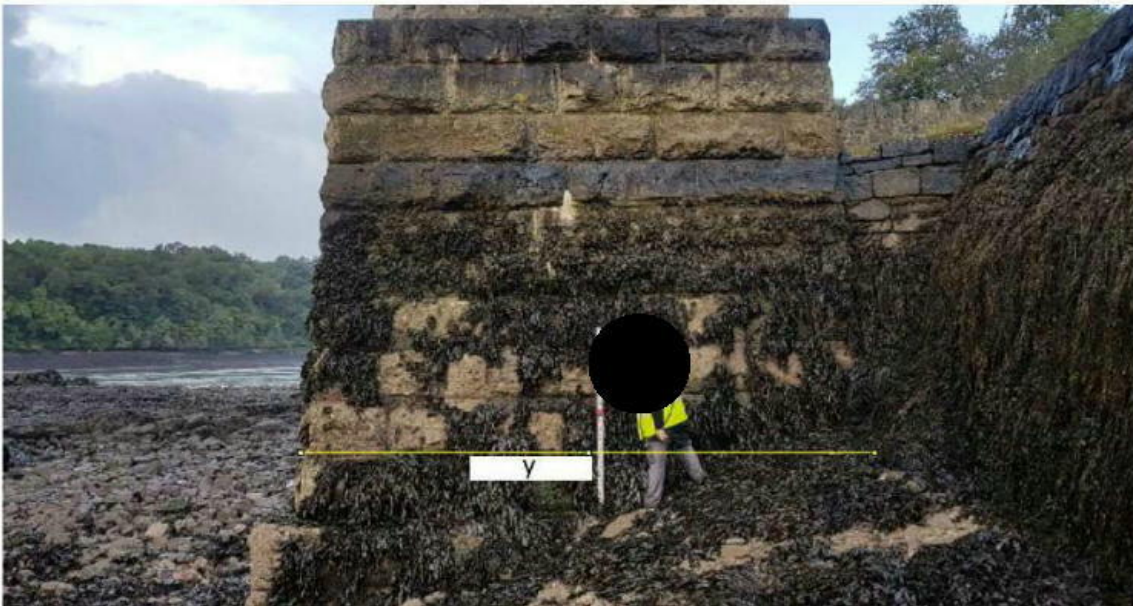
Fig 04: Pier 1 on east side looking west - Natural sloping gradient slopes 2.5m across the pier elevation - Yellow line is location of measured distance Y (refer appendix A for measurements) - No undermining - Good condition

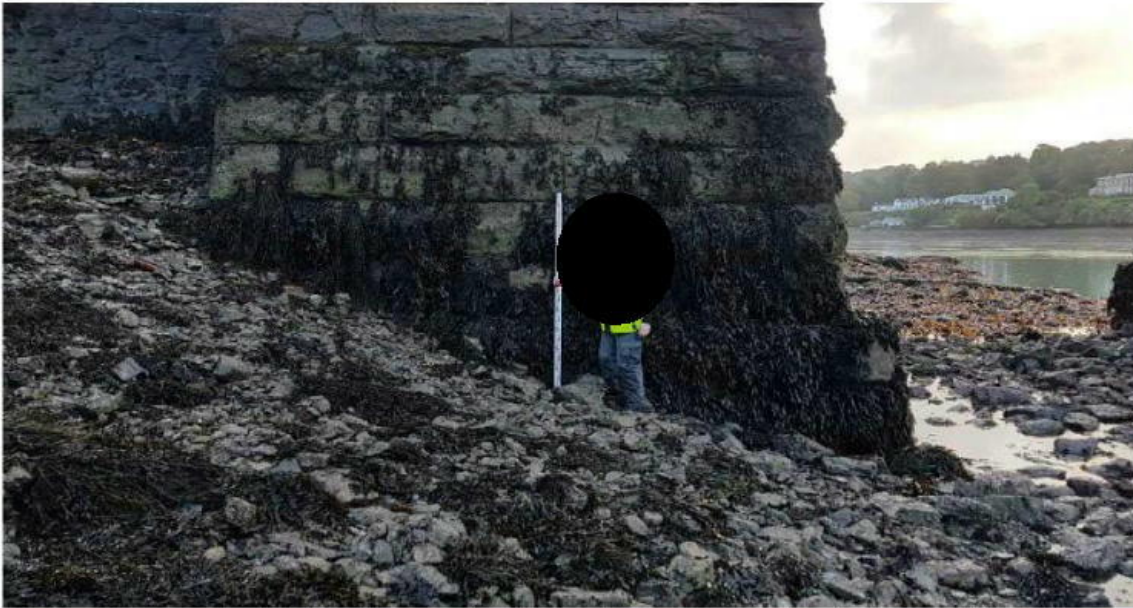
Fig 05: Pier 1 on west side looking east - Natural sloping gradient slopes 2.5-3.0m across the pier elevation – Small crab pool to the south 200-300mm depth - No undermining - Good condition

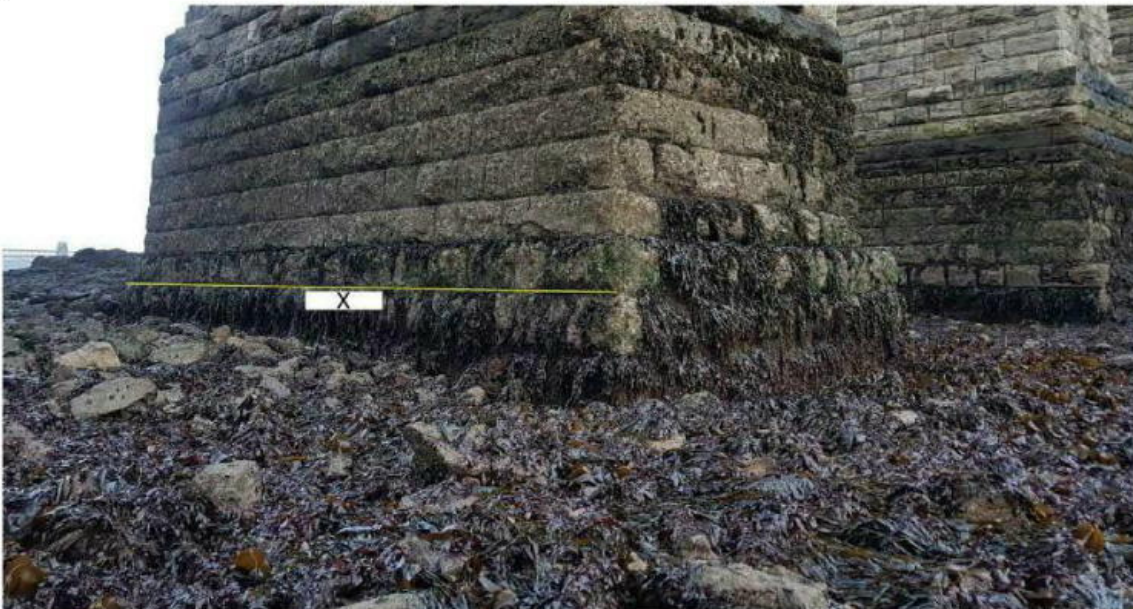
Fig 06: Pier 2 on east side looking west – Bed levels on the east are slightly lower than the west side mostly due to natural lay of the seabed – Some crab pools from minor scour 200-300mm depth – No undermining or significant scour to the structure – Good condition

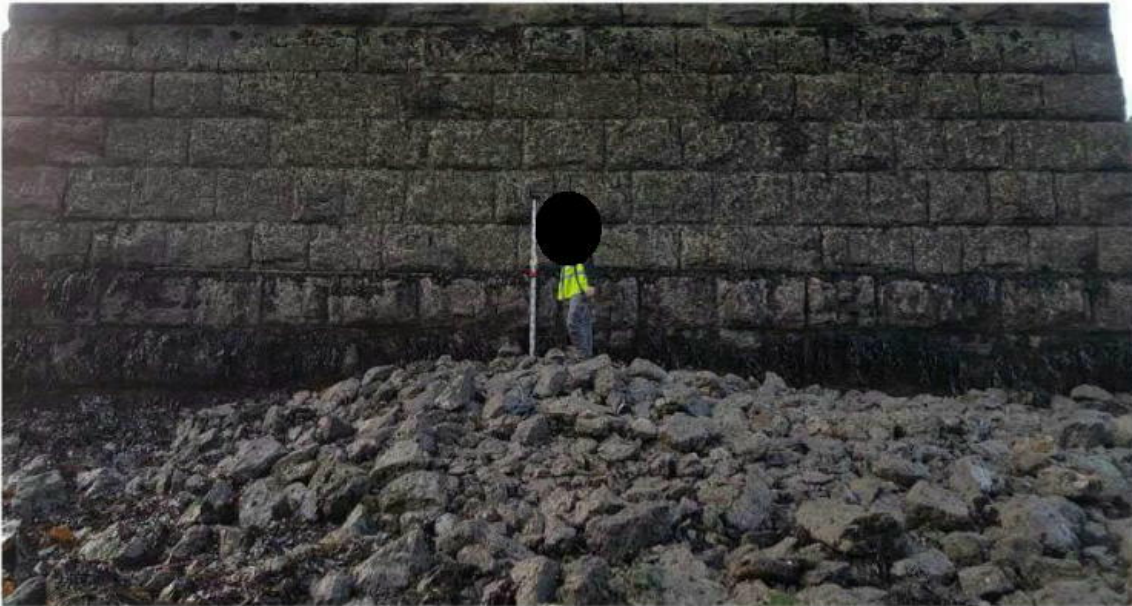
Fig 07: Pier 2 on the north side looking south from pier 1 – Bed levels are approx. 1m lower on the east side with small scour pools of 200-300mm depth – These are not thought to be threatening the integrity of the structure though should be monitored at next inspection – No undermining – Good condition

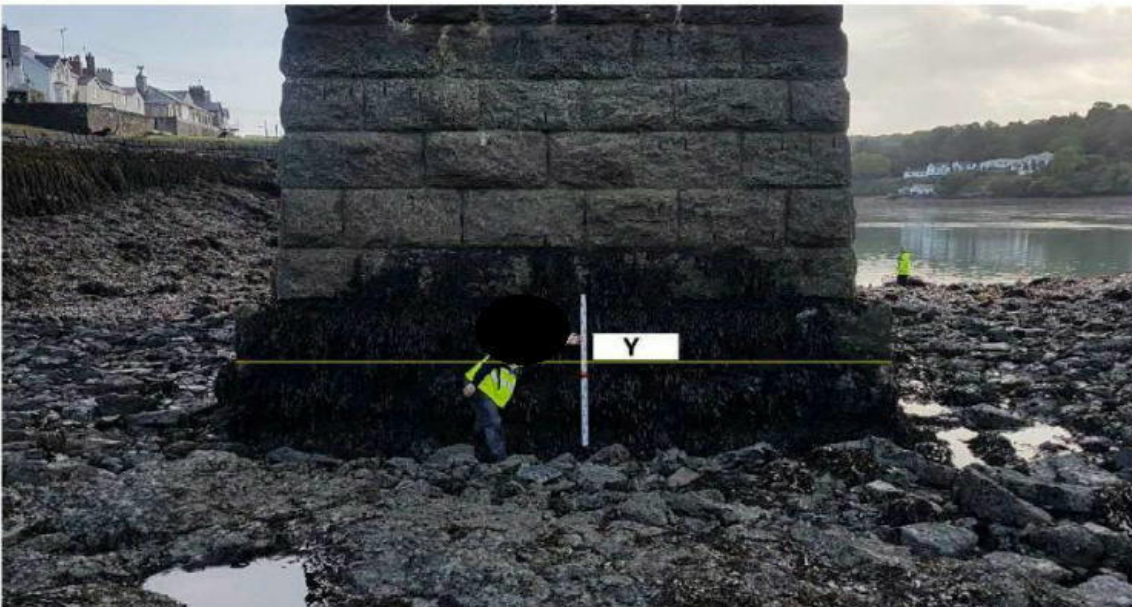
Fig 08: Pier 2 on the west side looking east – Small crab pool to the south 200-300mm depth - No undermining - Good condition

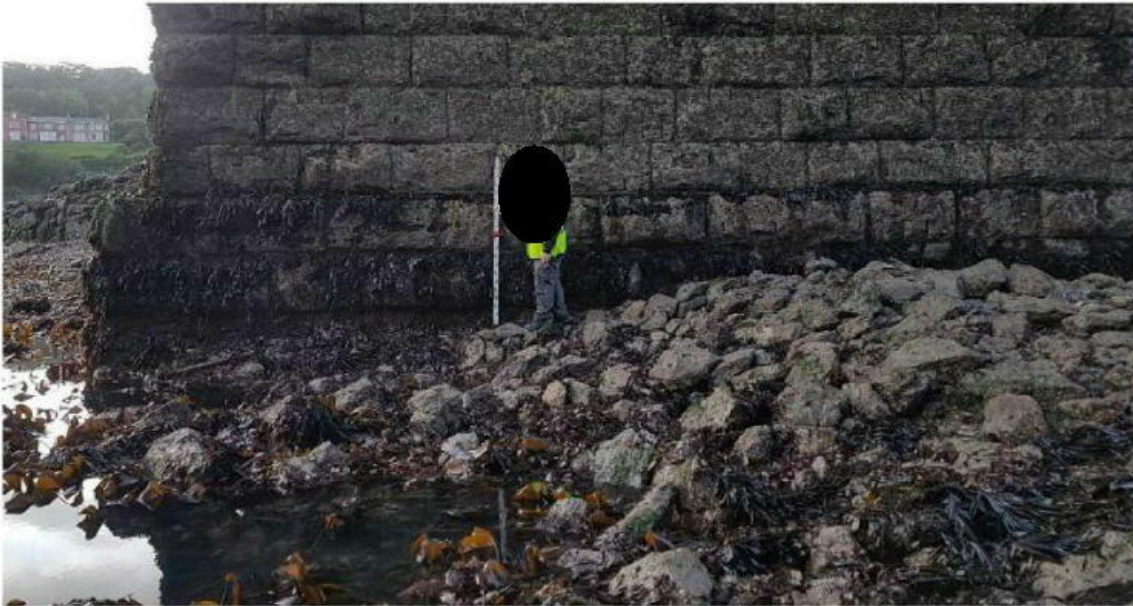
Fig 09: Pier 2 east end - Small crab pool 200-300mm depth – No undermining - Good condition

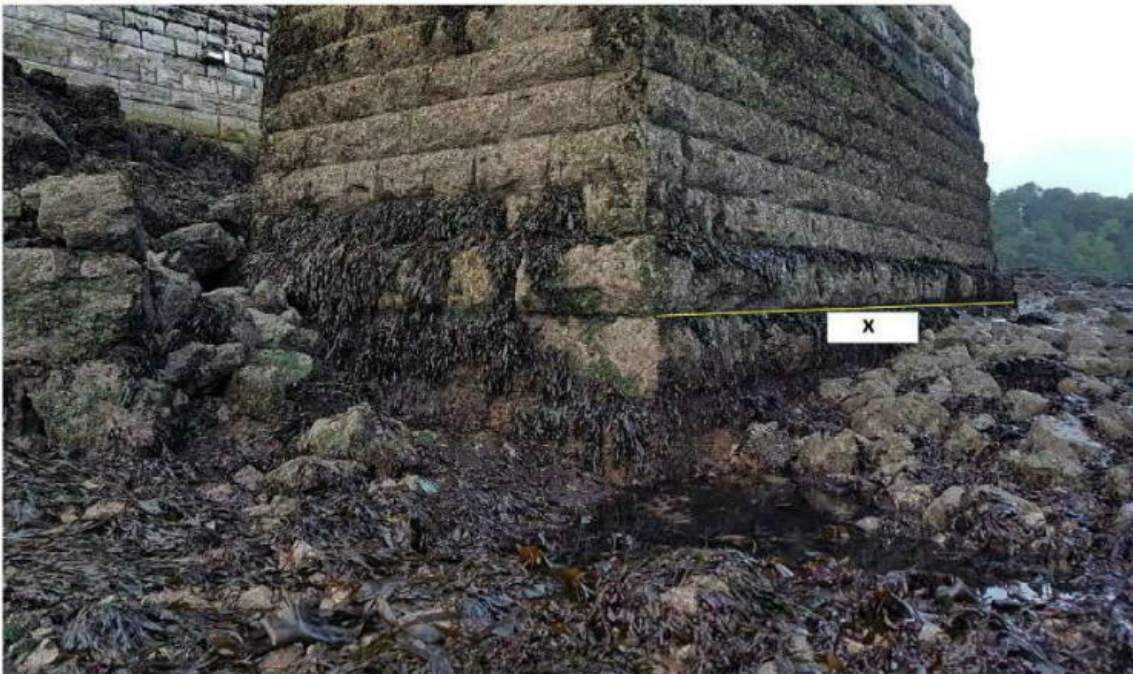
Fig 10: Pier 3 on the east side looking west – crab pool 300-400mm deep – Bed levels at the east end are approx. 1-1.2m lower than the west end - No undermining - Good condition – The retaining wall adjacent the east side of the pier has become messy and appears to have some section loss when compared to the wall further along

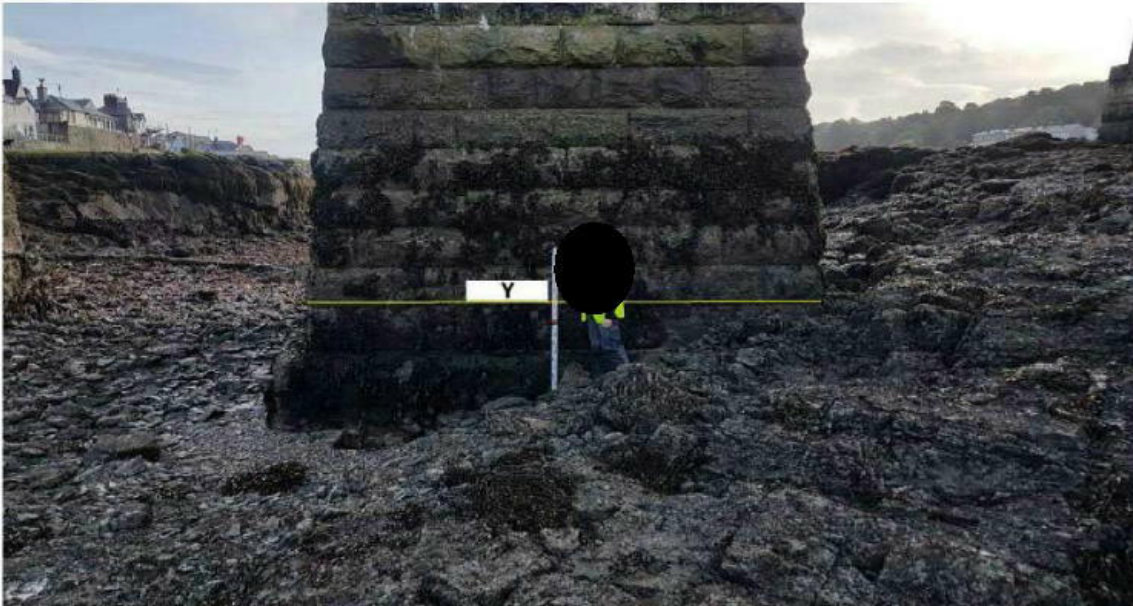
Fig 11: Pier 3 on the west side looking east - The sea bed here is exposed bed rock - No undermining - Good condition

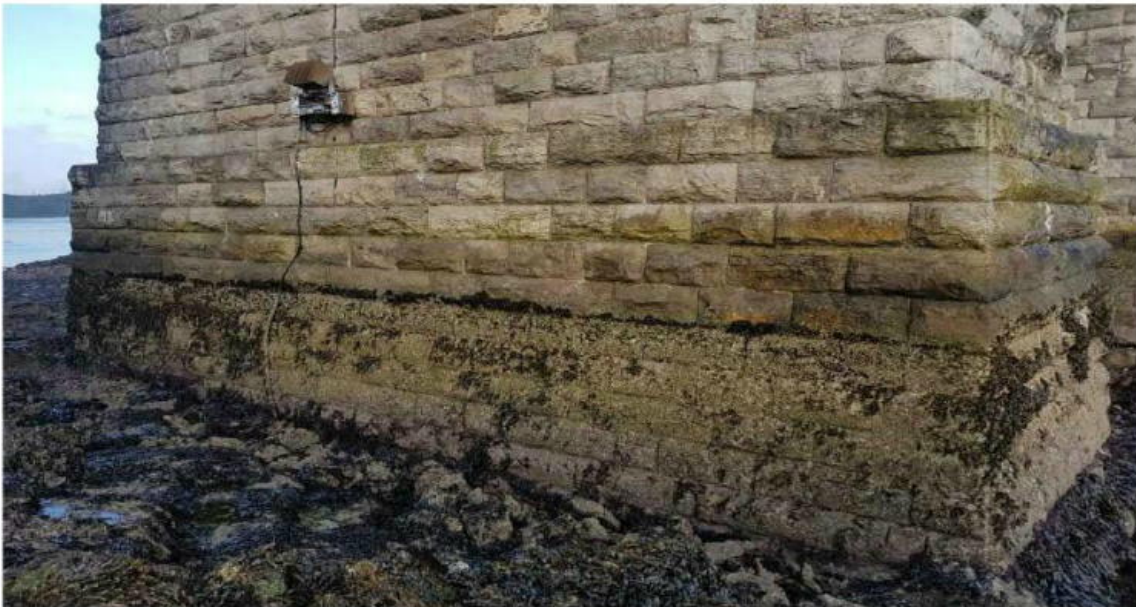
Fig 12: Pier 3 on the south side looking NW - The sea bed here is exposed bed rock - No undermining - Good condition

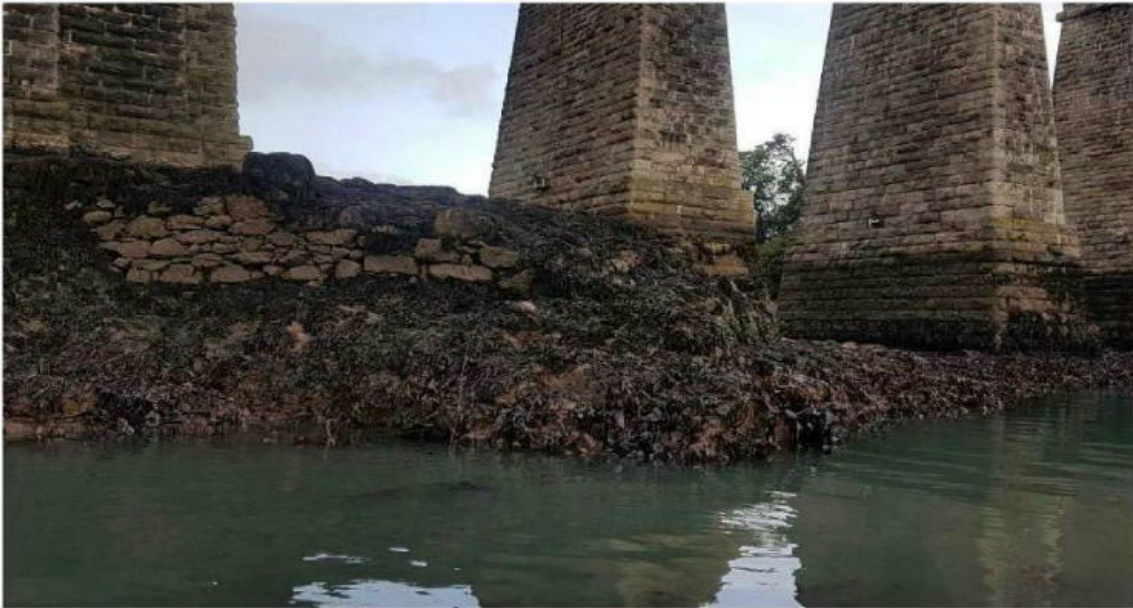
The retaining wall between piers 4 & 3 on the east side does have some partial collapse but generally remains mostly intact. Pier 4 is founded onto natural raised bedrock and is therefore exposed for longer durations than the adjacent piers and has less marine vegetation growing on it. At pier 5 on the north side there are several small stone blocks scattered in front of the pier that may have originally been part of a small wall/plinth acting as a scour protection measure.

Fig 13: Looking westward the retaining wall between piers 4 & 3 on the east side - The wall is missing several stones and appears to worsen as the wall moves around to the north side.

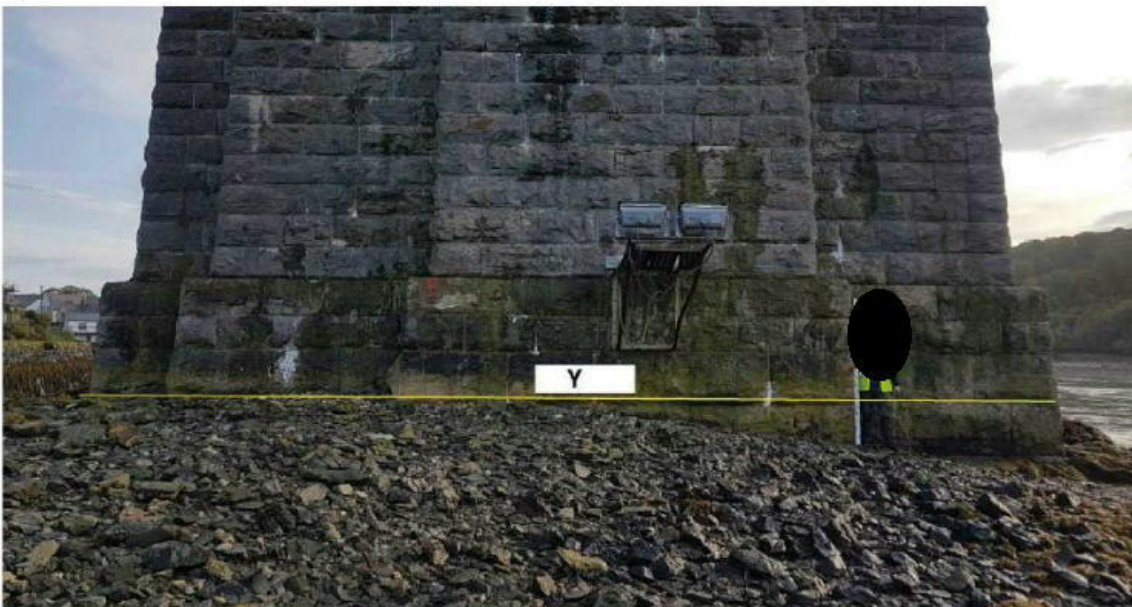
Fig 14: Pier 4 west face while looking east - This pier is on raised bedrock with no issues – Bed levels are 600-700mm lower on the south face compared to the north – No undermining – Good condition

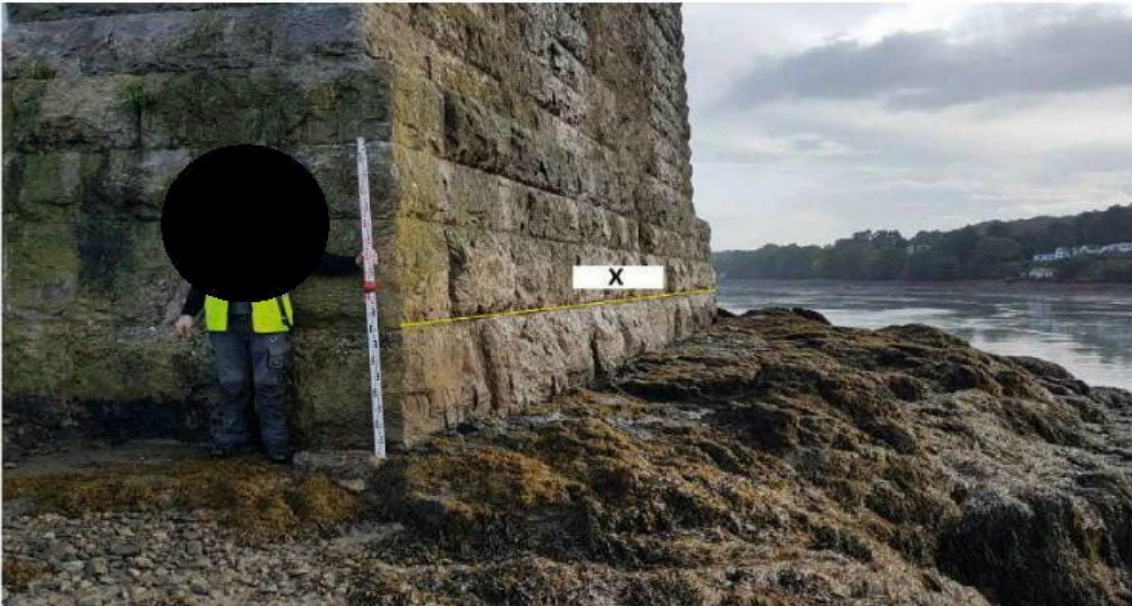
Fig 15: Pier 4 south face looking east – Less marine vegetation due to longer exposure during tide cycle - No undermining – Good condition

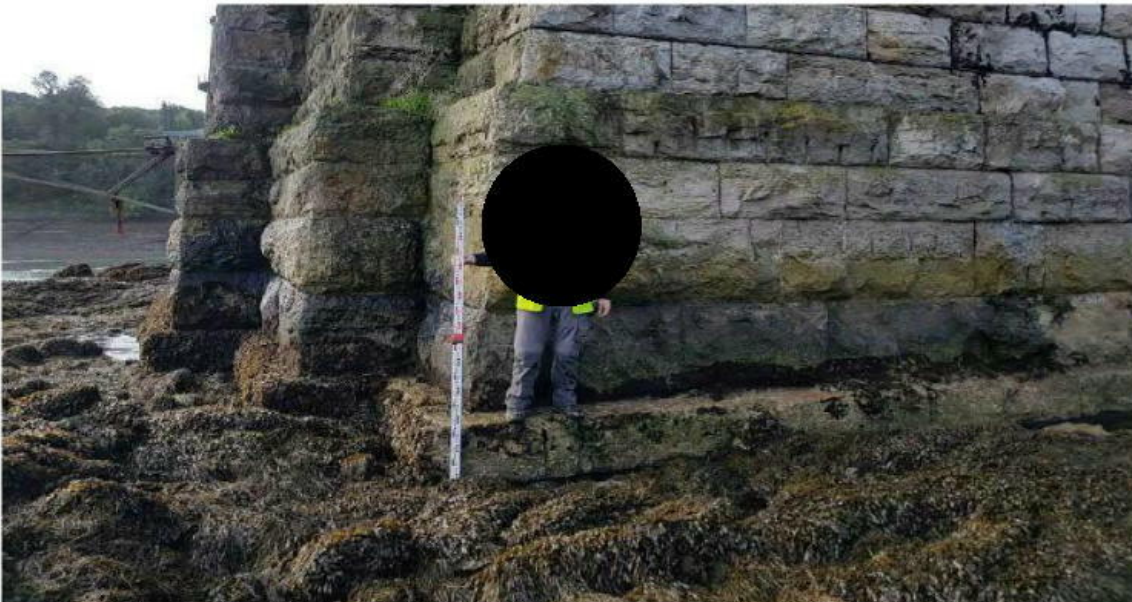
Fig 16: Pier 4 NE corner – Exposed bedrock - Good condition – No undermining

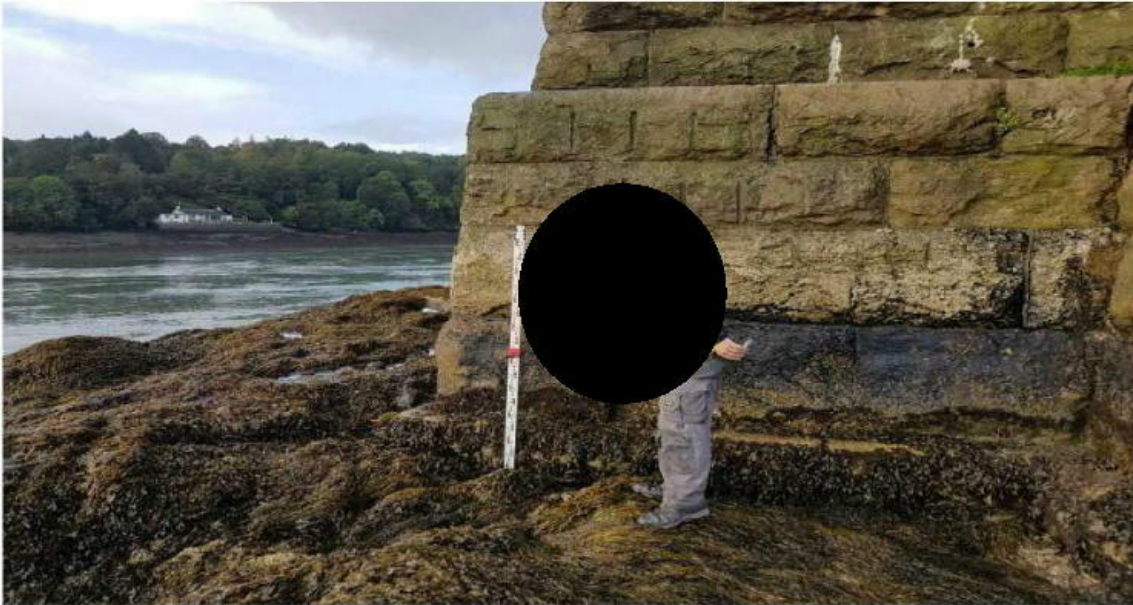
Fig 17: Pier 4 SE corner – good condition – no undermining

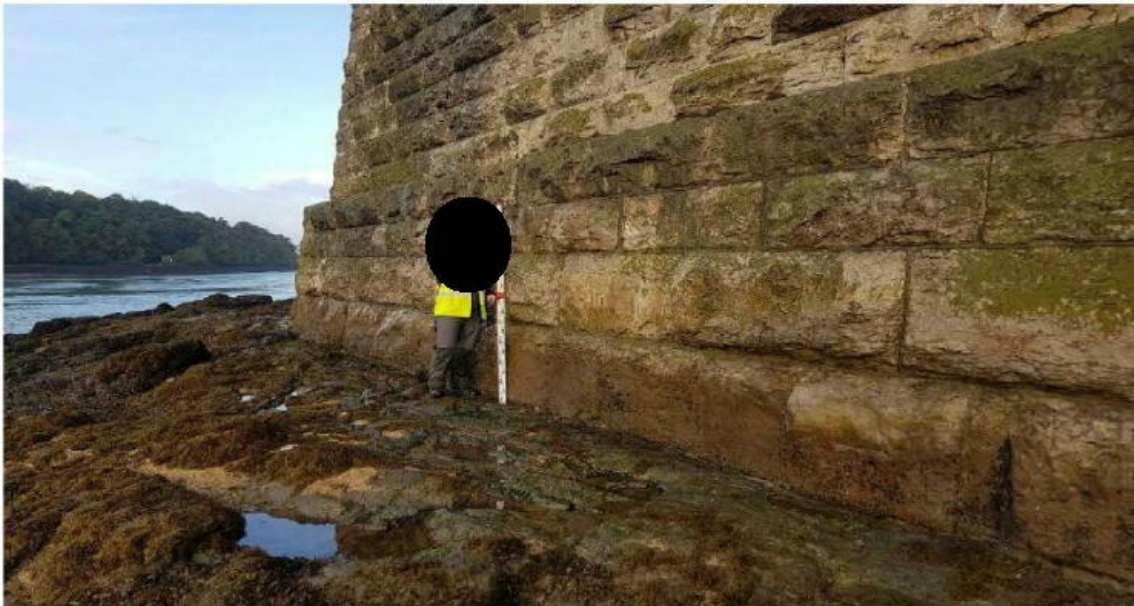
Fig 18: South face of pier 4 looking west – No undermining – Good condition

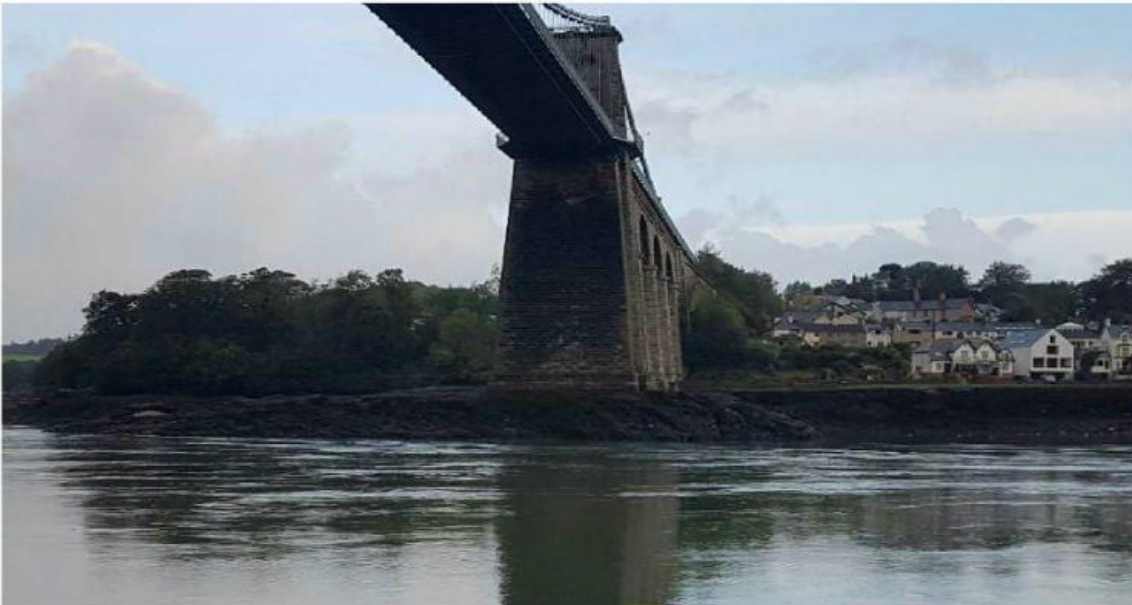
Fig 19: South face of pier 4 looking north – No undermining – Good condition

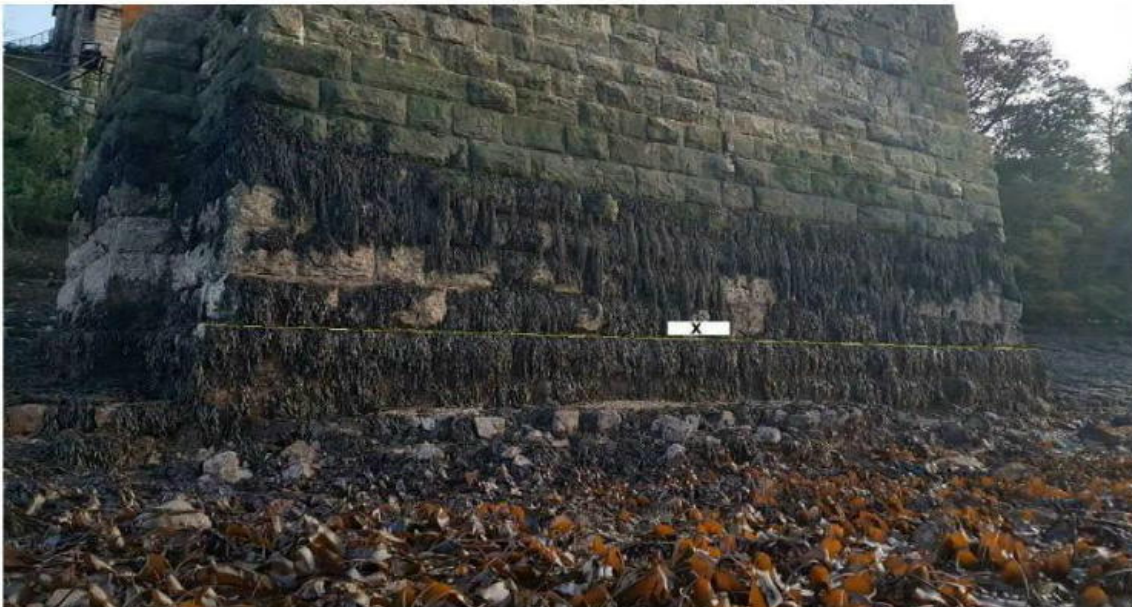
Fig 20: Pier 5 north face low tide cycle – Exposed remainder of small wall in front of pier otherwise Good condition – No undermining
