UK Highways Bridge Management

Principal Inspection Report Menai Bridge (Structure Ref. A5 Menai Bridge)

December 2019

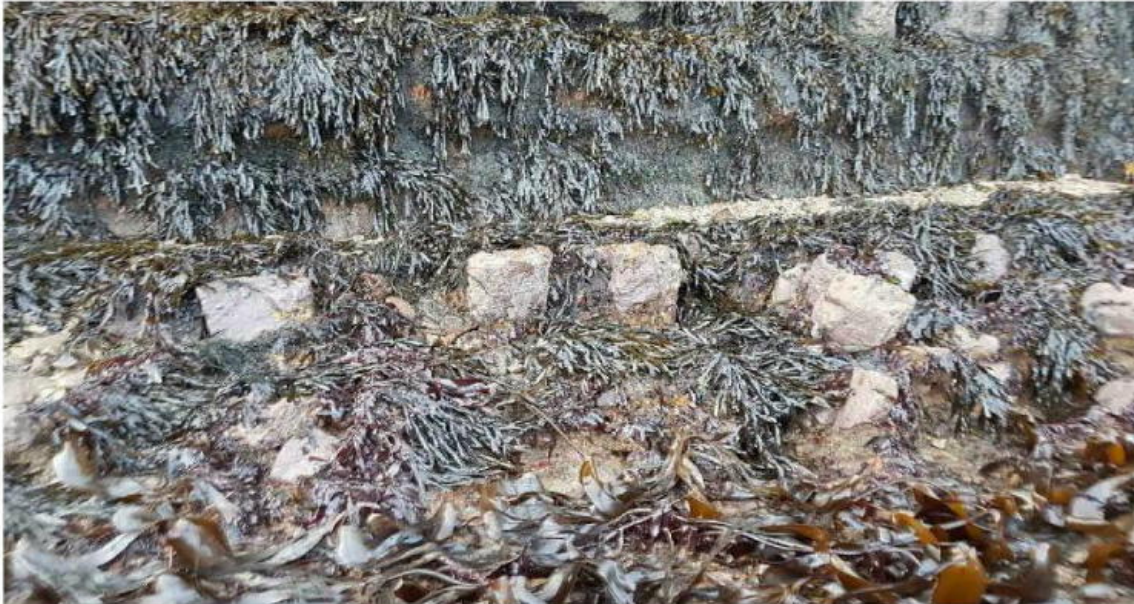
Fig 21: Pier 5 north face low spring tide – Loose stones laying on the sea bed immediately in front of the pier. It is possible these were originally a plinth or small wall protecting the pier base. Otherwise pier is in good condition with no undermining

1. Consider repairs to retaining wall between piers 3 & 4
2. Investigate further the loose stonework adjacent pier 5 on the north side

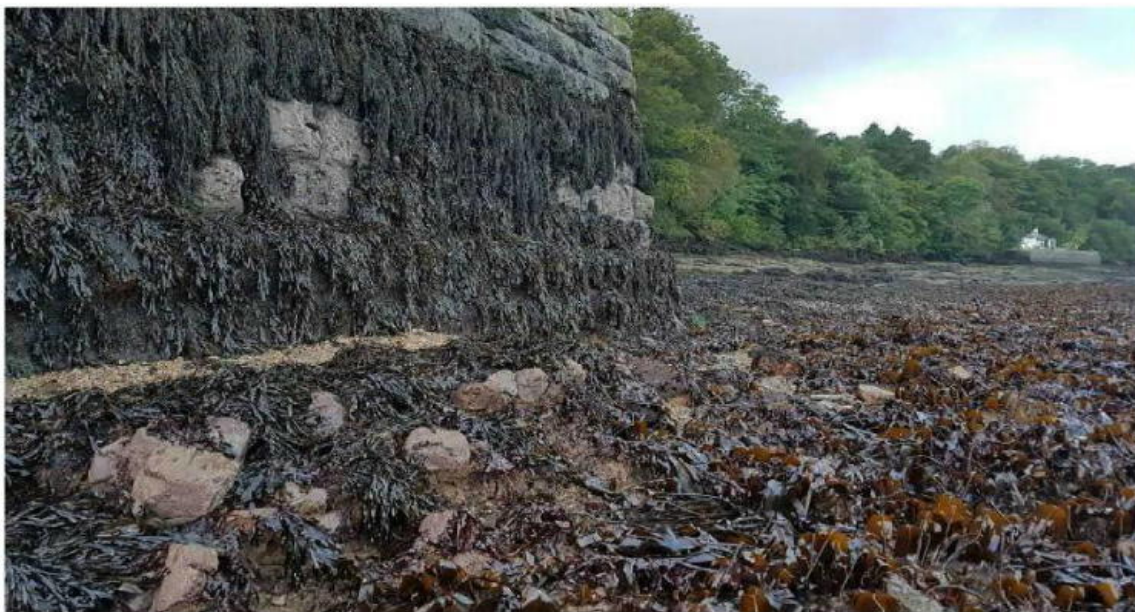
Fig 22: Pier 5 NW corner – Loose stones laying on sea bed appear to have originally formed a small plinth or wall otherwise good condition with no undermining

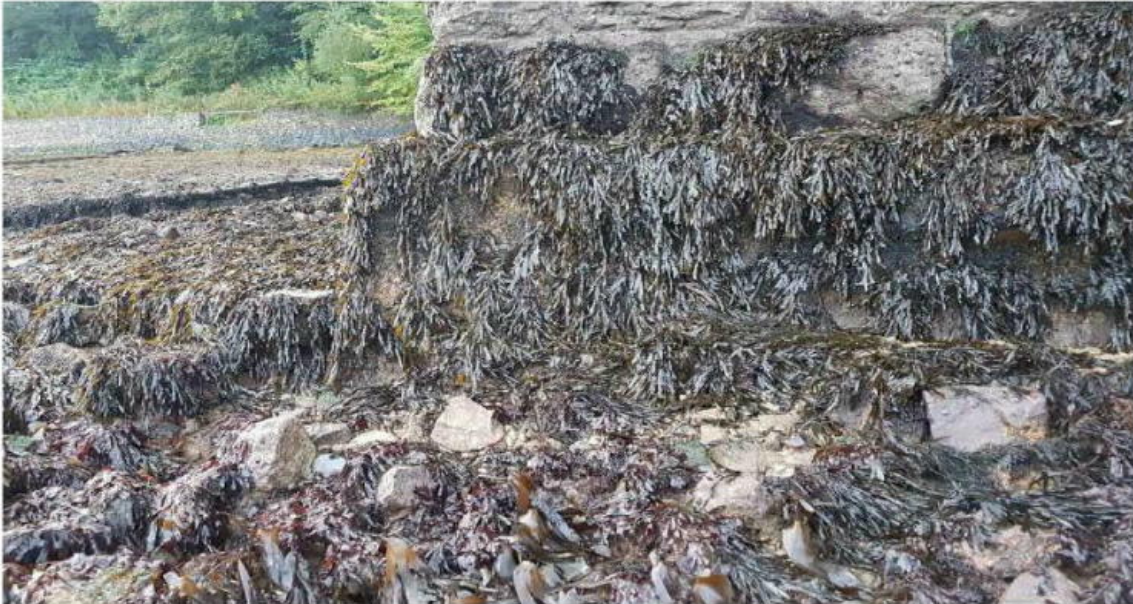
Fig 23: Pier 5 NE corner – Again loose stones laying on sea bed may have originally formed a small plinth or wall otherwise pier is in good condition with no undermining

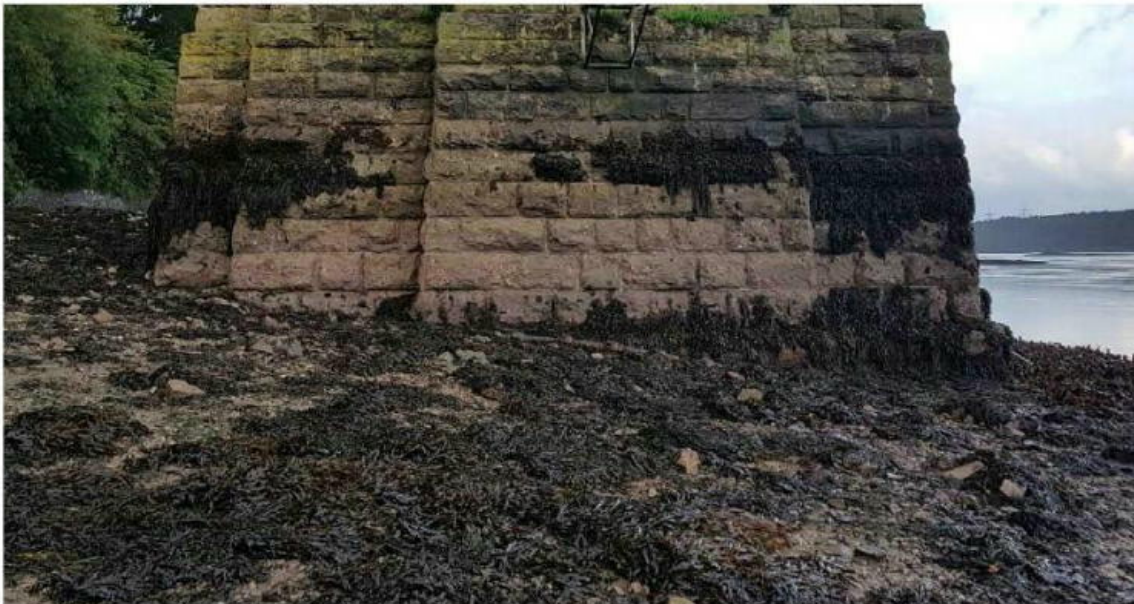
Fig 24: Pier 5 east face looking west – Good condition - No undermining

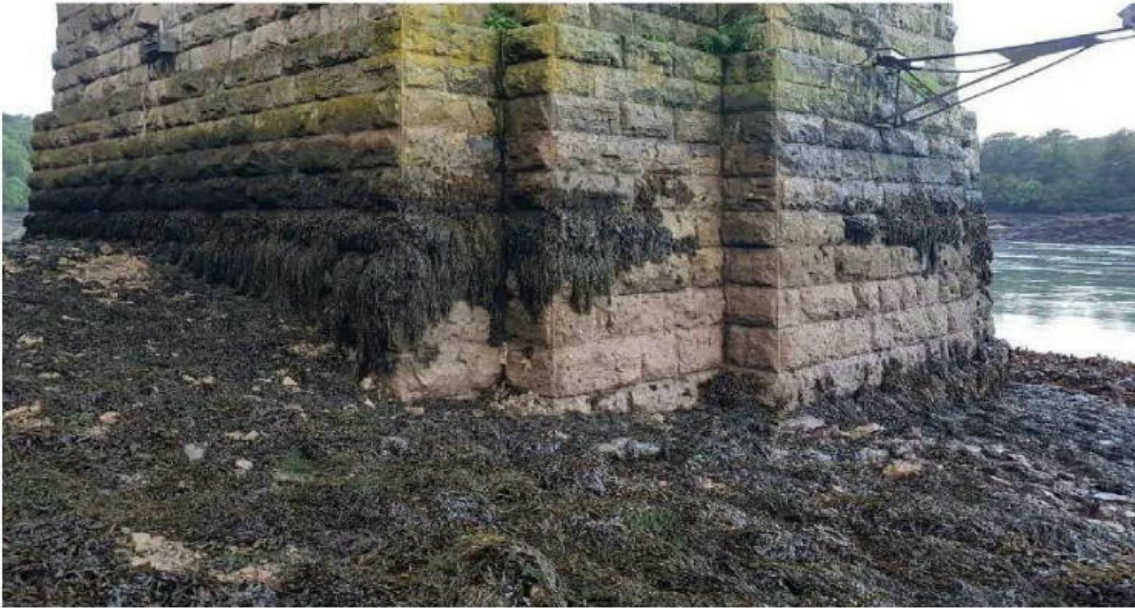
Fig 25: Pier 5 south and east faces looking NW – Good condition - No undermining

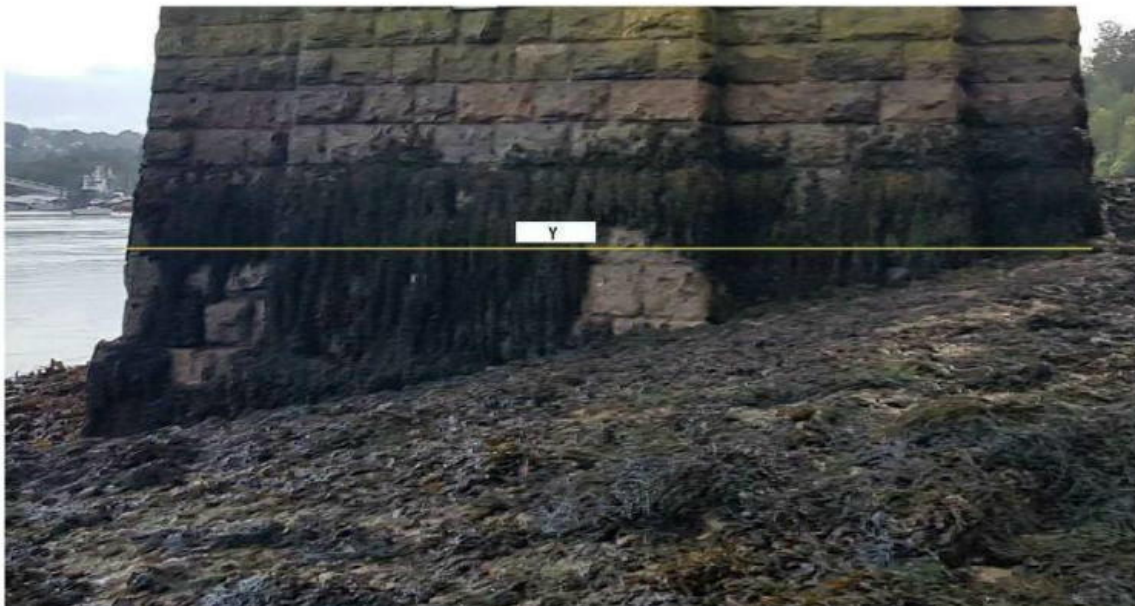
Fig 26: Pier 5 west face looking east – Good condition - No undermining

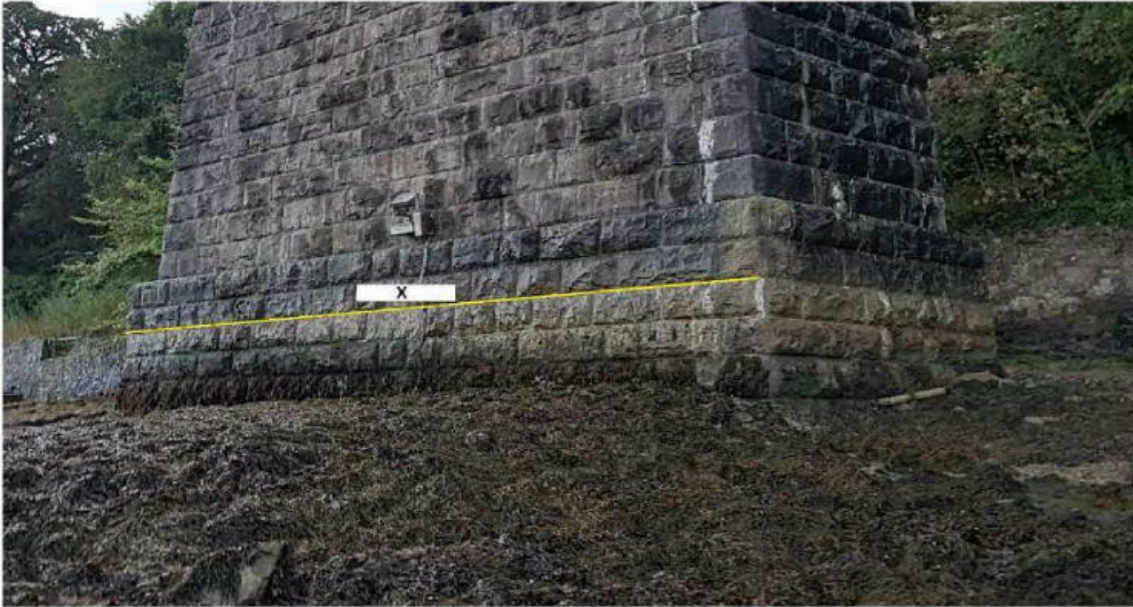
Fig 27: Pier 6 north face looking south – Good condition - No undermining

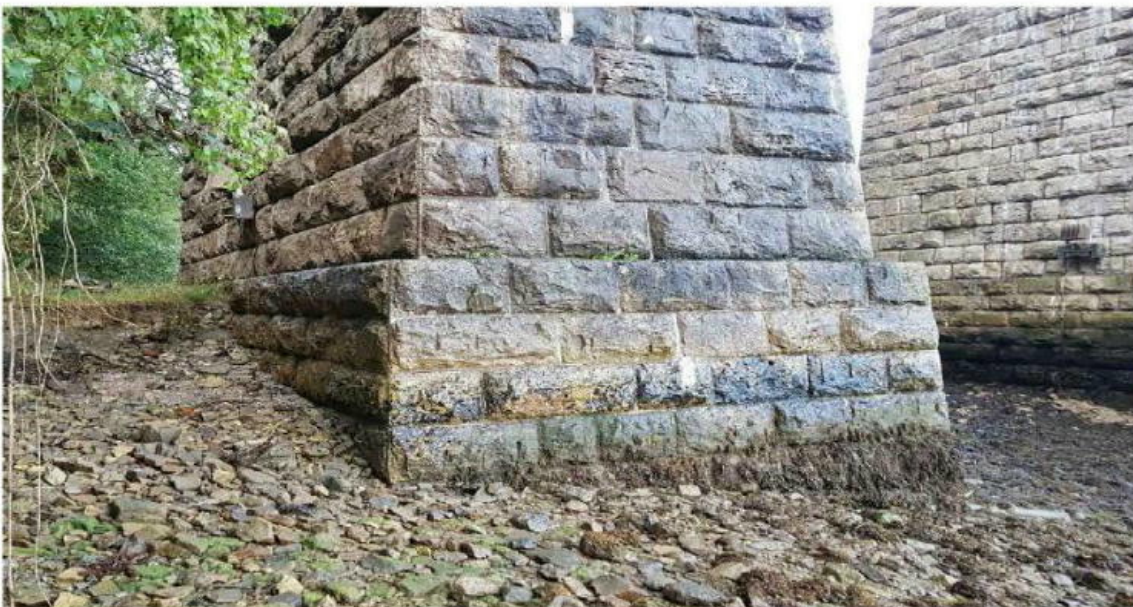
Fig 28: Pier 6 east face looking west – Good condition - No undermining

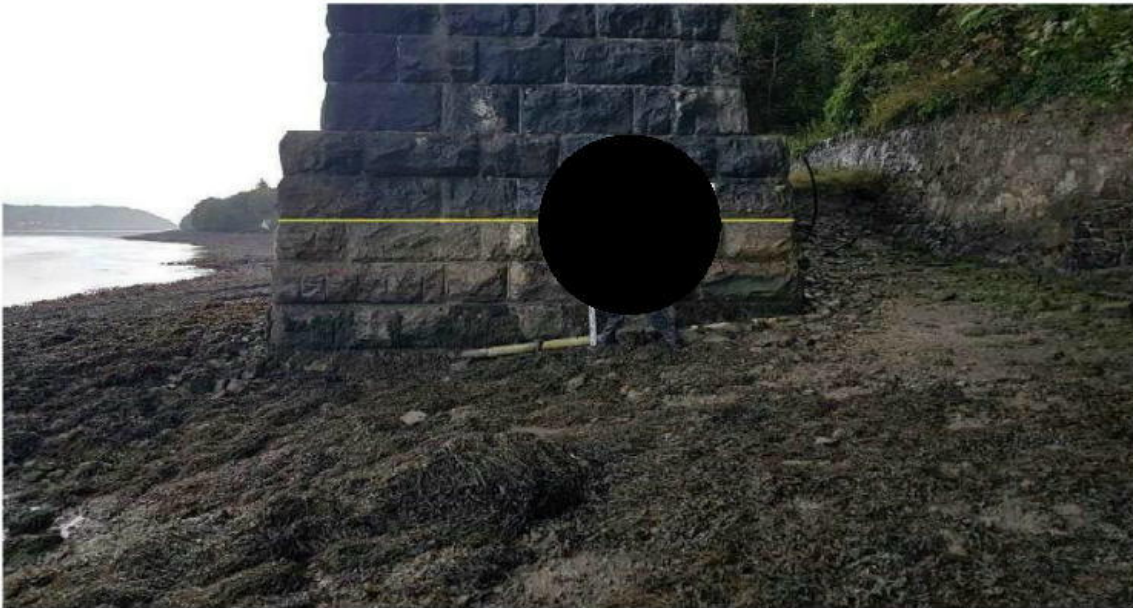
Fig 29: Pier 6 west face looking east – Good condition - No undermining
