Ruperra Castle

Structural Condition Survey and Strategic Appraisal Report

Project Number: 10247

Date: August 2024

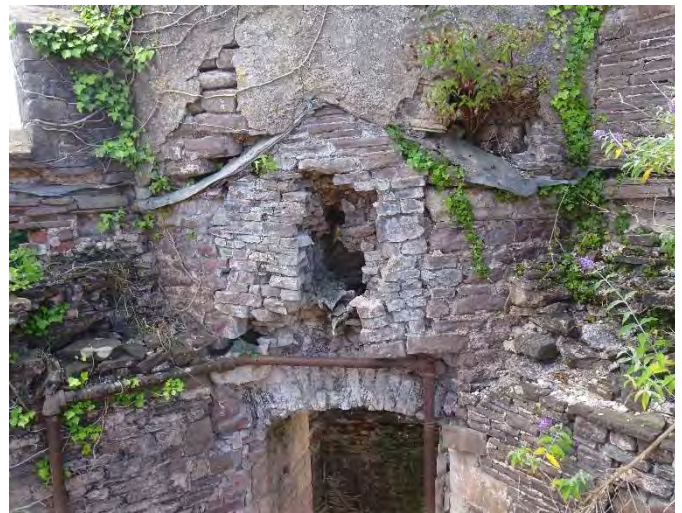
Cell G2 – Door into SW tower

4.5.2.2. The arches over the doorways to the SE and SW towers at second floor level have generally lost their faces therefore leaving the significantly vulnerable panels of masonry over poorly supported and at risk of collapse. The entrance into the NE and NW towers appears to have lost lintels which replaced original facing arches leaving the facework over vulnerable and poorly supported.

- 4.5.2.4. The current impact of this defect is a general reduction in the robustness of the wall heads with the potential for further loss of historic fabric. This defect is likely to accelerate with ongoing weather and vegetation attack and could result in the loss of larger panels of masonry and could compromise the integrity of the tower walls.

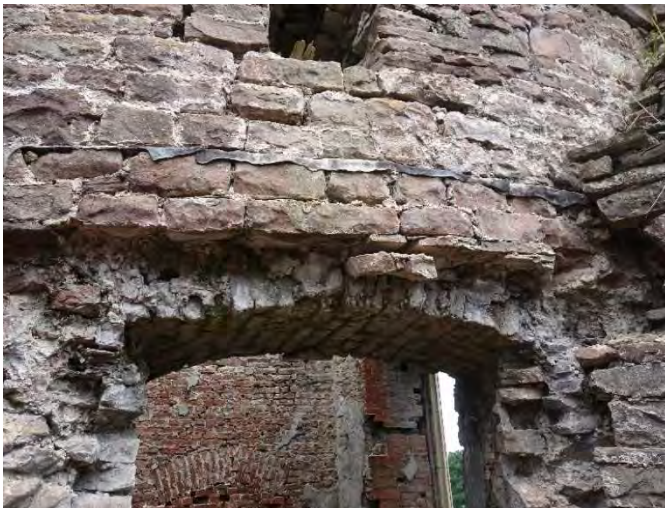
Cell C – internal elevation of NE tower (Pocket intact)

- 4.5.2.3. The interior of the NE tower has an example of an intact valley beam pocket with the surround masonry in better condition.

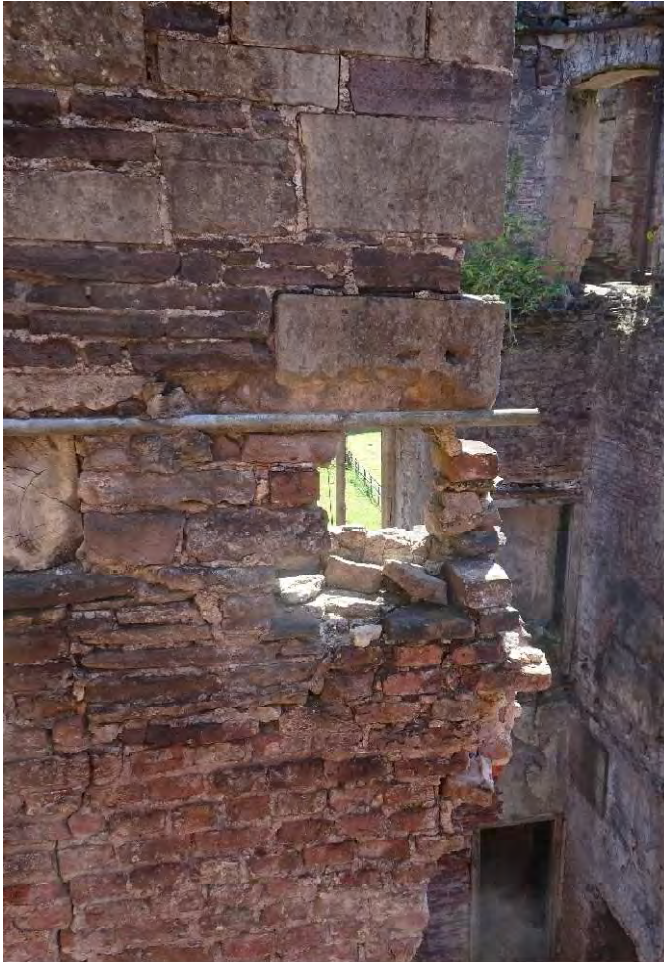
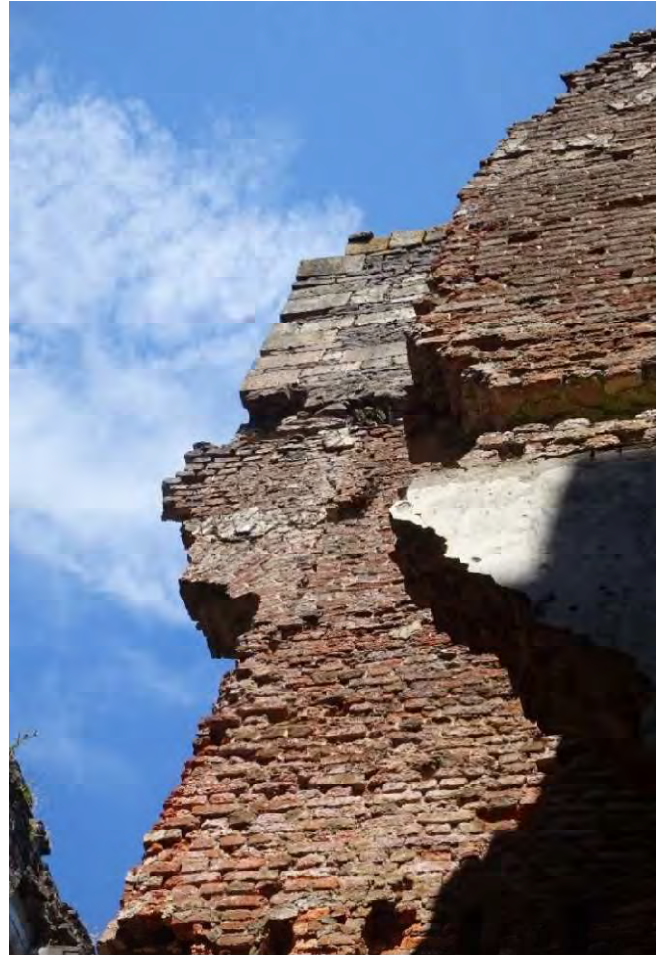
- 4.5.3.1. At second floor level in Cell G (north elevation), there is a significant patch of masonry (cross hatched in blue below) which is showing varying signs of degradation and is of significant structural concern.

- 4.5.3.2. As denoted with red lines, there is a significant crack visible on both sides of the wall which appears to suggest that this panel of masonry is separating from the rest of the wall. There is also a hole in the wall with a small badly eroded stack of masonry to the underside of the dressed stone which appears very vulnerable and is at risk of falling out.

- 4.5.3.3. Generally, the condition of this panel is very poor and there is a very significant risk of this section collapsing which has the potential to disturb and destabilise the dressed stone wall over and potentially lead to the total collapse of the wall panel.

- Risk to site users – Potential to strike building users or operatives working within the building. Collapses likely to comprise large panels falling from a significant height therefore impacts have the potential to be fatal.
Likelihood (7) / Consequence (10) / Total (7.0)
- Risk to historic fabric –Potentially significant loss of historic fabric due to loss of original masonry with potentially significant risk to surrounding masonry structure.
Likelihood (7) / Consequence (7) / Total (4.9)

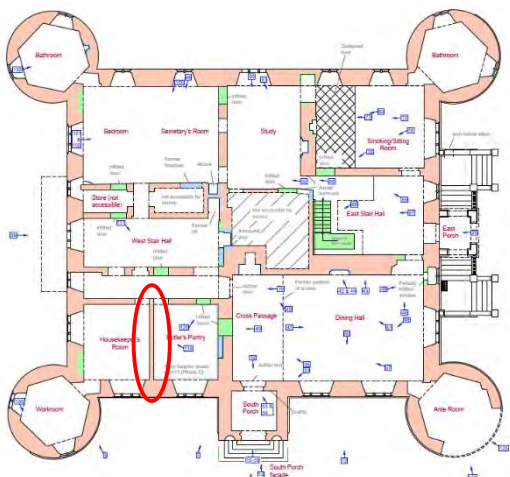
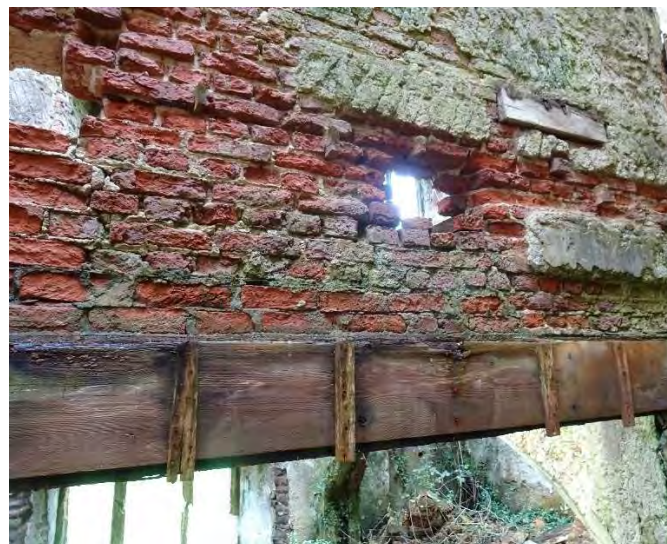
4.5.4. Cell G – Central cross wall beams and masonry panel (5.0 / 4.5)

- 4.5.4.1. The central cross wall between cells G1 & G3 is of brickwork construction and is supported on a twin pair of steel / iron beams at first floor clad both sides with timber. The masonry panel has several large voids approximately within 1m above the beam with the surviving brickwork deteriorated and locally loose. The north end of the wall is free standing, and the south end appears to be built into the south elevation of the building.
- 4.5.4.2. The beams have evidence of severe surface corrosion to both flanges, however, there does not appear to be any significant deformation of these beams, and the bearing appeared generally sound.

- Risk to site users – Potential for whole panel to strike building users or operatives working within the building. Likelihood (5) / Consequence (10) / Total (5.0)
- Risk to historic fabric – Potential for whole panel of masonry to fail in the event that the supporting beams fail, or further masonry is lost around the current voids.
- Likelihood (5) / Consequence (9) / Total (4.5)

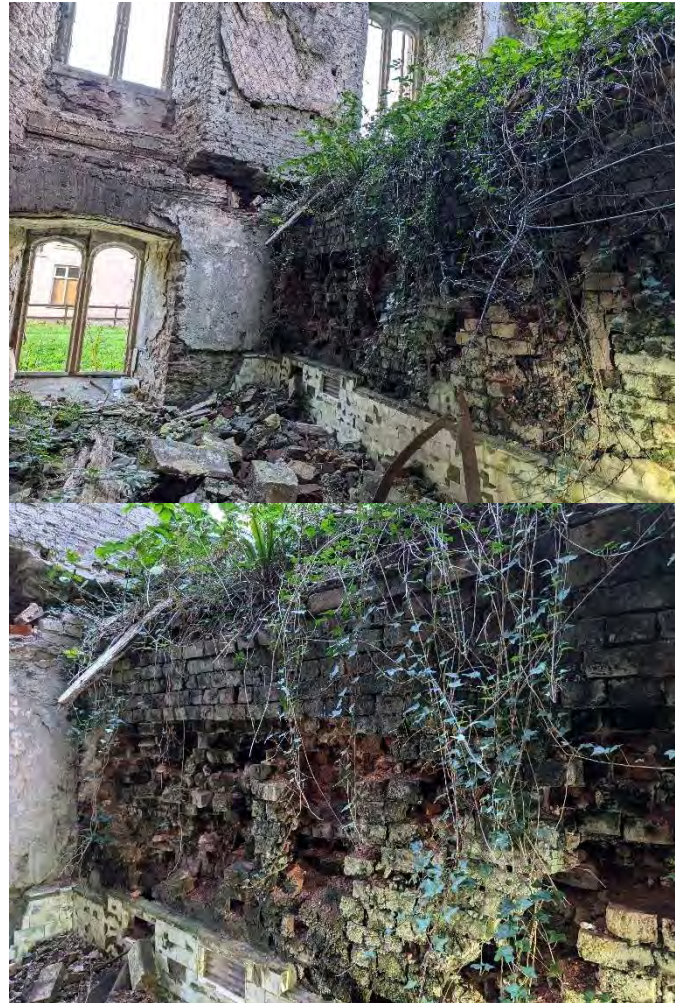
4.5.7.1. The masonry wall between the east and west larder in the vaults, has lost a significant amount of its facework on the west larder side. Approximately 50% of the face area is missing with voids of approximately 200mm in depth. The arch springing terminates just above the existing tile level therefore the deteriorated wall is resisting the thrust reactions from the vault. The loss of masonry is significantly reducing the capacity of the structure to resist these thrusts.

- Risk to site users – Failure of the west wall which could result in failure of the vault putting any users of the vaults at significant risk of harm.
Likelihood (4) / Consequence (10) / Total (4.0)
- Risk to historic fabric – Significant loss of historic fabric if the vault and wall fail, this would also likely block the current principal access into the vaults.
Likelihood (4) / Consequence (9) / Total (3.6)

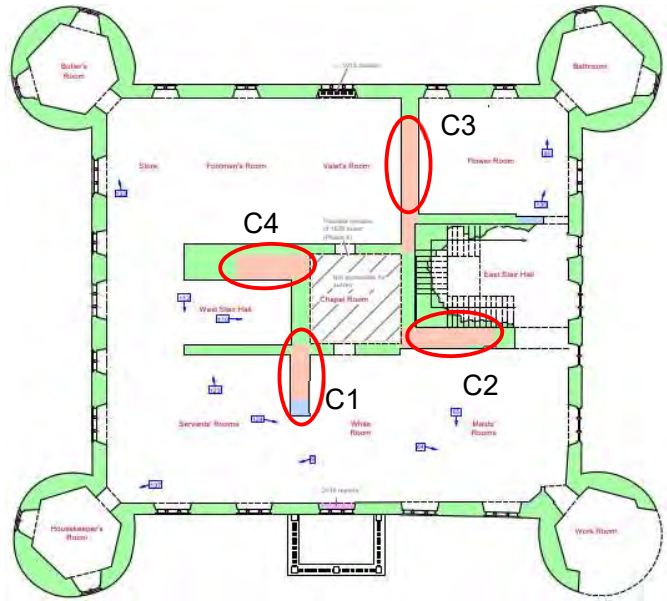
4.6.3. Chimney C1 (2.4 / 1.0)

4.6.3.1. The upper stack of chimney C1 is in very poor condition with significant structural defects putting the historic fabric at risk of collapse. There are several localised patches of masonry missing on the elevations and a significant full height crack on the east elevation of the stack which prompted a more recent phase of temporary stabilisation works. The temporary works comprised wrapping the stack in scaffolding to mitigate movement and potential collapse which would represent a significant loss of historic fabric and significant risk to building users.

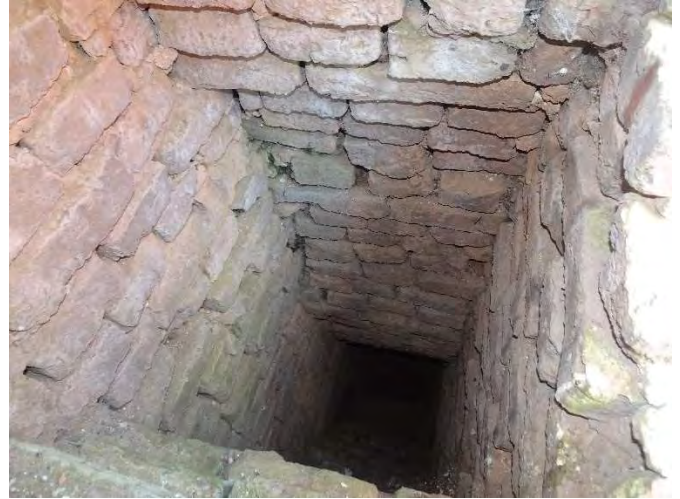
4.6.5.1. The stack of chimney 3 is in poor condition with some localised areas in very poor condition. On the east elevation there are large patches of brickwork missing exposing the flues, with remaining masonry in a significantly deteriorated state. The upper stack has a crack on the south end of the chimney which suggests movement within the masonry. The stonework is generally missing pointing. The stone capping to the chimney appears to be generally in reasonable condition.

4.6.5.2. Inspection within the holes into the flues on the east elevation of the stack identified that the masonry cross walls appear to be in reasonable condition generally.

- Risk to site users – Continued degradation of the facework particularly about the significant voids is likely to loosen localised patches of brickwork with the potential of striking building users.
Likelihood (6) / Consequence (7) / Total (4.2)
- Risk to historic fabric – Continued loss of historic brickwork about the exposed flues which reduces the overall robustness of the masonry panel with the potential to cause further localised collapses.
Likelihood (6) / Consequence (5) / Total (3.0)

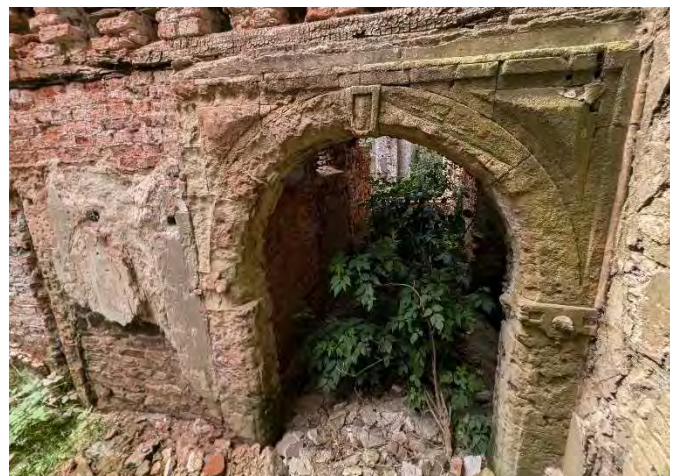
- 4.8.4.1. Generally, where inspected lintels and door openings were in reasonable condition with some localised areas in poor condition where jambs or heads shows signs of deteriorating masonry. These openings have been highlighted in GREEN on the appended condition summary sketches.
- 4.8.4.2. Progression is likely limited to long term degradation by means of vegetation or weather attack which has the potential to cause deterioration to the masonry.

4.8.4.3. AMBER defects where doorways are in poor condition are located in the following areas - First Floor (D1, D3, D4, D7, D16, D17), Second Floor (D1, D4A, D4, D5, D6, D7, D8, D9, D10, D12, D14, D15A, D16, D16A), Third Floor (D1, D3, D5).

4.8.4.4. Missing lintels leaving remaining masonry poorly supported and vulnerable to further localised deterioration which has the potential to accelerate fabric loss. Where lintels are missing the masonry panels over appear to have generally collapsed and are currently corbelling (somewhat stable) in their current state.

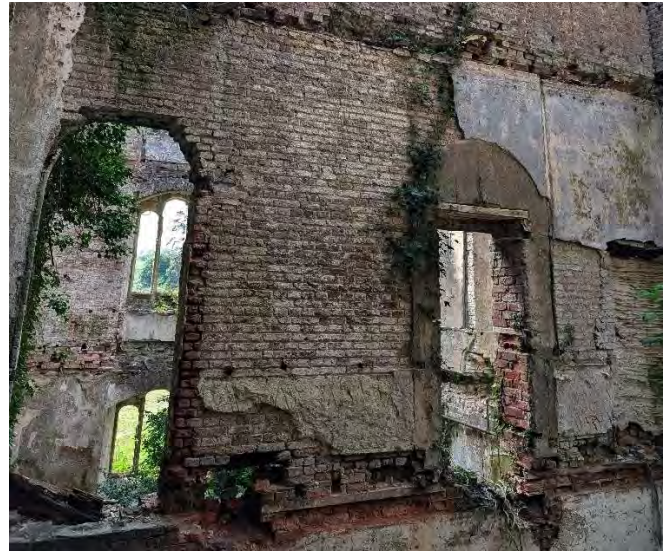
Cell D West Wall

4.8.4.6. Degraded or poorly constructed brickwork jambs separating from older masonry and at risk of localised collapse of whole sections of masonry.

- Risk to site users – Potential to strike building users or operatives working within the building.
Likelihood (4) / Consequence (5) / Total (2.0)
- Risk to historic fabric – Minor loss of historic fabric if newer panels fall onto historic masonry and cause damage. Likelihood (4) / Consequence (2) / Total (0.8)

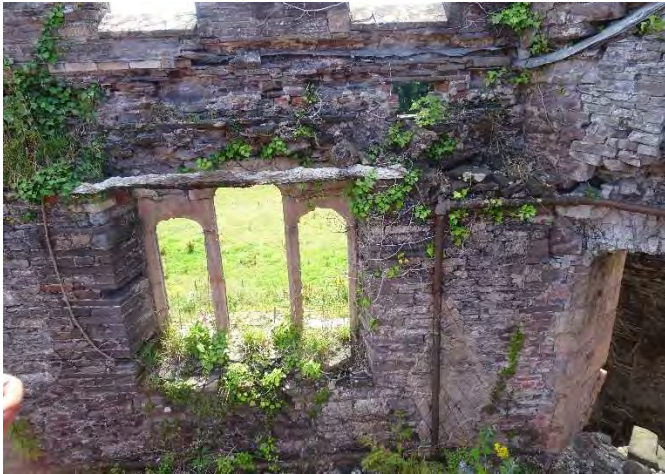
Opening W17

- 4.8.5.1. Location / Reference – All windows at 3rd Floor except for W16 and W13. The most significant defects of concern occur at windows W12, W17, W8.
- 4.8.5.2. Generally, all lintels have been lost from the head of the windows on all elevations at third floor level, and the masonry panel which would have sat on lintels have been lost. The remaining masonry on the shelves formed by the historic collapses is loose and vulnerable.
- 4.8.5.3. At opening W12, the existing iron lintels are significantly corroded and is at risk of failing and causing the panel of masonry over to collapse similar to what has occurred elsewhere.
- 4.8.5.4. At W17 and W8, the lintels have already failed and are loose in their current locations therefore at risk of falling to ground.

4.8.5.5. The current impact of this defect is a general reduction in the robustness of the wall heads with the potential for further loss of historic fabric. This defect is likely to accelerate with ongoing weather and vegetation attack.

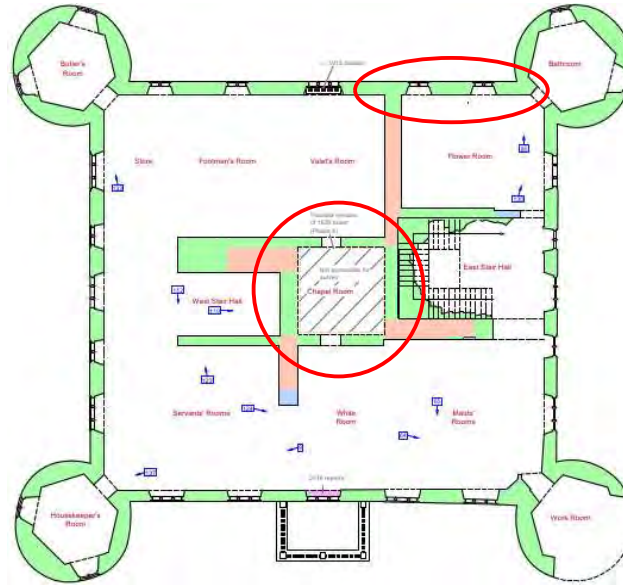
4.9.2.1. Location / Reference – This defect applies to all wall heads across the building. The south wall of Cell E has a large panel of ivy growth covering the east of the elevation. Significant tree growth on the north wall of Cell C. Large tree growth in Cell H making it inaccessible and not inspectable. Ivy and tree growths to heads of all towers apart from the SE Tower.

4.9.2.2. Vegetation is causing degradation of the masonry fabric in several areas around the building. Where present, Ivy and other plant species including buddleia have rooted between and behind masonry units degrading the joints and thereby loosening localised or clusters of bricks / stonework.

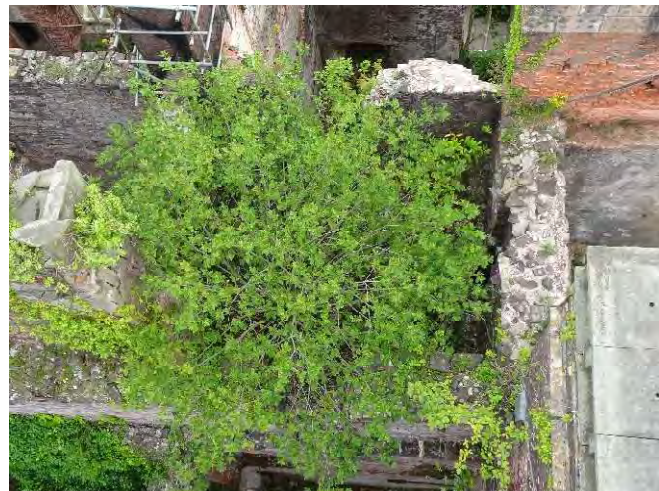
Cell H - 3rd Floor Level

4.9.2.4. The current impact of this defect is a general reduction in the robustness of the masonry (in particular wall heads) with the potential for further loss of historic fabric. Vegetation is likely to continue without intervention which is likely to accelerate degradation and loss of historic masonry.

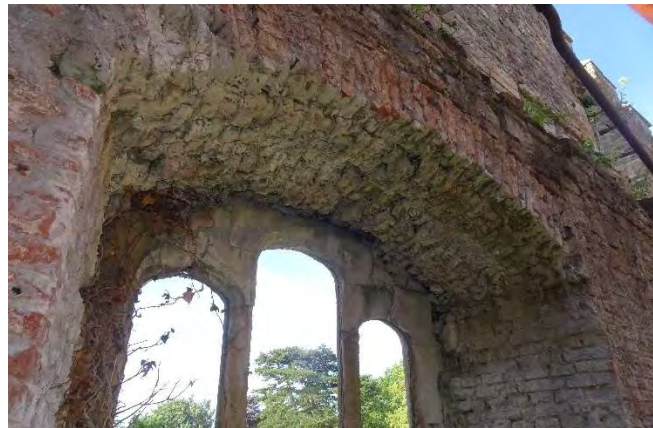
4.9.3.2. Generally, brick arches over window openings are in reasonable condition and very locally in poor condition. Where in poor condition the arches are missing very localised bricks, have degraded / weathered bed joints between brick courses however appear to be performing adequately in their slightly deteriorated state.

4.9.3.3. The current impact of this defect is a general reduction in the robustness of the brick arches with the potential for further loss of historic fabric.

- Risk to site users – Potential to dislodge localised bricks / clusters of masonry which could fall onto building users or operatives working within the building.
Likelihood (1) / Consequence (8) / Total (0.8)
- Risk to historic fabric – Potentially significant loss of historic fabric due to loss of original masonry with minor risk to surrounding masonry structure.
Likelihood (2) / Consequence (7) / Total (1.4)

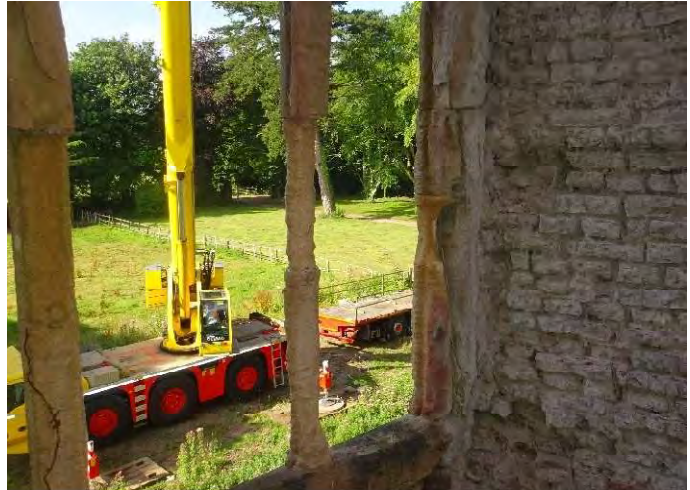
4.9.4.2. Window mullions are showing varying signs of degradation and erosion. Generally, mullions of the majority of the windows are significantly eroded with varying levels of section loss putting the remainder of the window surrounds at risk of failing resulting in a loss of historic fabric.

- Risk to site users – Continued deterioration of the mullions and spandrel panels puts the windows at risk of losing large sections of historic fabric which have the potential to fall onto persons using the building.
Likelihood (2) / Consequence (7) / Total (1.4)
- Risk to historic fabric – Potential loss of window mullions and spandrel panels if degradation continues. However, there are several windows of this type across the building therefore is likely a minor impact on overall historic fabric.
Likelihood (5) / Consequence (3) / Total (1.5)

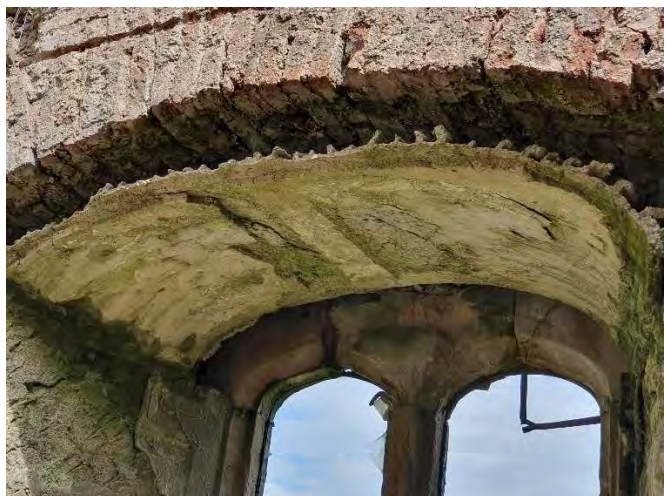
4.9.5.2. Remaining lath and plaster finishes across the castle (where inspected) are in variable condition. In cells E&F the plasterwork where present was noticeably in reasonable condition considering the exposed environment. Where in poor condition the plaster is loose and at risk of falling from height in small to large pieces. At one location, as shown in the photograph, the historic plaster on the underside of opening W9 at second floor in cell B has separated from the arch and appears very loose.

4.9.5.3. The current risk is a loss of potentially significant historic plasterwork and potential risk to building users as a result of falling debris.

- Risk to site users – Continued deterioration of the plaster at risk of causing large sections of historic fabric to fall with the potential to fall onto persons using the building.
Likelihood (3) / Consequence (5) / Total (1.5)
- Risk to historic fabric – Loss of historic plasterwork through continued degradation however is likely a minor impact on overall historic fabric.
Likelihood (3) / Consequence (3) / Total (0.9)

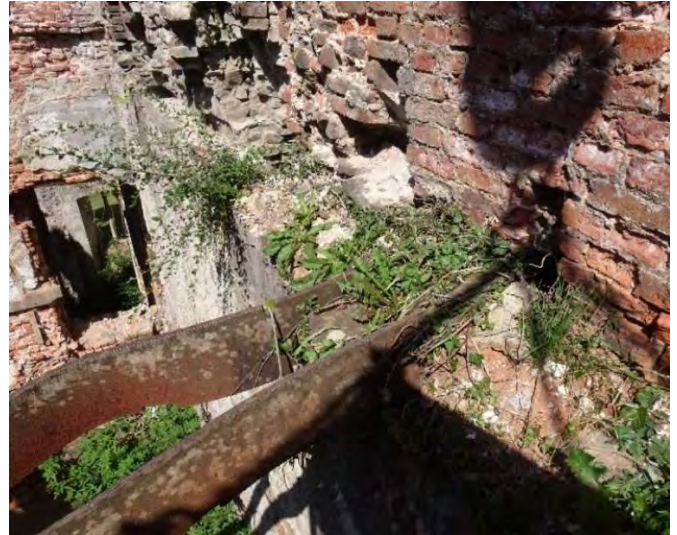
- 4.10.1.1. The surviving flitch plates of the original floor beam are heavily deformed (due to historic fire damage) and showing evidence of corrosion generally due to the exposed environment. The iron plates appear stable in their current state and are of historic significance.

- 4.10.1.2. Progression is likely to comprise continued corrosion and delamination to the ironwork with the potential to lose small sections in the future. Excessive deterioration has the potential to dislodge the beams and may present a risk to building users and a significant loss of historic interpretation.

- Risk to site users – If the flitch plates were to fall to ground there would be a moderate risk of injury to site users.
Likelihood (3) / Consequence (6) / Total (1.8)
- Risk to historic fabric – Continued degradation of the plates and potential loss of these flitch plates from their current location would represent a significant loss in historic fabric as the only surviving beam in its original position.
Likelihood (5) / Consequence (8) / Total (4.0)

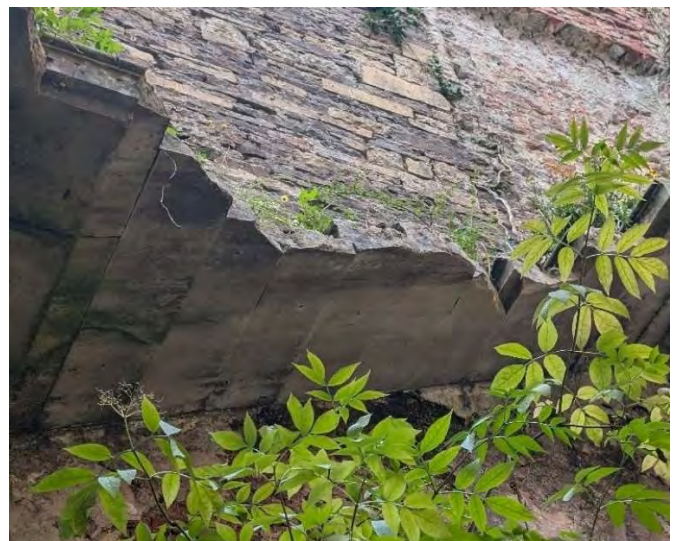
- 4.10.2.1. The remains of the cantilever stone staircase in Cell B generally appear to be in stable in its current state with some very localised areas of cracking observed to individual treads observed.

- 4.10.2.3. Landings at floor levels were briefly inspected and were found to be locally fractured and friable therefore there is a risk of pieces of masonry falling from height and onto building users.

4.10.2.4. Progression is likely to comprise continued weathering of the stone treads with the potential for further loss of sections of the treads where already cracked.

- Risk to site users – Potential to strike building users or operatives working within the building.
Likelihood (3) / Consequence (6) / Total (1.8)
- Risk to historic fabric – Minor loss of historic fabric due to loss of original masonry with minor risk to surrounding masonry structure.
Likelihood (3) / Consequence (3) / Total (0.9)

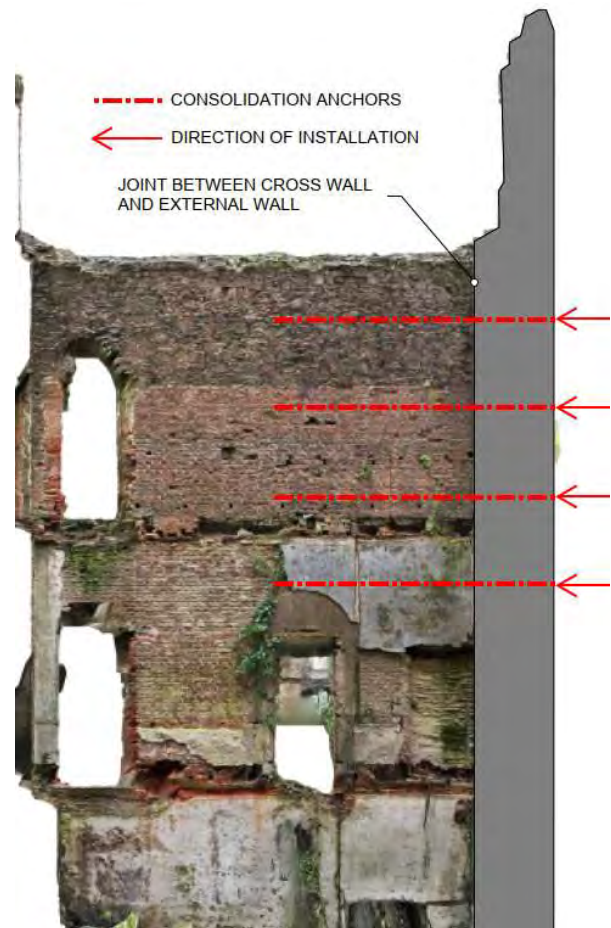
5.3.6. The adjacent sketch shows an initial proposal for the west wall of Cell D with anchors installed from outside to inside.

5.3.4. The anchors will enhance the capacity of the wall and its ability to resist lateral wind loading, and help mitigate the risks of whole wall panels falling into building which would be a considerable health and safety risk and a significant risk to the monument. They should also reduce requirements for temporary works to restrain the internal elevations during the works and permit the use of a more traditional access scaffold to undertake repair works to the joints and to the wall panels generally.

5.3.5. Anchors can be installed generally from outside the building which would be favourable from a general health and safety and risk to operatives' perspective.

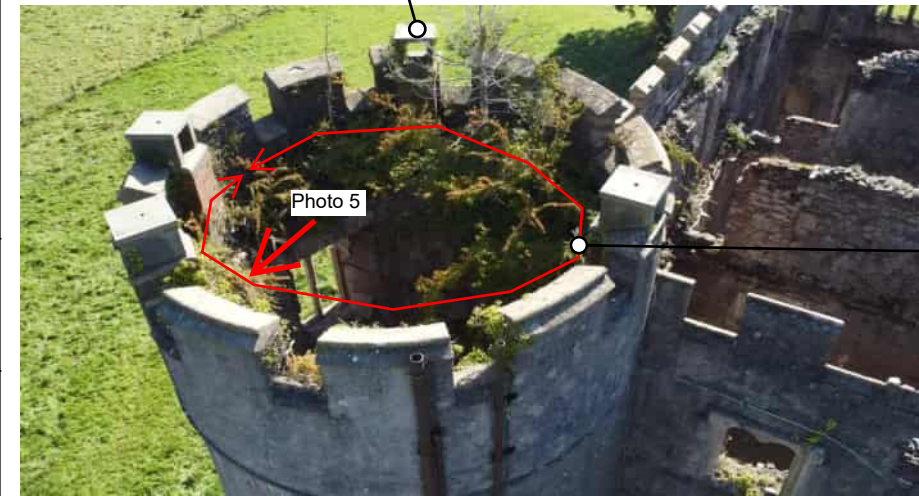
Photo 5

Significant vegetation along head of full perimeter of tower. Significant shrub on south side. Masonry at wall head significantly deteriorated by ongoing vegetation growth and weather attack.

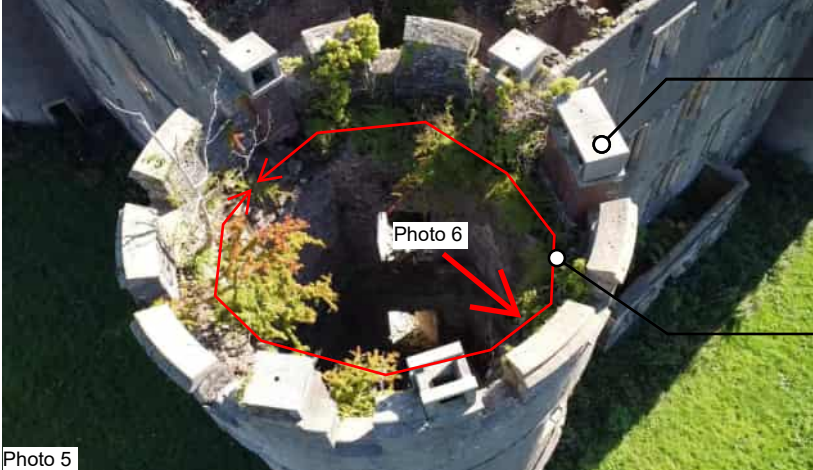
Photo 5

The NW Tower has 6 No. visible chimney stacks on the roof with flues that continue through the masonry walls below.

Significant Vegetation along head of full perimeter of tower. Significant shrub on north side. Masonry at wall head significantly deteriorated by ongoing vegetation growth and weather attack.

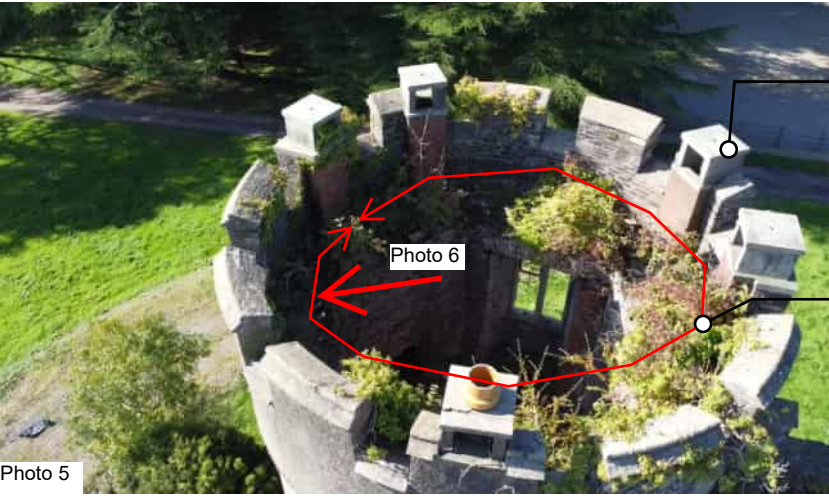
Photo 5

The tower has 5No. visible chimney stacks on the roof with flues that continue through the masonry walls below.

Significant Vegetation along head of full perimeter of tower. Significant shrub on north side. Masonry at wall head significantly deteriorated by ongoing vegetation growth and weather attack.
