Godre'r Graig Primary School, Godre'r Graig Preliminary Investigation and Additional Assessment

Report Reference: ESP.7234e.02.3302

Godre'r Graig Primary School Preliminary Investigation and Additional Assessment

Prepared for:
Neath Port Talbot County Borough Council
 The Quays, Baglan Energy Park,
 Brunel Way, Briton Ferry,
 SA11 2GG

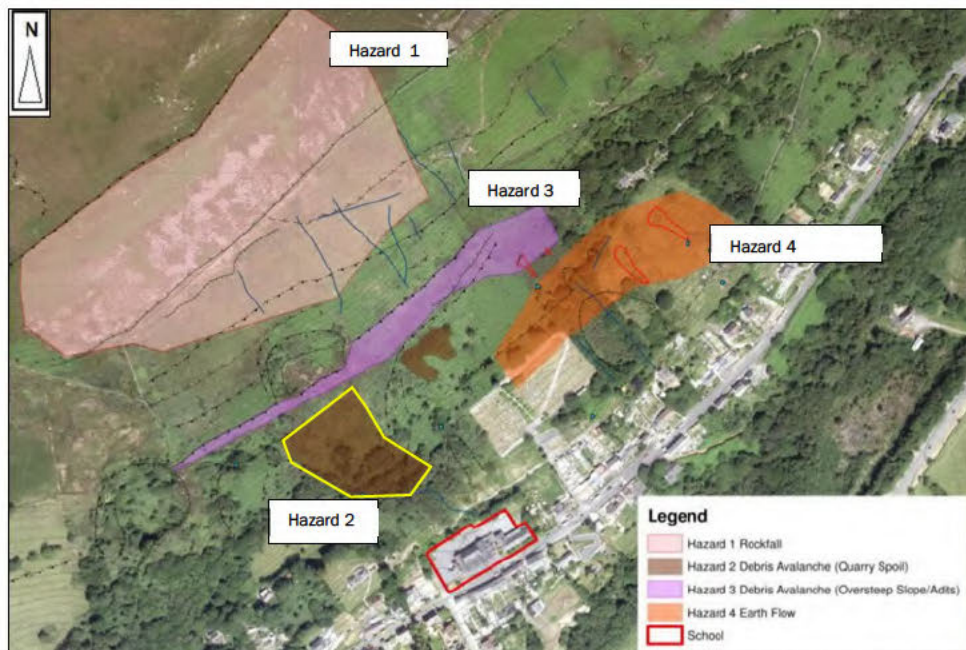
A Landslide Hazard and Risk Assessment for the terrain above the school was undertaken primarily to identify risks from potential landslides. The assessment identified four types of landslide hazards in the study area, two of which are natural and two are man-made. The hazards are outlined below, and their locations shown on Insert 3:

- Hazard Type 1: Rock fall initiating from outcrops of the Rhondda Sandstone
- Hazard Type 2: Impact from debris avalanche initiating from quarry spoil.
- Hazard Type 3: Impacts from debris avalanches originating from the over steep slope associated with the working of the Upper Pinchin seam.
- Hazard Type 4: Shallow earth slides.

Insert 3: Extract from Hazard Location Map taken from previous report ESP, 2019. Site 2 is highlighted in yellow.

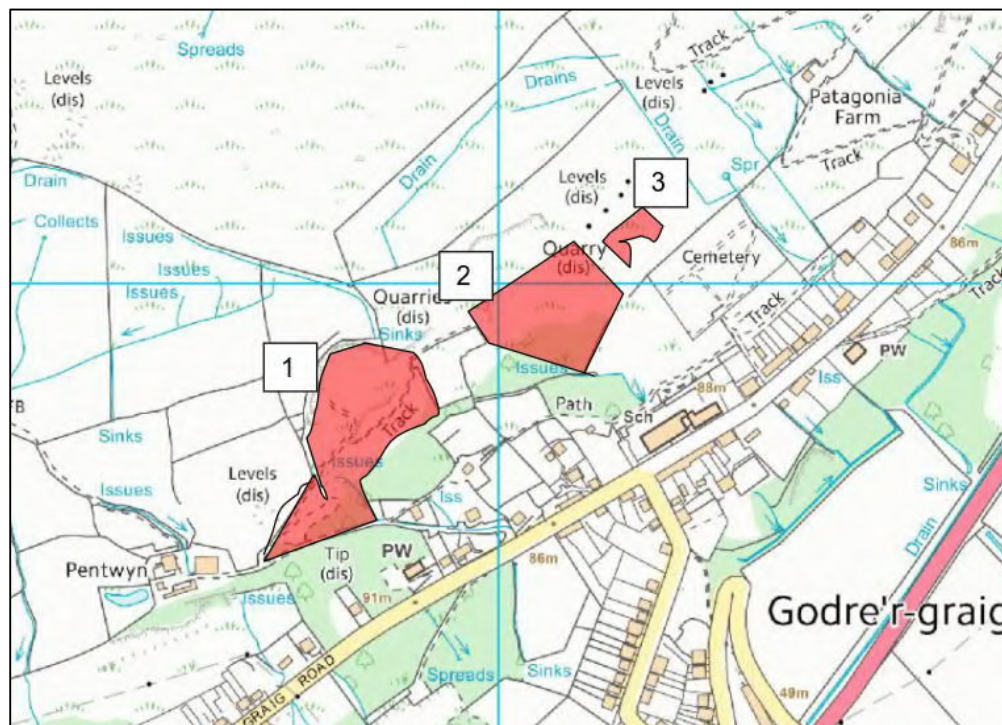
Insert 4: Extract from Coal Authority Report. Site Locations shown by red polygons.

The Coal Authority provided recommendations, considerations and actions for all three sites, however, pertinent recommendations for their site 2, which is the Spoil Tip above the school are replicated below:

- Although they suggest it unlikely, they speculated that a major failure of the spoil tip would be able to reach Godre'r Graig School;
- Consider clearing vegetation to allow inspection of drainage routes at Site 2;
- Consider undertaking a slope stability analysis for Site 2 based on available information supplemented by ground investigation; and
- Undertake an inspection during winter, when vegetation has died back to allow a more detailed viewing of the site with less vegetation constraints. The requirement for further inspection should be determined following the winter inspection.

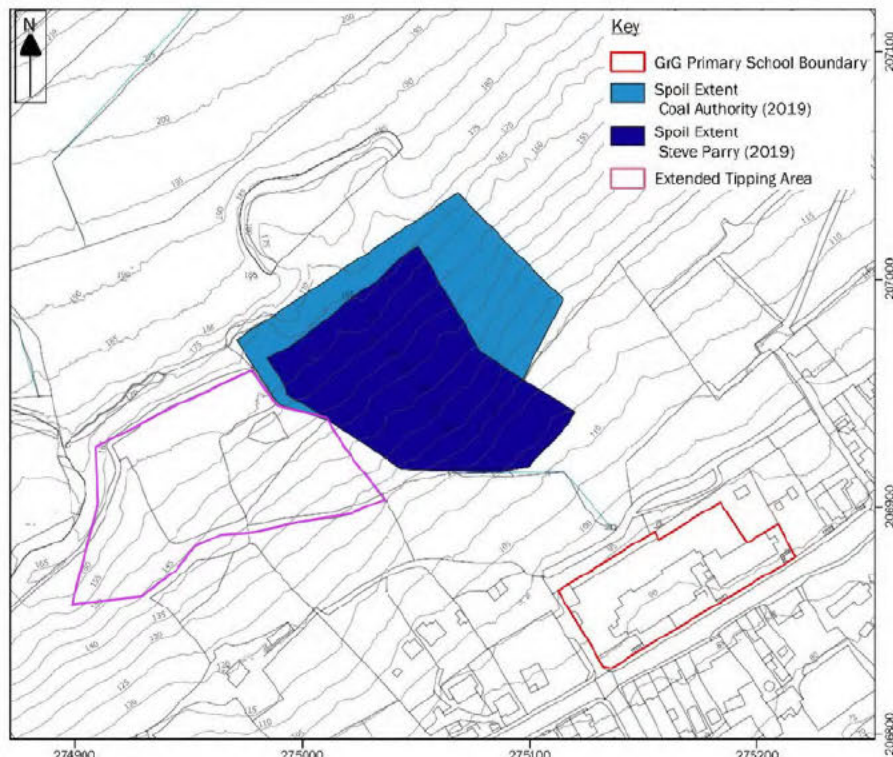
Insert 5: Preliminary Spoil Extent Boundaries identified by the Coal Authority and ESP/PEGS (2019).

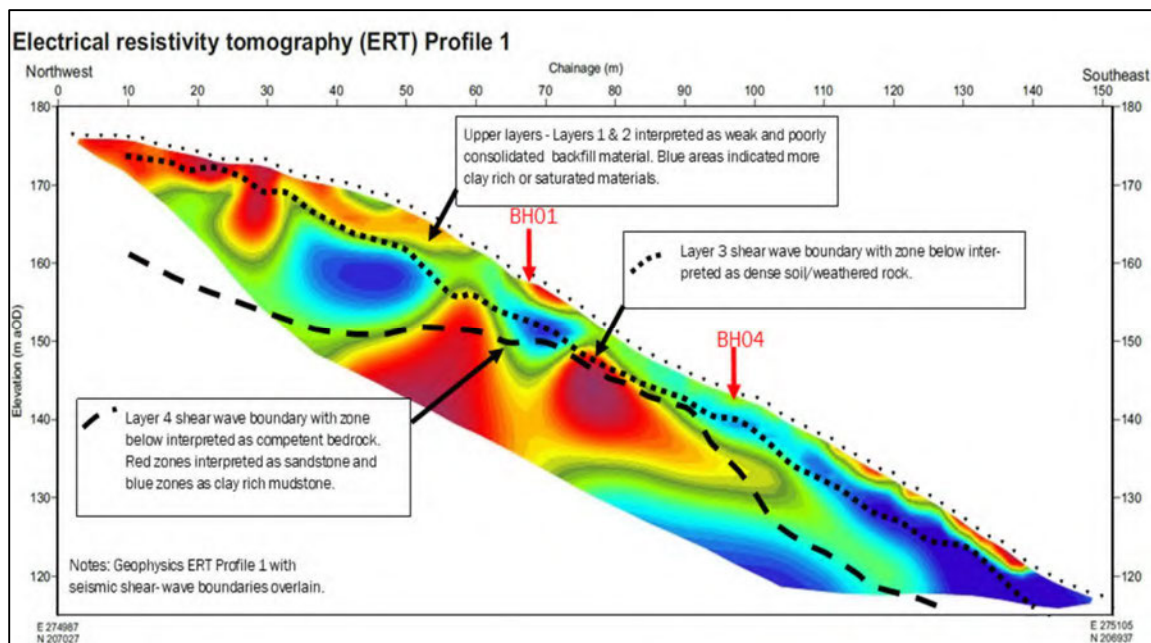
In the lower portions of the slope, the more conductive material is present at shallower depths and becomes indistinguishable from the unit interpreted as mudstone bedrock. Trial pitting in the area indicates this portion of the layer may represent clay rich Glacial Diamicton.

Laterally across the area, the resistivity survey indicates a deeper portion of dry backfill material to the west with a pinching out of the conductive backfill layer. This coincides with a marked drop in the S-wave refraction boundary and is indicative of deeper rockhead. The more conductive backfill is consistently present to the east which may be representative of the excavation related to the Upper Pinchin coal seam. On the lower portions of the slope, the Profile 2 indicates a possible shallowing out of the backfill material to the east and may represent the western extent at this level. Profile 2 corresponds with the location of former adits identified by the Coal Authority and in the historical mapping.

Insert 9: Summary of geophysical data (ERT and Seismic data) interpolated from Terradat report (2019). Full report displayed in Appendix K.

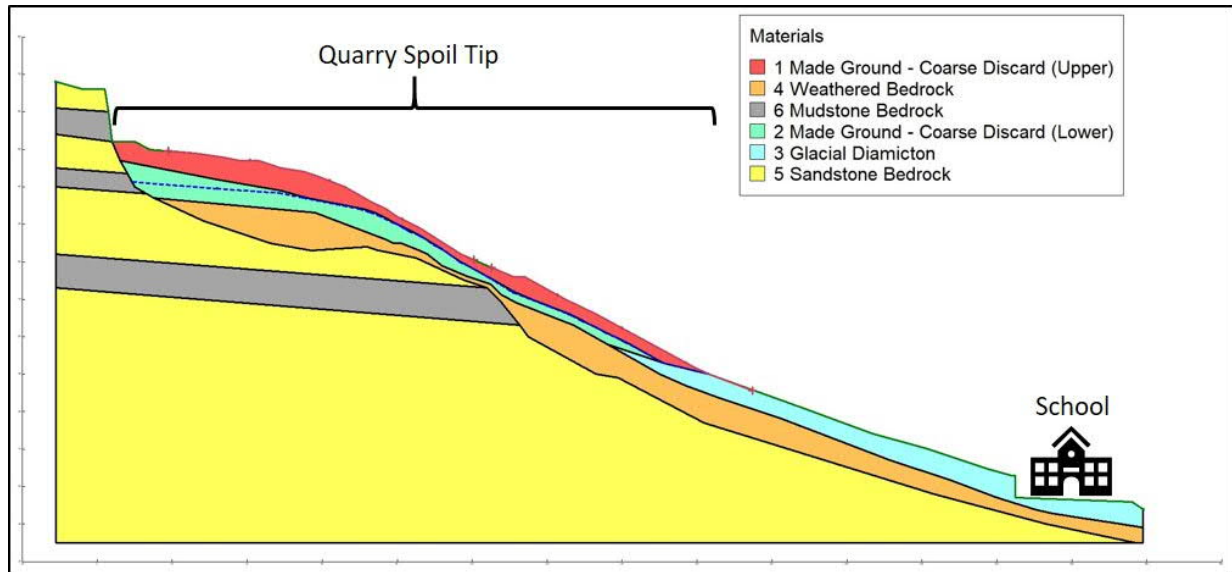
Initial groundwater monitoring data, along with visual observations has been used to draw an anticipated piezometric line (Water Table) in the Ground Model.

Insert 10: SlopeW digital Ground Model
