Bro Tathan East Building 354 External & Internal Visual Condition Survey

| Report Ref: | PR01 | Created | 19/06/24 |

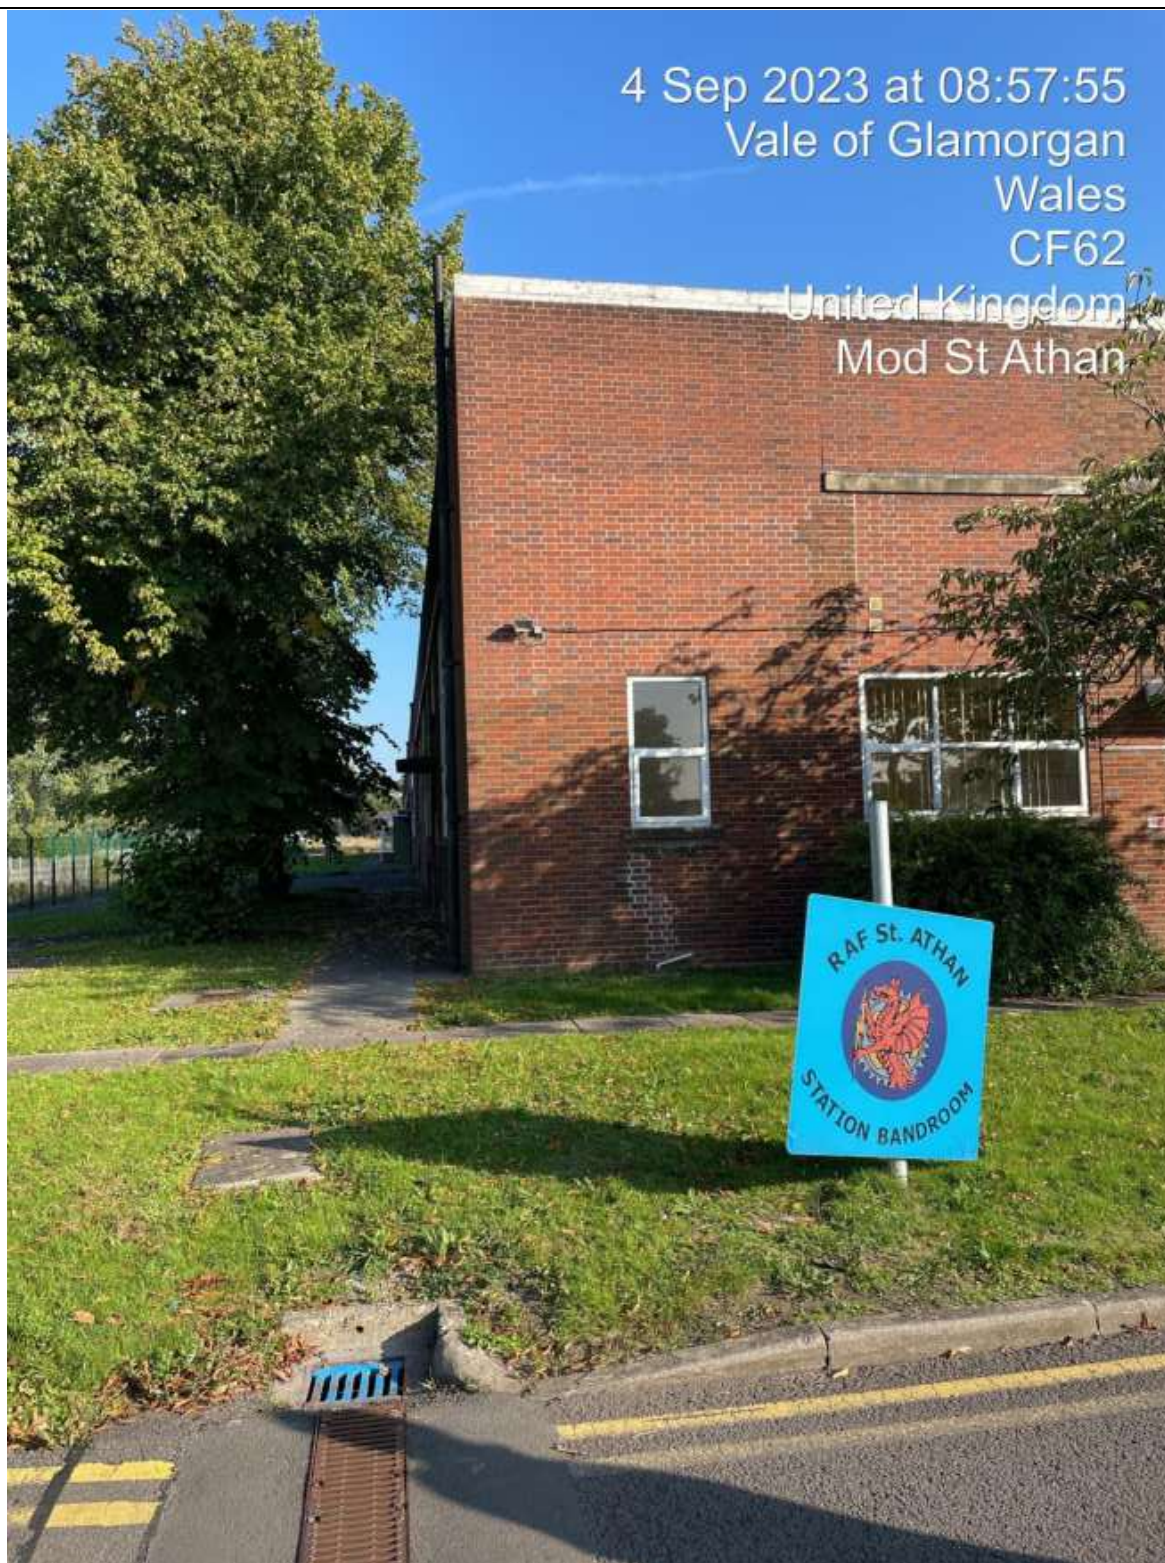
**Corner of Southern & Western Elevations. Note the Replacement Brickwork & Replacement Fenestration**

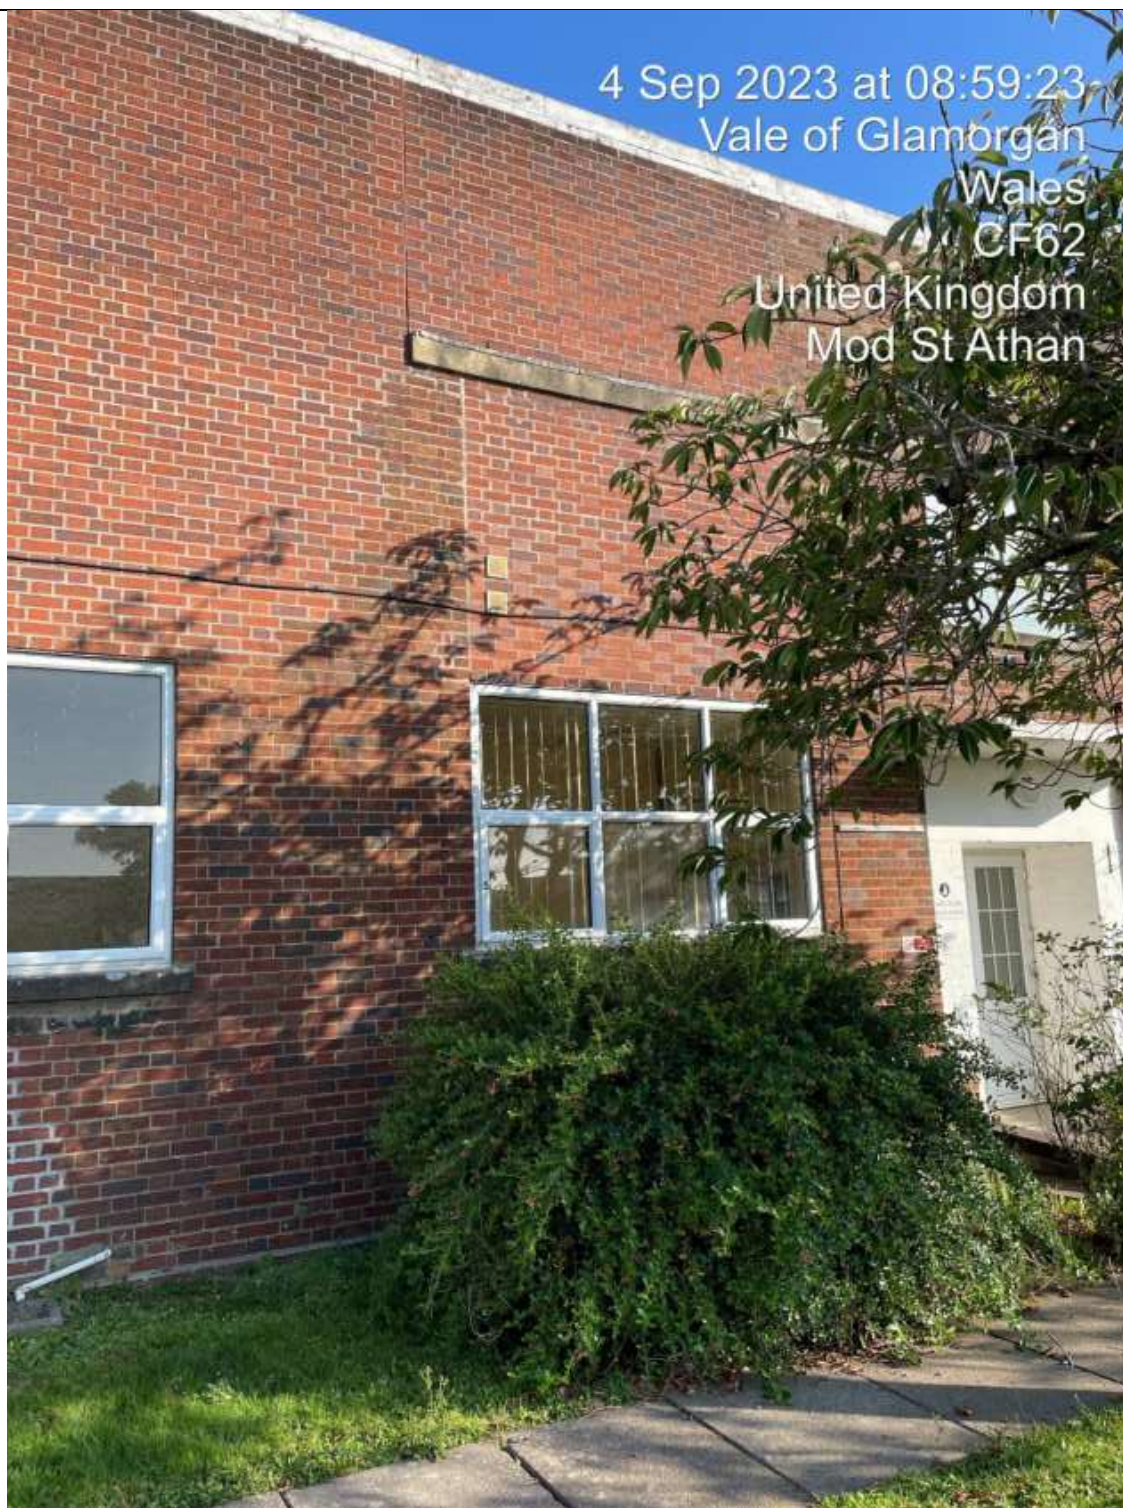
**Southern Elevation. Note the Replacement Brickwork & Replacement Fenestration.**

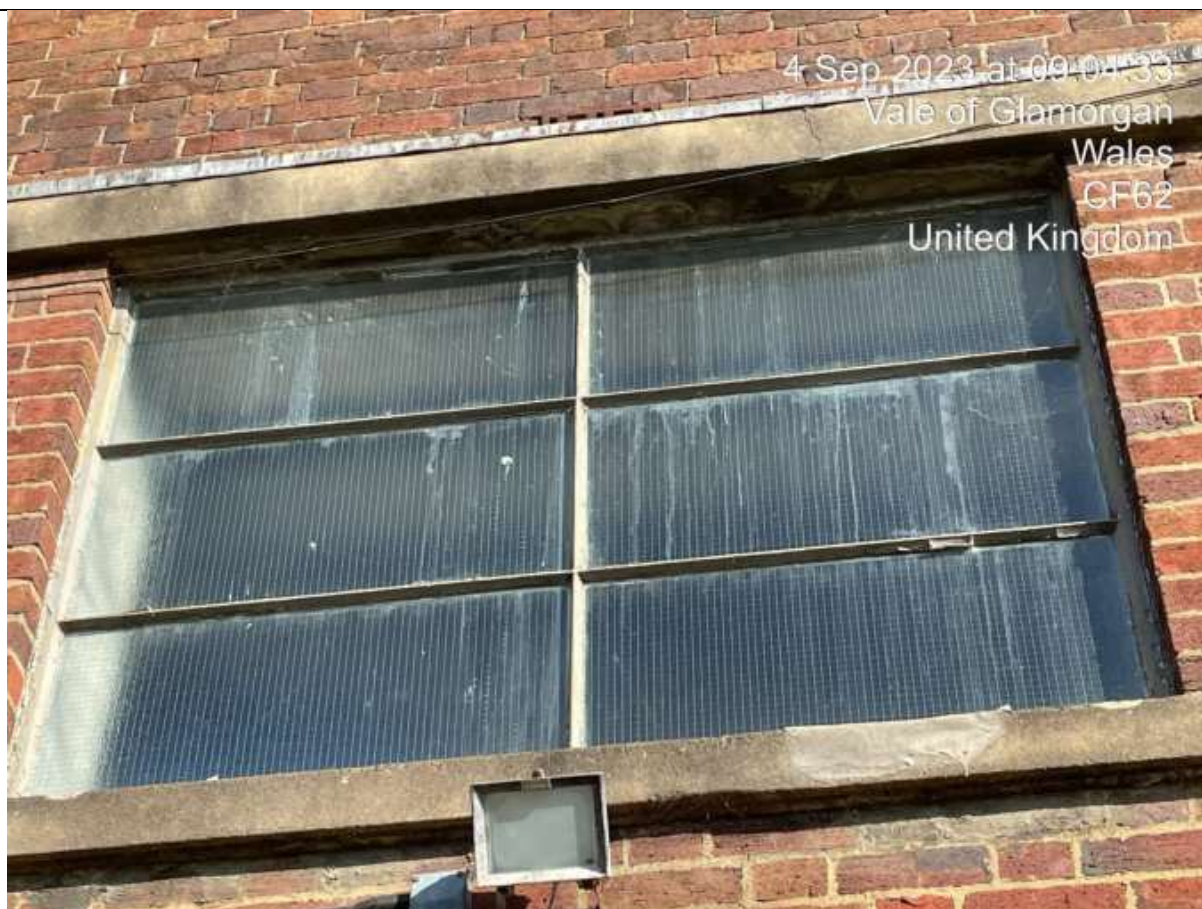
**Southern Elevation. Original Fenestration but Non-Original Glazing.**

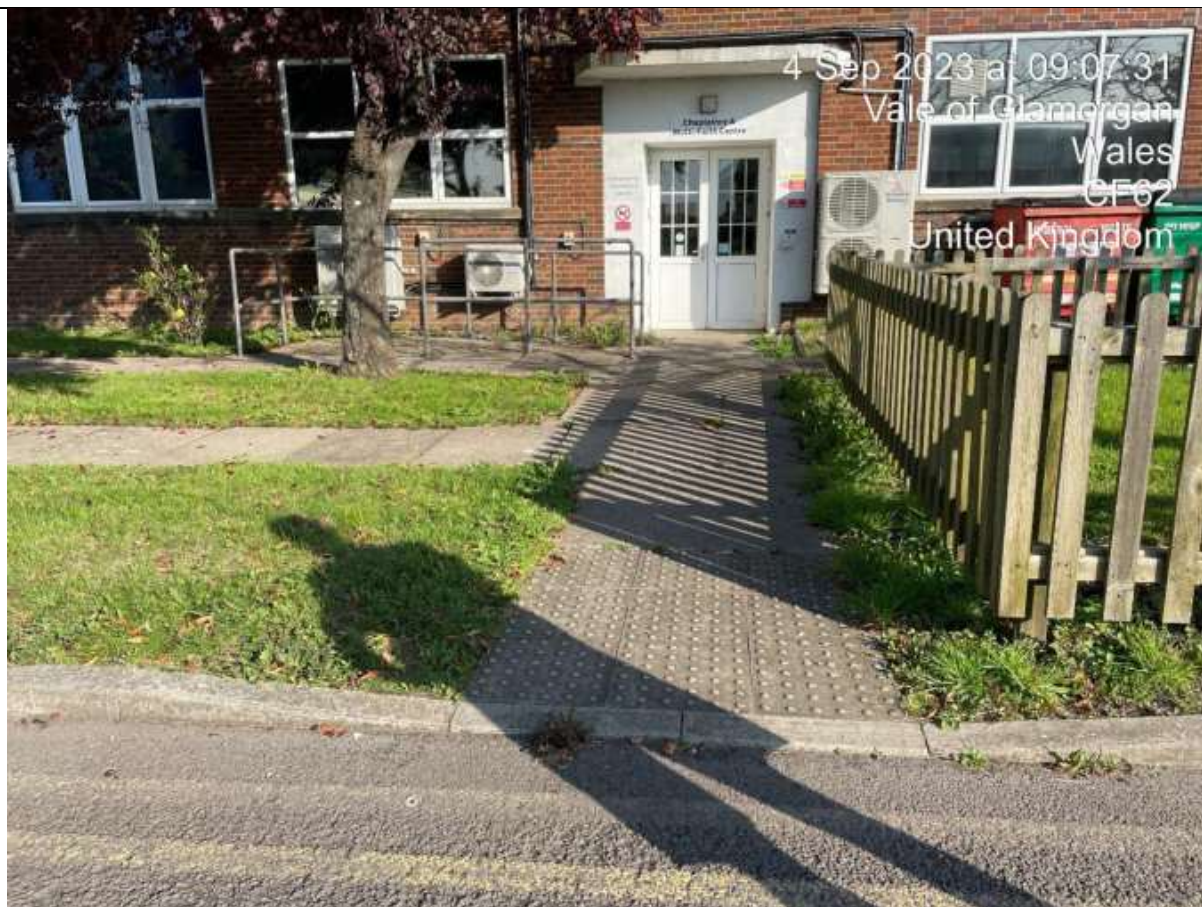
**Southern Elevation. Non-Compliant Entrance to Chaplaincy & Multi-Faith Centre.**

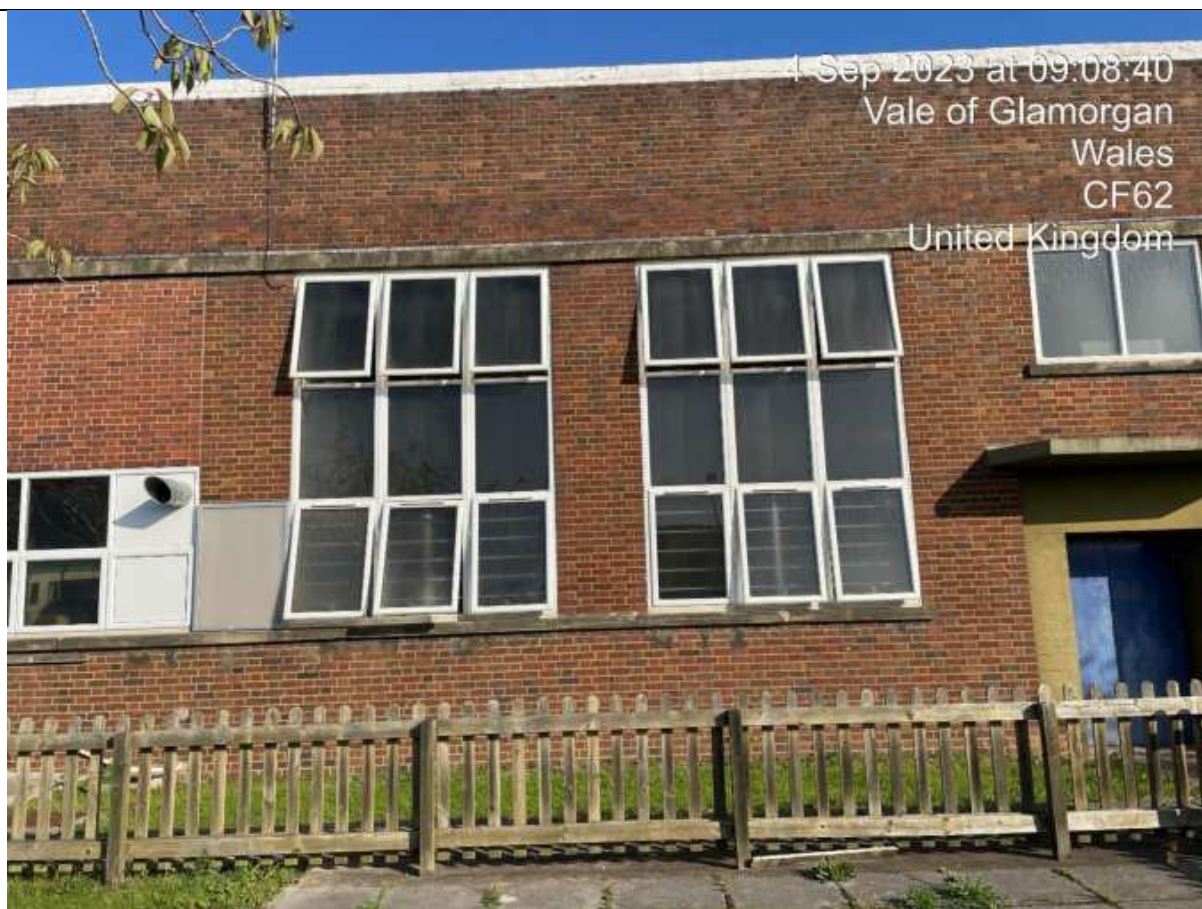
**Southern Elevation. Note the Replacement Brickwork & Replacement Fenestration.**

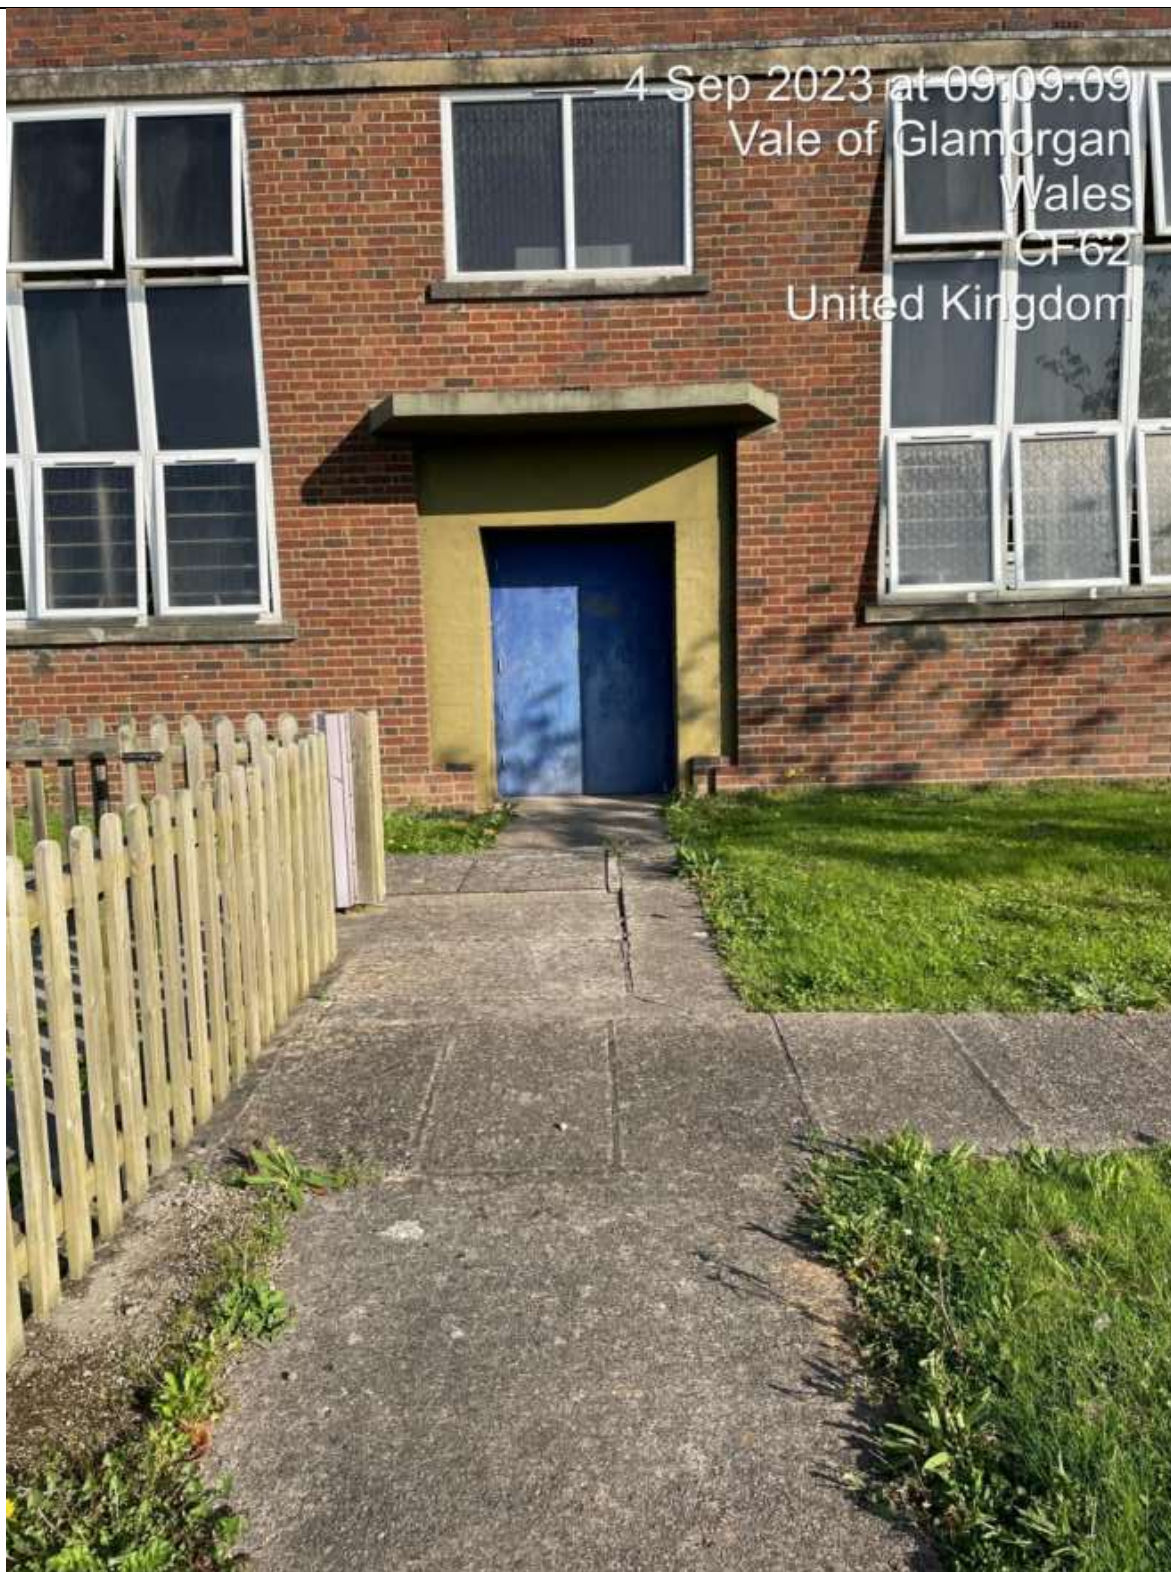
**Southern Elevation. Non-Compliant Entrance with Trip Hazards.**

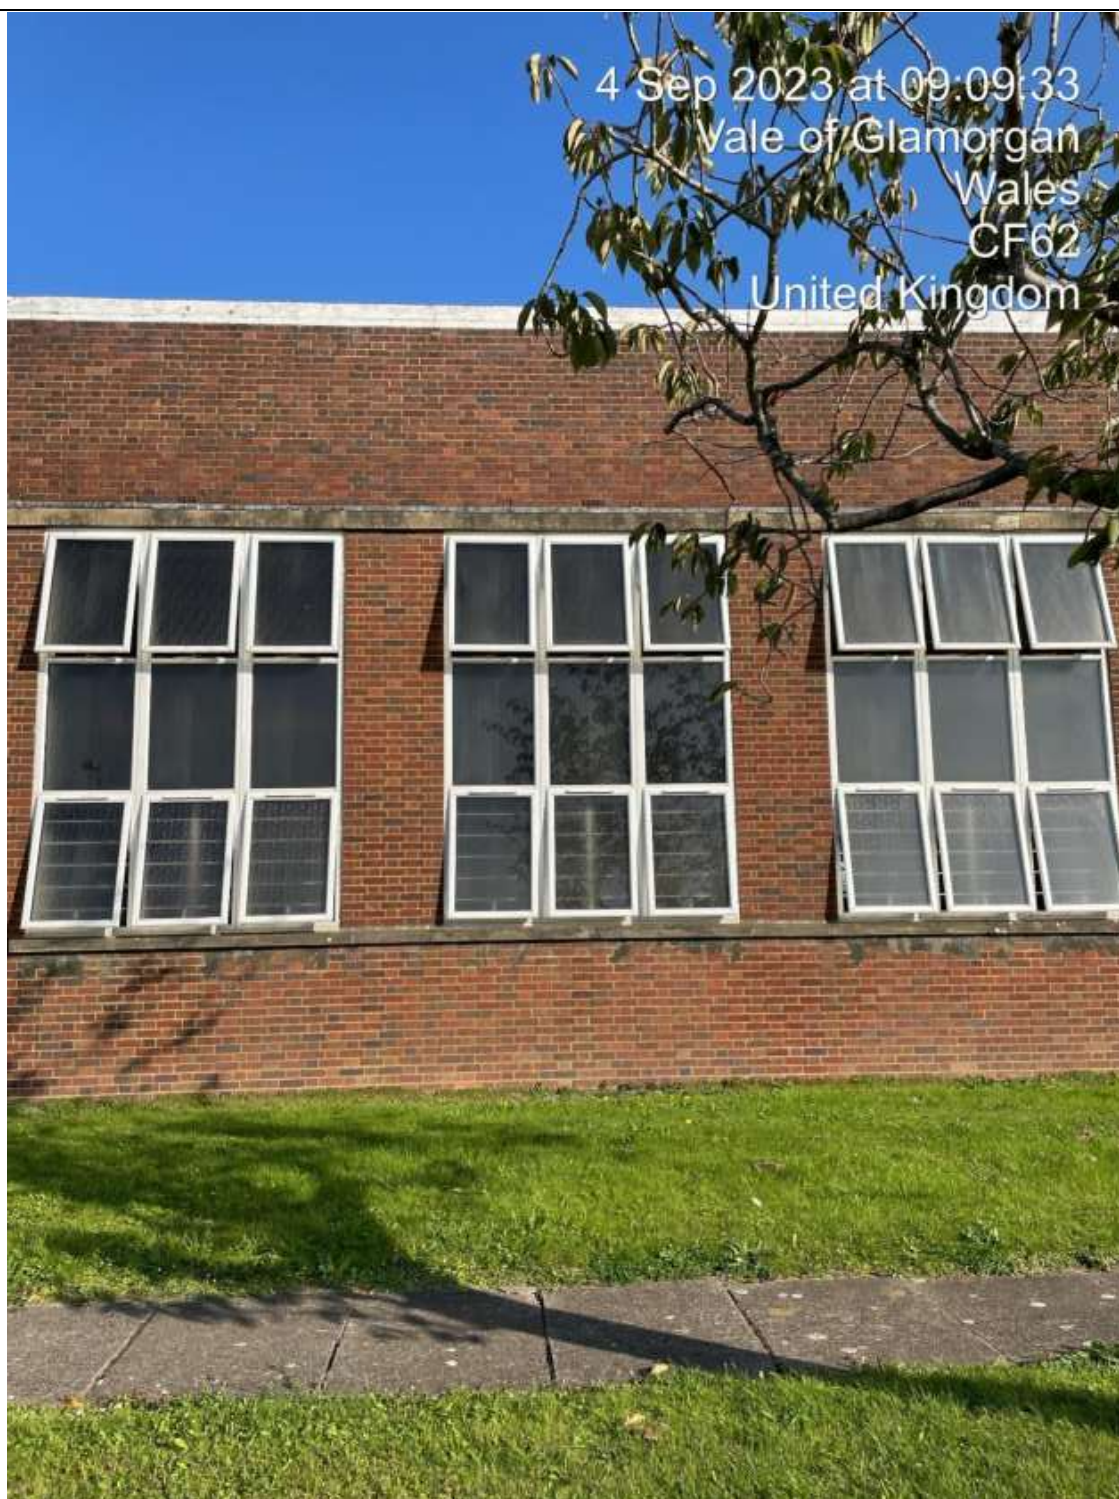
**Southern Elevation. Replacement Fenestration.**

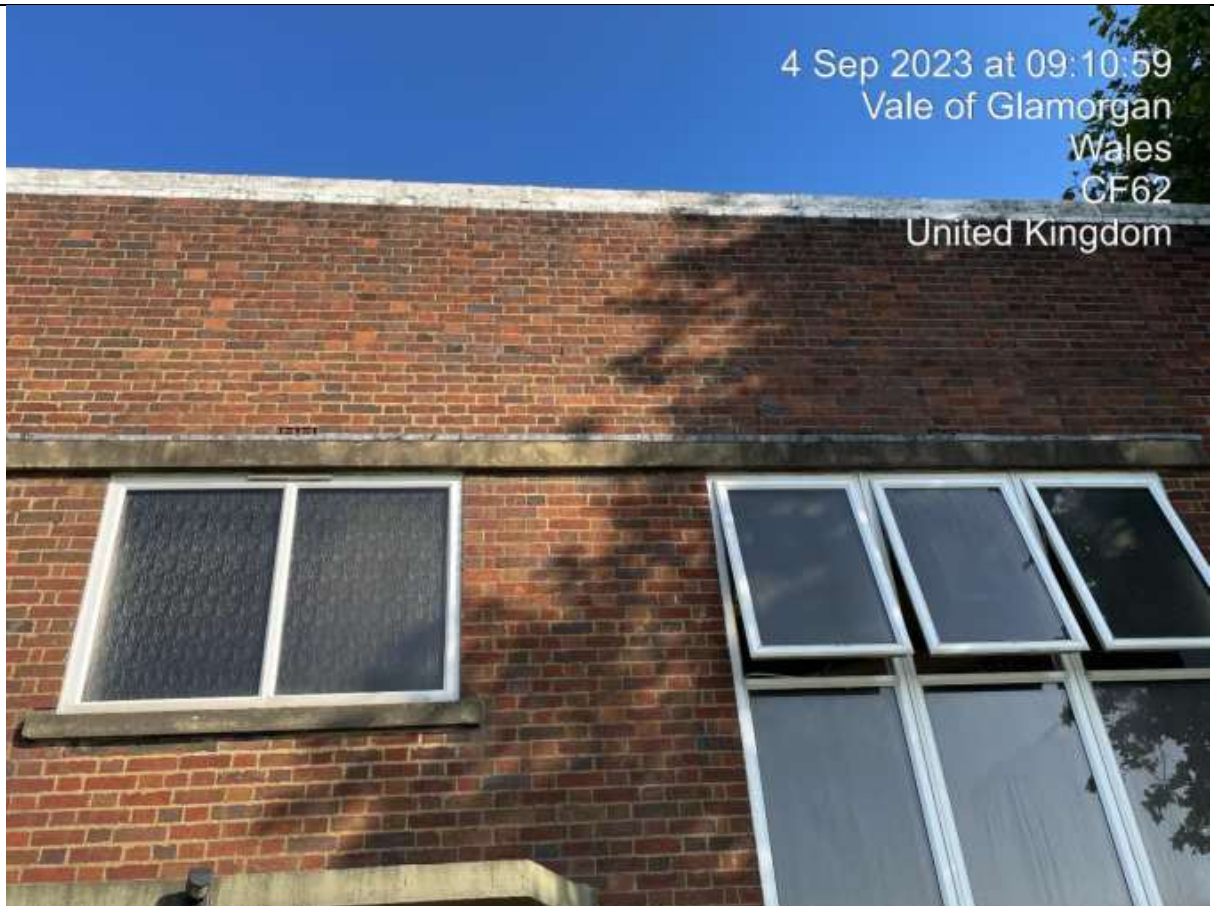
**Southern Elevation. Replacement Fenestration.**

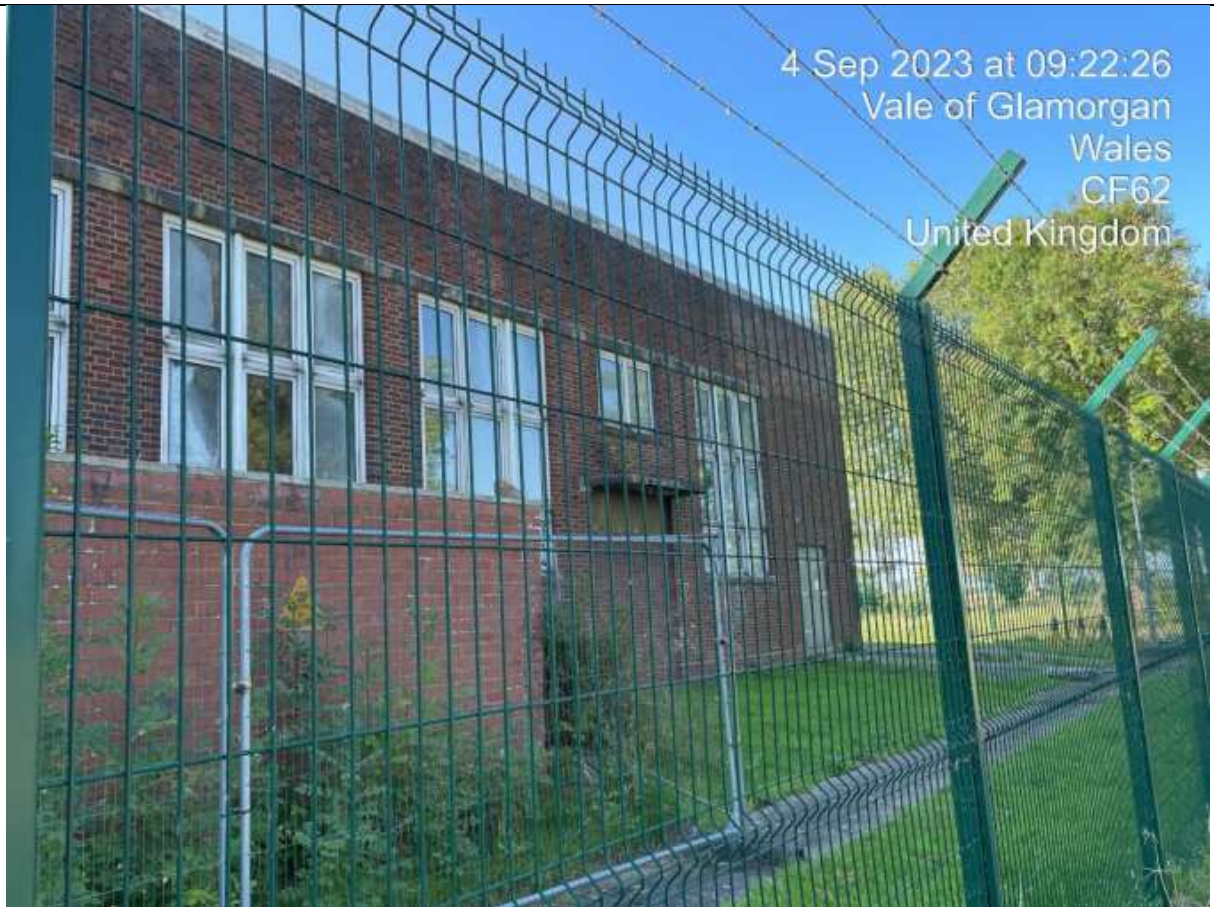
**Northern Elevation. Structural Collapse.**

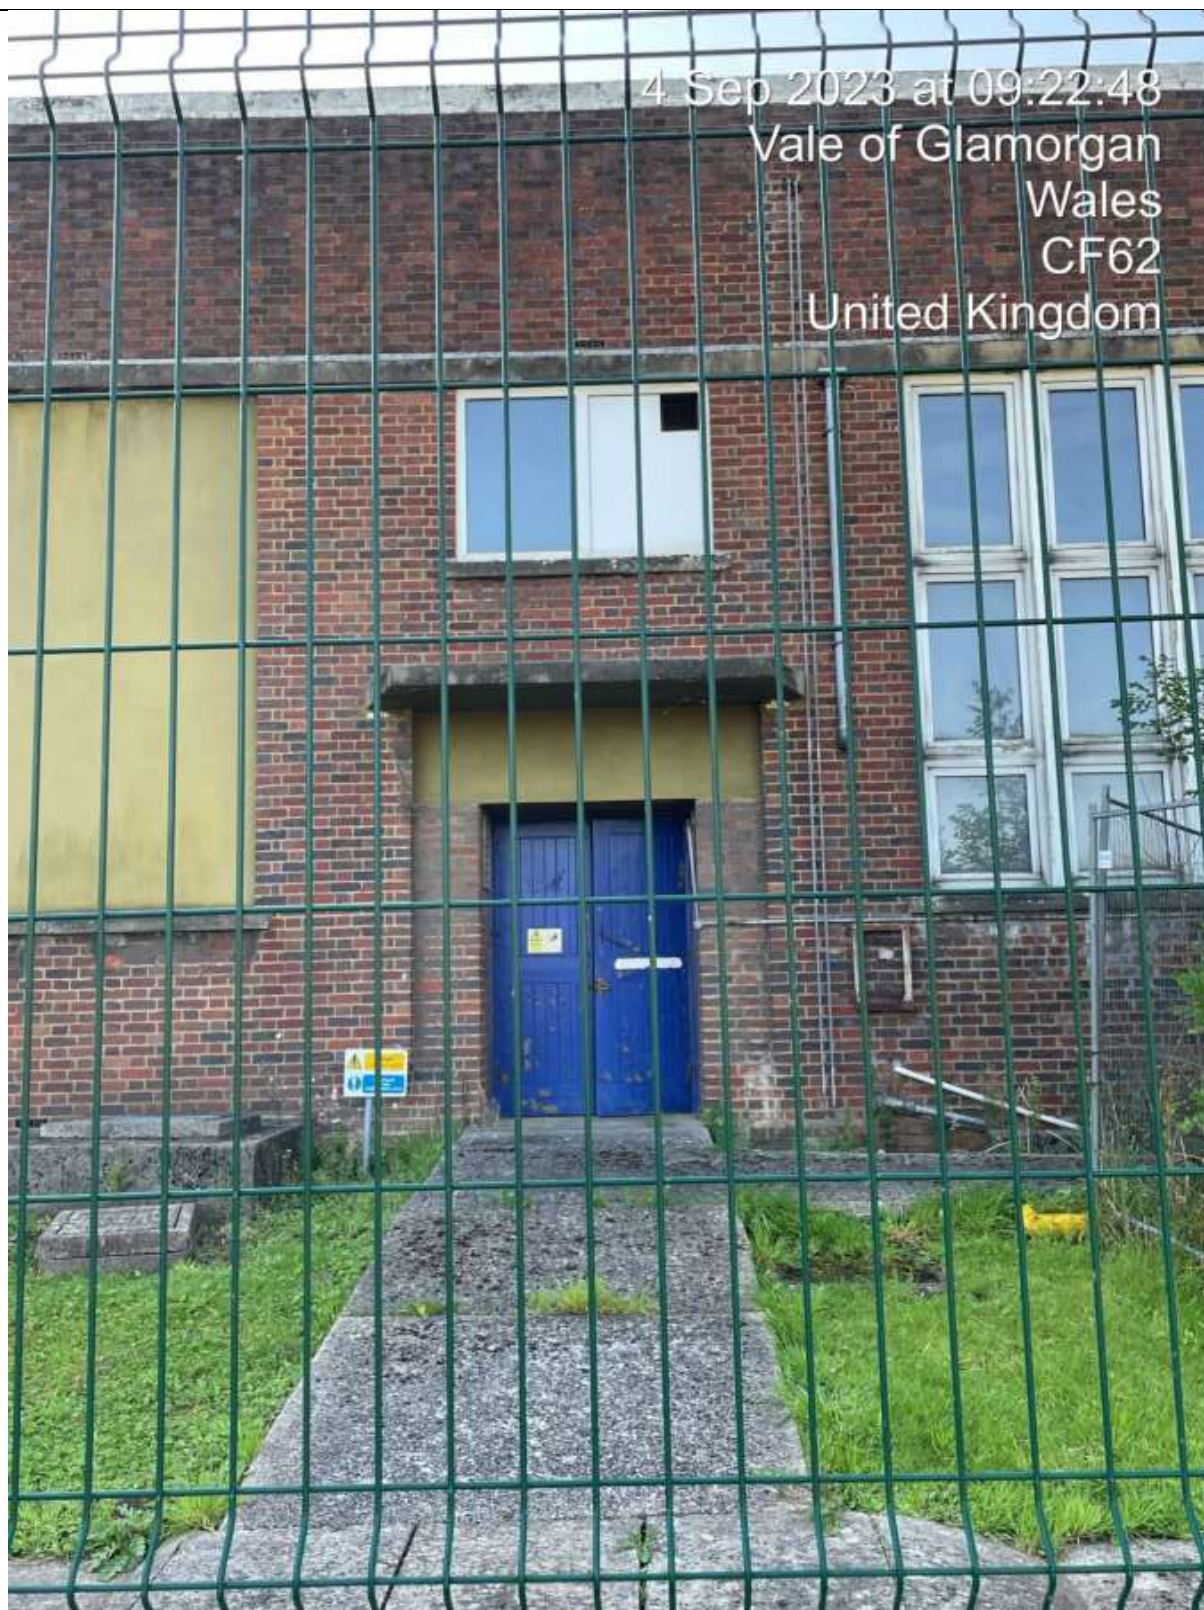
**Northern Elevation. Deterioration of Plant Room Doors.**

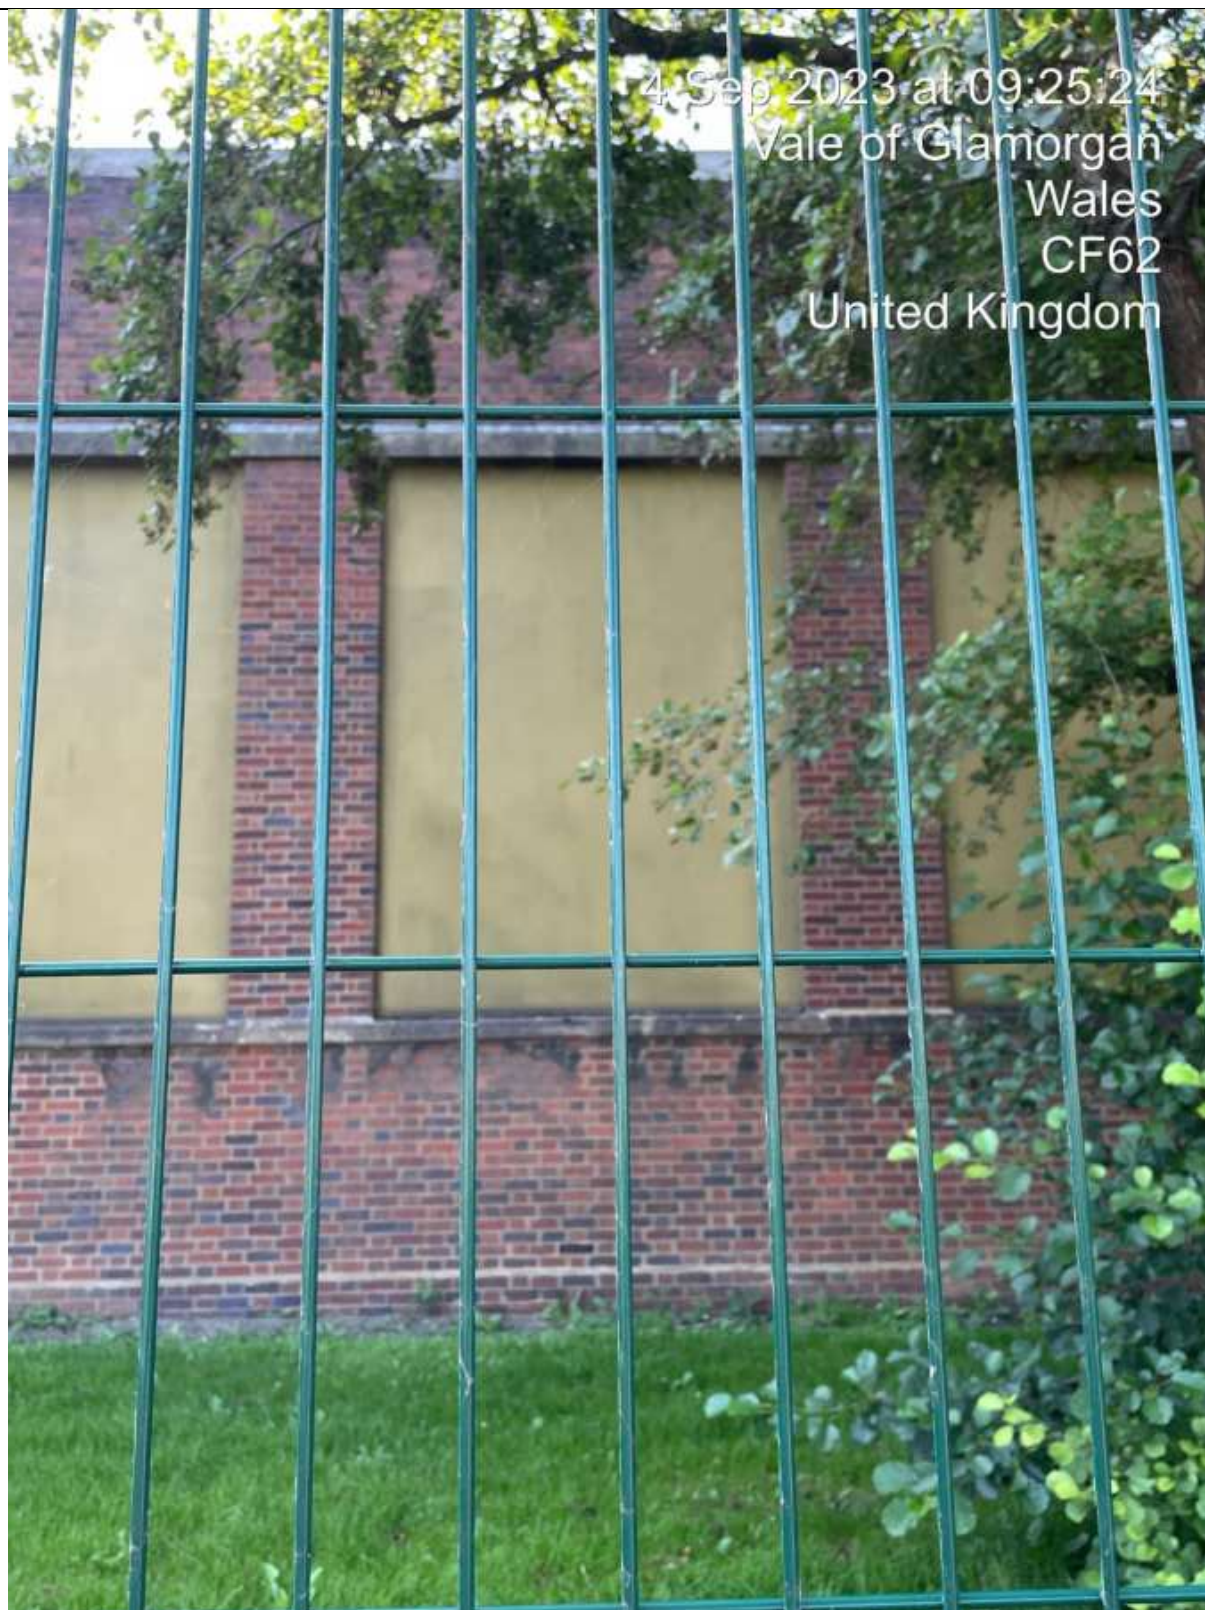
**Northern Elevation. Blanked Off Fenestration.**

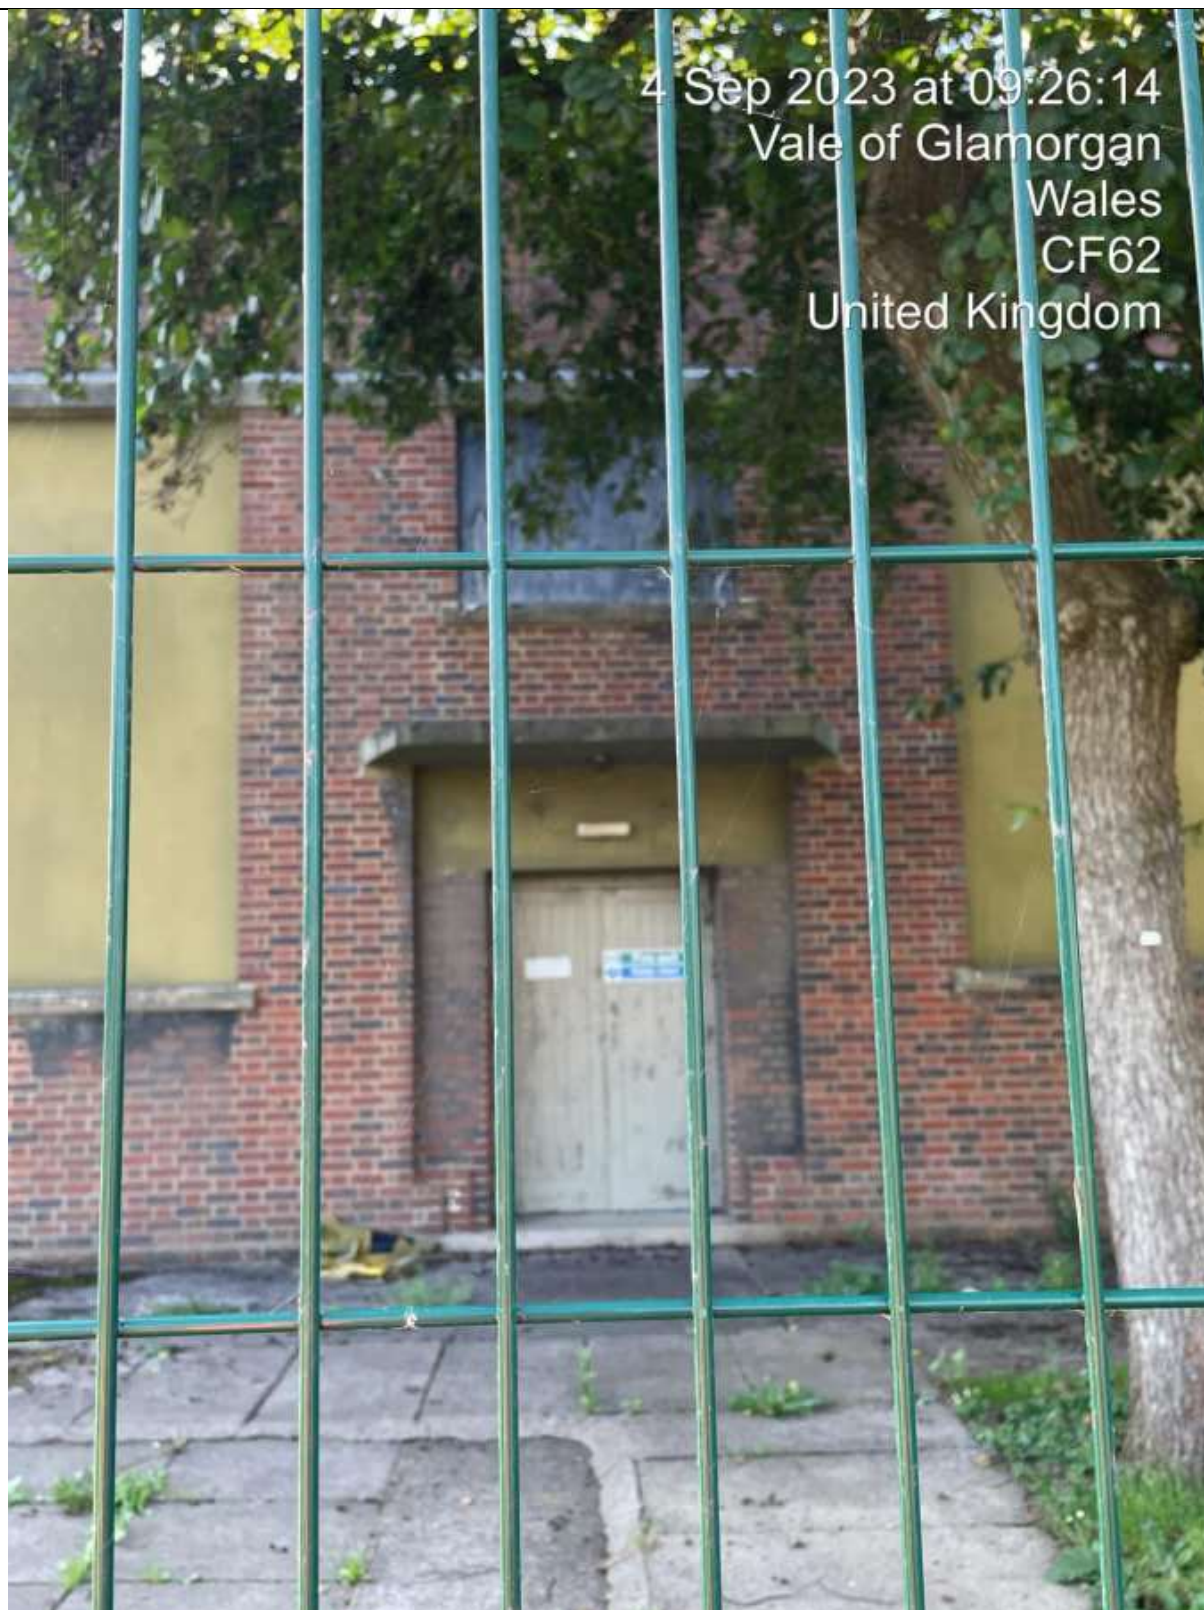
**Northern Elevation. Non-Compliant Fire Exit & Trip Hazards.**

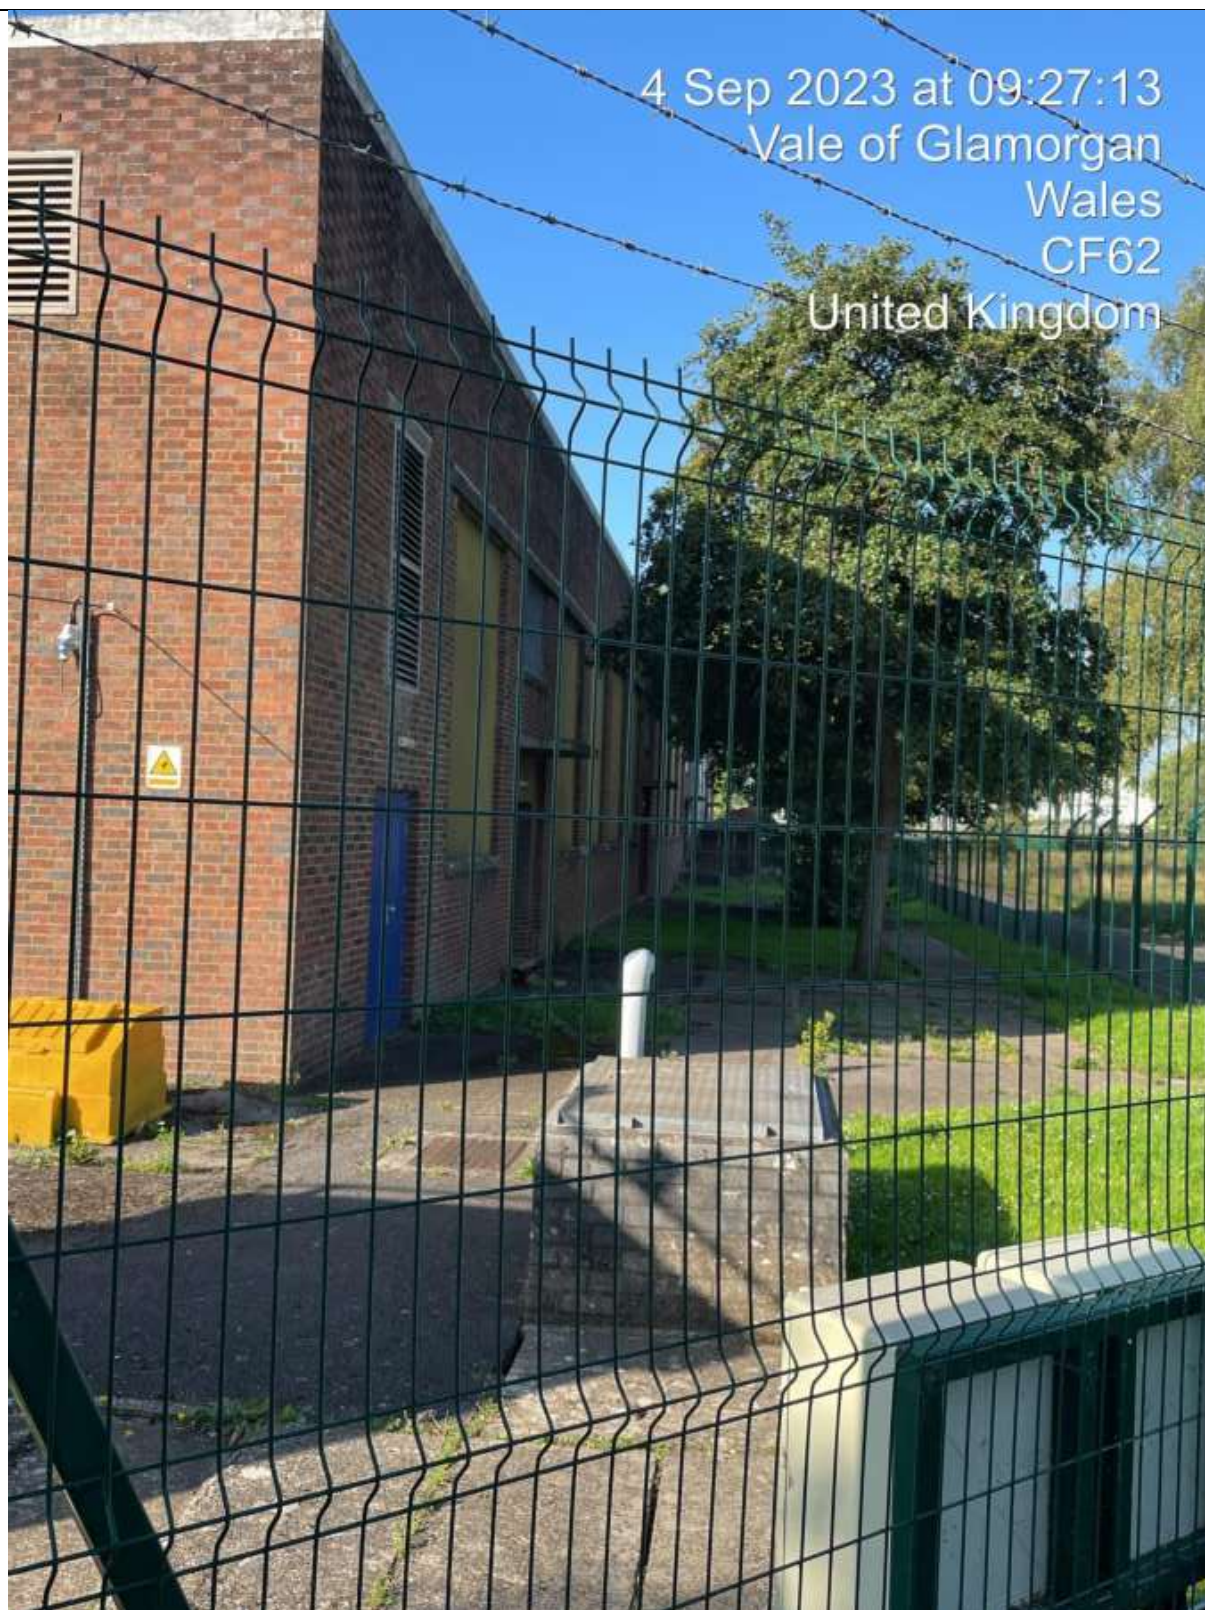
**Northern Elevation. SIGNIFICANT Trip Hazards.**

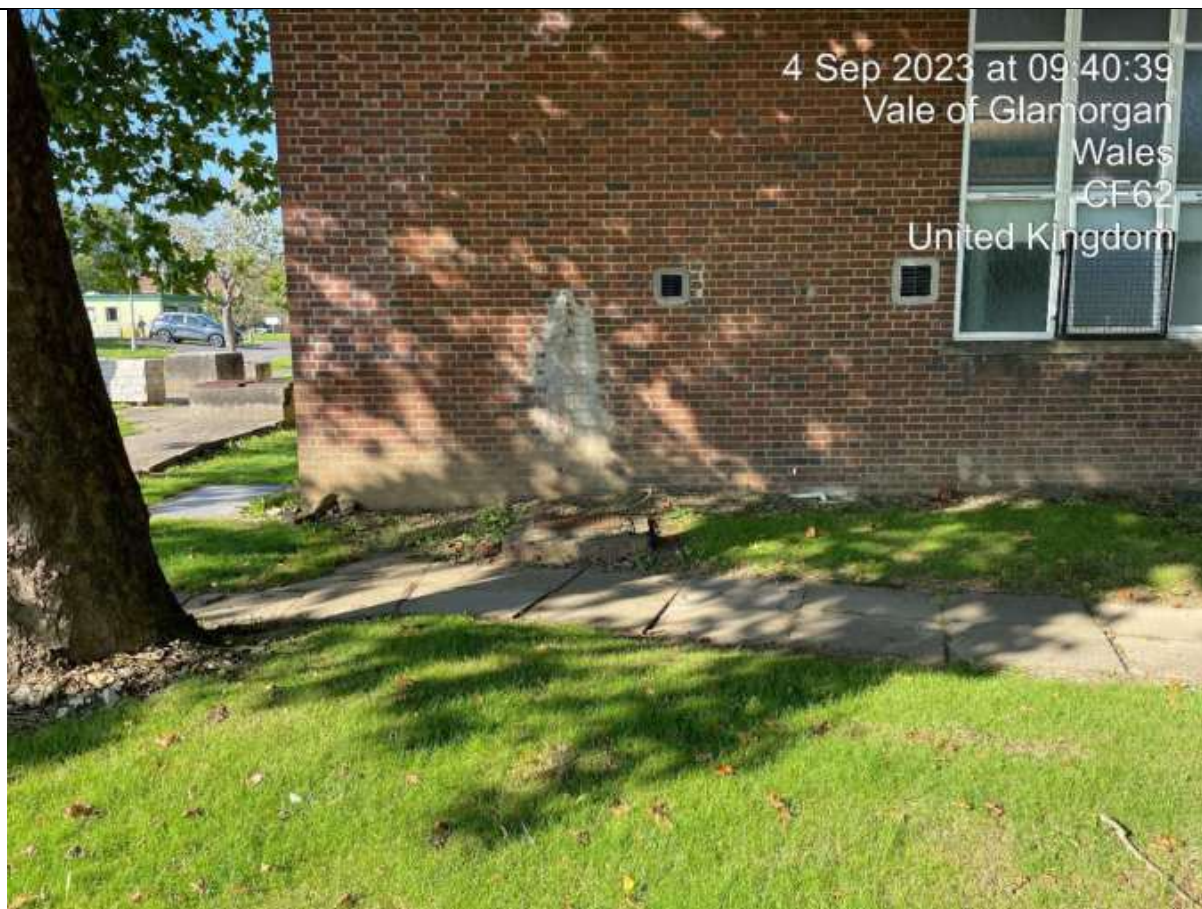
**Eastern Elevation. SIGNIFICANT Trip Hazards to Footpath.**

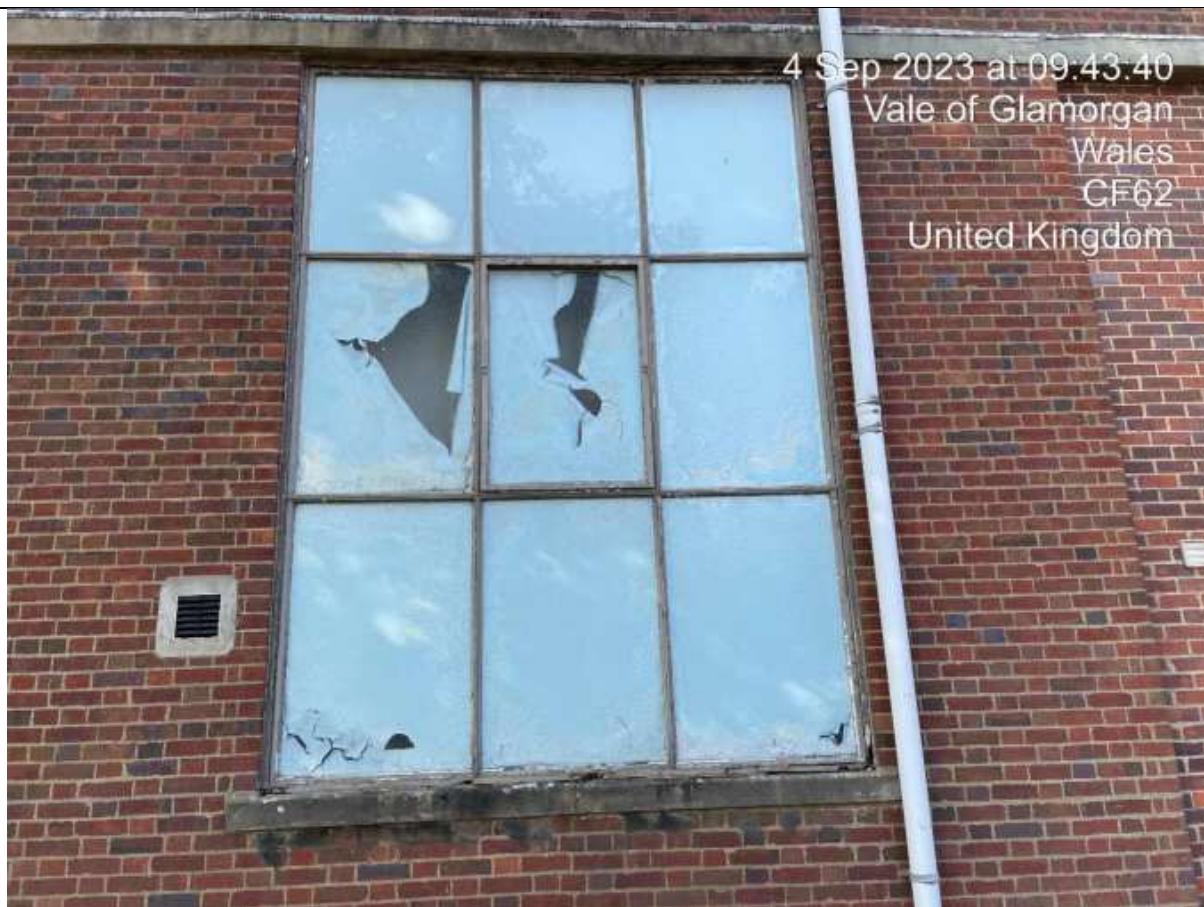
**Eastern Elevation. Original Fenestration Covered Internally.**
