Bro Tathan East Building 354 External & Internal Visual Condition Survey

| Report Ref: | PR01 | Created | 19/06/24 |

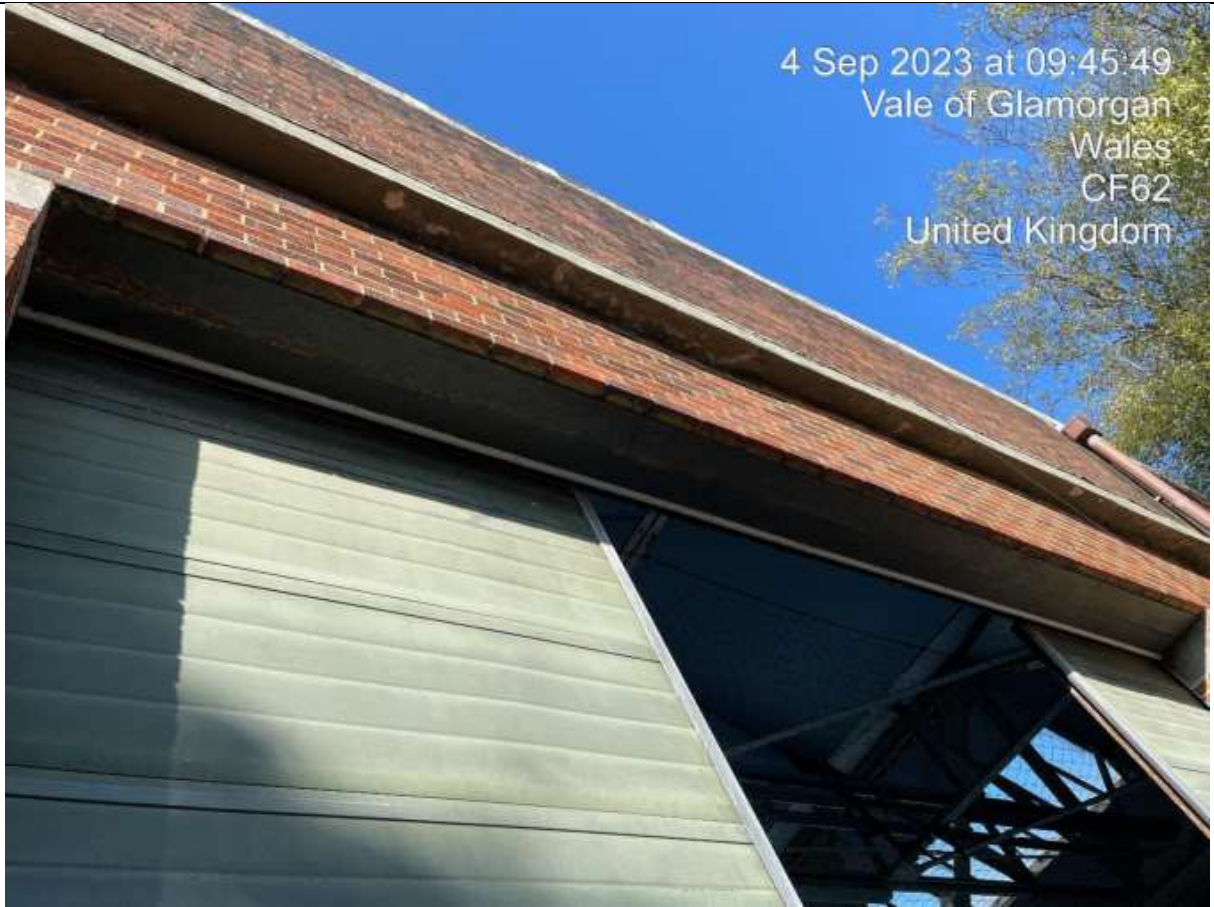
**Eastern Elevation. Corrosion to Replacement Steel Lintel.**

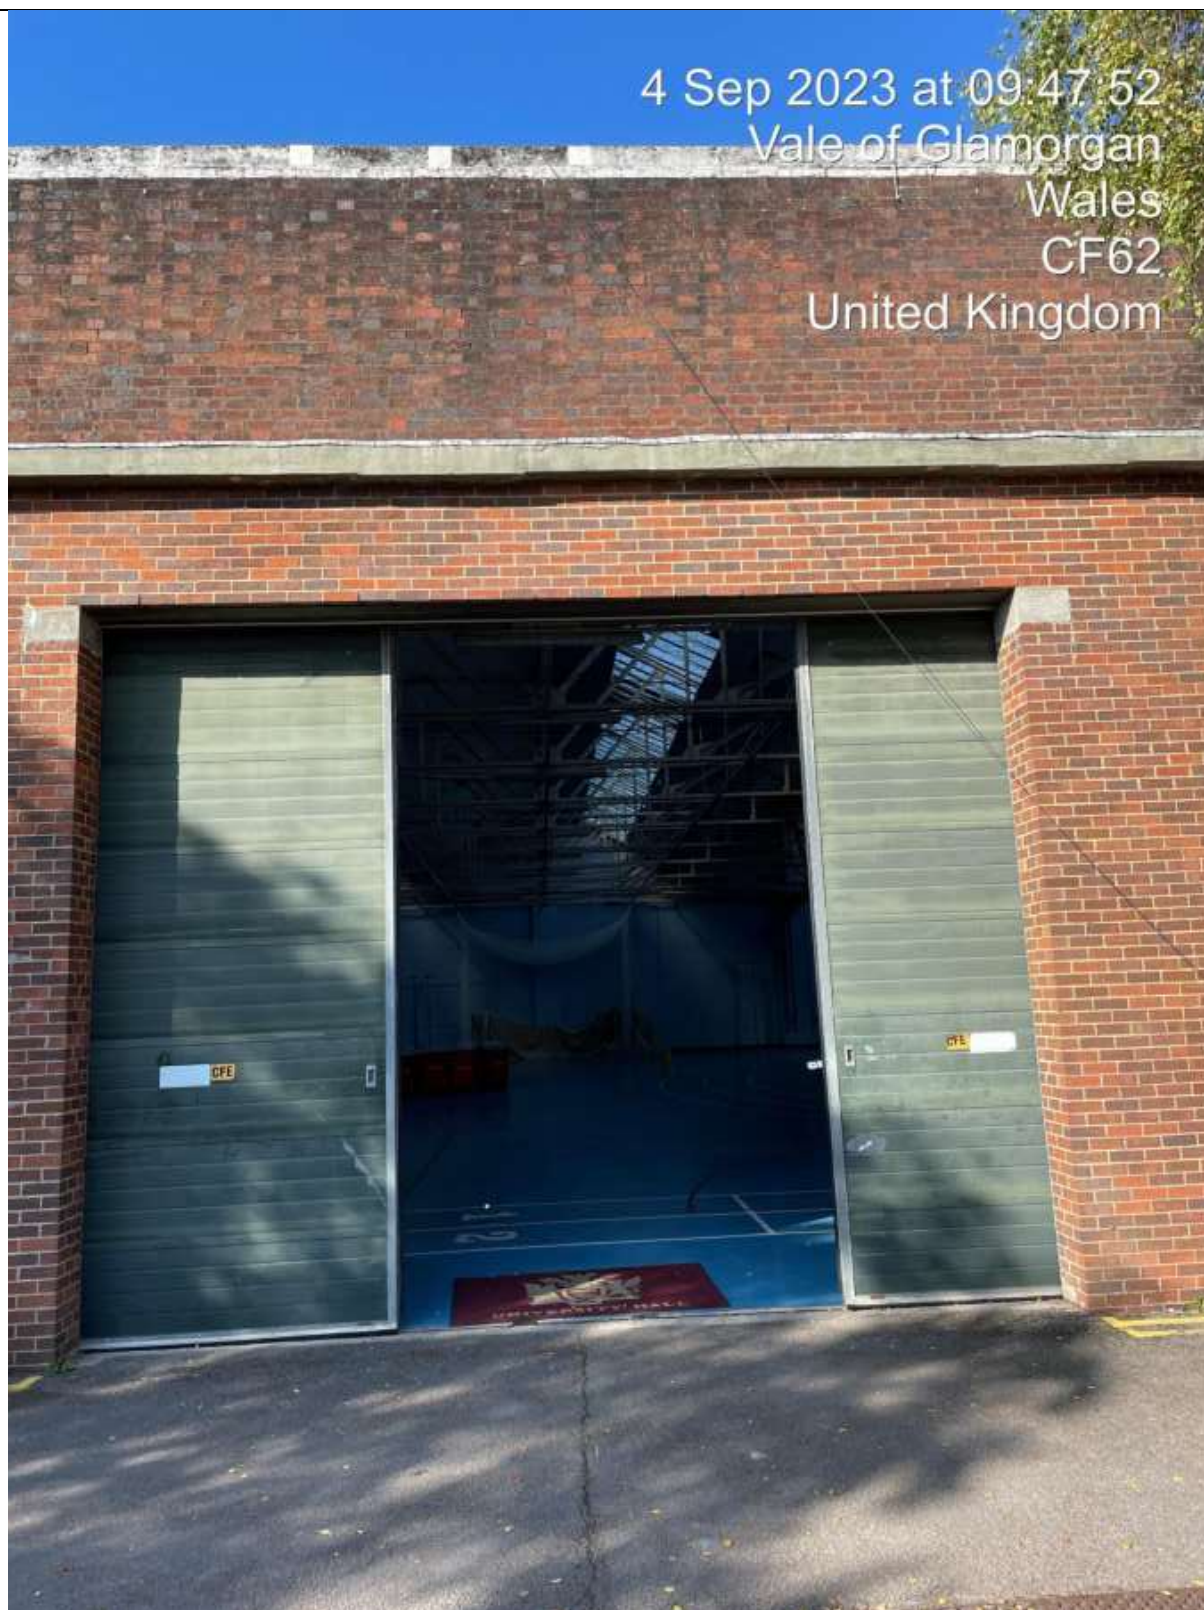
**Eastern Elevation. Modified Entrance.**

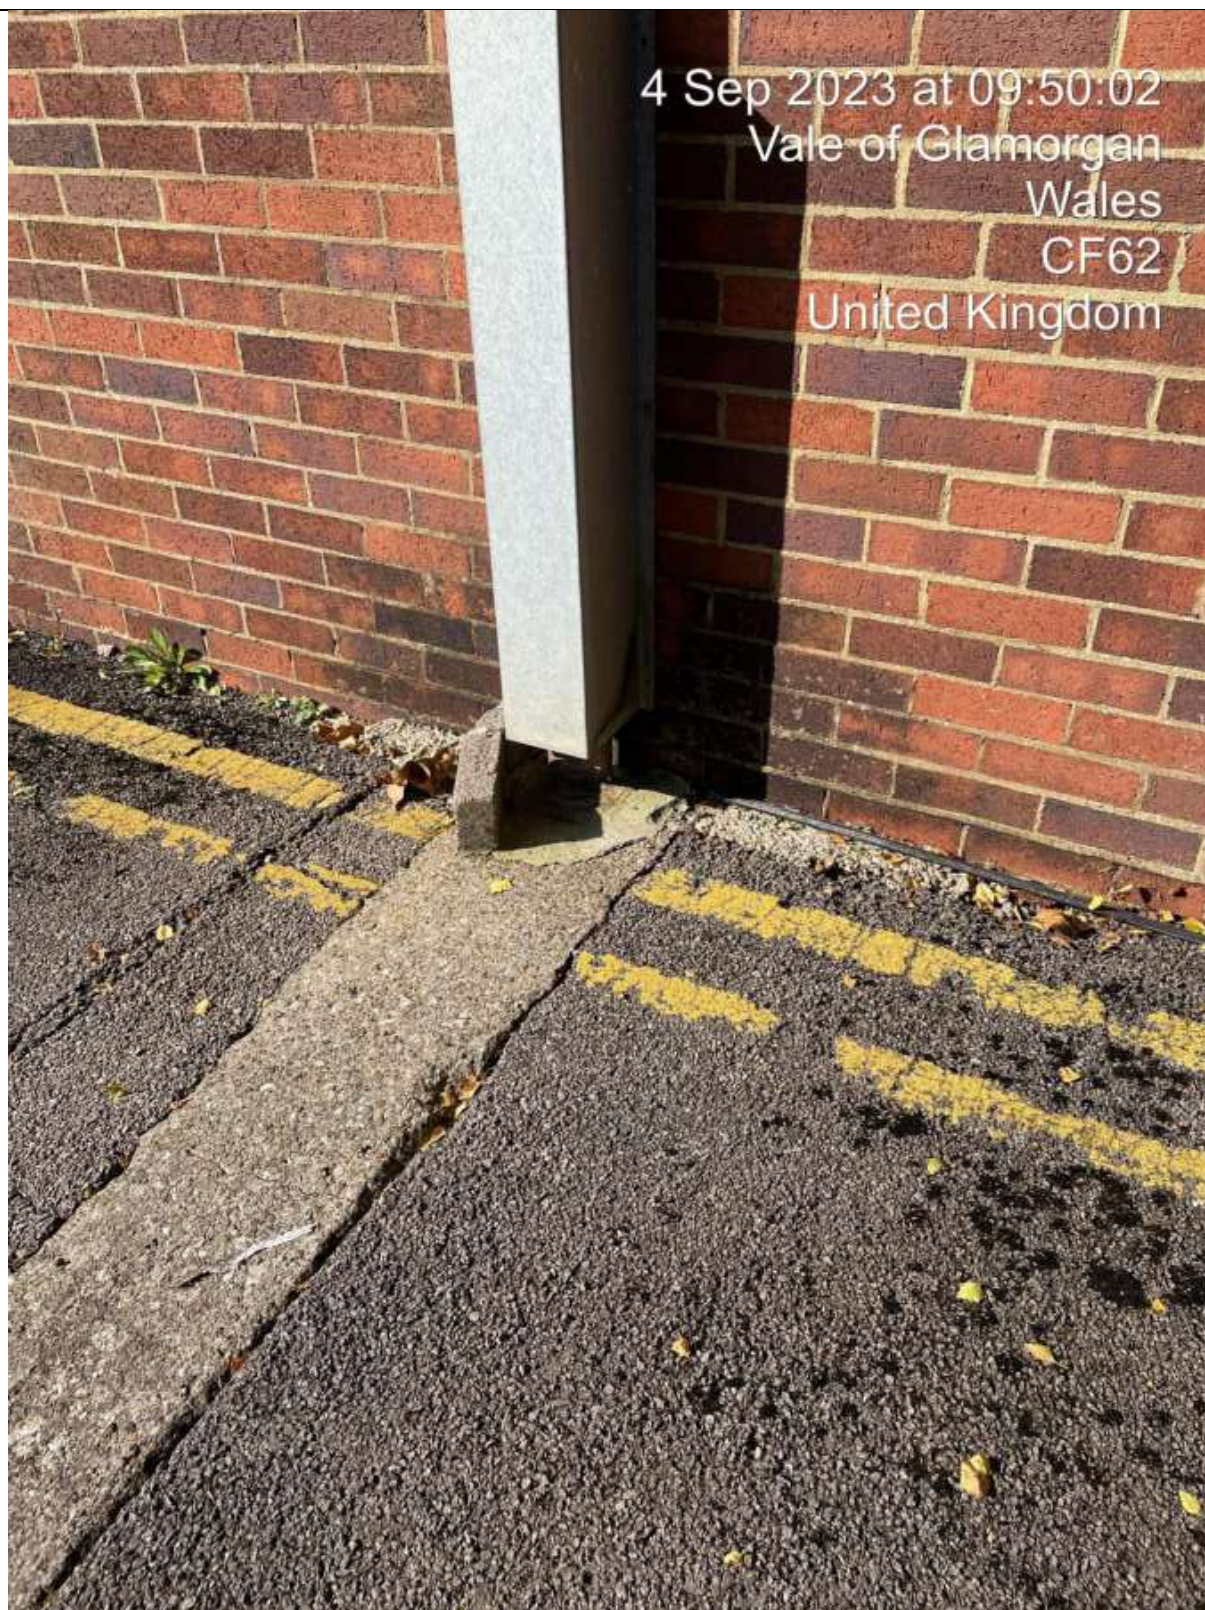
**Eastern Elevation. Downpipe from Hidden Gutter NOT PENETRATING TO DRAINAGE.**

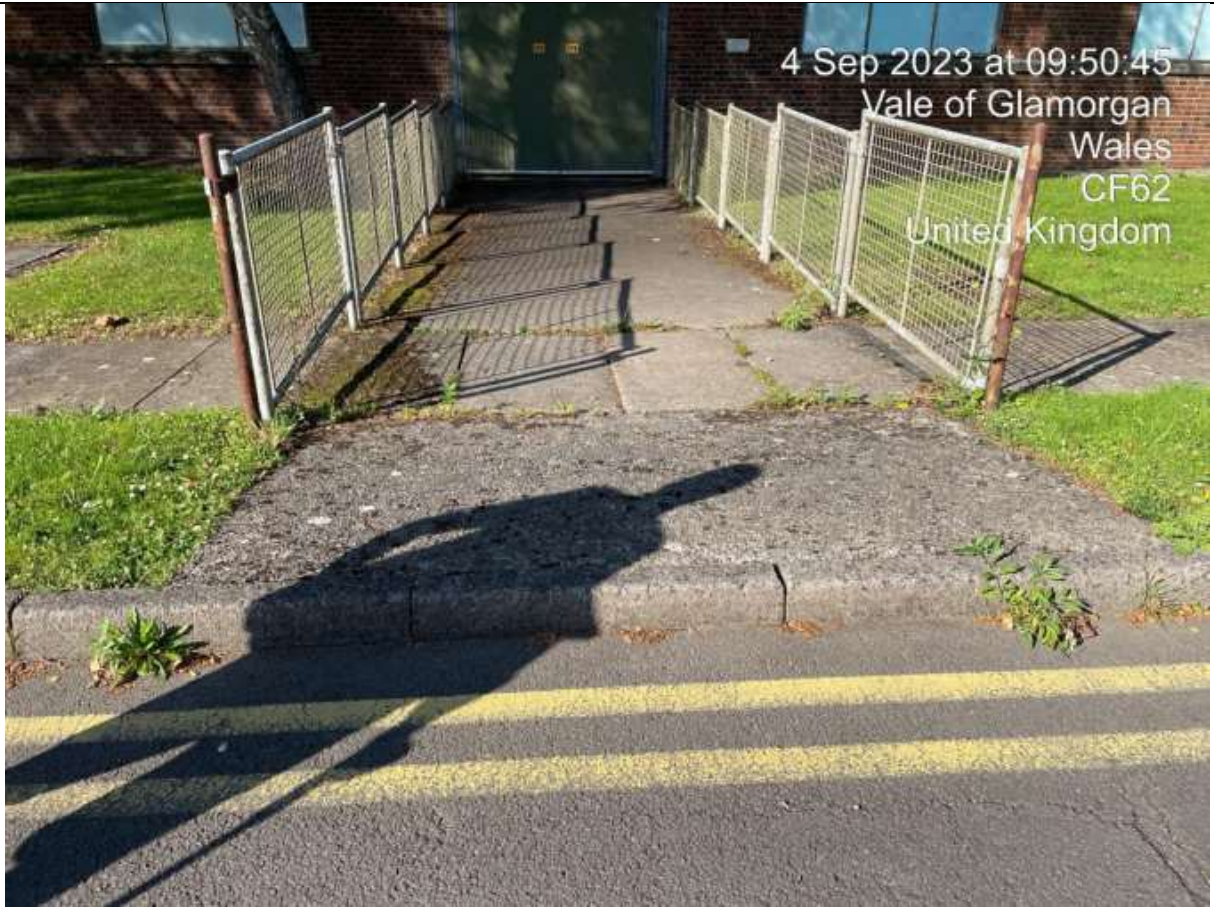
**Eastern Elevation. Non-Compliant Access & Egress.**

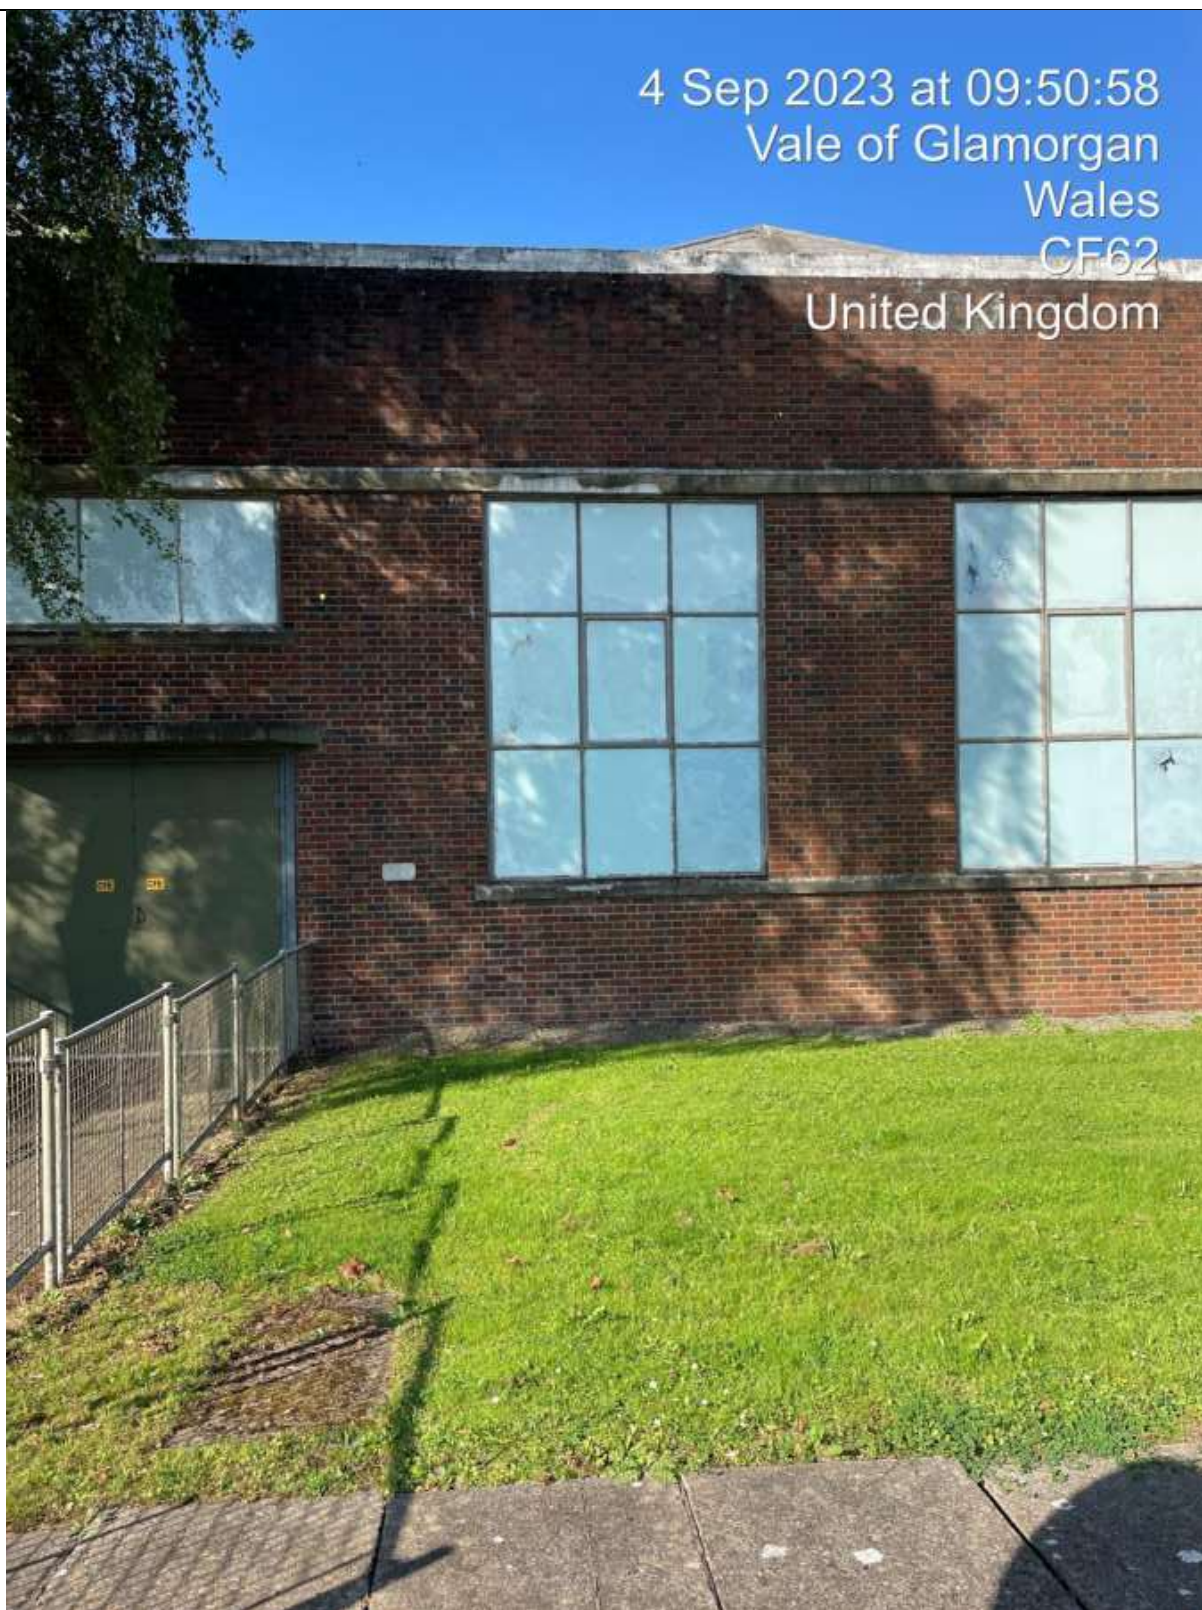
**Eastern Elevation. Original Fenestration.**

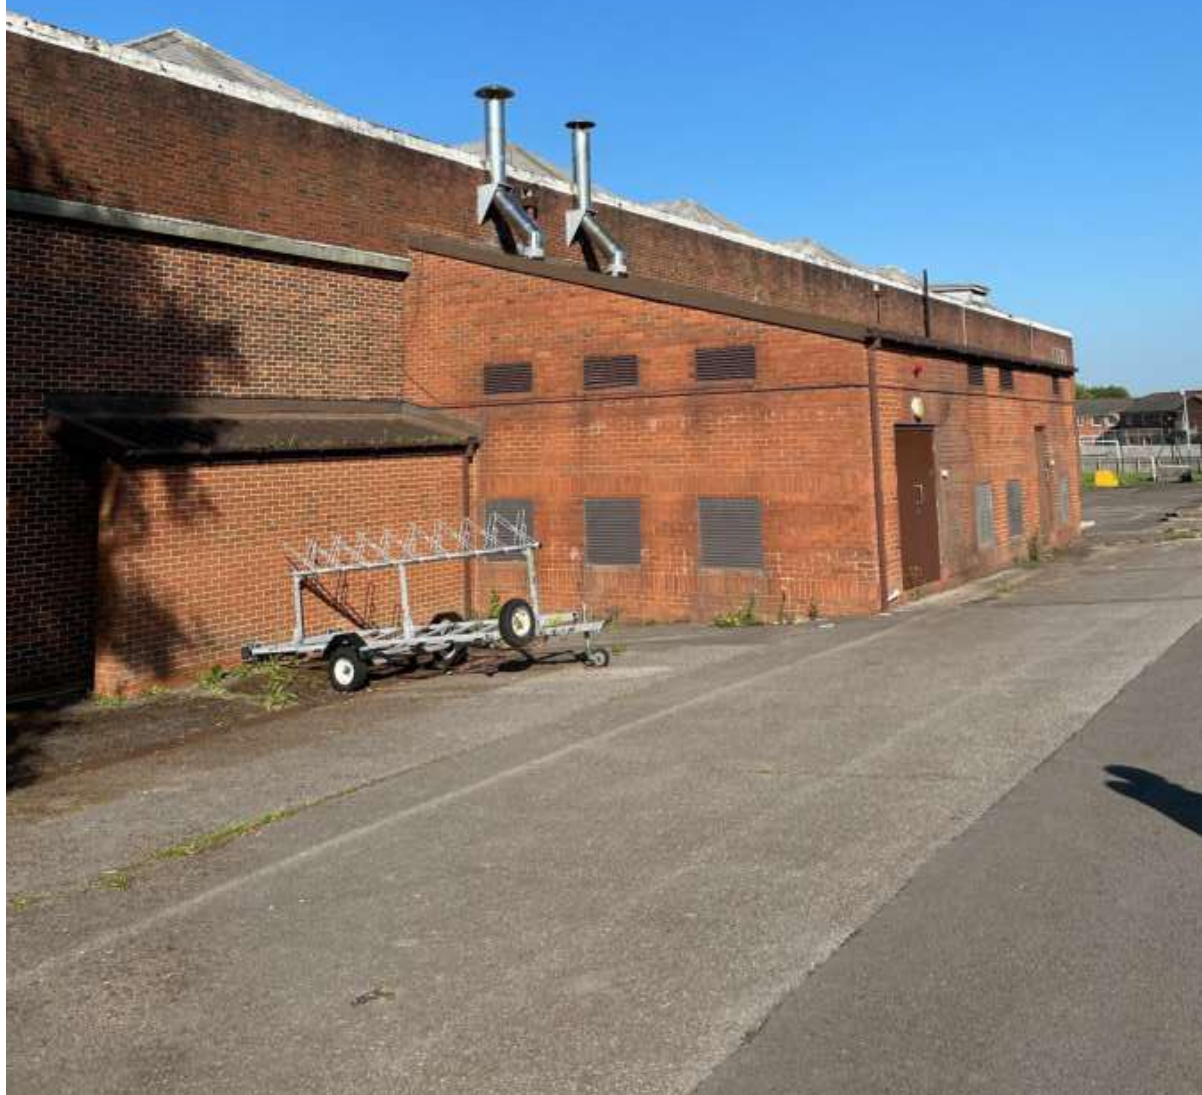
**Eastern Elevation. Non-Original Plant Room Addition.**

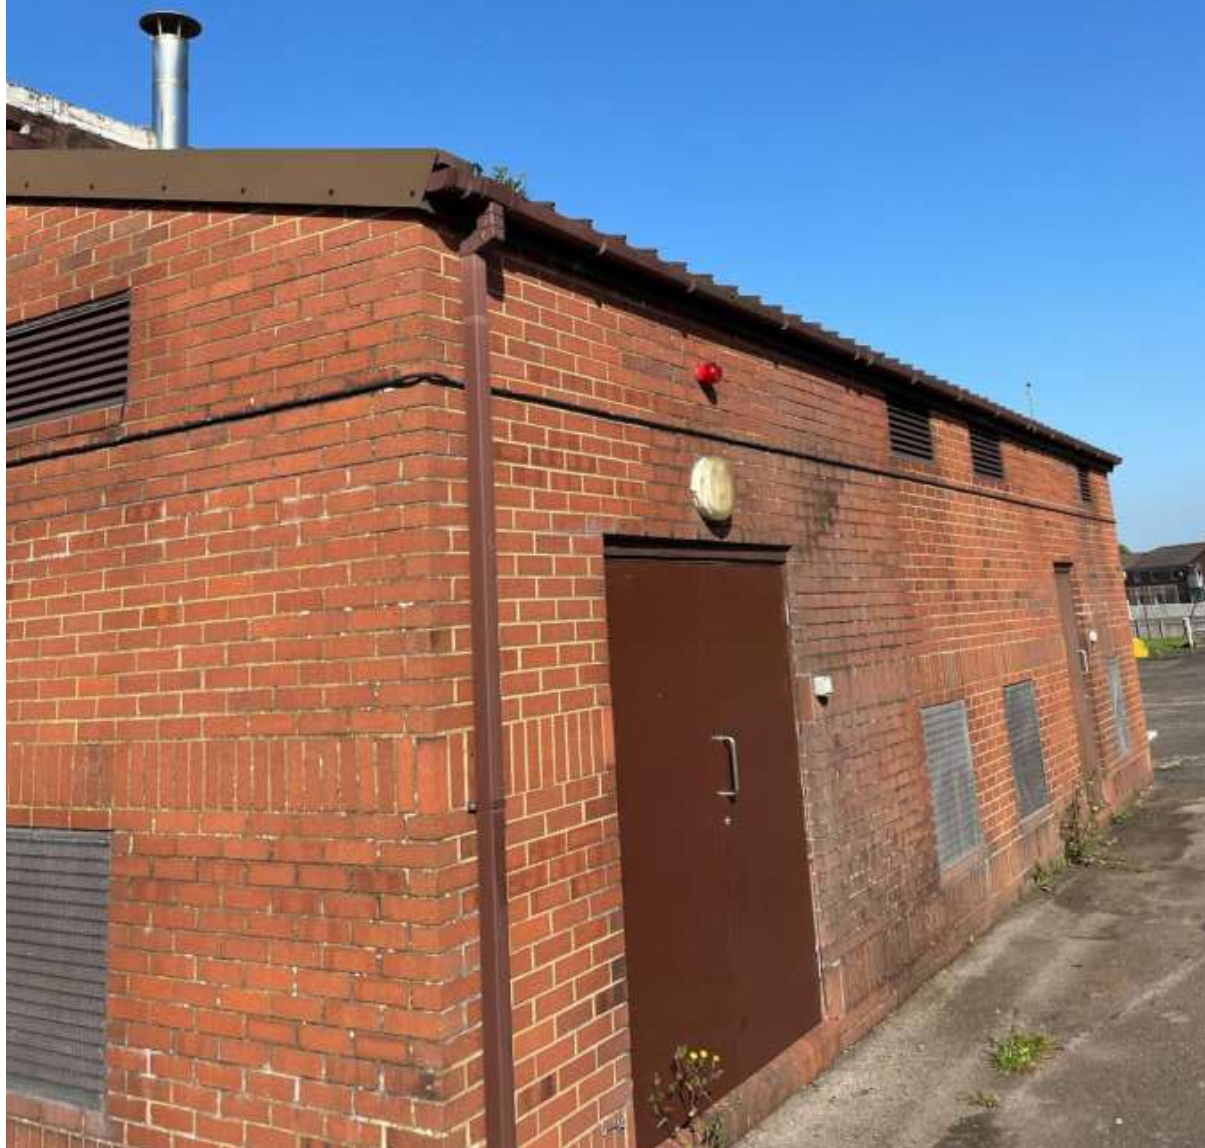
**Eastern Elevation. Non-Original Plant Room Addition.**

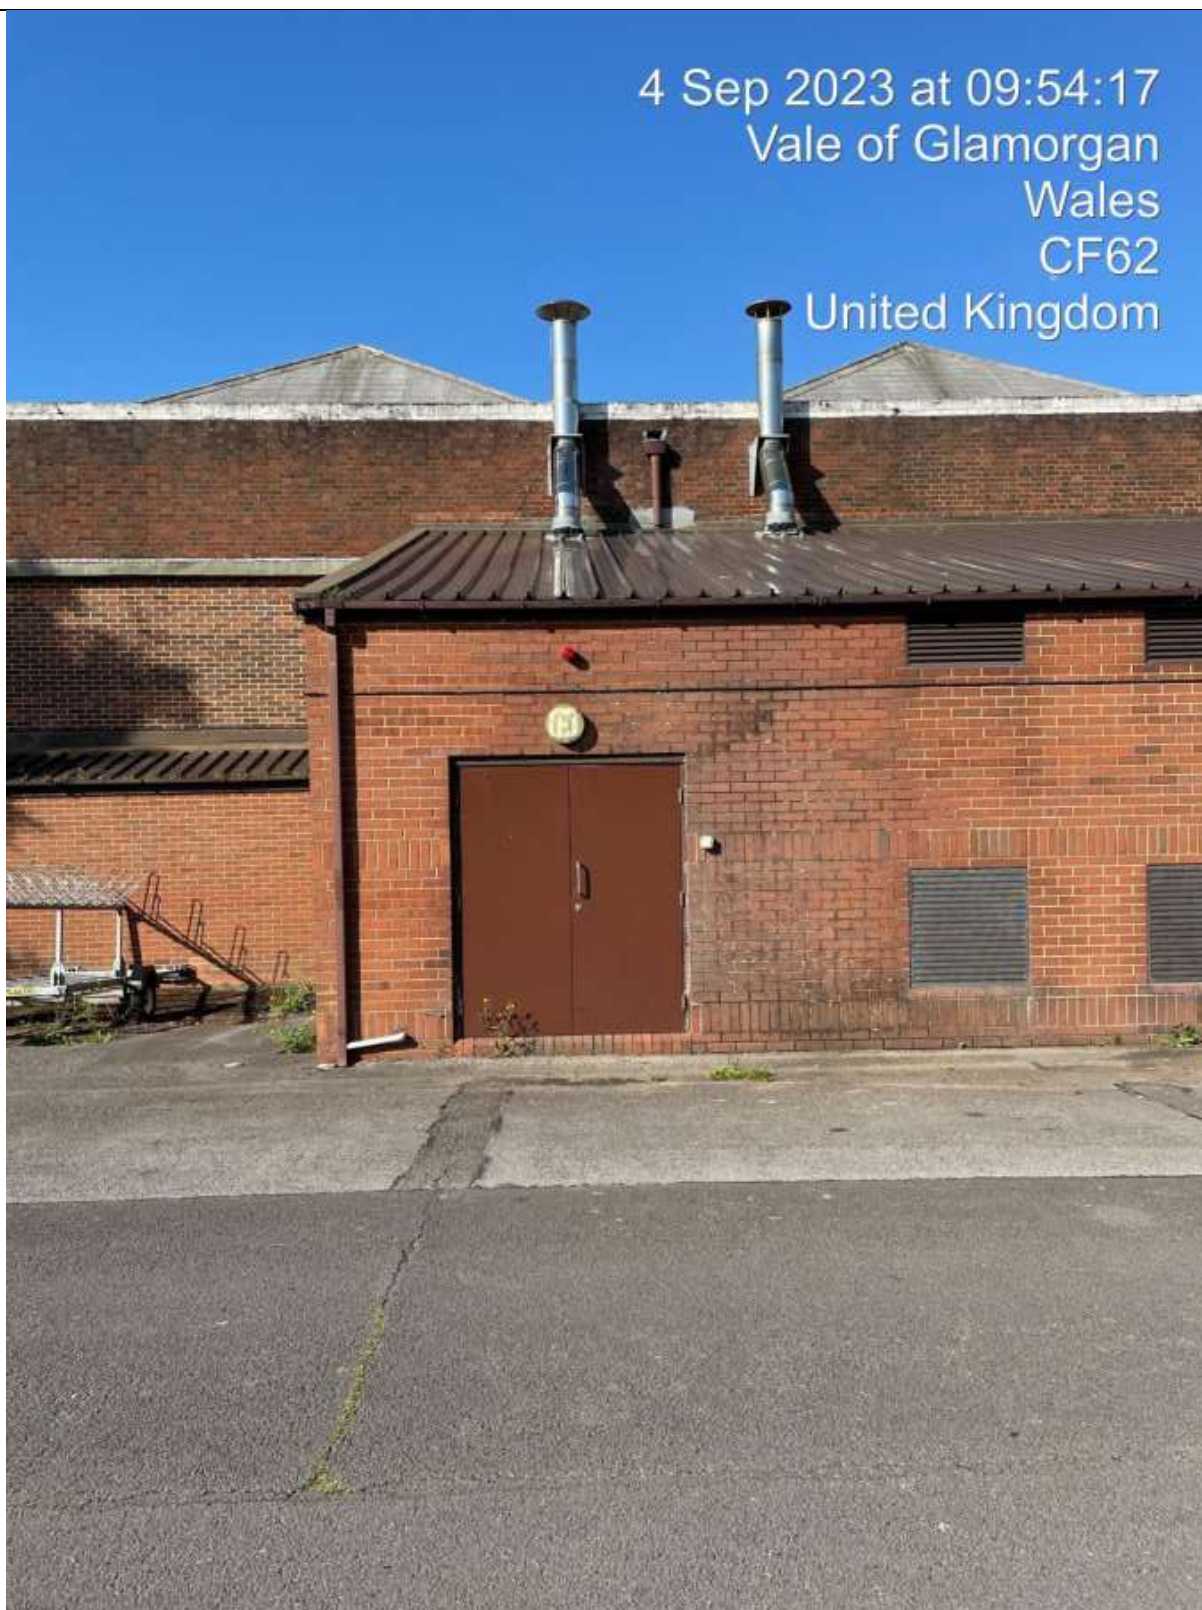
**Eastern Elevation. Non-Original Plant Room Addition.**

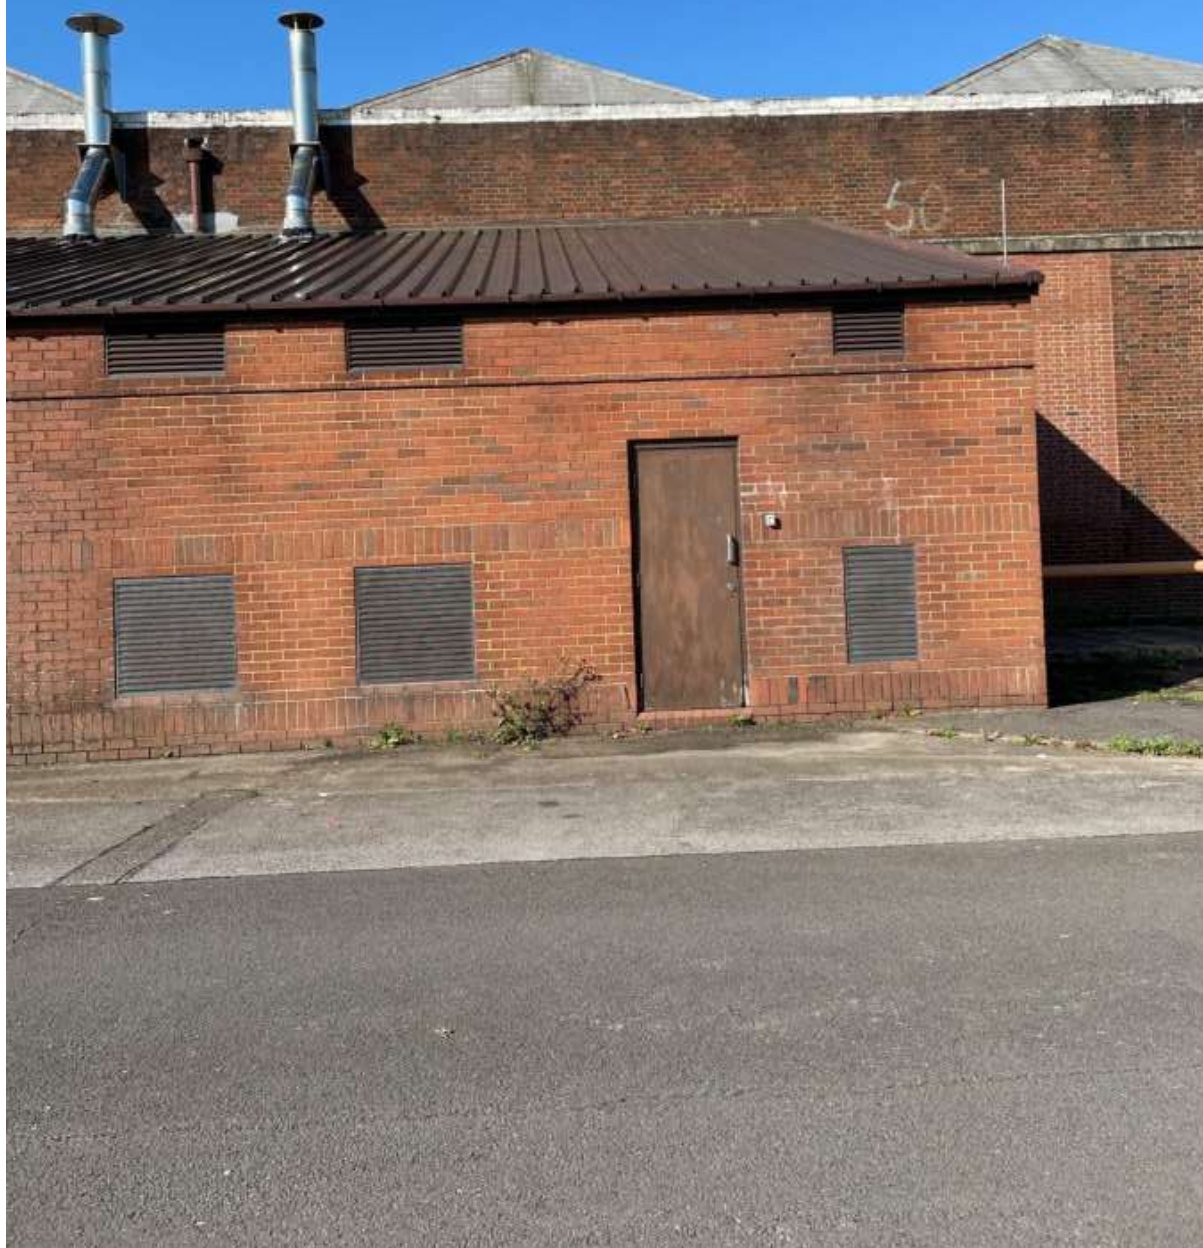
**Eastern Elevation. Non-Original Plant Room Addition with Deterioration to Door.**

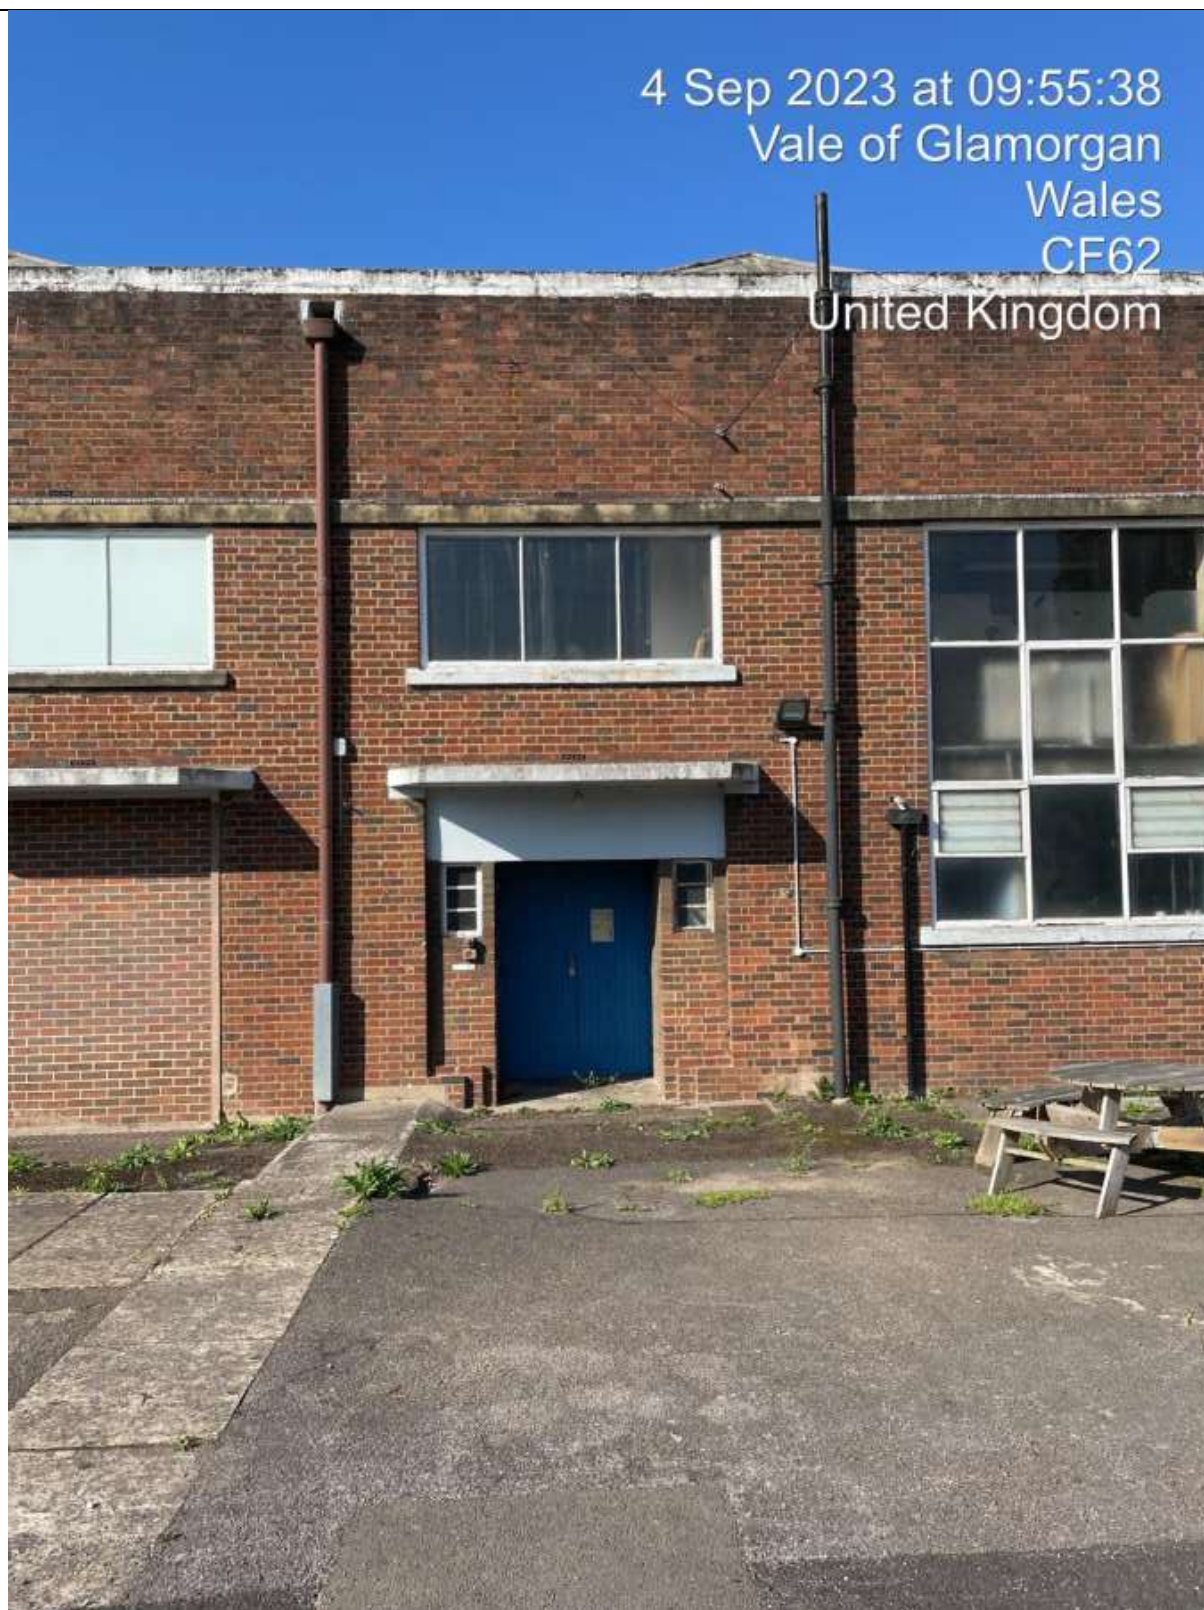
**Eastern Elevation. Deterioration to Doors.**

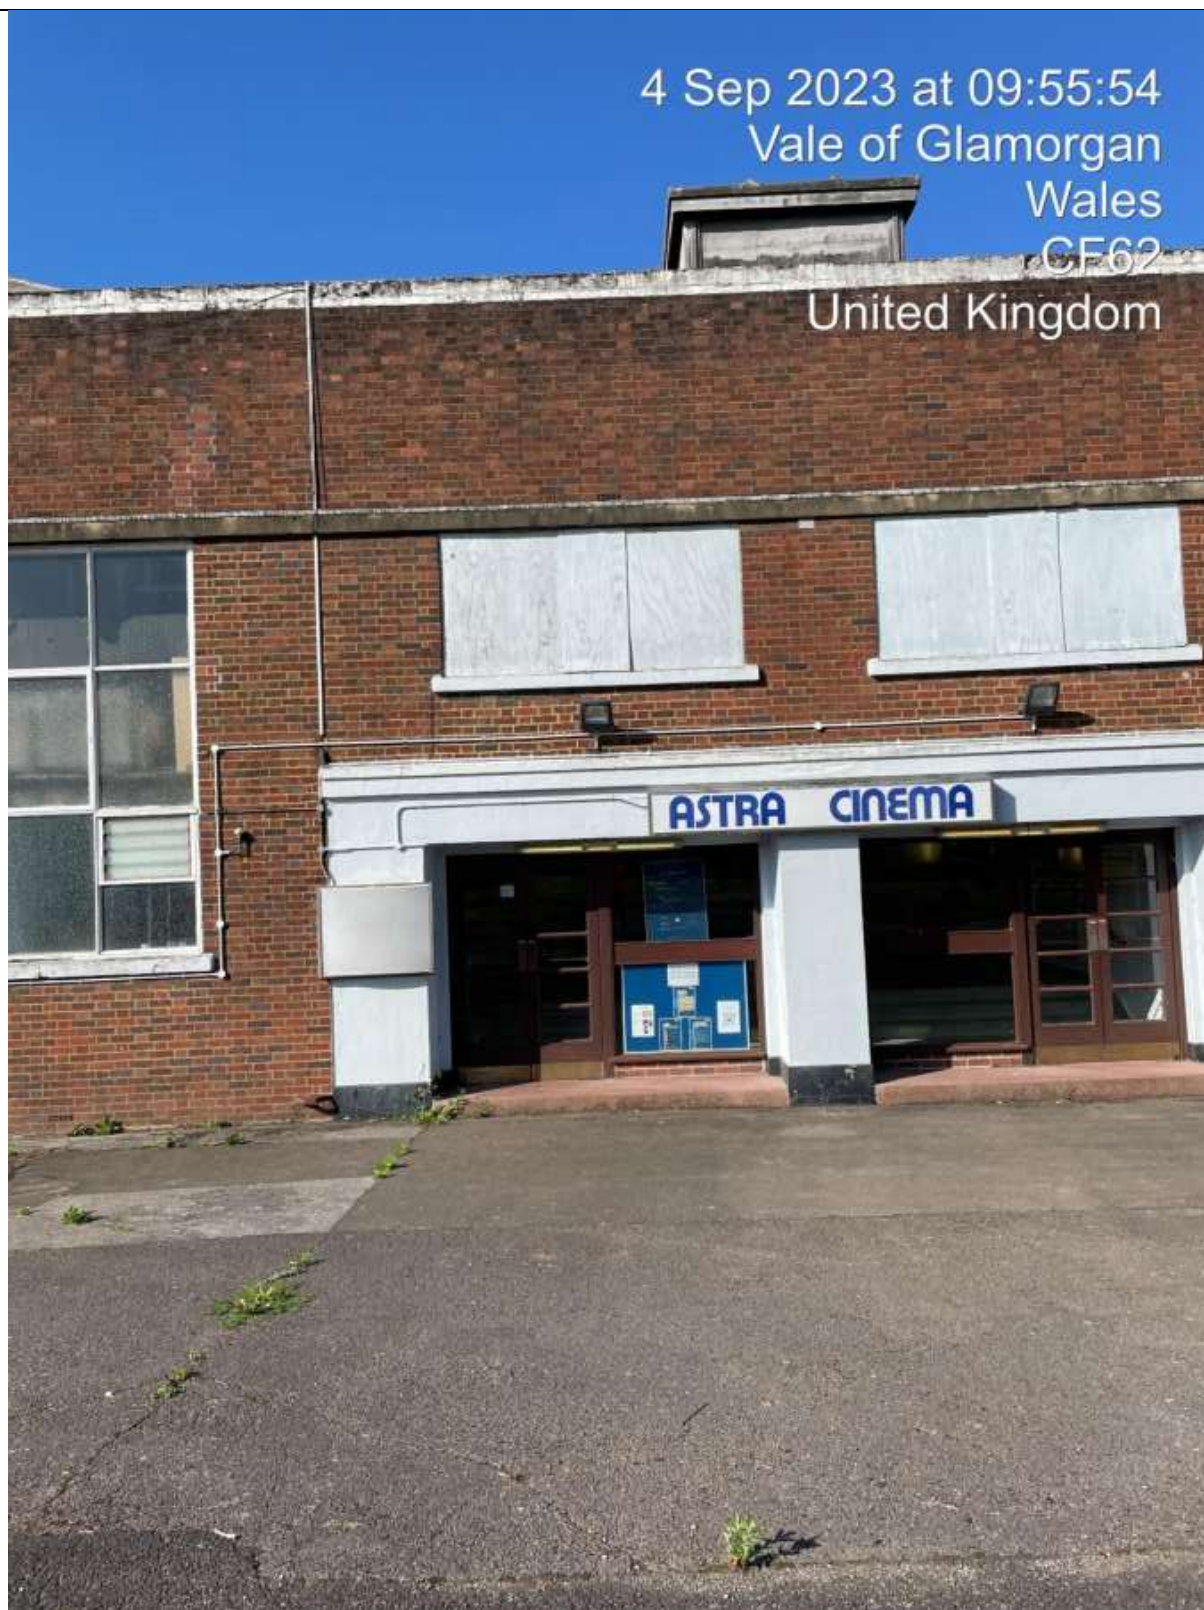
**Eastern Elevation. Non-Compliant Access & Egress Points.**

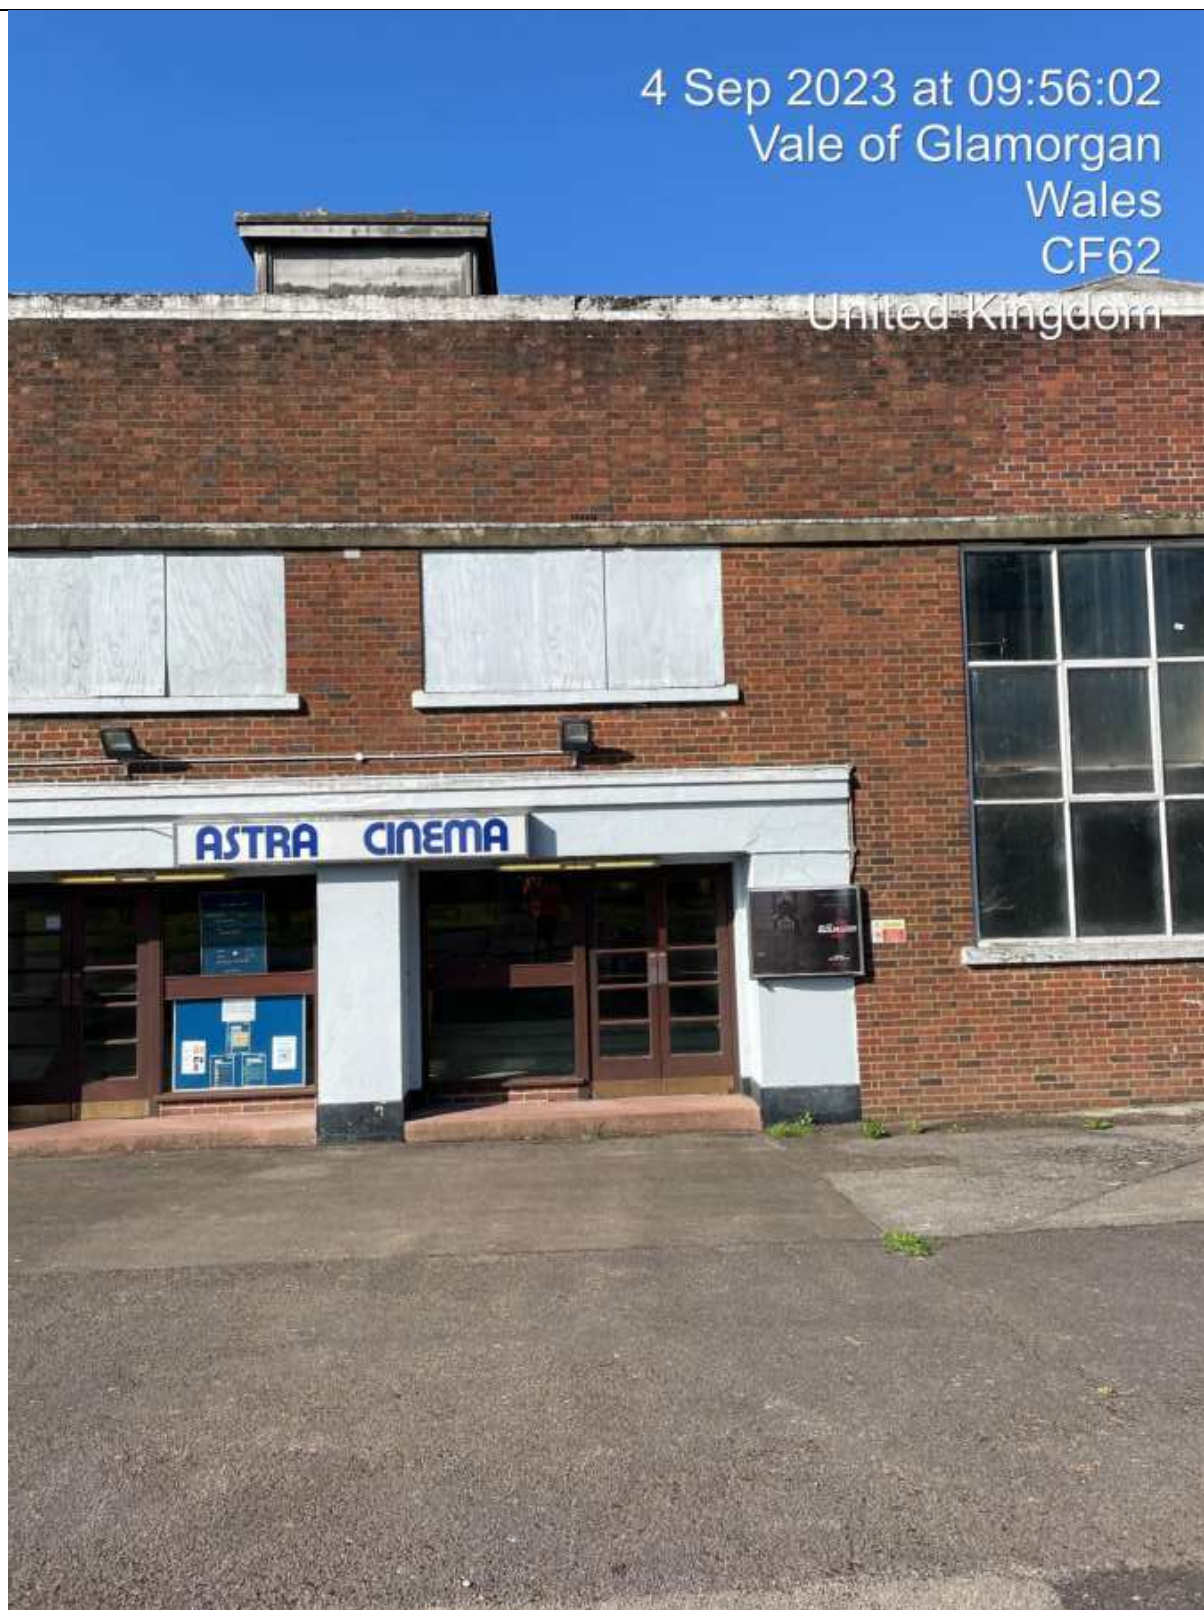
**Eastern Elevation. Non-Compliant Access & Egress Points.**

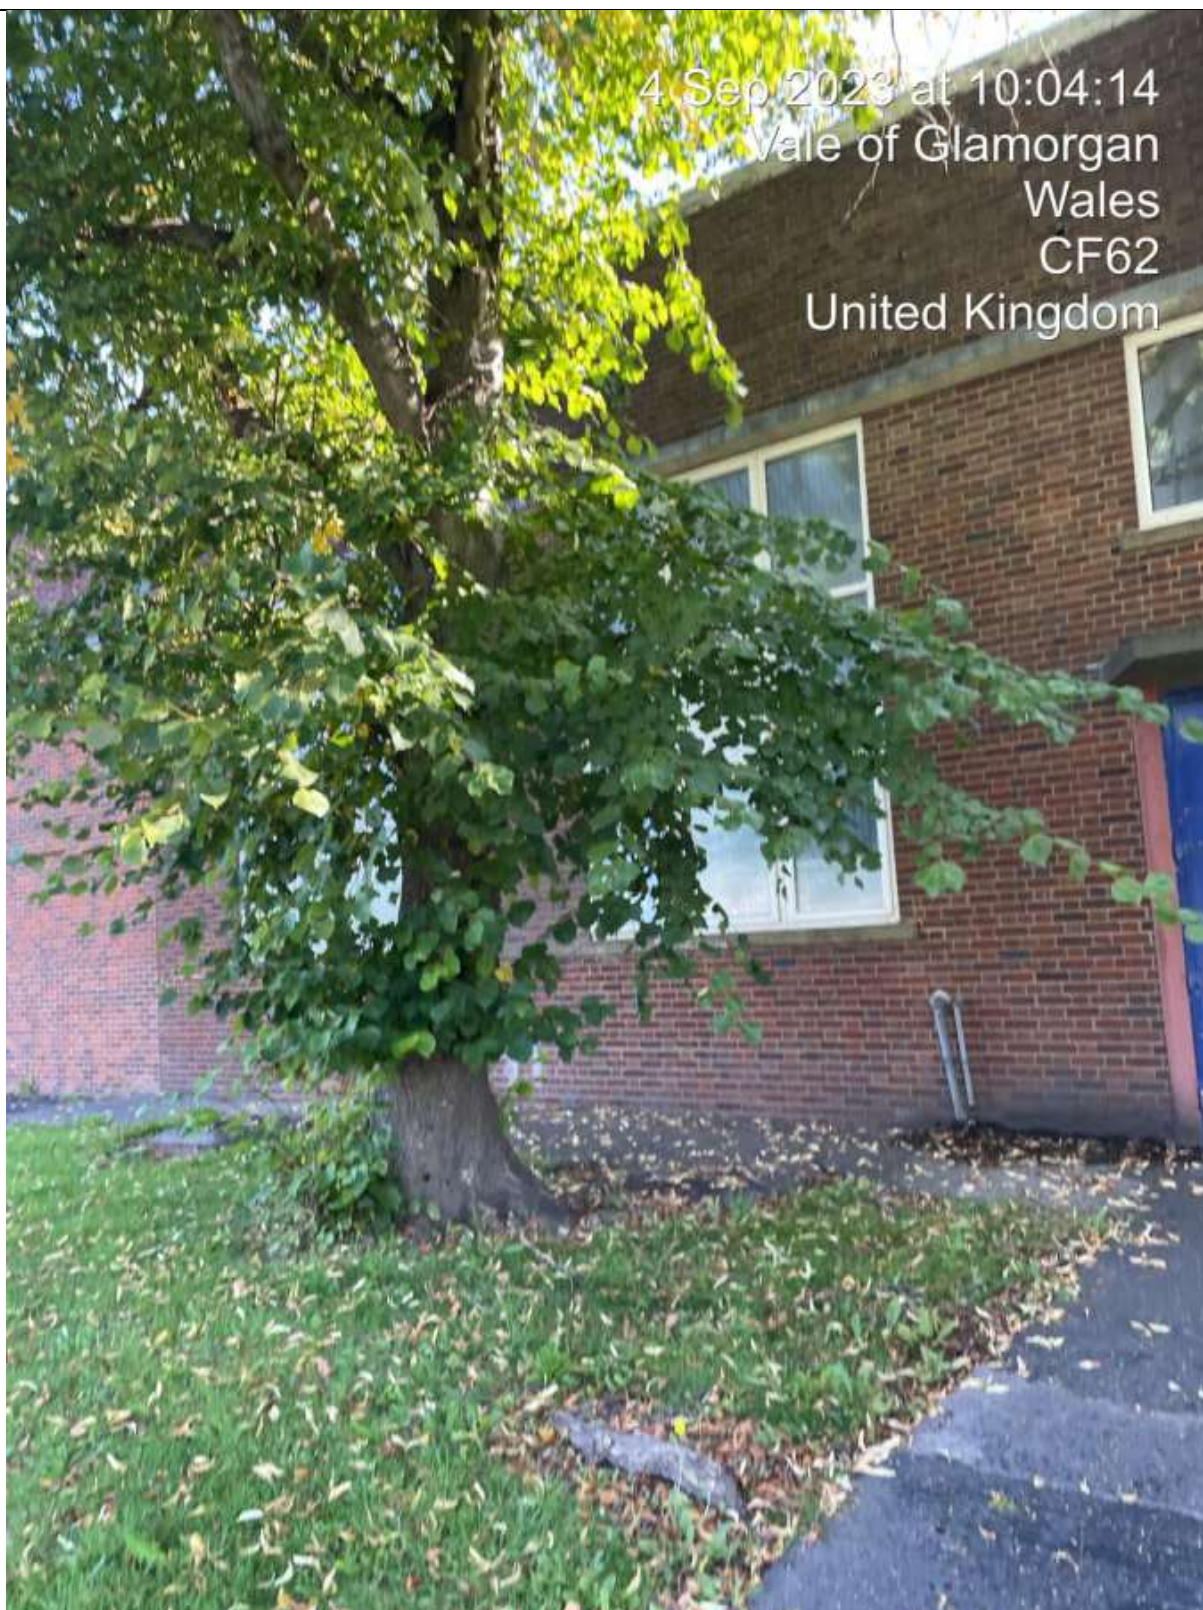
**Western Elevation. Proximity of Trees to Building cause suspect of Damage to Foundations.**

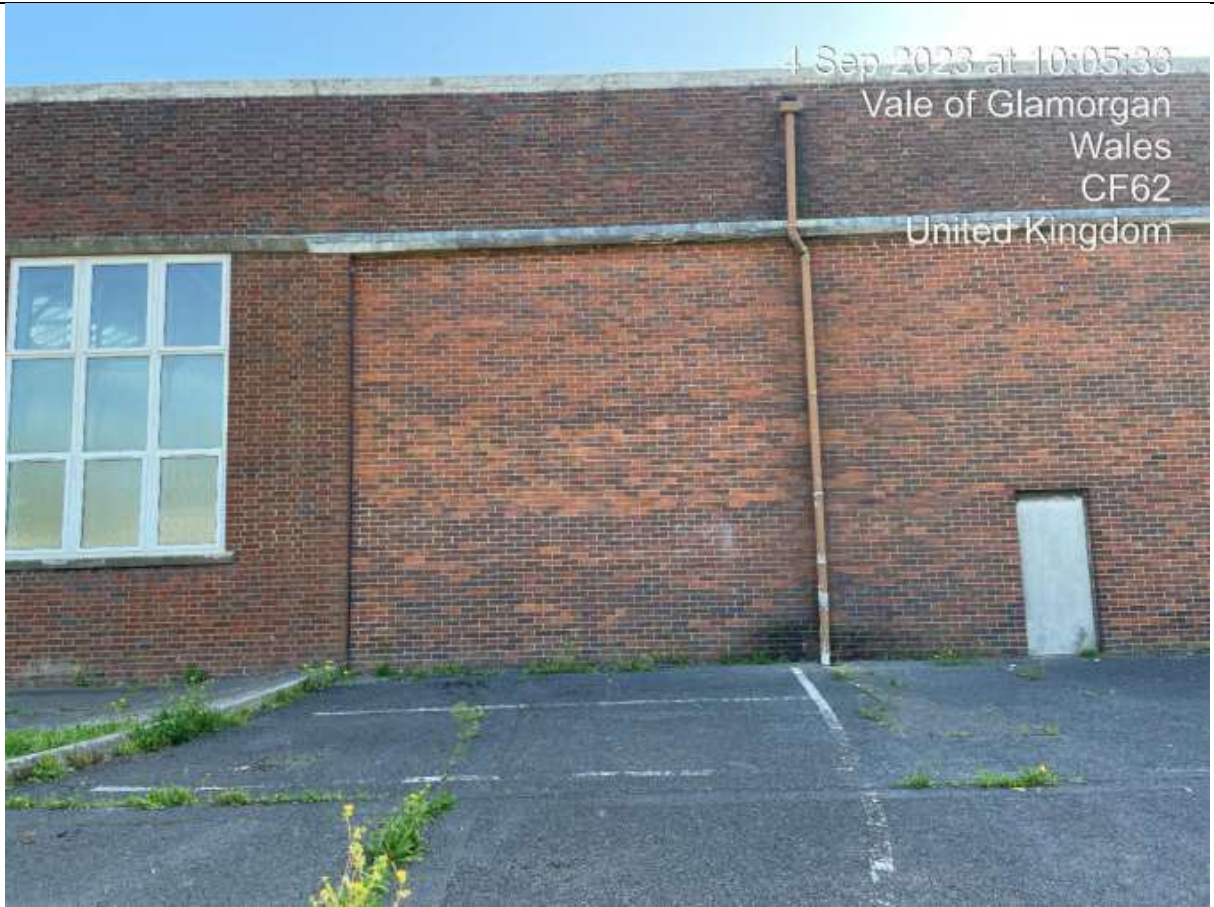
**Western Elevation. Bricked-Up Original Entrance Way.**
