Bro Tathan East Building 354 External & Internal Visual Condition Survey

| Report Ref: | PR01 | Created | 19/06/24 |

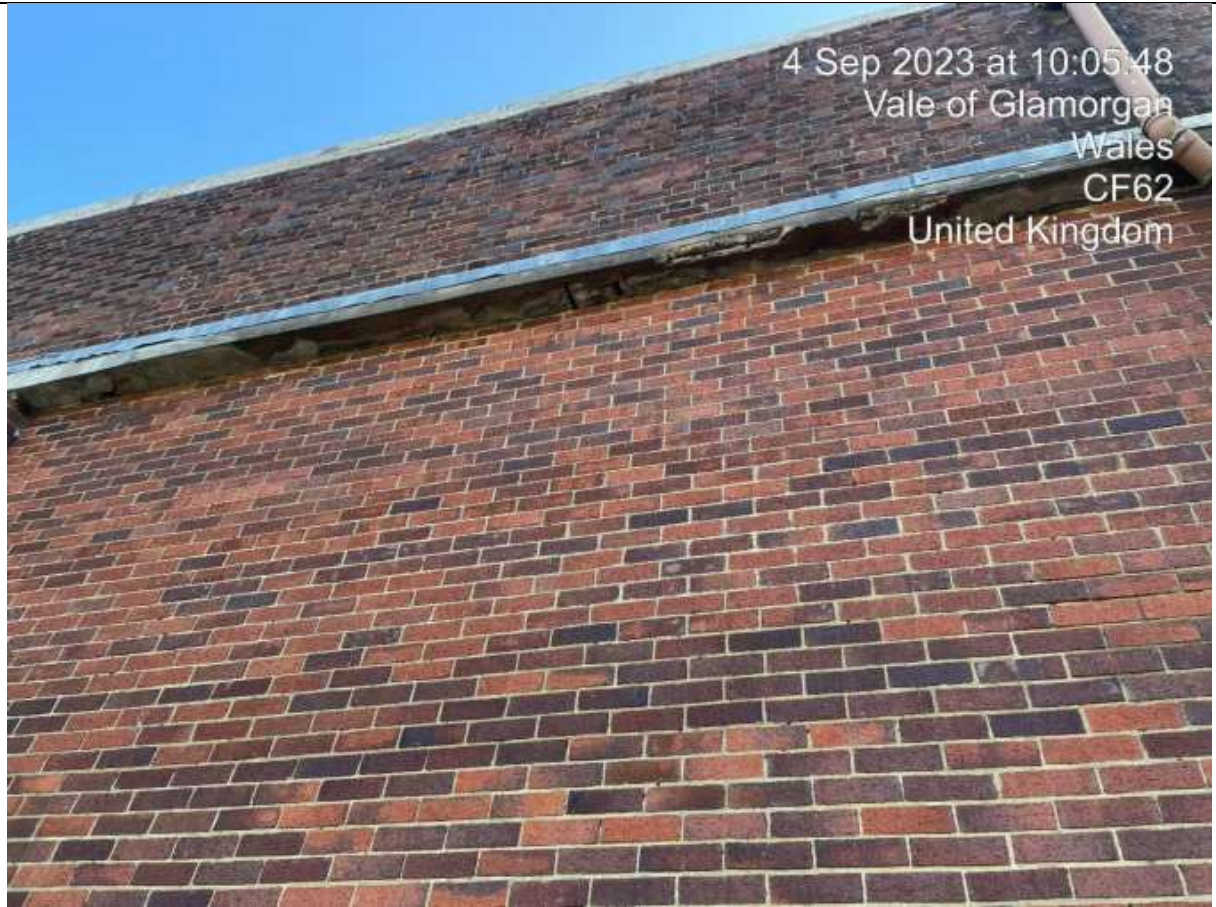
**Western Elevation. Deteriation to Lintel.**

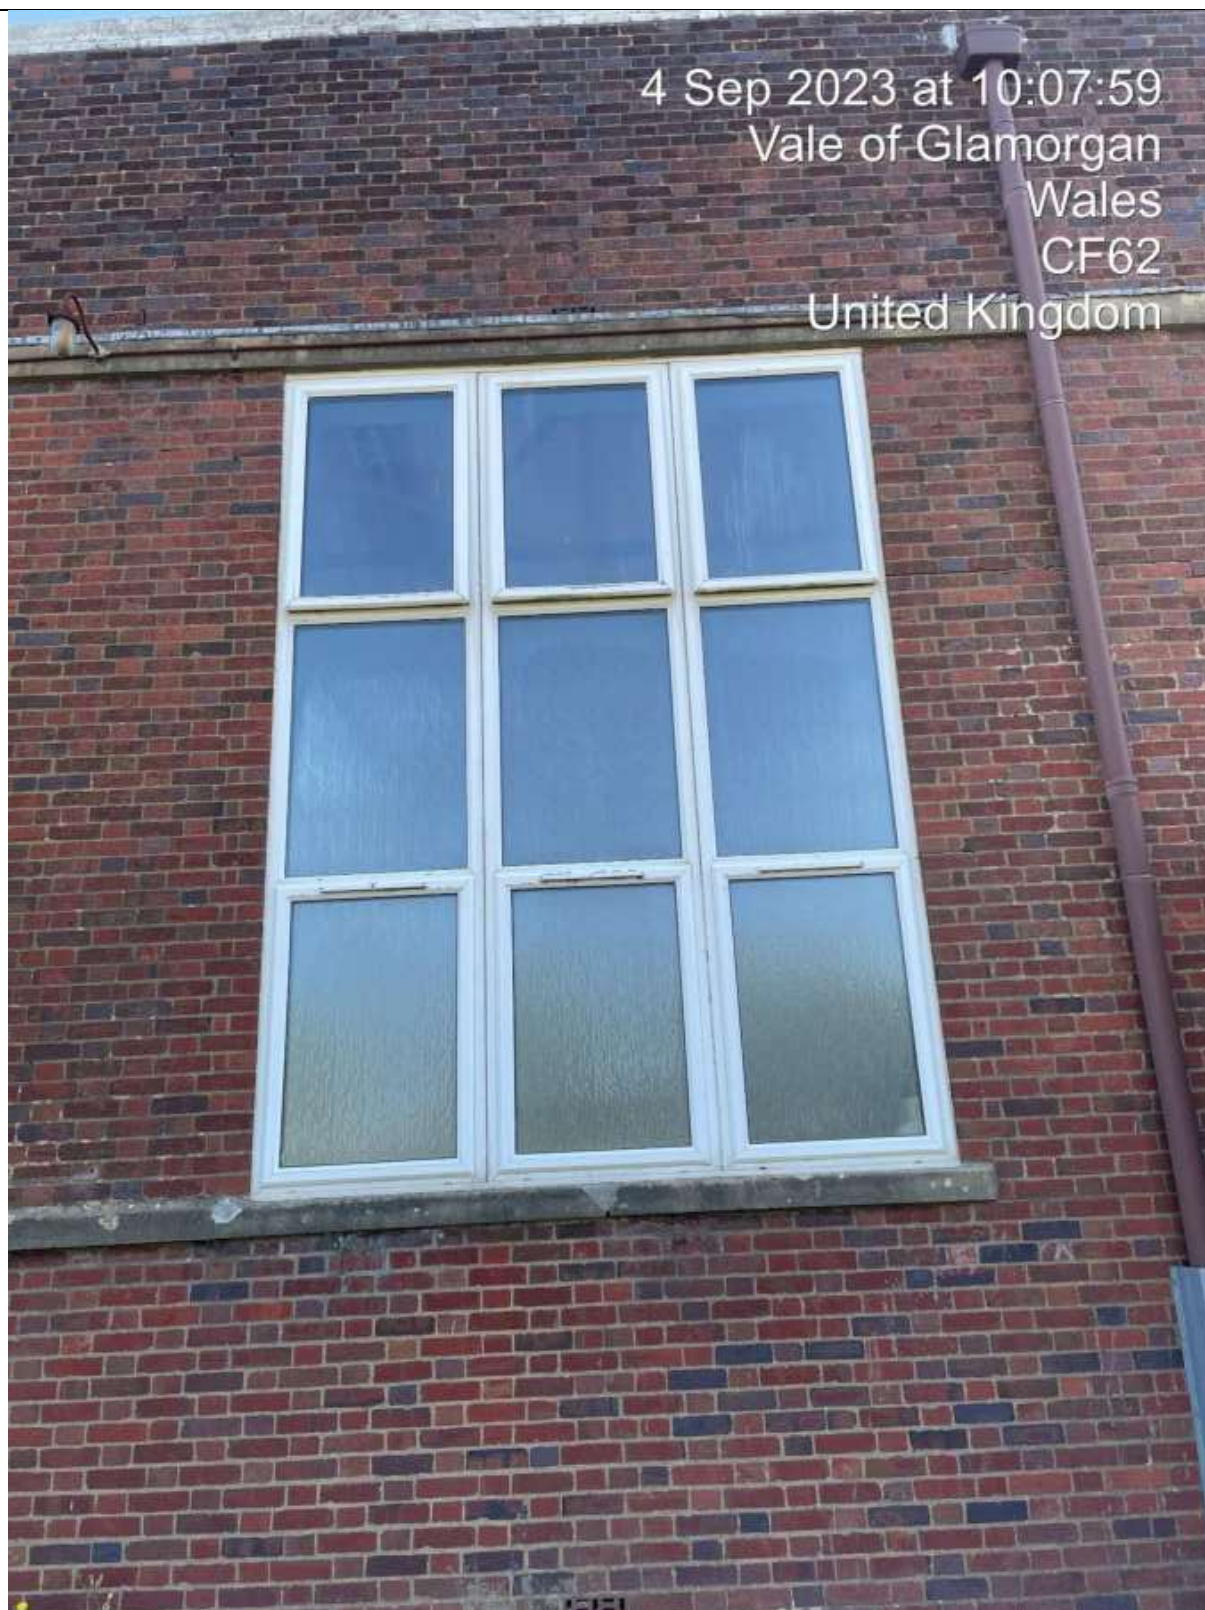
**Western Elevation. Replacement Fenestration.**

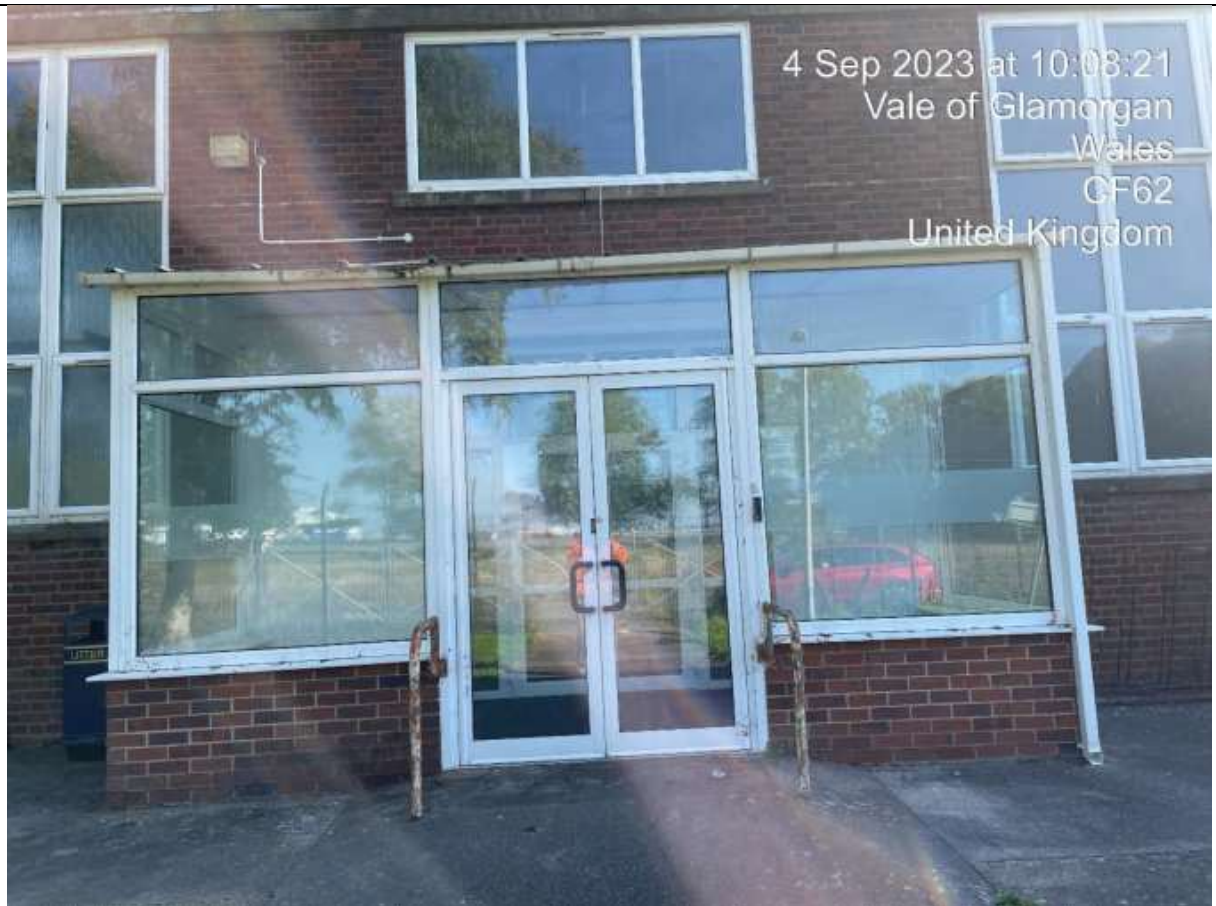
**Western Elevation. Later Entrance Porch that is Non-Compliant.**

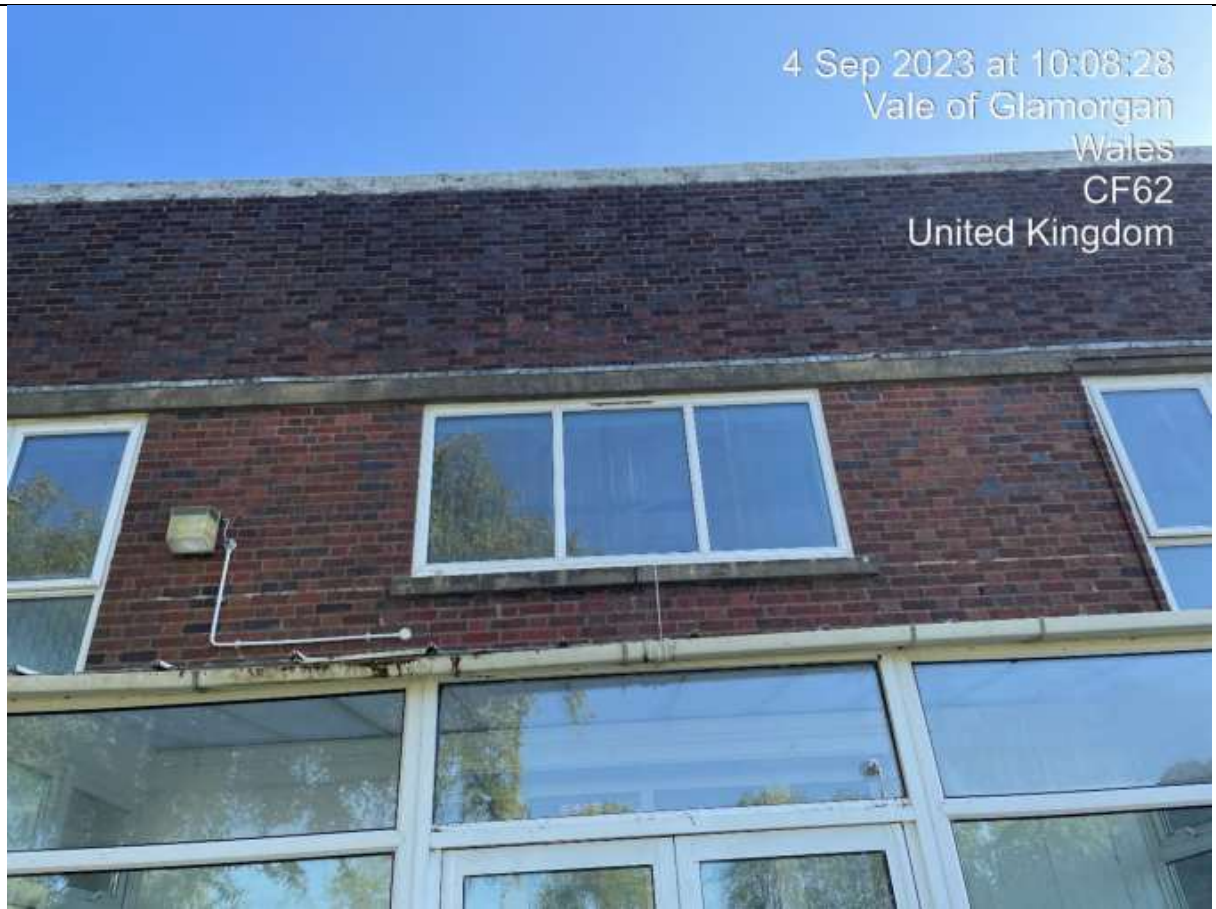
**Western Elevation Replacement Fenestration.**

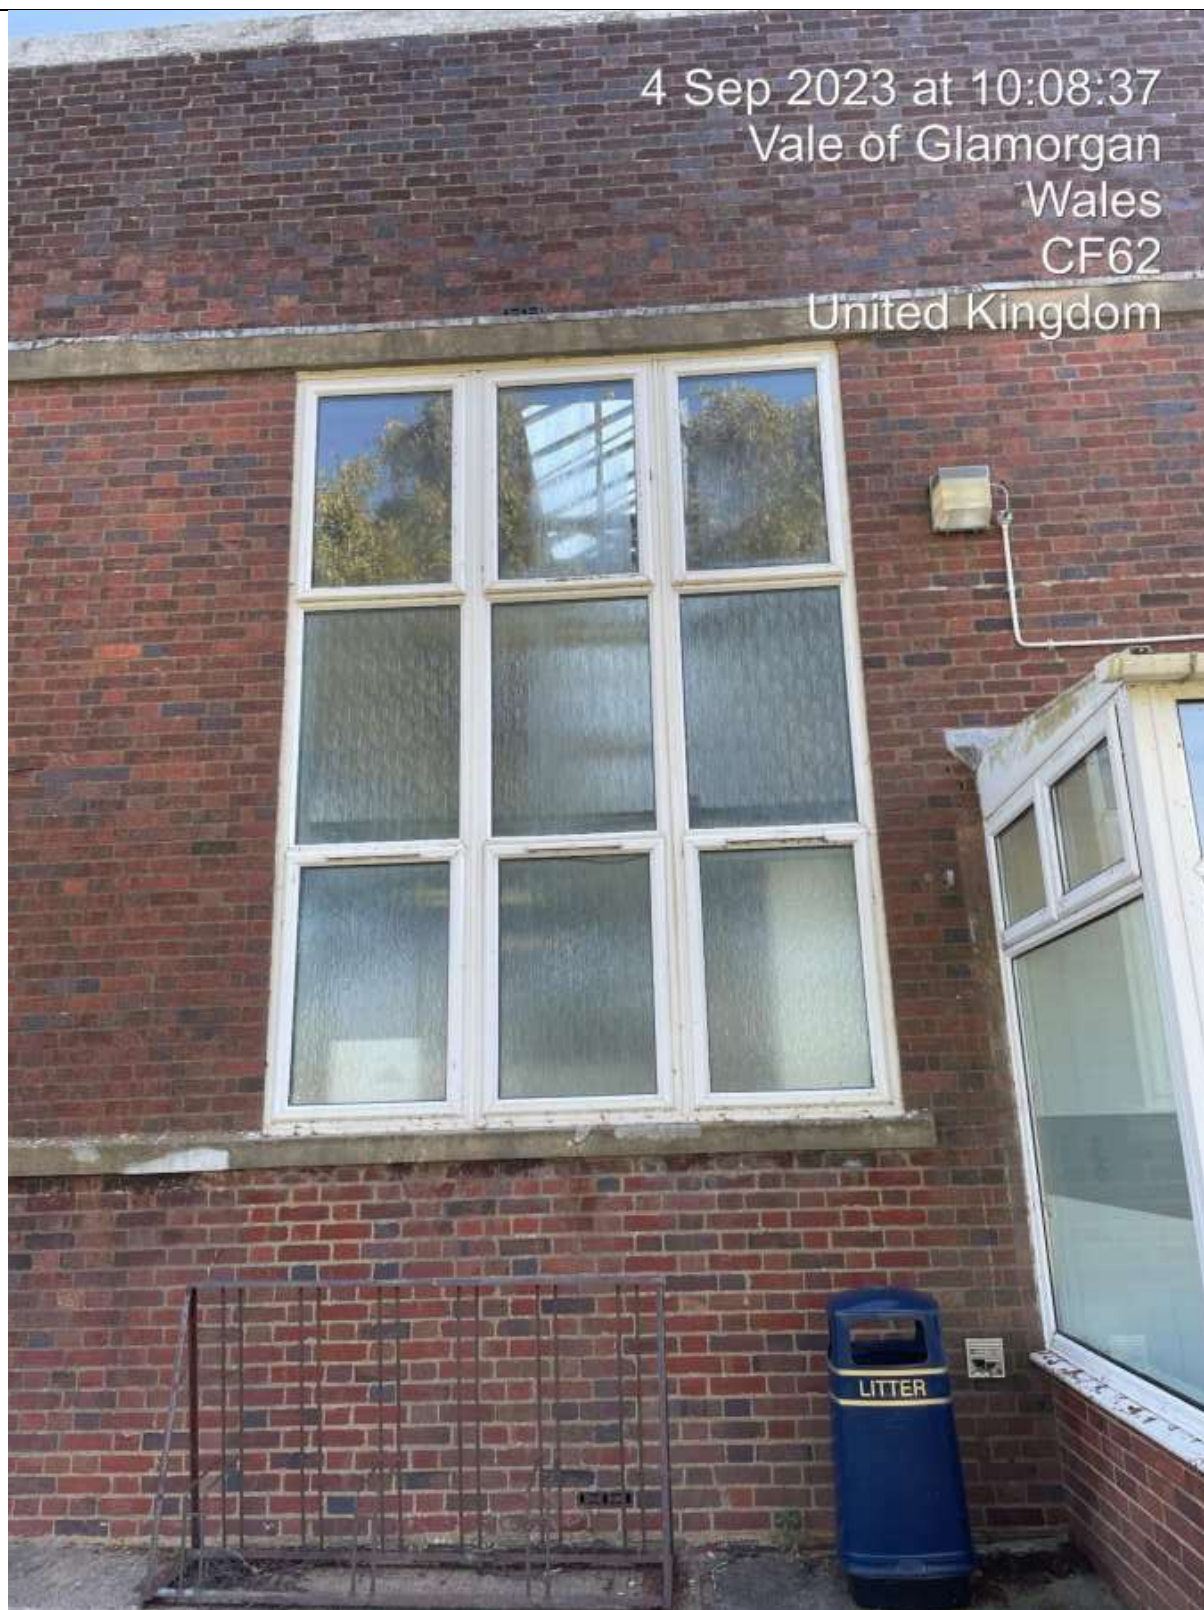
**Western Elevation. Replacement Fenestration.**

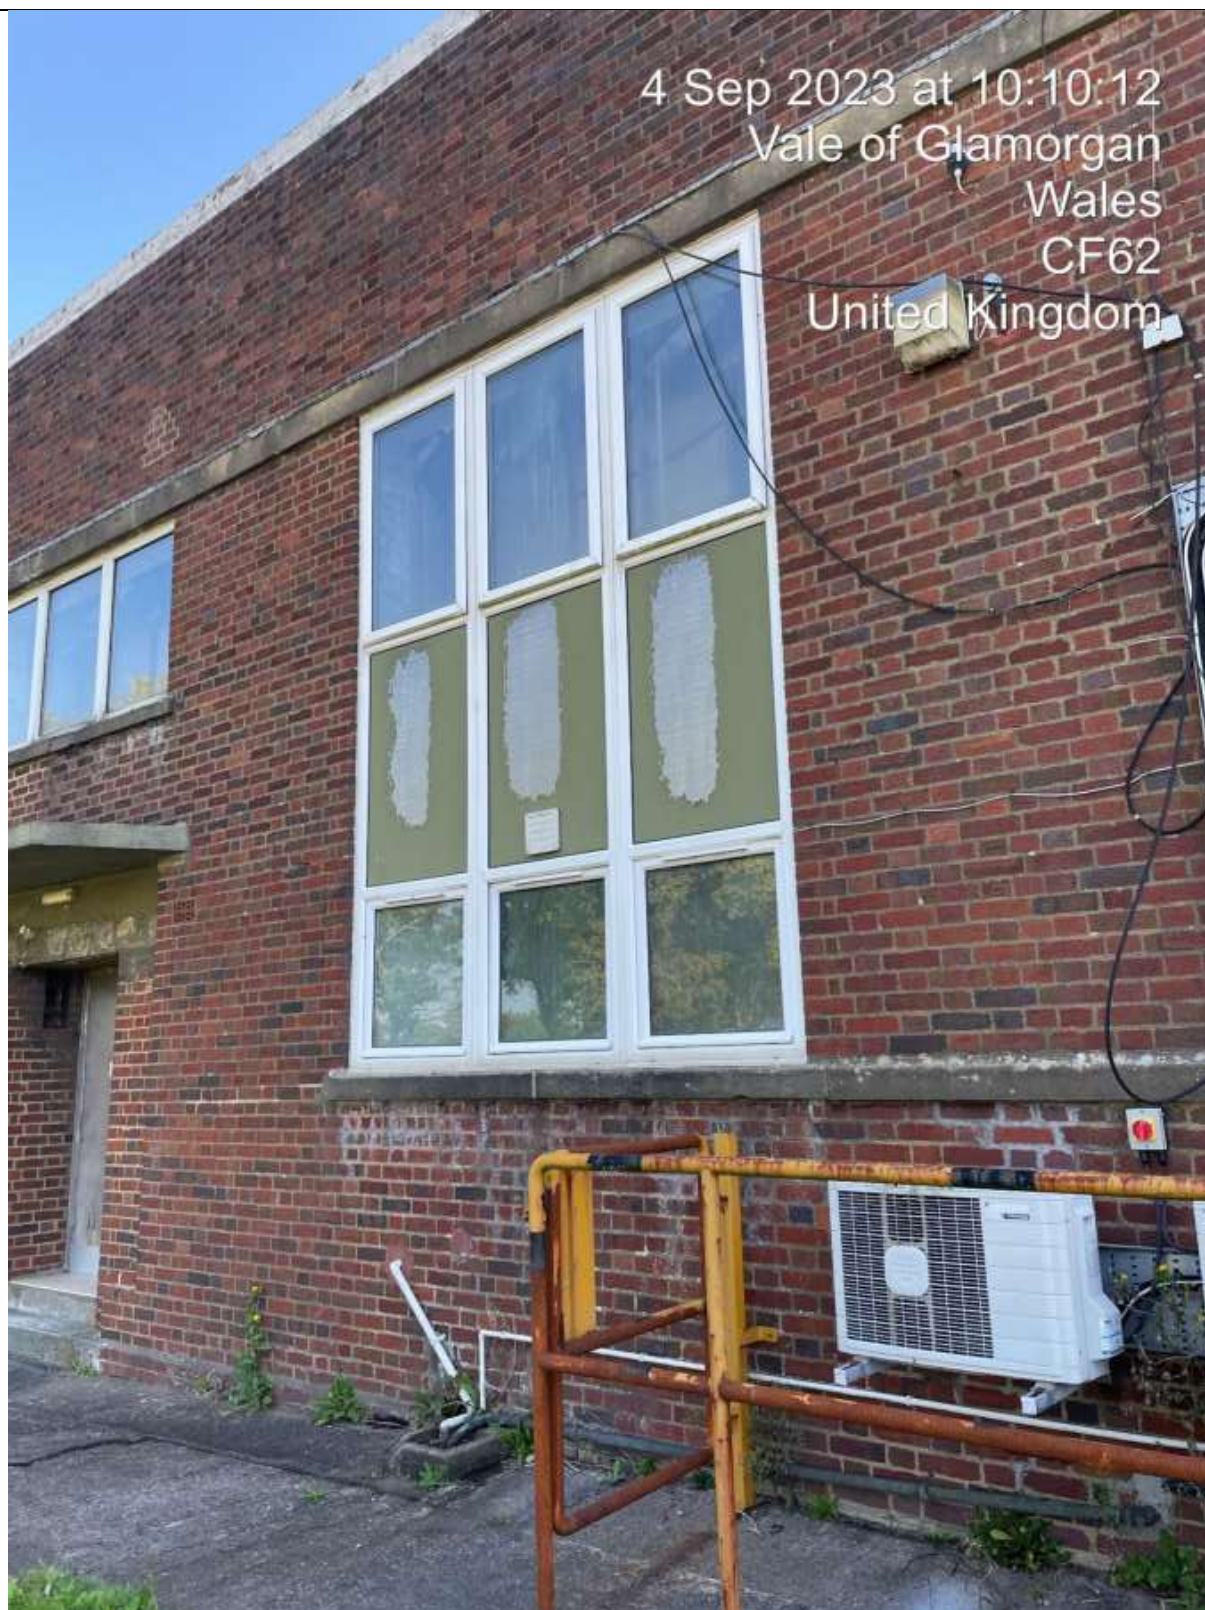
**Western Elevation. Replacement Fenestration that is Deteriorating.**

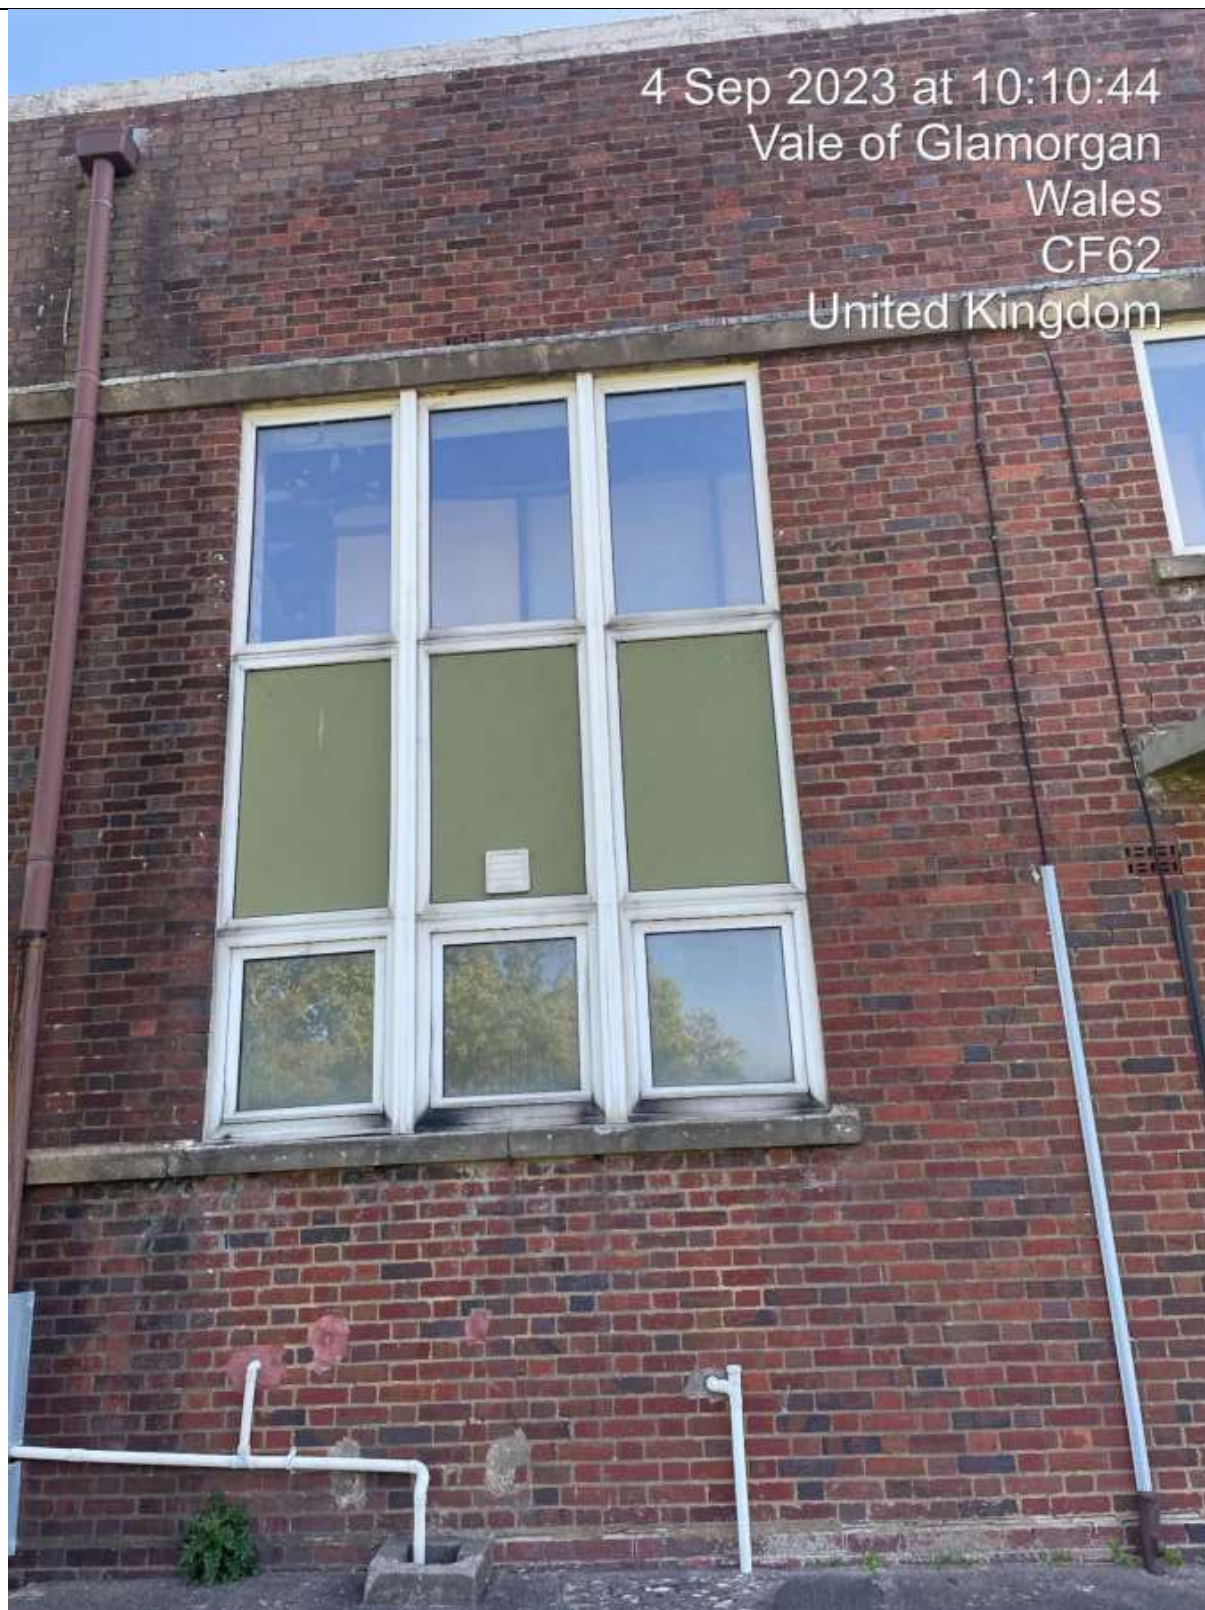
**Western Elevation. Replacement Fenestration.**

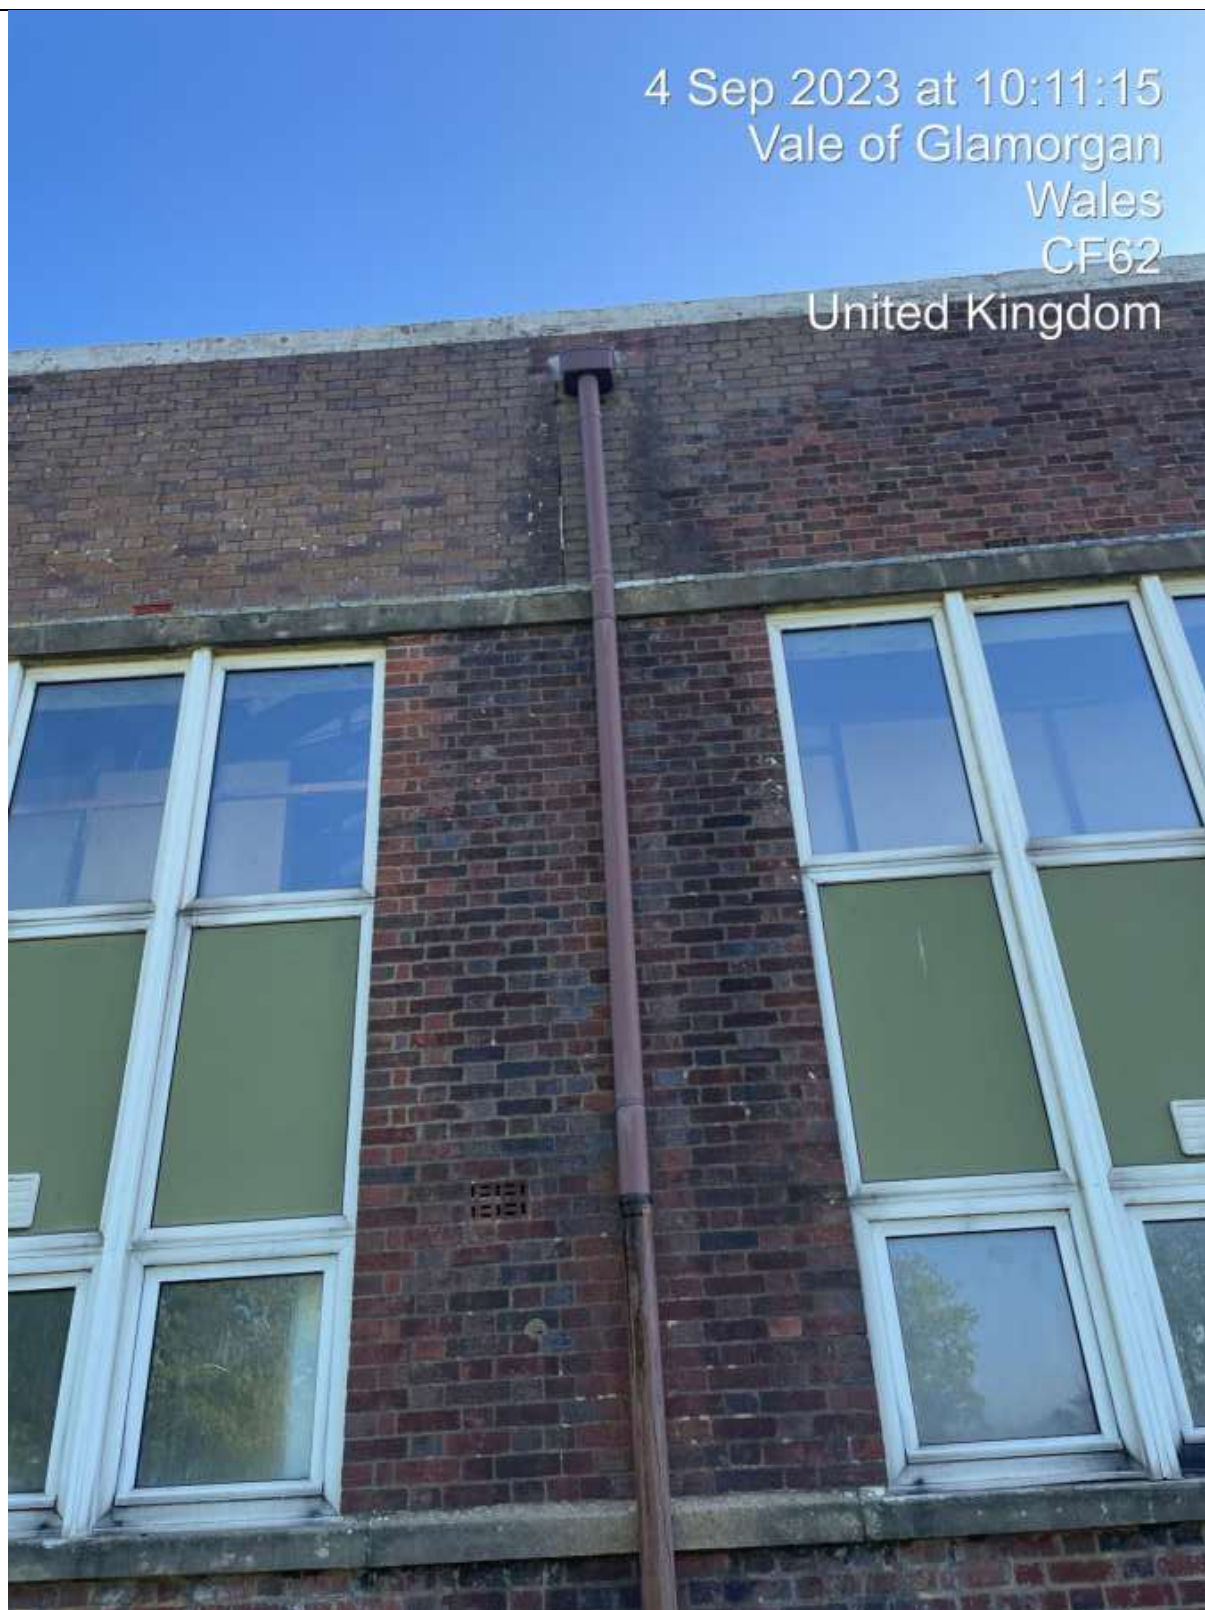
**Western Elevation. Downpipe from Hidden Gutter.**

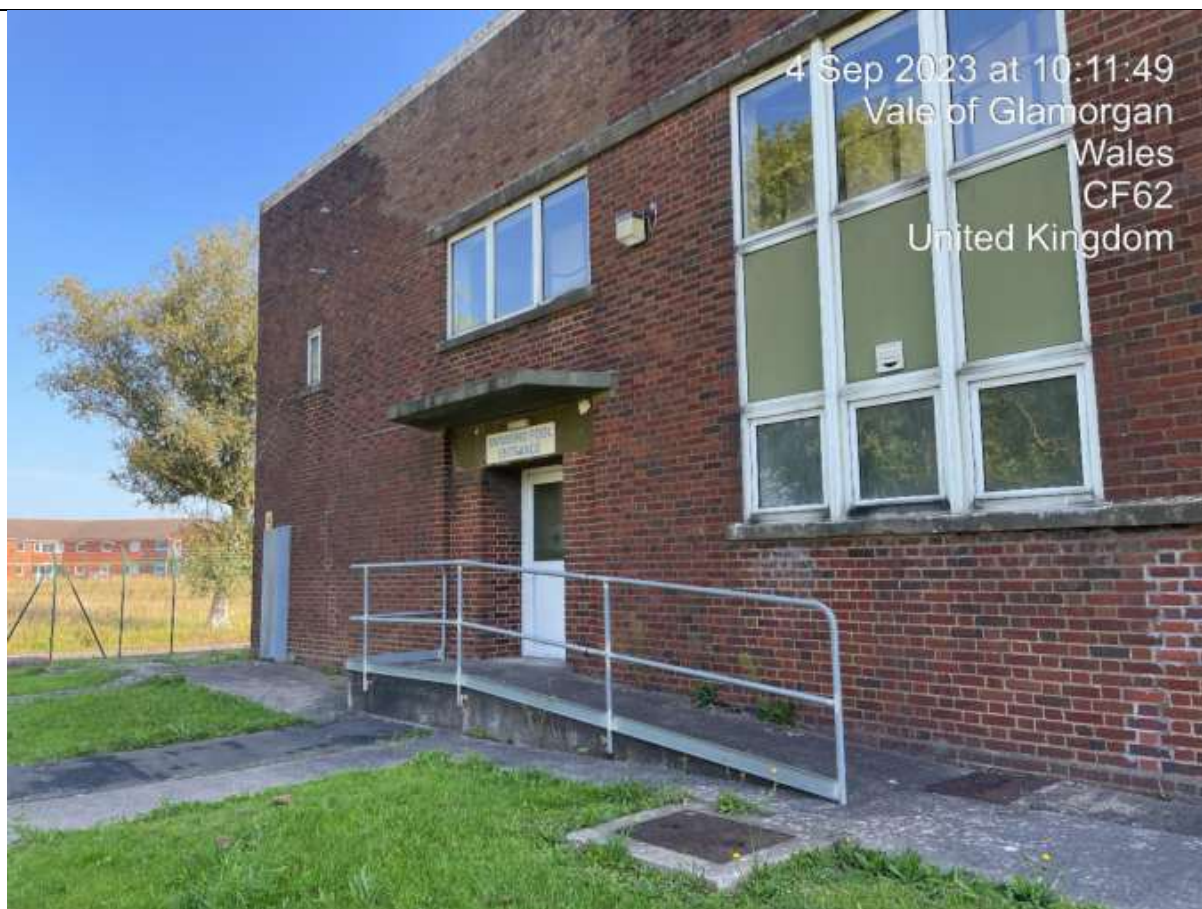
**Western Elevation. Swimming Pool Entrance. Note Non-Compliant.**

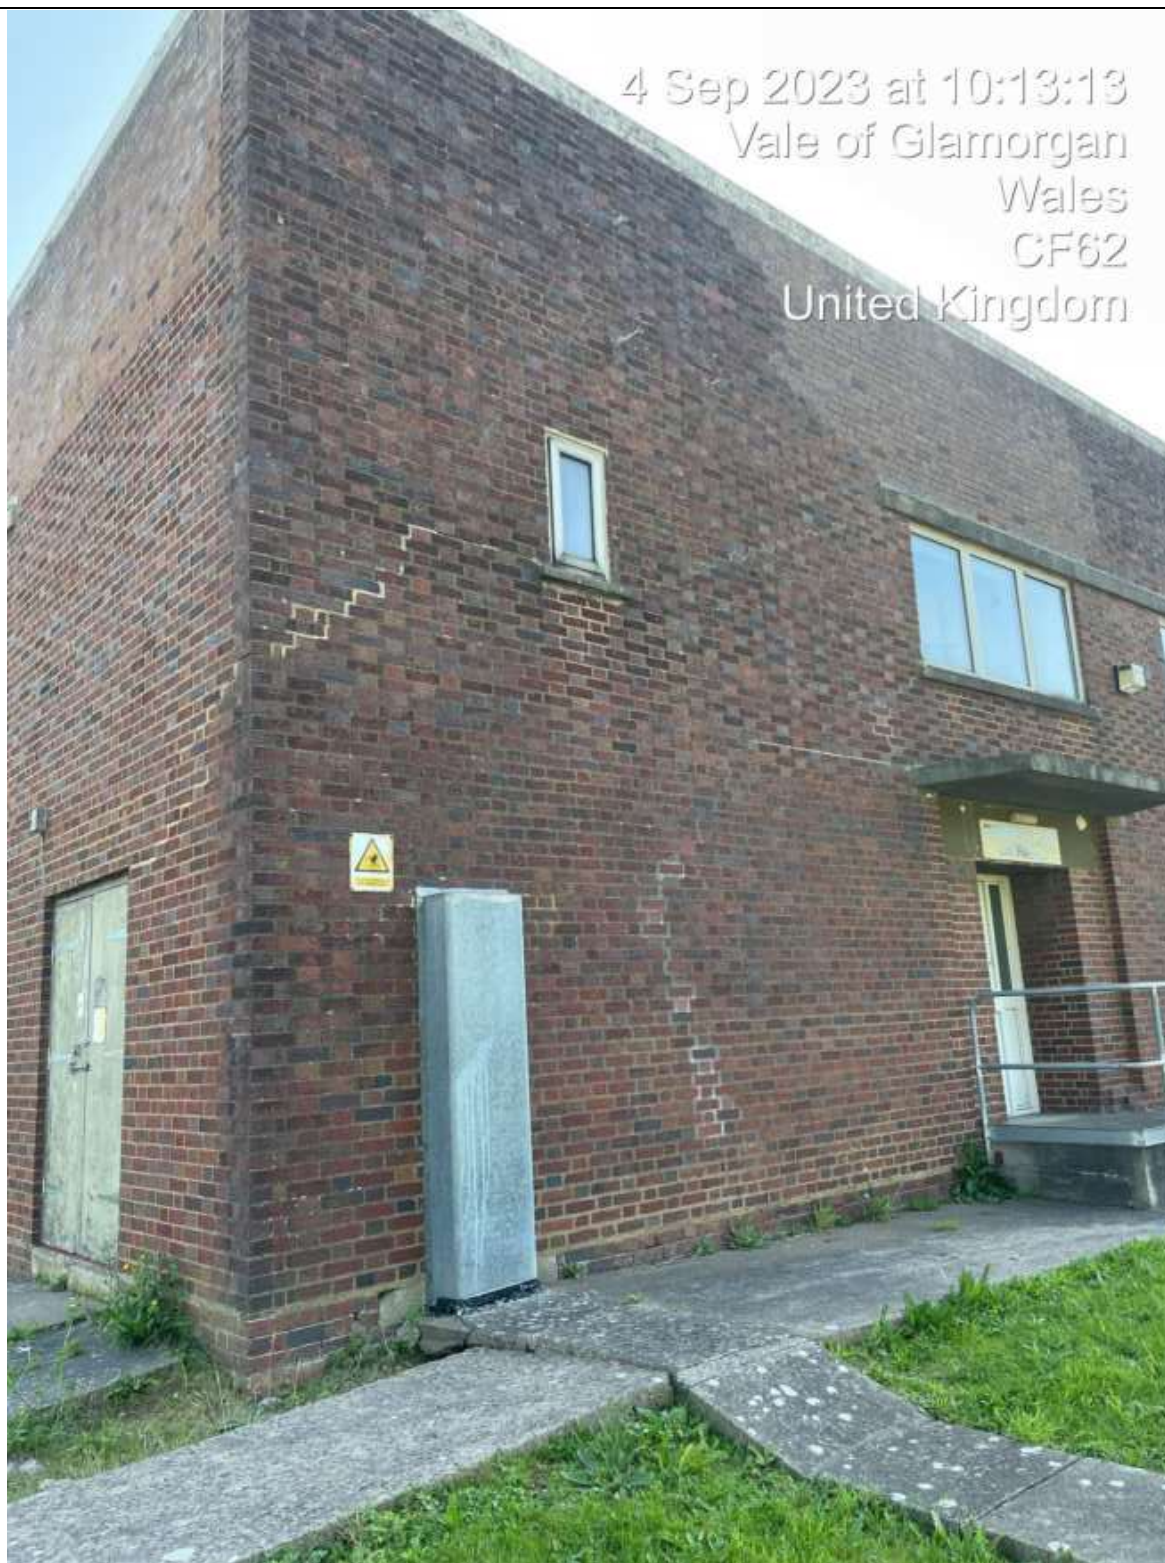
**Western Elevation. Significant Brickwork Replacement Demonstrating Structural Movement & Structural Rotation.**

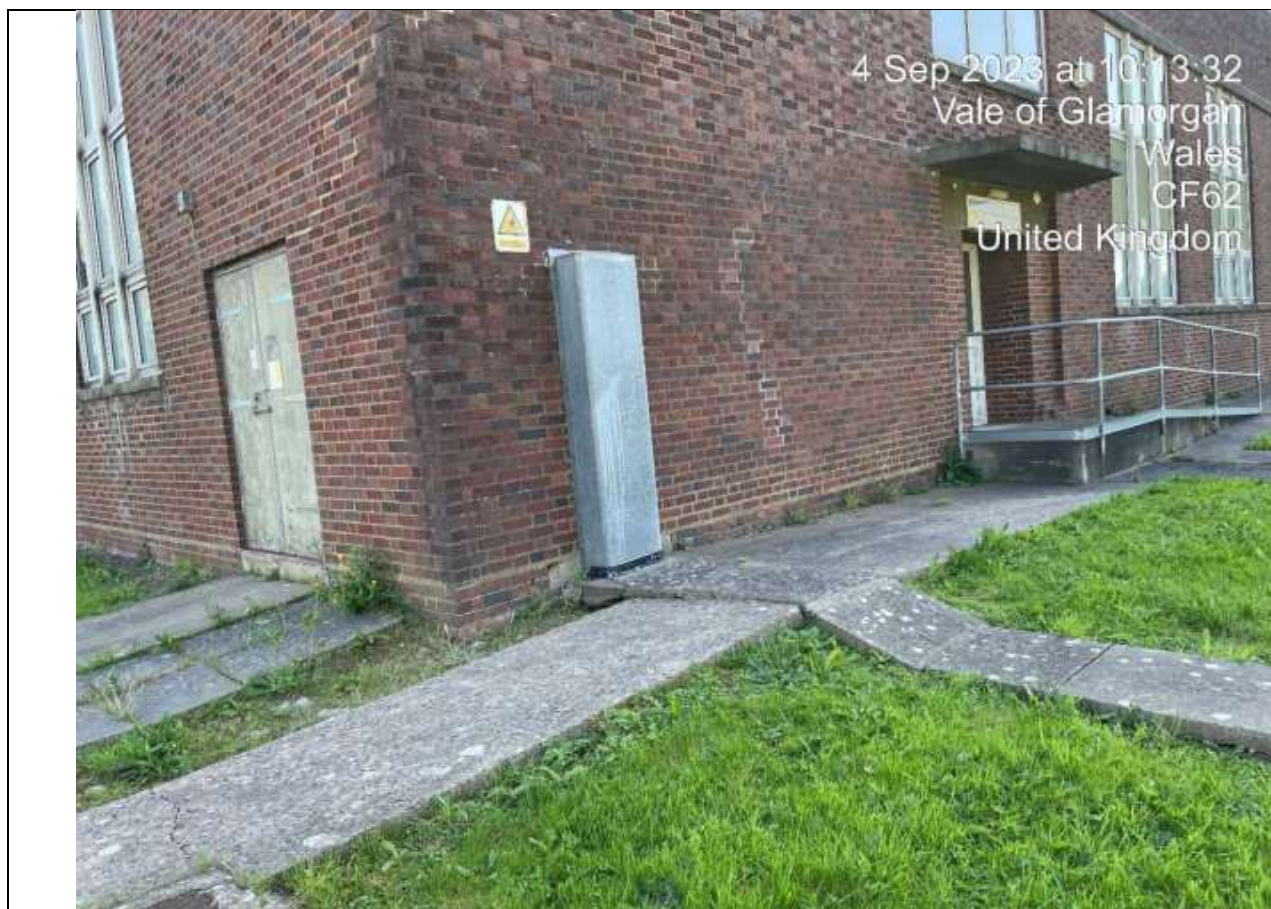
**Western Elevation. Significant Electrical Services Point of Penetration.**

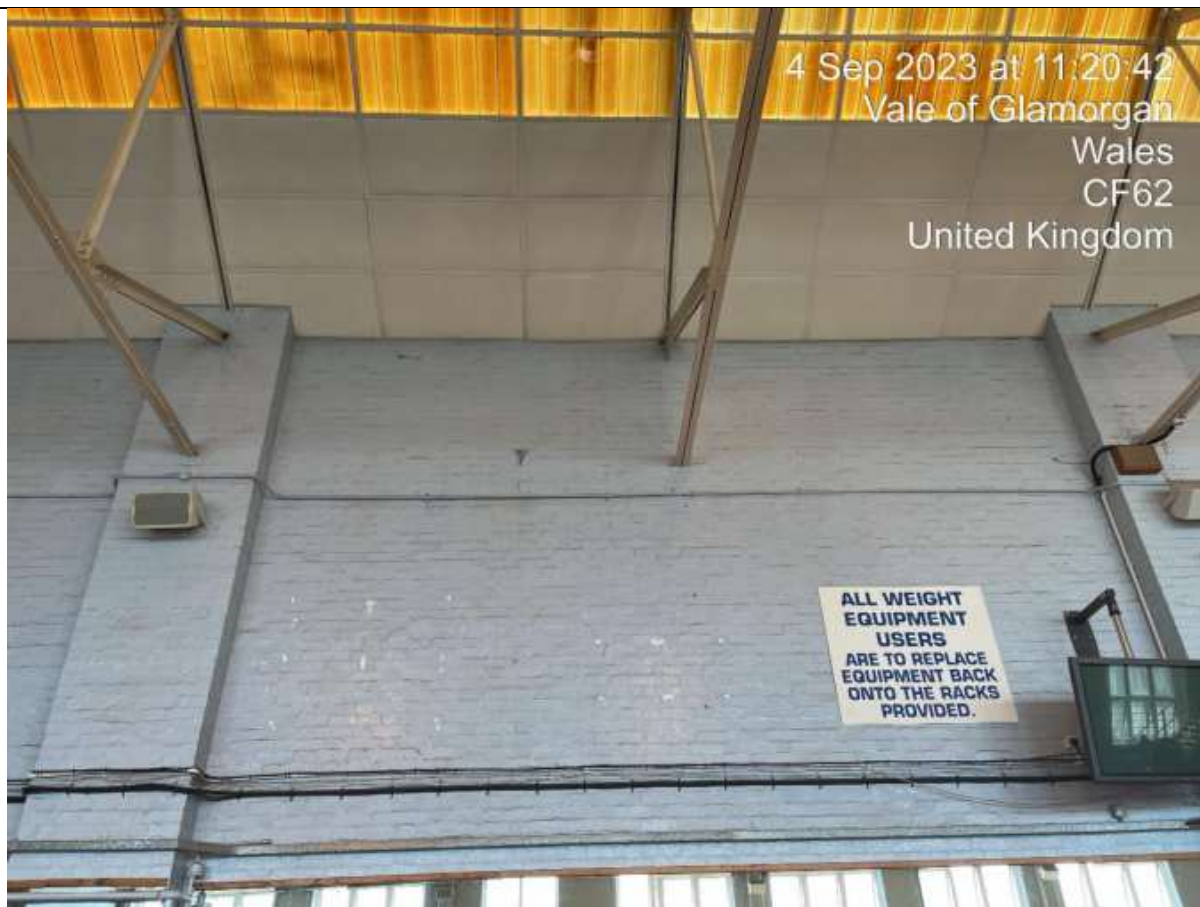
**Discoloration to Roof Lights.**

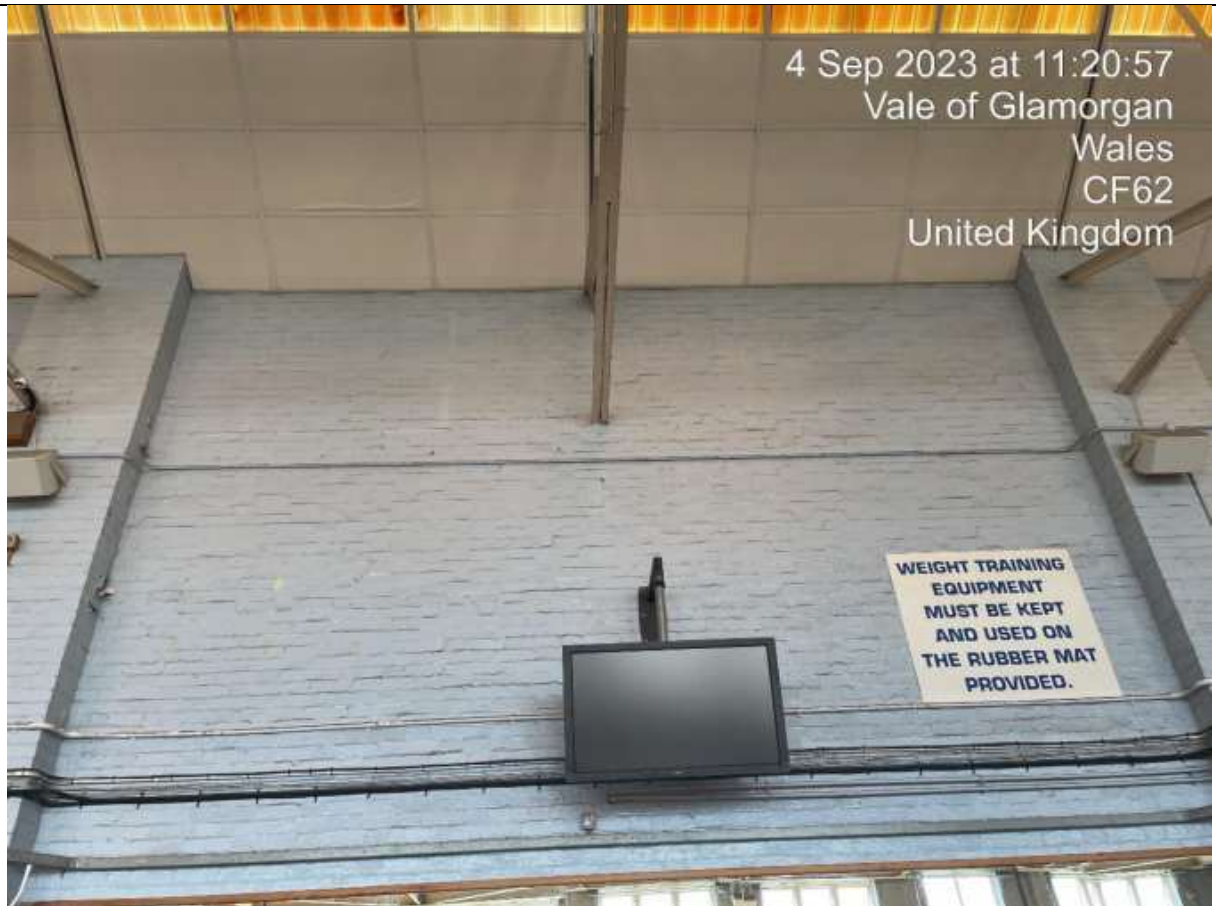
**Penetrating Damp & Unprotected Cable Installations.**

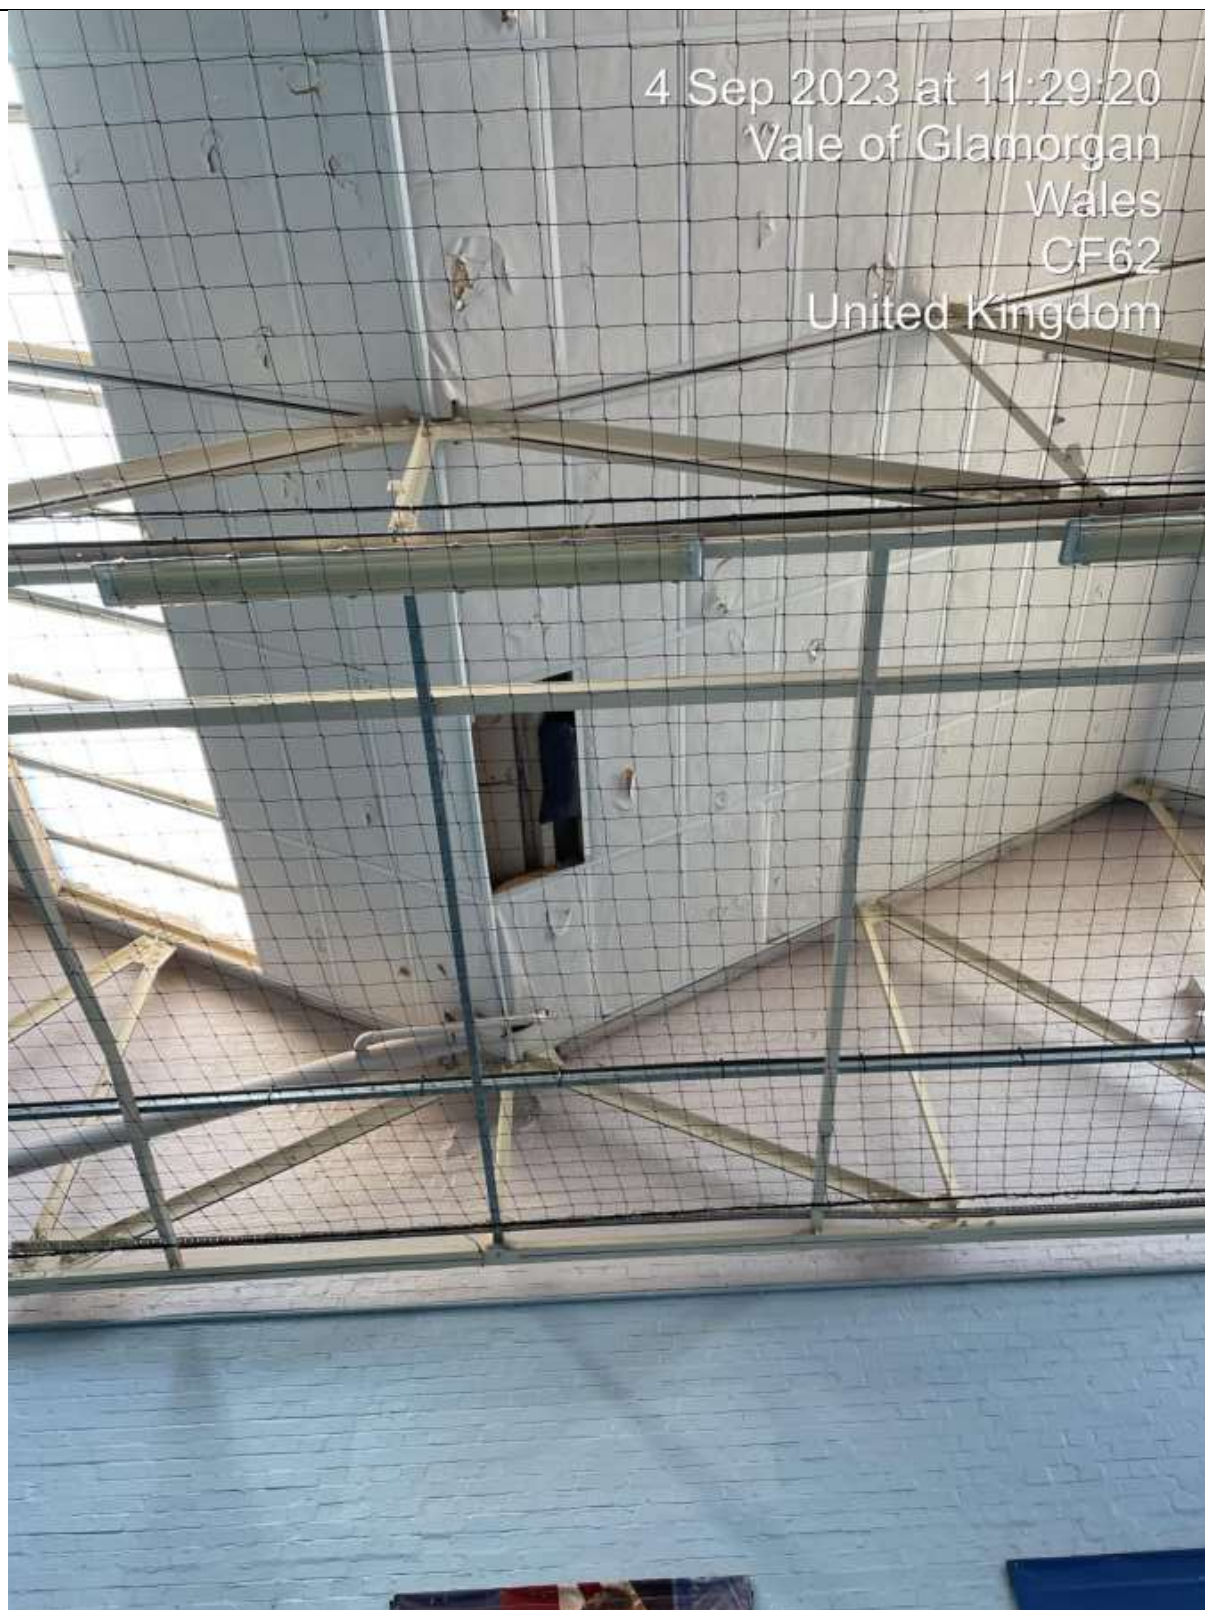
**Deterioration & Missing Suspended Ceiling Tiles.**

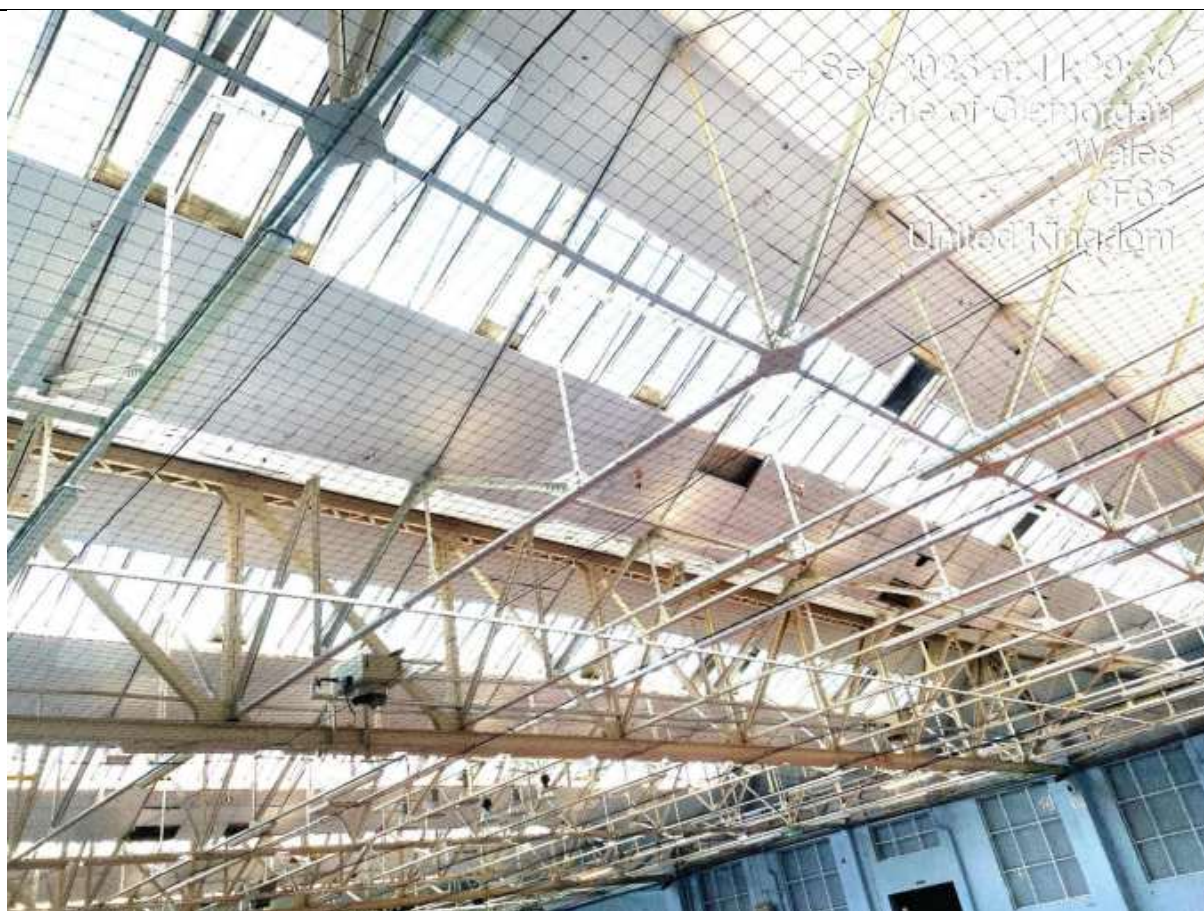
**Deterioration & Missing Suspended Ceiling Tiles. Slipped Roof Lights.**
