Bro Tathan East Building 354 External & Internal Visual Condition Survey

| Report Ref: | PR01 | Created | 19/06/24 |

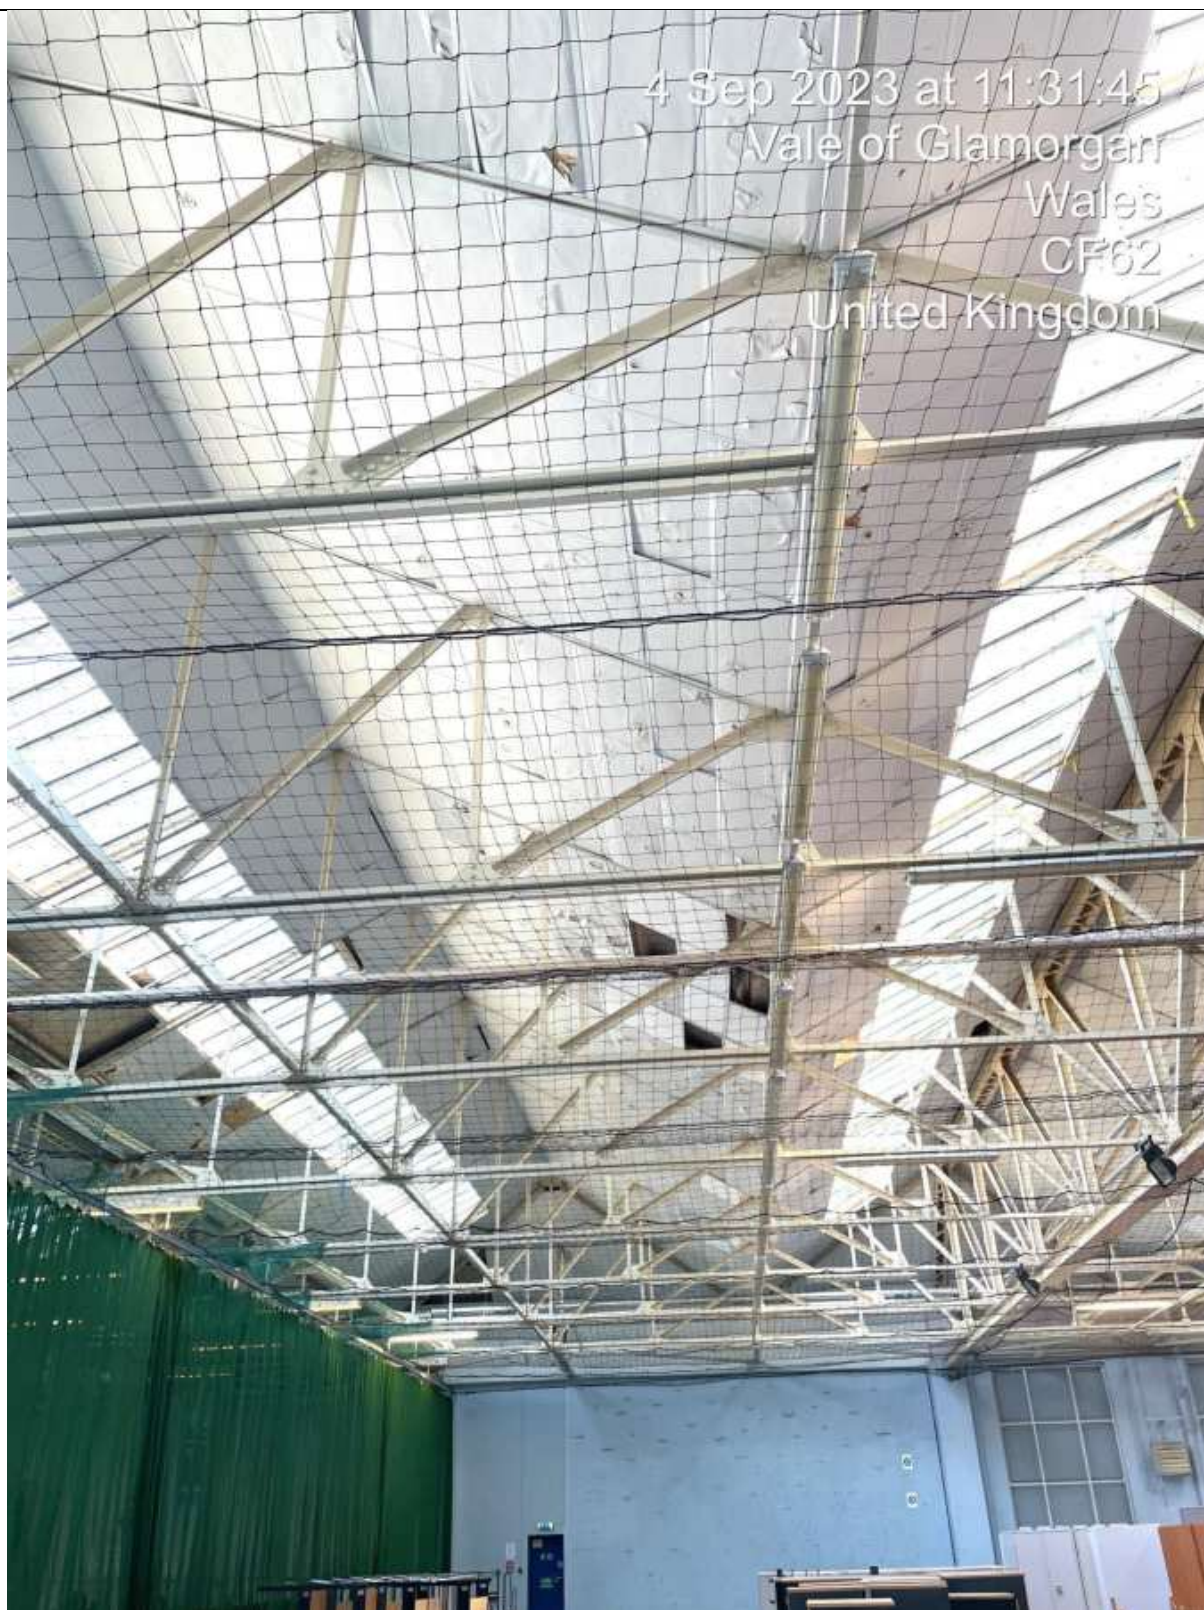
**Deterioration & Missing Suspended Ceiling Tiles.**

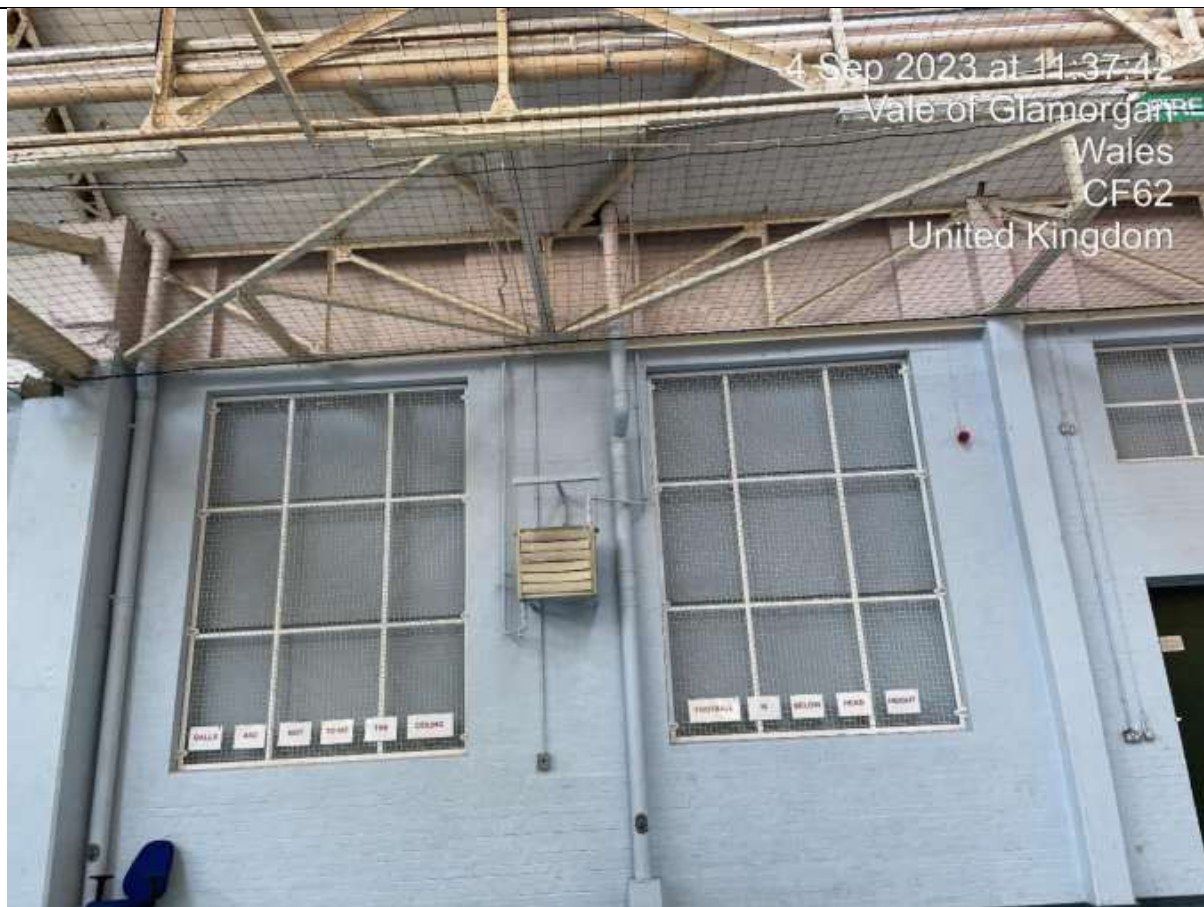
**Covered Original Fenestration.**

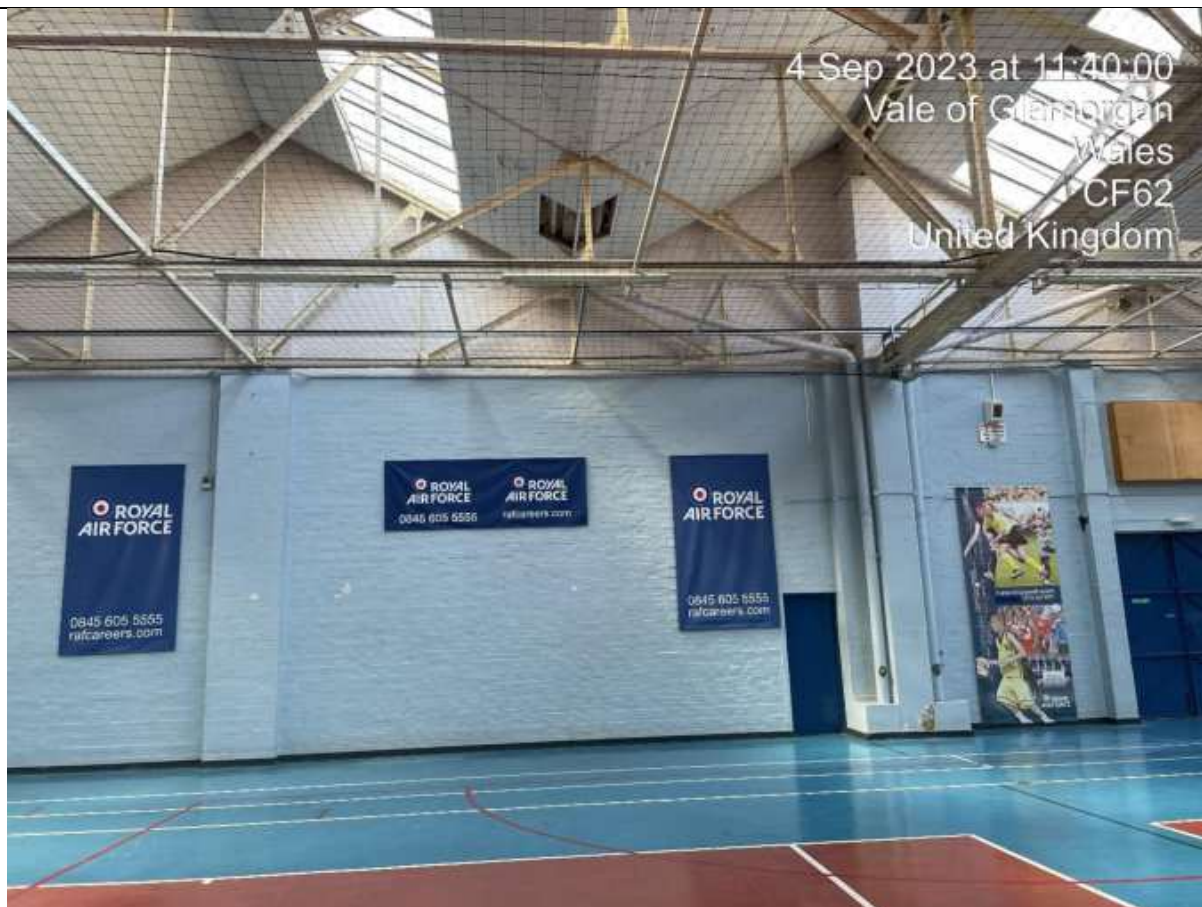
**Deterioration & Missing Suspended Ceiling Tiles.**

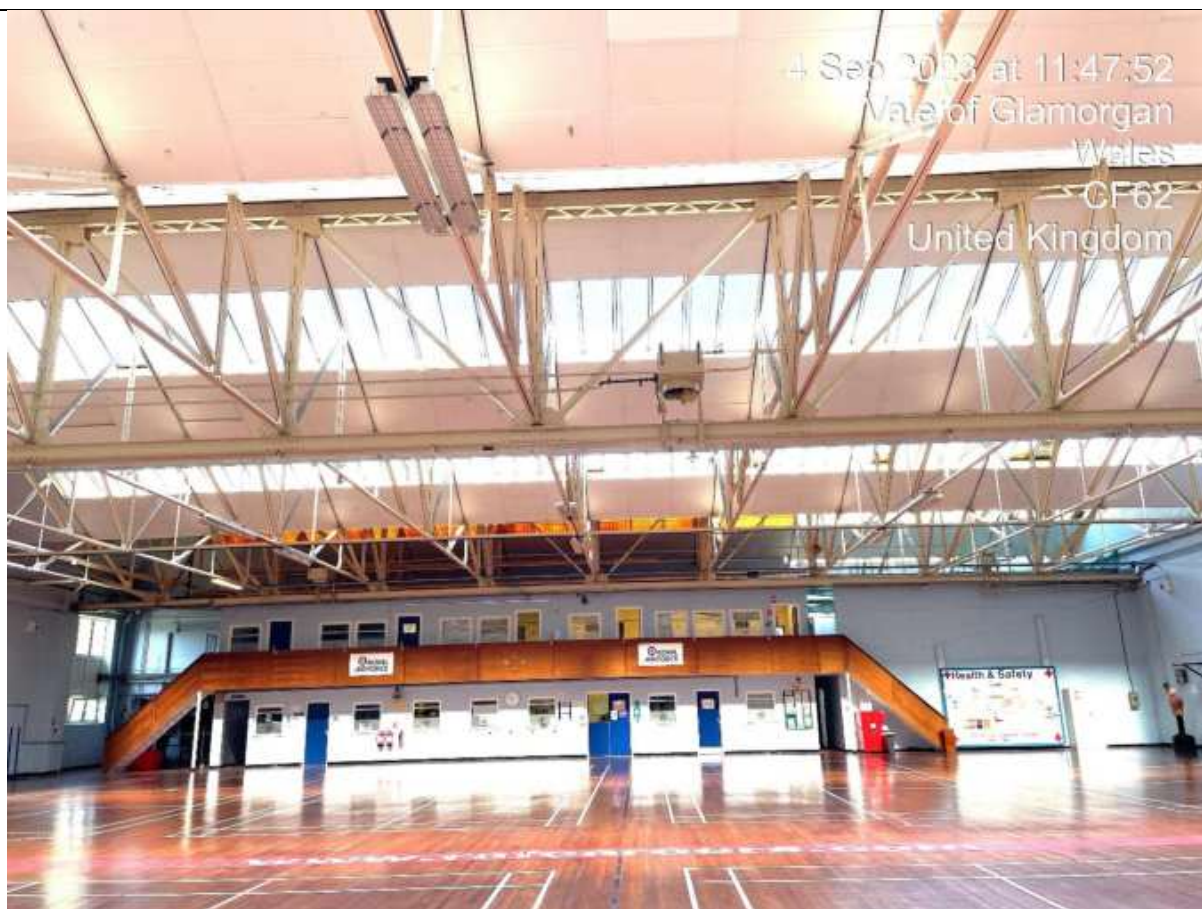
**Discoloration of Roof Lights.**

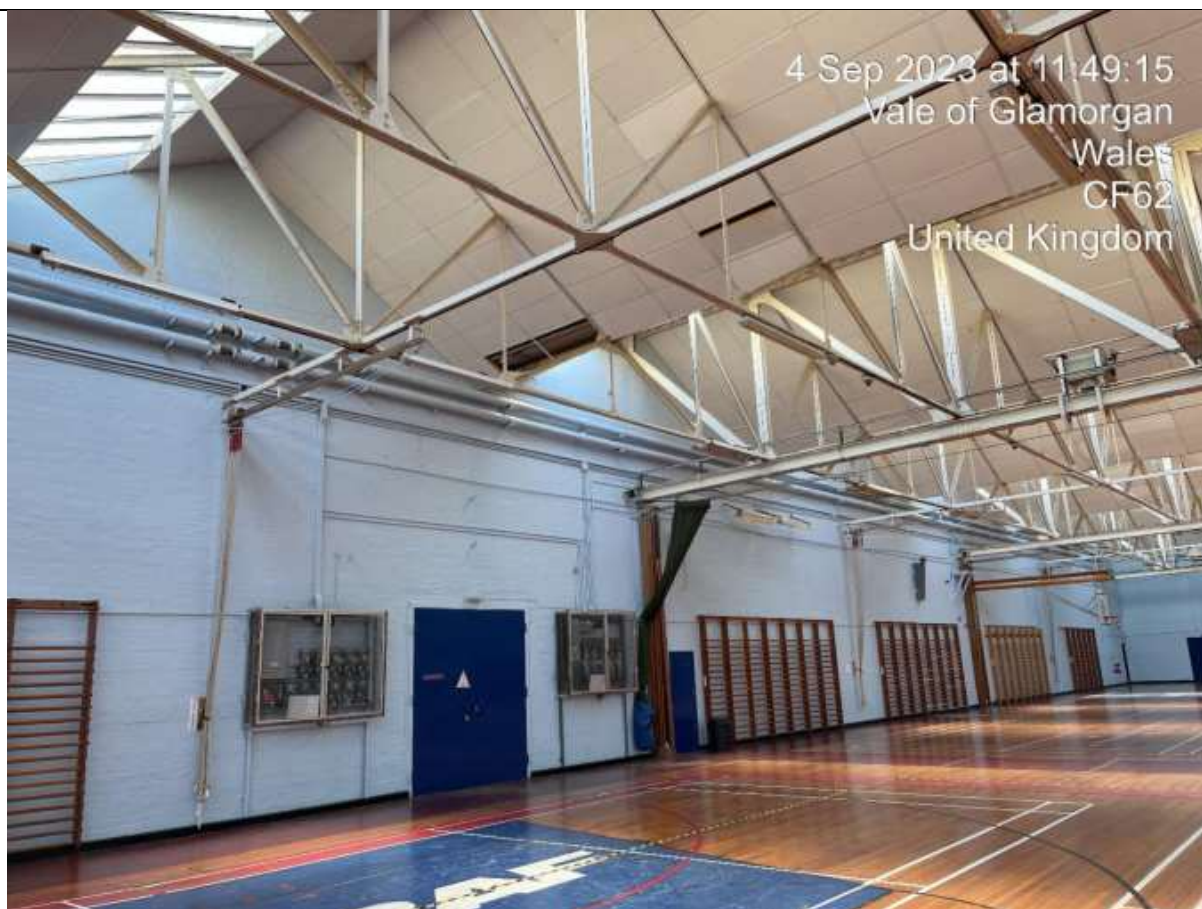
**Deterioration & Missing Suspended Ceiling Tiles.**

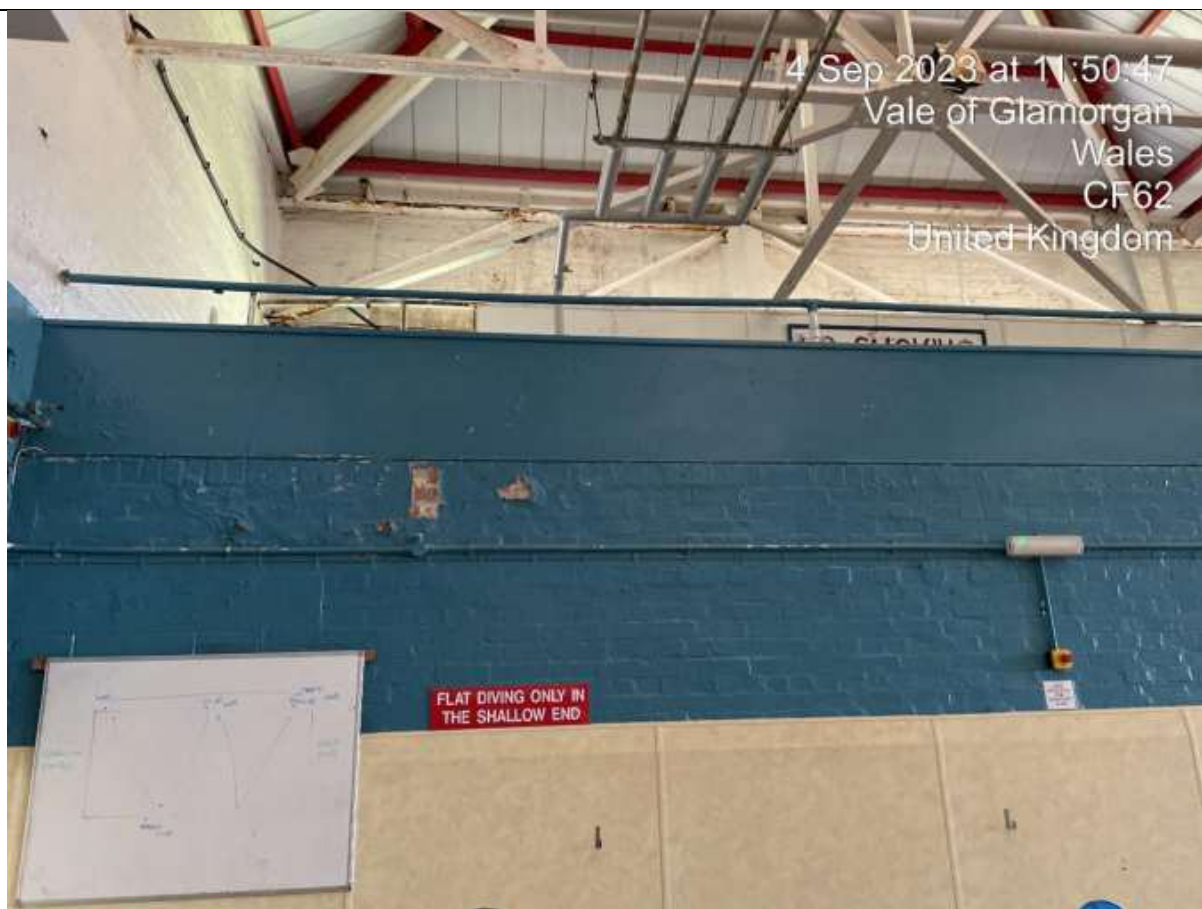
**Corrosion to Steel Roof Frame & Penetrating Damp.**

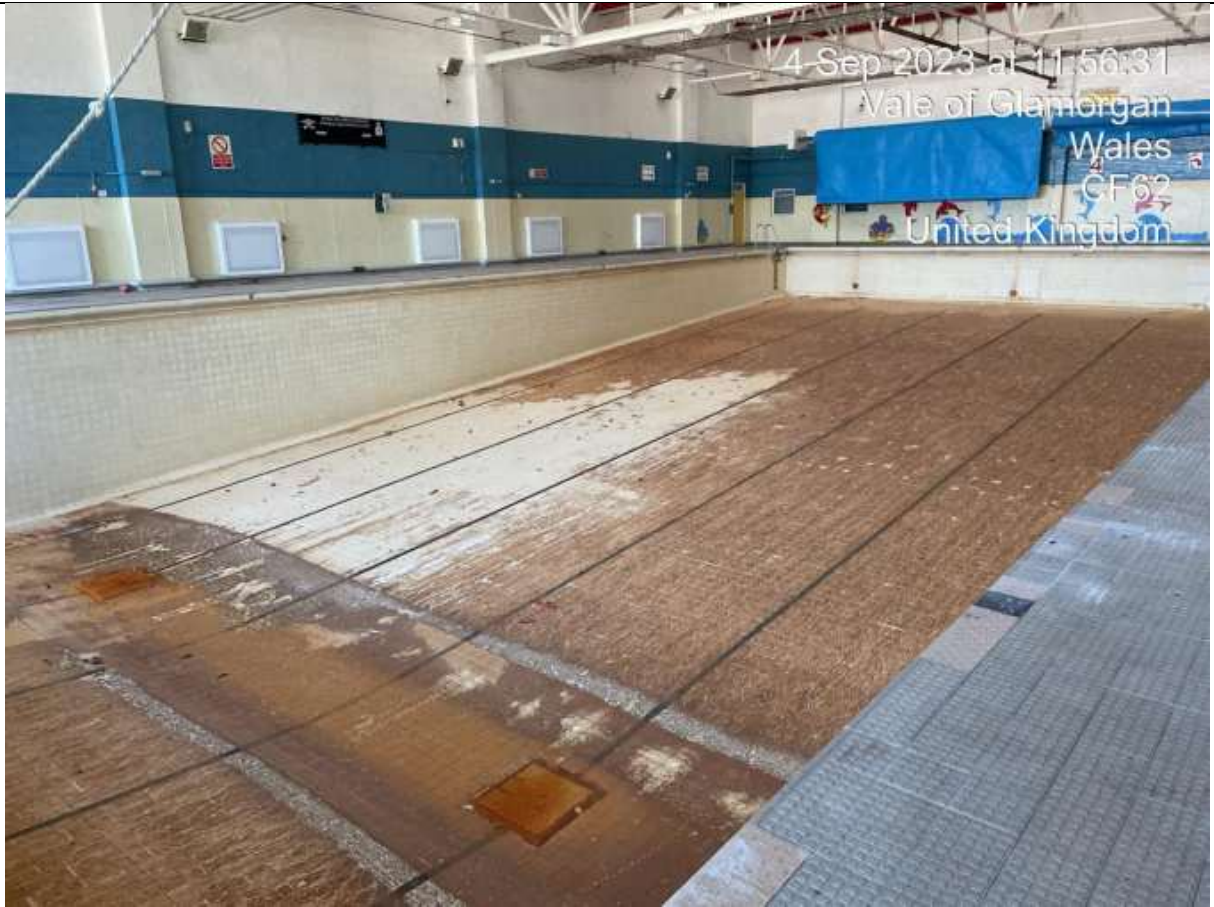
**Empty Swimming Pool with Residual Contamination.**

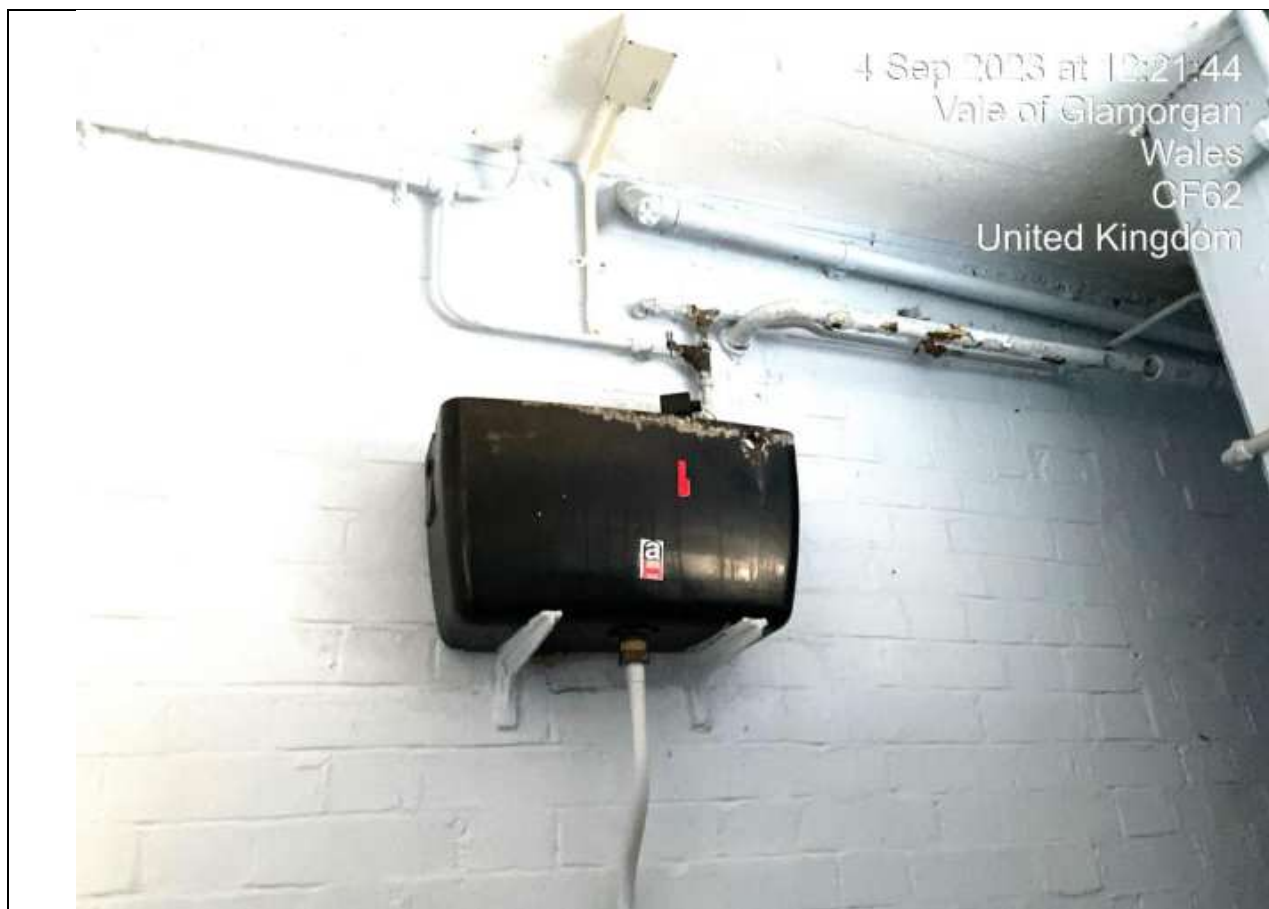
**Asbestos Content to High Level Toilet Cistern.**
