M4 Corridor around Newport

Environmental Statement Volume 3:
Appendix 10.24

Bat Roost Survey 2015 Report

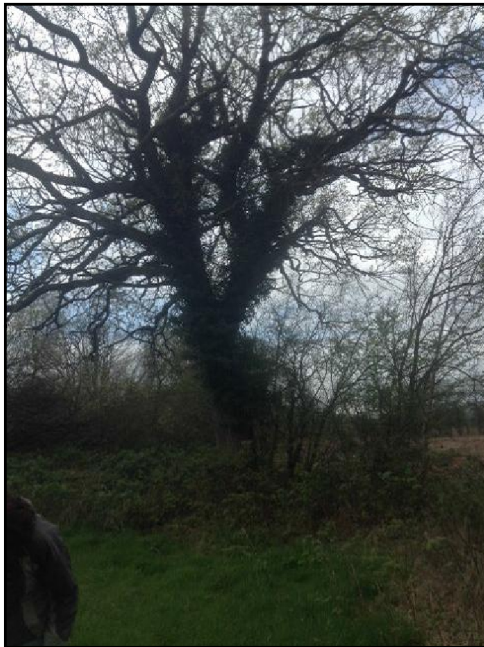
Photograph 3:
T39 - High potential bat roost.

- 2.4.2** Tree climbing inspections could not be carried out at trees T17, T39, T80, and T247 (see Figure 1a to 1f) because they were unsafe to climb due to the poor condition of the trees.

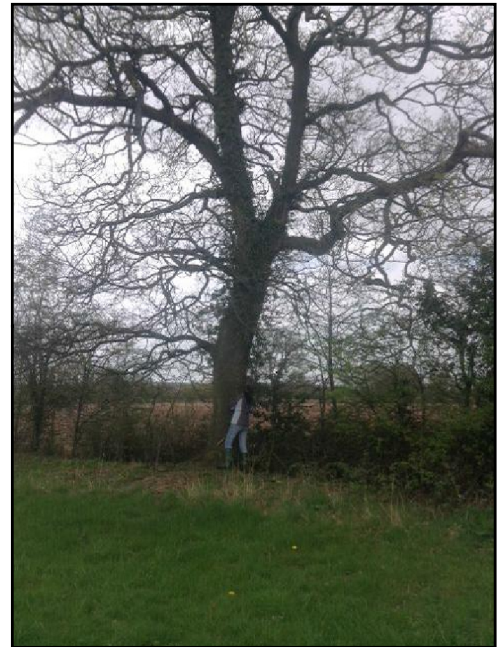
Photograph 4:
T45 - High potential bat roost.
