## **M4 Corridor around Newport**

Bat Survey 2016

M4CaN-DJV-EBD-ZG\_GEN-AX-EN-047

2016 Bat Surveys

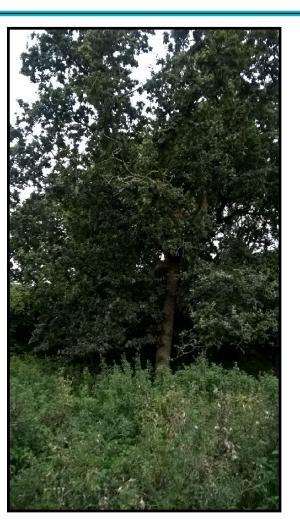
Photograph 1: Tree X3 – Probable bat roost.

**4.1.1** The ground level tree inspection of tree X3 (see Figure 2c, Photograph 1 on Figure 3) recorded only two features that could be potential roost features. Details of the inspection results are given in Table 5.

Tree ID	Х3
Tree Species	Pedunculate oak (Quercus robur)
Approximate Height (m)	10
Diameter at Breast Height (cm)	79
Life-stage	Mature
Condition	Good
Potential Roost Features	Raised bark on northern aspect Rot hole on northern aspect, approx. 10-15 cm deep
Evidence of Bats	None
Potential	Transitional- Low Maternity - Negligible Hibernation - Negligible

- 5.1.2 Trees T80, T274, and T375 and building T335 (see Figures 2a to 2c) are confirmed bat roosts, and trees T39, T45 and X3 are probable bat roosts, therefore an EPSL should be applied for to ensure works are carried out lawfully. A project licence is recommended that will include mitigation for all known roosts that will be impacted and roosts in trees which have not been surveyed (trees with low or medium potential).

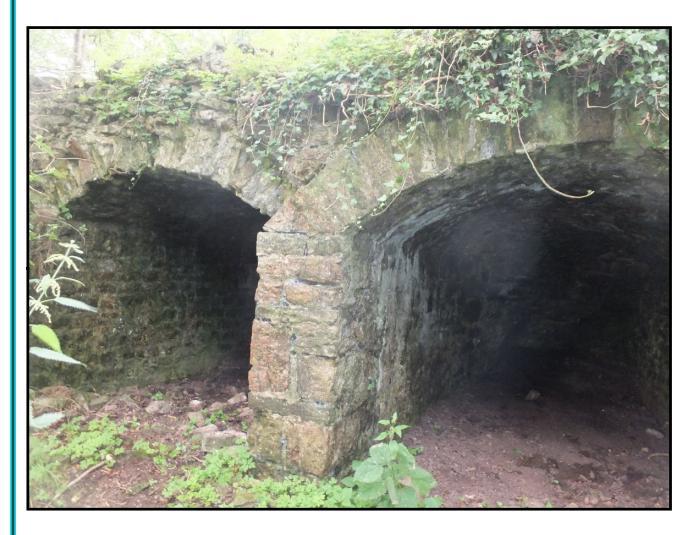
Photograph 3: Disused lime kiln building (T335) – Confirmed bat roost in 2016.

Tree Number	Visit Number	Date	Sunrise/Sunset Time	Surveyor Location	Details of Bat Emerging/Returning
Т80	1	Dawn 14/06/16	04:55	NE	One common pipistrelle bat circled the tree before entering to roost at 04:57
T335	1	Dusk 05/07/16	21:29	E	Three long-eared bats seen flying under the arches of the lime kiln, they were observed light sampling (flying in and out of the building) between 22:44 and 22:51, before flying away to the west of the kiln.

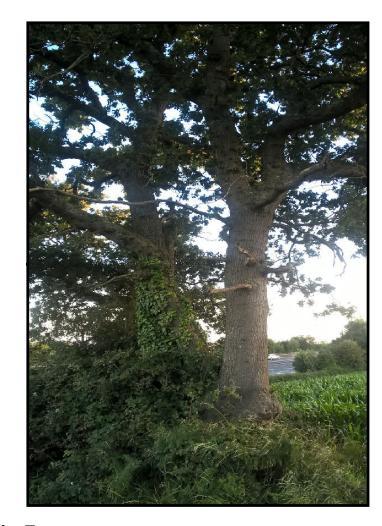
Photograph 5: Tree X1 – High bat roost potential (identified by RPS).

- Three dusk and dawn surveys of two additional trees identified by RPS (Tree 1 to the north of the M4 and Tree 1 on Maerdy Farm, hereafter known as trees X1 and X2 respectively).

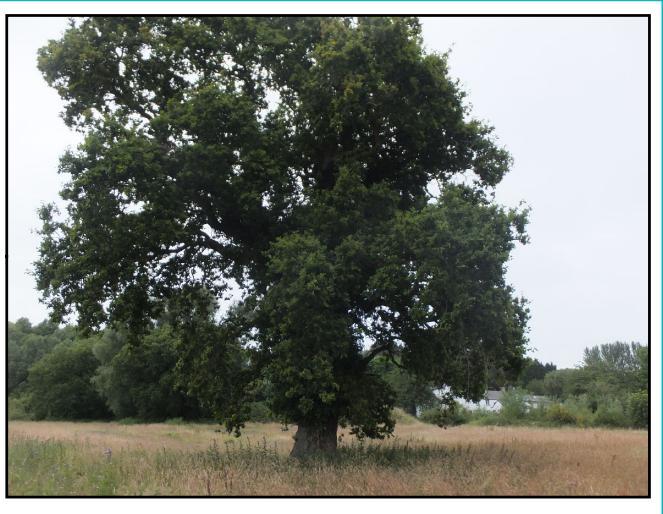
Photograph 2: Tree T80 – Confirmed bat roost in both 2015 and 2016 surveys.

- 4.2.1 One common pipistrelle bat was seen returning to a roost in tree T80 (see Figure 2a, Photograph 2 on Figure 3) during the first dawn survey visit. Three long-eared bats (*Plecotus* sp., most likely brown long-eared bat (*Plecotus auritus*)), were observed flying under the arches of a disused lime kiln building, although they were not seen directly emerging they were not observed flying in to the building (T335 on Figure 2c, Photograph 3 on Figure 3). The bats were observed "light sampling" (i.e. flying in and out from the roost) before exiting the location to the west.
