# NORTH SOUTH WEST WALES FEASIBILITY

Document title: Feasibility Report

Document reference: 5225267-ATK-EMP-000001

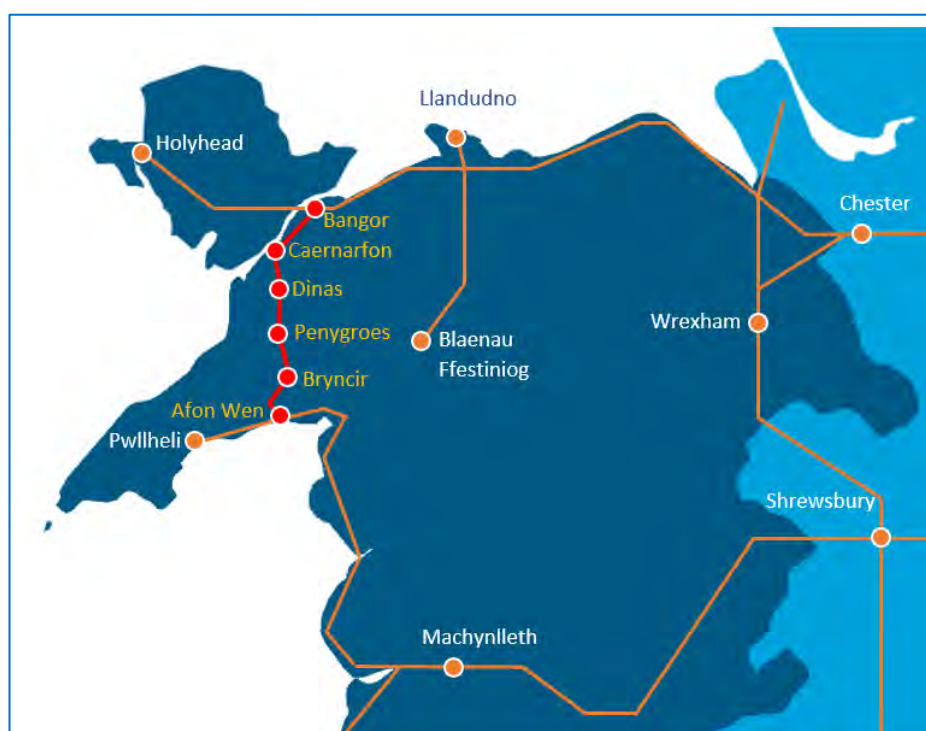
**Figure 1-2 – Overview of mainline railways within North Wales, showing the proposed Afon Wen to Bangor route in red split into five Route Sections**

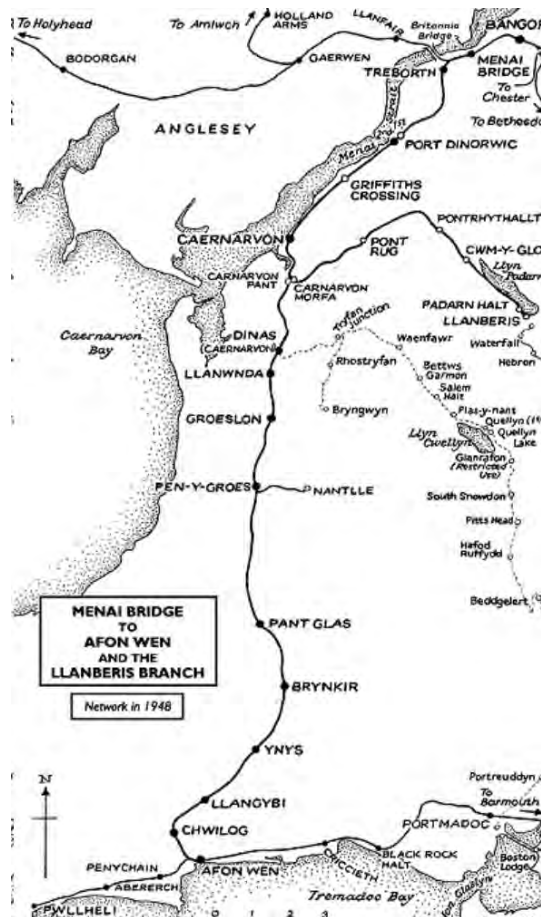
Figure 2-1 – Map showing former route between Afon Wen and Caernarfon<sup>3</sup>

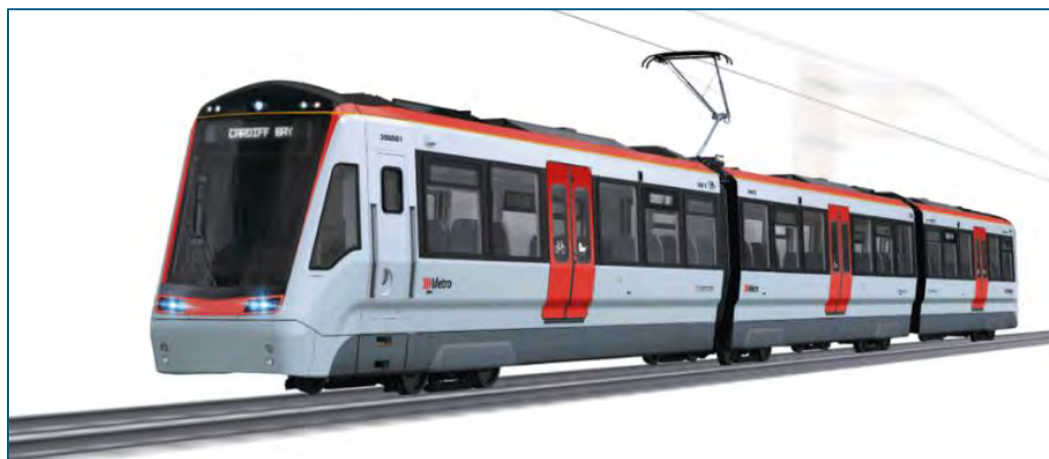
Whilst the original Class 399 units have a 750V DC and 25kV AC capability, the TfW Class 398 is bi-mode – i.e. operating on 25kV AC electrification and on-board batteries. Therefore on-street running for the Class 398 will be through use of batteries and no Overhead Line Equipment – rather than in Sheffield where the existing tram DC electrification system is used.

**Figure 4-1 – Image of Class 398 Tram-Train<sup>4</sup>**

At present the only Tram-Train which is operational in the United Kingdom is the Rotherham extension of the Sheffield Supertram system, which extends the original extensive cross city tram routes. However, TfW as part of the Core Valley Line Programme is also adopting Tram-Train principles for extensions to the existing system, and are currently testing and commissioning the Stadler Citylink Class 398 Metro Vehicles (see Figure 4-1) into service.

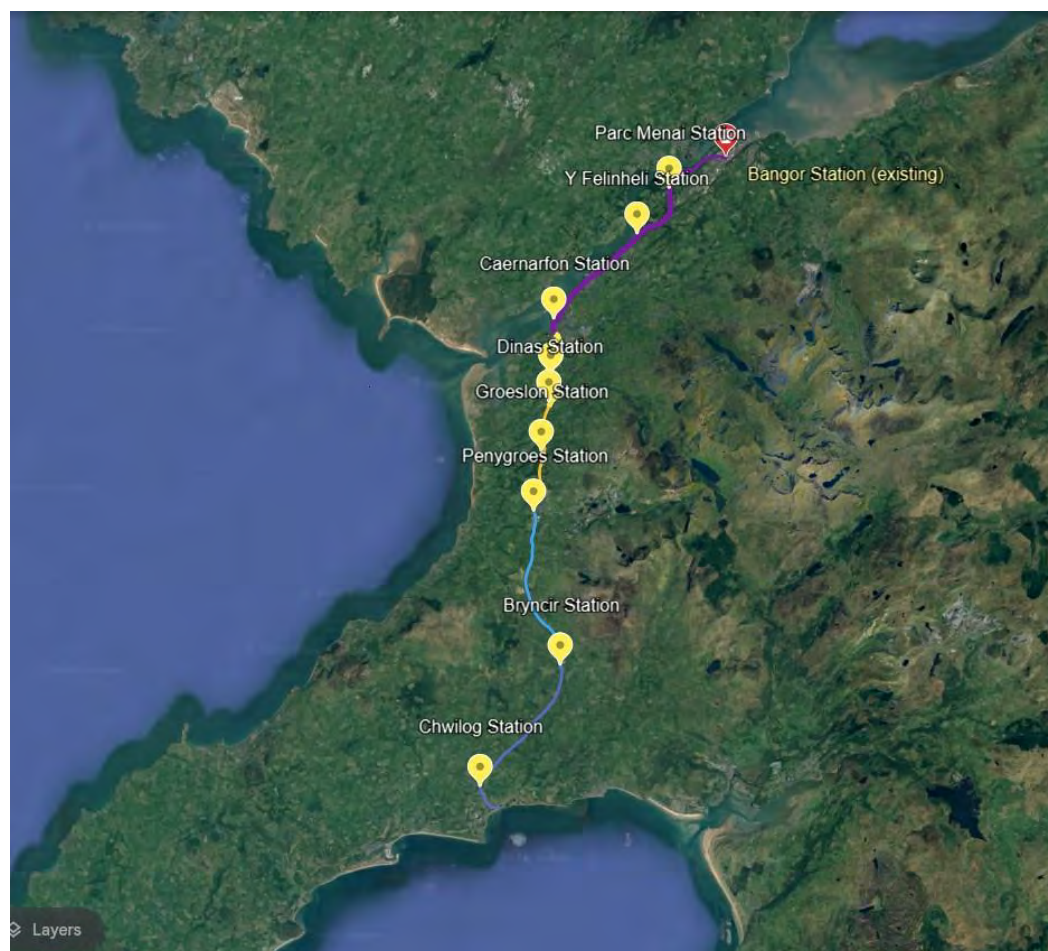
At present the potential station sites are shown below in **Figure 4-7** and are Parc Menai, Y Felinheli, Caernarfon, Dinas, Groeslon, Penygroes, Bryncir and Chwilog.

**Figure 4-7 – Map showing possible station locations along route**

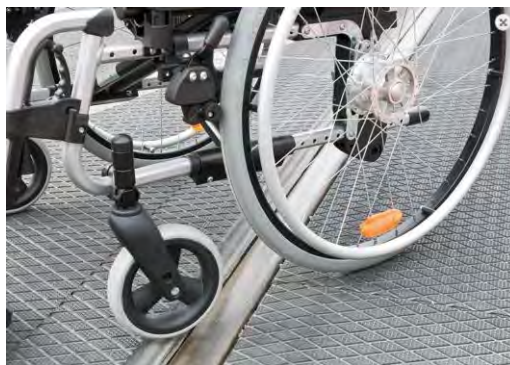
Figure 5-1 – Example of gap filler for street running section<sup>15</sup>

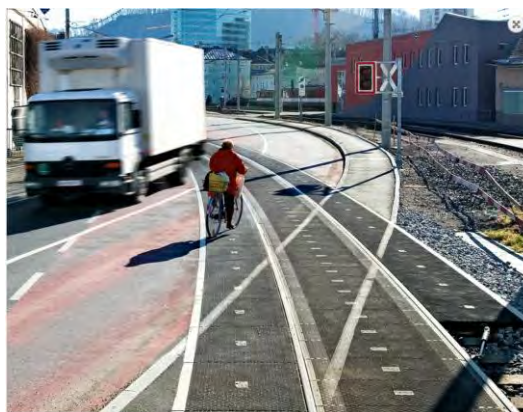
Figure 5-2 – Example of skewed road/rail crossing, with gap in-fillers<sup>16</sup>

On this basis, with the knowledge of the increased risks, the alignment has been designed to minimise the amount of integrated on-street running. Further investigations will be required to establish the best available mitigation measures - for instance the use of gap fillers where a replaceable, flexible rubber infill eliminates the flange groove completely (**Figure 5-1**) – at locations where on-street running cannot be reasonable avoided, particularly if road users cross the railway at a skewed angle (**Figure 5-2**).

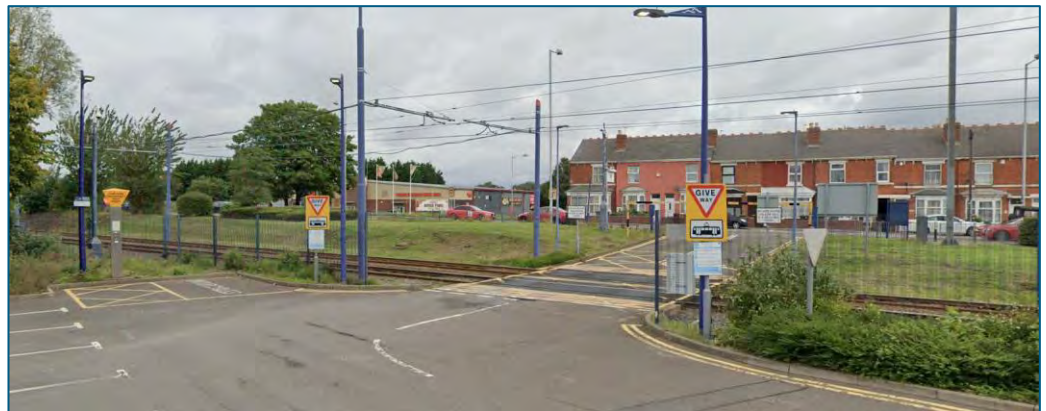
At minor road intersections it is proposed to install a Stop or Give Way junction, such as in Figure 5-3.

**Figure 5-3 – Example Give Way junction on segregated Tram Lines – Priestfield Tram Stop Car Park on West Midland Metro**

the rail vehicle with enhanced emergency braking would be operating slowly enough to stop at any obstruction encountered. This would therefore be similar to the junction shown in **Figure 5-3** previously for public roads, but due to the likely presence of animals in the adjacent fields it is proposed that gates would also be required to prevent animals from straying onto the operational railway.

| Type of Interface | Operating in Tram Mode | Operating in Train Mode |
|---|---|---|
| Access track likely to be lightly used by Authorised User(s) only | Install Stop/Give Way Junction (see <b>Figure 5-3</b> ) with gates if required to prevent animals straying onto railway (see <b>Figure 5-5</b> ) | Install new user worked crossing with gates |
| Lightly Used Road by members of public | Install Stop/Give Way Junction (see <b>Figure 5-3</b> ) | Install level crossing with barriers and Warning Lights |

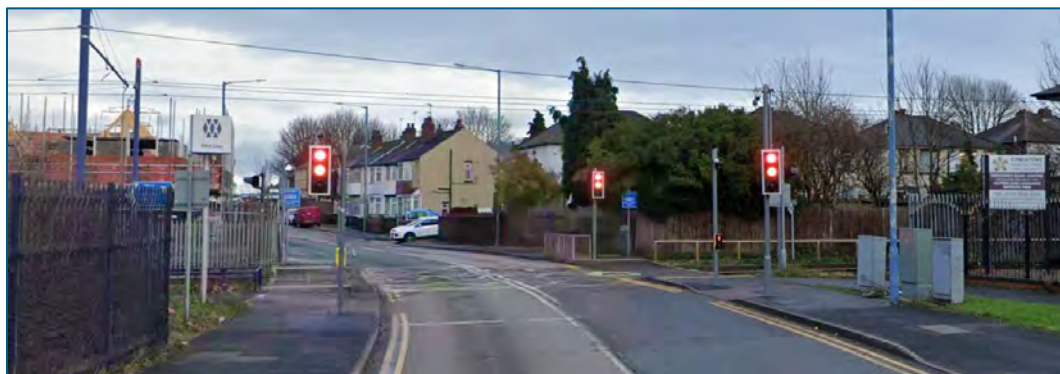
At junctions with greater flows of road traffic, higher speeds and/or reduced visibility splay it is proposed to install a traffic signal-controlled junction, due to the increased risk at these interfaces. An example of this style of junction is shown in **Figure 5-4**

**Figure 5-4 – Example Traffic Light Controlled junction on segregated Tram Lines – New Swan Lane on West Midland Metro**

| Type of Interface | Operating in Tram Mode | Operating in Train Mode |
|---|---|---|
| Access track likely to be heavily used or used by slow moving vehicles | Install traffic signal controlled junction (see <b>Figure 5-4</b> ) | Install level crossing with barriers/(Miniature) Warning Lights. |
| Heavily Used Road | Install traffic signal controlled junction (see <b>Figure 5-4</b> ) | Install level crossing with barrier and Warning Lighting – controlled by CCTV or Obstacle Detection |

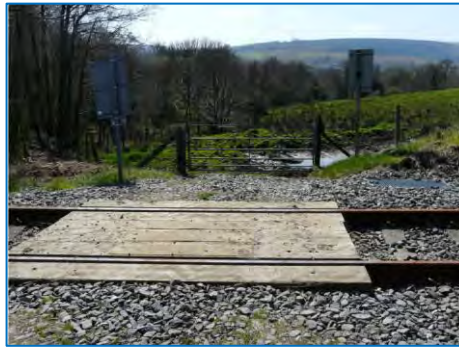
**Figure 5-5 – Example User Worked Crossing (near Aberdare, South Wales), showing signage and gates**

Thus the protection provision would be similar to a User Worked Crossing on Network Rail infrastructure, but with the additional safety safeguard of the Tram-Train operating with enhanced Tram mode braking if there was a trespass or misuse of the road. This does however require the Tram-Train vehicle to be able to stop if an obstruction is seen, so will limit the maximum line speed practicable to achieve line-of-sight distances.

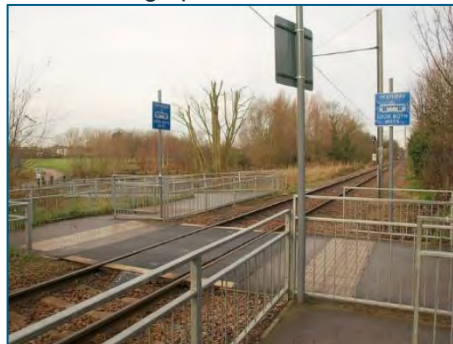
Each crossing must be treated individually and would be subject to a risk assessment which considers visibility, the speed of approaching Tram Trains, and the number and type of non-motorised user flow. The most basic crossing is completely passive and only provides fixed signage and guard rails. The design of the crossing must take into account human factors, and encourage pedestrians to look before they cross.

**Figure 5-6 – Example of passive pedestrian crossing (e.g. with no additional protection measures) across segregated Tram Lines – Morden Hall Park footpath crossing on London Tramlink<sup>18</sup>**

| Type of Interface | Operating in Tram Mode | Operating in Train Mode |
|---|---|---|
| Existing Pedestrian Crossing | Install new pedestrian crossing with warning signage (see <b>Figure 5-6</b> ) | Install new Footpath crossing with gates – and Whistle Boards/Miniature Warning Lights as required |

Ideally the footbridge across the A487 – which appears a new and substantial structure from the desktop study – will be retained, so it is currently intended that the land levels in the area are remodelled and potentially the access footpaths to the footbridge locally altered to allow the new railway to be constructed. There will be a requirement for a foot crossing at this location to retain the public right-of-way. This crossing will be similar to the example shown in Figure 5-6, previously in Section 5.

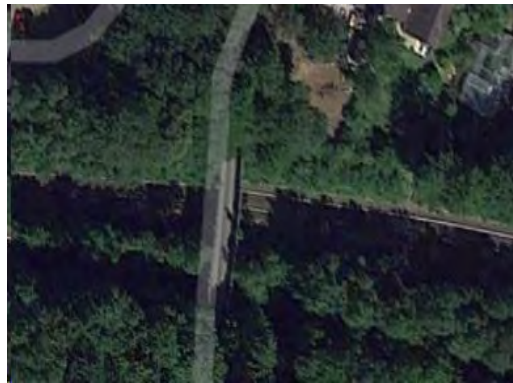
Situated 800m west of the junction for the mainline is an overbridge which was present prior to closure of the line however it is not clear whether this is a vehicle or pedestrian overbridge. Its current condition or clearances are not currently known (**Obstruction Number – BC-03-01**). More detailed information is required on this structure to establish whether any works are required.

Figure 7-4 – Footbridge Crossing Alignment  
Obstruction Number – BC-03-01

| Obstruction Number | Works Required On Existing Alignment | Maintain Alignment | | Works Required On Alternative Alignment | Alternative Alignment | |
|---|---|---|---|---|---|---|
| <b>BC-03-01 - Overbridge</b> | Carry out detailed surveys on existing condition and clearances | Minimal | Minimal | | | |

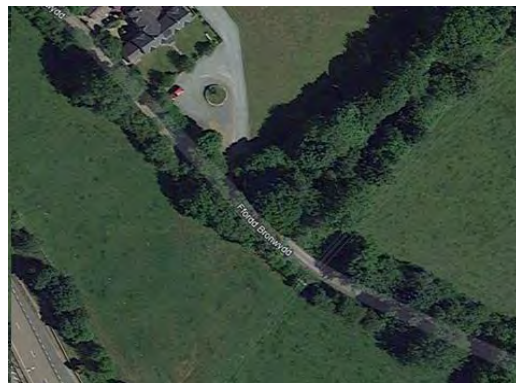
Figure 7-5 – Ffordd Bronwydd crossing alignment  
Obstruction Number – BC-03-02

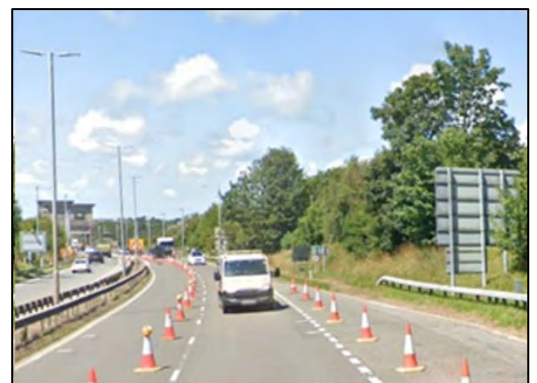
Figure 7-6 – A55 crossing alignment  
Obstruction Number – BC-03-03

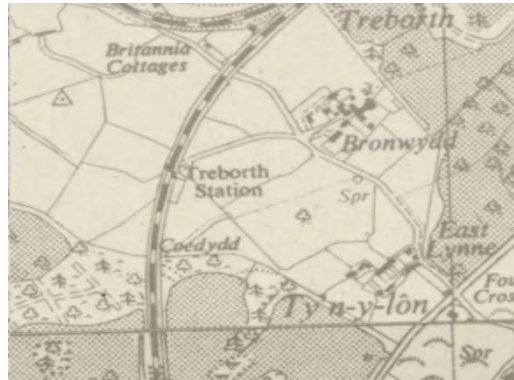
South of the A55 the original alignment curved slightly southwards to the former Treborth Station, which is now believed to be a private property. The alignment is now completely occupied by a waste water works and electricity distribution site with its associated access road. This is a significant obstruction (**Obstruction Number – BC-03-04**), due to the fact that this facility now appears to straddle the original alignment.

Figure 7-7 – 1945-1965 Map showing old alignment past Treborth Station

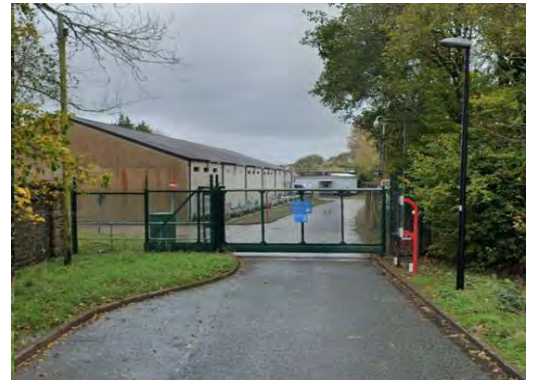
It is assumed from the provisional desktop study that due to the extent of building across the former alignment within the water works, a number of buildings would need to be demolished and all associated pipework, electrical supplies and access routes relocated as appropriate. At this stage this is presumed to require either the temporary or permanent closure of the site, to facilitate a major reconfiguration or even relocation of the works.

Figure 7-8 – Waterworks on alignment Obstruction Number – BC-03-04

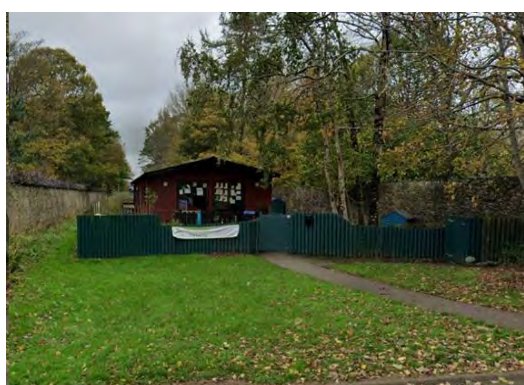
The original alignment continues south undisturbed for 100m where it enters Parc Menai Business Park which has been developed on old woodland. A small wooden structure has been constructed in this location which houses a local children's nursery. (**Obstruction Number – BC-04-01**).

Figure 7-10– Children's Nursery on alignment  
Obstruction Number – BC-04-01

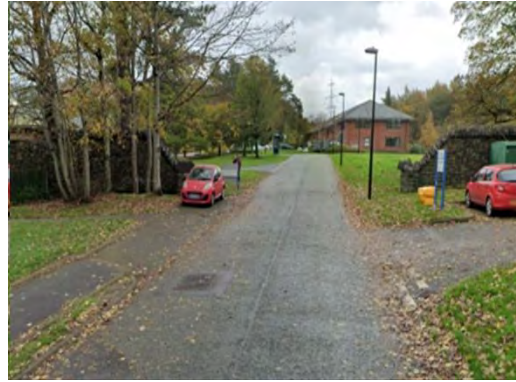
The alignment continues through the business park largely undisturbed where it is now used as a footway, however two roads, 250m apart, intersect the alignment providing access to various business (**Obstruction Number - BC-04-02 and BC-04-03**). The alignment continues undisturbed, although heavily vegetated, for a short section before reaching the North Portal of the Vaynol Tunnels.

Figure 7-11 - Ffordd Gelli Morgan crossing alignment  
Obstruction Number - BC-04-02

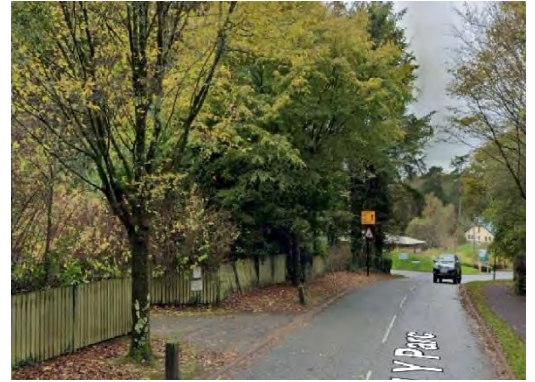
Figure 7-12 - Ffordd y Parc crossing alignment  
Obstruction Number - BC-04-03

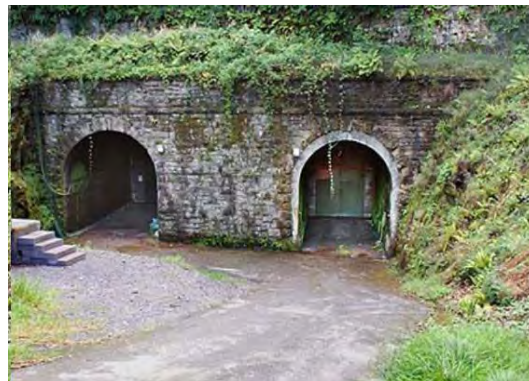
It may not be necessarily required to open both tunnel portals back up as there are potential locations for passing loops North of the tunnels. This should be reviewed taking account of the level of work required and the perceived benefits.

Figure 7-13 – Vaynol Tunnel  
Obstruction Number - BC-04-03

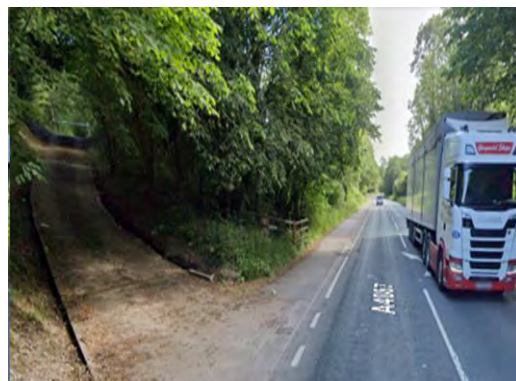
The route then falls sharply before being intersected by the A4087 road. It is understood that there was a bridge crossing the A4087 at this location which has since been removed. (**Obstruction Number - BC-05-01**).

Figure 7-15 – A4087 crossing alignment  
Obstruction Number - BC-05-01

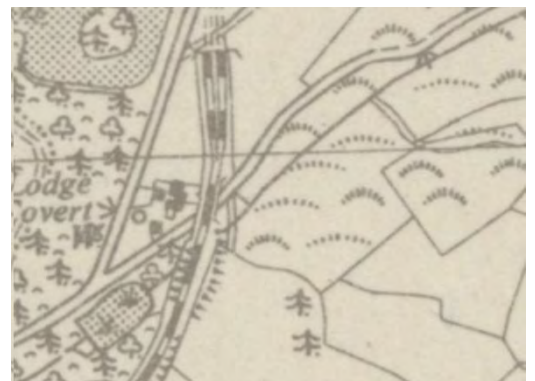
Figure 7-16 – 1945-1965 Map showing route crossing A4087

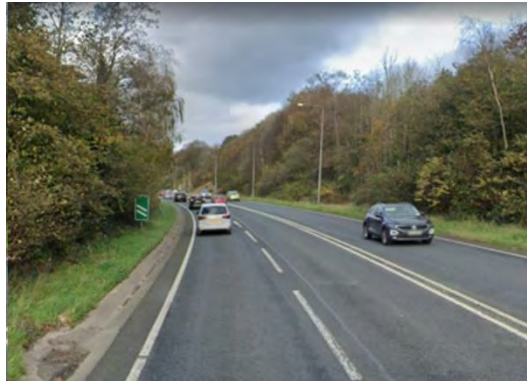
The alignment continues south through woodland at high level before it is intersected by the A487 road (**Obstruction Number - BC-05-02**), a road built following the closure of

the railway that is approximately 5m below the embankment to the east. The route continues along the A487 for approximately 200m before running along farmland.

*Figure 7-17 – A487 crossing alignment  
Obstruction Number - BC-05-02*

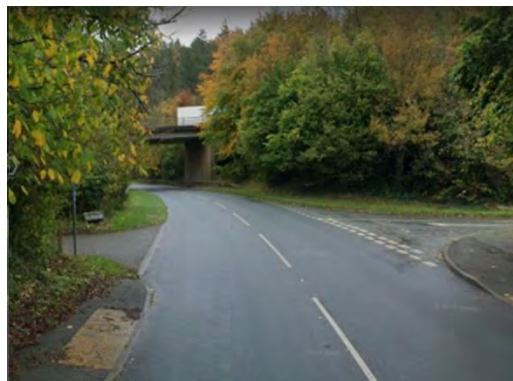
Continuing towards Felinheli, the route passes by a local farm before being intersected by the B4547 road (**Obstruction Number - BC-05-03**). The previous alignment passed under the road at this location via an overbridge which has subsequently been removed leaving steep gradients on both approaches to the road. As the alignment passes this junction the old route has been taken over by an access road to some residential properties with the land adjacent being predominately grass land.

*Figure 7-18 – B4547 crossing alignment  
Obstruction Number - BC-05-03*

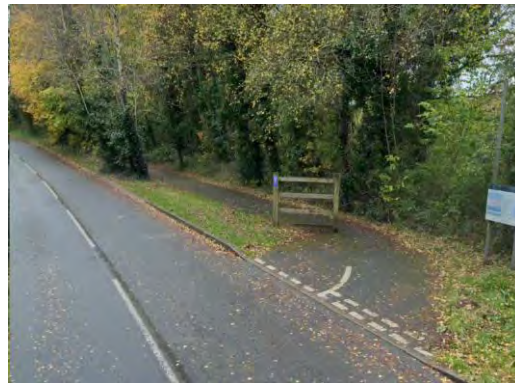
Part way down the access road the alignment diverts on to the cycle path which does not have sufficient width to accommodate the alignment due to the allotments that have been built adjacent to this (**Obstruction Number - BC-06-01**). To the North of the cycle path is the location of a branch line to the docks which is at a lower level.

Figure 7-19 – Alignment diverts on cycle path

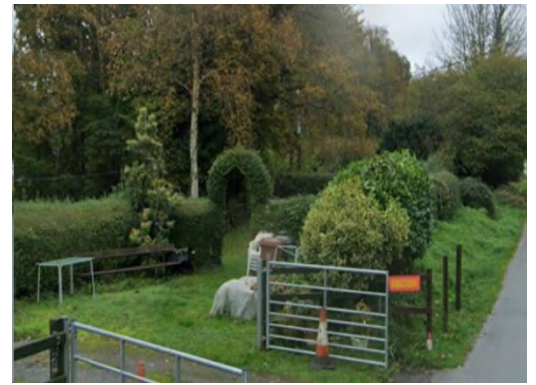
Figure 7-20 – Allotments along alignment  
Obstruction Number - BC-06-01

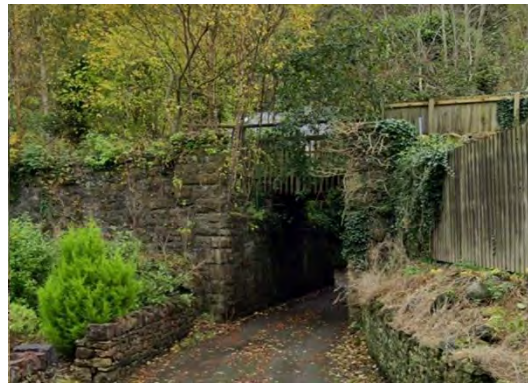
The narrow cycle path passes over a timber underbridge (**Obstruction Number - BC-06-02**) between 6850m and 6900m which does not appear to have sufficient width to accommodate the tram-train. This appears to have been installed recently to accommodate only the cycle path. The abutments of the original structure still remain however.

Figure 7-21 – Road crossing alignment  
Obstruction Number - BC-06-02

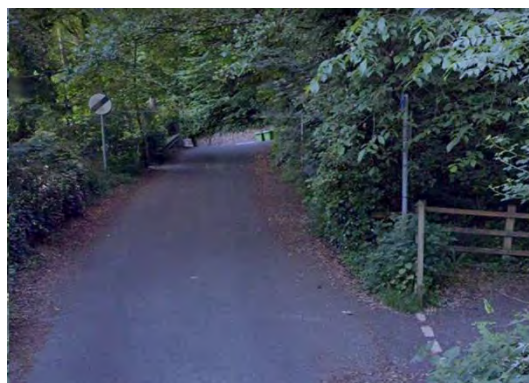
The alignment continues through a heavily vegetated section of the route parallel to Bangor Street where it meets a steep road (**Obstruction Number - BC-06-03**). It has not been possible to view the route through this section due to the vegetation therefore there may be additional obstacles in this location. The previous alignment passed under an overbridge which carried the old Padarn Railway towards the quarry – this bridge has since been removed. This is known locally as 'The Incline'. Today the cycle path is broken by the steep road and continues at different levels.

Figure 7-22 – The Incline  
Obstruction Number - BC-06-03

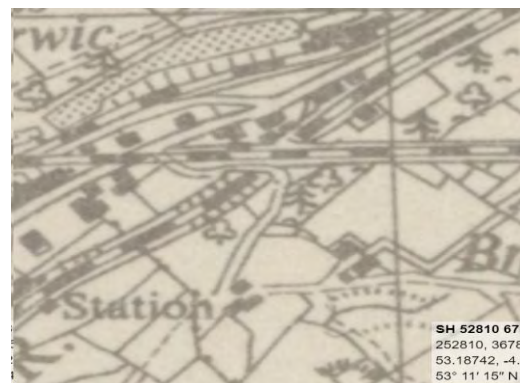
Figure 7-23 – 1945-65 map showing the previous  
route crossing under the Padarn Railway

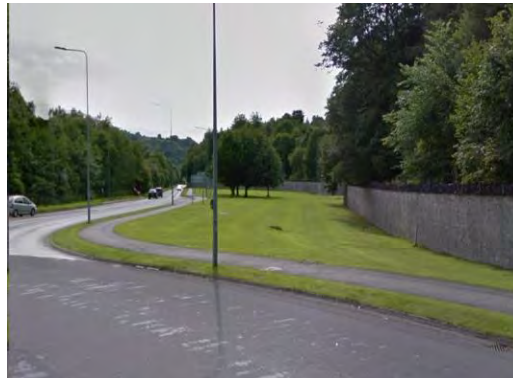
Figure 7-24 – Existing grass verge for alternative route

The alternative alignment continues along a wide grass verge for approximately 250m before crossing an access road and the B4547. This crossing will require the installation of a traffic signal controlled junction and will need to be situated at a suitable angle not to provide additional risk to road users. Afon Hylwen runs alongside the B4547 and will be to be spanned with a small underbridge.

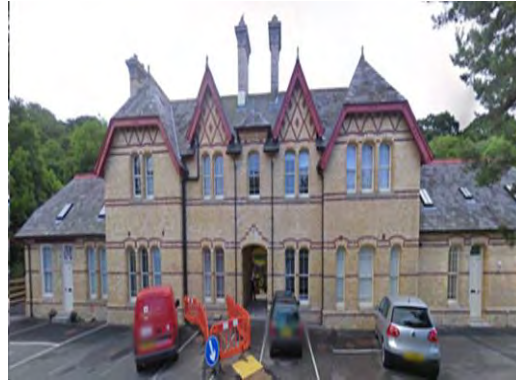
Continuing through the heavily vegetated area, the alignment reaches the location of the old Port Dinorwic Station (**Obstruction BC-06-04**). This station has been turned in to a residential property where the gardens occupy the old alignment. The building is currently Grade II listed. Adjacent to the old station building are commercial premises to the west and a residential property to the east. Both of which lie on the old alignment.

Figure 7-26 – Port Dinorwic Station  
Obstruction BC-06-04

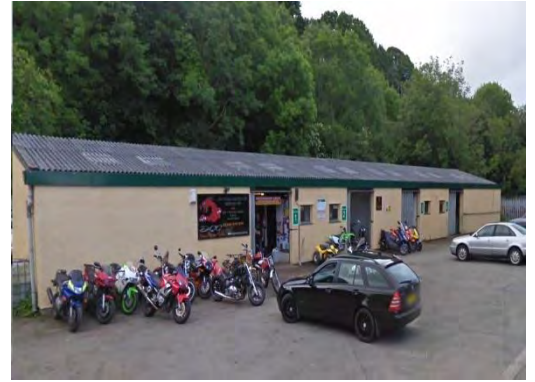
Figure 7-27 – Commercial premises adjacent to Port  
Dinorwic Station. Obstruction BC-06-04

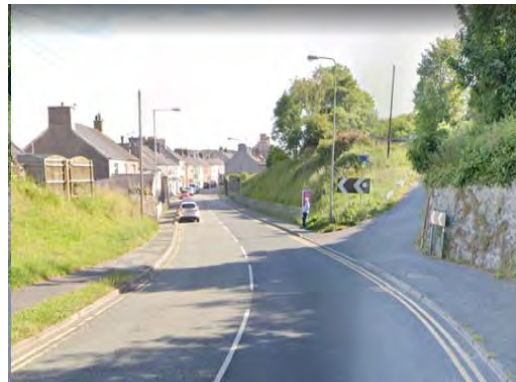
The alignment continues west along the cycleway before it reaches Caernarfon Road (**Obstruction BC-06-05**), a road approximately 3m below that of the cycleway. A bridge was located here previously allowing the train to cross over the road however this has since been removed. Part of the retaining wall carrying the tracks at a higher level remain in place forming an area of grassland.

Figure 7-28 – Caernarfon Road crosses alignment  
Obstruction BC-06-05

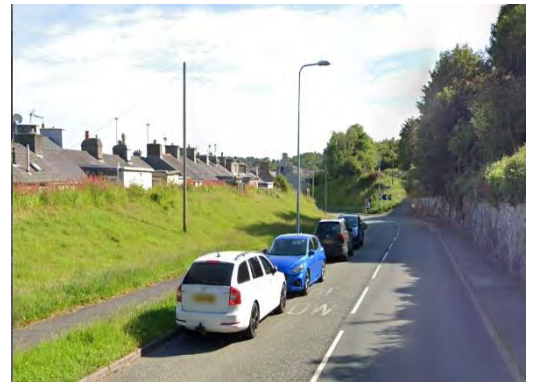
Figure 7-29 – Road along alignment with former  
retaining wall for railway

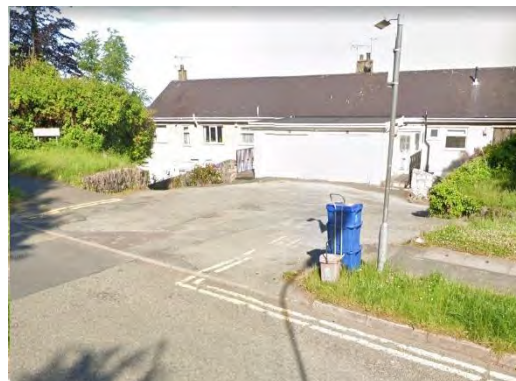
The alignment continues parallel with Caernarfon road crossing the entrance to several houses in Menai Court (**Obstruction BC-06-06**) and passing within 10m of other nearby residential properties. Since the closure of the line the road has been widened resulting in the alignment being taken by the carriageway (**Obstruction BC-06-07**) with the steep embankment to the north of the road.

Figure 7-30 – Alignment crosses access road to  
houses Obstruction BC-06-06

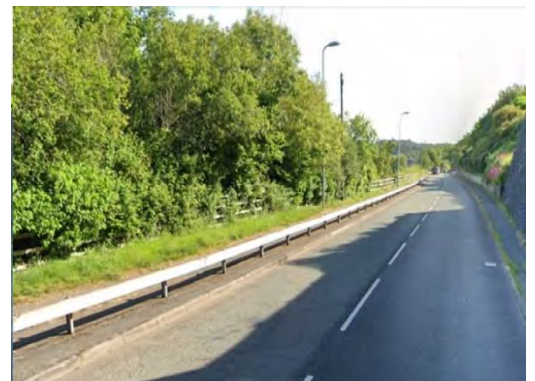
Figure 7-31 – Alignment taken by road  
Obstruction BC-06-07

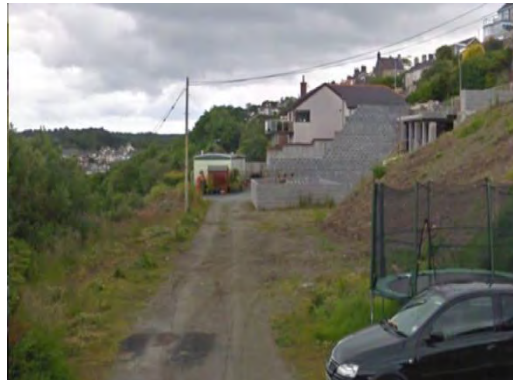
The alignment diverts off Caernarfon Road and heads behind a row of houses along an access road at the top of an embankment which is understood to be weak and has previously failed. There appears to have been several developments in this area where several properties have extended their gardens on to the old alignment (**Obstruction BC-07-01**).

Figure 7-32 – Access Road to Residential Property's Obstruction BC-07-01

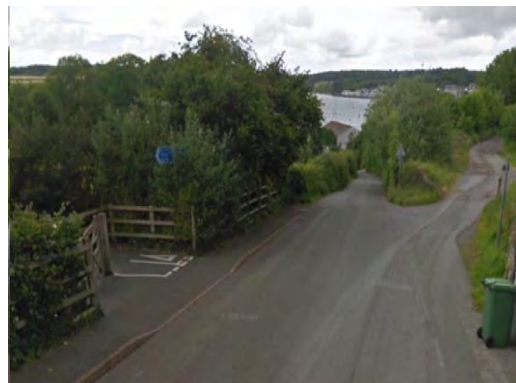
Figure 7-33 – Beach Road intersects alignment Obstruction BC-07-02

The route continues along the access road passing within 3m of the old crossing keepers house, now a residential property until it is intersected by Beach Road (**Obstruction BC-07-02**), the site of a level crossing on the former alignment. Recent aerial photos also show a new development adjacent to the intersection whose entrance falls on the previous alignment.

This access road appears to be the only vehicle access for the house in Menai Court, therefore will need to be maintained. It is therefore proposed to installed a Stop/Give Way junction at the entrance to this road. It should also be noted that it is likely that the footway will require removal as part of the bridge structure therefore any crossing should provide provision for pedestrian access.

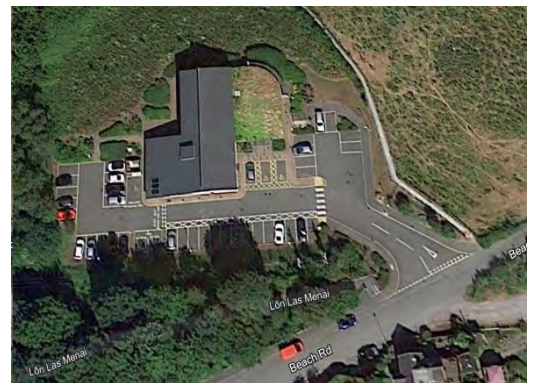
Figure 7-34 – New development adjacent to the alignment

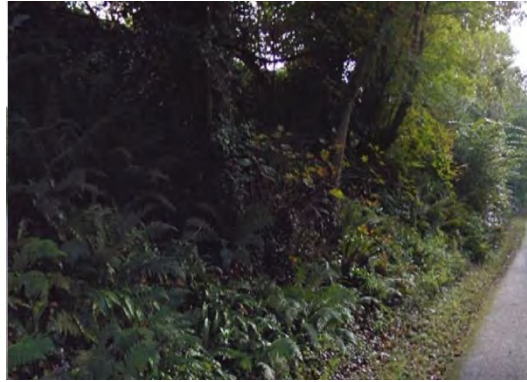
Upon crossing Beach Road the alignment joins the current Lon Las Menai Cycle route as it heads towards Caernarfon alongside Caernarfon Road. The first 400m of the cycle route is narrow with a steep embankment up to the road on the southern side and an embankment on the northern side down towards the sea with the majority of the previous alignment having been reclaimed by nature (**Obstruction BC-07-03**).

Figure 7-35 – Steep embankment  
Obstruction BC-07-03

There appears to be various developments along the alignment in this area where residential properties have built over the previous alignment. If the alignment does continue along this route, several properties will need to be purchased and demolished. The route in this section will pass along the top of a weak embankment that will require stabilisation works to be carried out – the exact condition of the embankment will need to be established at a later date.

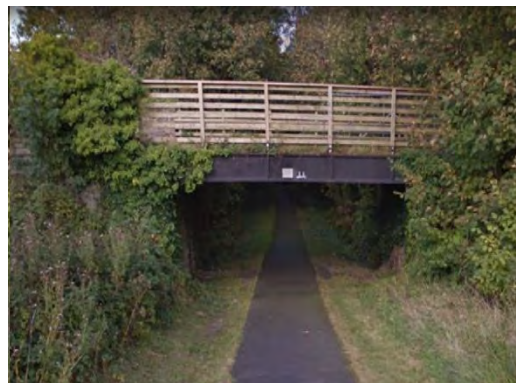
The route continues along the Lon Las Menai cycle route before reaching a metallic overbridge providing vehicle access to an adjacent field (**Obstruction BC-07-04**). The exact height of the bridge is unknown however there does not appear to be sufficient clearance for the rolling stock. The exact use of this access should be investigated to ascertain whether this access is still required or can be moved to an alternative location.

Figure 7-36 – Overbridge crosses alignment  
Obstruction BC-07-04

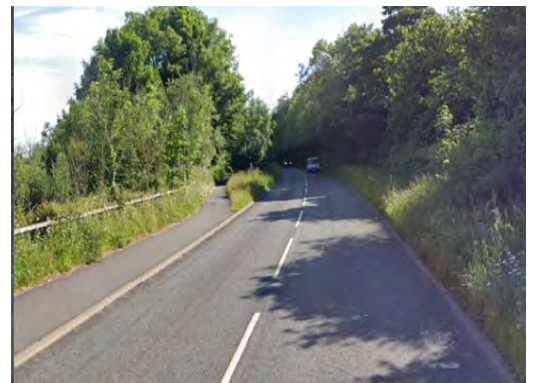
The route emerges from the heavily wooded area on to open grass land for a length of approximately 200m before continuing through another section of dense woodland eventually emerging where it is intersected by Caernarfon Road (**Obstruction BC-08-01**) on a skew.

Figure 7-37 – Caernarfon Road intersects alignment  
Obstruction BC-08-01

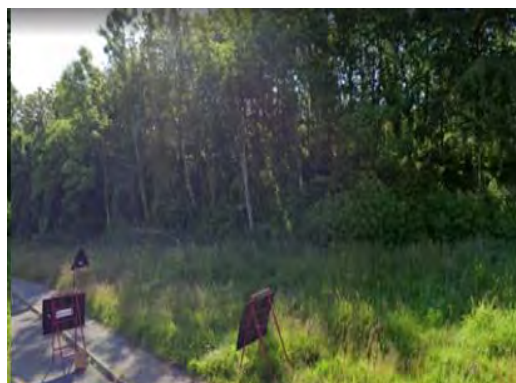
After crossing the road, the alignment runs parallel with Caernarfon Road for approximately 500m through heavily wooded area (**Obstruction BC-08-02**) before reaching Plas Menai Roundabout and the location of the former Griffiths Crossing Station, now a residential property. As this property was a previous station building the route does pass within 3m of this building.

Figure 7-38 – Heavily wooded area  
Obstruction BC-08-02

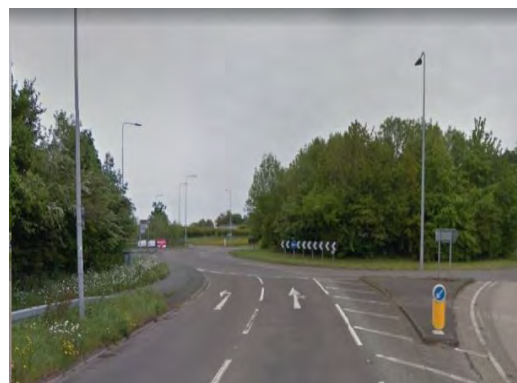
Figure 7-39 – Plas Menai Roundabout intersects  
alignment Obstruction BC-08-03

This section of the route requires the navigation through winding roads and across several road junctions in particular the roundabout at Griffiths Crossing. With this in mind it is recommended that the vehicle is run in tram mode for the section.

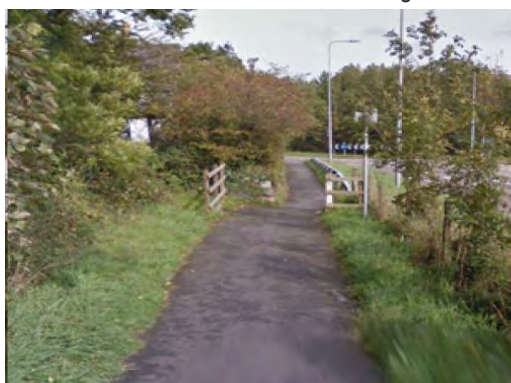
Figure 7-40 – Former Griffiths Crossing Station now a residential property  
Obstruction BC-08-04

The construction of the roundabout has limited the available width between the road and former station building. Due to the works required to the roundabout detailed above it is recommended that the alignment of the road is reconfigured which will allow the former station building to be maintained.

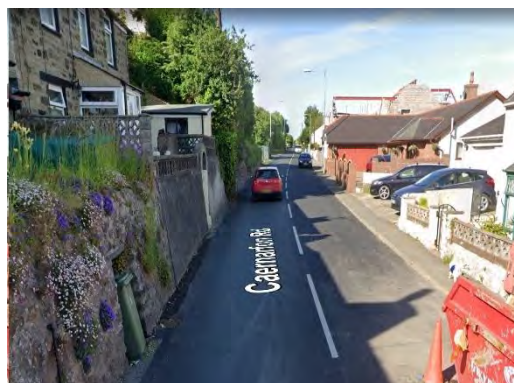
An alternative to routing along the back of these properties would be to continue the integrated on-street running along Caernarfon Road. Consideration should be given to the proximity of the houses along this road to ensure there is sufficient separation between the alignment and the houses as currently the southern side of the road does not have a footpath.

Figure 7-41 – Proximity of housing on Caernarfon Road an no footpath

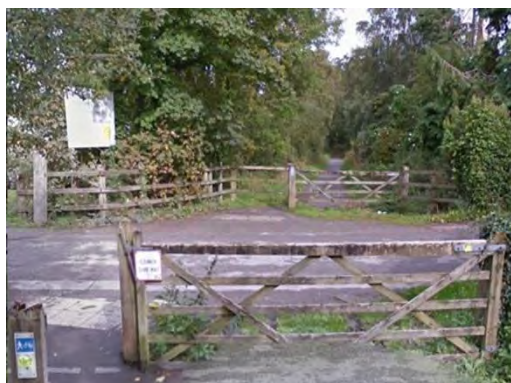
The alignment continues along Lon Las Menai cycle route for approximately 500m where most of the alignment has now been reclaimed by nature. The route is then intersected by an access road leading to several industrial premises (**Obstruction BC-09-01**).

Figure 7-43 – Road crosses alignment  
Obstruction BC-09-01

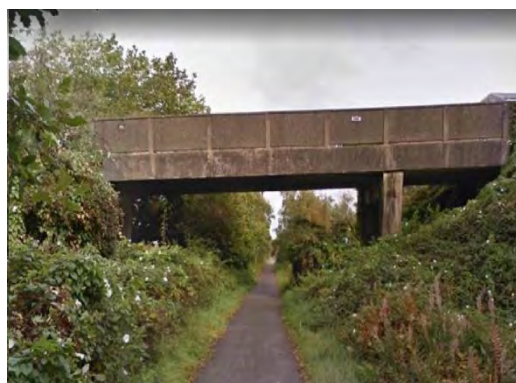
Continuing west towards Caernarfon the route is crossed by 2 overbridges (1 concrete and 1 metallic) that do not have sufficient clearance to accommodate the proposed vehicles – this will need to be confirmed following detailed surveys. The former (**Obstruction BC-09-02**) provides access to an adjacent industrial unit. The latter (**Obstruction BC-09-03**) appears to be in a state of disrepair and does not look like it currently serves any purpose, although this will need to be confirmed.

Figure 7-44 – Overbridge crosses alignment  
Obstruction BC-09-02

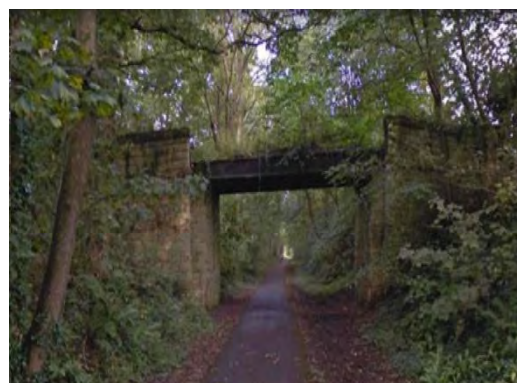
Figure 7-45 – Road crosses alignment Obstruction  
BC-09-03

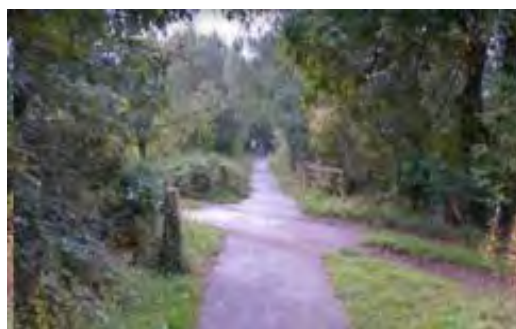
Further south, the alignment is intersected by an access track between two adjacent pieces of land (**Obstruction BC-09-04**). The alignment continues, crossing over 2 no. timber underbridges (**Obstruction BC-10-01**) which appear to have been constructed for the purpose of the cycle route only which do not provide sufficient clearance for the rolling stock. It is unclear what the purpose of these underbridges are and what they span although one is potentially an outfall of a water course which will need to be maintained. This will need to be investigated further.

Figure 7-46 – Access track crosses alignment  
Obstruction BC-09-04

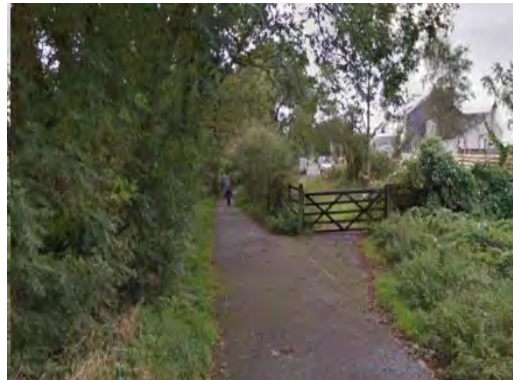
In the area of Port Waterloo, the alignment has been taken over by an access road to serve the local properties (**Obstruction BC-10-02**) and the cycle route has been moved approximately 8m to the South East. There is also a pumping station located on the southern side of the cycle path which restricts the available width. Another access road also crosses the alignment perpendicular in this location (**Obstruction BC-10-03**).

Figure 7-48 – Access track along alignment  
Obstruction BC-10-02

The access road on the alignment is currently being used for parking for the property owners of the adjacent premises. There is however a pumping station located on the southern side of the cycle route which will limit where the alignment can go. It is therefore recommended that the alignment is located as close as practicable to the pumping station whilst still allowing access. The cycle route can then be located adjacent to the houses. It should be noted that the width used for the tram-train does take in to account an OLE mast which could be located prior to or after this access road allowing for a narrower width requirement for the tram-trains at this specific location.

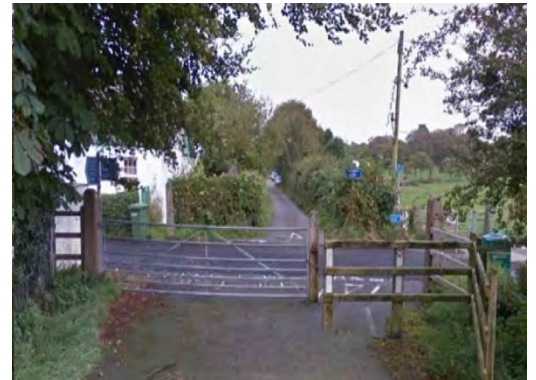
Figure 7-49 – Road crosses alignment  
Obstruction BC-10-03

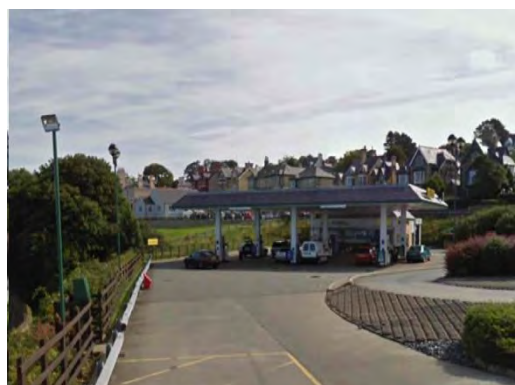
Figure 7-51 – Morrisons Petrol Station on alignment  
*Obstruction BC-11-02*

As the route through the Morrisons Petrol Station and Supermarket will cause significant disruption and require the relocation/removal of the petrol station three alternative routes have been considered.

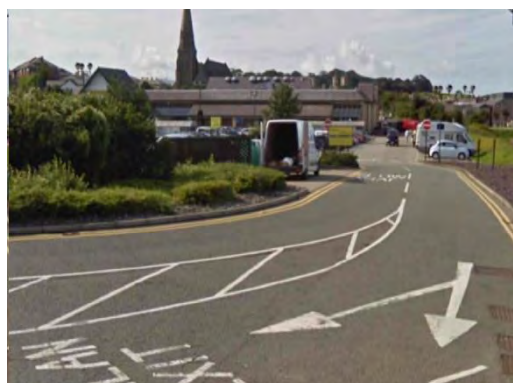
Figure 7-52 – Morrisons Supermarket on alignment  
*Obstruction BC-11-03*

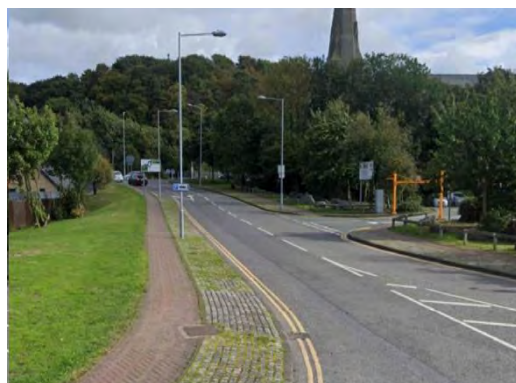
Continuing past the supermarket the alignment has once again been built upon with Balaclava Road crossing the alignment (**Obstruction BC-11-04**), and a council owned car park (**Obstruction BC-11-05**), (Balaclava Car Park) which is one of a number of town centre car parks and is in a prime location to serve the local business in the area. It has been advised by the local council that there are potential proposals to close the Penllyn Multi Storey therefore any works that impact Balaclava Car Park will need to take this into consideration.

Figure 7-53 – Balaclava Road crosses alignment  
*Obstruction BC-11-04*

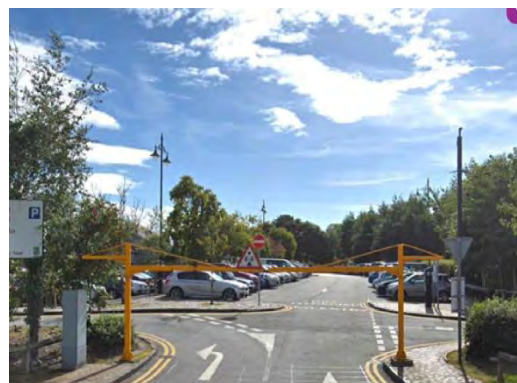
Figure 7-54 – Road crosses alignment  
*Obstruction BC-11-05*

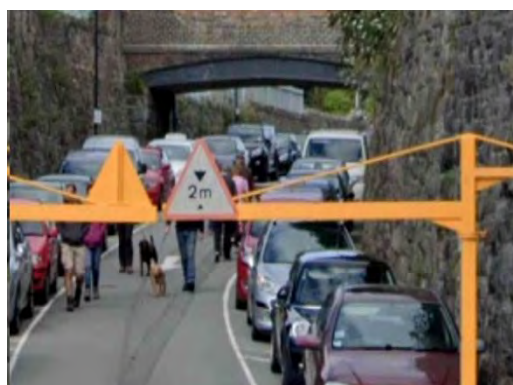
Between the main Balaclava car park and Crown Street to the South is additional parking down a narrow corridor flanked either side by retaining walls still intact from the previous alignment (**Obstruction BC-11-06**). Part way down this narrow corridor is an overbridge providing pedestrian access between Bangor Street and Balaclava Road, currently with insufficient clearance.

Figure 7-55 – Balaclava car park along alignment  
*Obstruction BC-11-06*

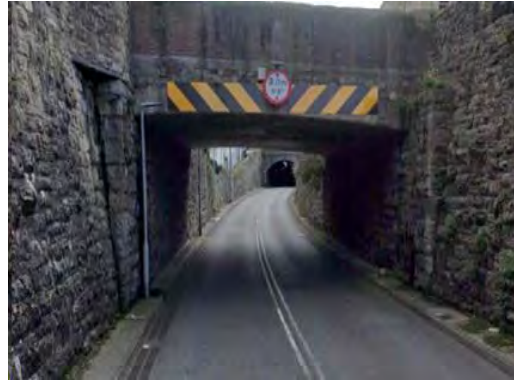
The alignment then emerges on to Crown Street where the retaining wall continues on the Eastern side but is broken for a short section on the west. The street is surrounded by residential and commercial properties on both sides. An overbridge carrying vehicles along Stryd y Porth Mawr, currently signed for 3m crosses the road (**Obstruction BC-11-07**). The alignment continues along Crown Street before reaching Caernarfon Tunnel (**Obstruction BC-11-08**) which was closed for a period of time following the closure of the line but has recently been opened up to traffic. The height of these is currently unknown however they are signed for 3m. It should be noted that this section of the route was historically two track.

Figure 7-56 – Overbridge crosses alignment  
*Obstruction BC-11-07*

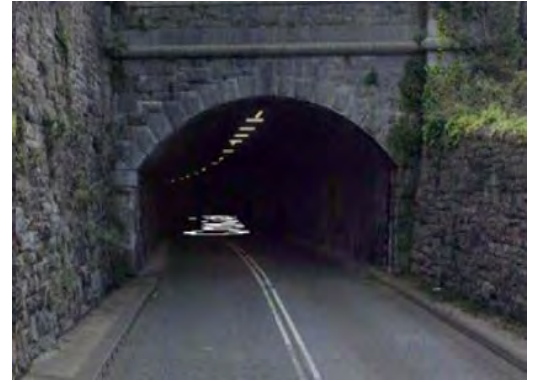
Figure 7-57 – Tunnel along alignment  
*Obstruction BC-11-08*

The line through Caernarfon Tunnel was previously two track providing sufficient clearance for those trains however since the re-opening of the road the road level has been built up resulting in a lack of available height. Works will be required to reduce the road height however surveys should be carried out prior to this to establish the tunnels invert levels to confirm available clearances. From current information the tunnels condition appears to be fair with only minor work required.

| Obstruction Number | Works Required on Existing | Significance | |
|---|---|---|---|
| <b>BC-11-08 – Caernarfon Tunnel</b> | Lower road level to provide suitable clearance through tunnel<br>Carry out repairs to tunnel | Moderate | High |

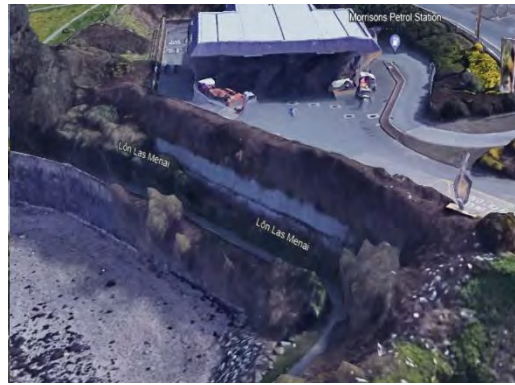
- 1) An alternative route is to follow the cycle route along the coastal path avoiding the Petrol Station and supermarket. This route will require the construction of a retaining wall above the existing cycle path and potentially significant sea defences. The route then continues through the existing Shell Site Car Park where it will follow the toe of the existing embankment and will require the removal of several car parking spaces. Consideration of the route should also take in to account the removal of Balaclava Car Park detailed below. The alignment runs the length of this car park before climbing and crossing the entrance of the Morrisons delivery area and Balaclava Road in to Balaclava Car Park.

Figure 7-58 – Alternative route along coastal path

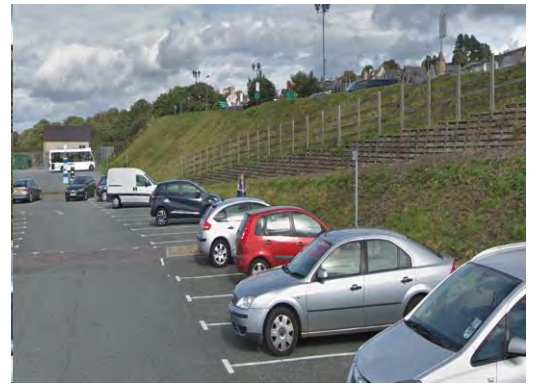
Figure 7-59 – Alternative route through Shell Site Car Park

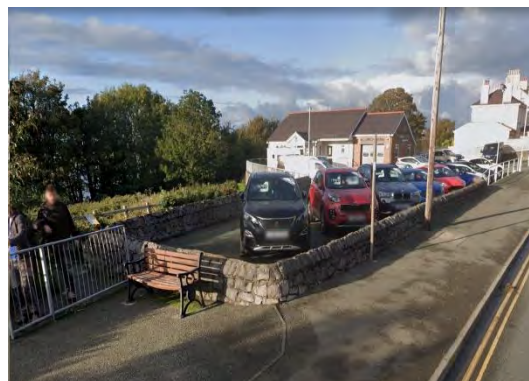
- 2) Upon reaching the outskirts of the town the route will divert from the footpath heading towards Ffordd Y Gogledd where it passes through residential apartments and a local small car dealership which will need to be purchased and relocated. The route then meets Ffordd y Gogledd where a traffic signal-controlled junction will need to be installed to allow the tram-trains to access the highway. This route proposes using integrated on-street running for a short section where track will be installed in each carriageway ensuring safe flow of traffic. The route continues along Ffordd y Gogledd where it meets an existing roundabout allowing traffic in to the Morrisons supermarket. This roundabout will need to be removed and a traffic signal-controlled junction installed, still allowing traffic into the supermarket.

Figure 7-60 – Car dealership on alternative route

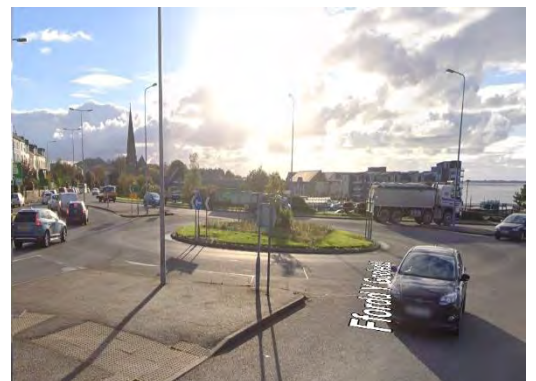
Figure 7-61 – Roundabout in to Morrisons

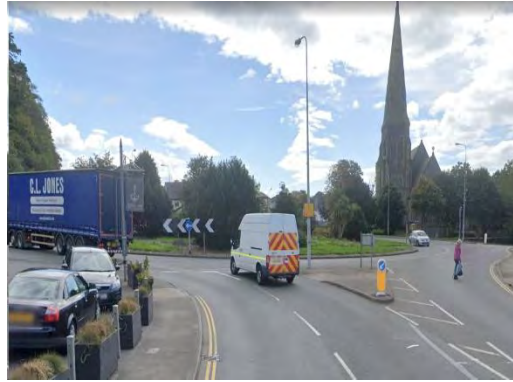
Further along Ffordd y Gogledd is another larger roundabout which will also need reconfiguration with traffic signals installed on each junction. The route then turns down Balaclava Road where it enters the Balaclava Road Car Park.

Figure 7-62 – St David's roundabout heading towards Balaclava car Park
