# NORTH SOUTH WEST WALES FEASIBILITY

Document title: Feasibility Report

Document reference: 5225267-ATK-EMP-000001

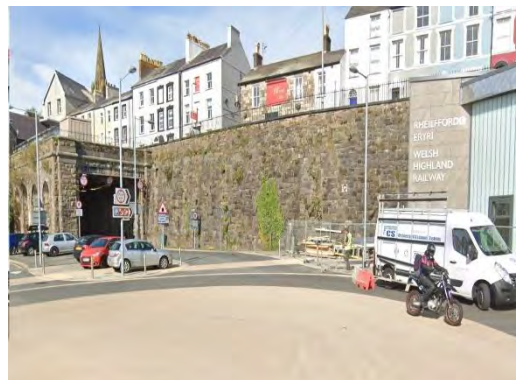
Figure 8-2 – South Portal of Caernarfon Tunnel

The alignment exits the South portal of the tunnel (currently Grade II listed), crossing a roundabout before being met by the new Welsh Highland Railway Station building **Obstruction - CD-01-01**) which has been recently constructed on an area of land previously used as its car park. The route between Caernarfon and Dinas has been redeveloped into the Welsh Highland Railway and the National Cycle Route 8.

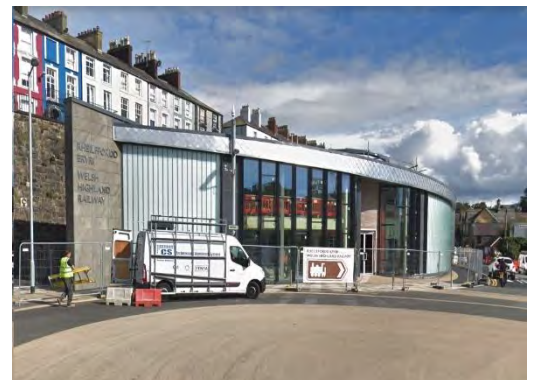
Figure 8-3 – New Welsh Highland Railway Station Building - Obstruction - CD-01-01

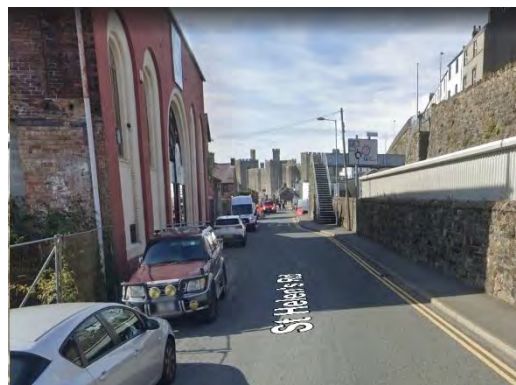
The existing railway runs alongside St Helens Road separated by a masonry wall approximately 2m high. The road has a footpath on both sides however on the southern side the footpath is intermittent and several business' entrances emerge directly on to the road. A number of parking bays are also located on the southern side of the road resulting in a reduction in the road width to an extent where two-way traffic flow is currently difficult. The road is on a bus route however it does not appear that this is heavily used as a through road by other traffic. Adjacent to the steel footbridge are two Grade II listed buildings.

Figure 8-4 – St Helens Road

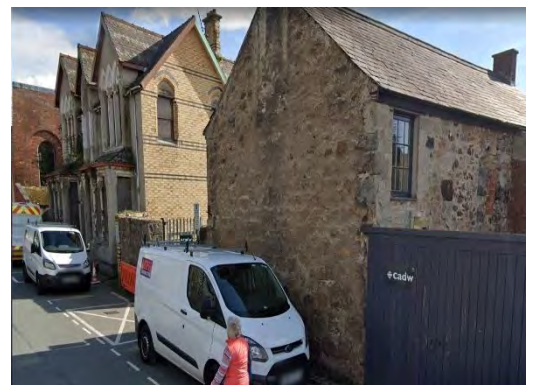
Figure 8-5 – Two listed building on St Helens Road

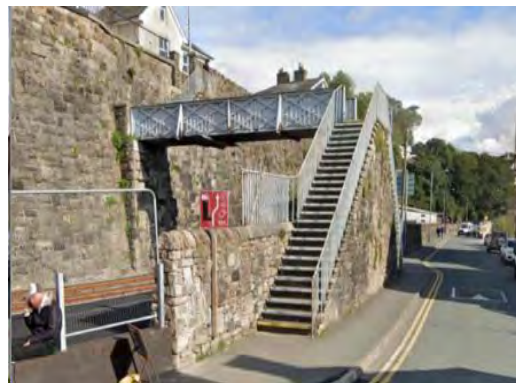
The route then continues along the Welsh Highland Railway track, passing the existing buffer stops before being crossed by a metallic footbridge with masonry abutments (**Obstruction - CD-01-02**) linking St Helens Road to Segontium Terrace. Situated approximately 15m to the east of the footbridge is the start of the platform for the Welsh Highland Railway which runs for approximately 130m with two tracks to allow for the locomotive to change ends.

Figure 8-6 – Footbridge crossing alignment  
Obstruction - CD-01-02

The position of the steps of the footbridge have resulted in the slight narrowing of the carriageway and with the proposal to use segregated on-street running it will be necessary to remove the footbridge. Due to the long alternative route, it is recommended to reconstruct the footbridge in a different location along the road. It may be possible to construct this further down the road using part of an existing car park.

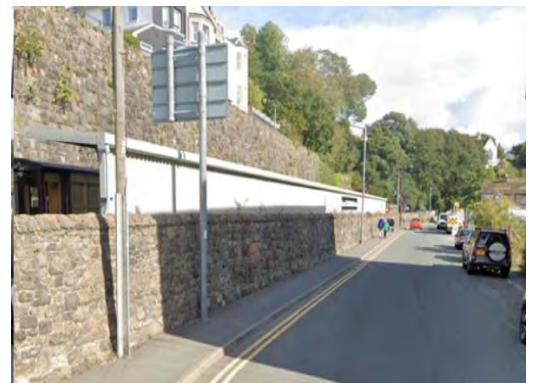
Figure 8-7 – Welsh Highland Railway Station  
Platform - Obstruction - CD-01-01

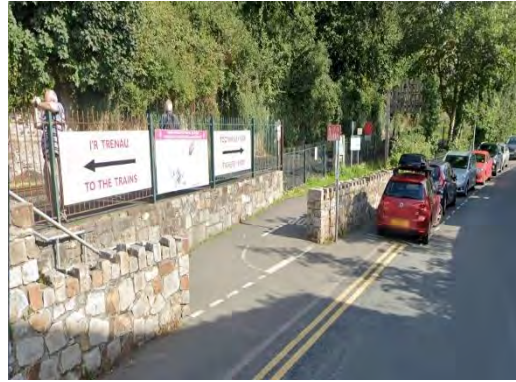
At the eastern end of the station platform the cycle route re-joins the alignment running alongside the Welsh Highland Railway separated by a metallic fence. The alignment is once again crossed by a metallic footbridge with masonry abutments (**Obstruction - CD-01-03**) linking St Helens Road to South Road. As this section of track was previously two tracks there is unused land to the north of the current tracks.

Figure 8-8 – Cycle route re-joins the alignment

The cycle route currently re-joins the alignment at the southern portal of the Caernarfon Tunnel and runs along St Helens road until joining the segregated cycle route adjacent to the Welsh Highland Railway Station. The proposed alignment utilises the existing cycle route in this location therefore a new route will need to be found.

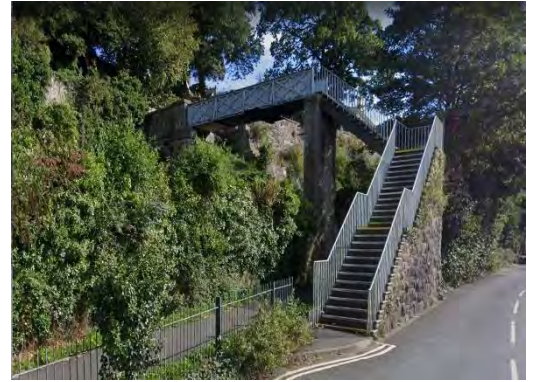
Figure 8-9 – Footbridge crossing alignment  
Obstruction - CD-01-03

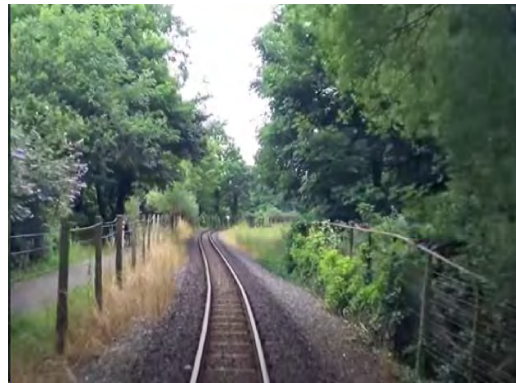
The alignment continues South where it reaches the location where the previous alignment diverted towards Llanberis. This was also where the old St Helens Road passed under the railway via an underbridge (**Obstruction - CD-01-04**) (see Figure 8-11). It is unclear whether the structure still exists.

Figure 8-10 – Potential underbridge  
Obstruction - CD-01-04

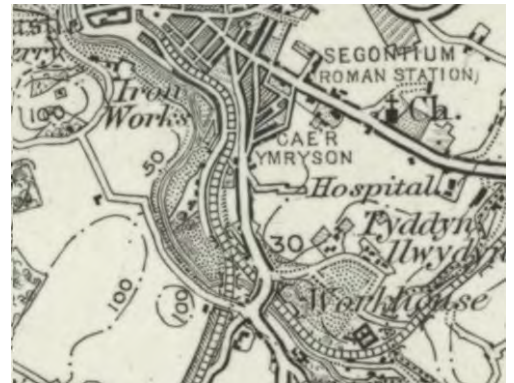
Figure 8-11 – 1945-65 Map showing previous railway passing under St Helens Road

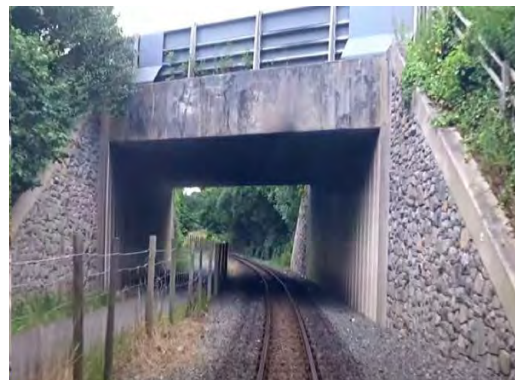
Significant highways developments have been carried out in this area since the closure of the line with St Helens Road now crossing over the alignment via a concrete overbridge (**Obstruction - CD-01-05**). The clearance of this new structure is currently unknown.

Figure 8-12 – St Helens Road overbridge crosses alignment  
Obstruction - CD-01-05

The St Helens Road overbridge currently does not provide sufficient clearance for the new tram-trains and will need to be reconstructed. These works will cause severe disruption to the surrounding network at the road will need to be closed for a period of time.

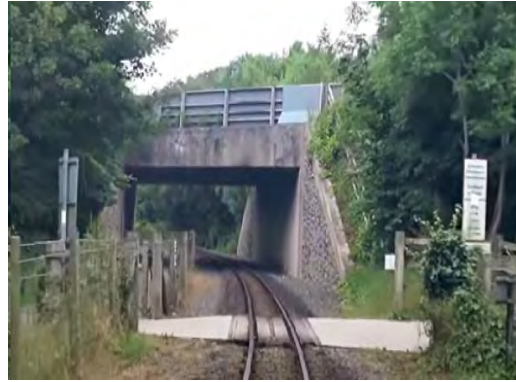
As the route leaves Caernarfon the surroundings become more rural in nature. Shortly after the St Helens road overbridge there is a pedestrian crossing, crossing the railway line providing access from St Helens road to the cycle path (**Obstruction - CD-01-06**). The alignment then continues until it reaches the River Seiont currently crossed by a multi span masonry arch bridge (**Obstruction - CD-01-07**). This structure was constructed to carry 1 track and as a result does not have sufficient width to accommodate the proposed tram-train and Welsh Highland Railway. It is also likely that the structure has insufficient strength to carry both.

Figure 8-14 – Pedestrian crossing  
Obstruction - CD-01-06

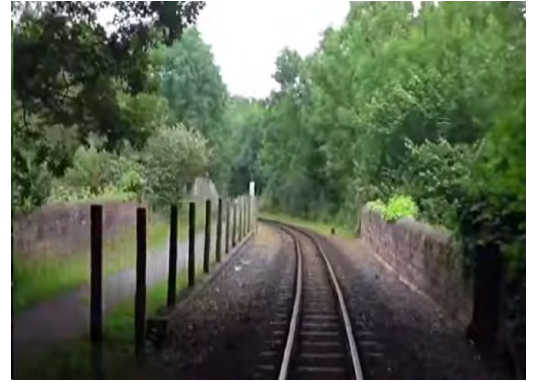
Figure 8-15 – River Seiont Underbridge  
Obstruction - CD-01-07

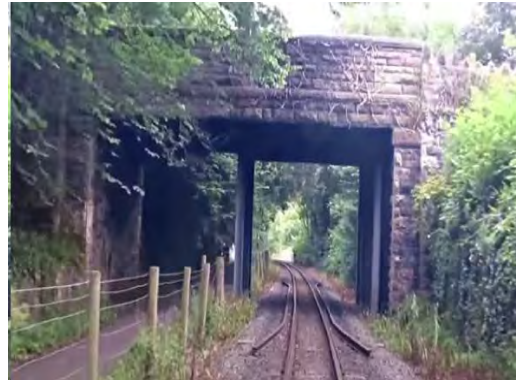
After crossing the River Seiont the alignment reaches a narrow masonry overbridge carrying Coed Helen Lane. This structure has been strengthened with a steel frame in the past and currently does not have sufficient clearance (**Obstruction - CD-01-08**). The lane provides the only access to Coed Helen Holiday Park.

Figure 8-16 – Overbridge carrying Coed Helen Lane  
Obstruction - CD-01-08

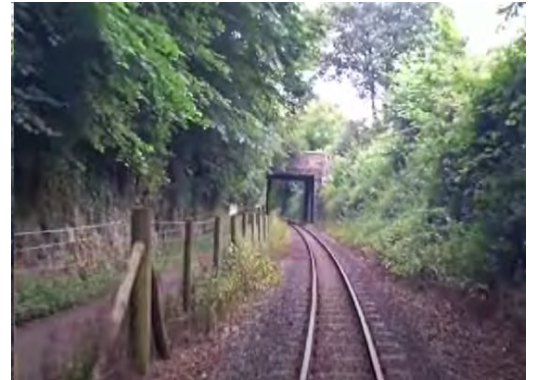
The alignment continues towards Dinas through a cutting with retaining walls on each side restricting the available width for the passage of the tram-train (**Obstruction - CD-02-01**). As the line emerges from the cutting it reaches the junction of Pant Road and an access road to Hendy Farm Caravan Site known previously as Hen-Dy Crossing (**Obstruction - CD-02-03**). A residential property, is situated at the corner of the junction, probably built at the location of the crossing keepers house restricts the width of the line at this point. (**Obstruction - CD-02-02**).

Figure 8-17 – Retaining walls along alignment  
Obstruction - CD-02-01

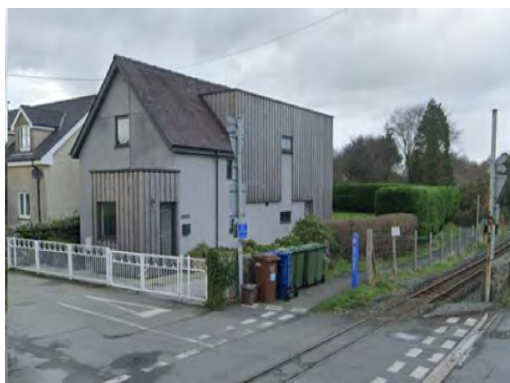
Figure 8-18 – House on alignment and Hen Dy crossing  
Obstruction - CD-02-02 and CD-02-03

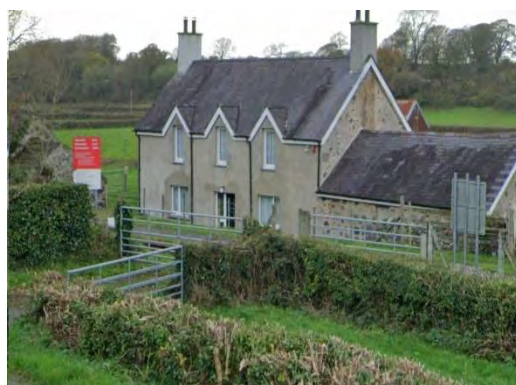
Approximately 200m south of Hen-Dy Crossing is an access track providing the only vehicle access to a nearby property (**Obstruction - CD-02-04**). Continuing south a masonry overbridge carrying Pant Road crosses over the route and does not appear to have sufficient clearance for both the tram-train and the Welsh Highland Railway. (**Obstruction - CD-02-05**)

Figure 8-19 – Access track crosses alignment  
Obstruction - CD-02-04

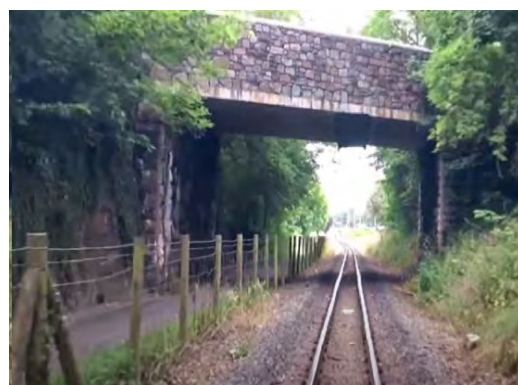
Figure 8-20 – Overbridge crosses alignment  
Obstruction - CD-02-05

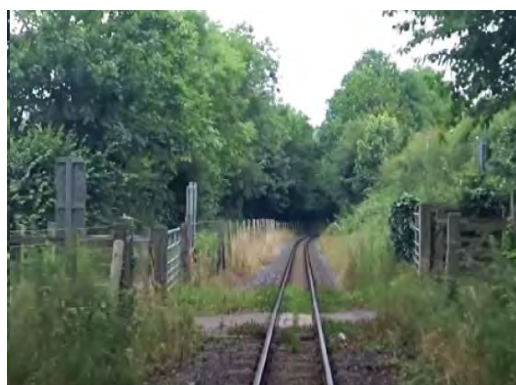
The route continues towards Dinas past several farm buildings and a local garden centre and is crossed by two access tracks with gates in close proximity, the latter providing the only vehicle access to a nearby farm. (**Obstruction - CD-02-06 and CD-02-07**)

Figure 8-21 – Access track crosses alignment  
Obstruction - CD-02-06

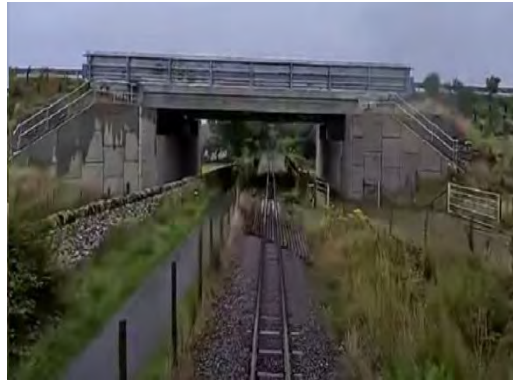
The route carries on south for approximately 400m before being crossed by the newly constructed A487 - Bontnewydd Bypass concrete overbridge (**Obstruction - CD-03-01**). The exact clearances of this concrete structure are unknown at this stage however there does not appear to be sufficient. This structure also crosses over an existing access

track which crosses the existing alignment (**Obstruction - CD-03-02**) at a high skew providing access to the adjacent fields. It is not clear whether the access track provides vehicle access.

Figure 8-23 – A487 Bontnewydd Bypass crossing alignment – Obstruction - CD-03-01 and CD-03-02

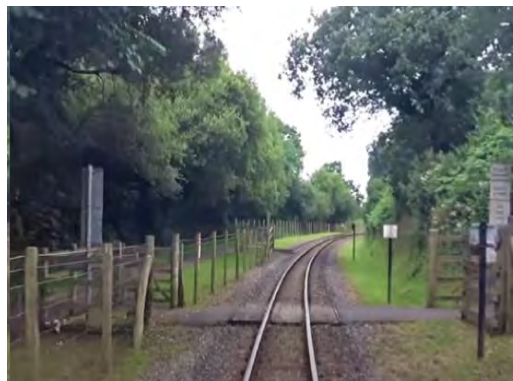
The Welsh Highland Railway Halt at Bontnewydd is located approximately 150m South of the Bontnewydd Bypass with a single platform 70m long on the western side. A pedestrian crossing leading in to the village is located at the southern end of the platform. The cycle path deviates for a short distance around the platform.

Figure 8-24 – Bontnewydd Halt and footpath crossing - Obstruction - CD-03-03

With Bontnewydd already having a Welsh Highland Rail halt it is recommended that tram-train station is also located here. It should be noted that the Welsh Highland Railway and tram-trains station platforms are not compatible therefore they will need to be separate. One solution for this would be to reconstruct the existing halt platform to a compliant level for the tram trains and construct a new halt platform on the eastern side of the Welsh Highland Railway Track. A pedestrian crossing shall also be installed at the end of the platform to allow access in to the village.

With the existing WHR halt and the relatively large village of Bontnewydd within 300m it is recommended that a new station be constructed in this location. Alterations to the existing halt will be required to allow both vehicles to stop at this station whilst also providing compliant platform heights for the each.

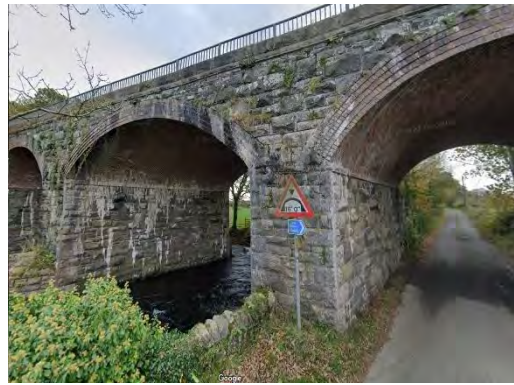
South of Bontnewydd Halt the alignment goes over the 3-span masonry arch Bontnewydd Viaduct (**Obstruction - CD-03-04**) over the River Gwyrfaï and a local road leading in to the village of Bontnewydd. This structure is Grade II Listed. Like the other structures along this section of the route, it does not have sufficient clearance to accommodate both the Welsh Highland Railway and the new Tram-Trains.

Figure 8-26 – Underside Bontnewydd Viaduct  
**Obstruction - CD-03-04**

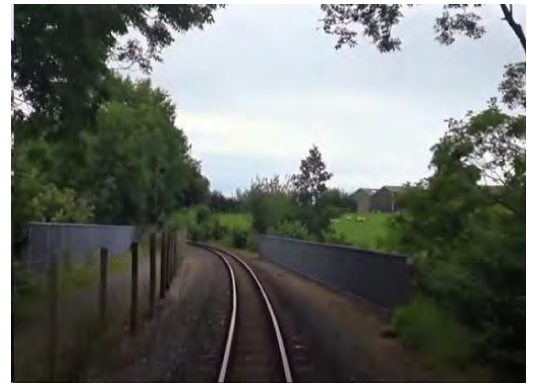
Figure 8-27 – Topside Bontnewydd Viaduct  
**Obstruction - CD-03-04**

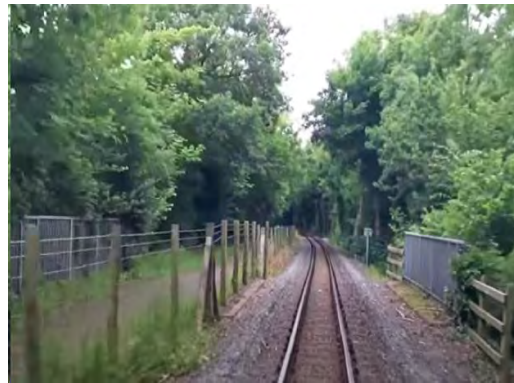
The route continues south past the village of Bontnewydd along an embankment and through predominantly rural surroundings before crossing an underbridge over an access track (**Obstruction - CD-03-05**). The span and construction material of this structure is unknown however there is insufficient width on this structure to accommodate both vehicles. 300m further south the route is then crossed by an access track with gates providing access between fields. (**Obstruction - CD-04-01**).

Figure 8-28 – Underbridge over access track  
**Obstruction - CD-03-05**

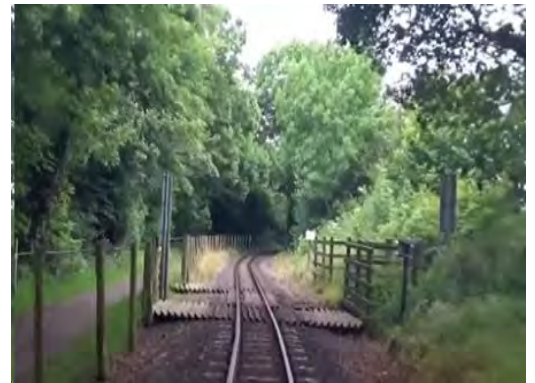
Figure 8-29 – Access track across alignment  
**Obstruction - CD-04-01**

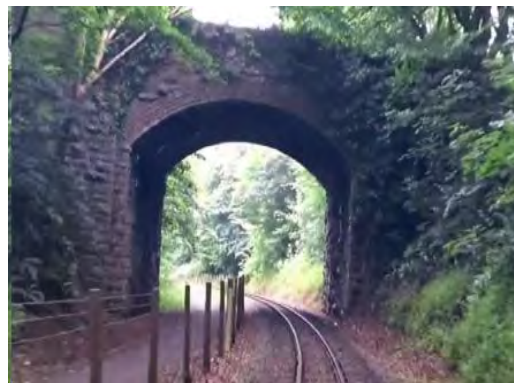
The route continues south where it is crossed by a masonry arch overbridge leading to Plas Dinas Country House (**Obstruction - CD-04-02**). The overbridge is narrow and only has clearance for one vehicle. Before reaching Dinas Station the route is crossed by an access track with gates between two adjacent pieces of farmland (**Obstruction - CD-04-03**).

Figure 8-30 – Overbridge crosses alignment  
**Obstruction - CD-04-02**

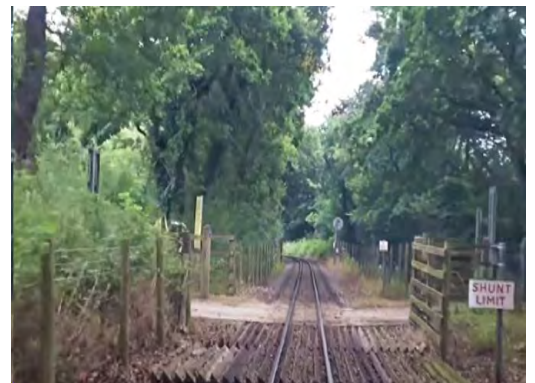
Figure 8-31 – Access track crosses alignment  
**Obstruction - CD-04-03**

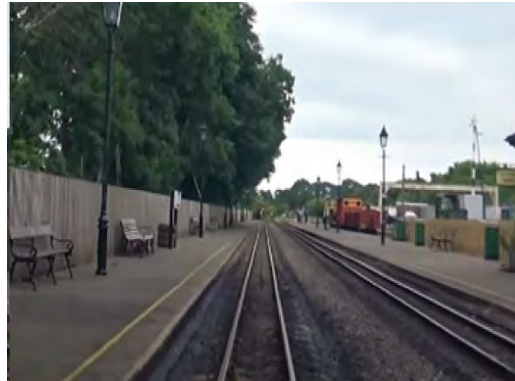
The alignment reaches the Welsh Highland Railway's Dinas Station (**Obstruction - CD-04-04**), its main operational and engineering base for the northern section of the line. The station has two platforms for passenger use to the west and two tracks to the east used as sidings. It should be noted that the platform heights do not comply with standard gauge rolling stock. A station building is situated towards the southern end of the station with a maintenance building located to the north. Previously called Dinas Junction this is the location where the WHR diverts away from the main line towards Snowdon.

Figure 8-32 – Dinas Station Platforms  
**Obstruction - CD-04-04**

An alternative option was considered where the WHR tracks would be permanently moved east, turning the existing eastern platform into an island platform - however the disruption caused was considered to be too significant for the benefits derived.

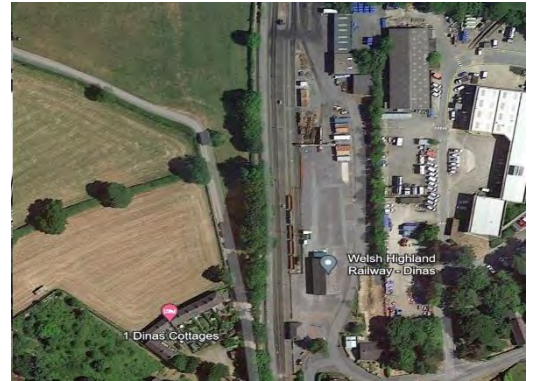
Figure 8-33 – Dinas Station Plan View  
**Obstruction - CD-04-04**

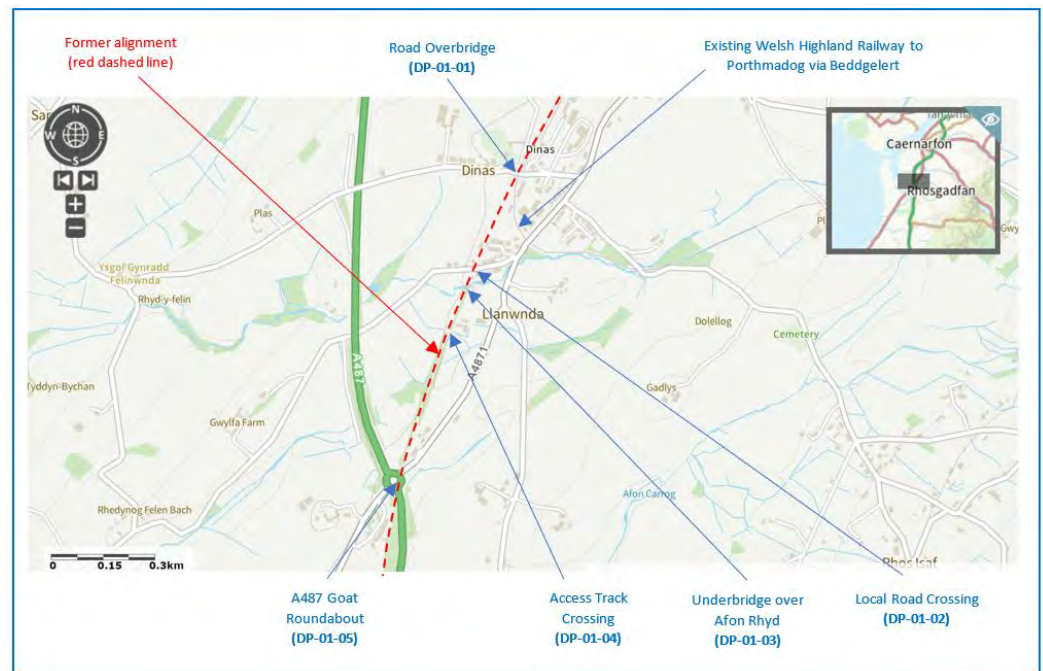
Although the former railway was single track in this area, there appears sufficient width to retain the active travel path alongside any new railway alignment – with the active travel path rebuilt to one side in order to provide sufficient space. However around Dinas Station where the Welsh Highland Railway and the reopened railway is proposed to co-exist (see Section 8), there is insufficient width in the existing corridor to additionally accommodate an Active Travel path. Therefore the Lon Las Cymru active travel path will need to be diverted onto another route between Caernarfon, Dinas and Llanwnda.

Figure 9-1 – Overview of Dinas to Goat Roundabout area showing all obstructions along the route

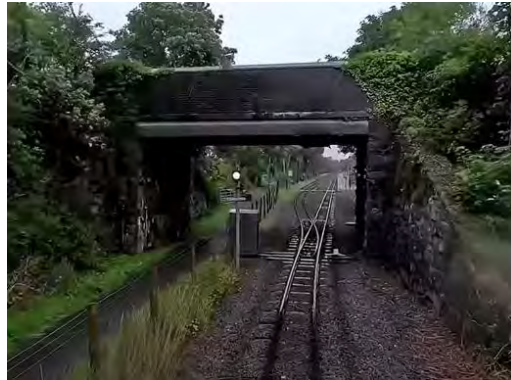
As shown above, the existing Welsh Highland Railway passes underneath a local road bridge called Ty'n Llan directly south of Dinas station, prior to the point where the Welsh Highland Railway diverges from the former Caernarfon to Afon Wen route. It is not clear whether this overbridge spanned one or two standard gauge tracks previously, but it is likely to need to be reconstructed to span both the existing Welsh Highland Railway line and the reopened line (**Obstruction Number – DP-01-01**).

Figure 9-2 – Ty'n Llan road overbridge  
Obstruction Number – DP-01-01

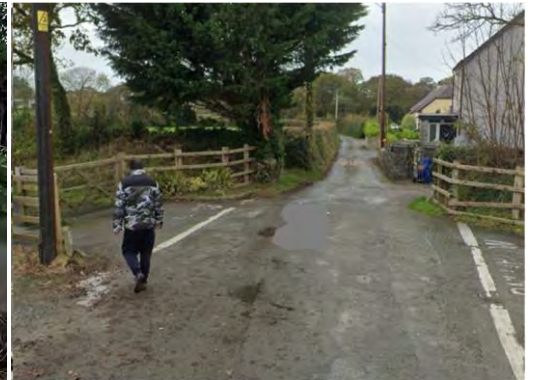
The former line then proceeds in a southerly direction, crossing a local road called Glanrhyd near the hamlet of Llanwnda – this appears to be a former level crossing, as the road and former alignment are on the same level (**Obstruction Number – DP-01-02**).

Figure 9-3 – Glanrhyd road crossing  
Obstruction Number – DP-01-02

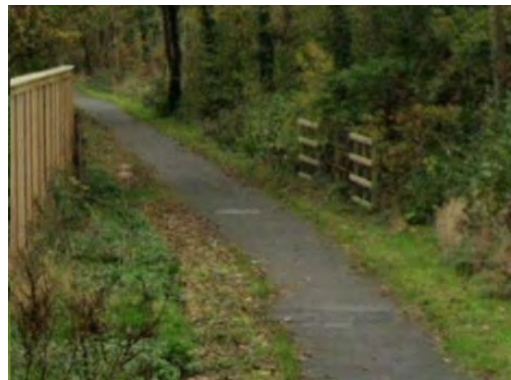
Figure 9-4 – Afon Rhyd underbridge  
Obstruction Number – DP-01-03

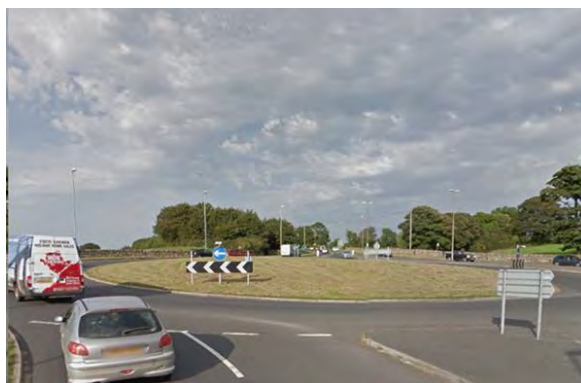
After a further 0.5km, the former alignment is lost under the A487/A4871 Goat Roundabout (**Obstruction Number – DP-01-05**). The roundabout has been constructed directly over the alignment and will need to be modified to allow the reopening of the railway in due course.

Figure 9-6 – A487/A4871 Goat Roundabout  
Obstruction Number – DP-01-05

#### **Goat Roundabout (Obstruction Number – DP-01-05)**

The roundabout serving the A487, A499 and A4871 has been constructed directly over the alignment and will need to be modified to allow the passage of the tram-train. It is proposed to run the alignment through the centre of the roundabout, which will require the installation of traffic signals to control road vehicles and indicate to the Tram-Train when to proceed. An example from Spain is shown in Figure 9-7 below. The alternative of constructing a bridge across the roundabout is judged a high cost intervention, and one which could negatively impact the residential properties which are either side of the roundabout near the former alignment. Detailed design studies may require a comprehensive remodelling of the road layout to ensure traffic flows are maintained, however the disruption caused by the limited number of Tram-Trains crossing the roundabout per hour is judged likely to be minimal.

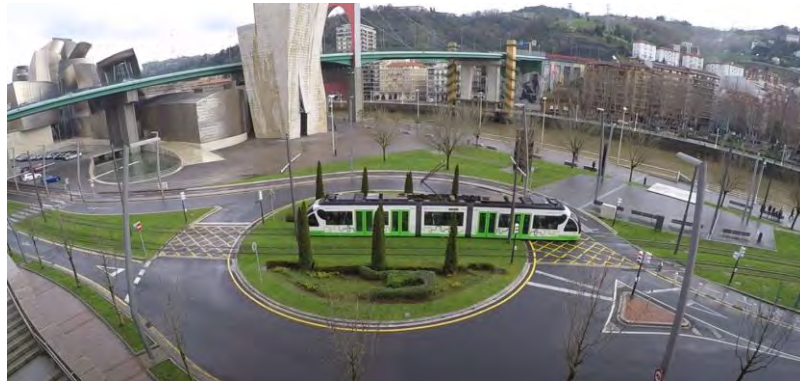
Figure 9-7 – Roundabout with tram lines through centre and traffic light controls (Bilbao, Spain)

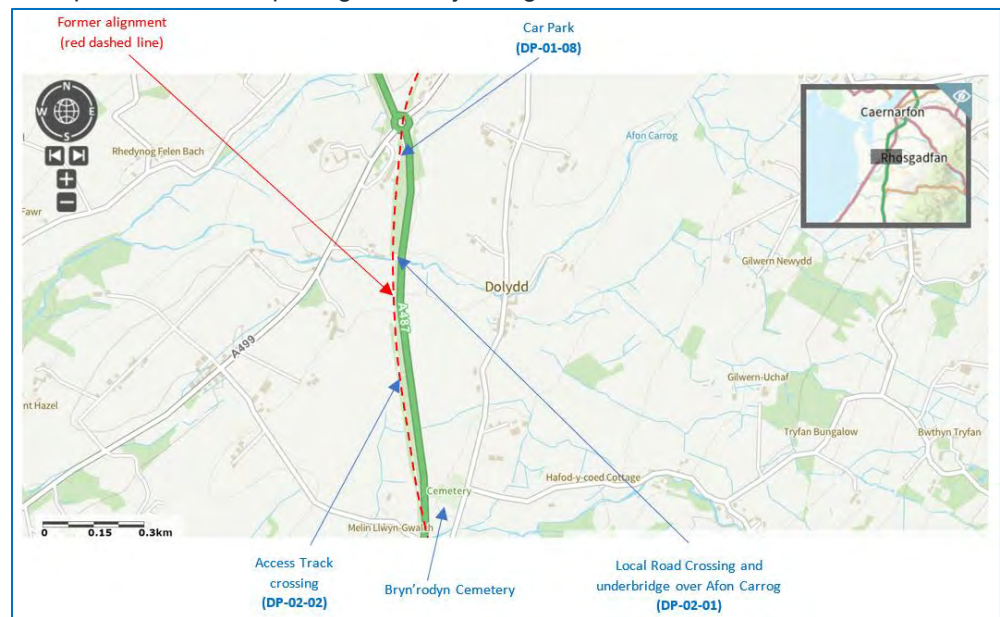
South of the Goat Roundabout, the former alignment proceeds on a north/south route towards Groeslon. Prior to the A487 road on the outskirts of Groeslon, there is relatively few impediments to reopening a railway along the former route noted.

**Figure 9-8 – Overview of Goat Roundabout to A487 (Bryn'rodyn Cemetery) area showing the obstructions along the route**

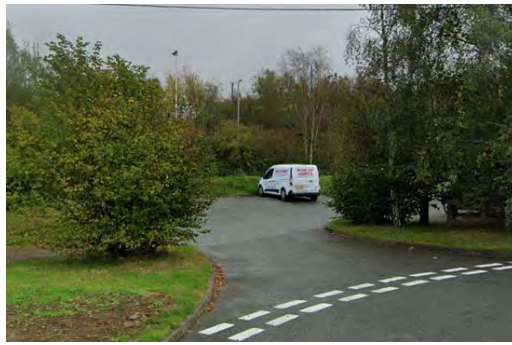
Directly south of Goat Roundabout, the former alignment has been built over by a small car park accessed off a small residential road. It appears the parking spaces are used by the local residential houses nearby – it is not marked as a public car park (**Obstruction Number – DP-01-08**). The former line then proceeds in a southerly direction, crossing a local access road between the A487 and A499 serving one property (**Obstruction Number – DP-02-01**). Around this location the former alignment must cross over the Afon Carrog, but no obvious structure is visible from the desktop surveys. Therefore there may be a culvert at this location to be maintained.

Figure 9-9 – Car park near Goat Roundabout  
Obstruction Number – DP-01-08

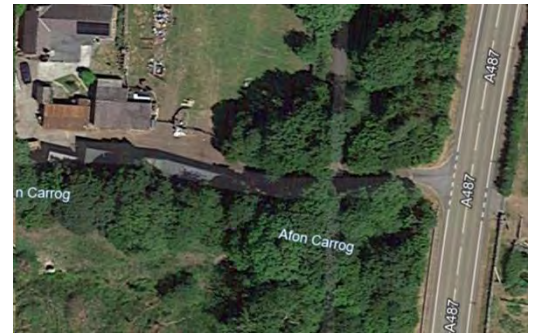
Figure 9-10 – Local Access Road near Afon Carrog  
Obstruction Number – DP-02-01

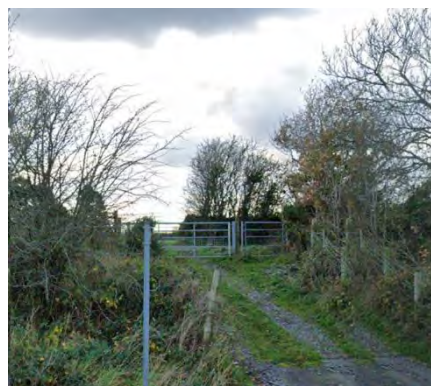
Approximately 300m further south, a farmers access track to allow access to land from the adjacent A487 is encountered (**Obstruction Number – DP-02-02**).

Figure 9-11 – Farmers Access Track crossing  
Obstruction Number – DP-02-02

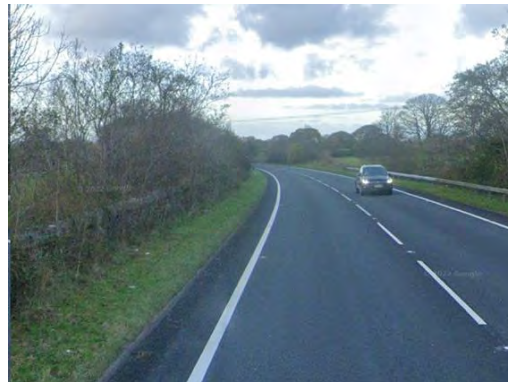
North of Groeslon the A487 road crosses the former alignment, with a number of existing underbridges in the location crossing access roads and streams (**Obstruction Number – DP-03-01**). The road completely changes the previous topography at this location, which therefore means the old route is no longer obvious and would require heavy engineering works to reinstate.

Figure 9-13 – A487 road crosses alignment  
Obstruction Number – DP-03-01

A significant engineering intervention would be required to reinstate the route at this location – it is thought from the desktop study that the new railway would need to pass under the A487, meaning a new heavily skewed overbridge would need to be constructed whilst ensuring the road remained open to traffic. It is noted that there are a number of obstacles in this location, with the A487 and thus the new railway interfacing with an Access Road and stream also.

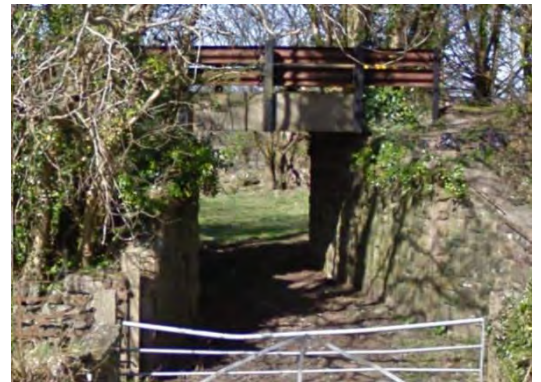
The former line then passes over two small underbridges, which each cross local access roads (**Obstruction Number – DP-03-02**).

Figure 9-14 – Underbridge over access road  
Obstruction Number – DP-03-02

The condition and dimensions of the existing underbridge is not known at present, but it appears to be a new deck on masonry wingwalls built more recently for the active travel route so is unlikely to be wide enough or have sufficient capacity to accommodate the reopened railway and the active travel route at this location. Therefore reconstruction of the existing underbridge is deemed required.

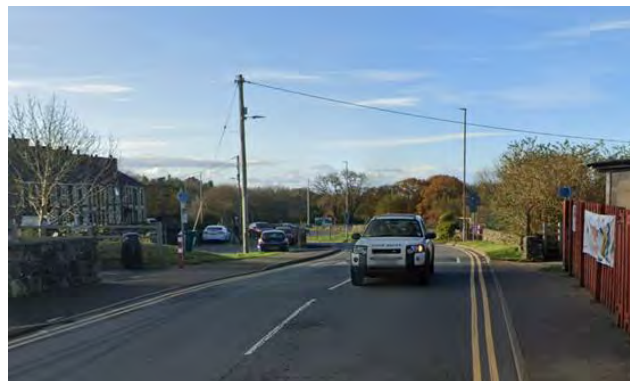
The former railway then passes through the western side of Groeslon village, with businesses and residential properties located adjacent to the former route. The route crosses Lon Cefn Glyn, which is the main road linking the village with the A487 bypass further to the west (**Obstruction Number – DP-03-03**). The former station was located at this location to serve the village, and it is currently presumed that a new station will be constructed to serve the locality.

Figure 9-15 – Lon Cefn Glyn road crosses alignment  
Obstruction Number – DP-03-03

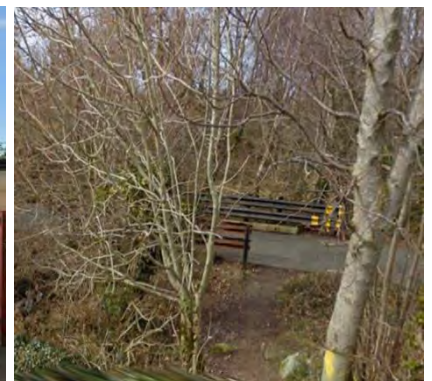
The former rail route – now the Lon Eifion / Lon Las Cymru Active Travel path – then skirts the western edge of the Groeslon village, crossing at least one culvert (**Obstruction Number – DP-03-04**).

Figure 9-16 – Culvert under alignment  
Obstruction Number – DP-03-04

Similar to **Obstruction Number – DP-03-02**, the condition and dimensions of the existing culvert/underbridge is not known at present, but it would also not appear to be

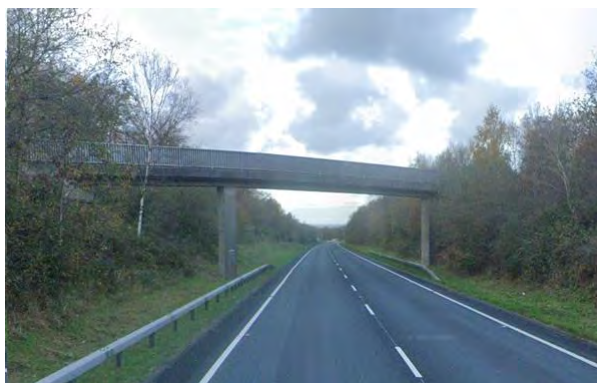
South of Groeslon the A487 road crosses the former alignment again, on a heavy skew. The Active Travel path at this location is diverted off the former rail route, such that it crosses the road at a more 90-degree angle (**Obstruction Number – DP-04-01**). Due to the fact the road is lower than the previous rail corridor, again the road completely changes the previous topography at this location and means heavy engineering works would be required to reinstate the former alignment.

Figure 9-18 – A487 road crosses alignment  
Obstruction Number – DP-04-01

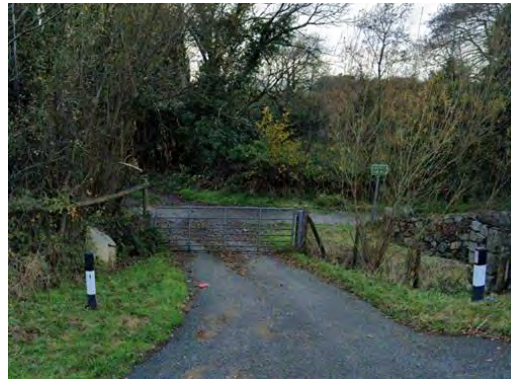
A number of existing access routes are encountered to the farmland, residential and commercial properties – with 5 access road crossings in the 1.75km south of Indigo Jones Slate Works - (**Obstruction Number – DP-05-01, DP-05-02, DP-05-03, DP-05-04 and DP-06-01**).

Figure 9-20 – Access road crosses alignment  
Obstruction Number – DP-05-01

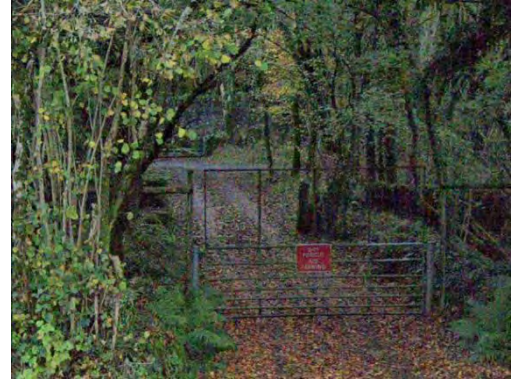
Figure 9-21 – Access road crosses alignment  
Obstruction Number – DP-05-02

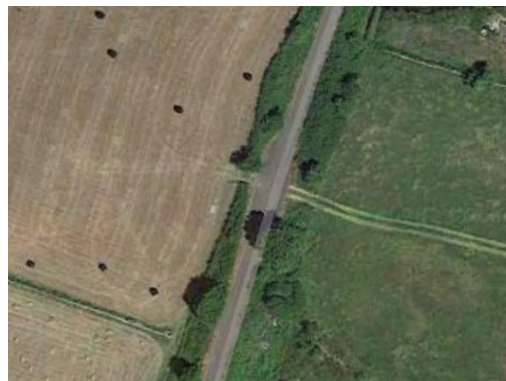
Figure 9-22 – Access road crosses alignment  
Obstruction Number – DP-05-03

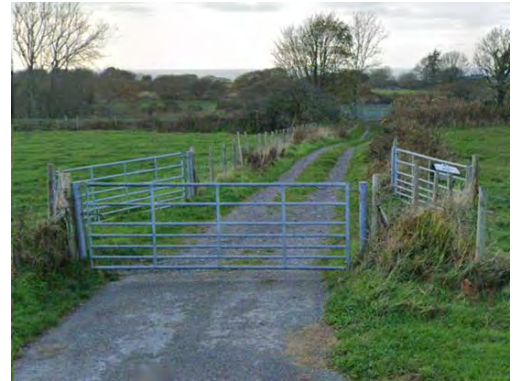
Figure 9-23 – Access road crosses alignment  
Obstruction Number – DP-05-04

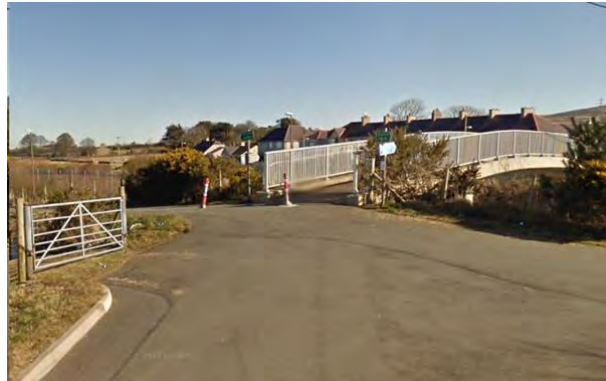
The construction of the A487 road previously has amended the topography in the area, particularly around the concrete footbridge created during the road scheme to connect via a footpath the two segregated sections of Clynog Road (**Obstruction Number – DP-06-02**). Since the former station location has been lost under the new road scheme, one potential location for a new station is next to the footbridge over the A487, as this location would allow the new railway to serve the village via the footbridge which provides access directly into the village centre to the east.

Figure 9-25 – Footbridge crosses alignment  
Obstruction Number – DP-06-02

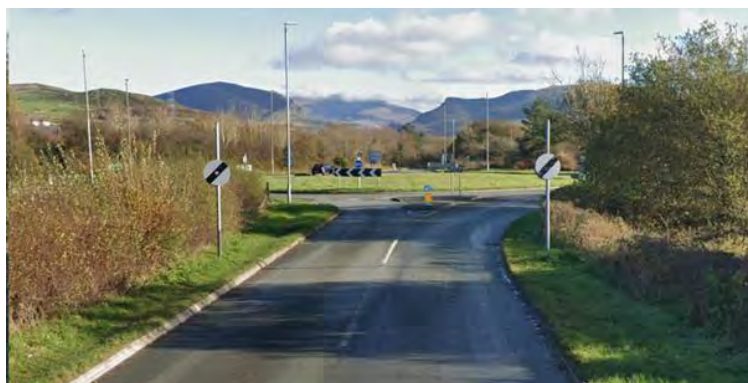
The current Active Travel route then crosses the western leg of the A487 / B4418 roundabout (**Obstruction Number – DP-06-03**) – which is the minor road to Pontllyfni.

Figure 9-26 – Pontllyfni Road crosses alignment  
Obstruction Number – DP-06-03

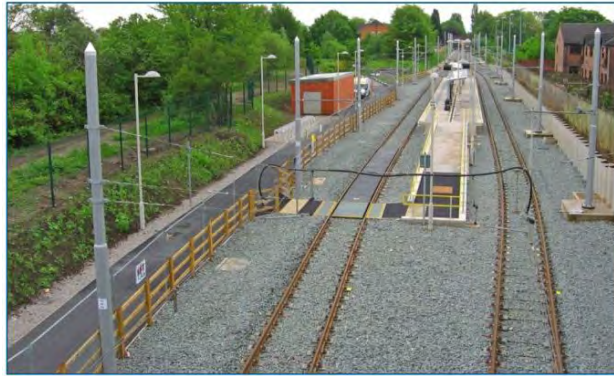
Figure 9-27 – View of St. Werburgh's Road Tram Stop on Manchester Metrolink, showing typical station pedestrian crossing point at end of platforms<sup>19</sup>

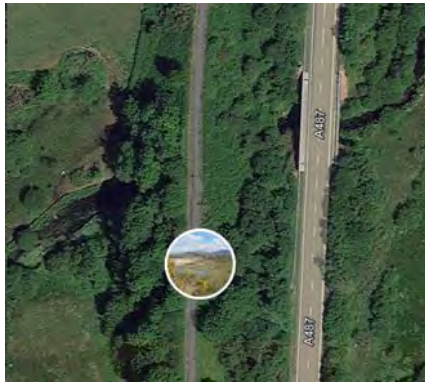
Figure 10-2 – Underbridge across Afon Llyfni  
Obstruction Number – PB-01-01

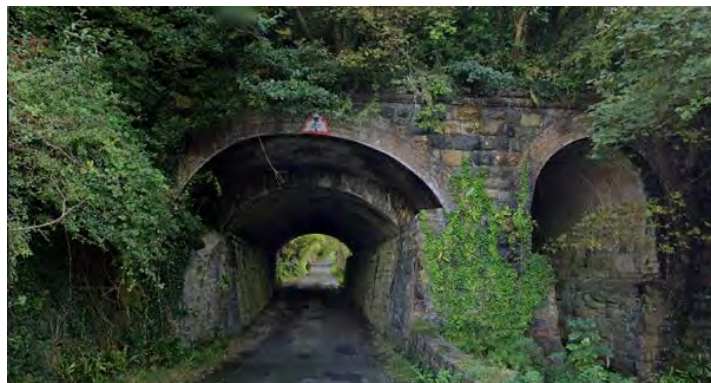
The former line crosses over two rivers – the Afon Llyfni (**Obstruction Number – PB-01-01**) and Afon Crychddwr (**Obstruction Number – PB-01-02**) – in quick succession. It is noted that the Afon Crychddwr (**Obstruction Number – PB-01-02**) bridge is a two span underbridge, crossing both the river and a local road.

Figure 10-3 – Underbridge across Afon Crychddwr and local road  
Obstruction Number – PB-01-02

This underbridge is a large structure with two spans – one spanning the river and the second span across a local road. From the desktop study information available it appears that the structure will have sufficient width to accommodate across it the reopened railway and the active travel path alongside it. It is consequently assumed that this structure can also be retained following surveys/assessments, and any repair works identified then being completed.

| Obstruction Number | Works Required On Existing Alignment | Maintain Alignment | | Works Required On Alternative Alignment | Alternative Alignment | |
|---|---|---|---|---|---|---|
| <b>PB-01-02</b><br><b>Afon Crychddwr and Local Road Underbridge</b> | Undertake surveys and assessments, and undertake any repairs as required | Minimal | Minimal | | | |

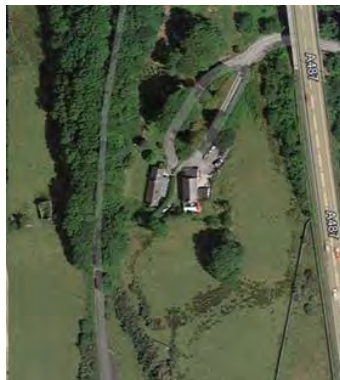
A third possible underbridge is located near farm buildings south of the Afon Crychddwr, but this is not visible in the desktop study as it is located within a wooded section (**Obstruction Number – PB-01-03**). The former railway route is then crossed by an Access Road to the Coedcae Newydd Farm (**Obstruction Number – PB-02-01**).

Figure 10-4 – Possible Underbridge  
Obstruction Number – PB-01-03

It has not been possible to establish the existence – or not – of an underbridge south of the Afon Crychddwr adjacent to some farm buildings from the current desktop study. A historic access appears on older maps, and therefore the condition and suitability of any structure should be investigated further in future studies.

| Obstruction Number | Works Required On Existing Alignment | Maintain Alignment | | Works Required On Alternative Alignment | Alternative Alignment | |
|---|---|---|---|---|---|---|
| <b>PB-01-03</b><br><b>Possible Underbridge</b> | Undertake surveys and assessments, and undertake any repairs as required | Minimal | Minimal | | | |

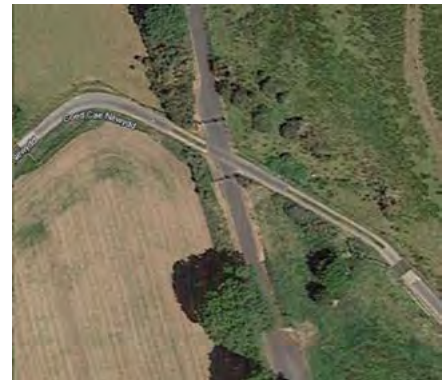
Figure 10-5 – Local Access Road near Coedcae Newydd Farm - Obstruction Number – PB-02-01

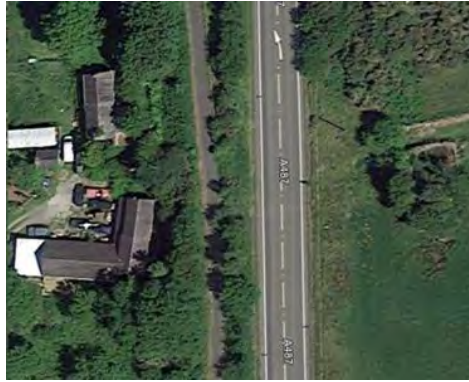
As indicated above, the A487 and directly adjacent Lon Las Cymru active travel route cross over a Possible Underbridge or culvert (**Obstruction Number – PB-02-02**) which is adjacent to a small set of farm buildings that is accessed via Access Track off the A487 (**Obstruction Number – PB-02-03**). A modern concrete overbridge (**Obstruction Number – PB-02-04**) then crosses the A487 and active travel route near the Berth Farm, which carries a small local road.

Figure 10-7 – Possible underbridge / culvert  
Obstruction Number – PB-02-02

| Obstruction Number | Works Required On Existing Alignment | Maintain Alignment | | Works Required On Alternative Alignment | Alternative Alignment | |
|---|---|---|---|---|---|---|
| <b>PB-02-02</b><br><b>Possible Underbridge</b> | Undertake surveys and assessments, and undertake any repairs as required | Minimal | Minimal | | | |

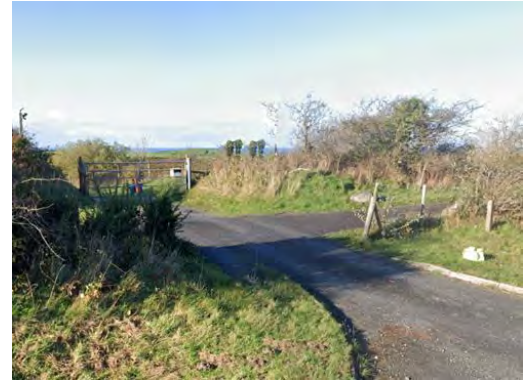
Figure 10-8 – Access Track Crossing  
Obstruction Number – PB-02-03

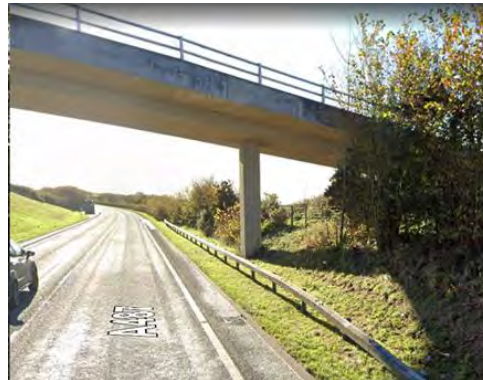
Figure 10-9 – Overbridge crosses alignment  
Obstruction Number – PB-02-04

| Obstruction Number | Works Required On Existing Alignment | Maintain Alignment | | Works Required On Alternative Alignment | Alternative Alignment | |
|---|---|---|---|---|---|---|
| <b>PB-02-04</b><br><b>Concrete overbridge near Berth</b> | Localised amendment of western span and/or foundations to western side of existing bridge to accommodate width and height of new Tram-Train Vehicles | Minimal | High | | | |

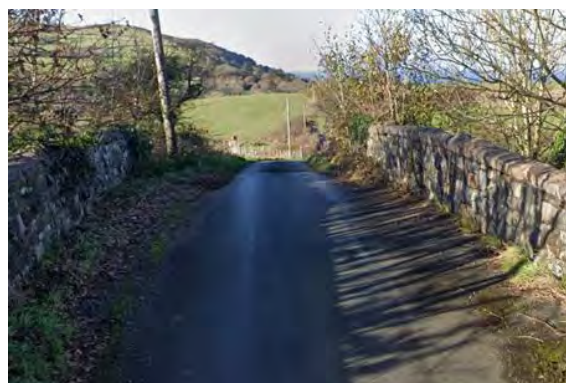
South of Melin Bryn-Gro Farm, the A487 deviates from the former railway alignment, with the former railway following a valley in the south-westerly direction. A stone overbridge (**Obstruction Number – PB-03-01**) carrying a small access road passes over the alignment, which is now occupied by the Active Travel route.

Figure 10-10 – Stone overbridge carrying local road  
Obstruction Number – PB-03-01

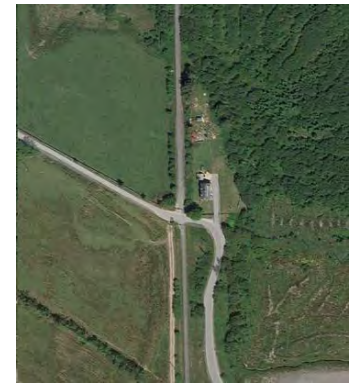
The former railway passes to the east of Cefn Graianog Quarry, which has relatively extensive workings either side of Graianog Farm. There are relatively few observable obstacles in this area – although there are potentially drainage ditches and culverts along the whole length of the former line which may need review at a later stage – until an Access Road to the Quarry and Farm is reached (**Obstruction Number – PB-04-01**).

Figure 10-11 – Local Access Road near  
Cefn Graianog  
Obstruction Number – PB-04-01

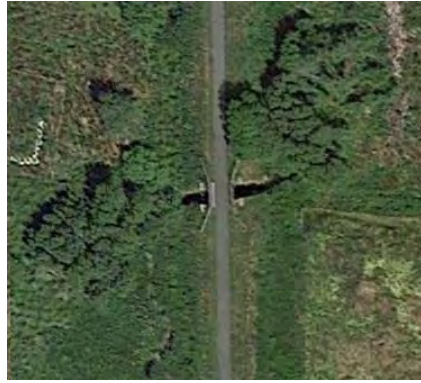
An underbridge (**Obstruction Number – PB-05-01**) does appear to be present south of Cefn Graianog, followed by an Access Track Crossing between farmland (**Obstruction Number – PB-05-02**).

Figure 10-13 – Underbridge  
Obstruction Number – PB-05-01

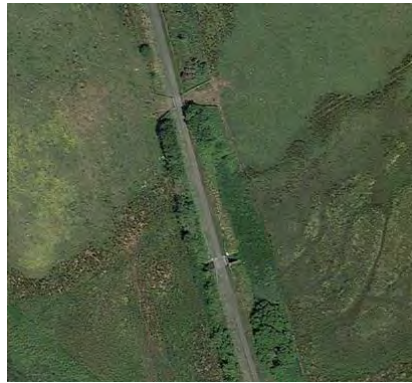
The former railway then appears to pass across an Access Track and then over an underbridge in quick succession (**Obstruction Number – PB-05-03**).

Figure 10-15 – Access Track and Underbridge  
Obstruction Number – PB-05-03

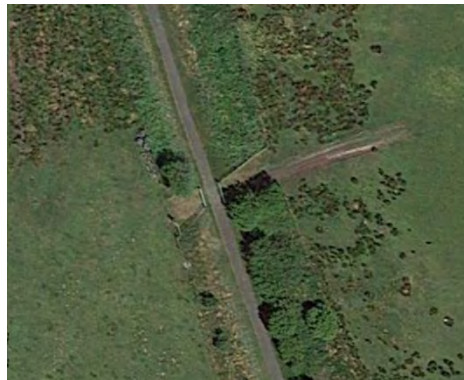
Figure 10-16 – Access Track Crossing  
Obstruction Number – PB-05-04

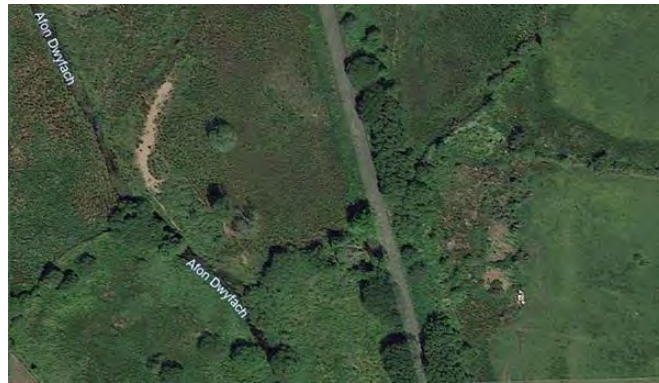
As the former railway alignment passes to the west of the small Pant Glas hamlet, the line crosses another possible underbridge/culvert (**Obstruction Number – PB-06-01**) which is likely to cross a tributary of the Afon Dwyfach which is running parallel to the railway at this location.

Figure 10-18 – Possible Underbridge/Culvert  
Obstruction Number – PB-06-01

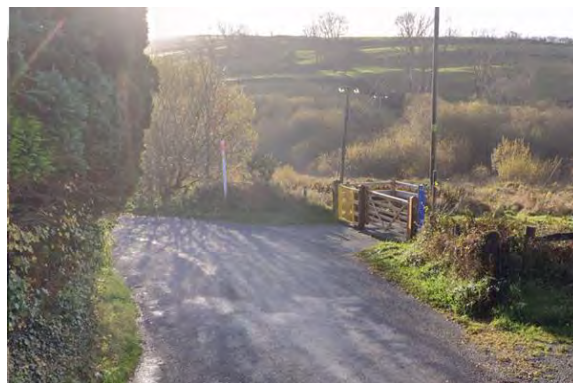
The route then approaches the former station of Pant Glas, which was located either side of the local access road which still crosses the alignment (**Obstruction Number – PB-06-02**). A small single platform station was located just south of the former level crossing, and a siding for goods was situated just north of the level crossing. The station served a sparsely populated area, with passenger services ceasing at the station in 1957 a number of years before the line between Afon Wen and Caernarfon was completely closed in 1964<sup>20</sup>.

Figure 10-19 – Local Road Crossing near former  
station  
Obstruction Number – PB-06-02

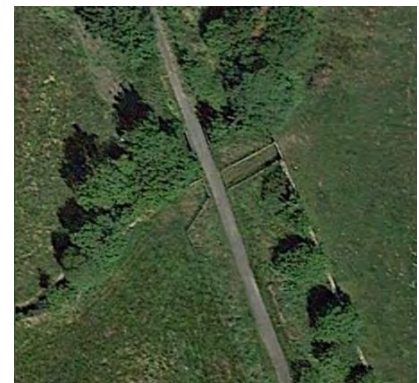
To the south of the former platform site, an Access Track between farmer's fields (**Obstruction Number – PB-06-03**) is visible – again historic records indicate a possible underbridge or culvert at this location also

Figure 10-20 – Access Track Crossing  
Obstruction Number –PB-06-03

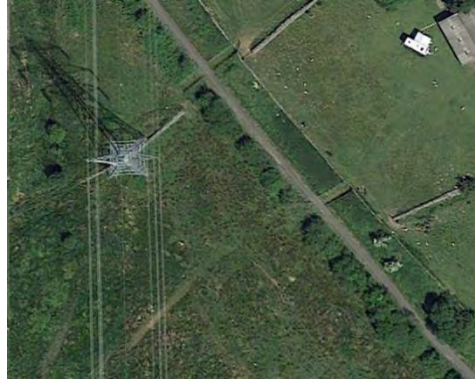
Figure 10-22 – Access track crosses alignment  
Obstruction Number – PB-06-04

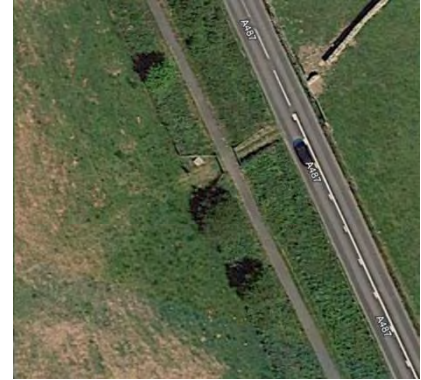
Figure 10-23 – Access track crosses alignment  
Obstruction Number – PB-06-05

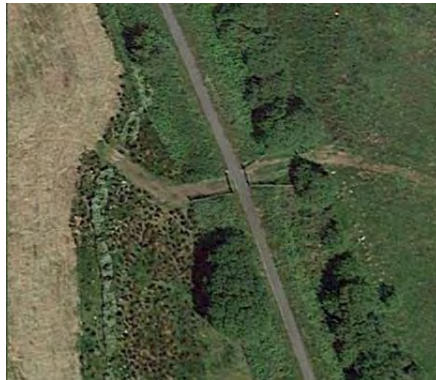
Figure 10-24 – Access track crosses alignment  
Obstruction Number – PB-07-01
