# NORTH SOUTH WEST WALES FEASIBILITY

Document title: Feasibility Report

Document reference: 5225267-ATK-EMP-000001

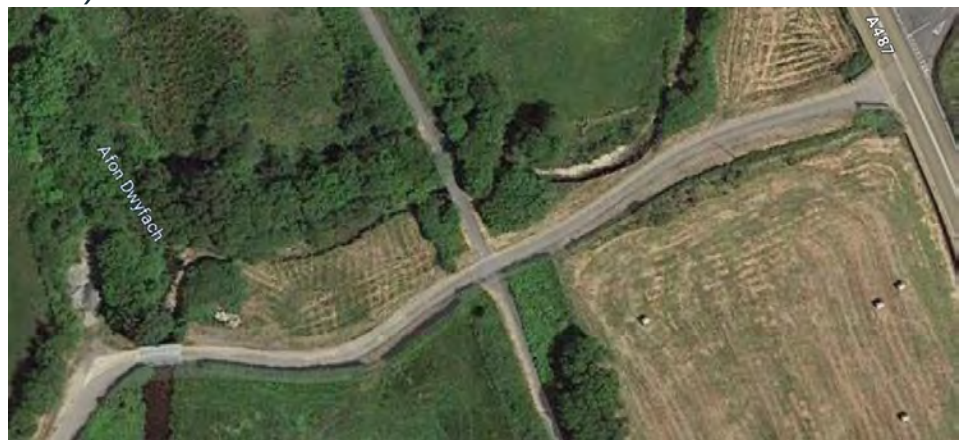
Near Derwin Fawr Farm the former railway crosses a tributary of the Afon Dwyfach (**Obstruction Number – PB-07-02**), before the fourth road/rail interface in this section is encountered - the access route to Derwin Fawr Farm itself (**Obstruction Number – PB-07-03**).

Figure 10-25 – Underbridge over tributary to Afon Dwyfach and Access Track crosses alignment  
Obstruction Number – PB-07-02 and PB-07-03

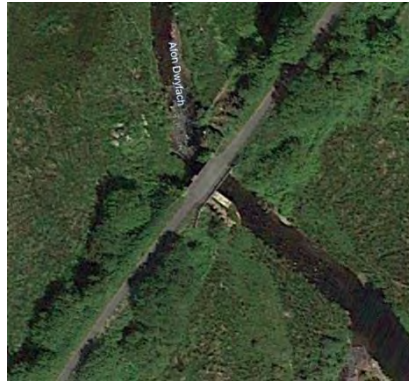
Approximately 500m further south the former alignment crosses the Afon Dwyfach (**Obstruction Number – PB-07-04**), before the river passes back under the railway a further 500m south again (**Obstruction Number – PB-08-01**).

Figure 10-26 – Underbridge over Afon Dwyfach  
Obstruction Number – PB-07-04

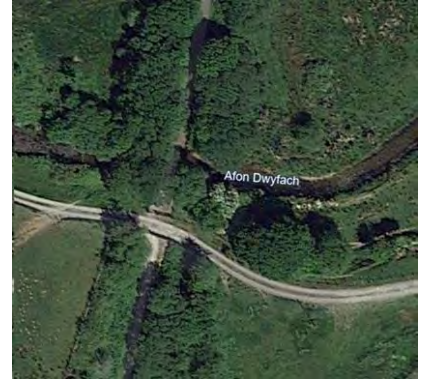
Figure 10-27 – Underbridge over Afon Dwyfach  
Obstruction Number – PB-08-01

As can be seen in the figure above, directly adjacent to the second underbridge across the Afon Dwyfach there additionally exists an Access Track (**Obstruction Number – PB-08-02**) providing a connection from the A487 road to the Derwin Bach Farm/Holiday Cottages.

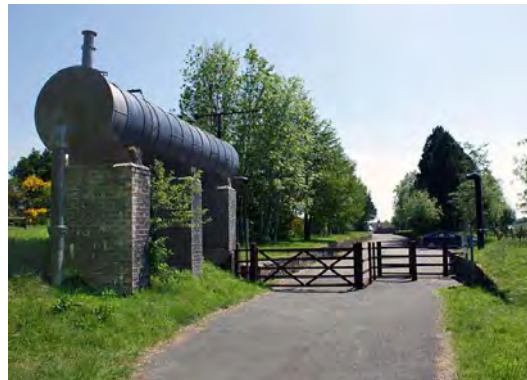
The former railway approaches the village of Bryncir, before running along the western side of the village itself. The former station has been adopted for a number of alternative purposes (**Obstruction Number – PB-08-03**) – north of the former platforms is a small carpark for the Lon Las Cymru cycle route, adjacent to the former water tank for supplying steam engines with water. The station platforms remain generally in place, with the area between the platform faces now an access track to the car park and the continuation of the cycle path itself (a passing loop was previously provided at this location, hence two former platform faces being present).

Figure 10-28 – View of Water Tank towards car park  
Part of Obstruction Number – PB-08-03<sup>21</sup>

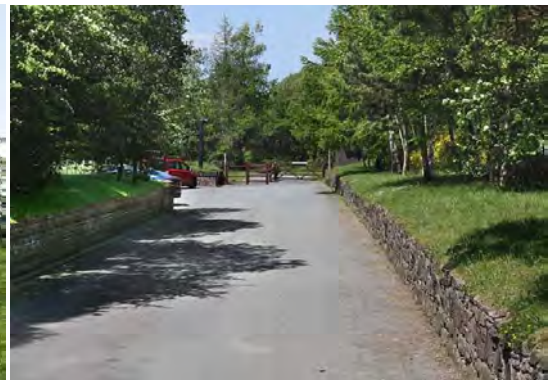
Figure 10-29 – View of platform faces towards car park  
Part of Obstruction Number – PB-08-03

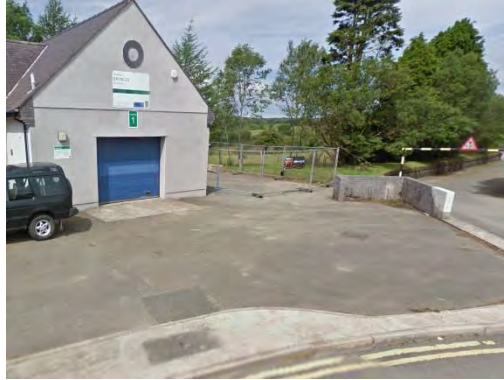
South of the former platforms, new buildings for businesses have been constructed directly adjacent to the old alignment (**continuation of Obstruction Number – PB-08-03**) and a local road to provide access to these businesses routed along the former alignment (**Obstruction Number – PB-08-04**).

Figure 10-30 – Commercial business constructed on alignment Obstruction Number – PB-08-03

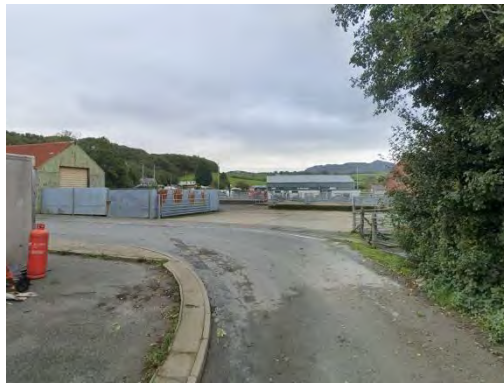
Figure 10-31 – Commercial business constructed on alignment Obstruction Number – PB-08-04

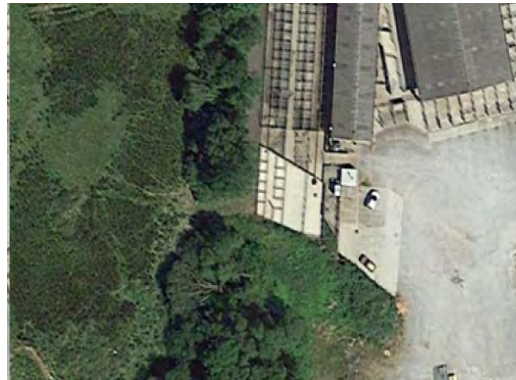
As the route leaves Bryncir it is crossed by an access track from the adjacent industrial units to the nearby field (**Obstruction Number – BA-01-01**). The alignment continues south through farmland and crosses over two possible underbridges with the latter crossing over a river. (**Obstruction Number – BA-01-02 and BA-01-03**). The exact size, condition and construction material are unknown at this stage.

Figure 11-2 – Access track crosses alignment  
Obstruction - BA-01-01

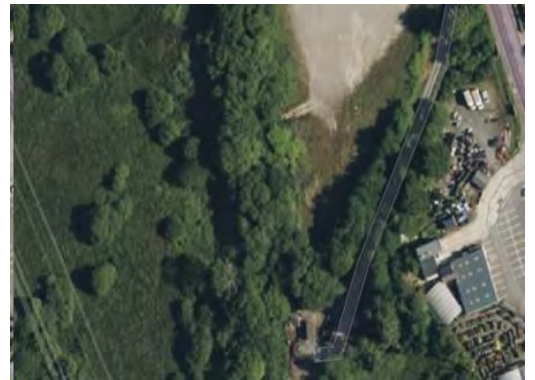
Figure 11-3 – Possible Underbridge  
Obstruction – BA-01-02

| Obstruction Number | Works Required On Existing Alignment | Maintain Alignment | | Works Required On Alternative Alignment | Alternative Alignment | |
|---|---|---|---|---|---|---|
| <b>BA-01-02</b><br>Underbridge | Undertake surveys and assessments, and undertake any repairs as required | Minimal | Minimal | | | |

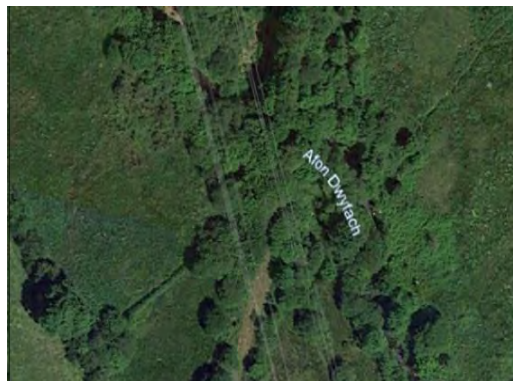
Figure 11-4 – Possible Underbridge  
Obstruction – BA-01-03

| Obstruction Number | Works Required On Existing Alignment | Maintain Alignment | | Works Required On Alternative Alignment | Alternative Alignment | |
|---|---|---|---|---|---|---|
| <b>BA-01-03</b><br>Underbridge | Undertake surveys and assessments, and undertake any repairs as required | Minimal | Minimal | | | |

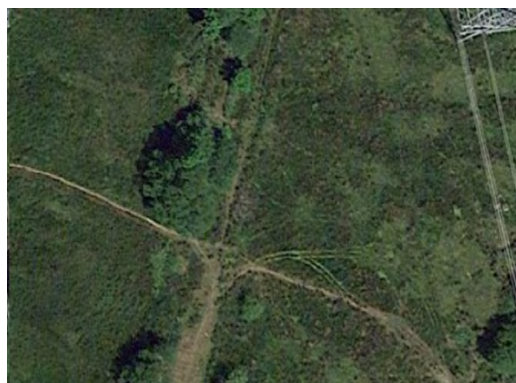
Figure 11-5 – Access track crosses alignment  
Obstruction - BA-01-04

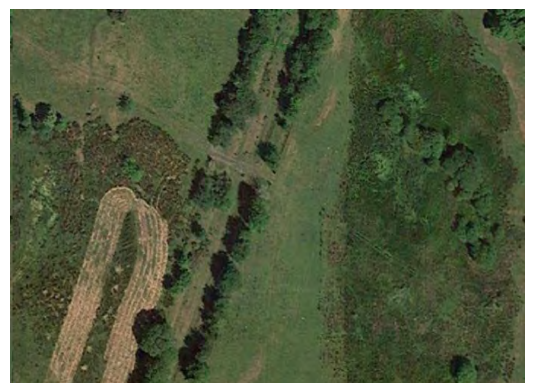
Figure 11-6 – Access track crosses alignment  
Obstruction – BA-01-05

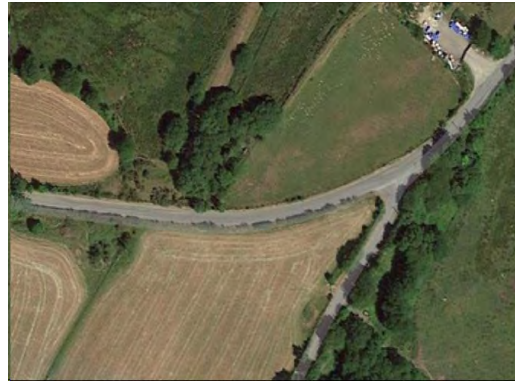
Continuing South the route is crossed by an access road to a nearby farm (**Obstruction Number – BA-02-01**). An overbridge was located here on the previous alignment however this has since been removed. This has however result in a slight level difference between the road and the adjacent land.

Figure 11-7 – Road crosses alignment  
Obstruction - BA-02-01

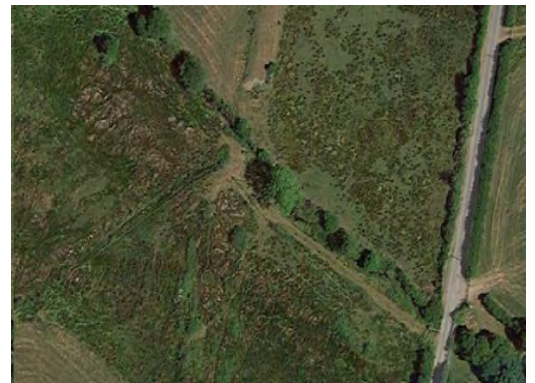
Figure 11-9 – Access track crosses alignment  
Obstruction – BA-02-03

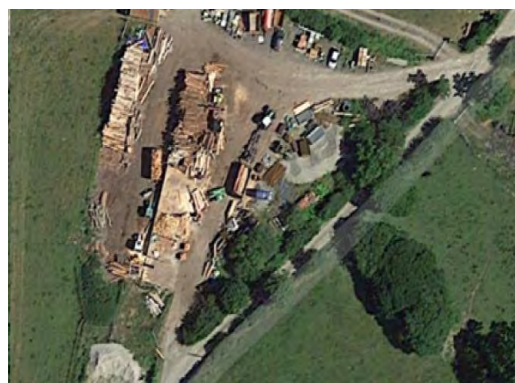
The alignment passes through another 2 access track crossings (**Obstruction Number – BA-02-02 and BA-02-03**) before reaching a farm who are using the old alignment as a timber storage area (**Obstruction Number – BA-02-05**). An access track also crosses the alignment at this location (**Obstruction Number – BA-02-04**).

Figure 11-10 – Access track crosses alignment and timber storage area  
Obstruction - BA-02-04 and BA-02-05

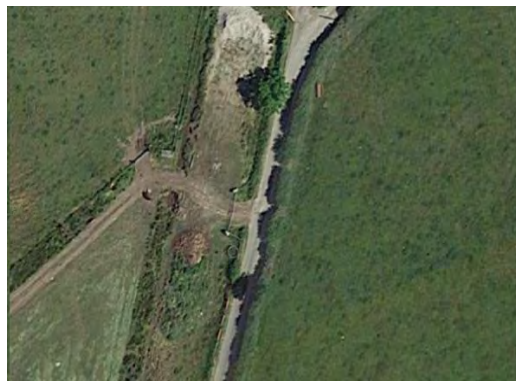
Figure 11-11 – Access track crosses alignment  
Obstruction - BA-02-06

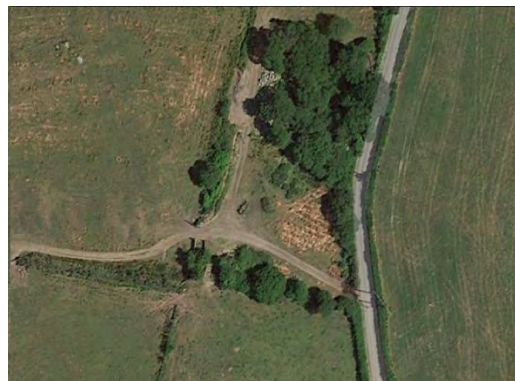
Figure 11-12 – Access track crosses alignment  
Obstruction – BA-03-01

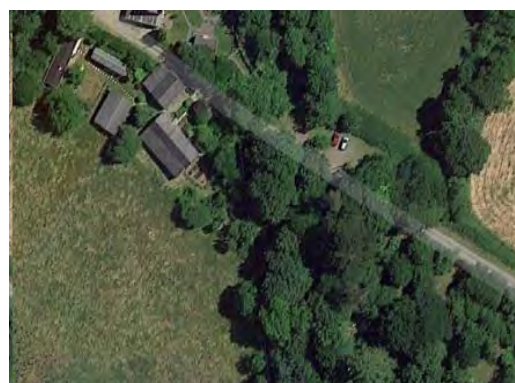
Figure 11-14 – Access track crosses alignment  
Obstruction – BA-03-03

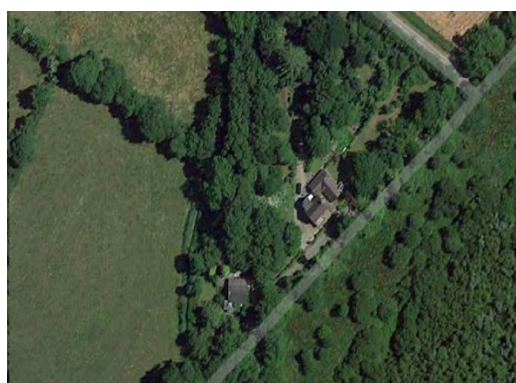
of the old Ynys Station where it is crossed by a road. The previous station building does not appear to still exist however there are two houses on either side of the alignment which could potentially have been the old station building.

Figure 11-15 – Road crosses alignment Obstruction  
- BA-03-04

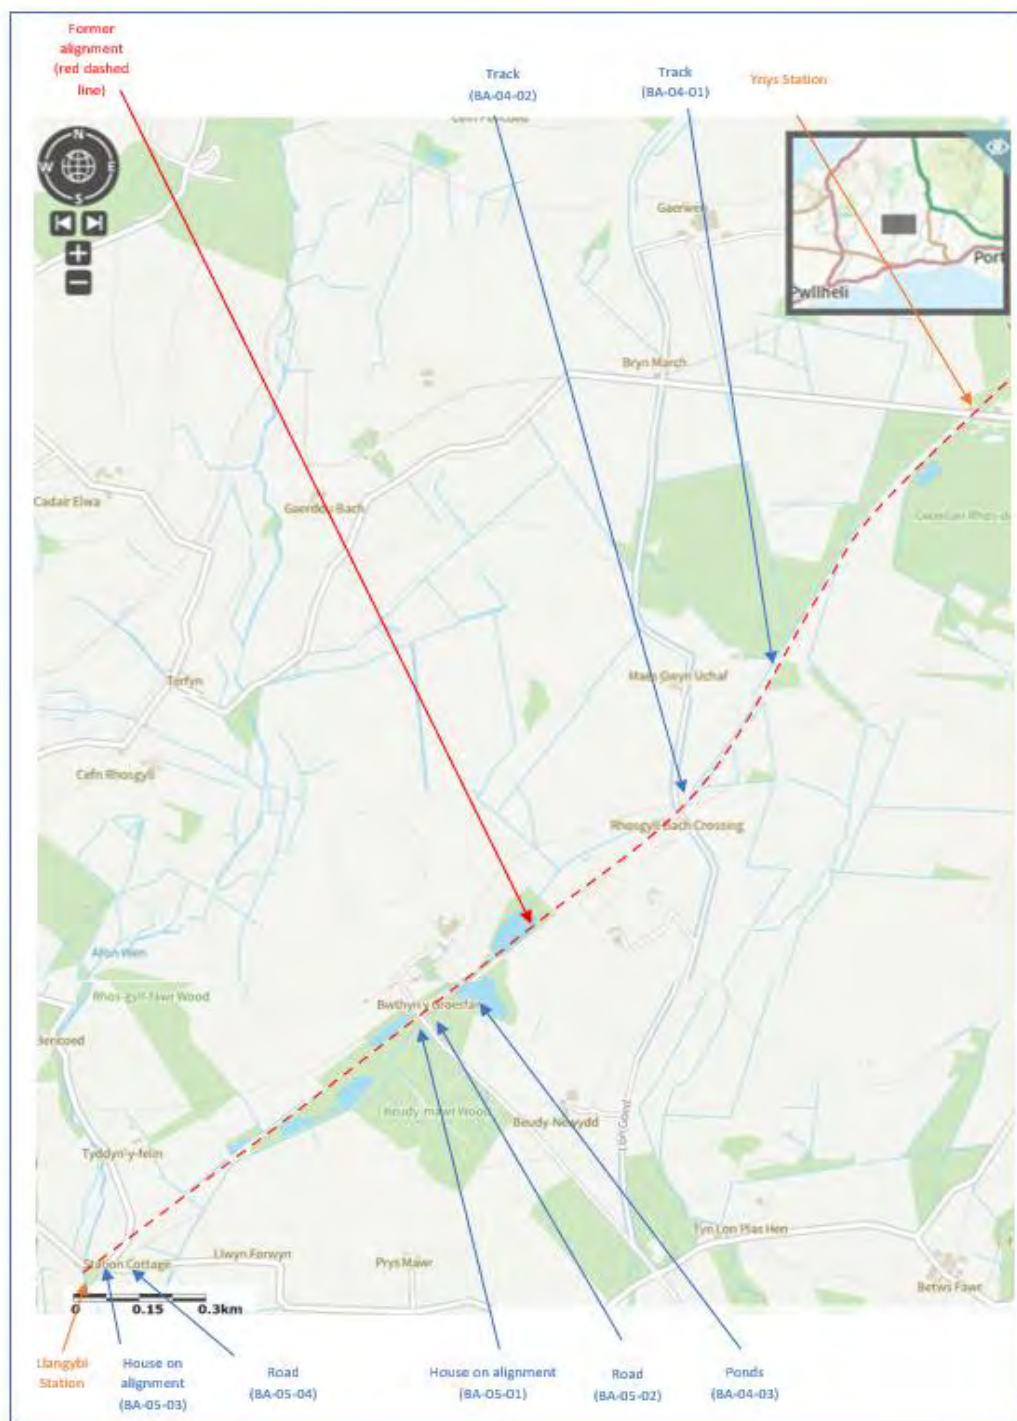
**Figure 11-17 – Overview of Ynys Station to Llangybi Station showing obstructions along the route**

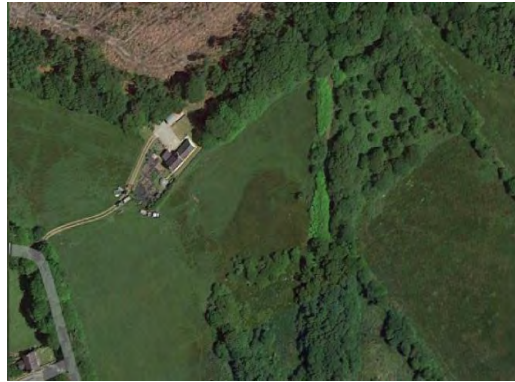
Figure 11-18 – Access track crosses alignment  
Obstruction - BA-04-01

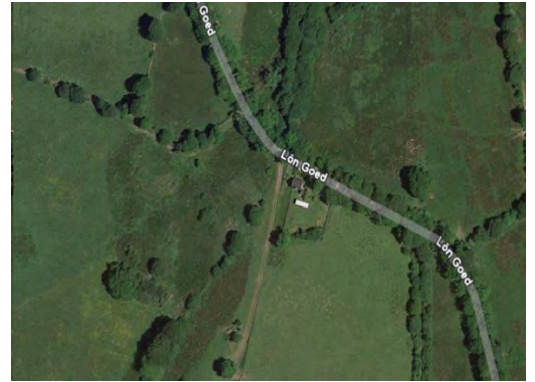
Figure 11-19 – Access track crosses alignment  
Obstruction – BA-04-02

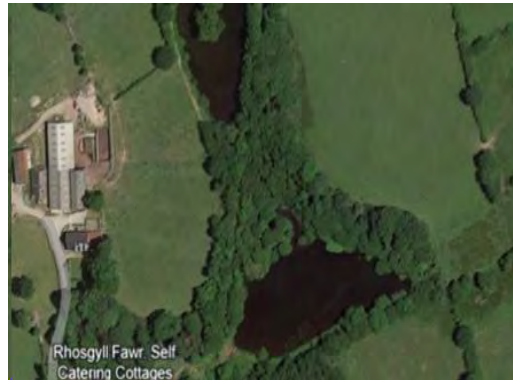
Approximately 400m south the alignment passes close by a number of ponds within an area of woodland (**Obstruction Number – BA-04-03**). The exact size of the ponds and condition of adjacent land is unknown and will need to be investigated to establish current ground conditions and whether they are suitable for the proposed route.

Figure 11-20 – Ponds Adjacent to Alignment  
Obstruction - BA-04-03

There are a number of ponds which run in close proximity to the previous alignment and will likely have an impact on the surrounding ground conditions. Surveys shall be carried out to establish if the existing ground conditions are suitable for the new route.

| Obstruction Number | Works Required On Existing Alignment | Maintain Alignment | | Works Required On Alternative Alignment | Alternative Alignment | |
|---|---|---|---|---|---|---|
| <b>BA-04-03</b><br>Ponds Adjacent to Alignment | Carry out surveys to establish ground conditions | Minimal | Minimal | | | |

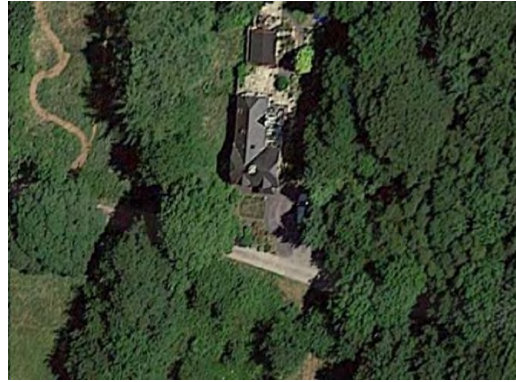
Shortly after the first set of ponds a house is located on the previous alignment. This which was not present during the operation of the old line (**Obstruction Number – BA-05-01**). An access road to nearby cottages also crosses the alignment at this point. (**Obstruction Number – BA-05-02**).

Figure 11-21 – House on alignment  
Obstruction - BA-05-01

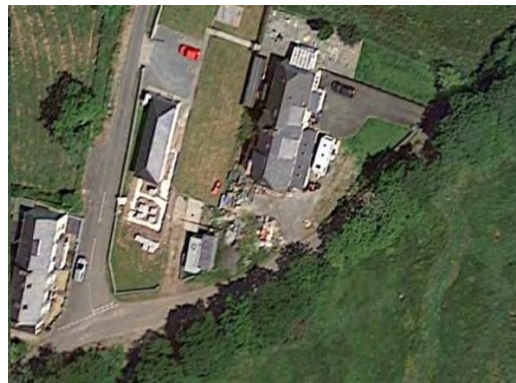
The route continues south and is met with the former Llangybi Station, with the station building now being used as a residential property with the old track bed is now being used as the garden (**Obstruction Number – BA-05-03**). A main road runs across the alignment at this point and was likely to have had a level crossing. (**Obstruction Number – BA-05-04**)

Figure 11-23 – House on alignment  
Obstruction - BA-05-03

The old Llangybi Station building still exists and is currently being used as a residential property with only the garden required to be purchased to install the new track bed. The new route will however be running very close to the current property and may cause noise issues to the property owner.

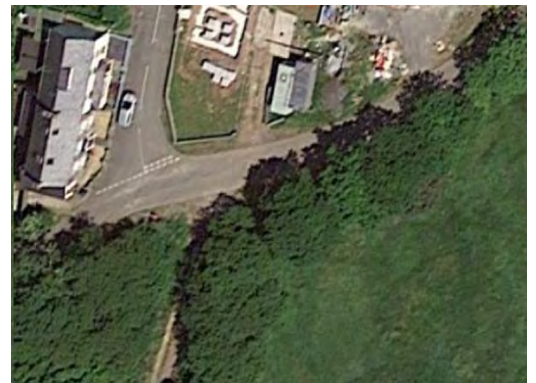
Figure 11-24 – Road crosses alignment  
Obstruction – BA-05-04

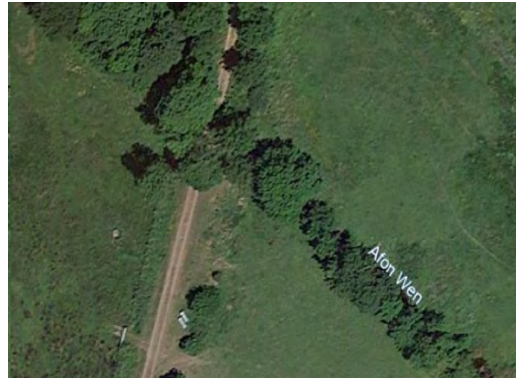
Figure 11-26 – Possible Underbridge  
Obstruction - BA-05-05

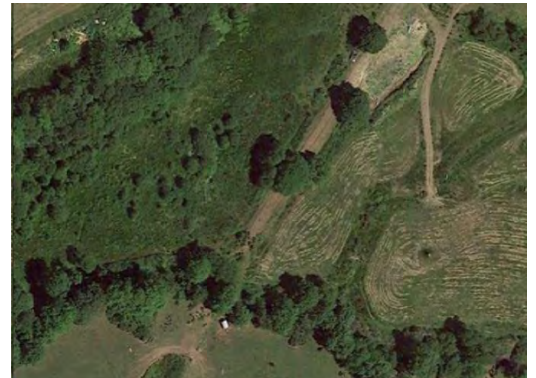
South of the former Llanybi Station the alignment crosses over Afon Wen twice, 450m apart where there are likely to be underbridges however the condition, construction material and dimensions are unknown at this stage (**Obstruction Number – BA-05-05 and BA-06-01**).

Figure 11-27 – Possible Underbridge  
Obstruction – BA-06-01

| Obstruction Number | Works Required On Existing Alignment | Maintain Alignment | | Works Required On Alternative Alignment | Alternative Alignment | |
|---|---|---|---|---|---|---|
| <b>BA-06-01 Underbridge</b> | Undertake surveys and assessments, and undertake any repairs as required | Minimal | Minimal | | | |

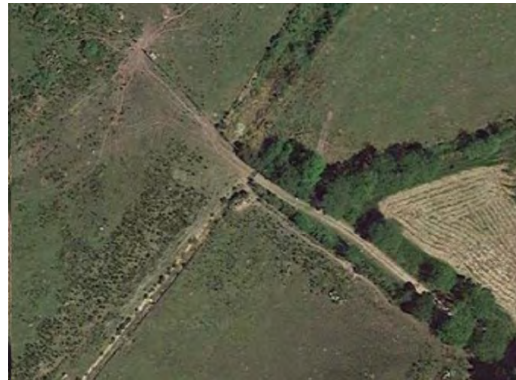
The route continues towards Afon Wen where it is crossed by two access tracks between adjacent pieces of land (**Obstruction Number – BA-06-02 and BA-06-03**).

Figure 11-28 – Access track crosses alignment  
Obstruction - BA-06-02

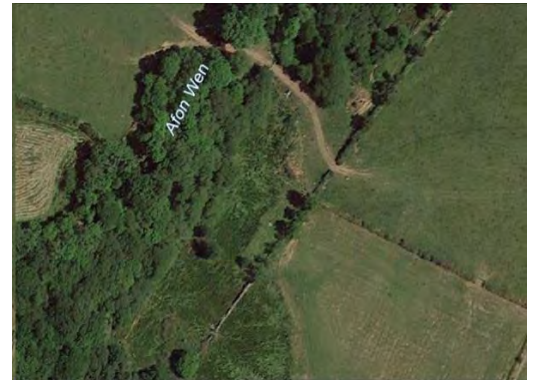
Figure 11-29 – Access track crosses alignment  
Obstruction – BA-06-03

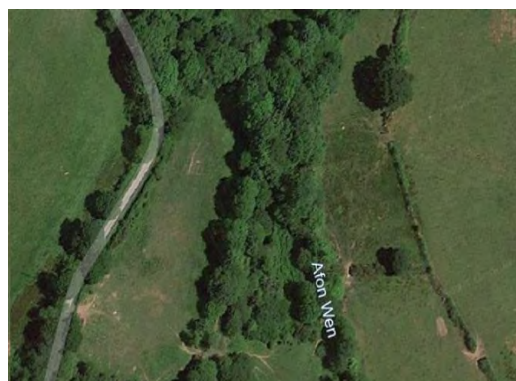
The alignment once again crosses over Afon Wen with a possible underbridge before being crossed by another access track shortly after. (**Obstruction Number – BA-06-04 and BA-06-05**)

Figure 11-30 – Possible Underbridge  
Obstruction - BA-06-04

| Obstruction Number | Works Required On Existing Alignment | Maintain Alignment | | Works Required On Alternative Alignment | Alternative Alignment | |
|---|---|---|---|---|---|---|
| <b>BA-06-04 Underbridge</b> | Undertake surveys and assessments, and undertake any repairs as required | Minimal | Minimal | | | |

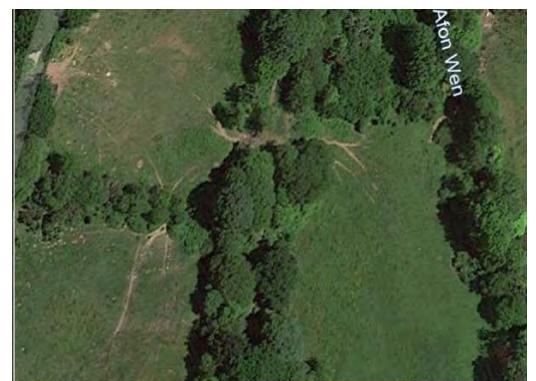
Figure 11-31 – Access track crosses alignment  
Obstruction – BA-06-05

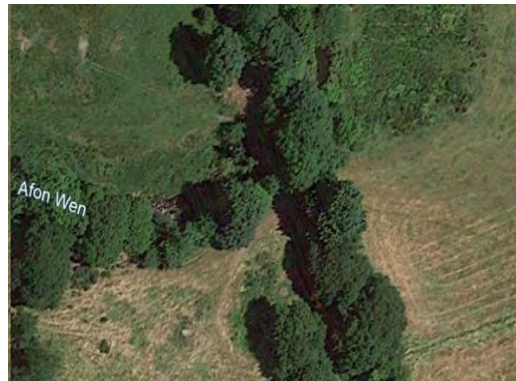
Before reaching the village of Chwilog the route passes over another two possible underbridges over the river and is crossed by another access track. (**Obstruction Number – BA-06-06, BA-07-01 and BA-07-02**)

Figure 11-32 – Access track crosses alignment  
Obstruction - BA-06-06

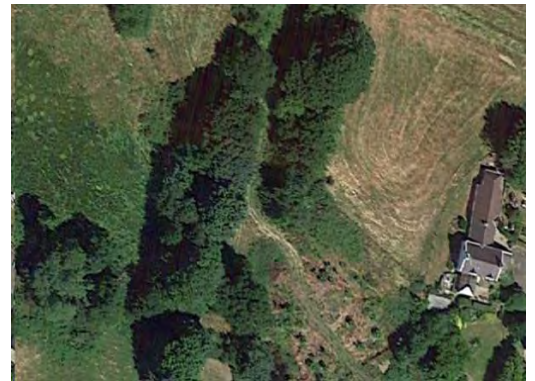
Figure 11-33 – Possible Underbridge  
Obstruction – BA-07-01

| Obstruction Number | Works Required On Existing Alignment | Maintain Alignment | | Works Required On Alternative Alignment | Alternative Alignment | |
|---|---|---|---|---|---|---|
| <b>BA-07-01 Underbridge</b> | Undertake surveys and assessments, and undertake any repairs as required | Minimal | Minimal | | | |

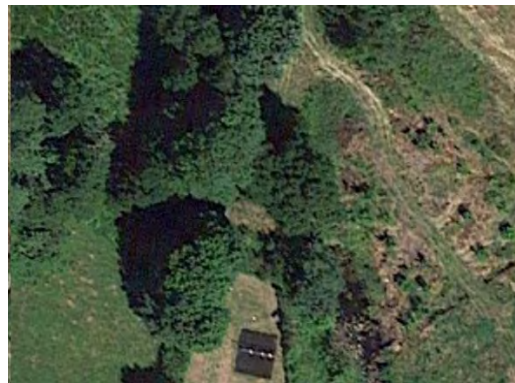
Figure 11-34 – Access track crosses alignment  
Obstruction - BA-07-02

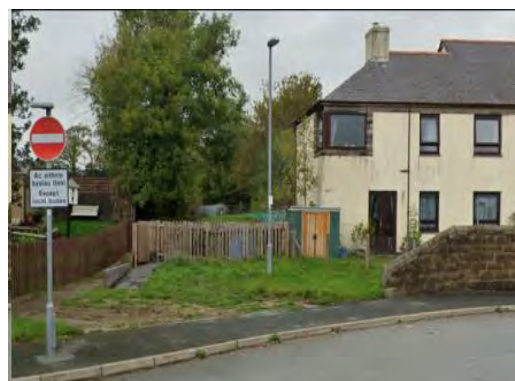
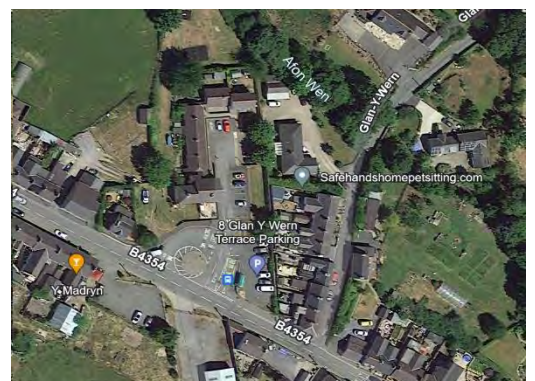
As the alignment enters the village of Chwilog it is met by several houses which have been built since the closure. (**Obstruction Number – BA-07-03**) This area of land was the location of the former Chwilog Station which had two sidings alongside the mainline however has since been removed. There does appear to be sufficient space alongside the houses however the alignment runs very close.

Figure 11-35 – Houses on alignment  
Obstruction - BA-07-03

Figure 11-36 – Houses on alignment  
Obstruction – BA-07-03

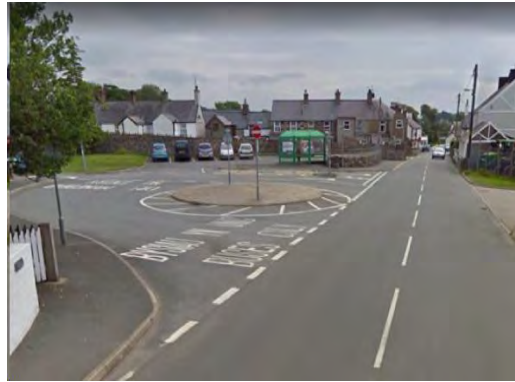
South of the former Chwilog station is the B4354 which was originally crossed with a level crossing that no longer exists and is now a bus turning area (**Obstruction Number**

– **BA-07-04**). On the southern side of the road the alignment has now been taken over by local business (**Obstruction Number – BA-07-05**).

Figure 11-37 – B4354 crosses alignment  
Obstruction - BA-07-04

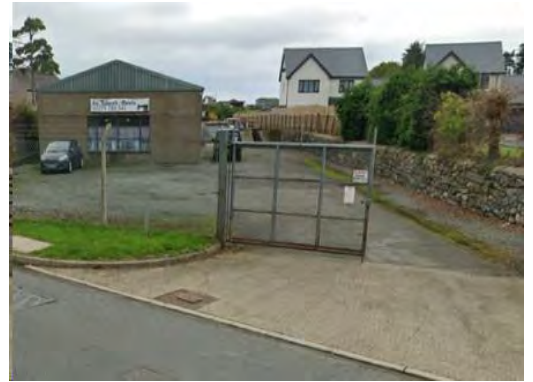
Figure 11-38 – Local businesses on alignment  
Obstruction – BA-07-05

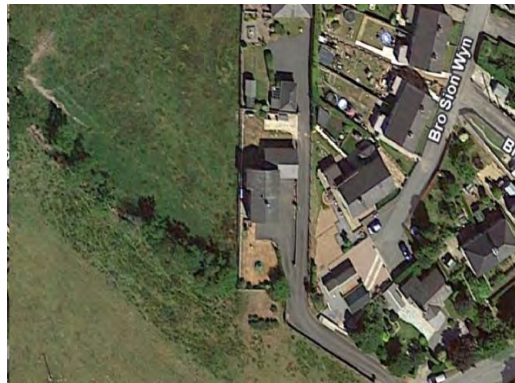
Continuing towards Afon Wen several houses have been built on the alignment . (**Obstruction Number – BA-07-06**). The route then passes by Ocean Heights Caravan Park and is crossed by its access road. (**Obstruction Number – BA-07-07**)

Figure 11-39 – Houses on alignment  
Obstruction - BA-07-06

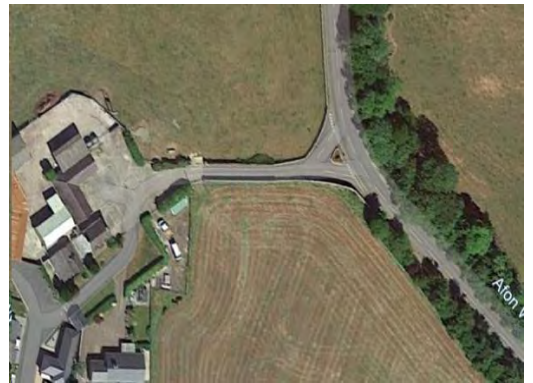
Figure 11-40 – Access Road crosses alignment  
Obstruction – BA-07-07

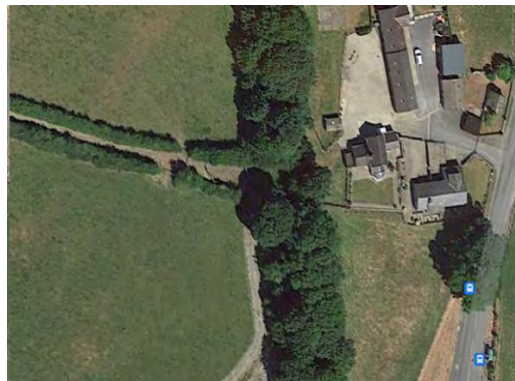
Before reaching the mainline the alignment is crossed by an access road to a nearby farm (**Obstruction Number – BA-07-08**) and then main A497 road (**Obstruction Number – BA-08-01**).

Figure 11-41 – Access track crosses alignment  
Obstruction - BA-07-08

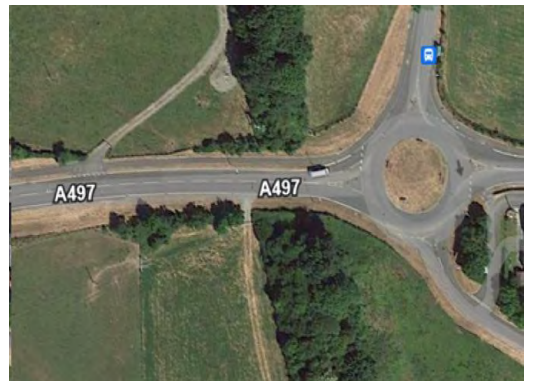
Figure 11-42 – A497 crosses alignment  
Obstruction – BA-08-01

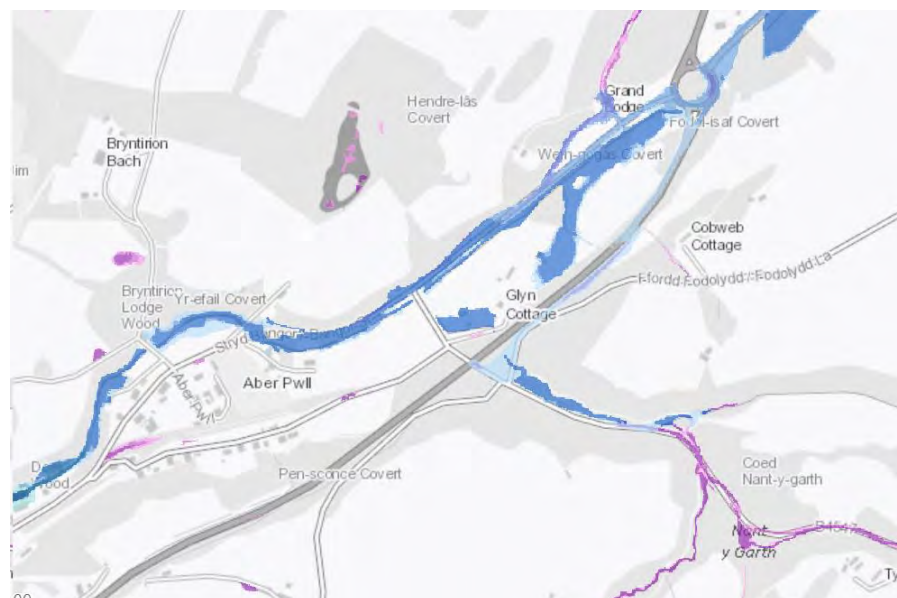
The area located between the Vaynol tunnels and east of Felinheli has been identified as being at high risk of flooding from the nearby river. The alternative route runs along Afon Heulyn and is likely to be impacted by flooding.

Figure 12-11 – Map showing Flood Risk East of Felinheli

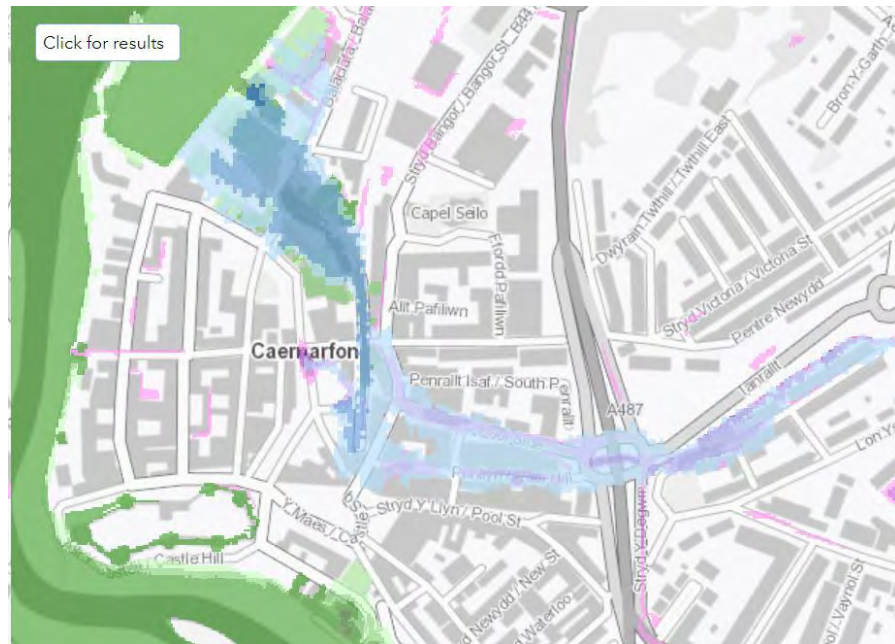
The centre of Caernarfon had been identified as a medium risk of flooding in particular the area around Crown Street and Caernarfon Tunnel.

Figure 12-12 – Map showing Flood Risk in Caernarfon Centre

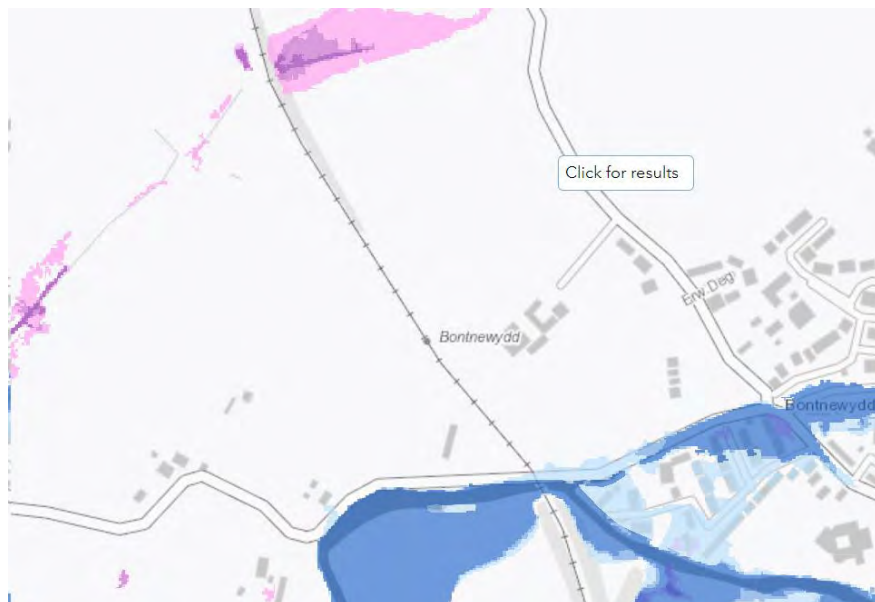
The area around Bontnewydd has two locations at high risk of flooding in particular surface water from Bontnewydd Bypass and high risk of flooding from Afon Gwryfai.

Figure 12-13 – Map showing Flood Risk at Bontnewydd

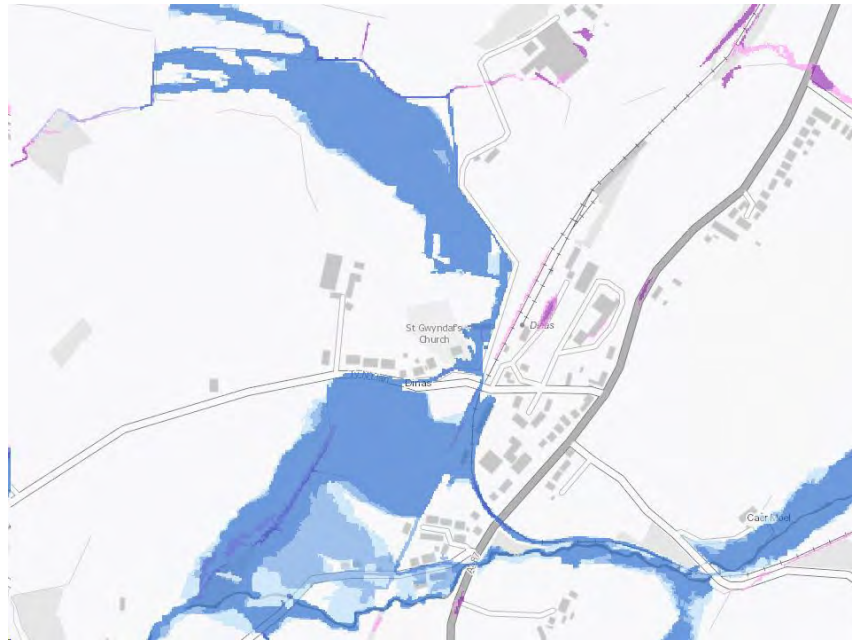
The area to the west of Dinas is highlighted as having a high risk of flooding from a river. The alignment passes through a section of this and will need to be investigated at a later date to understand ground conditions.

Figure 12-14 – Map showing Flood Risk at Dinas
