Bro Tathan East Building 354 External & Internal Visual Condition Survey

| Report Ref: | PR01 | Created | 19/06/24 |

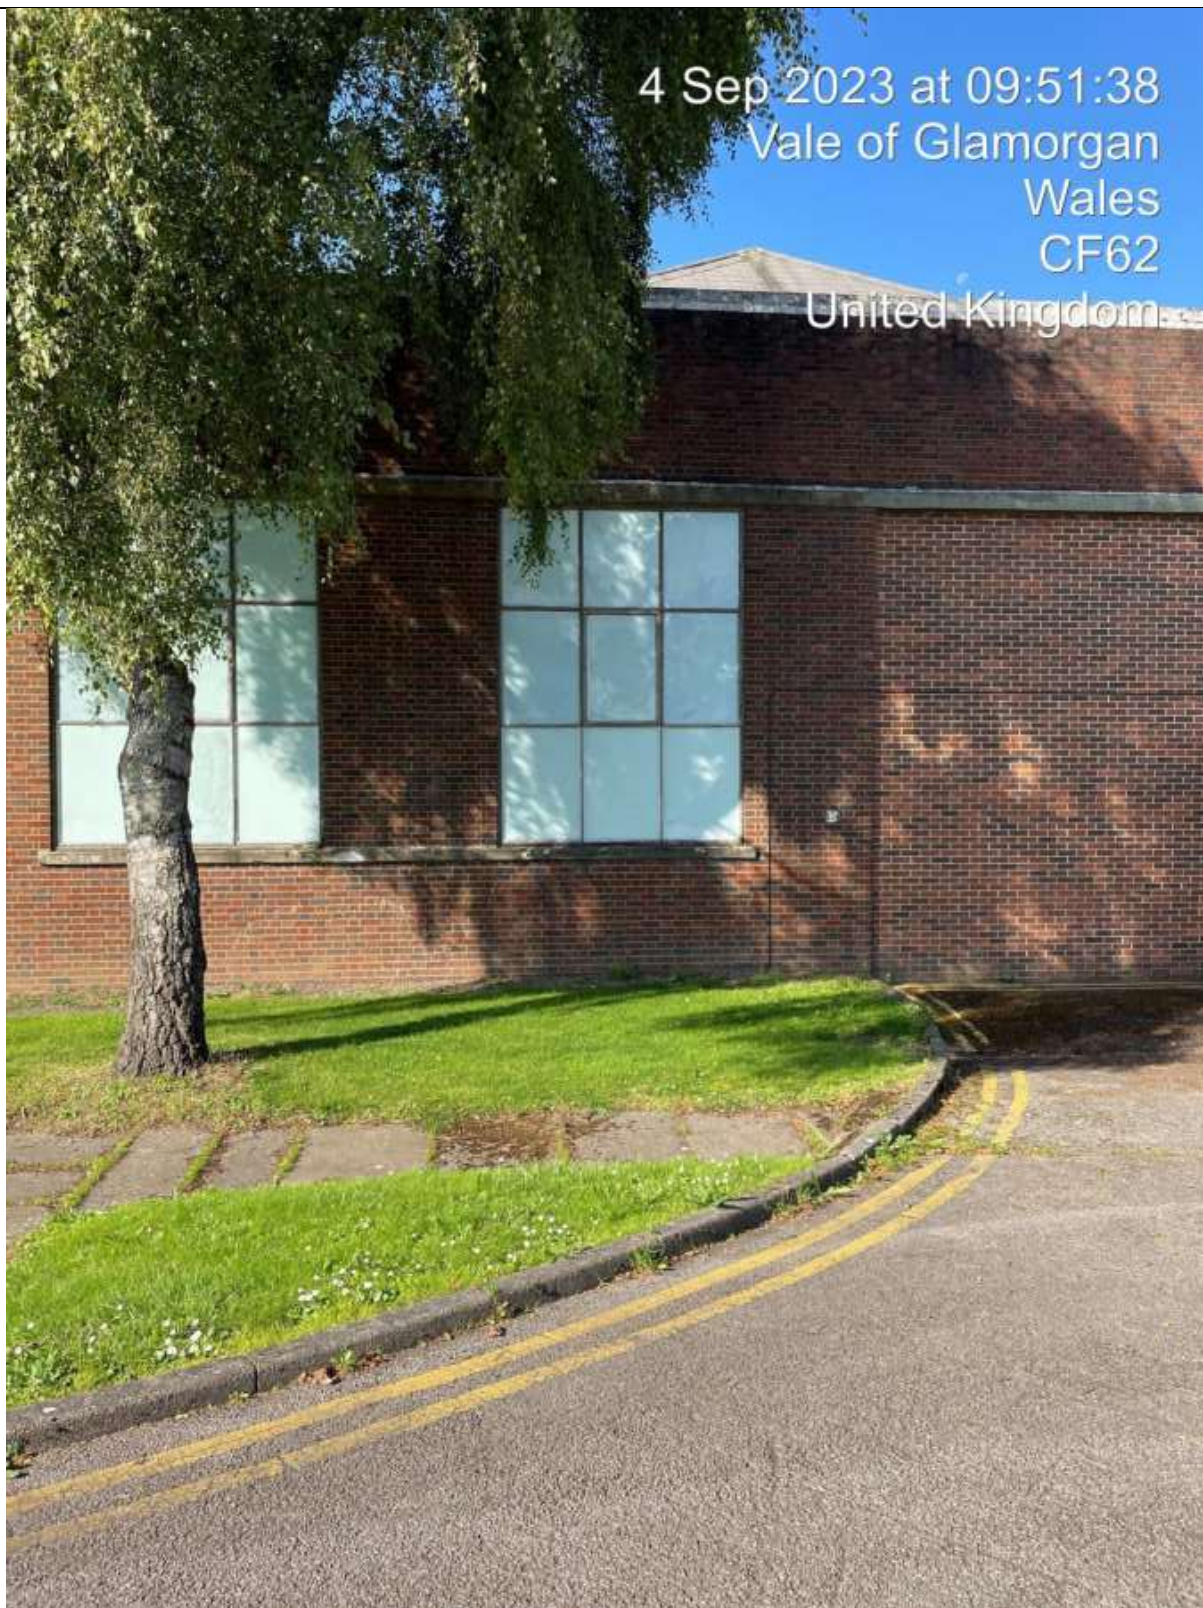
**Eastern Elevation. Original Fenestration.**

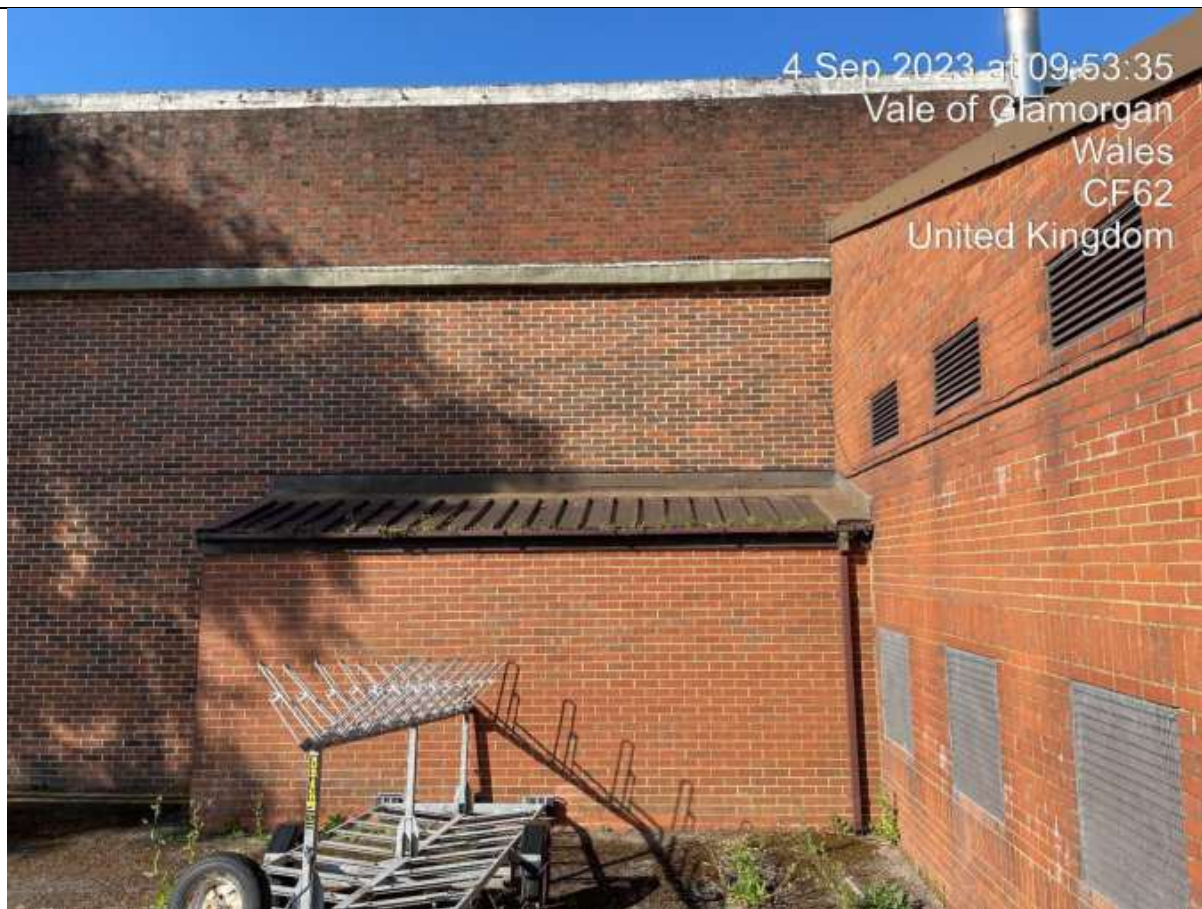
**Eastern Elevation. Non-Original Plant Room Addition.**

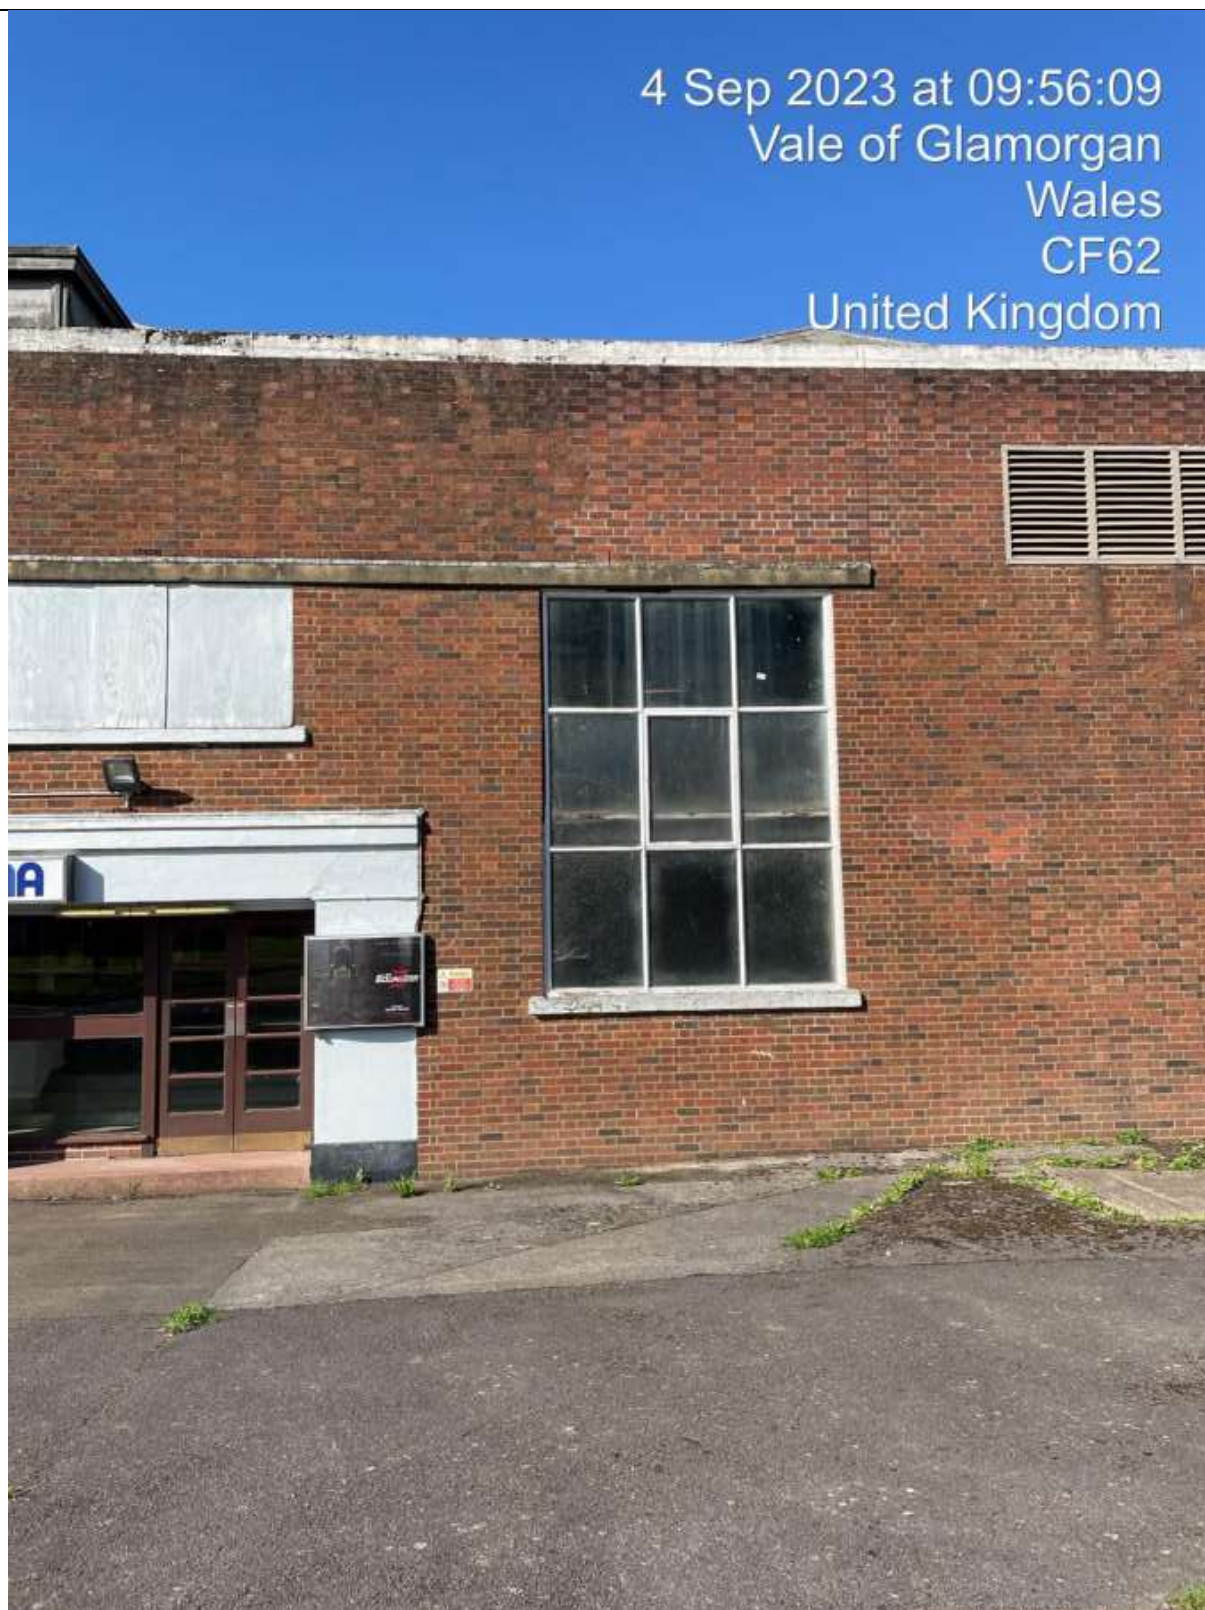
**Eastern Elevation. Replacement Fenestration.**

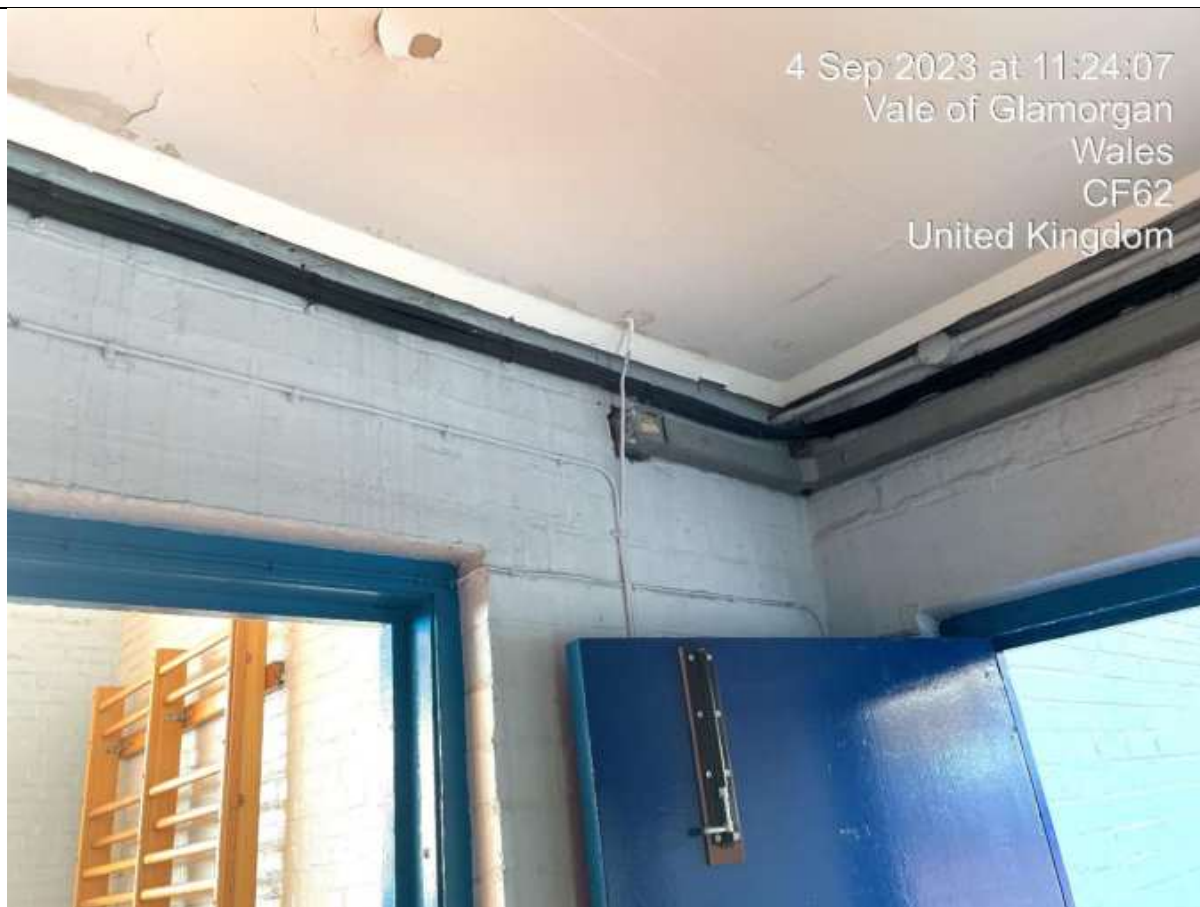
**Non-Compliant Fire Compartmentation, Service Penetrations & Ceiling Panelling that is suspected of having Asbestos Content of which the Condition is Considered Poor.**

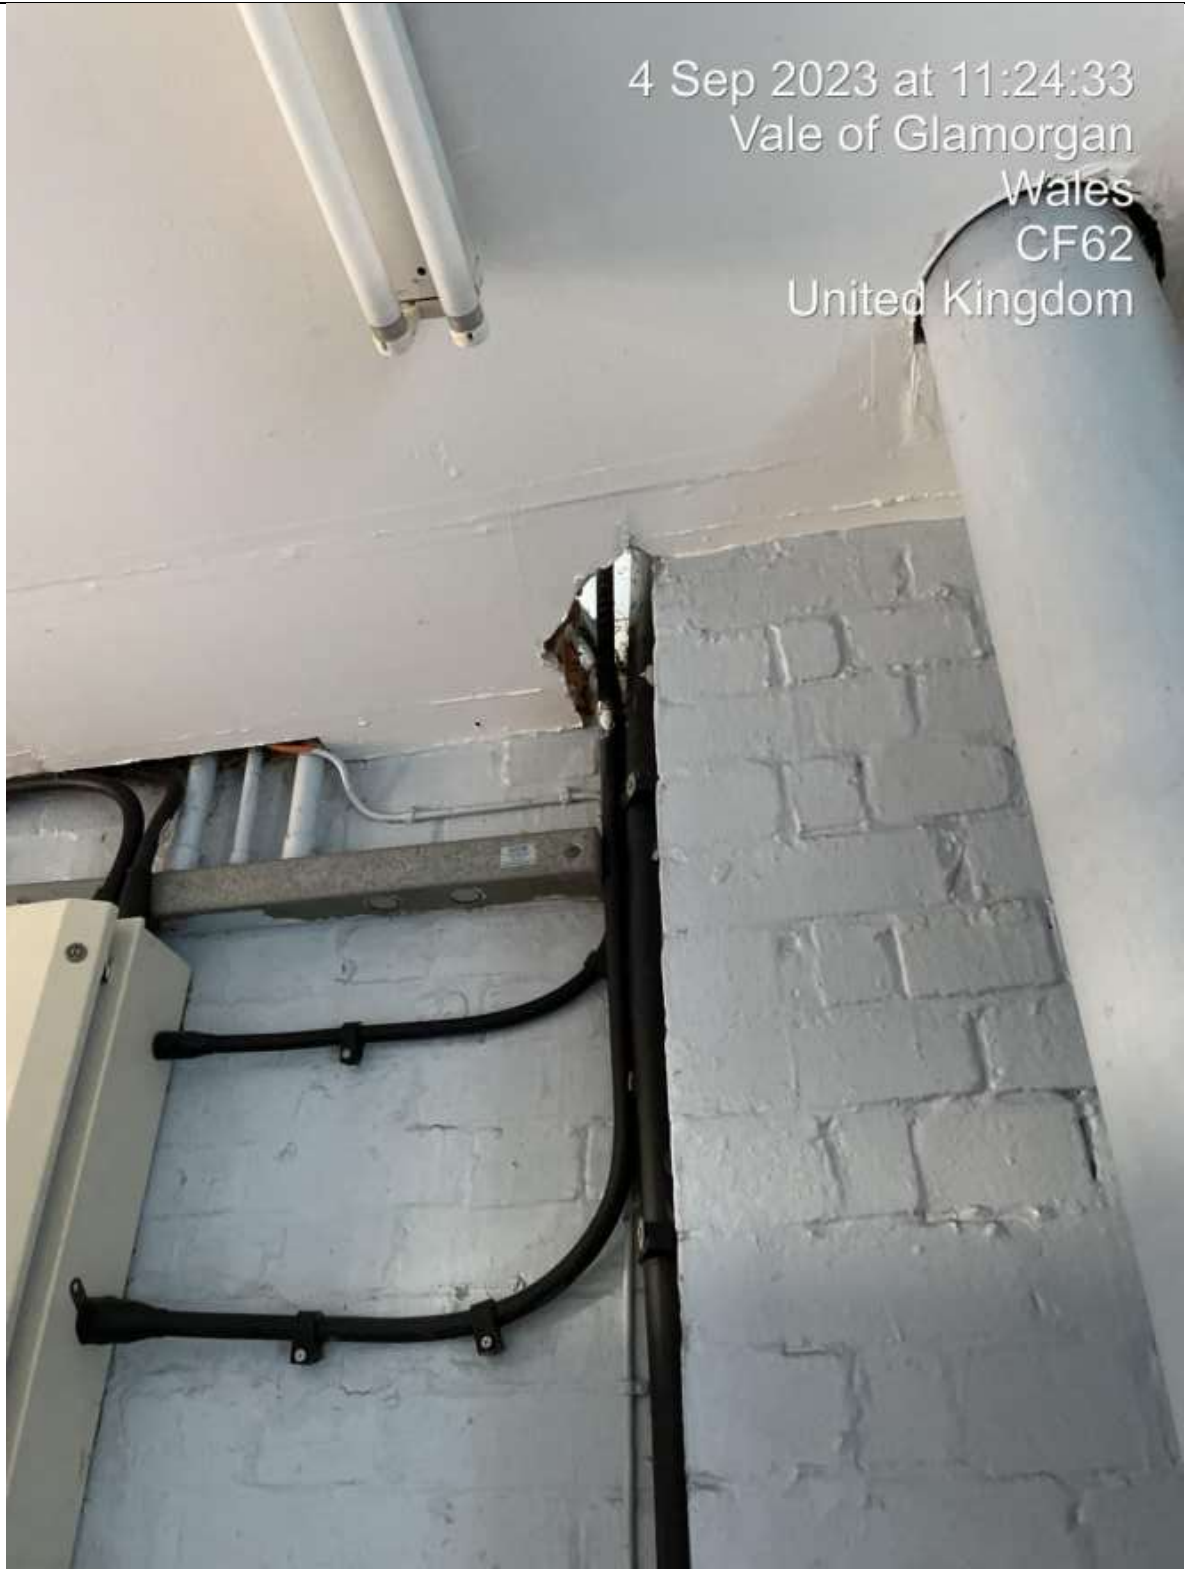
**Unprotected Service Penetrations & Ceiling Panelling that is suspected of having Asbestos Content of which the Condition is Considered Poor.**

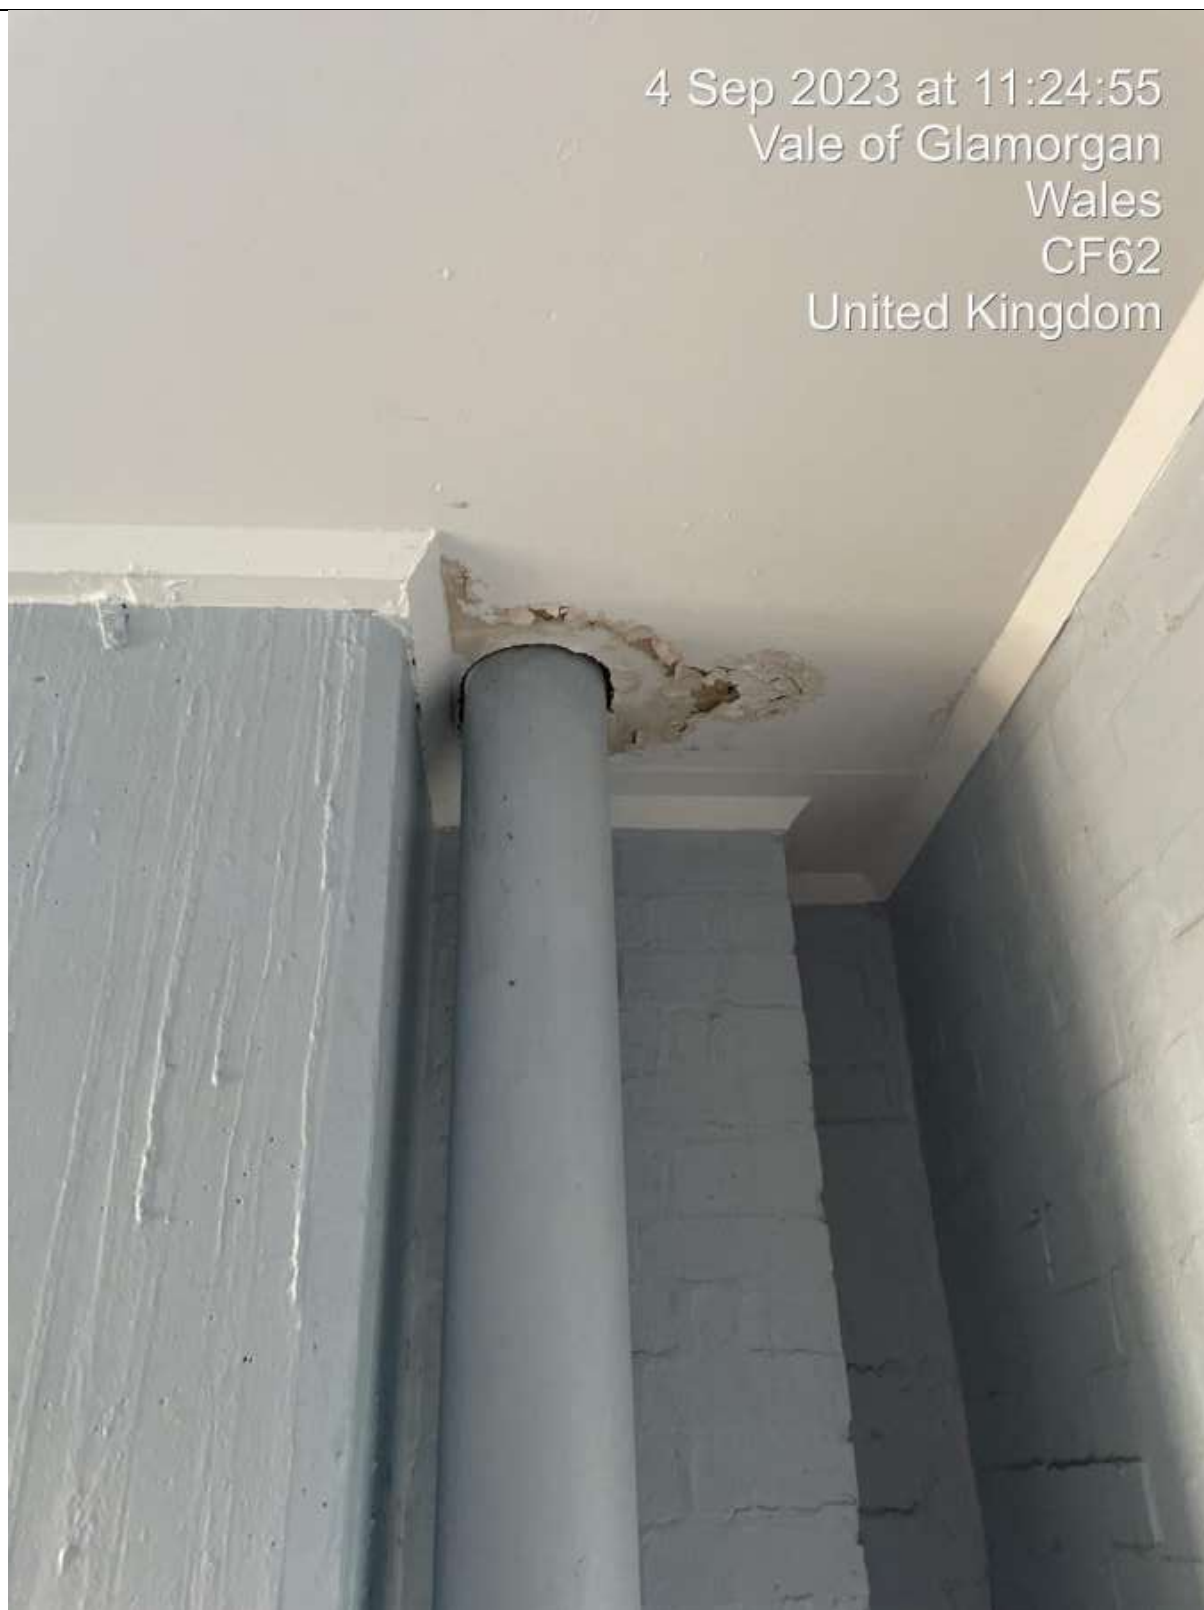
**Penetrating Damp.**

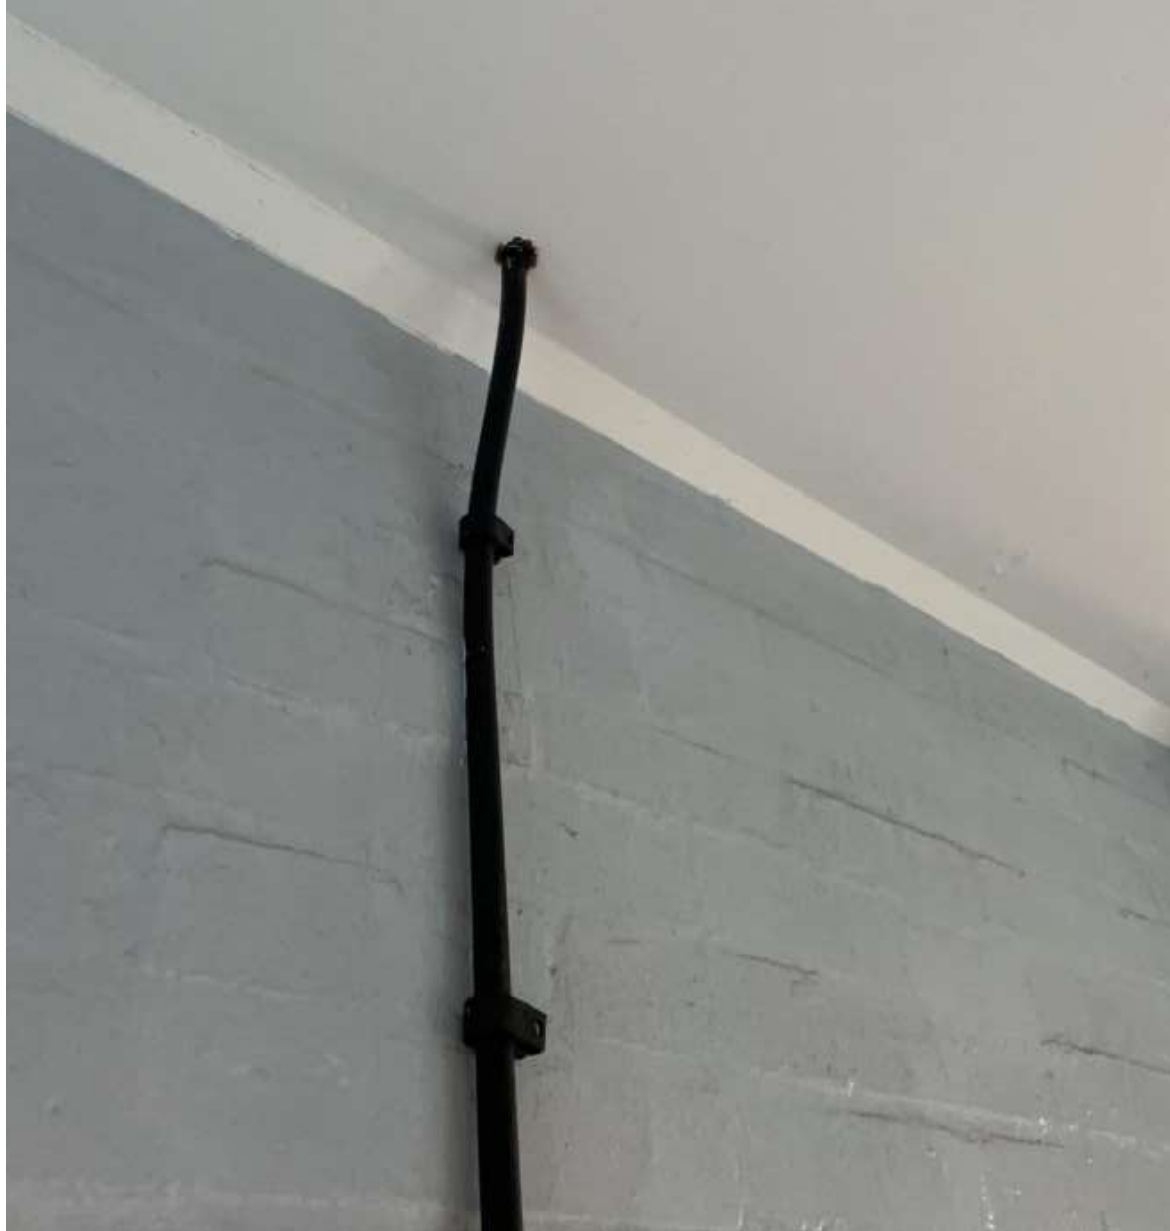
**Unprotected Service Penetration & Ceiling Panelling that is suspected of having Asbestos Content of which the Condition is Considered Poor.**

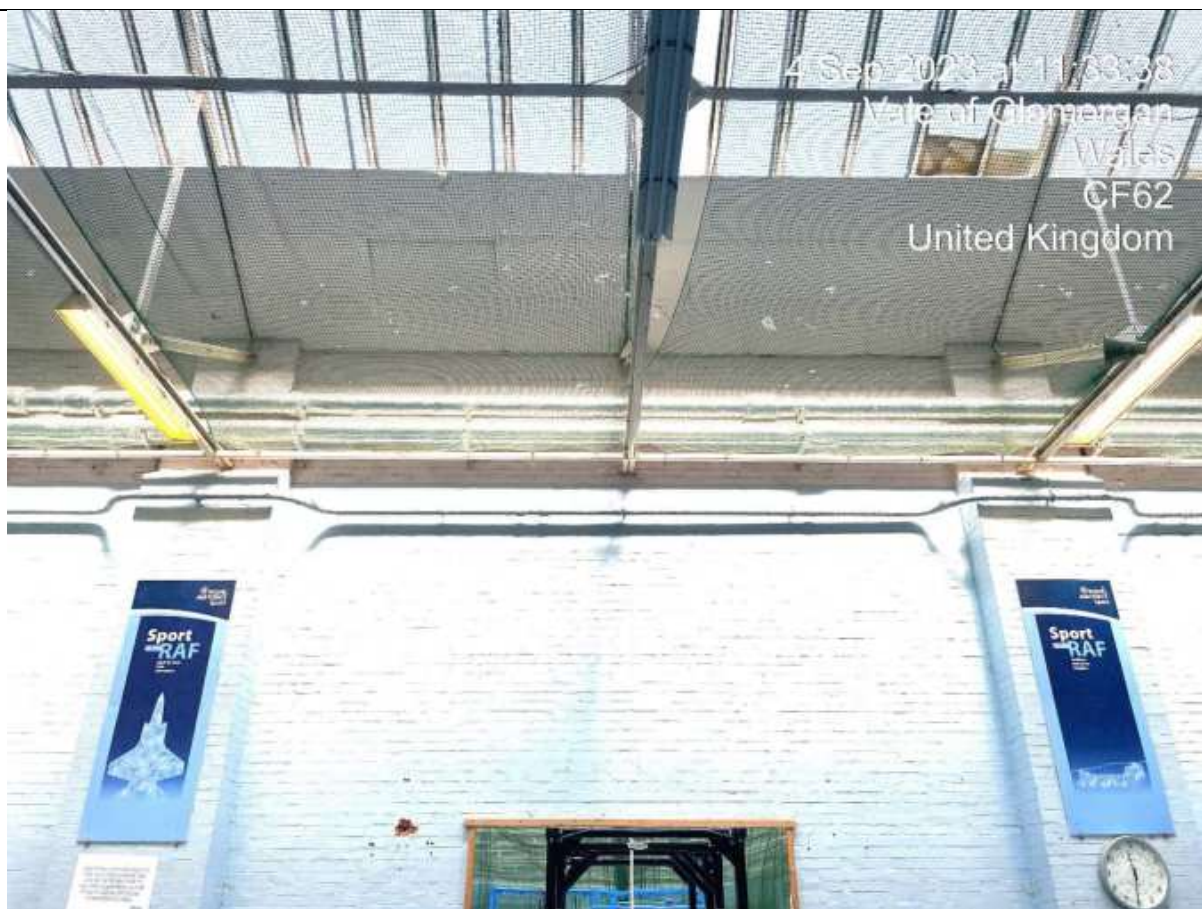
**Slipped Roof Lights.**

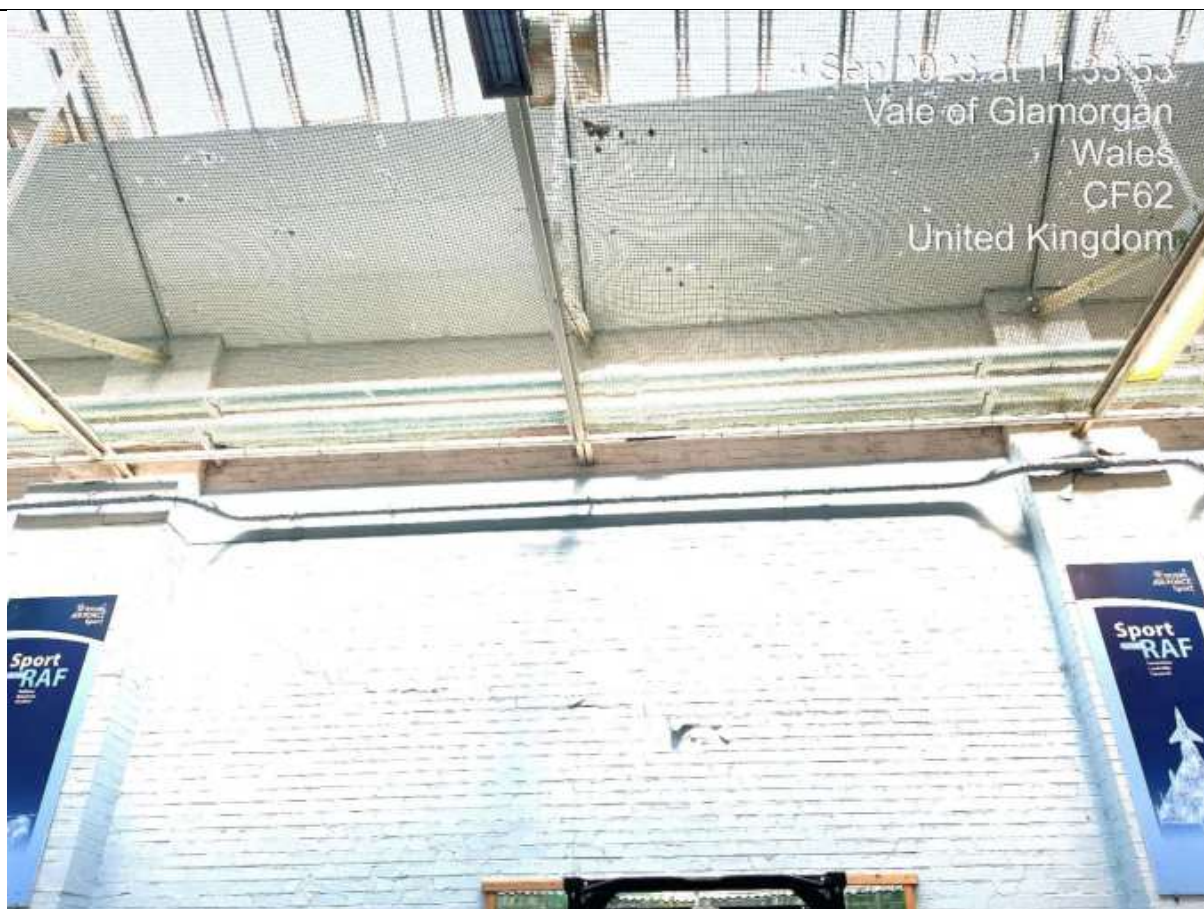
**Penetrating Damp.**

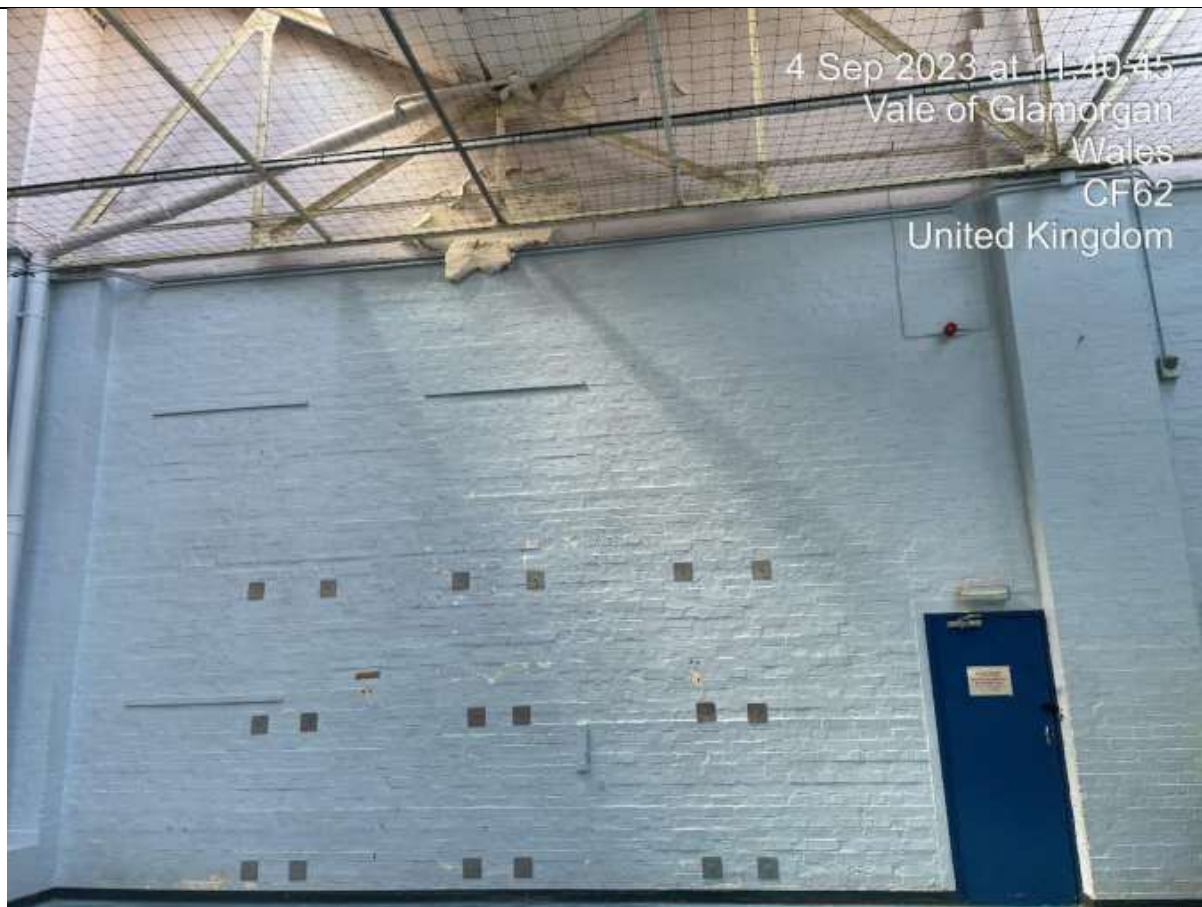
**Penetrating Damp.**

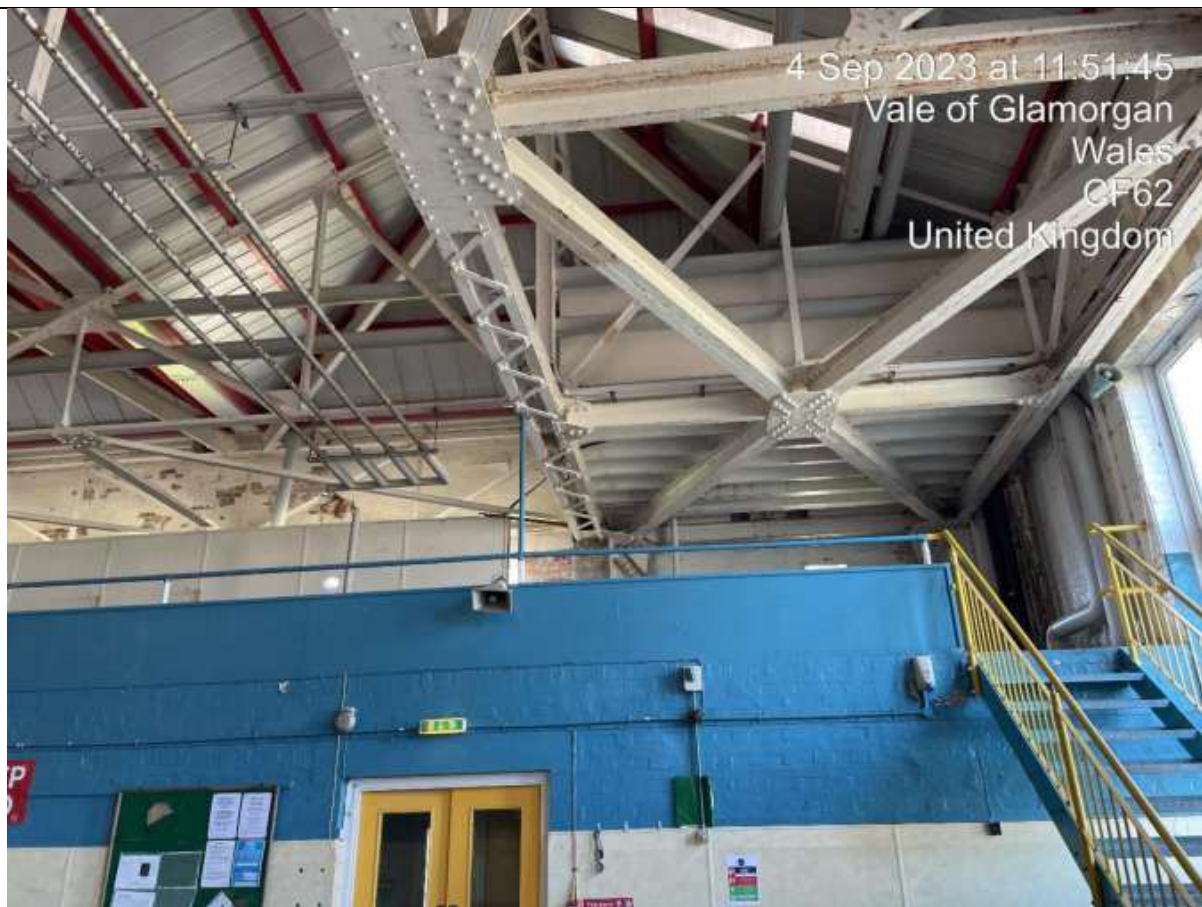
**Corrosion to Steel Roof Frame & Penetrating Damp.**
